Standing Building Survey  
Pleasance Road Tannery, Coupar Angus  
Perth and Kinross

Pleasance Road Tannery buildings from the south

5th May 2013

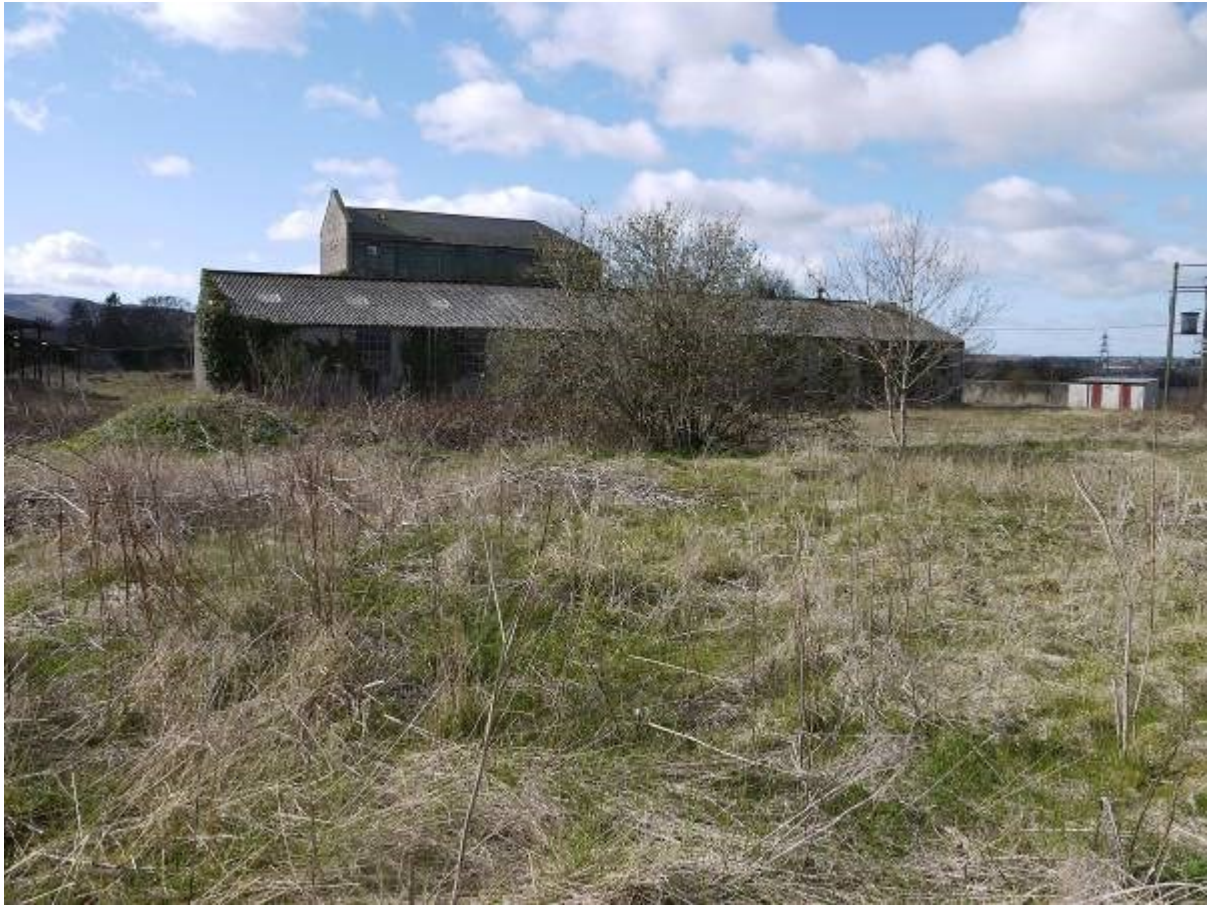
Illustration 4 general view of northern side of site showing Building E with top of Building A just visible looking south

The area to the north of Building E is grassed over, there are concrete surfaces on the western and southern sides of Building E and an access road running around its northern side and there are traces of former metalled surfaces between Buildings A and E and Buildings C and A.

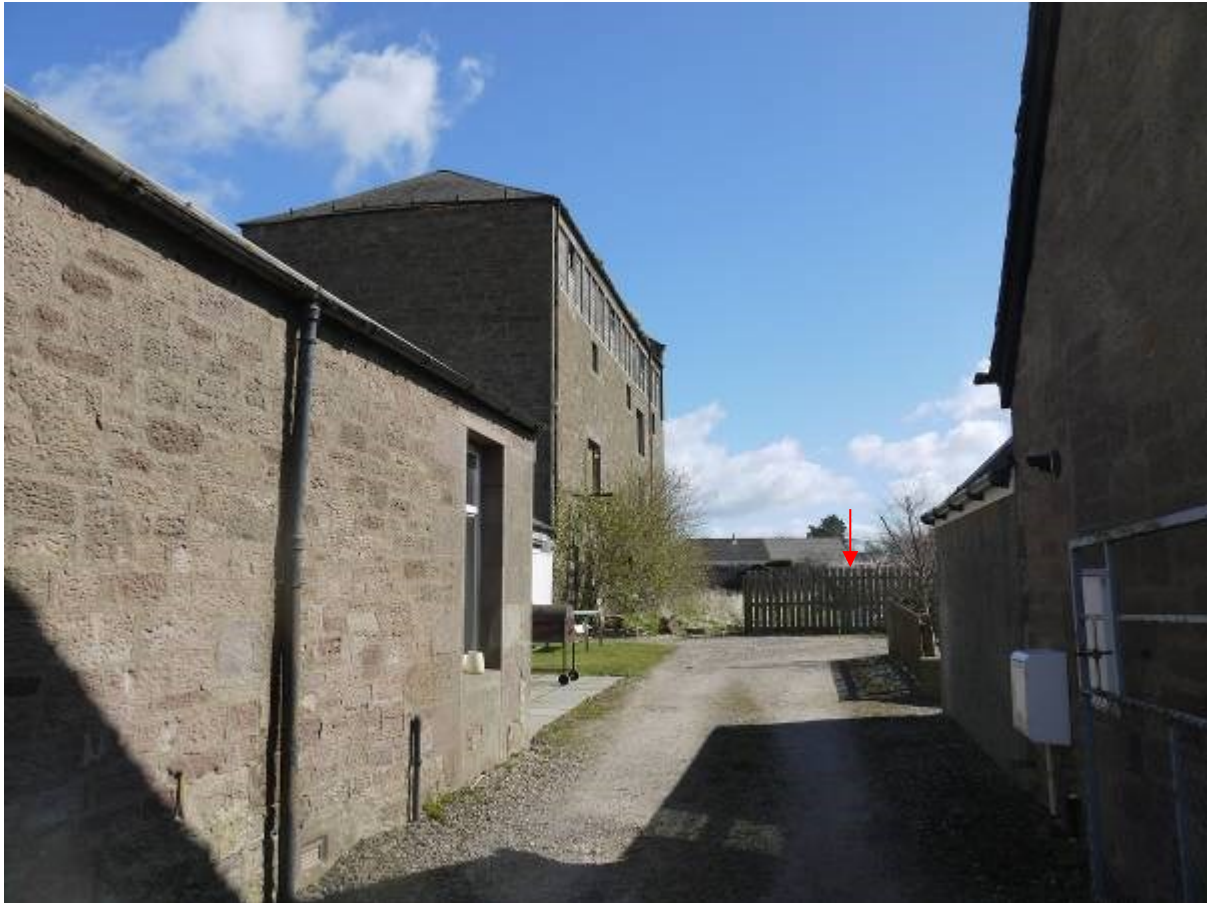
Illustration 6 General view of southern sides of Buildings B and A and location of Building C (at red arrow) looking east

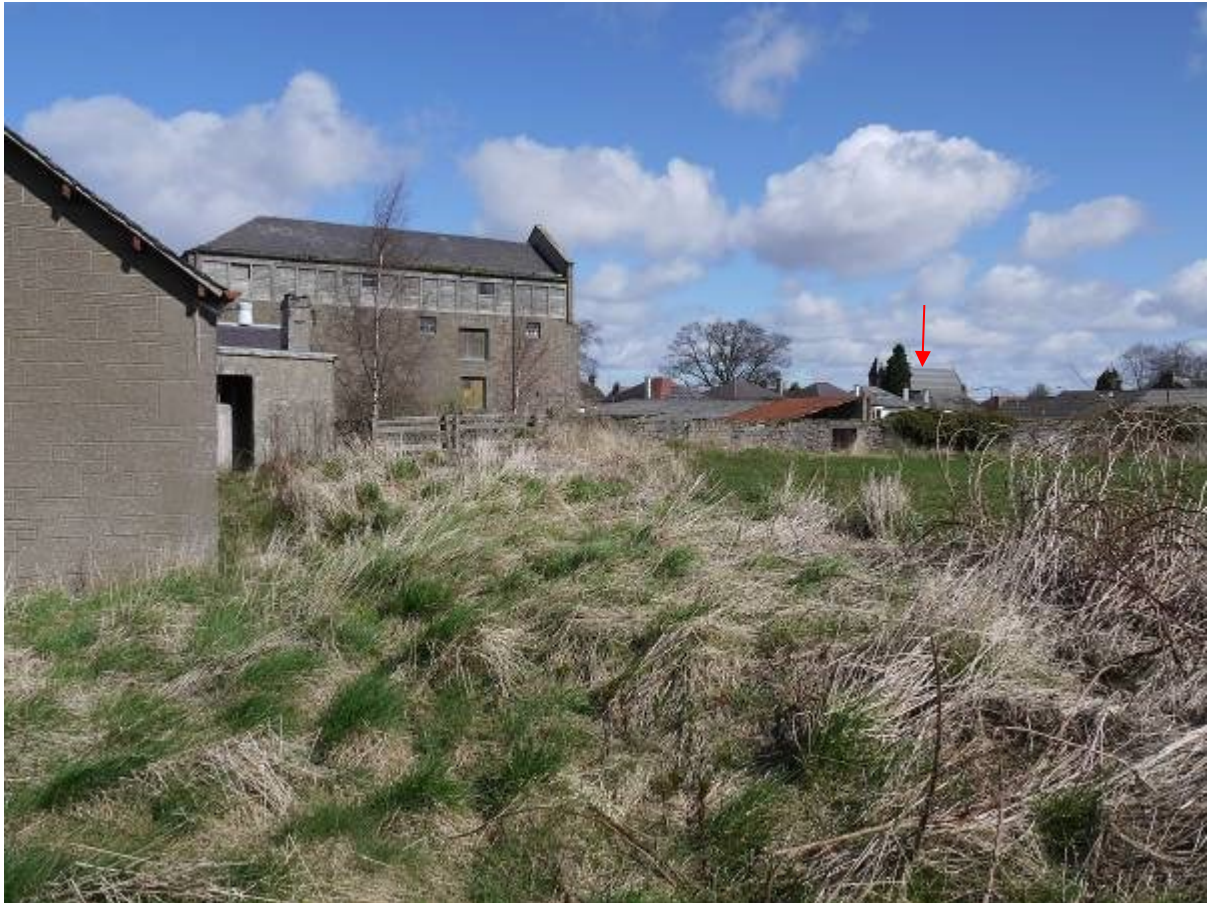
Illustration 7 General view of Building A and site from the south, Abbey Church marked by red arrow

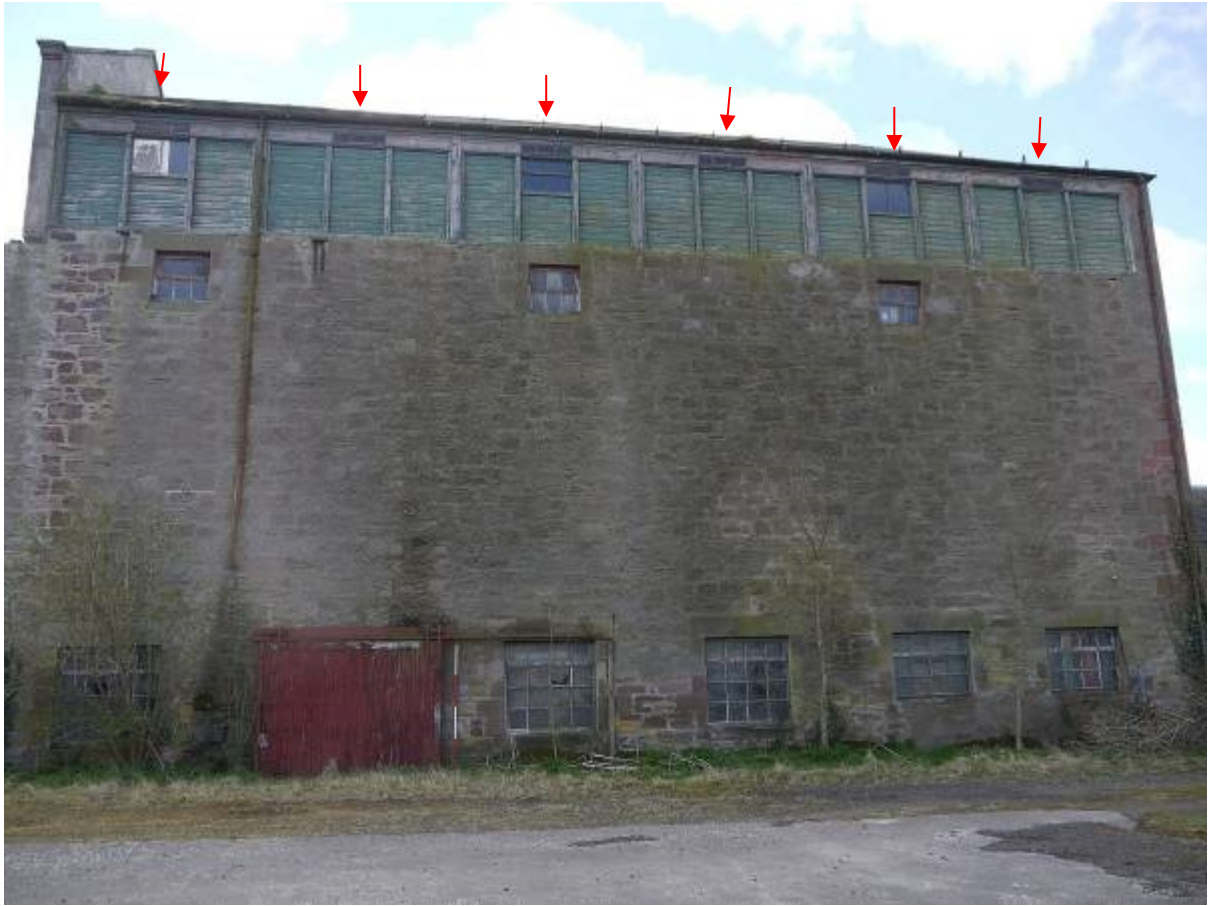
At ground floor level there are five windows and a sliding wooden door. At first floor level there are three slightly smaller windows. At the top floor level there are three small windows and six skylights/louvers.

Illustration 9 northern elevation of Building A (louvers at top floor level marked with red arrows)

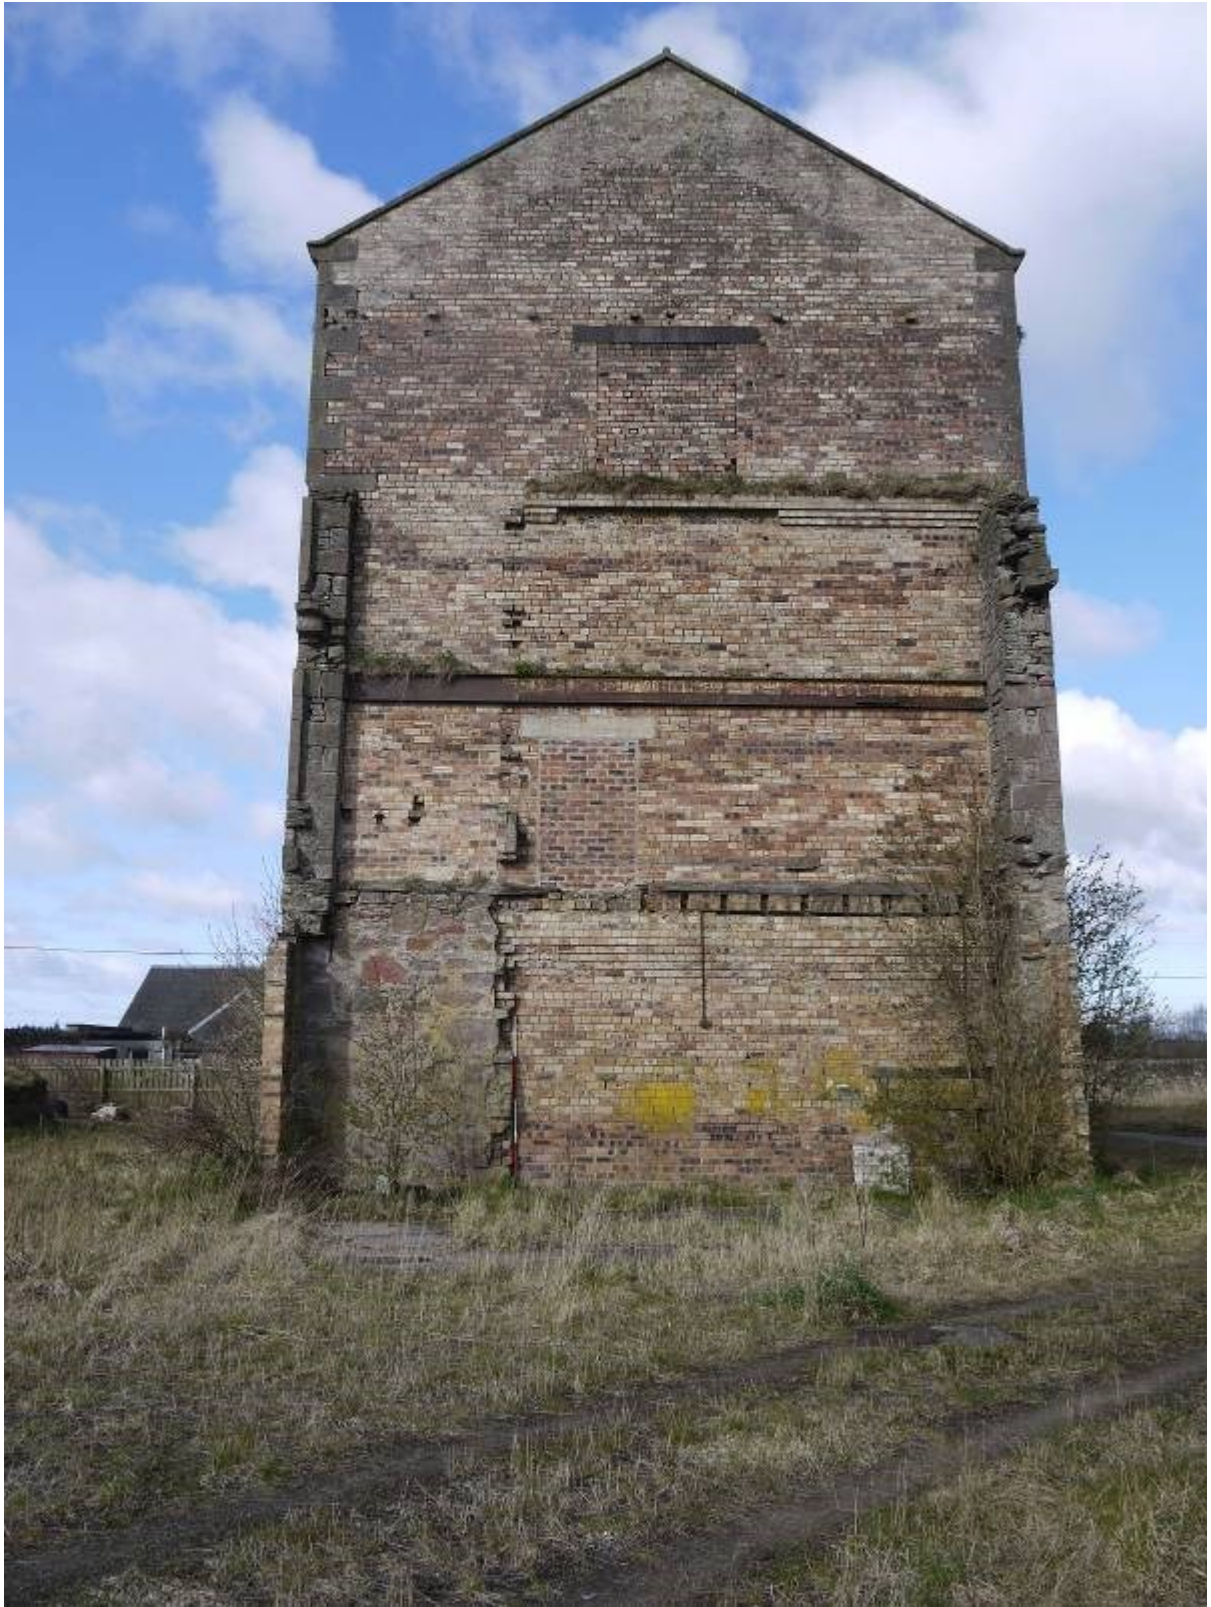
The western end of Building A has been demolished at some point in the past and this elevation is a section through the building. The ground floor, first and second floor levels have all been blocked with brick walls and blocked doorways are visible at first and second floor level. A steel girder is visible running across the building just above the lintel of the doorway at first floor level.

Illustration 10 eastern elevation of Building A

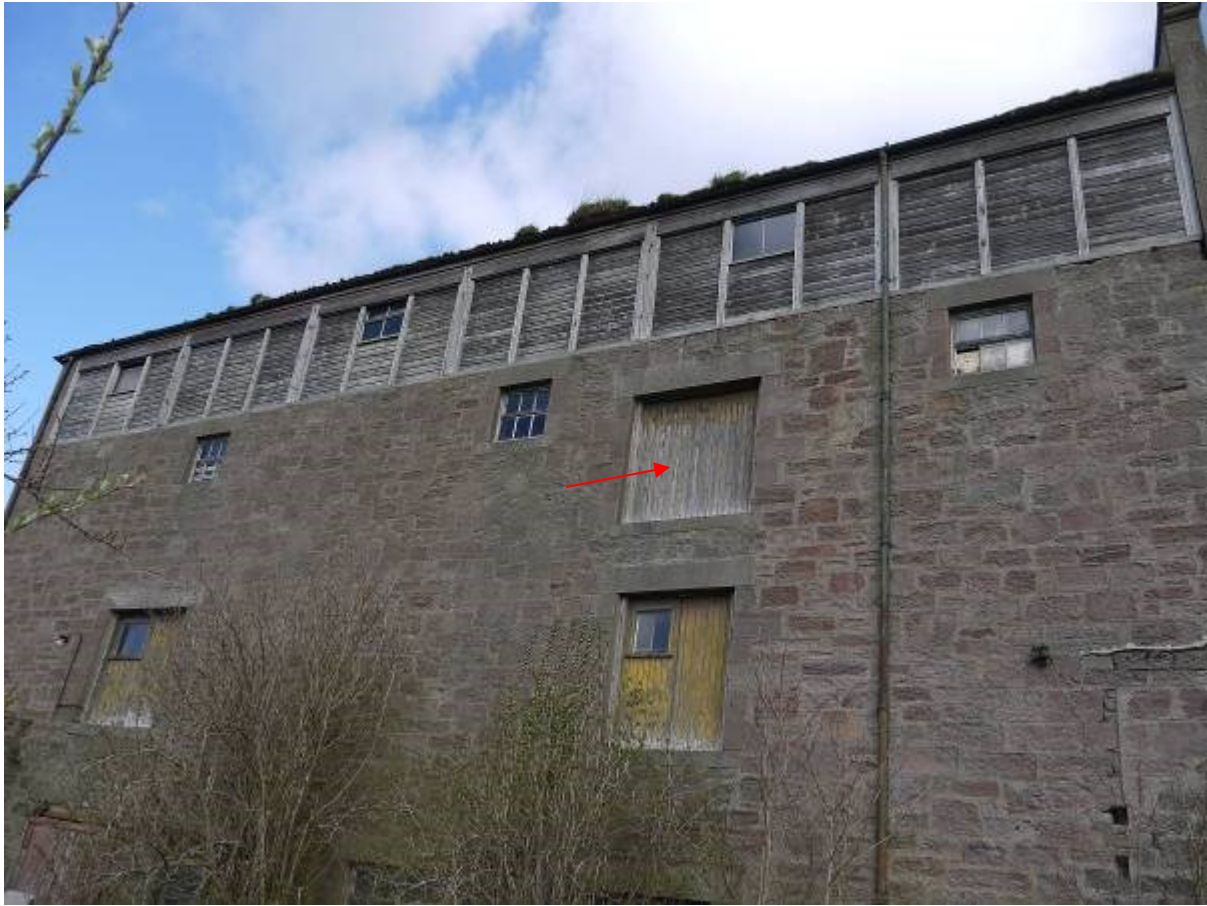
At ground floor level there are four windows and there is a sliding door at the western end of this elevation. At first floor level there are two wooden doors with small windows and then above that another wooden door and three small windows. At top floor level there are three small windows.

Illustration 11 southern elevation of Building A, red arrow indicates door in front of chute on first floor (see Illus 18)

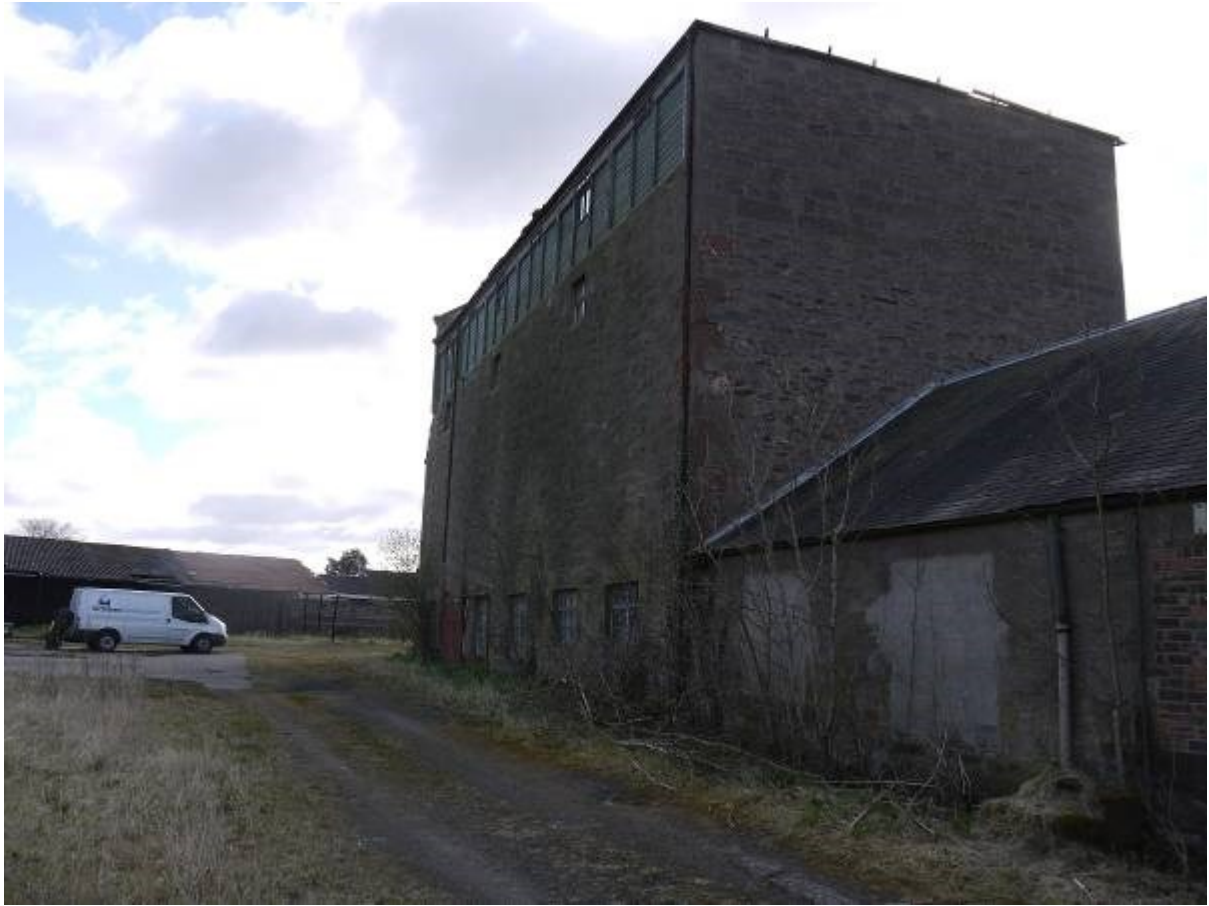
This elevation is plain and has Building B built against it.

Illustration 12 western elevation of Building A at junction with Building B

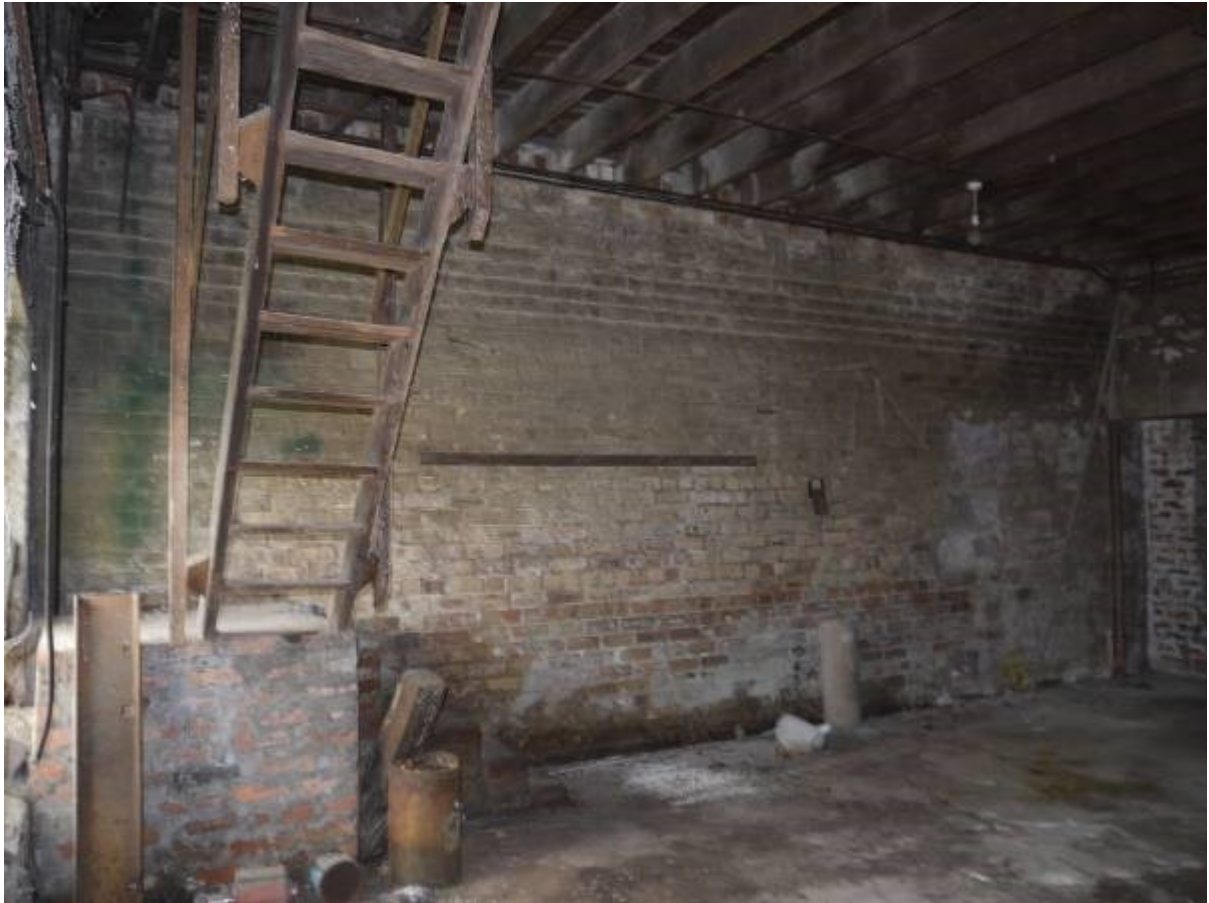
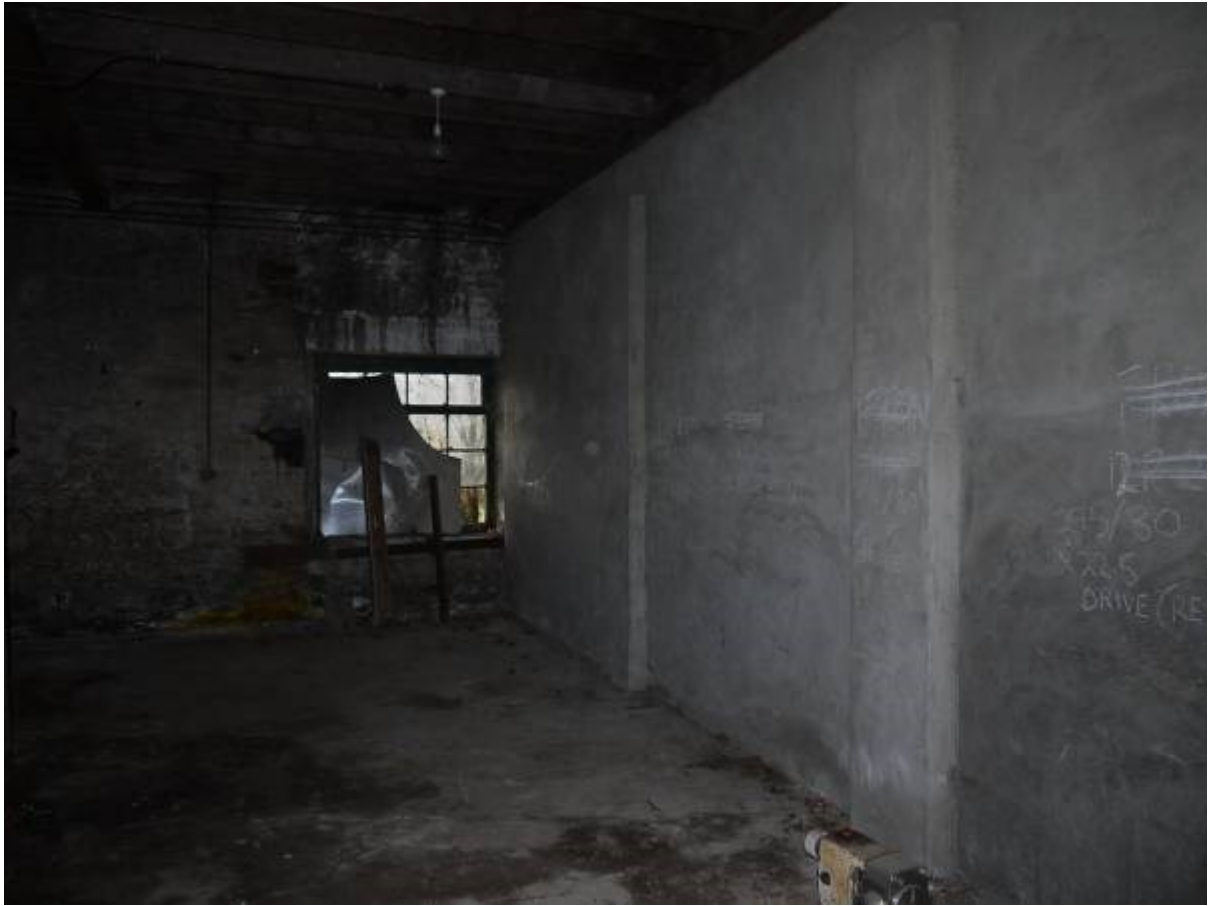
This has a concrete floor and a set of steps in its north eastern corner which lead up to a wooden stair which leads up to the first floor. Its eastern elevation is built of brick and its western elevation is built of concrete.

Illustration 13 Ground floor of Building A accessible from north side showing wooden stair to first floor

Illustration 14 western side of ground floor of Building A accessible from north

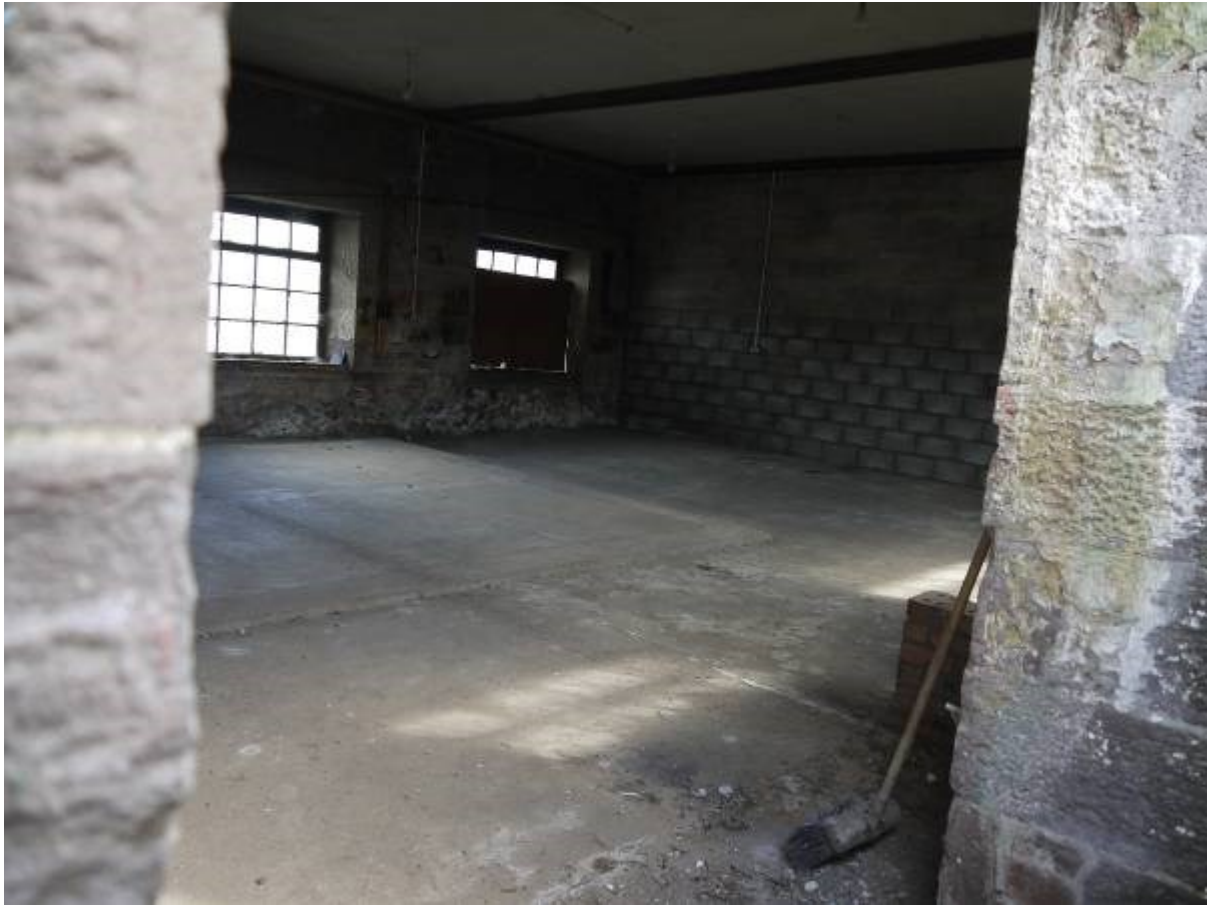
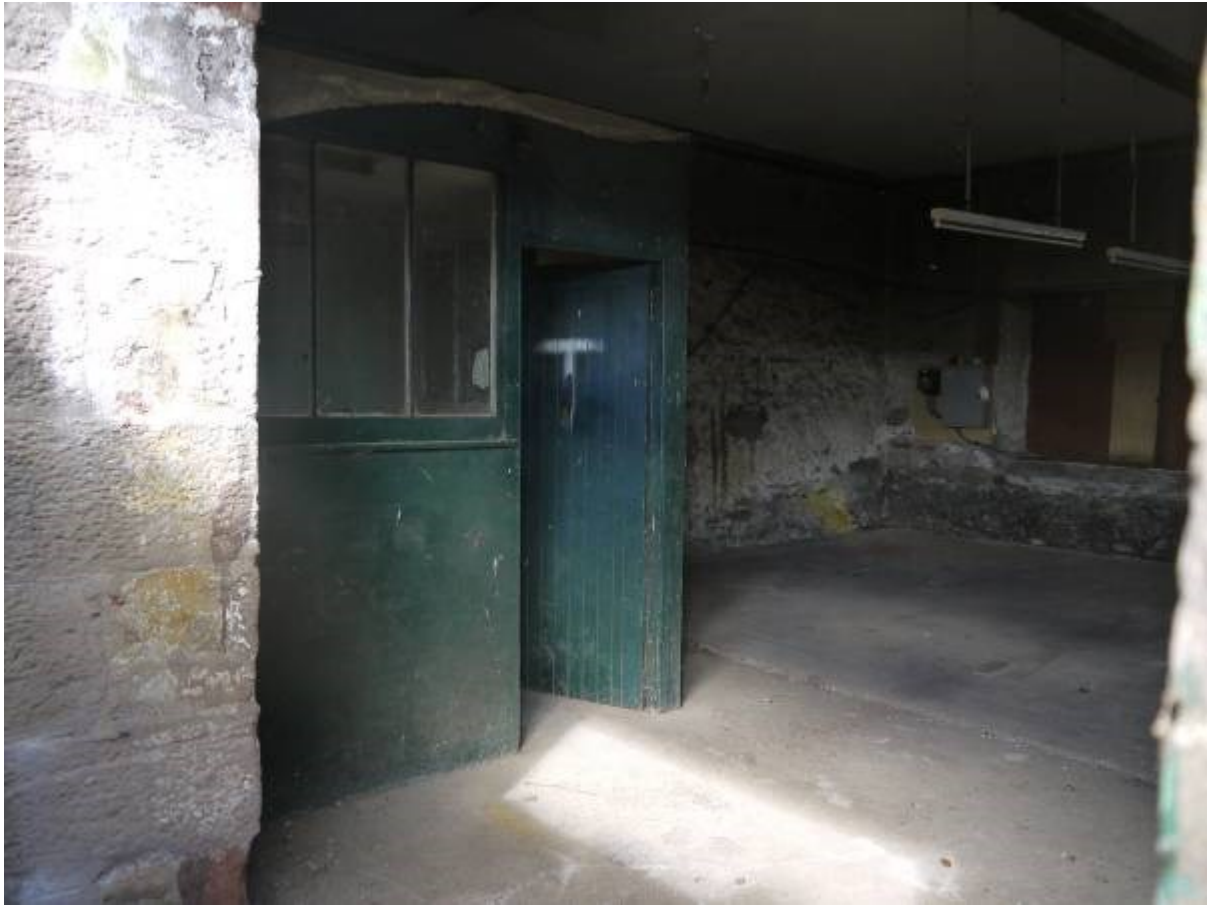
This has a concrete floor and a small wooden office building in its south western corner. Its eastern elevation is built of concrete breeze blocks and its western one is stone. There is no visible access to the first floor.

Illustration 15 Ground floor of Building A accessible from south

Illustration 16 Ground floor of Building A accessible from south showing office building

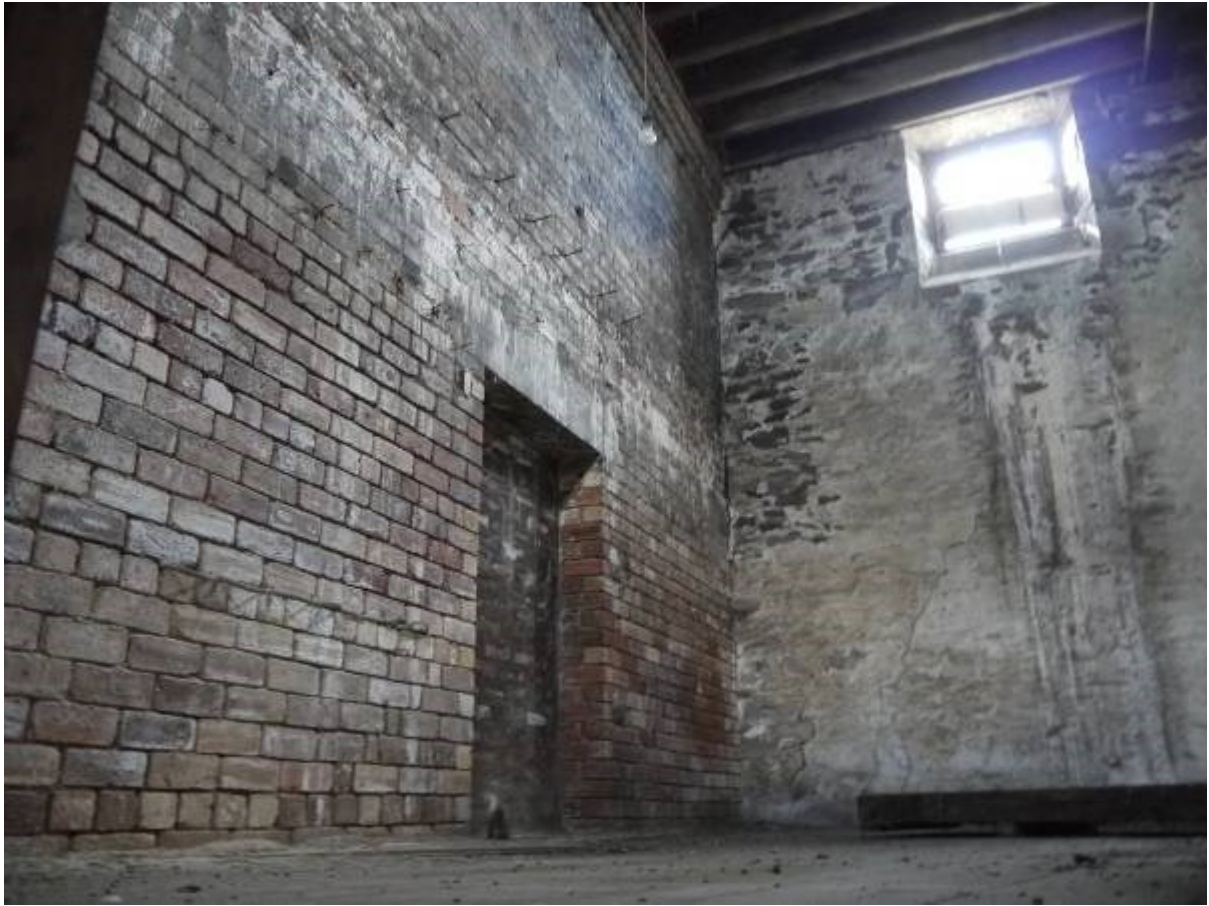
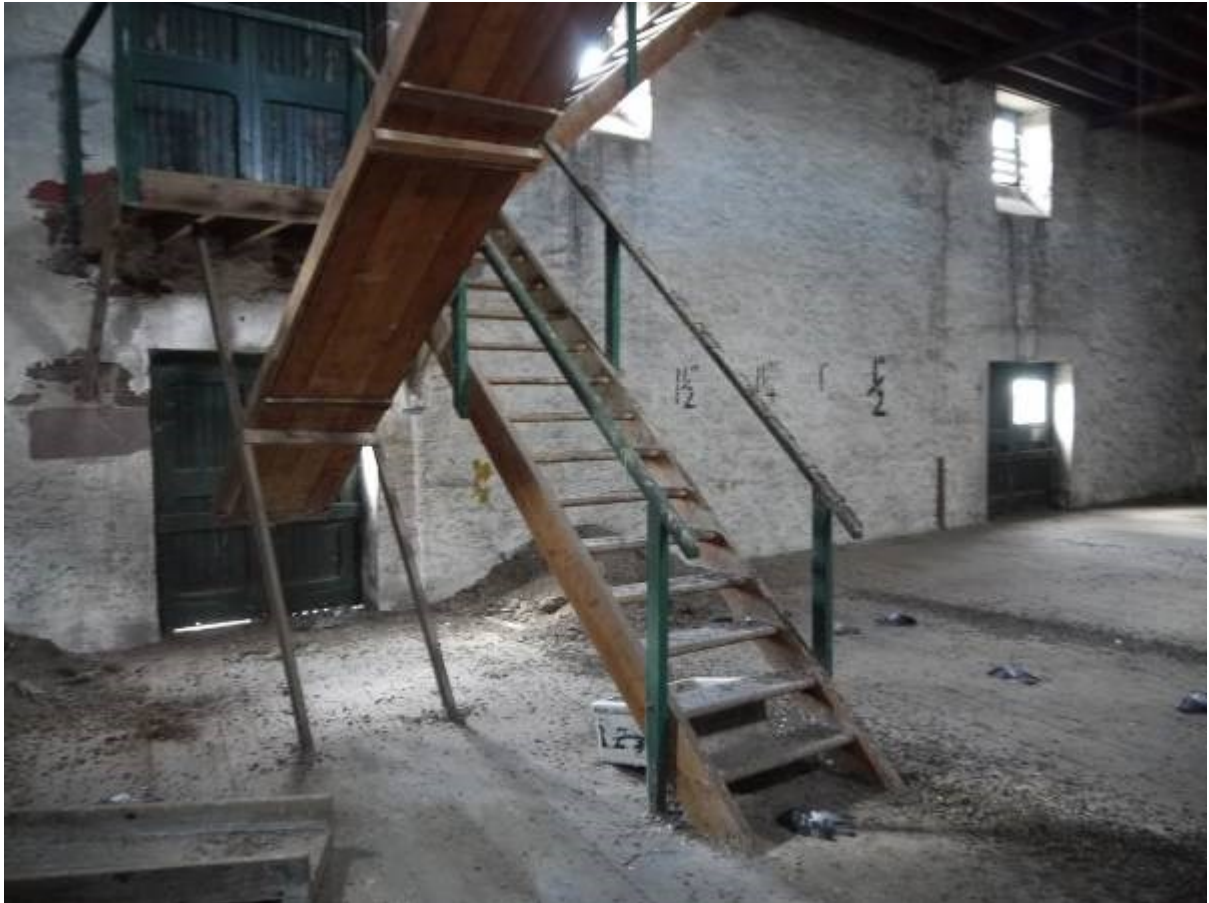
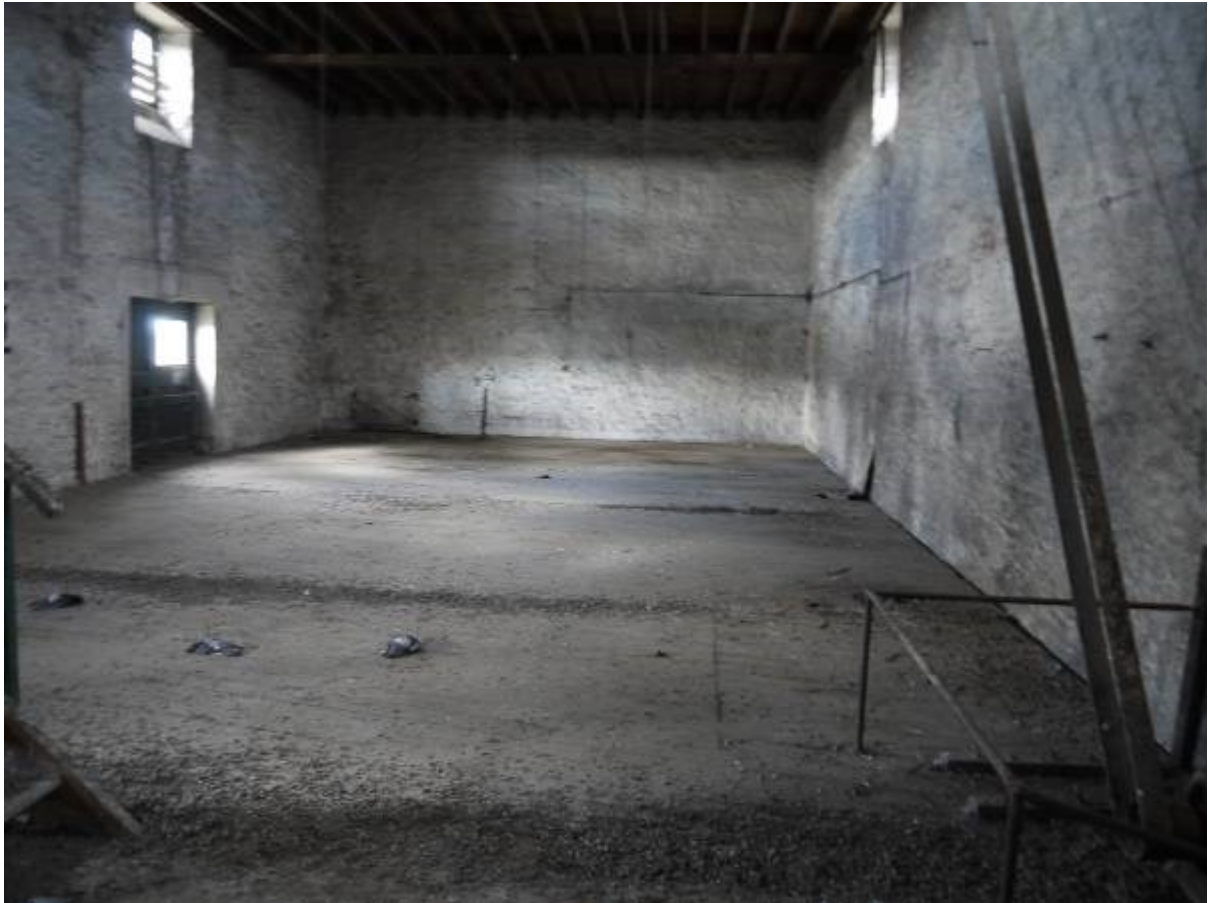
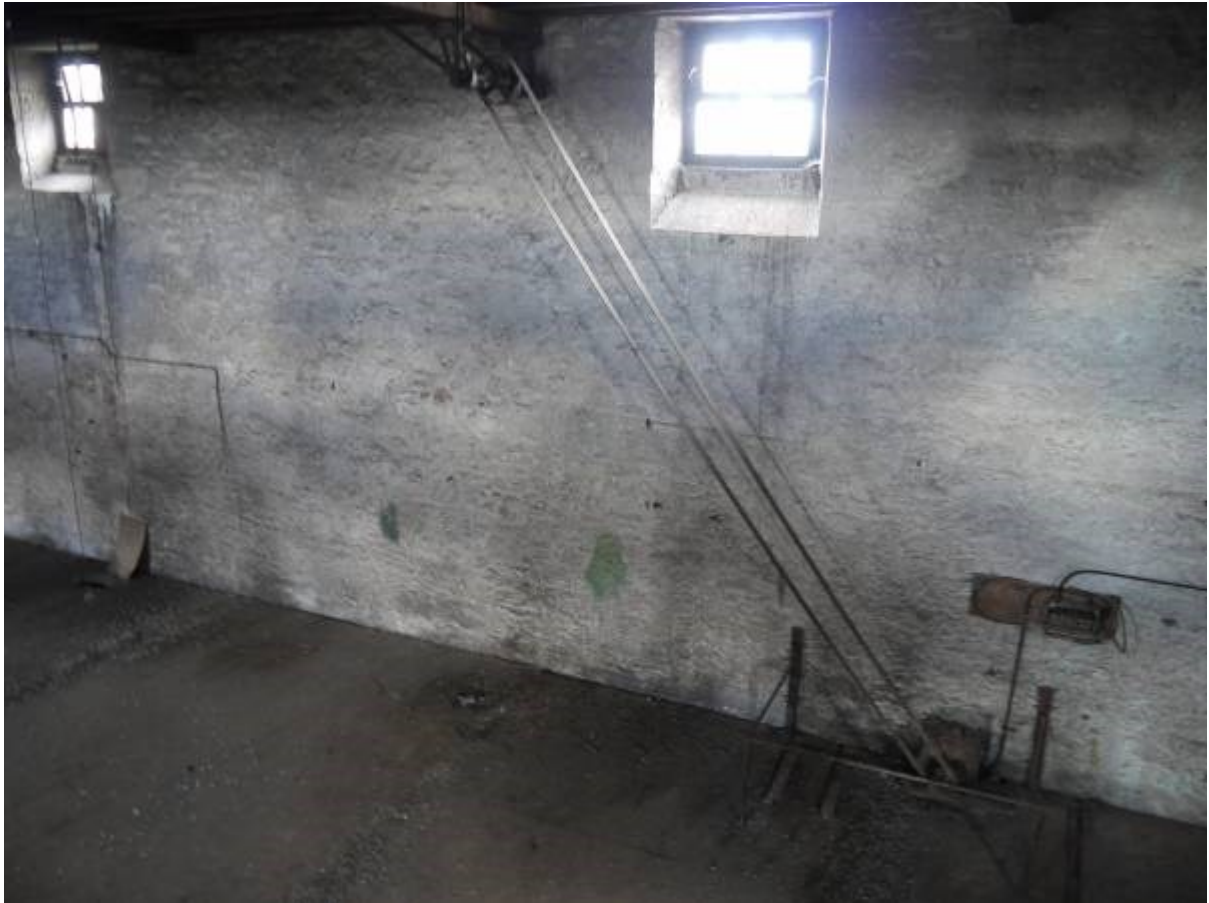
This is a very big enclosed space and has a wooden floor and a set of wooden stairs against its southern elevation which lead up to wooden door and then up to the top floor. Against its northern elevation there is an electric motor which drove a belt which runs up to top floor level. A wooden chute leads down from the top floor towards the lower of the two wooden doors in the southern internal elevation.

Illustration 17 eastern end of first floor level of Building A

Illustration 18 steps to top floor level on first floor of Building A, chute from top floor also visible

Illustration 19 western end of first floor of Building A electric motor and belt visible to right

Illustration 20 electric motor and drive belt on first floor of Building A looking north

Buildings A, B and C appear to belong to the Strathmore Tannery phase of activity on this site. Building A has the interesting survival of an entirely wooden top floor level with red leaded glass louvers on its northern side. This top floor level was presumably designed to aid the drying of the skins. The electric driven belt and chute at first floor level were presumably connected with the transport of material from the top floor down to a wooden doored access point on the first floor which is on the same side as the loading bay (Building C). The demolition of the western end of Building A at some point in antiquity has removed the other elements of the tanning industry such as the tanks etc. Building B presumably acted as the offices and accommodation for the tannery and is now still partly occupied at its western end. Building C appears to have been a loading bay and lies on the side of Building A that has the main wooden access doors. Buildings D and E would appear to relate to a later phase of activity on the site.

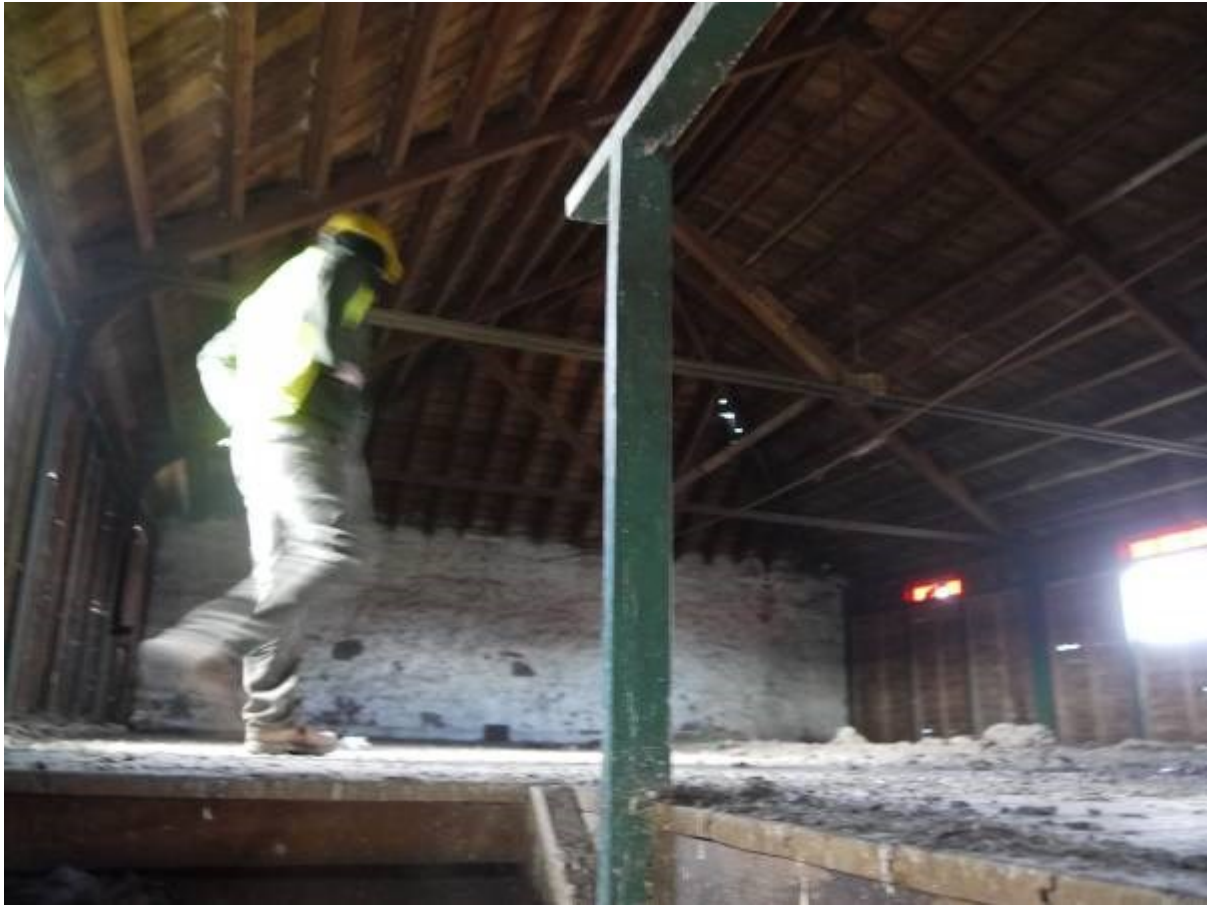
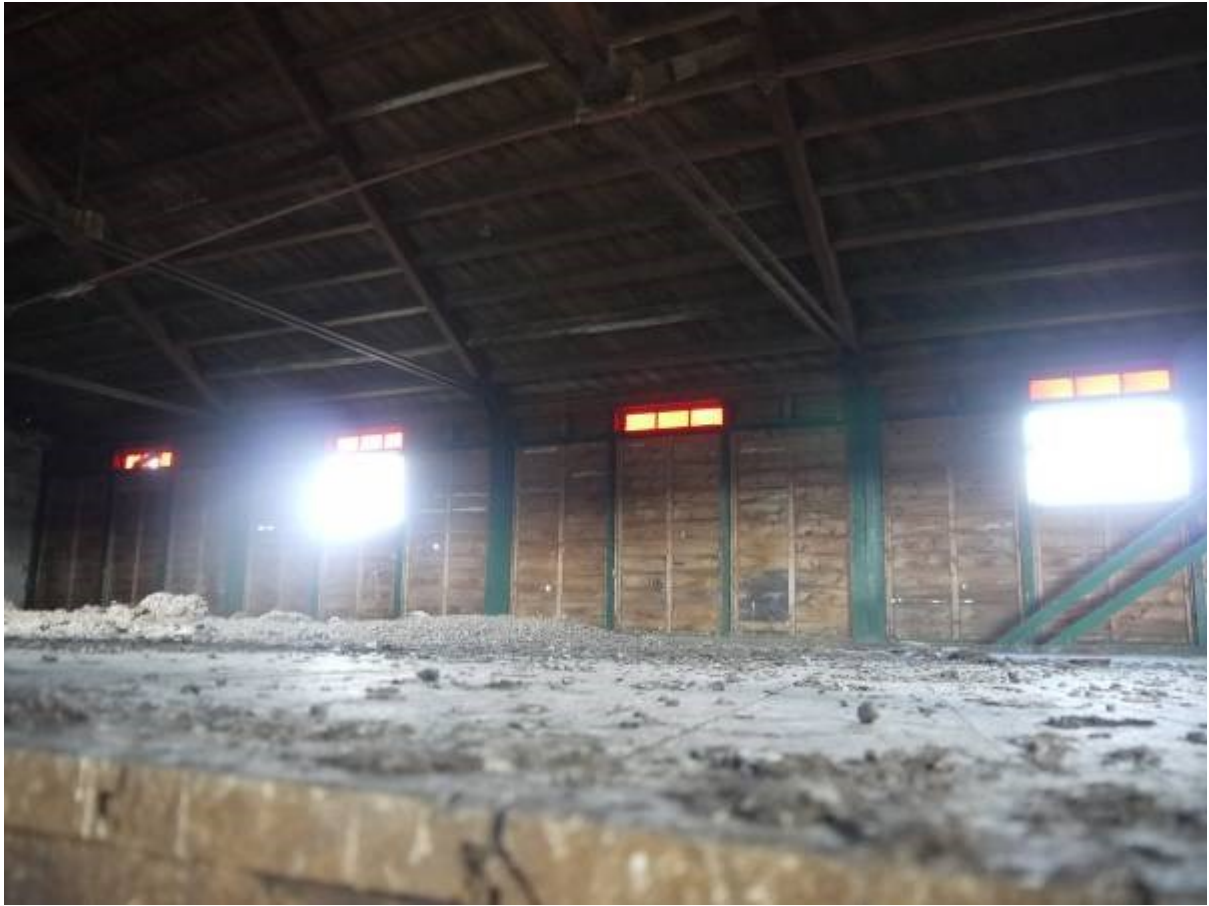
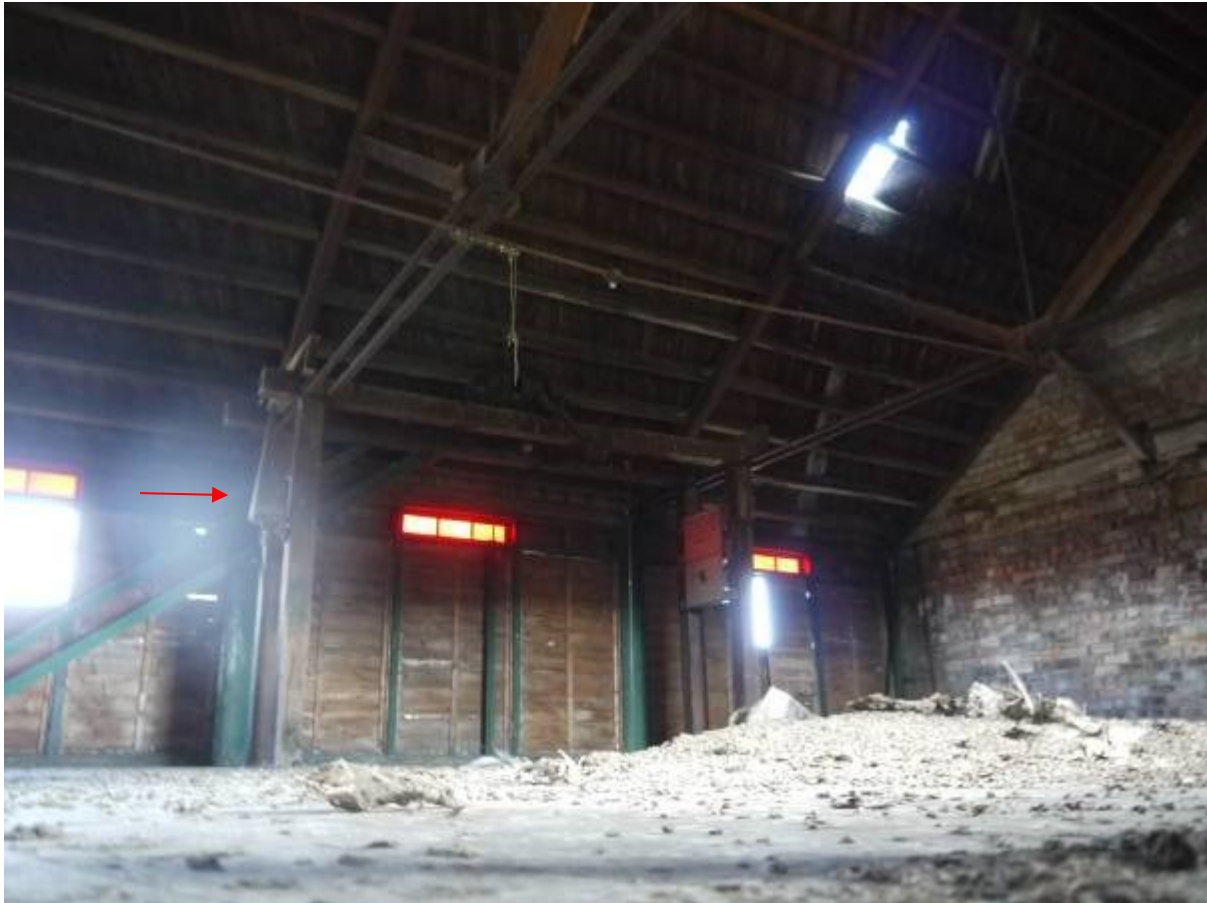
This is a much lower enclosed space than the first floor and has a wooden floor and a wooden roof. There are a line of narrow windows/louvers which have red leaded glass in them. One of the wooden upright on this floor has a fire extinguisher on it.

Illustration 21 western end of top floor of Building A

Illustration 22 northern side of top floor of Building A showing four of red leaded glass louvers

Illustration 23 eastern end of top floor of Building A showing remaining red leaded glass louvers and fire extinguisher at red arrow

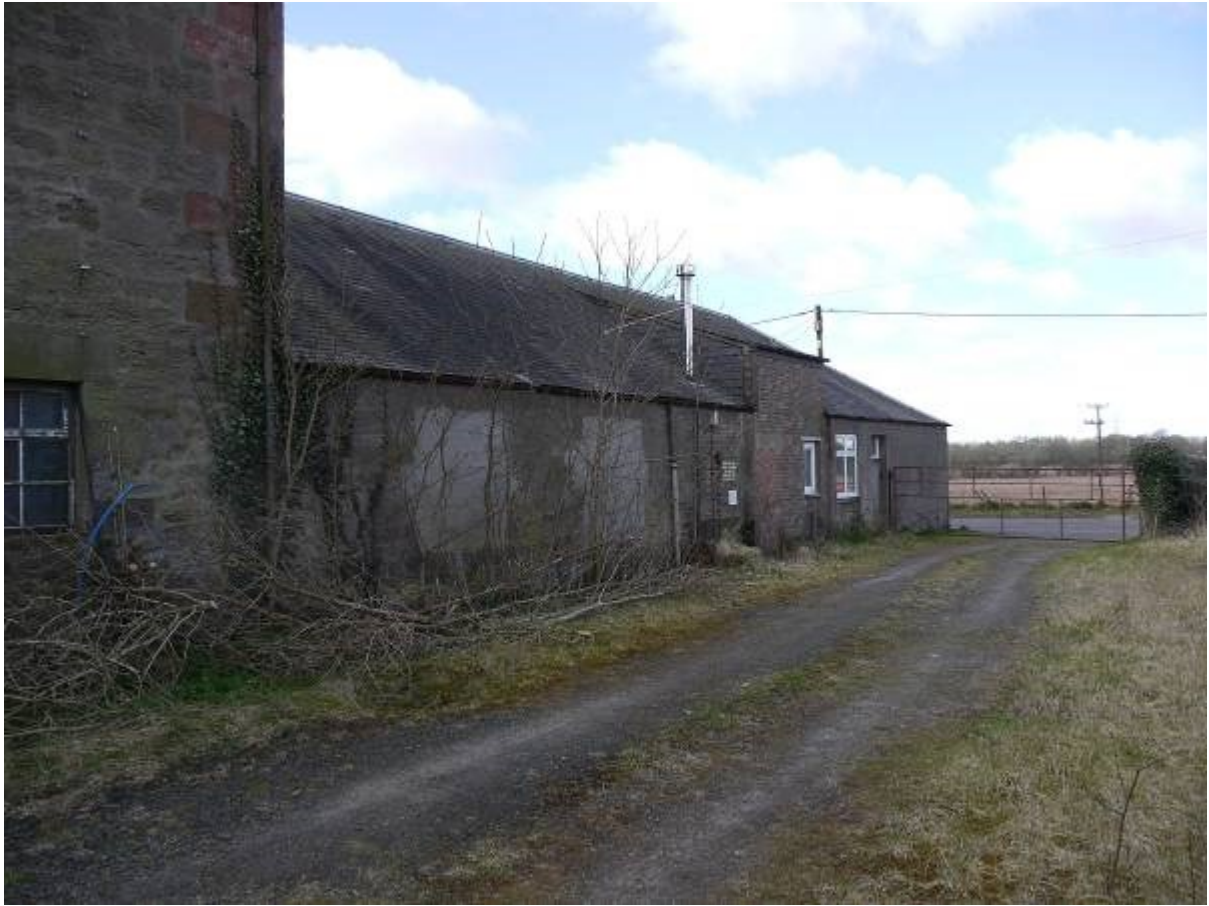
This elevation has four windows, two of which are blocked and a blocked doorway.

Illustration 24 north facing elevation of Building B looking west
