Standing Building Survey  
Pleasance Road Tannery, Coupar Angus  
Perth and Kinross

Pleasance Road Tannery buildings from the south

5th May 2013

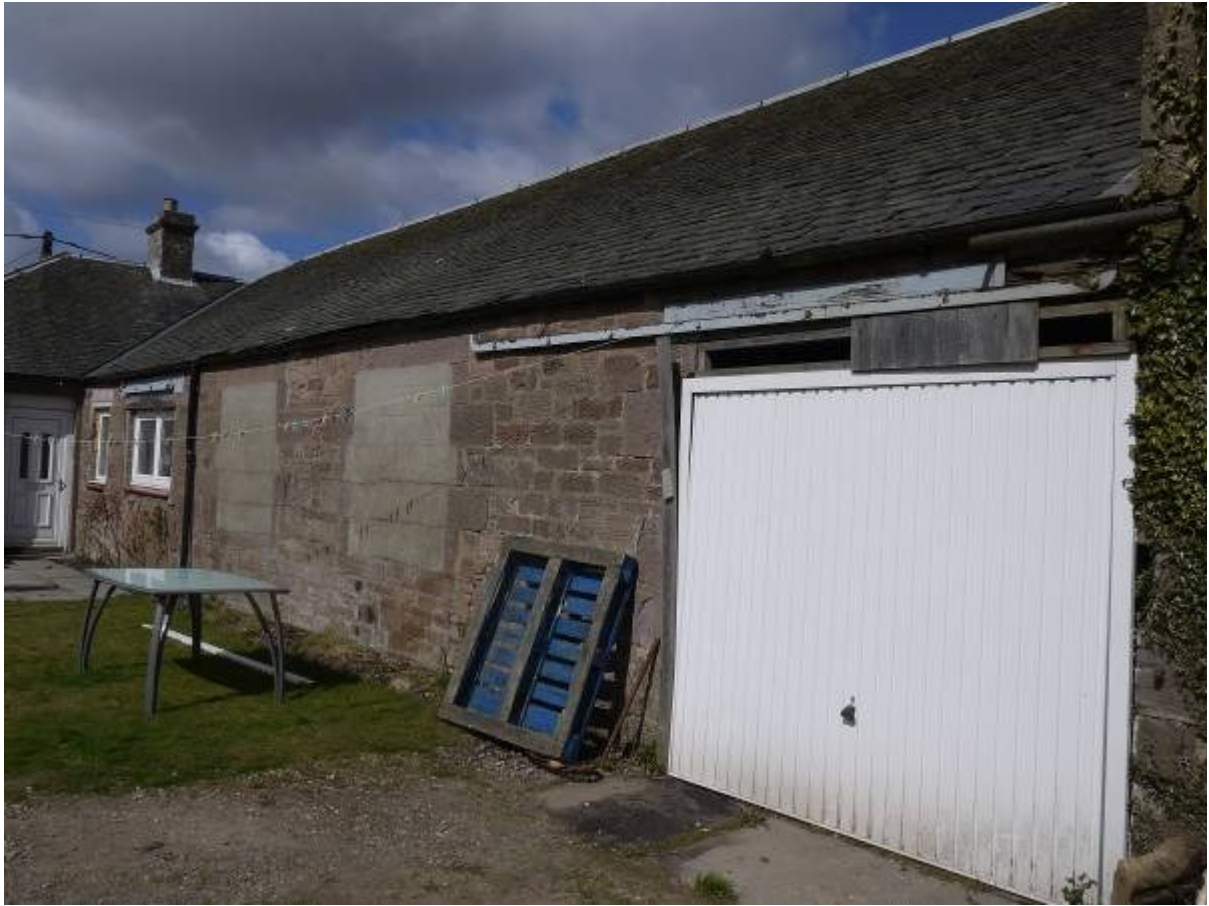
This elevation has four windows, two of which are blocked and another access door which is now in use as a garage.

Illustration 25 south facing elevation of Building B looking north west

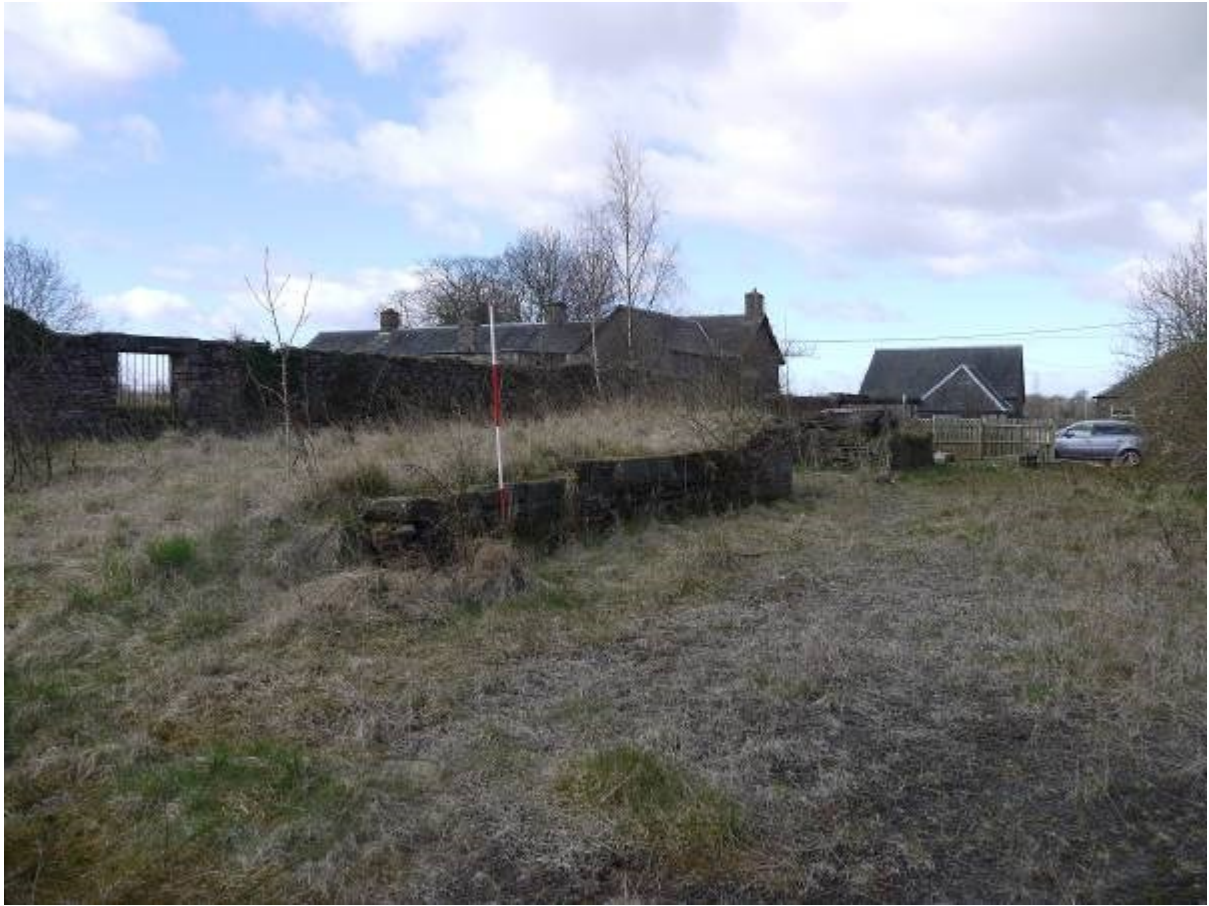
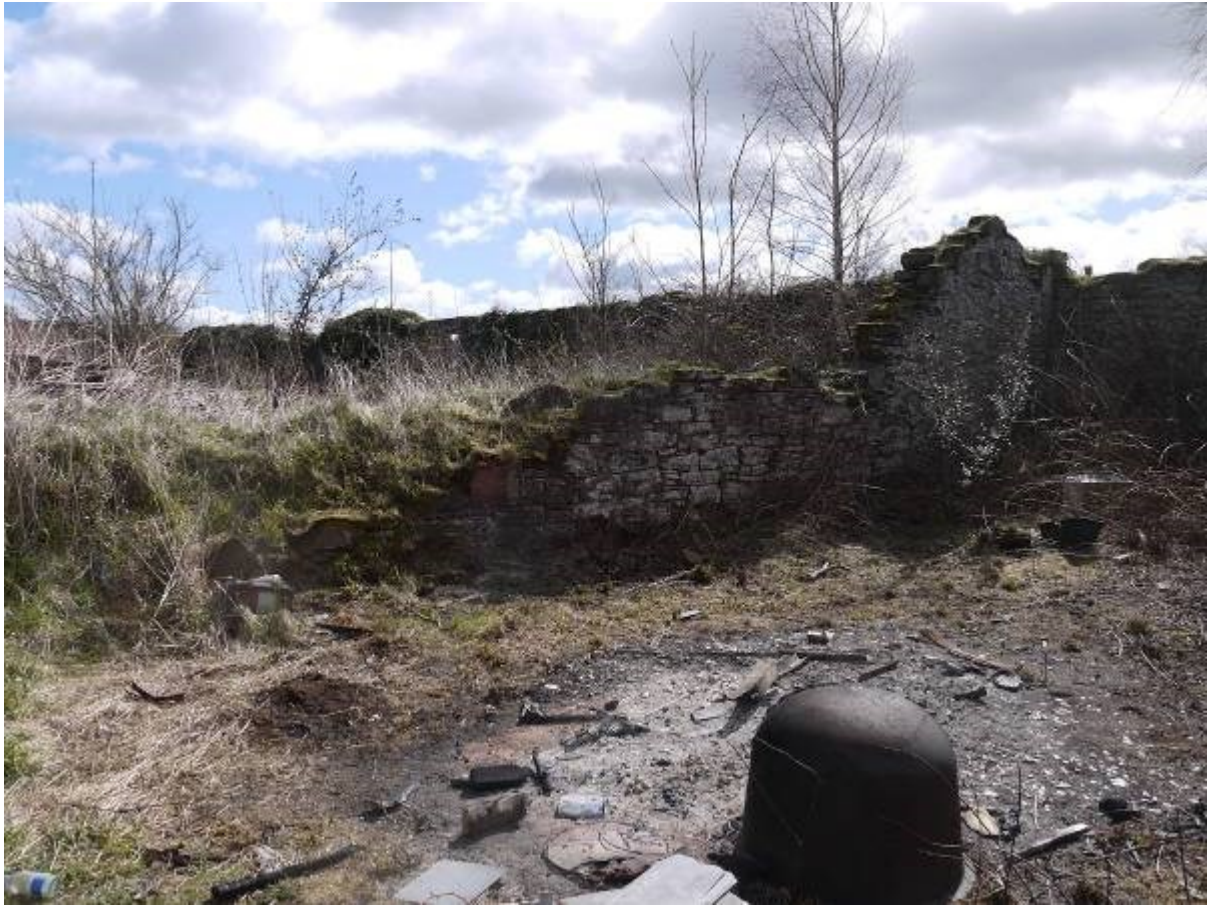
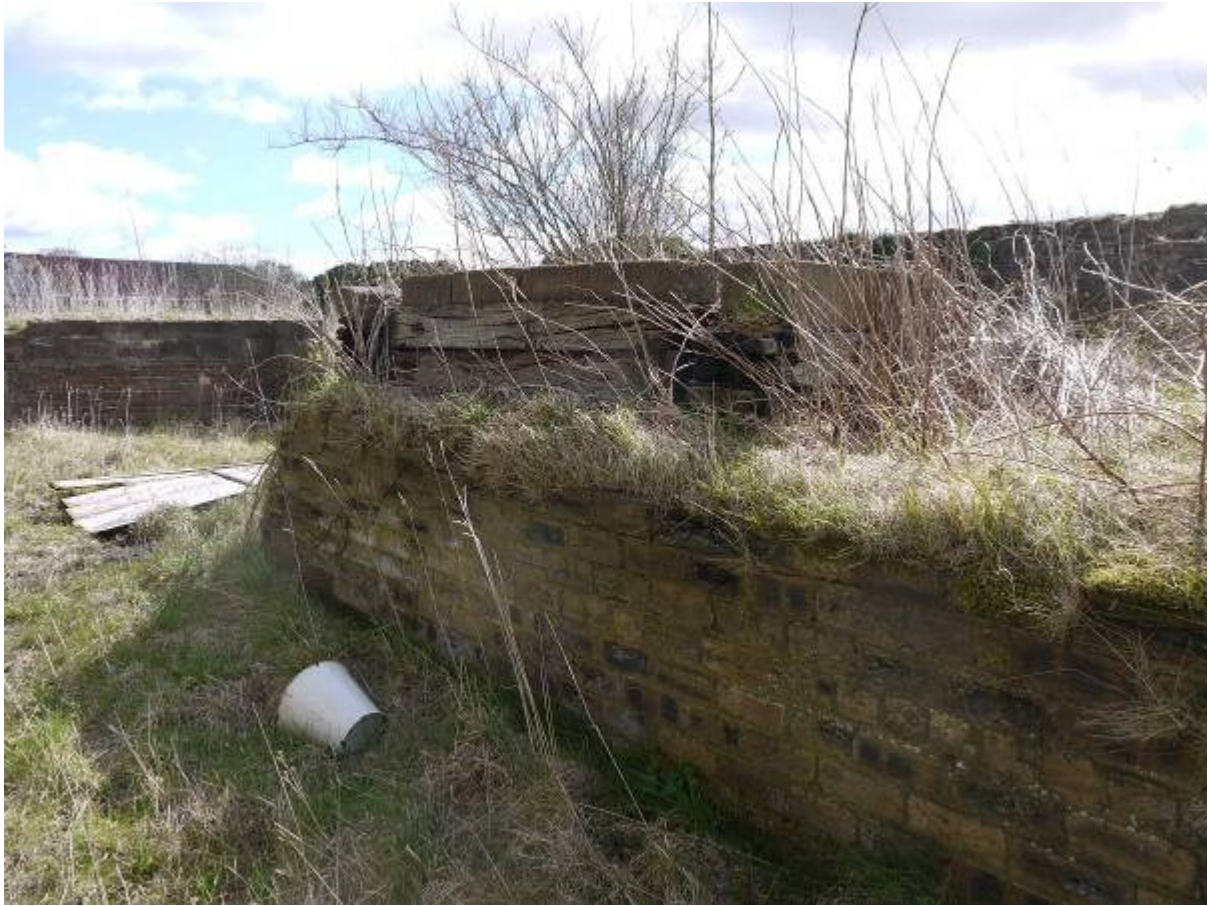
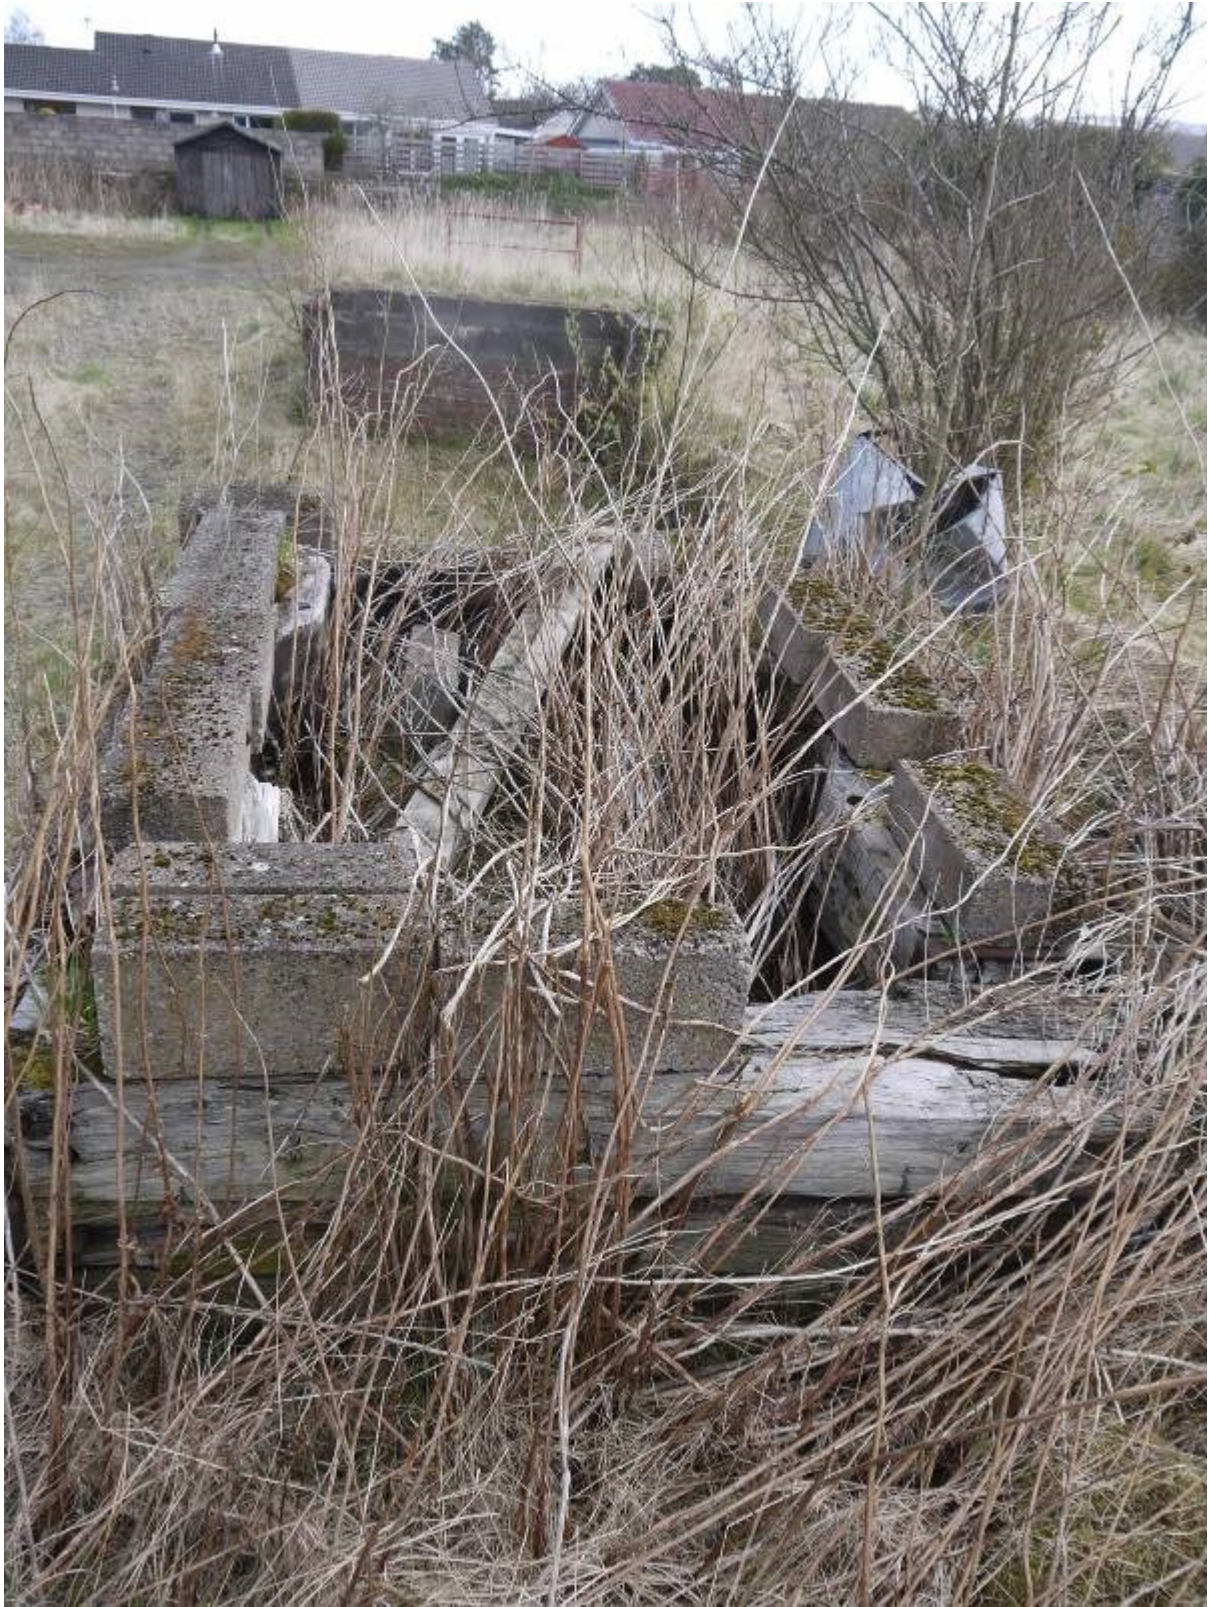
This structure lies to the south of Buildings A and B and is on an east to west alignment. Its walls are brick built on a stone base. At its eastern end a ramped slope leads up on to it. This building appears to have functioned as a loading bay for the tannery. At its western end there is a small structure built of wooden sleepers and loose bricks of uncertain function.

Illustration 26 north facing elevation of Building C (Loading Bay) looking west

Illustration 27 west facing elevation of Building C looking south east

Illustration 28 View of sleeper built structure in Building C looking south east

Illustration 29 Detail of structure on top of loading bay (Building C) built of sleepers and loose bricks looking east

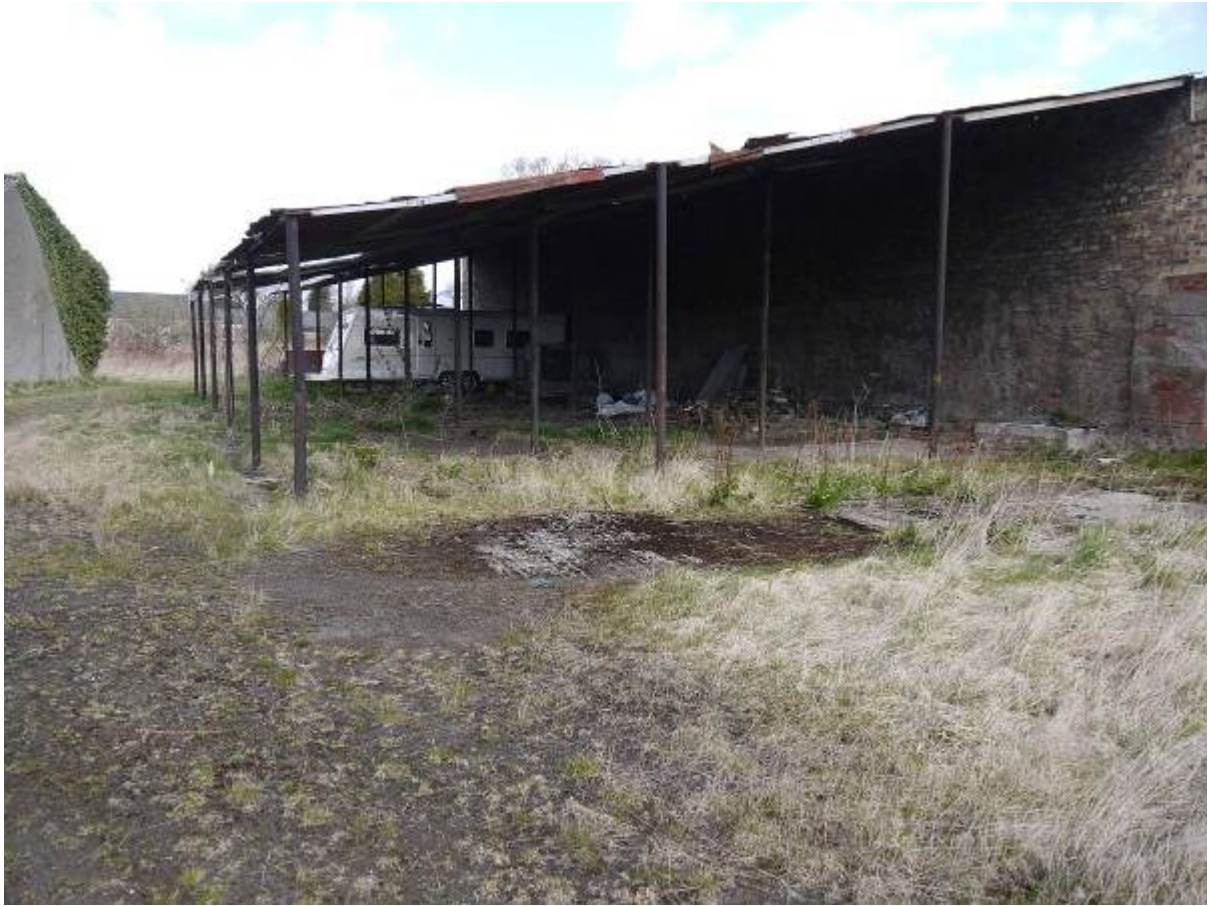
This is a corrugated iron lean to on vertical metal supports. Its eastern end is a brick and stone wall which provides the support for the structure. It has a concrete floor.

Illustration 30 Building D looking north

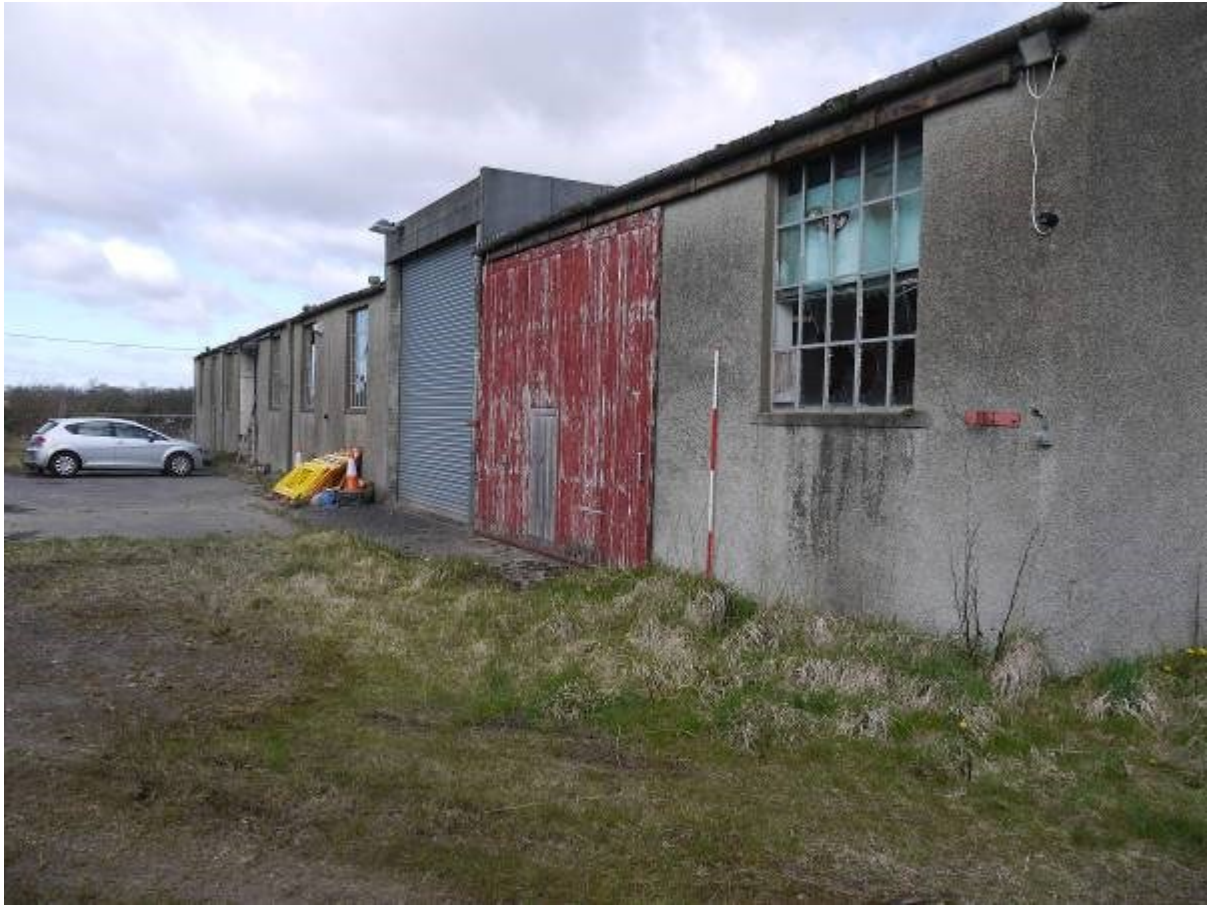
This elevation has seven windows (glass panelled) and two steel loading bay doors and a wooden door at its eastern end.

Illustration 31 south facing elevation of Building E looking north west

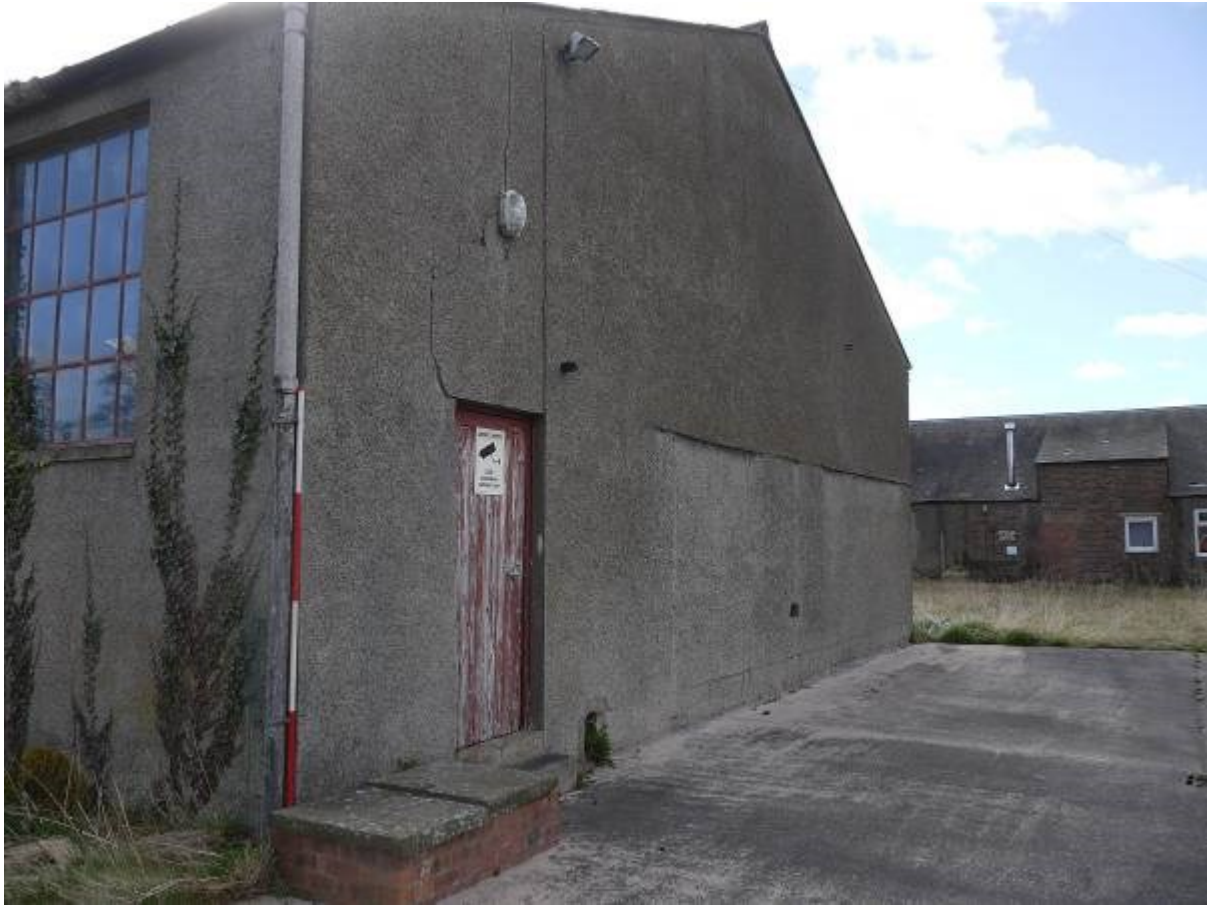
This is a plain elevation with a single door at its northern end.

Illustration 32 western elevation of Building E looking south east

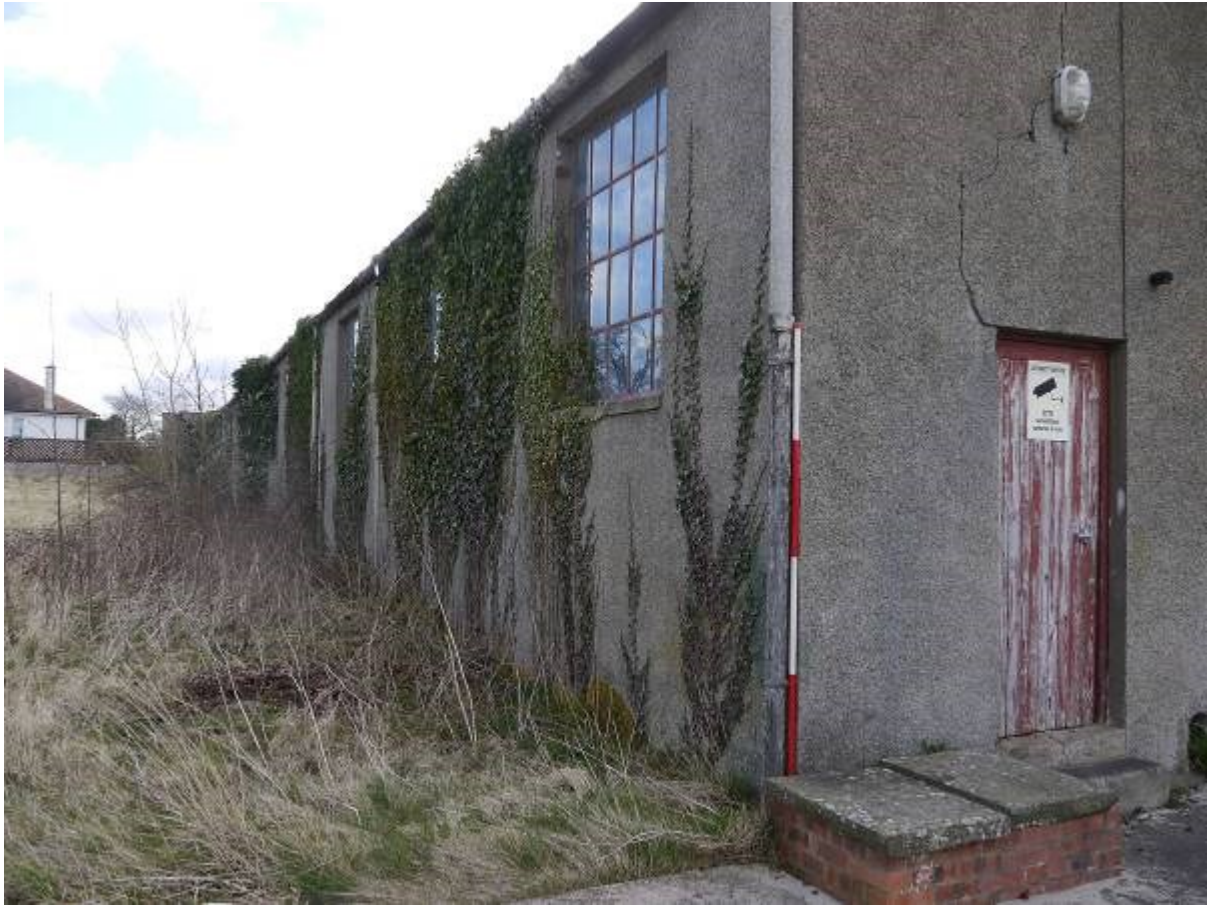
This elevation has nine windows (glass panelled).

Illustration 33 northern elevation of Building E looking east

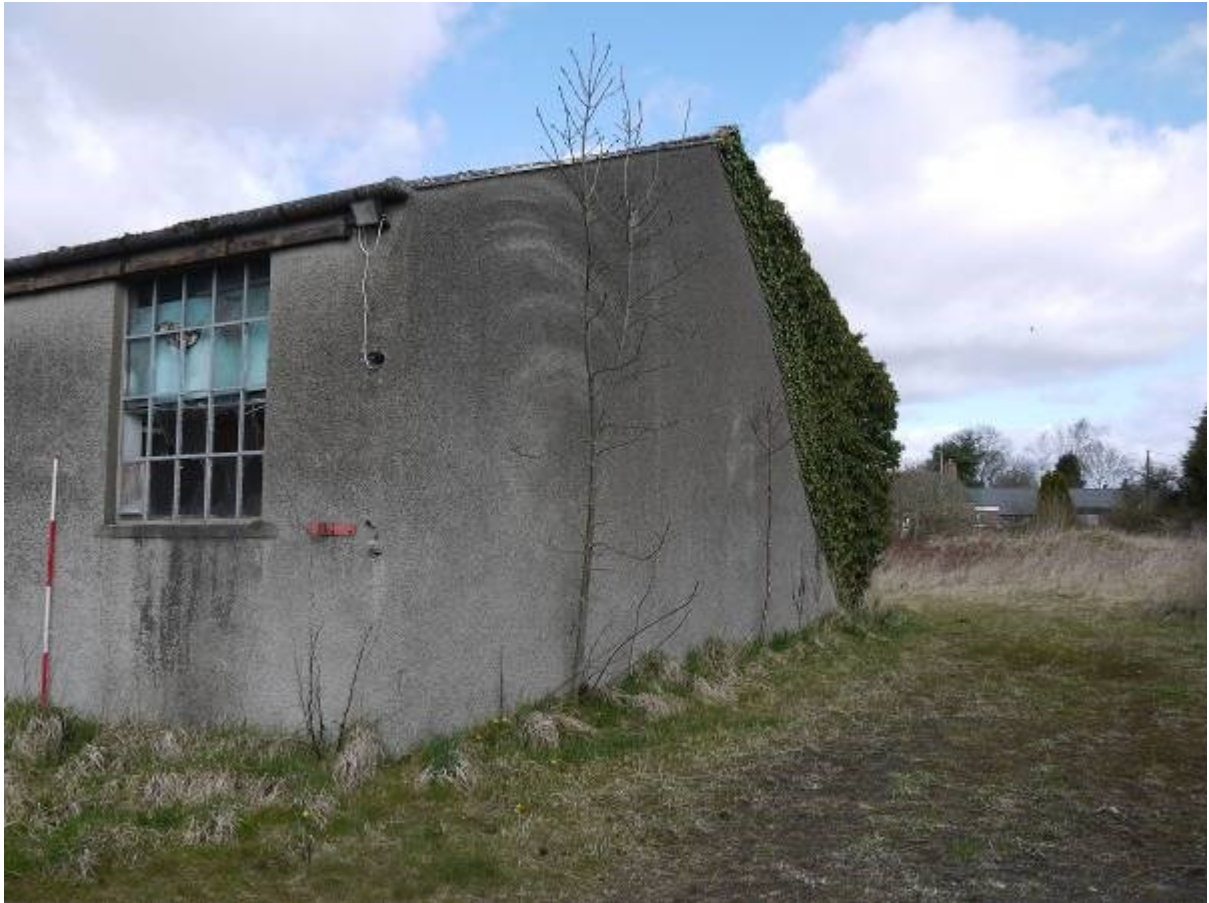
This elevation is plain.

Illustration 34 eastern elevation of Building E looking north

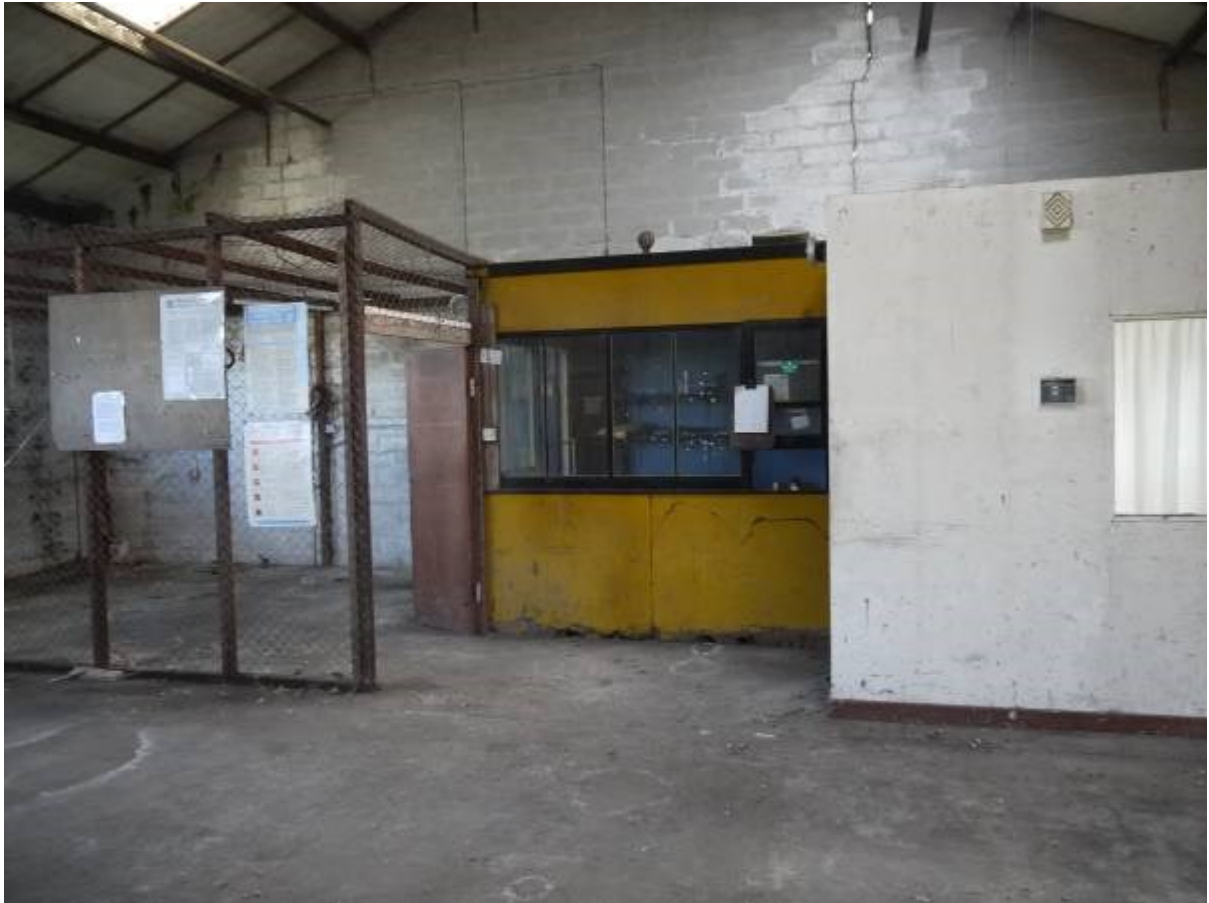
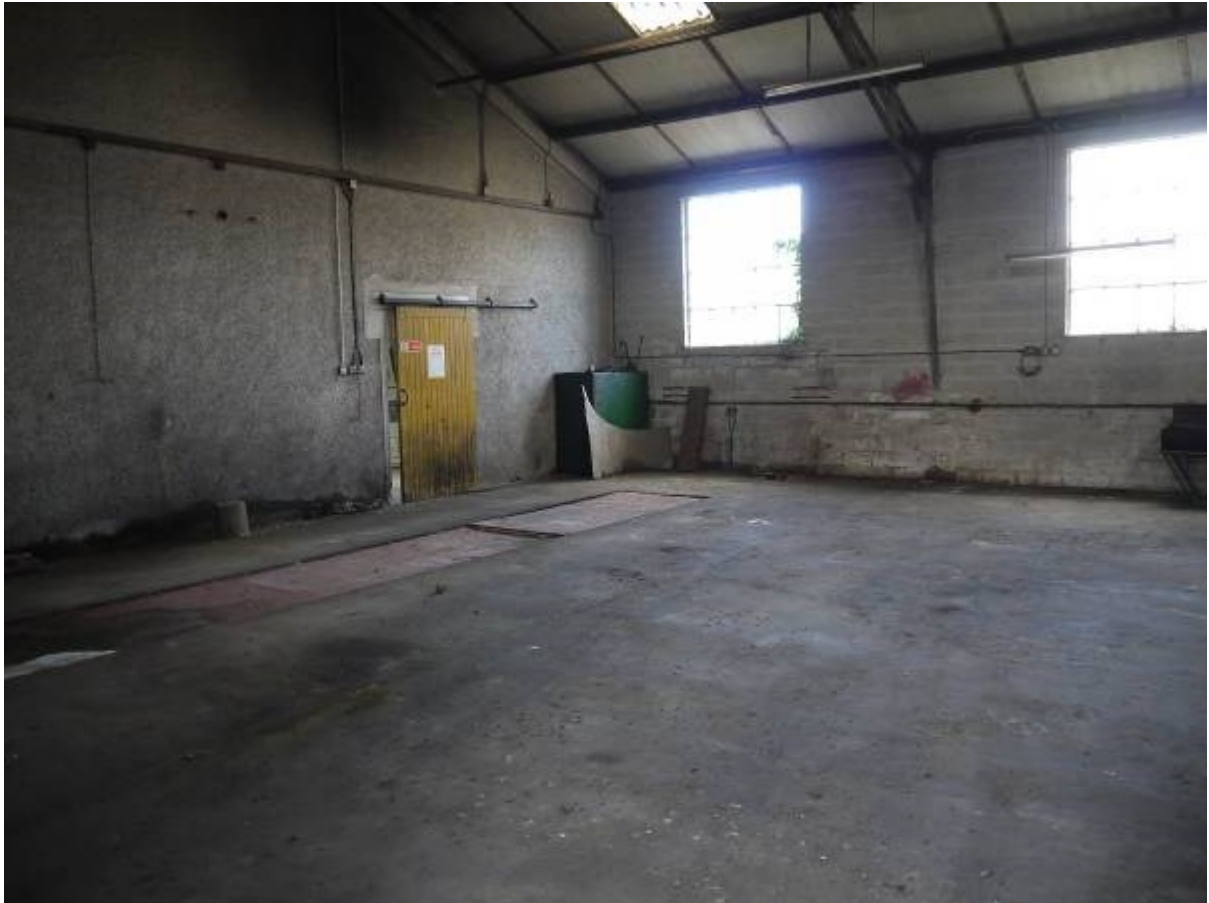
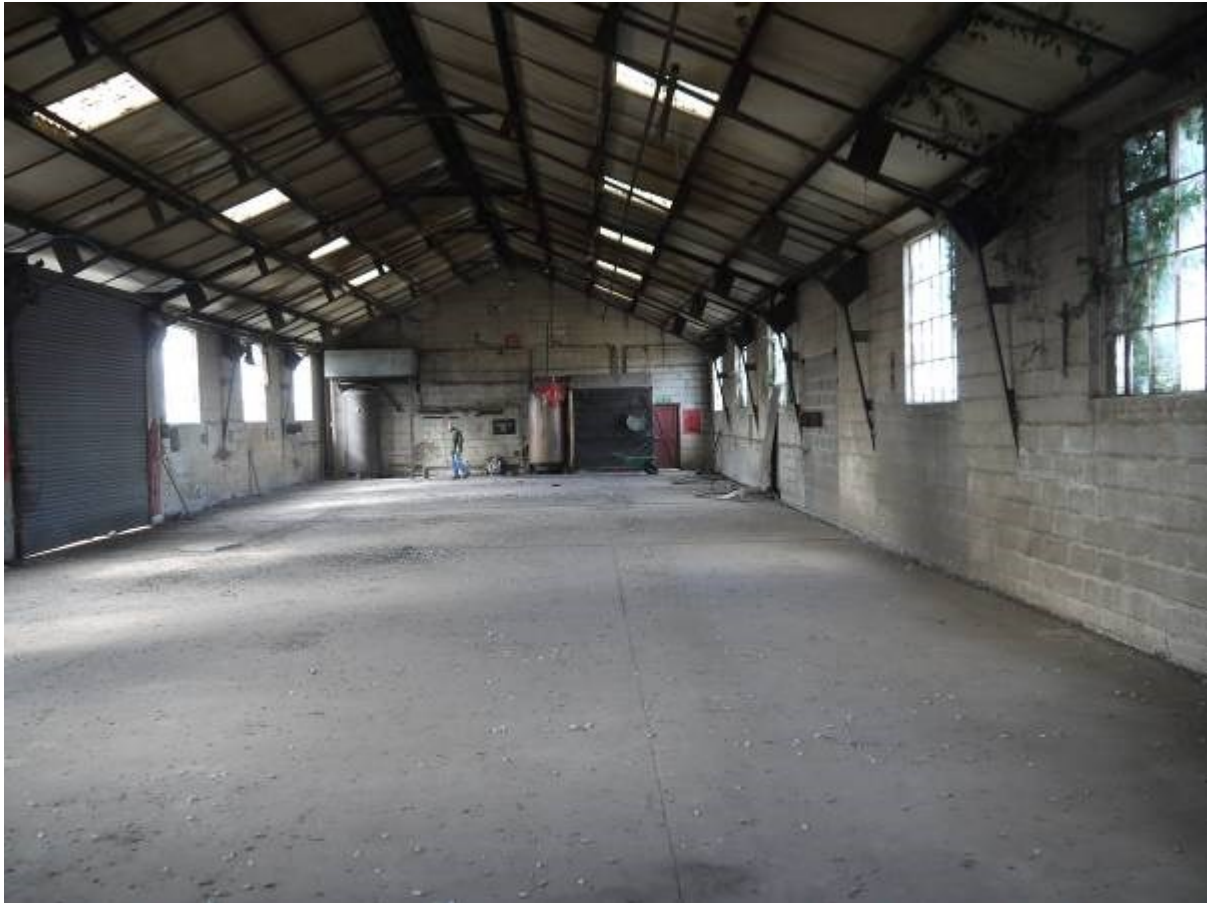
This building is split into two internal rooms, the one at the eastern end contains former offices the other room occupies the rest of the building and they both have concrete floors.

Illustration 35 Former office buildings at eastern end of Building E

Illustration 36 interior of eastern end of Building E looking north

Illustration 37 interior of remainder of Building E looking west

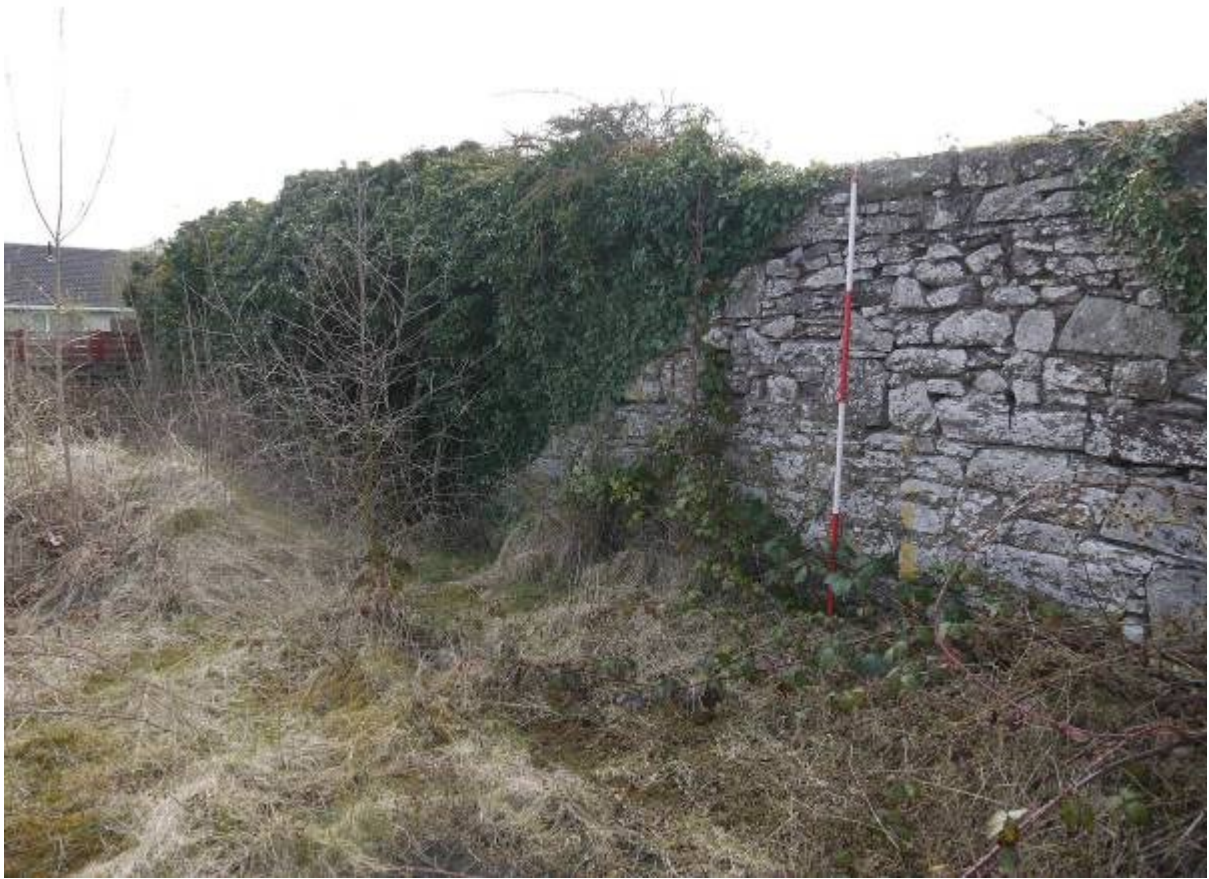
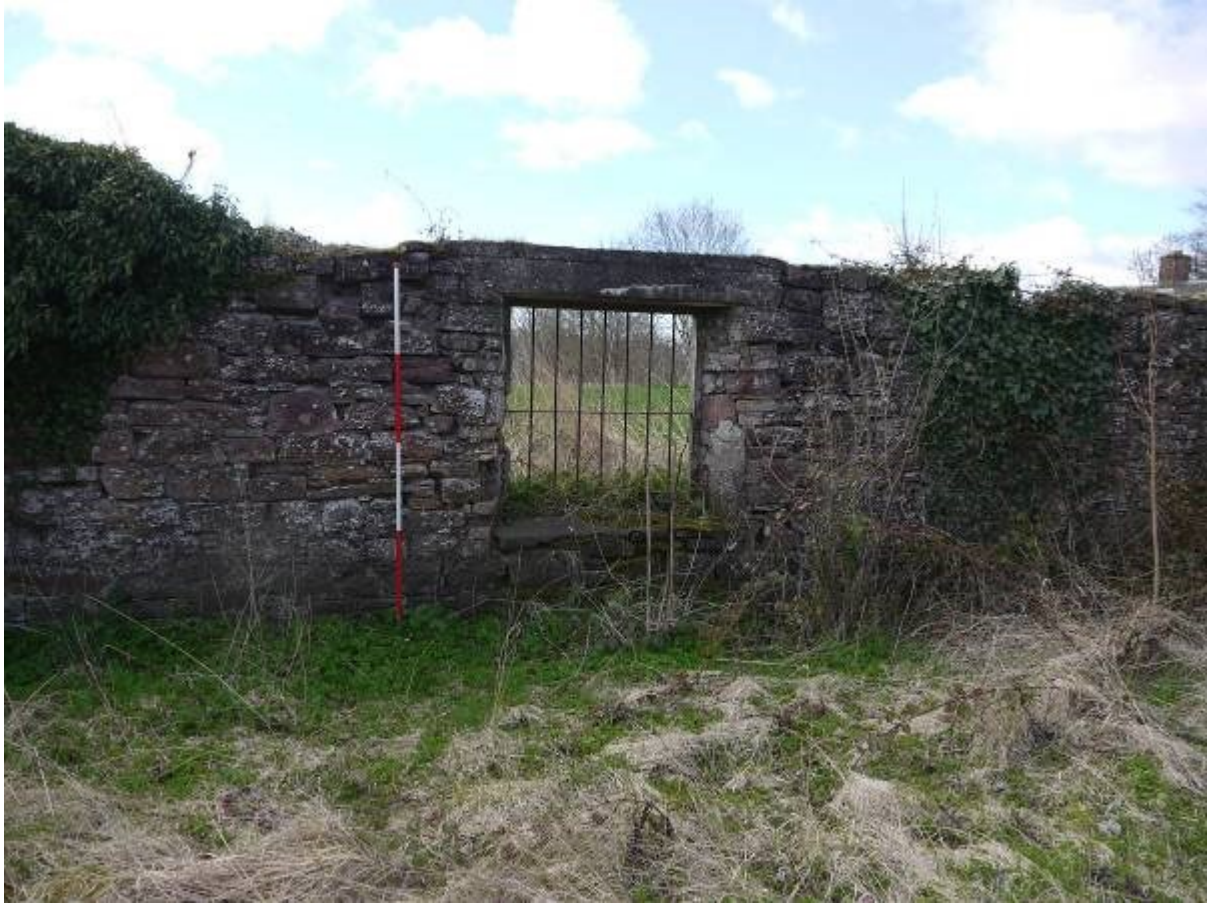
This building complex is surrounded by a stone wall on its eastern wide (back garden wall of properties) on Abbey Road and Abbey Gardens. Its southern side is surrounded by a tall stone wall

which has a window looking out from the loading bay. The northern and western boundaries are comprised of a wire fence, the entrance gates are in the western boundary.

Illustration 38 stone wall forming southern boundary around tannery buildings looking south east

Illustration 39 window in southern boundary wall looking south
