Standing Building Survey

Old England, Stanley, Perth and Kinross

Introduction

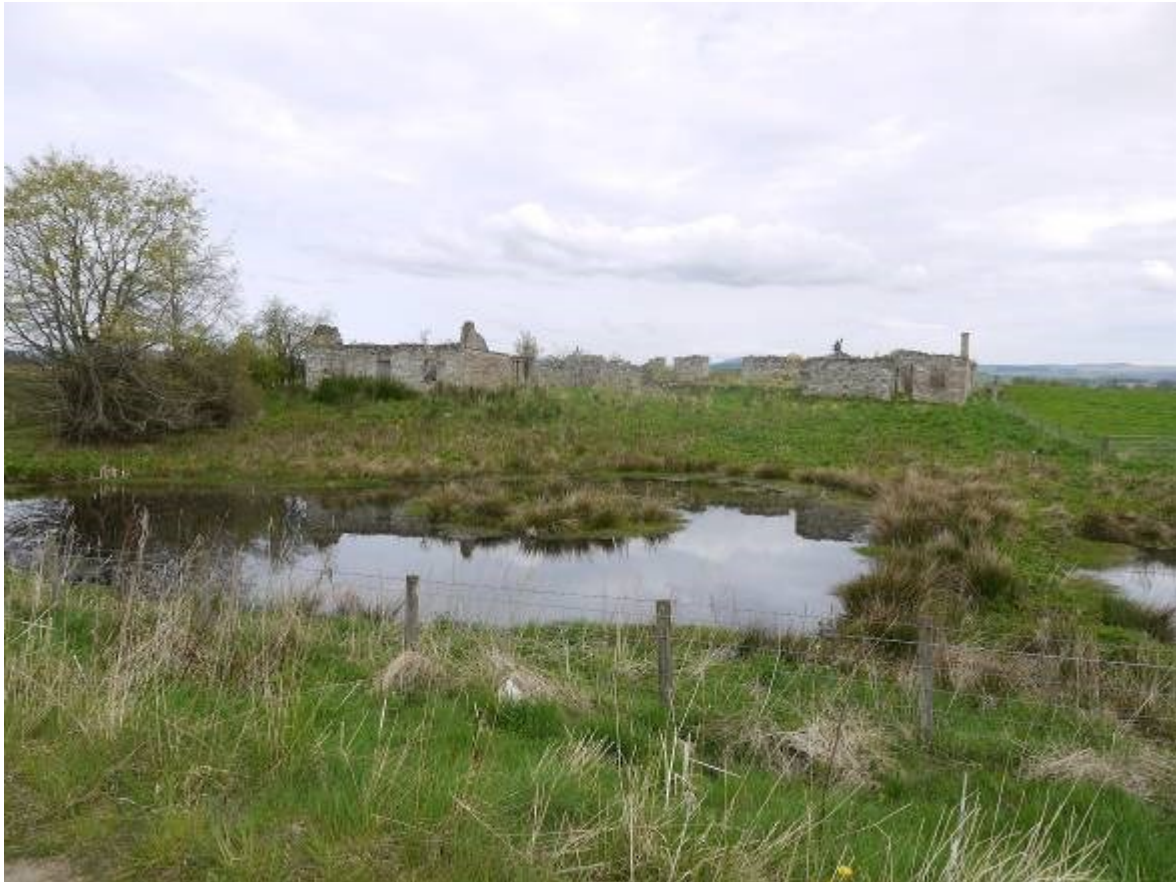
Group of derelict buildings at Old England from the south

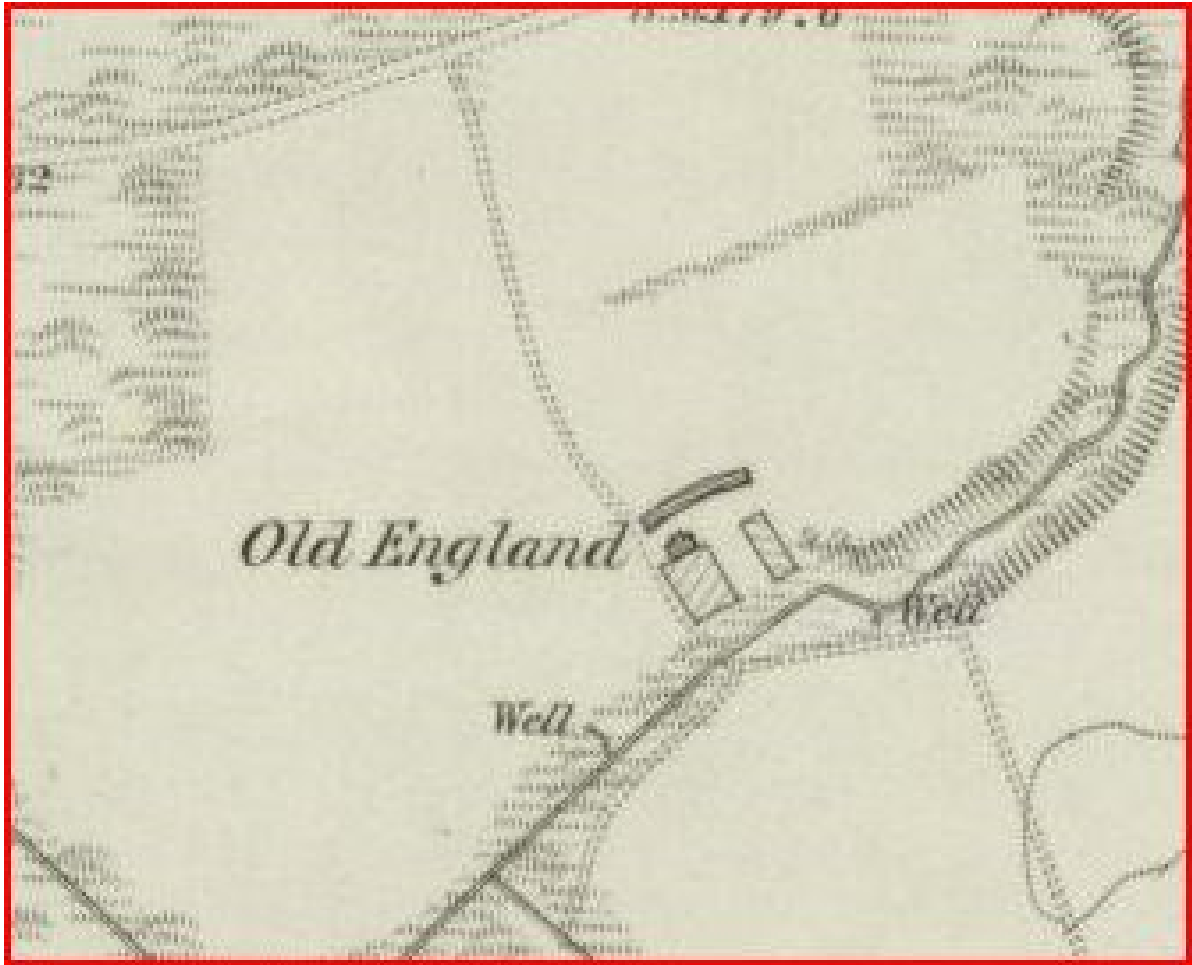
Illustration 2 Old England as marked on First Edition Ordnance Survey map of 1864 (©Trustees of National Library of Scotland)

The ruinous buildings at Old England due for demolition are deemed to be part of the local historic environment; they are shown as roofed on the 1st (1861) and 2nd editions (1901) of the 19th century Ordnance Survey maps of the development area. The building layout shown on the 2nd edition map is largely the one that still survives at the time of this survey. There is nothing shown at the site of Old England on William Roy's map of 1747-55, James Stobie's map of 1783 or John Thomson's maps of 1832. However limited research of the Census records indicates that there is a settlement at Old England by 1841 and 5 people are listed as living there, by 1901 there are 11 people in residence (9 of them members of the Garvie family) (www.Scotlandspople.gov.uk 1841 and 1901 Census). Occupied buildings are still visible on an aerial photograph of 1946 and the occupant (Robert McGregor) is listed in the Valuation Roll for that year (RCAHMS National Collection of Aerial Photography). McGregor is still listed up until 1955-56 but from 1957-58 the Proprietor (Colonel Hardie) is listed as occupier and in 1961-62 Old England is listed as 'uninhabitable'. The Valuation Roll entries also refer to a 'bothy' at Old England (Valuation Rolls Perth district 1946, 1955-56, 1957-58 and 1961-62).

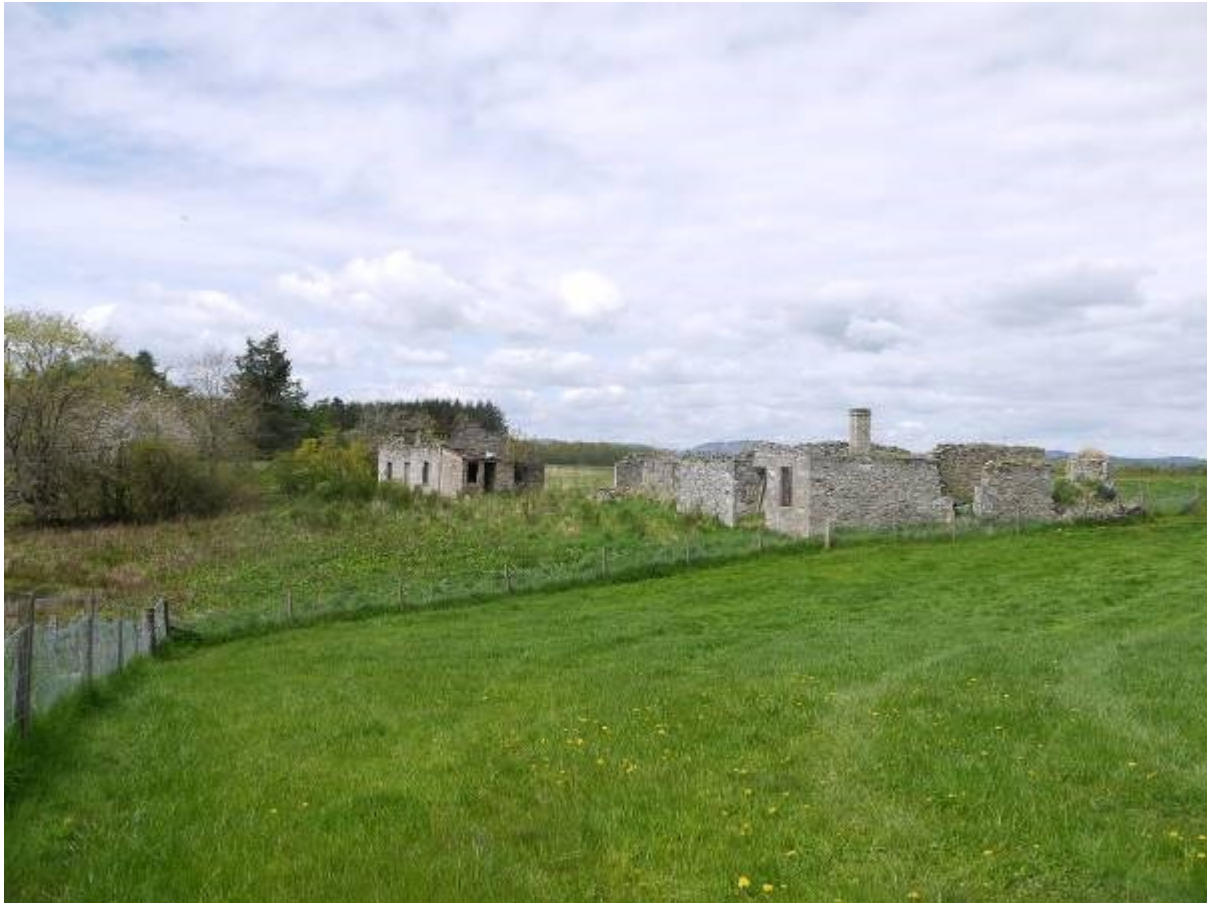
Illustration 5 Derelict buildings at Old England looking North West

The complex of buildings at Old England lie to the south of the road from Kinclaven to Murthly, Old England loch lies to the south west and the farm of Broomhill to the east.

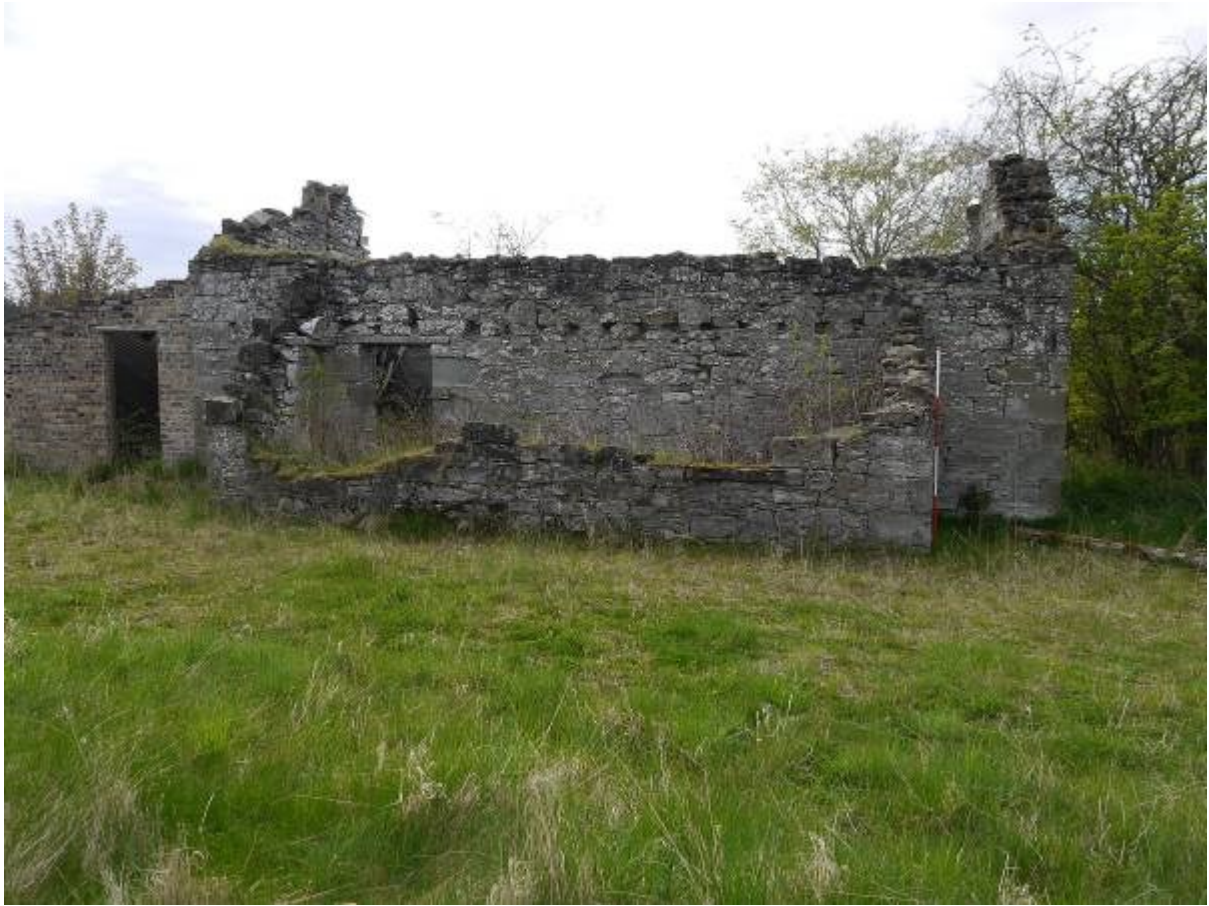
The roofless remains of a long porch like structure are built against the face of this elevation. A line of putlog holes for roof timbers is visible running along the wall. The porch has a doorway in its eastern end and evidence for a single north facing window in its northern wall. The elevation of the farmhouse proper has a single doorway.

Illustration 6 Northern elevation and 'porch' of Building A looking south

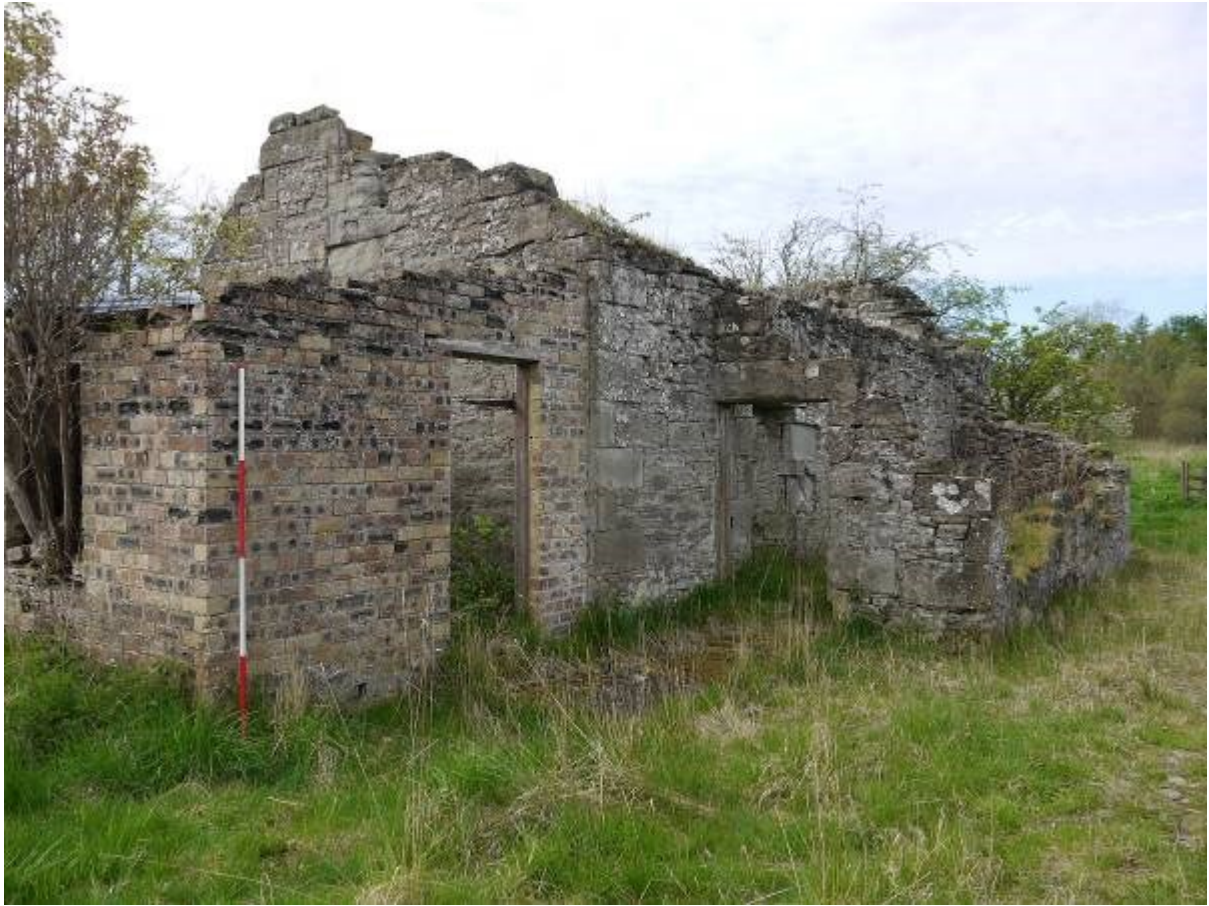
Illustration 7 Eastern end of Northern elevation of Building A showing brick extension and front porch looking west

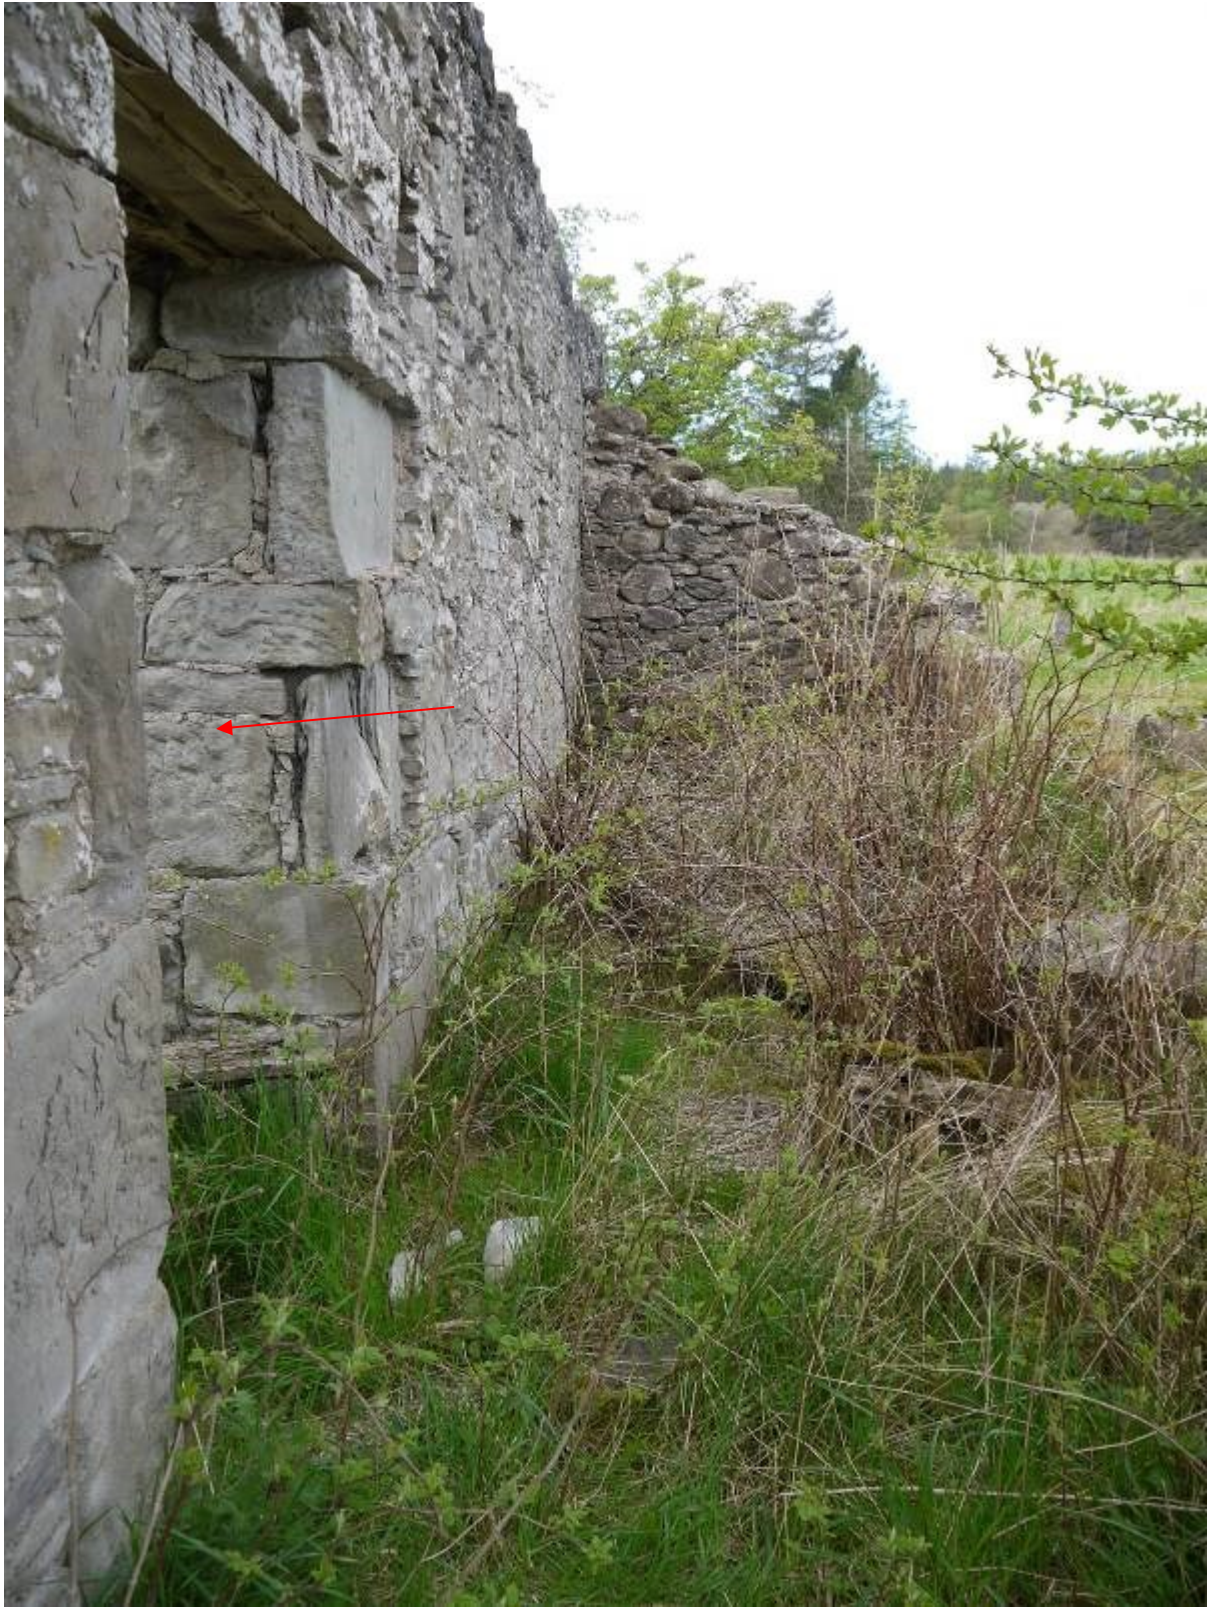
Illustration 8 interior of 'porch' of Building A looking west, doorway into house marked with red arrow

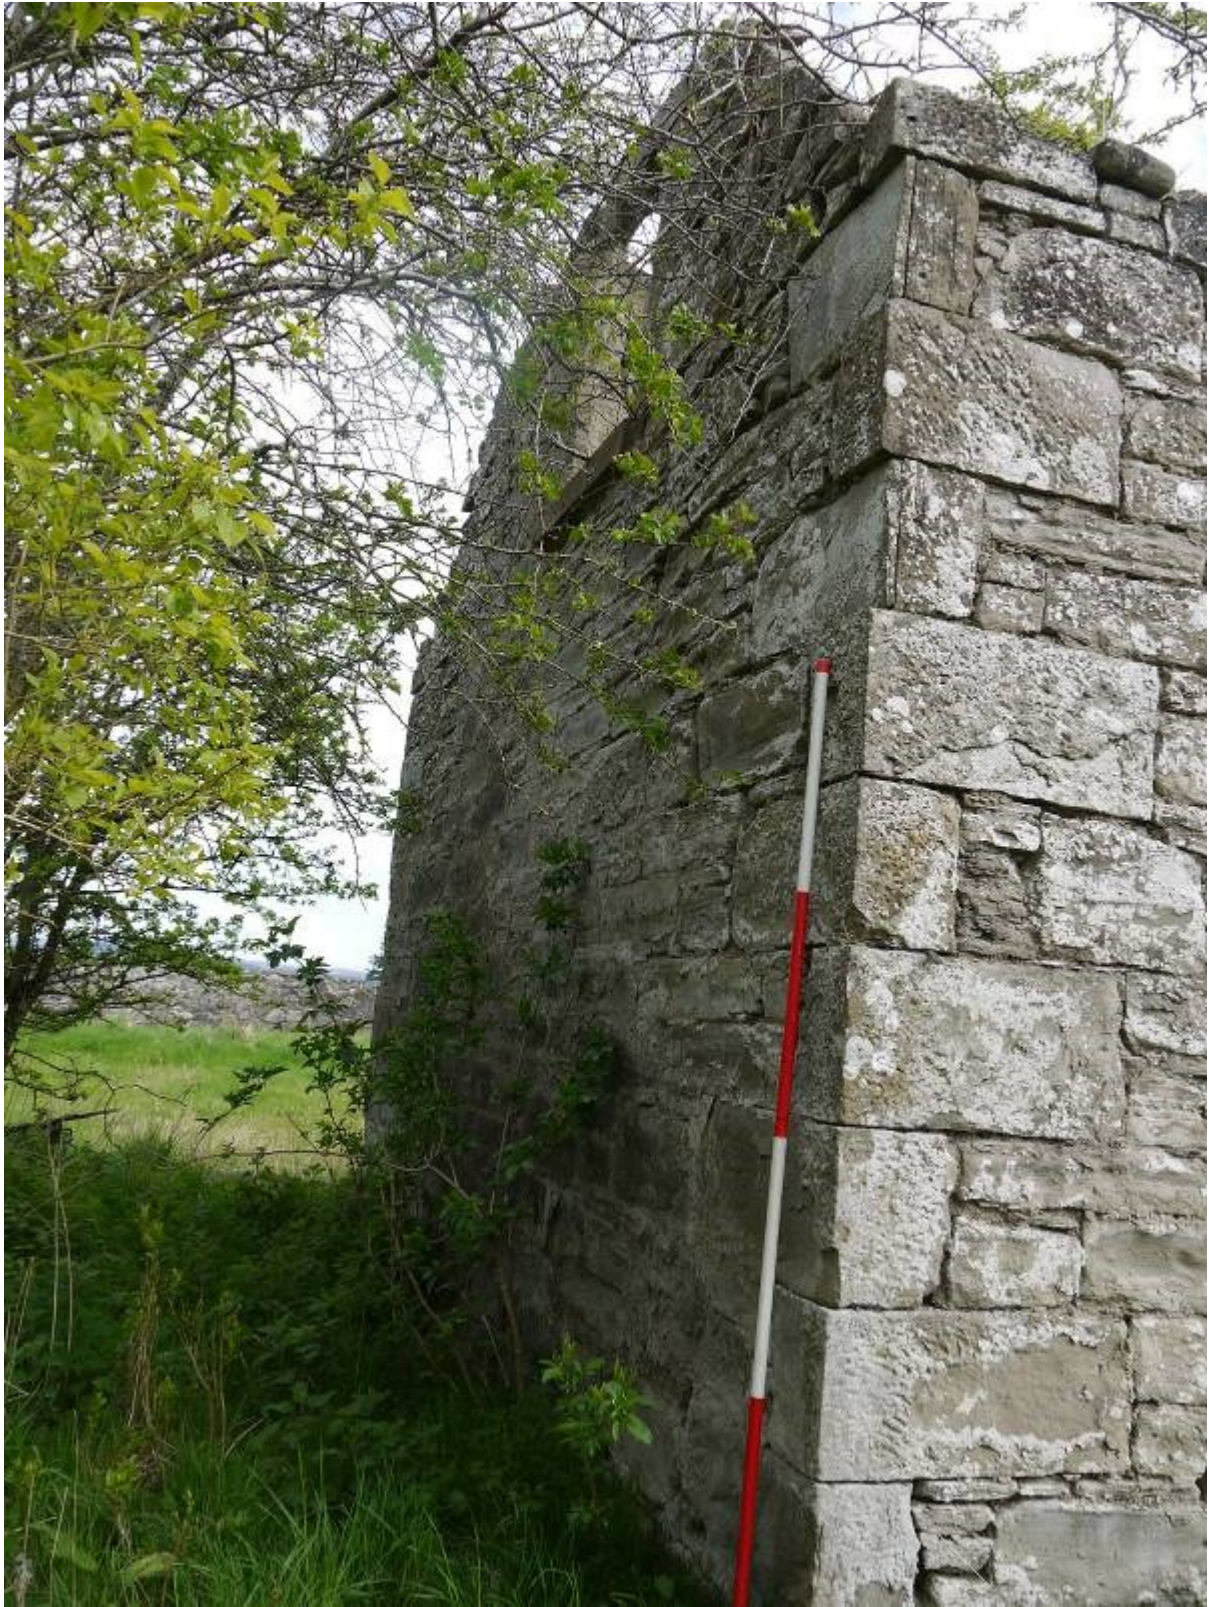
This gable end is blank apart from the remains of a window at first floor level.

Illustration 9 Western elevation of Building A looking north

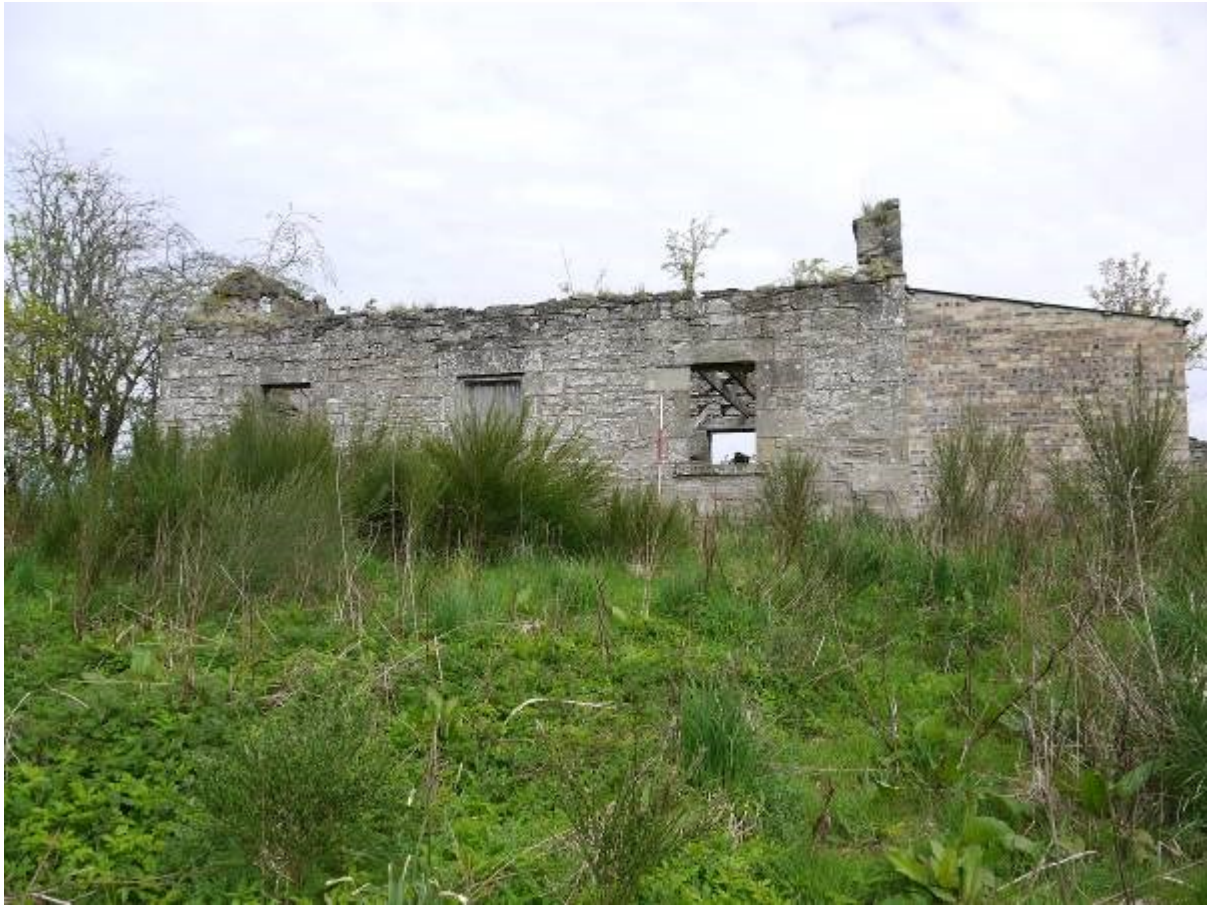
This elevation has a central doorway with a wooden door that is approached by a single step upwards; there is a surviving roof coping line above the door presumably for a small porch or protective roof. There are windows on either side of the doorway.

Illustration 10 Southern elevation of Building A looking north

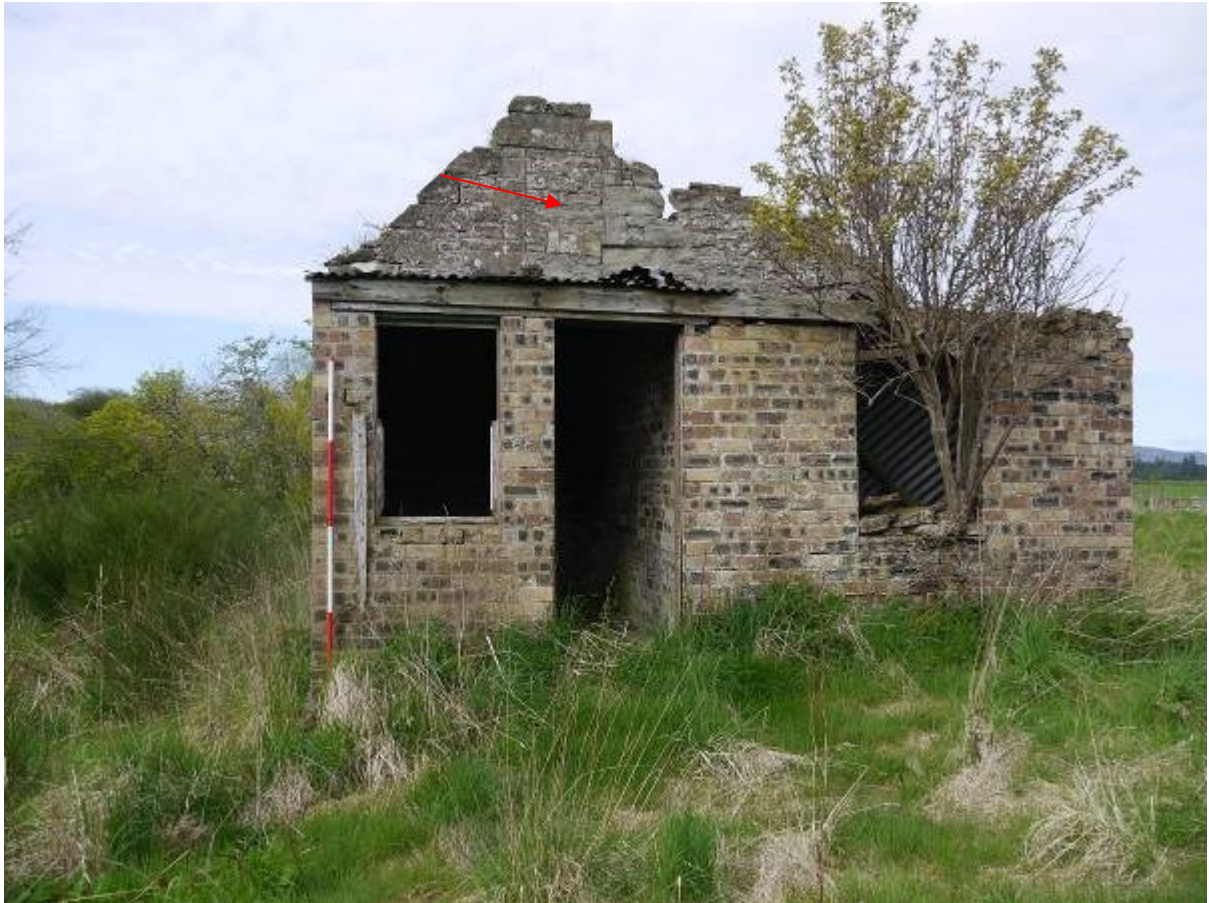
This elevation has a brick extension built against its wall face; above the roof line of this extension a blocked window is visible in the farmhouse wall.

Illustration 11 Eastern elevation of Building A showing brick extension, blocked window in farmhouse wall marked with red arrow

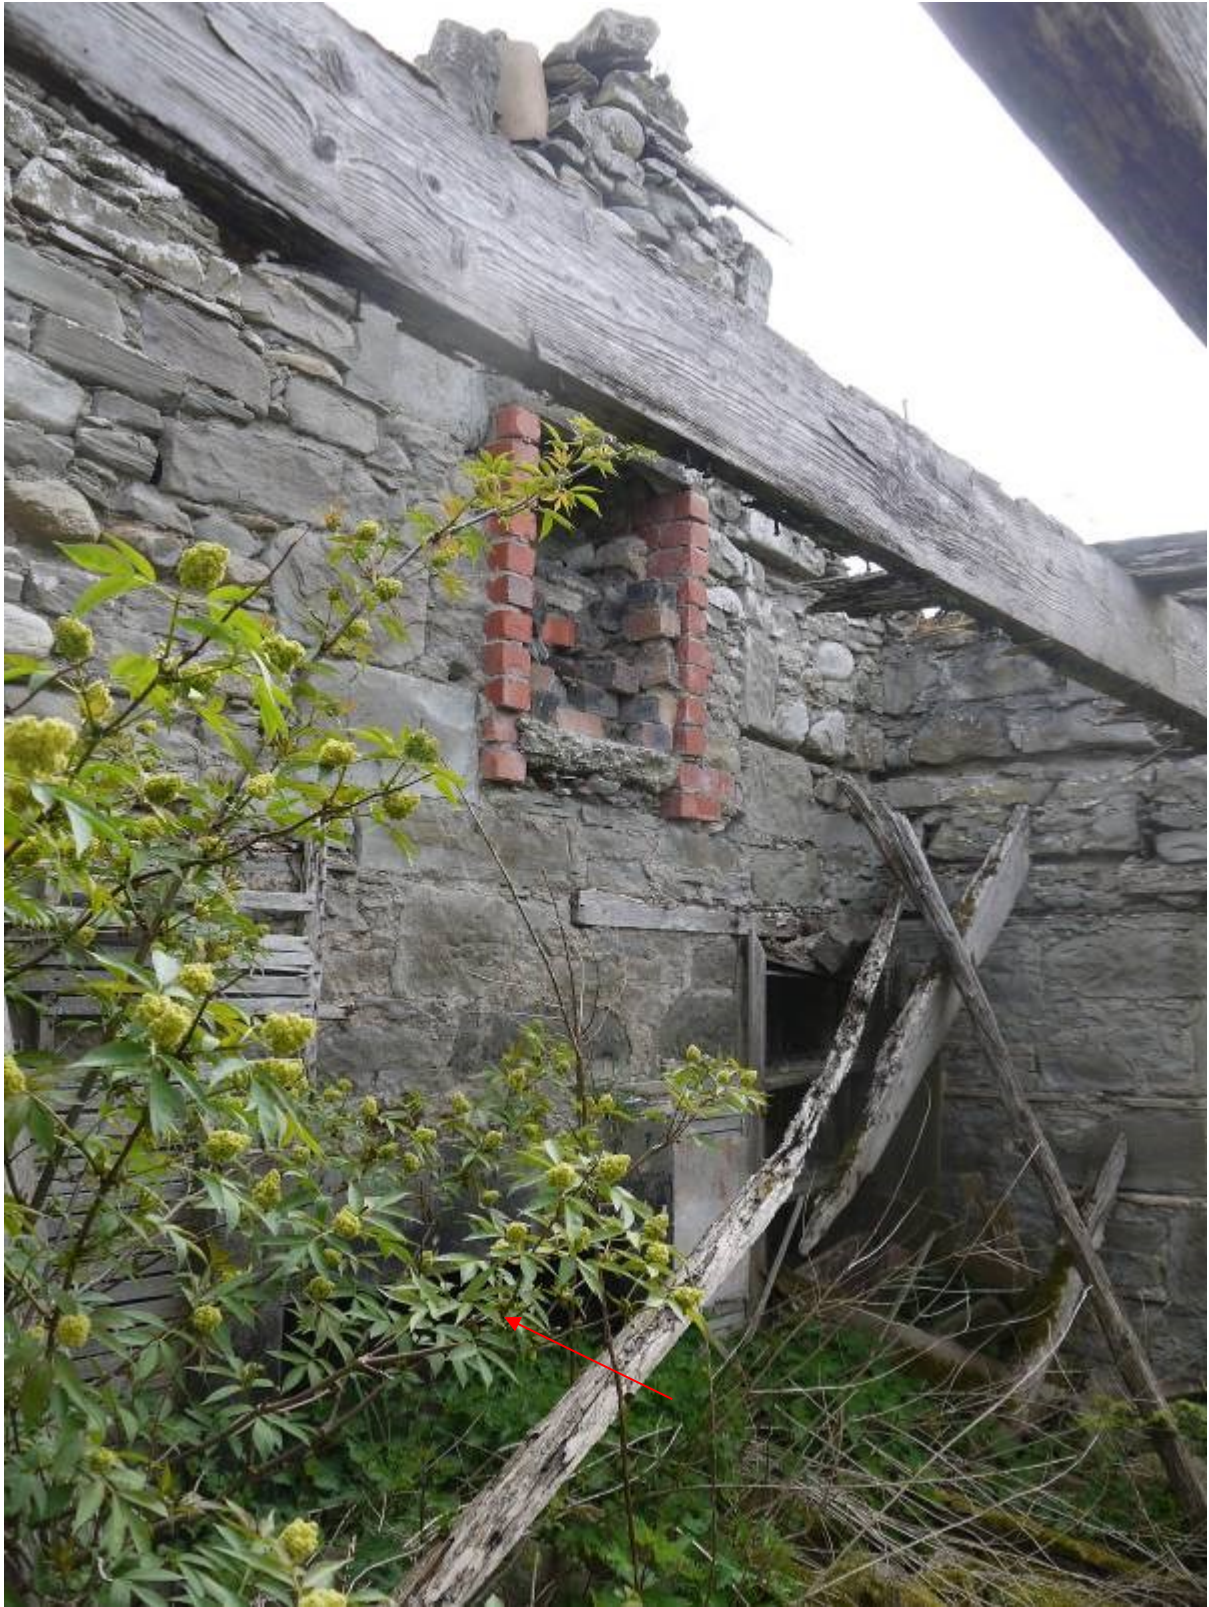
This elevation has a central fireplace at ground floor level and a cupboard at its southern end. The northern end has traces of wooden lath panelling still attached to the wall face. At first floor level of this elevation a brick built fireplace has been built into a former window space which has been blocked.

Illustration 12 Internal western elevation of Building A showing surviving wooden wall panelling, fireplace at first floor level and cupboard and fireplace at ground floor level (marked with red arrow)

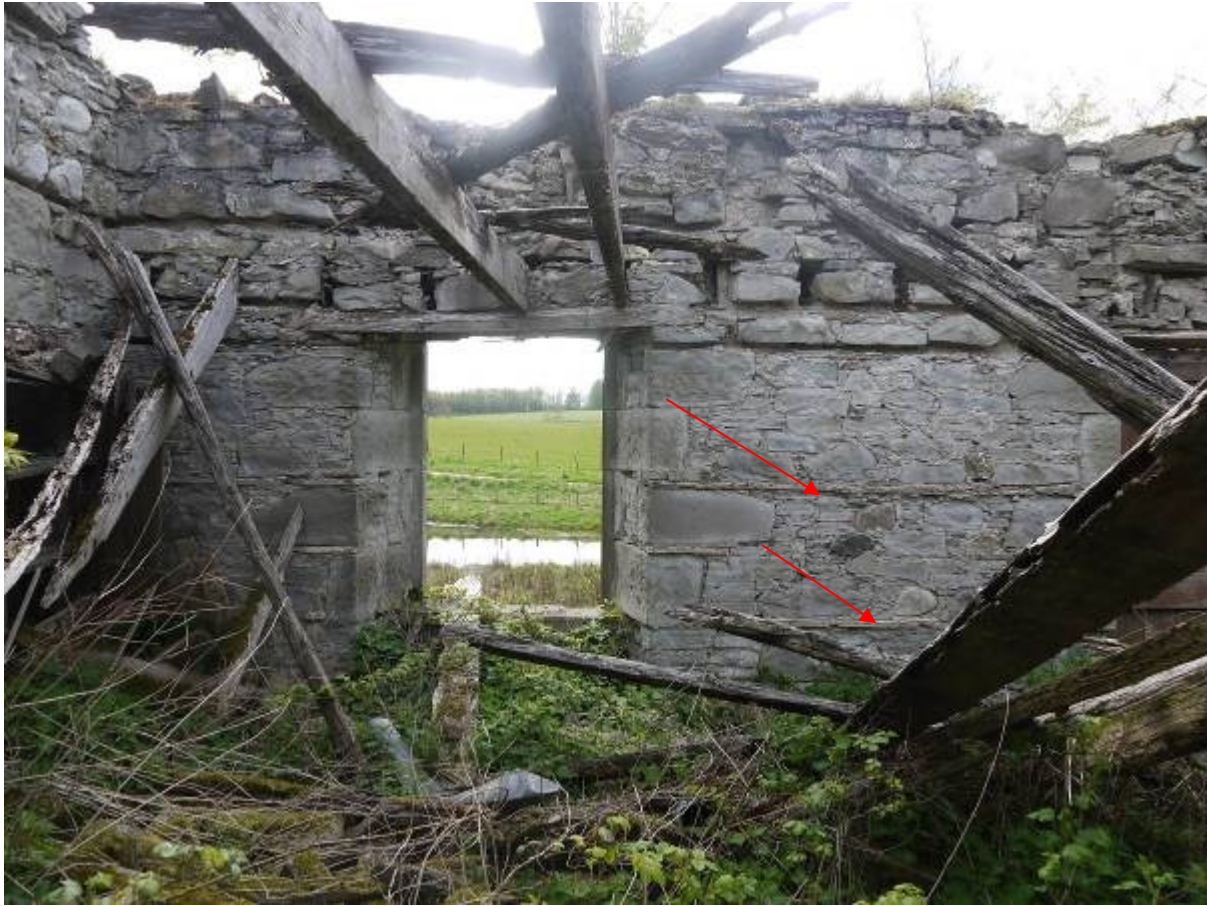
This has two windows and a central doorway.

Illustration 13 Internal northern elevation (eastern end) looking south, red arrows indicate planks built into wall face

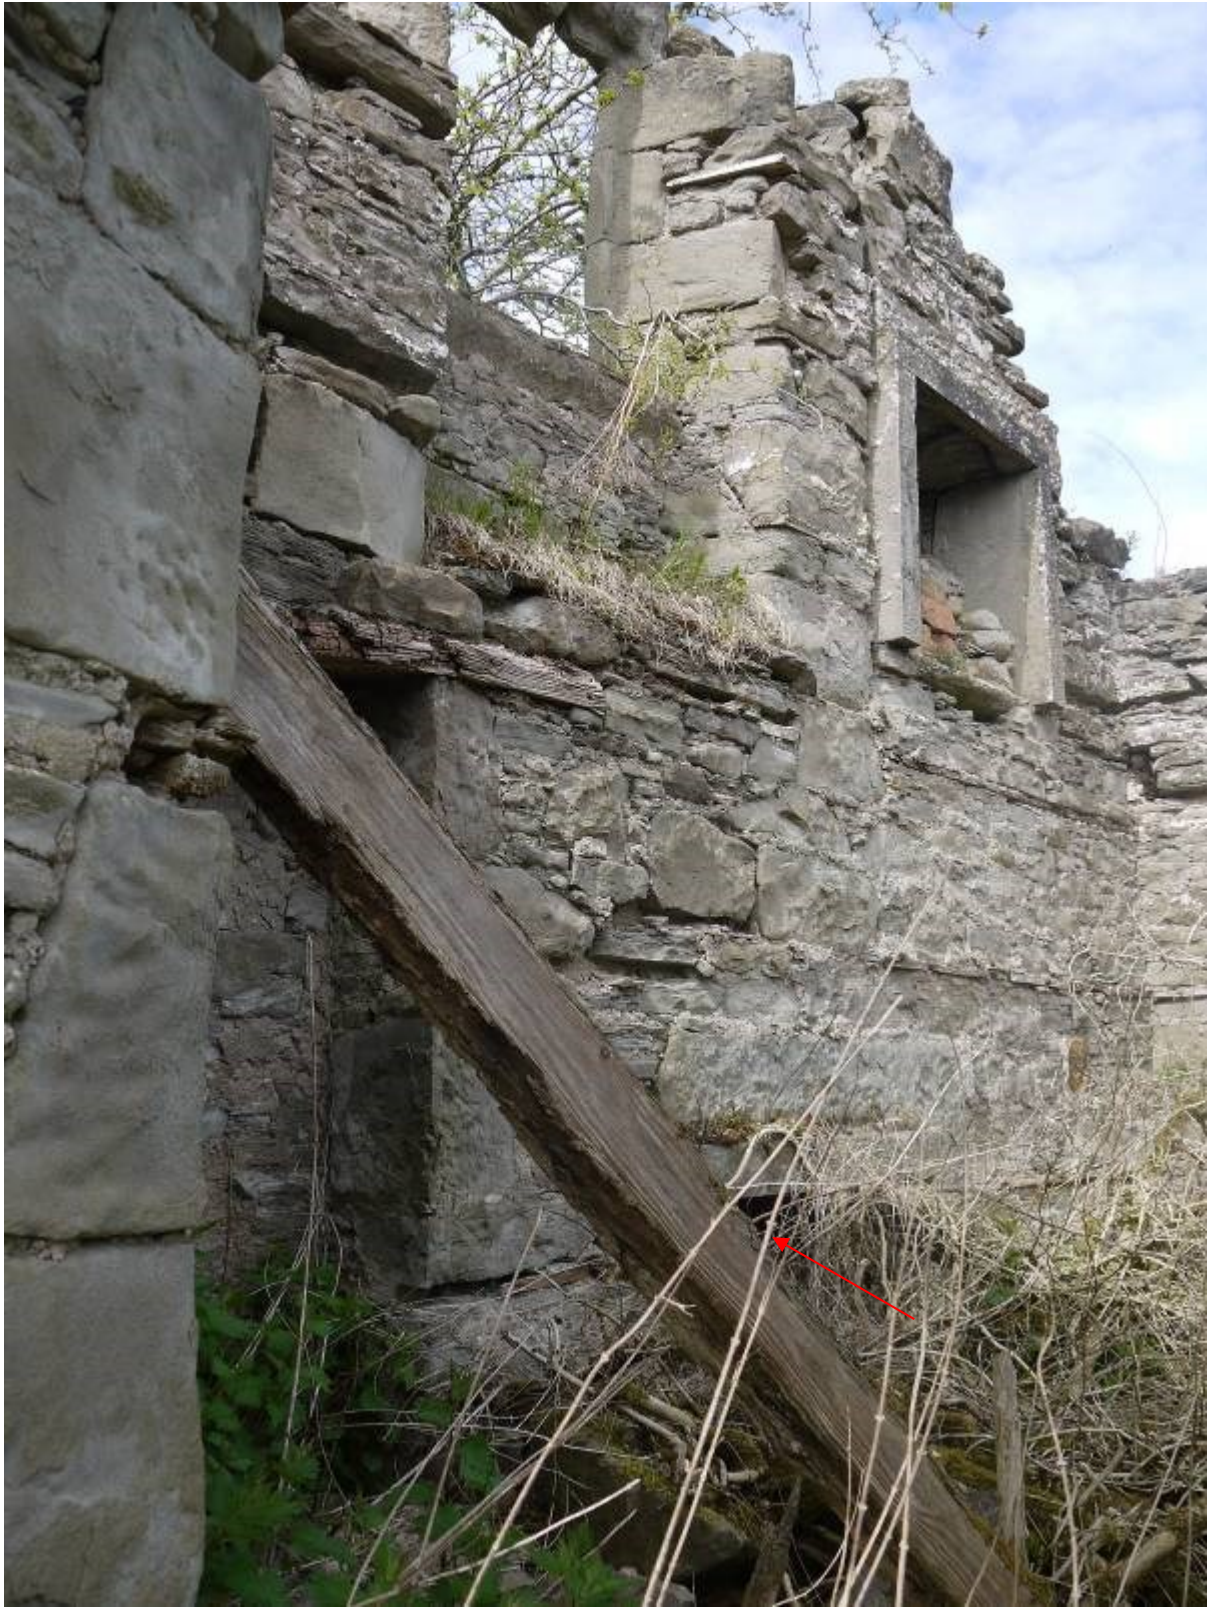
This elevation has a central fireplace at ground floor level and a cupboard at its southern end. At first floor level there is a window and a fireplace at its northern end.

Illustration 14 Internal eastern elevation of Building A showing fireplace and window on first floor level, red arrow indicates ground floor fireplace

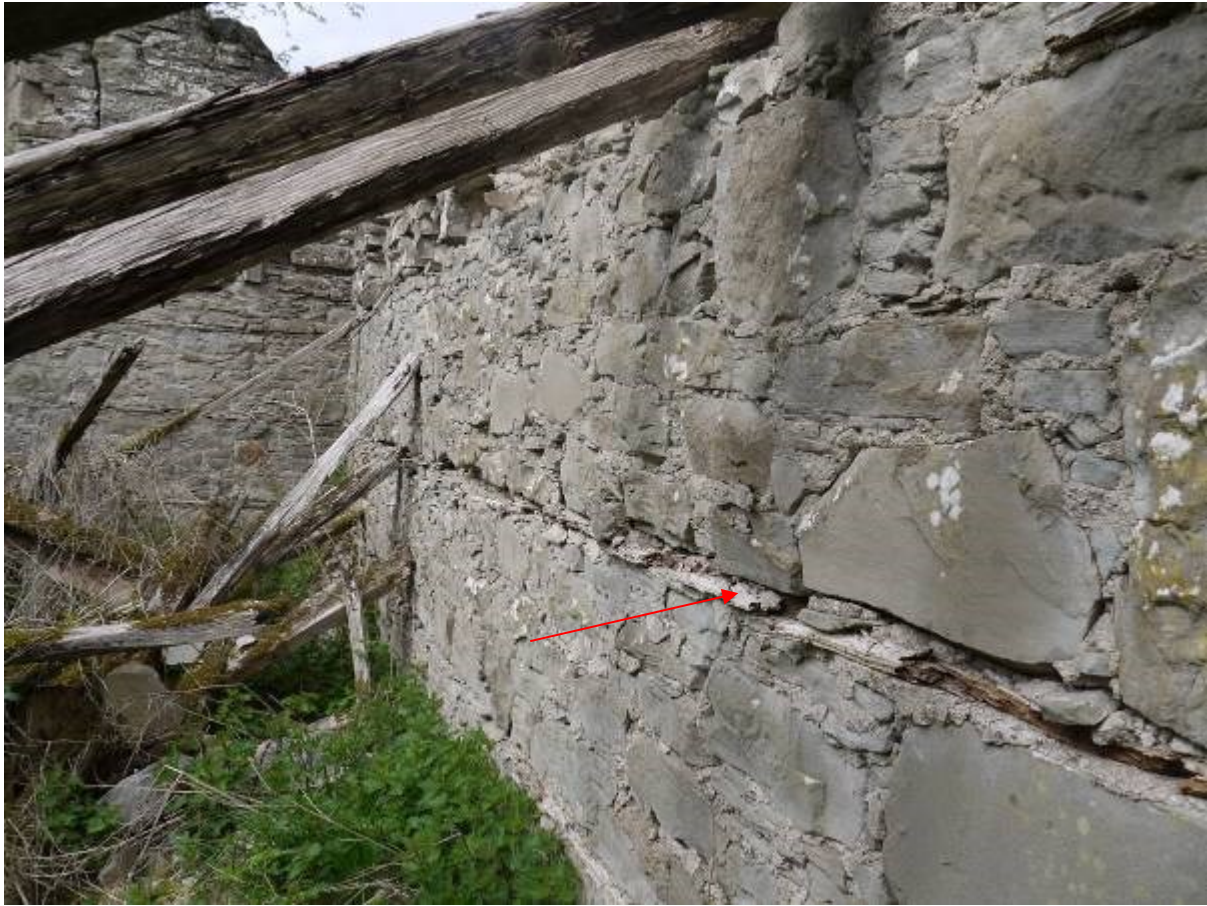
This elevation has a single doorway towards its eastern end.

Illustration 15 Internal southern elevation of Building A showing plank built into wall (red arrow)

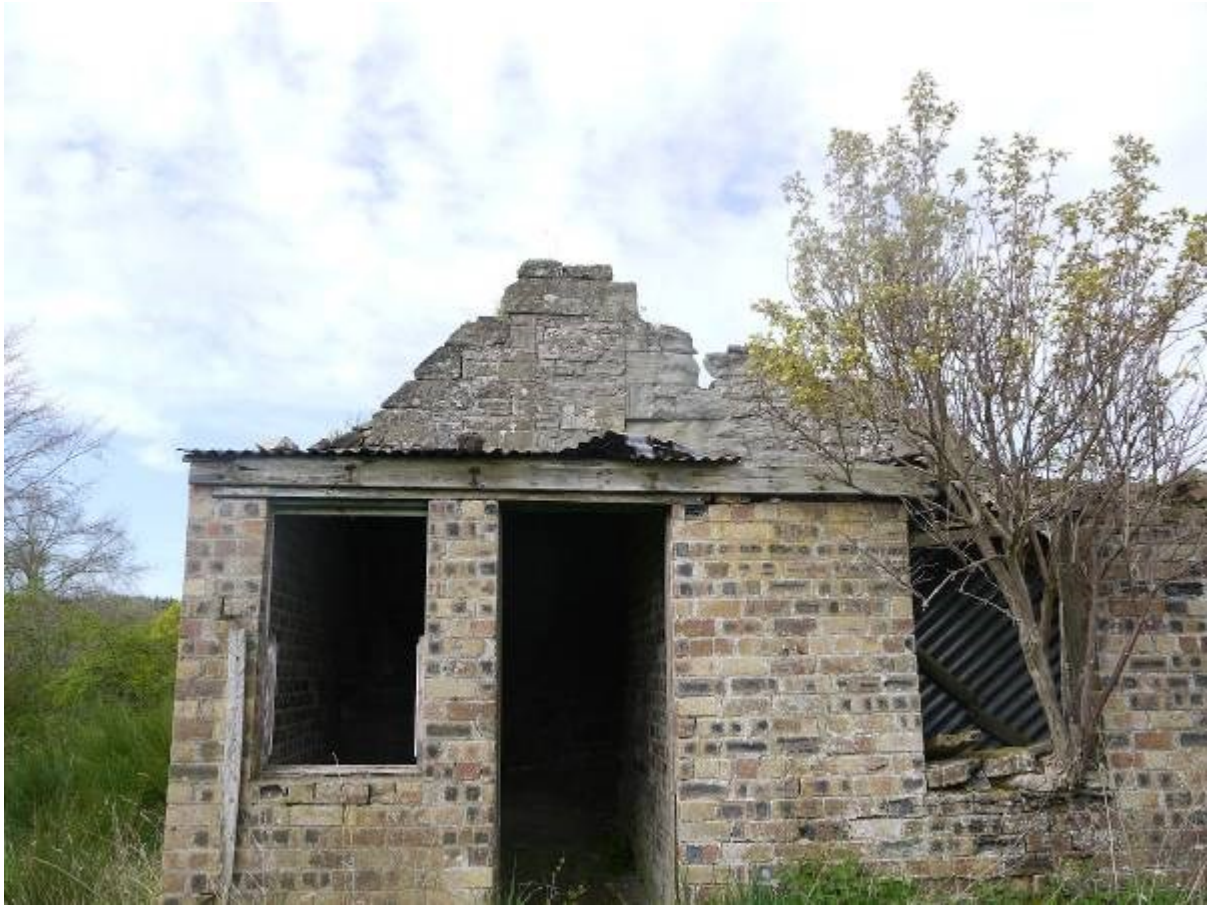
This elevation has a doorway into the room at the southern end and two windows.

Illustration 16 Eastern elevation of brick built extension at eastern end of Building A

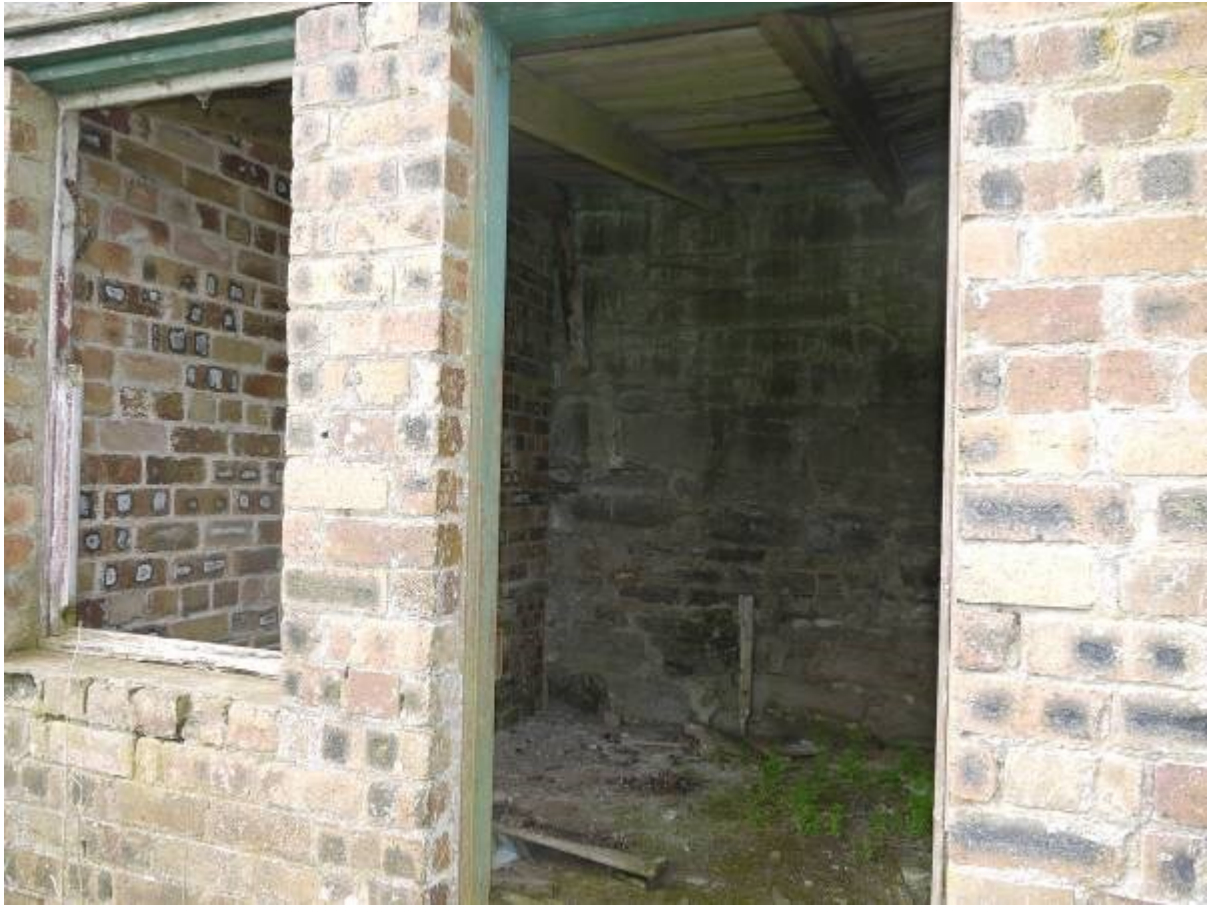
The two rooms inside this extension have concrete floors; the corrugated iron roof above the northern room has collapsed into it.

Illustration 17 Interior of room at southern end of brick extension

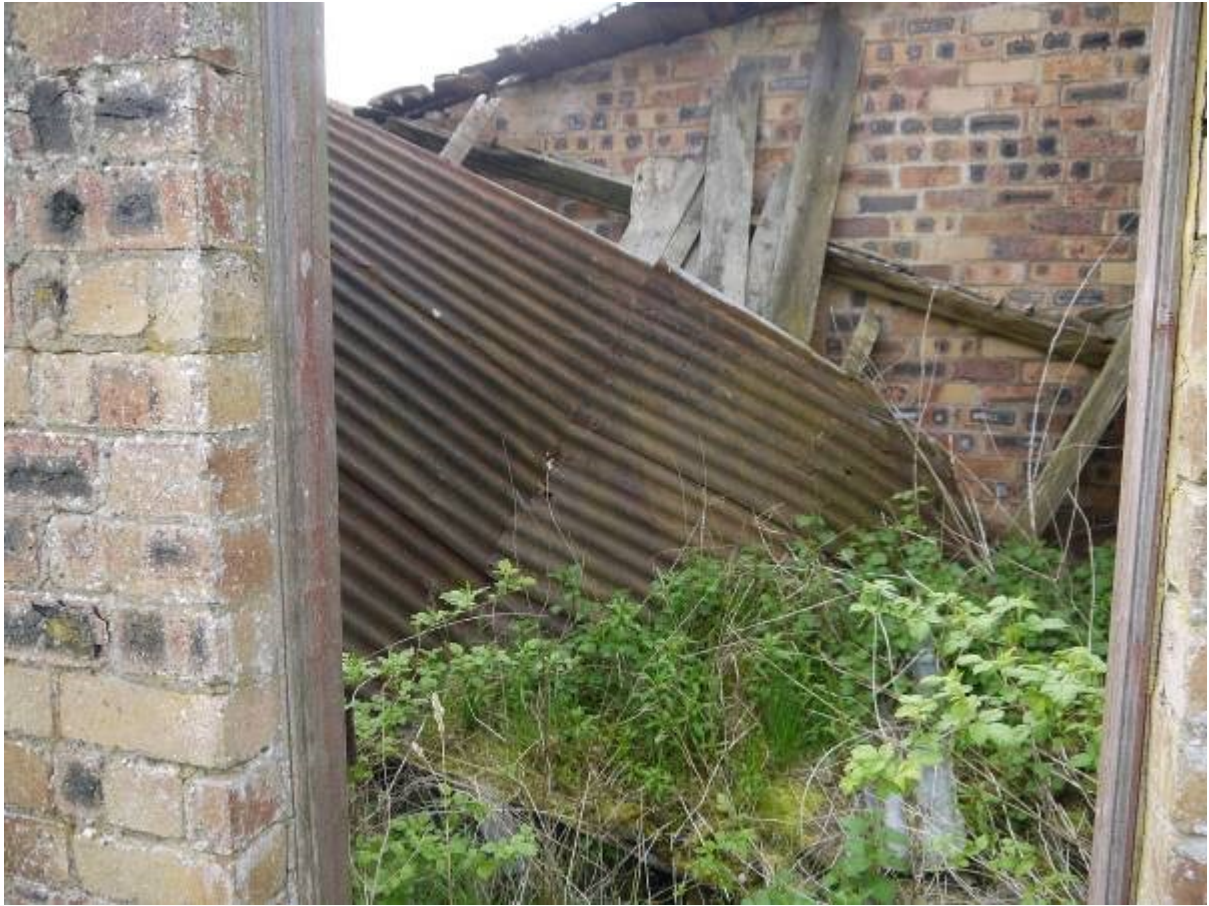
Illustration 18 Interior of northern room in brick extension
