Standing Building Survey

Old England, Stanley, Perth and Kinross

Introduction

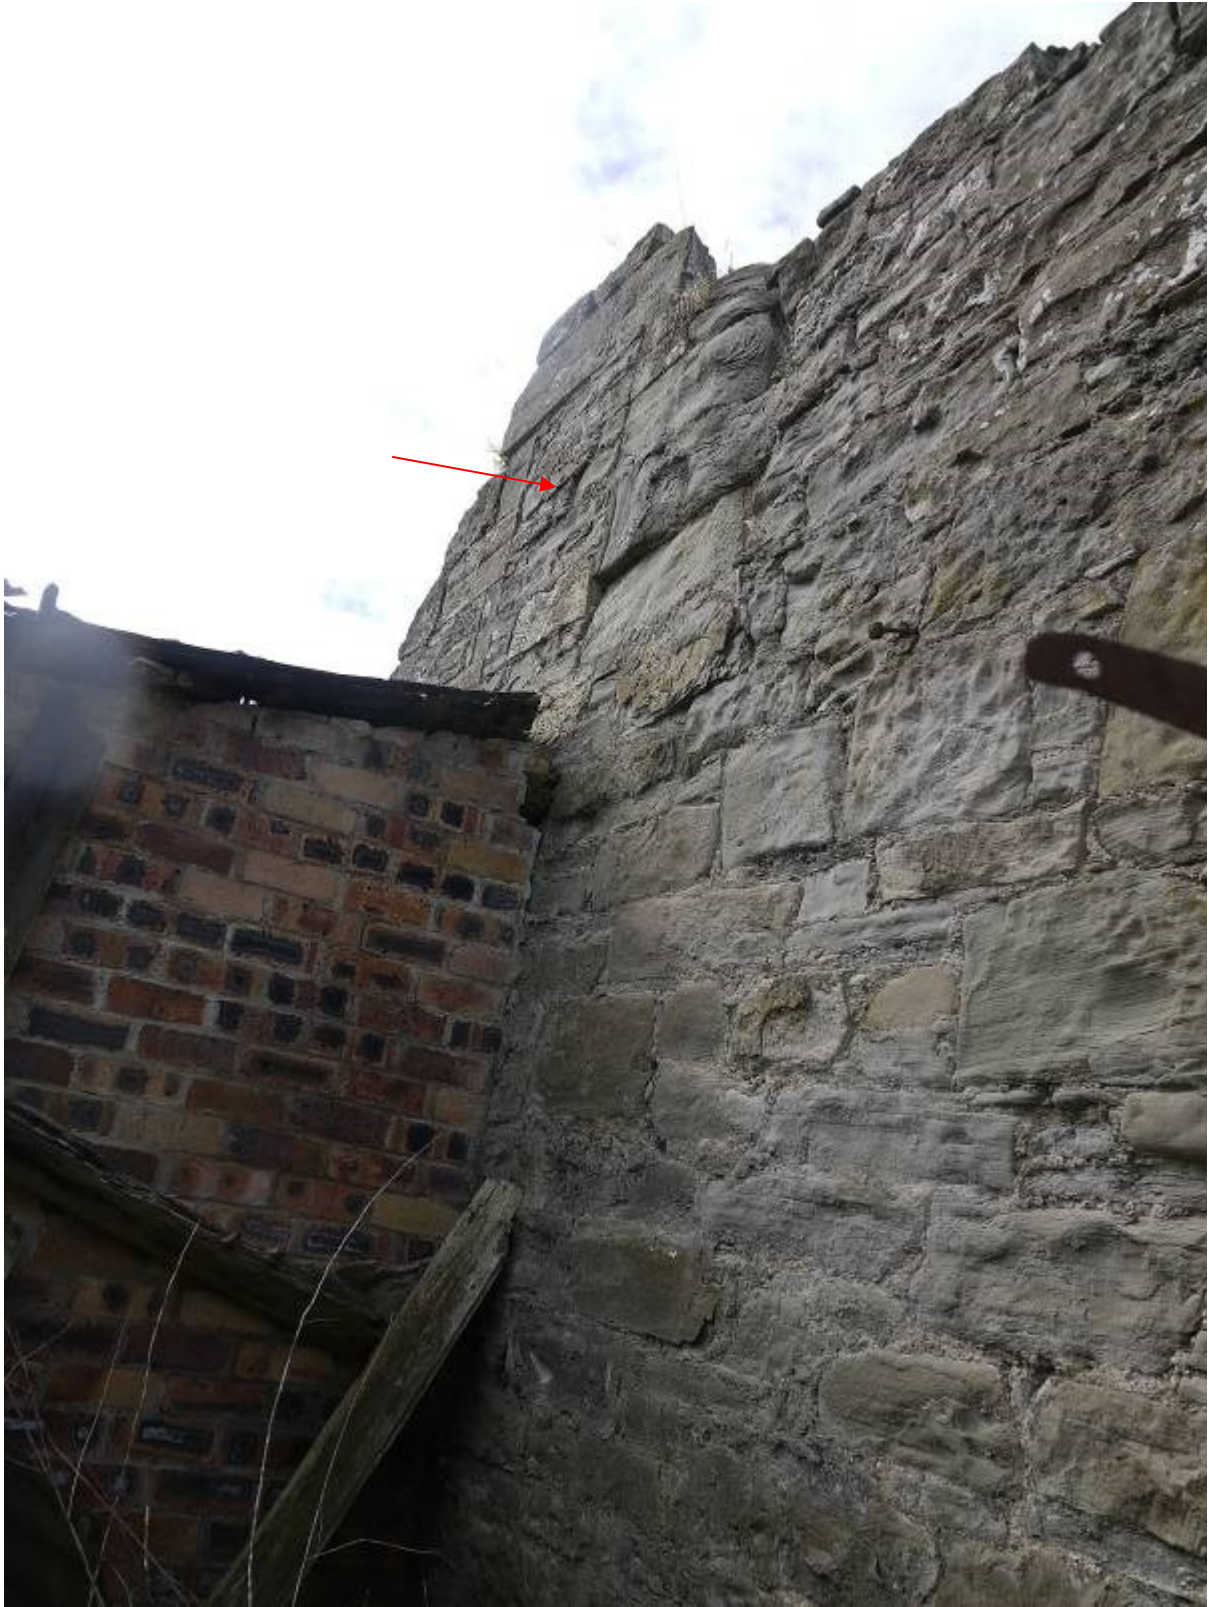
Illustration 19 View of interior of brick extension showing junction with eastern wall of farmhouse and blocked window (red arrow)

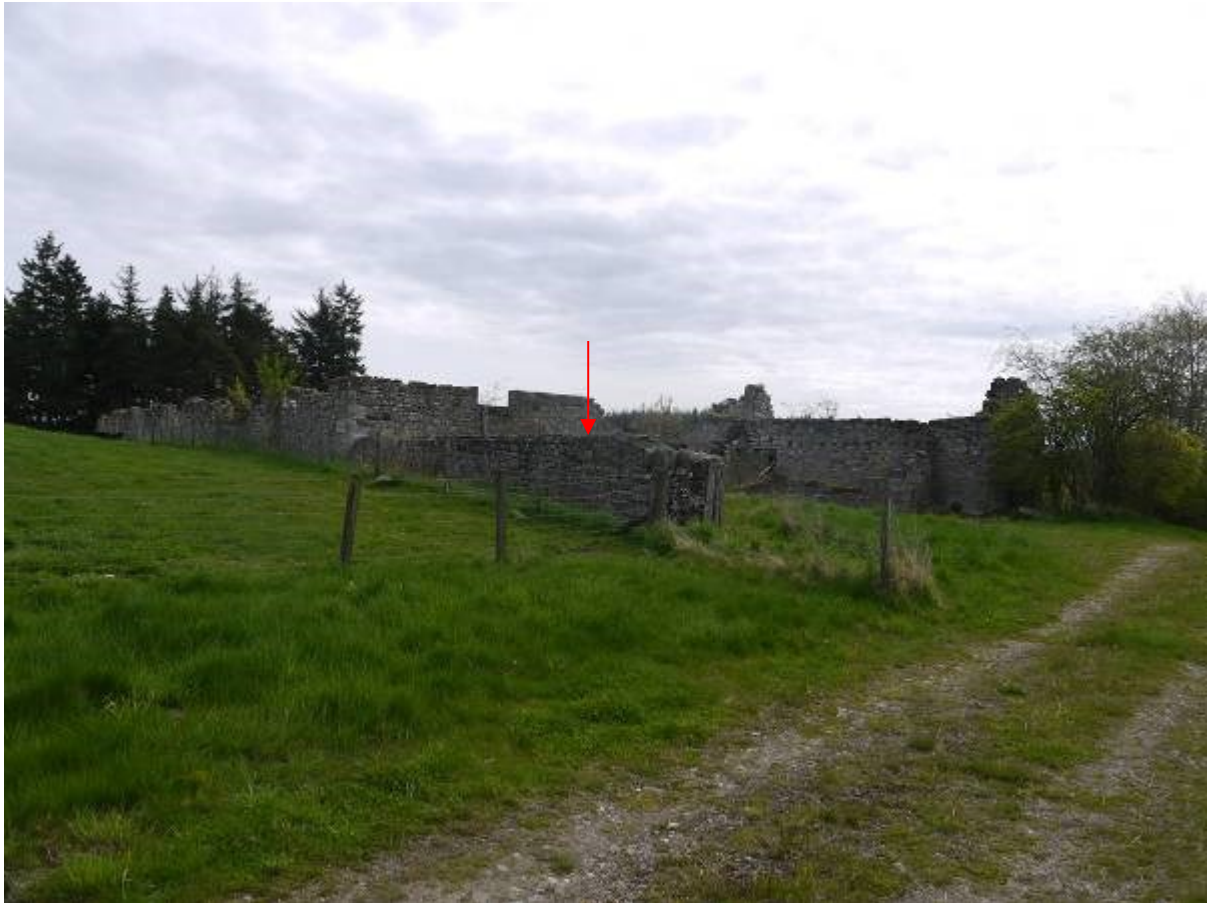
This wall is built of mortar bonded rough sandstone blocks and stands 1.6m high and is 0.33m wide. Three upright concrete pillars have been inserted at its western end. This wall encloses an area that includes a small area of concrete but is otherwise grassed over.

Illustration 20 Building complex looking south east, red arrow indicates wall line described in text

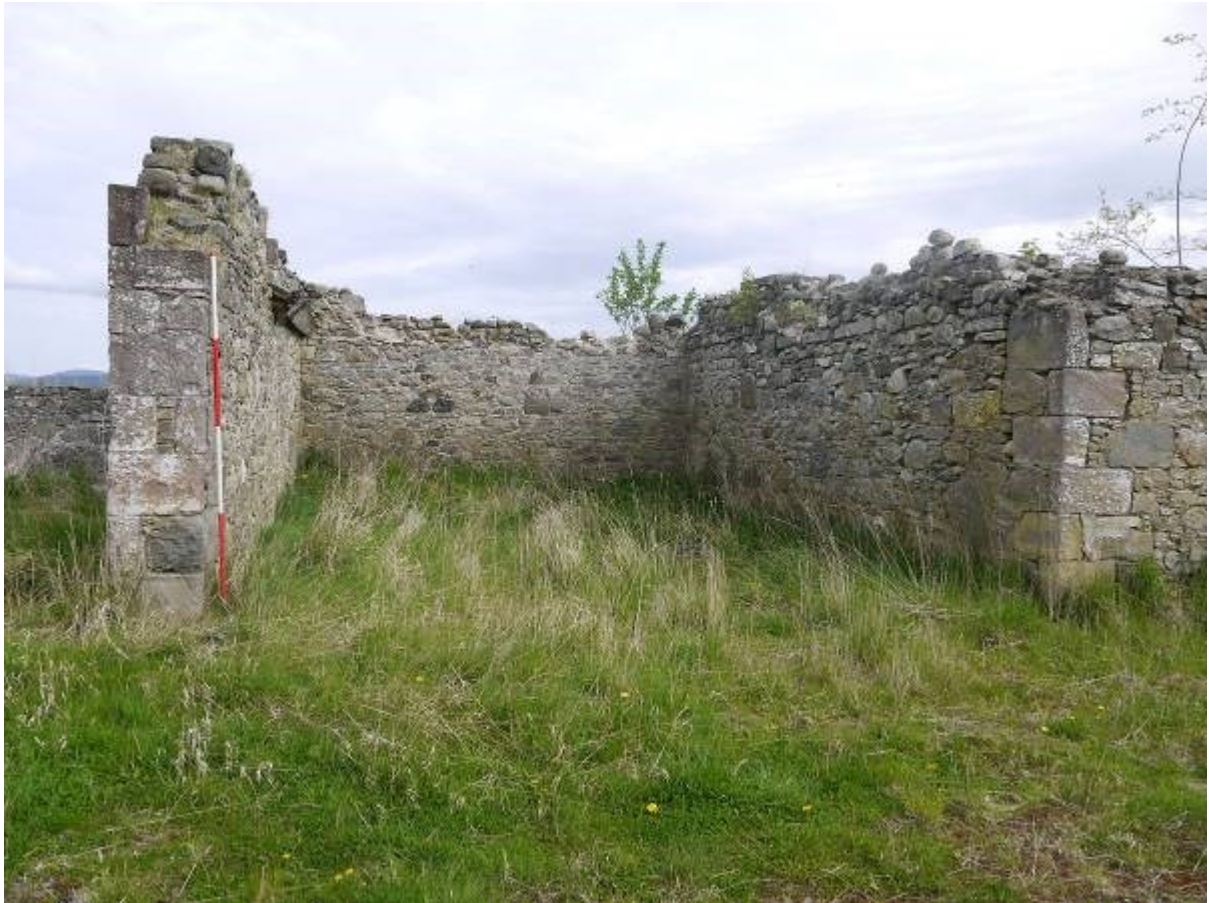
This is a roofless small open ended structure which faces south. Its external western elevation is built of mortar bonded sandstone rubble of various sizes with shaped green sandstone blocks forming quoins at its northern and southern ends. There is the surviving sill of a single window visible.

Illustration 21 Building B looking north

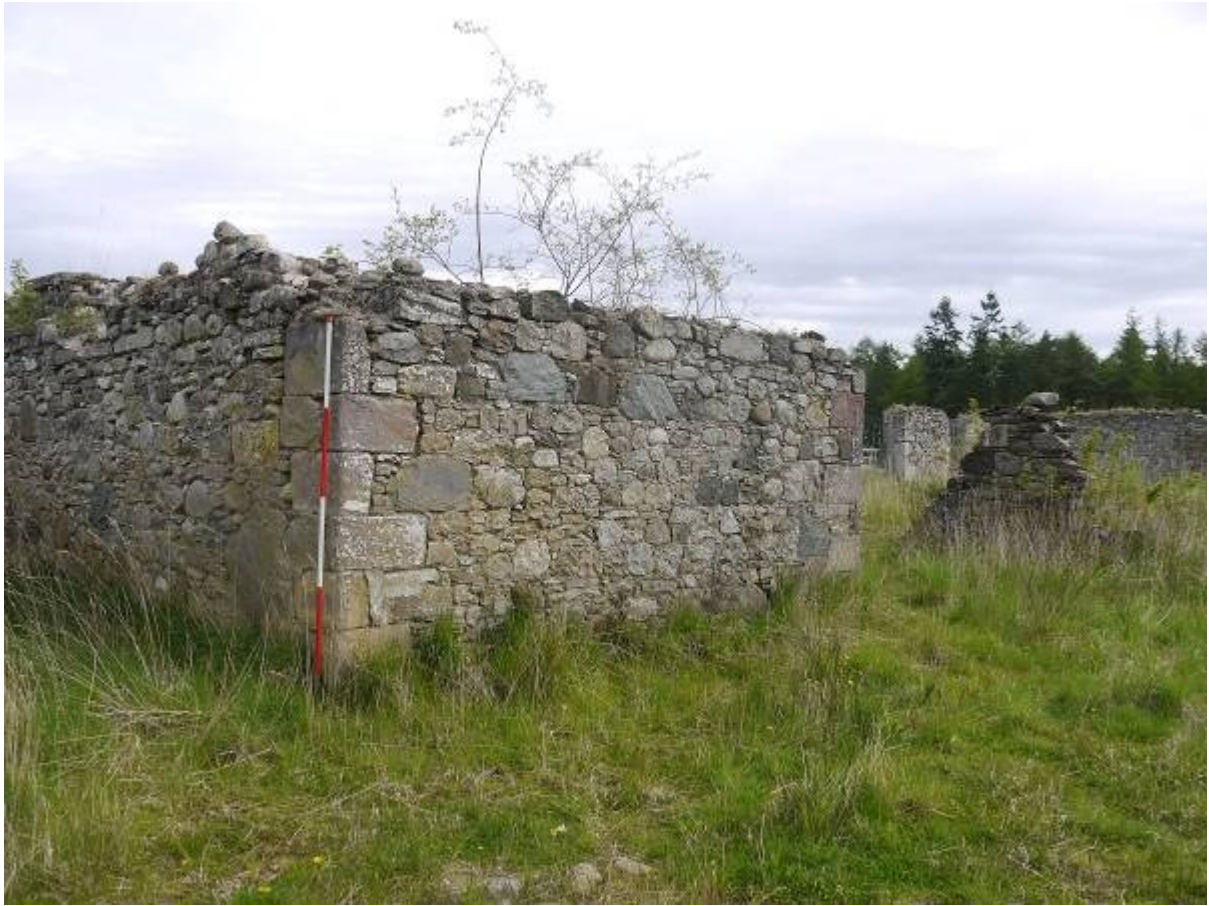
This roofless long building is built of mortar bonded sandstone rubble with shaped sandstone blocks forming quoins at its corners. Its external western elevation is blank, its southern elevation has a wide entrance doorway and its northern elevation contains three doorways and two windows. There is a single doorway in its eastern elevation leading into Building E.

Illustration 22 Southern elevation of Building C looking north east

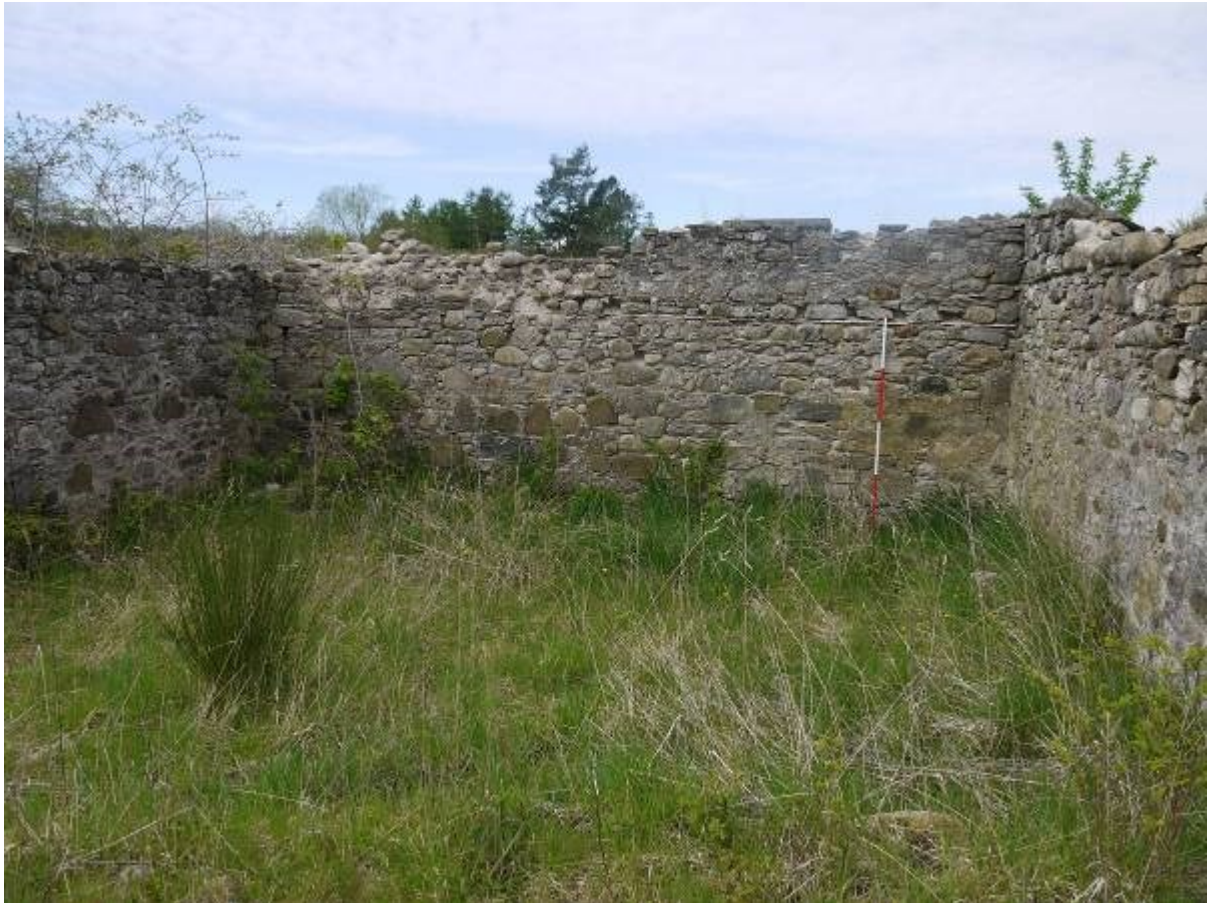
This building's floor is slightly higher for most of its length in association with the doorways in its northern wall. There is a drain visible in the floor at its eastern end.

Illustration 23 Interior of western end of Building C looking west

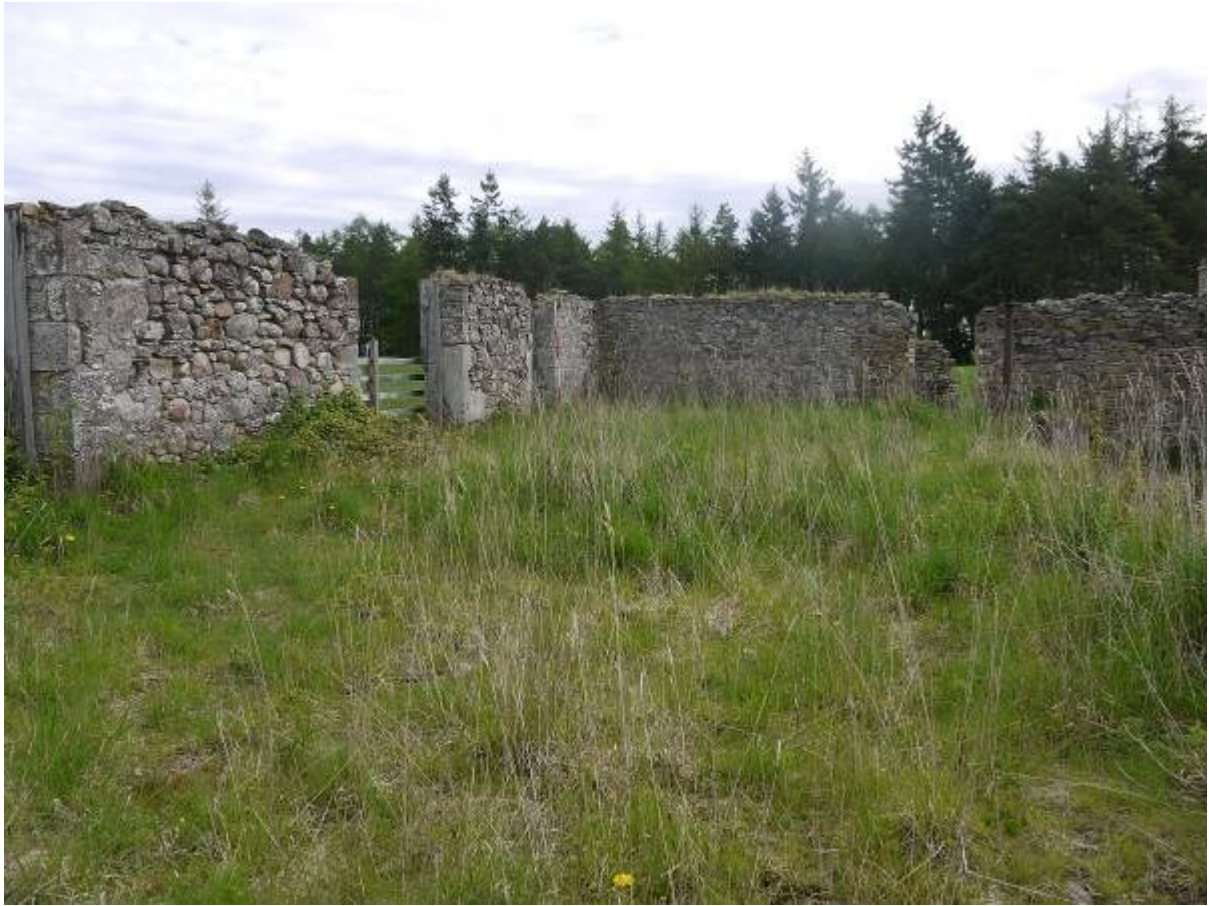
Illustration 24 Interior of Building C looking east

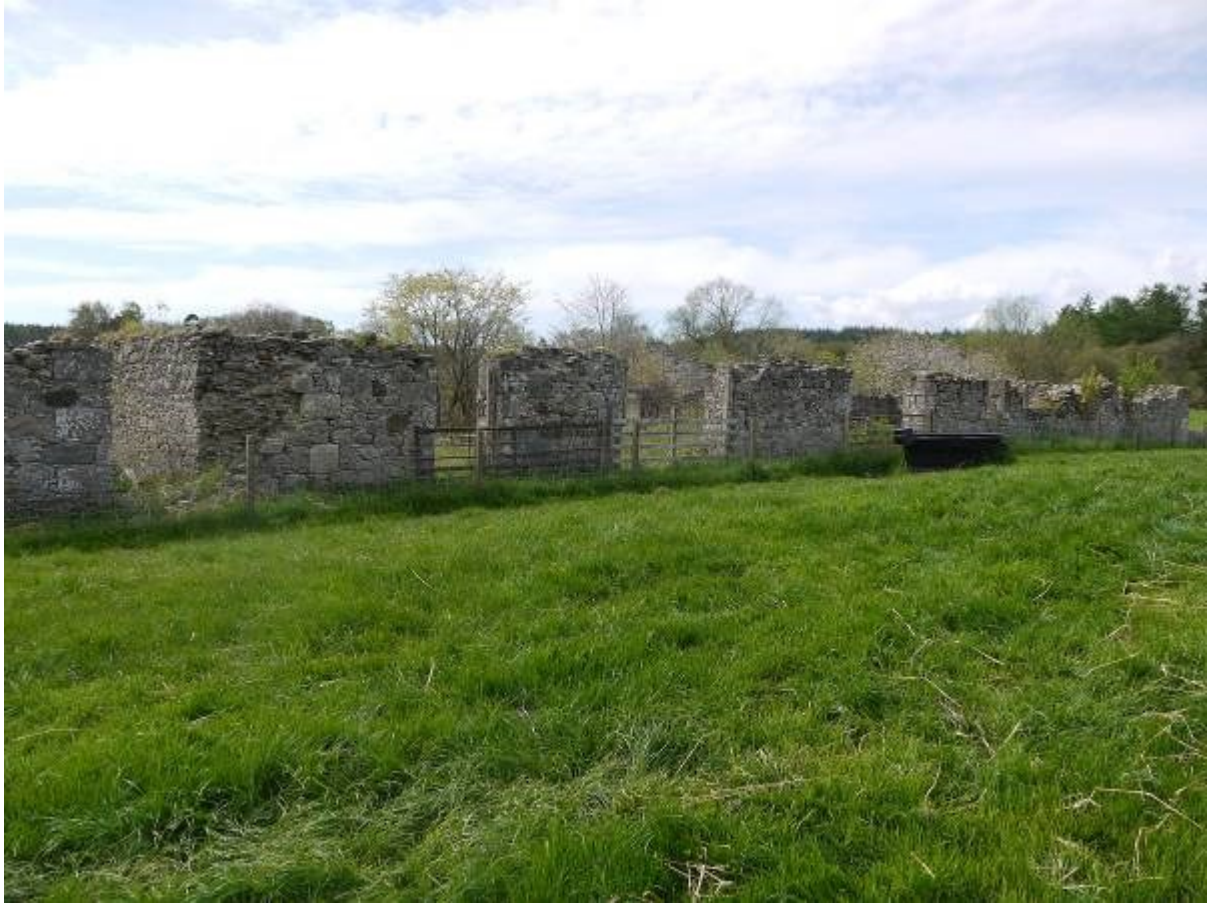
Illustration 25 Northern elevation of Building C looking south west

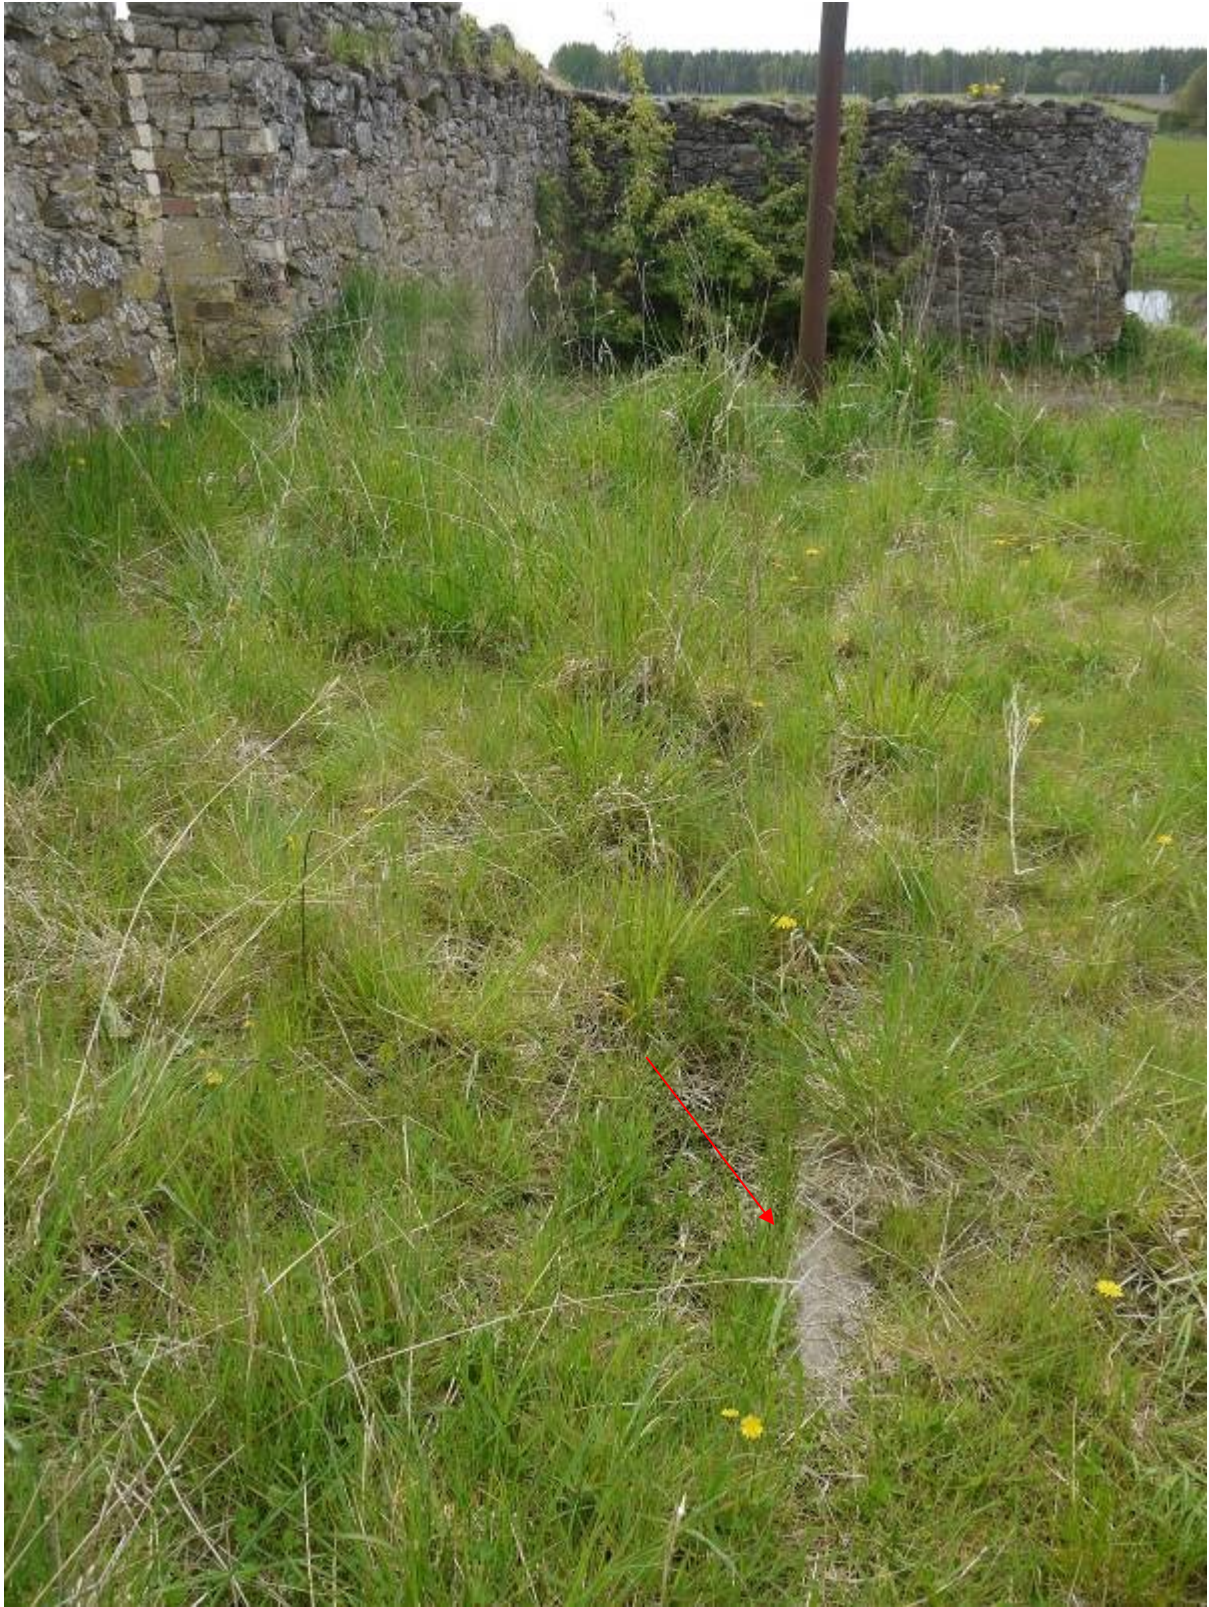
Illustration 26 Drain in floor at eastern end of Building C (red arrow), surviving cast iron roof support visible in back ground

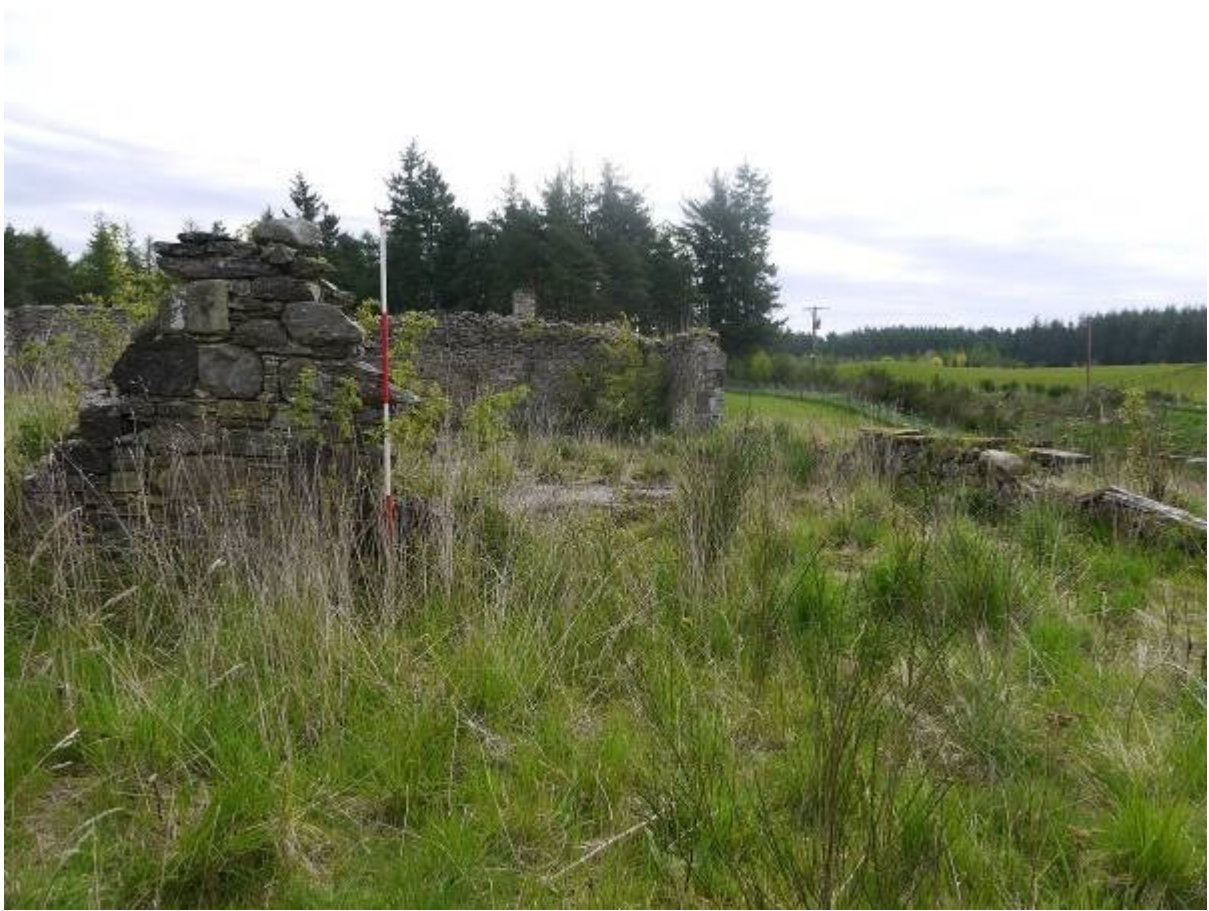
This roofless long building runs parallel with Building C and has a concrete floor at a lower level than the interior of that building. Its southern elevation comprises a low wall that is capped with concrete and the building on this side appears to have been open. Its northern elevation also appears to have been open although there is a single surviving cast iron pillar which suggests that any roof structure was supported in that manner. The eastern end of this building stands much higher at its junction with Building E. There is an internal water tank at its north eastern end.

Illustration 27 Building D looking east

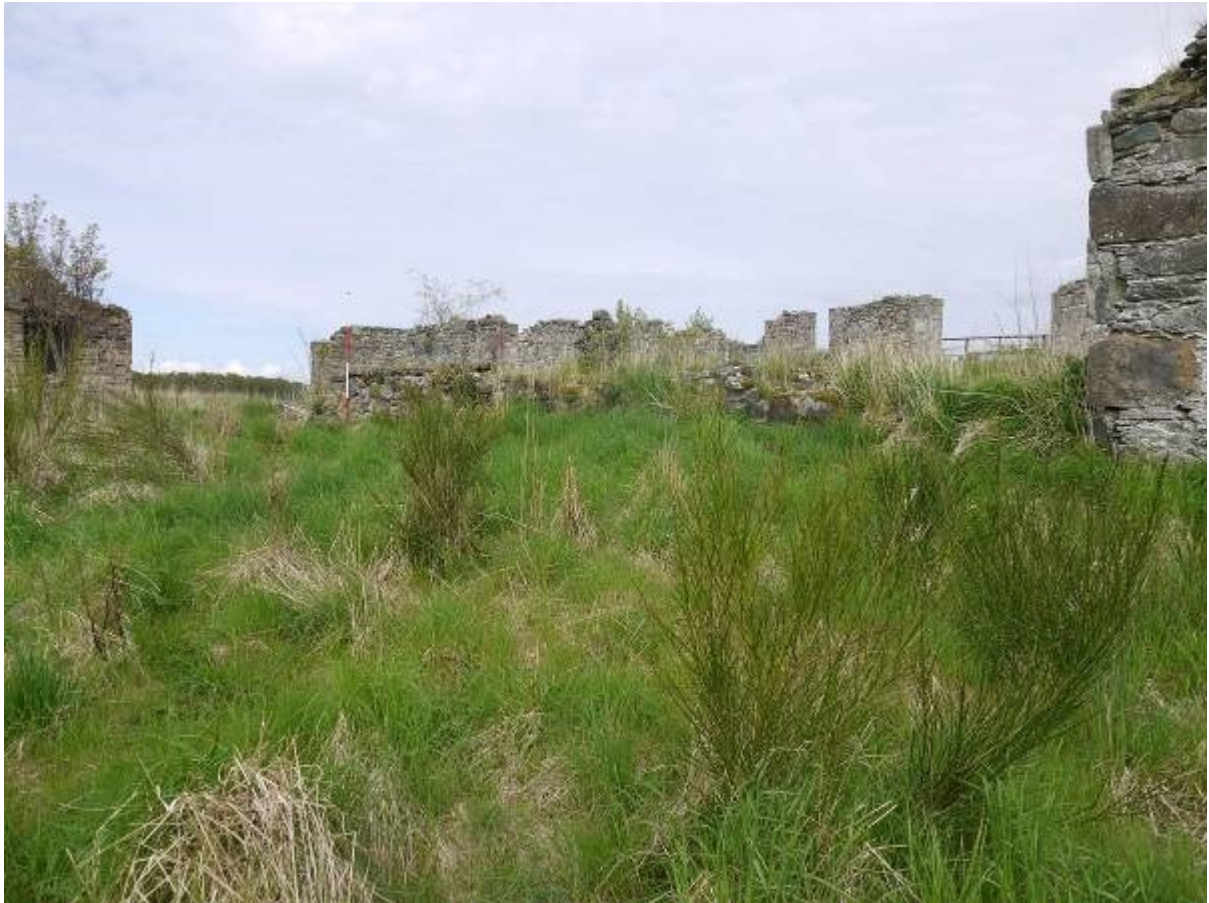
Illustration 28 Southern elevation of Building D looking north

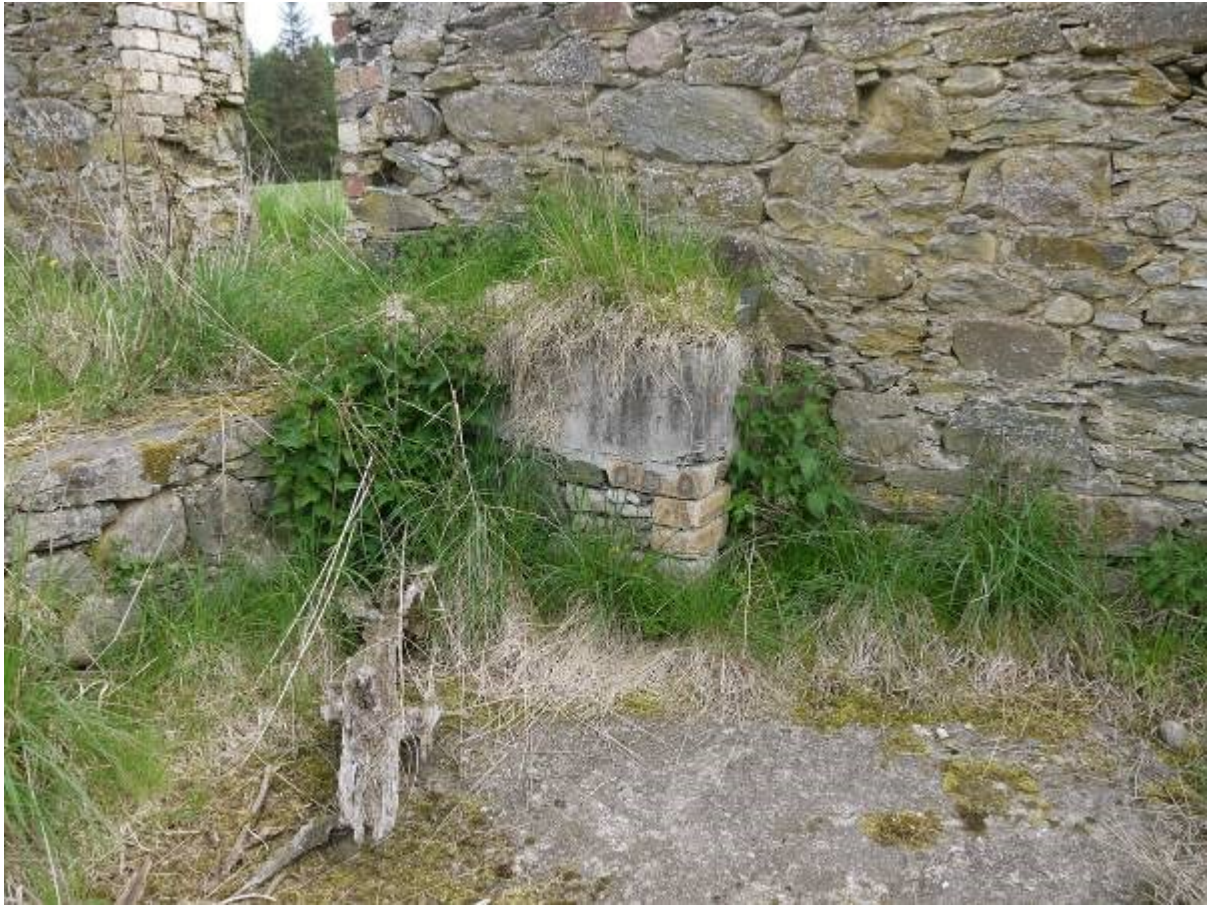
Illustration 29 Water tank at north eastern end of Building D

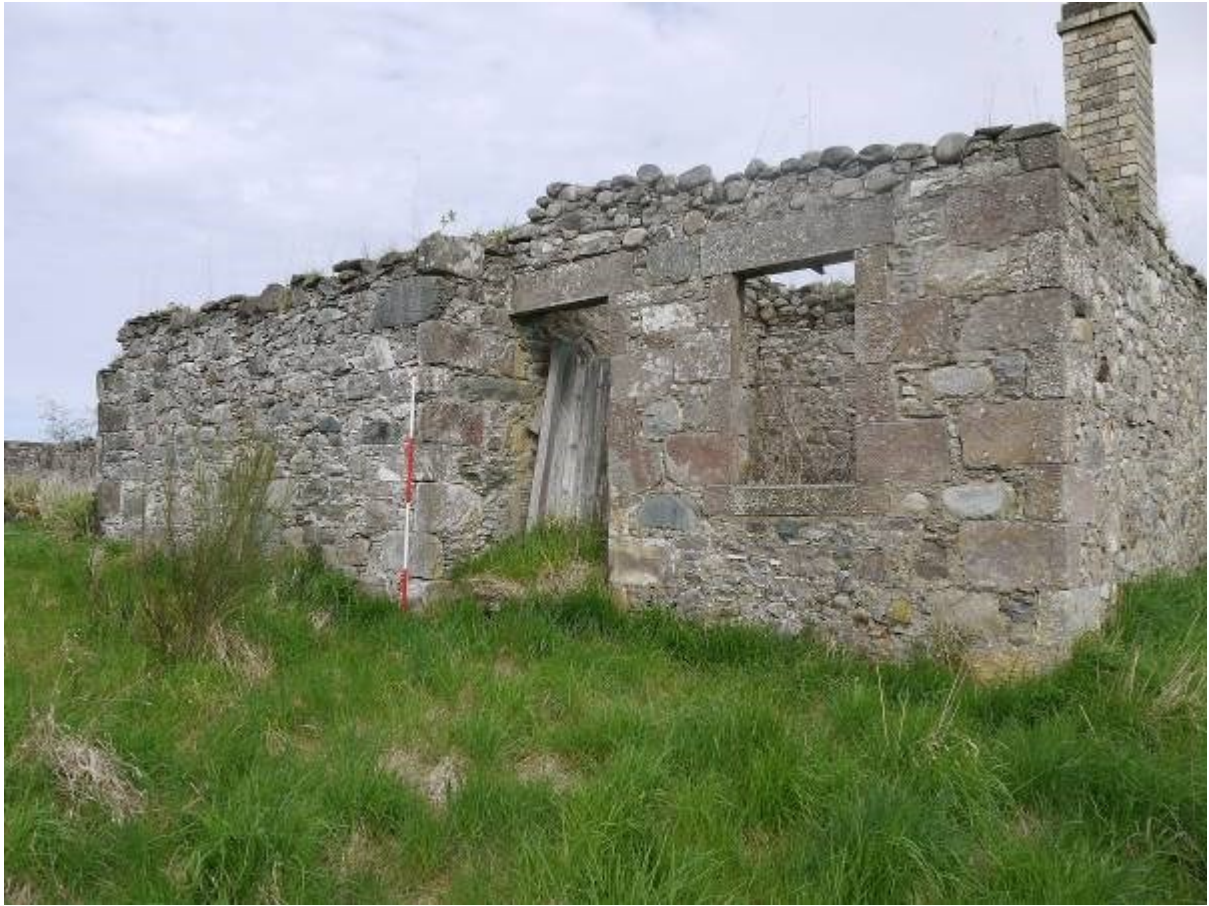
This elevation has a single doorway with a step up to it on its western side and a single window.

Illustration 30 Southern elevation of buildings D and E looking north

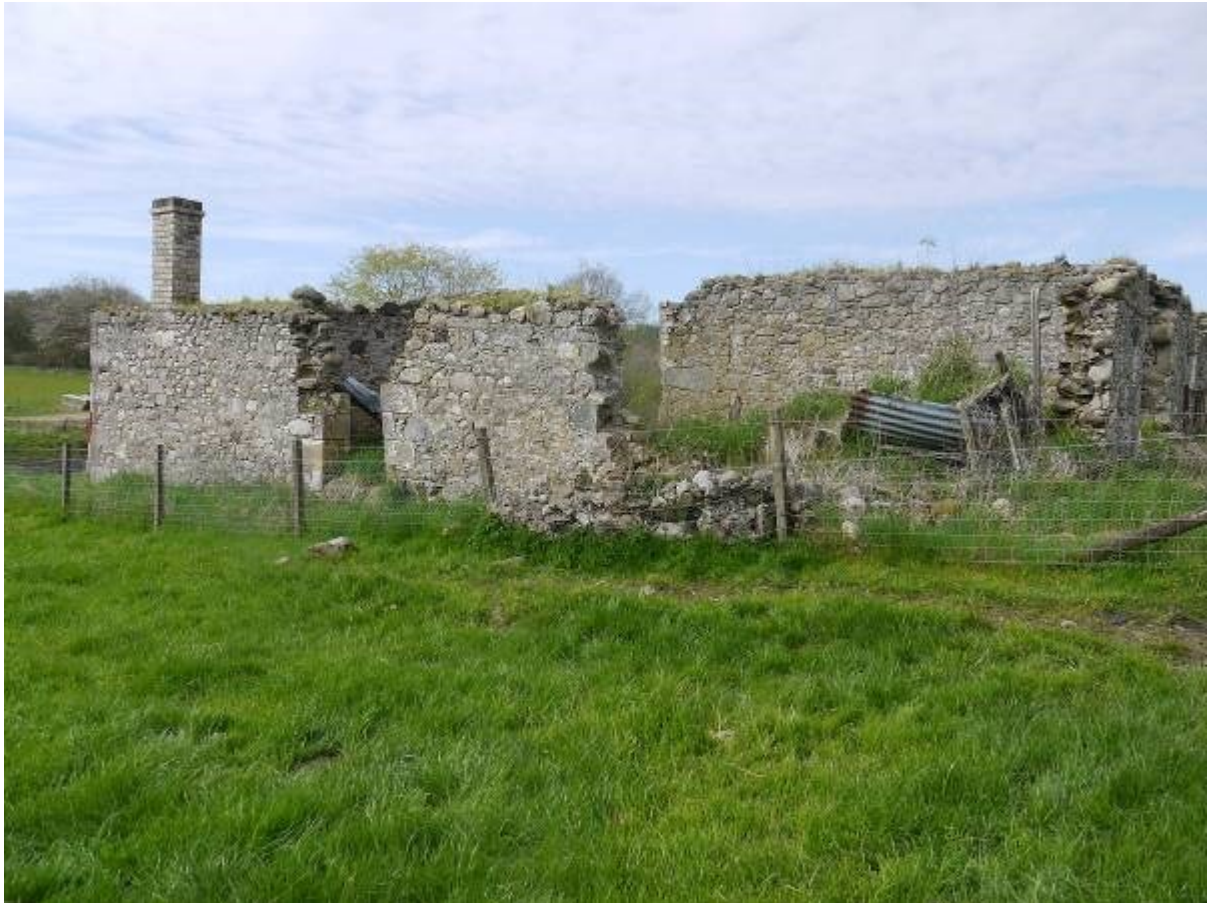
This elevation has a single doorway and its northern end has collapsed. There is a brick built chimney at its southern end.

Illustration 31 Eastern elevation of Building E looking west

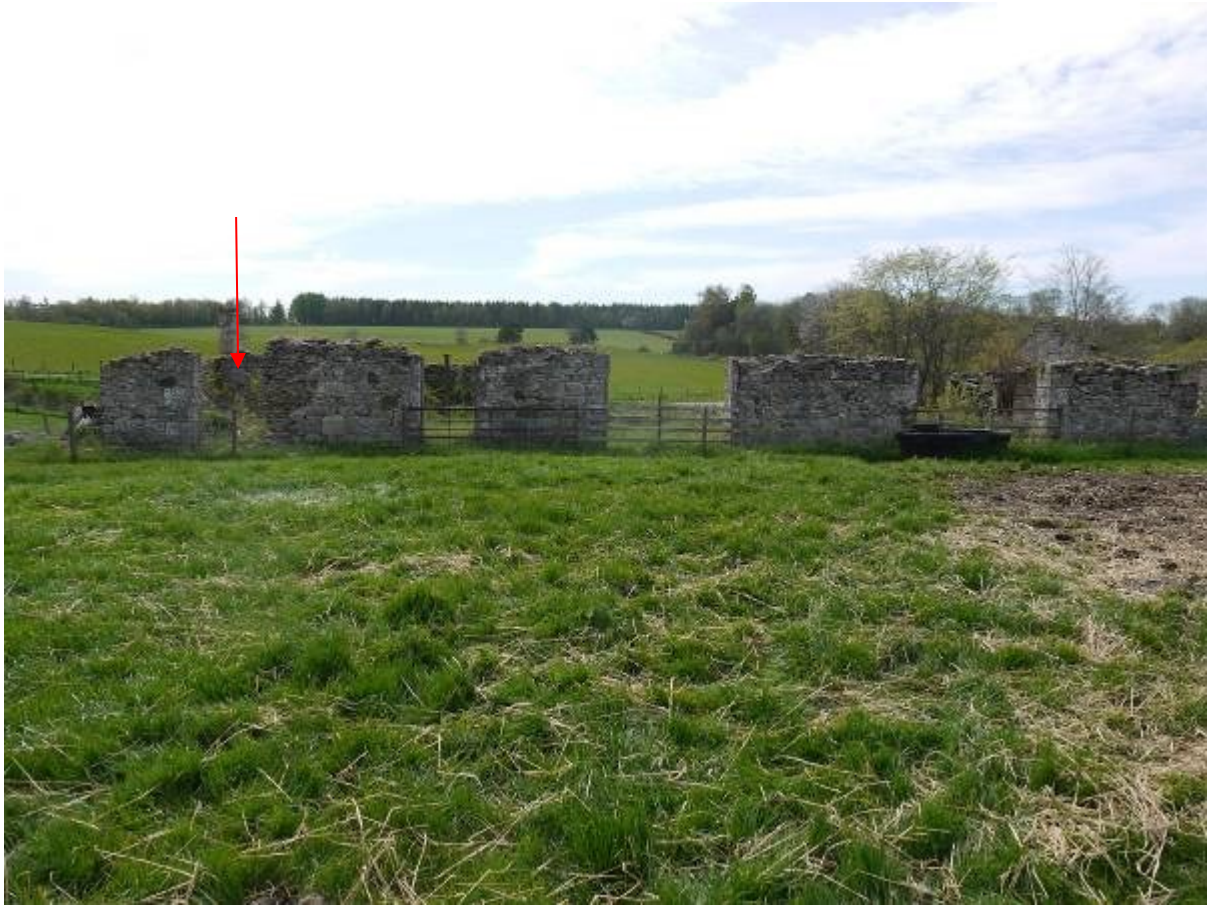
This elevation has a single doorway.

Illustration 32 Northern elevations of Buildings C and E (marked with red arrow)

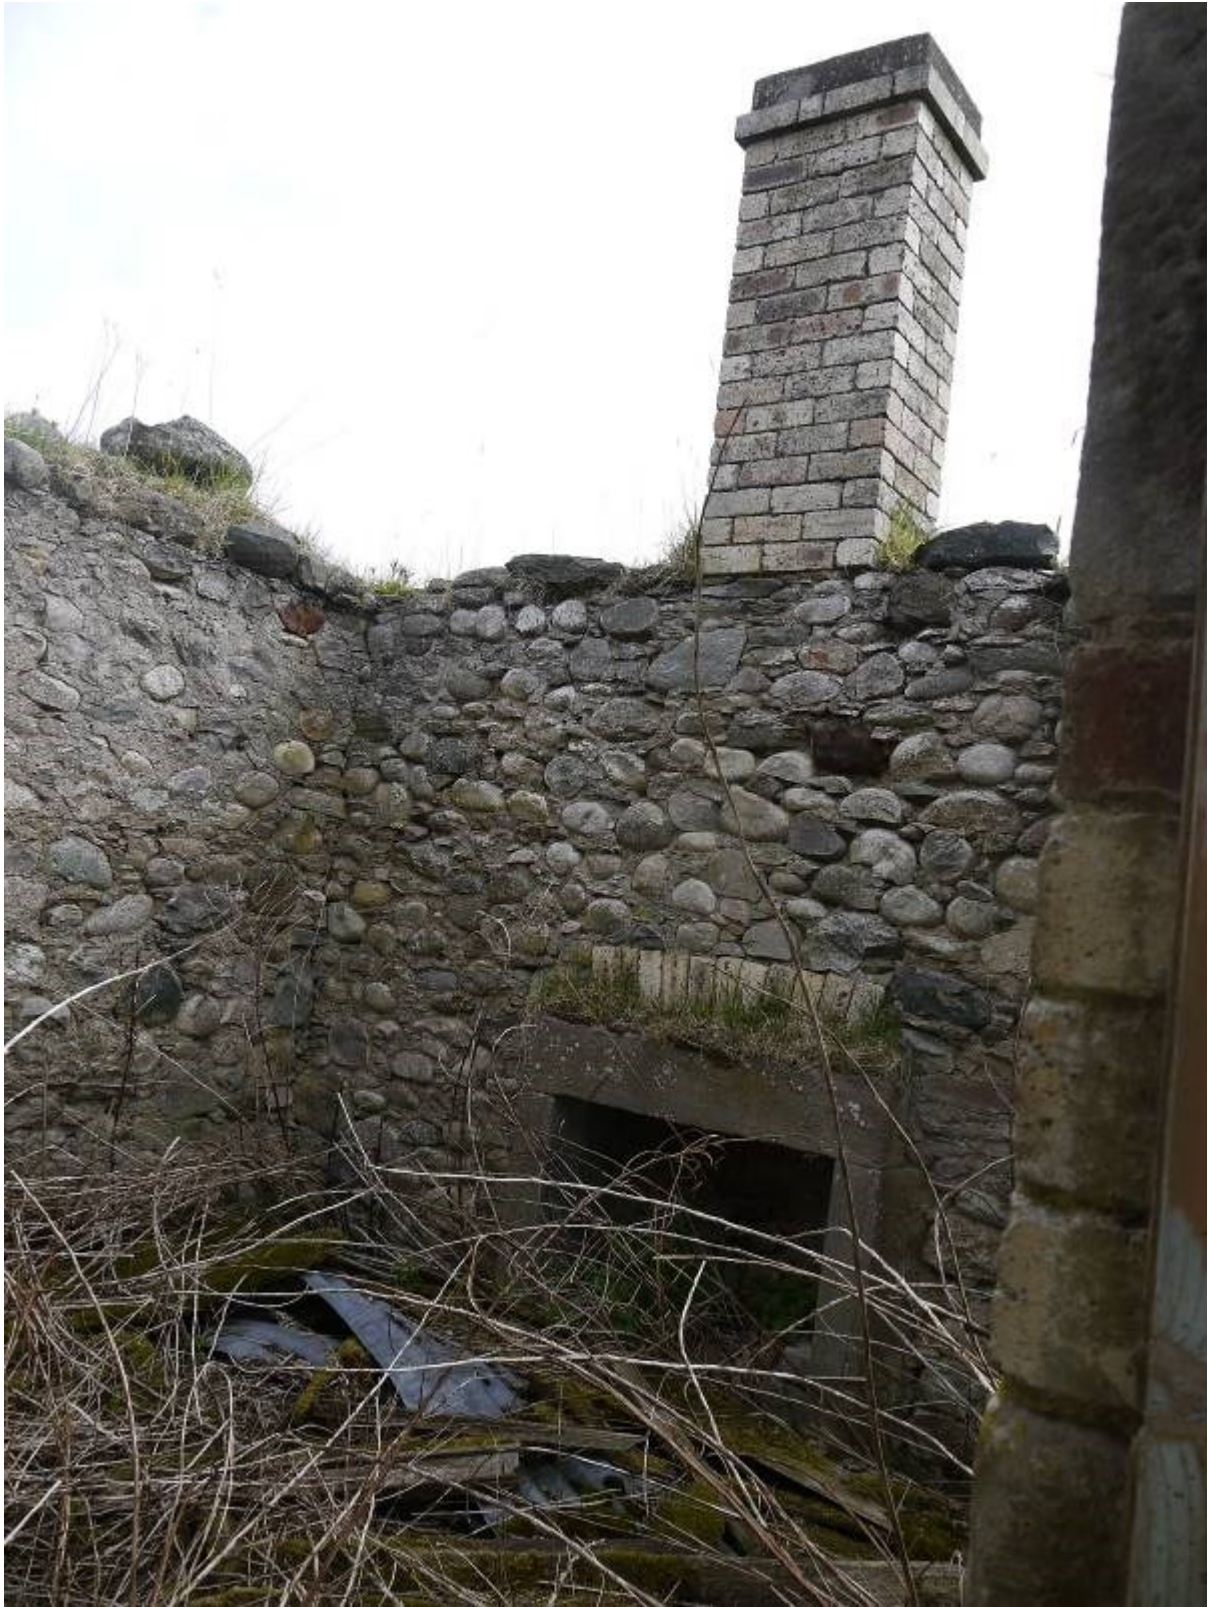
There is a very small room at the southern end of this building with a fireplace in its eastern wall. The remainder of the building comprises a long open room with a door into Building C in its western wall. The remains of a collapsed corrugated iron roof are visible.

Illustration 33 Interior of room at southern end of Building E showing fireplace and associated brick chimney looking north east

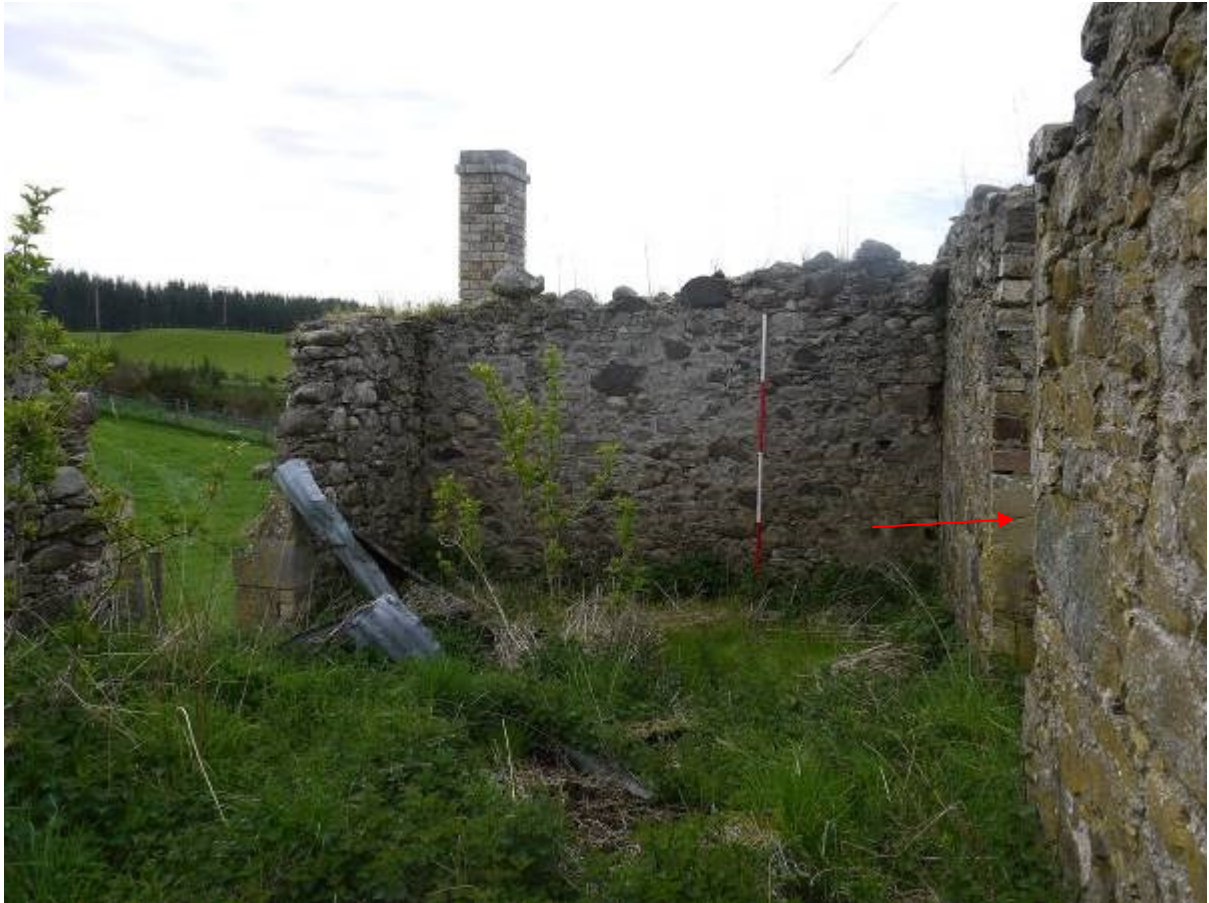
Illustration 34 Southern half of other room in Building E looking south, doorway into Building C marked by red arrow

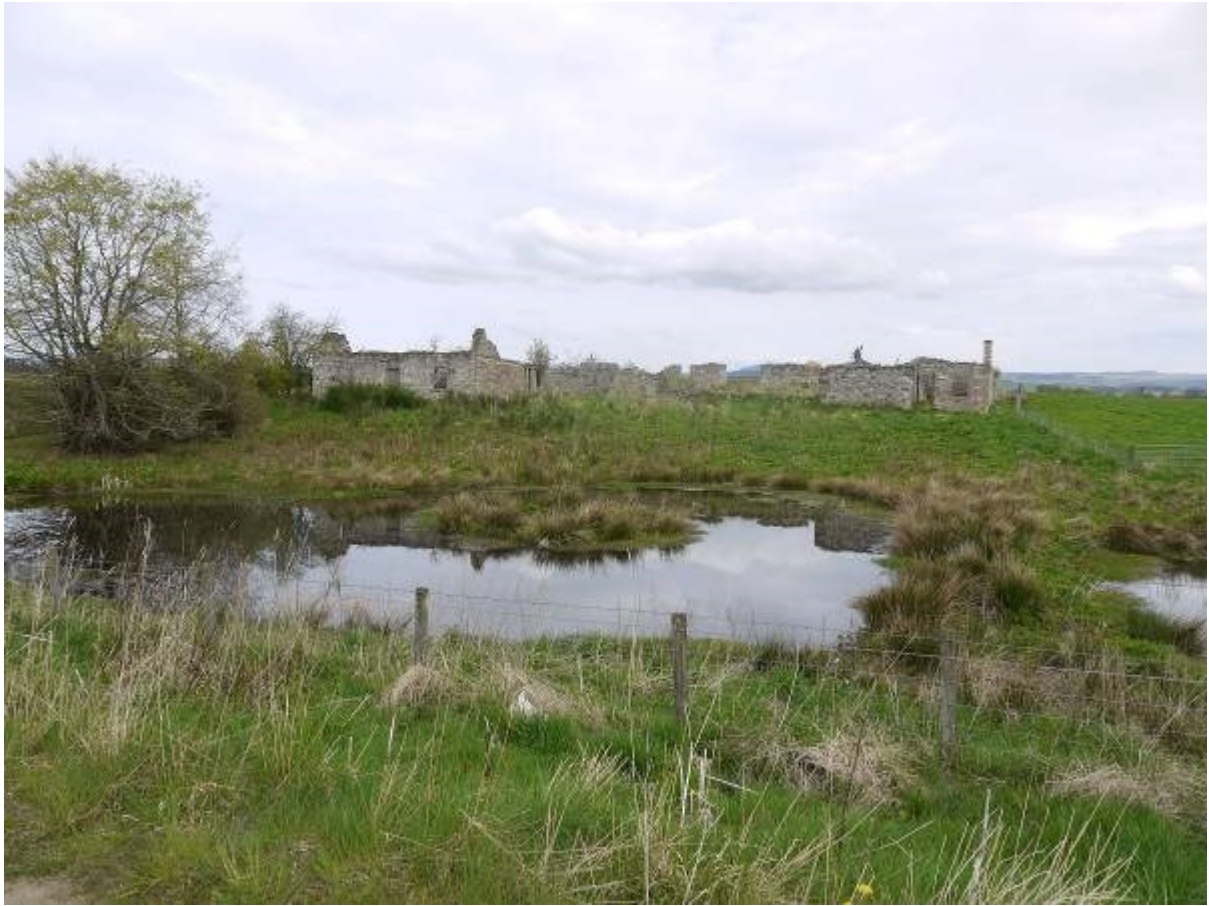
The remains of a cobbled stone yard are visible between Building A and Buildings B to E. To the south of the buildings are traces of a former garden area overlooking a small water filled pond.

Illustration 36 Building complex looking north (former garden area between pond edge and buildings)
