Standing Building Survey

Old England, Stanley, Perth and Kinross

Introduction

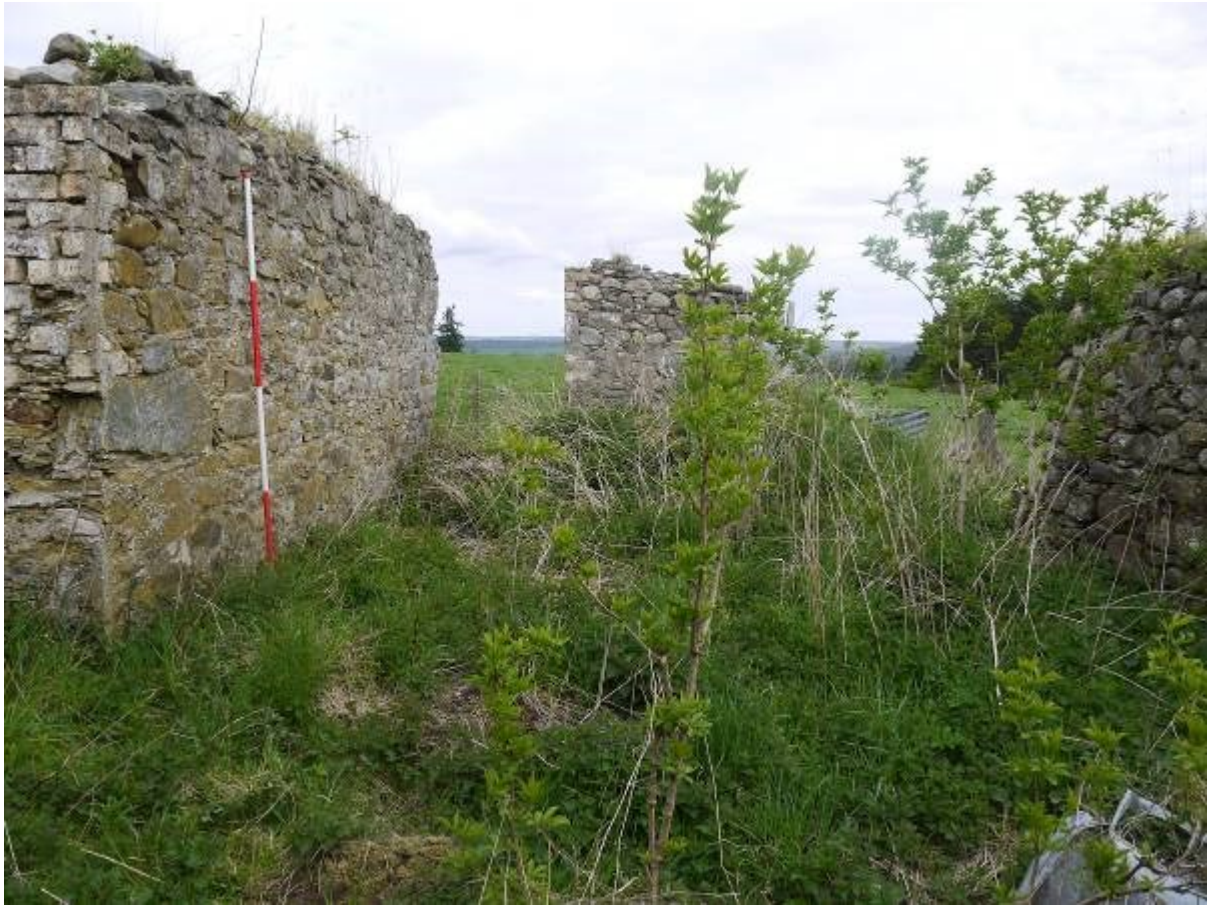
There is a very small room at the southern end of this building with a fireplace in its eastern wall. The remainder of the building comprises a long open room with a door into Building C in its western wall. The remains of a collapsed corrugated iron roof are visible.

Illustration 35 Northern half of other room in Building E looking north
