Standing Building Survey and Site Evaluation
The Kennels, Lower Polmaise, Stirling Council

9th July 2013

Introduction (Illus 1)

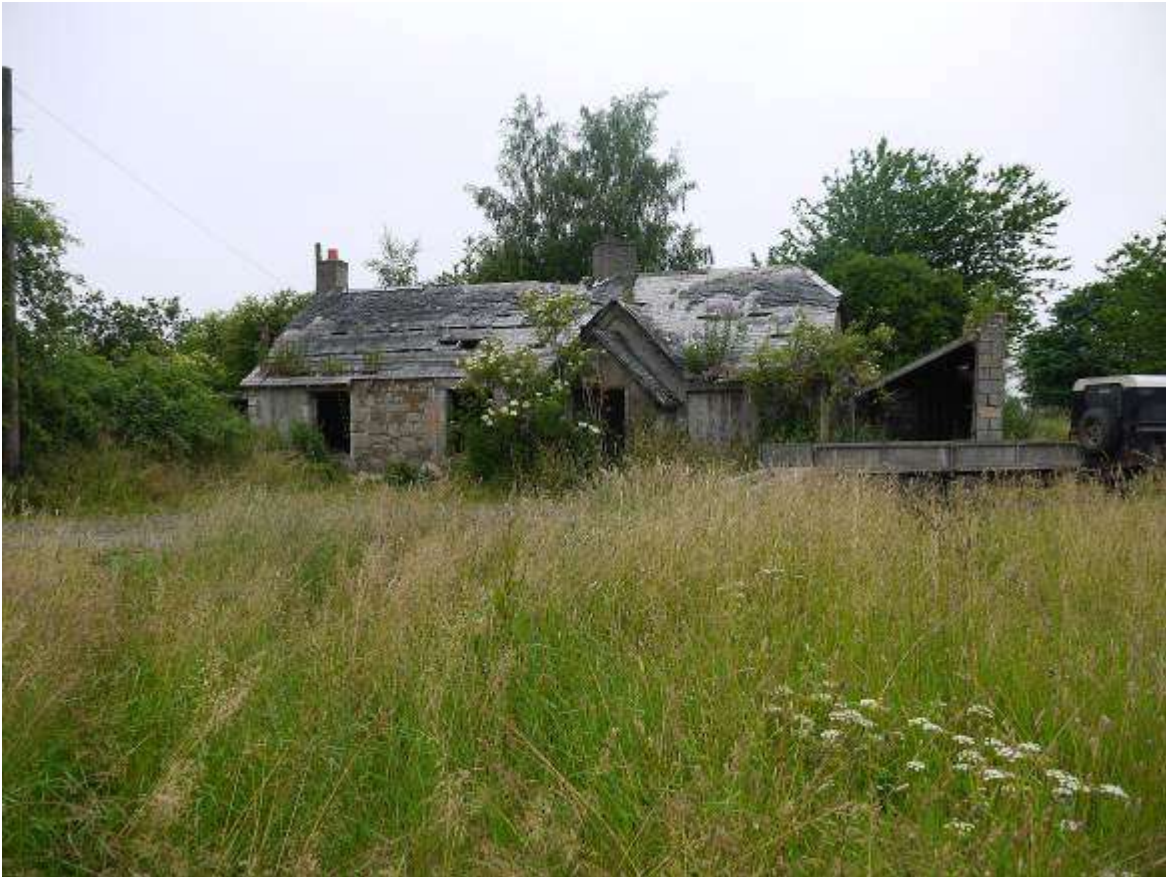
Derelict cottage, The Kennels, Lower Polmaise looking North West

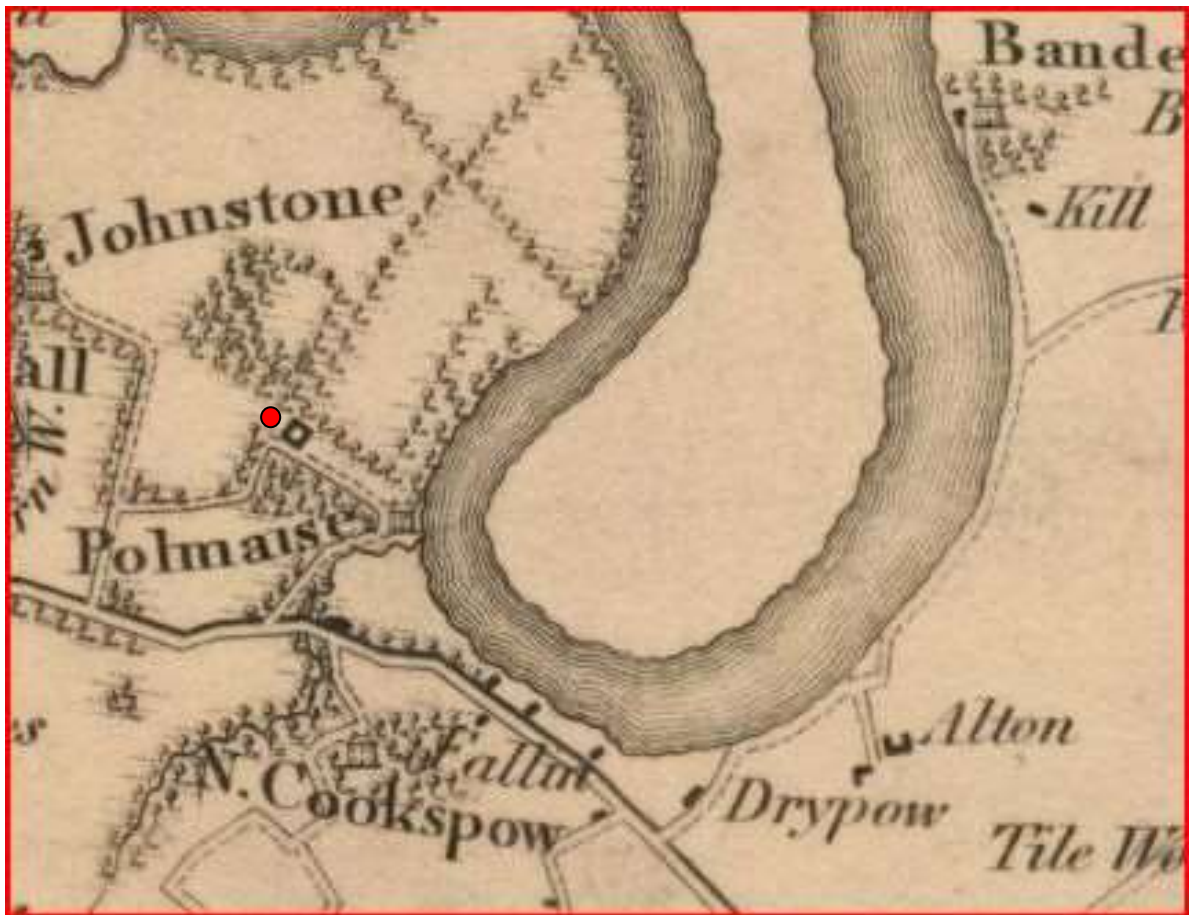
Illustration 2 Buildings at Polmaise as shown on Grassom's map of 1817, red dot shows location of redevelopment (©Trustees of National Library of Scotland)

The proposed development impacts directly on the remains of a 16th century roll-moulded doorway (SMR 1190.06) which were incorporated into a 19th century farm building. The farm itself is marked on both Grassoms's 1817 map (Illus 2) and the First Edition Ordnance Survey map of the 1860's (Illus 3). The precise origin of the doorway is uncertain but there is a good chance that it was recovered from an earlier predecessor building in this location, perhaps the original Wester Polmaise House which is recorded on a variety of 17th century maps and which was a separate building to the 17th century Wester Polmaise House of 1691 (SMR 1190.01). If this is the case then there is a high likelihood that the present farm complex contains earlier building remains either within its fabric or surviving as foundations below the present ground surface.

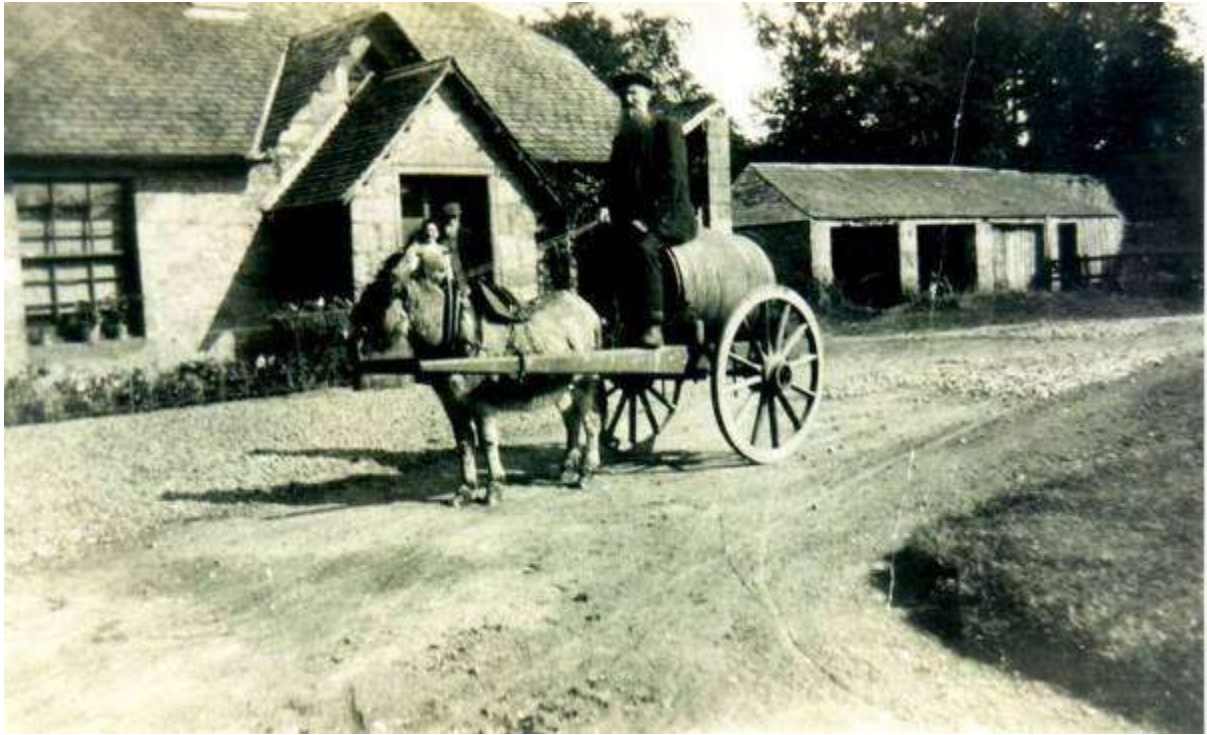
Illustration 4 19th century photograph of Buildings 1 and 5 looking North West (courtesy Ms Karen Millar)

There are fragmentary standing walls and a stone floor to the North East of the Building complex that belong to a structure that is visible in the 19th Century photograph of the site and on the First Edition Ordnance Survey map (Illus 3 and 4). This is now too damaged to clearly understand its function.

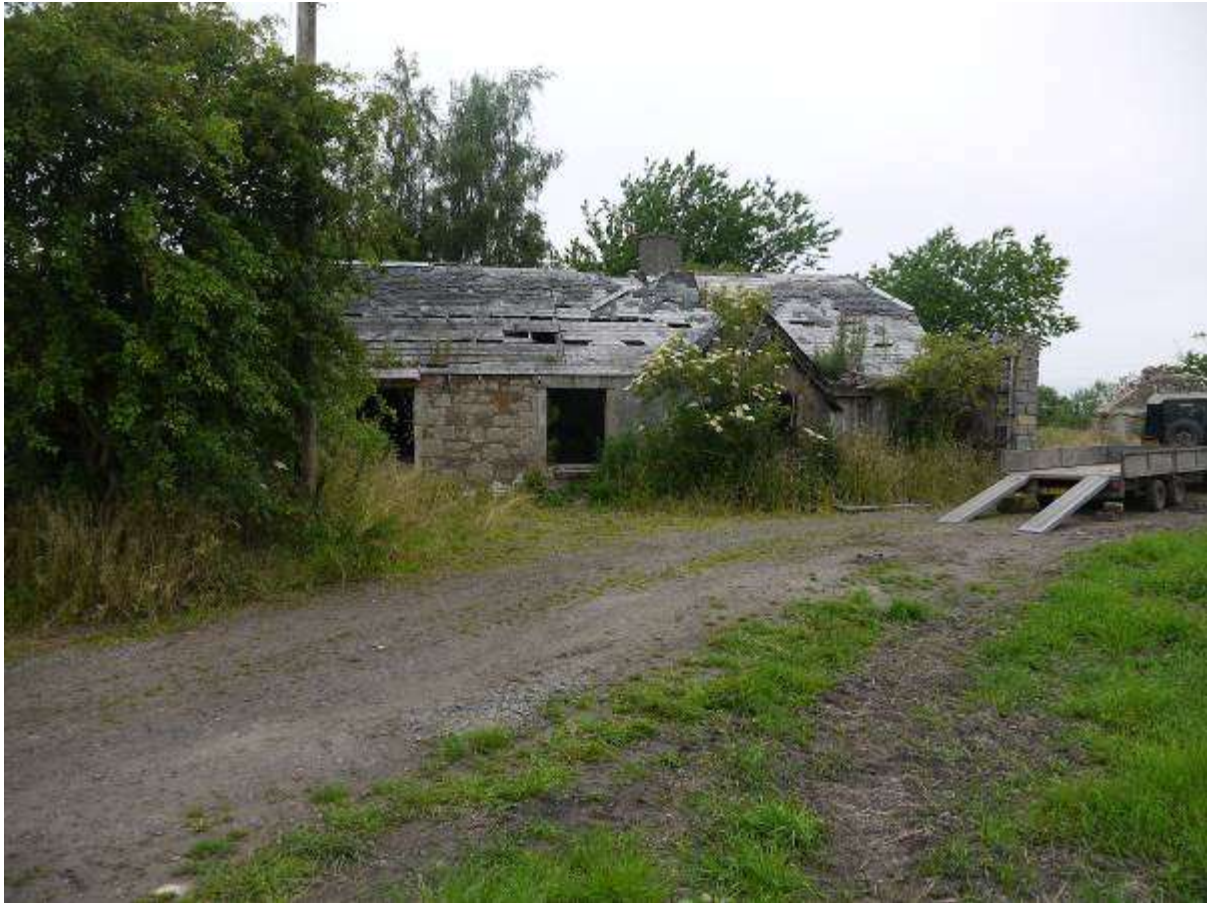
Illustration 6 General view of group of buildings looking North West

The cottage and outbuildings at The Kennels lie on the western side of a track way that runs from the north east to the south west, the partially roofed remains of derelict farm steading buildings lie on the eastern side of this track way.

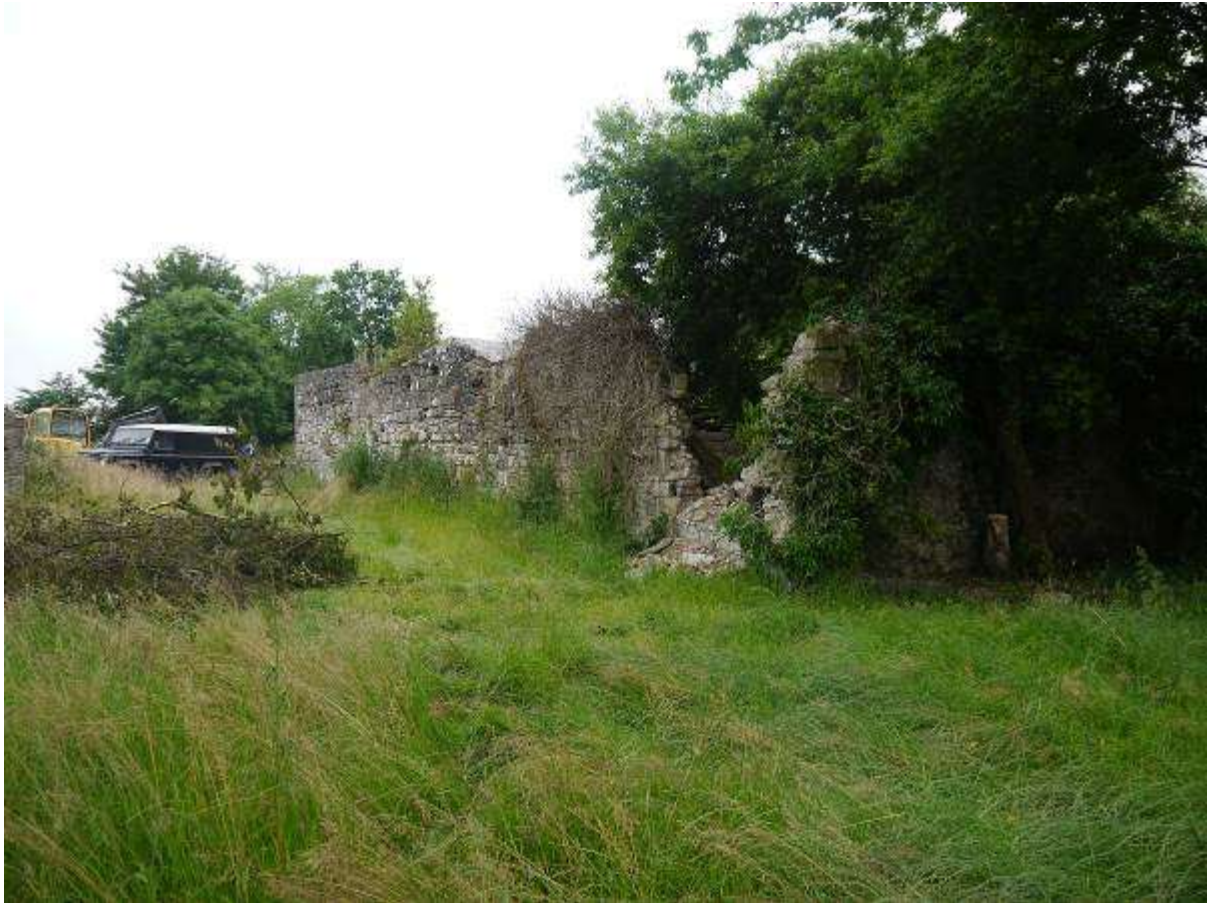
Illustration 7 General view of Building complex looking South East (Walls H and J in foreground)

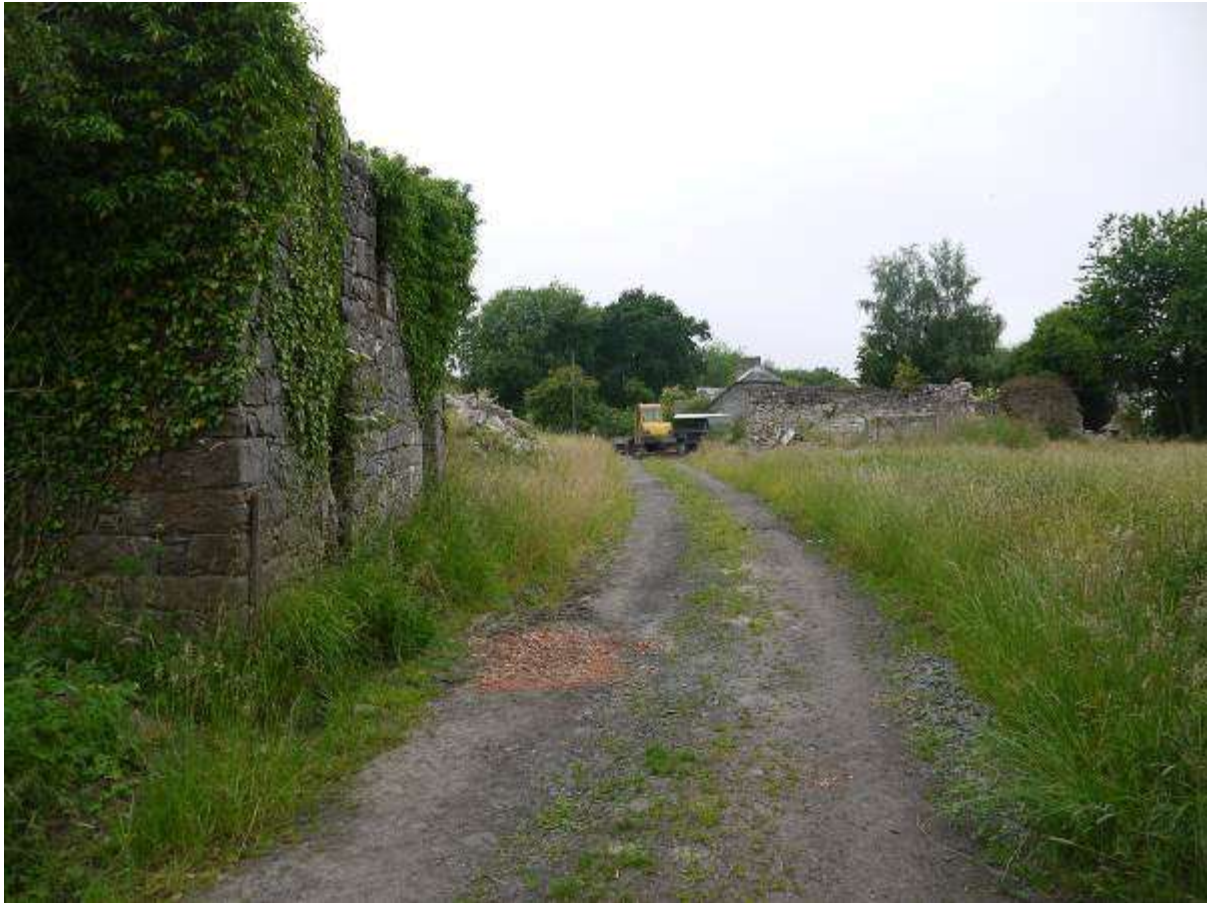
Illustration 8 General view of Building complex looking south west (ruins of steading complex on left of photograph)

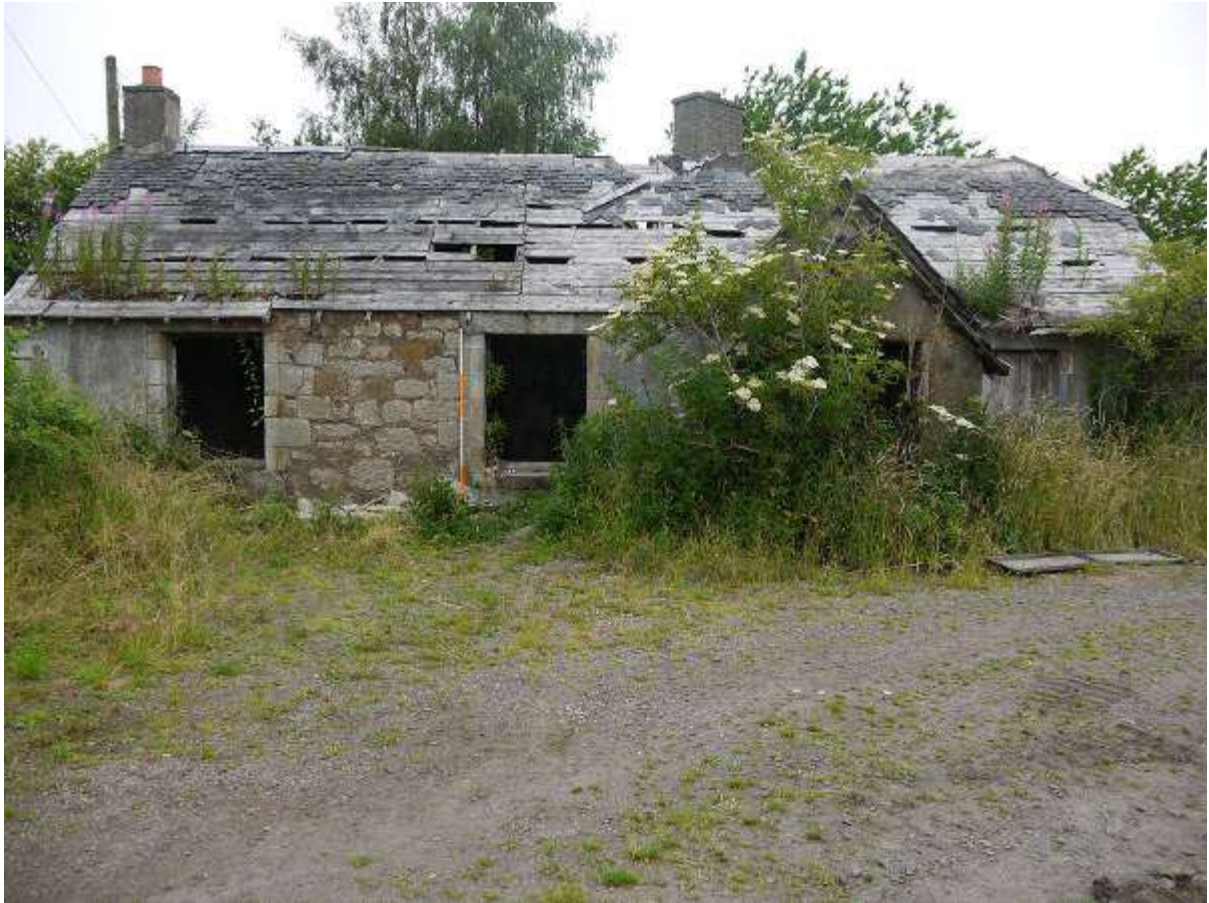
Illustration 9 South eastern elevation of Building 1

This elevation is built of mortar bonded shaped yellow sandstone blocks and its exterior wall face is still partially harled with concrete. At its southern and northern ends the corners are defined by alternately sized shaped sandstone quoins. It has two windows (now unglazed) to the south of a porched entrance doorway and another single window (now blocked) on the north side of the doorway. The external doorway into the porch includes the reused 16th century roll moulded doorway (SMR 1190.06). The porch has two separate triangular slated roof lines and an eroded regular space above the top one may have originally contained a date stone. A later brick built single roomed extension has been added to the southern end of this elevation, it is accessed by a doorway between Building 1 and the extension.

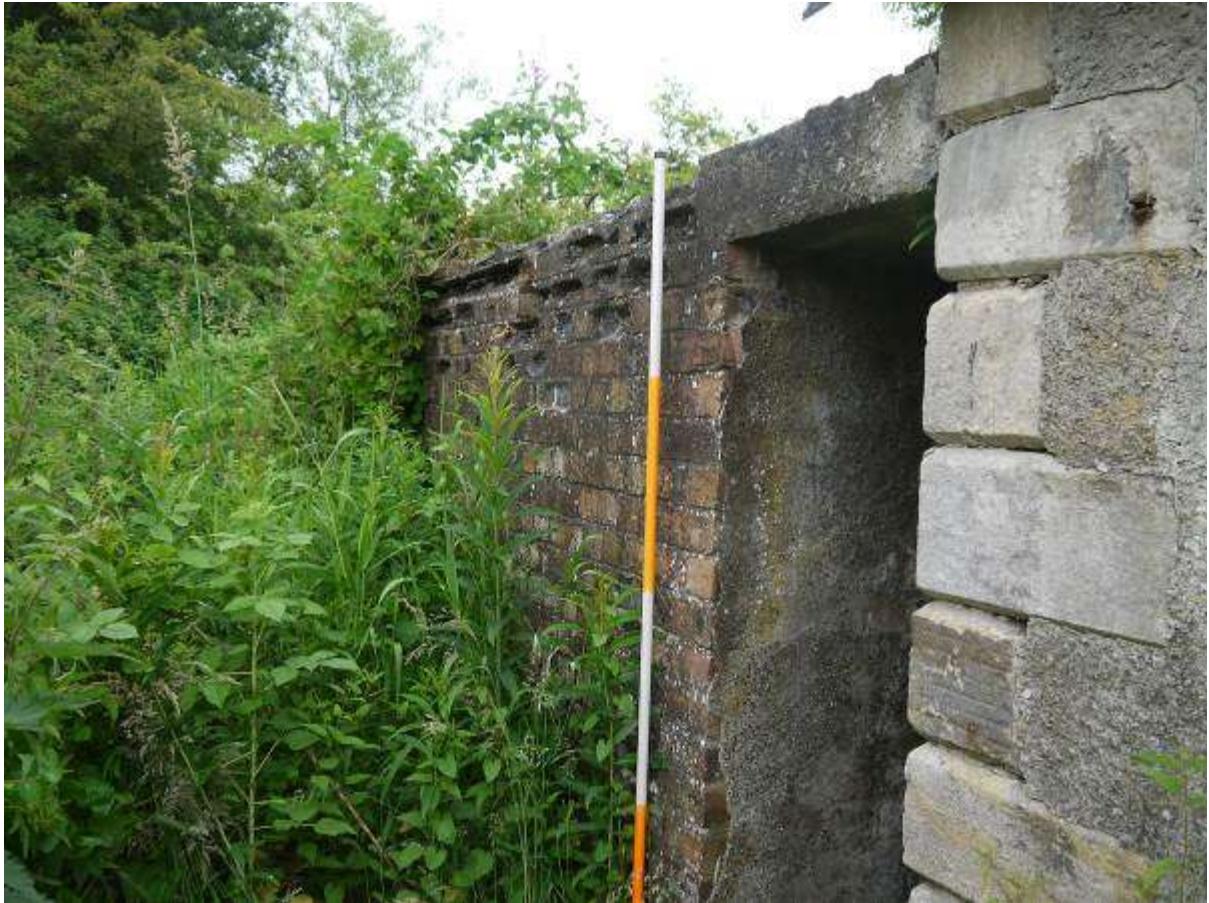
Illustration 11 south western end of eastern elevation of Building 1 showing brick extension and shaped sandstone quoins in corner of Building 1

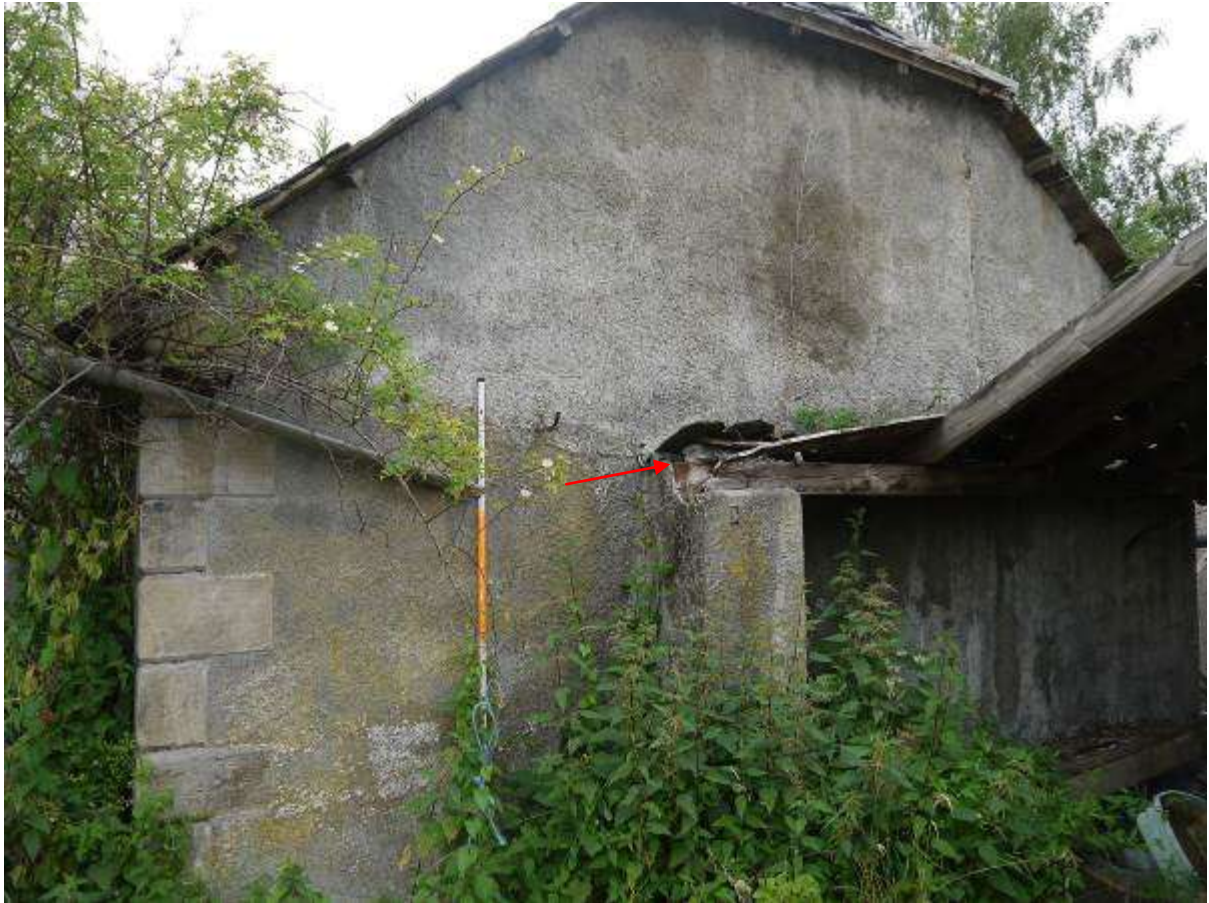
Illustration 12 north western end of south eastern elevation of Building 1 showing shaped sandstone quoins in front corner

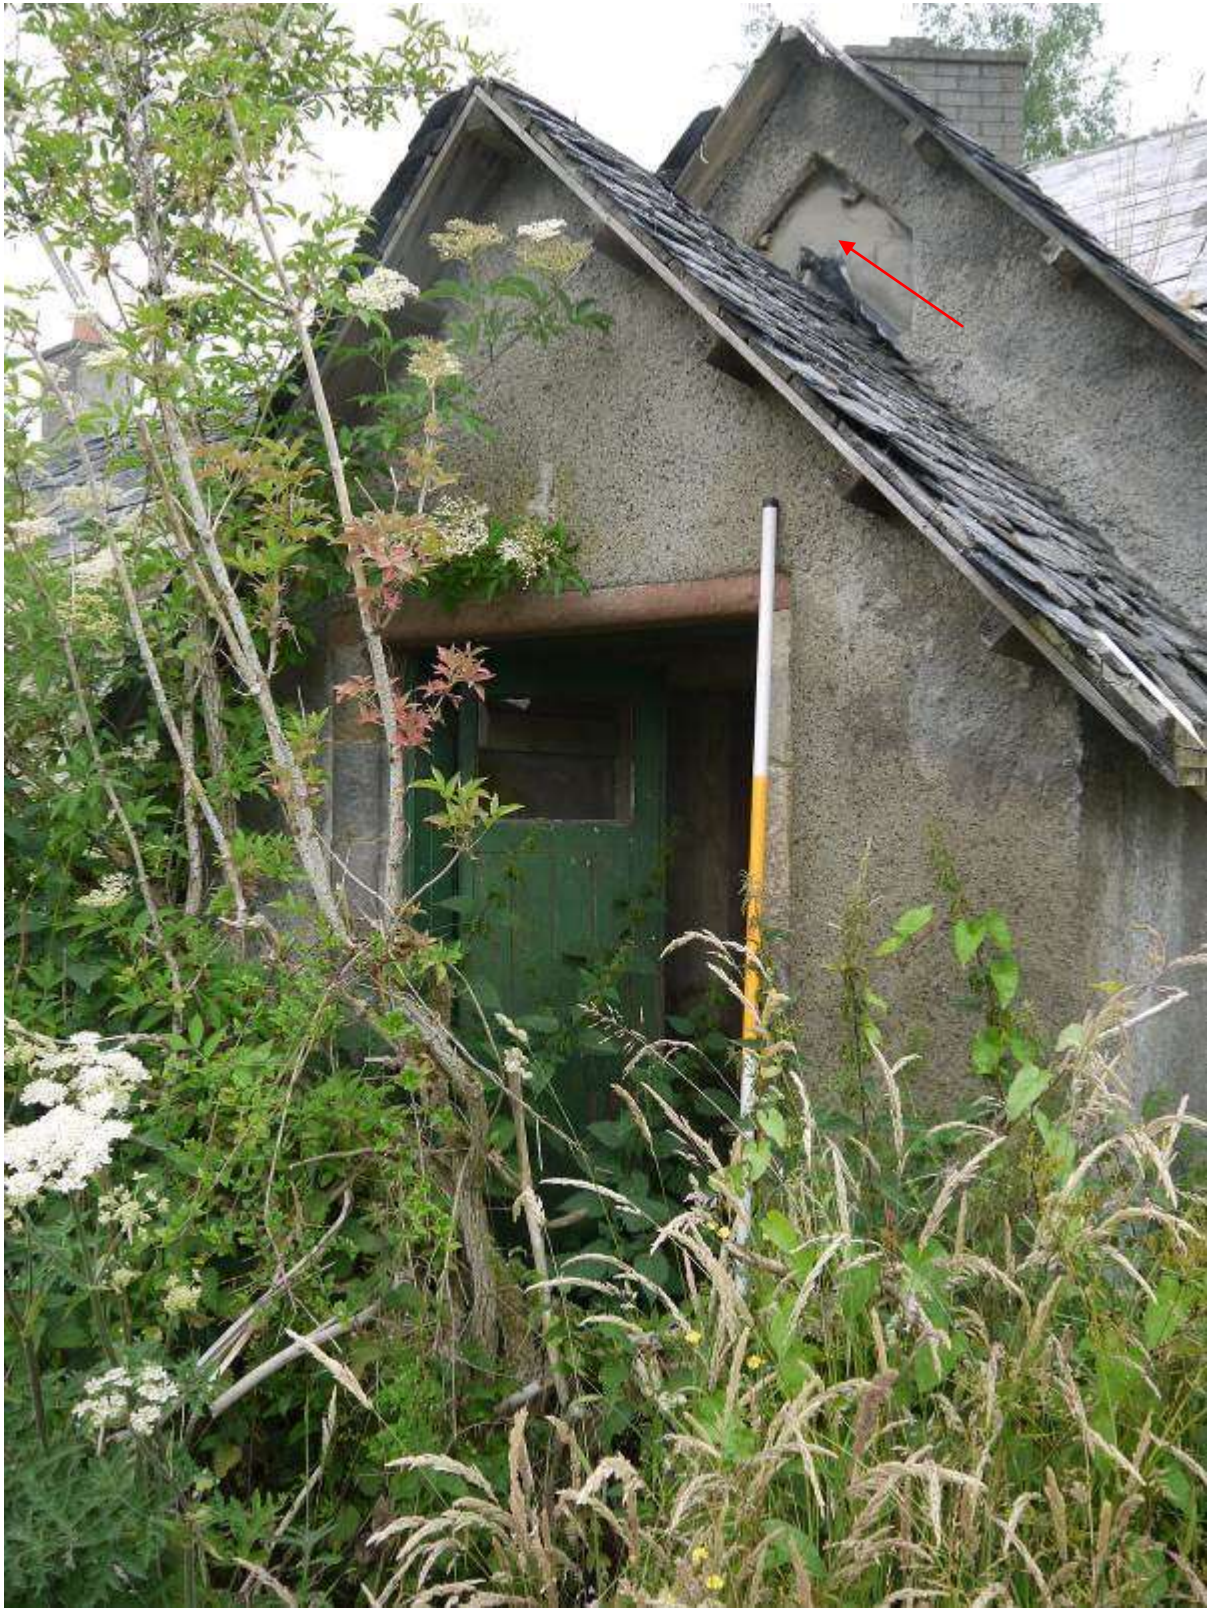
Illustration 13 Porched entrance to Building 1 with reused roll moulded doorway, possible location of date stone marked with red arrow

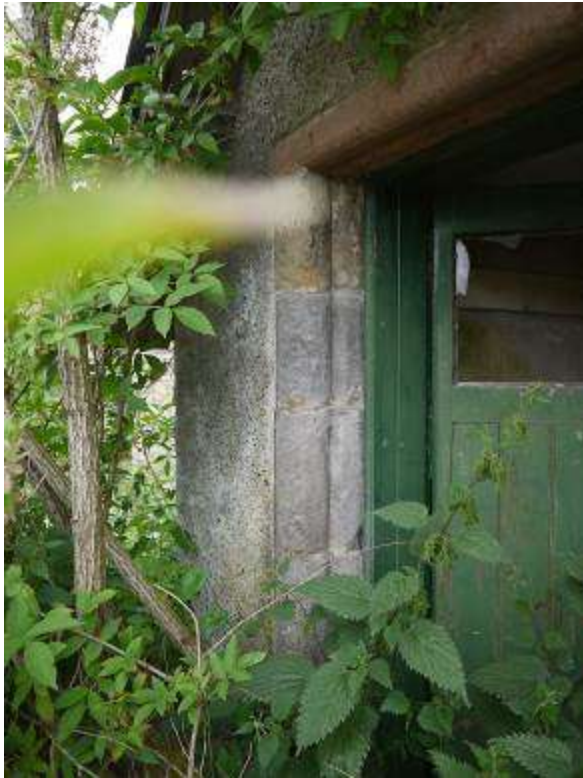
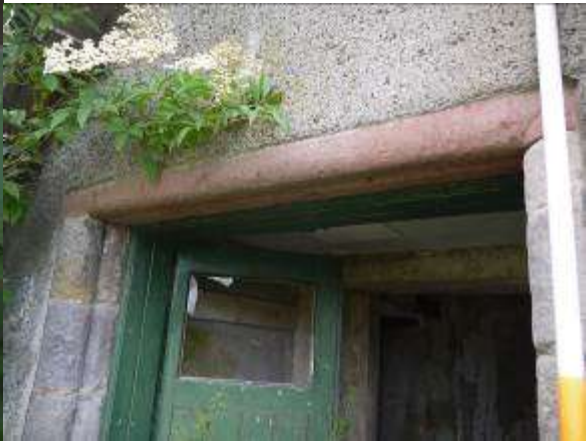
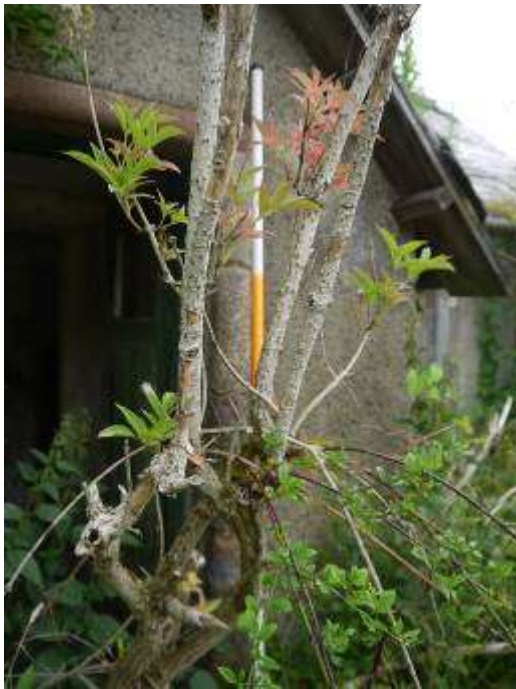
Illustration 14 Detail views of south western side of roll moulded doorway, top lintel and north eastern side

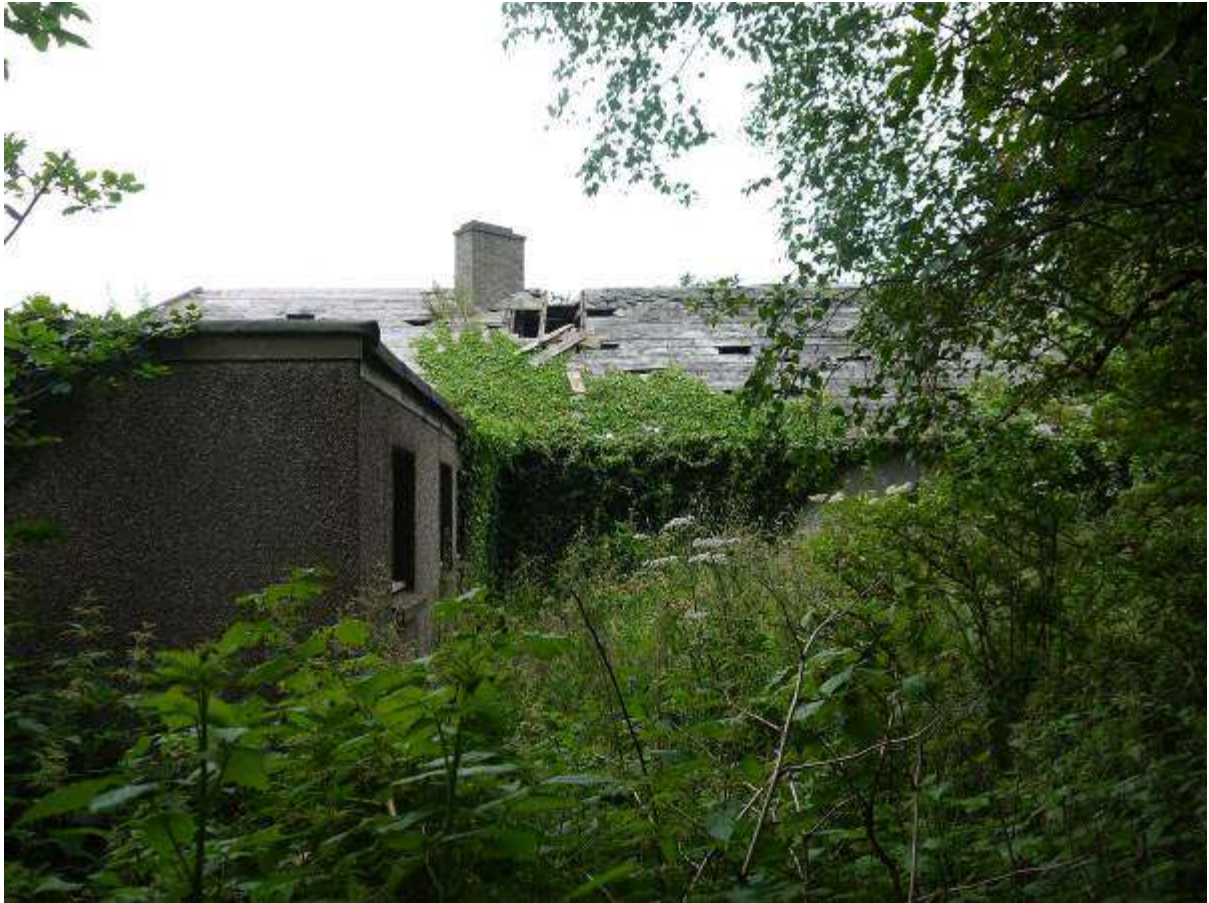
This elevation is blank for most of its length and harled with concrete. A later flat roofed extension (Building 2) is built against this elevation towards its northern end. There is a small window (now blocked) close to the northern end of this elevation.

Illustration 16 North western elevation of Building 1 showing junction with Building 2 looking south east

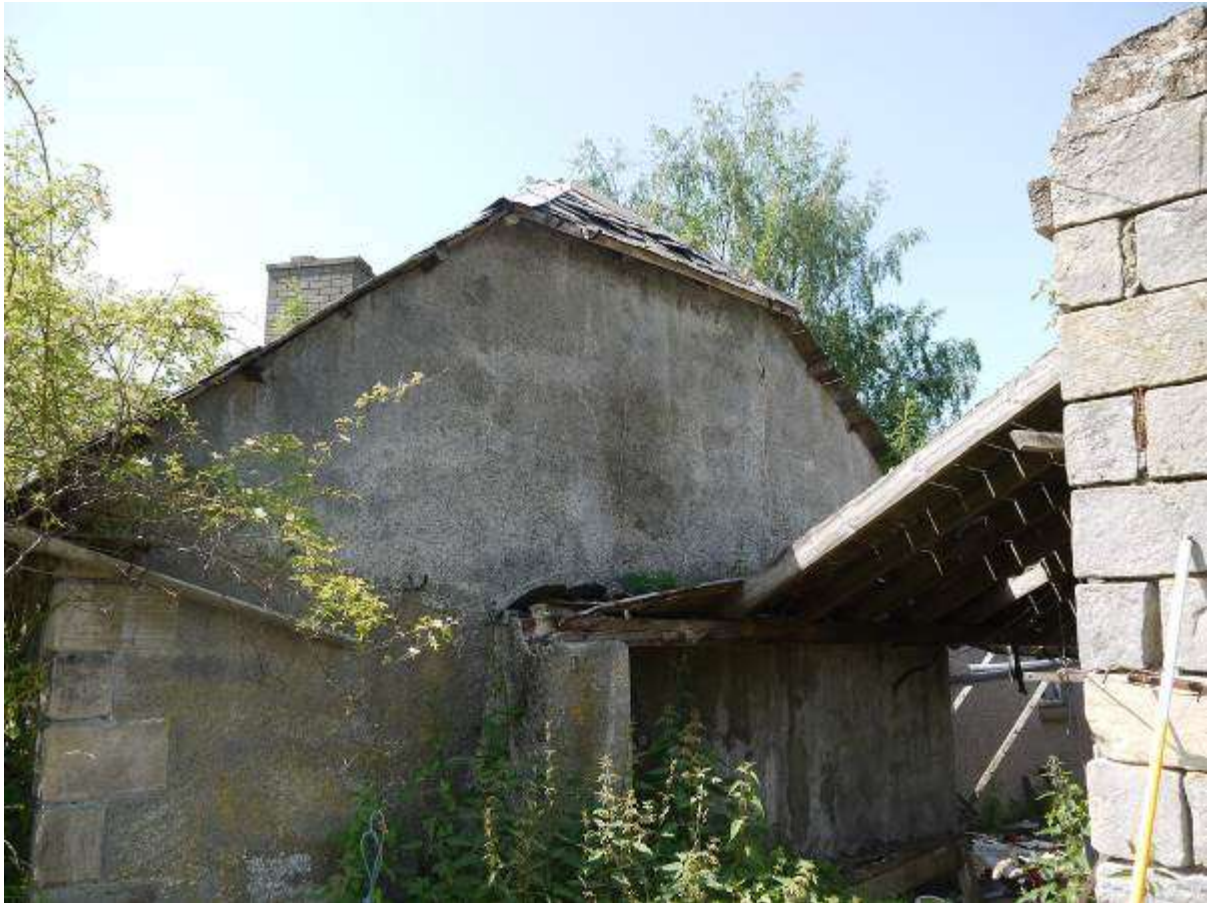
This gable elevation is blank and harled with concrete, the shaped corner quoin stones are only visible at its eastern end the western end is blank. The top of the gable is flat and slightly angled inwards to meet the roof line.

Illustration 17 North Eastern elevation of Building 1 showing angled top to gable looking south west, shaped quoins at end of Wall H visible behind scale to right of photograph

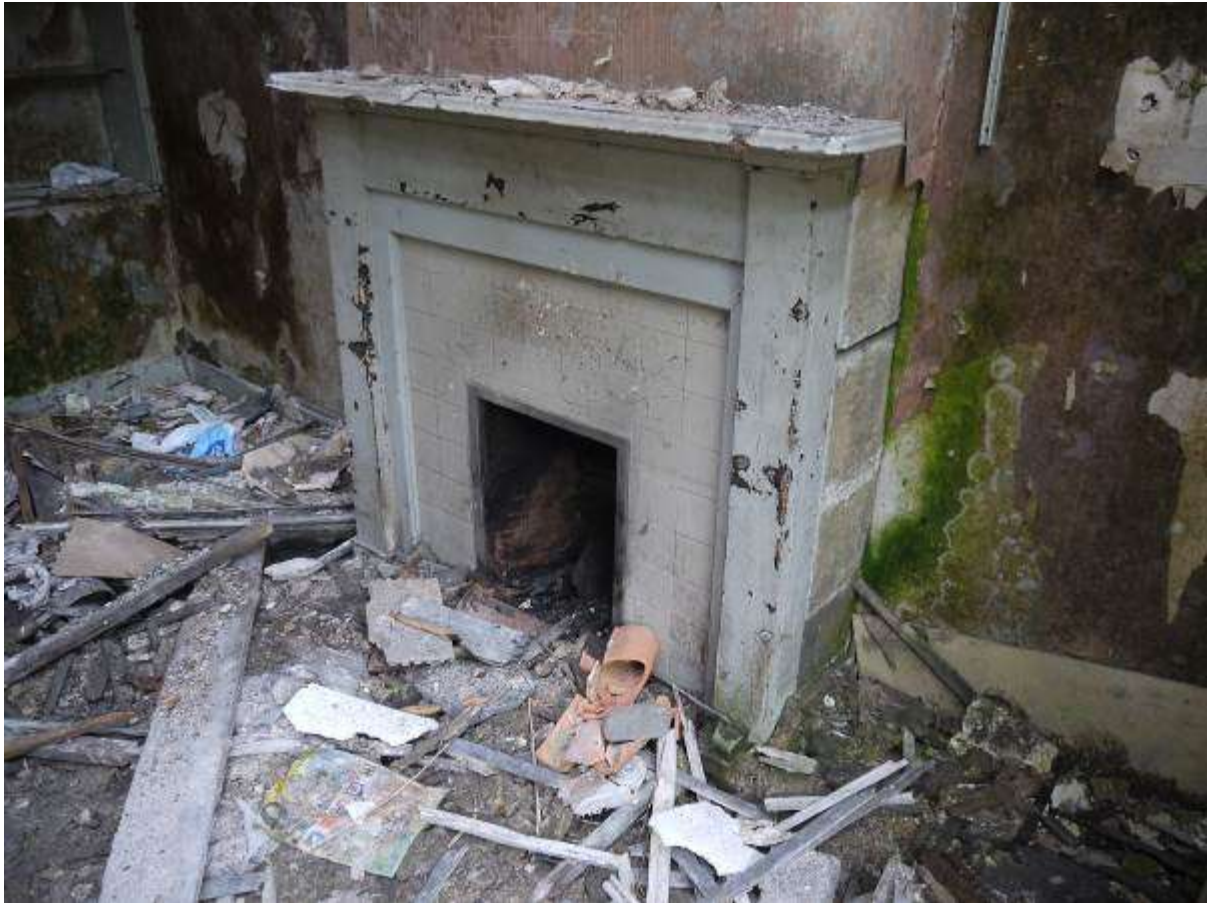
This building contains three rooms that occupy the entire width of the structure. The small room at the southern end contains a fireplace in its southern wall. The middle room contains a fireplace in its northern wall; the third room at the northern end contains a fireplace in its southern wall, a flight of wooden stairs to an attic floor level and is accessed from the porch. Another doorway in the western wall of this room allows access to Building 2.

Illustration 18 Fireplace in central room of Building 1

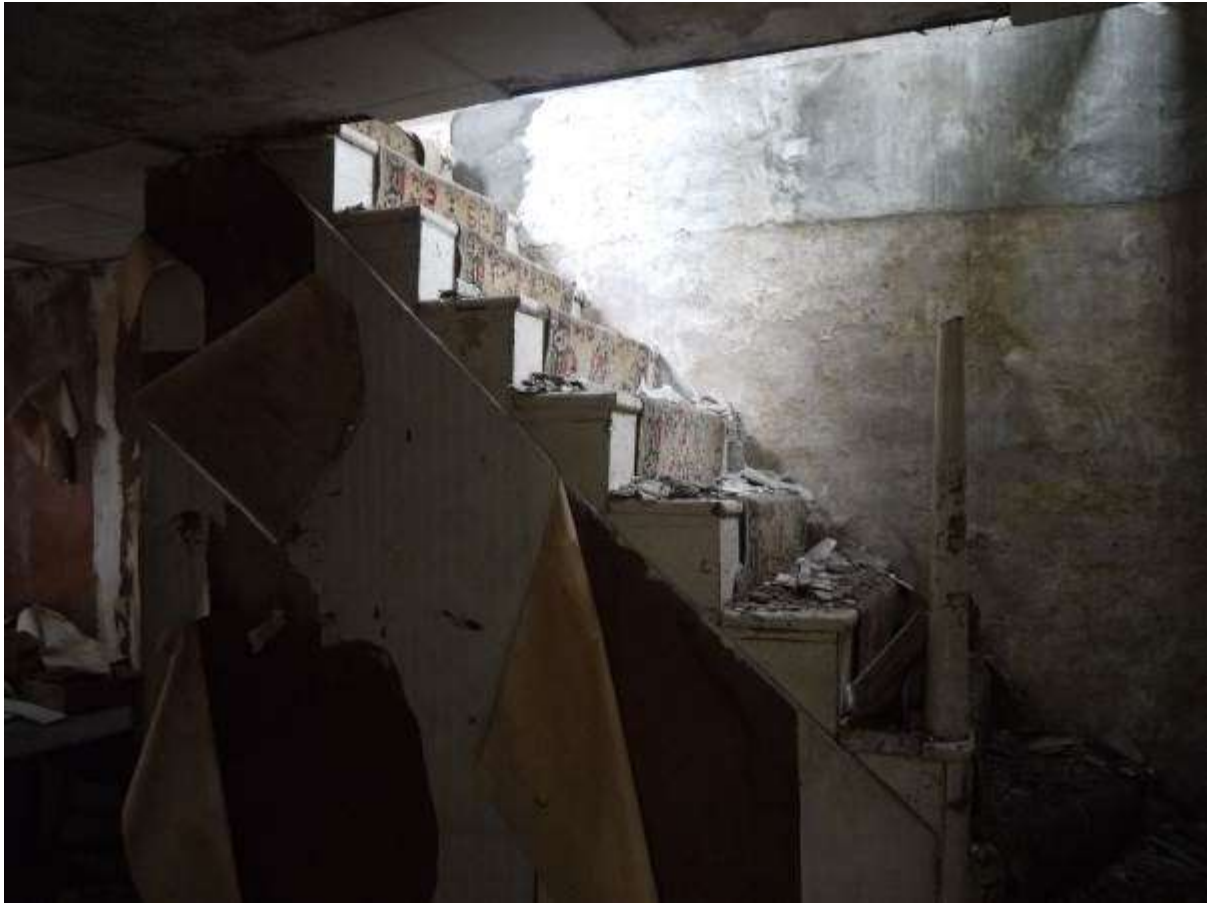
Illustration 20 staircase to attic floor level inside Building 1

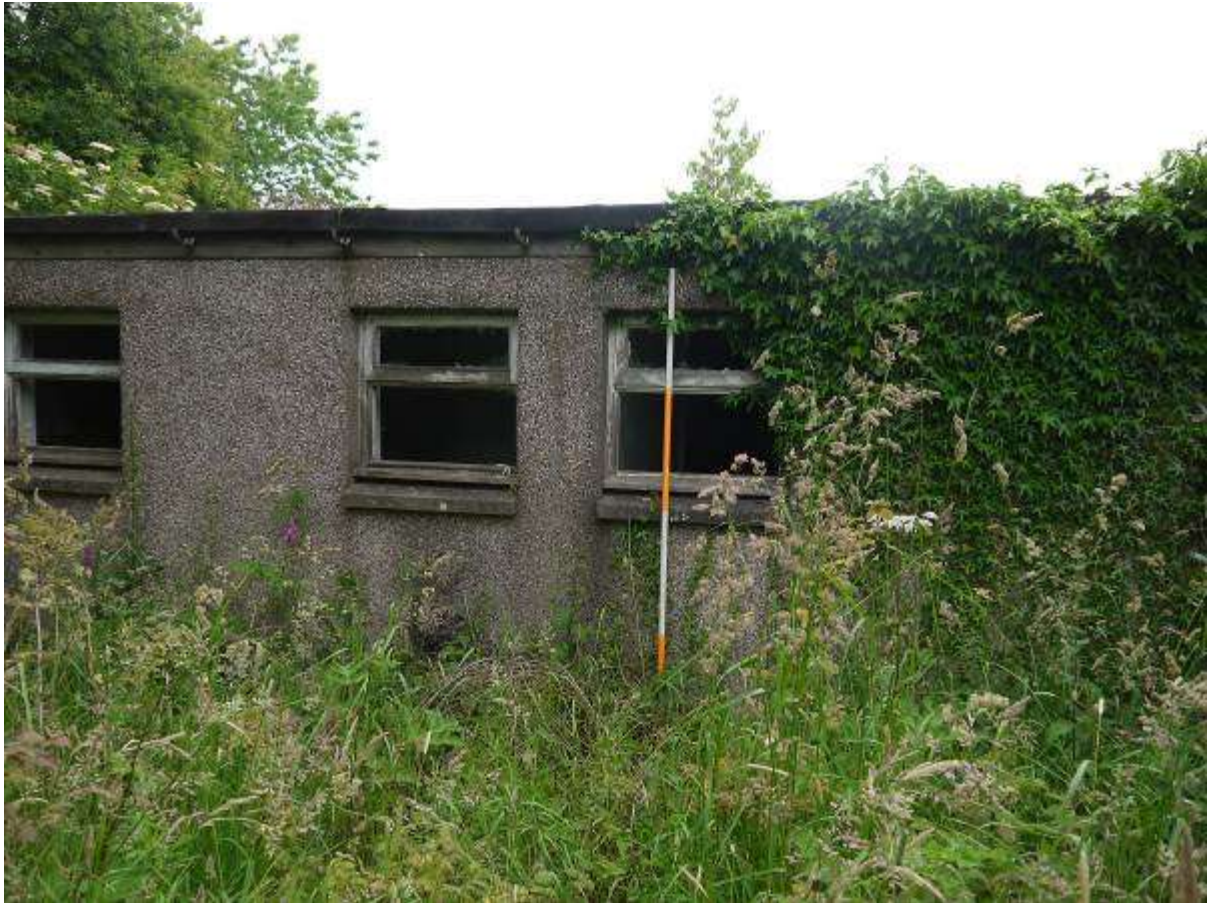
Illustration 21 South western elevation of Building 2 looking North East

This is harled with concrete and contains four small wooden framed windows; it has a gutter running along its roofline.

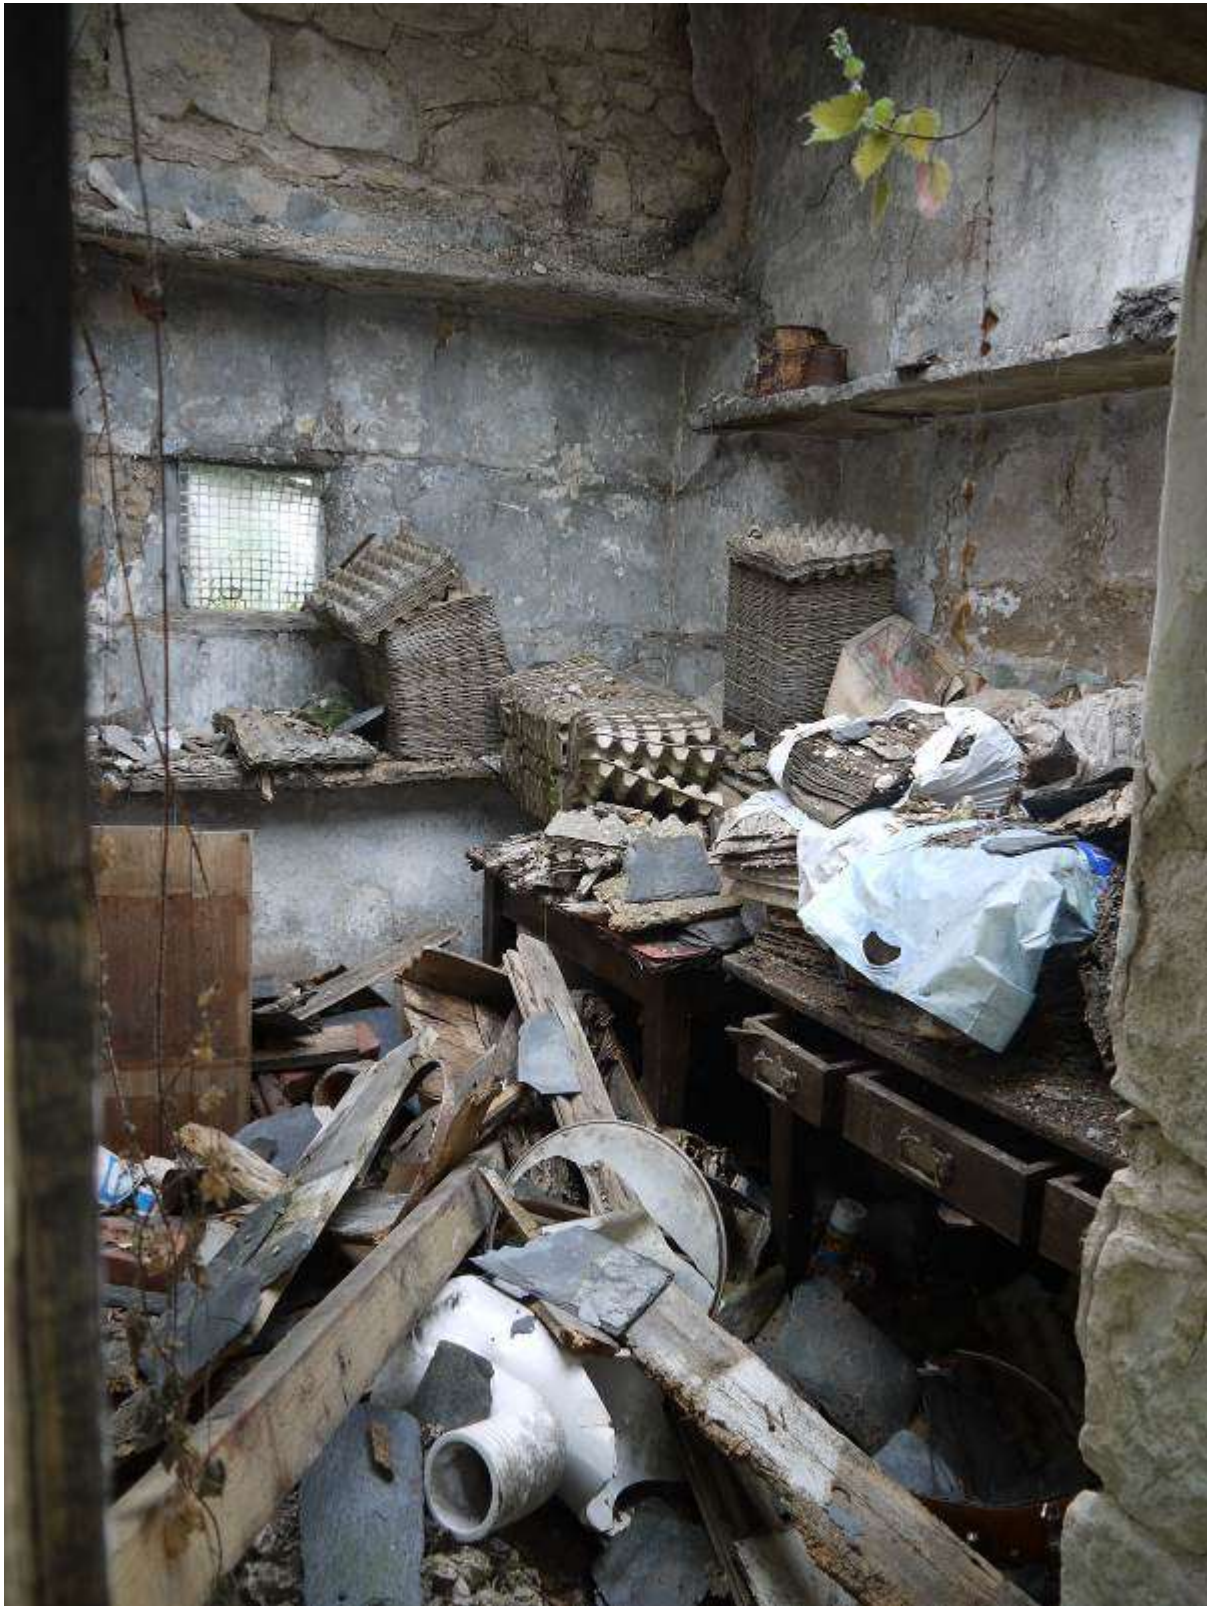
This room is at the south eastern end of Building 3, has a wooden door and measures 3m northeast to southwest by 2.22m north west to south east. It contains wooden furniture, stone shelving and cardboard egg boxes.

Illustration 22 Internal view of Room A in Building 3 showing window in boundary wall H, wooden furniture and egg boxes
