Standing Building Survey and Site Evaluation
The Kennels, Lower Polmaise, Stirling Council

9th July 2013

Introduction (Illus 1)

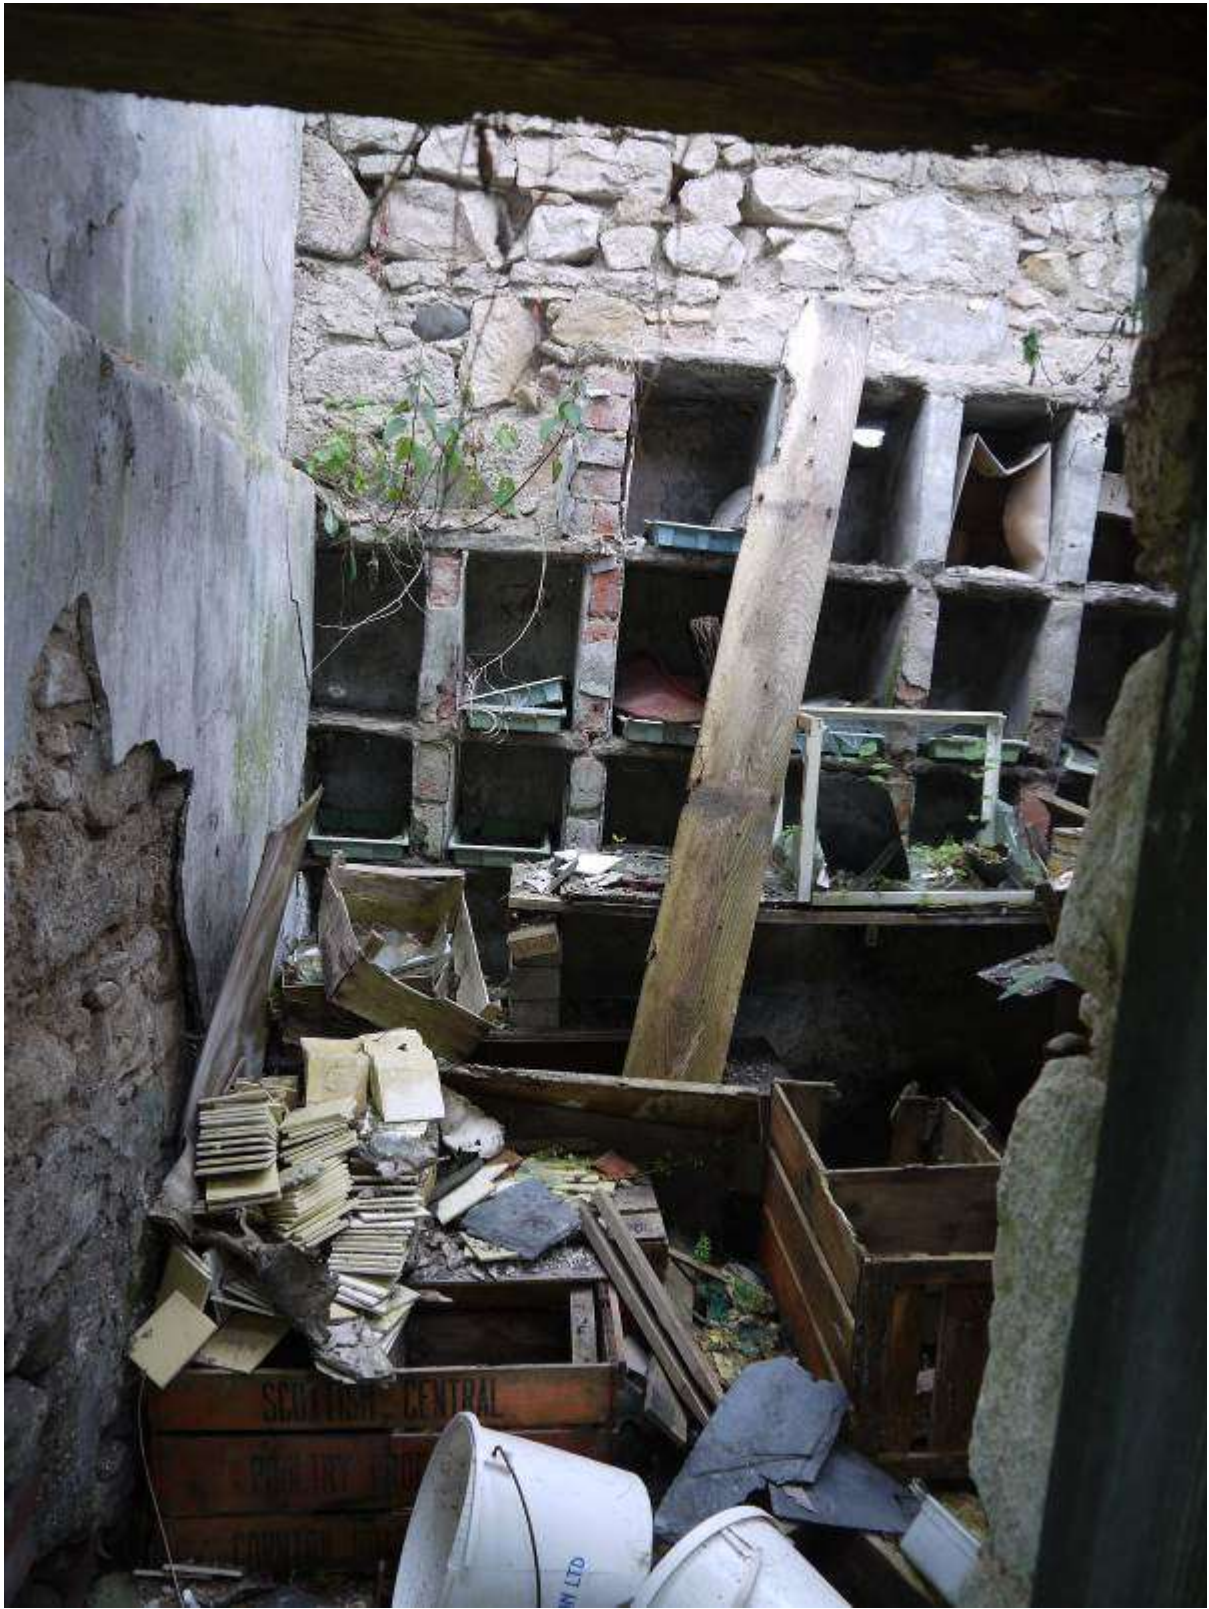
This room has a wooden door, measures 3m north east to and 2.22m north west to south east and contains sixteen stone and brick built shelves in the face of its north eastern wall.

Illustration 23 Internal view of Room B in Building 3 showing stone built boxes in face of wall

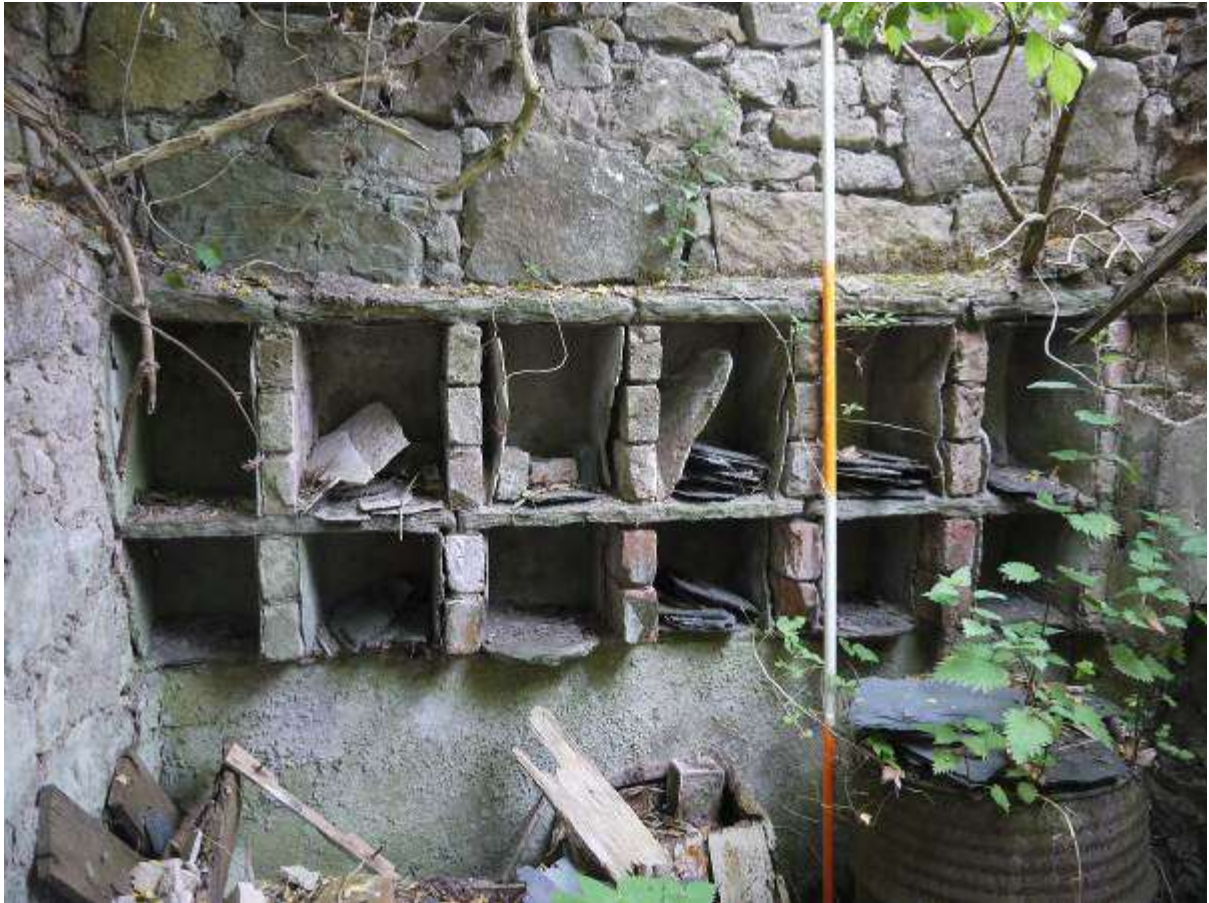
This room has a wooden door, measures 3m north east to south west and 2.22m north west to south east and contains twelve stone and brick built shelves in the face of its north eastern wall.

Illustration 24 Internal view of Room C showing stone and brick built boxes in wall face

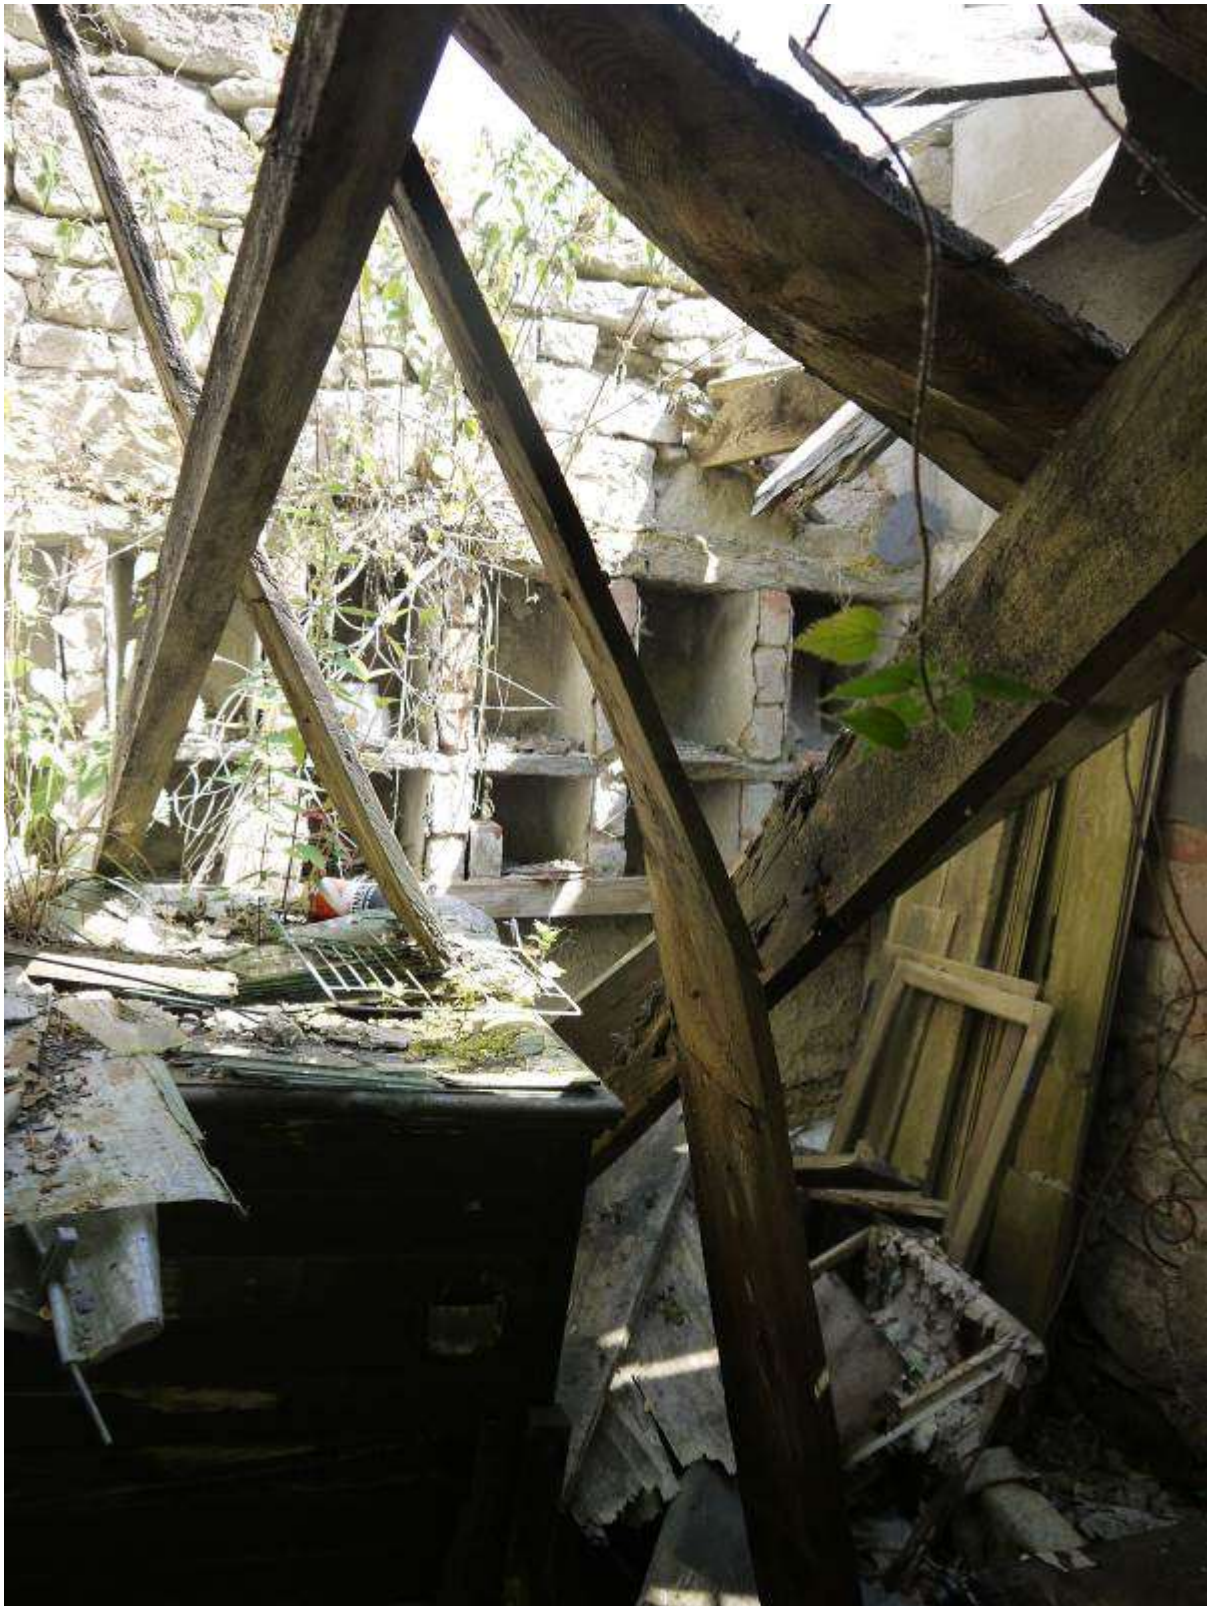
This room has a wooden door, measures 3m north east to south west and 2.22m north west to south east and contains twelve stone and brick built shelves in the face of its north eastern wall.

Illustration 25 Internal view of Room D in Building 3 showing stone and brick built boxes

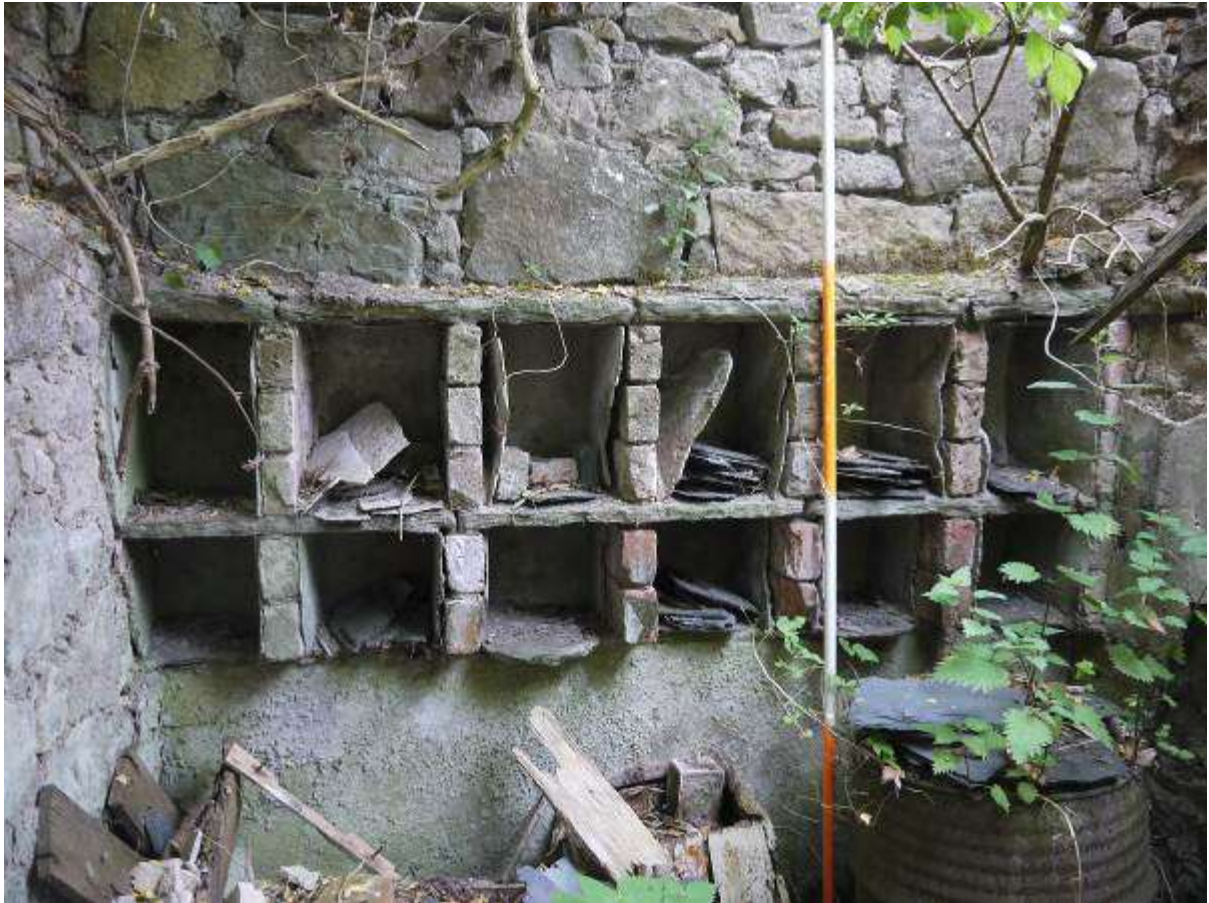
This room has no surviving door, measures 3m north east to south west and 2.22m north west to south east and contains twelve stone and brick built shelves in the face of its north eastern wall and six in the face of its north western wall.

Illustration 26 Internal view of Room E in Building 3 showing stone and brick built boxes in wall face

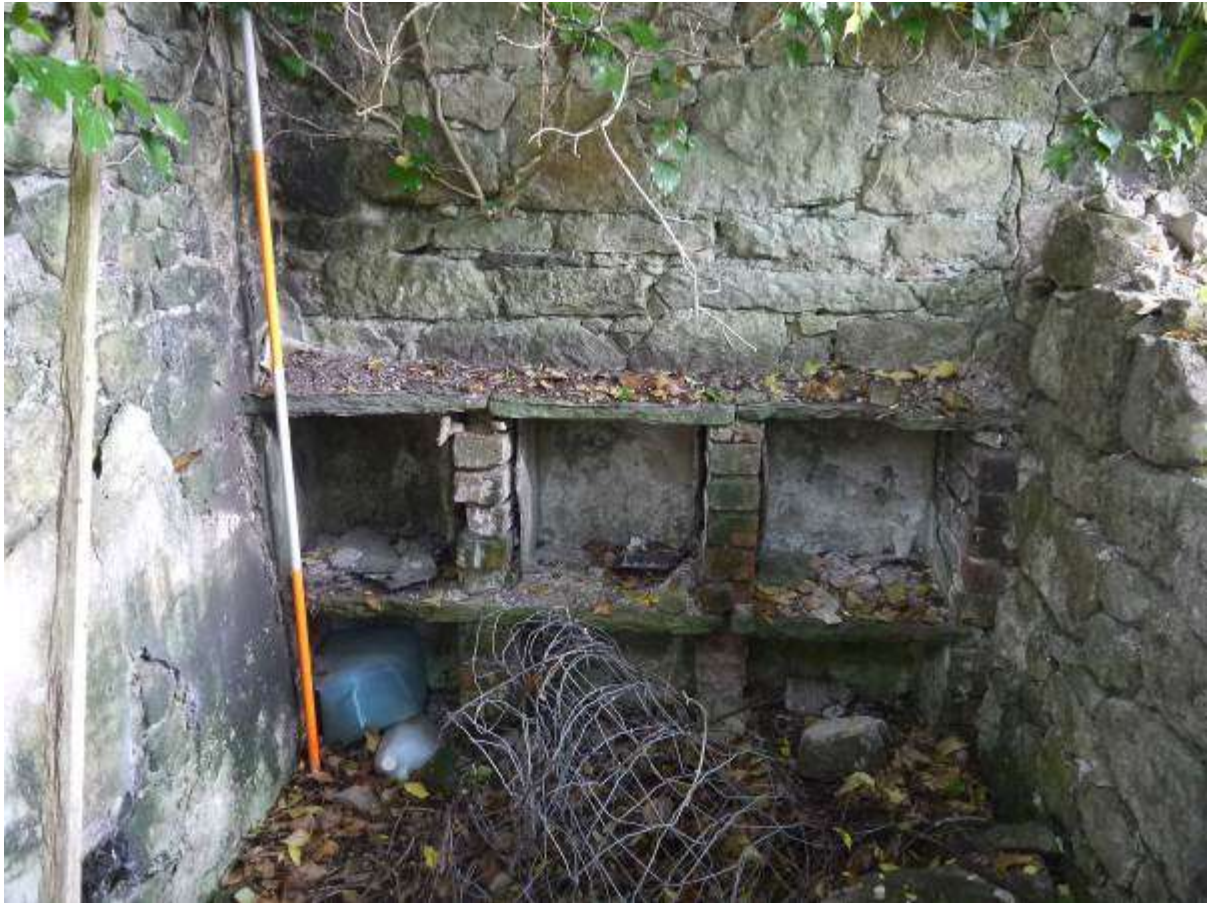
This room has no surviving door and contains six stone and brick built shelves in the face of its north western wall.

Illustration 27 Internal view of Room F showing stone and brick built boxes in wall face

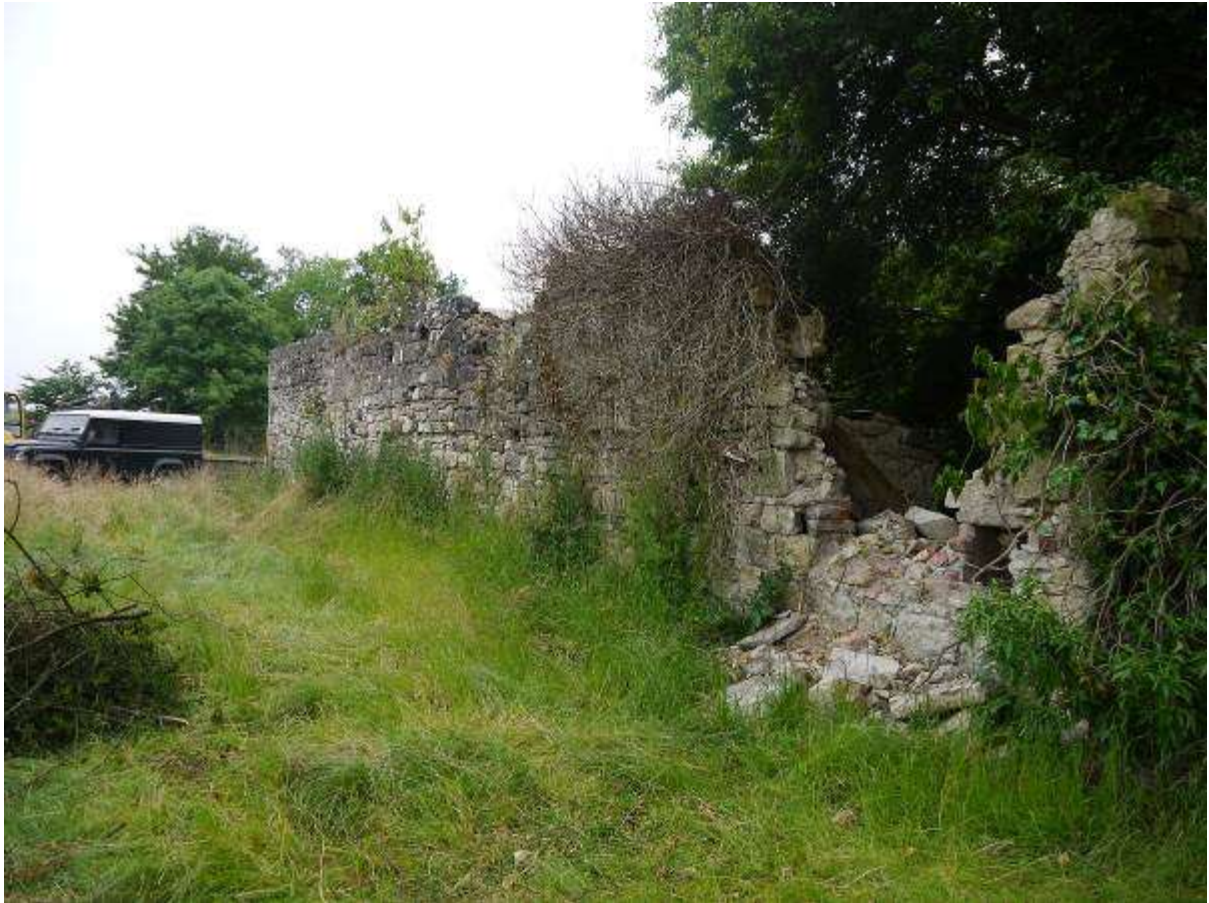
Illustration 28 North West facing external elevation of Wall H looking South East

Both these boundary walls are built from shaped sandstone blocks and have occasional handmade bricks in their fabric. The eastern end of wall H has shaped sandstone quoins of a similar style to those at the end of the eastern elevation of Building 1. Both these walls stand 3.05m high and are 0.45m thick.

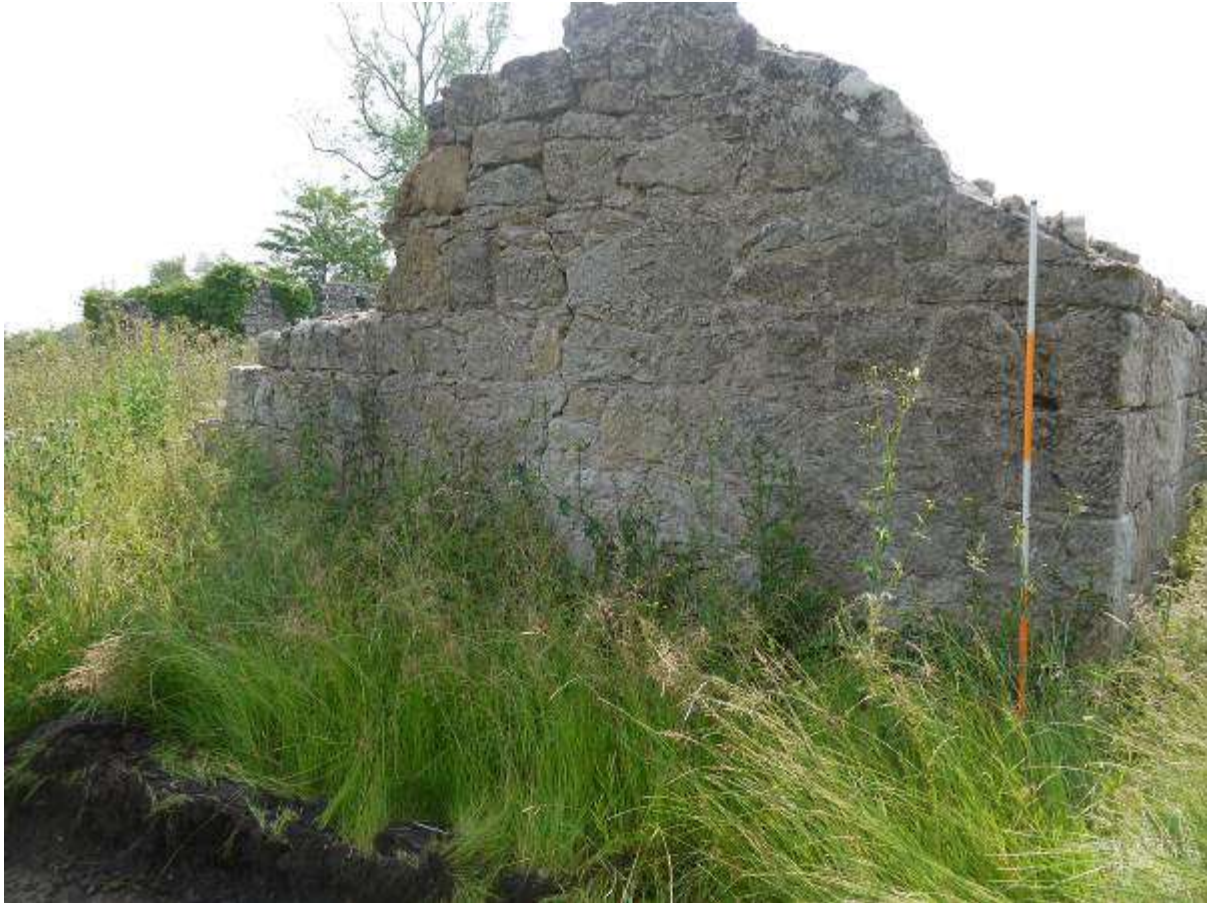
There are fragmentary standing walls and a stone floor to the North East of the Building complex that belong to a structure that is visible in the 19th Century photograph of the site and on the First Edition Ordnance Survey map (Illus 3 and 4). This is now too damaged to clearly understand its function.

Illustration 30 Surviving standing wall corner of Building 5 looking South East

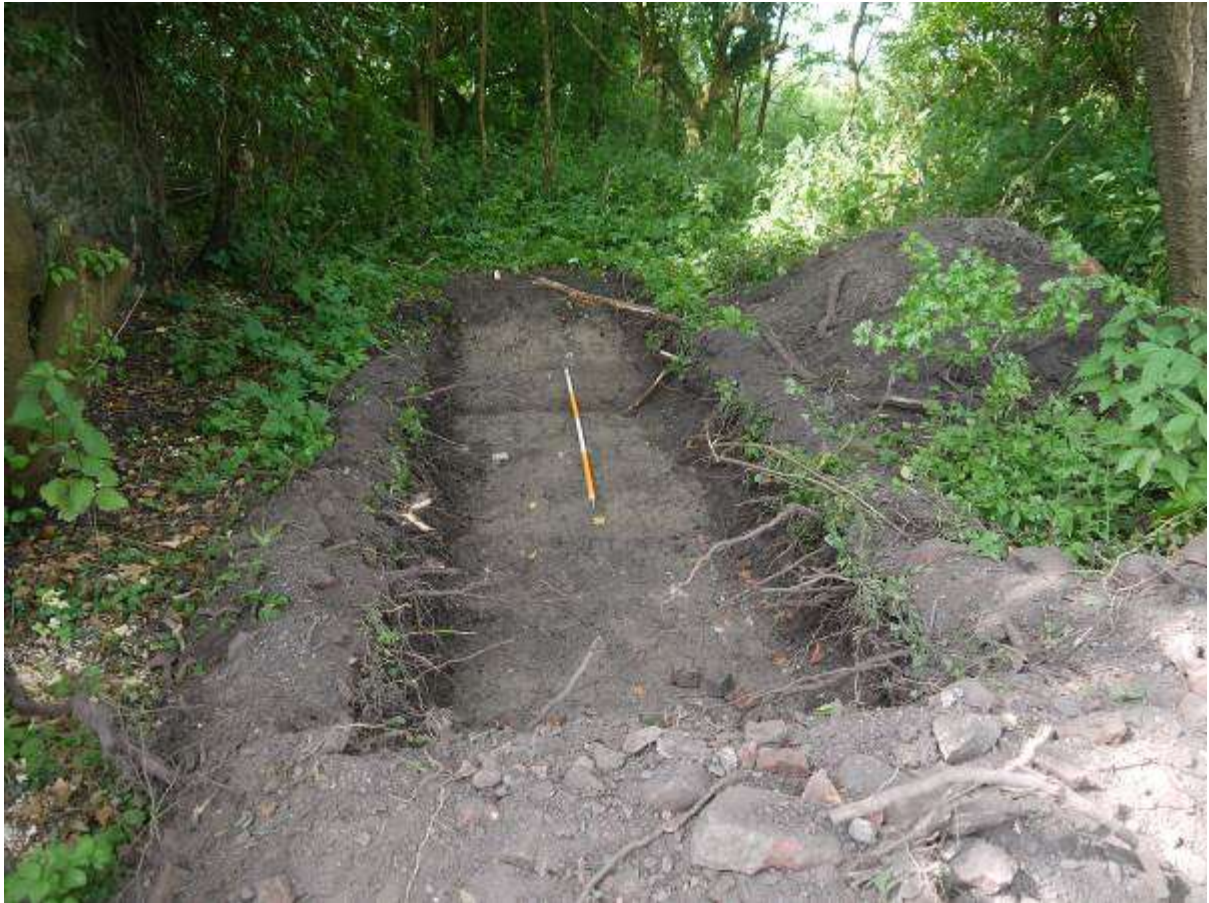
This trench measured 5.2m north east to south west by 1.4m north east to south west. A compact layer of blue grey clay with coal fragments (Natural) was located at a depth of 0.40m below modern ground level. This was sealed by 0.20m of rubble and brick which was in turn sealed by 0.20m of dark brown silty clay (topsoil). A single fragment of architectural stone was retrieved from the dump of rubble and brick (Illus 33).

Illustration 32 Trench 1 looking South West showing natural clay (below scale)

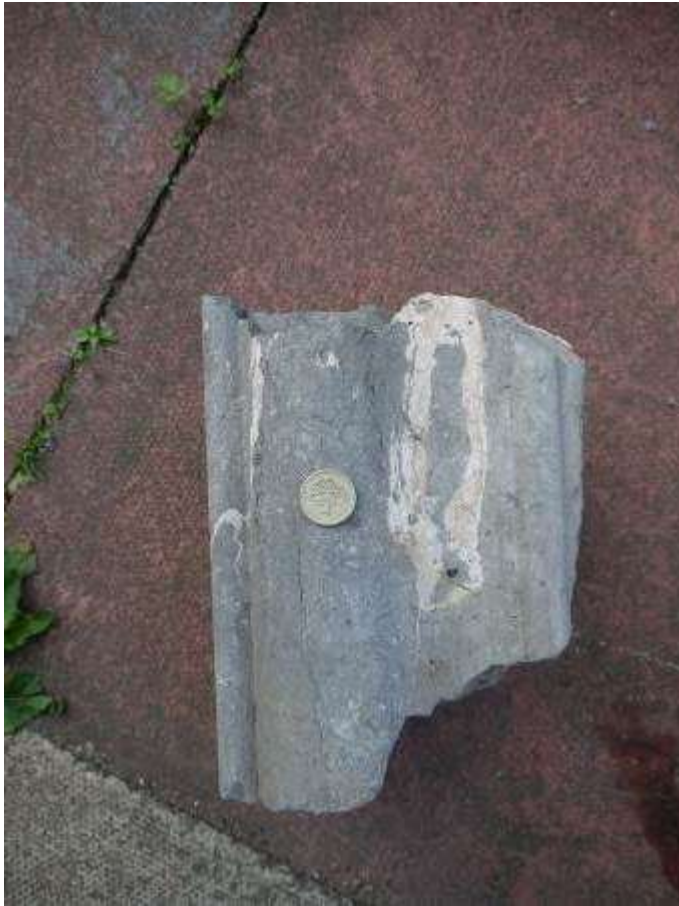
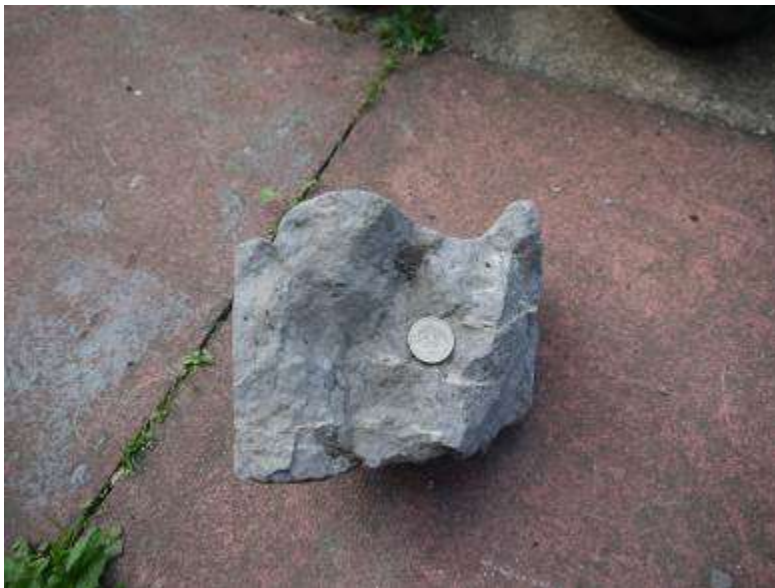
Illustration 33 Architectural fragment from Trench 1

The five trenches opened located natural clay at depths varying between 0.20m and 0.60m below modern ground level. In all trenches apart from Trench 3 deposits of rubble and brick had apparently been dumped in an attempt to stabilise the ground surface. The only find is the fragment of architectural stone from Trench 1 which appears to be from a window moulding, this will be shown to a specialist for further comment.

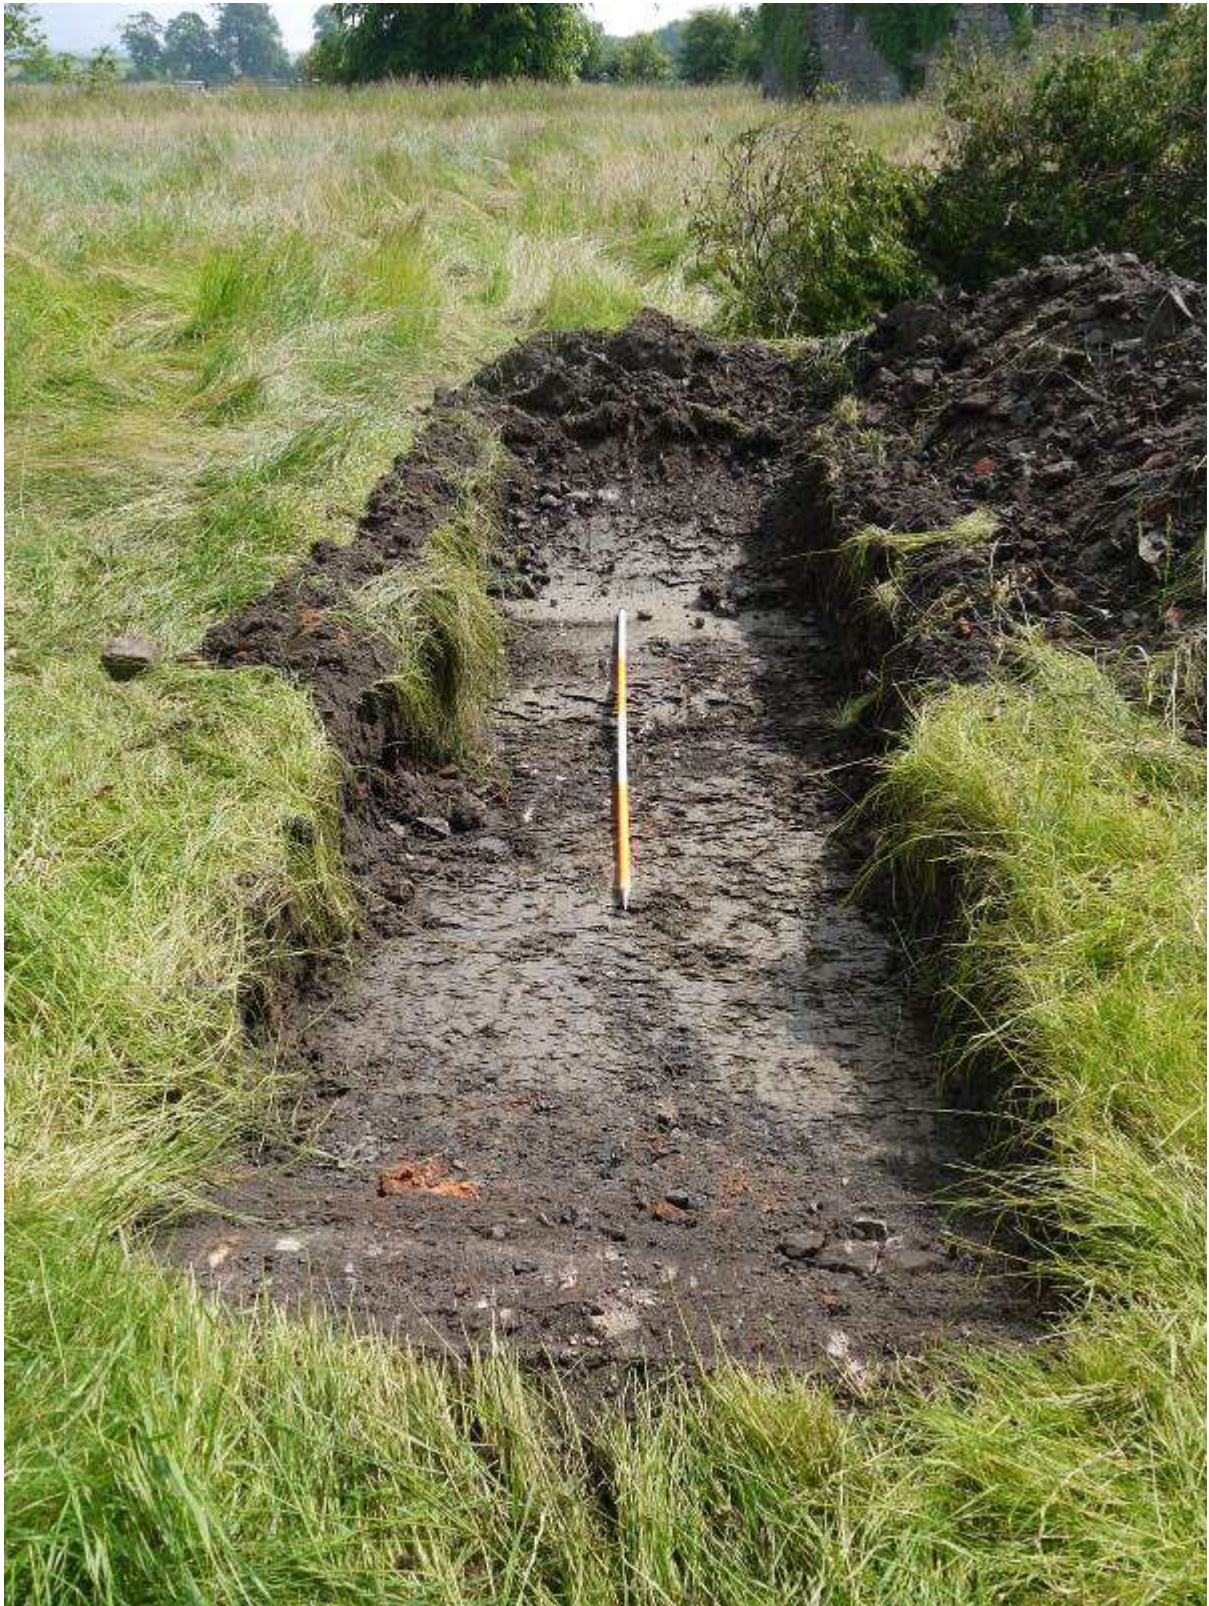
This trench measured 5.3m south west to north east by 1.4m south east to north west. A compact layer of blue grey clay with coal fragments (Natural) was located below 0.20m of dark brown silty clay. There were no finds.

Illustration 34 Trench 2 showing natural clay looking North East

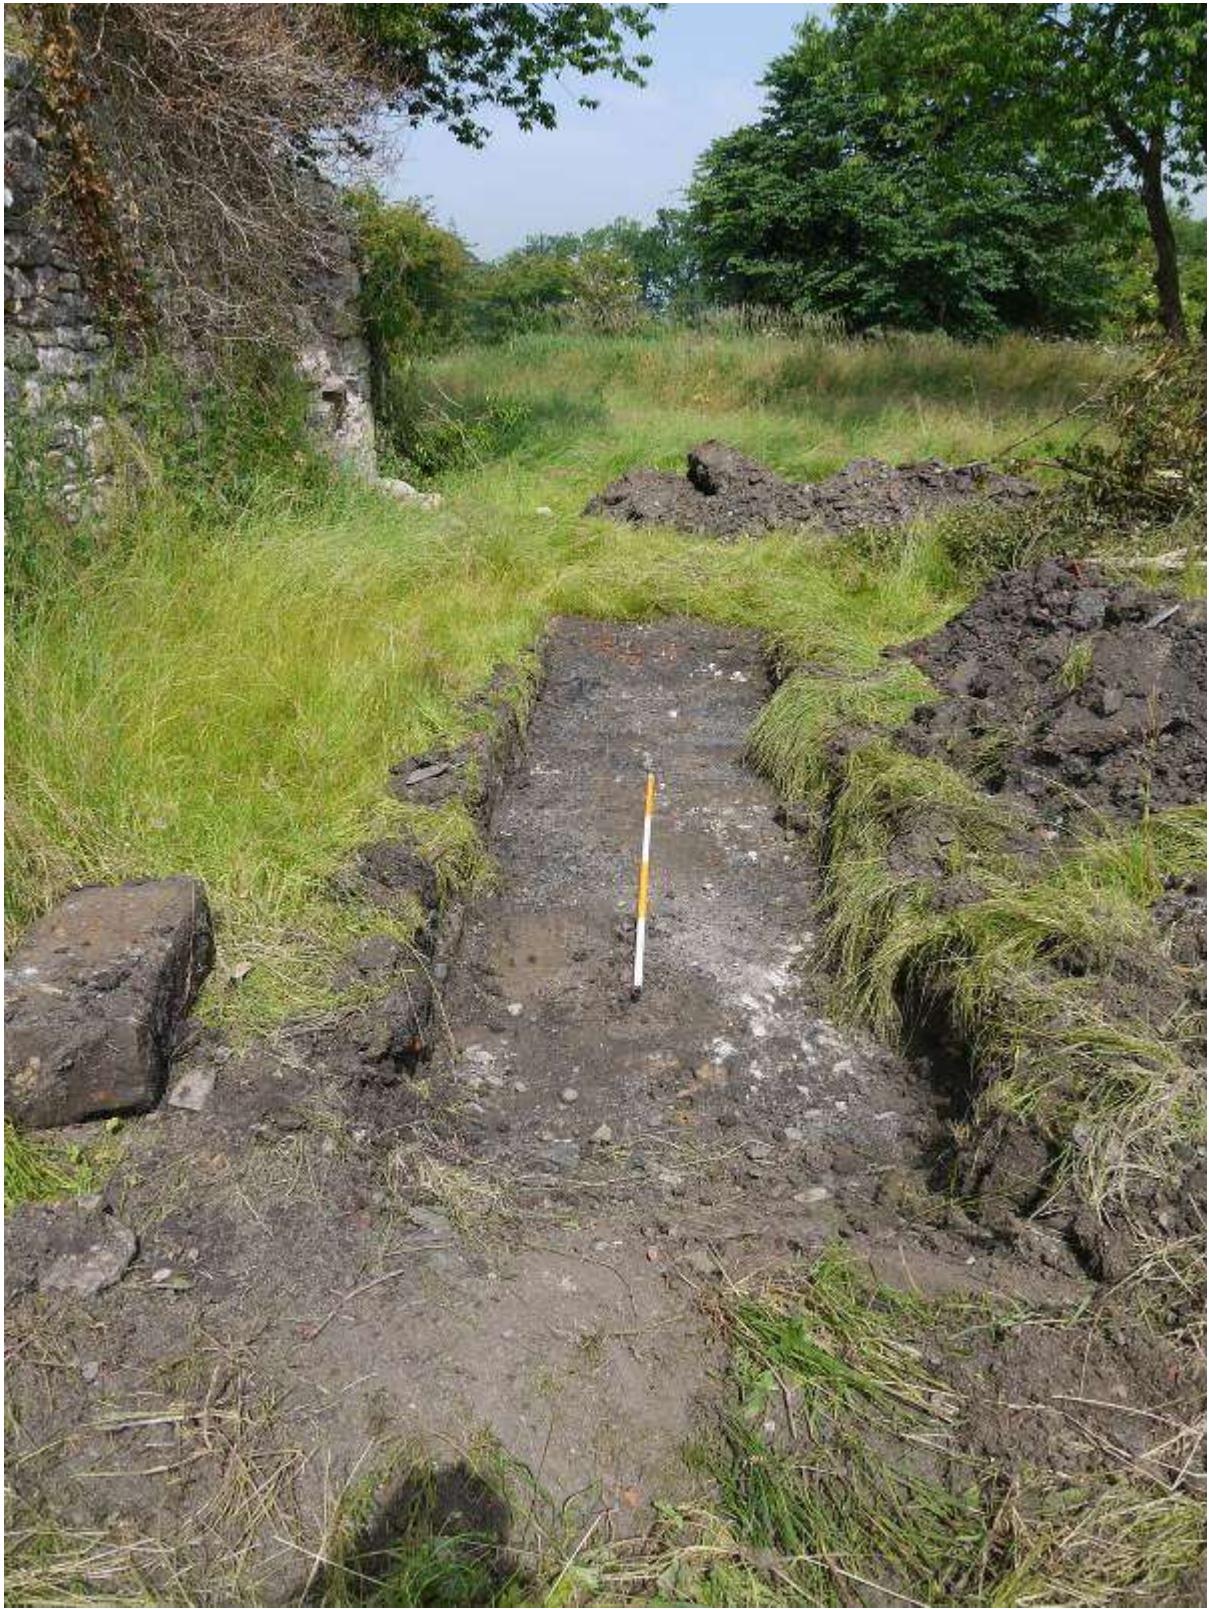
This trench measured 5.3m north west to south east by 1.4m north east to south west. A compact layer of blue grey clay with frequent coal fragments (Natural) was located below 0.30m of dark brown silty clay. There were no finds.

Illustration 35 Trench 3 showing natural clay looking North West

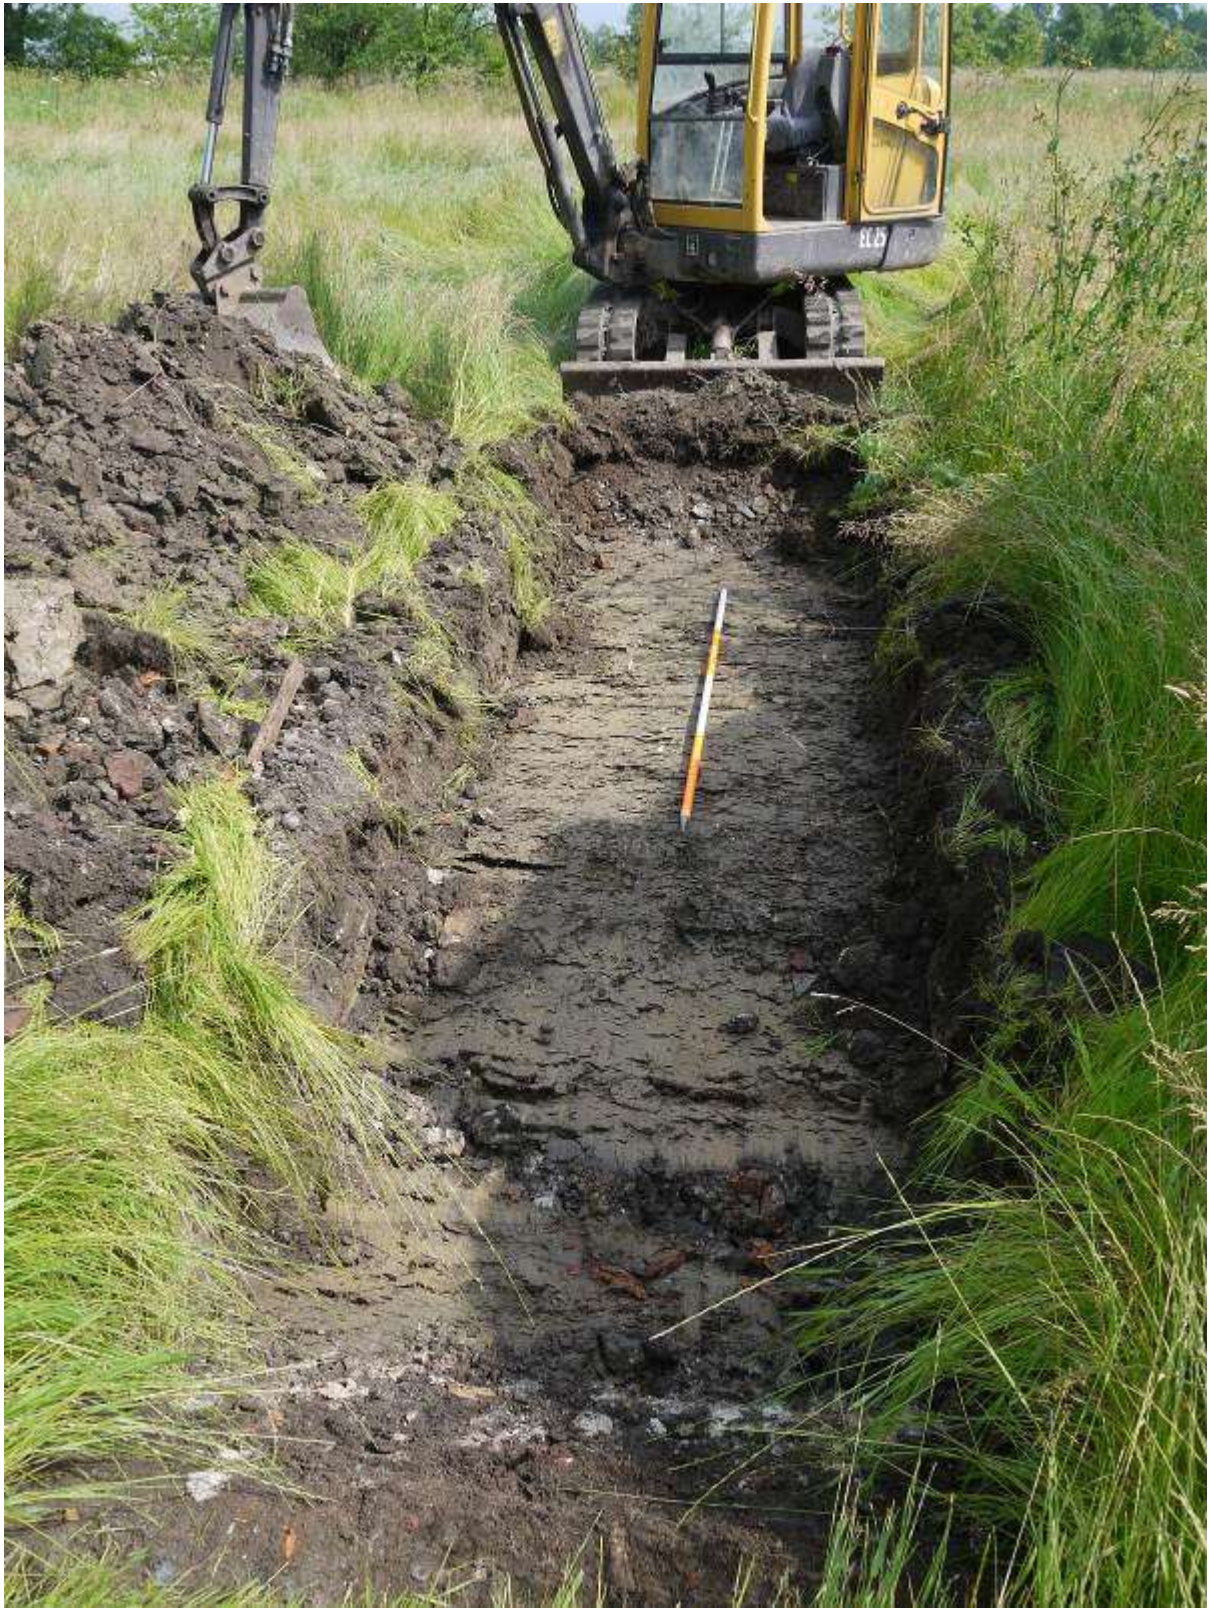
This trench measured 5.50m north east to south west by 1.4m north west to south east. Compact yellow clay (Natural) was located below 0.30m of dark brown silty clay (topsoil). There were no finds.

Illustration 36 Trench 4 showing natural clay looking north east

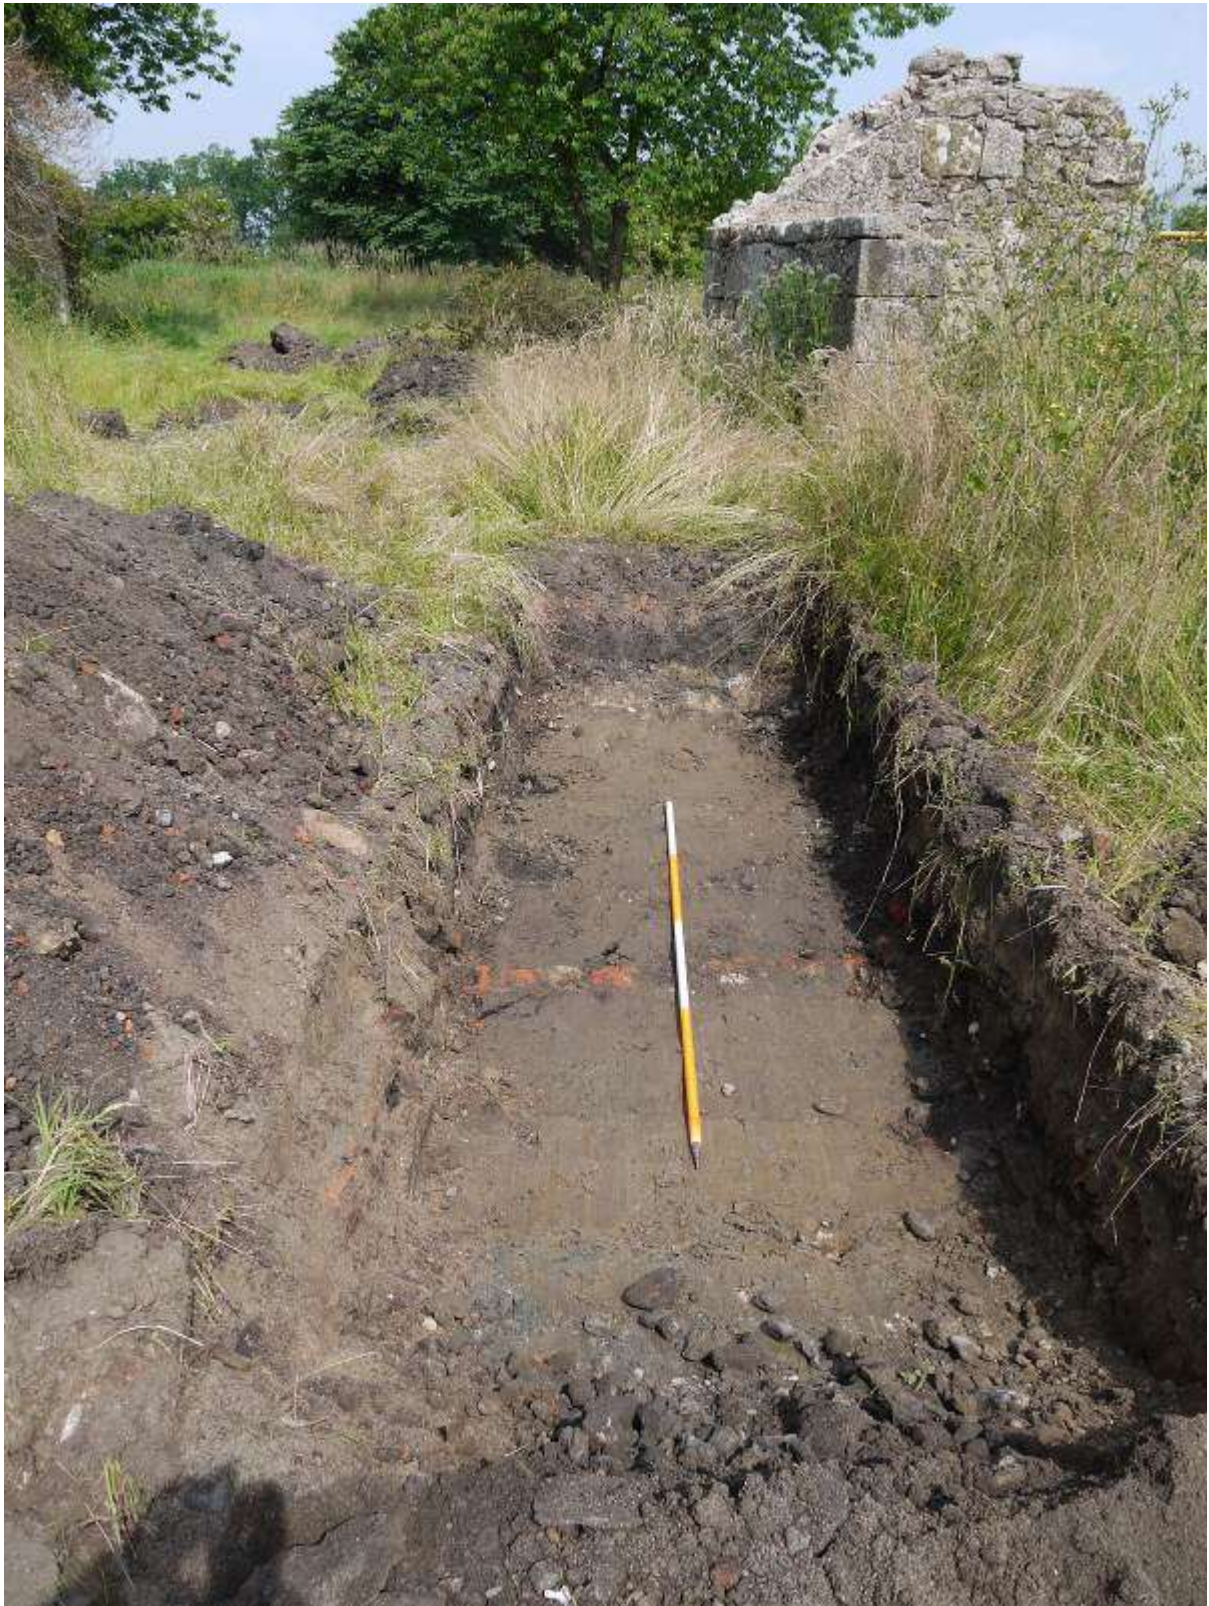
This trench measured 5.45m north west to south east by 1.4m south west to north east. A compact blue grey clay and coal fragments was located at a depth of 0.60m below modern ground level. This was sealed by rubble and brick 0.29m thick which was in turn sealed by 0.31m of dark brown silty clay. There were no finds.

Illustration 37 Trench 5 showing natural clay and course of field drain looking north west
