Standing Building Survey
Former Stables, South Lochton, Abernyte
Perth and Kinross

Introduction

Discovery & Excavation in Scotland Entry

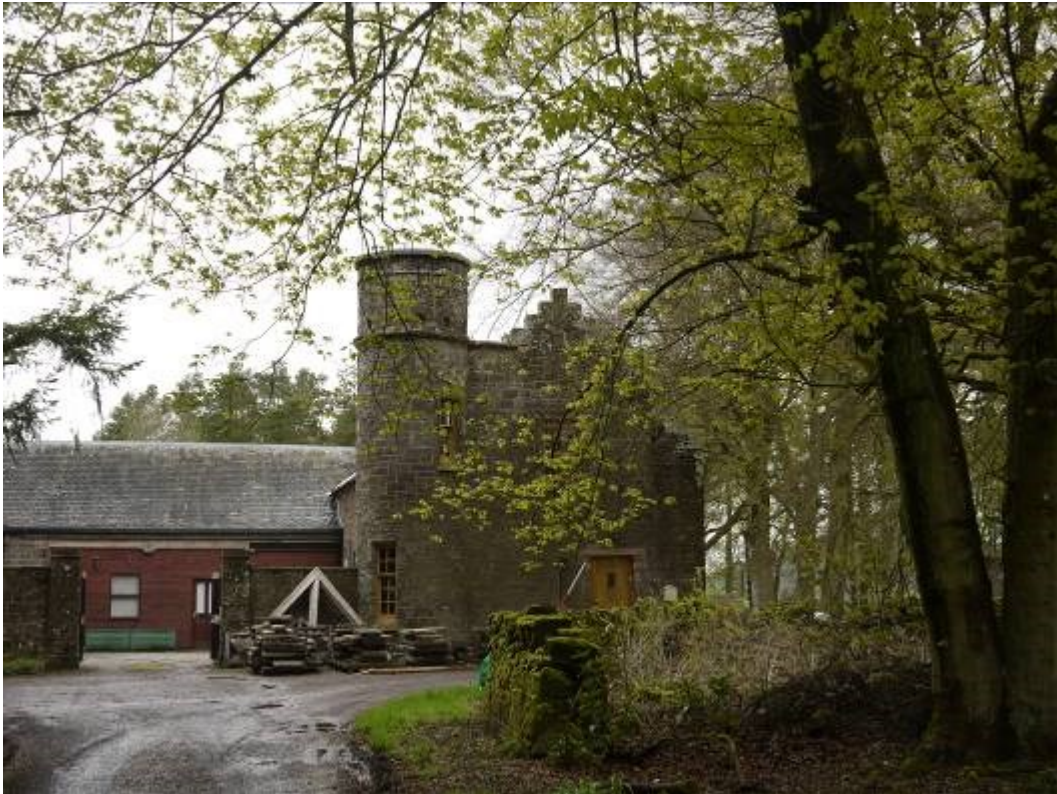
South Lochton former stables from the south

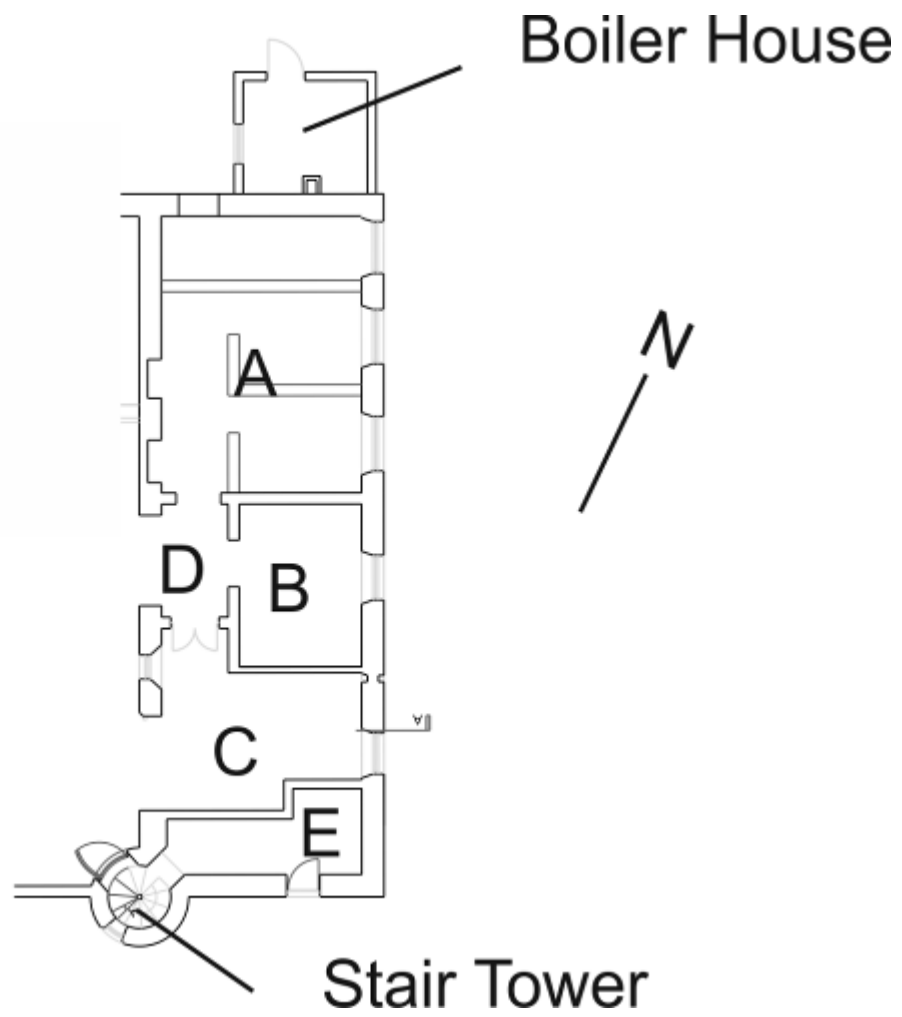
Illustration 3 Location of Rooms A, B, C, D and E, stair tower and boiler room (based on supplied architect's survey)

This is split into three rooms and a lobby as indicated on illustration 3.

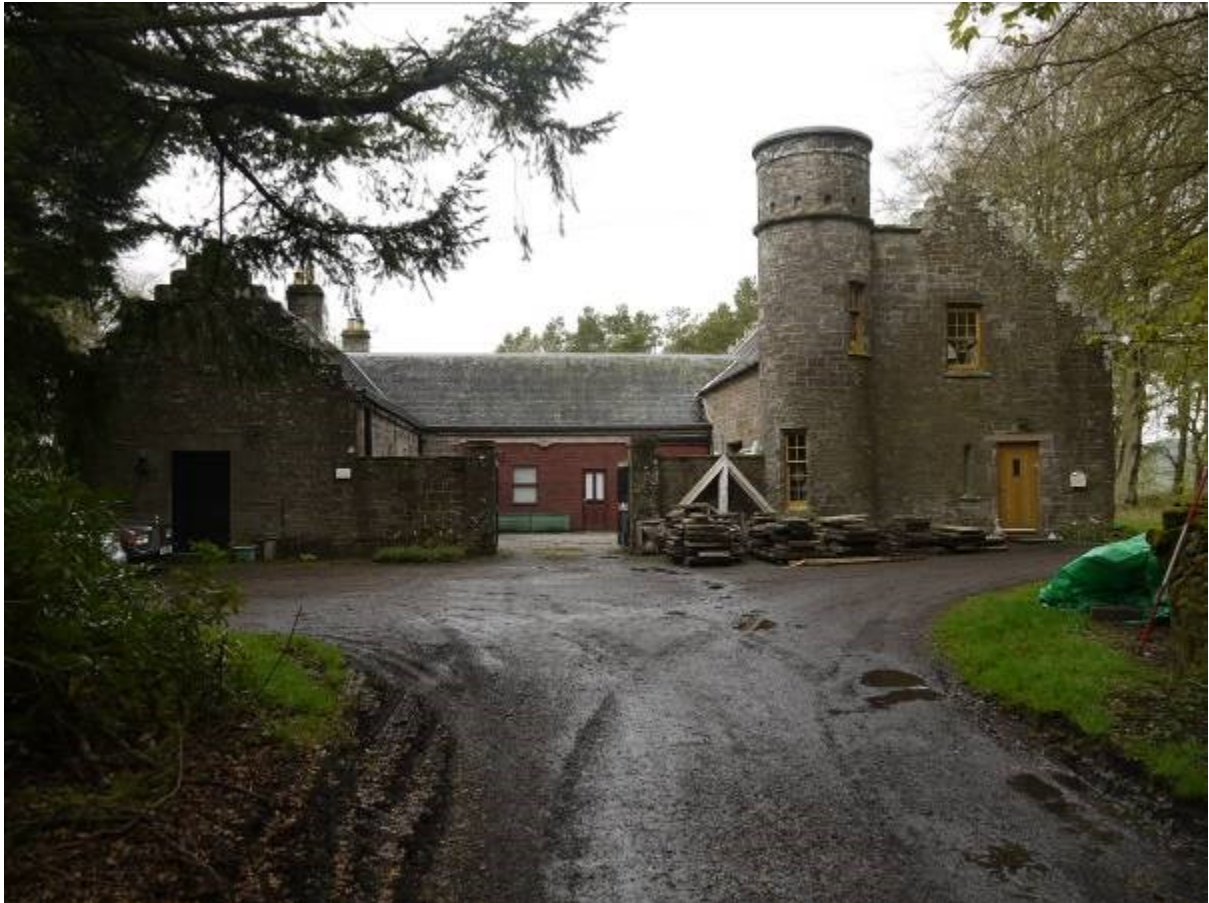
Illustration 4 Complex of buildings at South Lochton including former stables (to right with stair tower) looking North

The former stables at South Lochton form the eastern side of a quadrangle of buildings, those to the west and north are still occupied.

This structure is built of mortar bonded shaped red sandstone blocks, has a ground floor and an attic floor level and is topped with a slate roof. It has a stair tower at its south eastern corner.

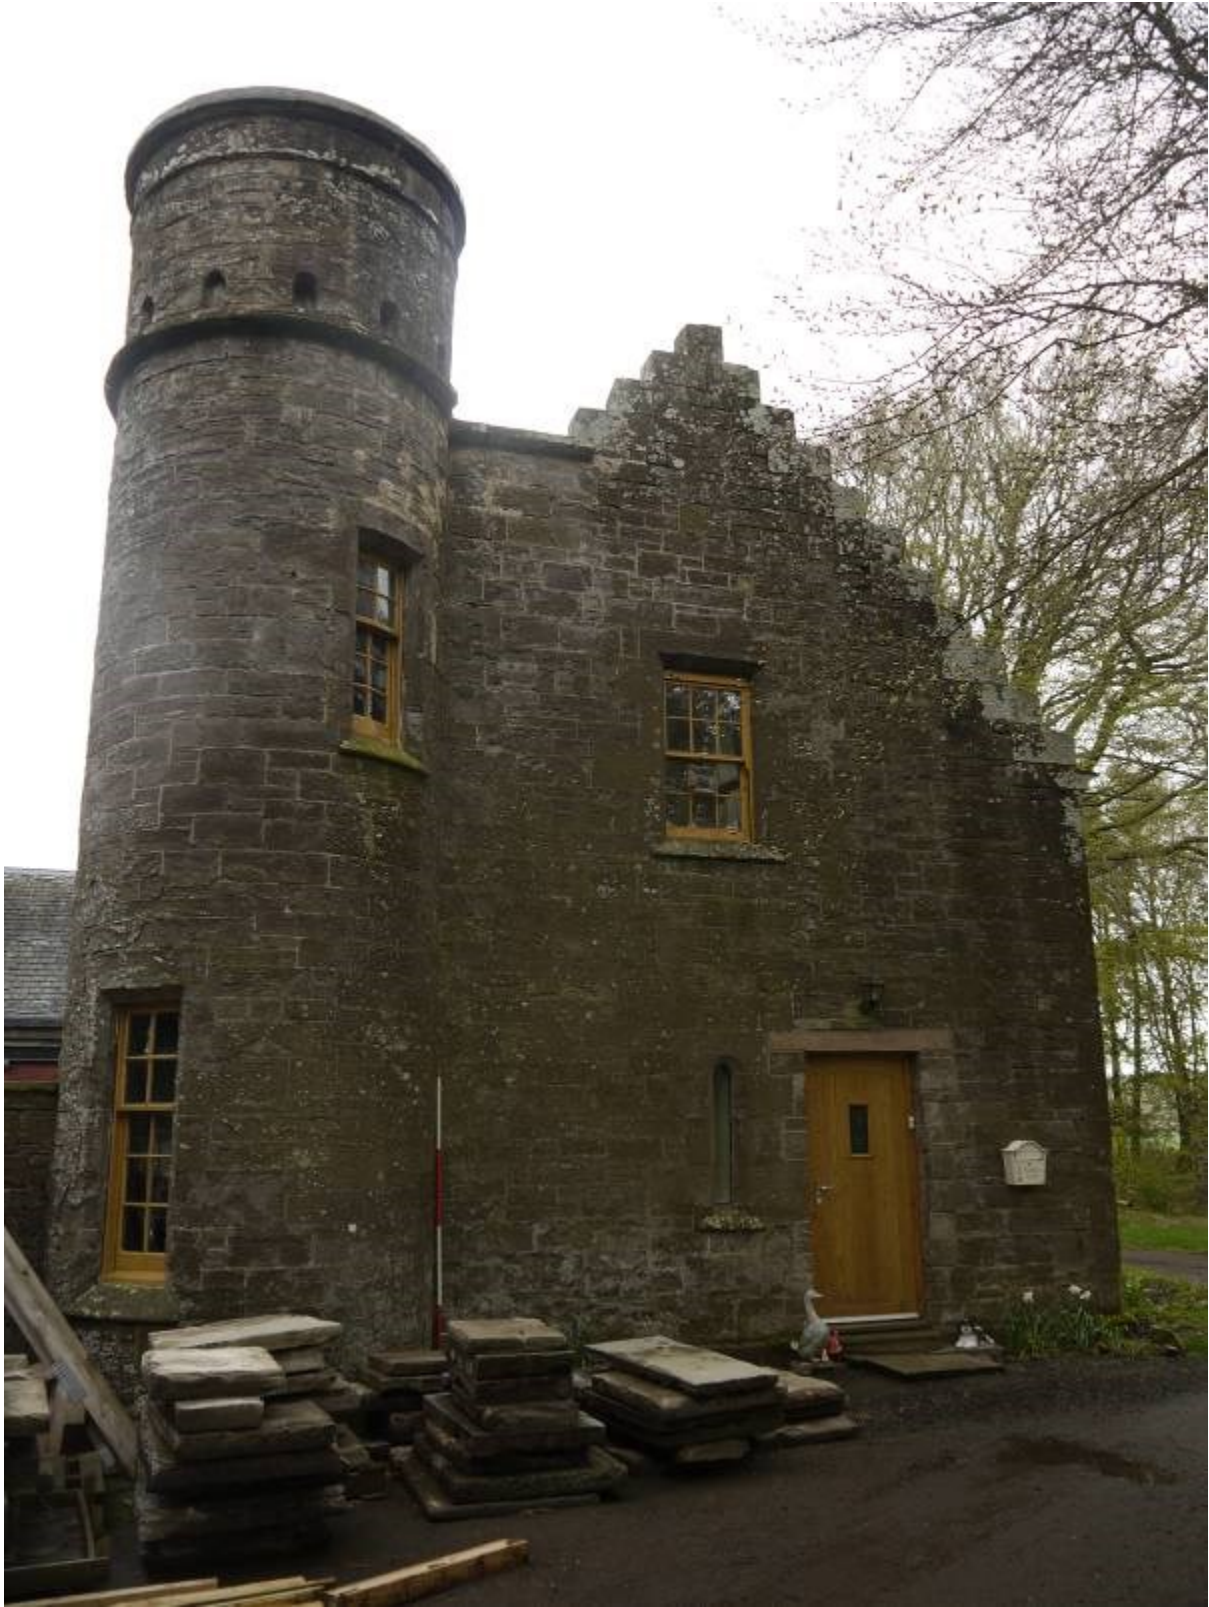
This gable elevation has the stair tower on its western side and a single doorway at ground floor level with a narrow window beside it. There is another window at attic floor level. The stair tower has two windows in it, at ground floor and attic floor level and has surviving pigeon holes around its top. The top of the gable is fully crow stepped on its eastern side but only partially on the side with the tower.

Illustration 5 Southern elevation of former stables

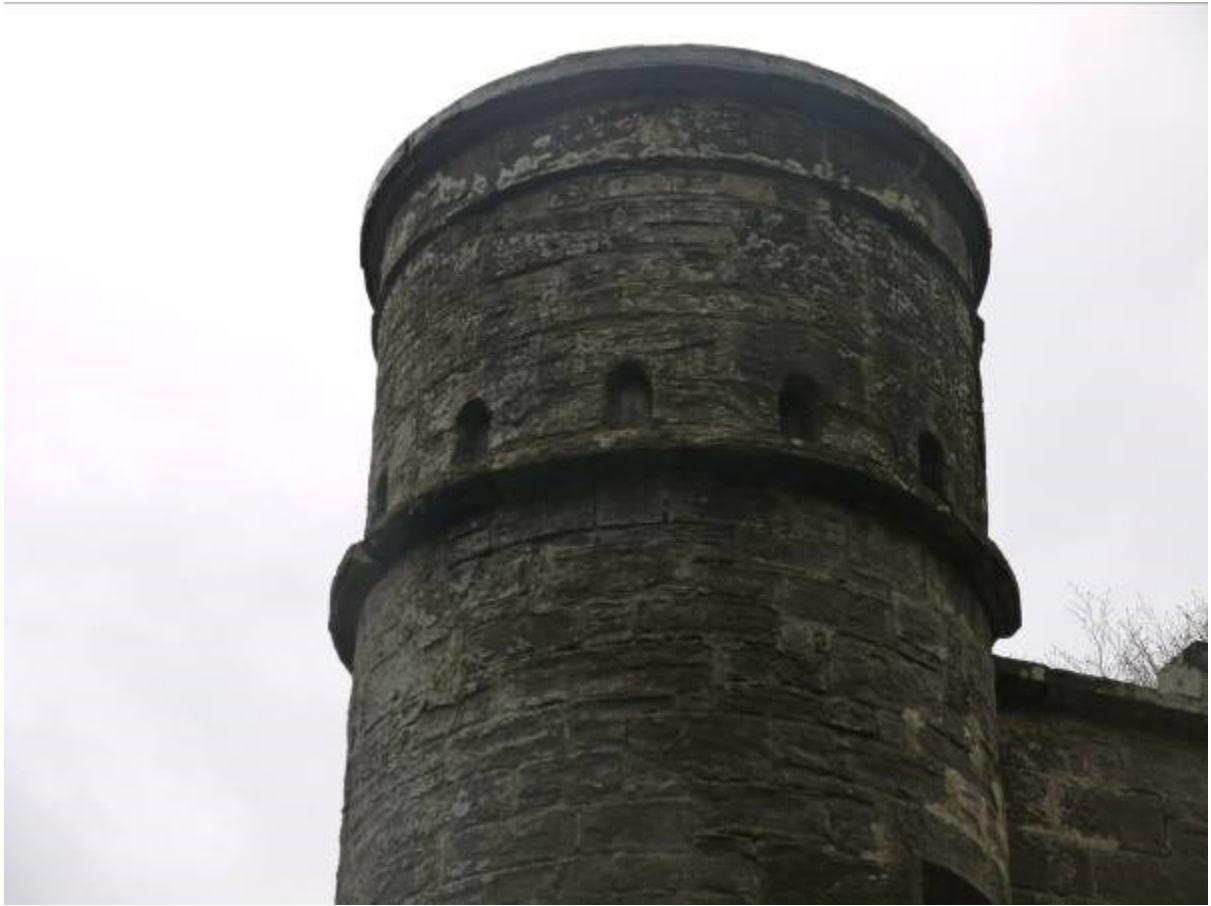
Illustration 6 Pigeon holes in top of stair tower

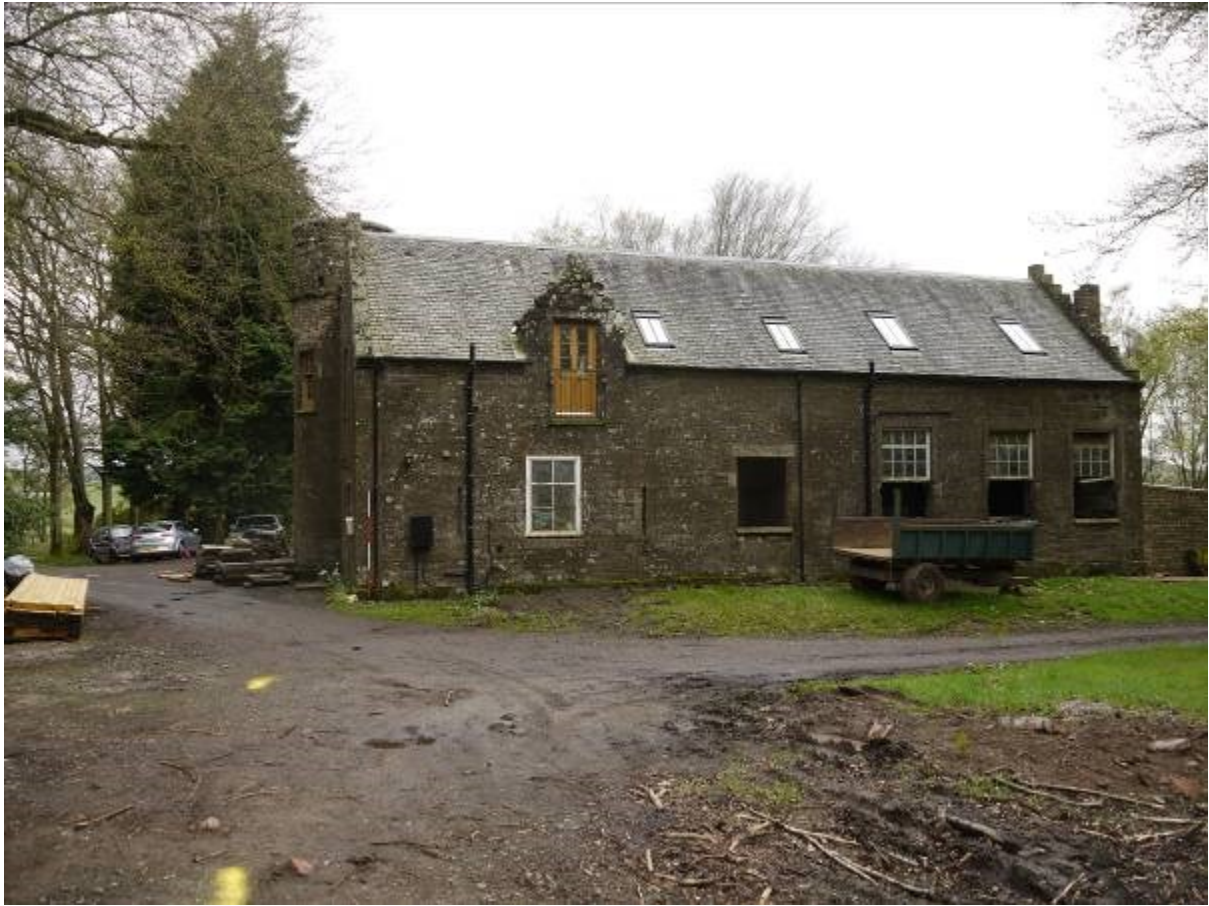
This elevation contains seven windows at ground floor level, five of these are large and two are narrow. There is a doorway at attic floor level with a cast iron balustrade. At the northern end of this elevation there is a brick built boiler house with a chimney. A date stone incised '1937' lies propped against the boiler house wall.

Illustration 7 Eastern elevation of former stables

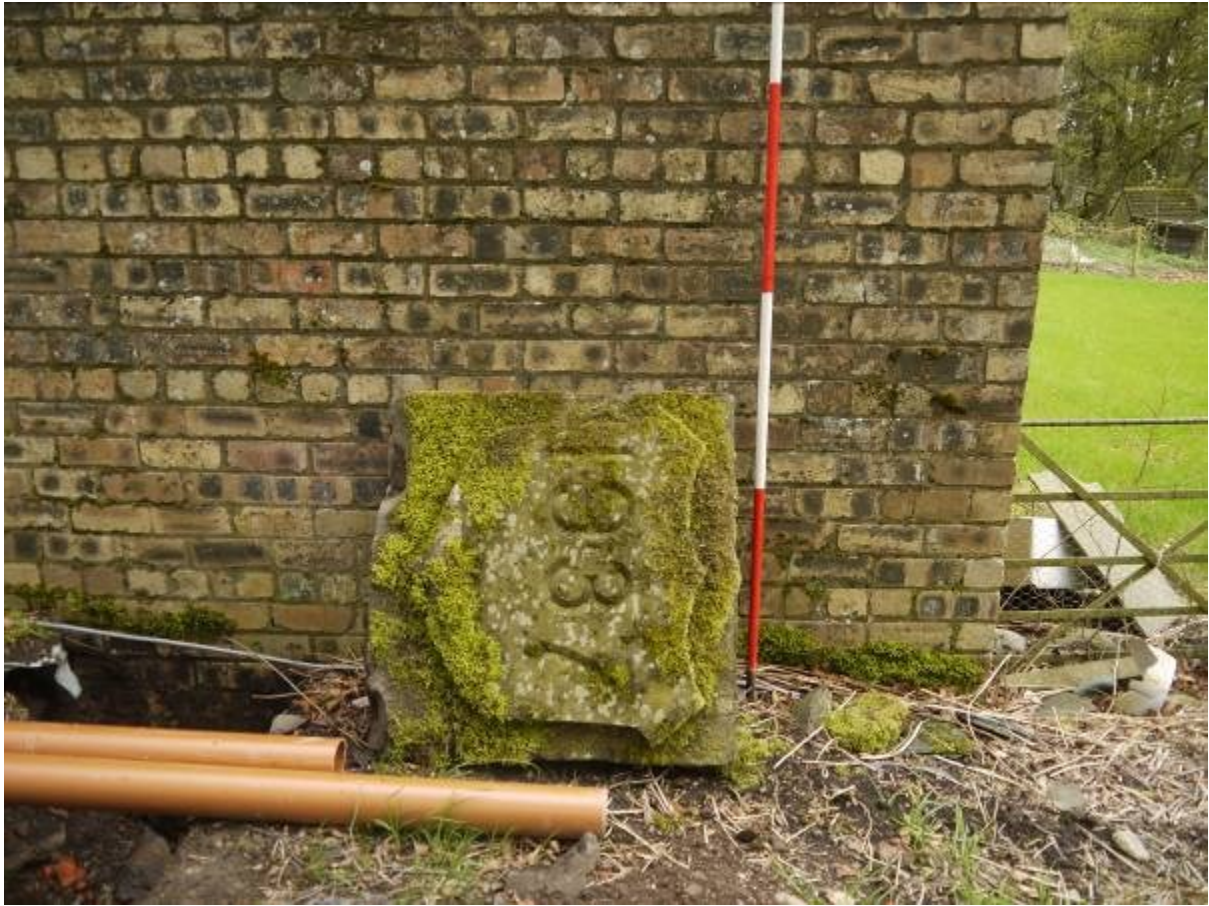
Illustration 8 Date stone propped against eastern wall of boiler house

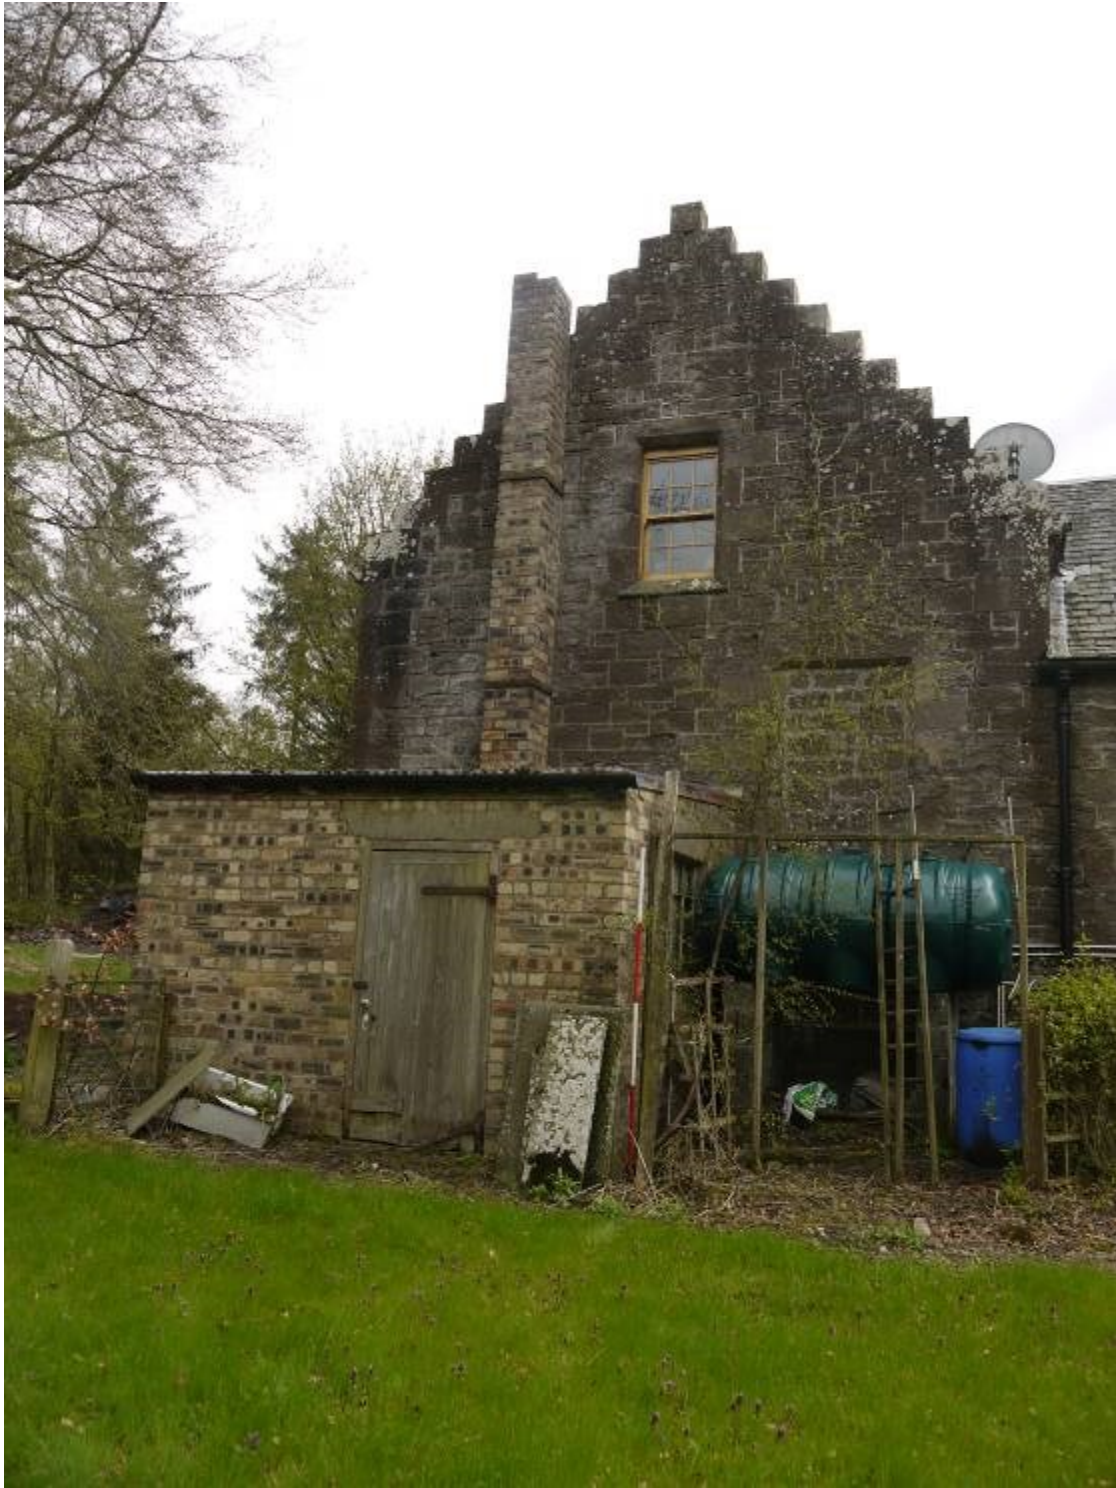
This gable elevation has a blocked window at ground floor level, another window at first floor level and the apex of the gable is fully crow stepped. The northern elevation of the boiler house is attached to this elevation and has a single wooden door.

Illustration 9 Northern elevation of former stables

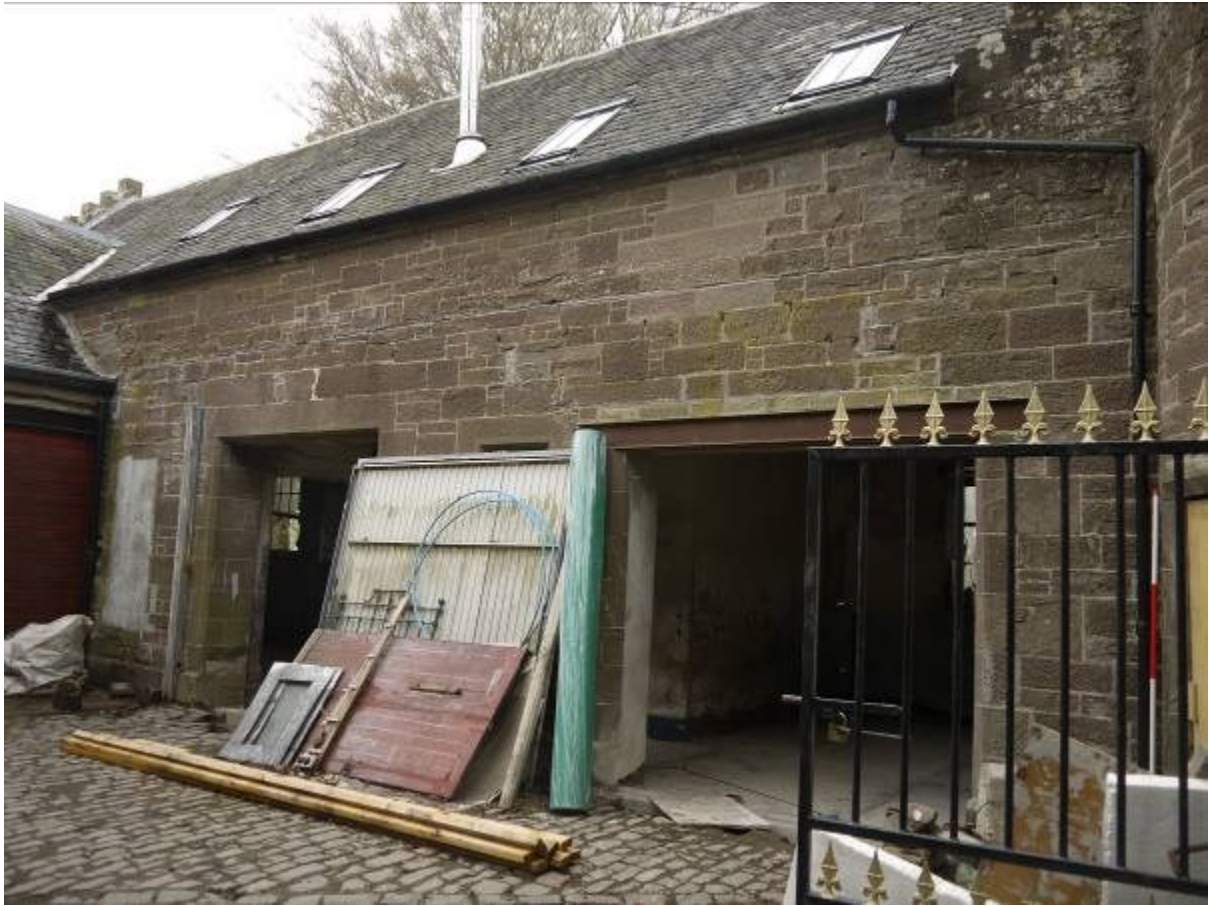
This elevation has the stair tower at its southern end and there is a doorway into the tower at this point. There are two large doorways into the building either side of a small window, these appear to originally have had sliding doors which have been removed. There is a blocked window at the northern end of this elevation.

Illustration 10 Western elevation of former stables

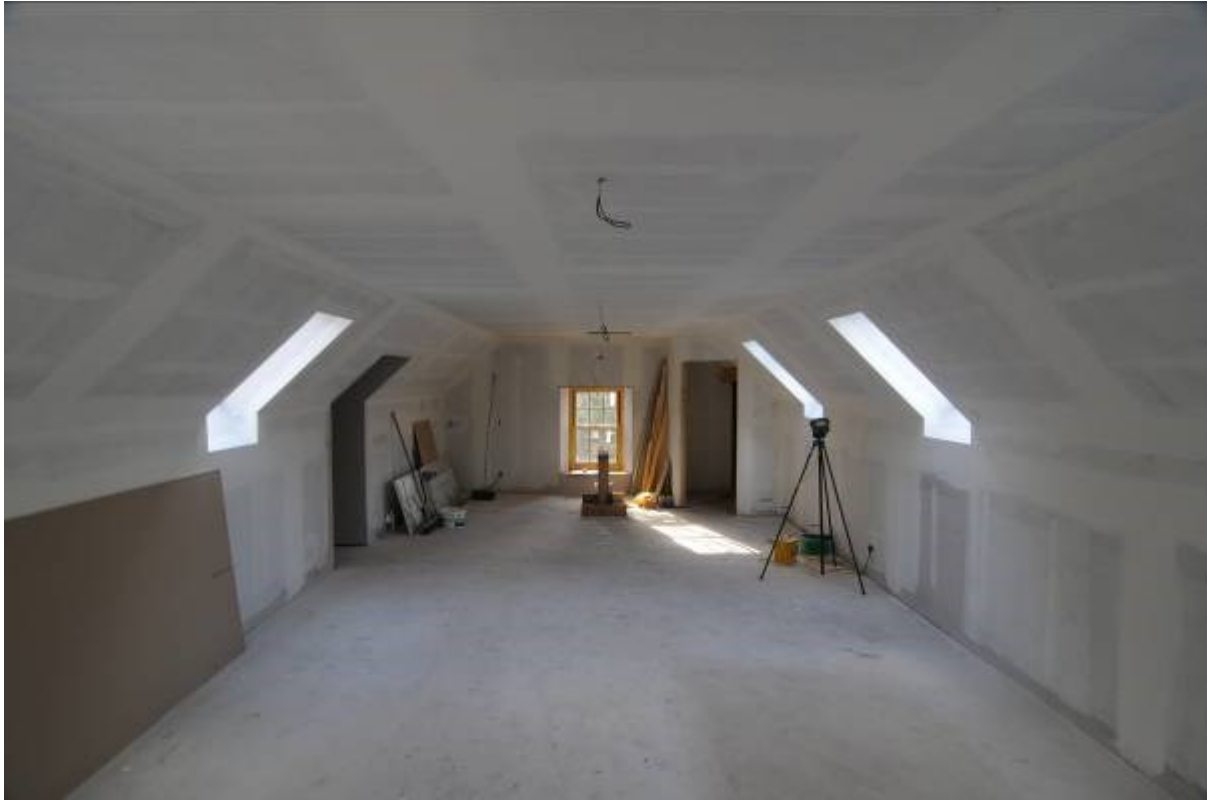
This is accessed by the stair tower and runs the full length of the building and there are windows at each gable end. There are two windows in the roof on the western side of this room and a single window on its eastern side. A modern timber floor has been inserted in advance of conversion into a living space.

Illustration 11 General view of upper floor of former stables looking south, stair tower access to right

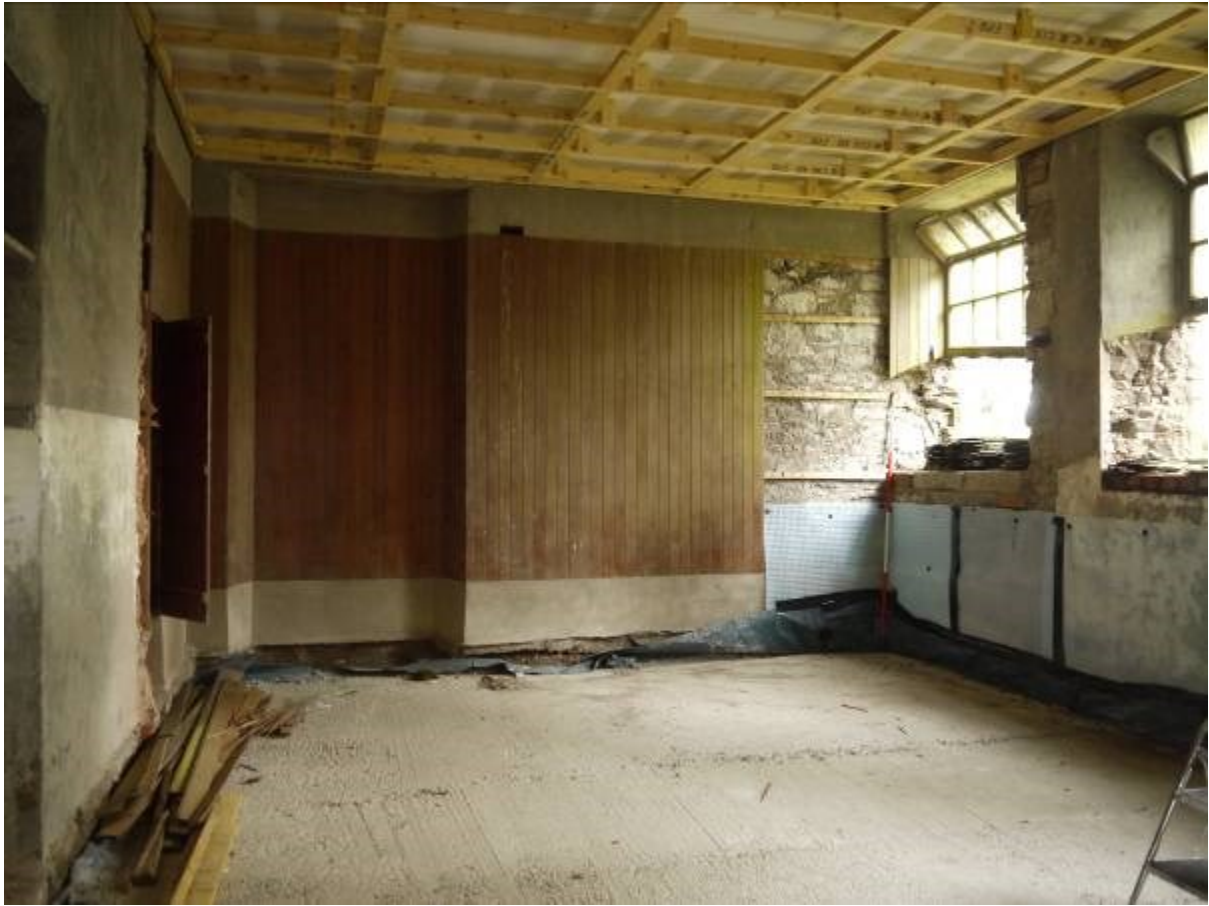
This lies at the northern end of the building and has a concrete floor. There are three windows on its eastern side, its northern end is partially wood panelled, its southern end has a doorway into the lobby and its western side contains three cupboards.

Illustration 12 Interior of room A looking north

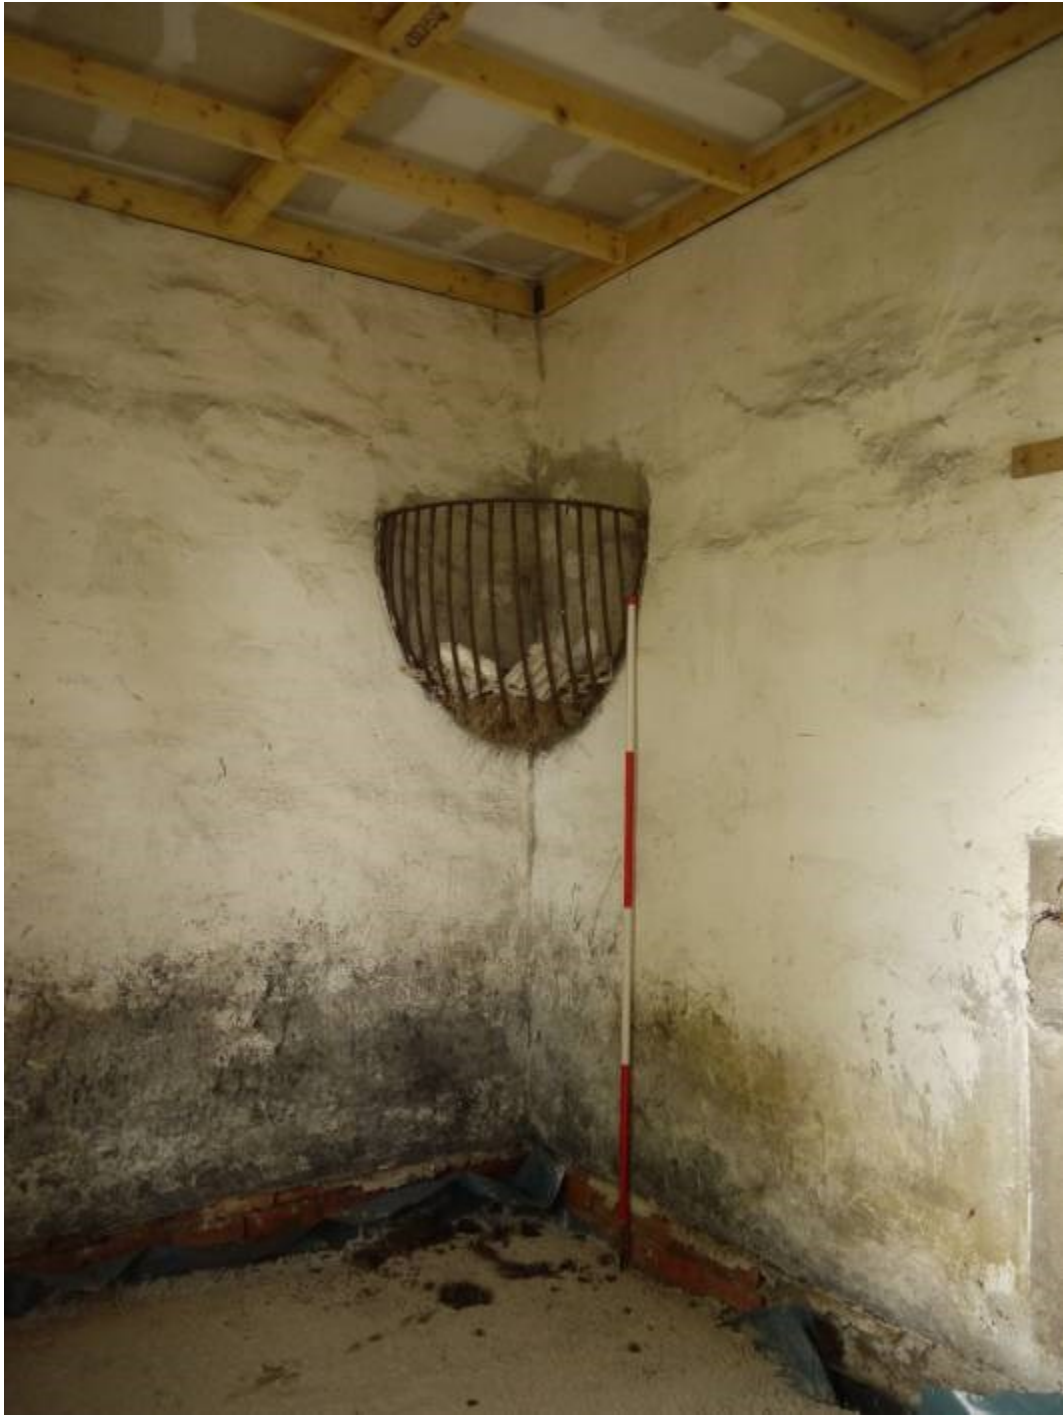
Illustration 14 Horse feeder on wall of Room B

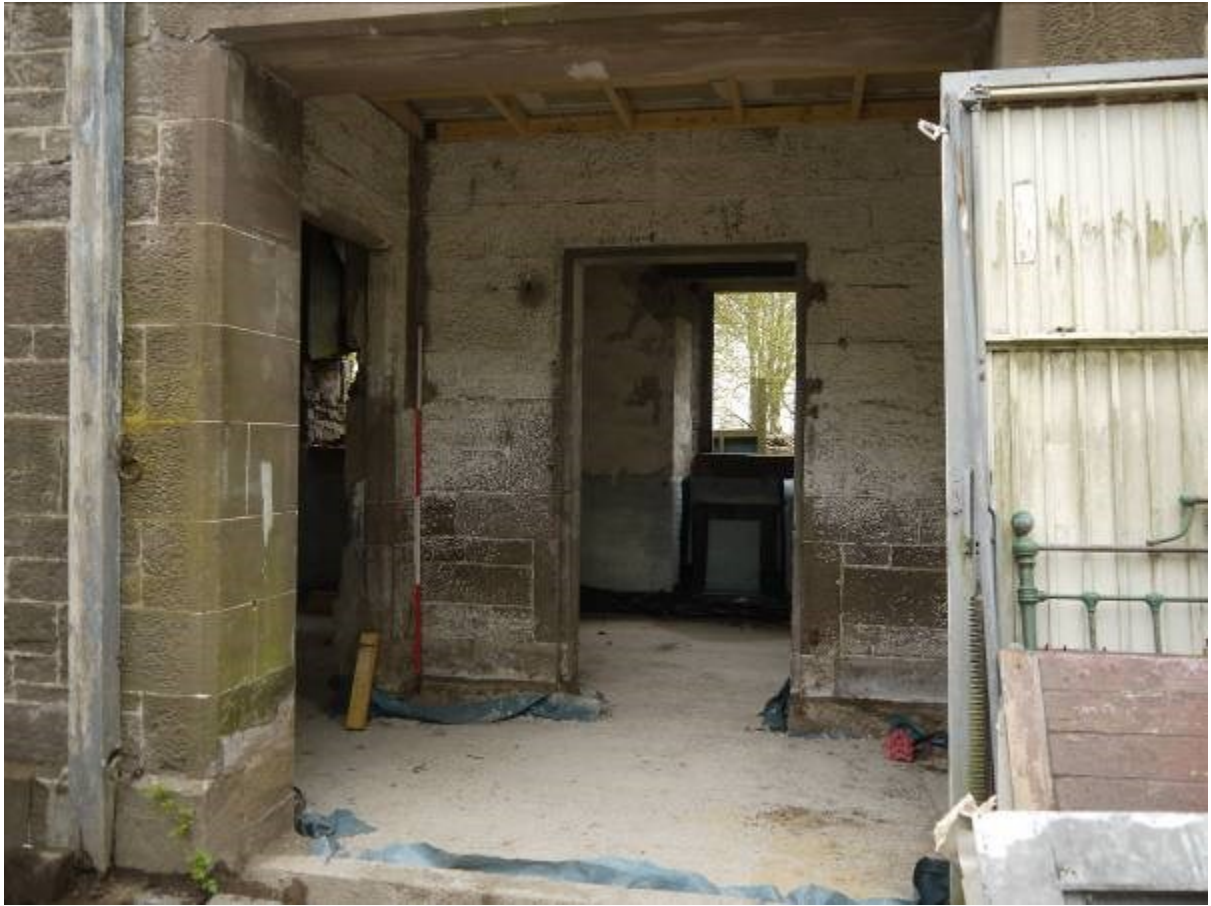
This forms a lobby between the other three rooms and has concrete floor. There is a large doorway in its western wall and doorways into Rooms A, B and C in its other walls. There are cast iron door fittings visible at the entrance into Room B and at the large doorway.

Illustration 16 Room D looking East

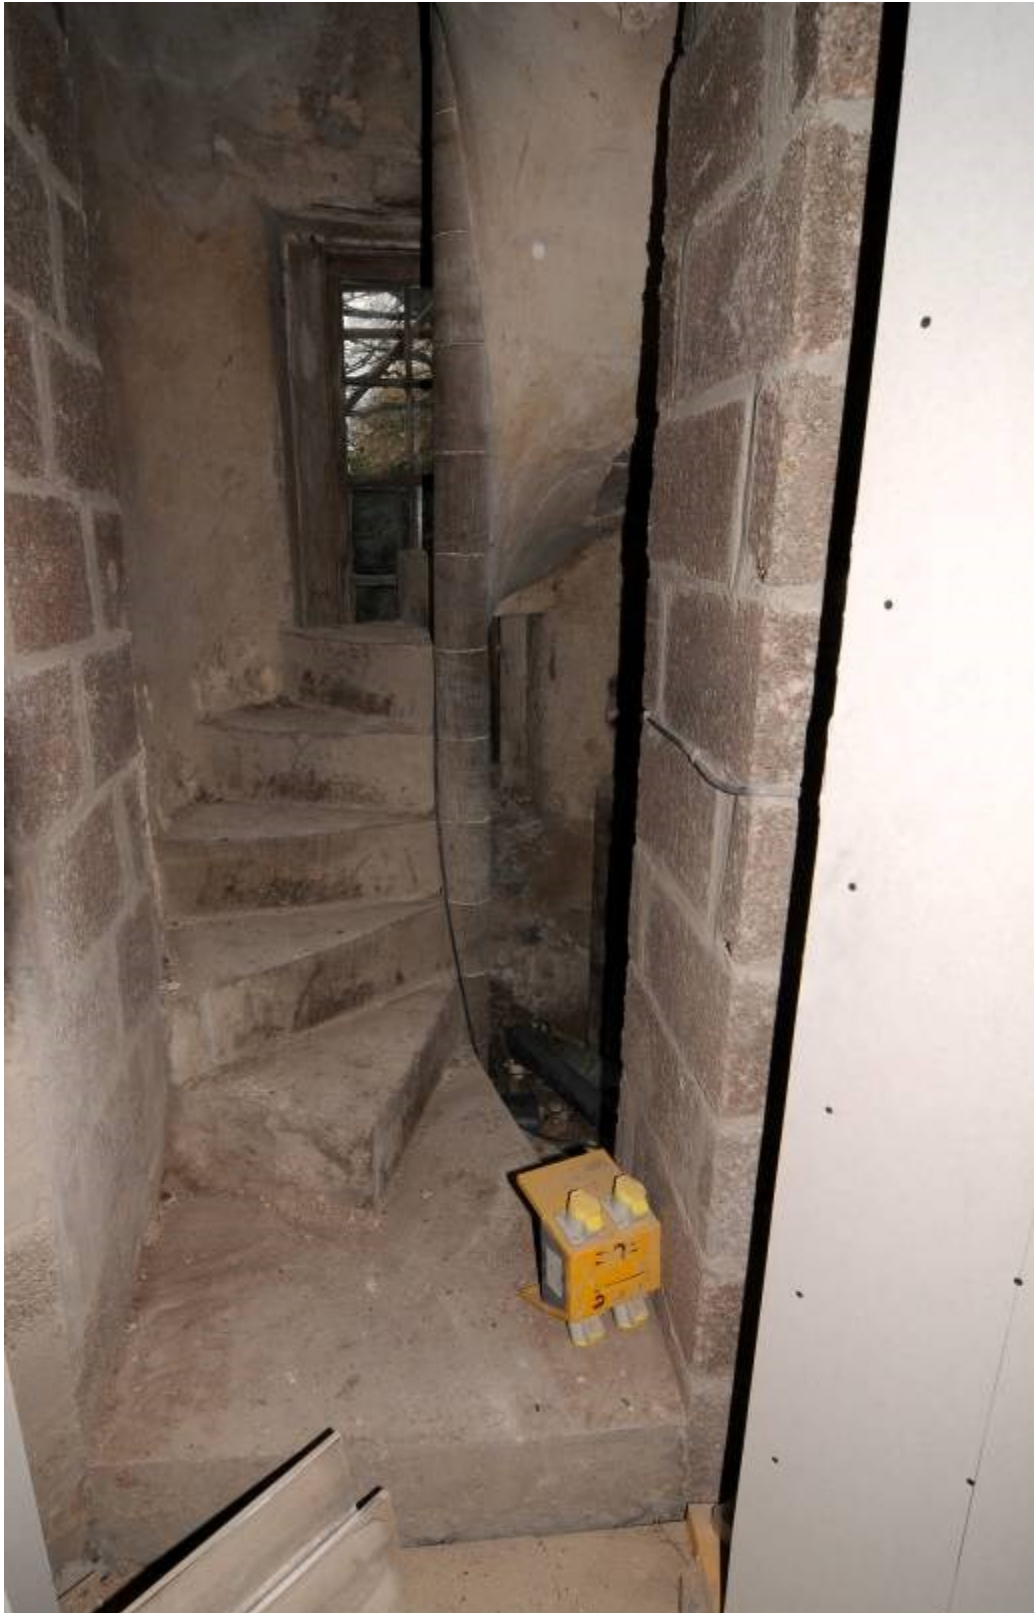
This small room provides access to the stair tower to the attic floor level and has a doorway and a window in its southern side.

Illustration 17 Interior of Room E showing access to stair tower
