Standing Building Survey
Former Steading, Nether Craighill,
Aberdeenshire Council

Former steading, Nether Craighill from the west

13th May 2014

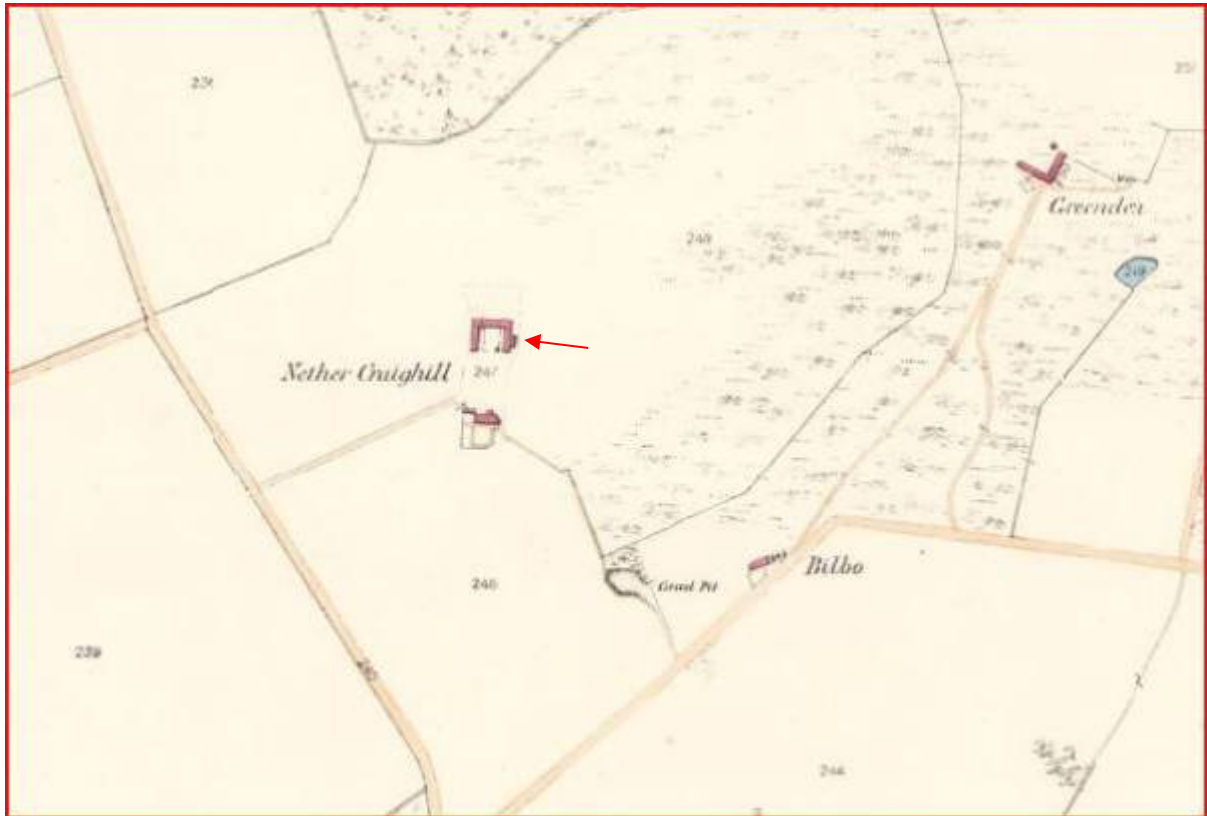
Illustration 2 Original group of buildings at Nether Craighill (red arrow) as shown on First Edition Ordnance Survey map of 1868 (©Trustees of the National Library of Scotland)

From limited research the earliest reference found to Nether Craighill is on 15th November 1797 where Robert Hadden is listed as owning 1 horse valued at £0.2.3 (Farm Horse Tax Rolls 1797-1798 Volume 10). The steading is marked on the First Edition Ordnance Survey map of 1868 which shows a group of three buildings around an open courtyard area to the S and the layout is mapped that way until we get to the maps of the 1950's where the steading is shown as a large single building, very much as it survives today.

Part of the building layout as visible on the First Edition Ordnance Survey map of 1858 can still be defined in the amalgamated steading complex although elements of the earlier structures have either been blocked or partially demolished. What can no longer be identified is the long building that would have formed the northern side of the original steading complex although the surviving stone built wall running along the northern side may represent a remnant of that structure. Structures 1 and 2 have eventually been reroofed and amalgamated (with Structure 3) to form a substantial roofed steading complex.

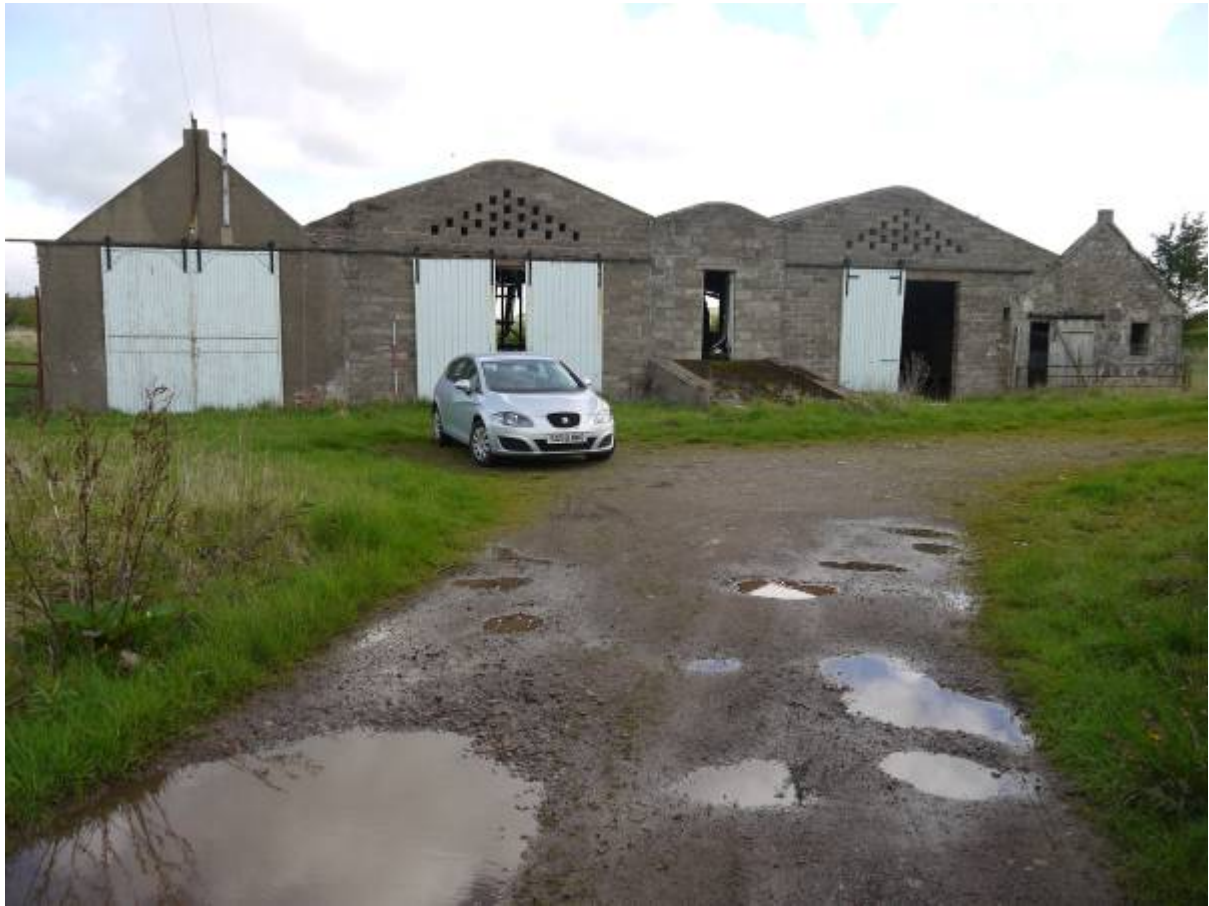
Illustration 4 Steading complex looking north Structure 1 to left, Structure 2 to right, Structure 3 in middle.

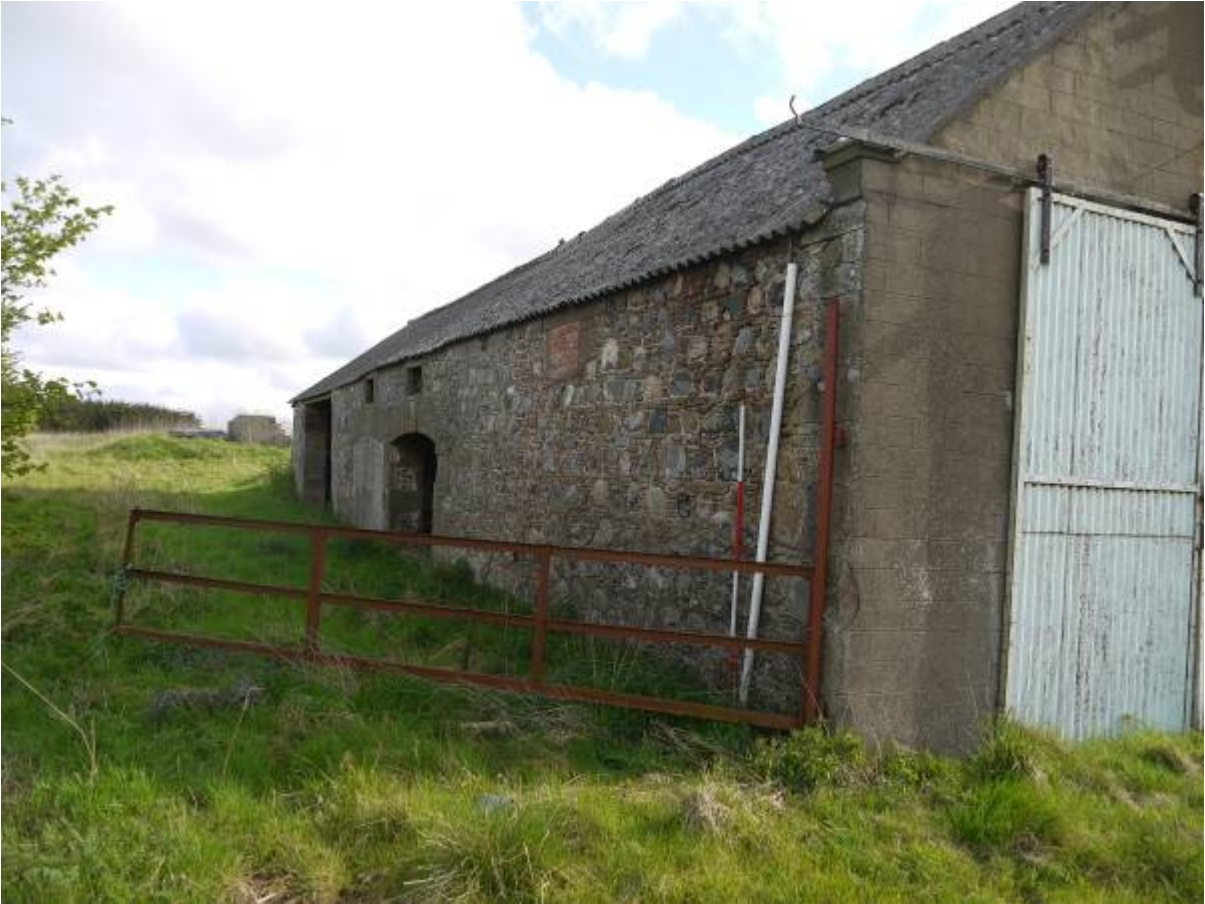
Illustration 5 West facing elevation of Structure 1 looking NE

This elevation has shaped sandstone quoins at its corners and its wall is built of a mixture of small flat sandstone slabs and courses of rough slightly worked boulders (both granite and schist). All of the stonework is bonded with lime mortar. There is a large doorway at its eastern end which has the remains of a sliding wooden door; there are two smaller doorways in the middle of this elevation both of which have arched lintels built of individual shaped stone blocks. One of these doorways has been blocked with concrete breeze blocks. There are three small windows just below the roof line each measuring 0.40m by 0.60m, the window closest to the southern end of this elevation has been blocked with bricks). The roof is built of corrugated sheeting.

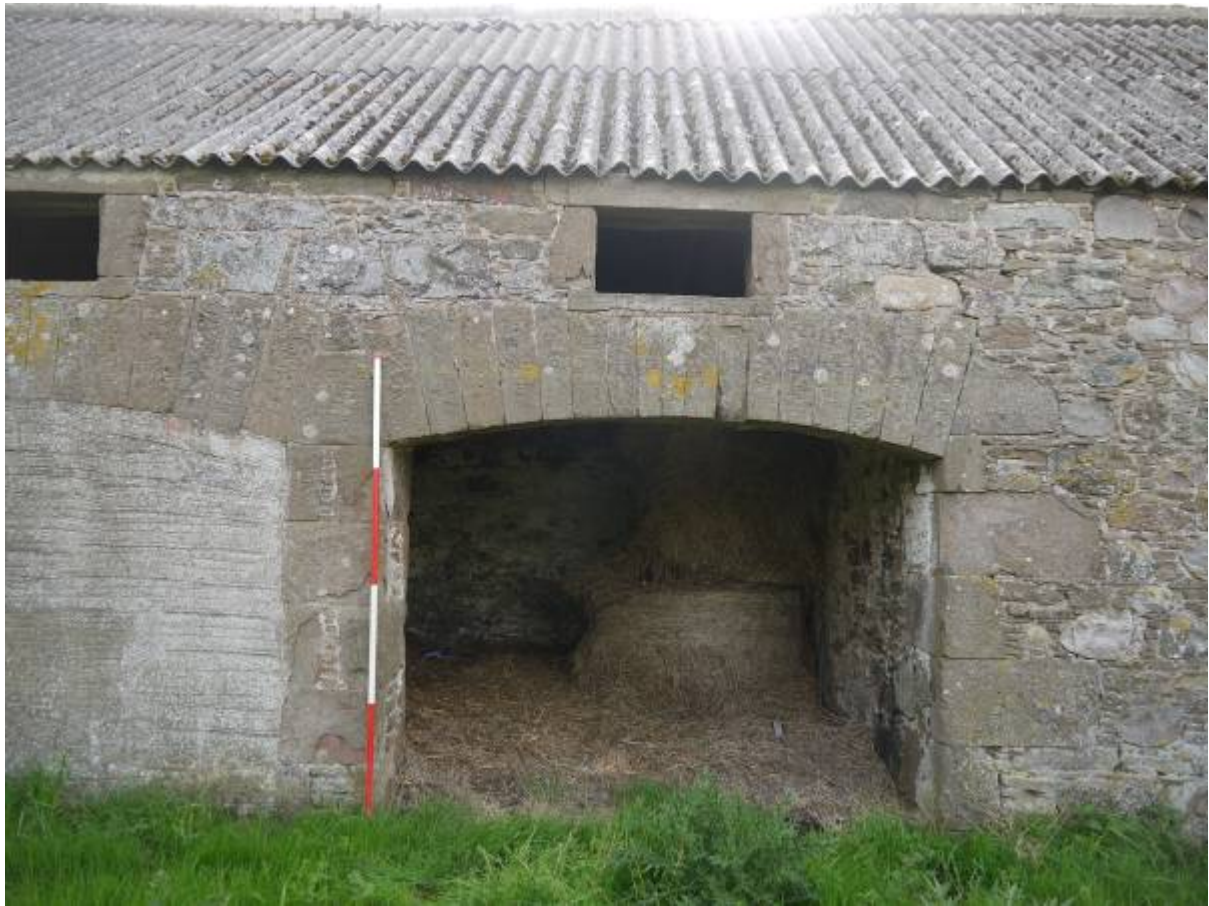
Illustration 7 Detail of West facing elevation showing arched doorways and small windows at roof line looking East

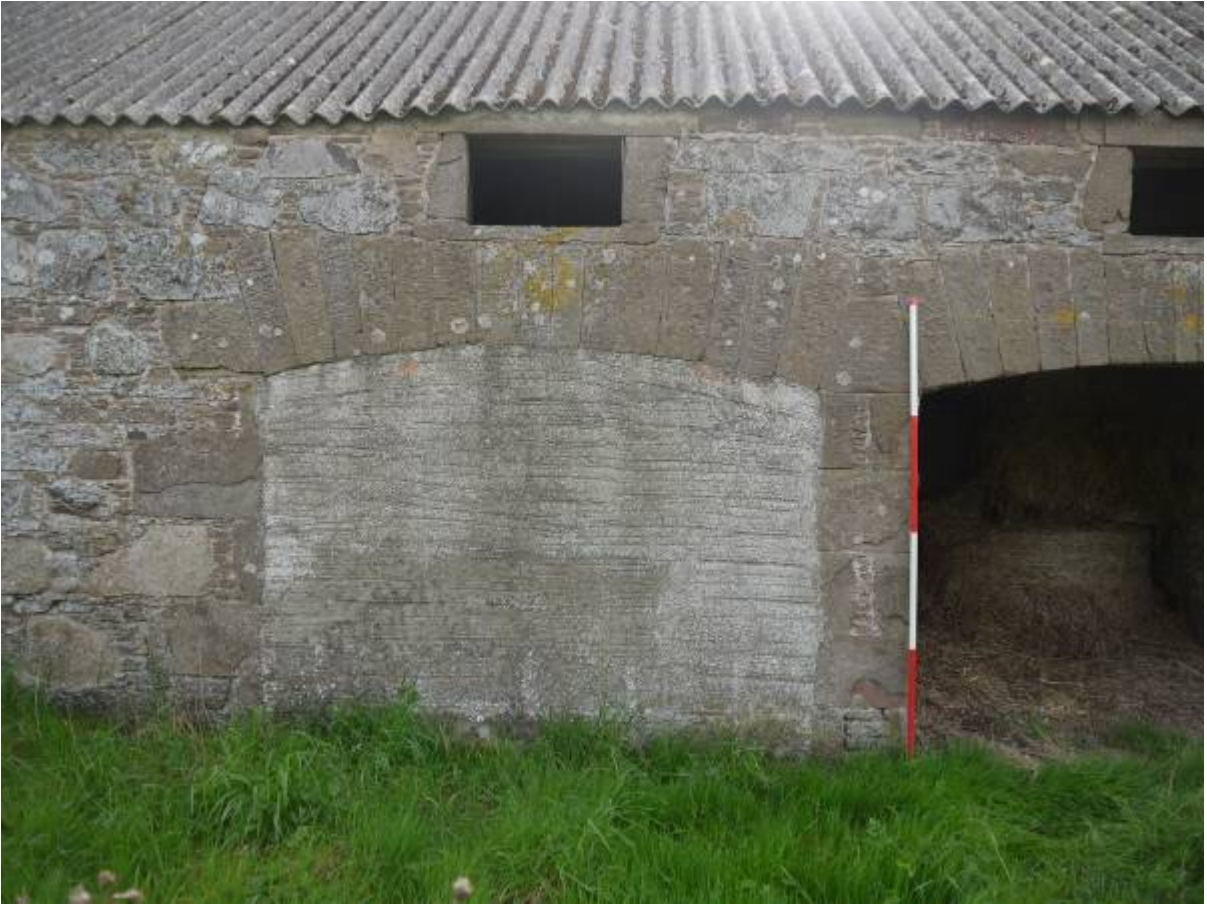
Illustration 8 Blocked arched entrance in West facing elevation of Structure 1

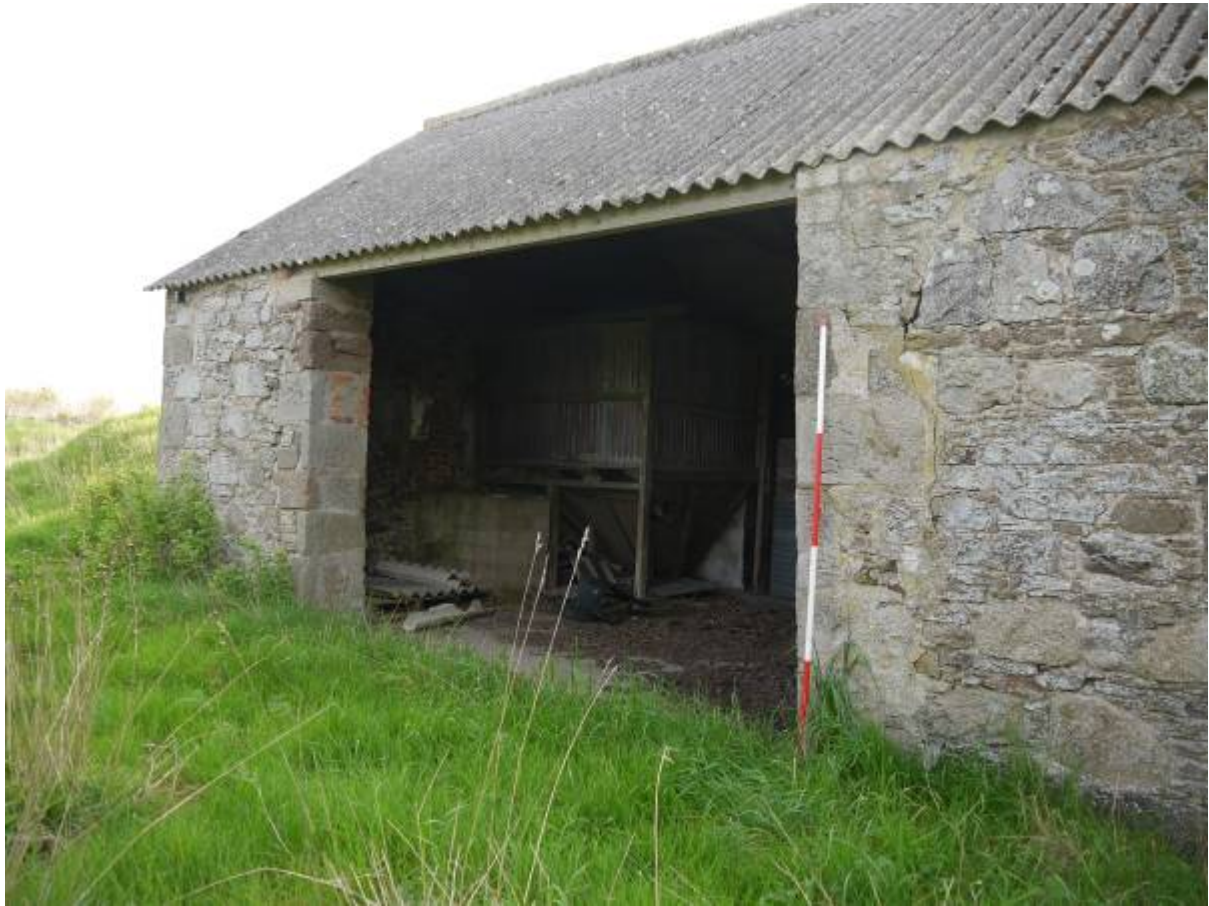
Illustration 9 Detail of large entrance door at N end of West facing elevation of Structure 1

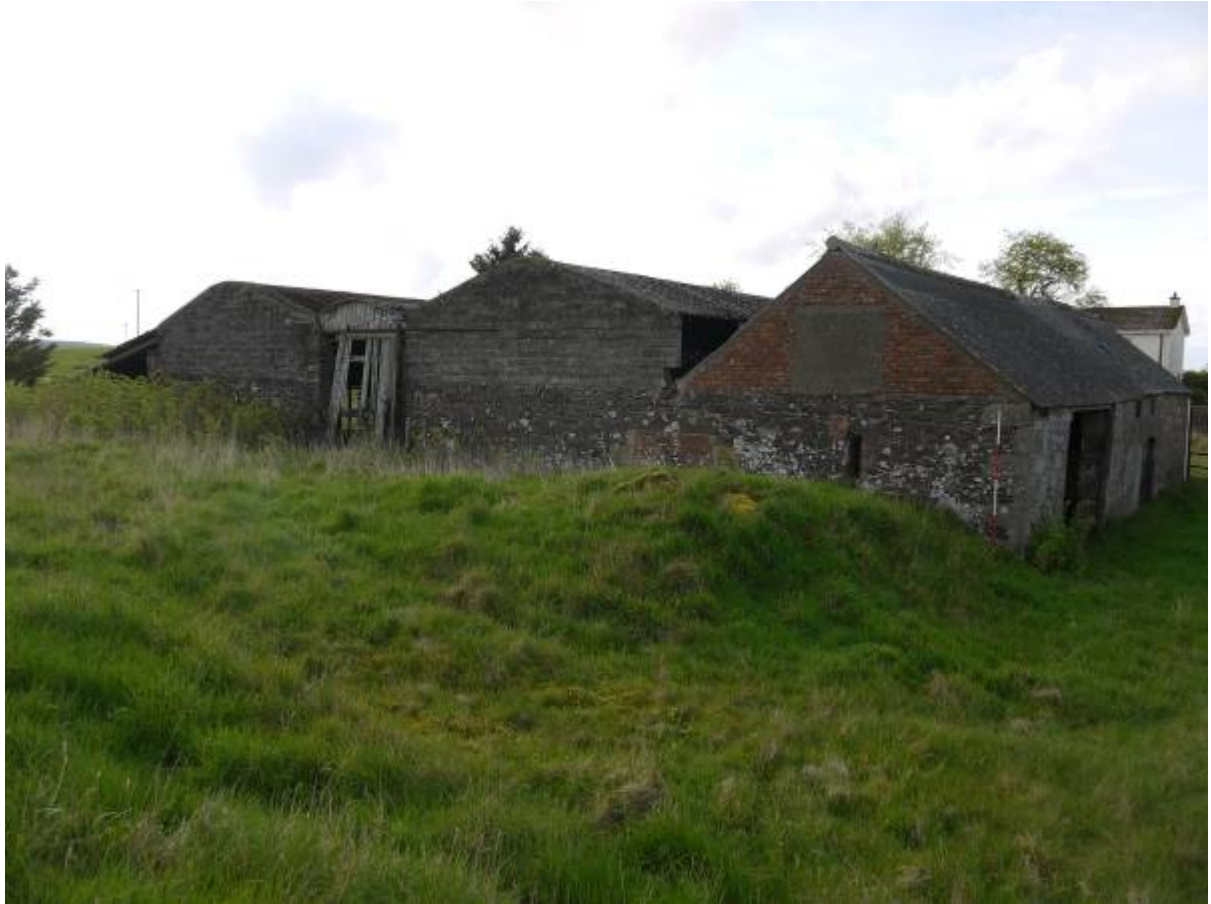
Illustration 10 North facing elevation looking SE Structure 1 to right

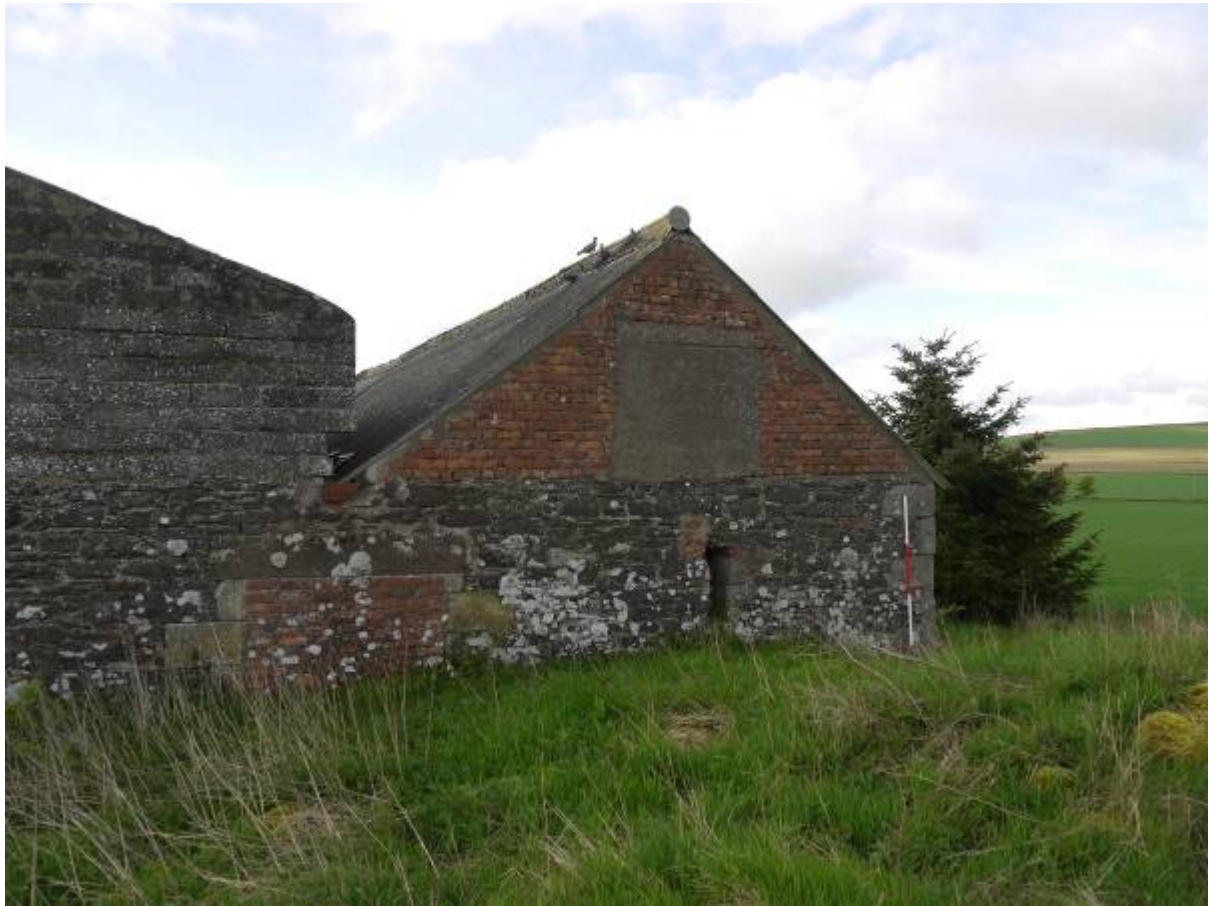
Illustration 11 Detail of Western end of North facing elevation showing blocked window and doorway

The western end of this elevation is the gable end of Structure 1 and comprises courses of shaped stones bonded with lime mortar. There is a single narrow window in this elevation, the top of the gable has been rebuilt in brick and contains a blocked window. The remainder of this gable until it reaches structure 2 is built of concrete blocks on top of a wall of shaped stones, the top of a entrance blocked with bricks is visible at the point where the stone wall meets the eastern wall of

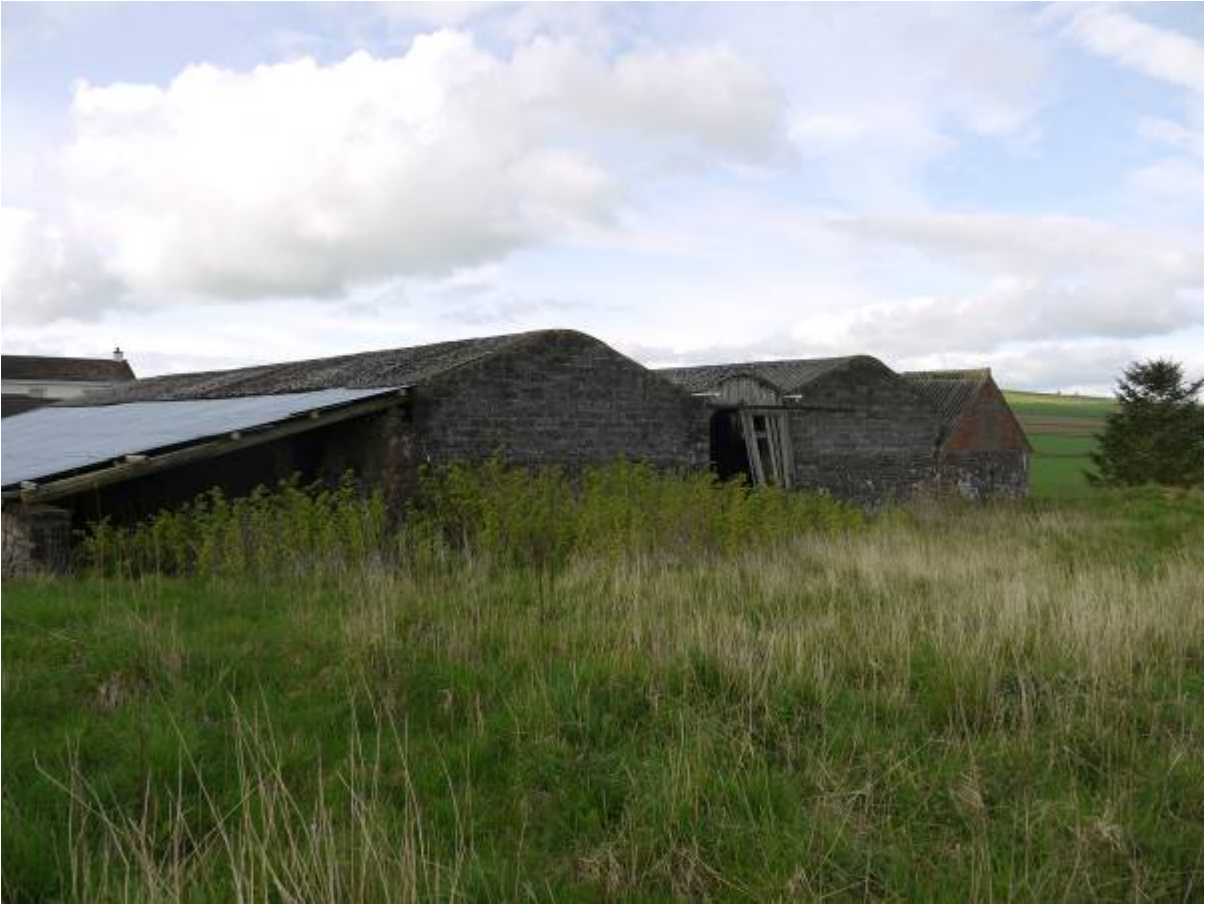
Illustration 12 North facing elevation looking SW

structure 1. Two gables have been built with concrete blocks on either side of an entrance into the steading complex and roofed with corrugated sheets. The eastern end of this elevation comprises a fragment of coursed stone wall which supports a lean to tin roof.

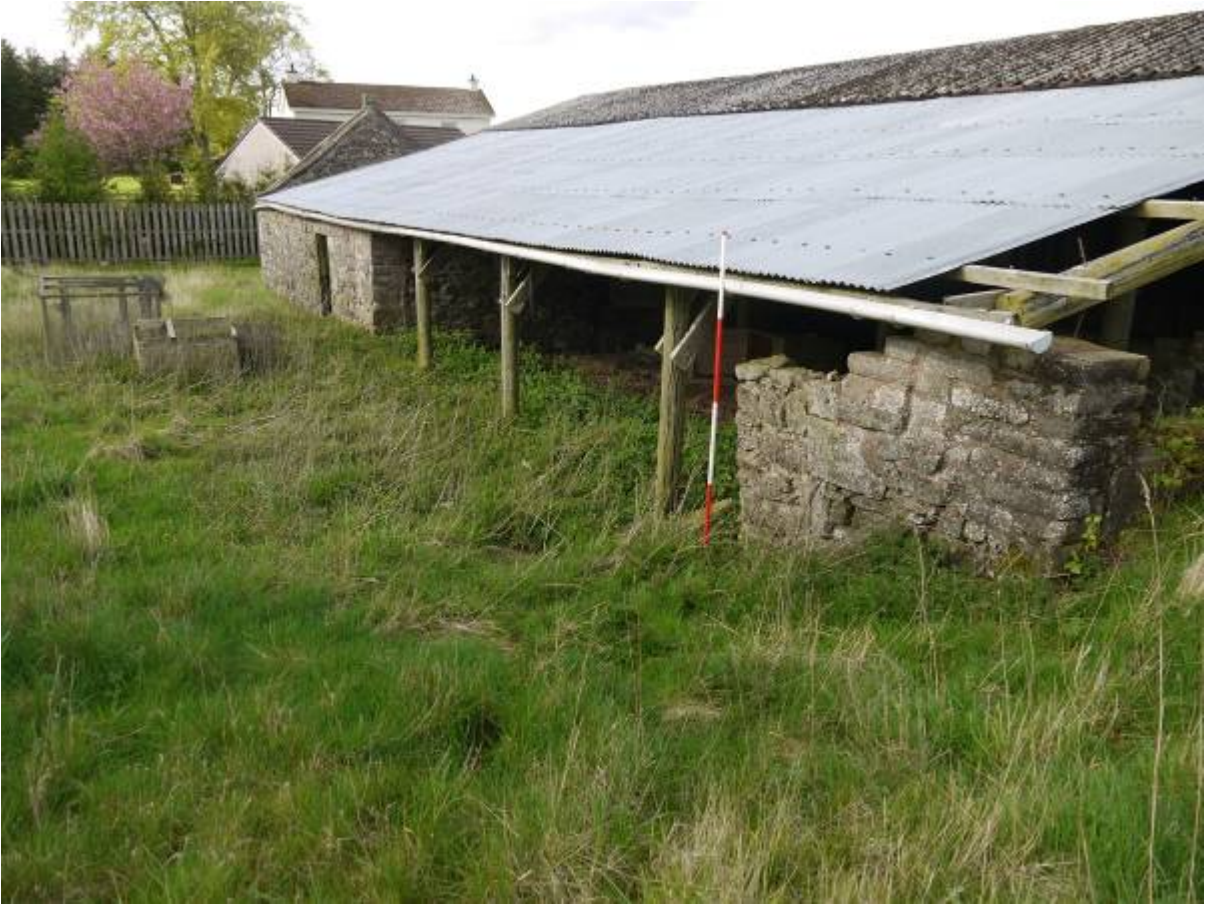
Illustration 13 East facing elevation looking SW

This elevation has a course mortar bonded stone wall with a single doorway at its southern end and a fragment of standing stone wall at its eastern end. The remainder of this elevation is now open fronted and the entire length supports a corrugated iron lean to roof.

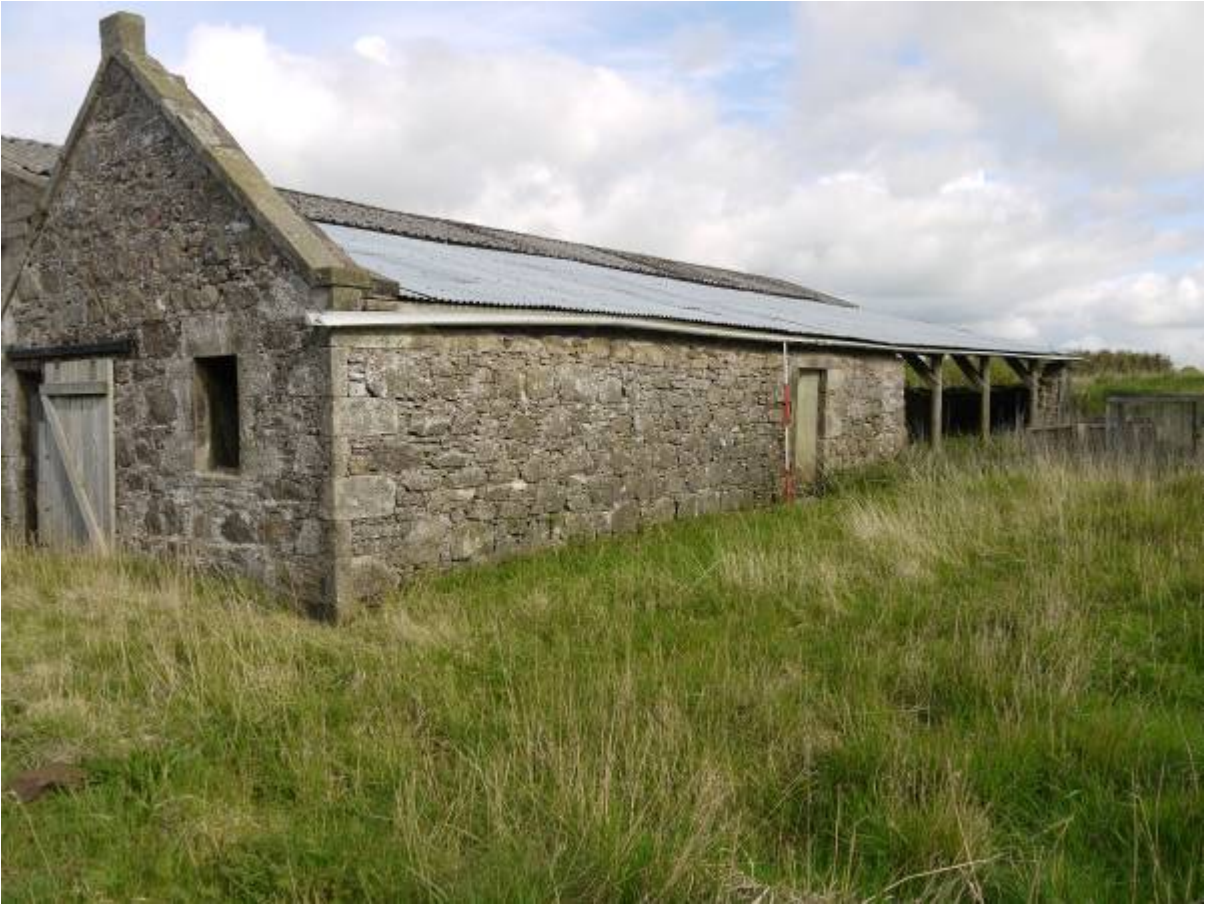
Illustration 14 Southern end of East facing elevation showing Structure 2 in foreground

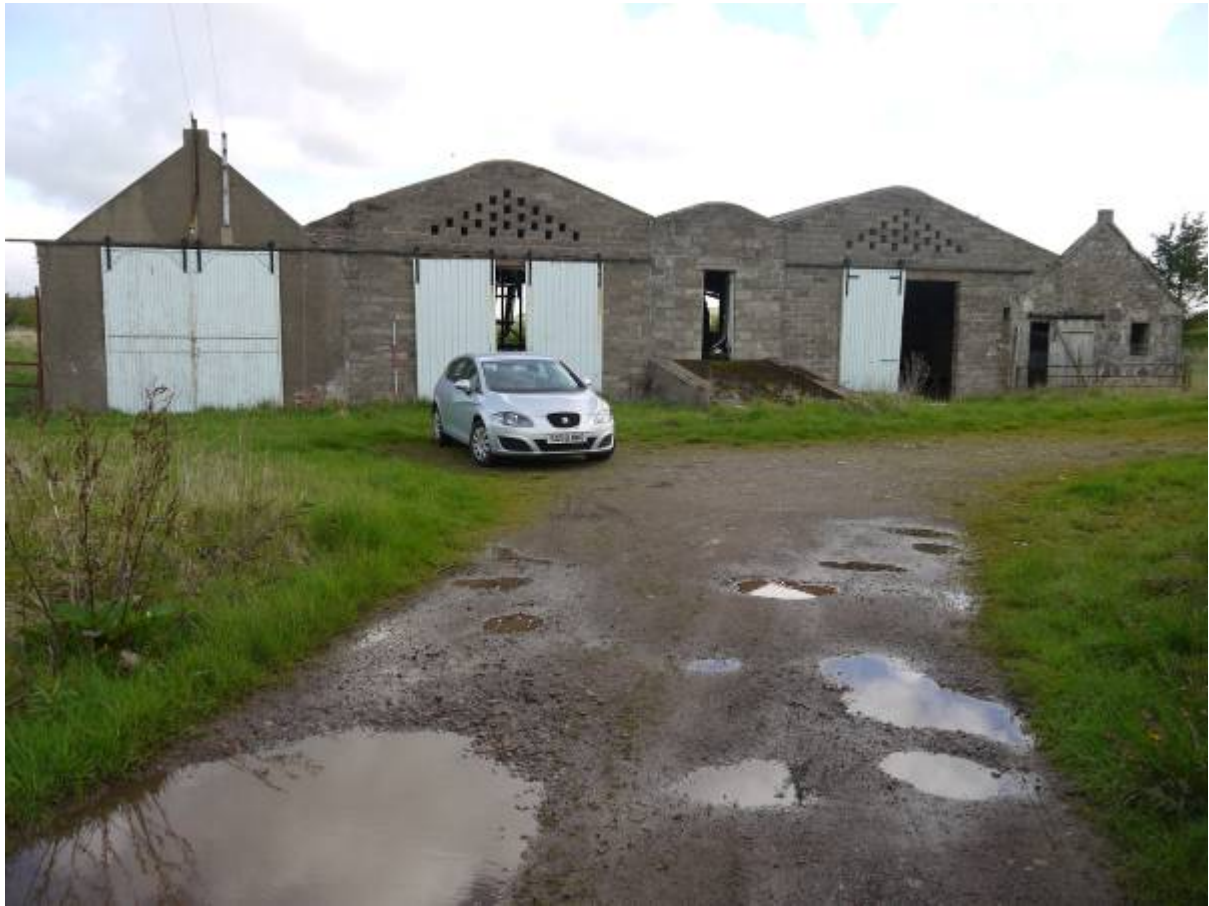
Illustration 15 South facing elevation looking N

This elevation has four gable ends; three of these are built of concrete blocks with large sliding wooden doors the fourth is the southern gable of the stone building (Structure 2). That gable is built of shaped mortar bonded stone blocks with a single window and a doorway with a sliding door. A stone built ramp provides access to a narrower doorway that leads on to an elevated walkway inside the steading.

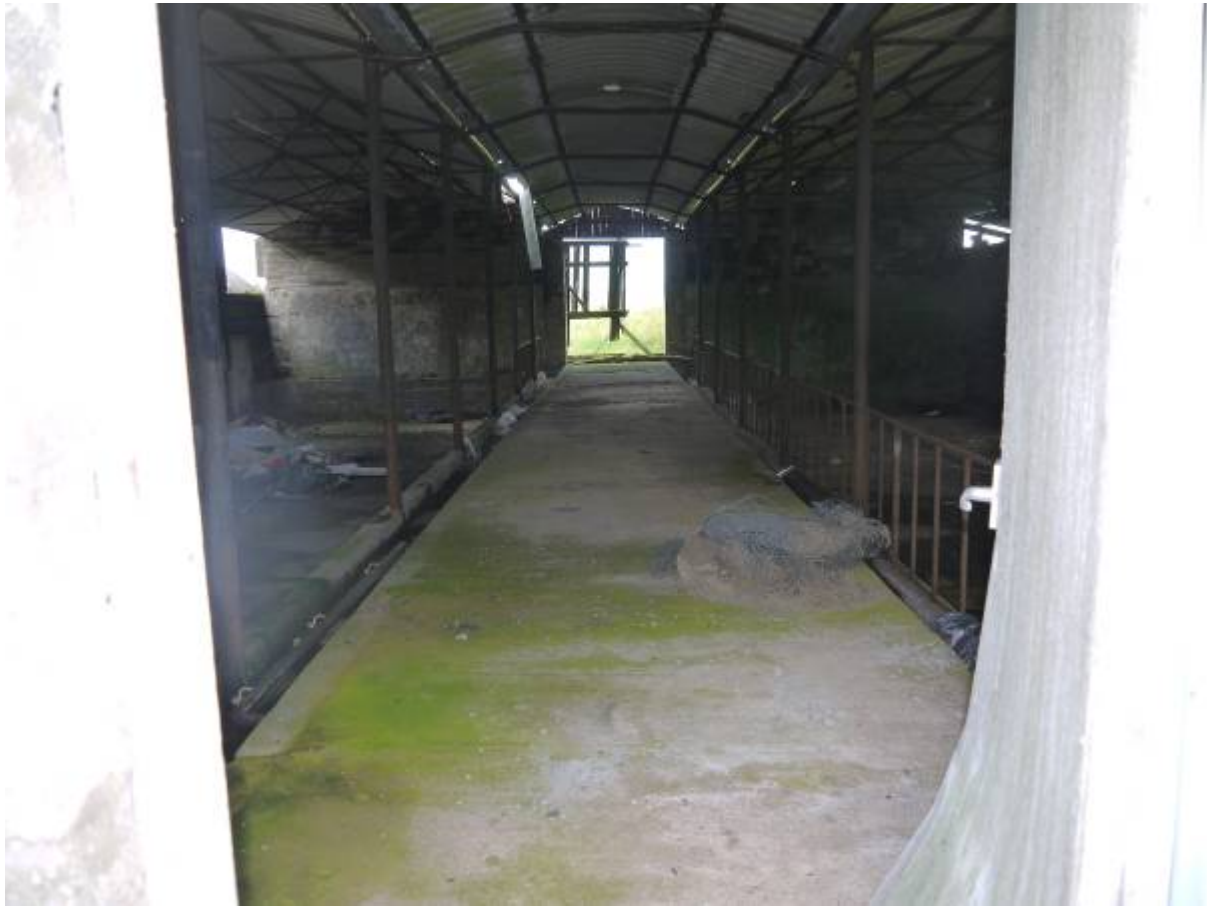
Illustration 16 Internal elevated walkway in Structure 3 looking north

This is divided by an elevated walkway running across the whole building which has an iron fence on its eastern side and is open on its western side. Iron columns support the roof along its length. Either side of the walkway are large open areas with concrete floors. Its internal western and eastern elevations comprise the former walls of Structures 1 and 2. Its internal northern elevation is formed by a coursed rough stone wall which has concrete blocks on top.

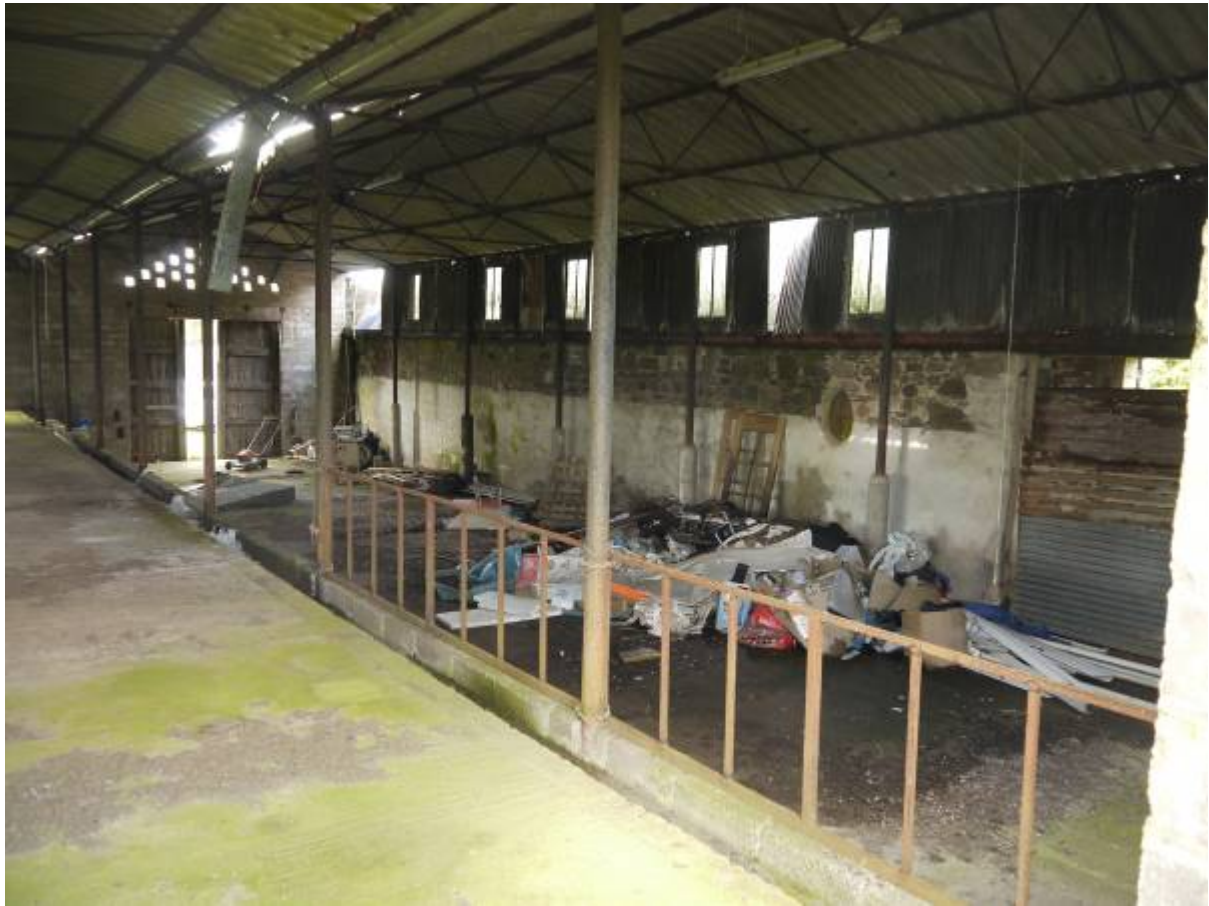
Illustration 17 Interior of Structure 3 from walkway looking South West, Eastern wall of Structure 1 in background

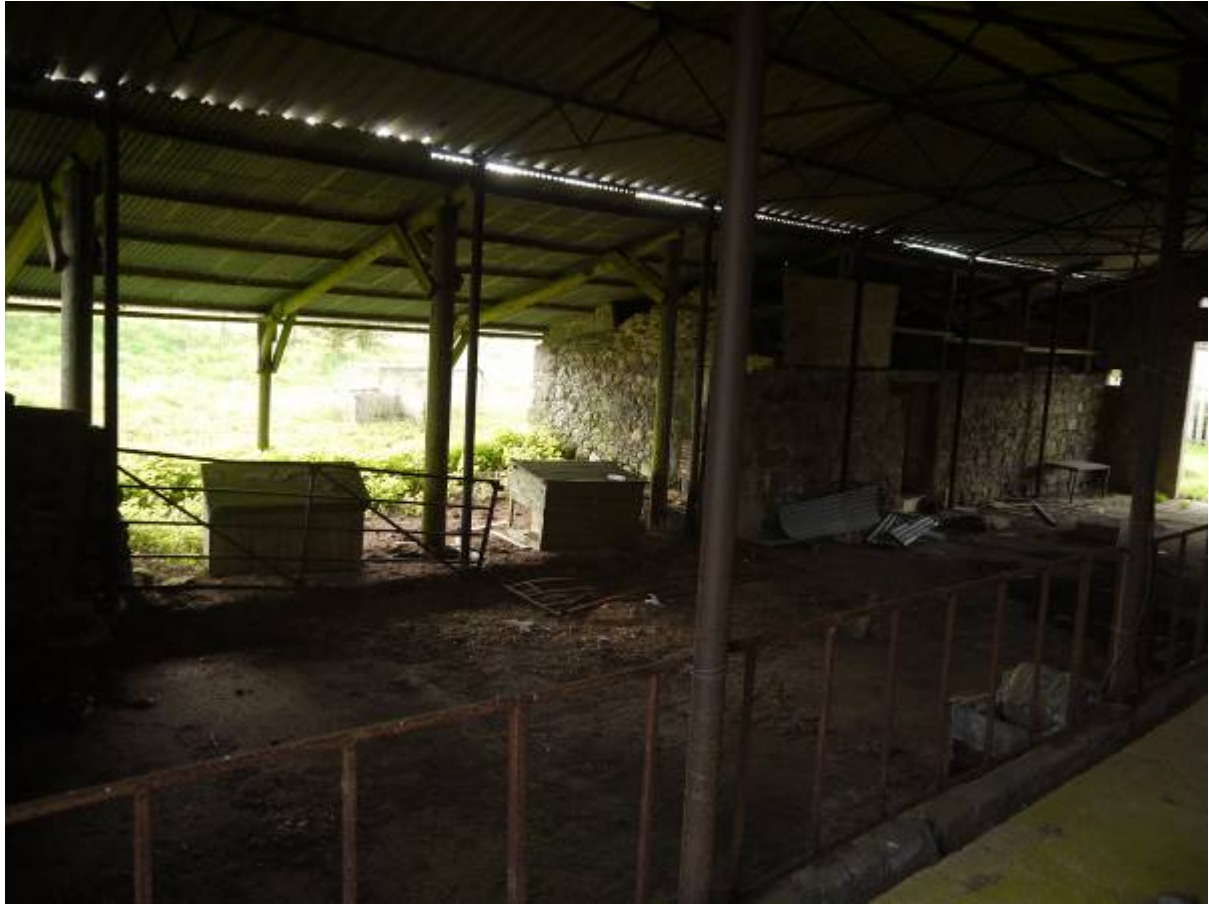
Illustration 18 Interior of Structure 3 from walkway looking East, Western wall of Structure 2 to right

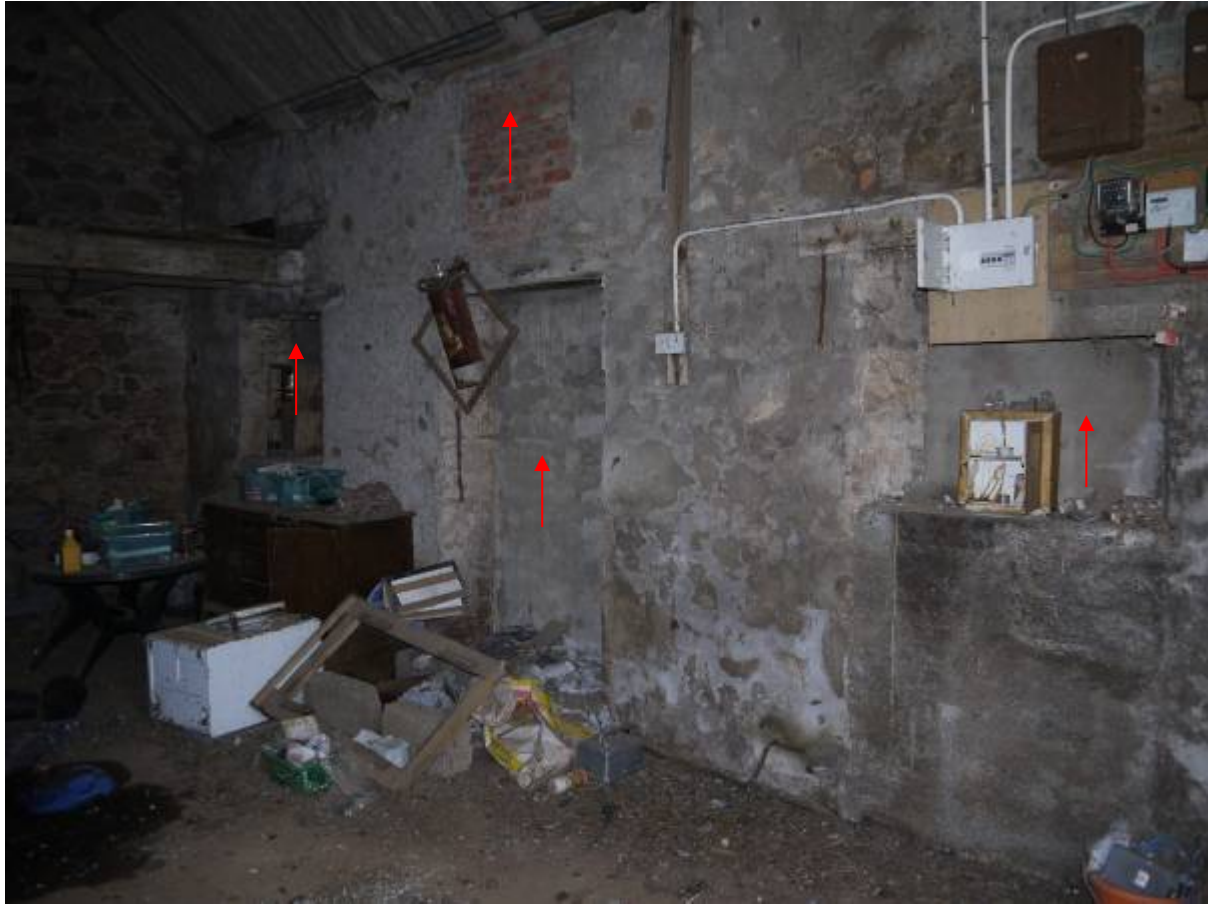
Illustration 19 View of interior of Southern end of Structure 1 showing blocked doorway and windows (red arrows) in Eastern wall

The southern end of this structure has been converted into a storage area, and its internal eastern elevation contains a blocked doorway with blocked windows on either side and a bricked up smaller window above the doorway. The internal western elevation is blank but does have a small bricked up window just below the roof line. The internal northern elevation is blank. The remainder of Structure 1 has been formerly used as an animal shed and has a concrete floor.

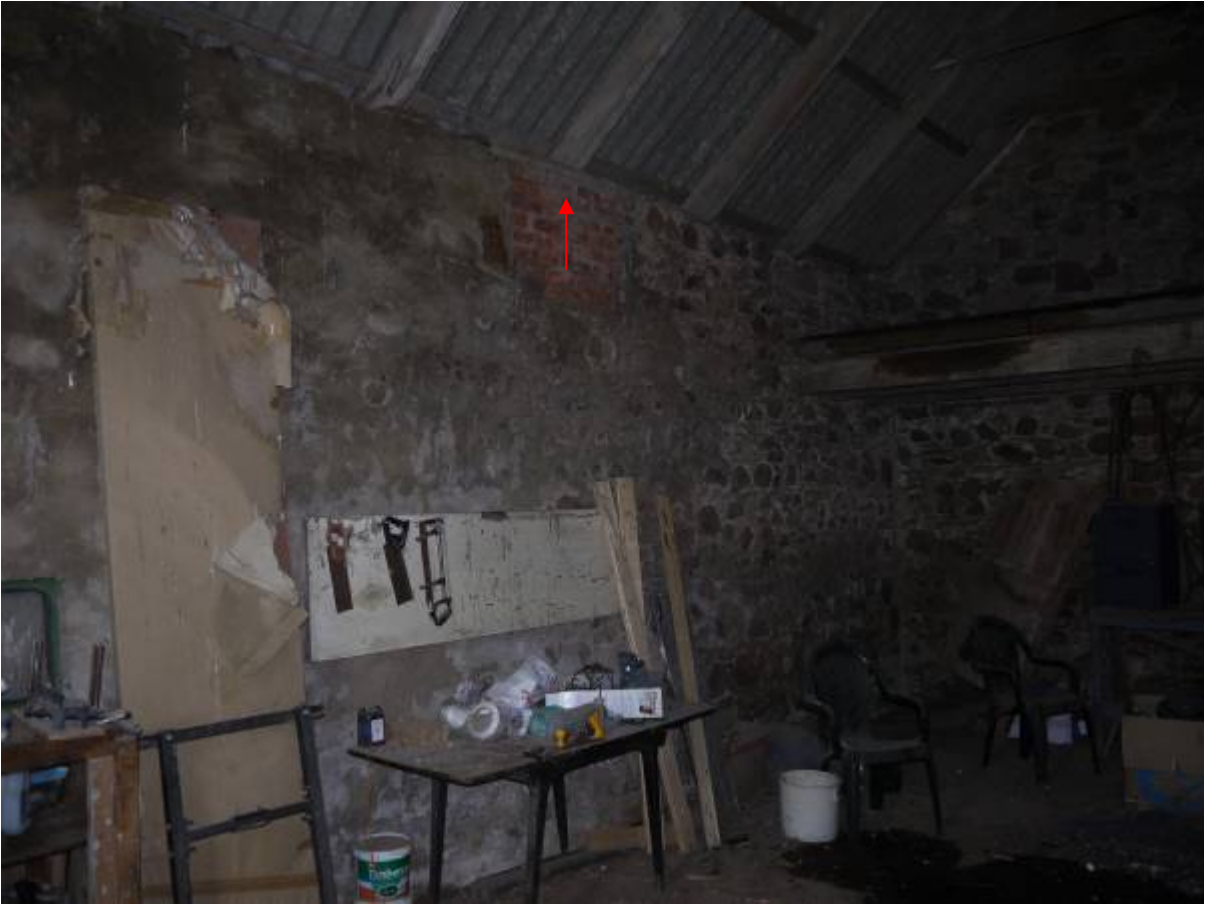
Illustration 20 Interior of southern end of Structure 1 showing blocked window at roof line (red arrow)

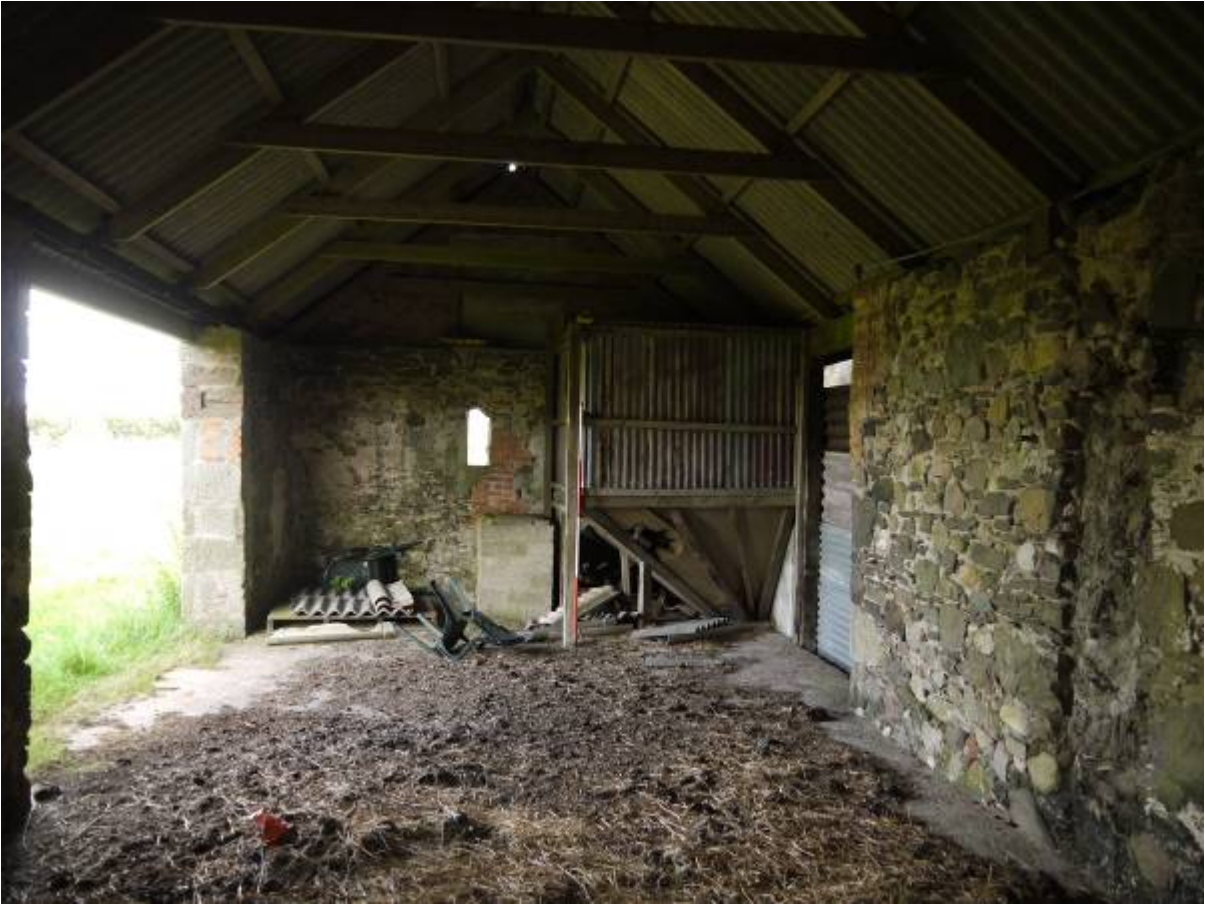
Illustration 21 Interior of Structure 1 looking north

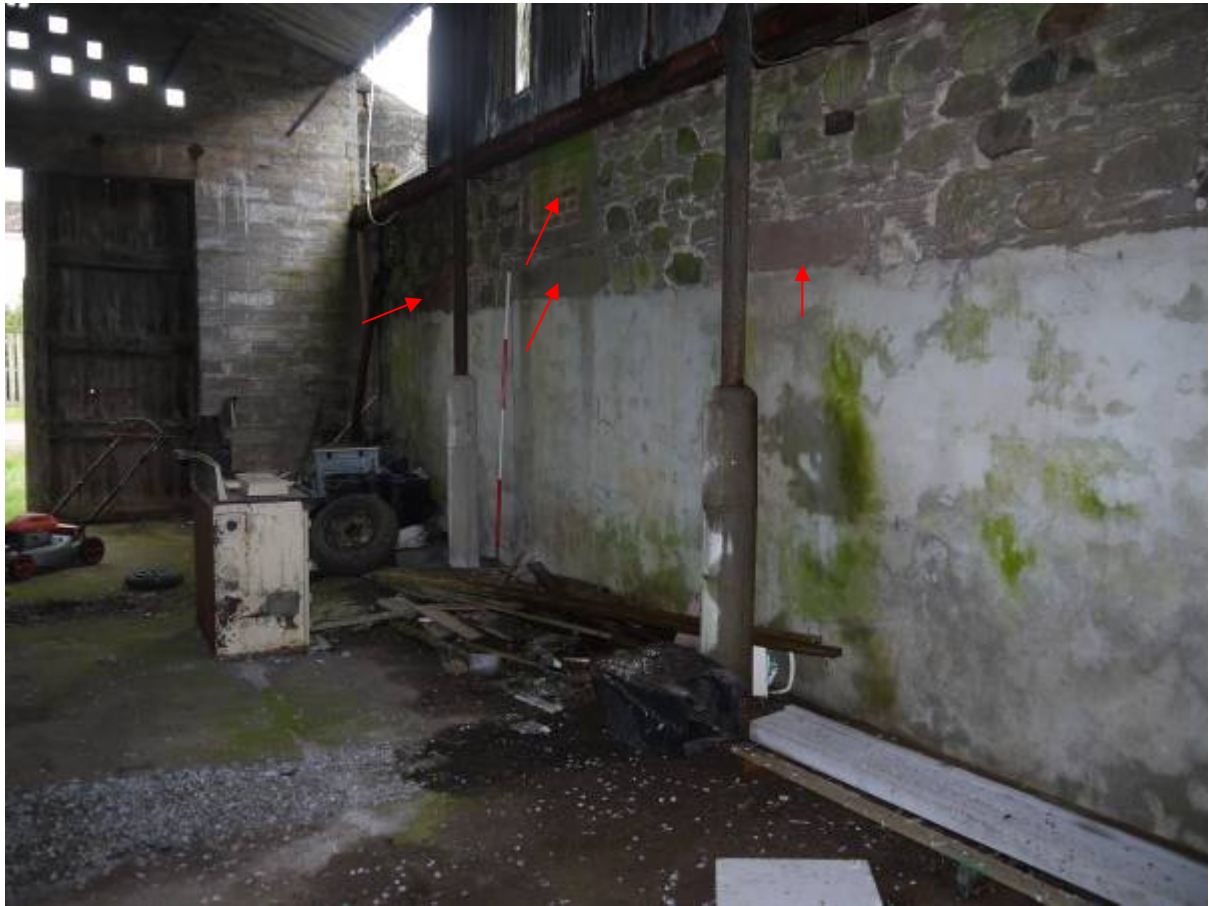
Illustration 22 Western elevation of Structure 1 (now inside amalgamated structure) showing blocked windows and doorway (red arrows)

This elevation has three small blocked windows at roof height and a blocked doorway with blocked windows on either side. There is a single oval iron plate set into the wall which looks like part of a former bracer for this wall. There is a large doorway at its northern end.
