Standing Building Survey
Former Steading, Nether Craighill,
Aberdeenshire Council

Former steading, Nether Craighill from the west

13th May 2014

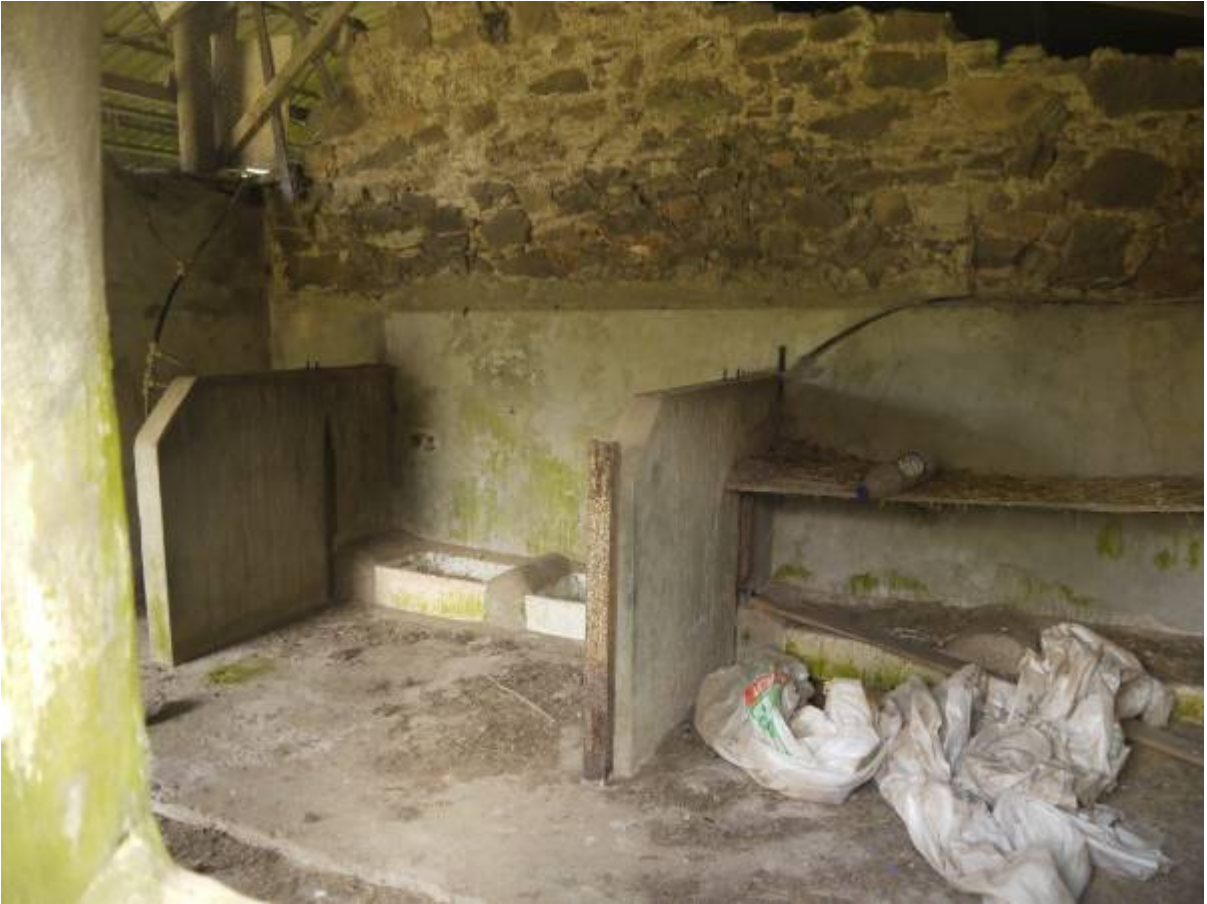
Illustration 23 Interior of southern end of Structure 2

The southern end of this structure was last used as an animal byre and has three concrete stalls. The next room to the north has doorways in its western and eastern elevations and an internal cobbled floor. The floor includes a defined cobbled walkway between the doors. A doorway in the northern wall leads to the remainder of this structure which is now open and has been used as an animal shed; there are badly damaged traces of cobbling in this part of the structure.

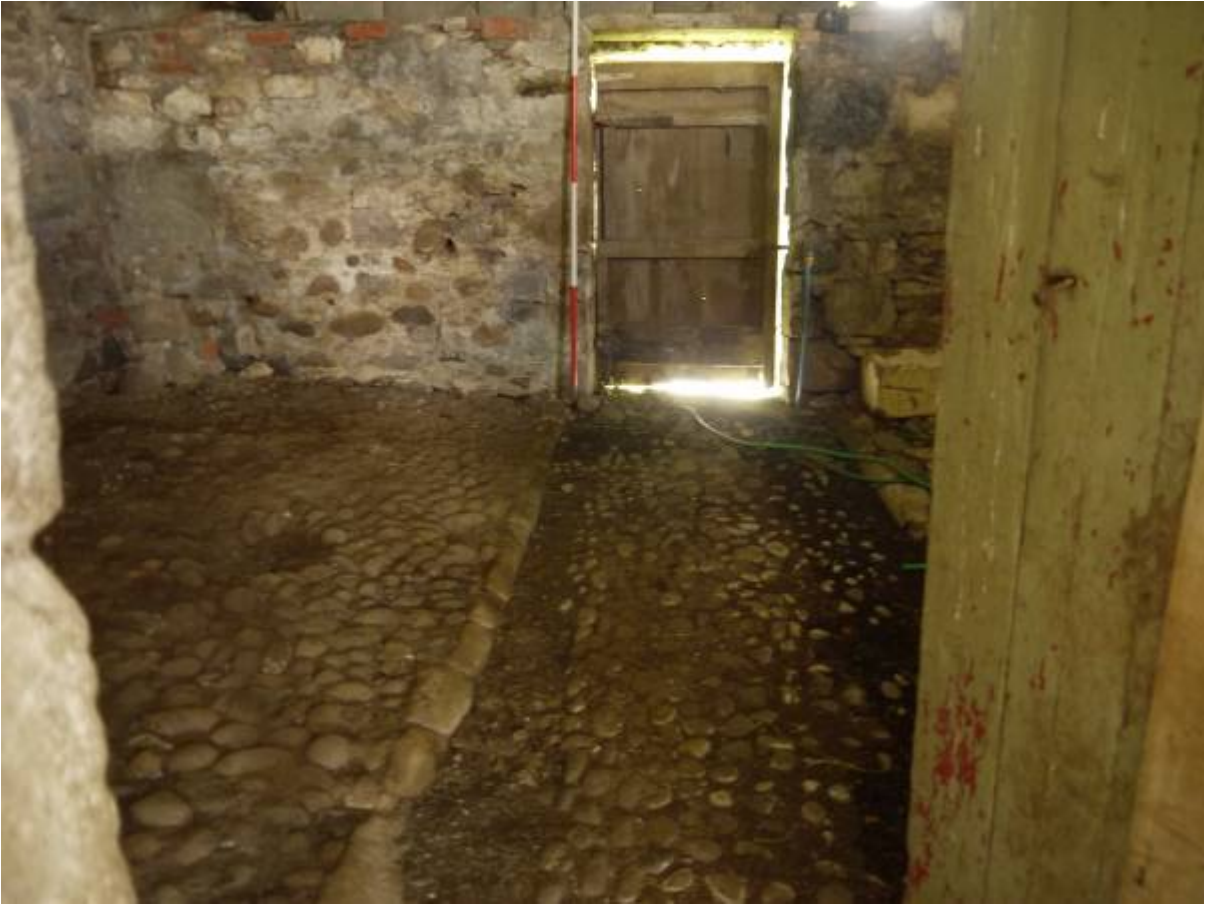
Illustration 24 Cobbled floor inside Structure 2 showing defined walkway to doorway

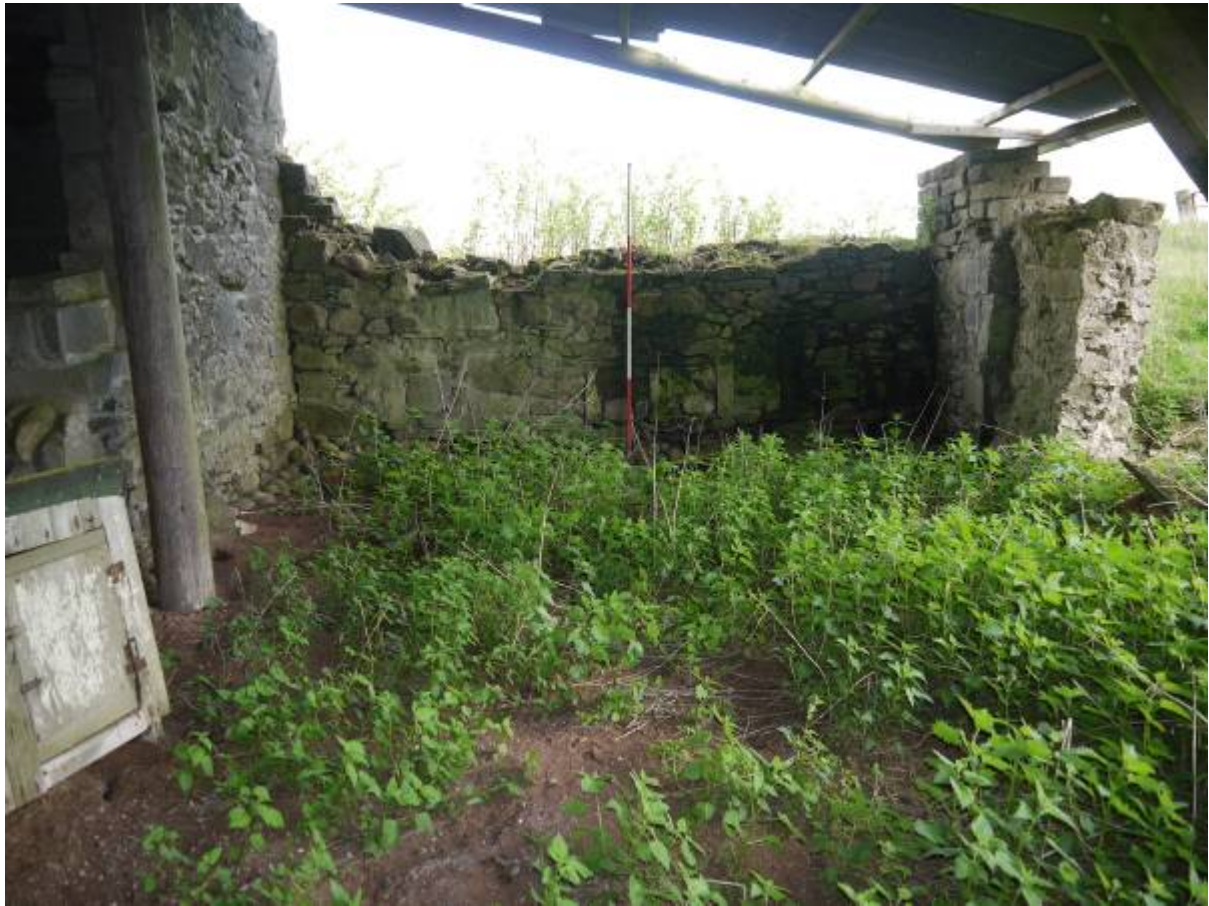
Illustration 25 Interior of northern end of Structure 2 looking north

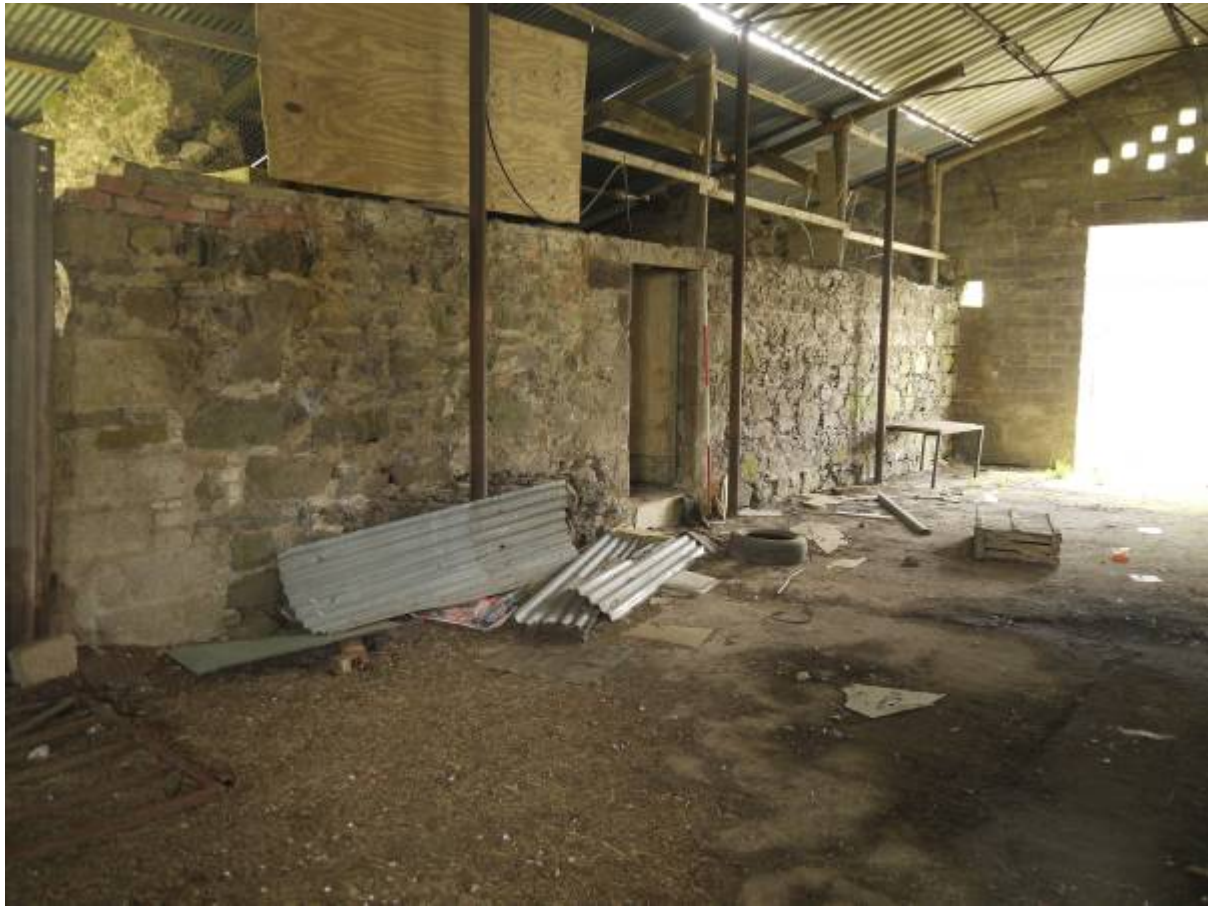
Illustration 26 Eastern elevation of Structure 2 (now inside amalgamated structure) showing doorway beside scale
