Archaeological Evaluation  
Land 100m NE of Shepherd's Cottage,  
Urlar, Aberfeldy, Perth and Kinross

31<sup>st</sup> October 2014

## **Introduction**

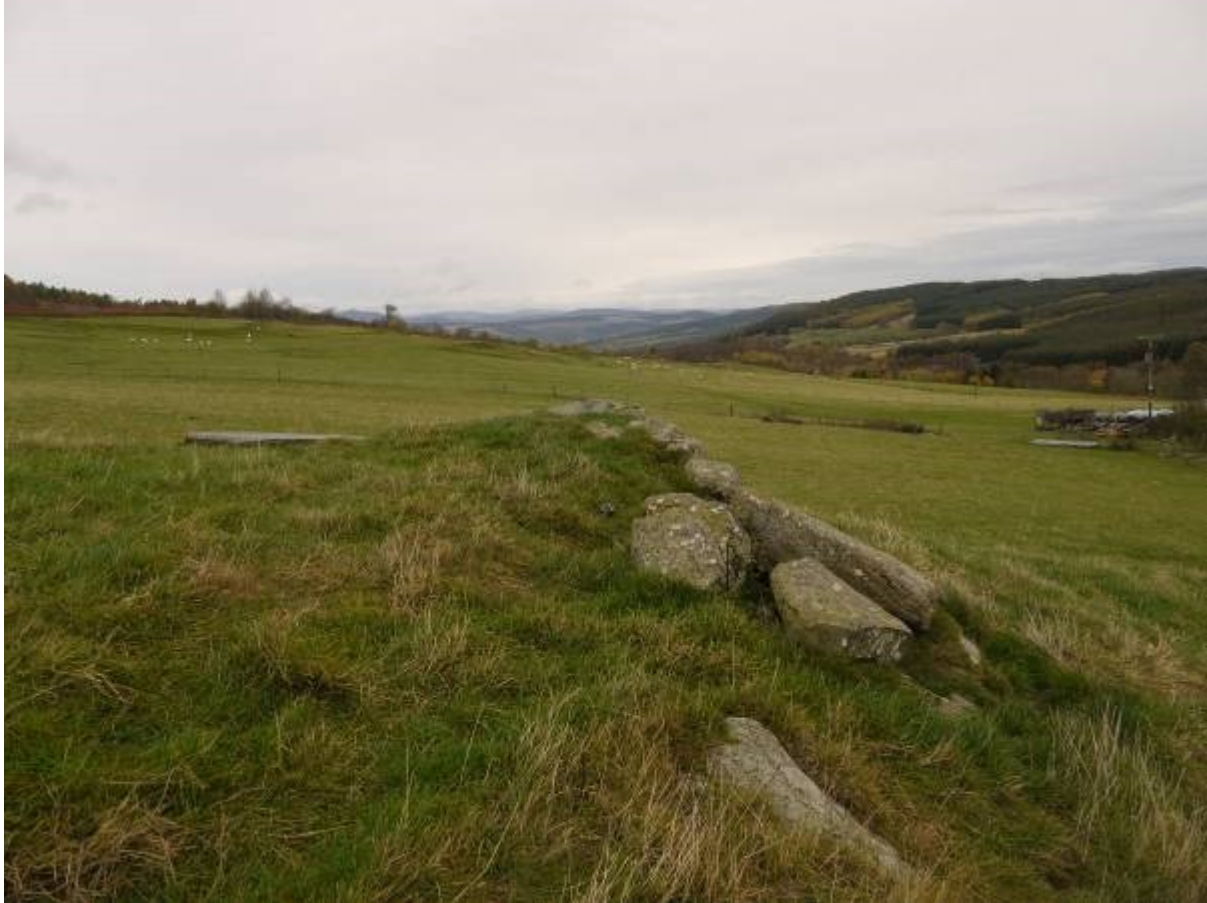
General view of crop marked rocks in vicinity of development area looking east

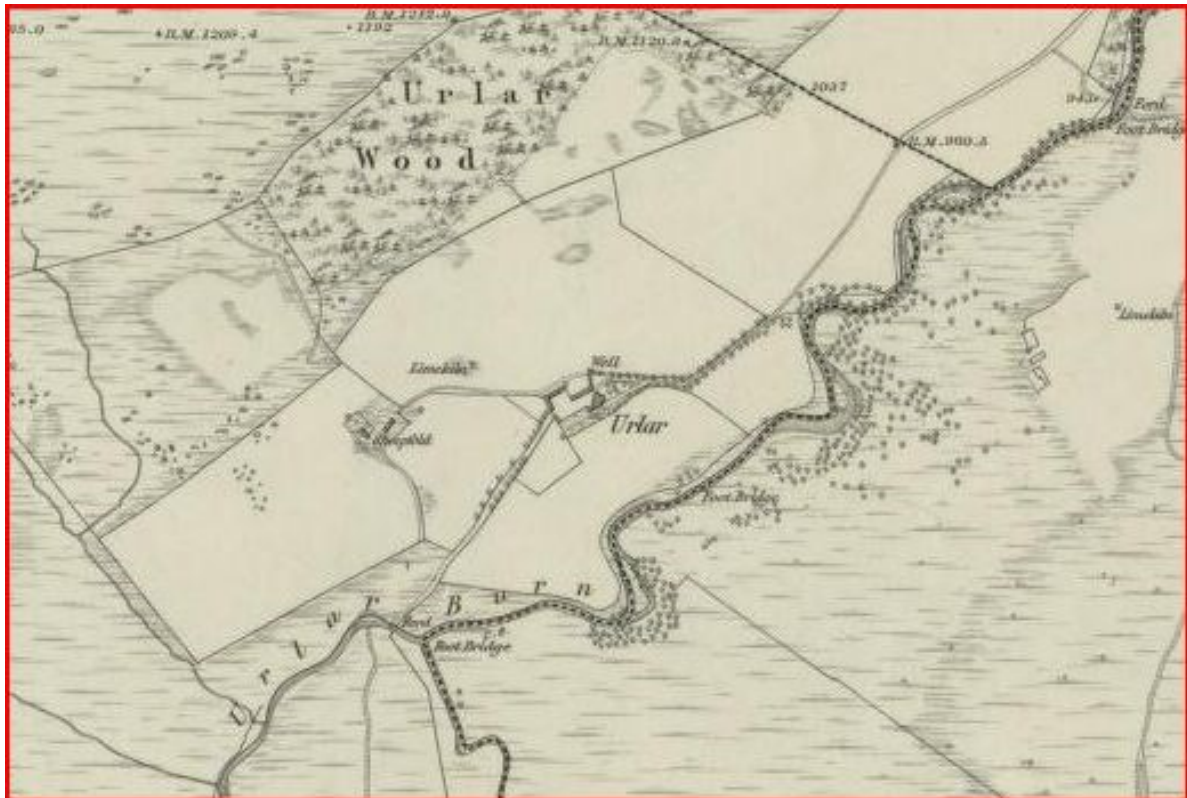
Illustration 2 Urlar as shown on First Edition Ordnance Survey map of 1867, the lime kiln is in the vicinity of the cup marked stones (©Trustees of the National Library)

Urlar Cup and Ring Marked Stone (MPK1011) is located within the development site on the SE lip of a knoll and consists of a partially turf-covered out crop bearing at least 34 cup marks on its upper surfaces. They include 3 possible dumb-bells and 2 cup and ring marks and range from 3cms to 8cms in diameter and up to 4cms in depth. The site also contains the remains of a possible cairn. On the First Edition Ordnance Survey map of 1867 a lime kiln is marked in the vicinity of the cup marked stones (Illus 2). Archaeological excavations carried out at Ben Lawers in Perth and Kinross between 2007 and 2010 has shown that prehistoric archaeological remains associated with cup and ring marked stones survive in the vicinity of the sites (Bradley, Watson and Anderson-Whymark 2012). It was felt possible that archaeological remains might also survive in proximity to the cup marked rocks at Urlar.

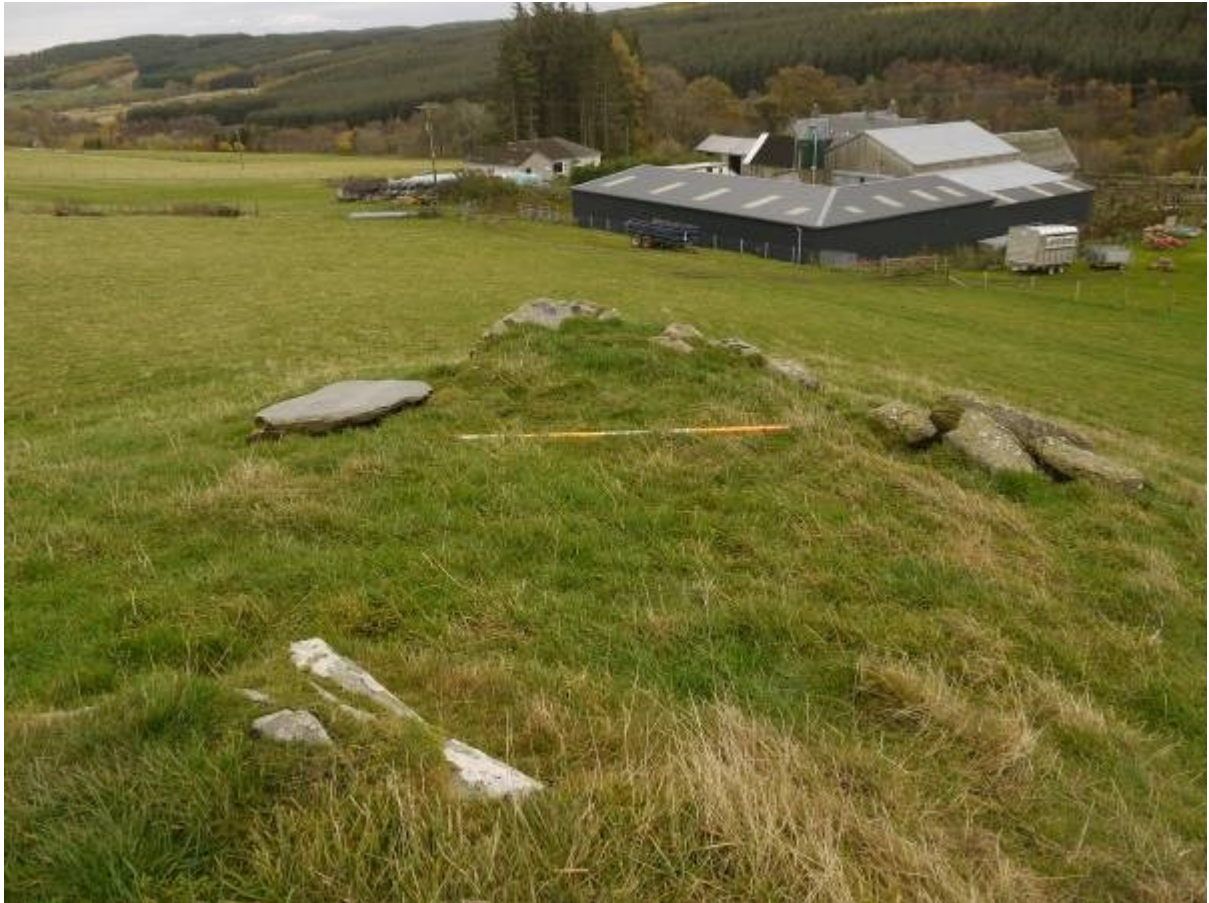
Illustration 3 General view of location of cup marked rocks looking East, Urlar Farm in background

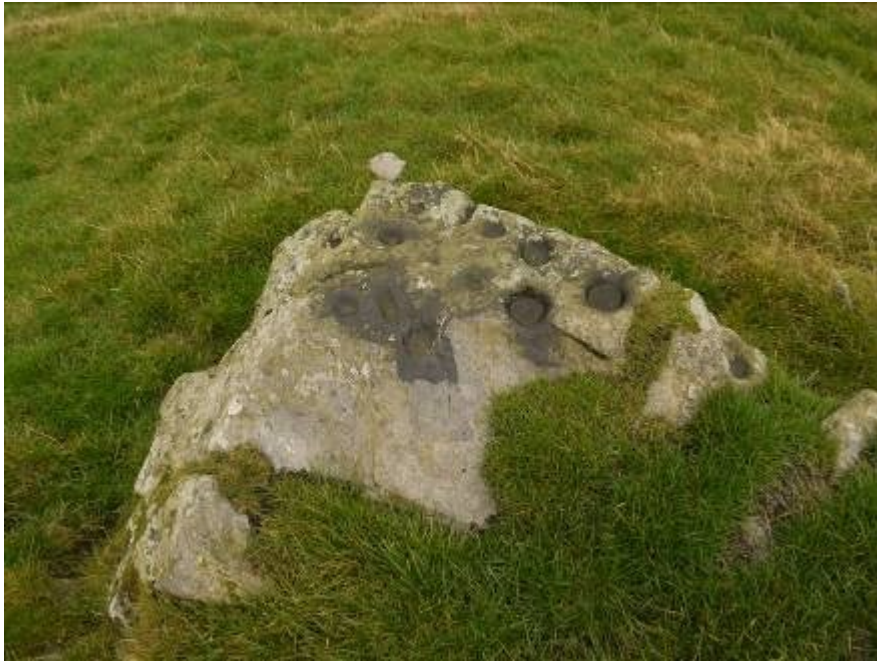
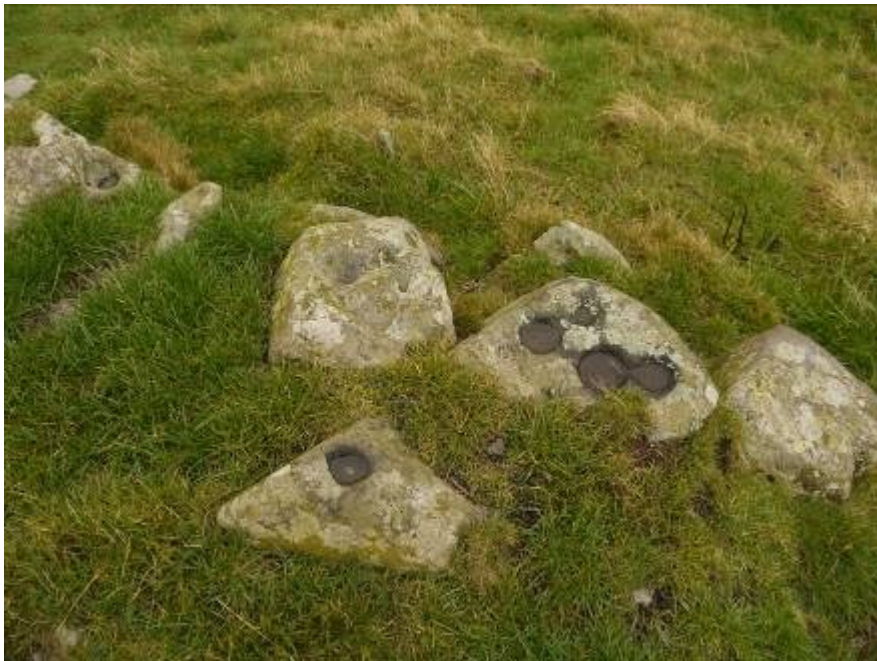
Illustration 4 and 5 Detail views of sets of cup marks

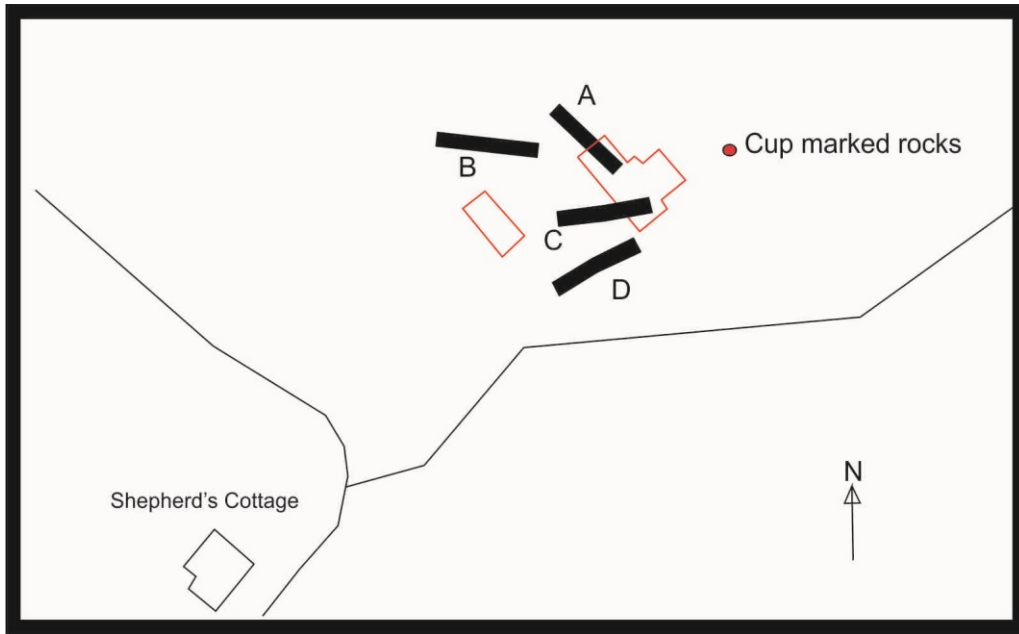
Perth and Kinross Heritage Trust requested that a 5% sample of the development area was trenched in order to assess for the presence of archaeological remains. Four trenches measuring 20m by 2m were opened in the footprint of the proposed development area.

Illustration 6 Trench location in relation to footprint of new house and shed and the location of the cup marked rocks Scale 1:2000

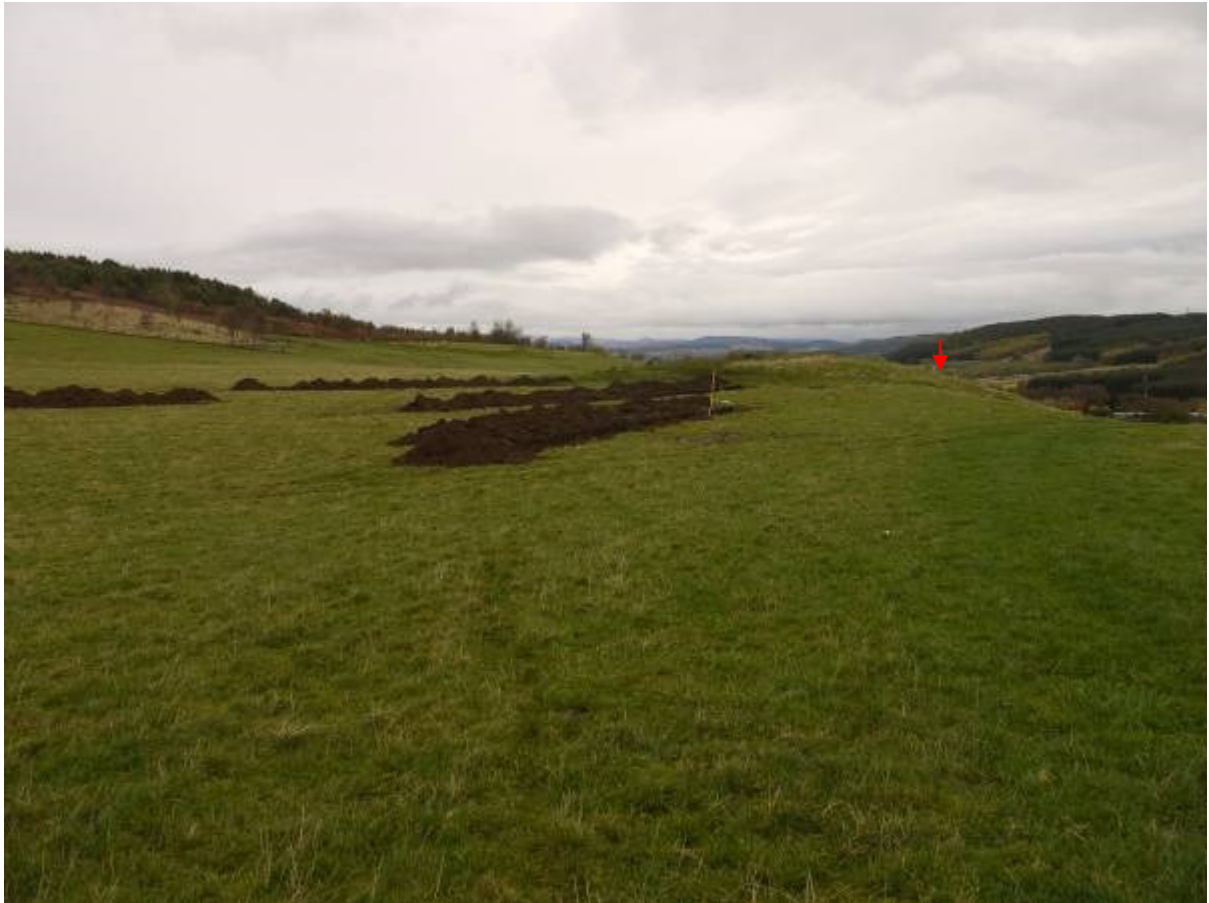
Illustration 7 General view of site looking North East showing all four trenches open, location of cup marked rocks are indicated by red arrow

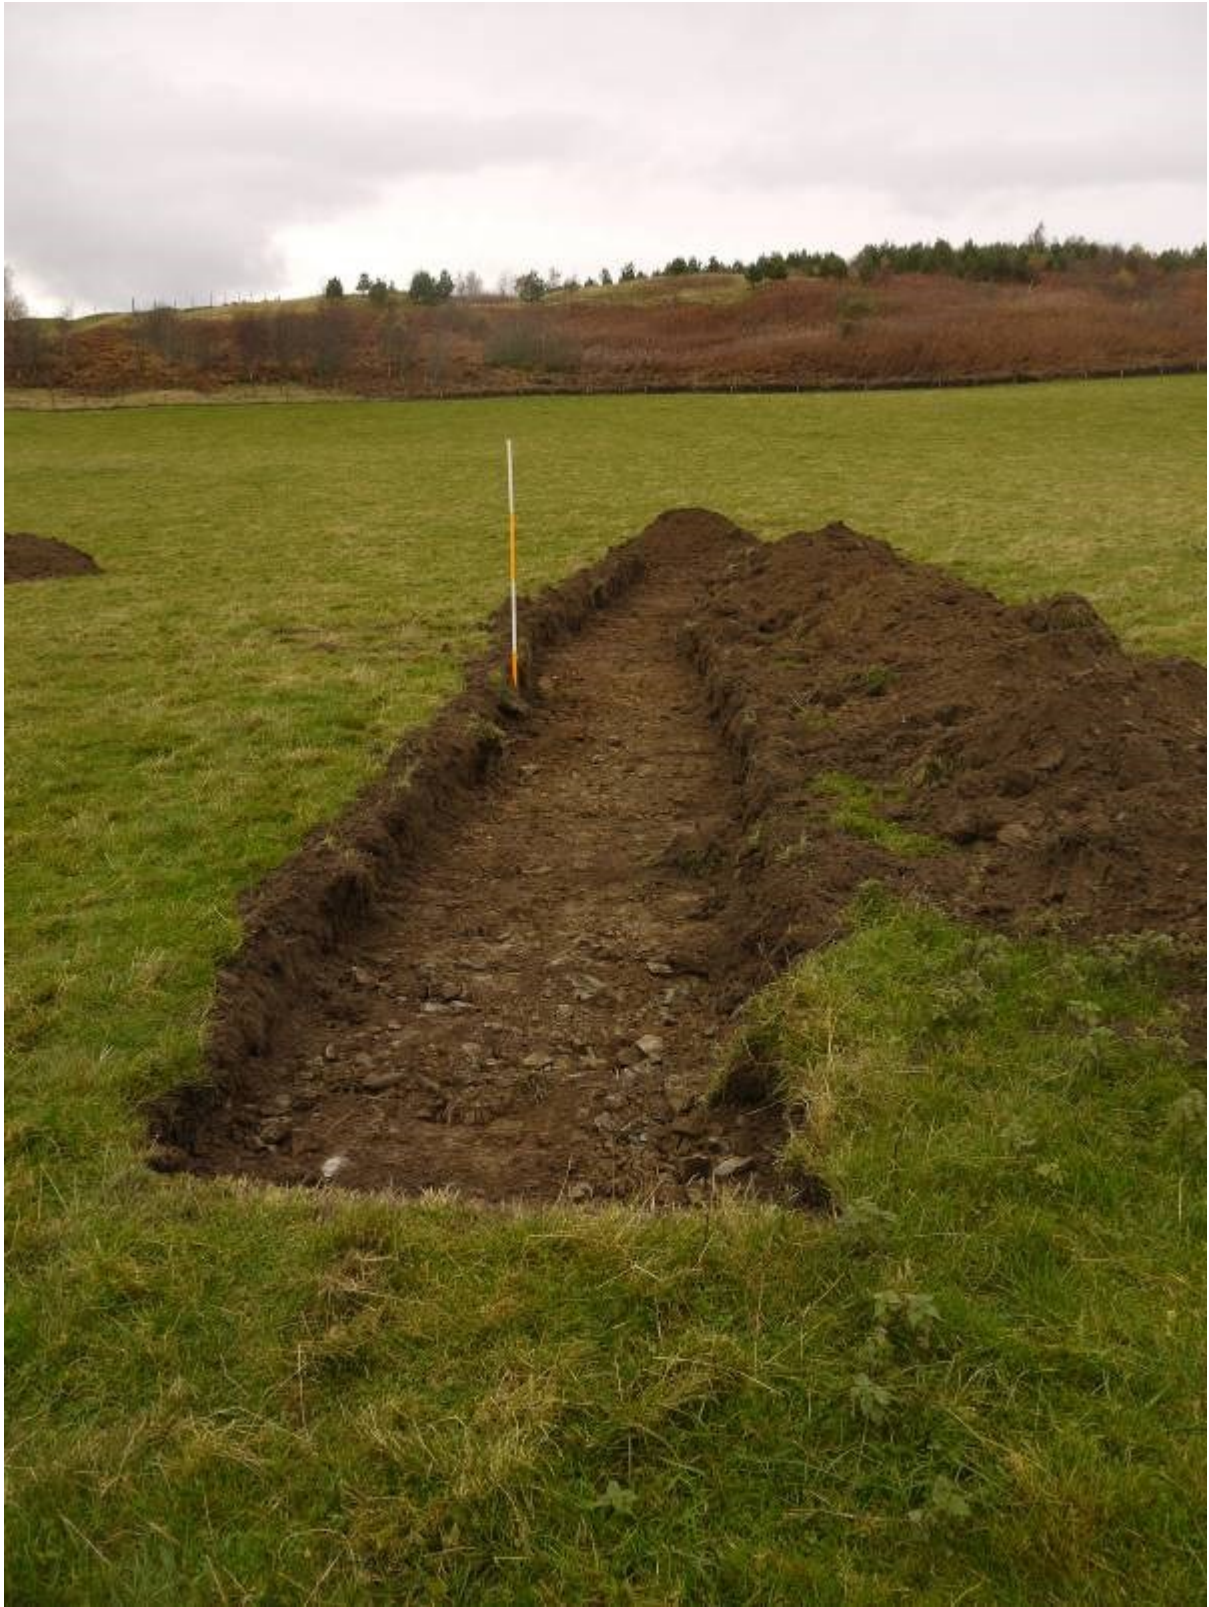
This trench was opened on a NW – SE alignment at the northern end of the area. At its SE end 0.20m of brown sandy clay ploughsoil was removed to reveal a deposit of natural broken stone and yellow clay. At its northern end 0.40m of brown sandy clay ploughsoil was removed to reveal natural broken stone and yellow clay. Nothing of archaeological interest was located.

Illustration 8 General view of excavated Trench A looking north west showing natural broken stone and clay

The same deposit pattern was recorded in all four of the evaluation trenches and nothing of archaeological interest was located. The author feels that this evaluation suggests that there is no need for any further work prior to any development on the site. The final decision on the need and scale of any further work however rests with Perth and Kinross Heritage Trust.

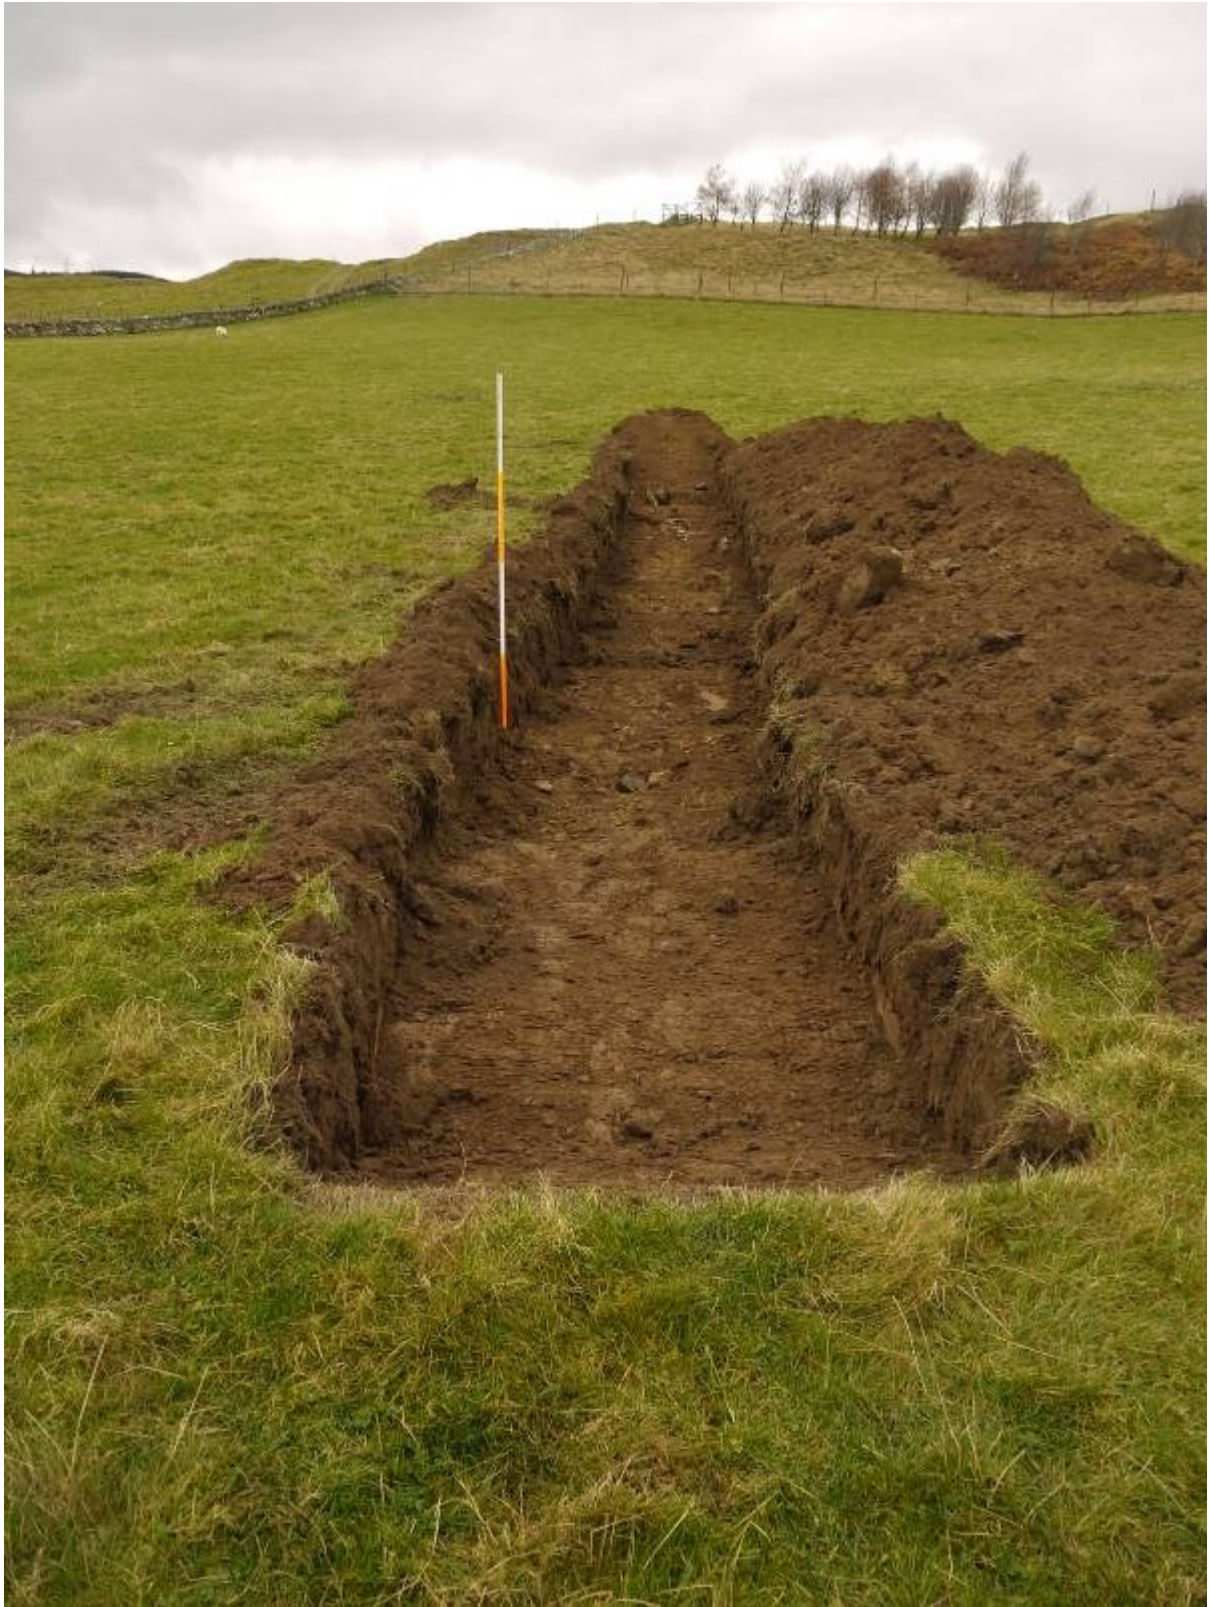
This trench was opened on an E-W alignment at the western side of the area. Along its length 0.30m of brown sandy clay ploughsoil was located overlying a brown sandy clay subsoil 0.45m deep which overlay natural broken stone and yellow clay. Nothing of archaeological interest was located.

Illustration 9 General view of excavated Trench B looking north north west showing natural broken stone and clay

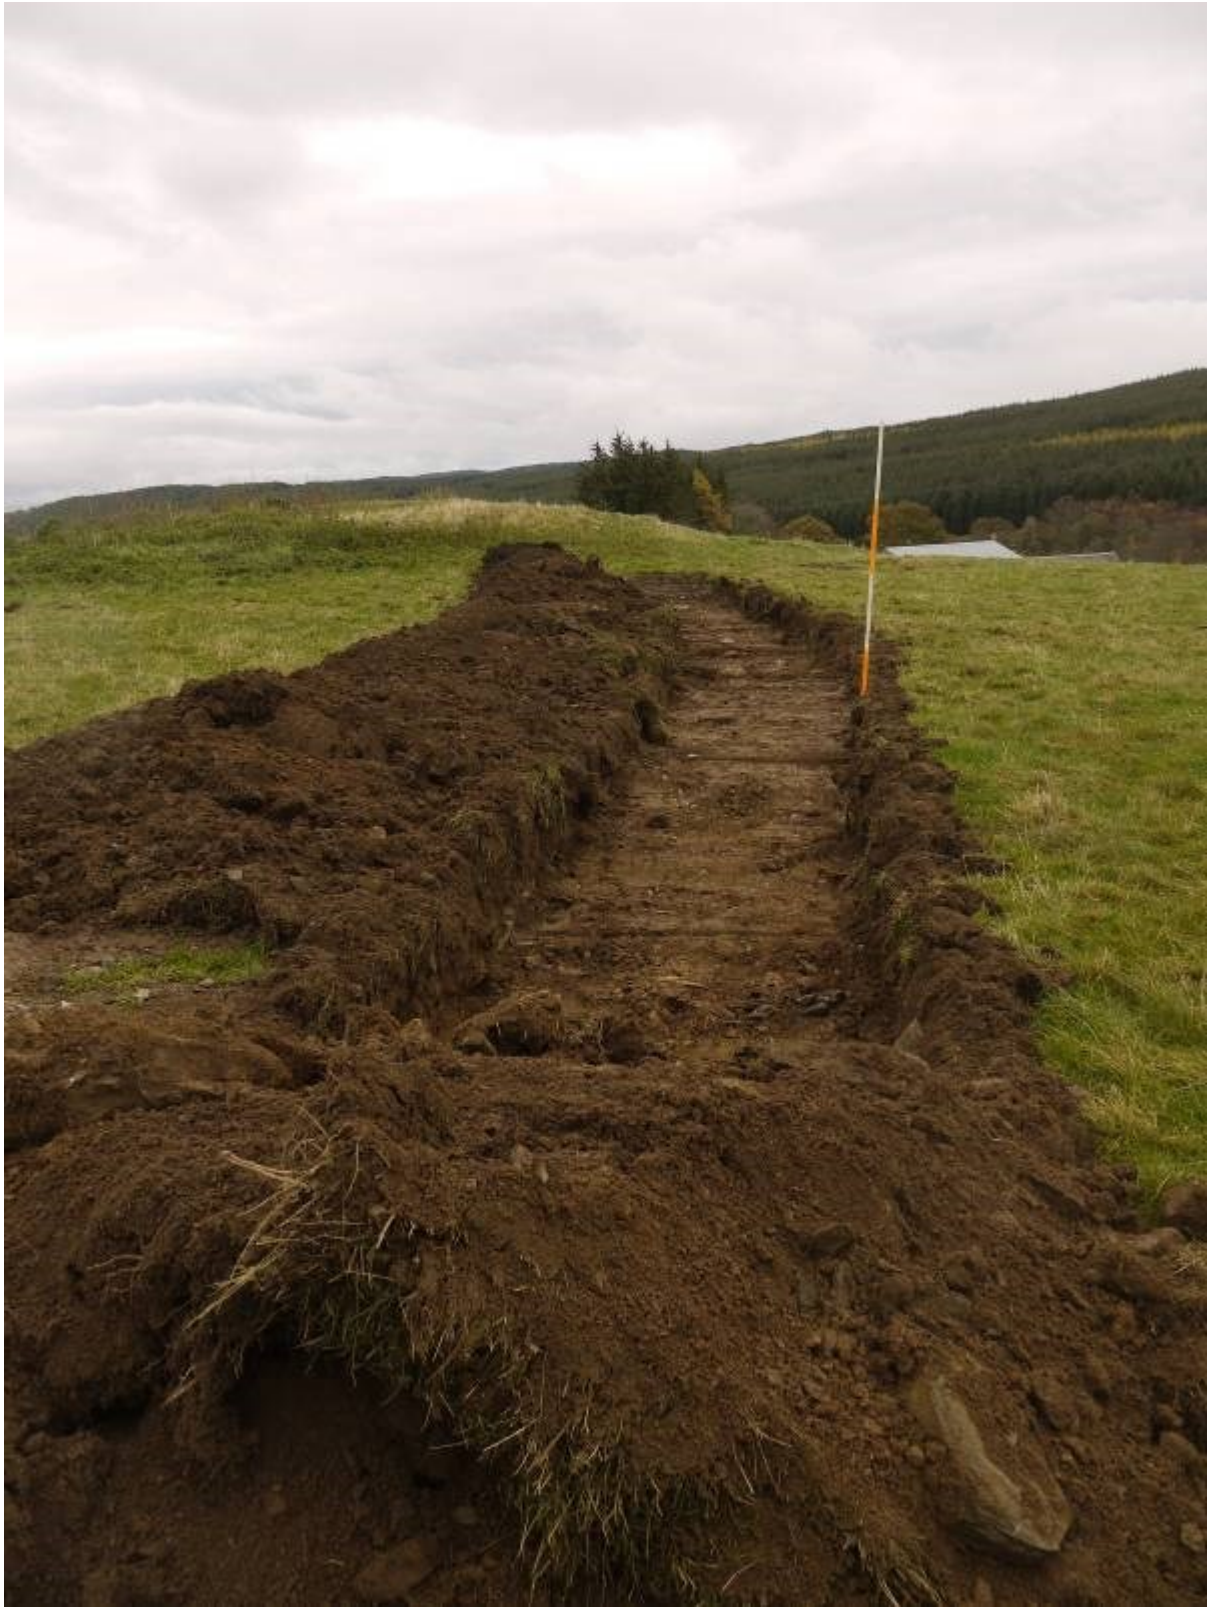
This trench was opened on a SSW-NNE alignment across the southern end of the house footprint. At its NNE end 0.20m of brown sandy clay ploughsoil was located overlying natural broken stone and yellow clay. At its SSW end 0.50m of brown sandy ploughsoil was located overlying natural broken stone and yellow clay. Nothing of archaeological interest was located.

Illustration 10 General view of excavated Trench C looking north north east showing natural broken stone and clay, knoll with cupmarks visible in background

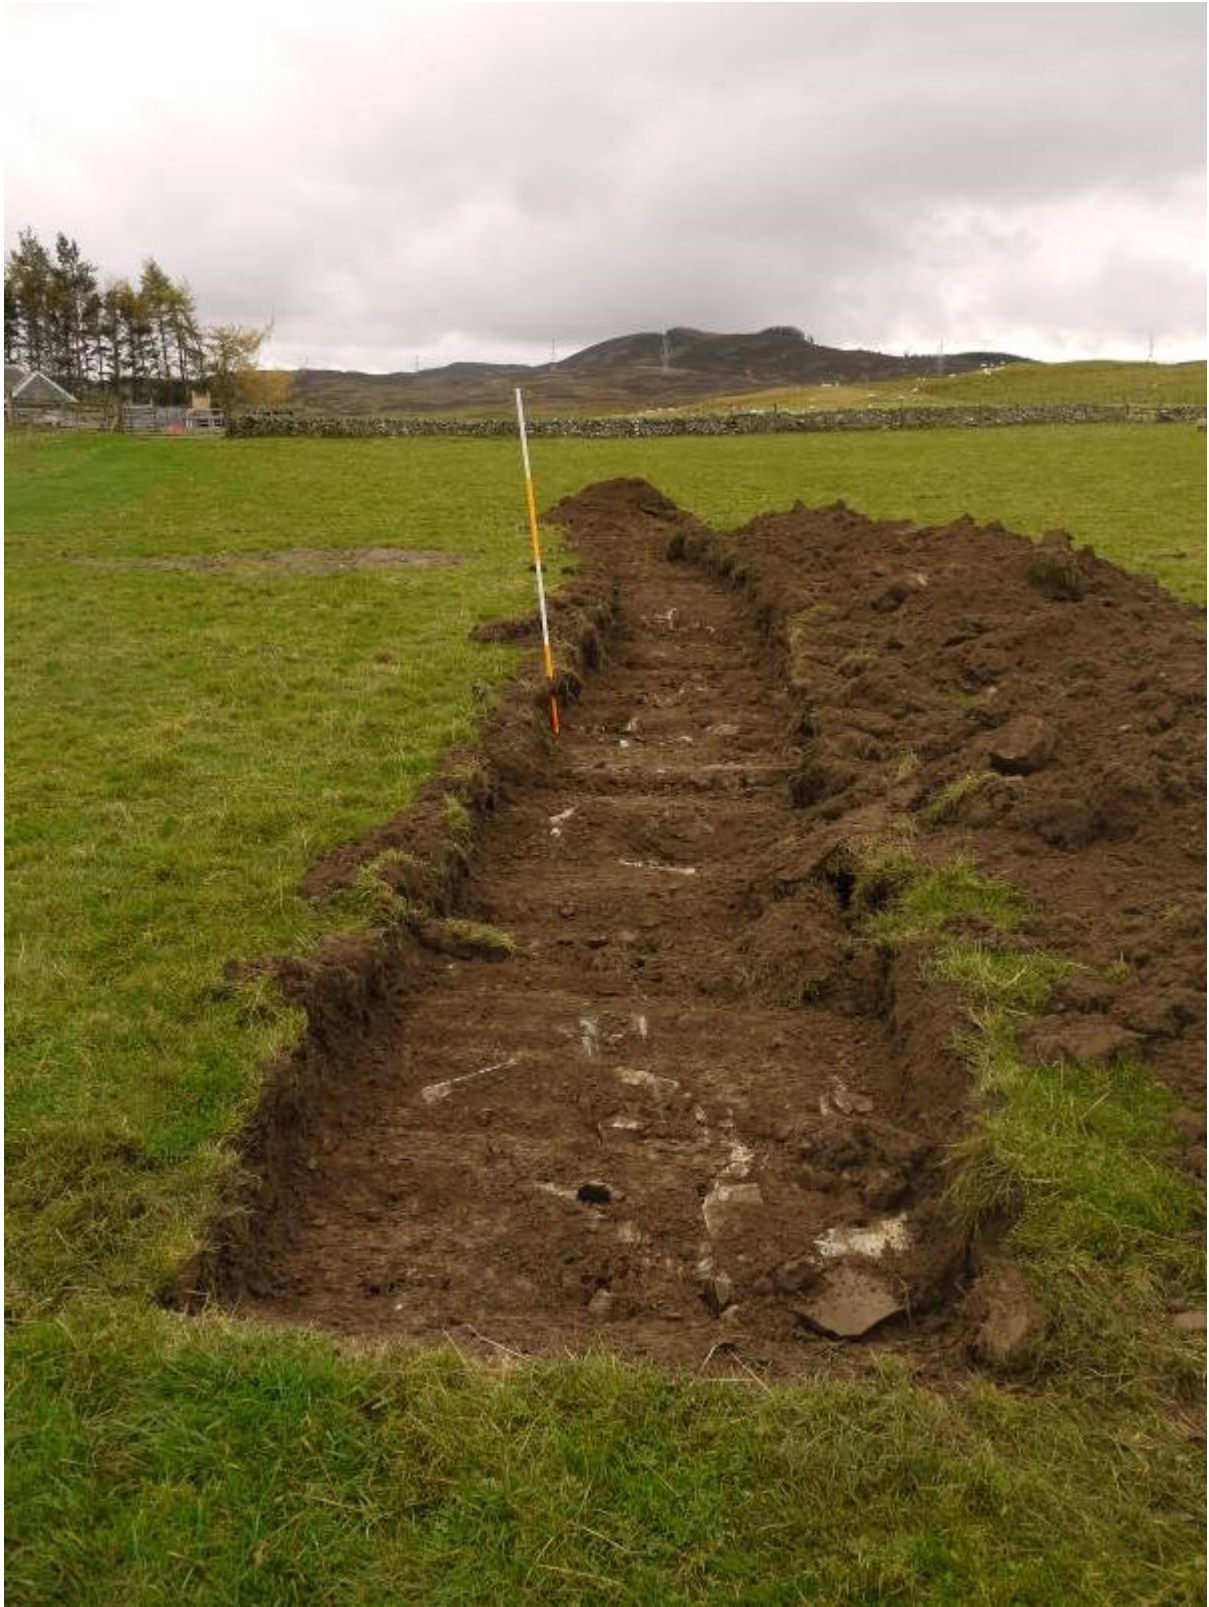
This trench was opened on a SW-NE alignment towards the southern end of the area. At its North Eastern end 0.30m of brown sandy clay ploughsoil was located overlying natural broken stone and yellow clay. At its South Western end 0.50m of brown sandy clay ploughsoil was located overlying natural broken stone and yellow clay. Nothing of archaeological interest was located.

Illustration 11 General view of excavated Trench D looking south south west showing natural broken stone and clay, Shepherd's Cottage visible in background.
