Standing Building Survey

Former United Free Church, Wolfhill, Perth and Kinross

26th June 2015

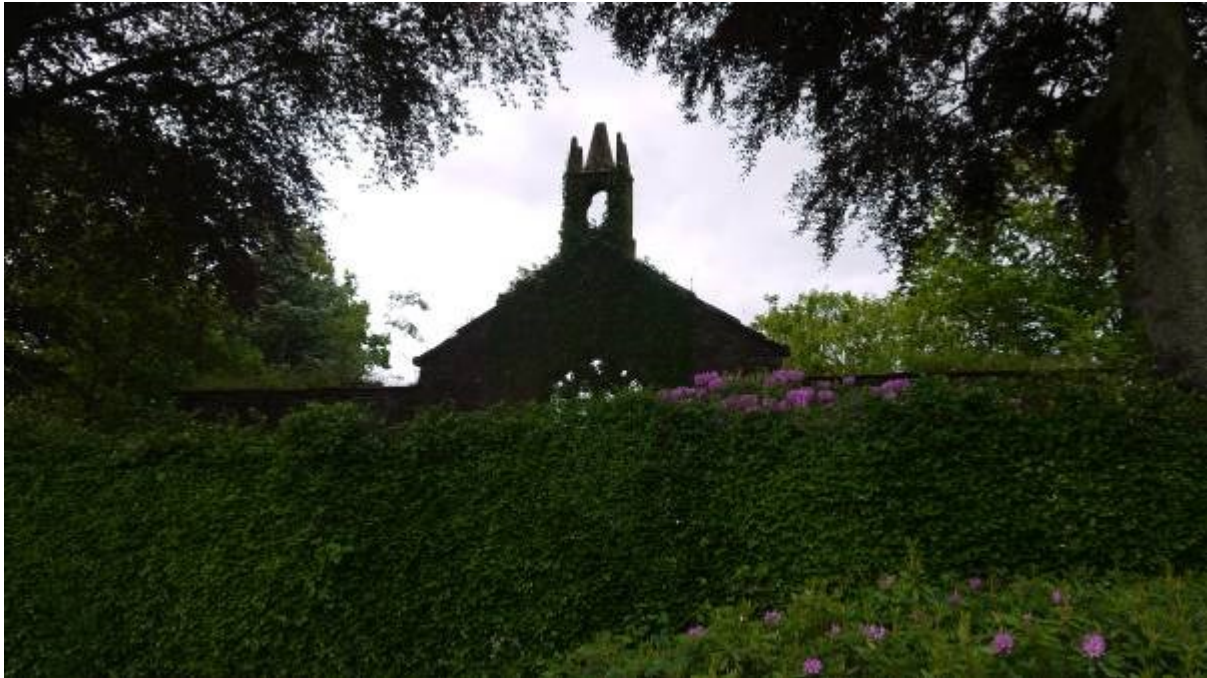
North wall and pinnacled bellcote of former United Free Church looking South from road

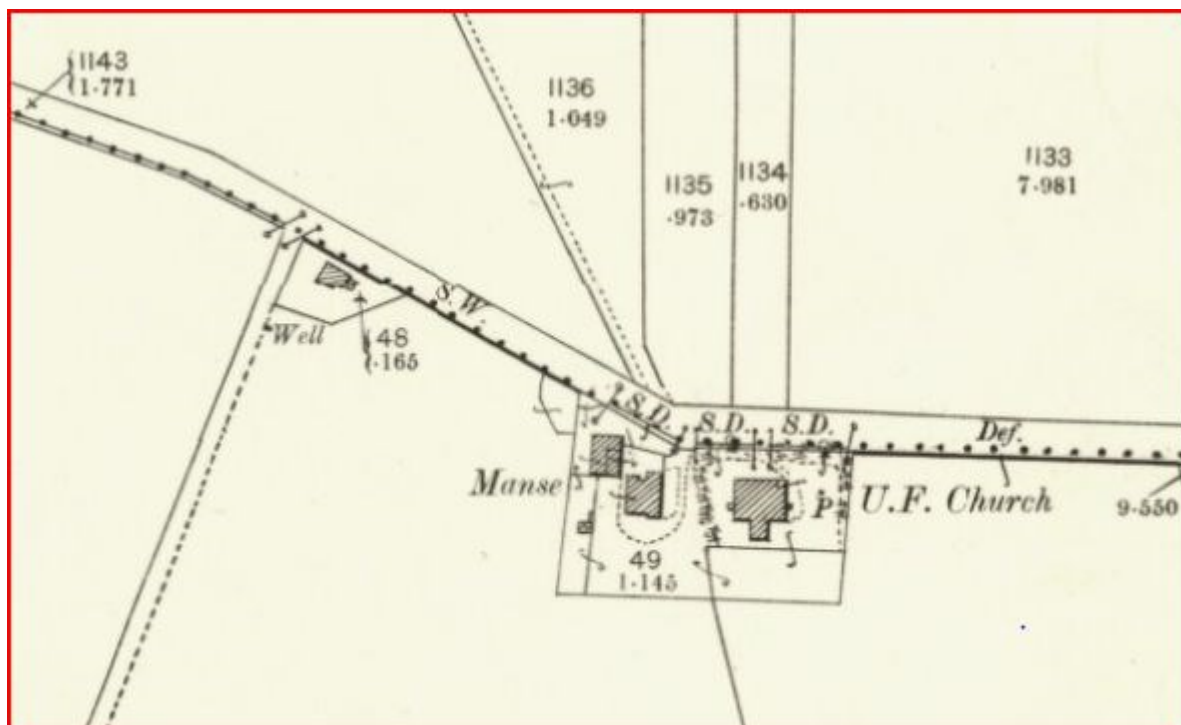
Illustration 2 United Free Church and Manse as shown on Second Edition Ordnance Survey map of 1899 (Trustees of the National Library of Scotland)

Historical Background (Illus 2 and Appendix)

The United Free Church at Wolfhill (normally referred to as Cargill Free Church) was built in 1845 and its accompanying manse in 1852. From a congregation of 360 in 1848 the building of a church at Burrelton, and the depletion of the population, tended to reduce the membership. By 1901 the congregation was listed being 201 (Ewing 1914). After the local union with Wolfhill this church ceased to be used in 1948 and was sold (Lamb 1961).

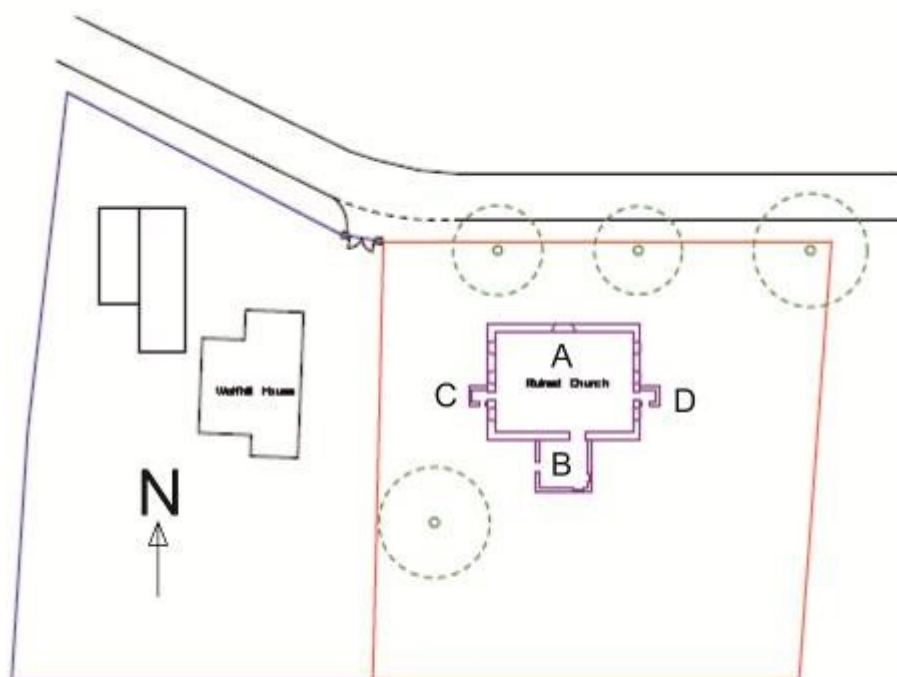
Illustration 3 Ground plan of former United Free Church showing buildings as labelled for survey (based on Architects drawing)

Building Survey (Illustration 3)

The former church building comprises four separate elements which were labelled A to D and recorded in turn.

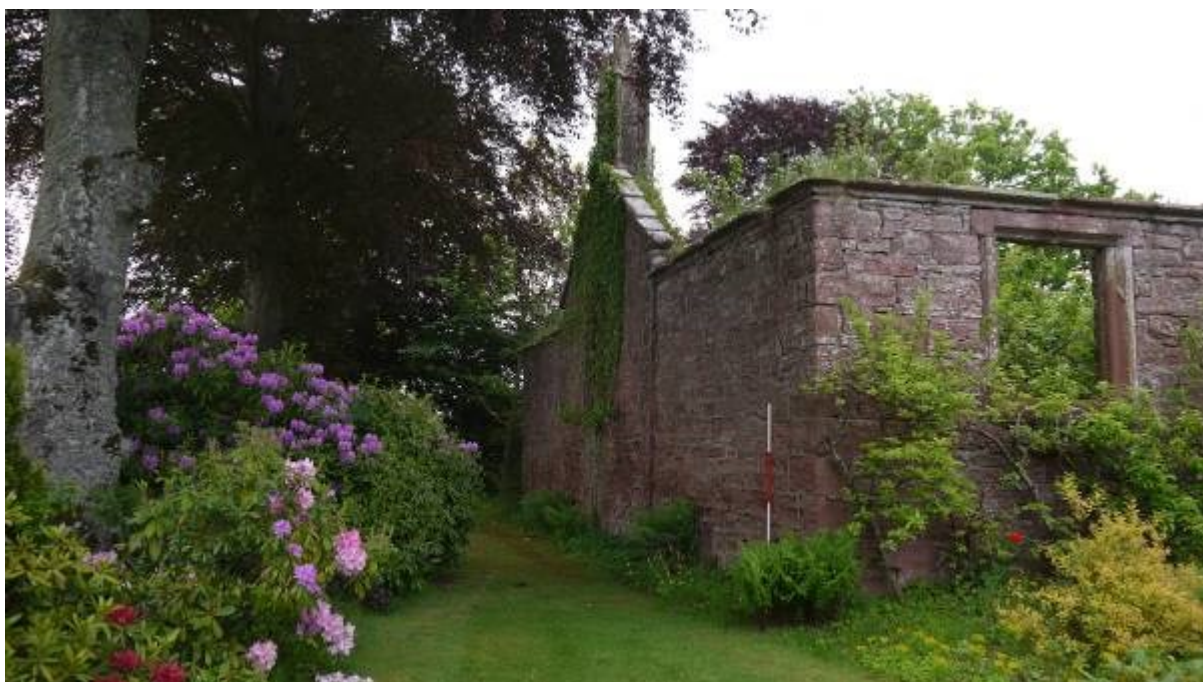
This elevation has a central gabled pediment that is capped with a pinnacle bellcote. The pediment contains a single Tudor arched window 2.4m above ground level which has four vertical arched lights below a central rounded light with diamond shaped lights on either side. The gable wall head has overlapping coping stones. The wall faces on either side of the pediment are blank and are also capped with coping stones.

Illustration 5 Northern elevation of Building A looking East

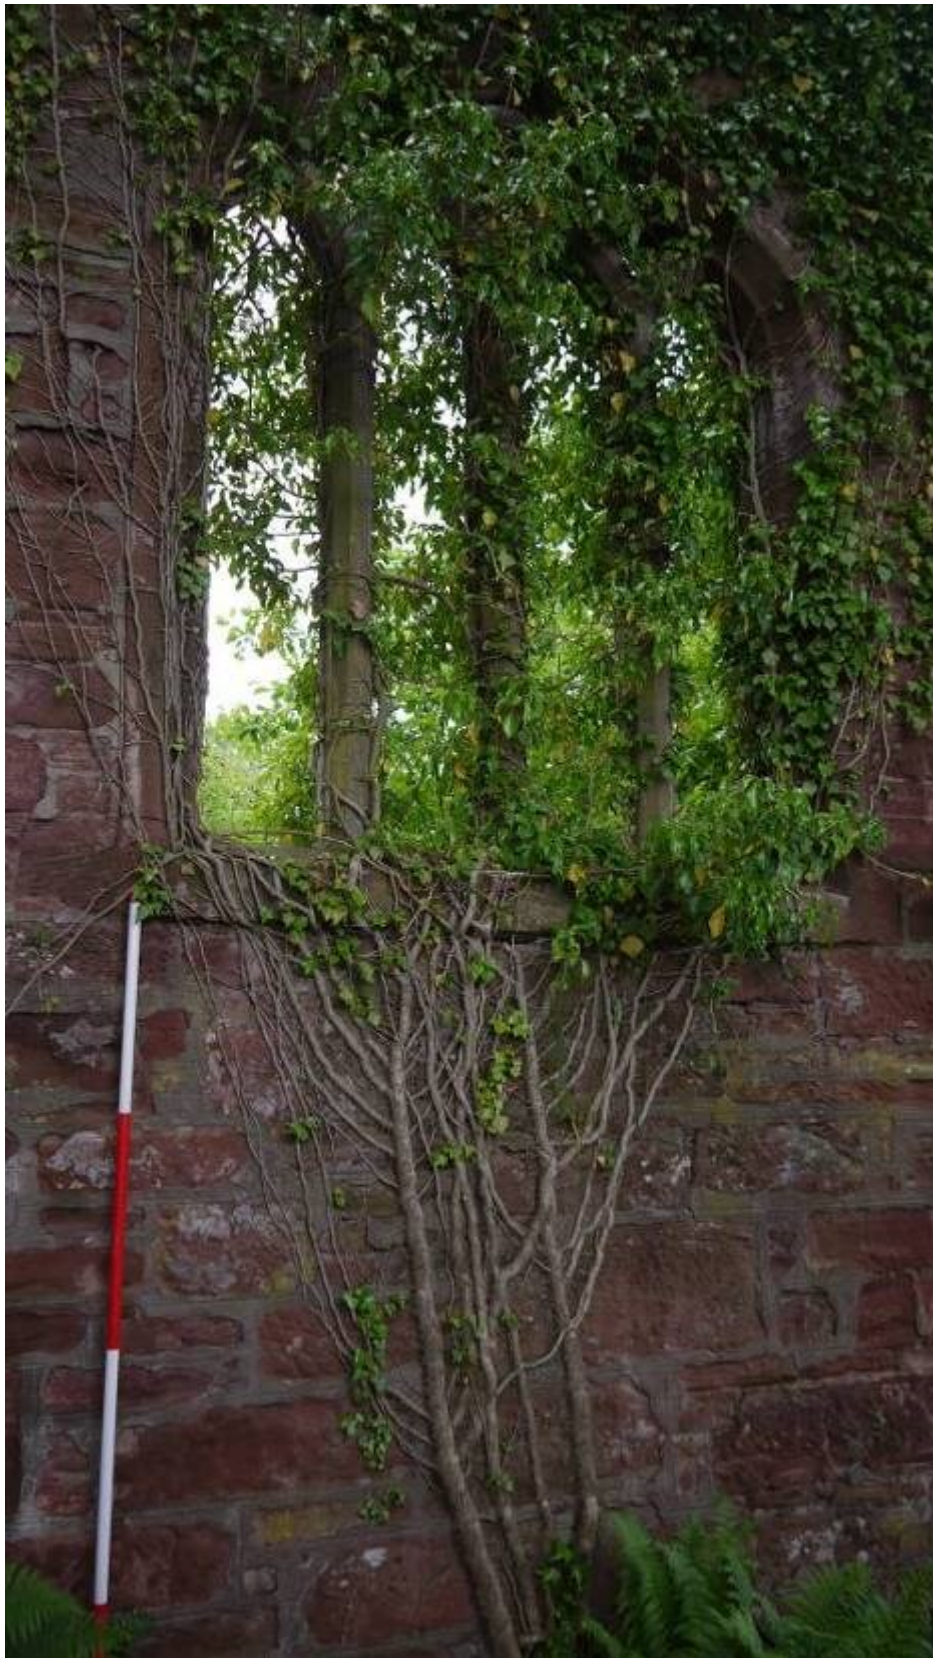
Illustration 6 Central window in external Northern elevation of Building A looking South

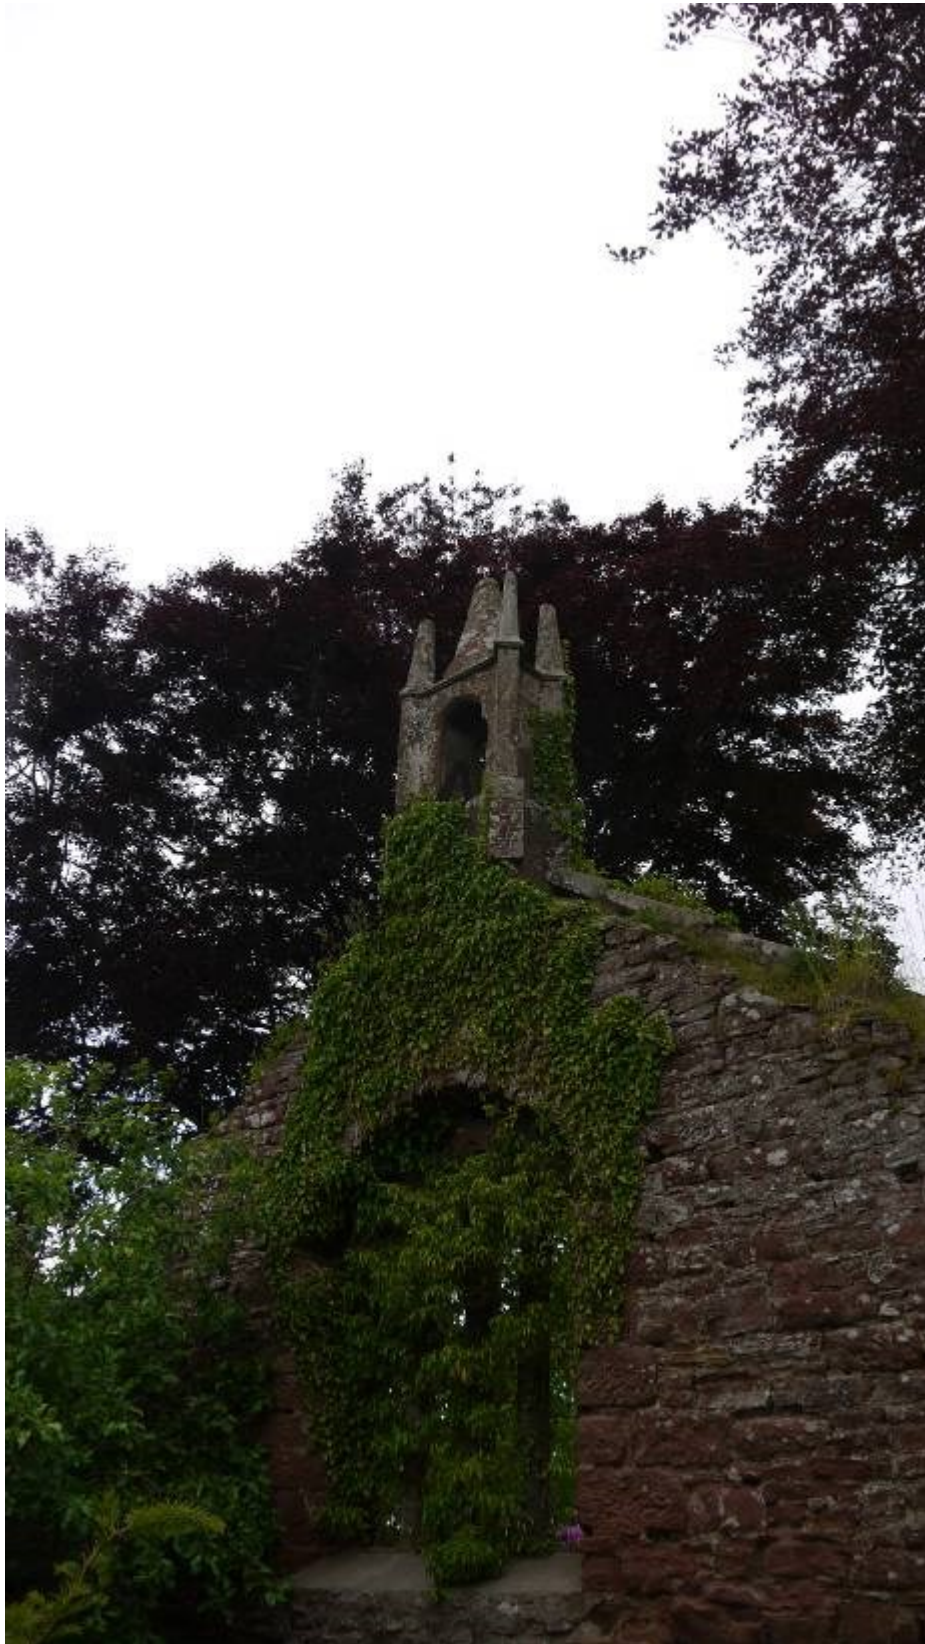
Illustration 7 Pinnacled bellcote on Northern elevation of Building A looking North

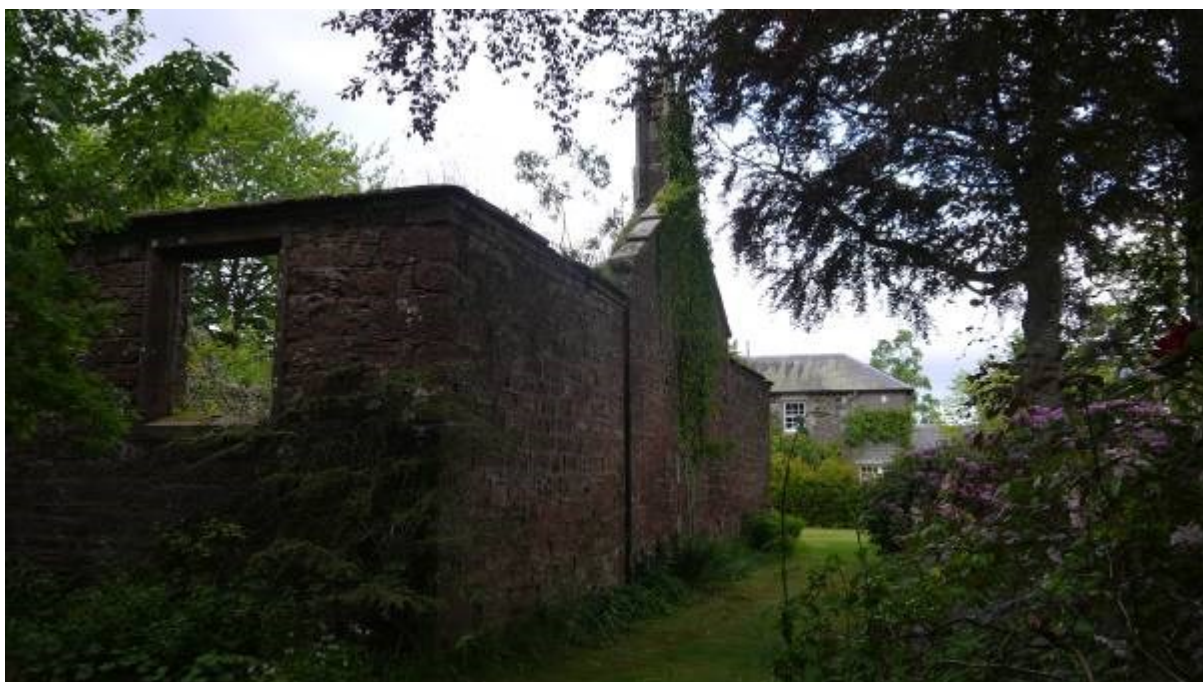
Illustration 8 Northern elevation of Building A looking West

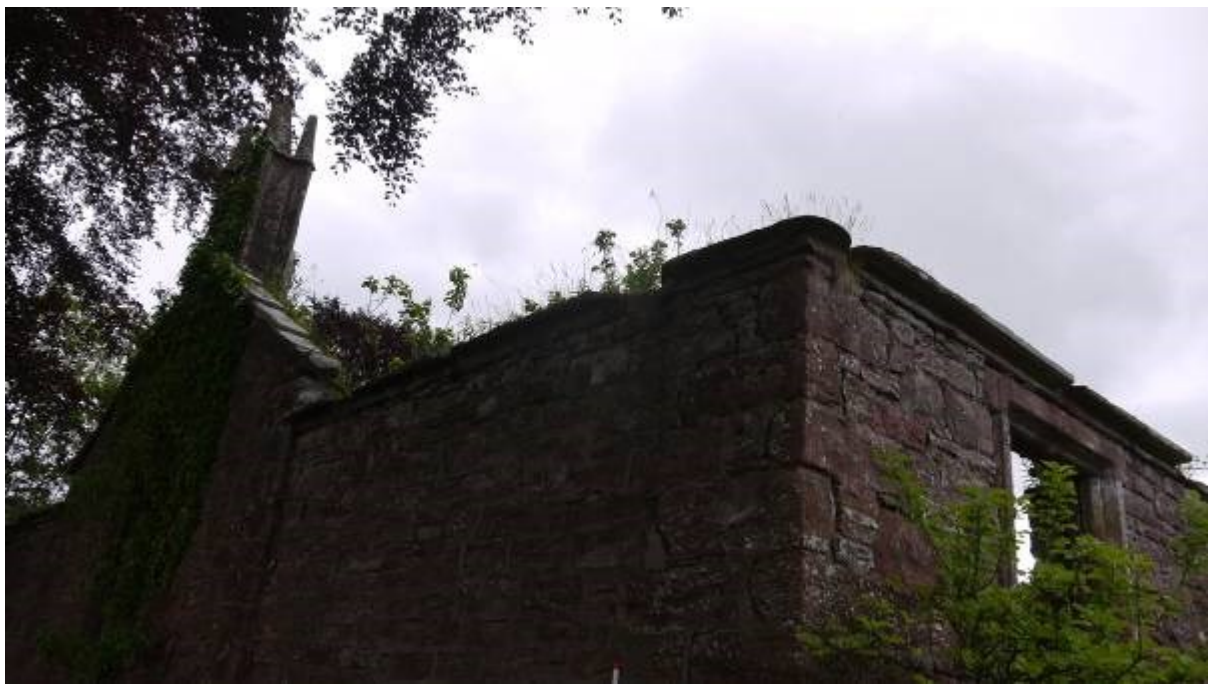
Illustration 9 Detail view of coping stones on wall head of Northern elevation of Building A at its North Western corner and on gable wall head looking East.

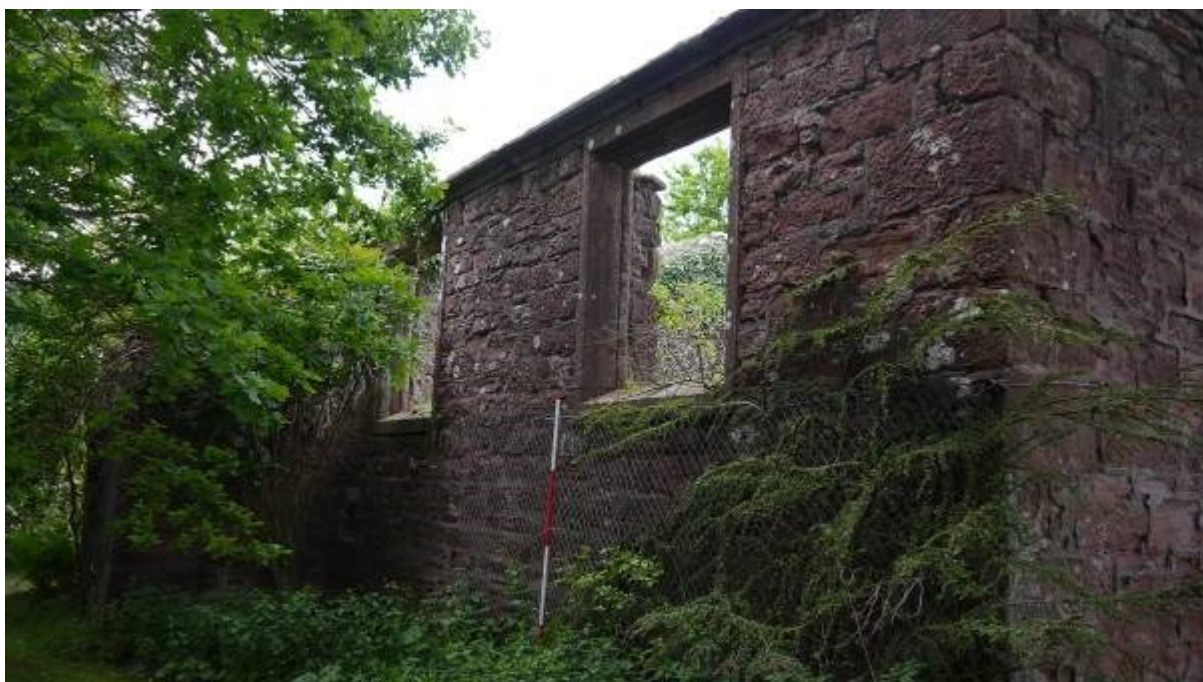
This elevation contains 3 rectangular windows, 2 of these are on the North side of Building D the third one on the South side. The wall head is capped with coping stones.

Illustration 10 Northern end of Eastern elevation of Building A looking South West

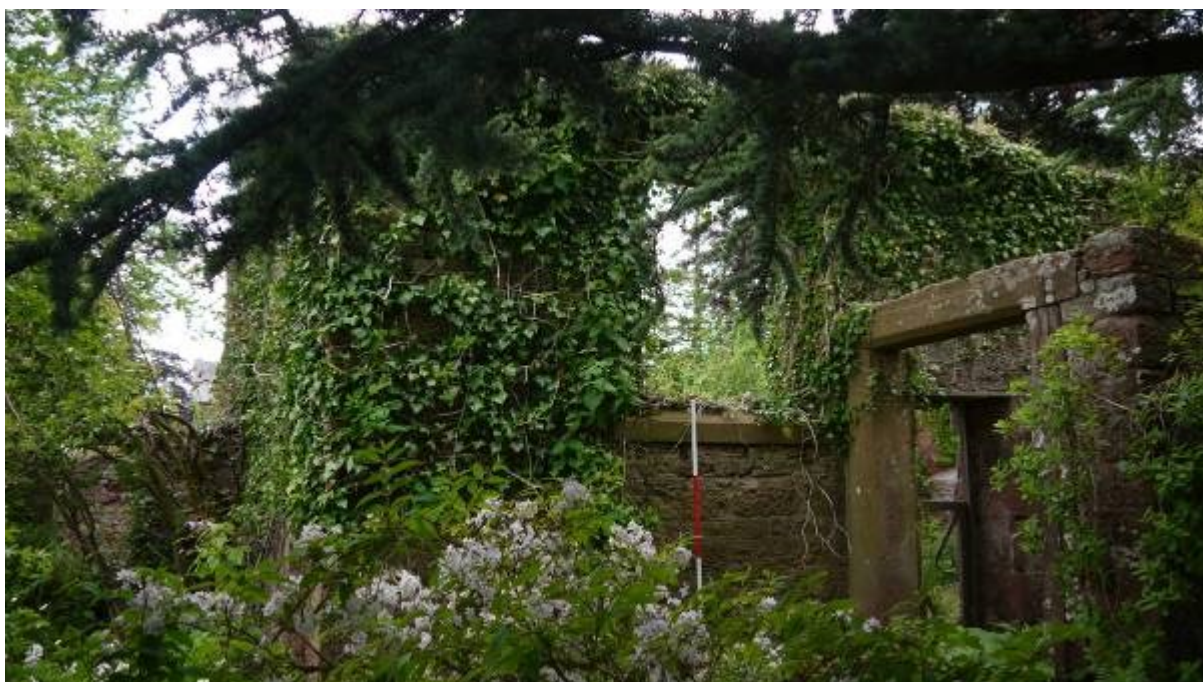
Illustration 11 Southern end of Eastern elevation of Building A, Building D to right of scale

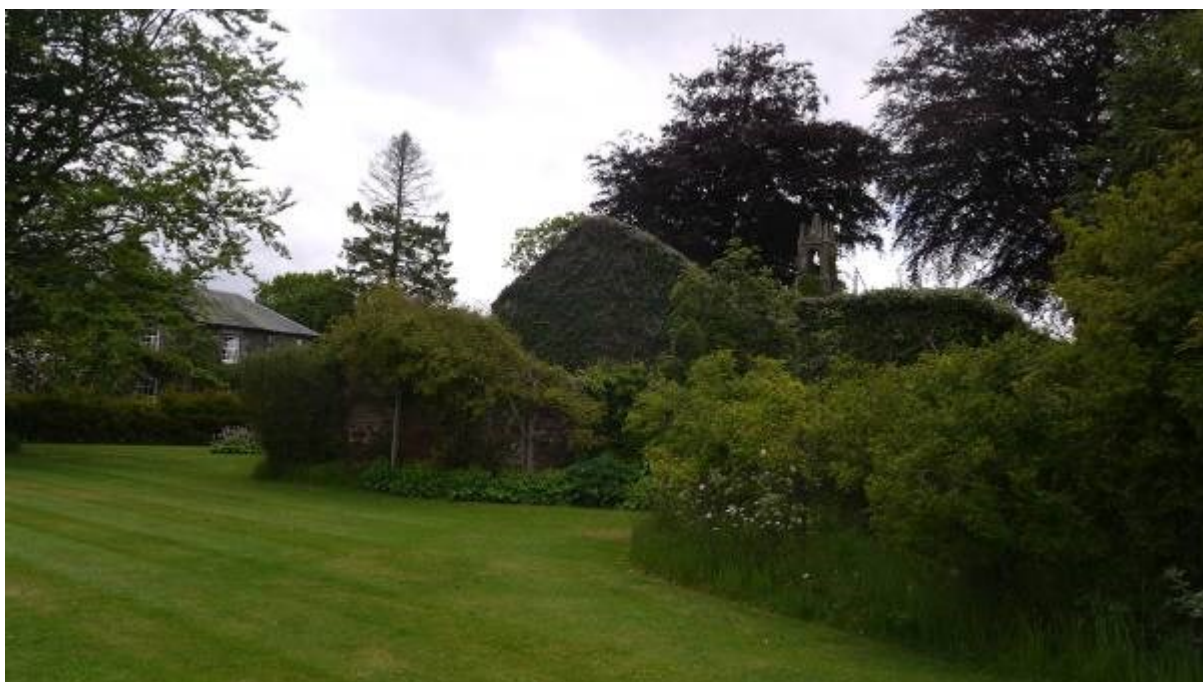
This elevation has a blank face, a central gable in the same position as that on the North elevation and has Building B built against it. The wall head is capped with coping stones. A blocked relieving arch is visible on the western side of the west elevation of Building B.

Illustration 12 Southern elevation of Building A looking North

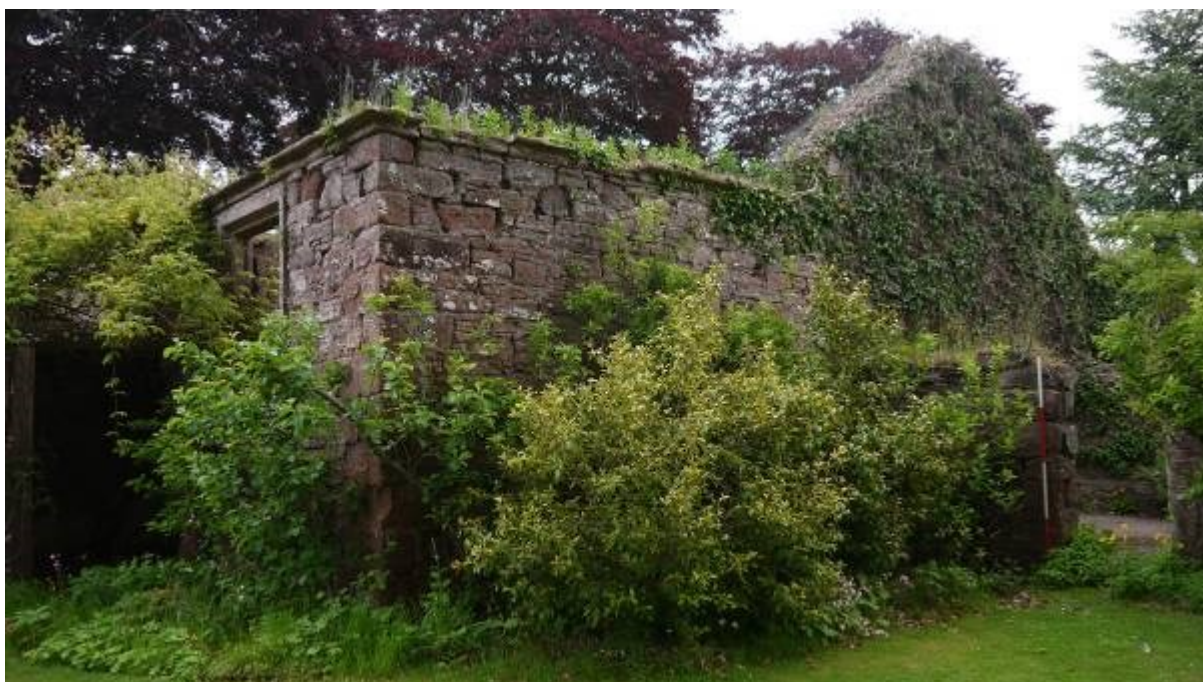
Illustration 13 Western end of Southern elevation of Building A looking North East

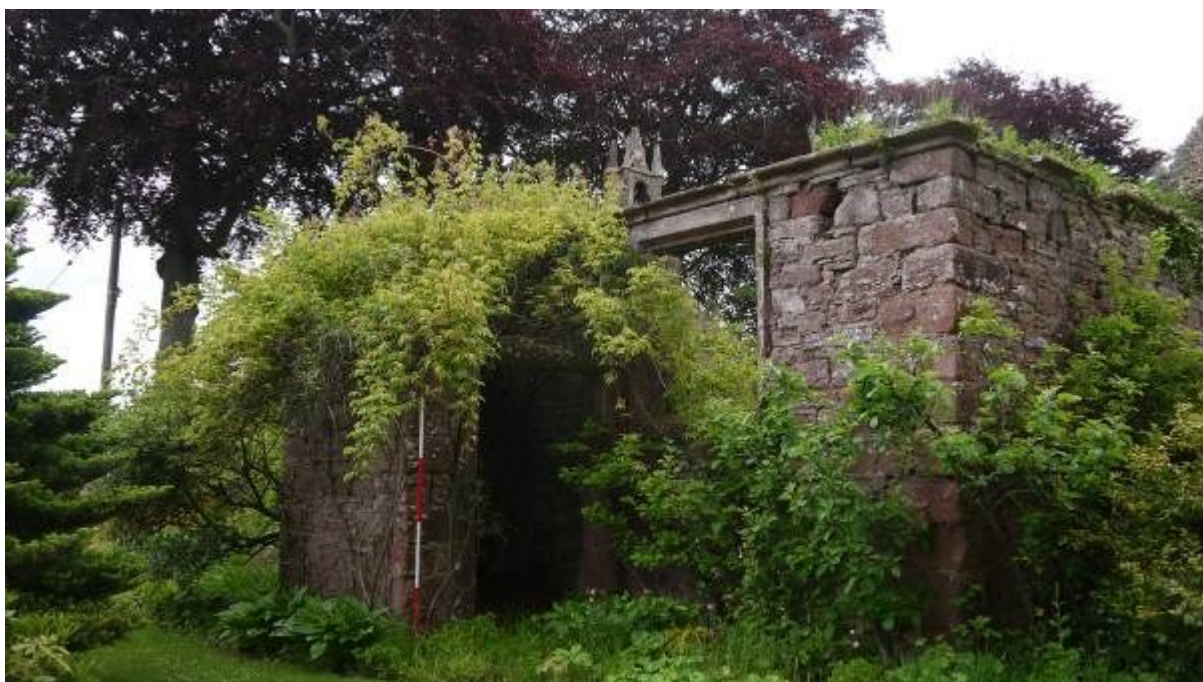
This elevation contains 3 rectangular windows, 2 of these are on the north side of Building C and the third is on its south side. The wall head is capped with coping stones.

Illustration 14 Western elevation of Building A looking North East (Scale is leaning against Building C)

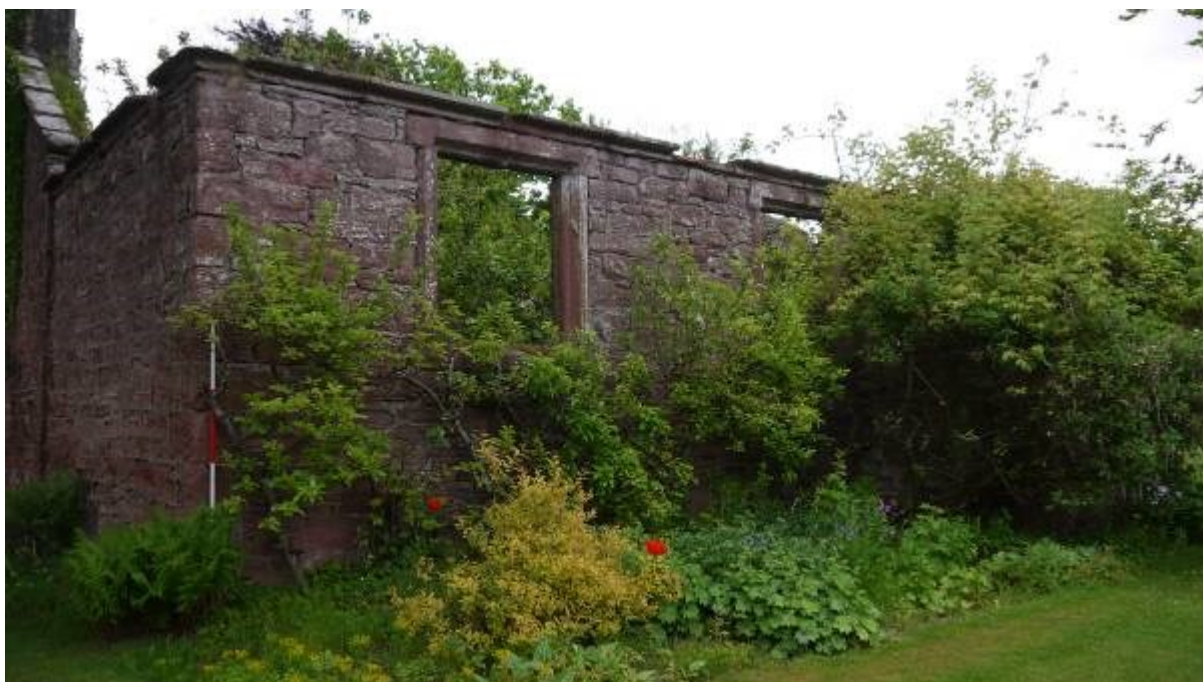
Illustration 15 Northern end of Western elevation of Building A looking South East

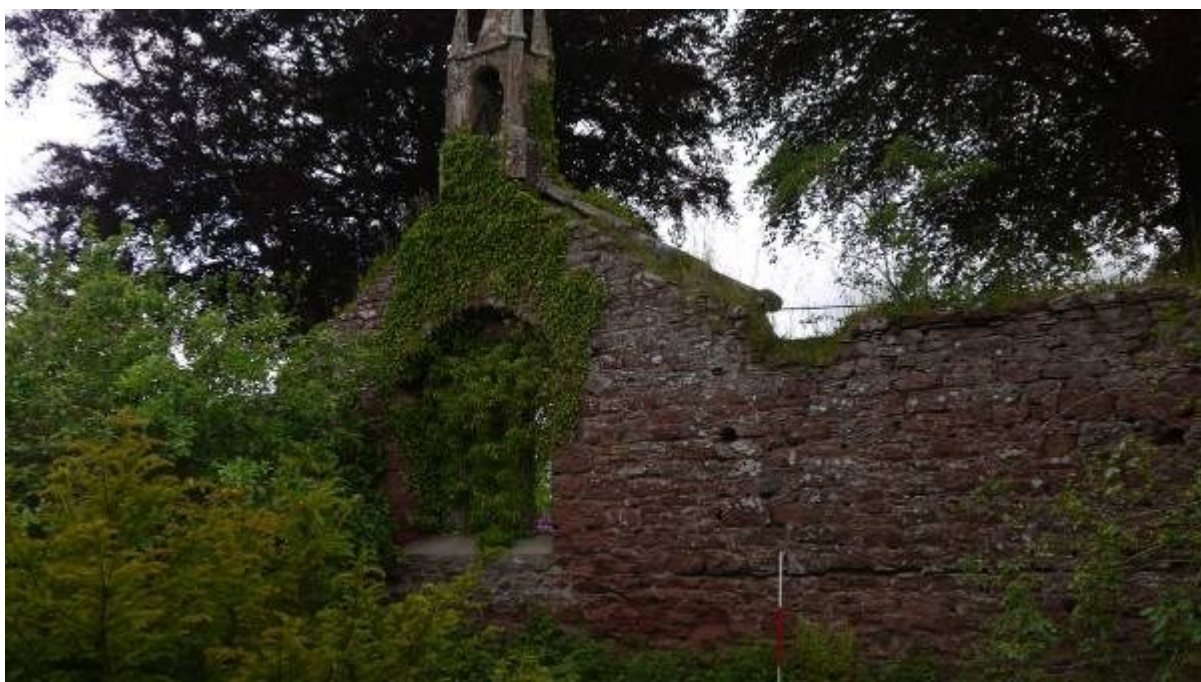
This elevation contains the inside face of the Tudor arched window, which has wooden uprights for three of its lights. The inside face of the wall projects out into the interior of the building for 0.70m along its entire length. At a height of 1.70m from internal ground level there is a recessed slot running along the wall face which contains the remains of wooden planks. This stops at the position of the window but then starts up again on its western side.

The recessed grooves running along the internal walls of Building A were provided as supports for internal wooden panelling. Building B presumably acted originally as the church vestry, Buildings C and D are porched doorways allowing the congregation to enter from both Eastern and western sides.

Illustration 16 Internal Northern elevation of Building A looking North (recessed panelling groove is visible behind scale)

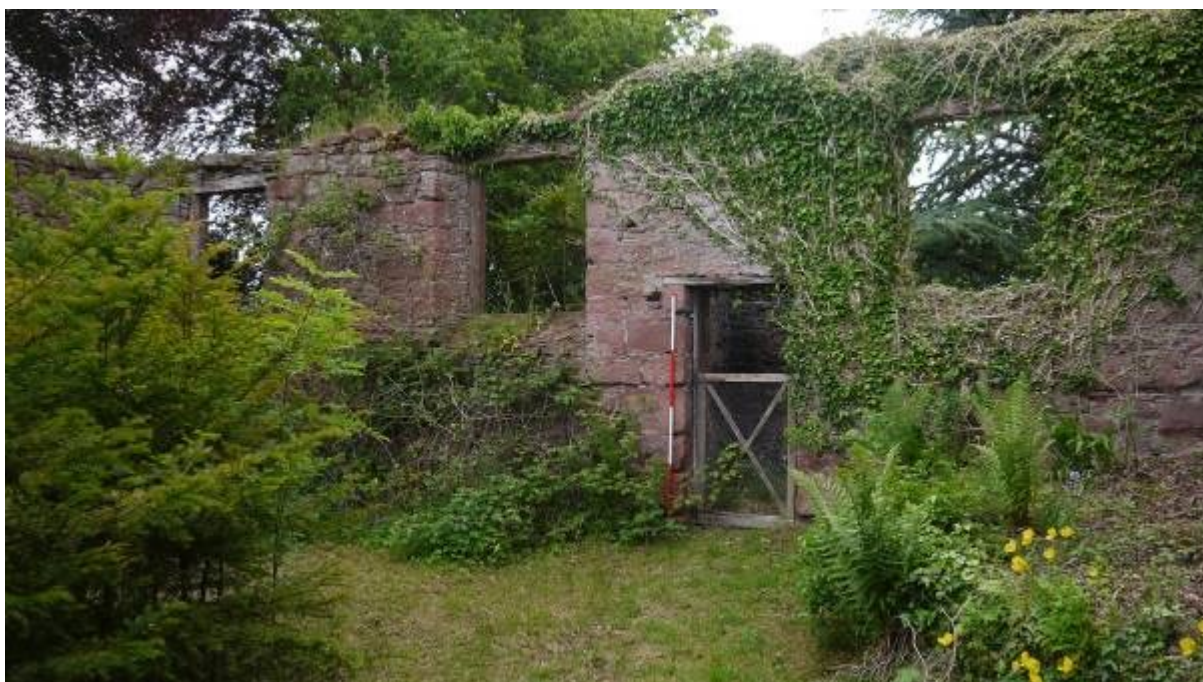
This elevation contains the inside faces of three windows and a doorway in from Building D. The doorway has a wooden frame and still contains a half wooden door with wire mesh infill. A recessed slot at 0.13m above ground level indicates the former location of the floor level inside this building. At 1.30m above ground level a recessed slot similar to that in the northern elevation is visible but it contains no wooden planks. At 1.3m south of the north eastern corner there is a small recess in the face of the wall measuring 0.28m by 0.30m.

Illustration 17 Internal Eastern elevation of Building A looking East

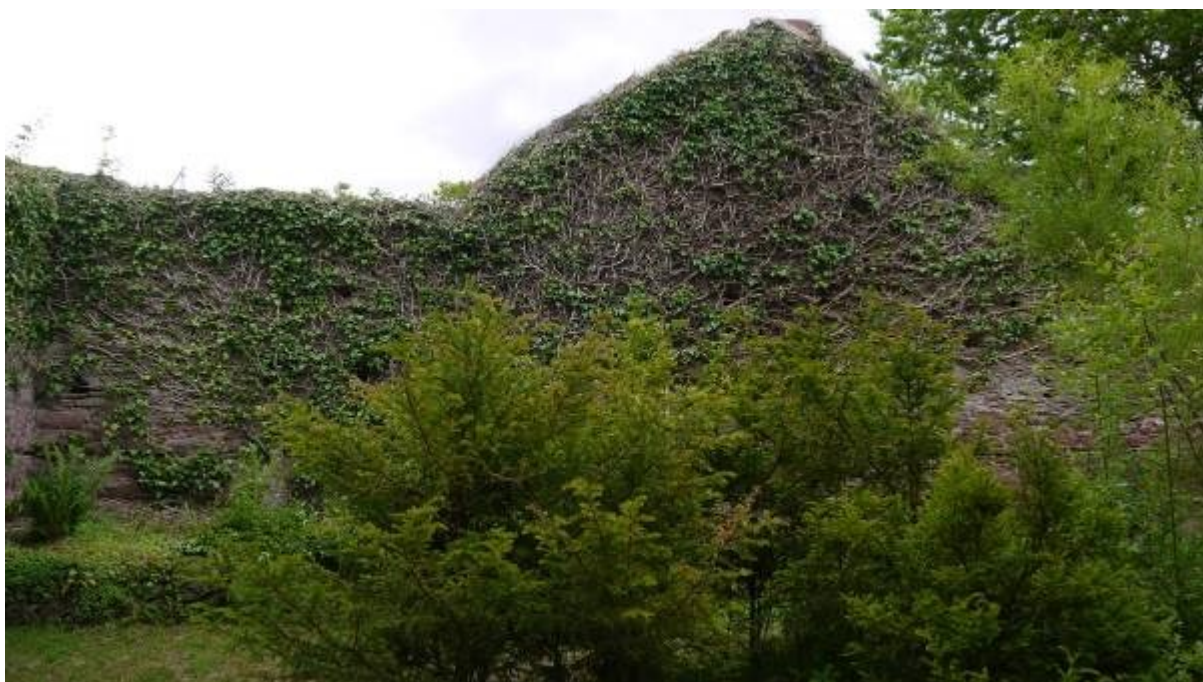
This elevation contains a doorway in from Building D and the other side of the relieving arch which measures 1.88m by 0.68m and is blocked with stones and bricks. A recessed slot at 0.26m above ground level indicates the former level of the floor. At 1.40m above ground level there is a recessed slot which contains timber planking.

Illustration 18 Internal Southern elevation of Building A looking South

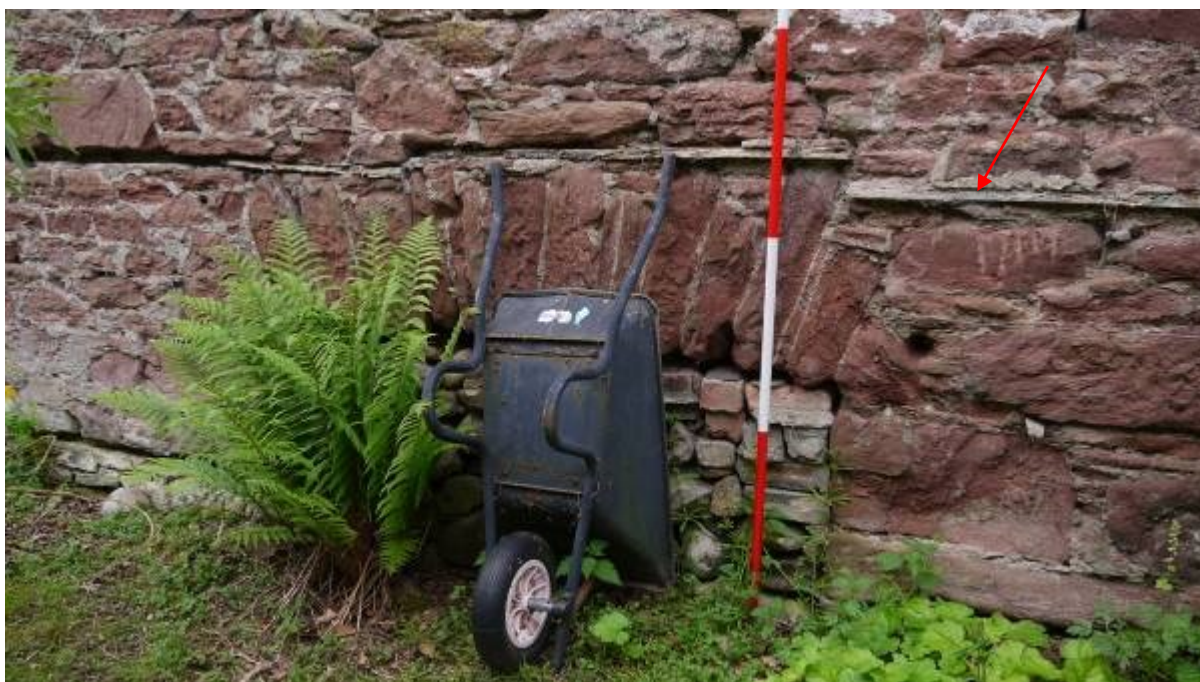
Illustration 19 Relieving arch in internal Southern elevation of Building A, panelling recess is visible (red arrow)

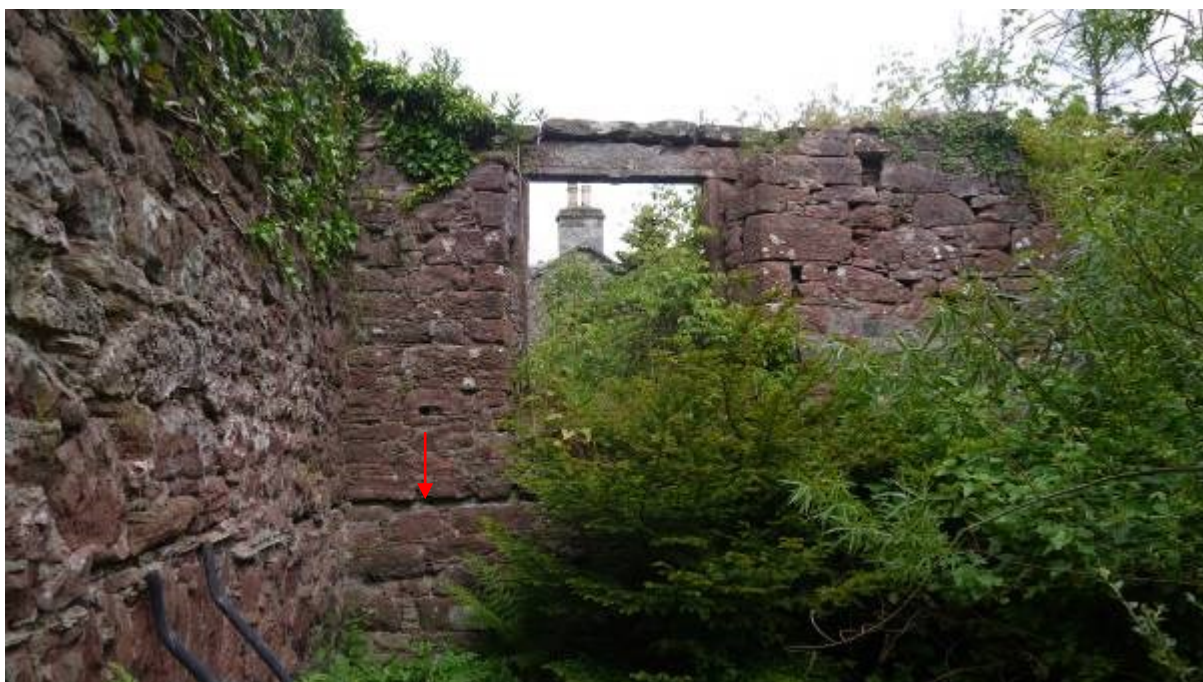
This elevation contains the inside faces of three windows and a small recess similar to that in the Eastern elevation. A recessed slot at current ground level indicates the former internal floor level. A recessed slot at 1.10m above current ground level is also visible but contains no timber.

Illustration 20 Internal Western elevation of Building A (recessed groove for panelling support visible at red arrow)

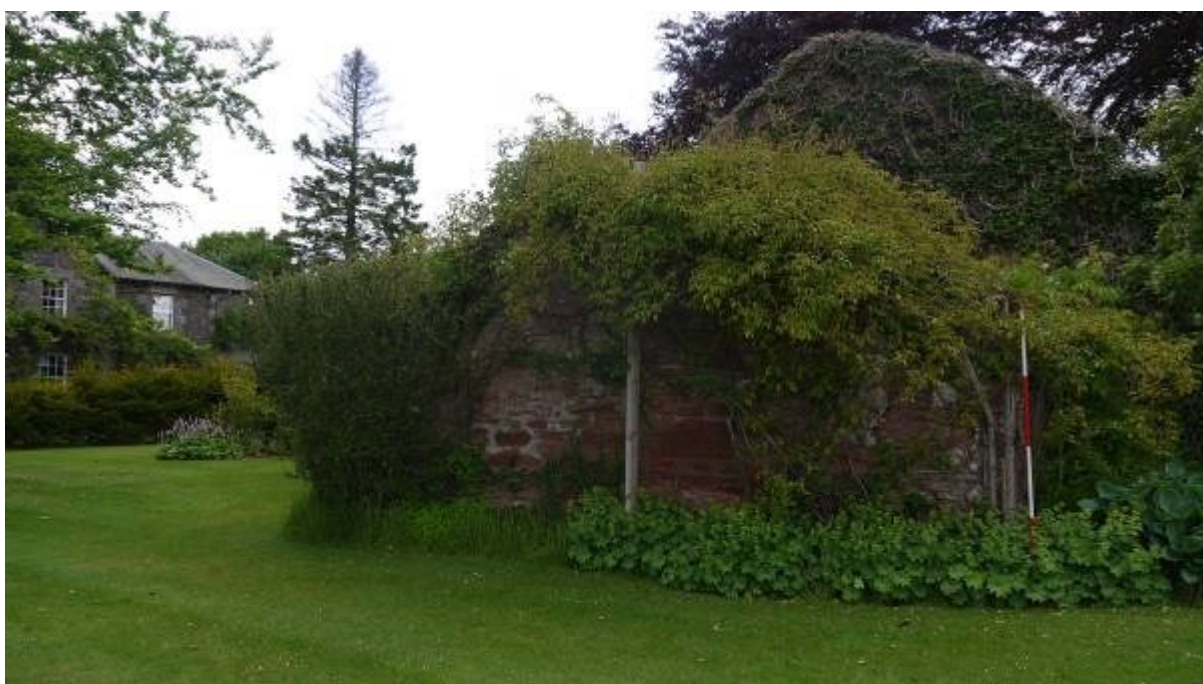
This elevation is blank and is a gable end.

Illustration 21 External Southern elevation of Building B looking North

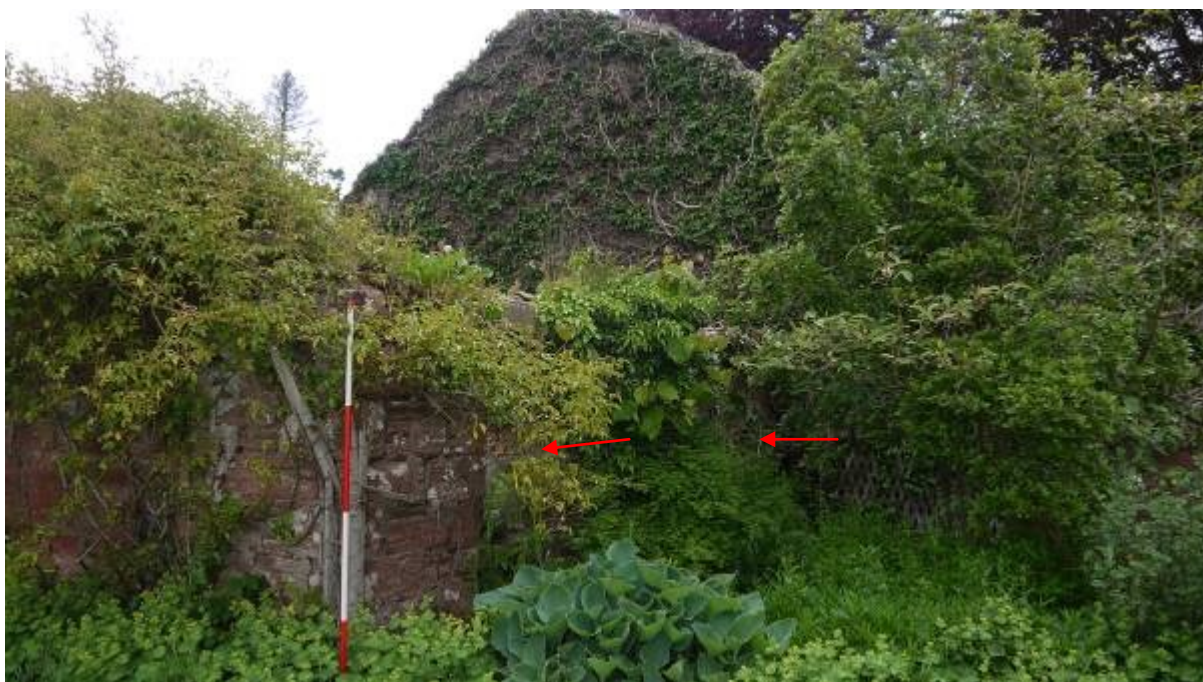
This elevation has two windows.

Illustration 22 Eastern External elevation of Building B looking North (red arrows indicate position of windows)

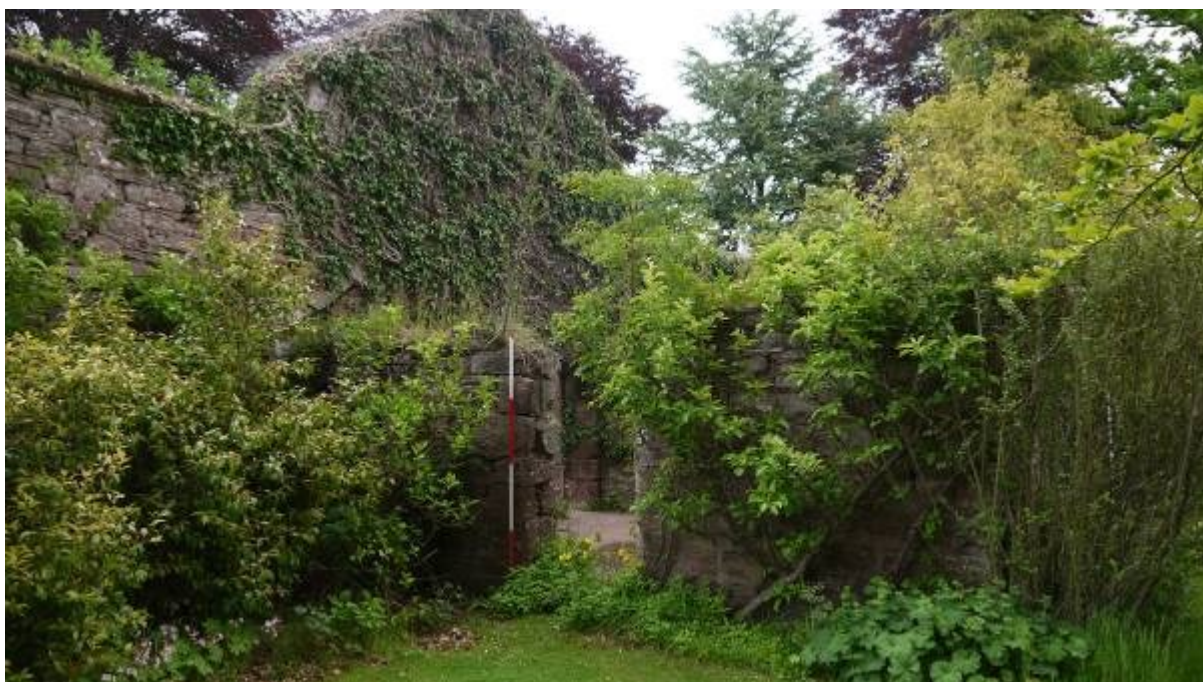
This elevation contains a doorway that is 1.97m high and 0.91m wide.

Illustration 23 External Western elevation of Building B looking East

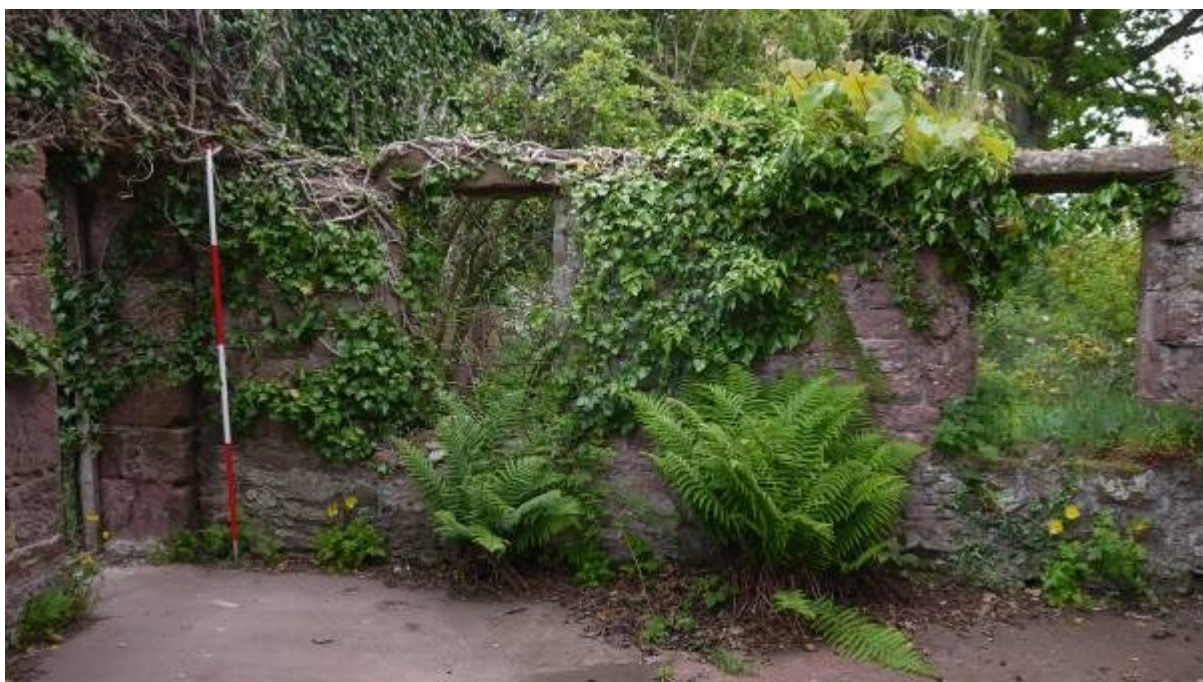
This contains the internal faces of two windows.

Illustration 25 Internal Eastern elevation of Building B looking West

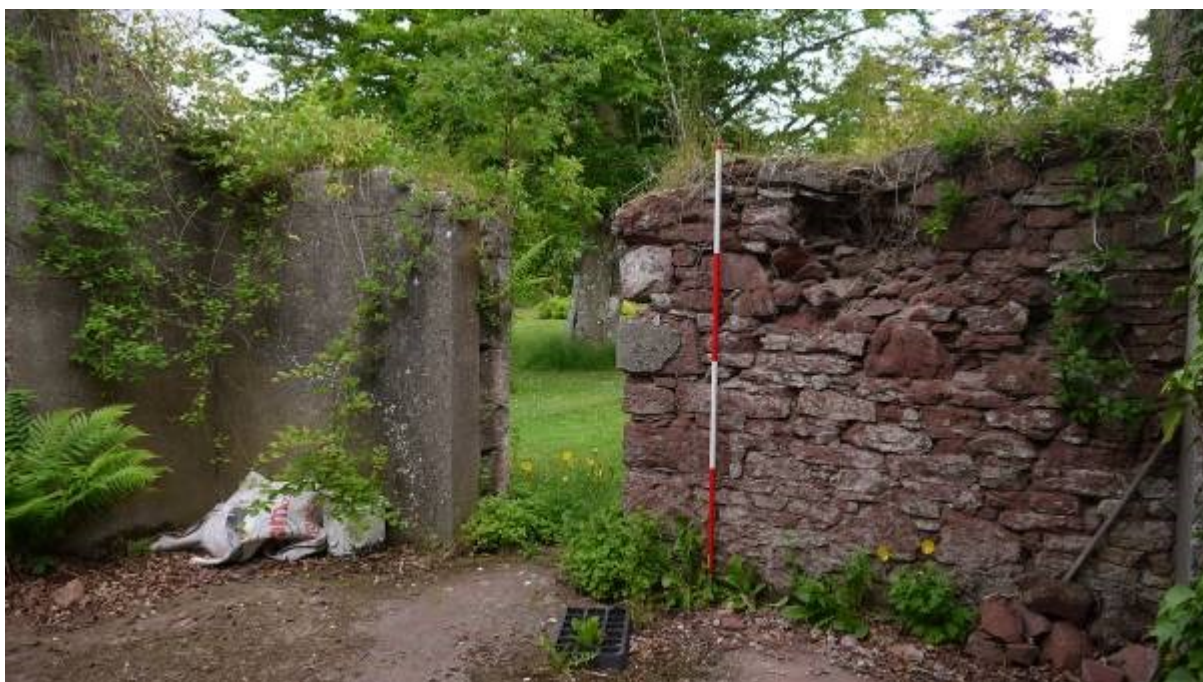
This contains a doorway.

Illustration 26 Internal Western elevation of Building B looking West
