Standing Building Survey

Former United Free Church, Wolfhill, Perth and Kinross

26th June 2015

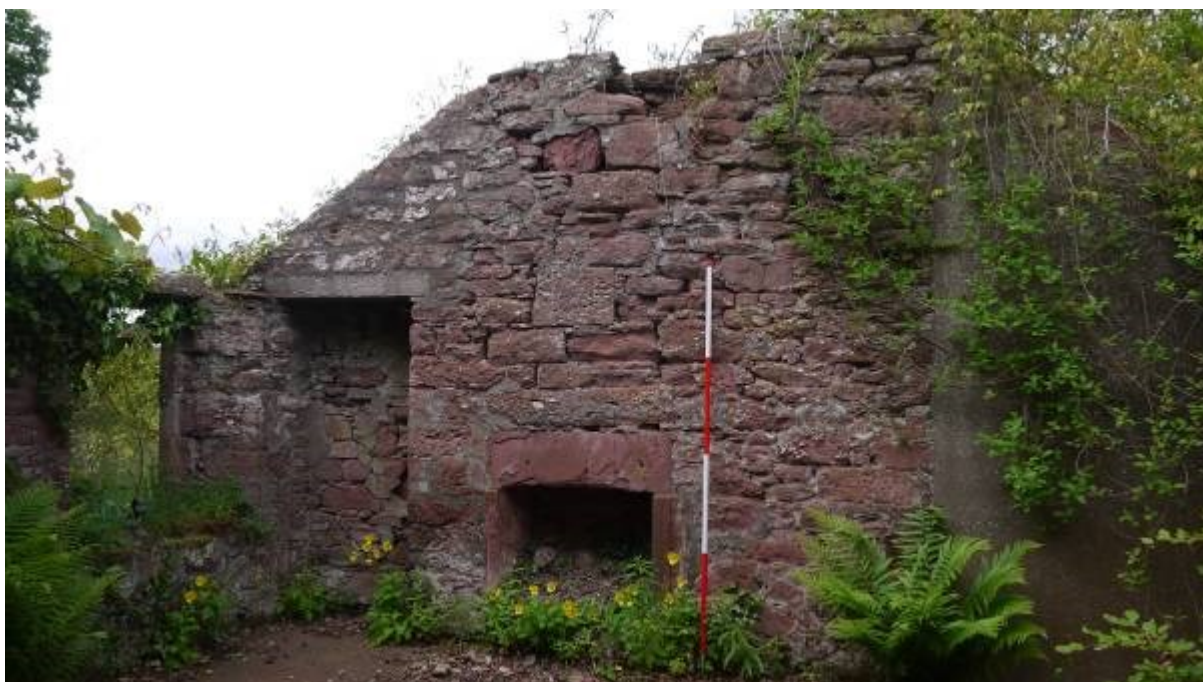
This contains a fireplace and a cupboard to the east.

Illustration 27 Internal Southern elevation of Building B looking South

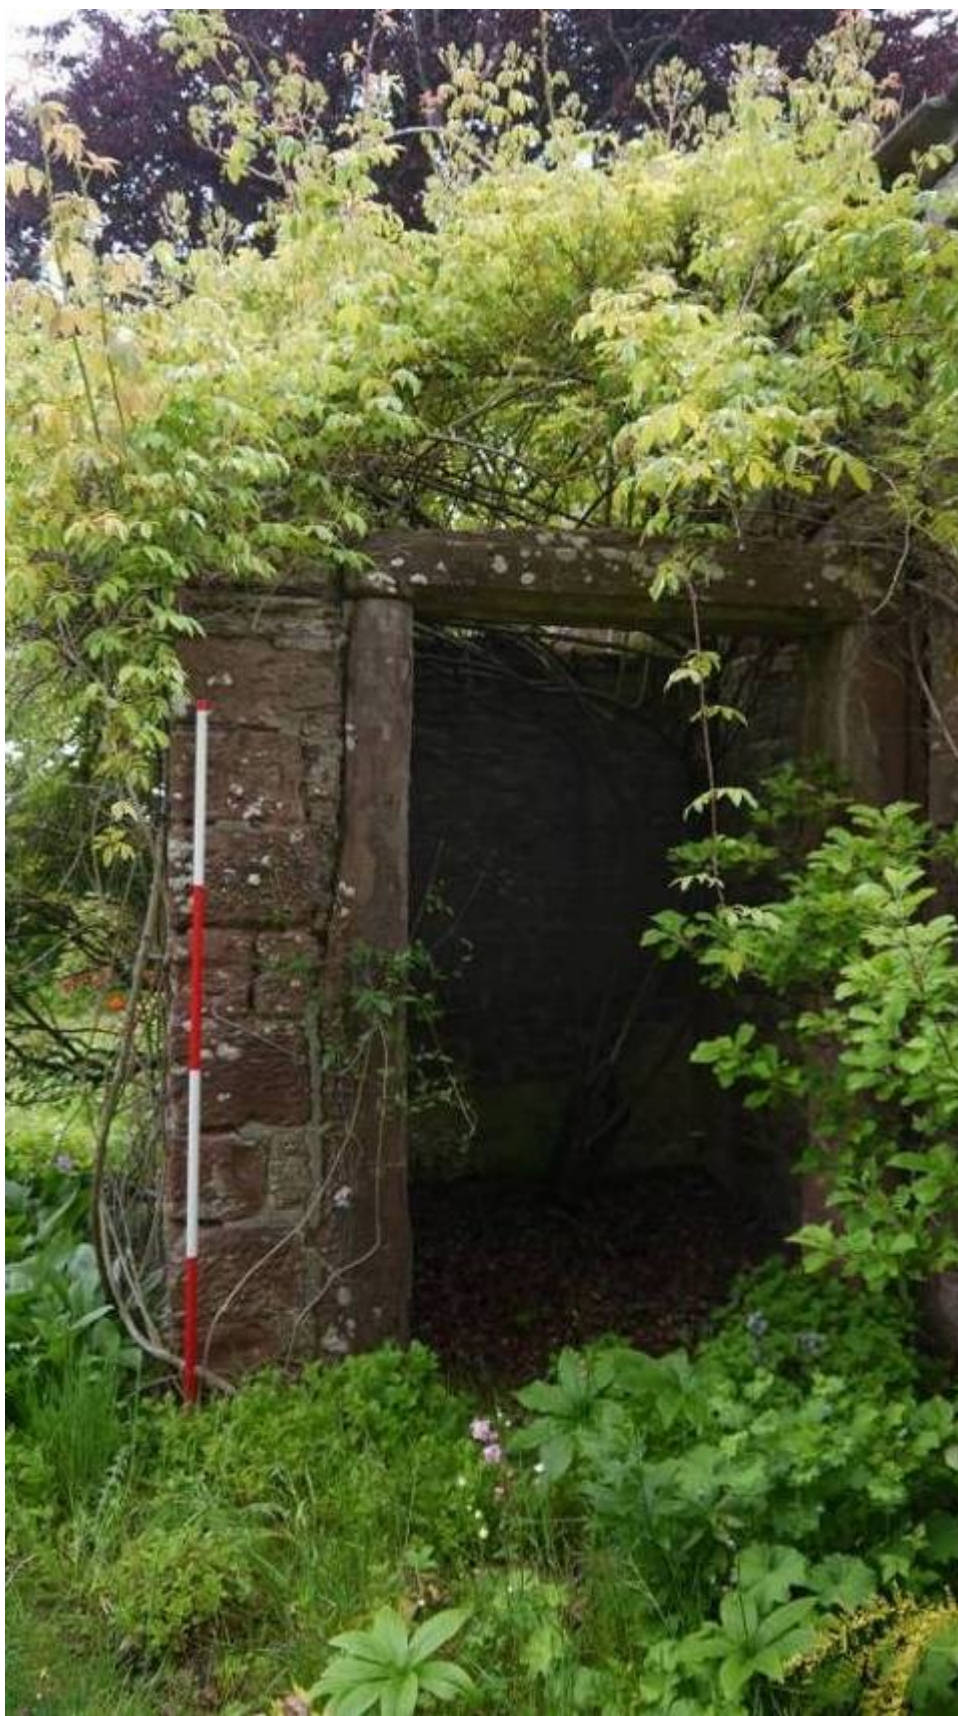
This is built against the Western side of Building A and is a former porched doorway into that building. It has a doorway in its external southern elevation 1.42m high and 2.28m wide and a blocked doorway in its eastern internal elevation. All the other elevations are blank and it seems to have had a flat roof.

Illustration 28 Southern elevation of Building C looking North

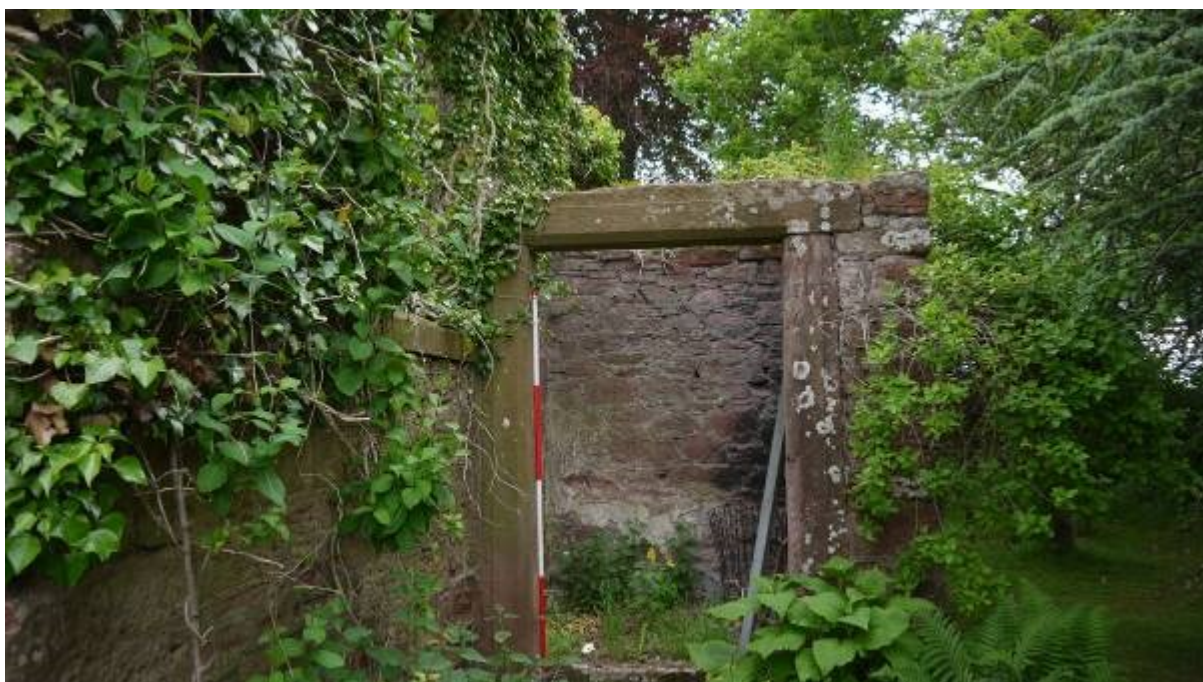
This is built against the Eastern side of Building A and is a former porched doorway into the building from that side. It has a doorway in its external southern elevation 1.42m high and 2.28m wide and another in its internal western elevation. All the other elevations are blank and it seems to have had a flat roof.

Illustration 29 Southern elevation of Building D looking North
