Archaeological Watching Brief
Extension to house and new garage to rear,
Kirk House, 8 The Square,
Torphichen, West Lothian

23rd May 2016

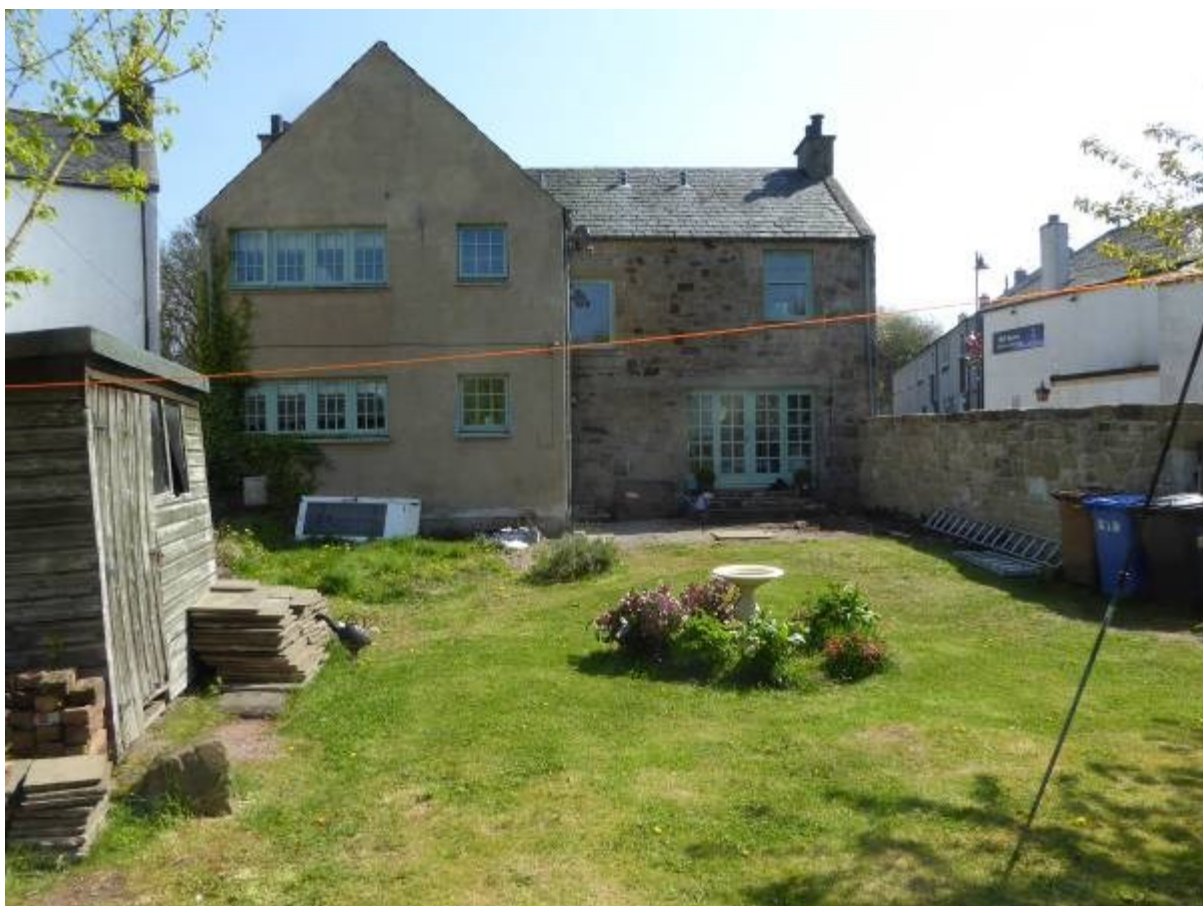
Illustration 4 General view of rear of Kirk House, 8 The Square, Torphichen looking East

Two hand dug test pits in the footprint of the new extension to the house were monitored.

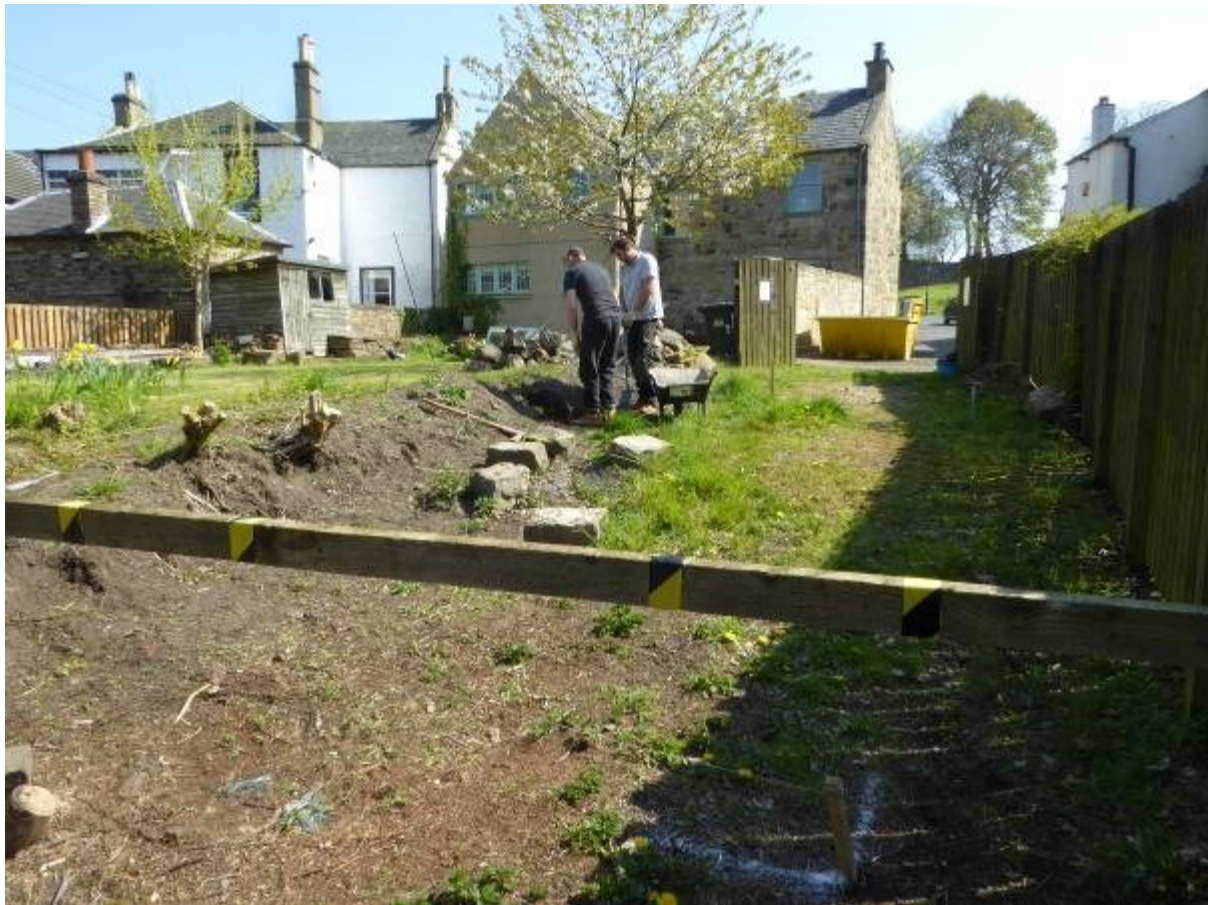
Illustration 5 General view of location of new garage looking East

The entire lengths of the Northern and Western foundation trenches for the new garage were monitored during their machine excavation.

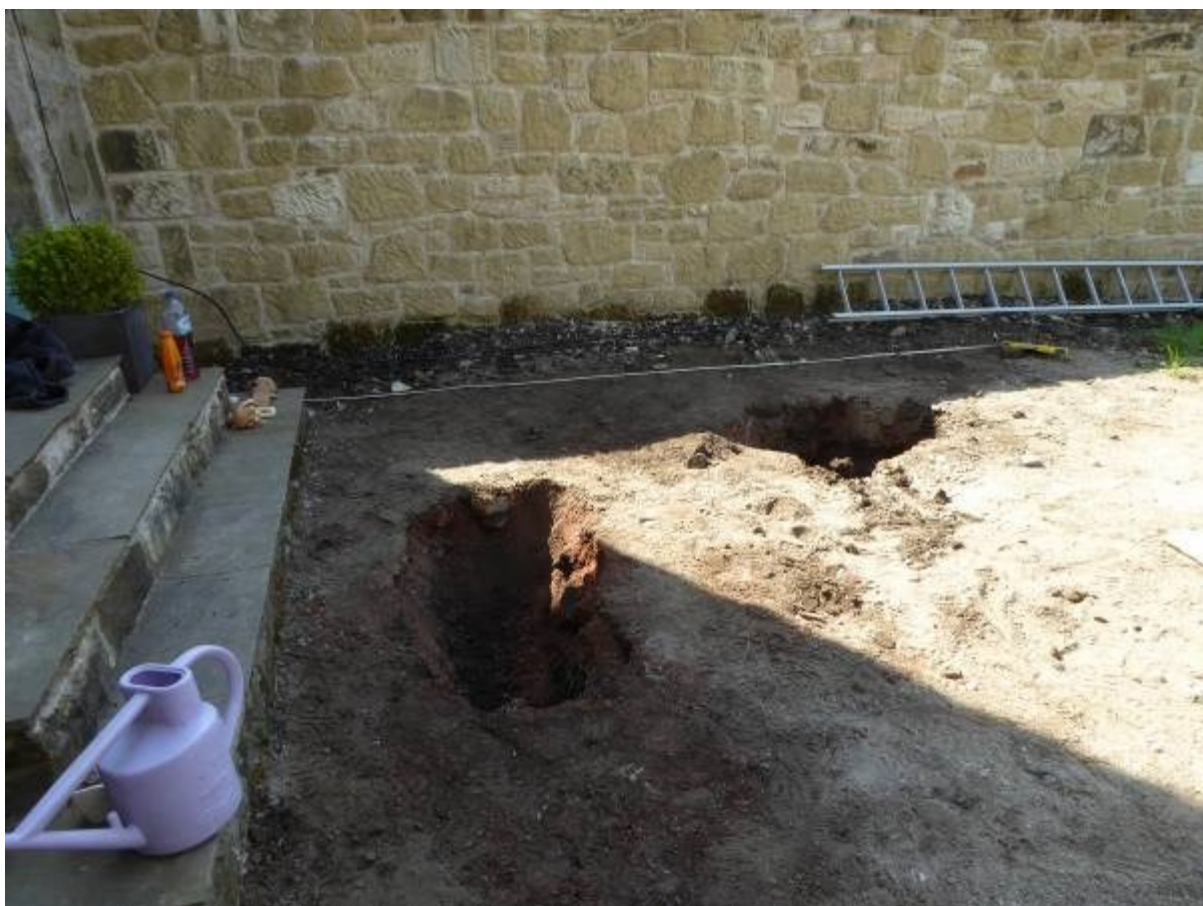
Illustration 6 General view of test pits 1 and 2 looking South

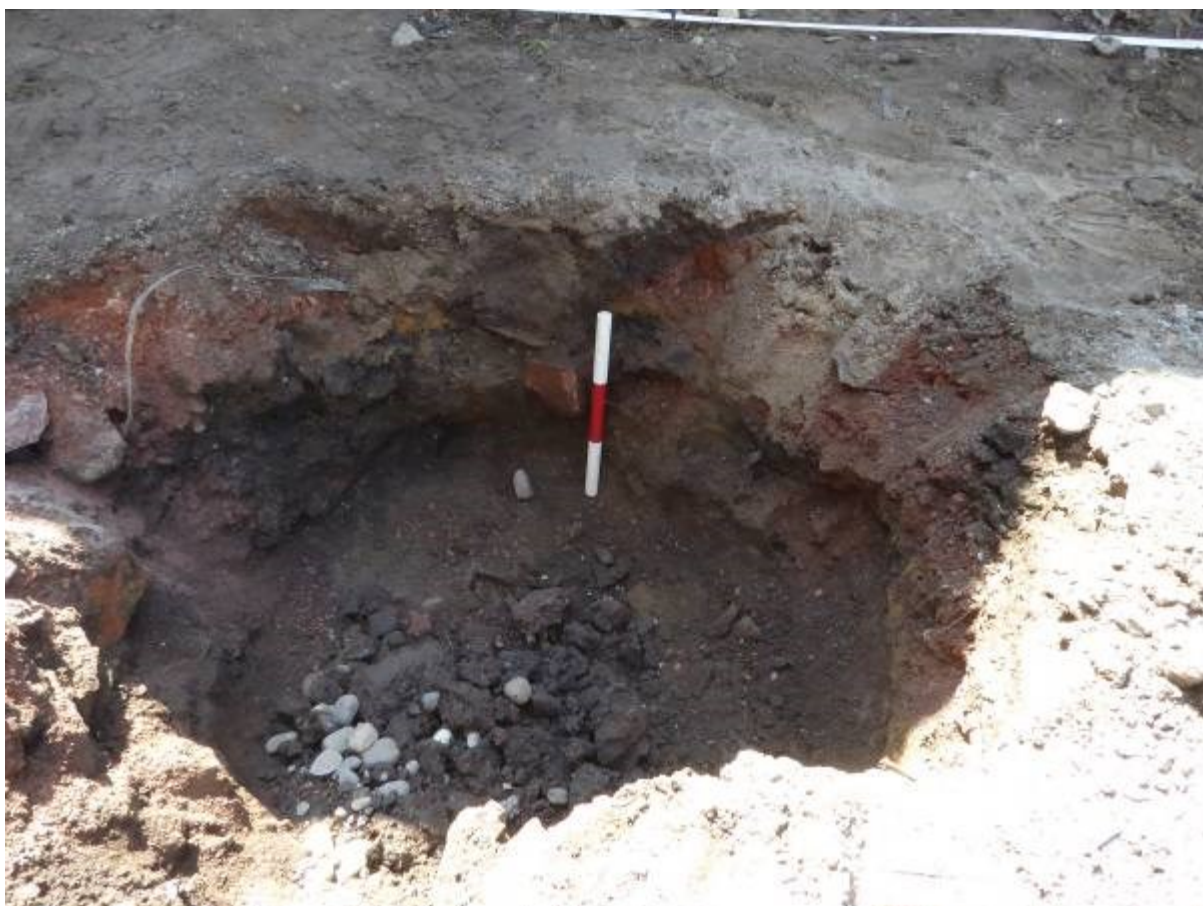
Test Pit 1 measured 1.25m by 0.70m and was dug to a depth of 0.60m. A deposit of 0.20m of loose broken stone and concrete fragments (1) overlay 0.40m of grey black sandy clay (2). At the bottom of this test pit a 20th century brown glazed waste pipe running from the current house was located (3). The only find recovered from this trench was a sherd of Standard White Earthenware from the base of a vessel; this ceramic was of early modern date.

Illustration 7 Excavated Test Pit no 1 looking South

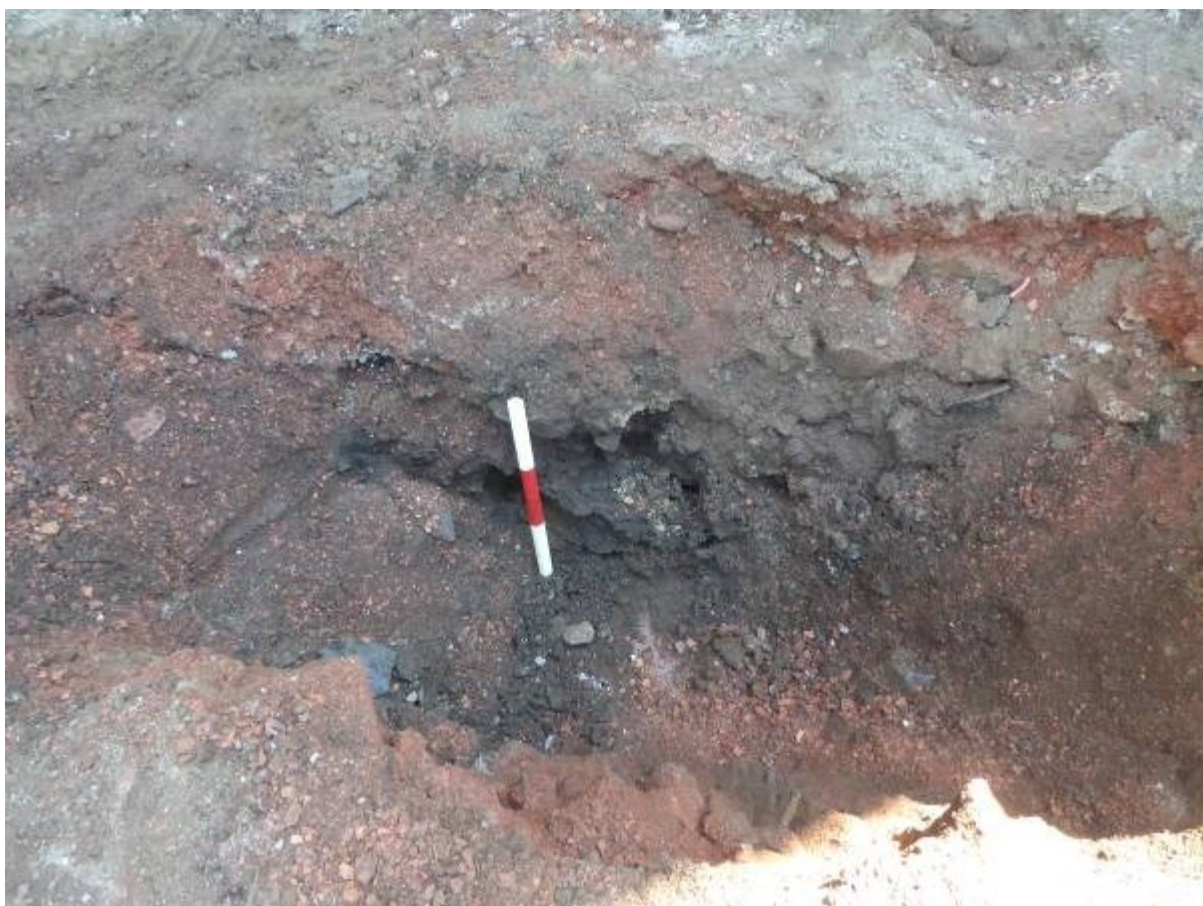
Test Pit 2 measured 0.60m by 0.80m and was dug to a depth of 0.51m. A deposit of 0.19m of grey black sandy clay (4) overlay 0.10m of broken red bricks (5) which overlay 0.22m of broken stone and clay (6). The only find from this trench was a 19th century brass poker with a leather bound handle (Illus 9).

Illustration 8 Excavated Test Pit no 2 looking South

All of the deposits encountered in the test pitting of the footprint of the house extension date to the 19th/20th centuries and there was no trace of any residual material. The layer of broken stone and clay at the base of Test Pit 2 looked like it was a deliberately laid surface and may represent the courtyard area shown on the 19th century Ordnance Survey map (Illus 2).

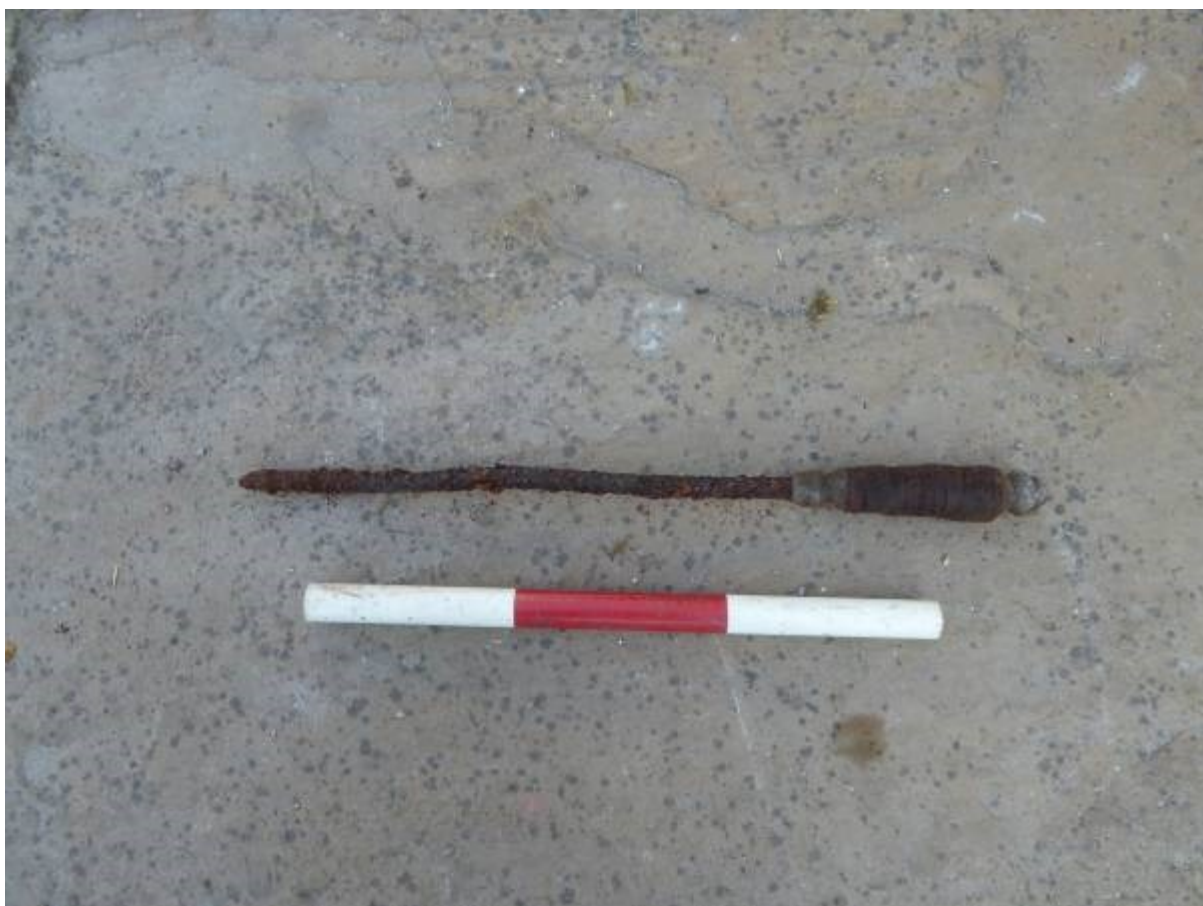
Illustration 9 Poker with leather bound handle from Test Pit 1

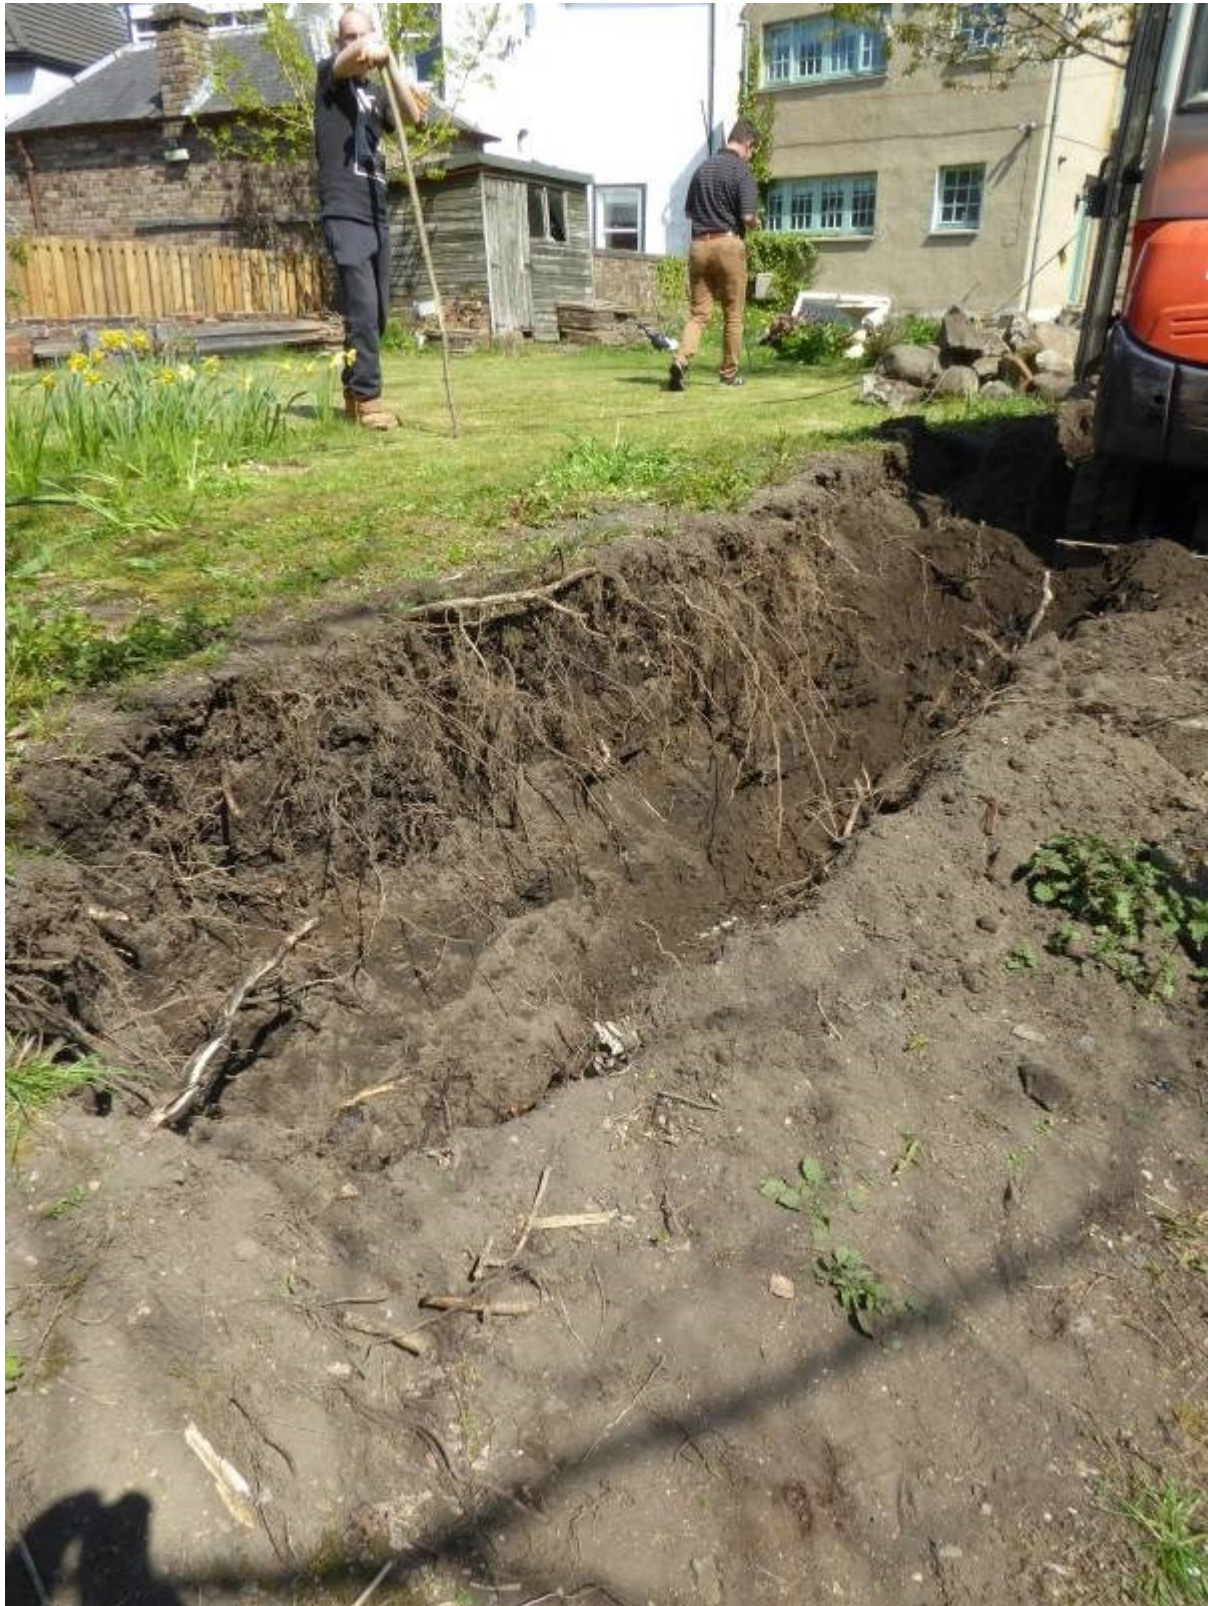
This trench was 0.60m wide and 7m long and was dug to a depth of 1.10m at its western end and 0.60m at its eastern end. A deposit of 0.57m of very rooty dark grey black sandy loam topsoil (100) overlay 0.16m of light brown sandy clay (101) which overlay 0.39m of grey brown silty clay (102). 102 sealed a deposit of former building stones most of which had mortar on their faces (103). Finds from this trench included bottle glass, window glass and broken waste pipe fragments all of which are of early modern date.

Illustration 10 South facing section of Northern foundation trench for garage looking North East

The back garden of this property appears to have been artificially raised by at least 0.50m by the dumping of soil deposit 100. That deposit overlay light brown sandy clay 101 which resembles an old ground surface. The stone dump (103 and 201) appears to have been laid down to create a roadway leading to the electricity substation to the rear of the site (built in the 1950's). All finds recovered were of a date no earlier than the 19th century.

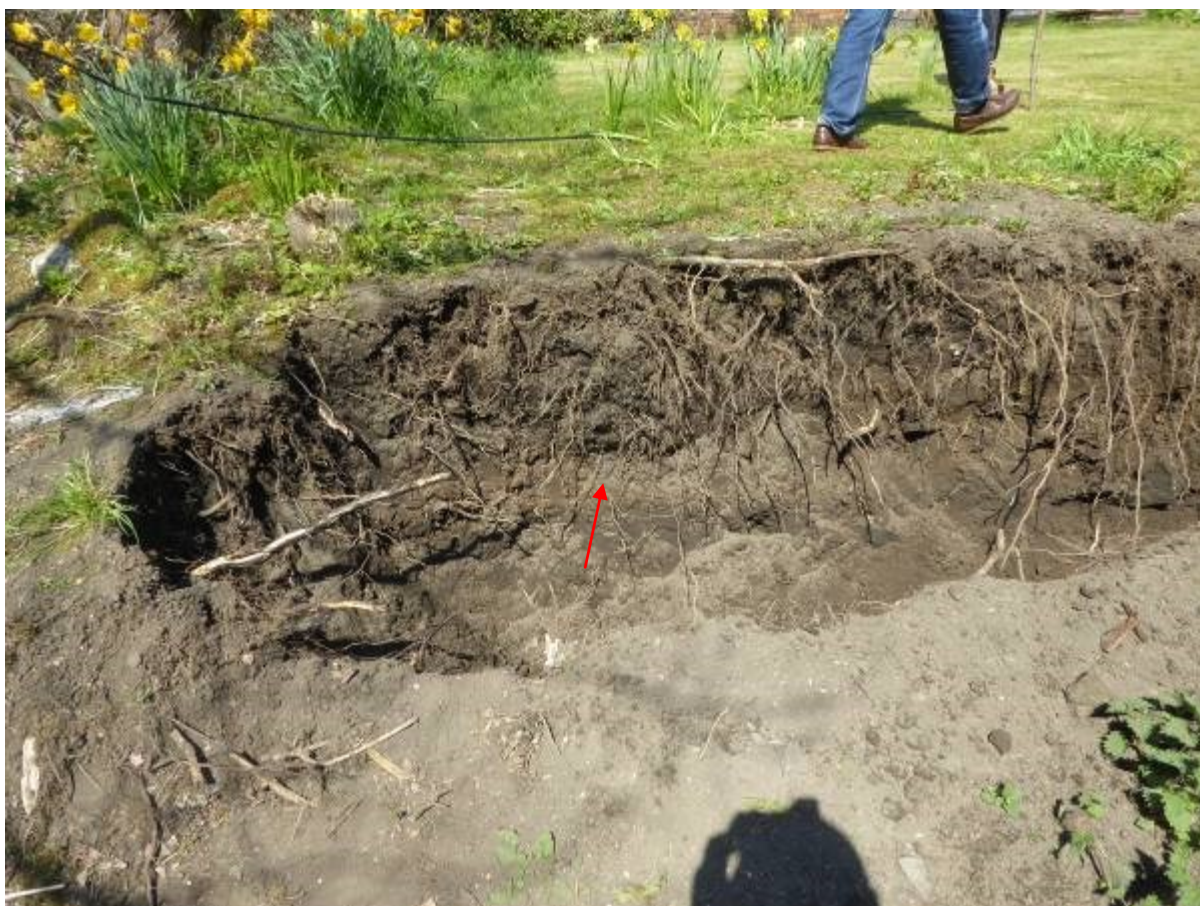
Illustration 11 Detail of South facing section for Northern foundation trench showing potential buried Old Ground Surface 101 (red arrow)

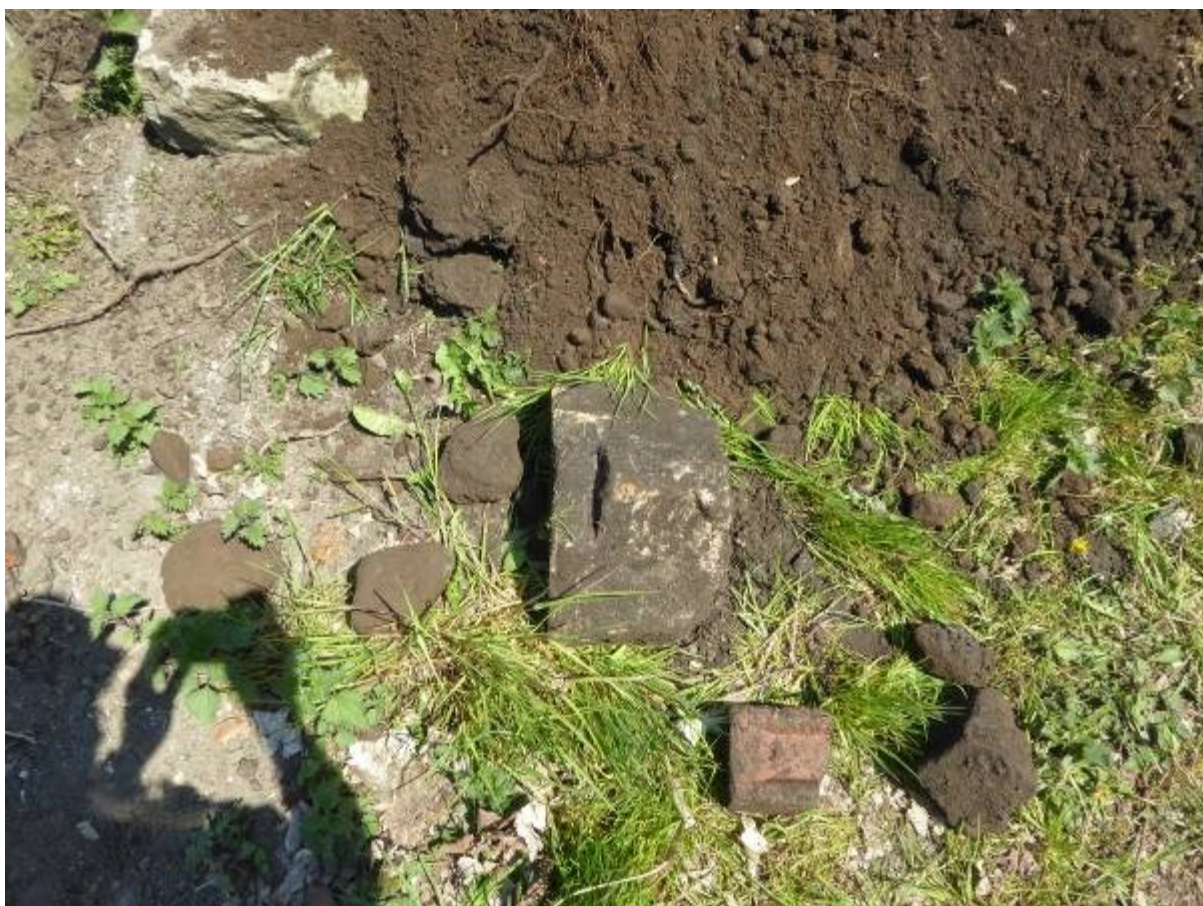
Illustration 12 Reused building stone from Context 103 in Northern foundation trench for garage

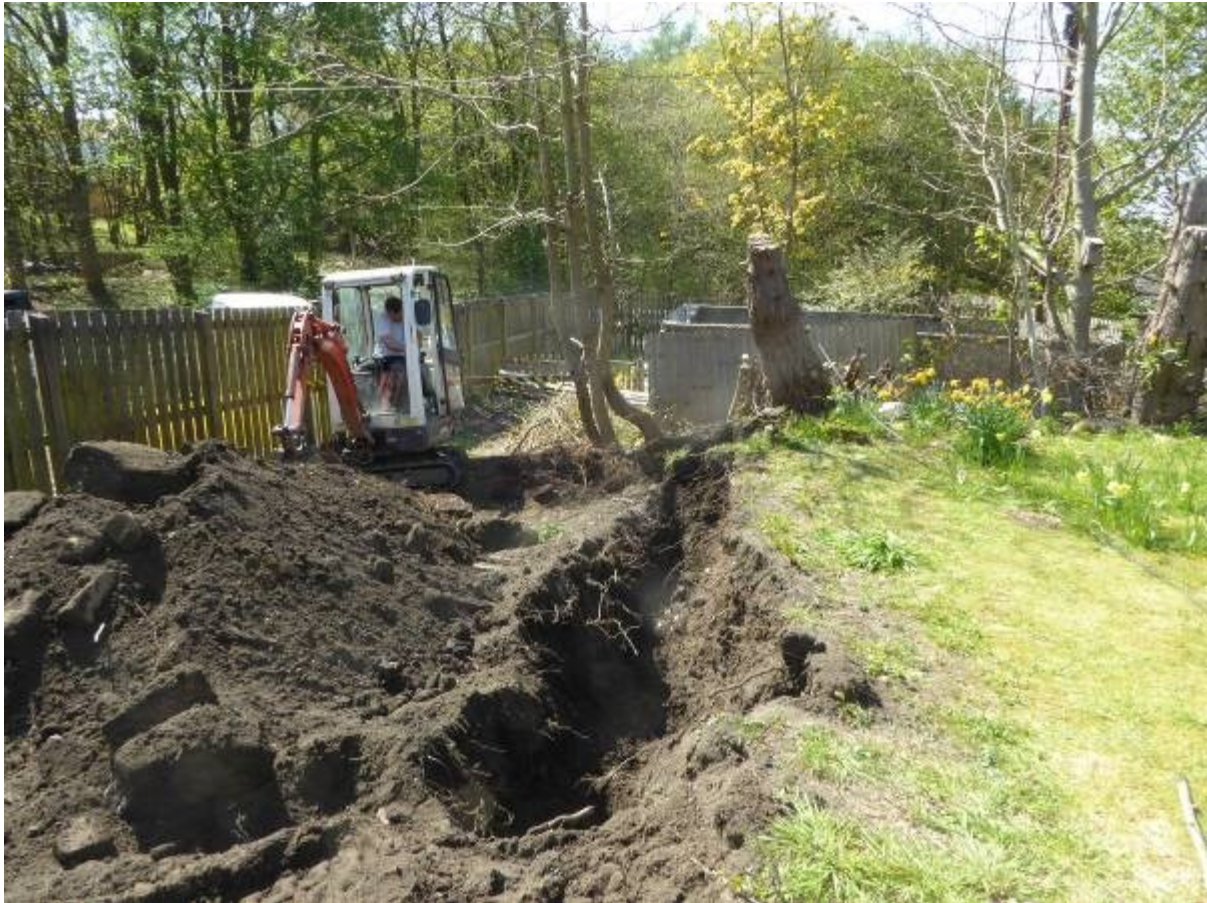
This trench was 0.60m wide and 4m long and 0.70m deep. A deposit of 0.40m of dark brown sandy clay (200) overlay a continuation of the dump of building stones encountered in the Northern foundation trench (201) which continued until formation level was reached. There were no finds from this trench.

Illustration 13 Excavated Northern and Western foundation trenches for garage looking West with electricity substation in the background
