Archaeological Watching Brief

Stobhall Castle, Perth and Kinross

2nd November 2018

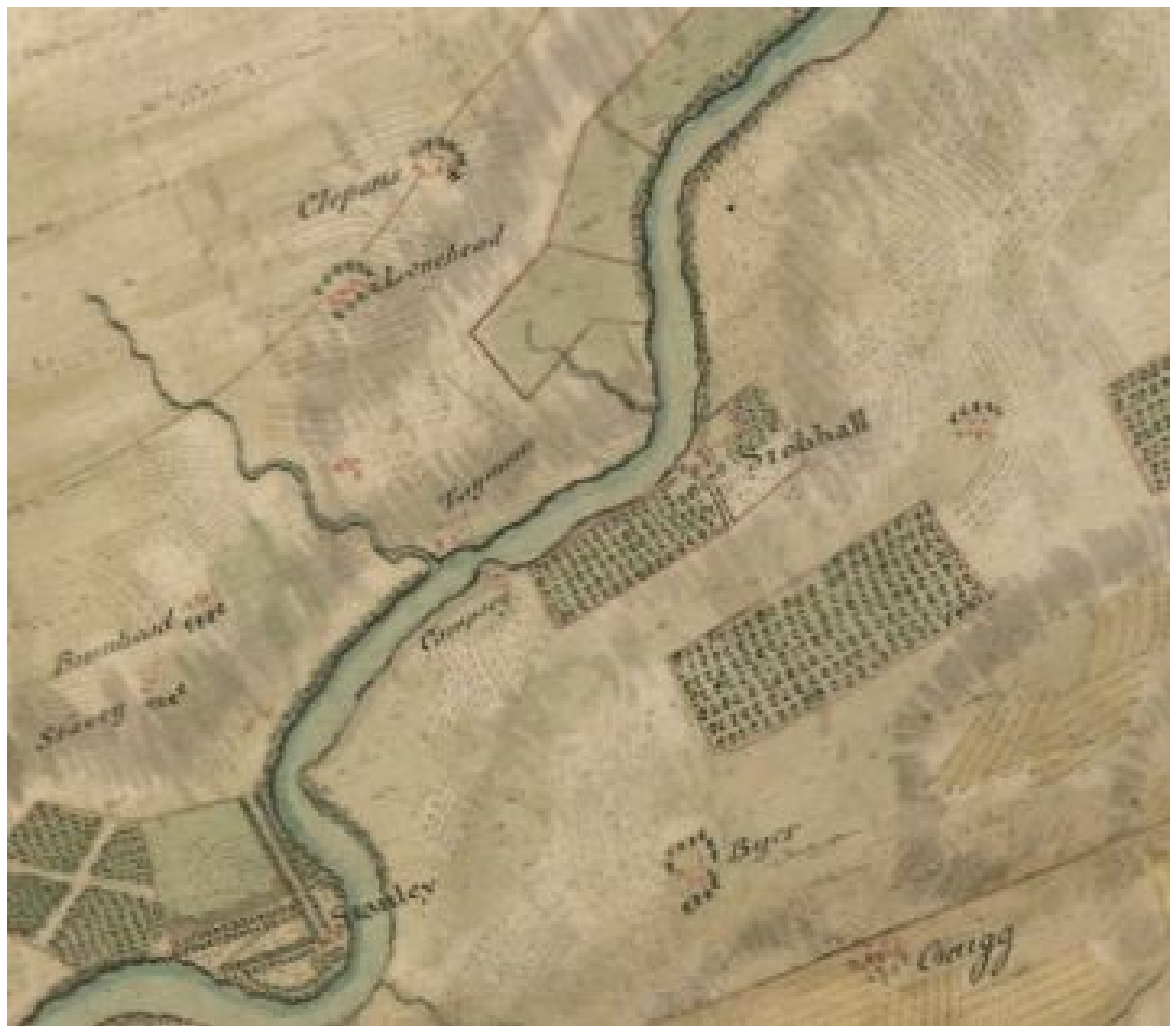
Illustration 2- Stobhall Castle as shown on William Roy's 'Military Survey of Scotland', 1747-55 (© Trustees of National Library of Scotland)

Historic records suggest that the promontory at Stobhall has been in use since at least the 1300's and it is likely that a form of defensive settlement existed here prior to this. The castle of Stobhall comprises four buildings (the tower-house -built early in the 17th century, a chapel block-containing a chapel and dwelling house, built in the late 16th century, and a laundry block and another domestic range, both later buildings) all within an irregular courtyard wall (Illus 3). The archaeological potential for recovery of deposits that pre-date these buildings was unknown as no archaeological investigation had taken place previously at Stobhall. However, it has been suggested that Stobhall succeeded Castle Hill, a medieval defensive site north of Cargill, as the local seat of power.

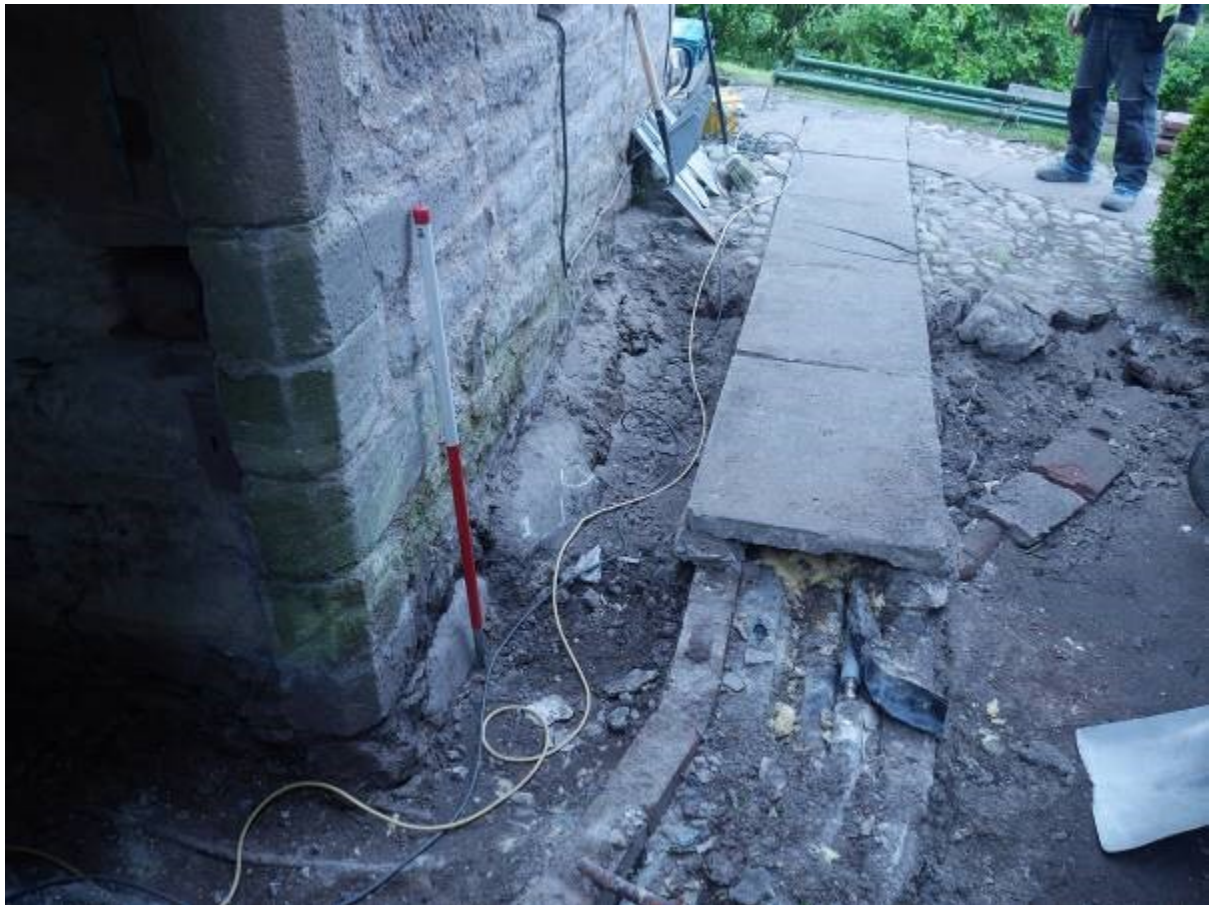
Illustration 5- Lower foundations for tower house (context 102) looking West

The removal of stone cobbles and slabs by mini excavator in the open area between the laundry and tower house was monitored. The cobbles and slabs (100) were 0.07m deep and overlay a dark grey brown sandy clay (101). 101 was excavated to a new formation level of 0.40m below the original cobbled surface. The foundations for the tower house were exposed (102) and these were comprised of large rounded boulders bonded with a red brown clay (Illus 5). A similar foundation was also exposed for the laundry building (103) (Illus 6). The only finds recovered from 101 were pieces of fired clay field drain of a late 19th c / early 20th c date. These excavations also exposed a concrete lined pipe box (104) which ran East to meet another concrete lined pipe box (105) running between the laundry building and the tower house. Both pipe boxes were removed in order to relay the service pipes. The removal of pipe box 105 which ran into the tower house exposed an ornate arched doorway (106) leading into the lower sub-basement level of the chapel (Illus 7 to 9). There were no finds from the excavation of the pipe boxes.

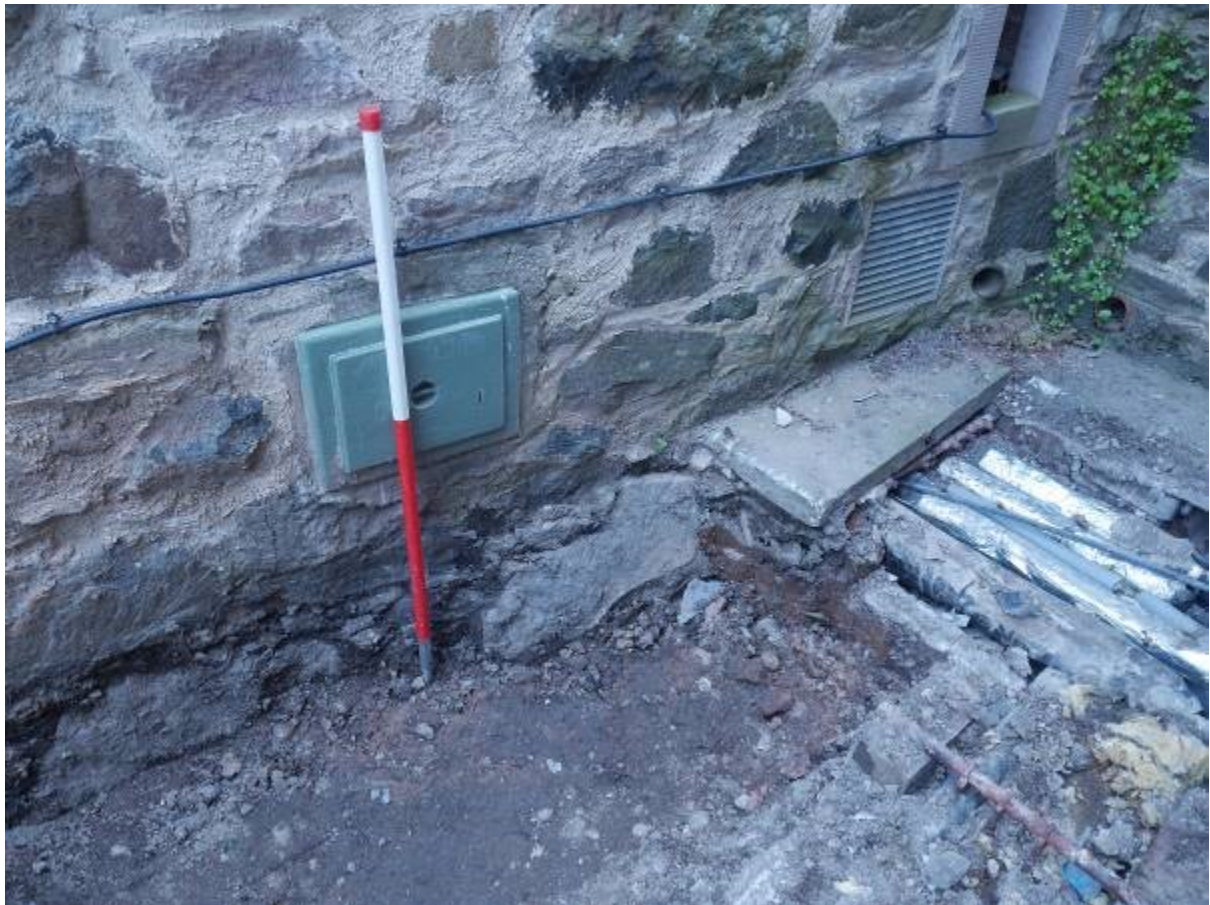
Illustration 6- Lower foundations for laundry building (Context 103) looking North

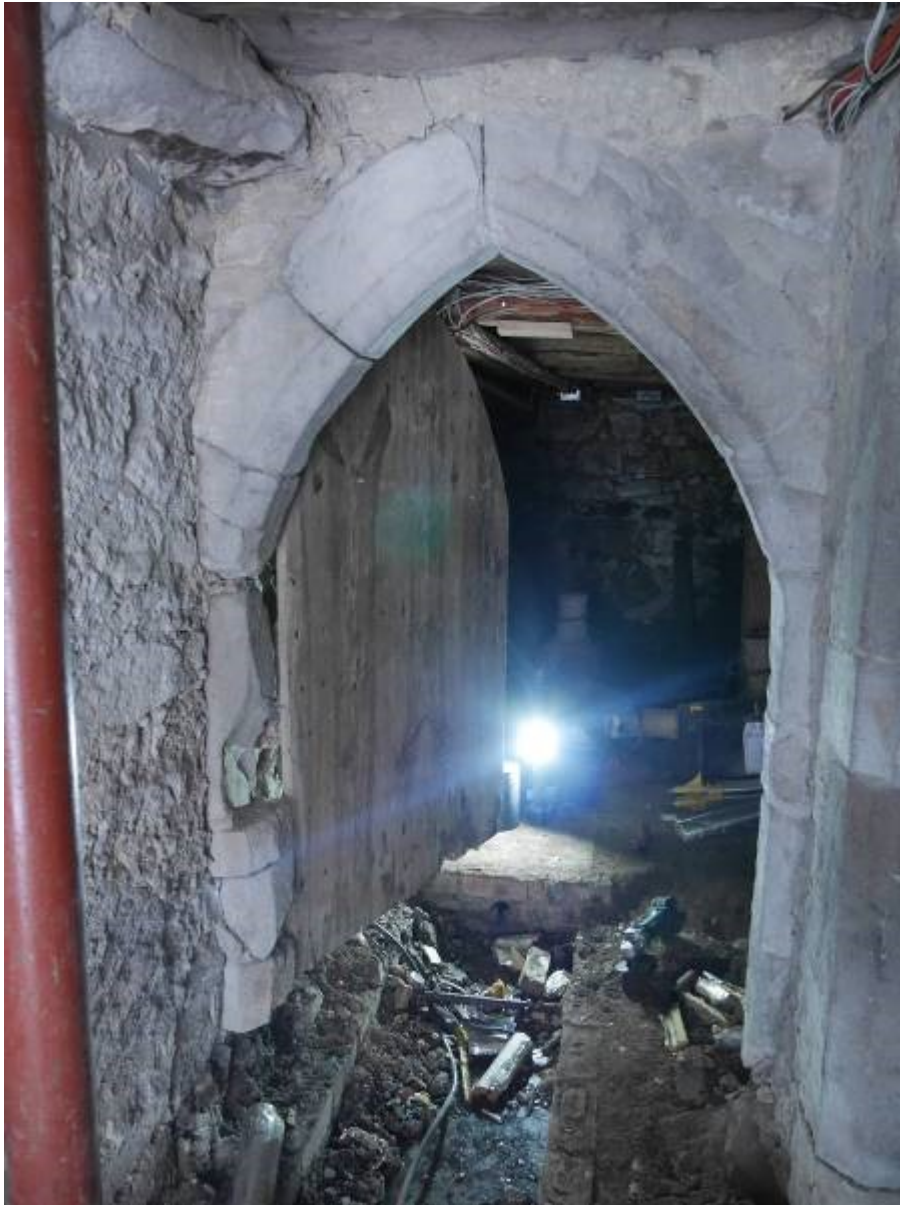
Illustration 7- Arched doorway (Context 106) into Chapel building looking South

Of most interest in this monitoring exercise is the arched doorway (106) that was exposed leading into the lower sub-basement level of the chapel. It was obvious that the tower house had been built partly over this doorway indicating that the chapel is the earliest building in this part of the castle complex. All of the other deposits exposed and excavated would appear to be of early modern date, the demolished larder building was quite clearly of a recent date.

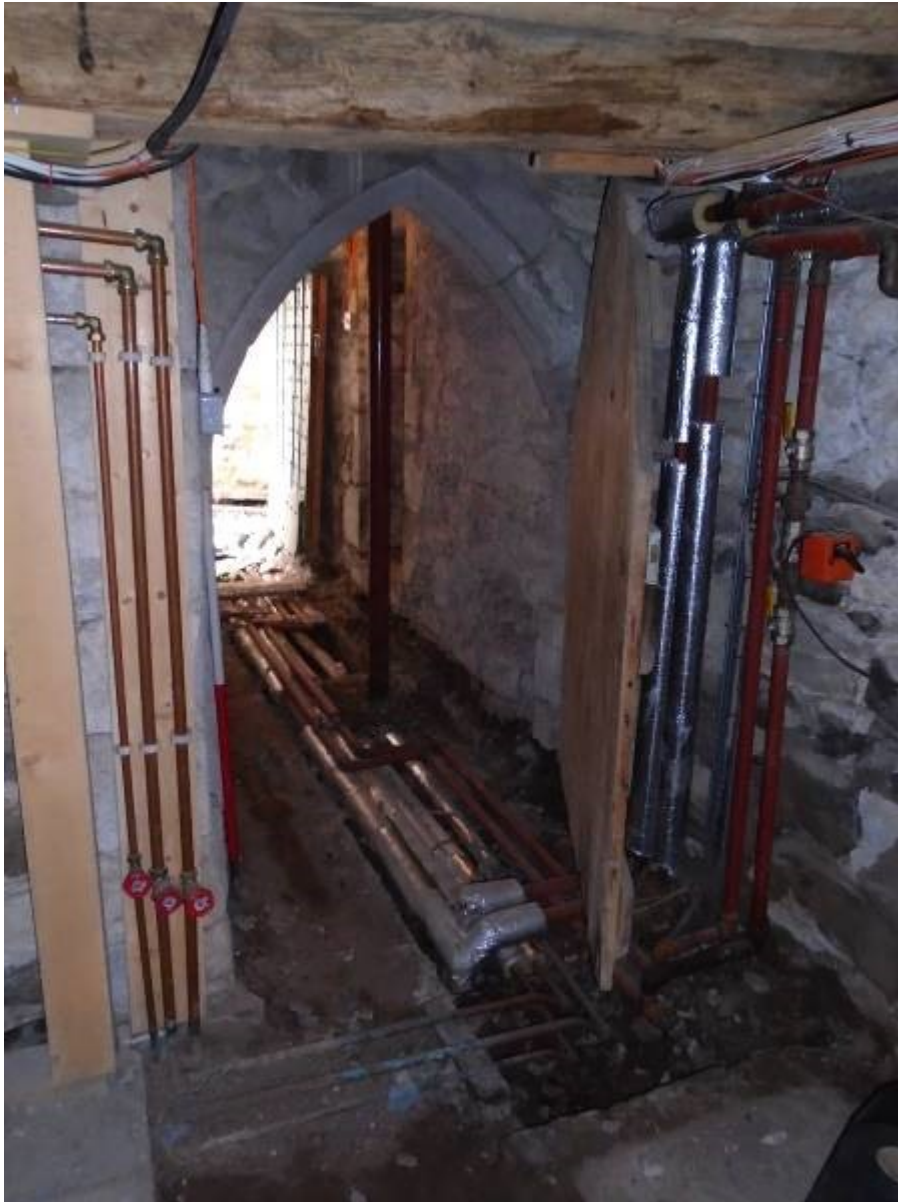
Illustration 8- Arched doorway (Context 106) into Chapel building looking North

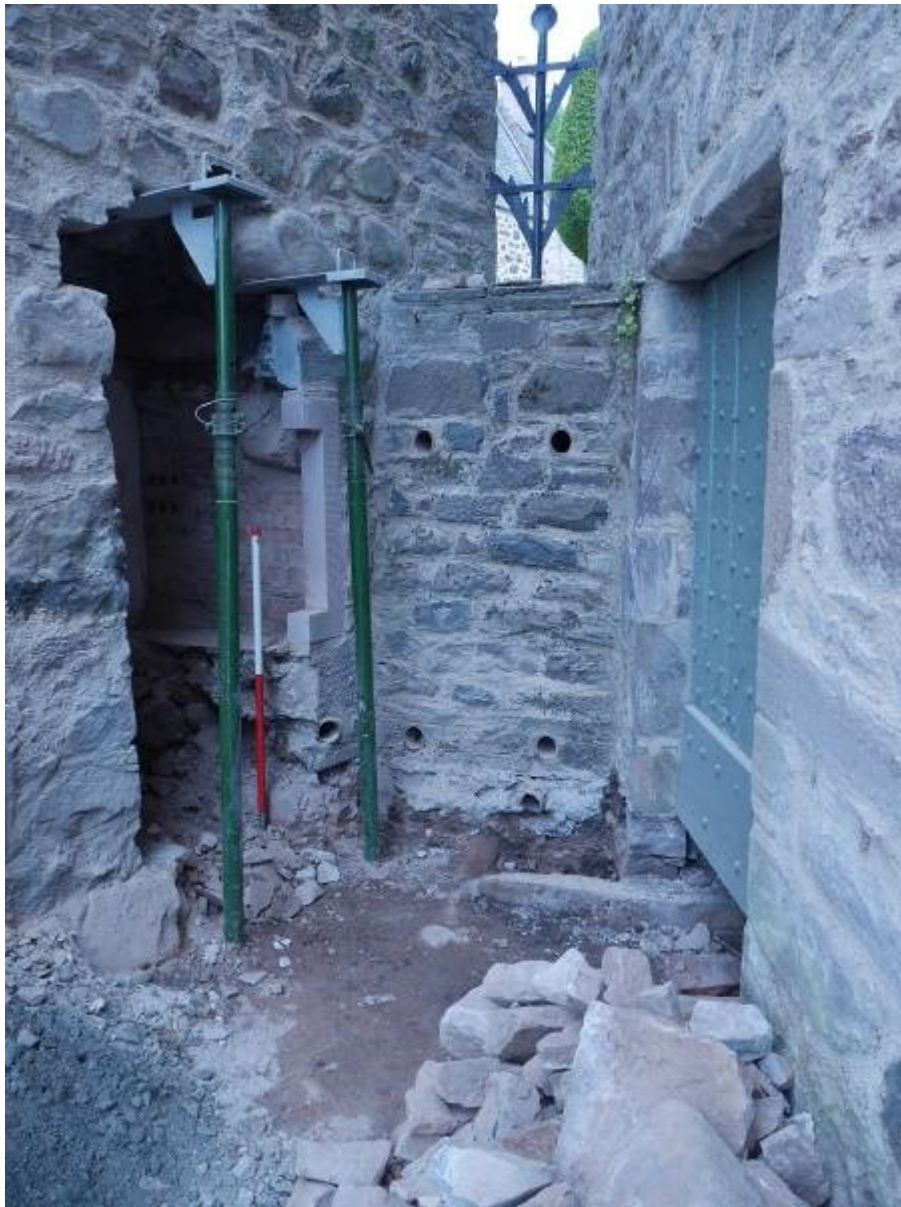
Illustration 10- New doorway into Laundry looking North East

A new doorway measuring 1.90m by 0.80m was cut into the South wall of the laundry building and this exposed a wall core comprised of rounded stones bonded with an orange brown clay (107) (Illus

10 and 11). The pipe box (105) continued into the laundry building through the foundation course of the wall. There were no finds.

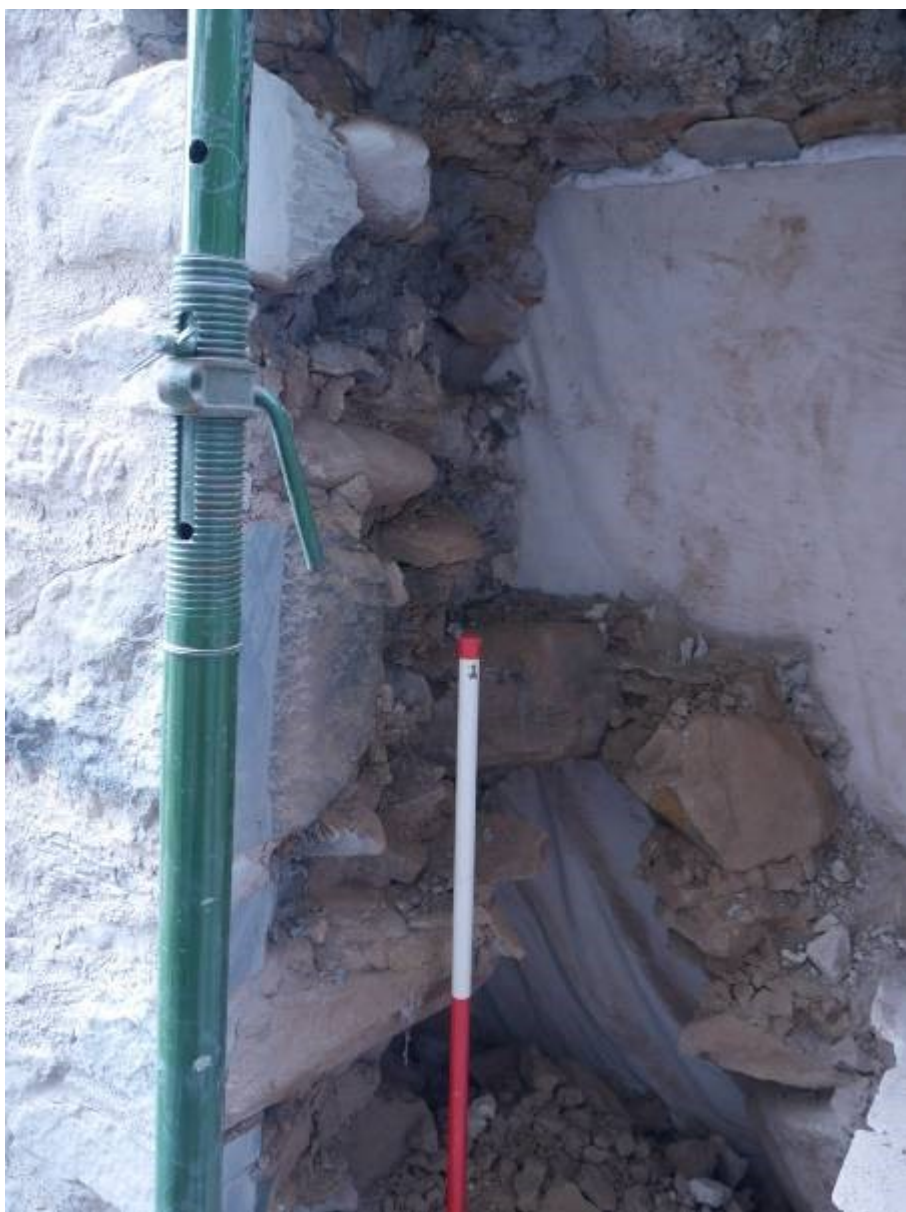
Illustration 11- Exposed wall core for South wall of Laundry building looking North

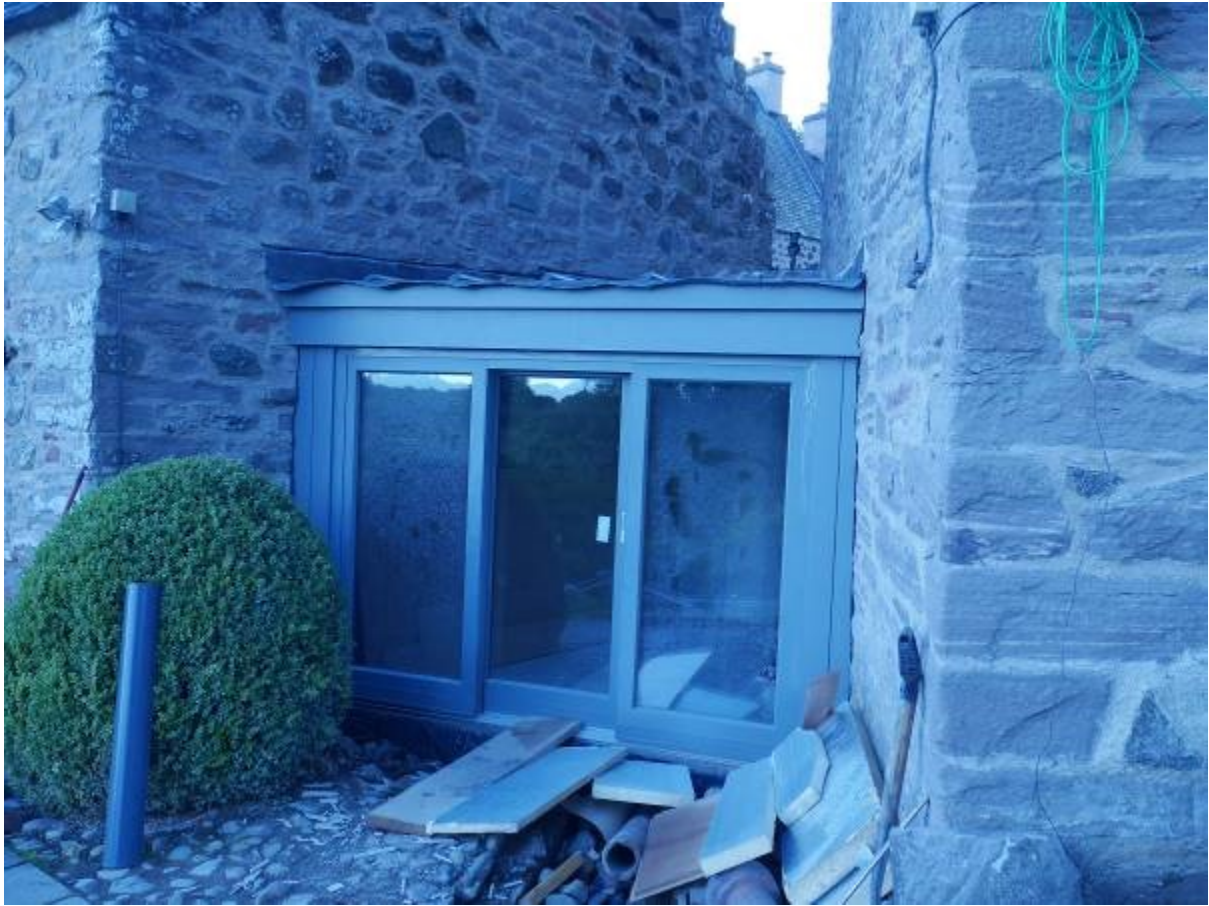
Illustration 12- new covered walkway in place looking North East

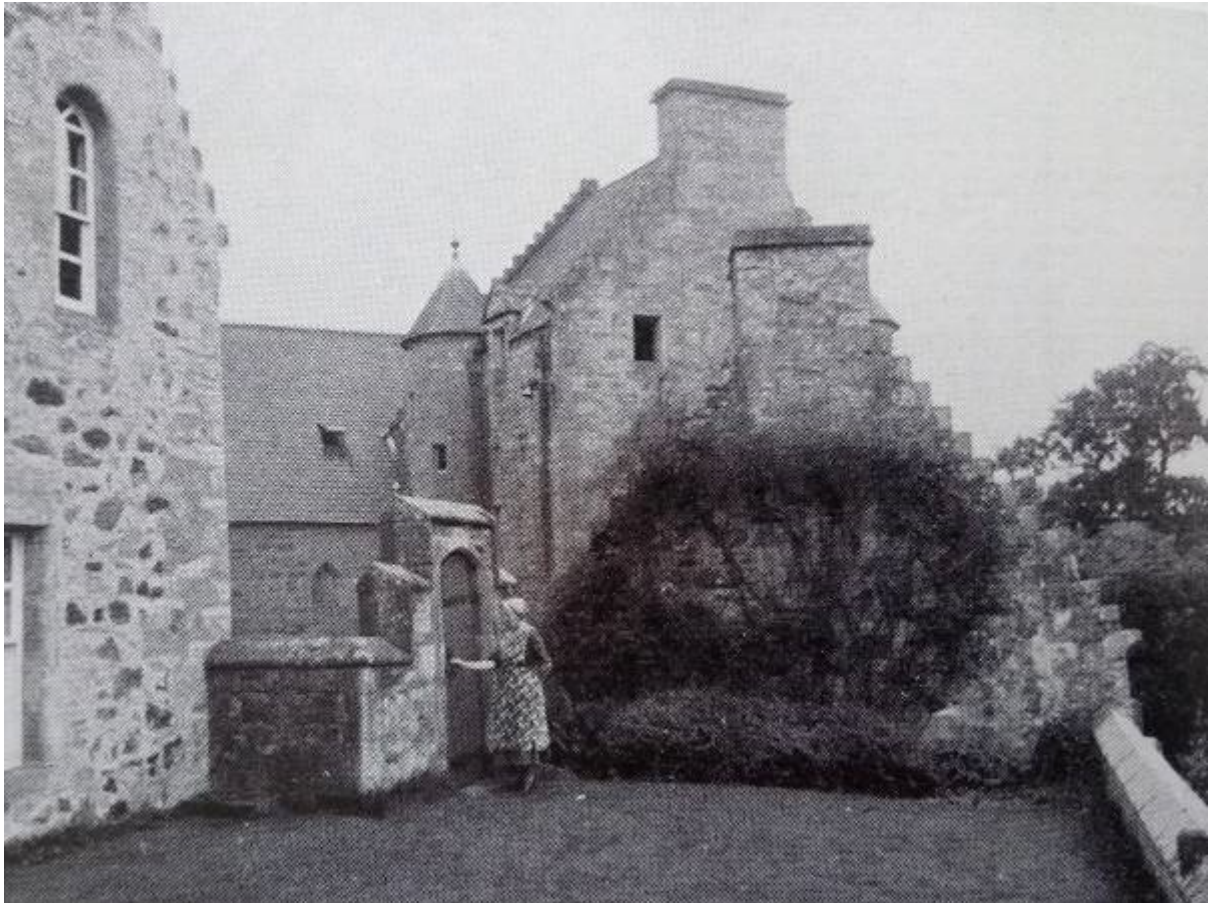
Illustration 13- Laundry building from the North in 1938 prior to later construction of larder and connecting passage with Dower House (to the left) (from *Shrines and Homes of Scotland* by Sir John Stirling Maxwell (1937))

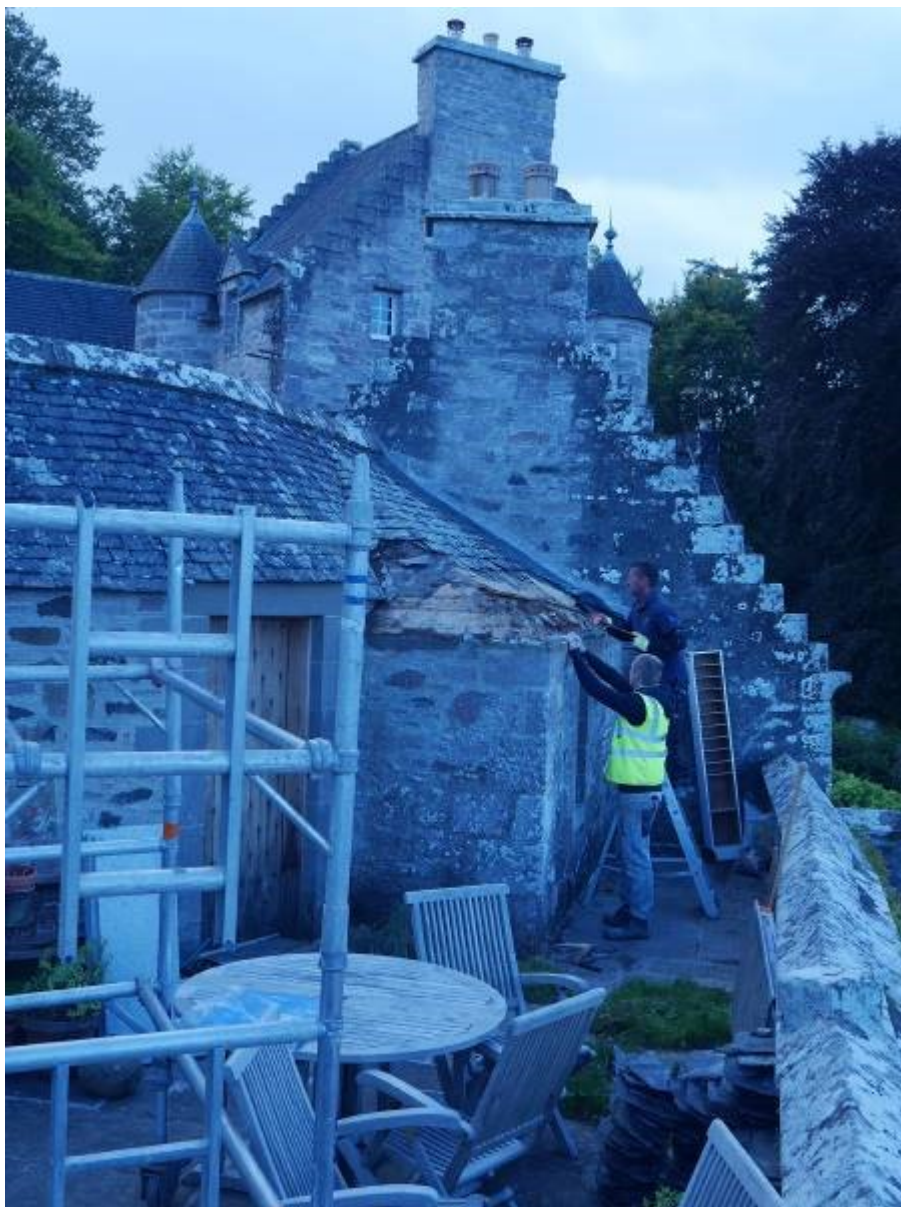
Illustration 14- Larder in process of demolition looking South

The larder building was seen to be butted against the North wall of the laundry building. The formation level for the proposed new conservatory area lay at a depth of 0.40m below the existing concrete floor (200) of the larder building. The concrete floor (200) was 0.20m thick and overlay a thick orange brown clay with stones and mortar flecks (201). The top and edge of a different wall foundation (202) was exposed running North under the riverside wall for a length of 2.7m. There were no finds.
