Standing Building Survey
Shannoch Farmhouse, Logiealmond,
Perth and Kinross

20th September 2018

Introduction

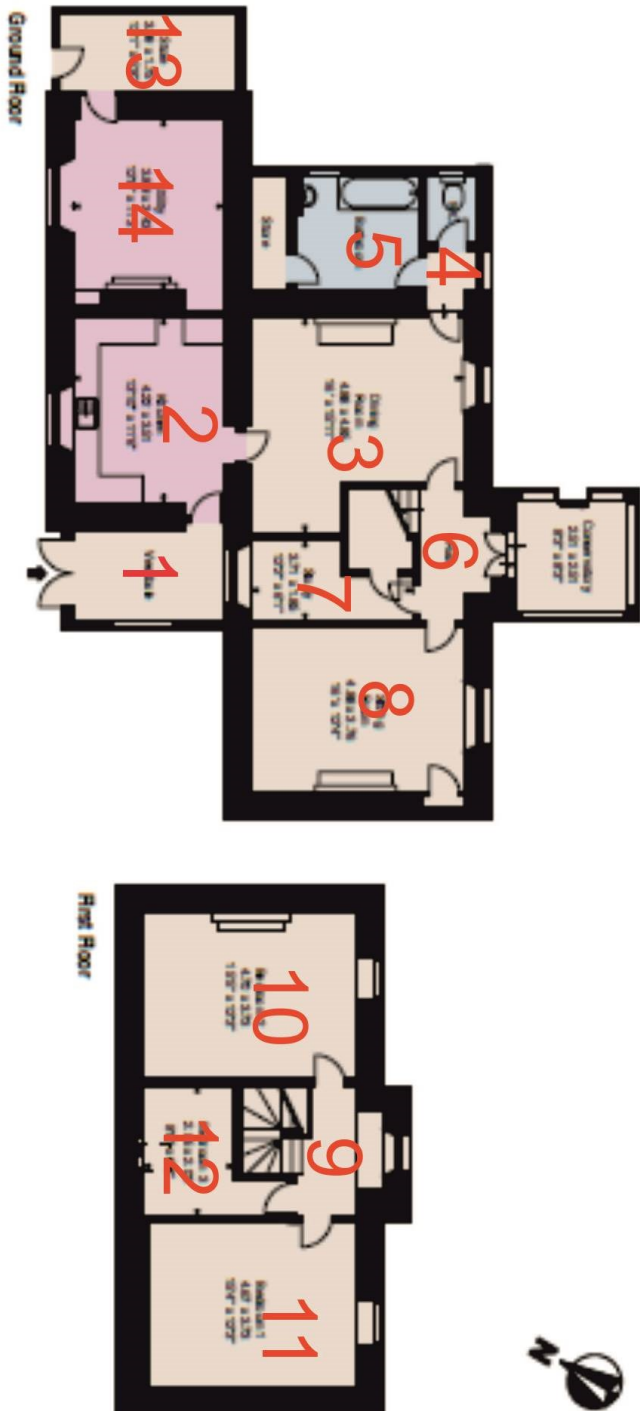
Illustration 5 Ground and upper floor plans of Shannoch Farmhouse (numbers refer to text descriptions of rooms) (based on Saville’s sale plans)

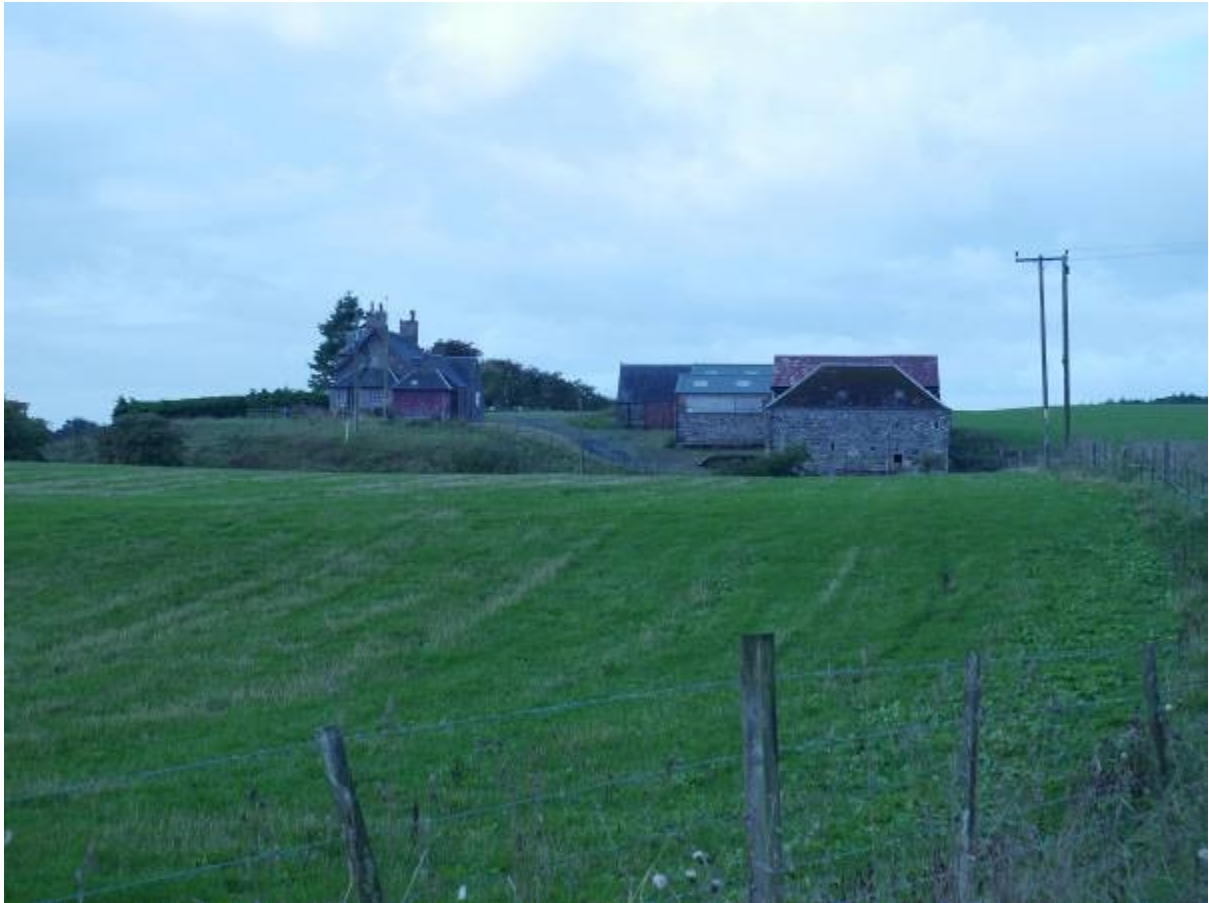
Illustration 6-Shannoch Farmhouse and steadings looking West (mill building to left of telegraph poles)

Shannoch Farm lies on elevated ground to the West of the road to Little Glenshee. It is reached by a rough track that crosses the course of a burn. There is an associated group of farm steading buildings (including a mill) to the North of the farmhouse.

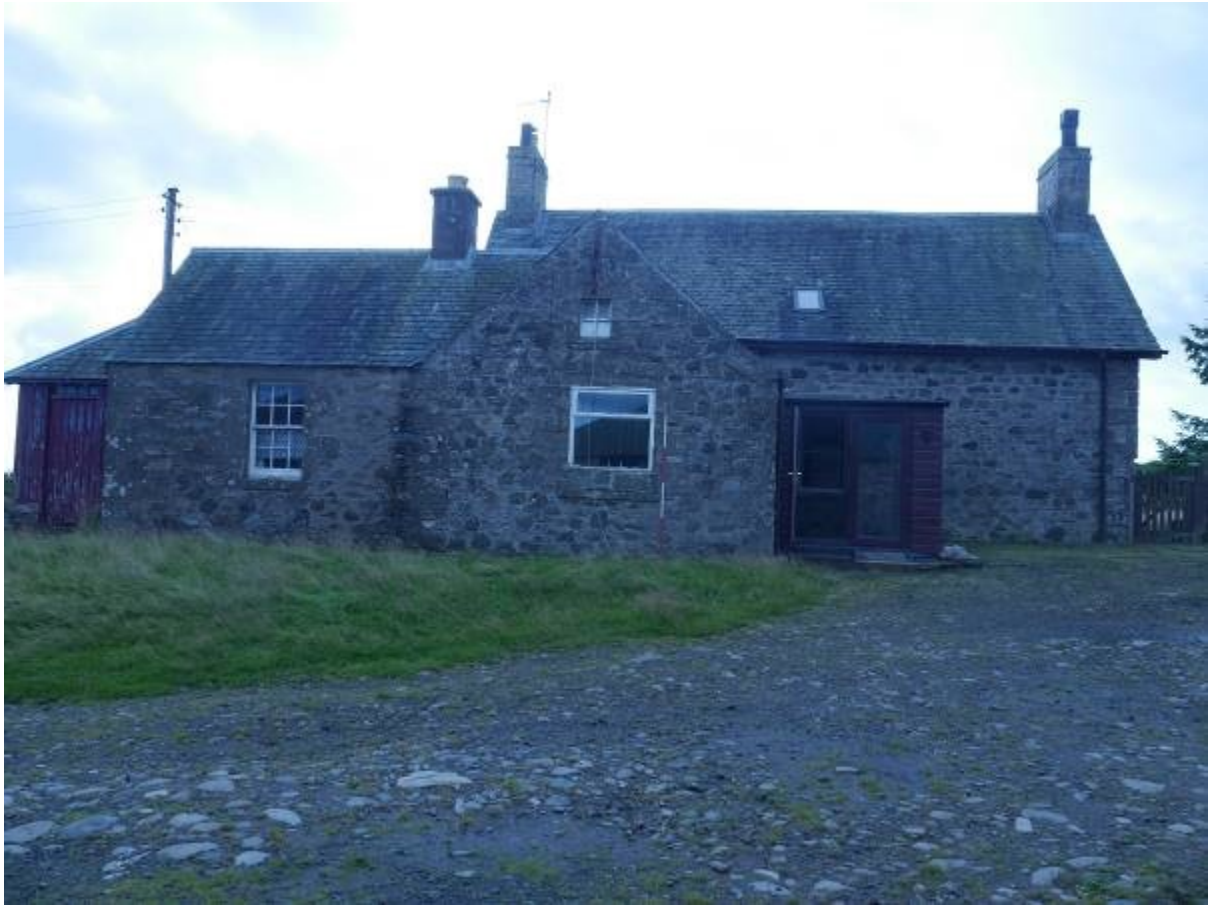
This elevation has a wooden shed (coal store) (13) at its Eastern end, this has a door leading into it. There is then a single window for the 'bothy' (14) which has been added to the original buildings Eastern gable, this structure has been built against the original Eastern external face of the farmhouse and the earlier shaped ashlar quoins on the corner are still visible. There is a brick built chimney in the 'bothy' roof. There is then a window for the farmhouse kitchen and then a modern wooden porch with a doorway. The porch covers a window for room 7 in the farmhouse. The remainder of this elevation is blank with shaped ashlar quoins at its western end corner.

Illustration 7-Northern elevation of farmhouse looking South

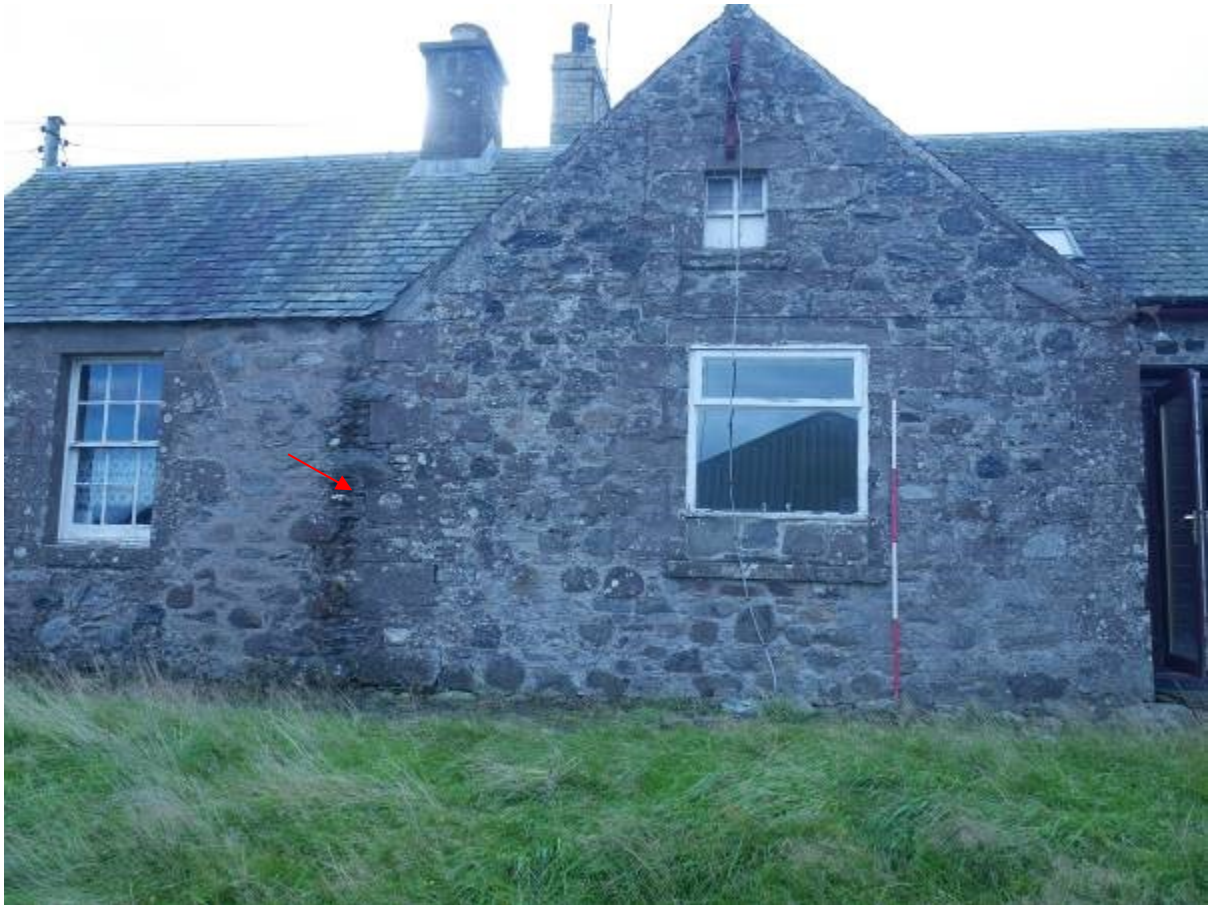
Illustration 8-Detail of Northern elevation showing junction of 'bothy' with original Eastern end of farmhouse, shaped ashlar quoins visible (red arrow)

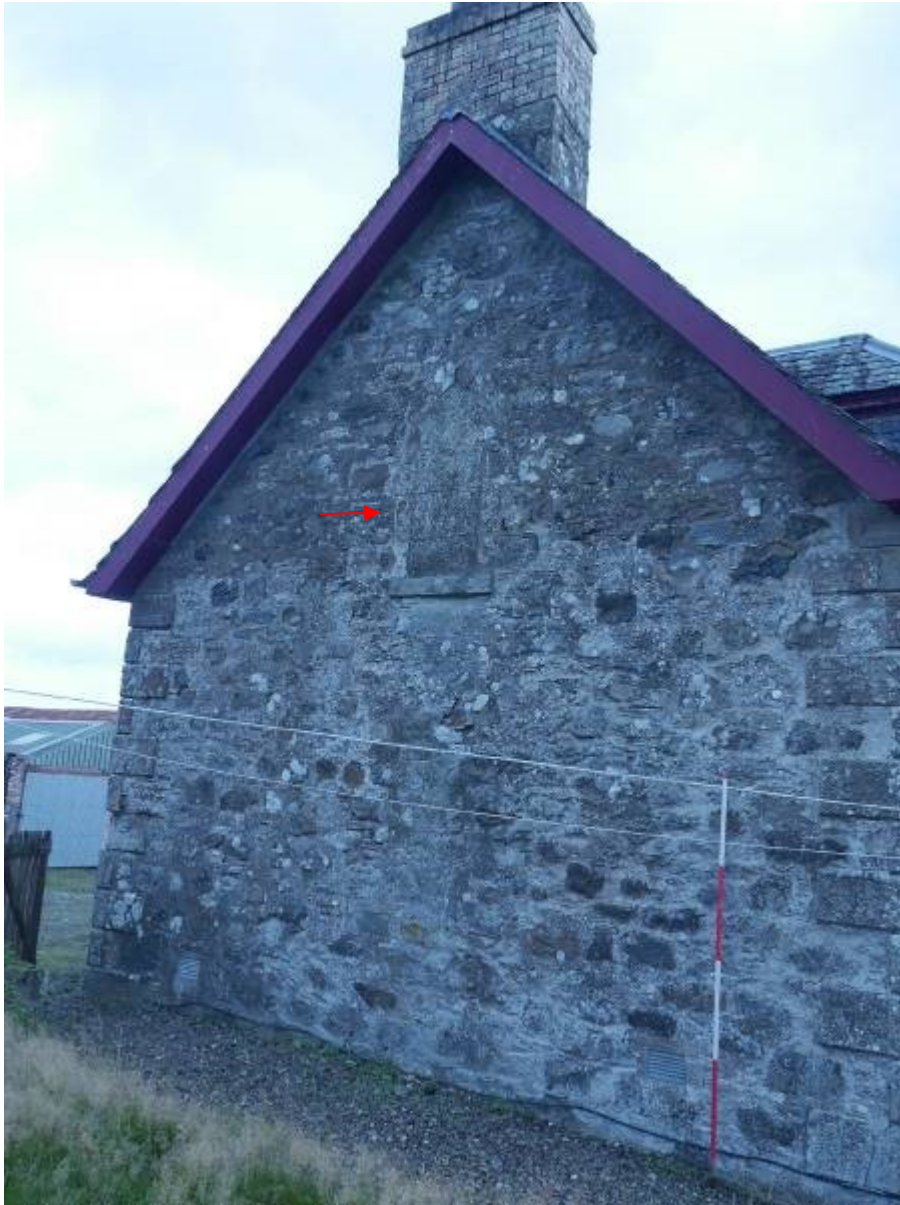
This elevation is the Western gable end of the farmhouse and is plain with shaped ashlar quoins at its Northern and Southern corners. There is a blocked window with a rounded arch at first floor level and a brick-built chimney at the point of the gable. The wooden flashings at the roof line are painted purple.

Illustration 9-Western elevation of farmhouse looking North East showing blocked arched window at first floor level (red arrow).

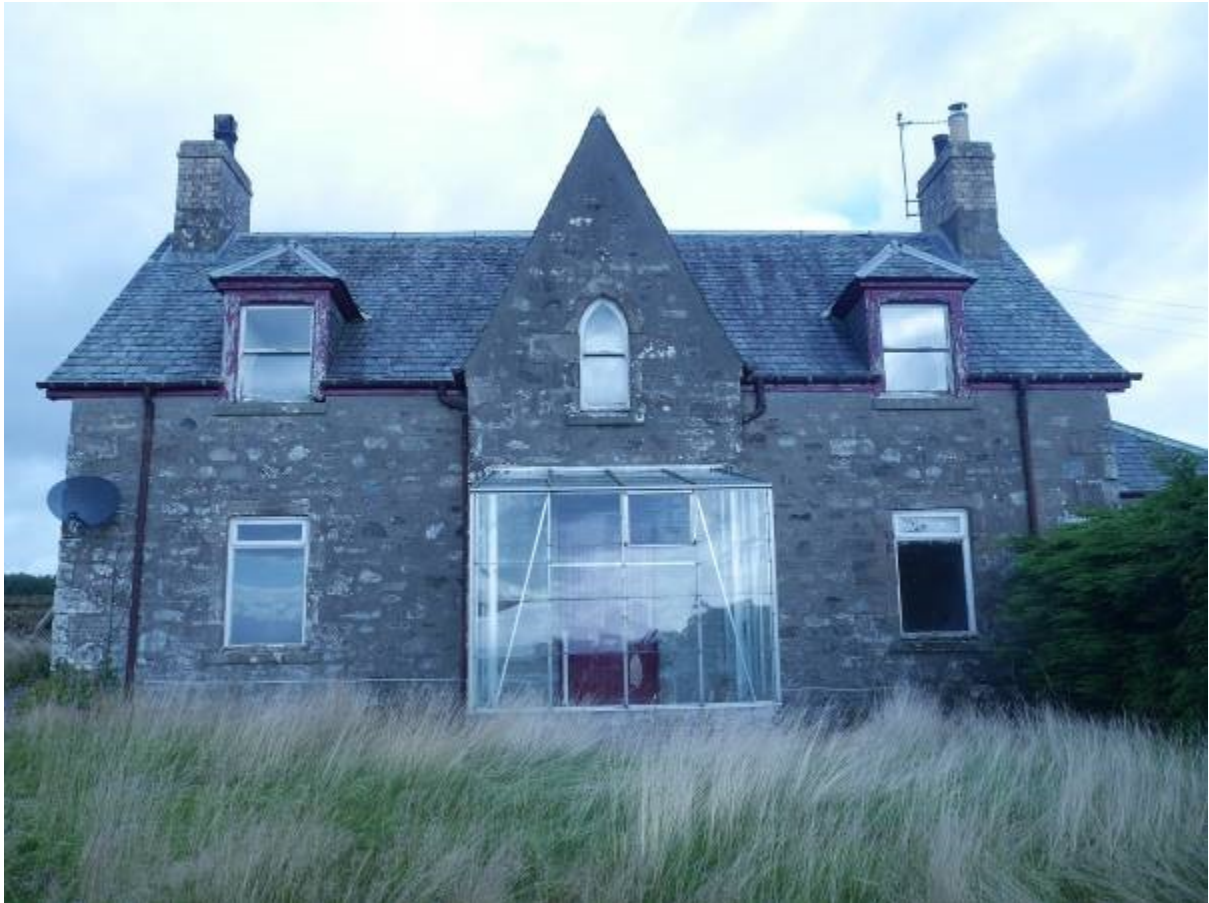
This elevation has shaped ashlar quoins at its Western and Eastern ends and a central pediment with a triangular gable. The pediment contains the original double entrance doors into the farmhouse from the South and has a window with a rounded arch. There are windows either side of the pediment for the ground floor rooms of the farmhouse and gable windows in the roof line for the rooms on the upper floor. There is a small greenhouse/conservatory covering the doorway into the farmhouse.

Illustration 10-Southern elevation of farmhouse showing central pediment with round arched window

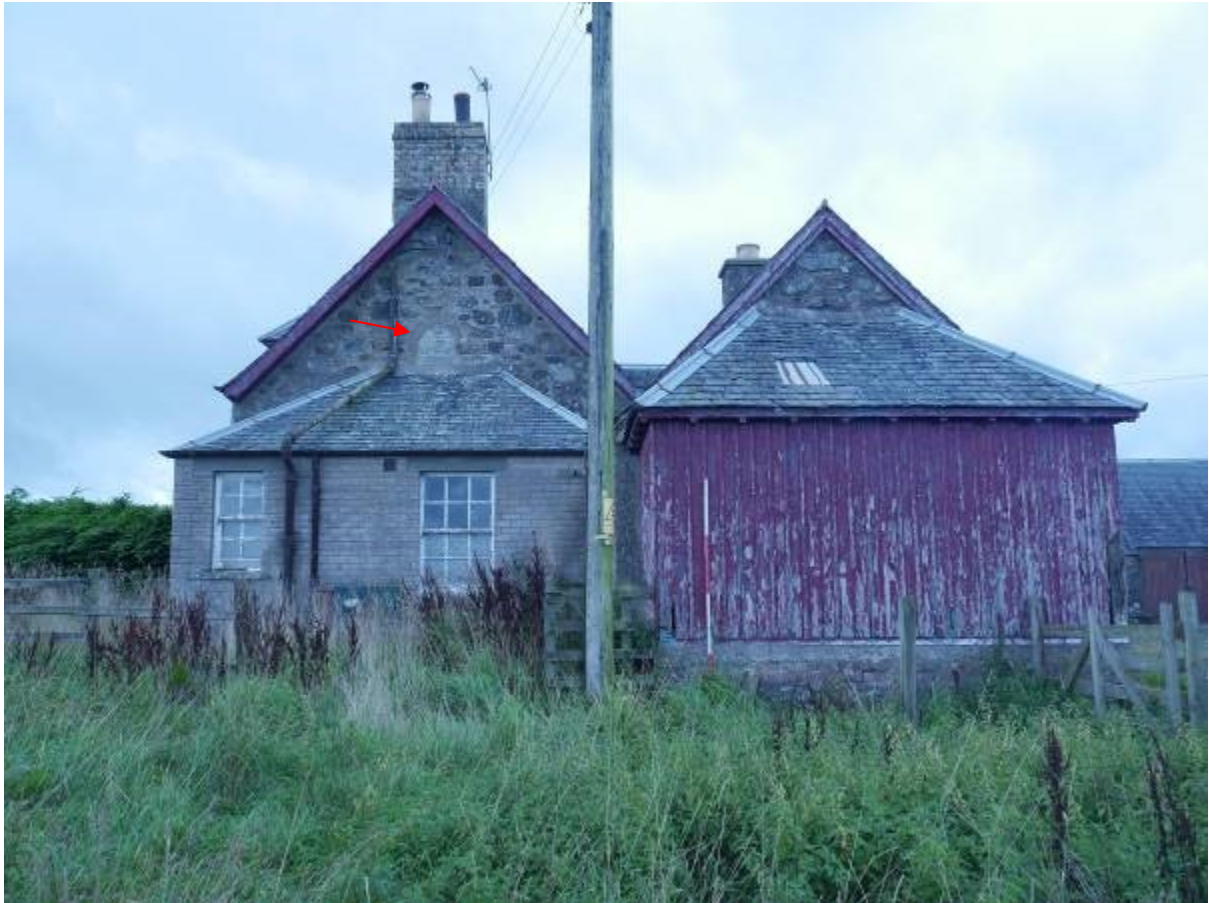
This elevation contains the gable end of the original farmhouse which has a blocked window with a rounded arch at first floor level. This original gable end has a brick-built chimney at its point and purple painted wooden flashings at the roof line. Built against this gable end are the brick-built rooms which contain the ground floor toilet and bathroom (5), both these rooms have windows in this elevation. The 'bothy' (14) has been built against the northern section of this elevation and the wooden shed (13) is built against the 'bothy's gable end.

Illustration 11-Eastern elevation of farmhouse looking West, blocked window with round headed arch visible behind later toilet/bathroom block (red arrow).

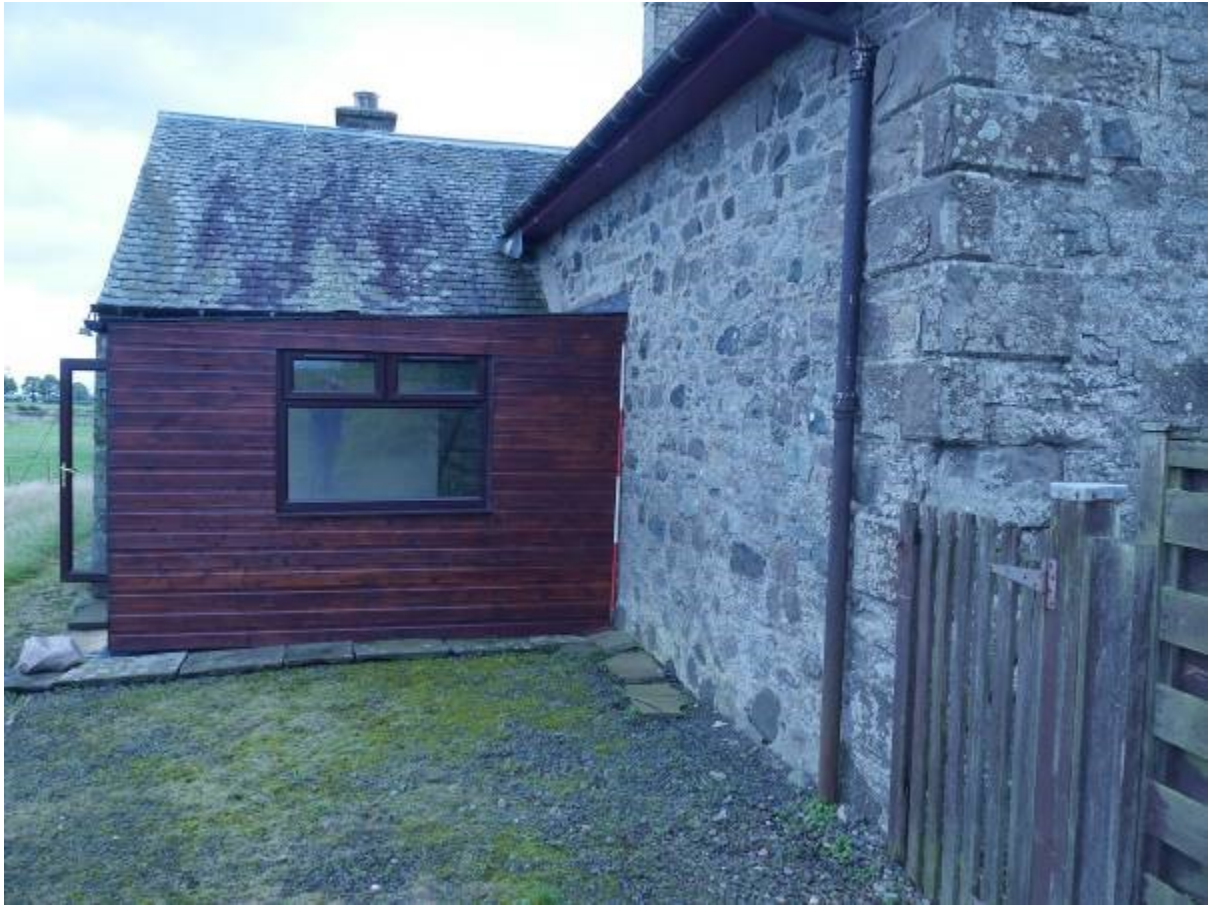
This is built of vertical wooden planks and is entered by a door from the north. It has a concrete floor.

Illustration 12-Modern wooden porch (1) attached to Northern elevation of farmhouse looking East

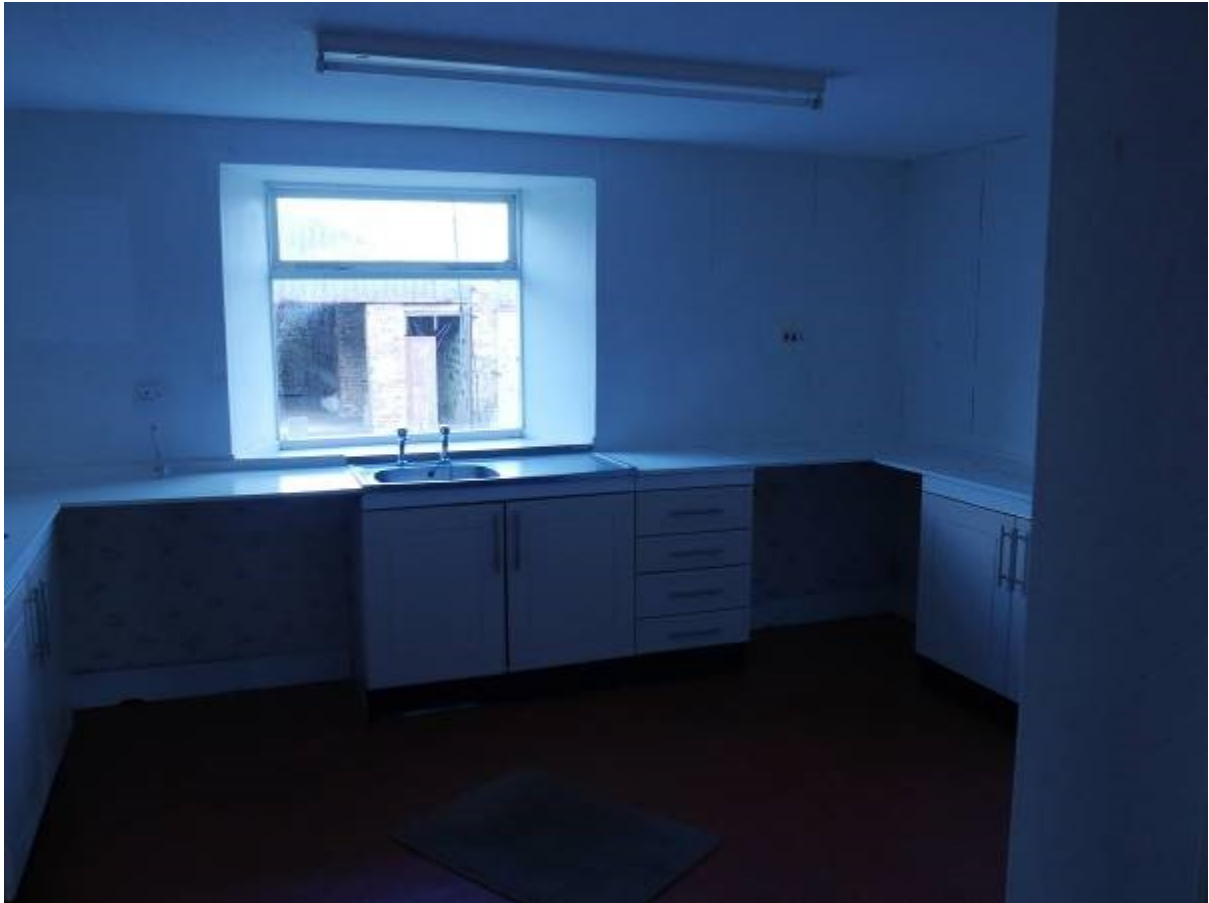
Illustration 13-Kitchen (2) in farmhouse looking North

This contains modern kitchen units and is decorated with wallpaper on wooden panels. There is linoleum on the concrete floor.

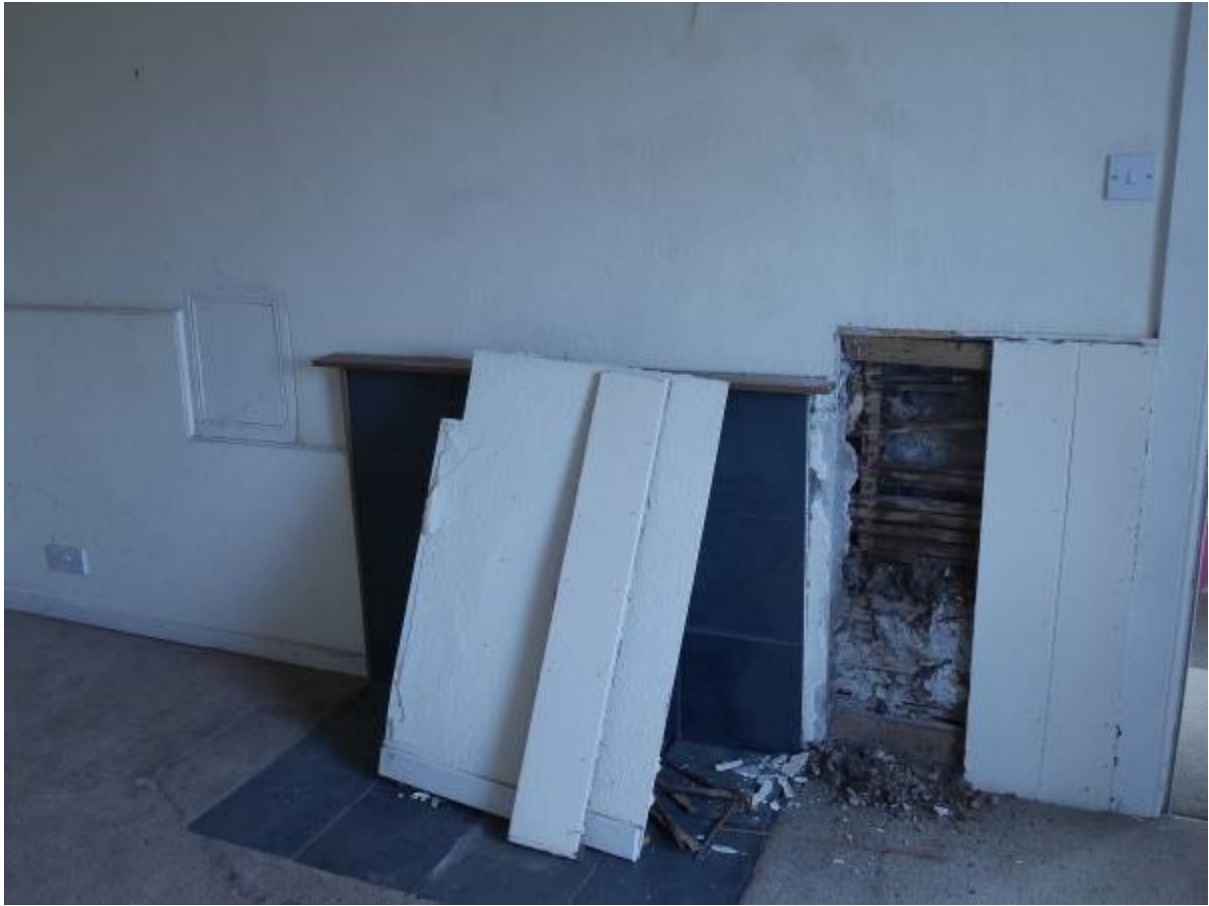
This room has a fireplace for a wood burning stove in its Eastern wall and is decorated with wallpaper on wooden panels. An exposed section of the original stone wall shows that the wooden panels are fixed to a wooden lath frame that is attached to the stone wall. There is a carpet on the floor.

Illustration 14 Fireplace in lounge (3) with wooden lath and plaster exposed in wall

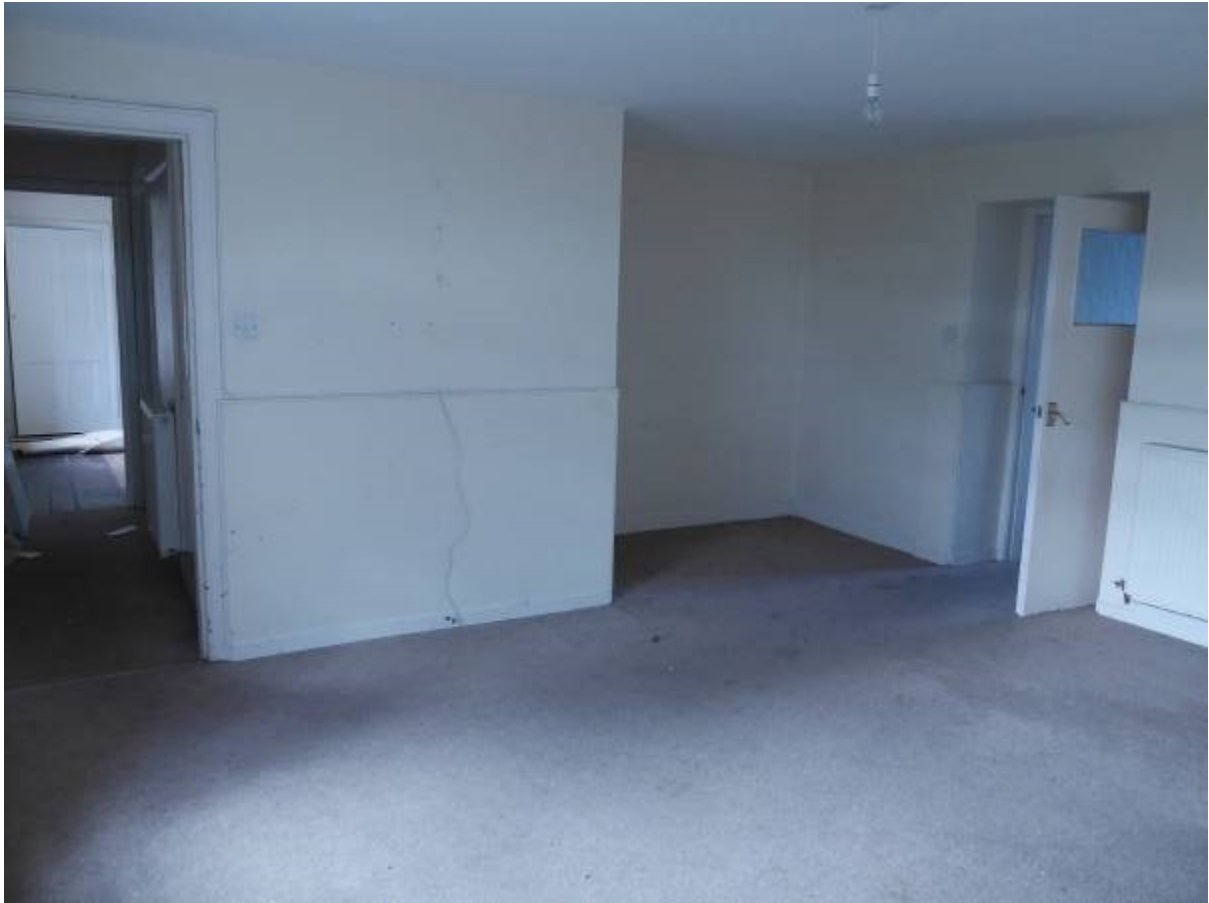
Illustration 15-Lounge (3) looking West showing enclosed stairwell to first floor

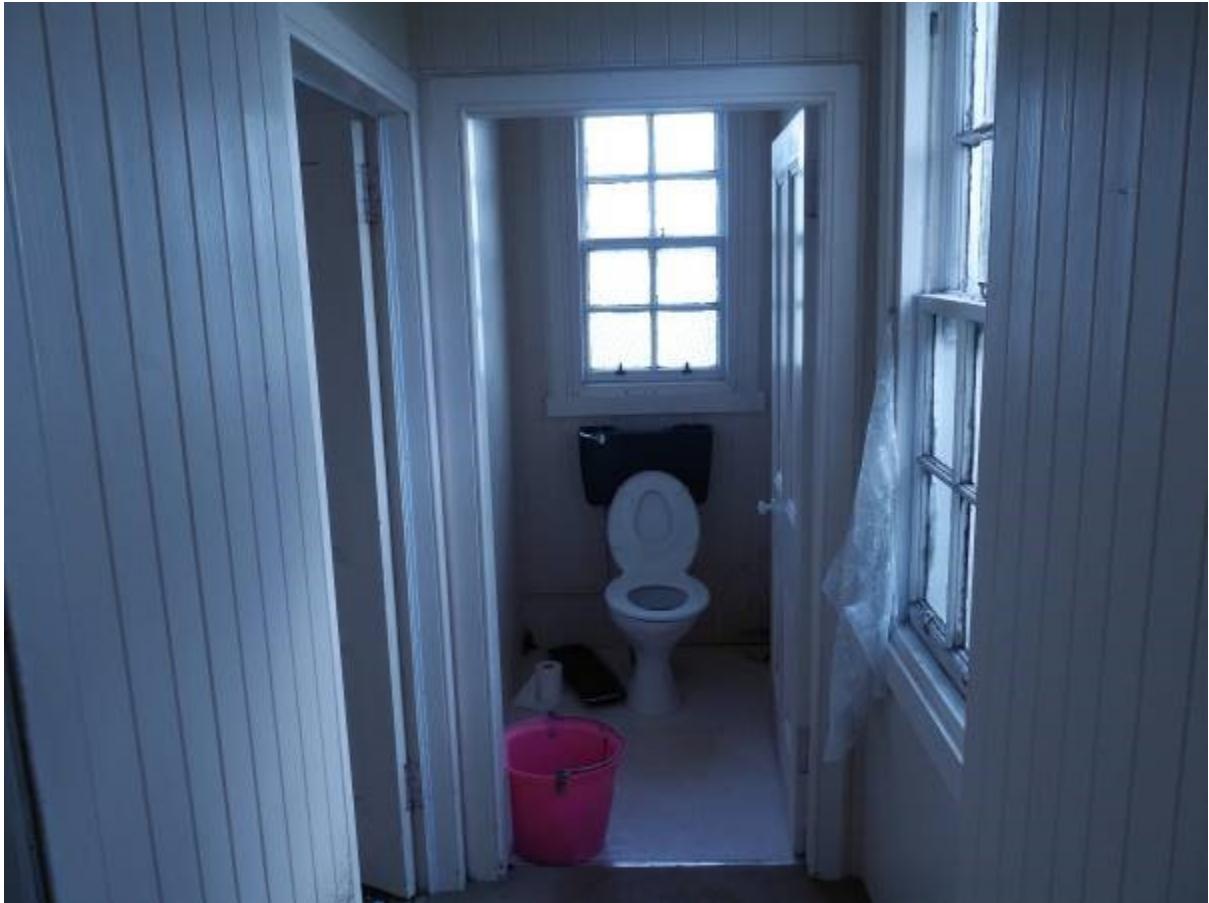
This leads to the toilet and kitchen which have been added to this side of the farmhouse and there is a step down to this level from the lounge.

Illustration 16-Wood lined passage (4) to toilet looking East

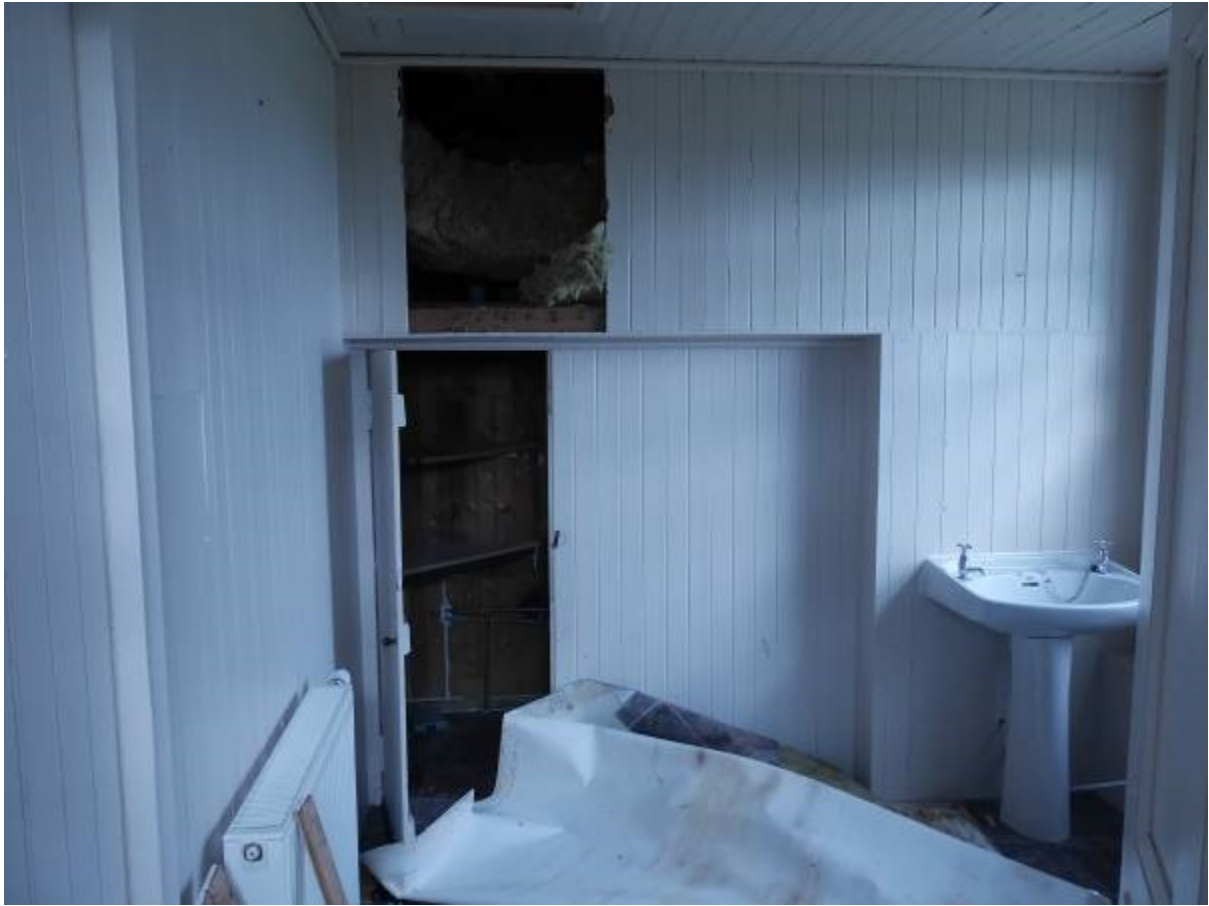
Both these rooms are wood panelled on both walls and ceiling and have concrete floors.

Illustration 17-Interior of wood lined bathroom (5) looking North

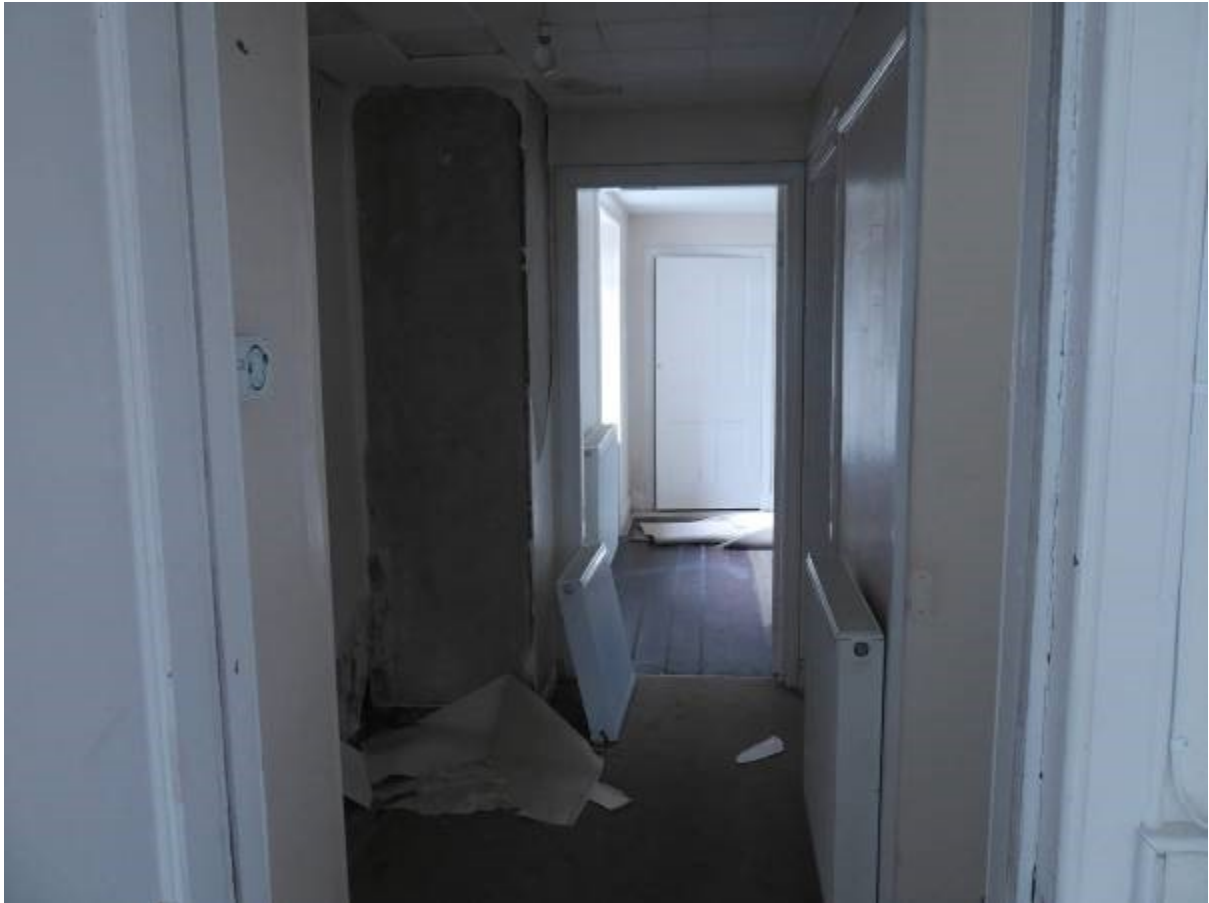
This contains the original doorway into the farmhouse from the South and its walls are made up of wooden panels on plaster on the stone wall faces. The stairs to the upper floor are accessed from here.

Illustration 18-Original entrance lobby to farmhouse (6) looking West

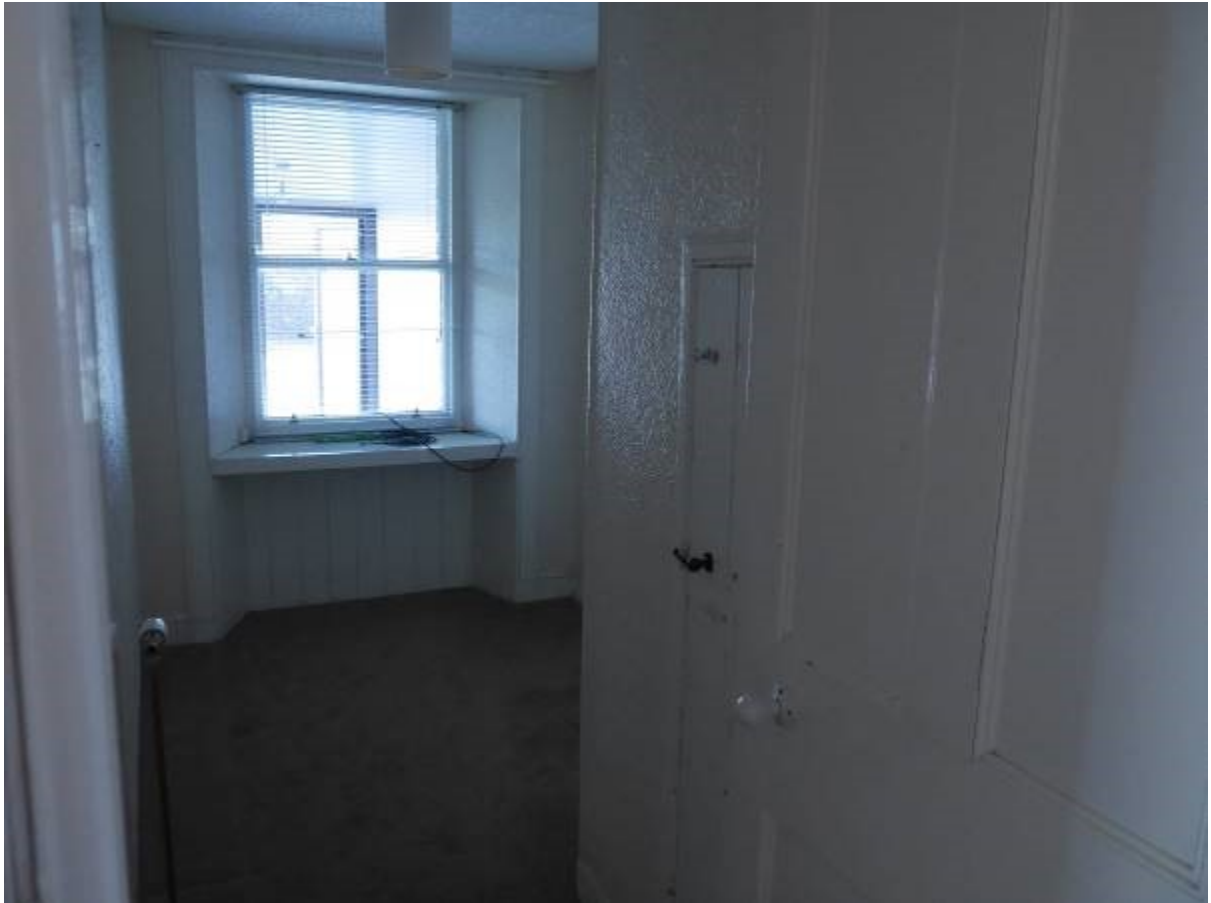
This small room has a window in its Northern wall which looks out into the porch and is decorated with wallpaper on wooden panels. There is a wooden shelf/seat below the window.

Illustration 19-Interior of small room (7) with window looking out into porch

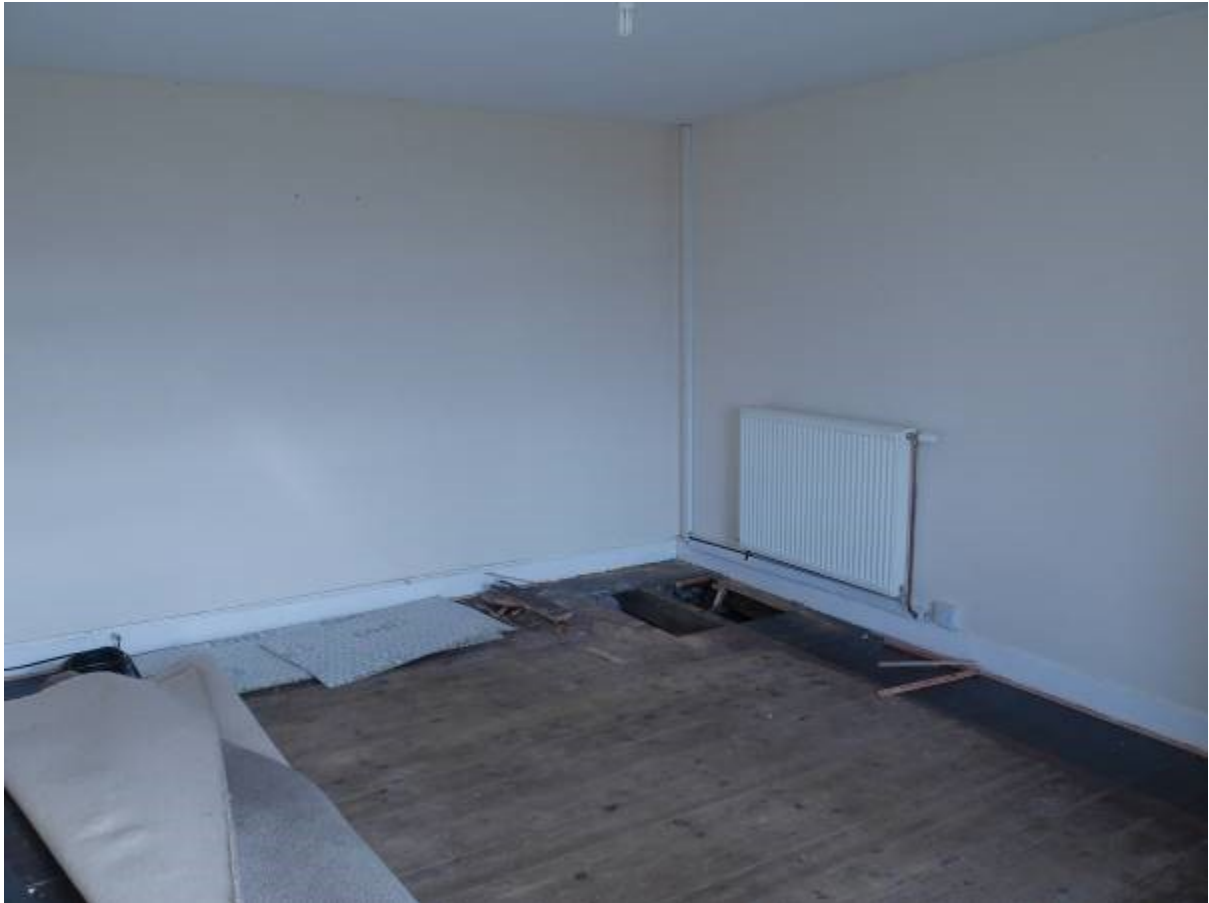
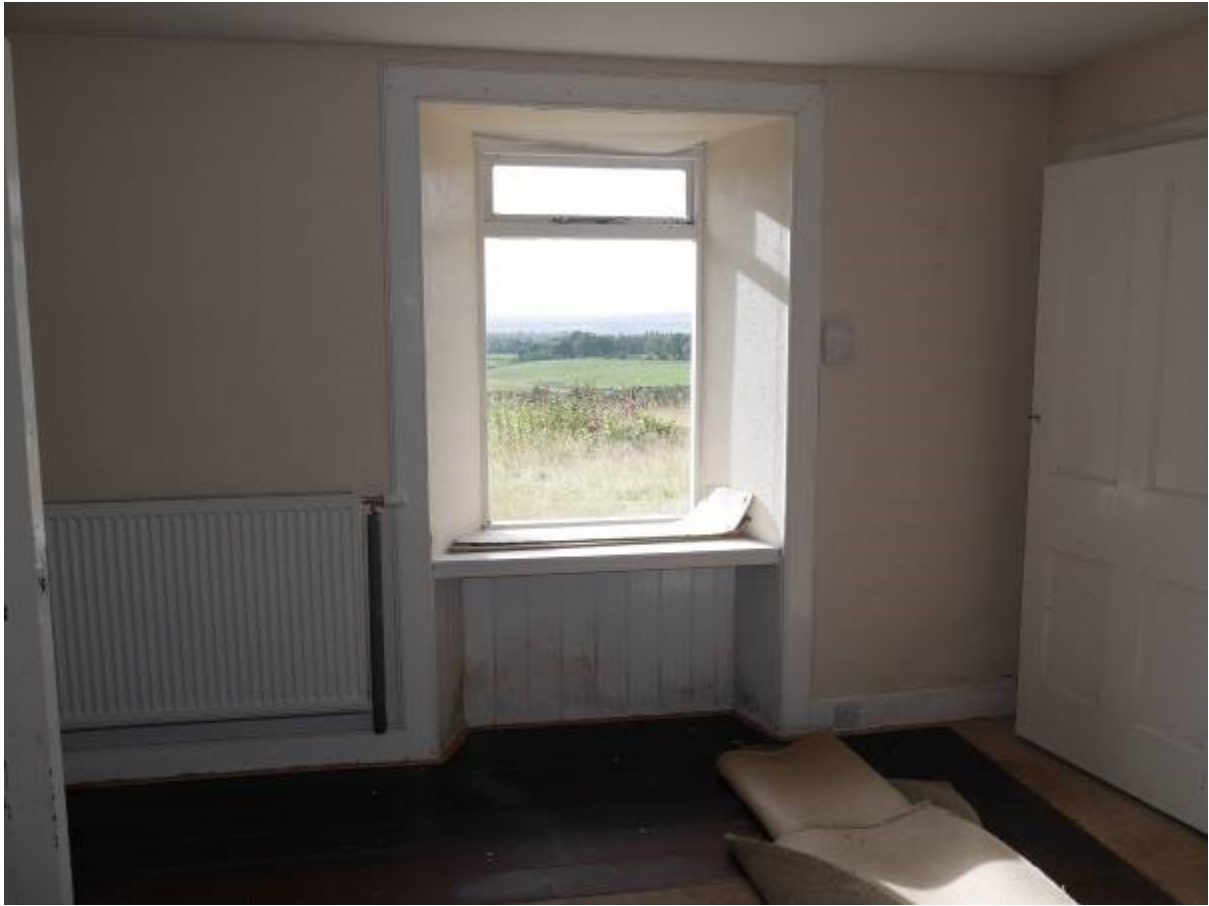
This room has a wooden floor and is decorated with wall paper on wooden panels. There is a cupboard in its West wall and a window with a wooden shelf/seat in its South wall.

Illustration 20-Interior of second lounge (8) with wooden floor looking North

Illustration 21-Interior of second lounge (8) looking South, wall cupboard visible to right

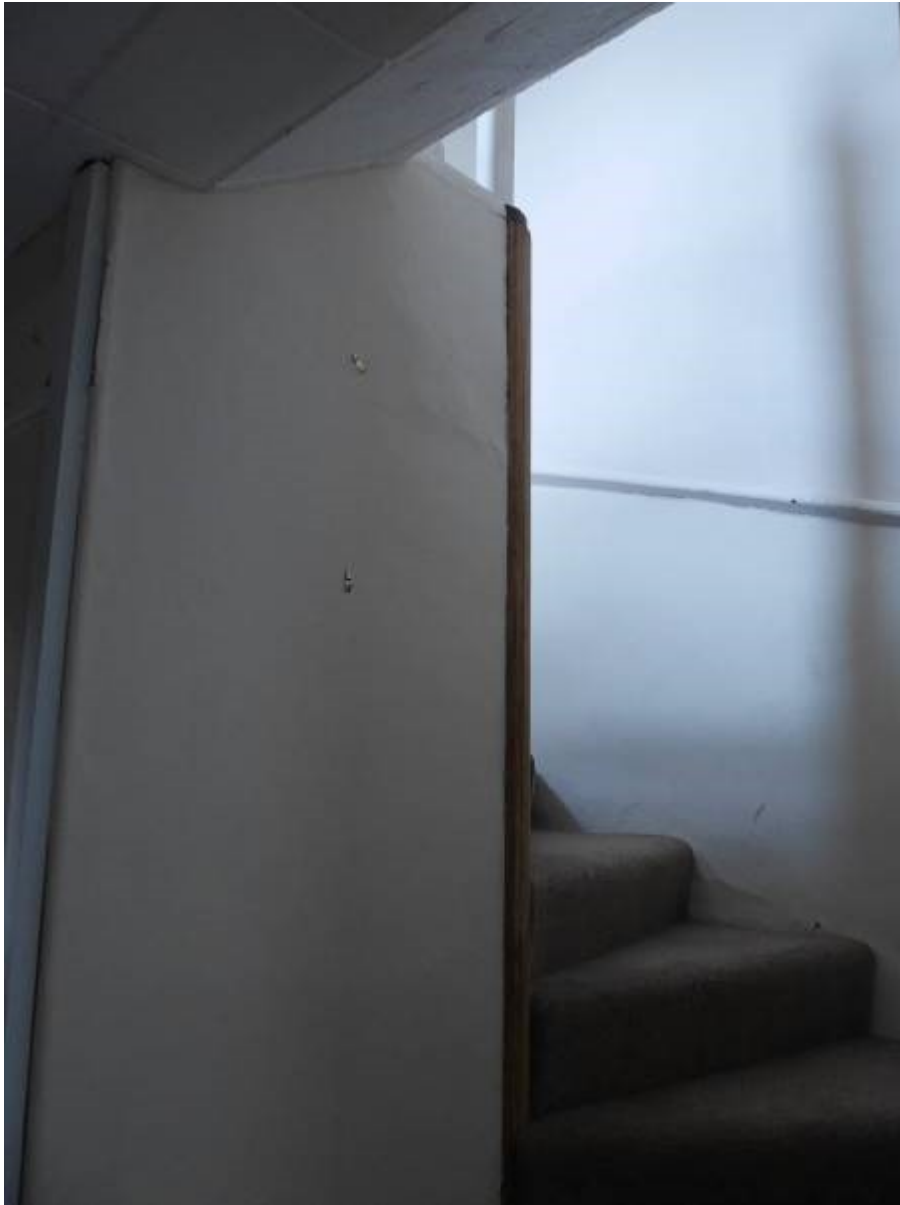
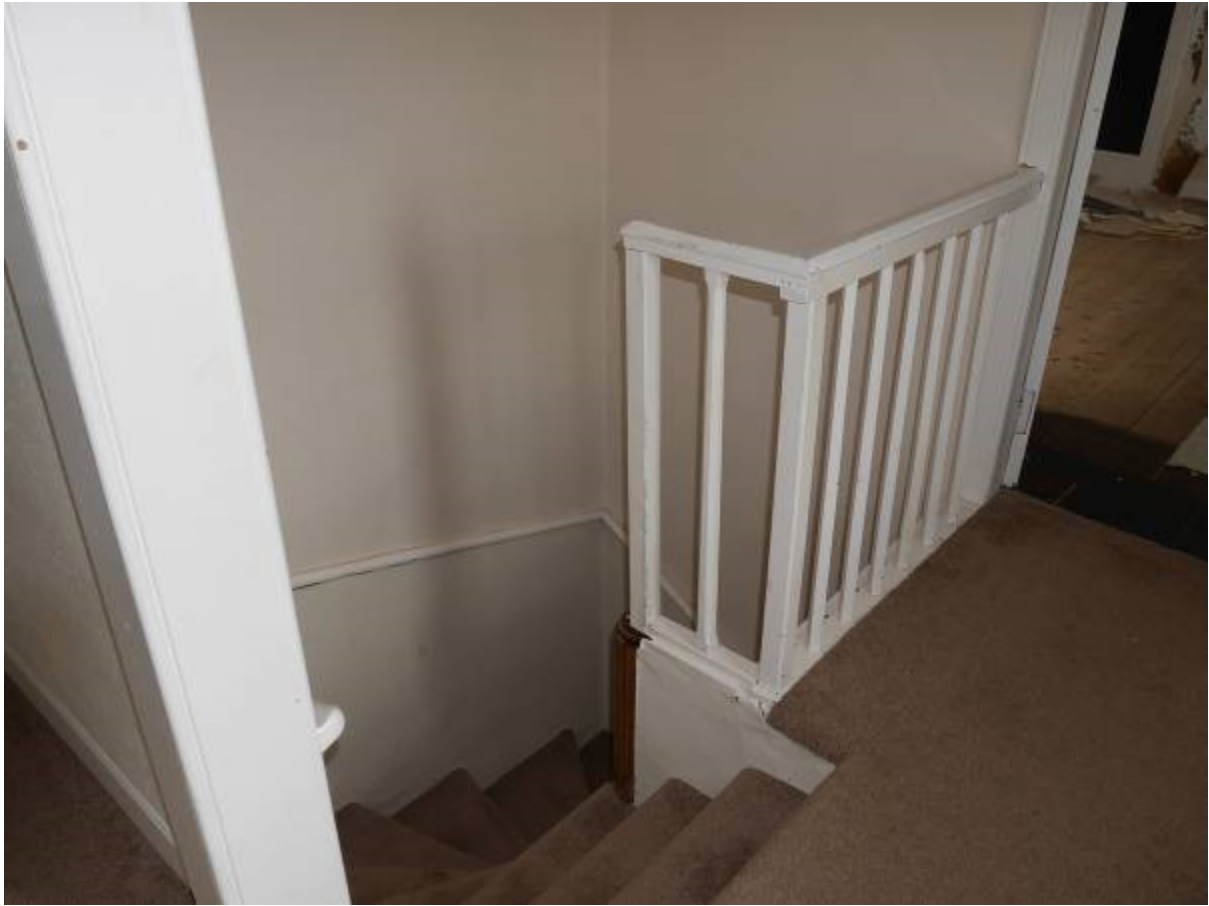
This staircase has an ornate wooden central pillar, a wooden banister and a wooden balustrade at first floor level.

Illustration 22-Stairs up to first floor level showing central wooden pillar

Illustration 23-Wooden balustrade at the top of the stairs

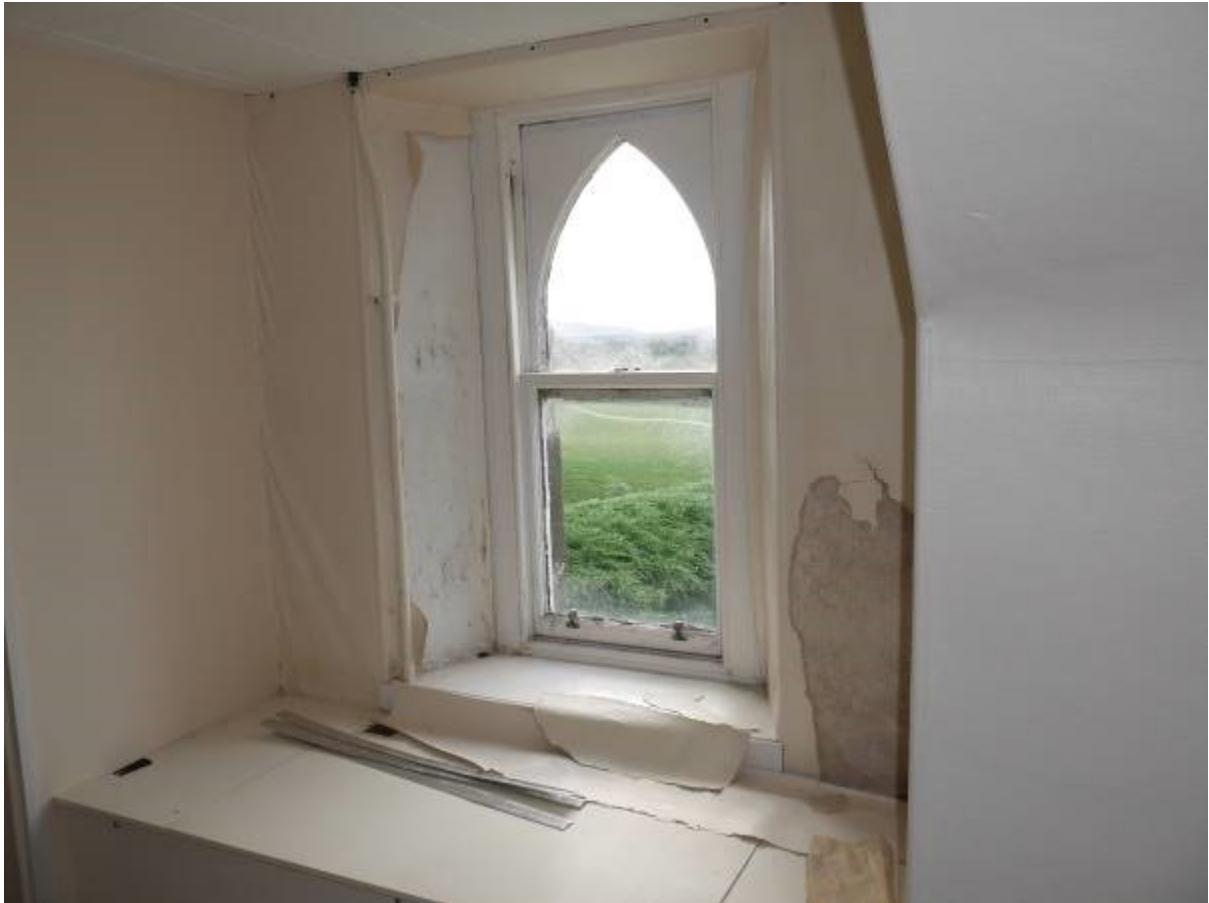
This is carpeted and has a window with a rounded arch in its South wall. There is a modern wooden chest below the window.

Illustration 24-Interior of window in pediment looking South from upper lobby (9)
