Standing Building Survey
Shannoch Farmhouse, Logiealmond,
Perth and Kinross

20th September 2018

Introduction

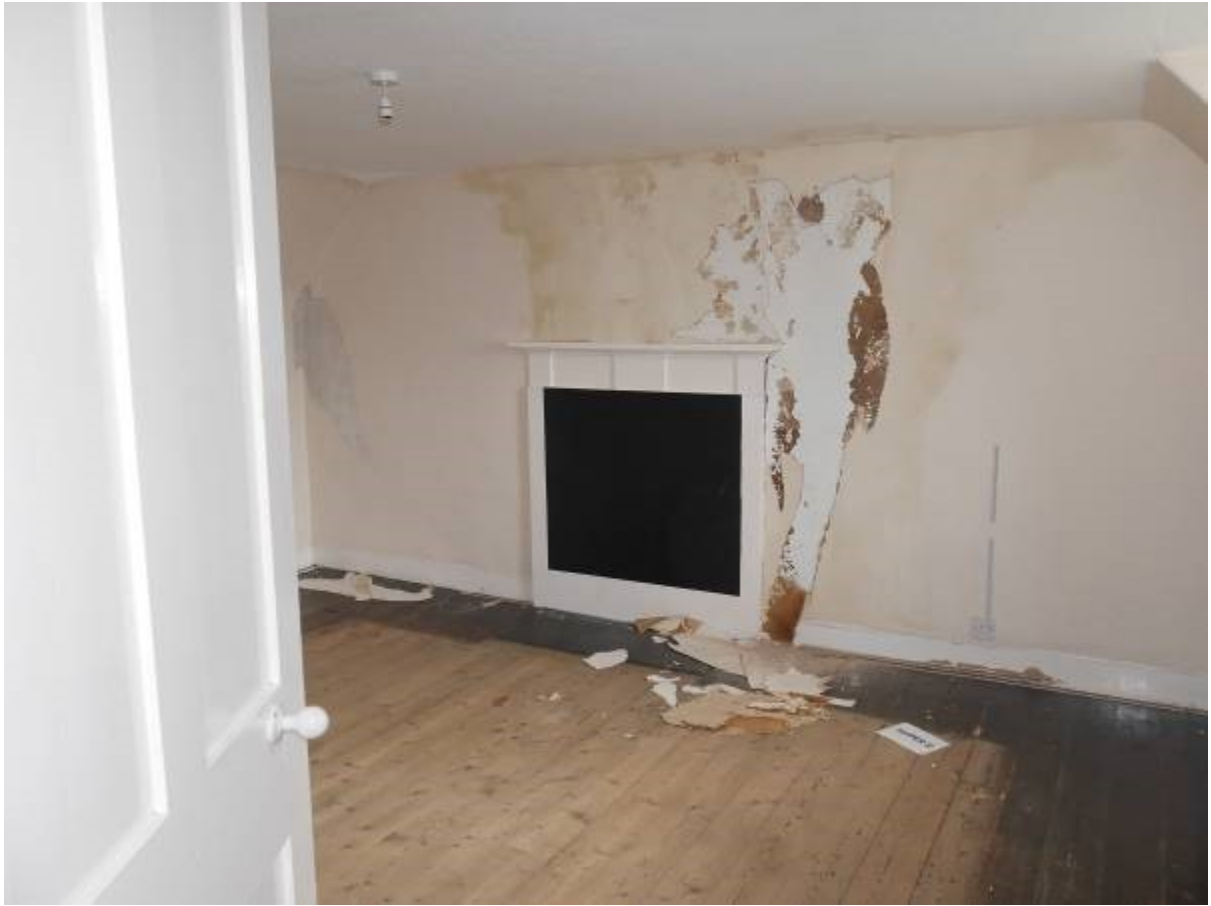
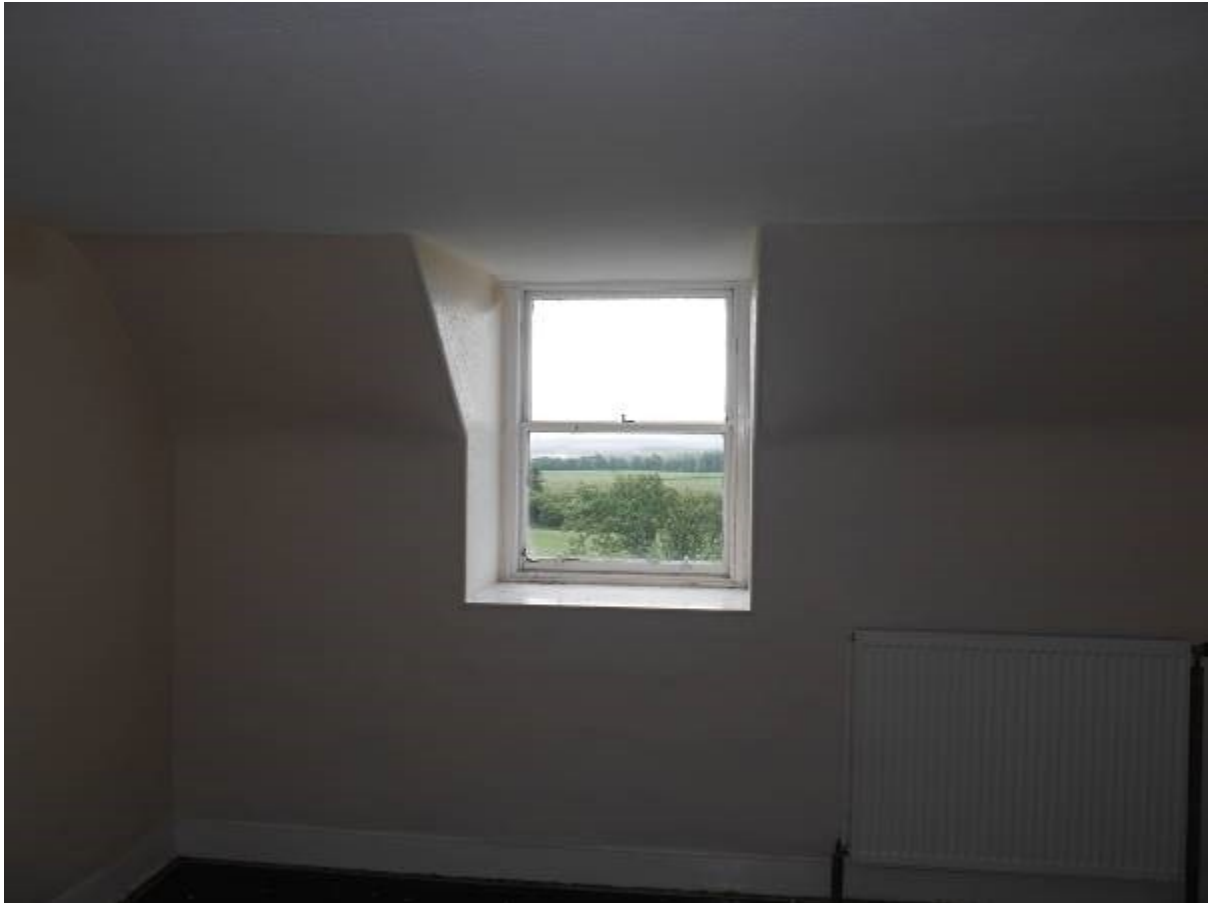
This has a wooden floor, a gable window in its Southern wall and a blocked fireplace in its East wall. It is decorated with wallpaper on wooden panels. The roof lines in this room are slightly pitched.

Illustration 25- Blocked fireplace in upstairs bedroom (10) looking North East

Illustration 26- Interior of gable window in upstairs bedroom (10) looking South

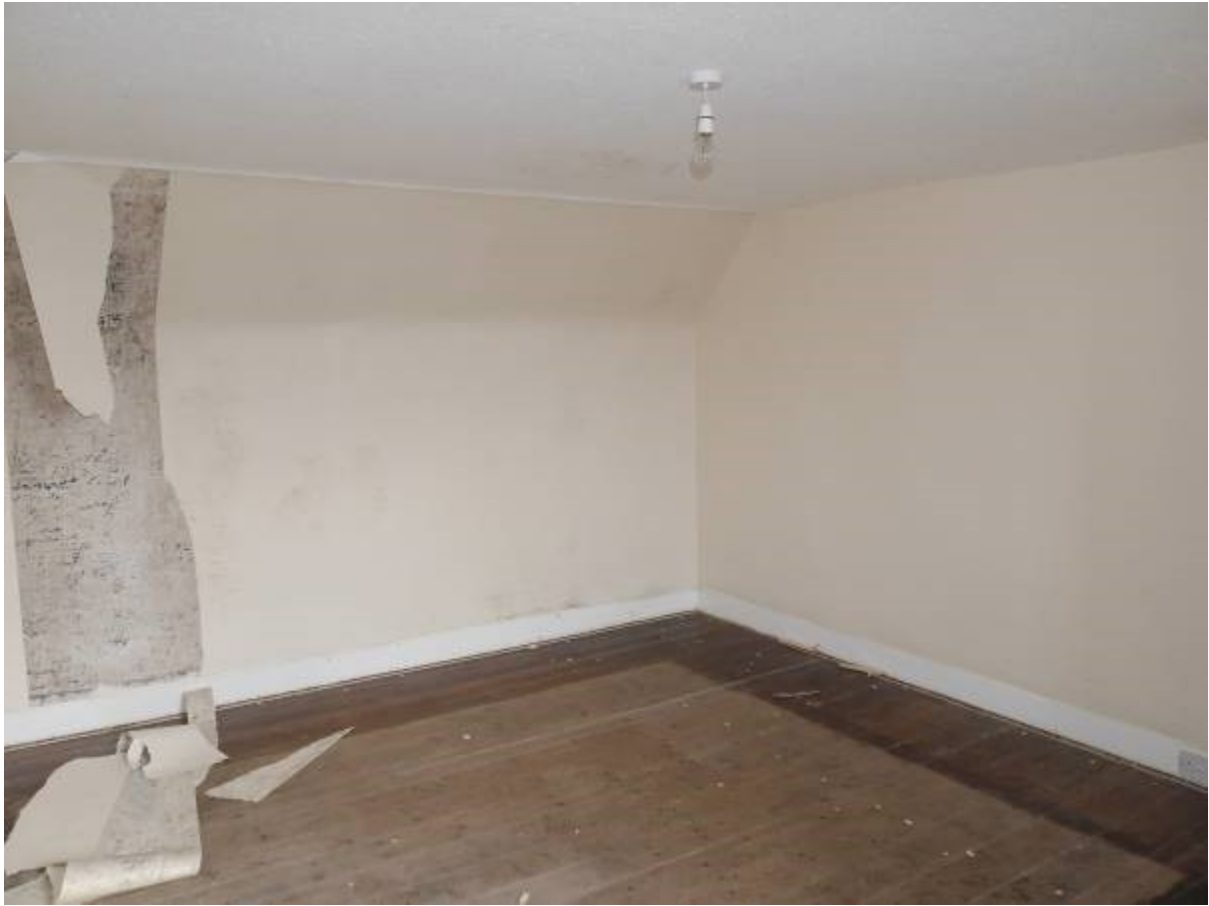
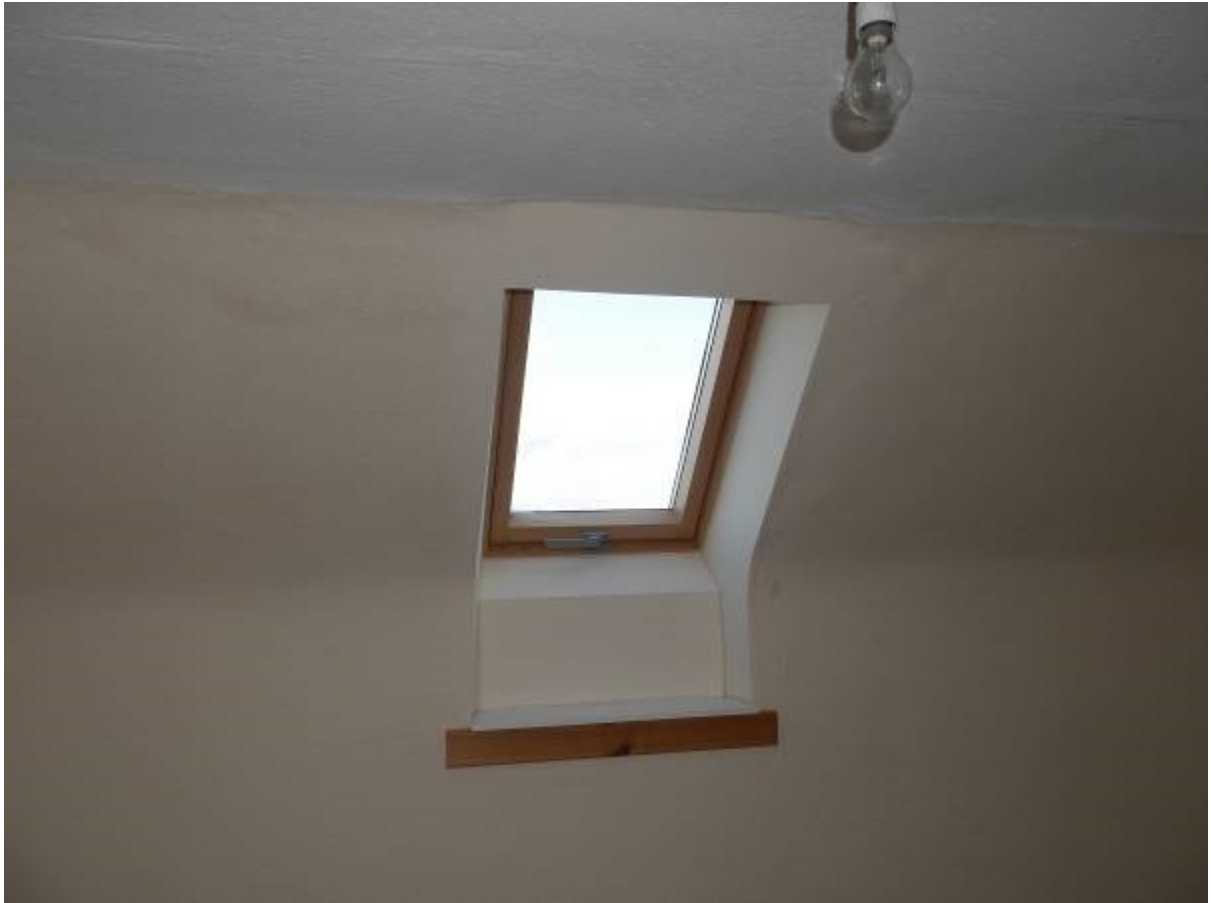
This room has a wooden floor, a gable window to the South and is decorated with wallpaper on wooden panels. The roof lines in this room are slightly pitched.

Illustration 27- Interior of upstairs bedroom (11) looking North East

Illustration 28-Interior of gable window in upstairs bedroom (11) looking South

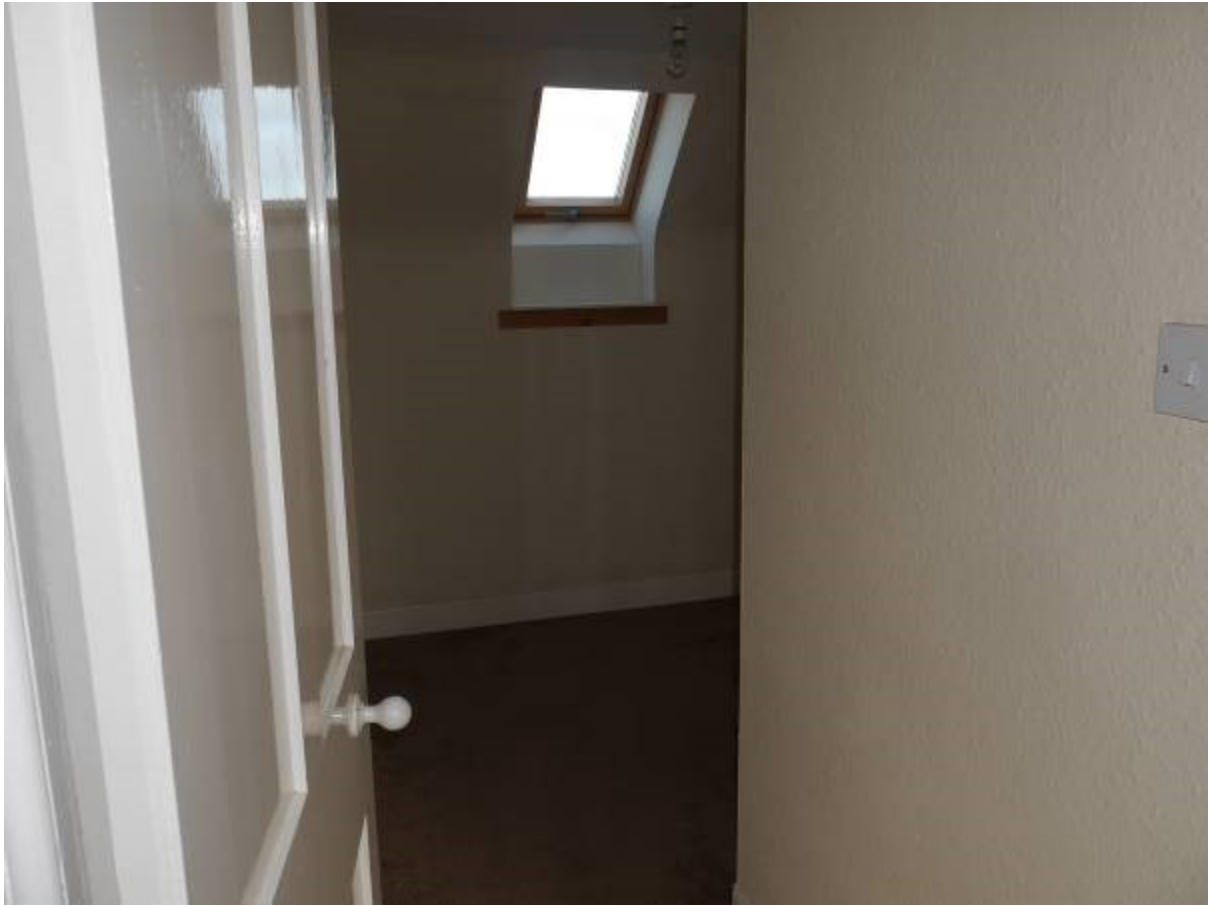
Illustration 29 -Interior of small upstairs bedroom (12) looking North

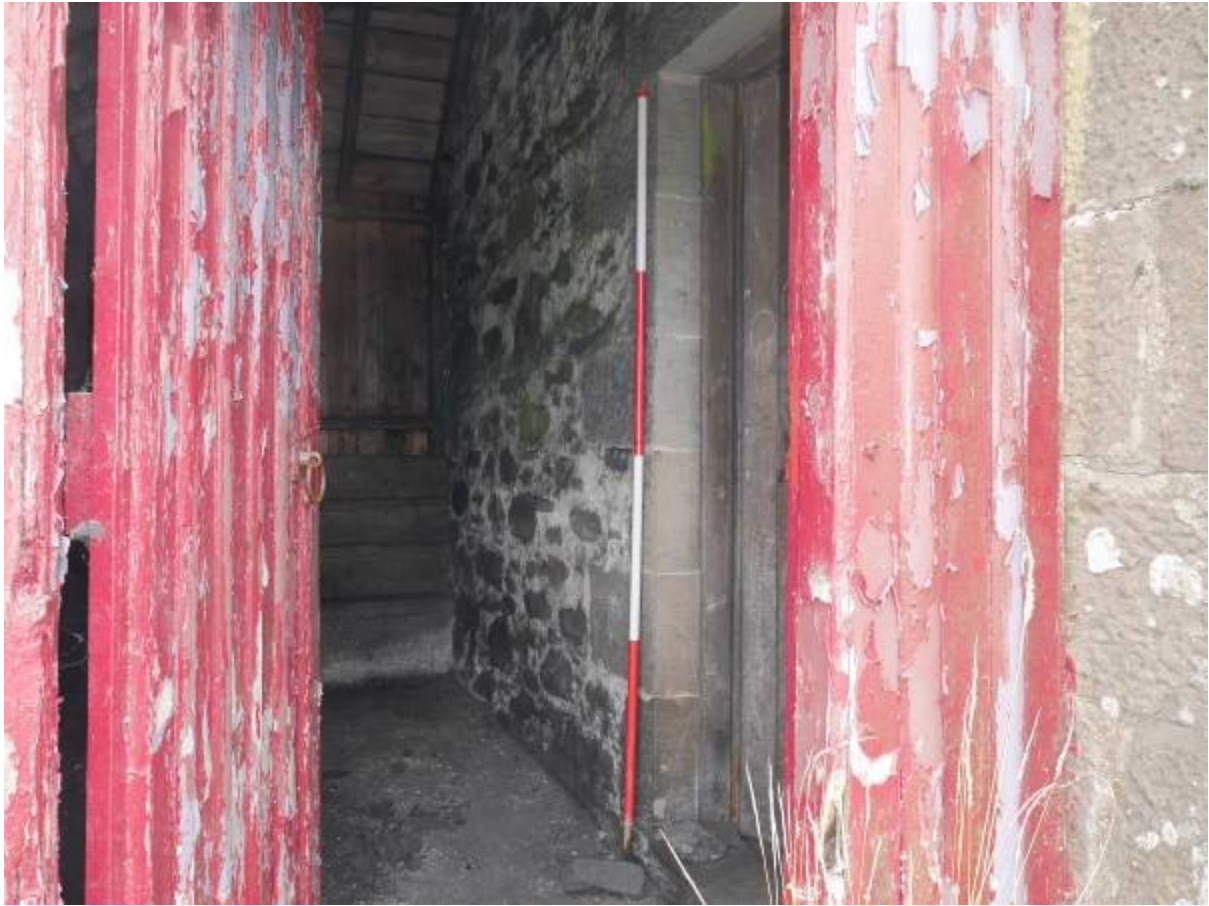
This is built of vertical wooden planks and externally painted red/purple. It has a concrete floor and was last used as a coal store. The doorway into the 'Bothy' is accessed from this shed.

Illustration 30- Interior view of wooden extension/coal store (13) looking South doorway into 'bothy' (14) visible to right of scale

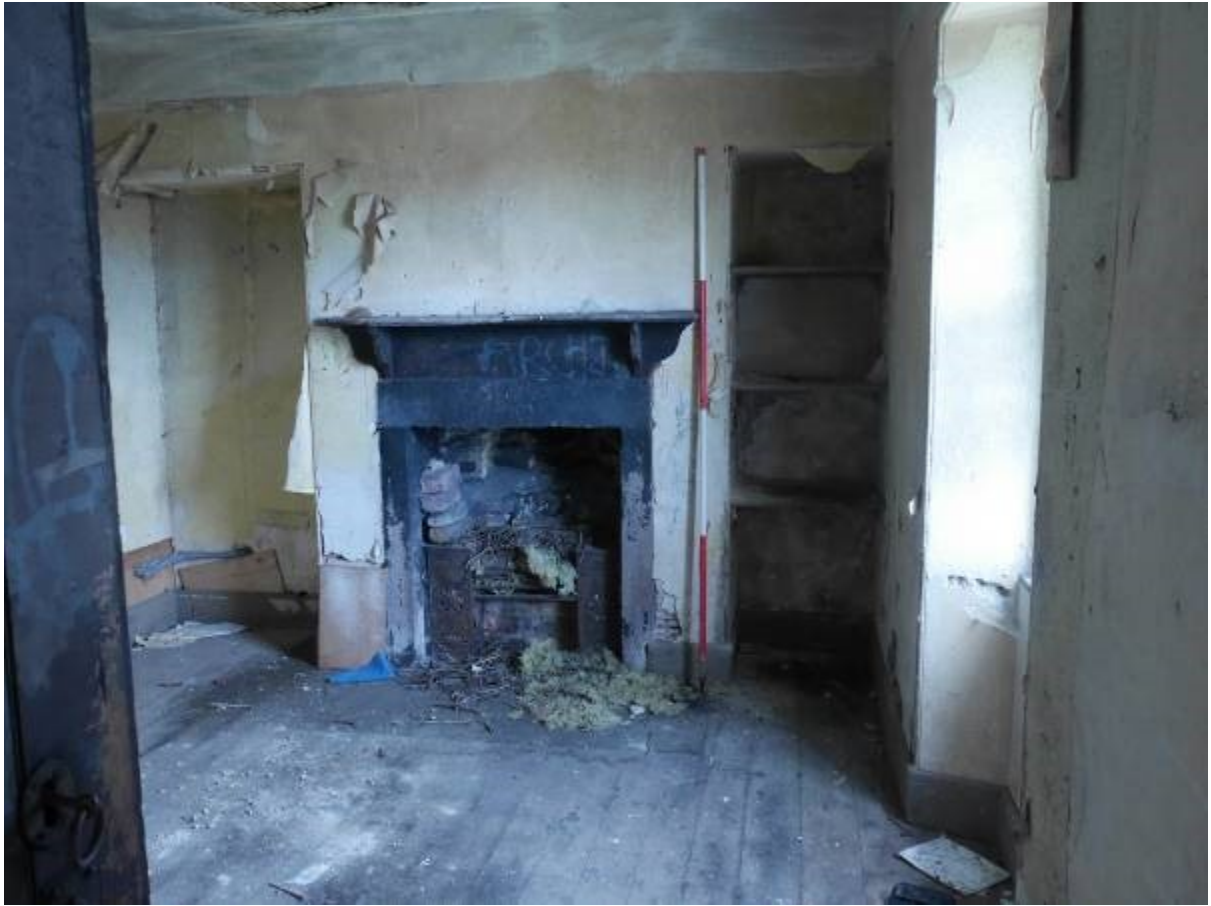
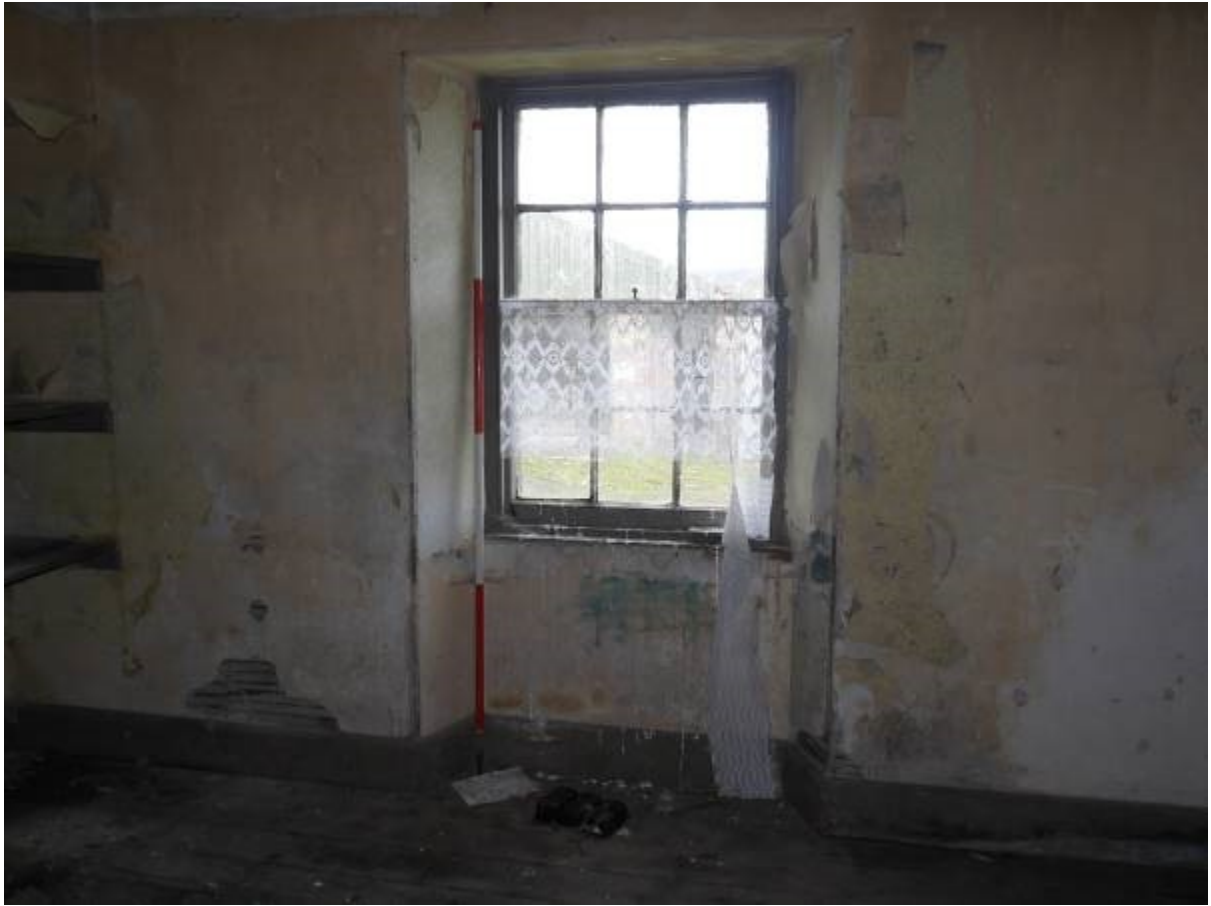
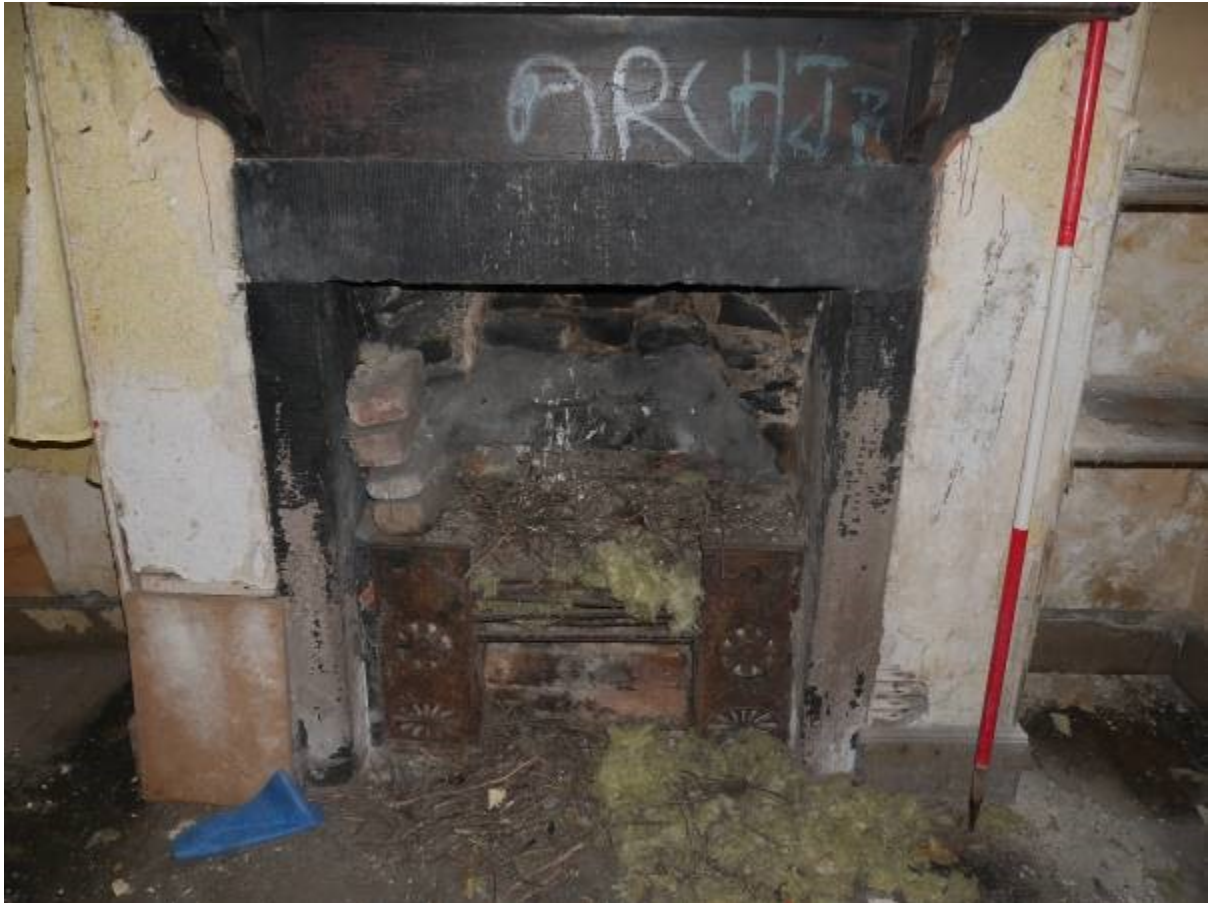
This is a single living room with a wooden floor and a large fireplace in its Western wall. The walls are decorated with plaster on wooden lath and the ceiling is of a similar construction. The fireplace has a wooden mantelpiece and is built of large vertical shaped stones, it contains the remains of a decorated cast iron fireplace/range. A piece of graffiti saying 'Archie' is painted across the top of the fireplace.

Illustration 31-General view of interior of 'bothy' (14) looking West

Illustration 32-Interior view of 'bothy' window looking North

Illustration 33 -Detail of fireplace in 'bothy' (14) showing decorated cast iron grate and graffiti

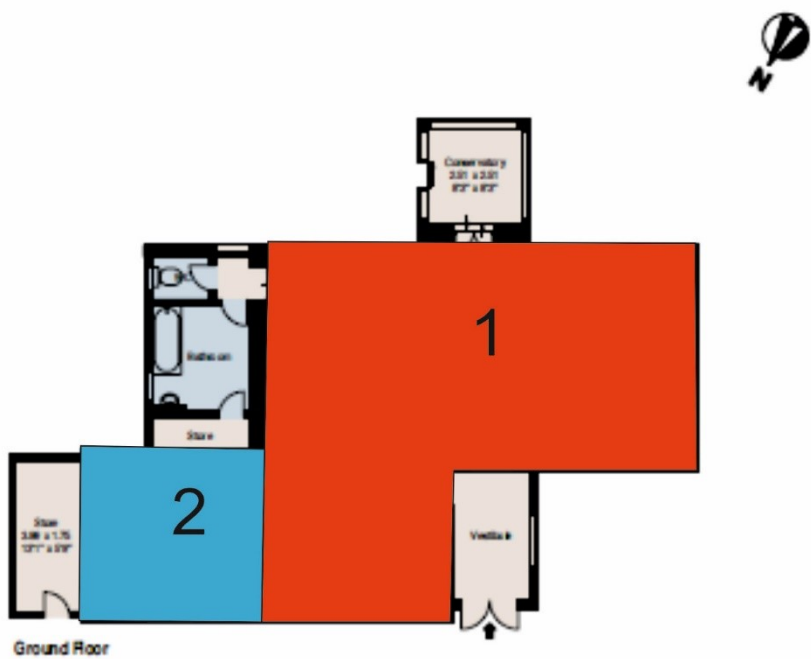
The original ground plan of the farmhouse appears to have been L-shaped as is shown on the First Edition Ordnance Survey map (Illus 4). The 'bothy' (14) appears to have been added next then followed by the shed (13), toilet and bathroom (4 and 5)) these additions have created the more regular modern ground plan. The first-floor windows in the Eastern and Western gables and Southern pediment of the farmhouse all have round arches at their heads something that may be regarded as a style of the Estate.

Illustration 34- Suggested phasing of building, red area 1 indicates first phase with blue area 2 as first addition to ground plan. Further modern extensions to ground plan are left uncoloured.
