Standing Building Survey
Former Panmure Church, Monifieth
Angus Council

21st March 2019

Introduction

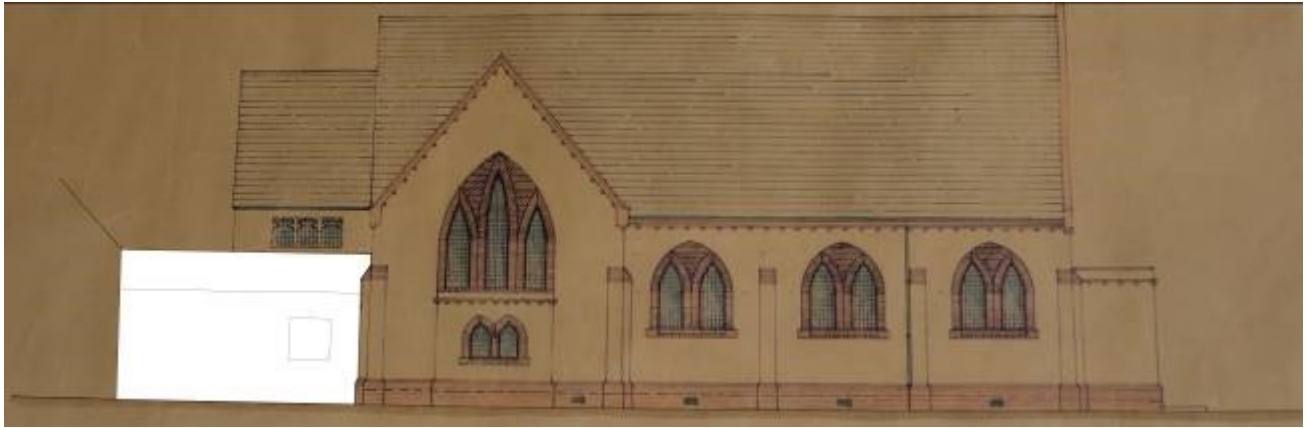
Illustration 5 – Western and Eastern elevation of Former Panmure Church, toilet block added against face of church shown in white (based on original architect's drawings supplied by the client)

This is a harled wall face containing three groups of two arched windows with red brick surrounds and a simple buttress at its Southern end. The roof line is defined by a single course of red bricks. The lower part of the wall face is not harled and comprises seven courses of mortared red bricks. The roof down pipes are cast iron.

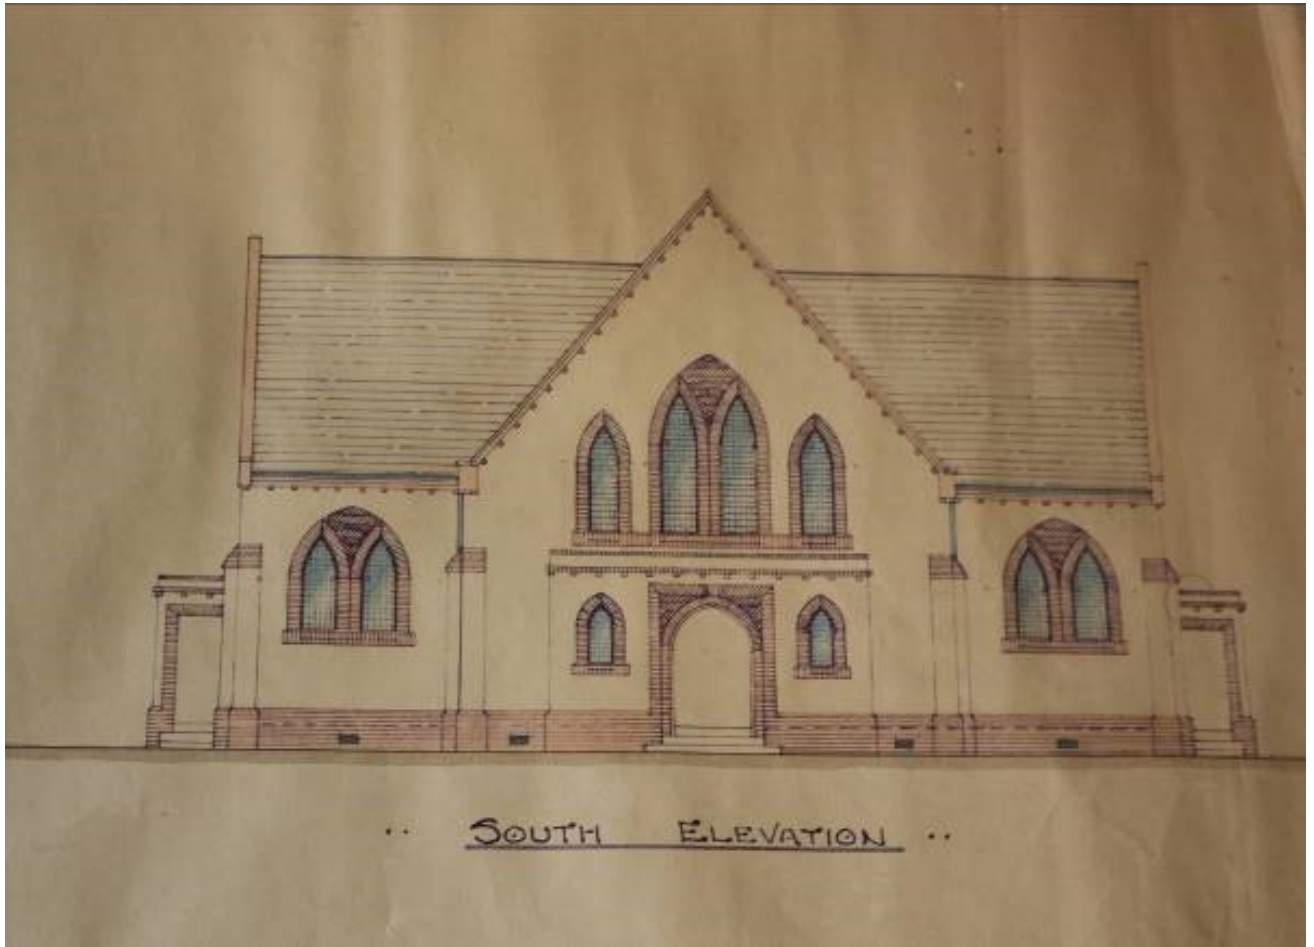
Illustration 6- Southern elevation of Former Panmure church, Monifieth (Original architects drawings supplied by client)

This is the Southern gable end to the church with simple buttresses at its Western and Eastern ends and comprises a harled wall face containing four arched windows with mortared red brick surrounds above a projecting entrance lobby with double wooden doors and single arched windows with mortared red brick surrounds on either side. The gable roof lines are defined by single courses of mortared red bricks and the buttresses are capped with red tiles. A slightly cambered area of red bricks sits in front of the main entrance that includes a crucifix that is picked out by bricks laid out in a slightly different pattern.

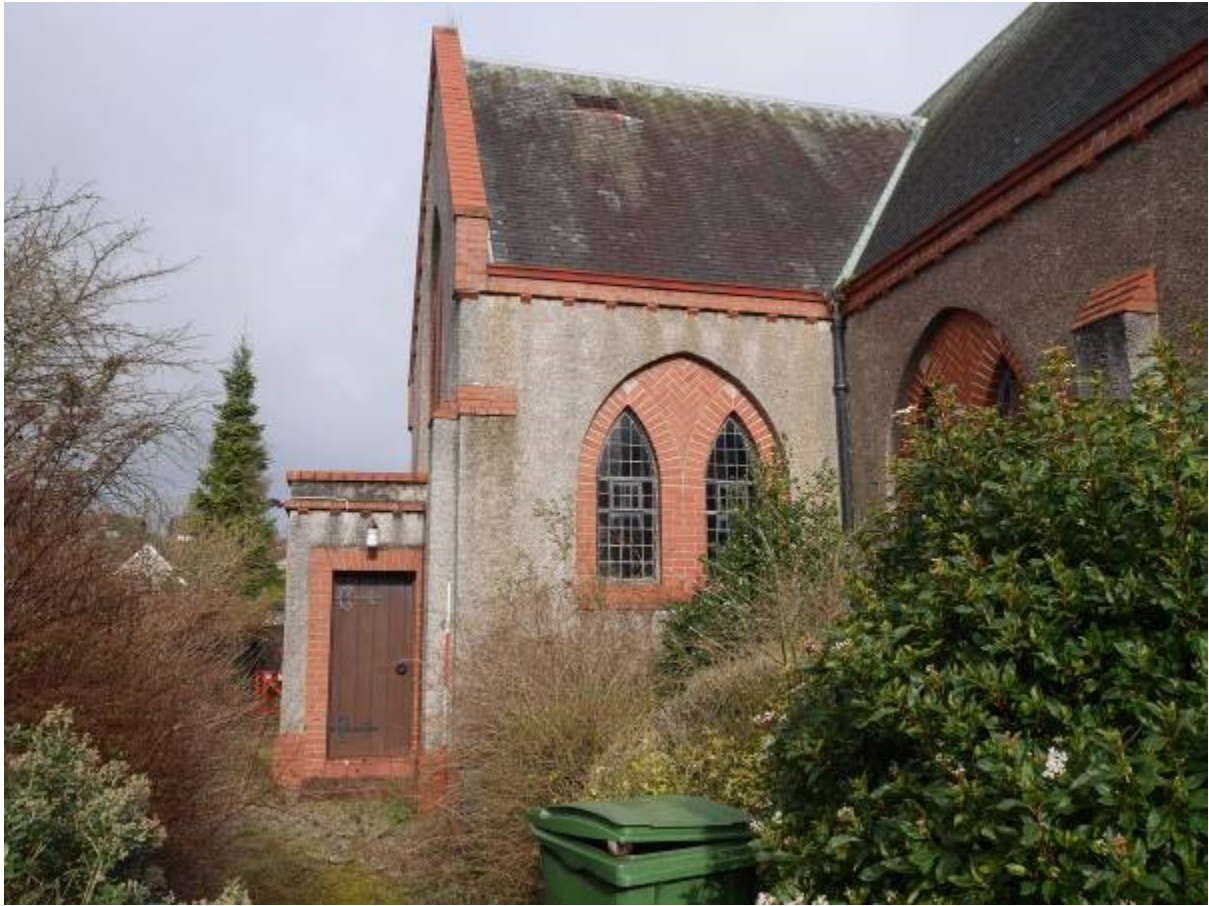
Illustration 9- Southern elevation of Western Transept and entrance lobby

This is a harled wall face containing a pair of arched windows with red brick surrounds, the lower section of the wall is not harled and comprises seven courses of mortared red bricks. There are simple buttresses at the West end of the wall line and then a lower flat roofed entrance lobby containing a doorway with a wooden door defined by two courses of mortared red bricks. The roof line of the transept is defined with two courses of mortared red bricks and the roof line of the lobby also has two courses of red bricks separated by a narrow section of harled wall.

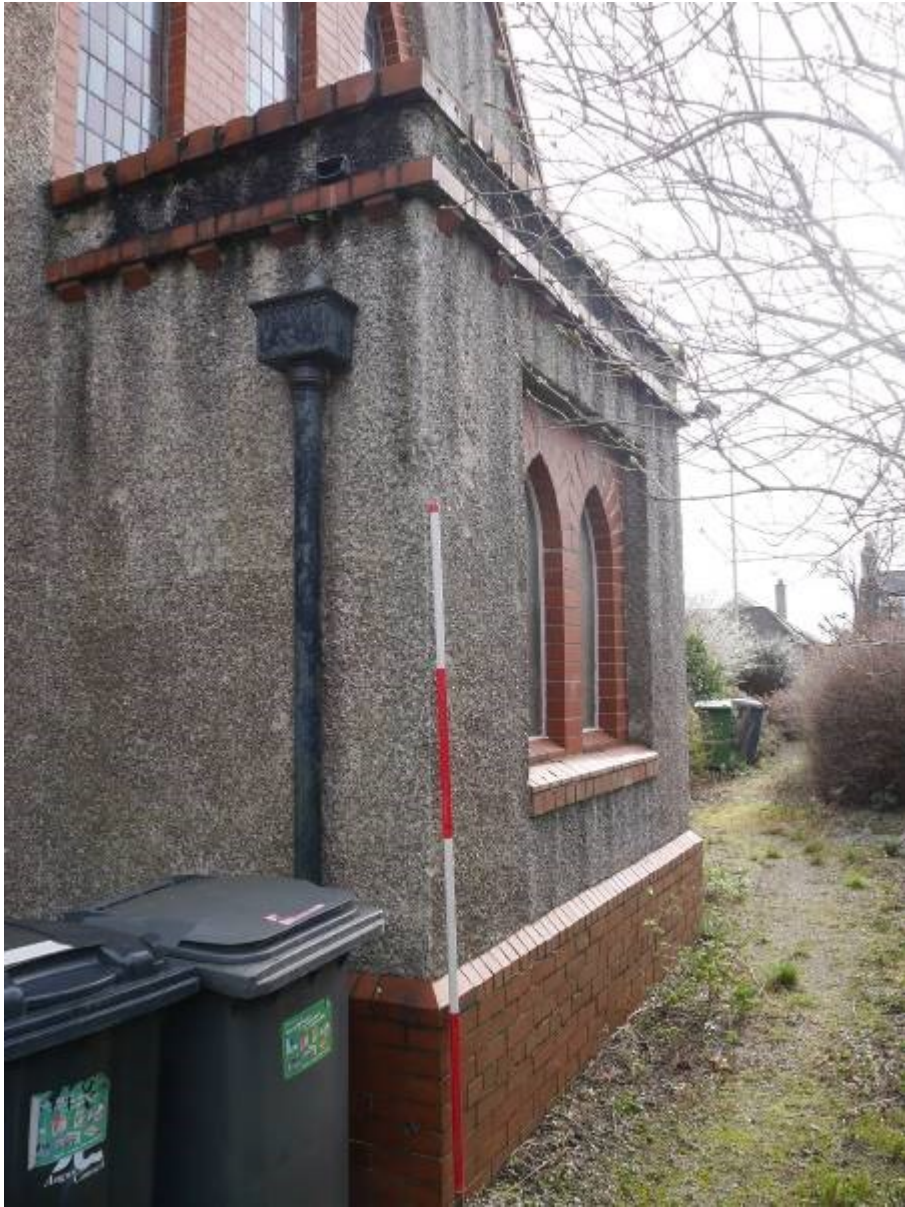
Illustration 10- Western elevation of West Transept and entrance lobby

This is the gable end to the transept and is a harled wall face which contains three arched windows with red brick surrounds. The lower flat roofed entrance lobby is also harled apart from seven courses of mortared red brick at its base and contains two arched windows with red brick surrounds.

The gable roof line is defined by two courses of mortared red bricks and the roof line to the lobby has two courses of mortared red brick separated by a narrow section of harled wall.

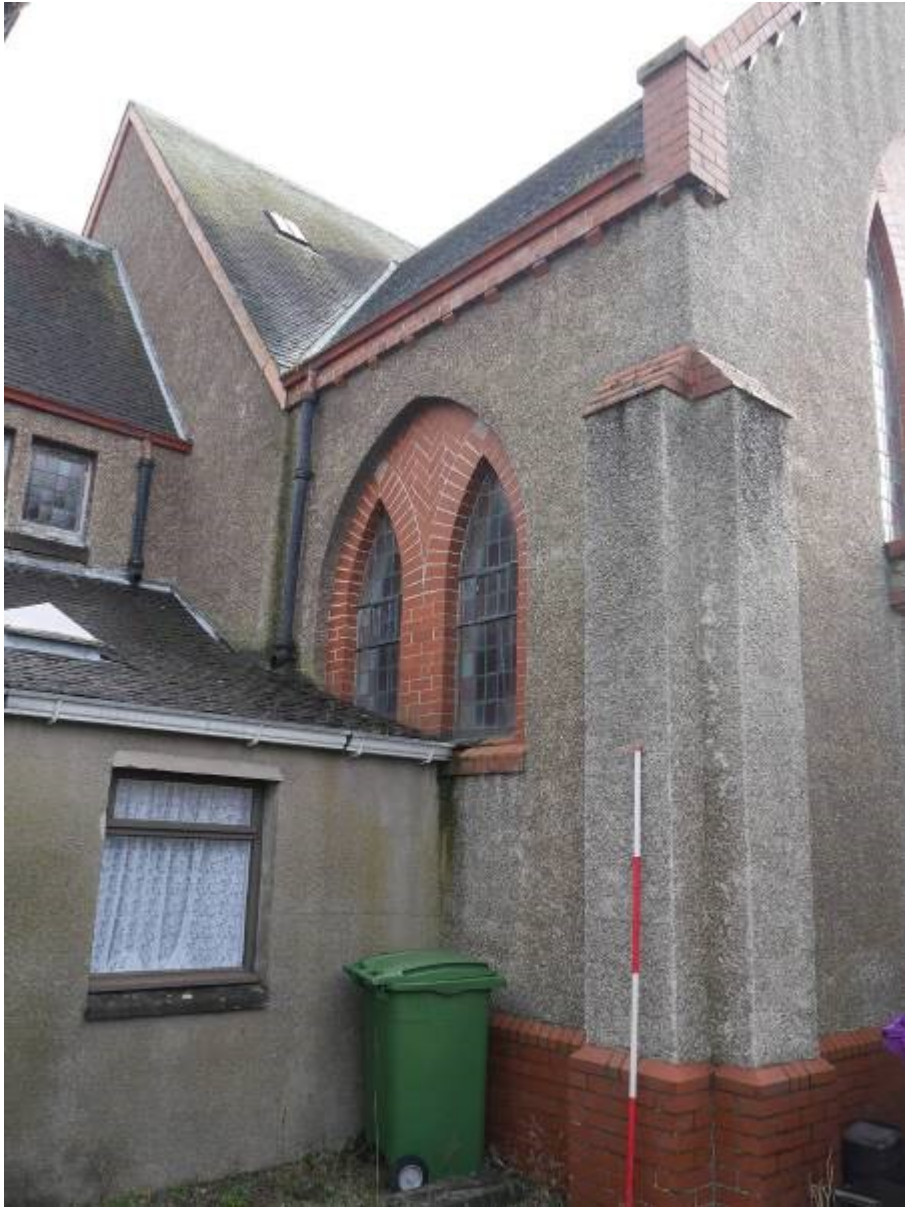
Illustration 11- Northern Elevation to Western transept

This is a harled wall face containing a pair of arched windows with red brick surrounds, the lower part of the wall comprises seven courses of mortared red bricks.

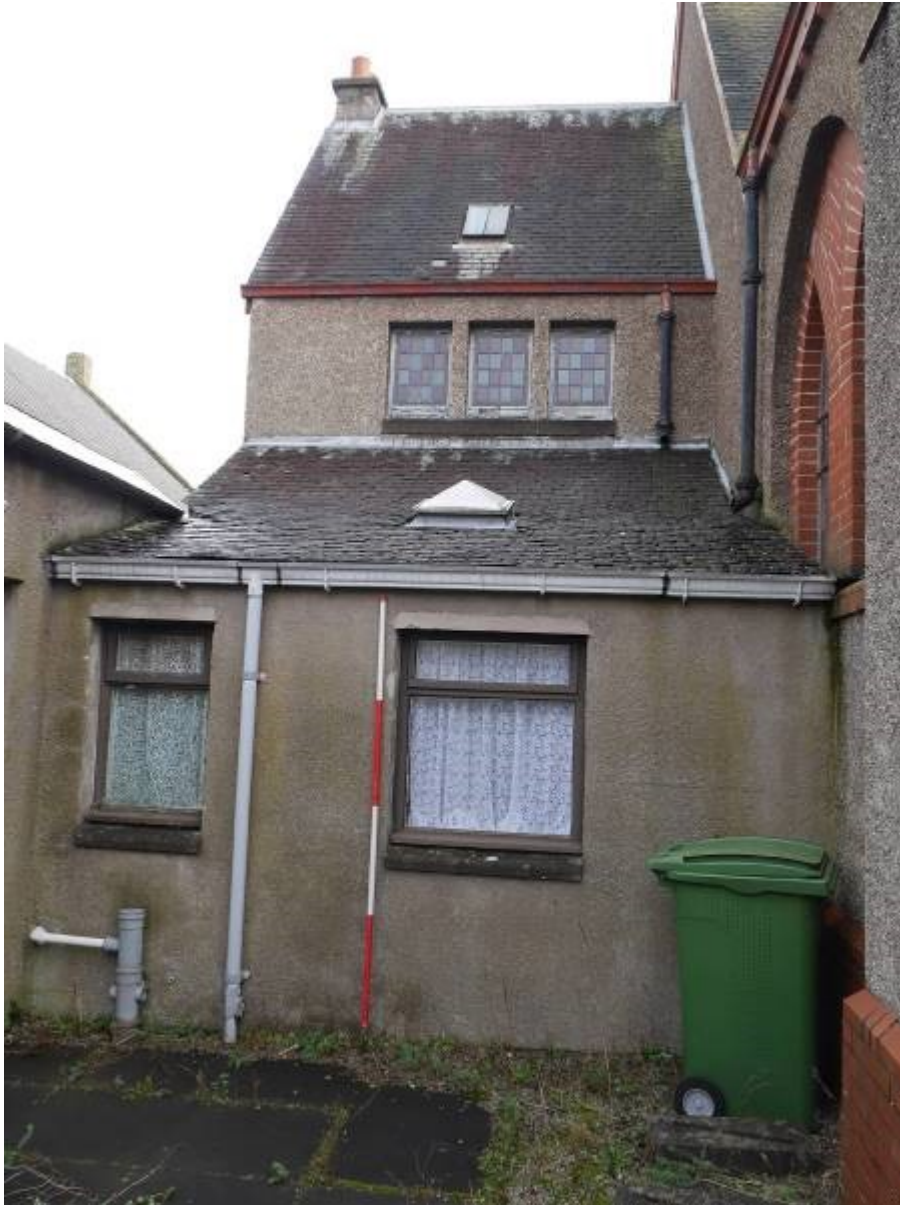
Illustration 12- Western elevation to Choir and toilet block

This is a harled wall face that contains three square windows. A toilet block has then been built against the wall face and this has a slated roof, a harled wall face and contains two windows.

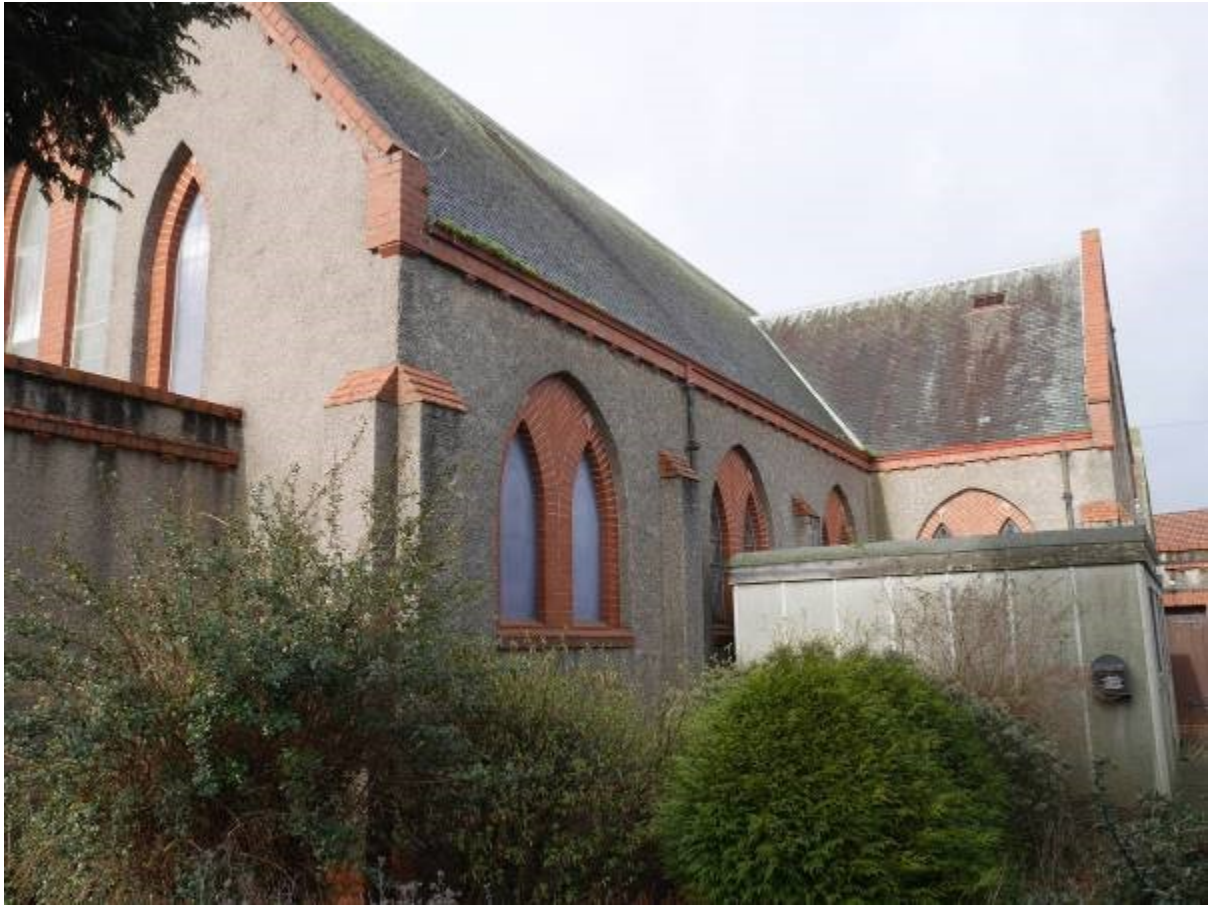
Illustration 13- Eastern Elevation to Building A showing location of Porta-cabin

This is a harled wall face apart from seven courses of mortared red bricks at the base. It contains three groups of two arched windows with red brick surrounds. There is a simple buttress capped with red tiles at the Southern end of the wall line.

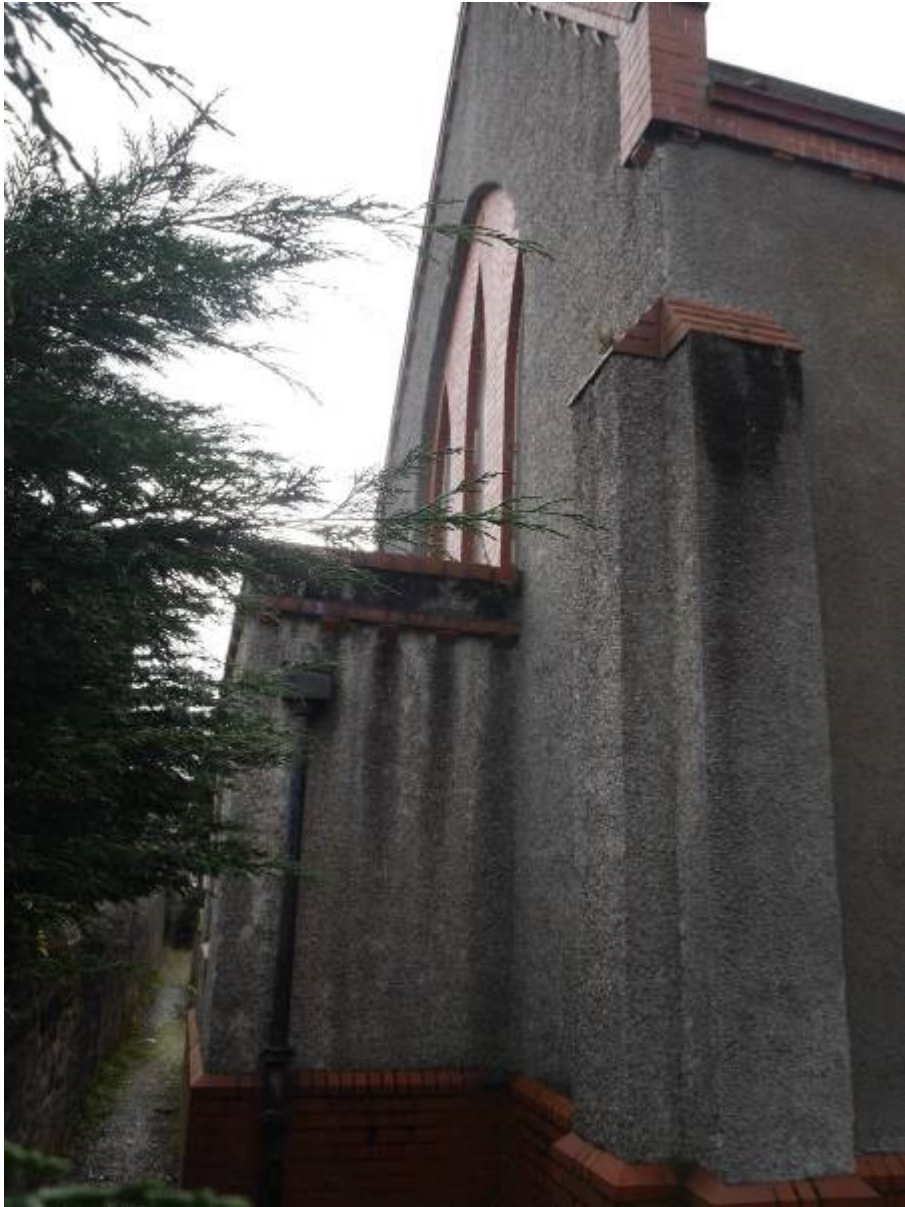
Illustration 16- Eastern elevation to Eastern transept and entrance lobby

This is a harled wall face apart from seven courses of mortared red bricks at its base and contains two arched windows with red brick surrounds. There are simple buttresses capped with red tiles at the Eastern end of the wall line and then a lower flat roofed entrance lobby containing a doorway with a wooden door defined by two courses of mortared red bricks. The roof line of the transept is defined with two courses of mortared red bricks and the roof line of the lobby also has two courses of red bricks separated by a narrow section of harled wall.

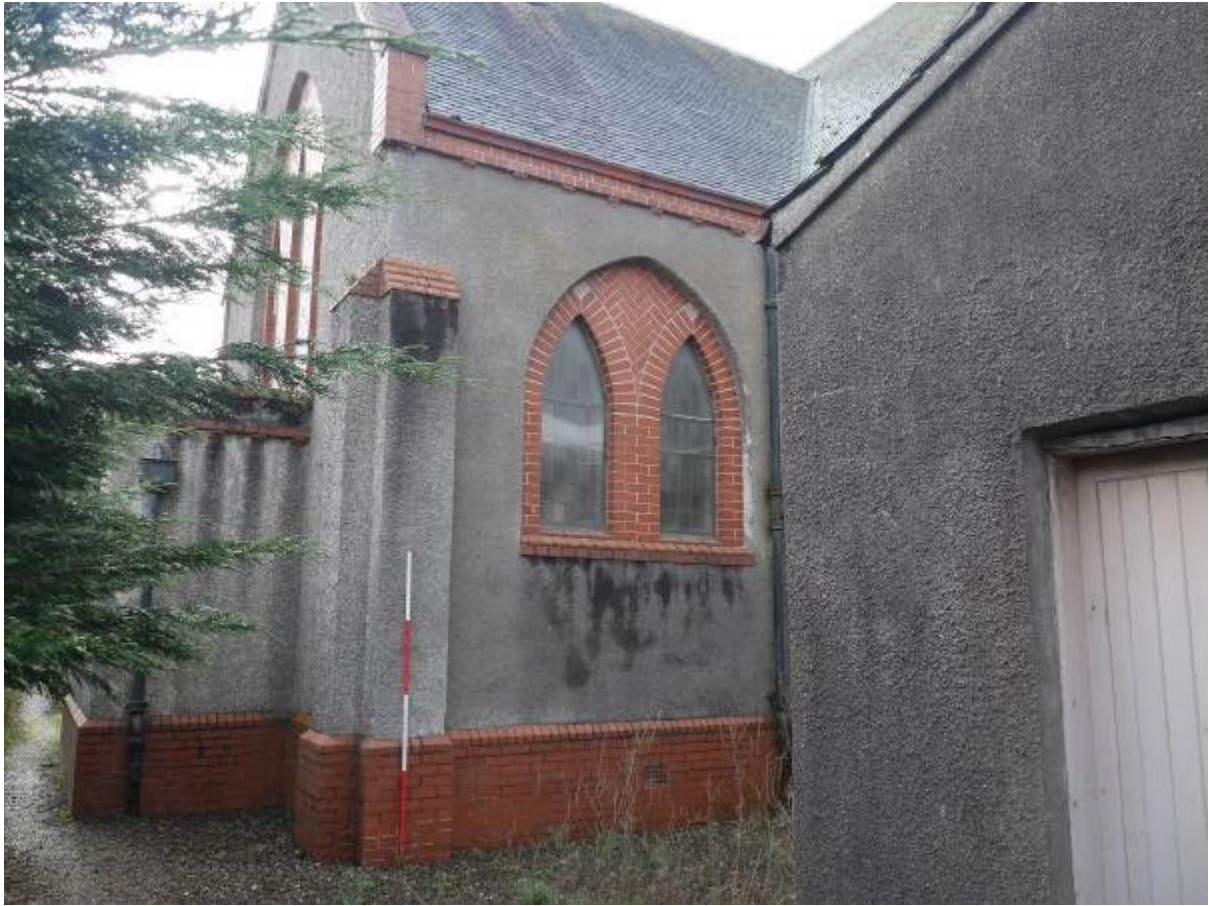
Illustration 17- Northern elevation to East transept

This a harled wall face containing a pair of arched windows with red brick surrounds, the lower part of the wall comprises seven courses of mortared red bricks and includes a single decorative brick panel.

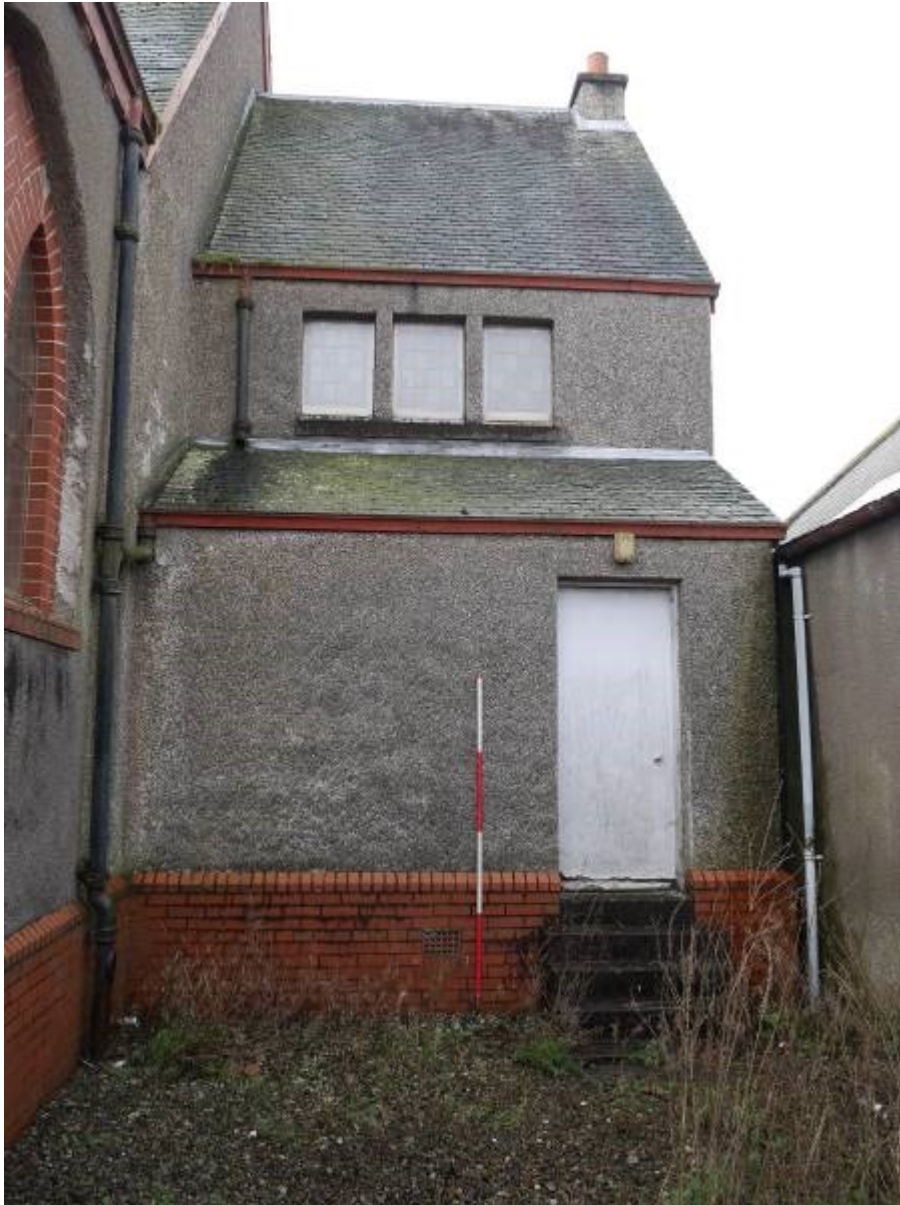
Illustration 19- Eastern elevation of choir

This is a harled wall face containing three square windows its roof line has a single course of mortared red bricks. There is then a lower slated roof above another harled wall face that contains a single doorway with four steps up to it. This lower extension also has a course of mortared red bricks at its roof line and unlike the toilet block on the Western side of the choir is part of the original 1935 build.

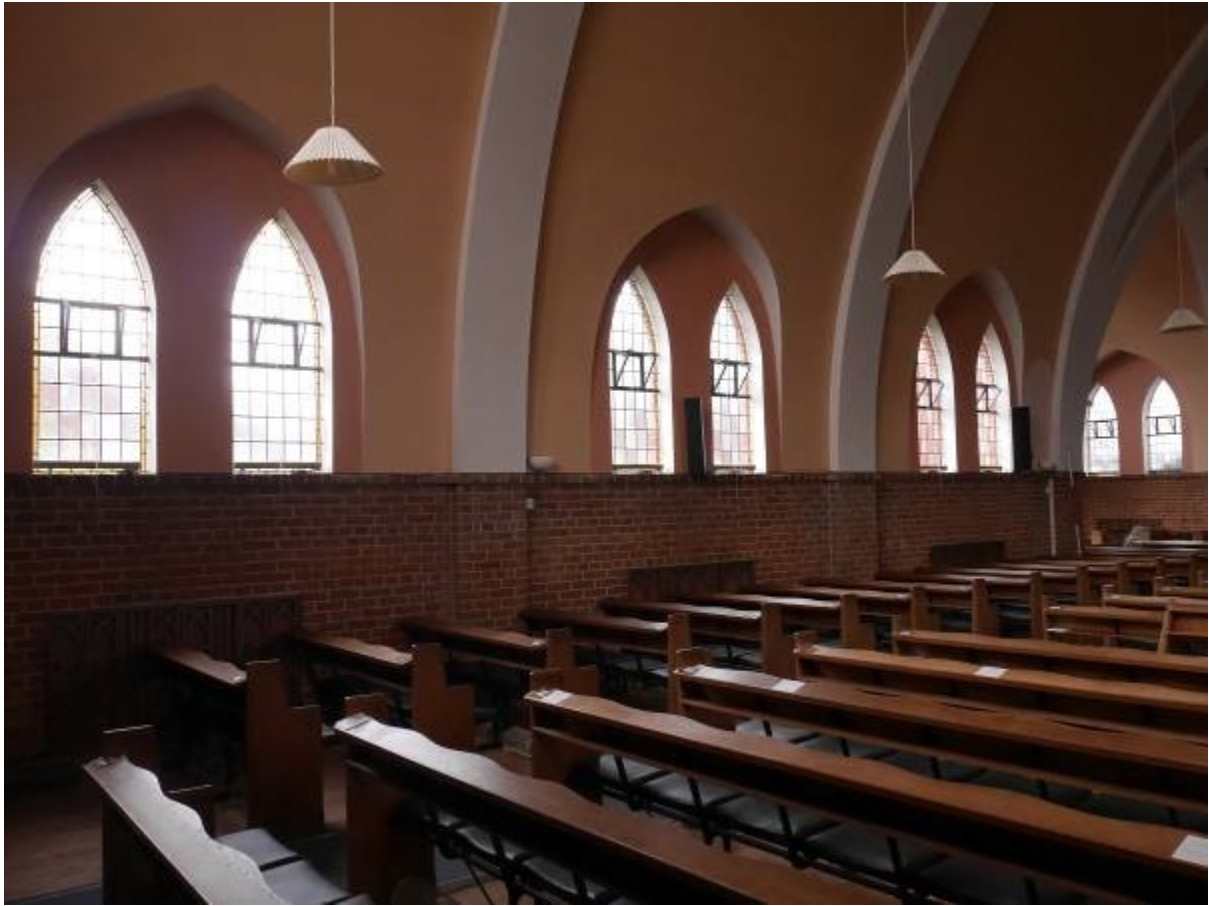
Illustration 24- Western elevation of Nave looking West

This wall is built of 21 courses of mortared red brick to a height of 1.85m above the floor level and is then plastered to the ceiling. It contains three pairs of arched leaded windows that contain blue, yellow and purple glass. There are three recesses in the wall with decorated metal screens which may be for radiators and three springers for the arched ceiling. At its Northern end there is a white painted arch shaped area.

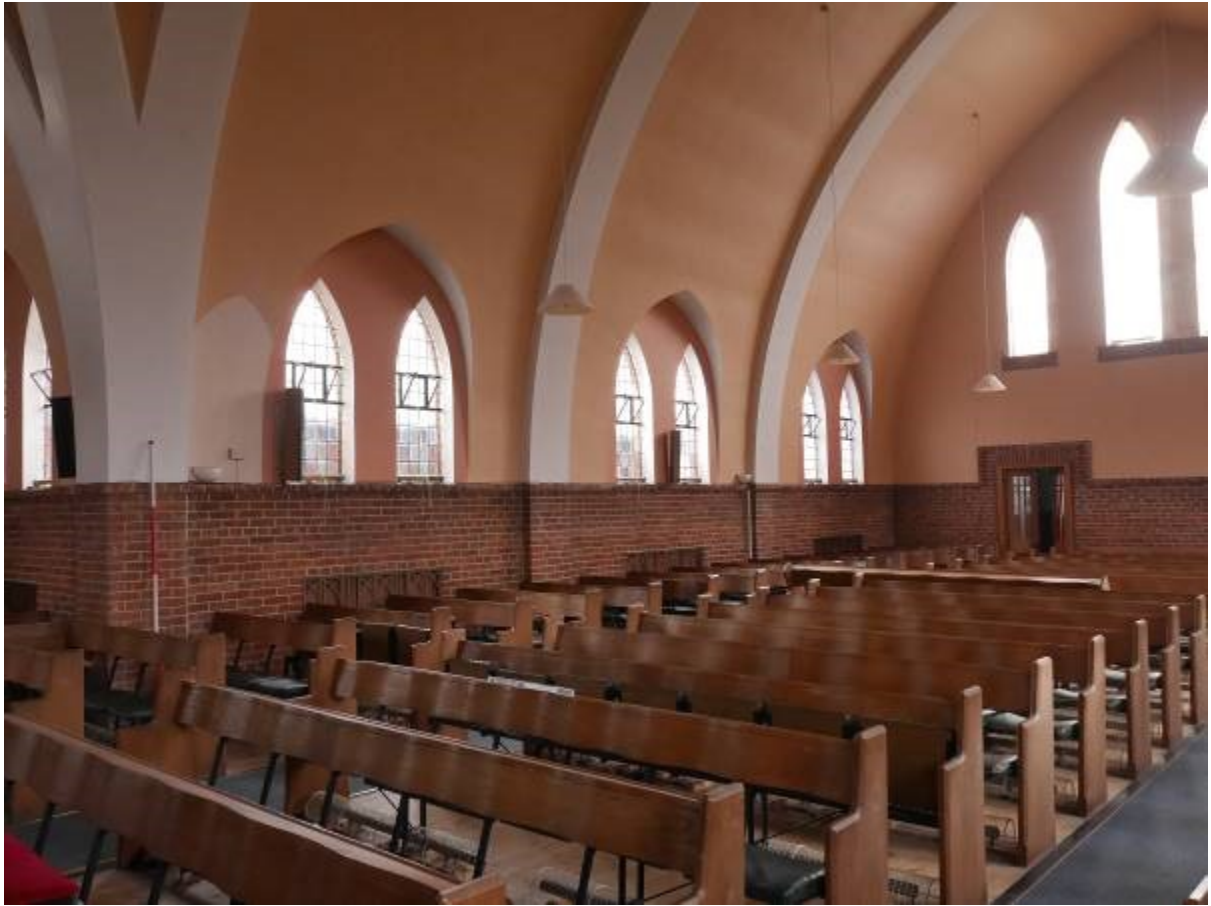
Illustration 25- Eastern elevation of Nave in Building A looking East

This wall is built of 21 courses of mortared red brick to a height of 1.85m above the floor level and is then plastered to the ceiling. It contains three pairs of arched leaded windows that contain blue, yellow and purple glass. There are three recesses in the wall with decorated metal screens which may be for radiators and three springers for the arched ceiling. At its Northern end there is a white painted arch shaped area.

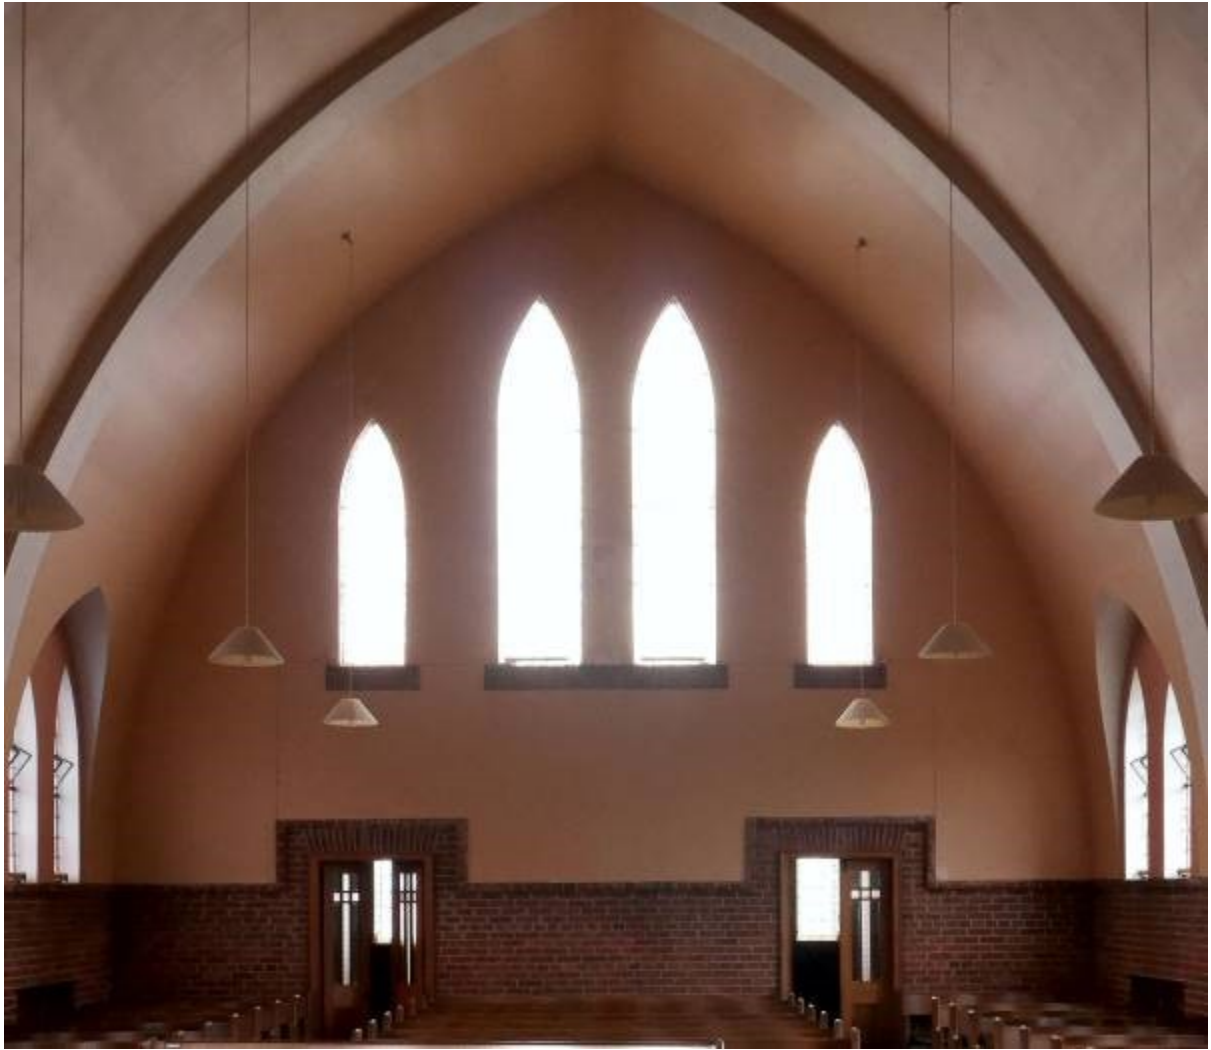
Illustration 26- Southern elevation of Nave in Building A looking South

This wall is built of 21 courses of mortared red brick to a height of 1.85m above the floor level and it then plastered to the ceiling. There are two doorways into the entrance lobby which have decorative courses of mortared red brick over their tops. There are four pointed leaded windows (two large with smaller ones on either side) in the upper part of the gable that contain blue, yellow and purple glass.

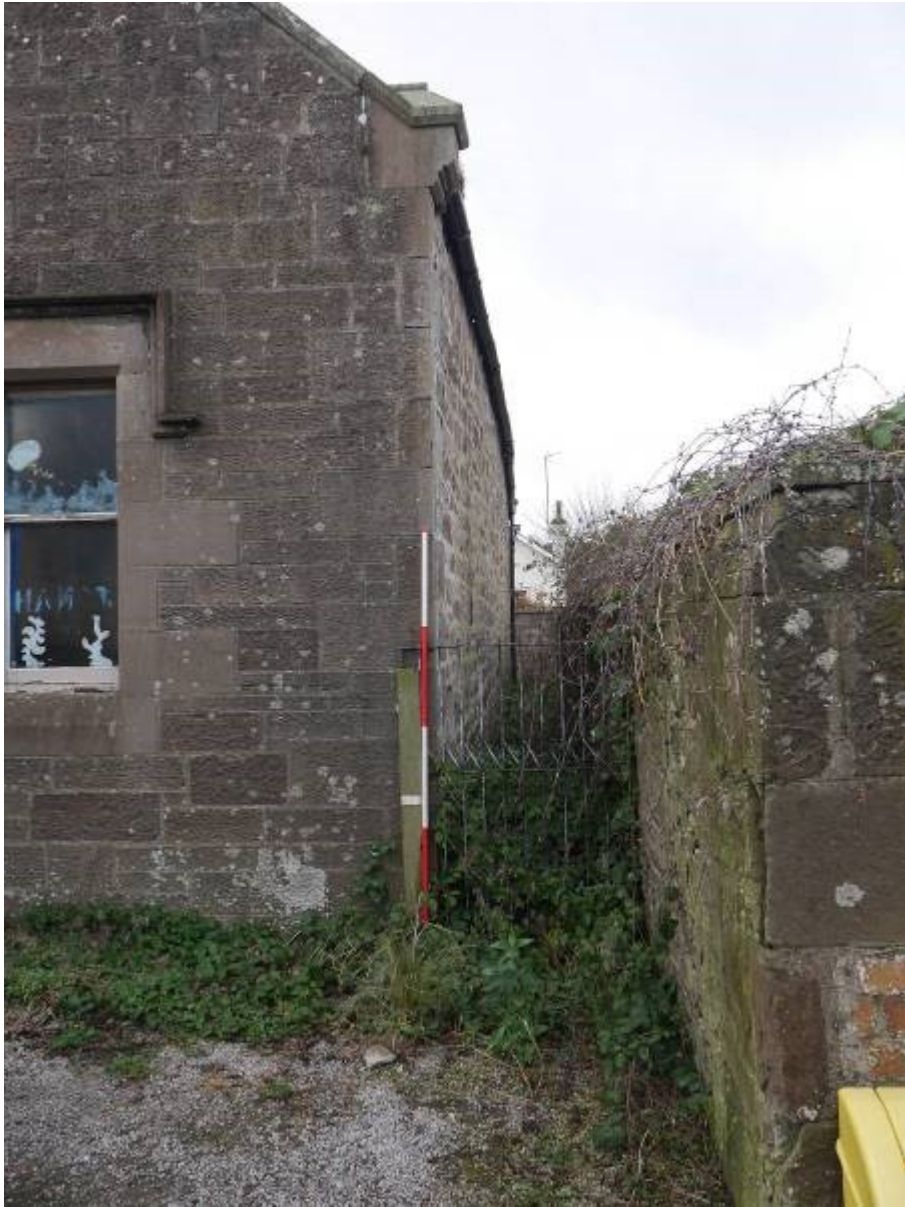
Illustration 40- Northern elevation of Building B

This is built of mortared shaped sandstone blocks with alternate shaped quoins at its corners and sculpted stones at the roof line at each end. It is a blank wall face.

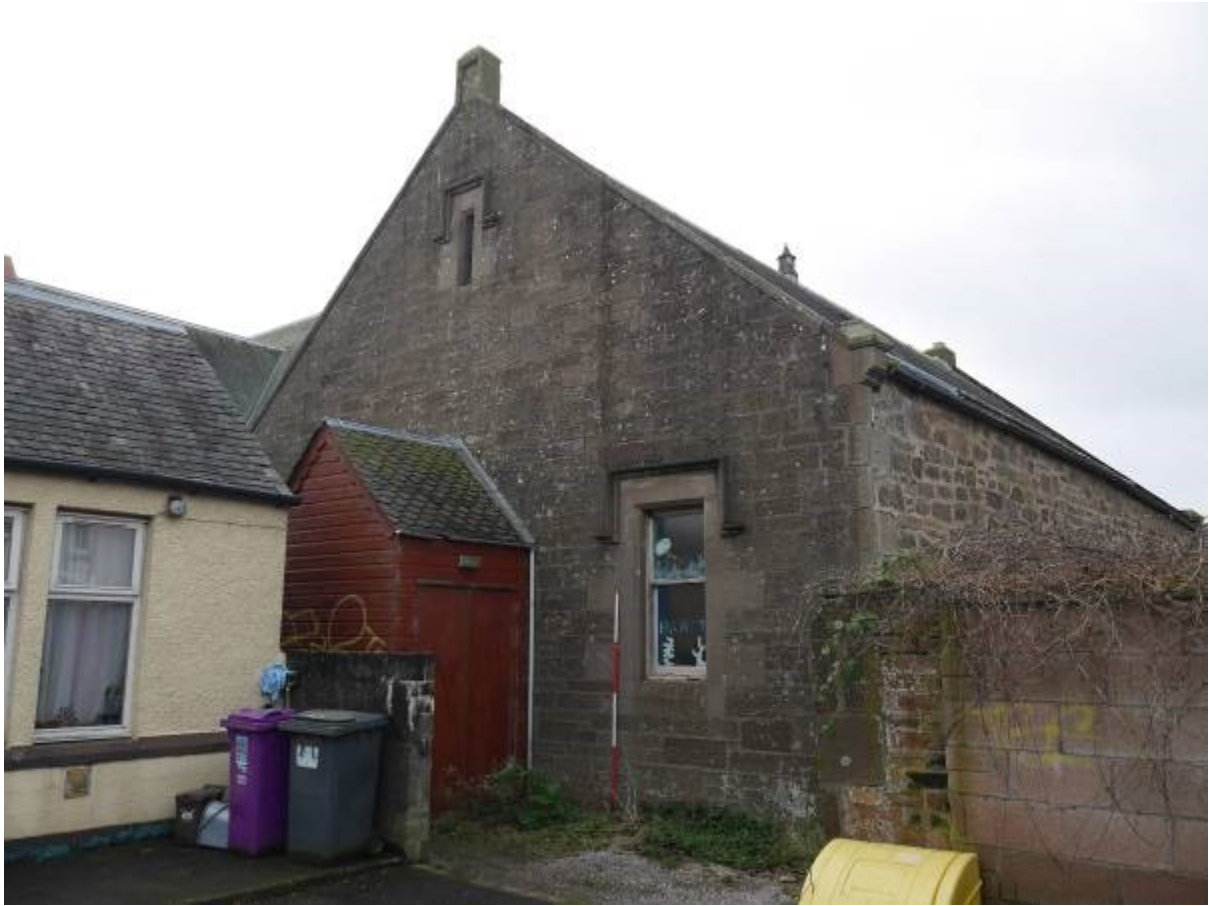
Illustration 42- Eastern elevation of Building B showing windows with decorative cornices, more recent wooden entrance hall also visible

This is the Eastern gable of the former 19th century church building and is the most visible surviving elevation of that building. It is built of shaped sandstone blocks with alternate shaped quoins at its corners and sculpted stones at the base of the roof line at each end. A more recent wooden entrance lobby has been built against this elevation, this has a slated roof and double wooden doors that are accessed from the North. There are single glazed frosted windows to either side of the entrance lobby that are defined by shaped ashlar blocks and have decorative stone cornices at their heads. There is a narrow-glazed window in the head of the gable that is defined by shaped ashlar blocks and has a decorative cornice at its head. There is an undecorated square finial on top of the gable. A more recent storeroom has been built against the Southern elevation of Building B and it is accessed by a wooden doorway in a harled wall face at the Southern end of this elevation.

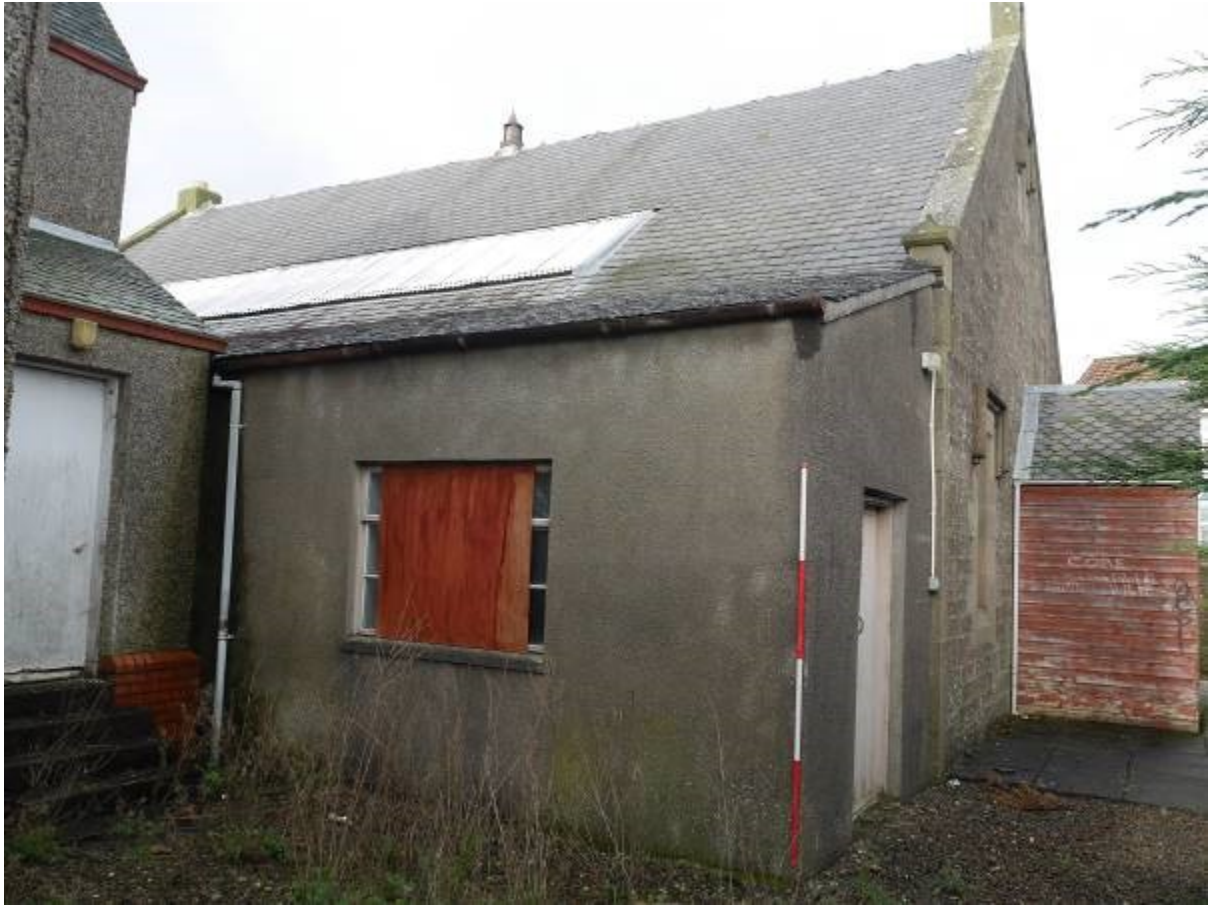
Illustration 44- Southern elevation (Eastern section) of Building B showing modern storeroom built against it and inserted skylights in slated roof

This is the Southern wall of the more recent storeroom and comprises a harled wall face with a partially boarded up glazed metal framed window. The storeroom has a slated roof. The roof of the former 19th century church is also slated and has had large skylights inserted into it.

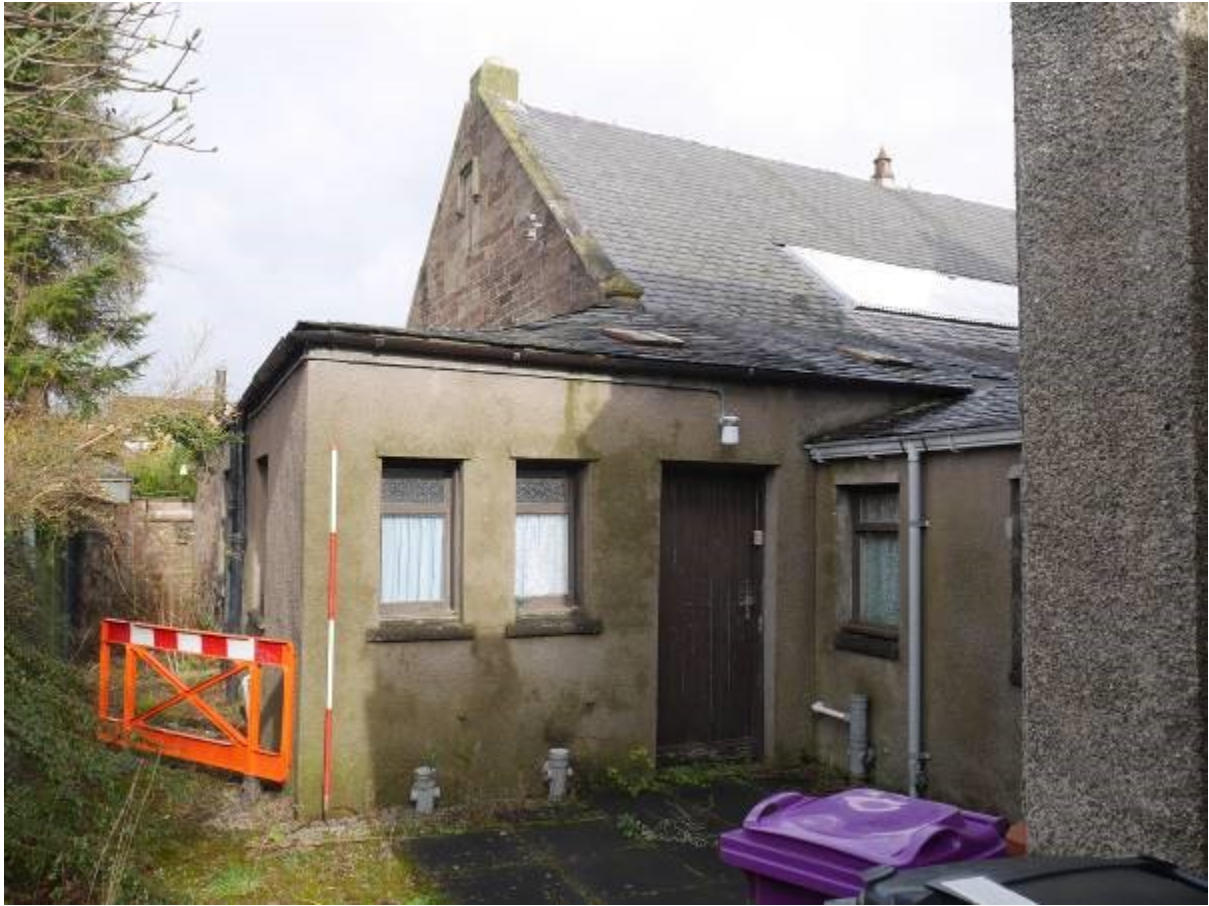
Illustration 45- Southern Elevation of Building B (Western section) showing toilet, kitchen and classroom built against it, surviving visible section of Western elevation also visible

This section of the Southern elevation includes the harled wall face of the toilet and entrance lobby. There are two glazed windows with metal frames and a wooden doorway.

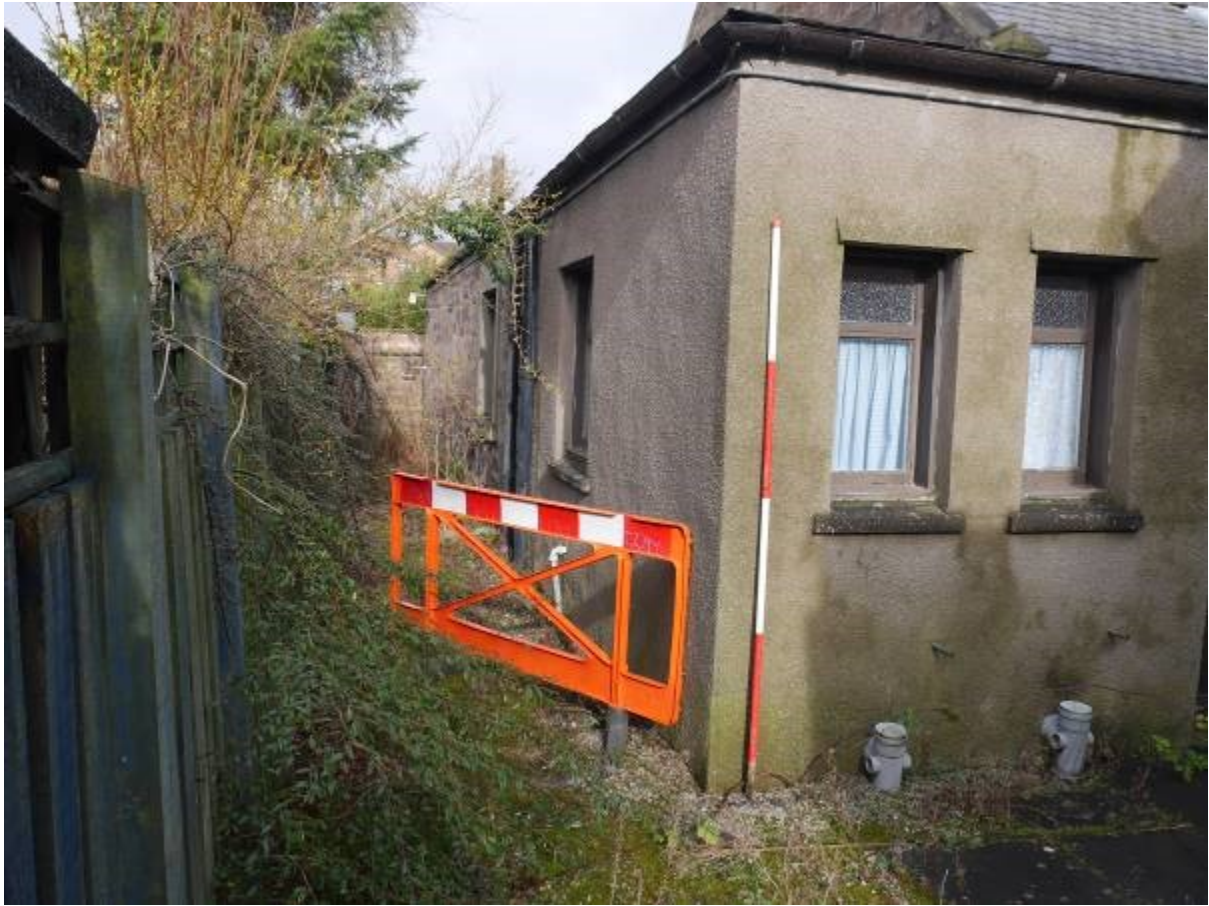
Illustration 46- Western elevation of Building B

This elevation of the former 19th century church has had a classroom, kitchen and toilet built against it. The western elevation of the classroom is a harled wall face containing two glazed windows with metal frames and has a slightly pitched slated roof. The visible section of the original western elevation of the 19th century church is built of shaped sandstone blocks and has a slit window in the head of the gable with a decorative cornice at its head. There are sculpted stones at each end at the wall heads at each end of the wall line. There is a chimney pot at the top of this gable.
