Standing Building Survey
Former Panmure Church, Monifieth
Angus Council

21st March 2019

Introduction

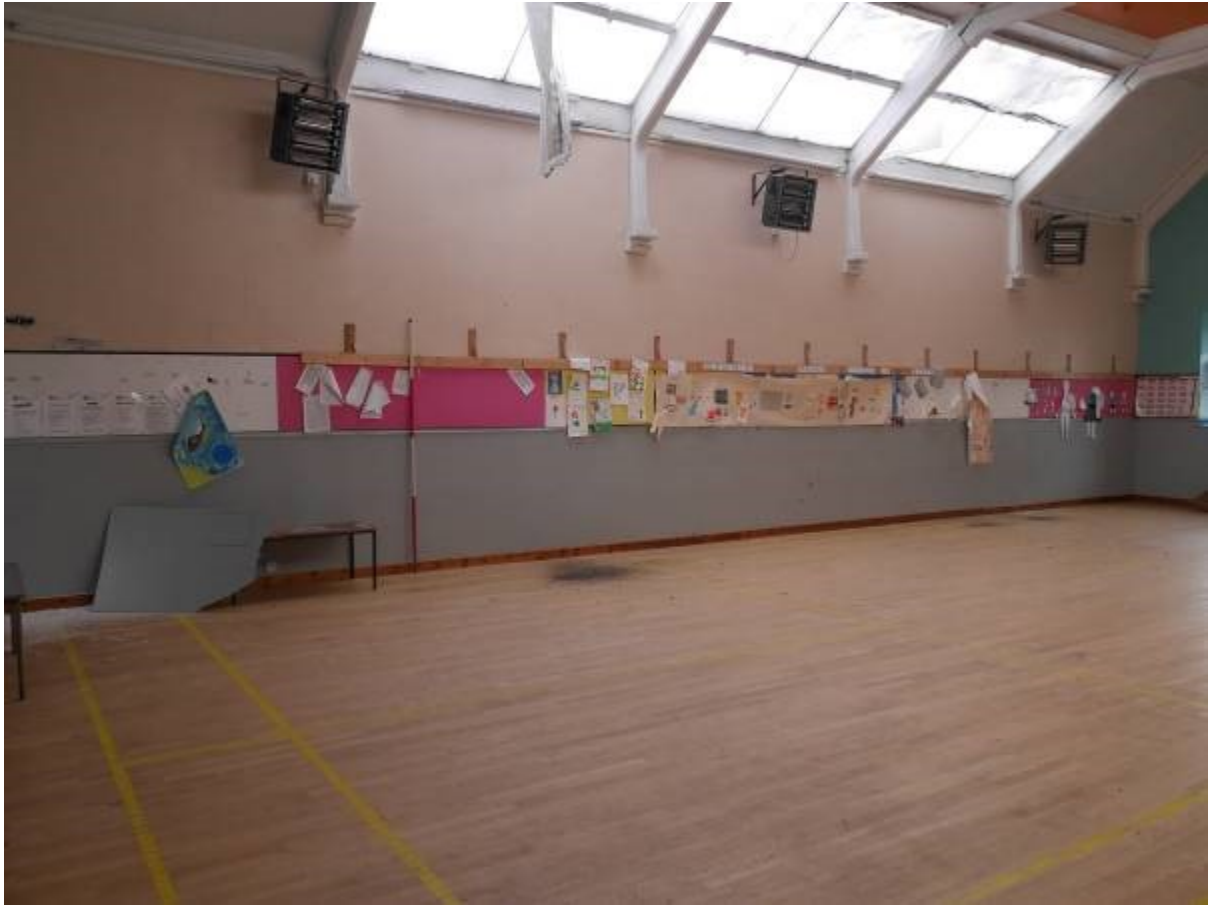
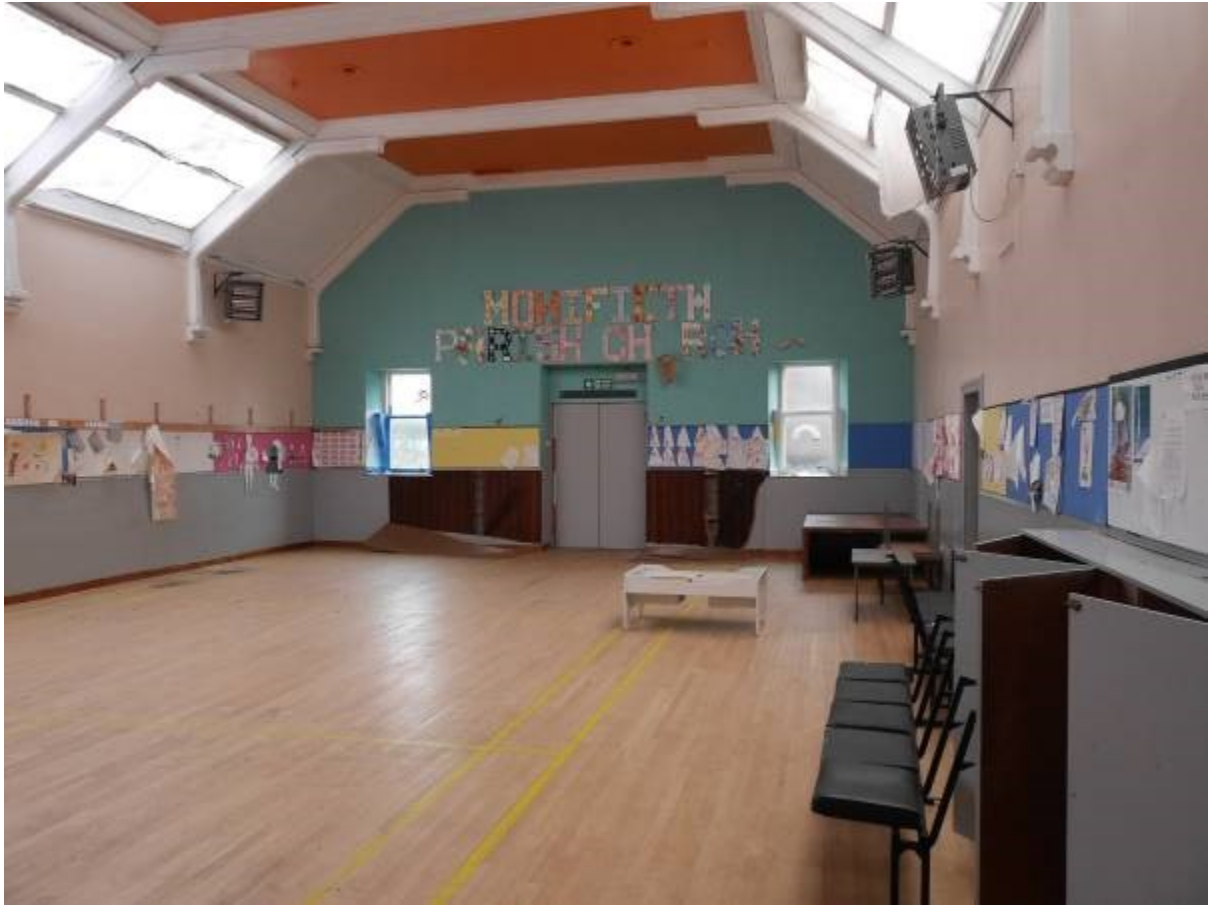
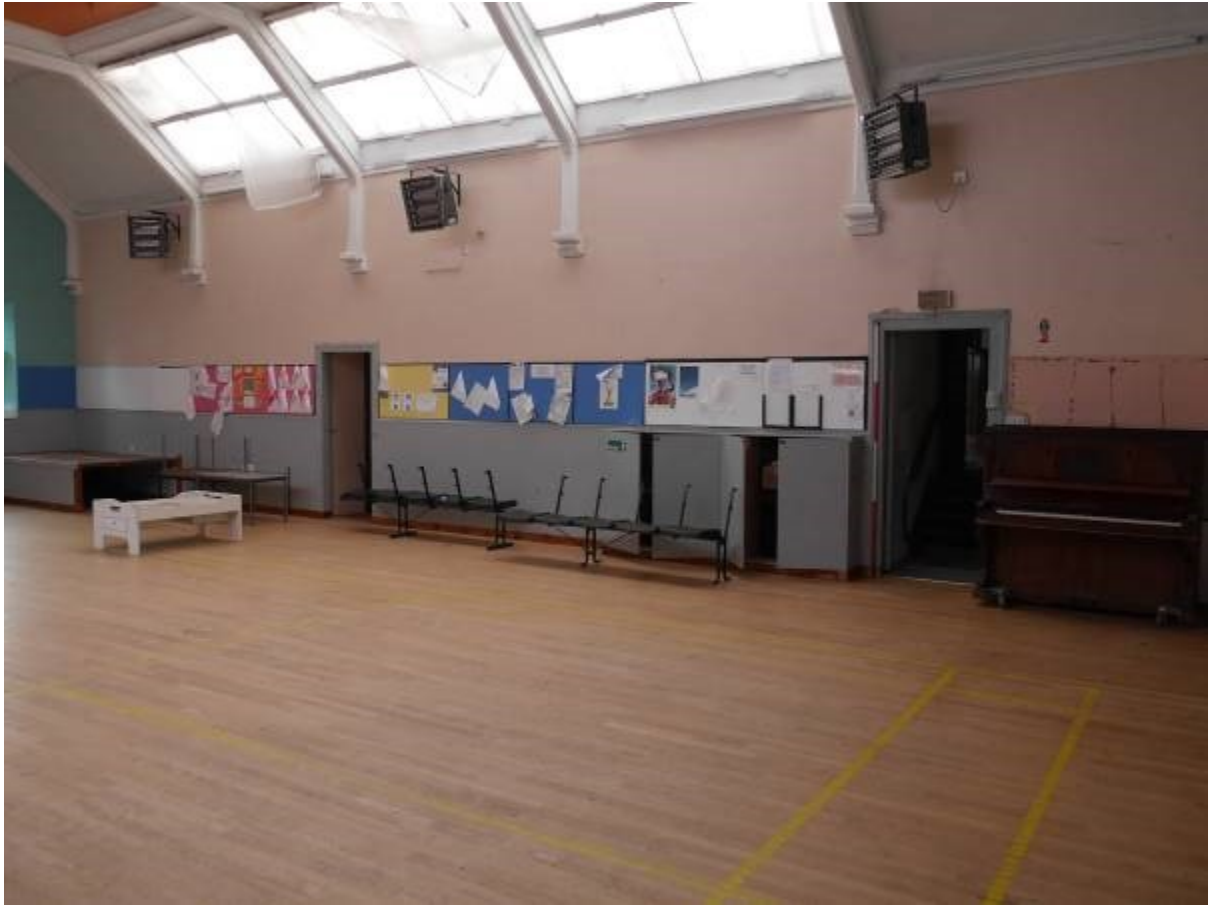
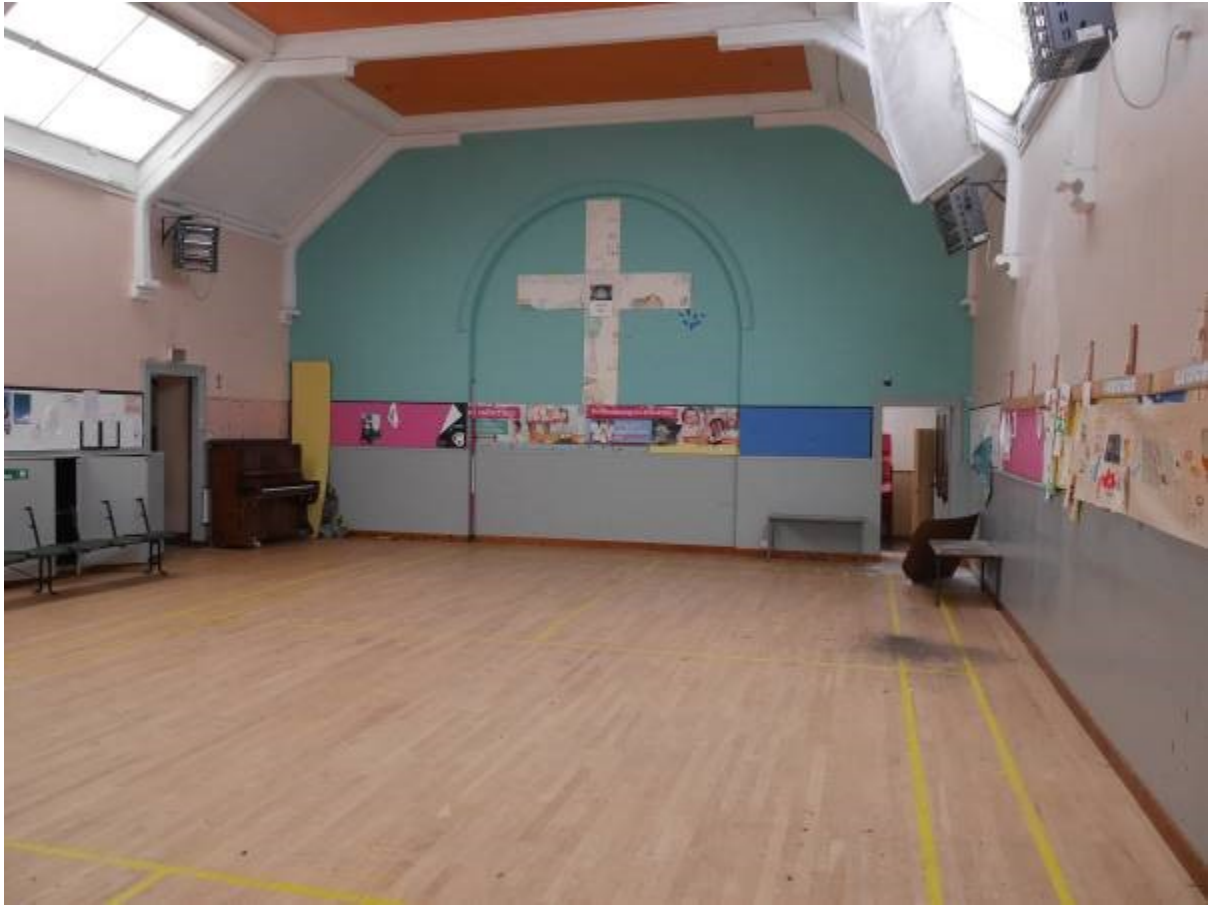
Illustration 50- Northern elevation of Main Hall in Building B looking North

This has a wooden floor with a badminton court painted on it. Its Northern elevation has three large skylights in the roof, three space heaters and is painted buff, purple and grey. There is a notice board running the length of the elevation. The Western elevation is painted blue, has a paper crucifix and a recessed arch in the centre and a single doorway into the classroom. On the original architects plans this is shown as being the location of the altar for the original church building (see Illustration 4). The Southern elevation has three large skylights in the roof, three space heaters and a doorway in from the anteroom and a doorway into the former boiler room. The Eastern elevation contains the main entrance into the hall which has two pointed glazed windows on either side. The wall is painted blue and has 'Monifieth Parish Church' spelt out in paper letters on it.

This is slightly canted and supported on six wooden beams which stand on supports in the Northern and Southern elevations. The canted sections are painted white and the ceiling is painted orange and divided into six sections. There are three large skylights on either side of the roof in the canted sections.
