Standing Building Survey  
Wester Ballinluig steading  
Perth and Kinross

Wester Ballinluig steading from the South, Ben Vrackie in the background

17<sup>th</sup> December 2018

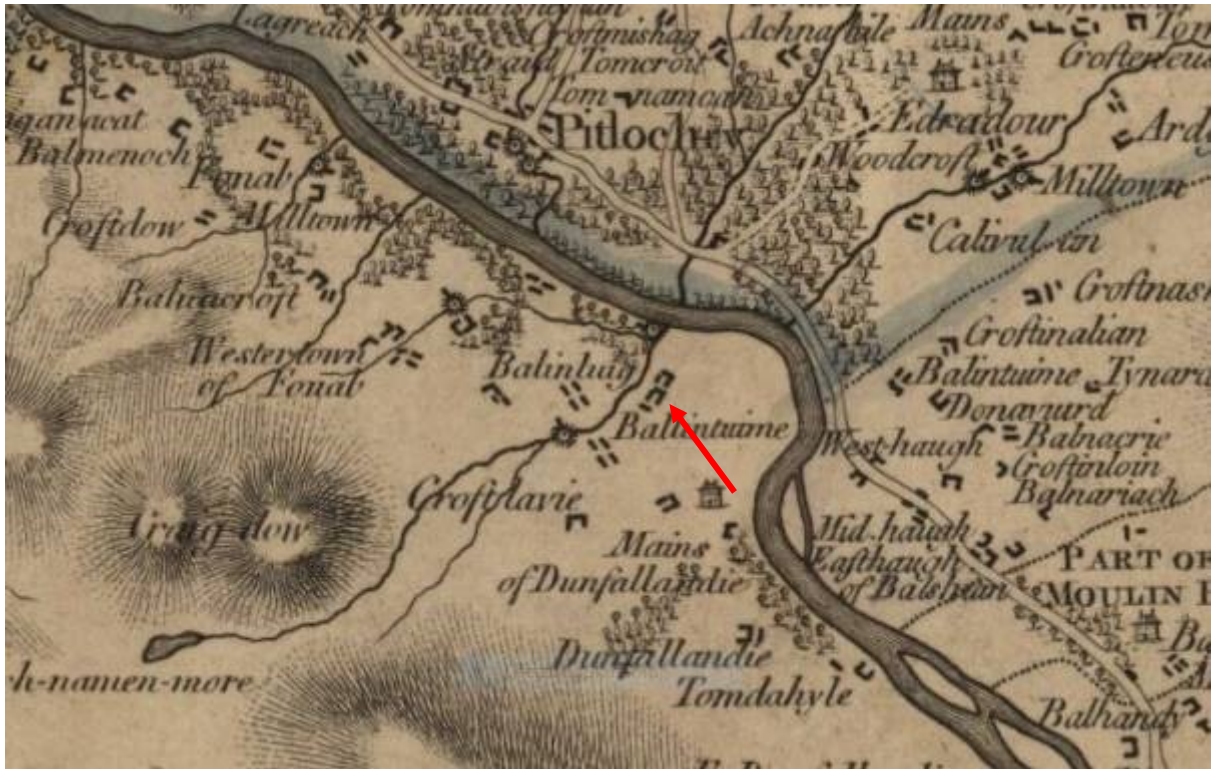
Illustration 2- Ballinluig as marked on Thomas Scobie's map of 1783 (red arrow) (© Trustees of National Library of Scotland)

A settlement at Ballinluig is shown on Stobie's map of 1783 (Illus 2) but it is not until 1867 that the steading is shown in its modern ground plan on the First Edition Ordnance survey map (Illus 3) (. A settlement at Ballinluig of Dunfallandy is listed in the census of 1841 and a total of 26 people are listed as living in six separate buildings (1841 Census, Scotland's People). The 1855 valuation roll lists the proprietor of Wester Ballinluig as being Miss Margaret Fergusson of Dunfallandy, Edinburgh and lists James Fergusson as residing at Wester Ballinluig (1855 Valuation Roll, Scotland's People).

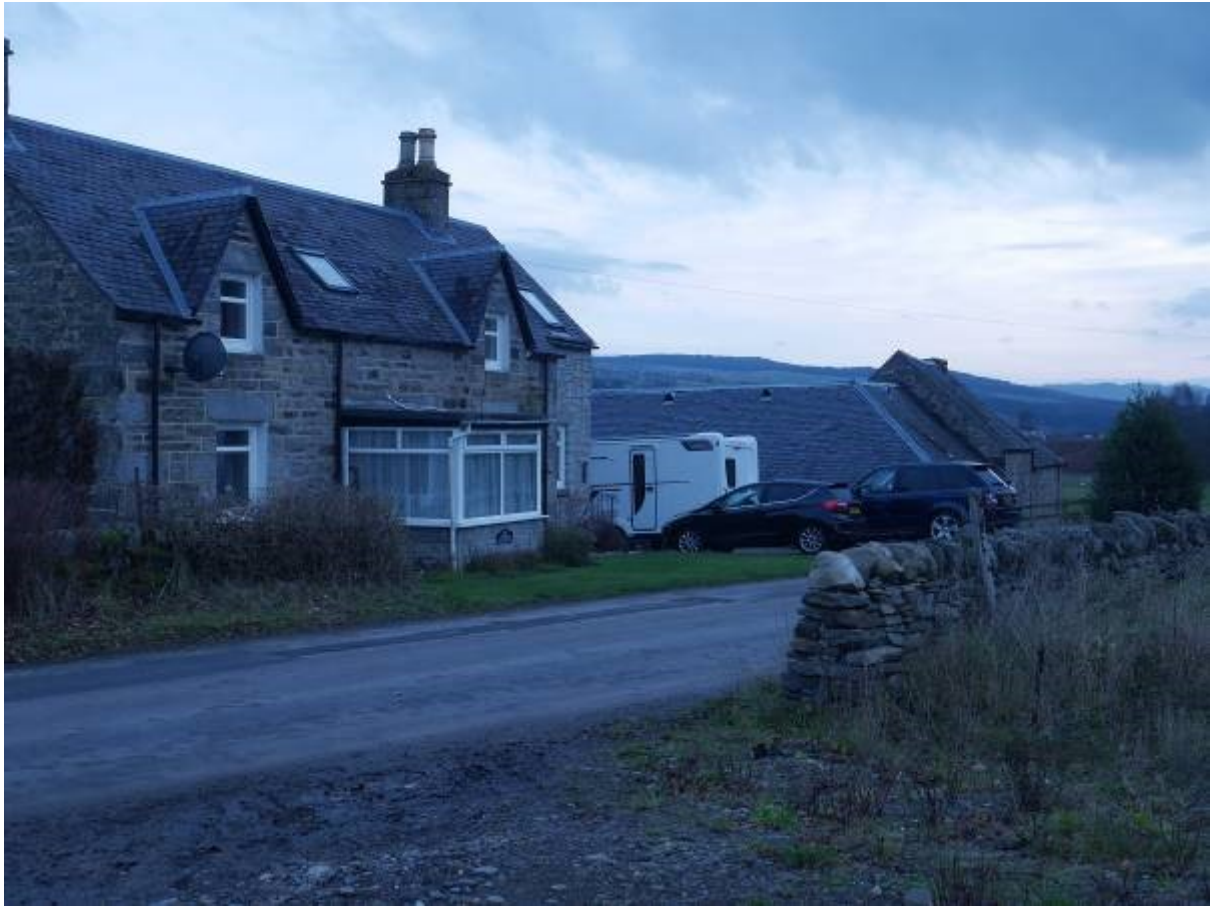
Illustration 5- Wester Ballinluig farm house with steading visible behind parked cars looking South

Wester Ballinluig steading forms part of Ballinluig Farm which lies to the West of the River Tummel and lies on the Eastern side of the road to Dunfallandy House.

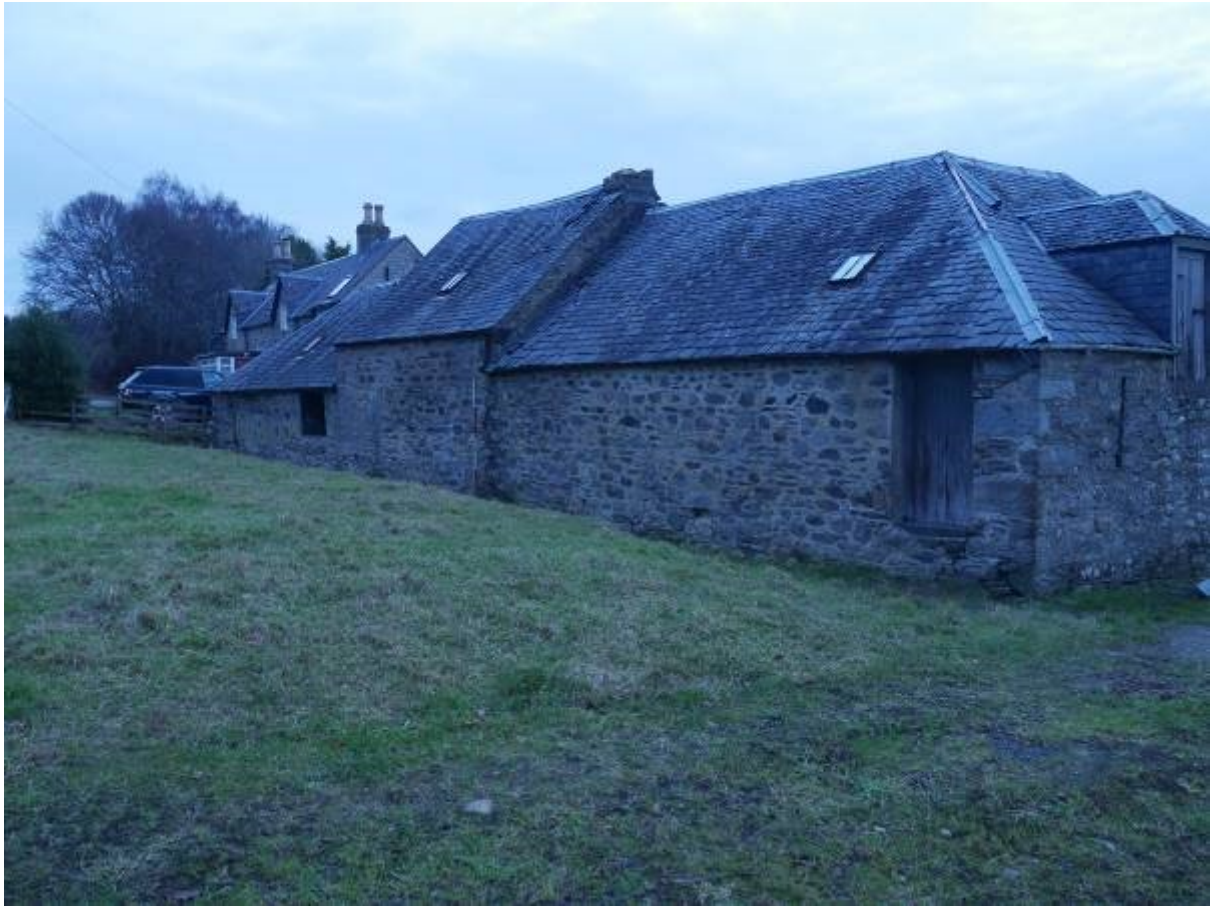
This elevation has a mortar bonded wall face which is a mixture of shaped and rough stone and there are shaped quoins at its corners. The roof line at the centre of this elevation is slightly higher where it covers the former store (2). At its Northern end there is a single unglazed window that looks into the small room behind cattle feeder 3a. In the centre of the elevation there are three circular holes just below the roof line. At its Southern end there is a single doorway with a wooden door that is raised above ground level. The roof is slated with three small skylights, has a ventilation hole above room 3 and a damaged chimney above the northern end of room 1.

Illustration 7- Northern western elevation of the steading looking North

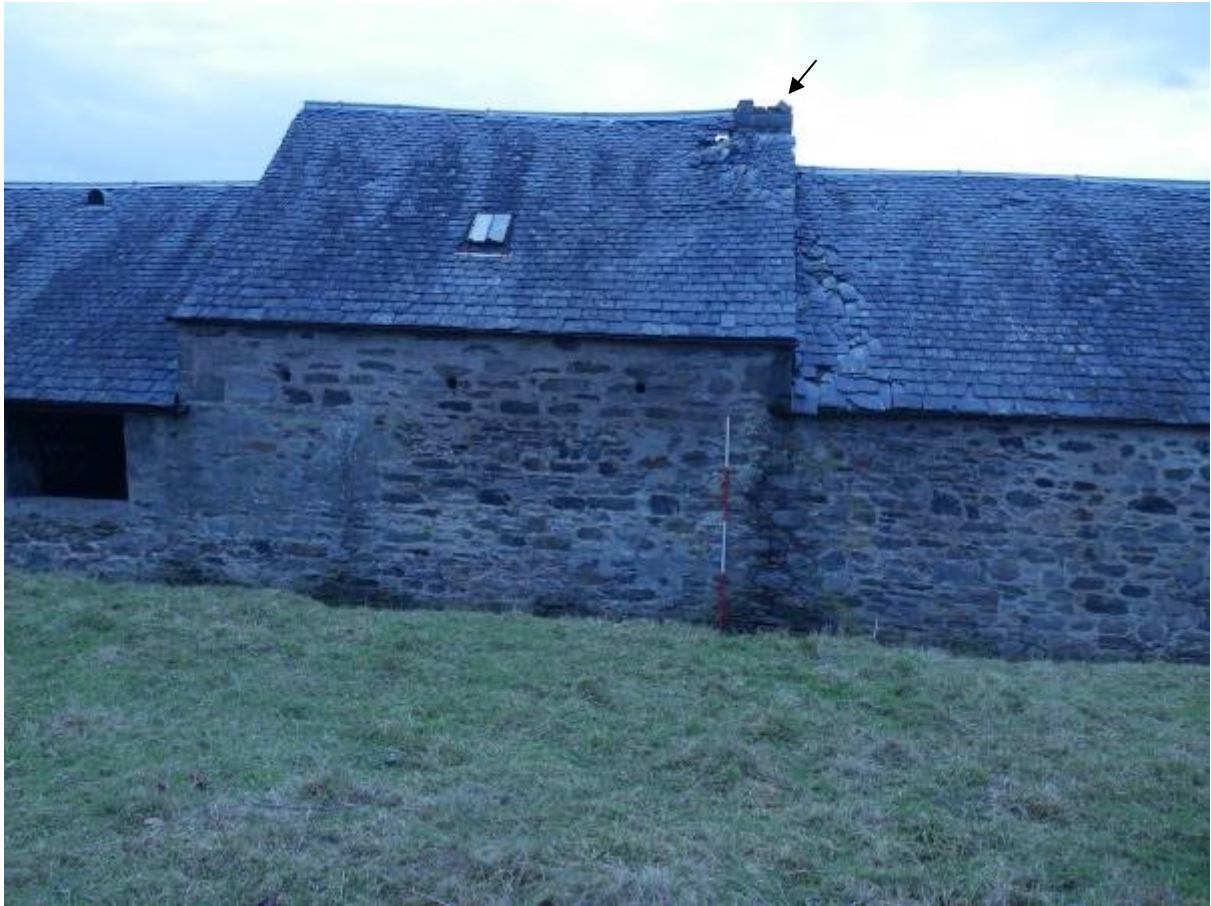
Illustration 8- Detail of North Western elevation showing higher roof line, three holes in wall face, ventilation hole in roof of room 3 and chimney for fireplace in room 1 (black arrow)

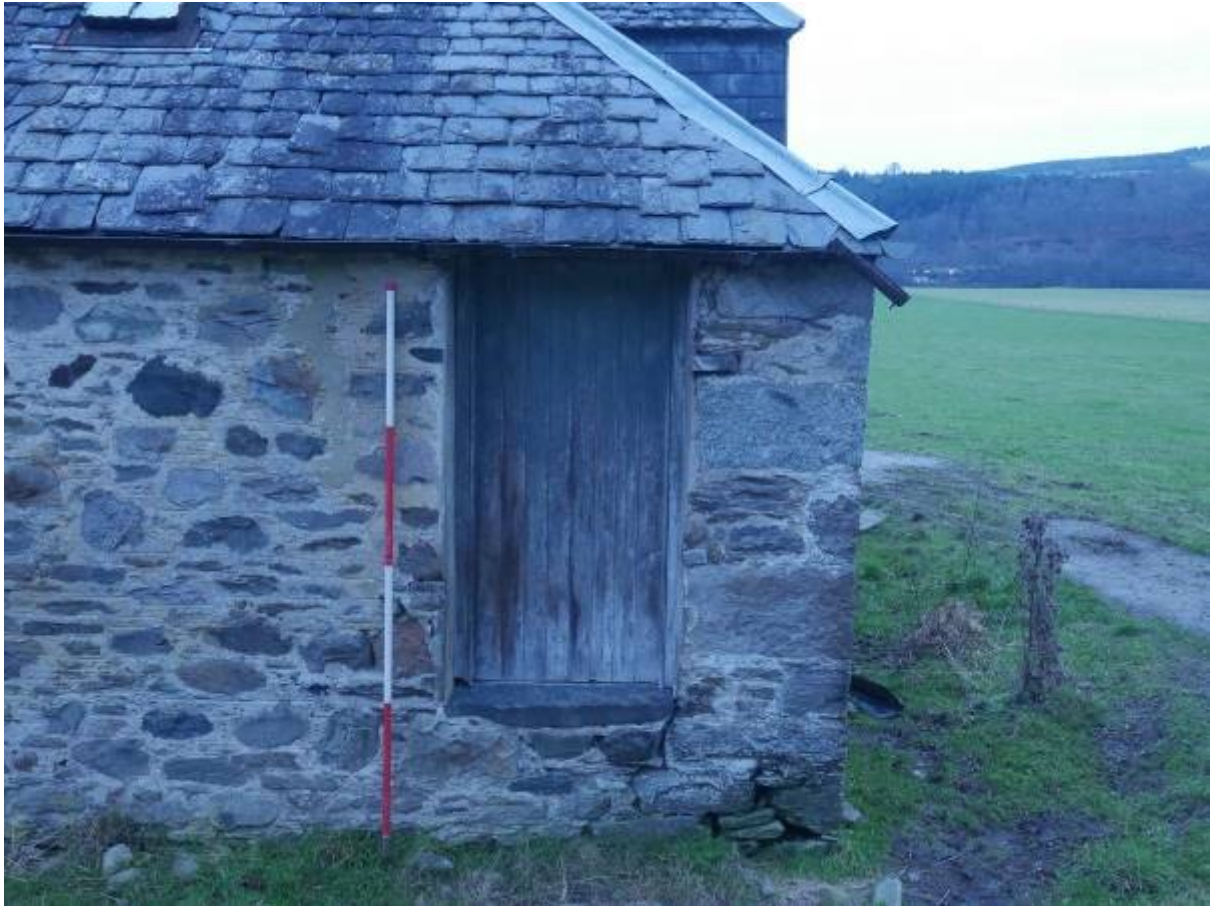
Illustration 9- Southern end of North Western elevation showing doorway raised above ground level

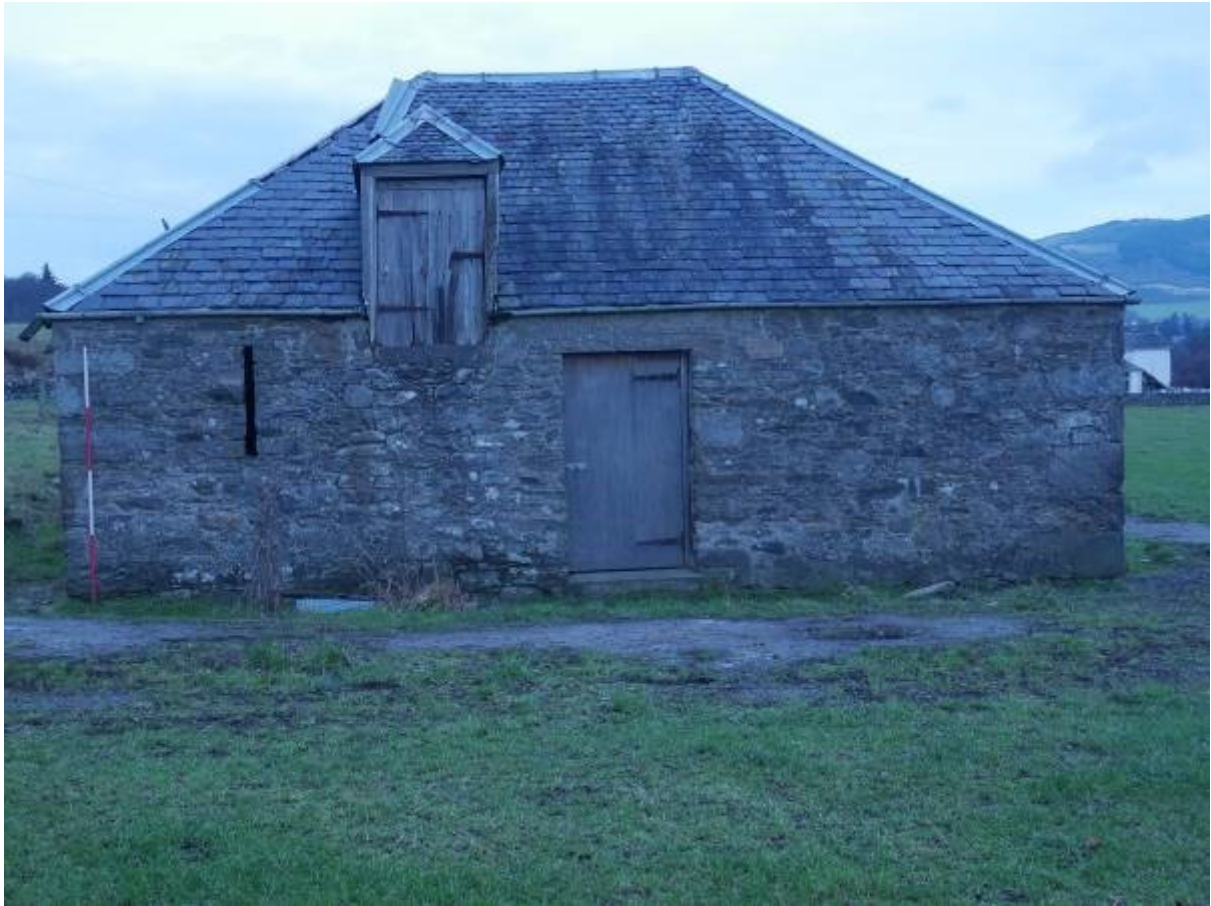
This elevation has a mortar bonded wall face which is a mixture of shaped and rough stone, there are shaped quoins at its corners. There is a narrow unglazed slit window at its Western end, a doorway with a wooden door in the middle giving access to room 1 and another doorway with a wooden door in a small dormer in the roof that provides access to the roof space.

Illustration 10- Southern elevation of steading showing slit window, doorway into room 1 and doorway in roof dormer.

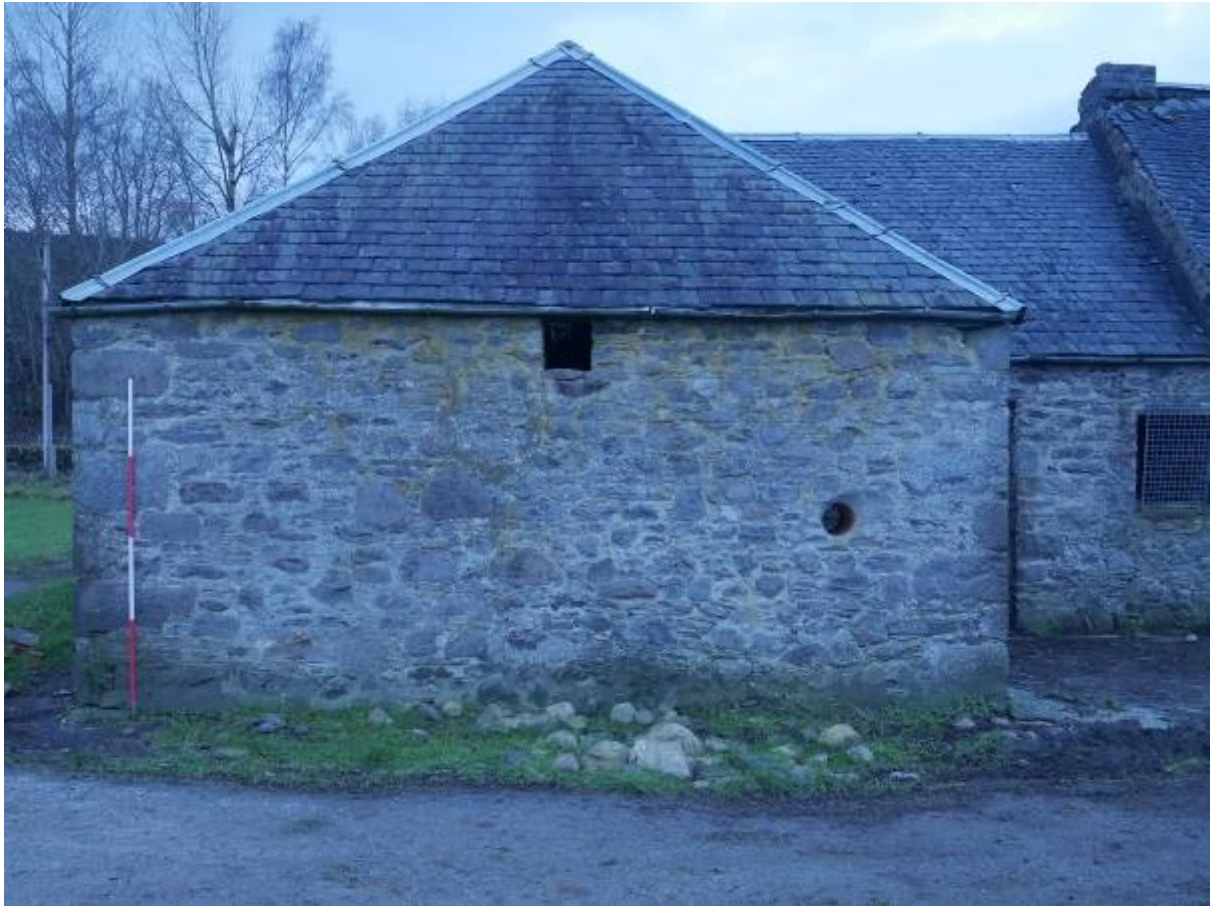
This elevation has a mortar bonded wall face which is a mixture of shaped and rough stone with shaped quoins at the corners. There is a small square unglazed window at the roof line and a modern circular hole cut through the wall that is lined with ceramic. It is assumed that this allowed for the insertion of a bar to keep the animals in the shed.

Illustration 11- Eastern elevation of room 4 showing small unglazed window and circular hole in wall

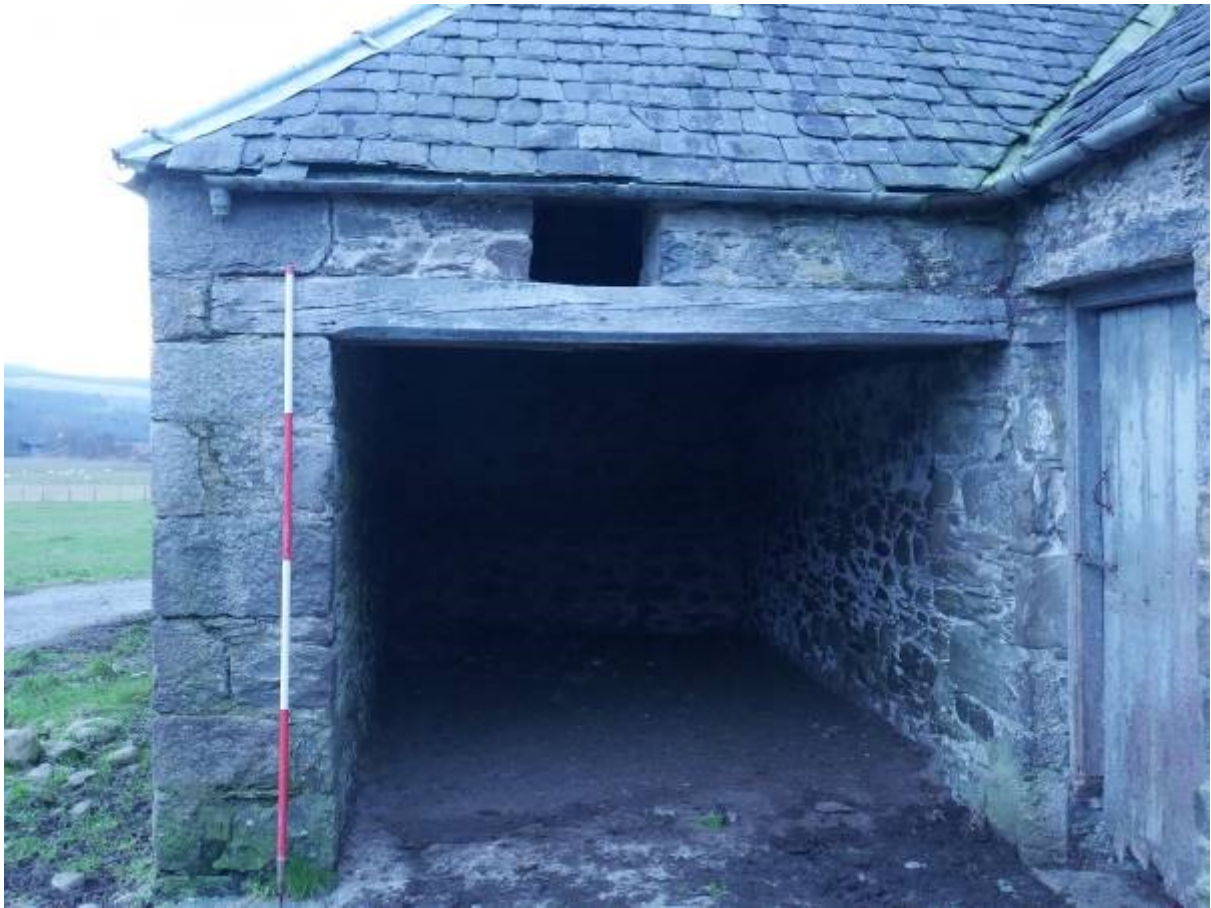
This elevation contains the access to the former cattle shed which has a wooden lintel and a small unglazed window at the roof line.

Illustration 12- Northern elevation of room 4 showing main access with wooden lintel and small unglazed window in roof line

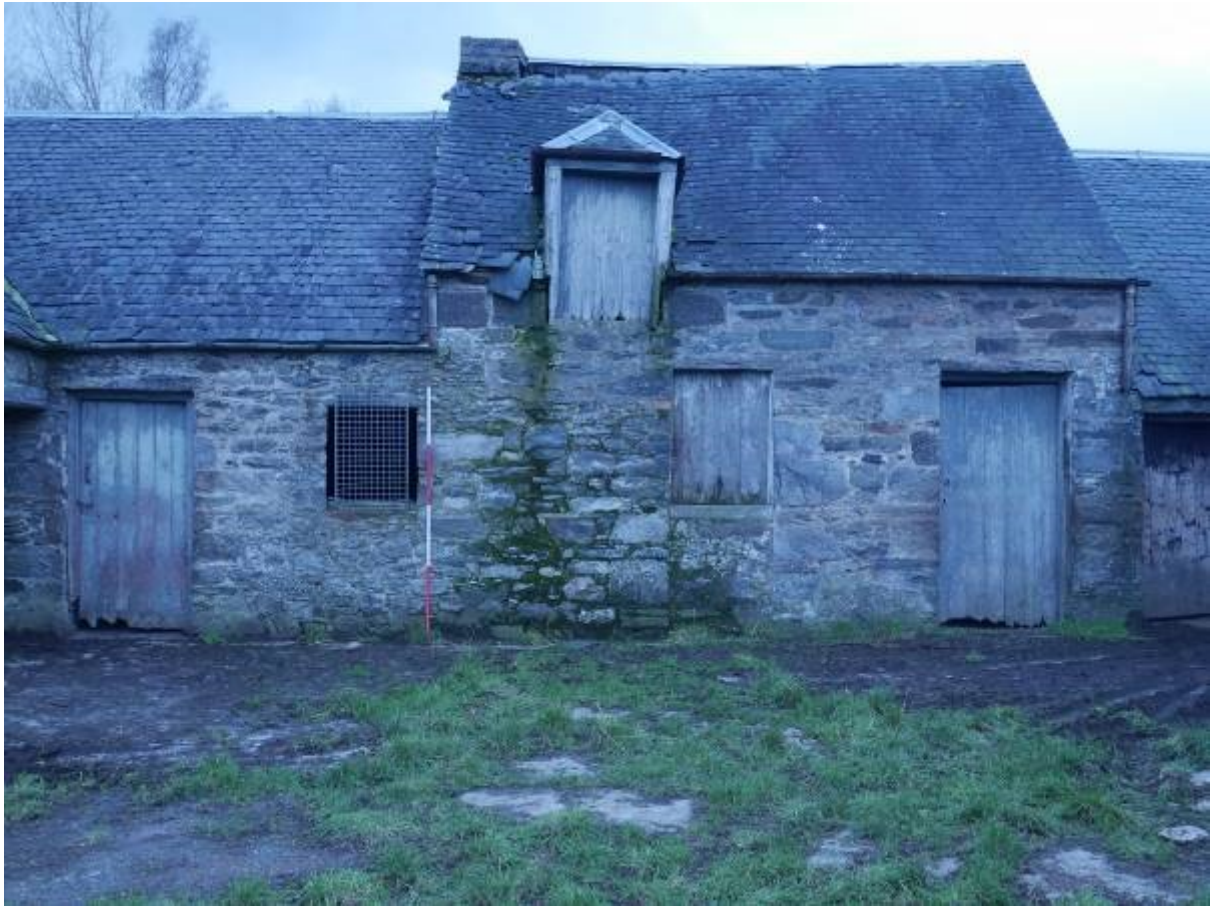
This elevation has a mortar bonded wall face which is a mixture of shaped and rough stone. There is a doorway with a wooden door at its Southern end giving access to room 1, a window covered with a metal grille looking into room 1, another window with wooden shutters and another doorway with a wooden door that leads into store room 2. A doorway at the northern end provides access to cattle feeder 3A. There is a doorway with a wooden door in a dormer in the roof line above room 2 providing access to the roof space. There is a ventilation hole in the roof line above room 3.

Illustration 13- Eastern elevation of rooms 1 and 2 showing higher roof line, doorways and windows into 1 and 2 and doorway in roof dormer.

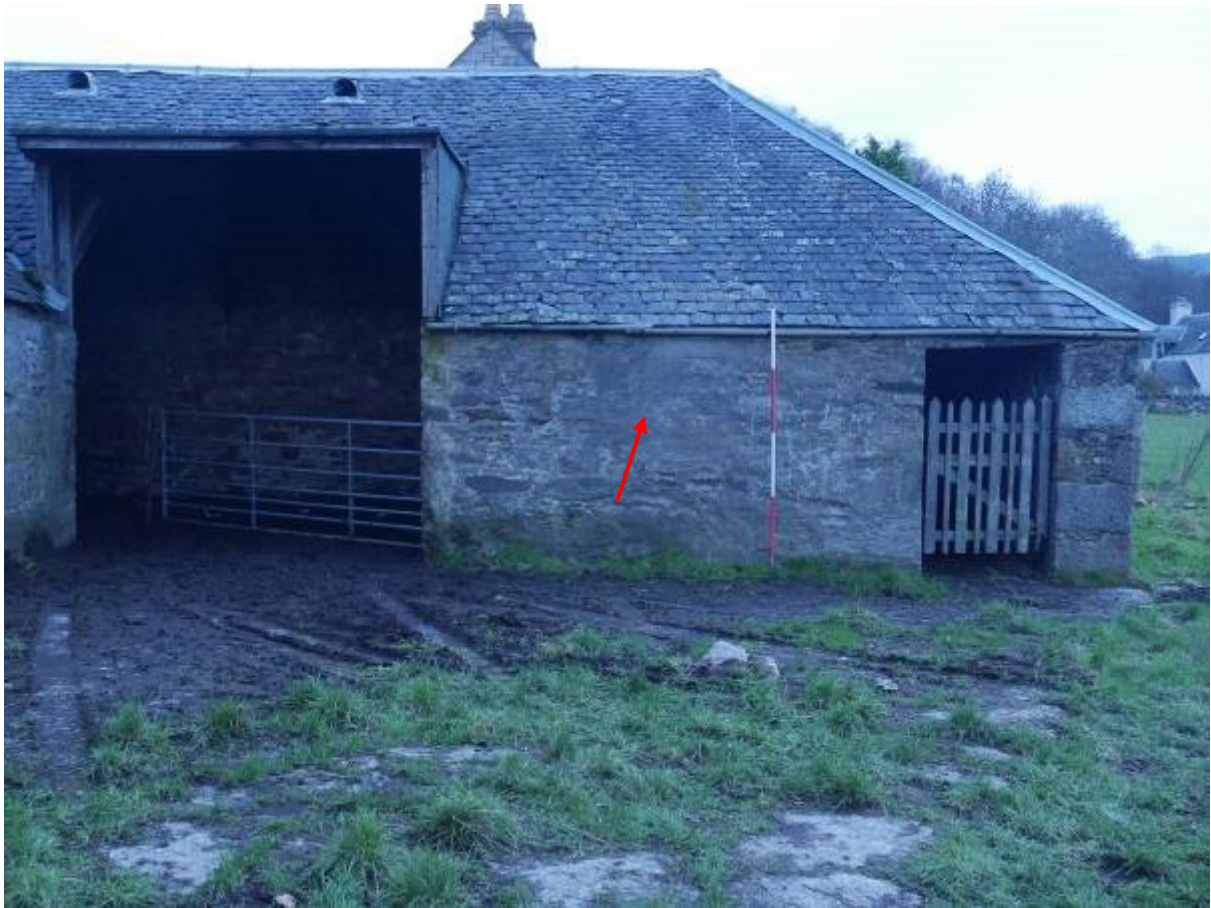
There is a wide entrance into the cattle shed 3 at its Western end, a blocked window and a small doorway with a wooden door leading into feeder access 3b. The wall where present is a mixture of mortar bonded shaped and rough stone. There are two ventilation holes in the roof line.

Illustration 14- Southern elevation of room 3 showing main access and doorway into room behind cattle feeder 3b and ventilation holes in roof, red arrow shows location of blocked window.

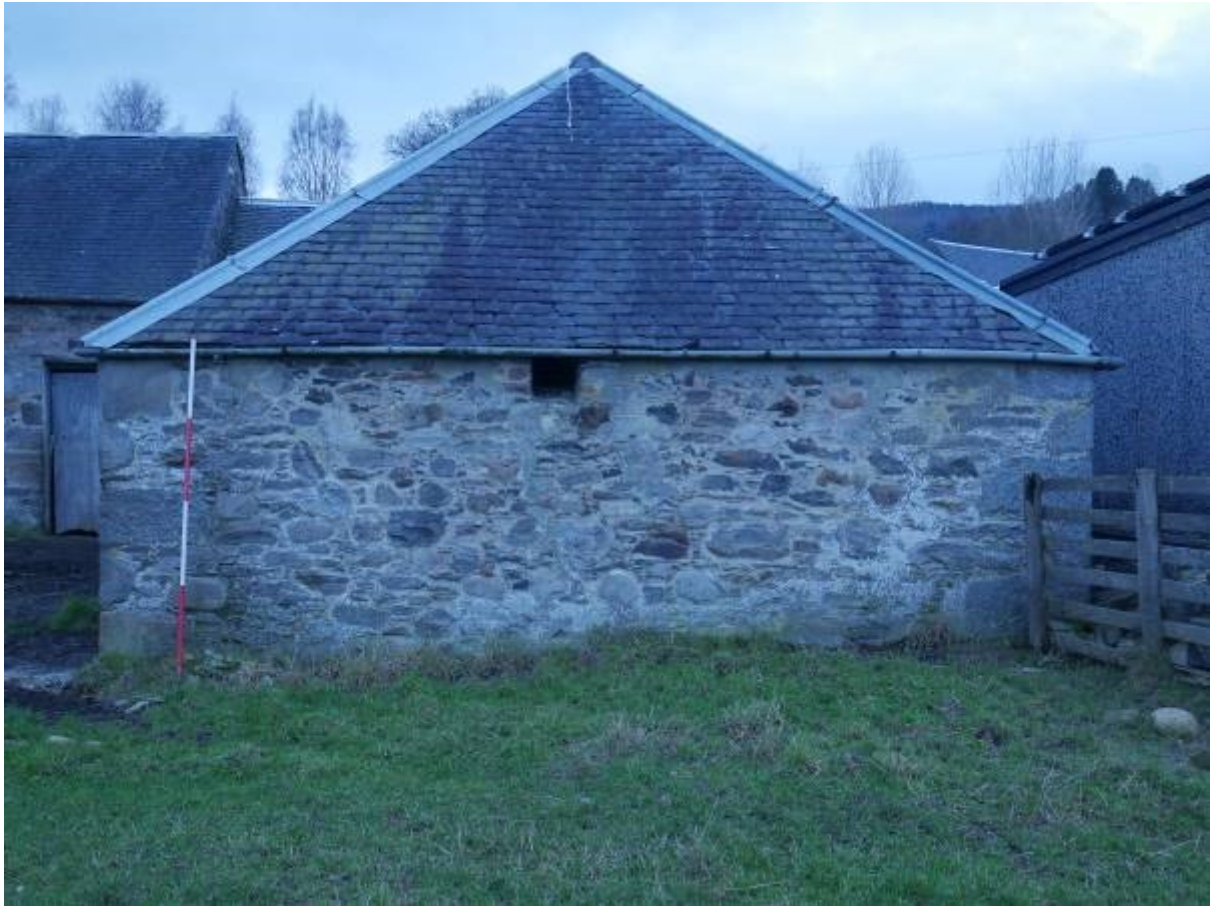
This elevation has a mortar bonded wall face which is a mixture of rough and shaped stone. There is a small window at the roof line.

Illustration 15- Eastern elevation of room 4 showing small window in roof line

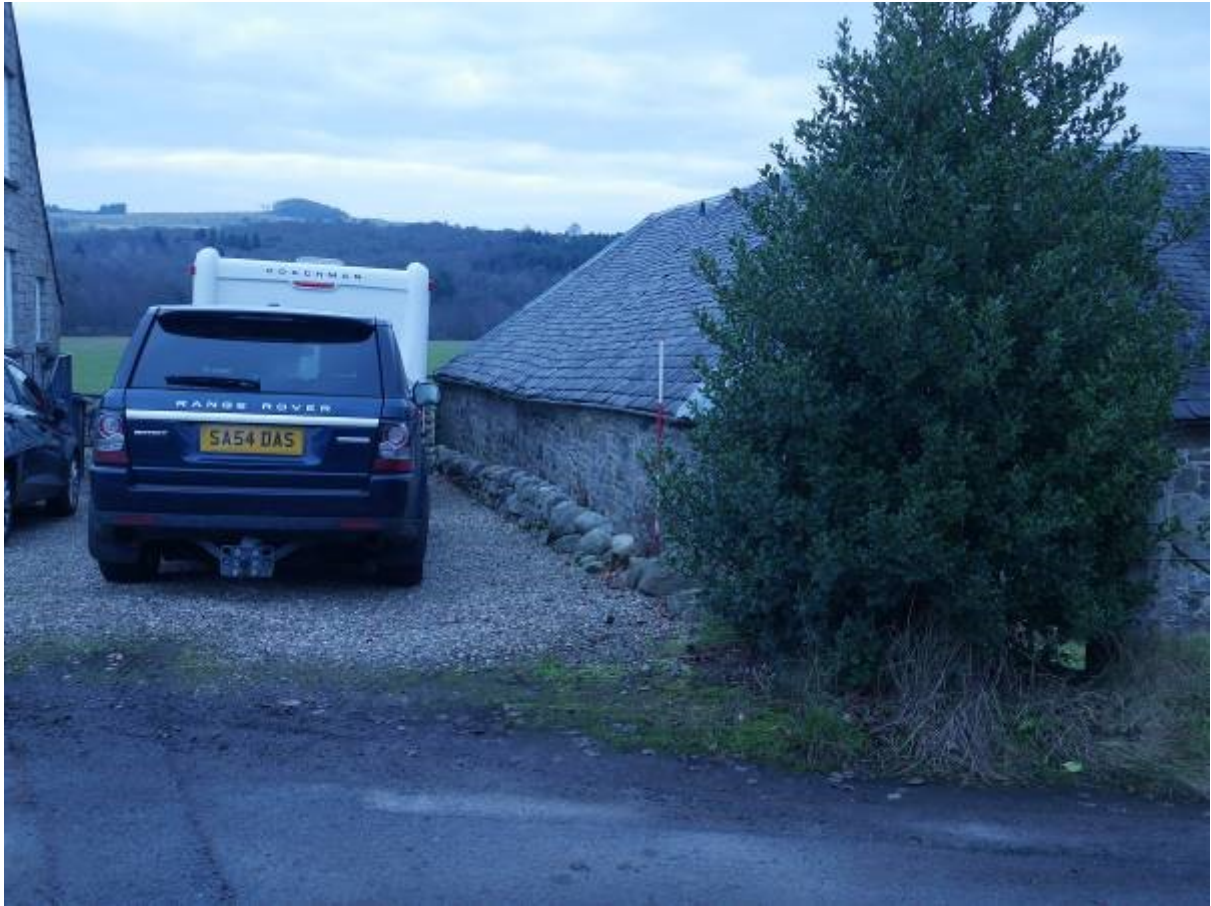
This elevation has a blank mortar bonded wall face which is a mixture of rough and shaped stone. There are shaped stone quoins at its Western and Eastern ends.

Illustration 16- Northern elevation of room 4

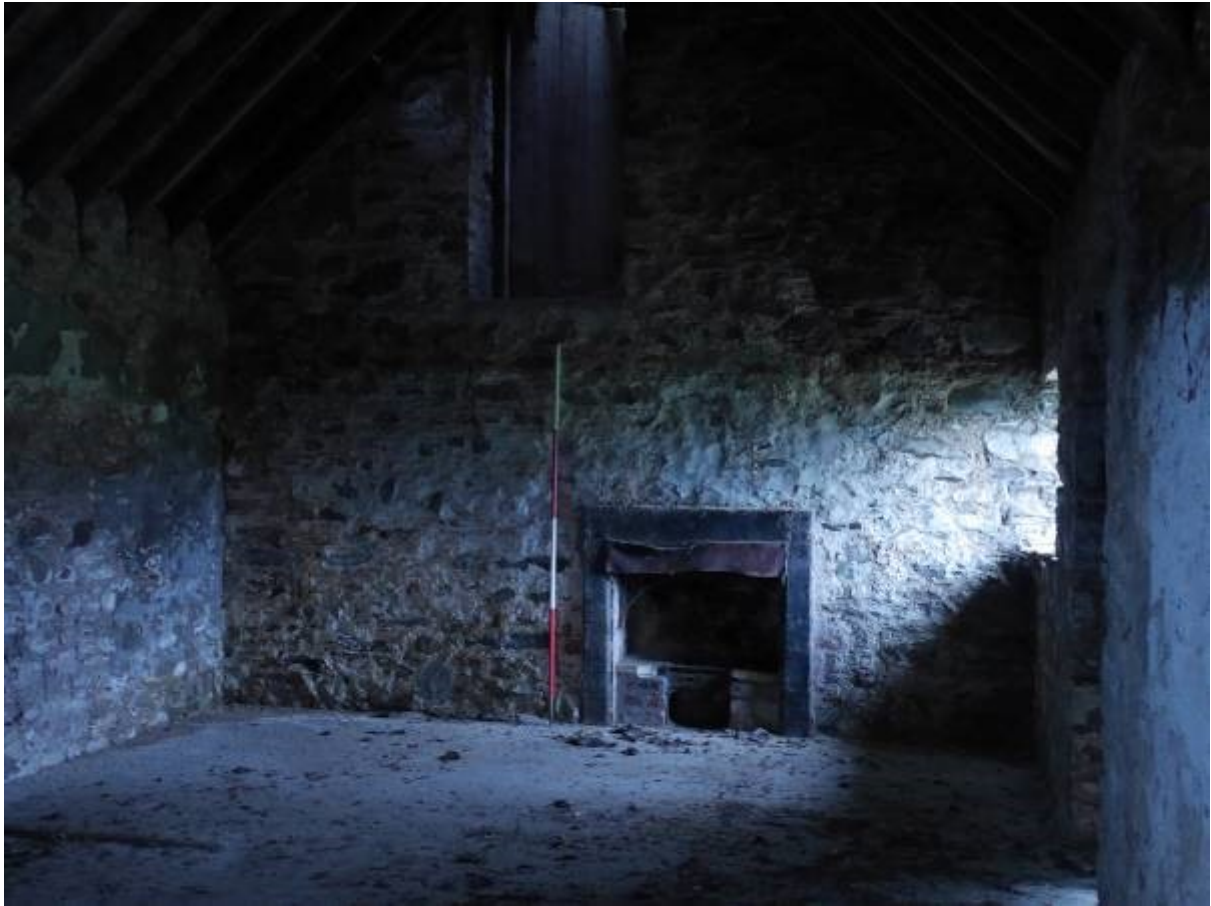
This room has functioned as a dwelling and has a concrete floor and a brick-built fireplace in its internal Northern elevation. The fireplace contains the remains of a cast iron grate. There is a doorway raised above the floor level in its internal Western elevation and another doorway with a wooden door higher up the internal Northern elevation presumably to provide access to room 2 and a former roof space. The wall between rooms 4 and 1 does not extend up to the roof line (Illus 19).

Illustration 17- Interior of northern end of room 1 showing fireplace and doorway providing access to room 2 and a former roof space

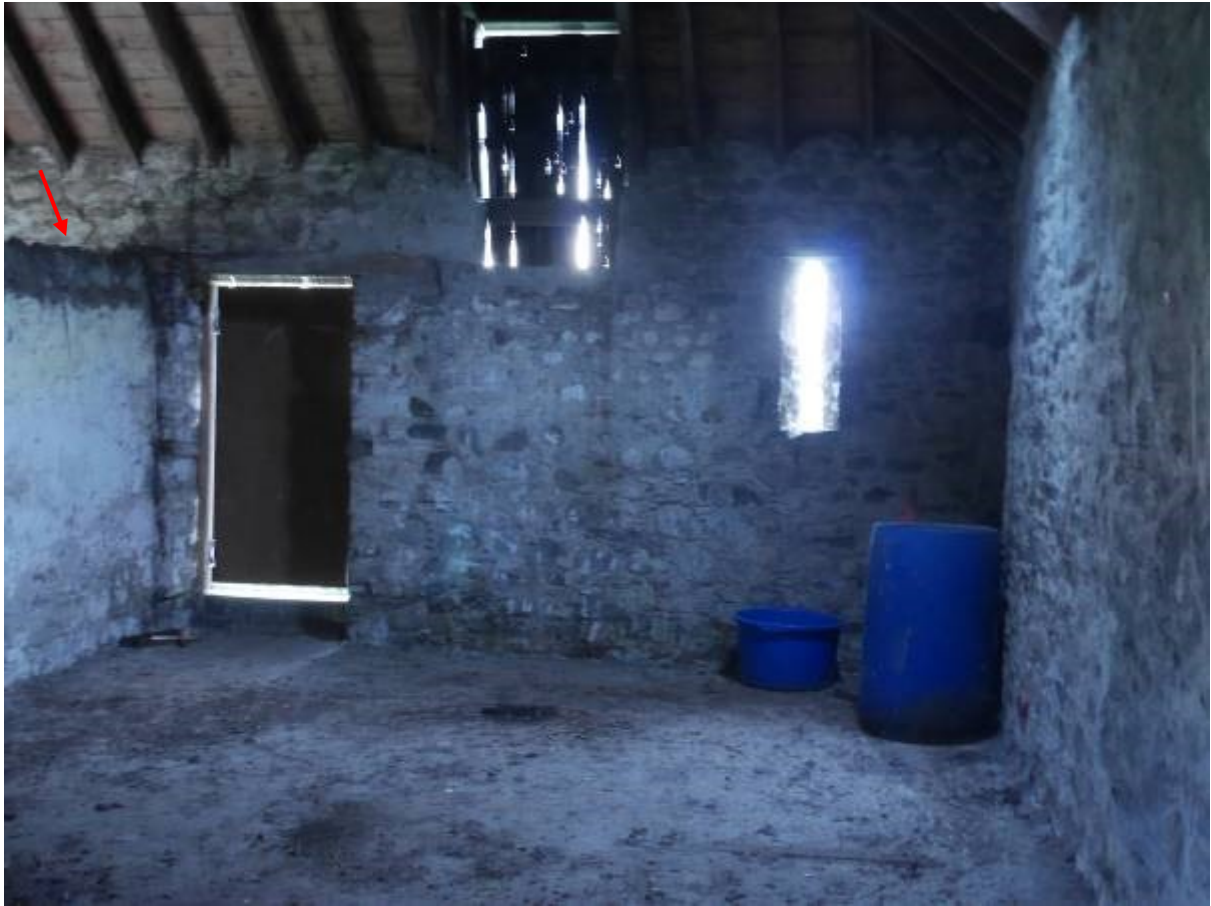
Illustration 18- Interior of southern end of room 1 showing slit window, doorway into room and doorway in roof dormer. Lower wall between rooms 1 and 4 is indicated with a red arrow

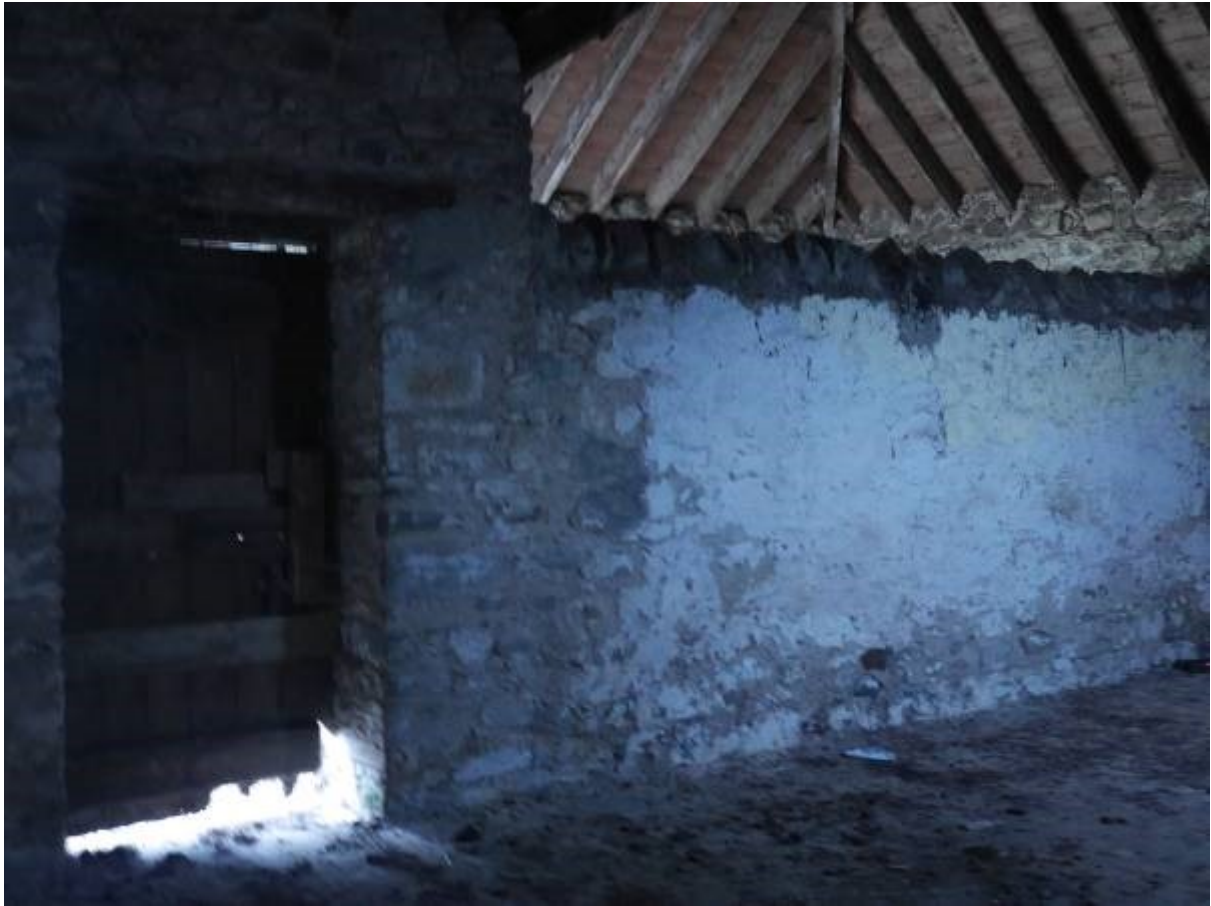
Illustration 19- Detail of lower wall between rooms 4 and 1

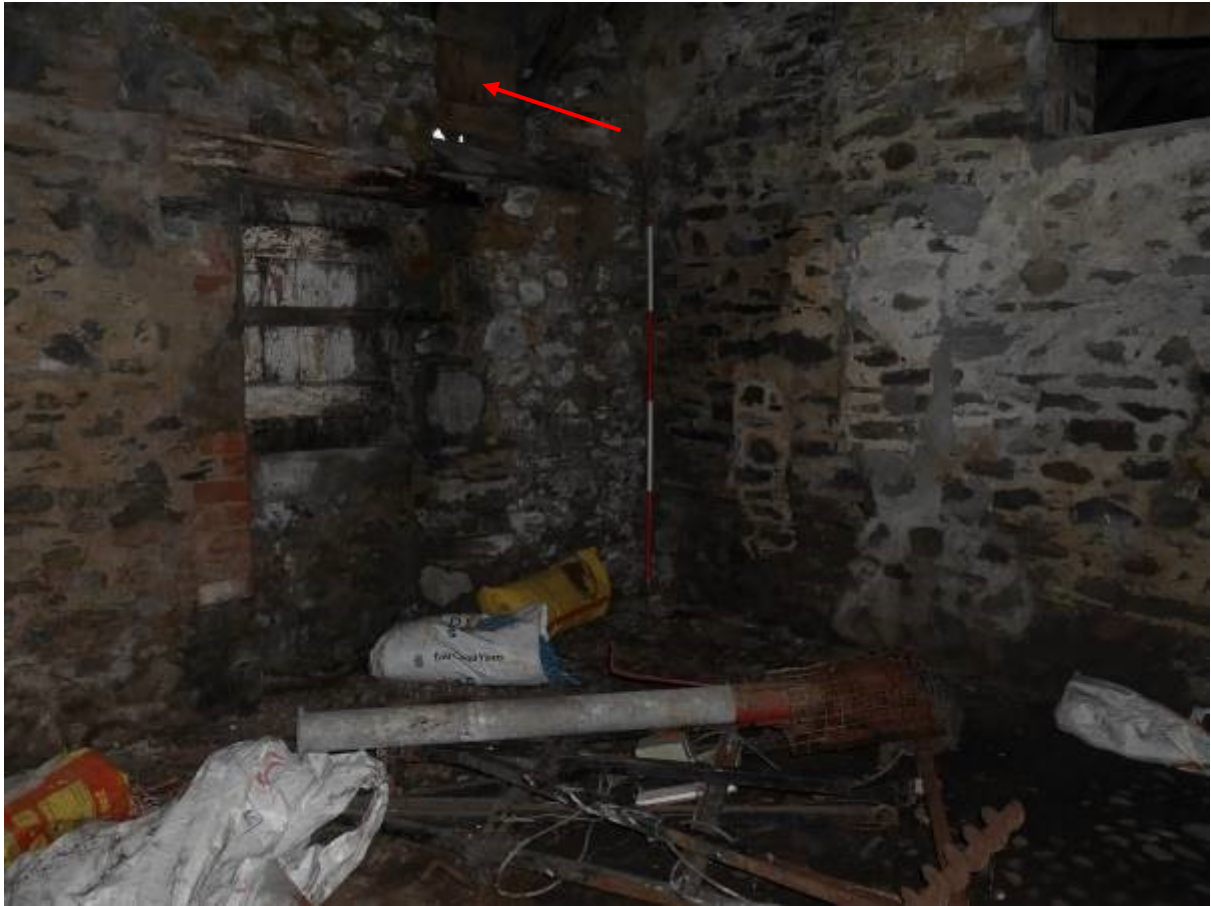
This room has functioned as a store and has a cobbled stone floor. There is a doorway with a wooden door high up in its internal southern elevation providing access to a former roof space and room 1.

Illustration 20- Interior of room 2 looking South East showing part of Northern face of wall between rooms 1 and 2 and cobbled floor. Doorway in roof line of external eastern indicated by red arrow, shuttered window is also visible.

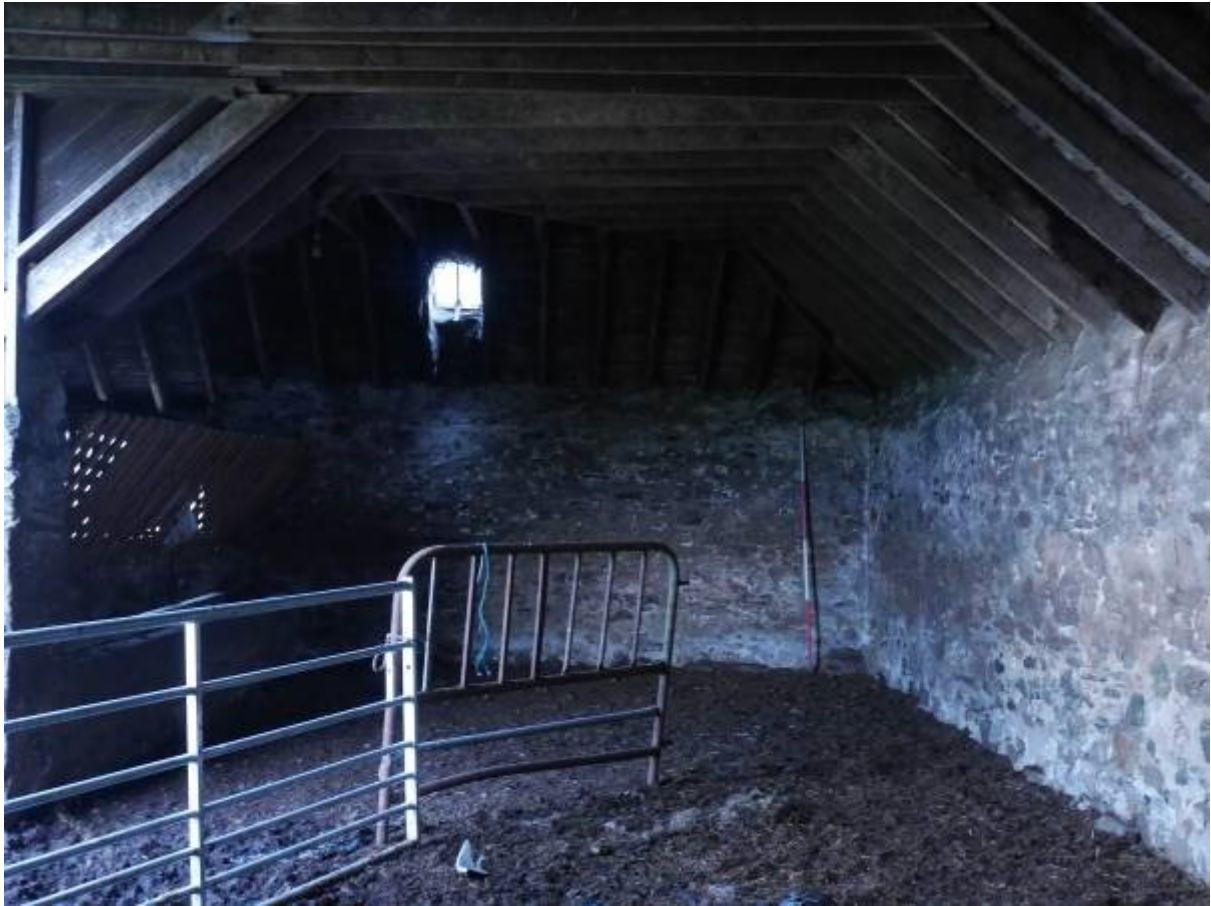
This has functioned as a shed to house cattle and has wooden feeders (A and B) at its Eastern and Southern ends. There is a stone trough running along the base of feeder B at the Eastern end. Both feeders are accessed from small rooms behind with external doorways.

Illustration 21- Interior of room 3 looking West, feeder 3A visible to left

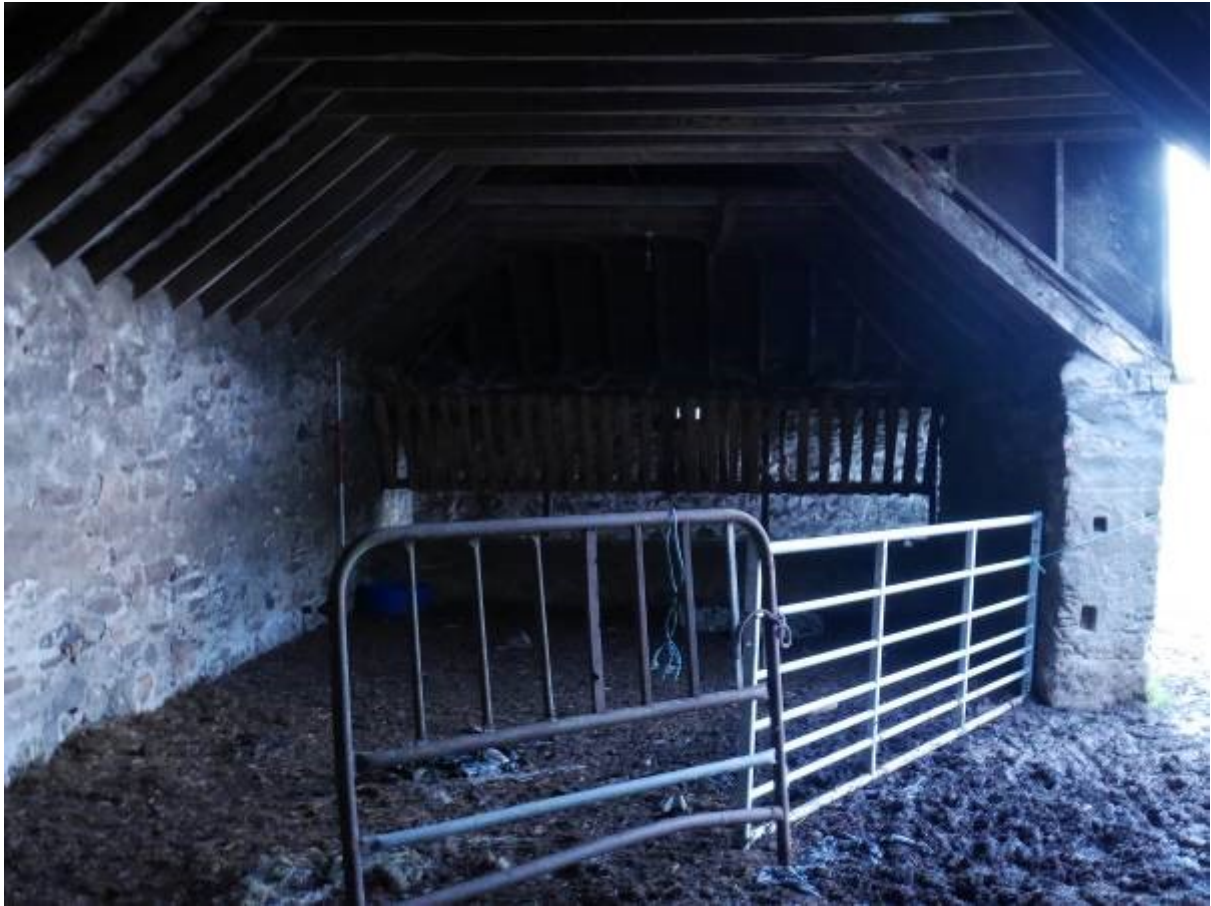
Illustration 22- Interior of room 3 looking East, feeder 3B visible to rear
