Standing Building Survey  
Mucklarie Farmhouse, Snaigow  
Perth and Kinross

Building 1 at Mucklarie Farmhouse from the East

4<sup>th</sup> March 2019

## **Introduction**

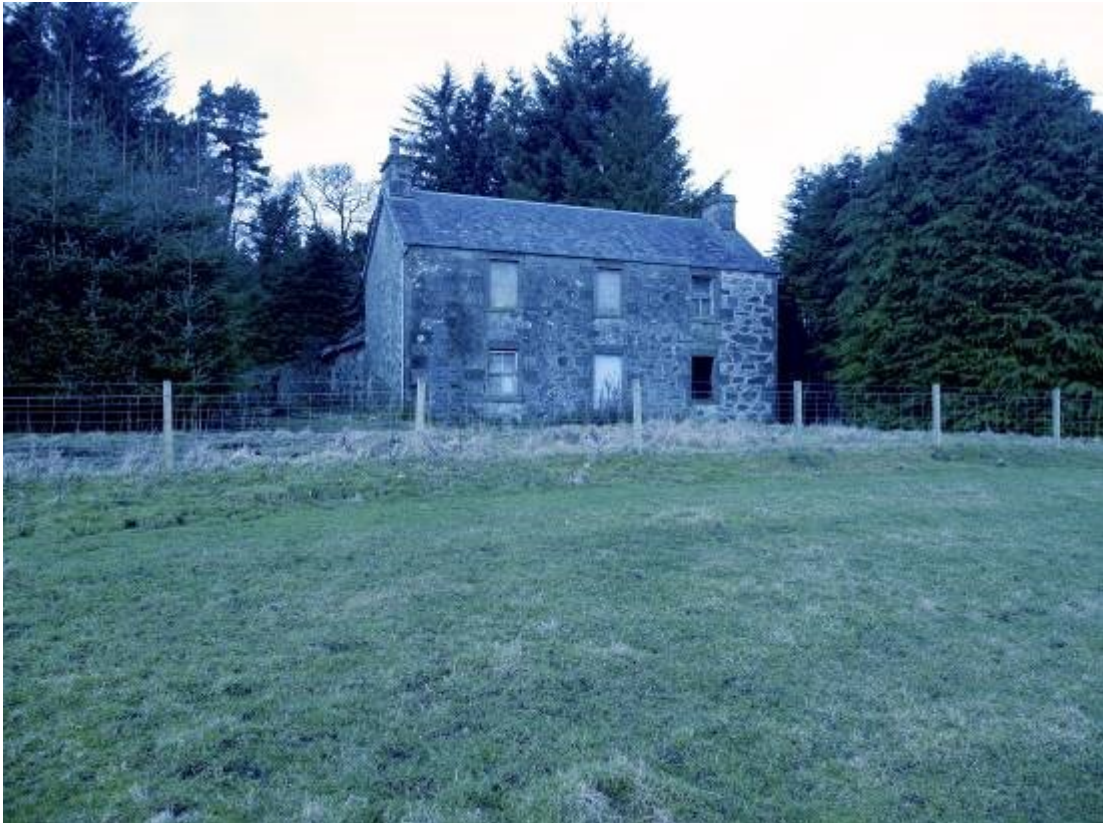
This building is laid out on a North to South alignment and has a slate roof with chimneys at each gable end.

This is built of mortar bonded rough green sandstones with cut red sandstone blocks at the corner quoins, doorway and windows. At first floor level there are three plain windows, two of these are completely blocked with wood the third is half blocked and half glazed. At ground floor level there is a plain window which is blocked with wood, a doorway with a wooden door painted light blue and another window which is unblocked.

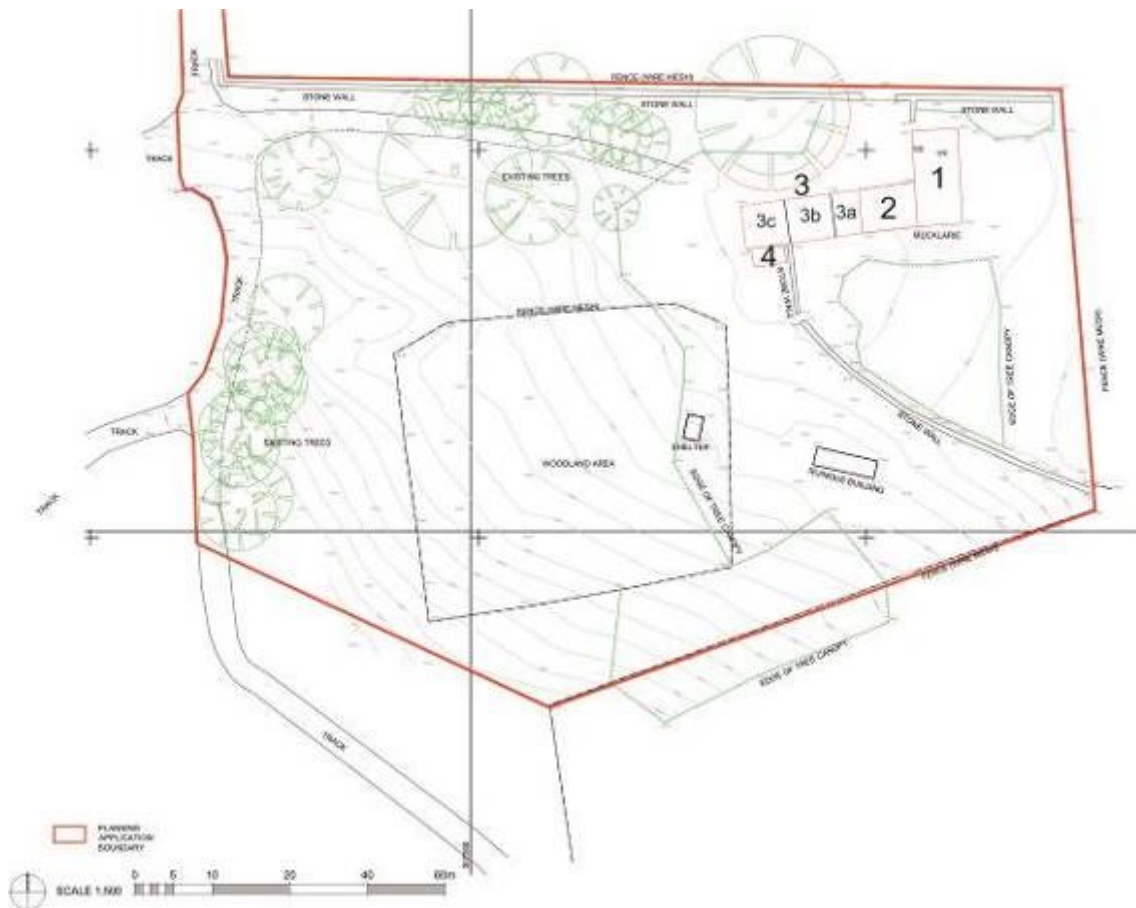
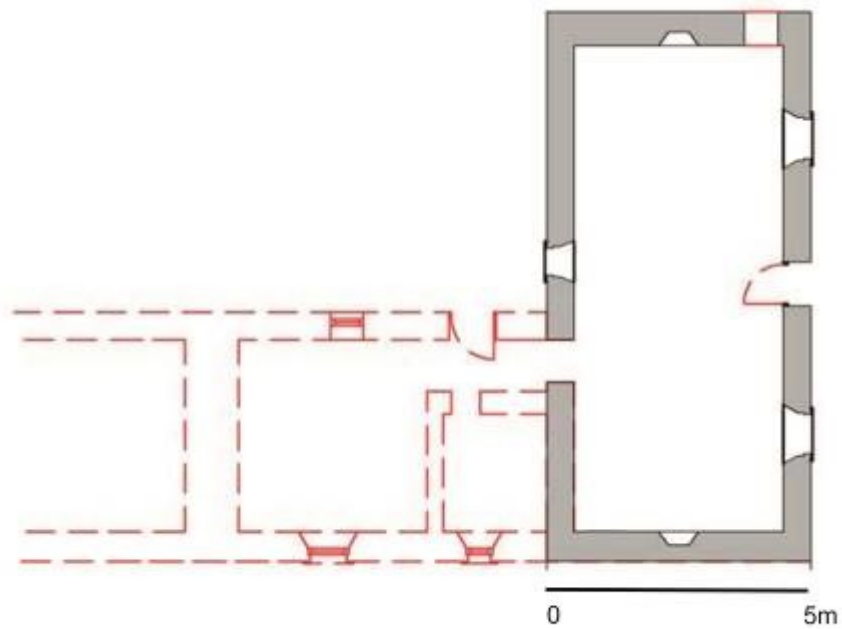
Illustration 4- Top drawing shows the ground floor plan of the Mucklarie Farmhouse building complex (numbers refer to text descriptions of buildings) Lower drawing shows ground floor plans of Buildings 1 and 2 (based on supplied architect's plan)

The group of buildings at Mucklarie Farmhouse have been numbered individually for this survey (as indicated on illus 4).

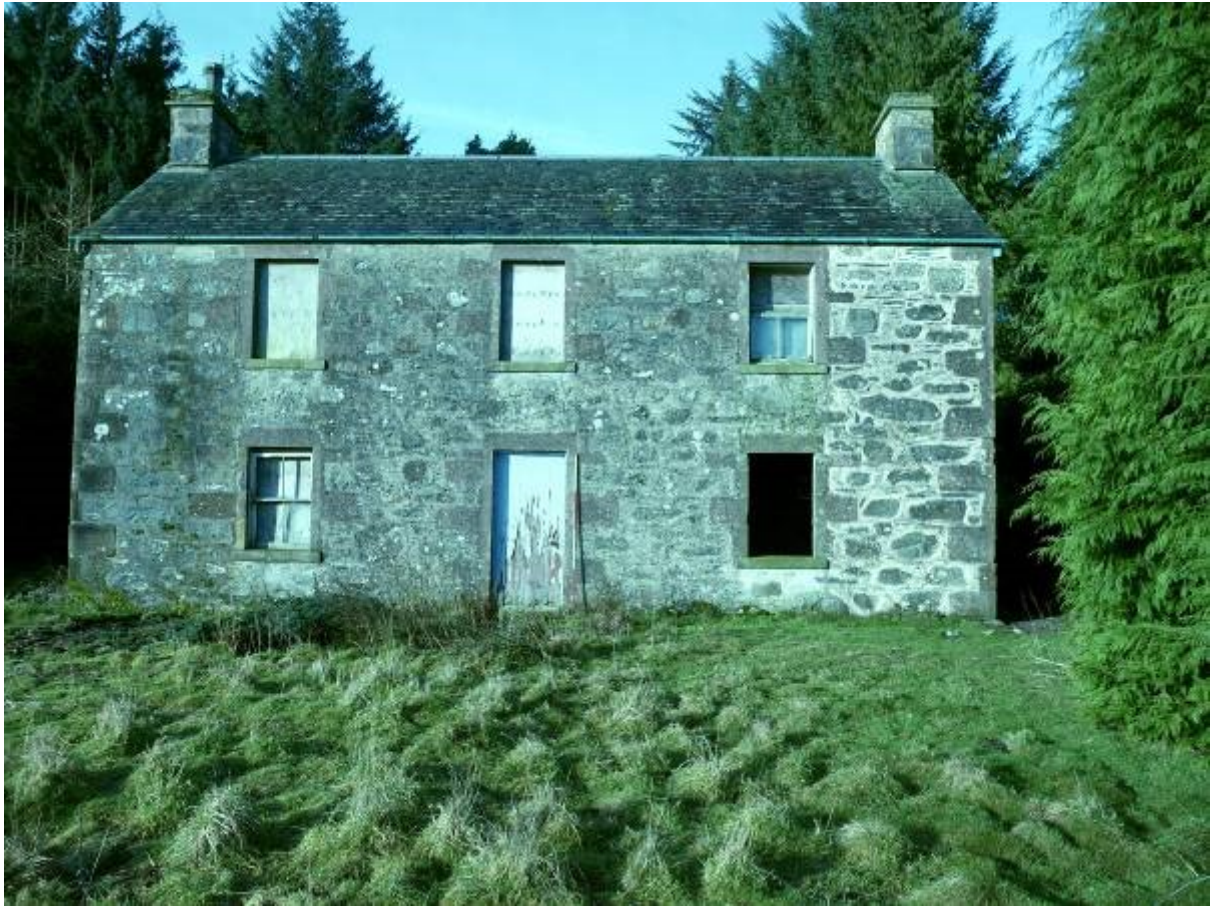
Illustration 6- Eastern elevation of Building 1

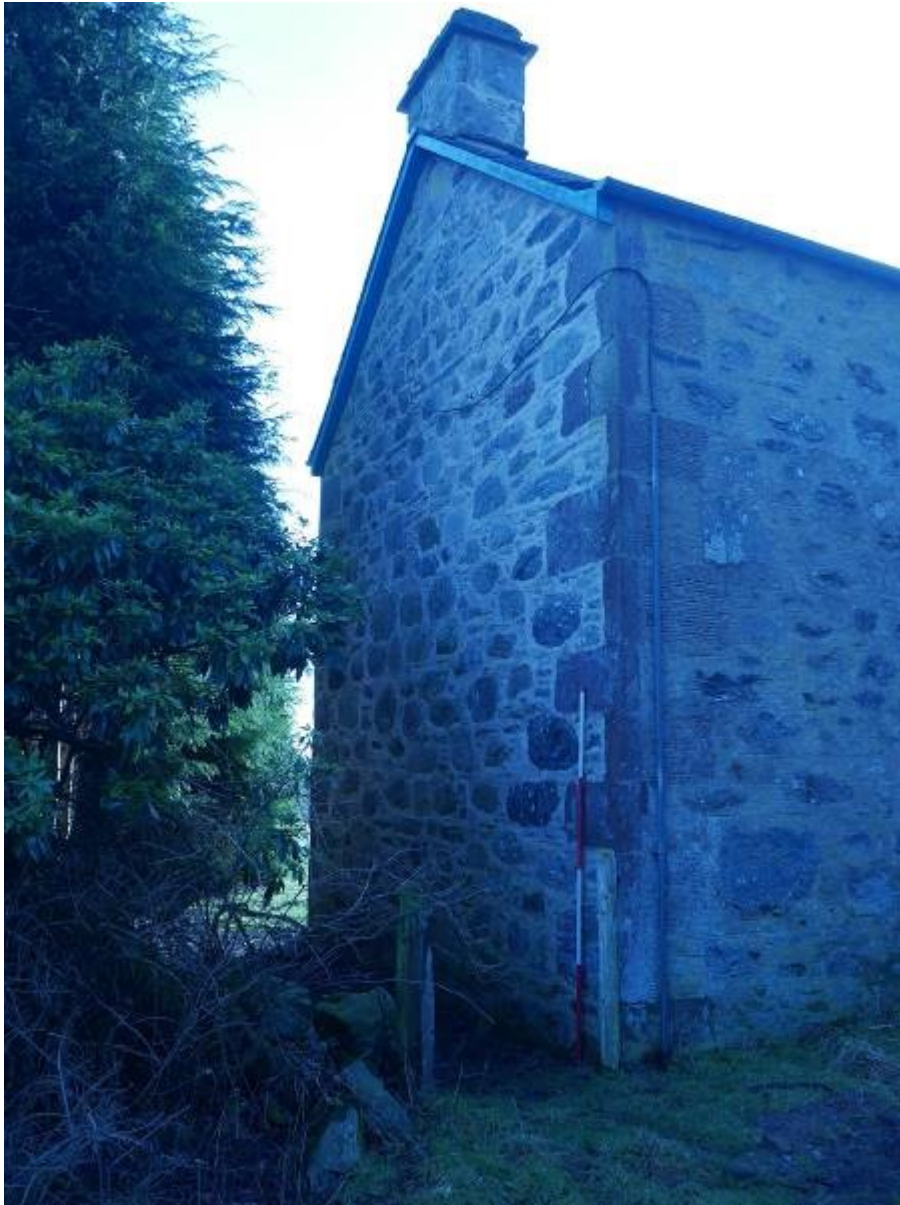
This is a gable end to the building with a chimney at its apex. The plain wall face is built of mortar bonded green sandstones with cut red sandstone quoins at the corners. The wooden roof flashings are painted light blue.

Illustration 7- Northern elevation of Building 1

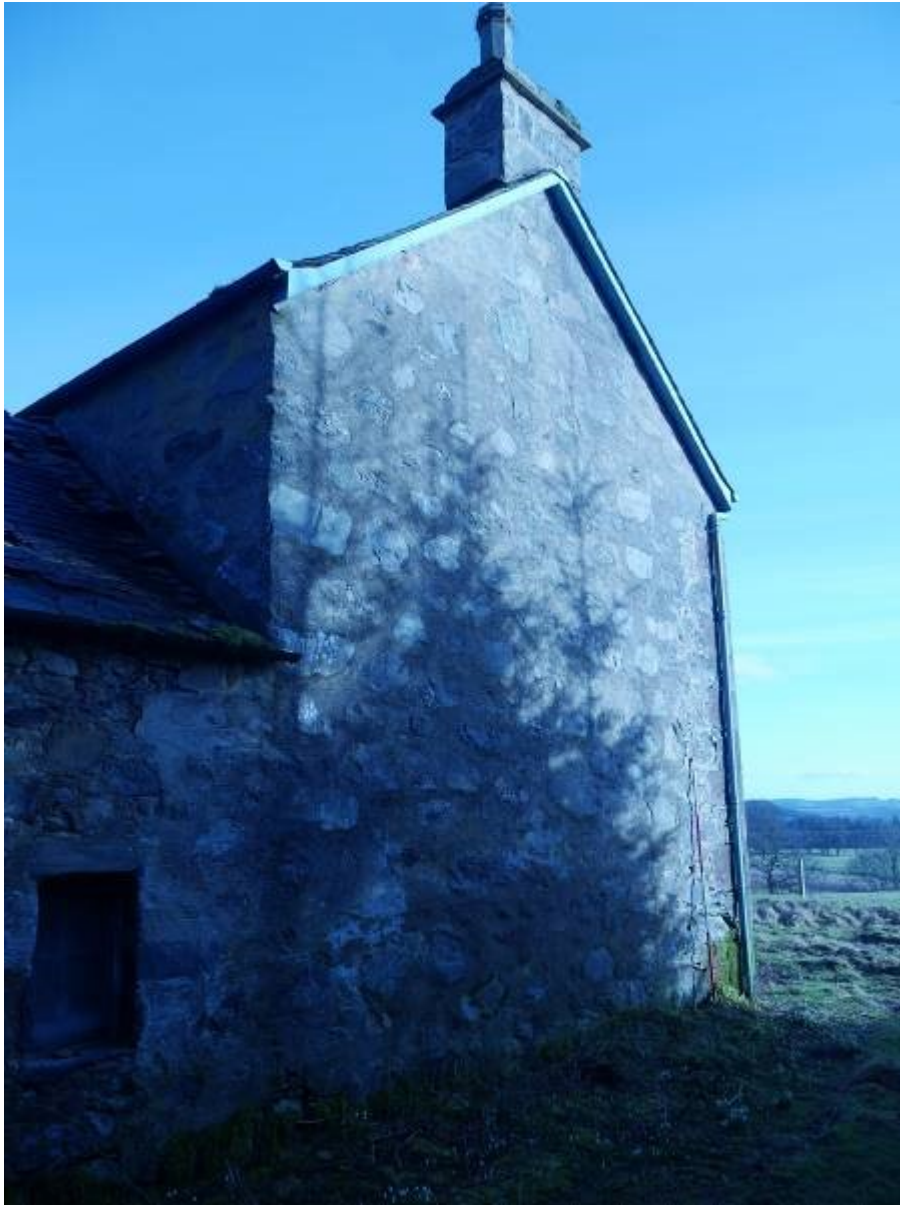
This is the other gable end to this building and has a chimney at its apex. The plain wall face is built of mortar bonded green sandstones with cut red sandstone quoins at the corners. The wooden roof flashings are painted light blue.

Illustration 8-Southern elevation of Building 1

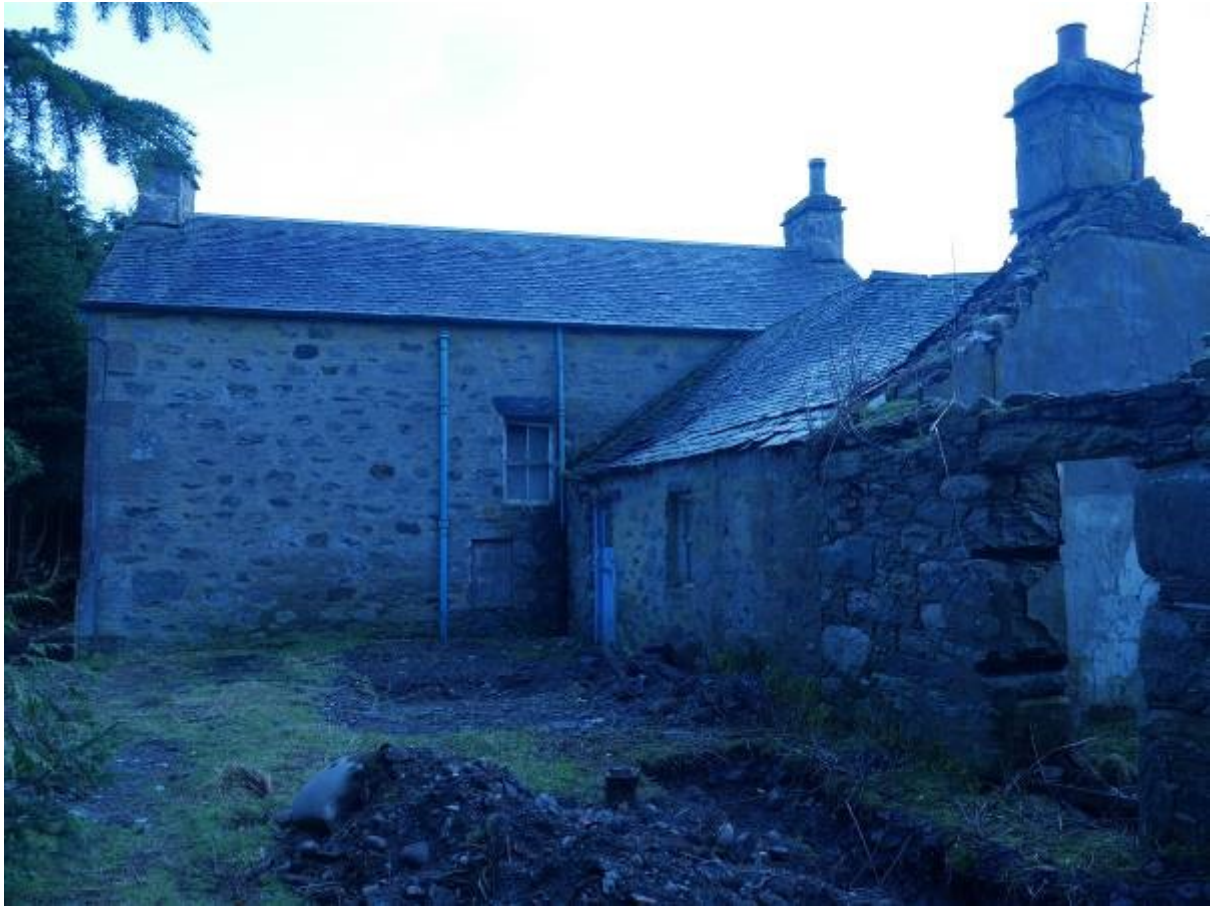
This is built of mortar bonded green sandstones with cut red sandstones at its northern corner. Building 2 is built against the wall face and there are two windows (one glazed and blocked internally and one fully blocked) above each other adjacent to the junction of the two buildings.

Illustration 9- Western elevation of Building 1 showing Buildings 2 and 3 built against it.

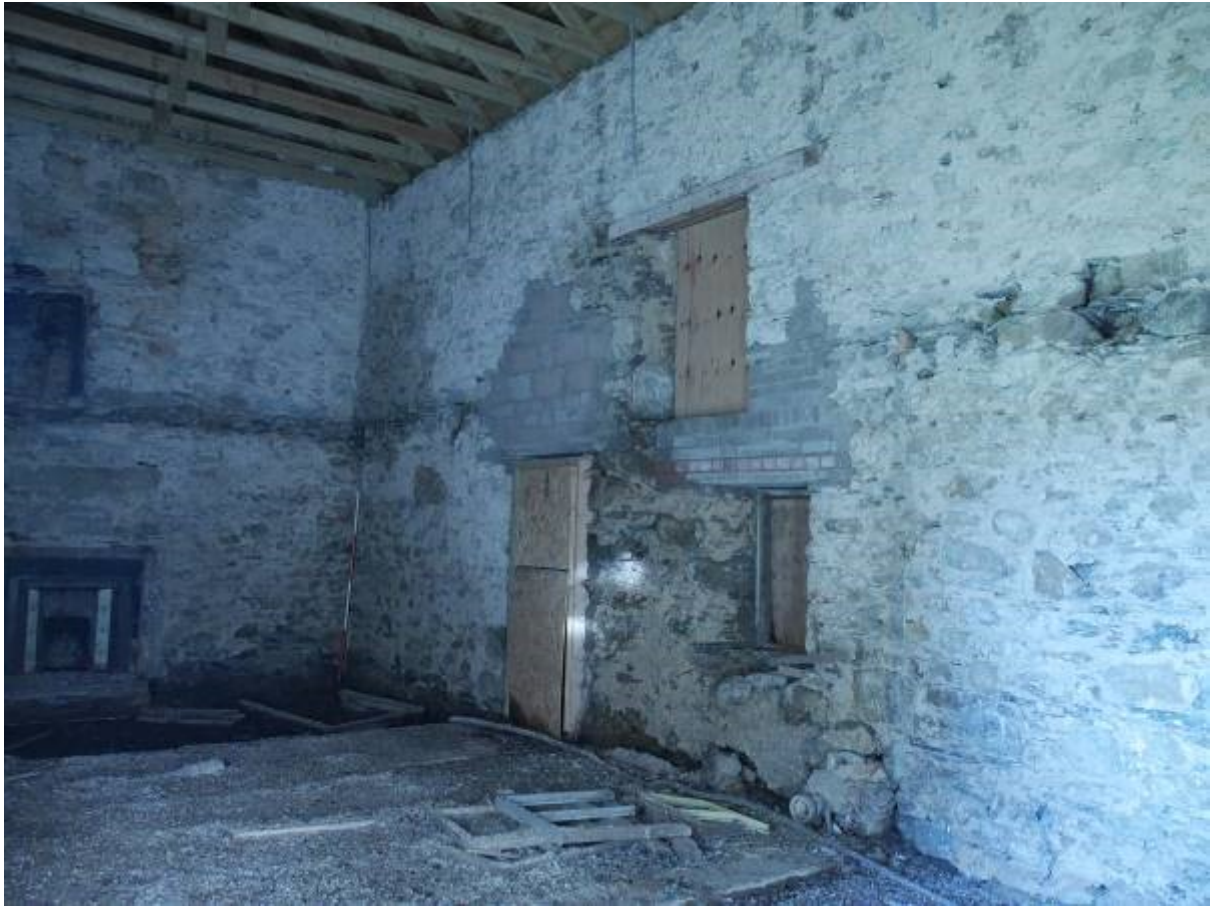
The rough stone wall face is painted white and contains a doorway into Building 2 which is blocked with wood. On the northern side of the doorway there are two windows above each other which are blocked with wood. The upper window has a wooden lintel. A hole in the wall above the

blocked doorway has been repaired using mortared breeze blocks and there are visible mortared brick repairs between the windows.

Illustration 10 - Internal Eastern elevation of Building 1

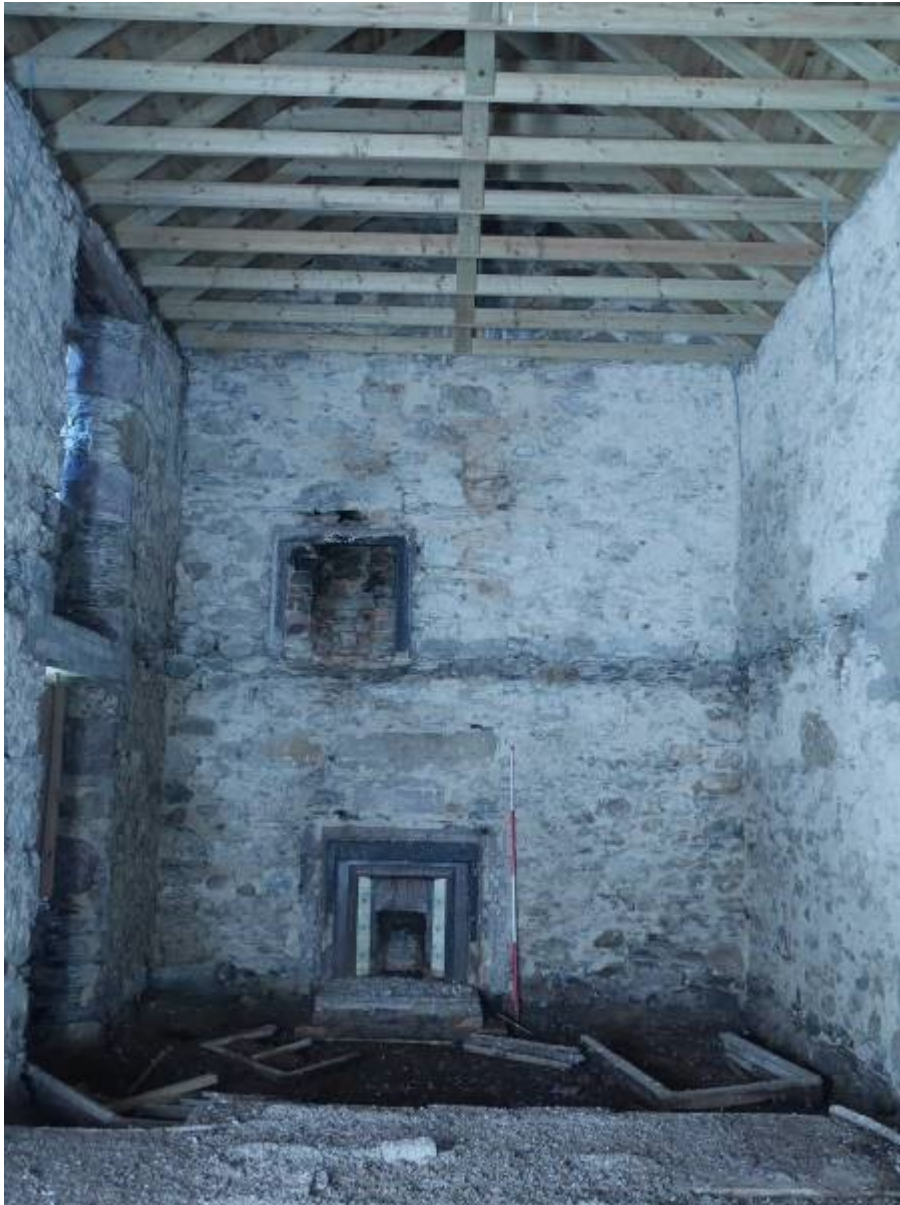
The rough stone wall face is painted white and contains a fireplace at first floor level and another larger fireplace at ground floor level. The lower fireplace is tiled with decorated tiles with a floral pattern (Illus 11), the upper one has had its tiles removed (Illus 12).

Illustration 11 - Internal Northern elevation of Building 1

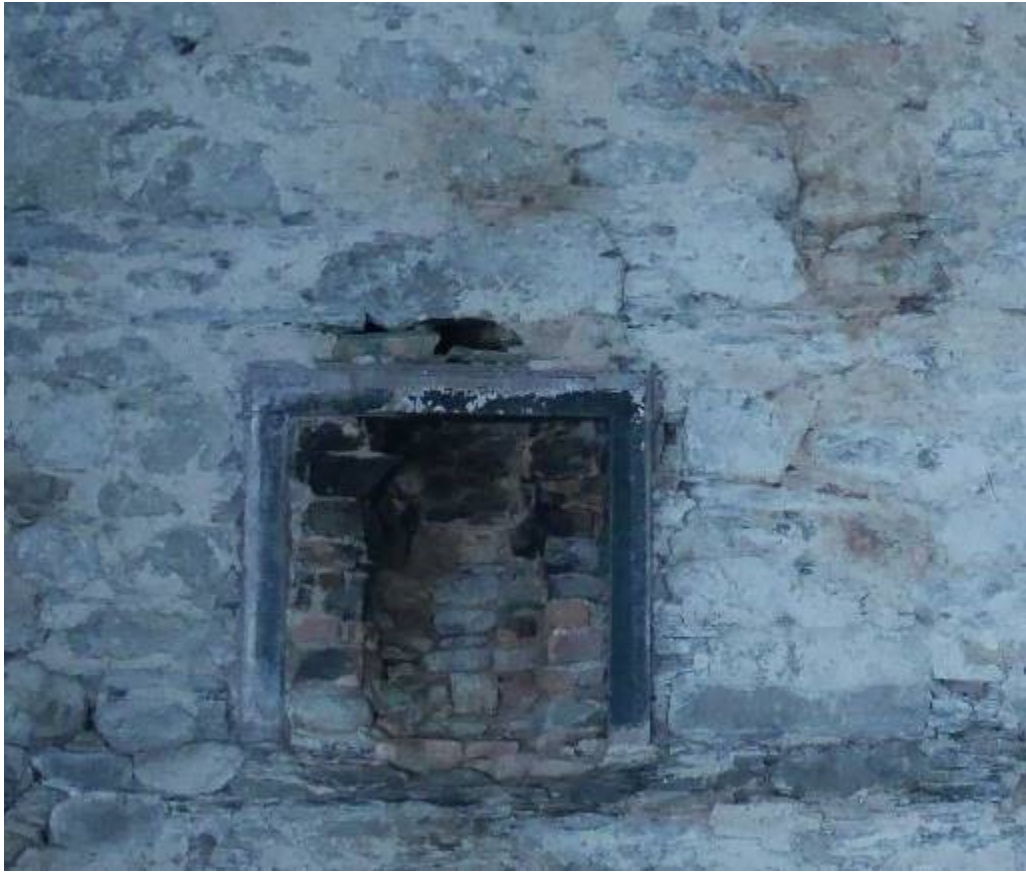
Illustration 12- Fireplace at first floor level in internal Northern elevation of Building 1

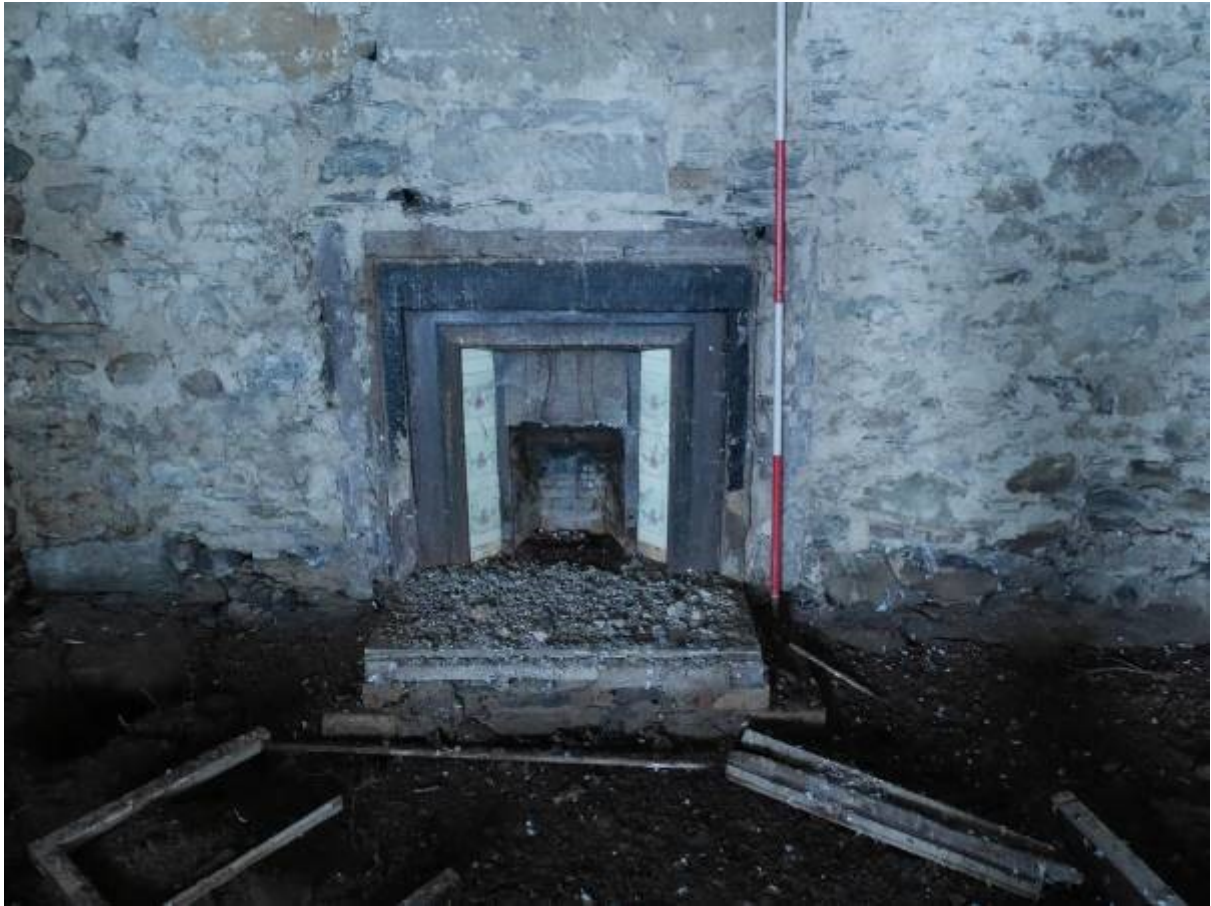
Illustration 13- Fireplace at ground floor level in Northern elevation of Building 1 with decorated tiles

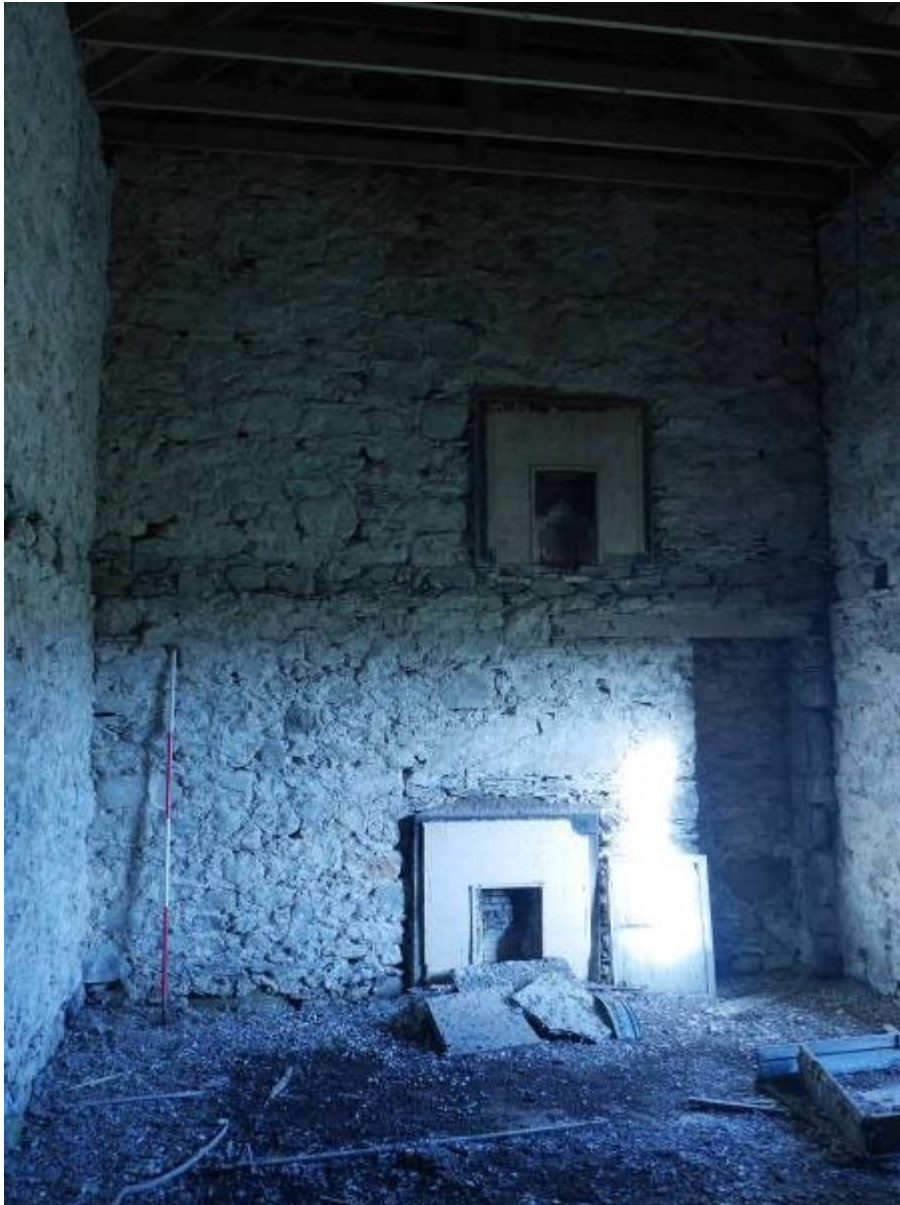
The rough stone wall face is painted white and contains fireplaces at first floor and ground floor level. Both fireplaces are tiled with plain tiles. There is a cupboard in the north eastern corner with a wooden lintel (Illus 14).

Illustration 14- Southern internal elevation of Building 1 showing fireplaces on first and ground floor level.

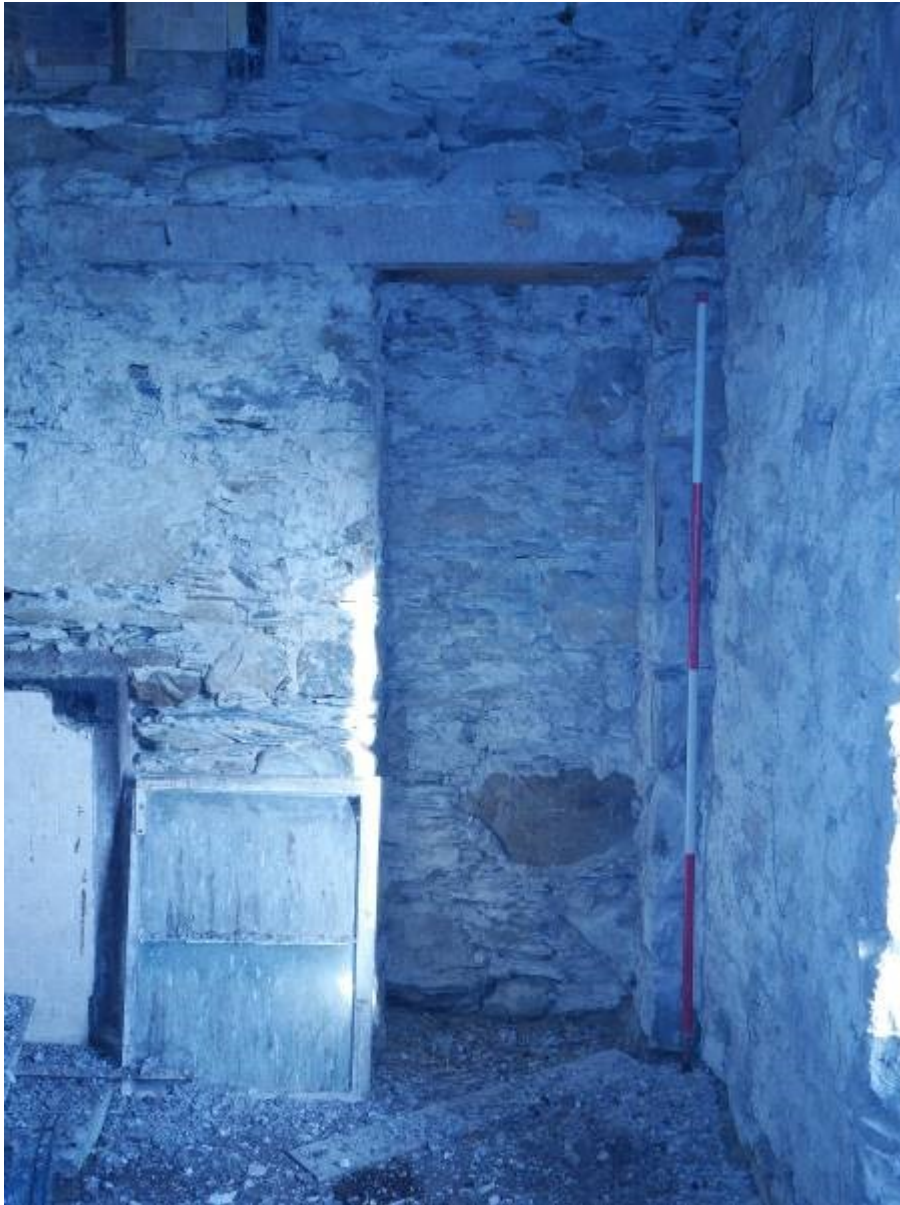
Illustration 15- Cupboard in internal Southern elevation of Building 1

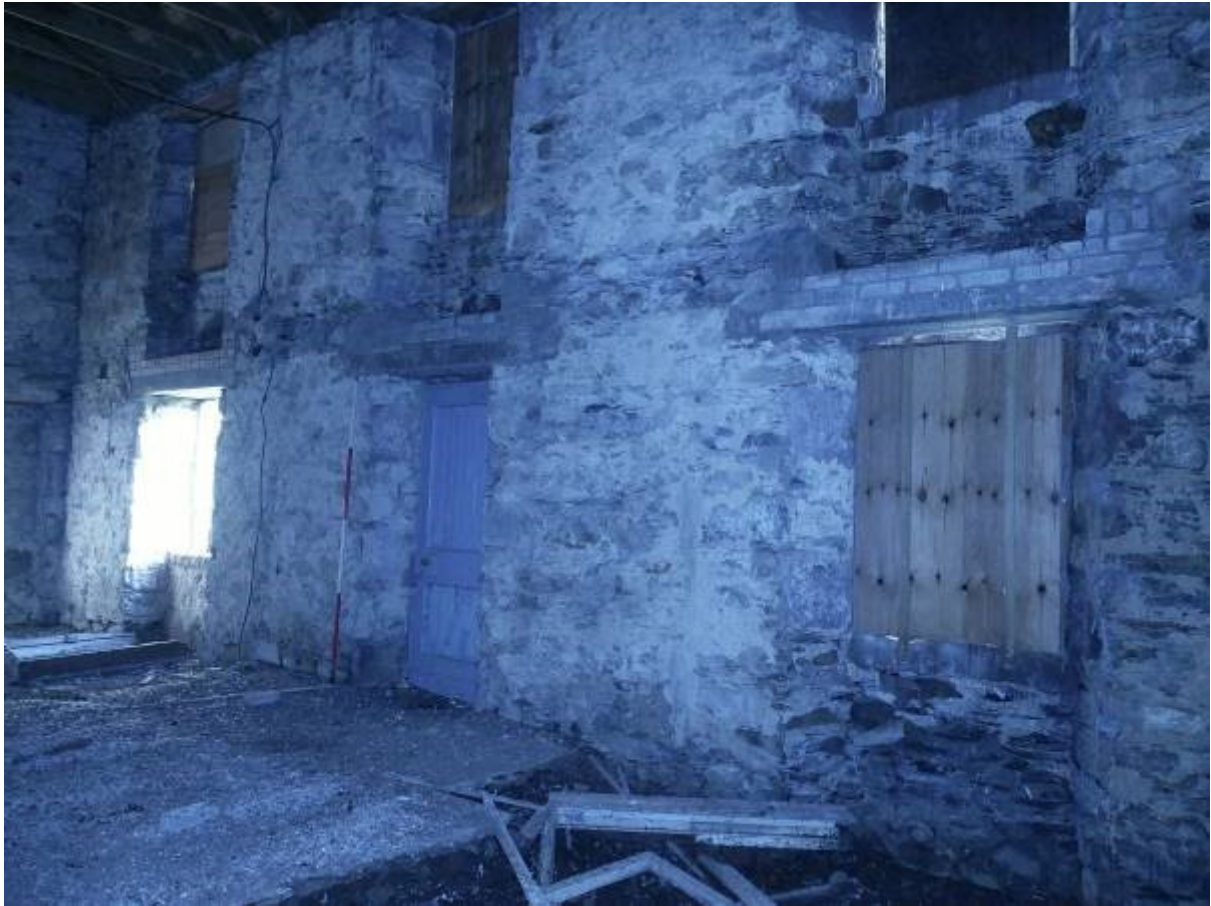
The rough stone wall face is painted white and at first floor level contains three windows with angled recesses. All three are blocked with wooden panels. At ground floor level there is an open window at the northern end of the elevation, a doorway with a wooden door and a window blocked with a wooden panel.

Illustration 16 – Internal Western elevation of Building 1

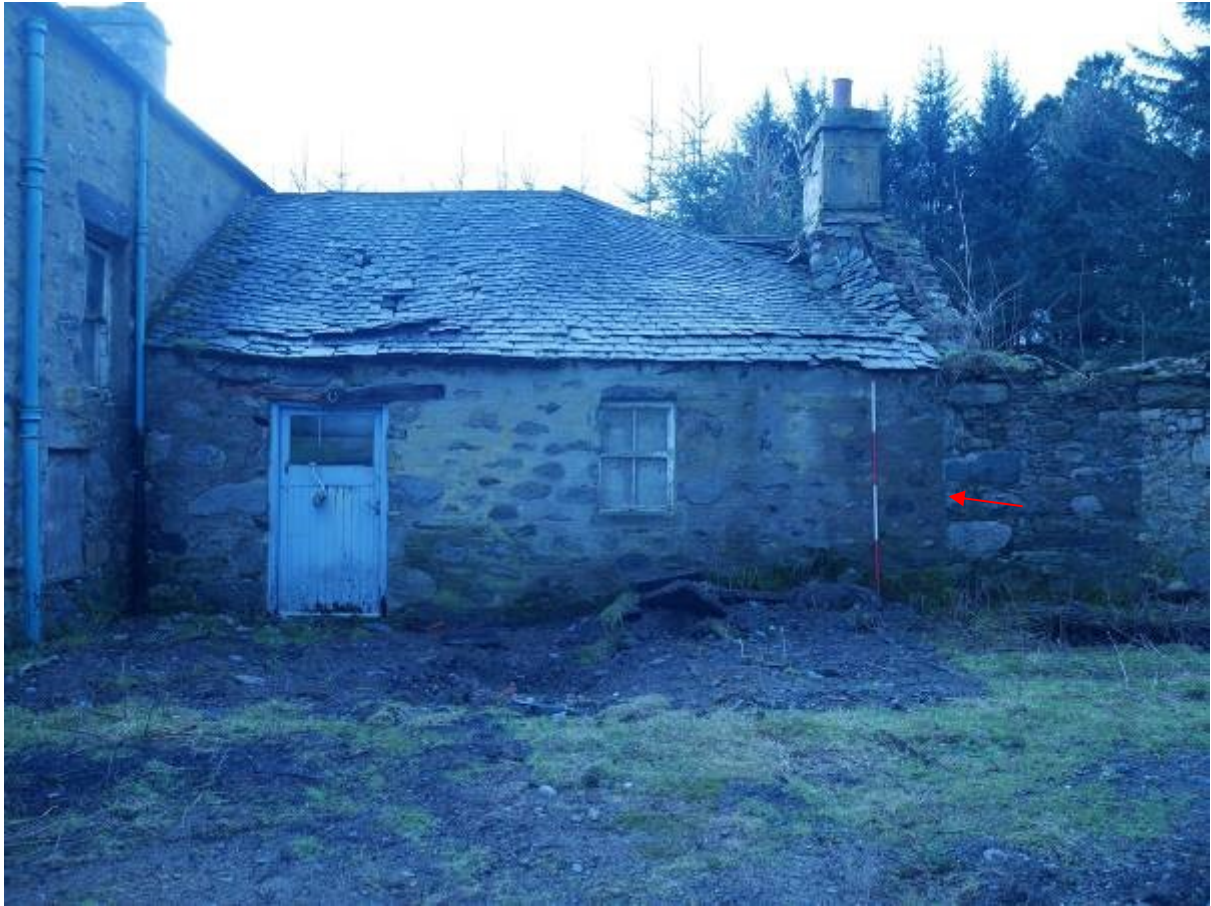
This is a wall built of mortar bonded green sandstones and has a plastered face. It contains a doorway with a wooden door painted blue and a wooden lintel. There is a single glazed window that is blocked internally with wood.

Illustration 17 - Northern elevation of Building 2, note straight joint between the Western end of Building 2 and the Eastern end of Building 3 (red arrow)

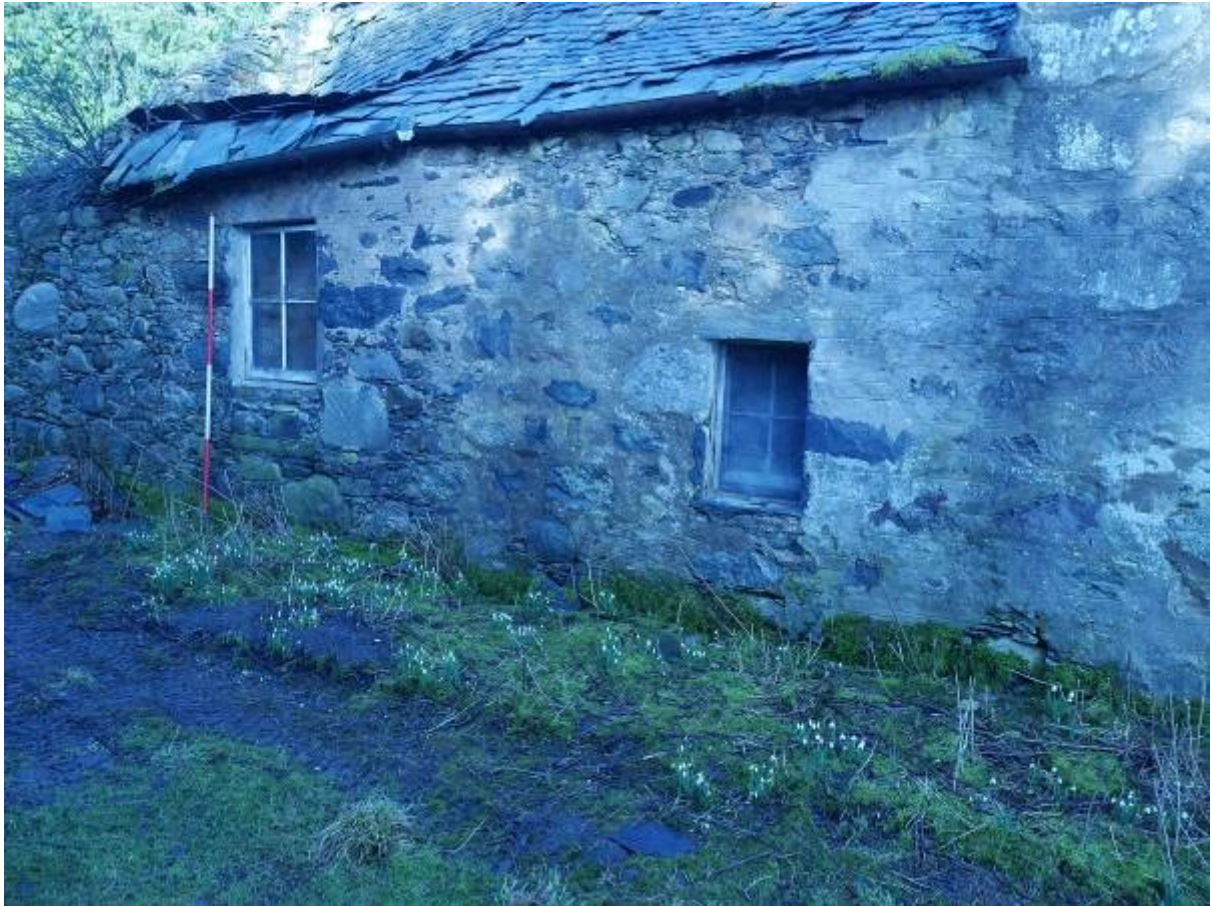
This wall is built of mortar bonded rough green sandstones and rounded boulders mixed with slates. It contains a glazed window that is blocked internally with wood and another smaller glazed window at a slightly lower level at its Eastern end.

Illustration 18 - Southern elevation of Building 2

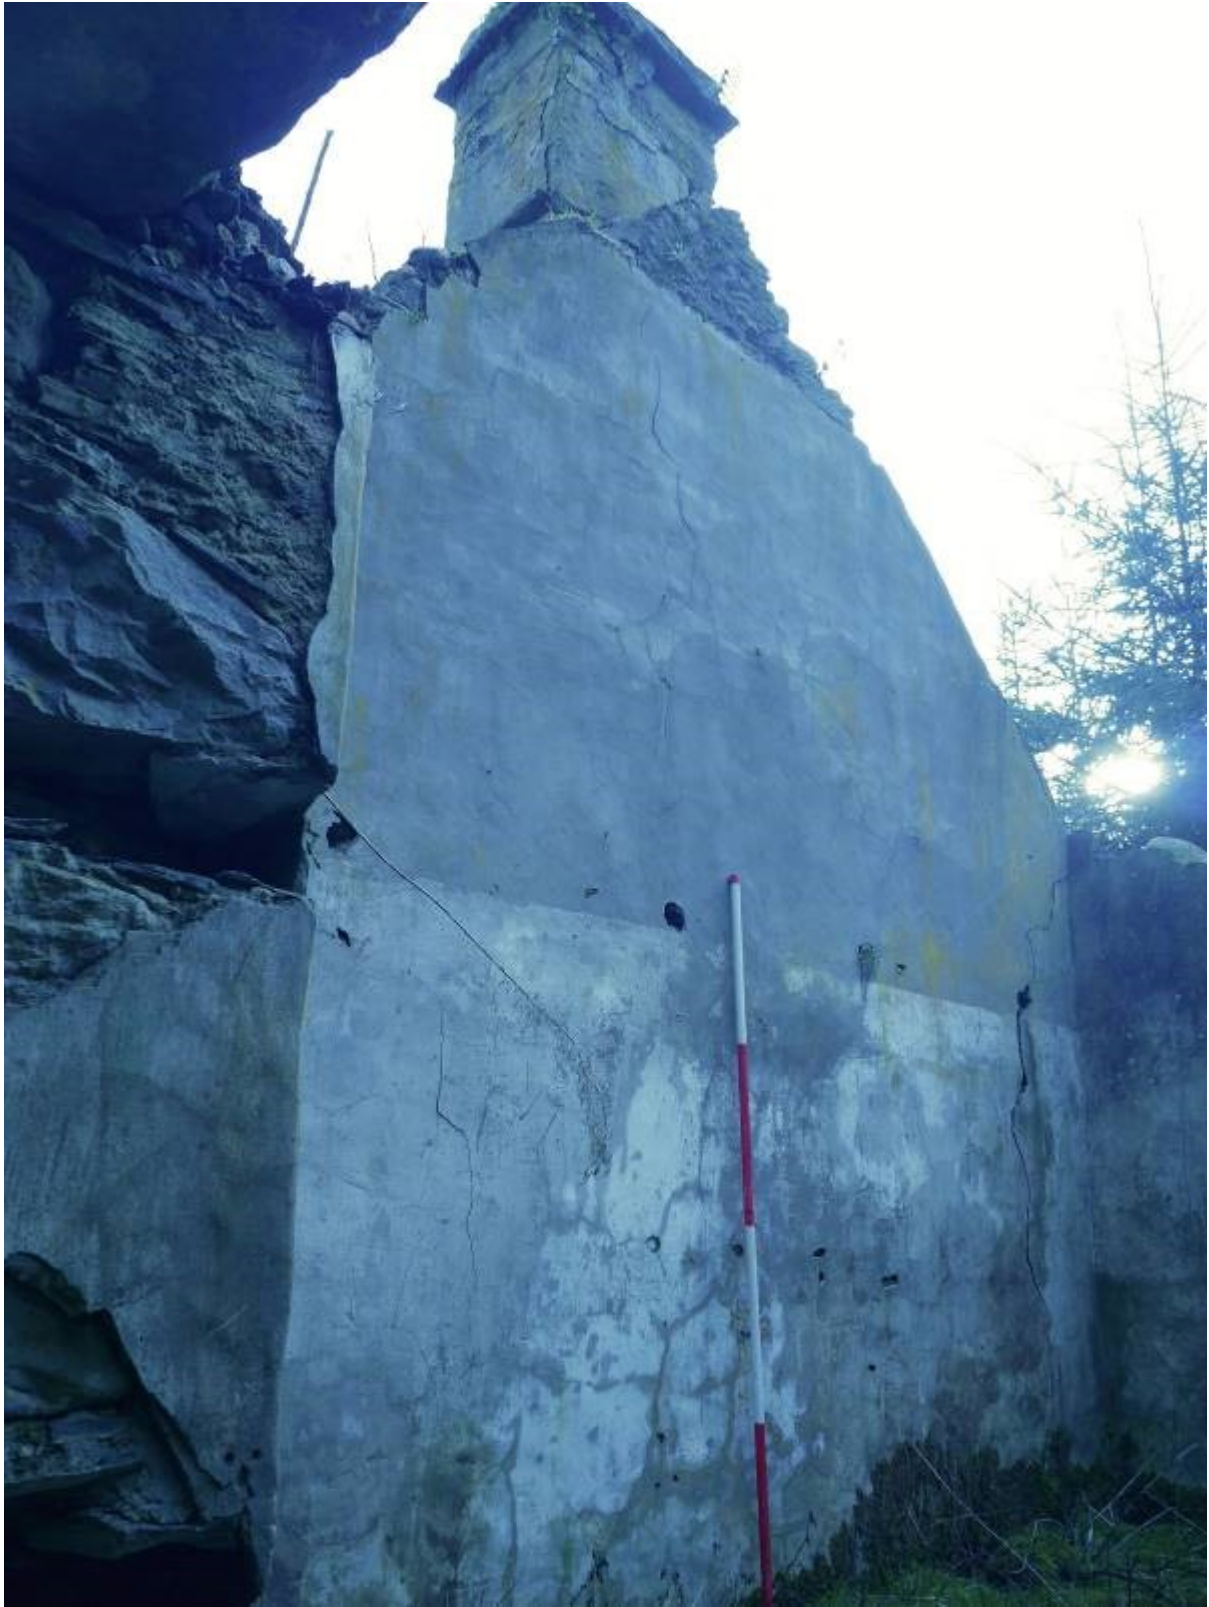
This is a gable end to Building 2 and has a chimney at its apex, Building 3 is butt jointed against this elevation.

Illustration 19 – Western elevation of Building 2 visible behind butt jointed Building 3

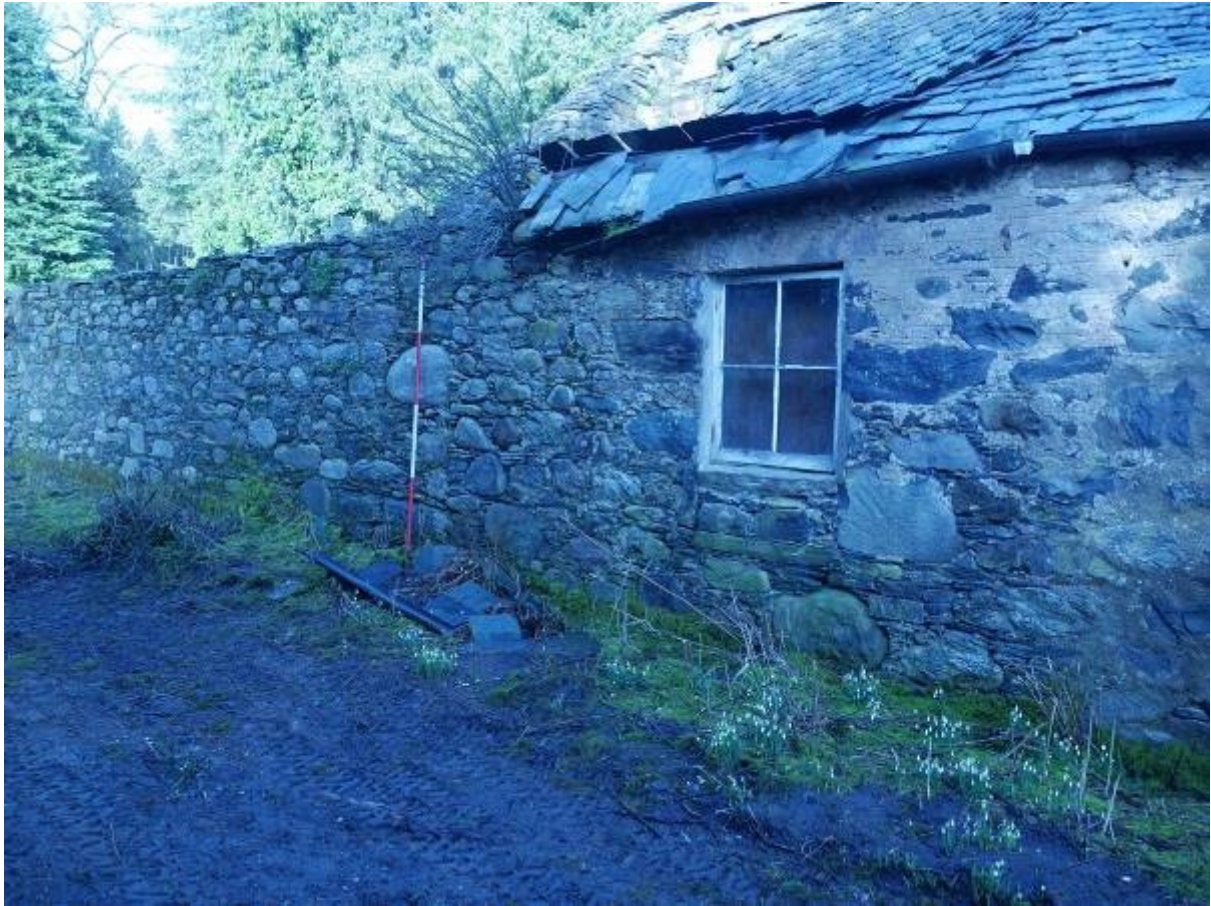
This building is now roofless and is built against the Western elevation of Building 2 (Illustration 20), it is subdivided into three rooms (3a, 3b and 3c).

Illustration 20 – Butt joint between Buildings 2 and 3 visible in Southern elevation (to the right of the scale)

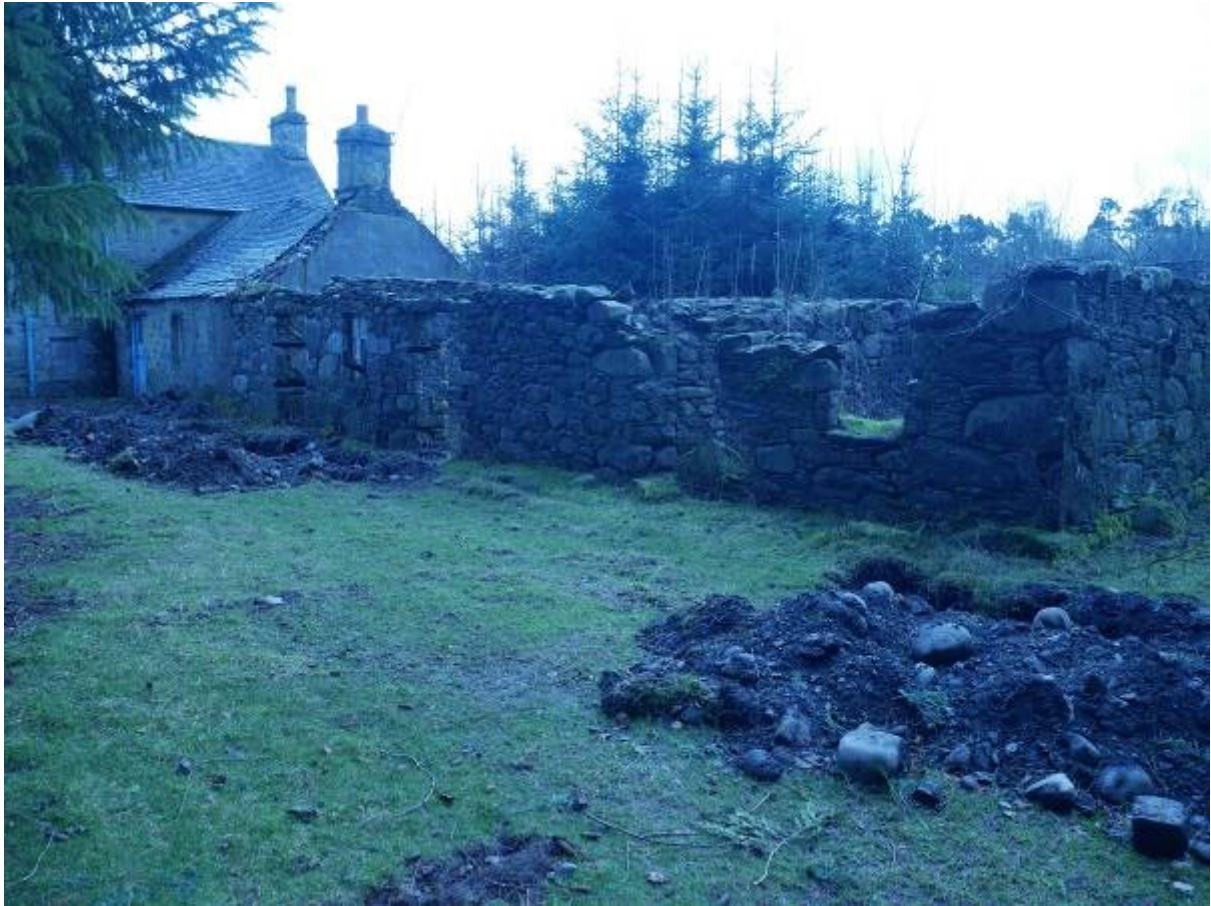
This is a mortar bonded rough stone and slate wall with large sandstone quoins at its junction with the Western end of Building 2. There is a doorway into Room 3a which has a surviving stone lintel, a glazed window into Room 3b with a cast iron stove or boiler chimney running out through it and a doorway into Room 3c which has a stone lintel and an open window on its Western side.

Illustration 21 - Northern elevation to Building 3

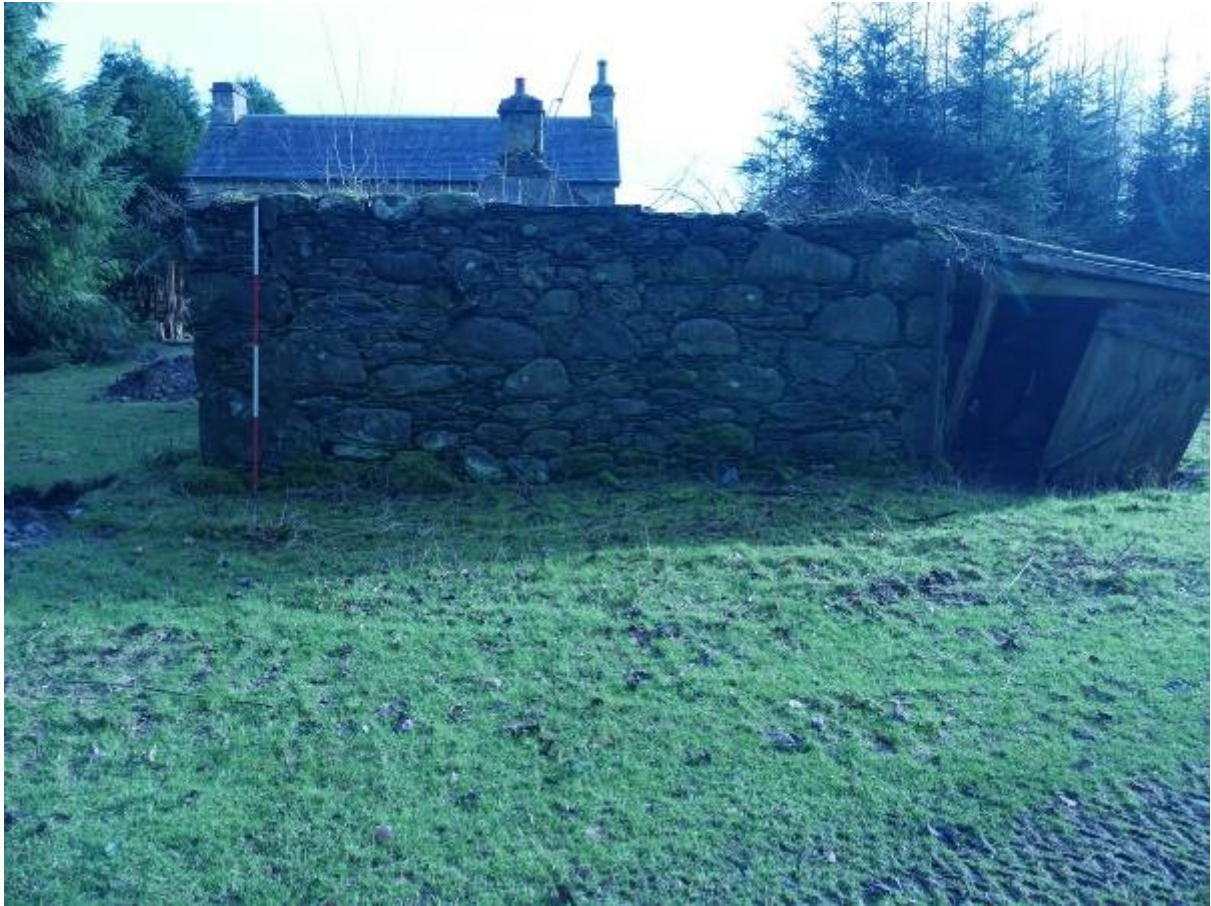
This wall is built of mortar bonded rough stones and slates and is a blank face.

Illustration 22 - Western elevation to Building 3, collapsing Building 4 visible on right
