Standing Building Survey  
Mucklarie Farmhouse, Snaigow  
Perth and Kinross

Building 1 at Mucklarie Farmhouse from the East

4<sup>th</sup> March 2019

## **Introduction**

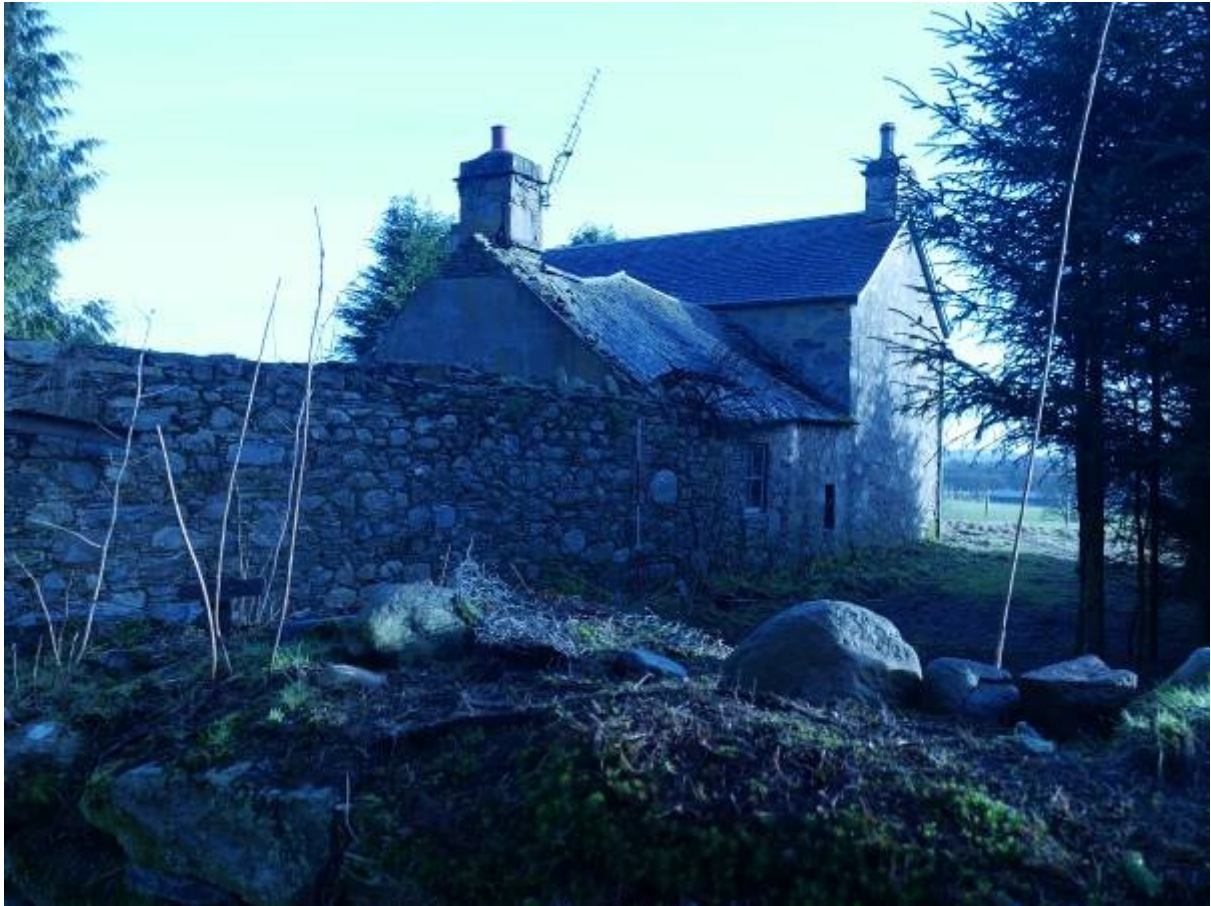
This wall is built of mortar bonded rough stones and slates and apart from a doorway into Room 5 is a blank wall face. A garden wall runs South of this elevation.

Illustration 23 - Southern elevation of Building 3 up to edge of doorway into room 3b

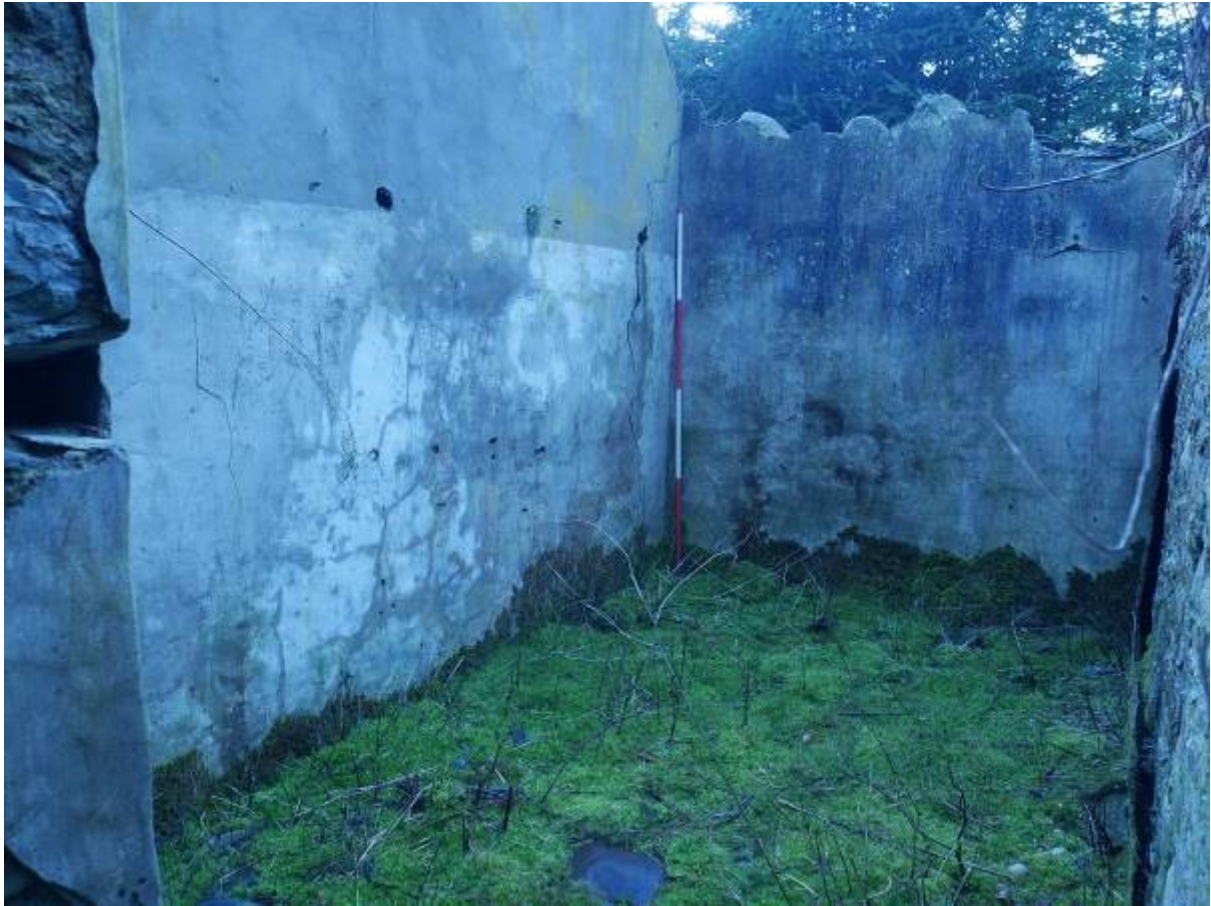
The Western, Southern and Northern internal elevations of this room are painted white. The Eastern elevation is built of small mortar bonded rounded stones and has plaster collapsing from its wall face. The chimney for Building 2 is visible at the apex of the gable in the Western elevation. The doorway into this room is in its Southern internal elevation. The floor level is buried under collapsed roof slates and timbers and is not visible.

Illustration 25 – Plastered internal Northern and Western elevations of Room 3a in Building 3

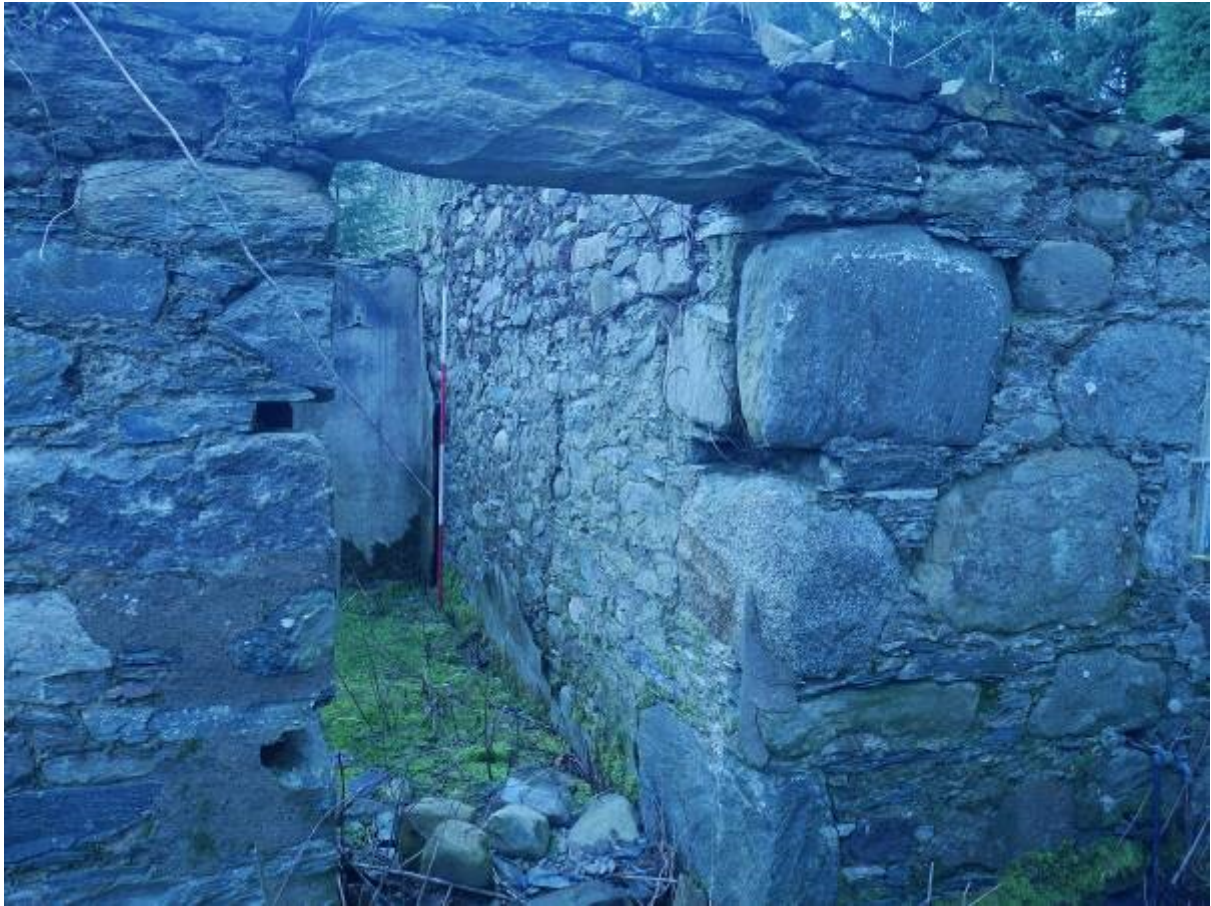
Illustration 26 – Internal Eastern elevation of Room 3a in Building 3

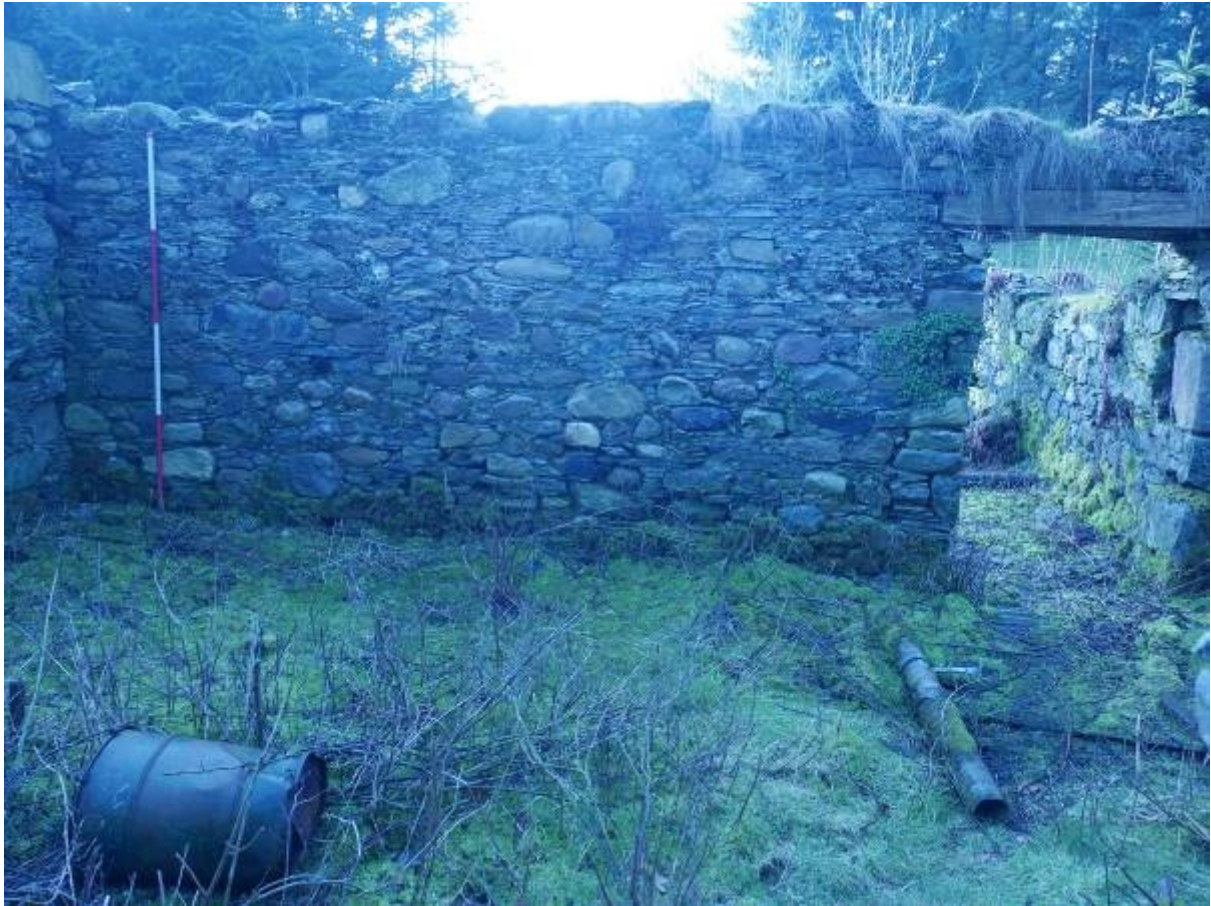
The doorways into this room are in its internal Northern and Southern elevations. The Western and Eastern internal elevations are blank wall faces. There is a rusty cast iron stove or boiler against its Southern elevation and a glazed window, the stove/boiler chimney runs out through the window. The floor level is buried under collapsed roof slates and timbers and is not visible.

Illustration 27 - Internal Northern elevation of Room 3b in Building 3

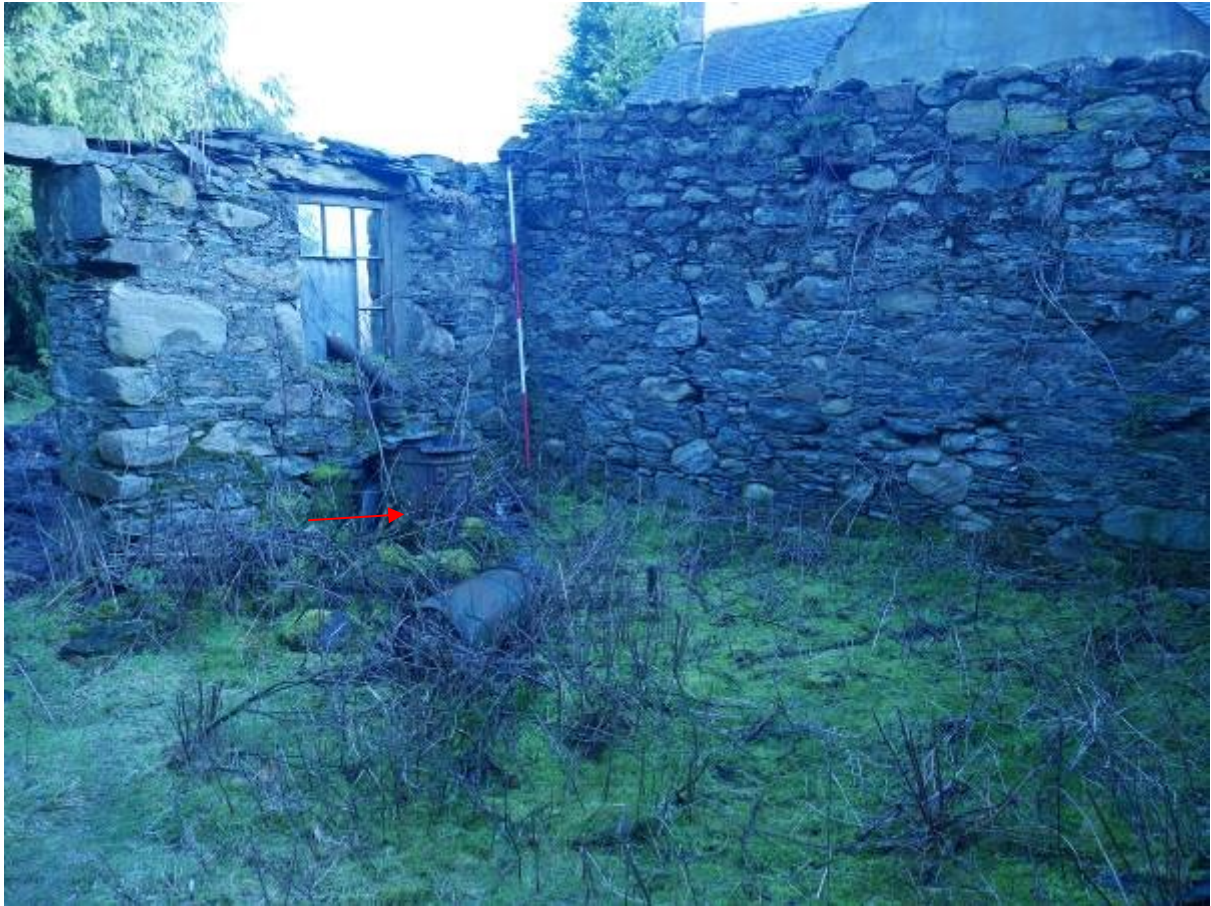
Illustration 28 – Internal Western and Southern elevations of Room 3b in Building 3 showing cast iron stove or boiler (red arrow)

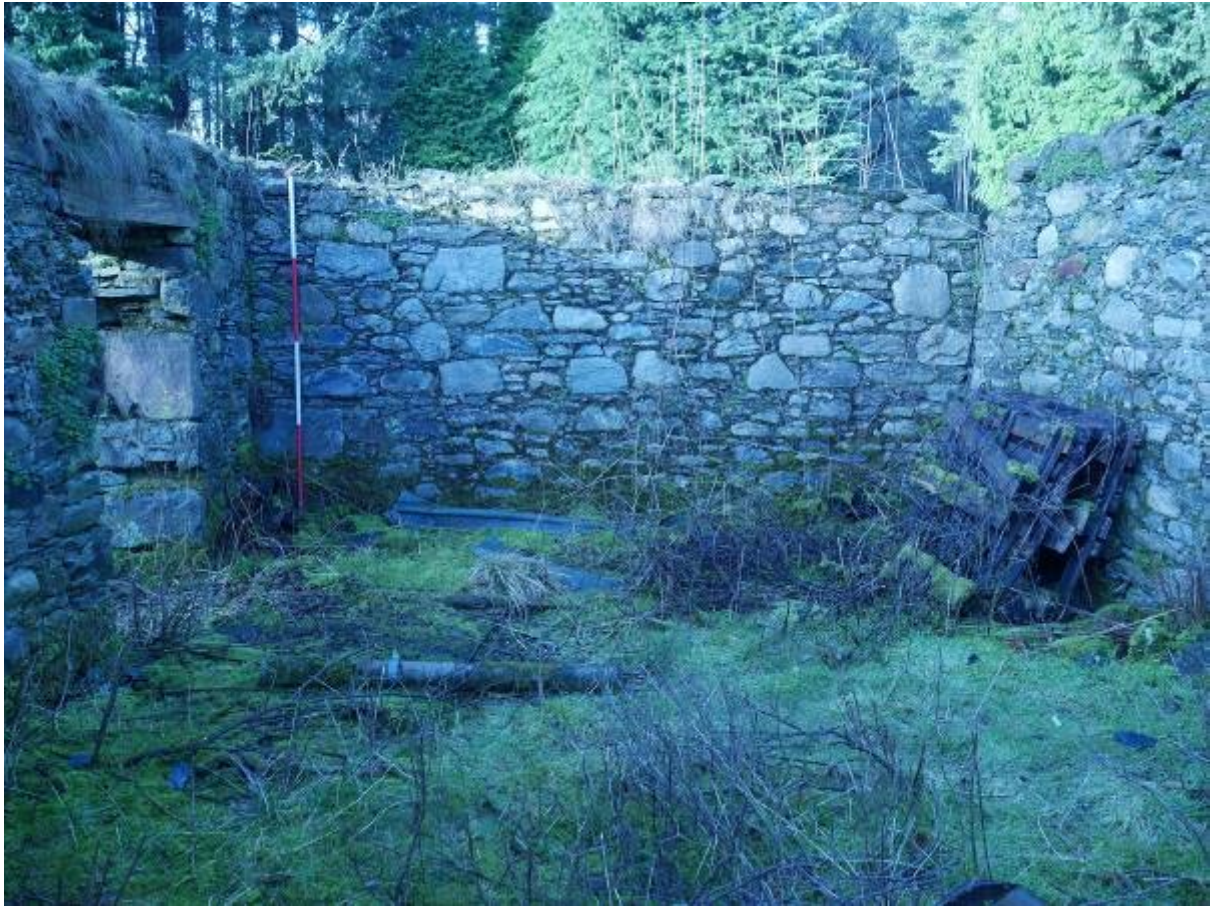
Illustration 29 - Internal Eastern elevation of Room 3b in Building 3

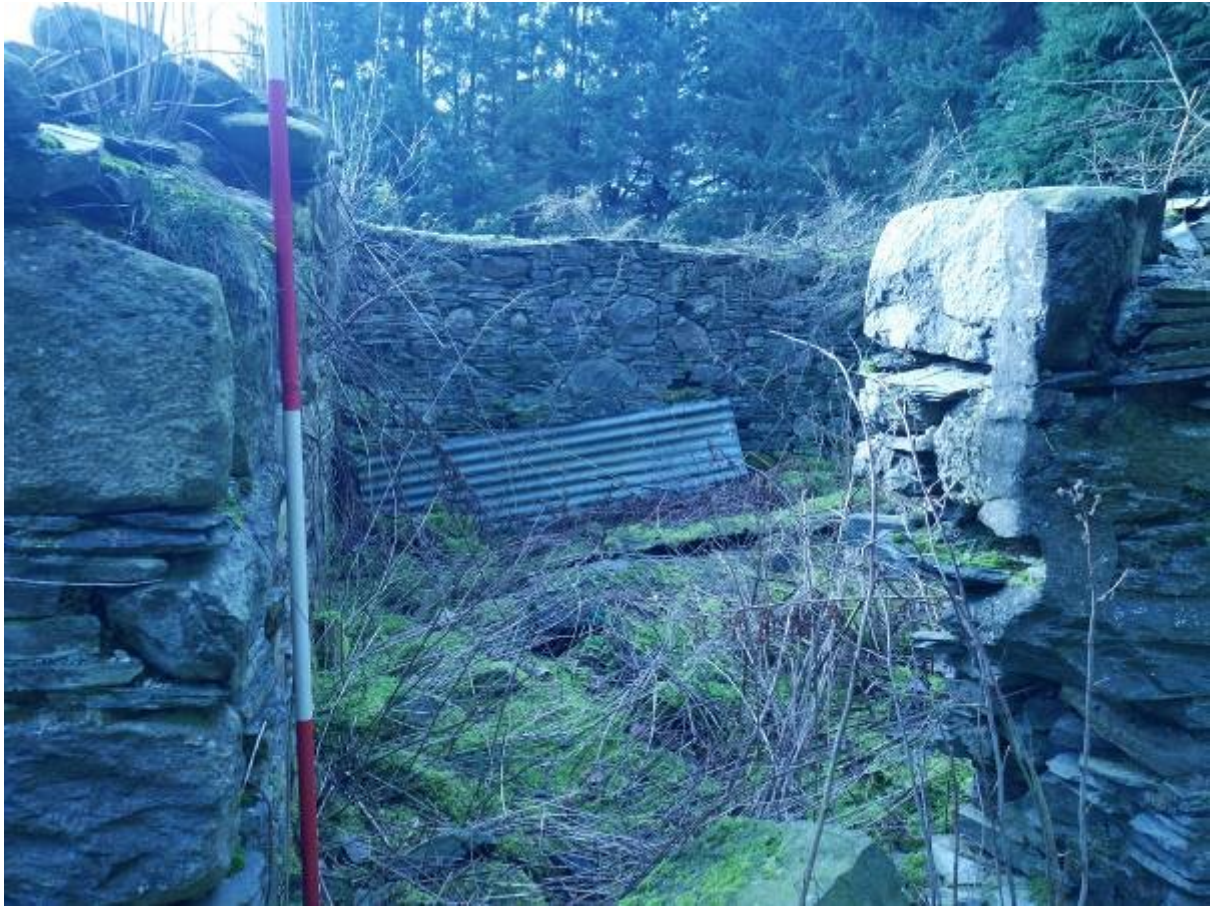
The doorway into this room is in its internal Southern elevation and there is an unglazed and open window space on the Western wide of the doorway. The Northern, Western and Eastern internal

elevations are blank. The floor level is buried under collapsed roof slates and timbers and is not visible.

Illustration 30 – General view of interior of Room 3c in Building 3

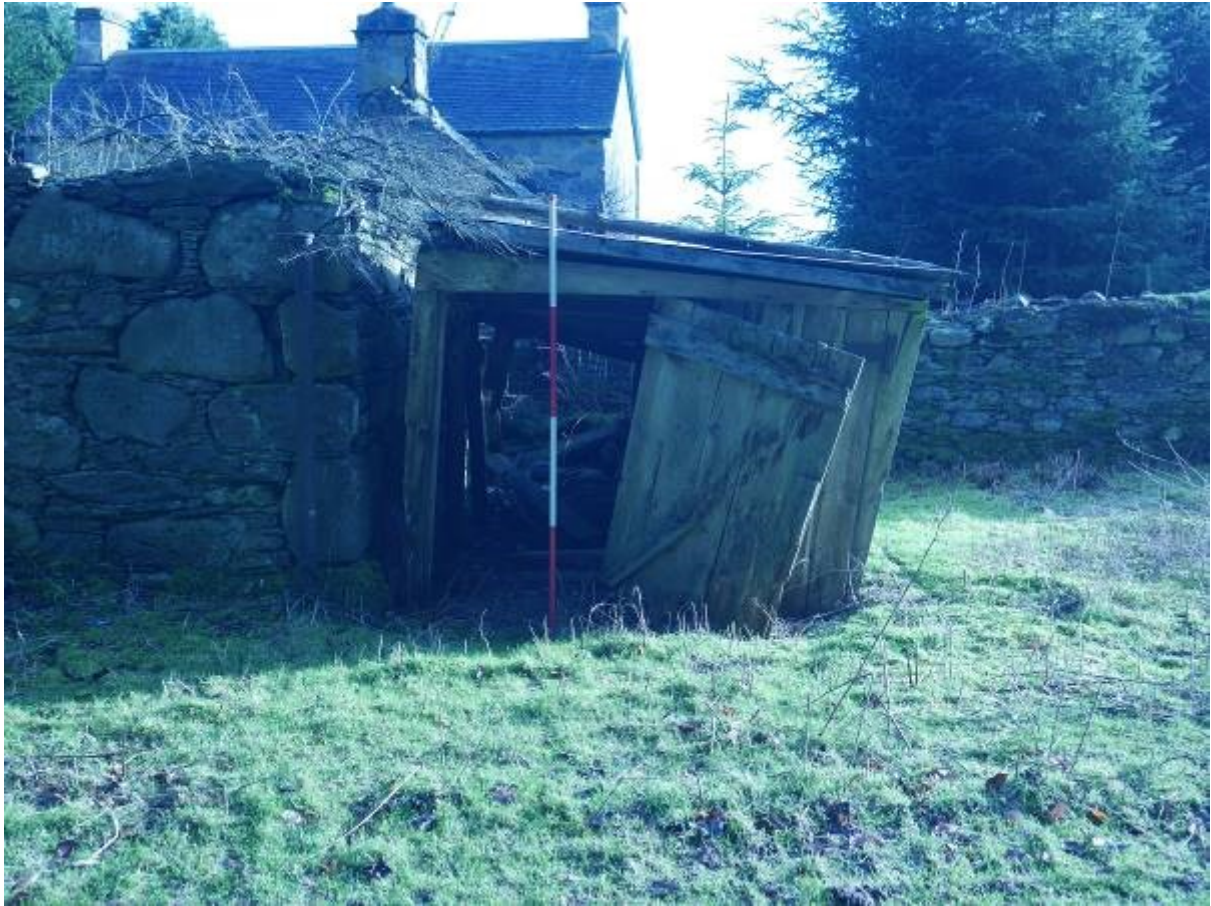
This is a collapsing wooden shed or garage that stands against the Western end of the external Southern elevation of Building 3.

Illustration 31 – Building 4 looking East

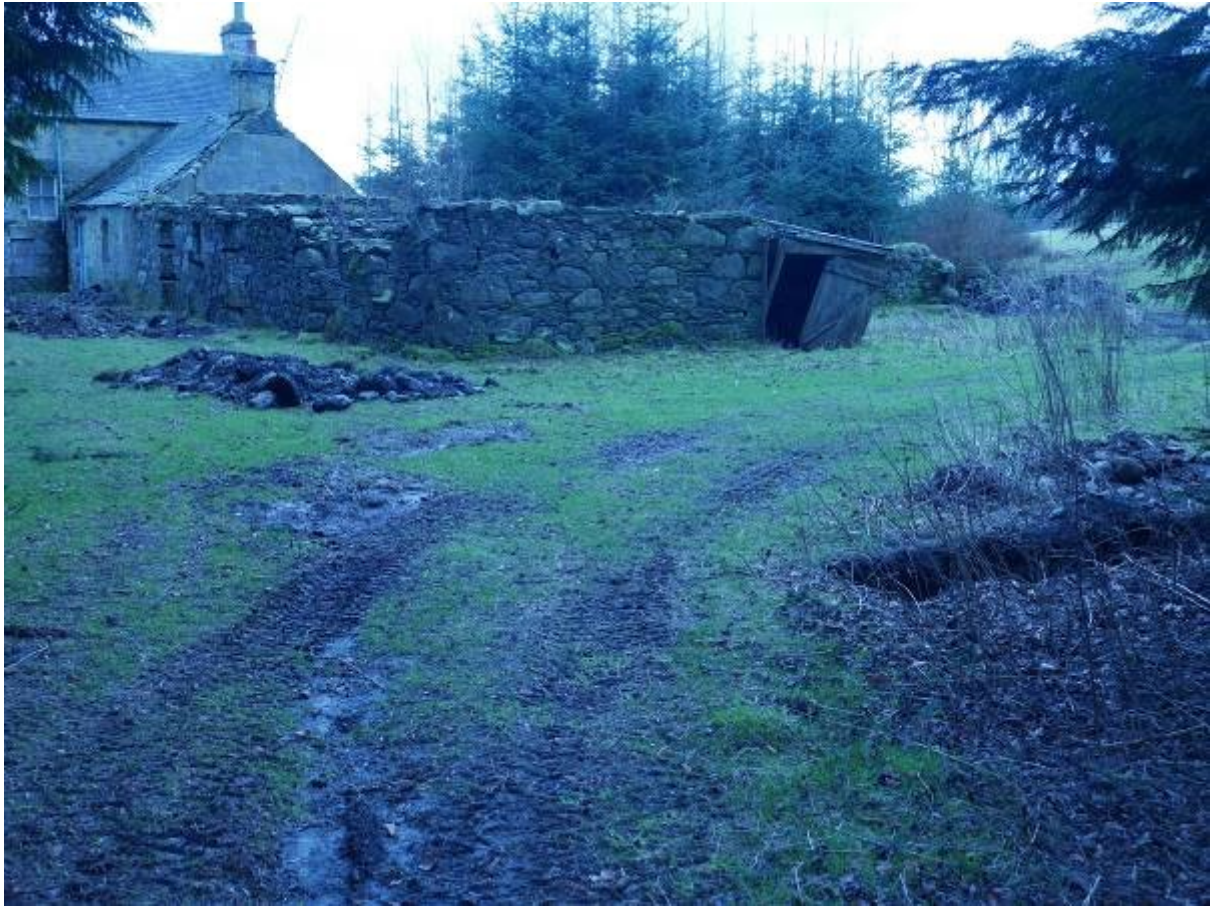
Illustration 32 – General view of location of machine dug trenches to North of building complex.

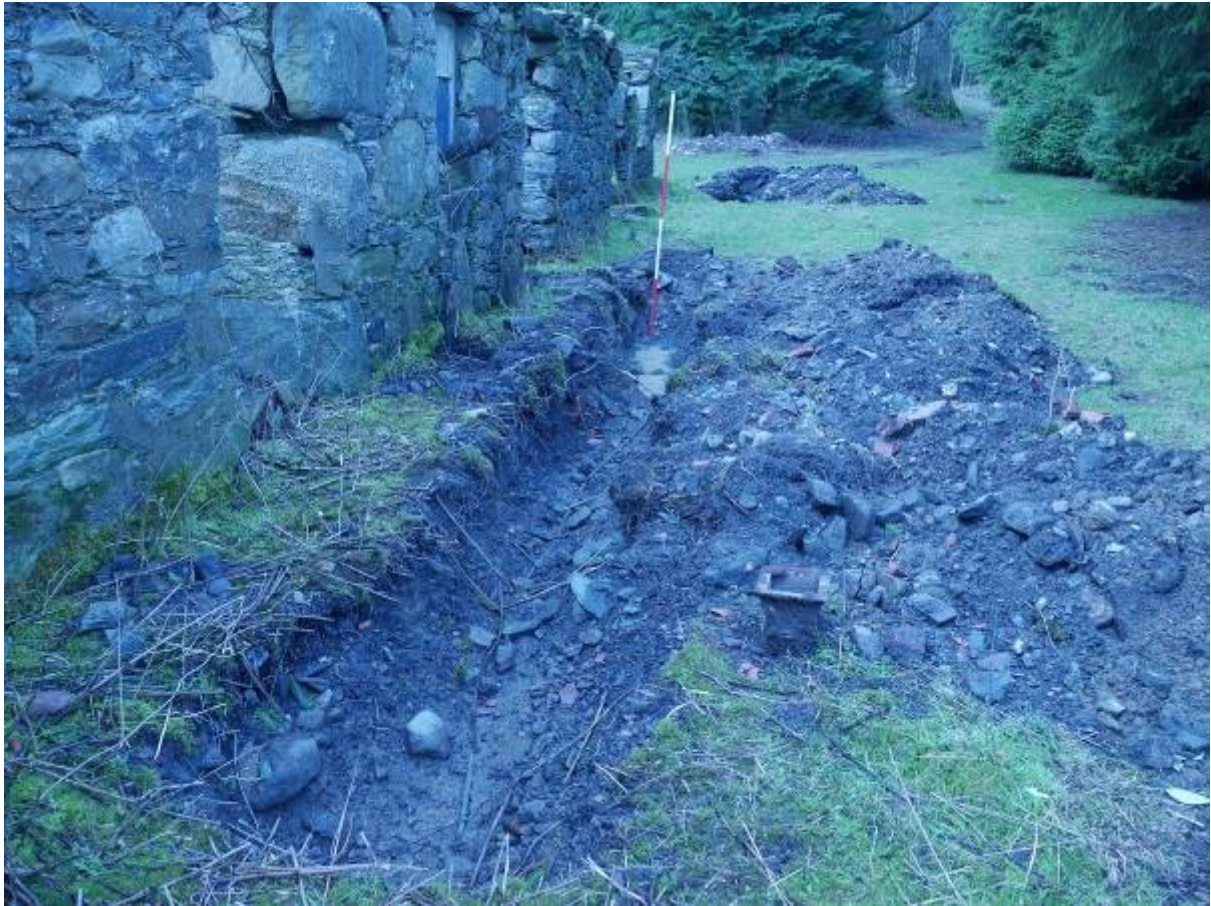
There are three machine excavated trenches lying on the Northern side of Buildings 2 and 3. The first of these measures 10m by 1m and is 0.5m deep. The second is 5m by 1m and 0.7m deep, the third trench lies 15m West of the buildings, measures 3m by 1m and is 0.5m deep. Natural clay and stone is visible in all three trenches at 0.20m, 0.30m and 0.50m respectively. These trenches appear to have been dug to trace the course of a water pipe.

Illustration 33 – General view of Machine dug trench 1 looking West

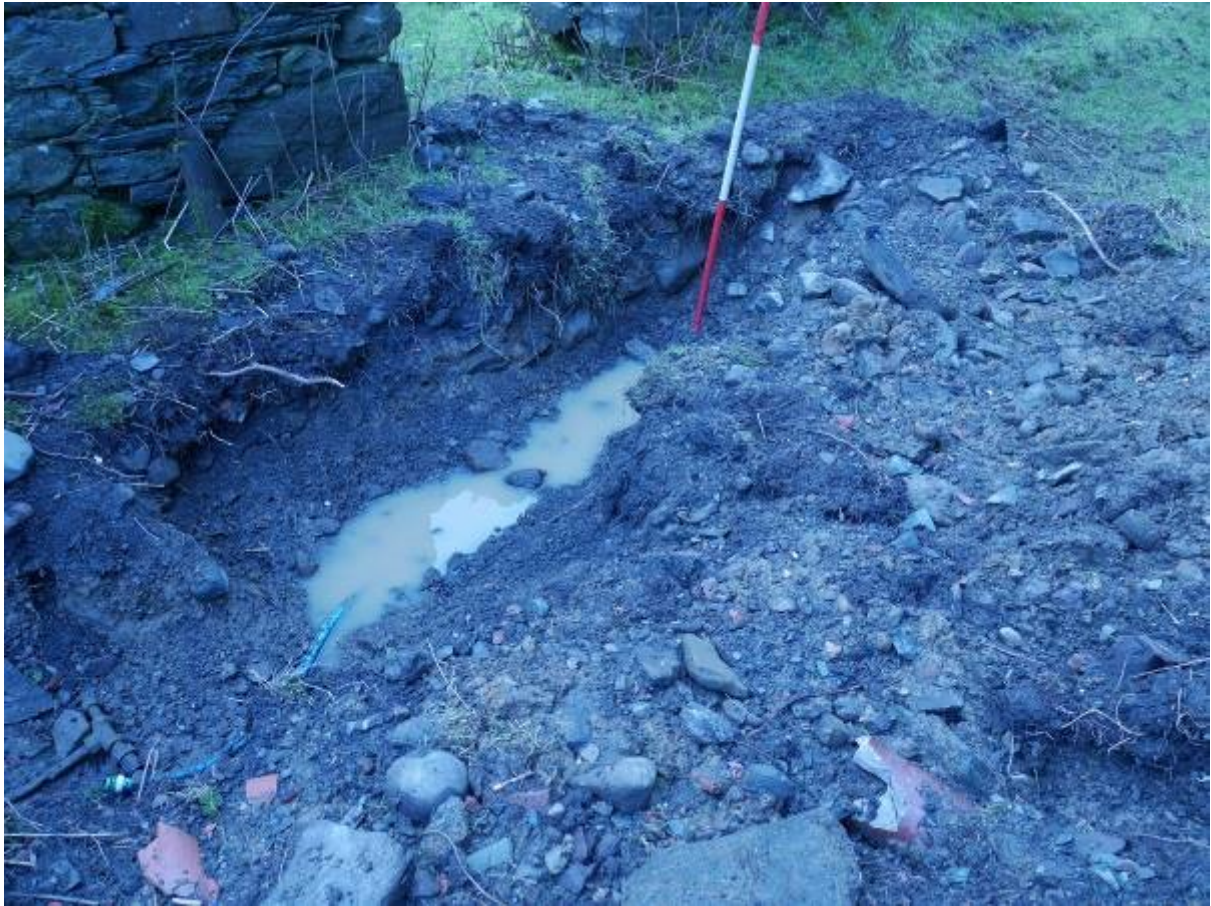
Illustration 34 – General view of machine dug trench 2
