Standing Building Survey
Kirk O' The Muir manse,
Kinclaven, Perth and Kinross

8th April 2019

| TYPE(S) OF PROJECT: | Standing Building Record |

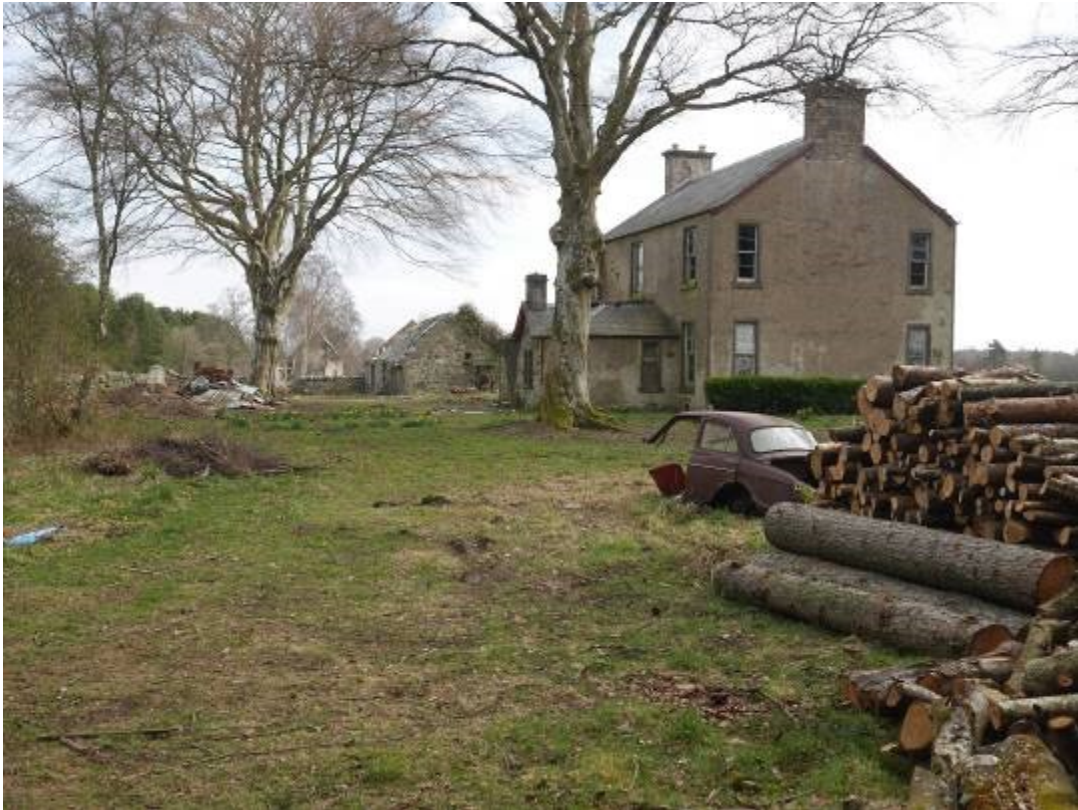
Kirk O' The Muir manse looking North East (Building B visible to left and Kirk O' The Muir church visible to rear)

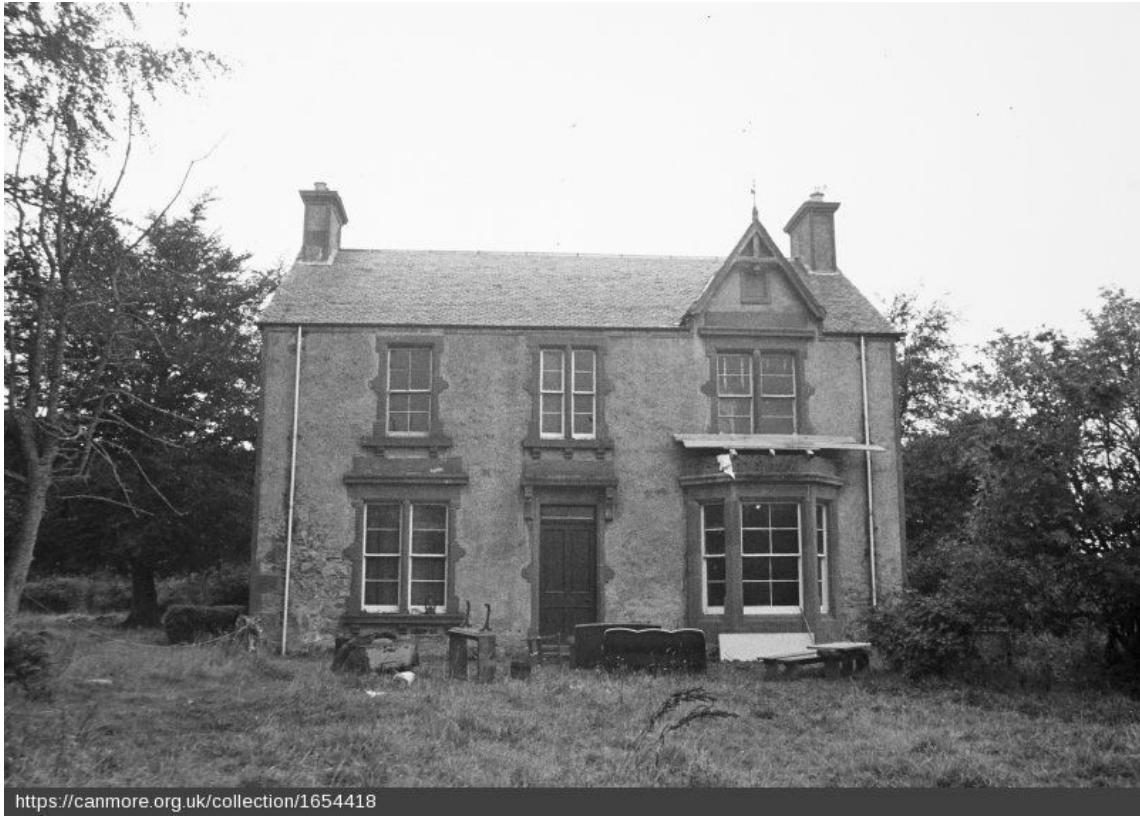
Illustration 3 - Manse building as recorded by RCAHMS for C-list survey of 1975 (© Canmore)

The presence of a building on the site in the 1860's would suggest that the date stone of 1870 on the North Eastern end of the manse marks the date of some alterations or additions to the structure rather than its original construction. On careful examination the building shown on the 1863 OS map can be seen to have a slightly different footprint to the existing structure (A in the survey) and there is no garden wall running between it and the adjacent building (B in the survey). By the Second Edition OS map of 1901 the bay window on the Southern side of the building, the boiler house and stores on its Northern side and the garden wall between buildings A and B have been built. The United Free Church (of which the original Seceders had become a part) reunited with the Church of Scotland in 1929 and on the retiral of the respective ministers of Kinclaven and Kirk O' The Muir in 1938 the two congregations came together under a new minister and were housed at Kinclaven church. The manse building thus has a last recorded occupation of 1938 and was certainly empty by the time of the RCAHMS C list survey of 1975 (Illus 4) (<https://canmore.org.uk/collection/1654418>).

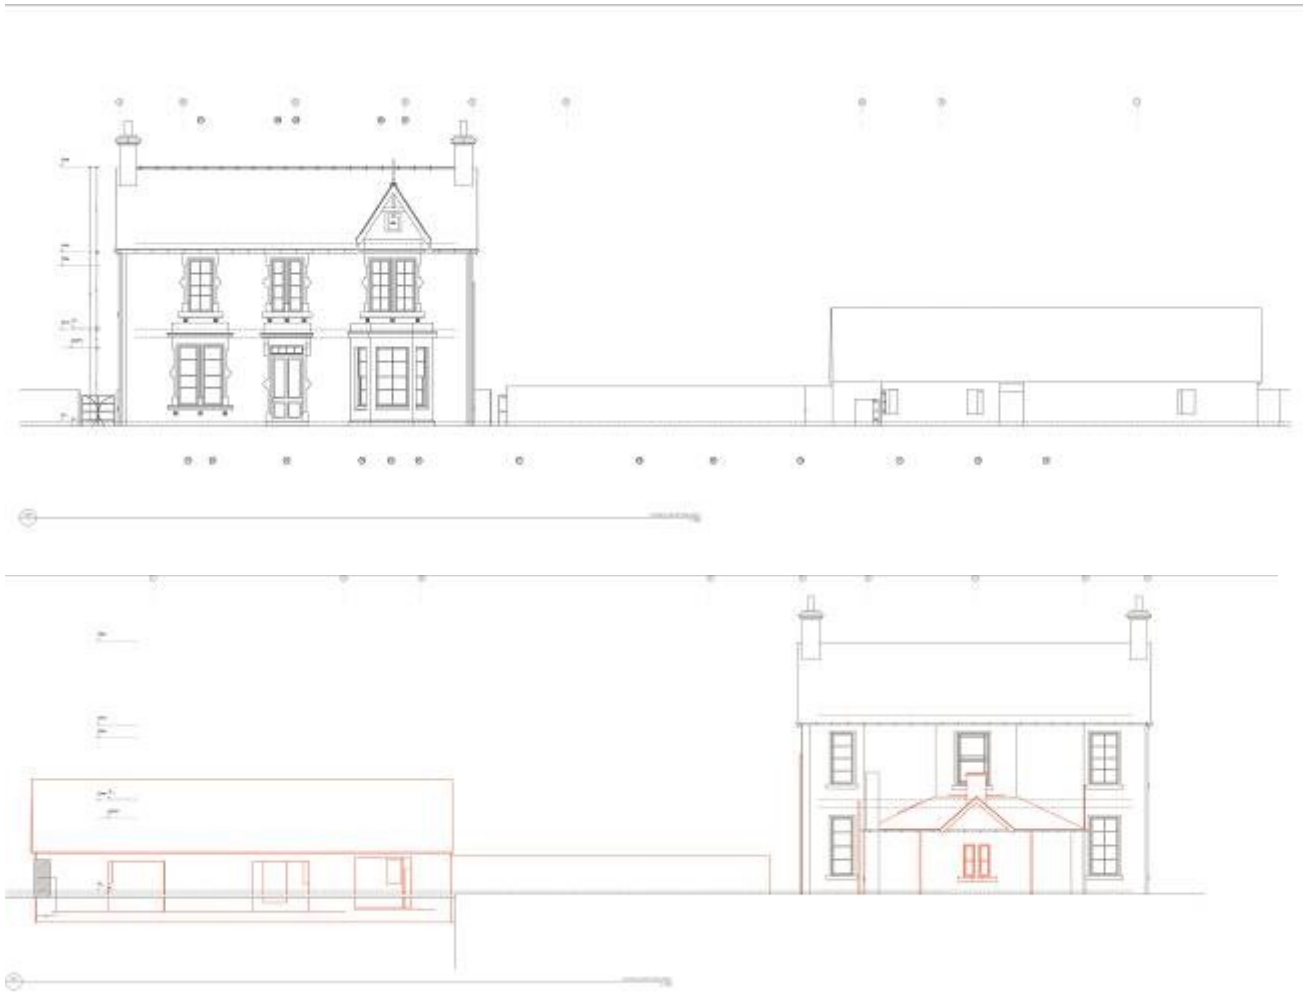
Illustration 6- Upper drawing Southern elevations of Buildings A and B at Kirk O' The Muir, Lower drawing Northern elevations of Buildings A and B (based on supplied architects' drawings)

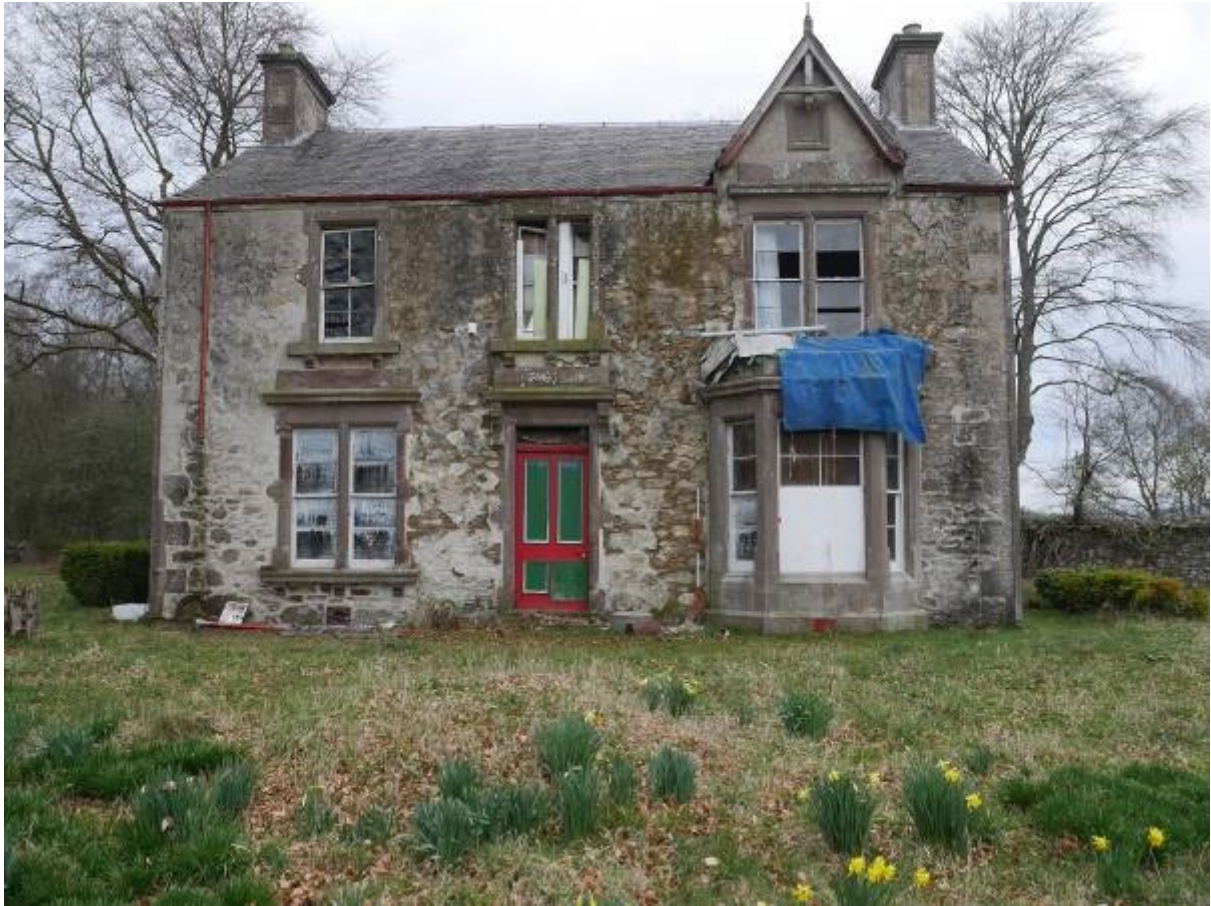
This is built of mortar bonded rough stone with cut ashlar at the corners, it is defined by a thin 'string' course that runs down the edges and along the roof line. It was originally plastered white and traces of this remain on the wall face. There is a central doorway with a pediment that contains a red painted wooden door. At the western end of this elevation there are glazed paired sash windows separated by a thin bar of stone. These have a pediment and sill that is supported by carved stones. At the eastern end there are bay fronted glazed sash windows with a parapet that is covered with protective sheeting. At first floor level there is a single glazed sash window at the western end, paired narrow windows above the door and paired sash windows separated by a thin bar of stone above the bay window with a small wooden framed pointed gable that contains a date stone marked '1870'. The surviving gutter and down pipe are painted red.

Illustration 7 - Building A Southern Elevation (note datestone of 1870 in small gable)

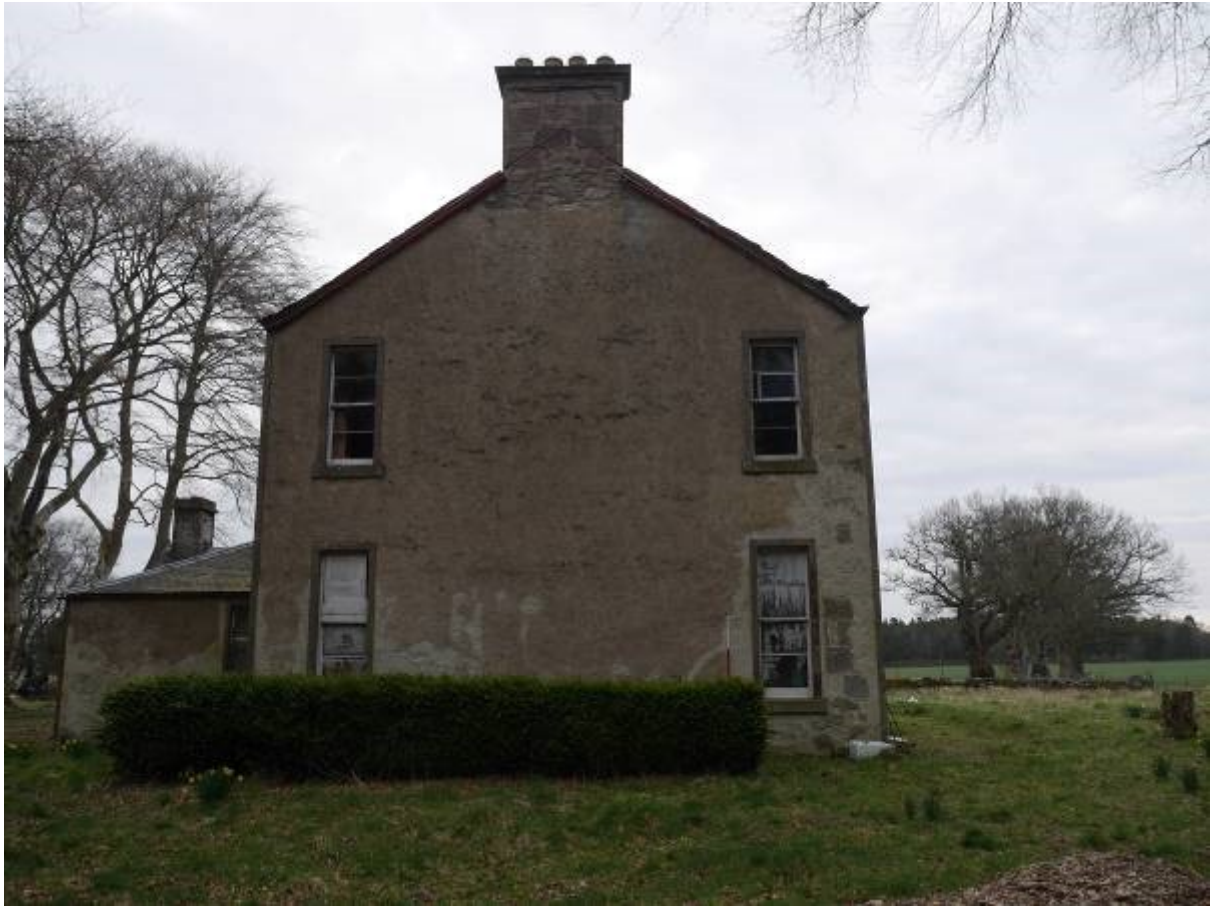
This is a gable end to the building with a chimney at its apex. It is built of mortar bonded stone with cut ashlar at its corners and is plastered white. The elevation is defined at each end by a thin 'string' course running down the edges of the building. There are pairs of glazed sash windows at each end of the elevation and wooden plank roof supports run down the roof line.

Illustration 8 - Building A Western Elevation

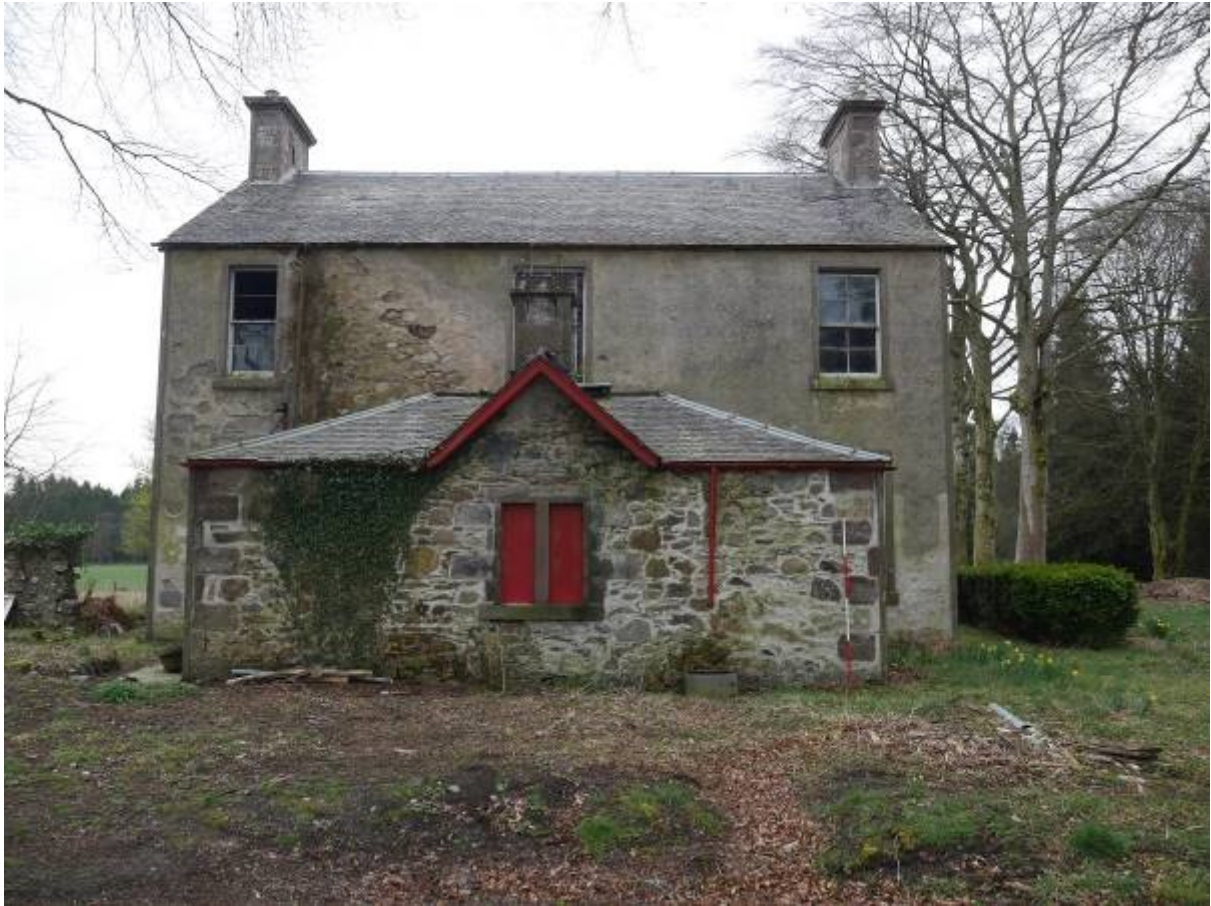
This is built of mortar bonded rough stone with cut ashlar at the corners and is plastered white and is defined by a thin 'string' course running down the edges of the building. At first floor level there is a narrow glazed four pane sash window at its eastern end, a larger glass paned window in the middle and a glazed eight pane sash window at its western end. A boiler house and store projects out from this elevation, and there is a narrow glazed four pane window at ground level at its eastern end and an glazed eight pane sash window at its western end.

Illustration 9 - Building A Northern Elevation

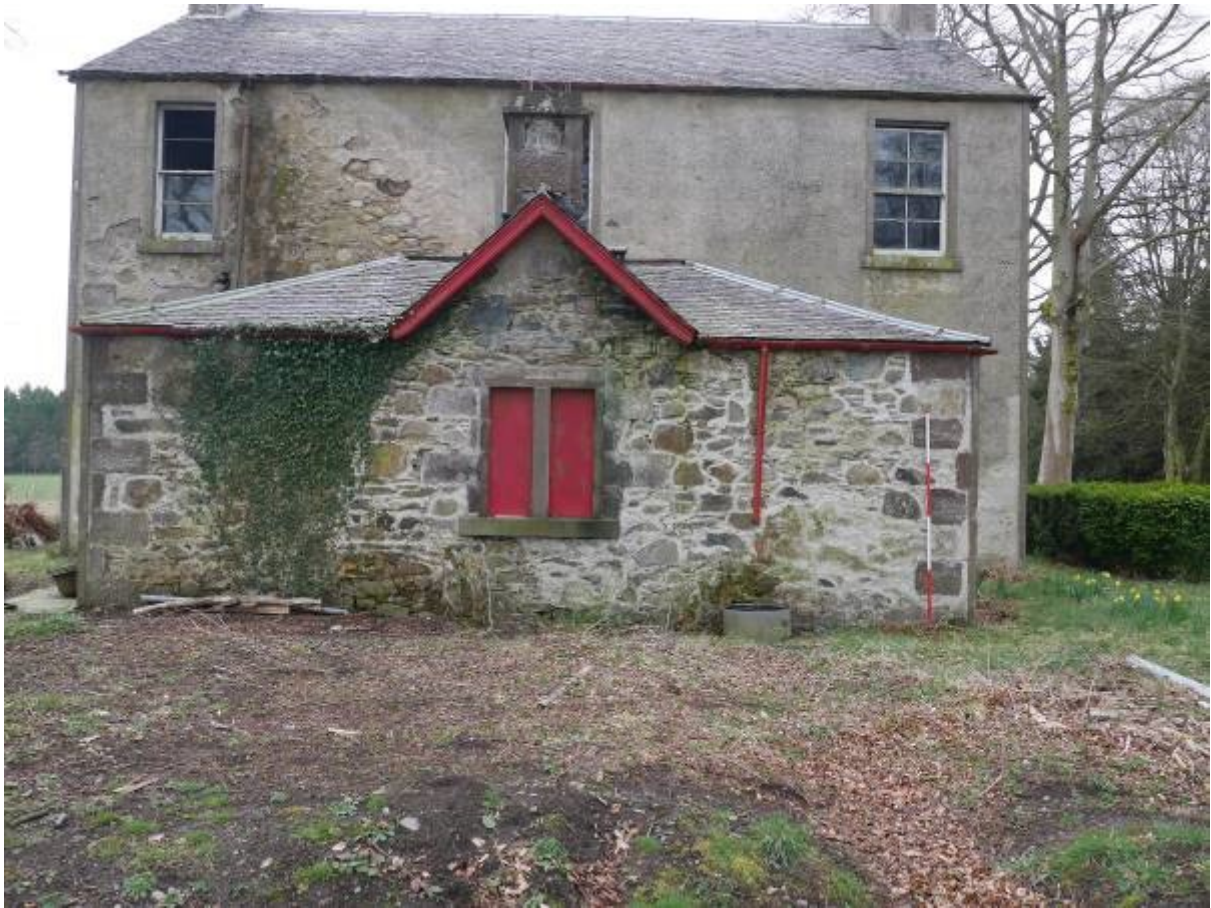
This is built of mortar bonded rough stone with cut ashlar at the corners and is defined by thin narrow 'string' courses running down the edges of the building. It has a central gable with a small chimney at its apex above double windows that are blocked with red painted wooden boards. The wooden planks defining the gable and the gutter and down pipe are painted red.

Illustration 10 - Boiler house and stores Northern elevation

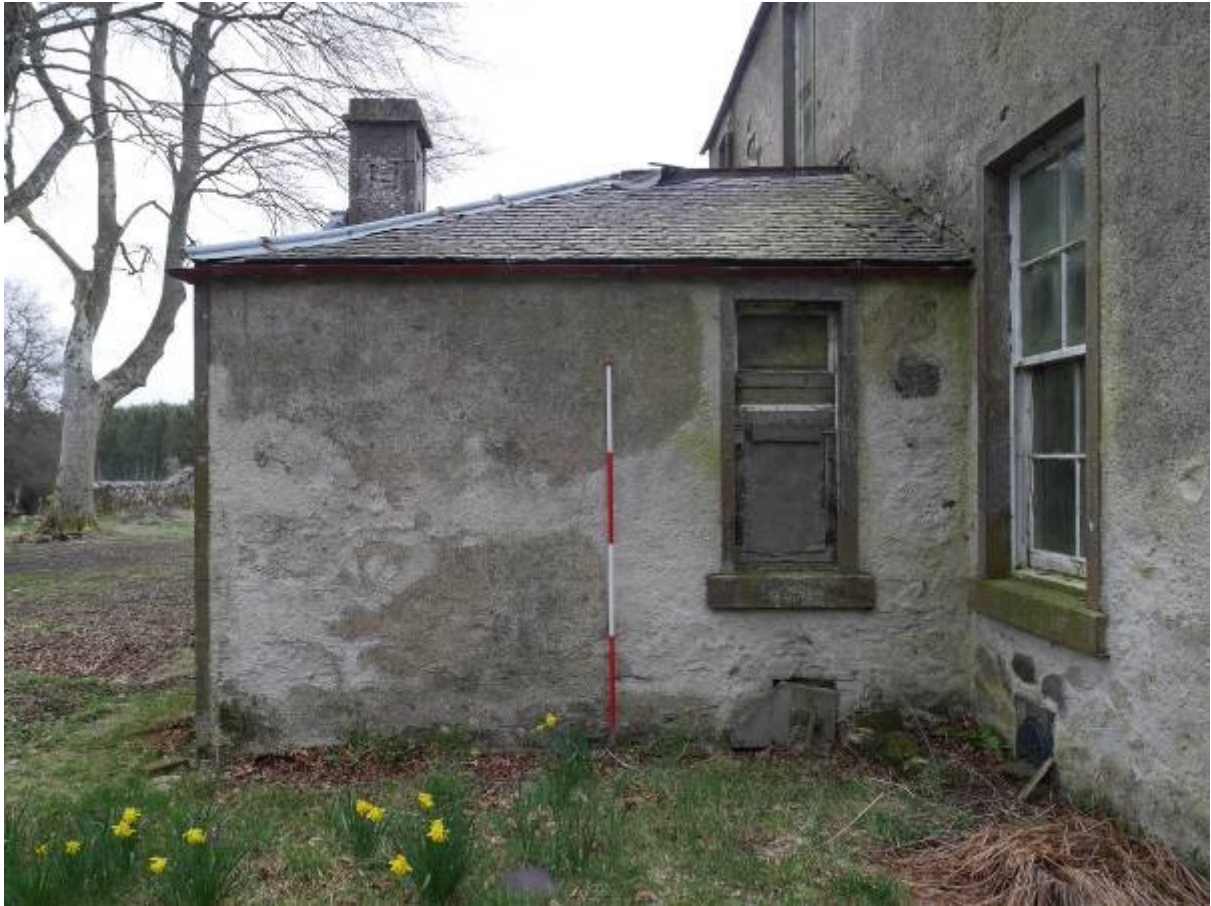
This wall face is plastered white and contains a single partially boarded up sash window. Its northern end is defined by a narrow 'string' course and the gutter is painted red.

Illustration 11 - Boiler House and stores Western elevation

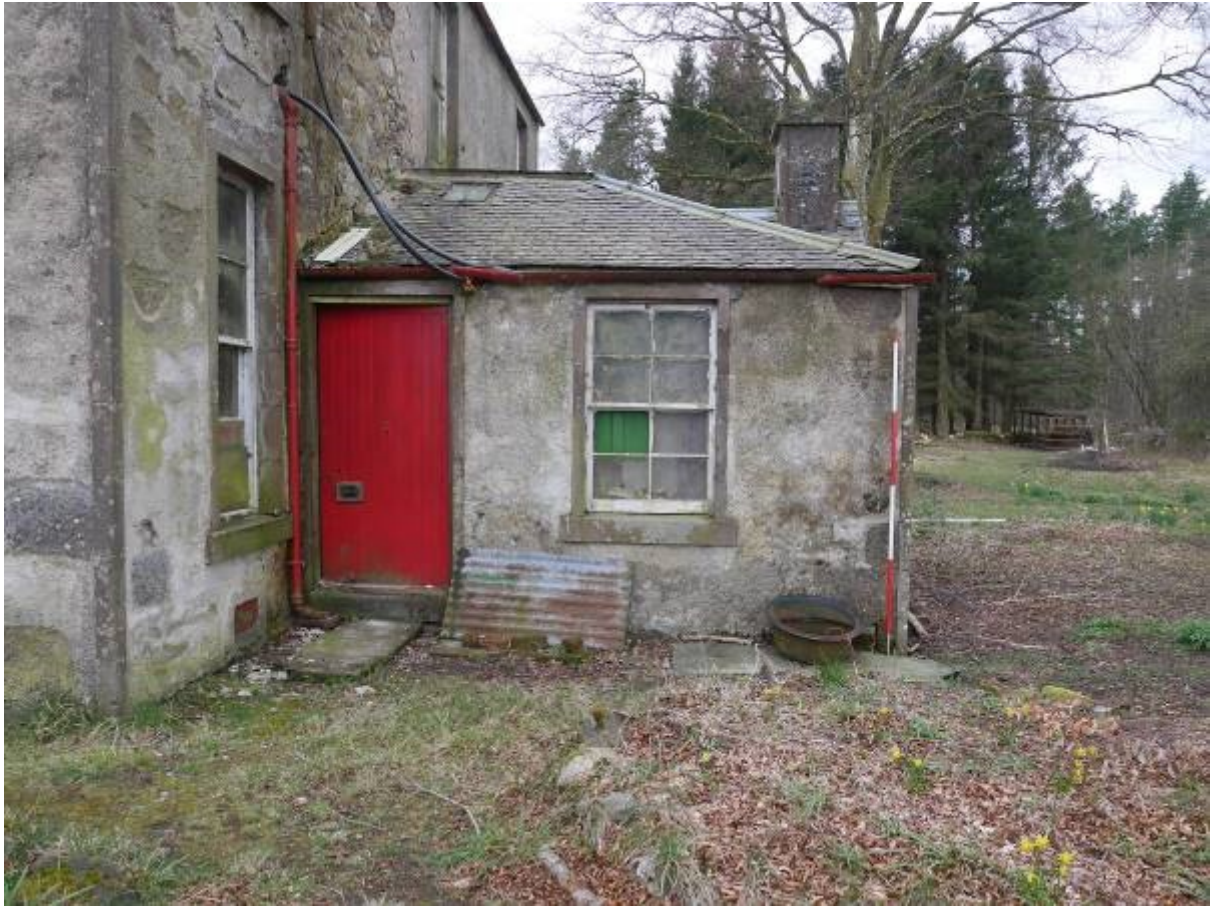
This wall face is plastered white and contains the back door to the property which is painted red and a partially blocked eight pane sash window. The gutter is painted red.

Illustration 12 - Boiler house and stores Eastern elevation

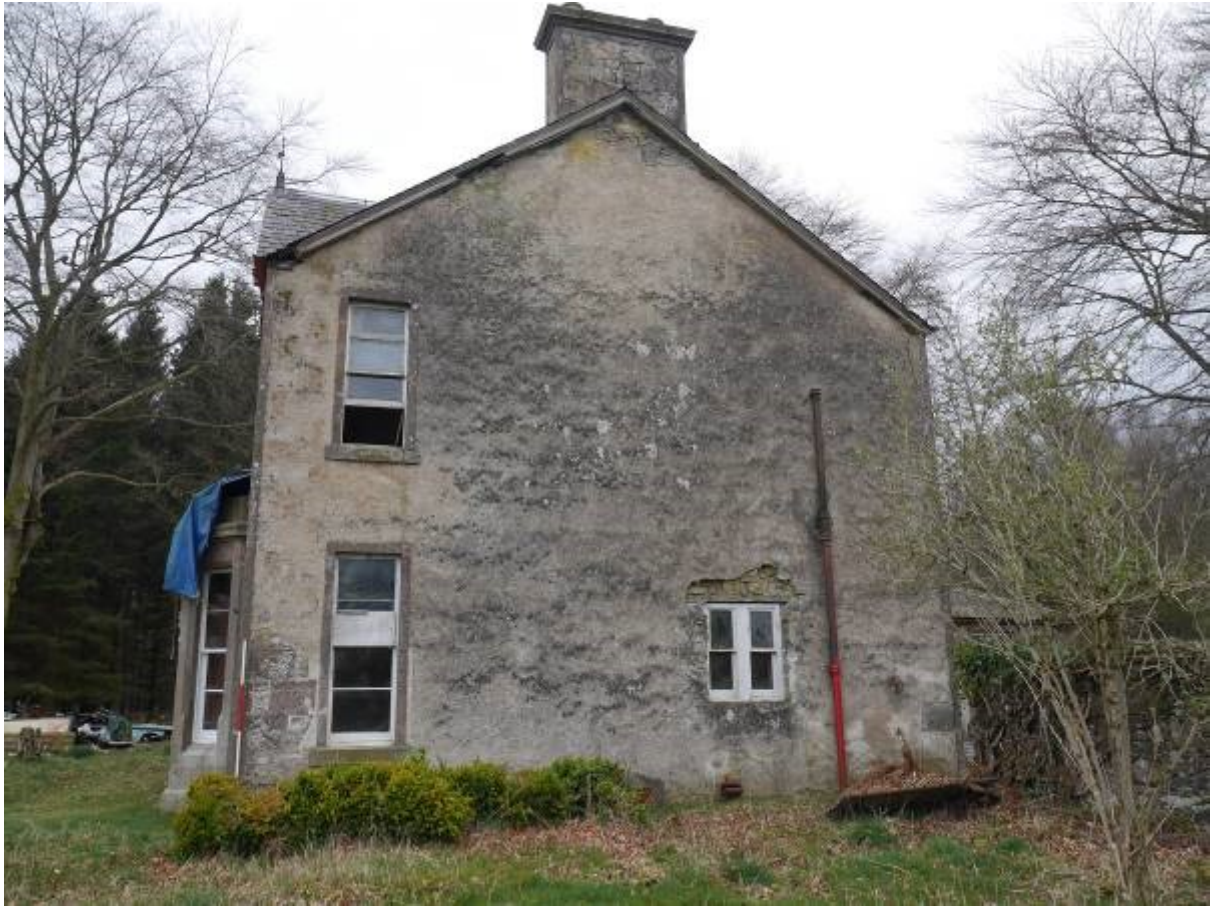
This is a gable end to the building with a chimney at its apex. It is built of mortar bonded stone with cut ashlar at its corners and is plastered white. The elevation is defined at each end by a thin 'string' course running down the edges of the building. At its Southern end there is a pair of narrow glazed sash windows at first floor and ground level. Towards the Northern end of this elevation there is a four paneled sash window and a down pipe painted red.

Illustration 13 – Building A Eastern elevation

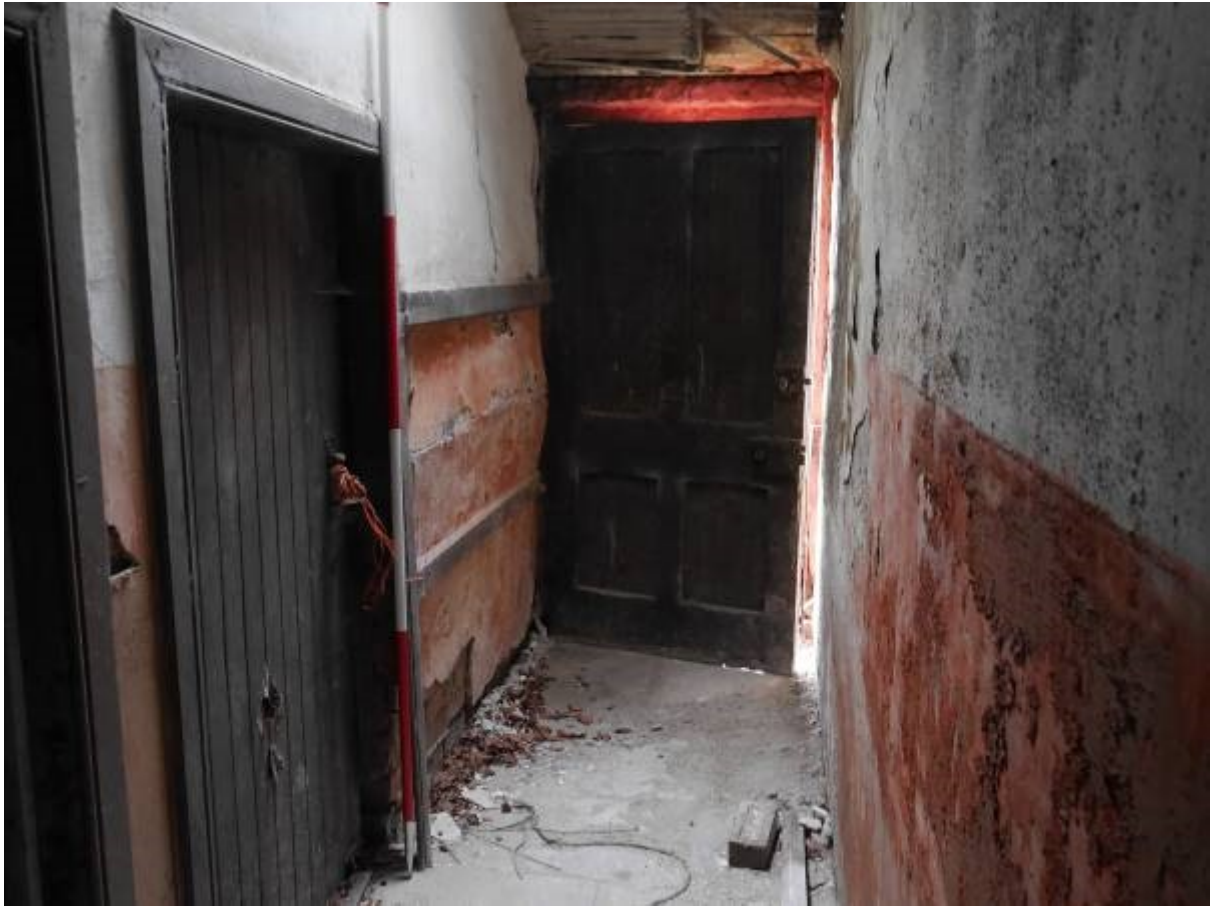
This has a corridor with a stone slabbed floor running down its southern side. The corridor has a wooden lath ceiling and has plastered walls that are painted red on their lower half and white on their upper half. The northern side of the corridor contains three wooden doors that provide access into the boiler room and stores. These three rooms were not accessed as they are collapsed and dangerous. The manse building proper is accessed by a doorway at the Western end of the corridor in its Southern wall.

Illustration 14 - Corridor in Boiler House/Stores looking East

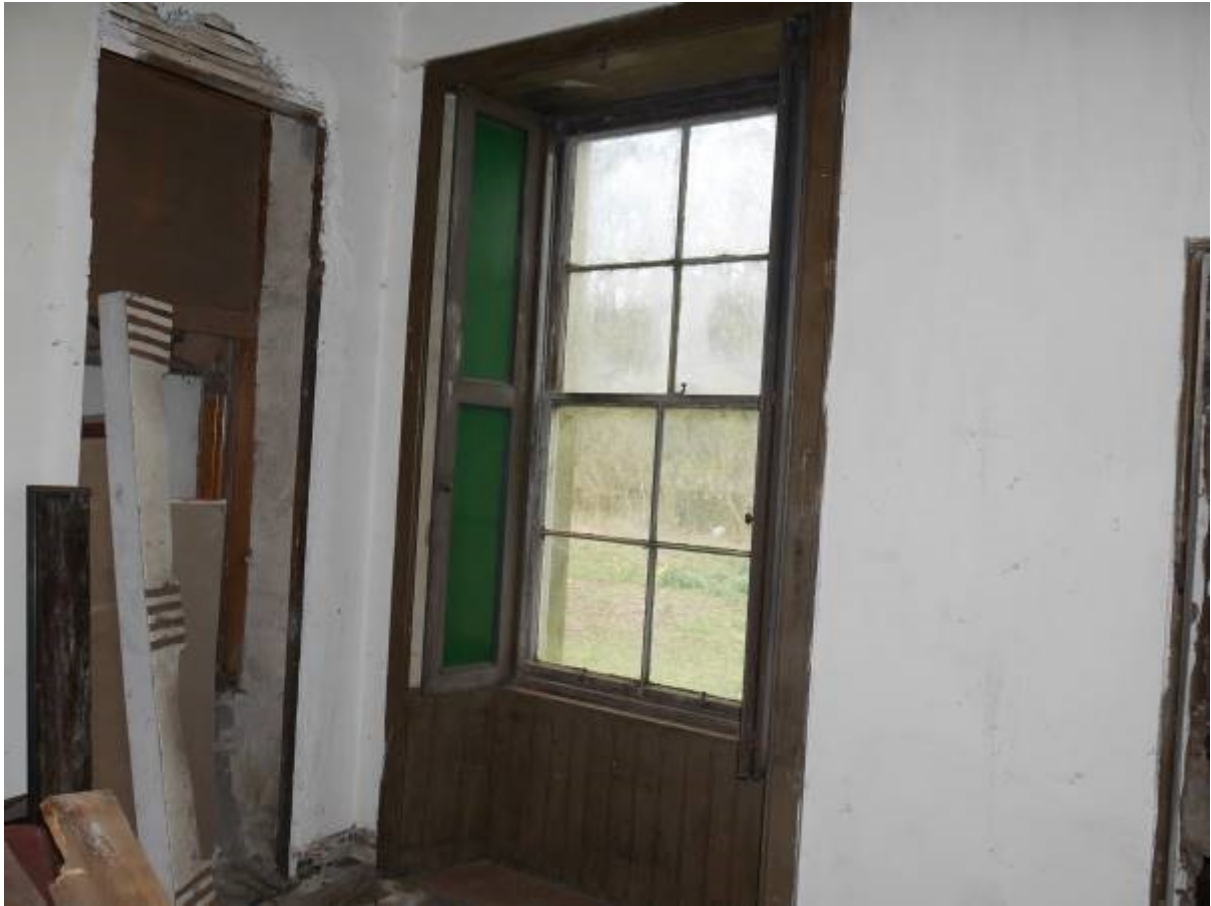
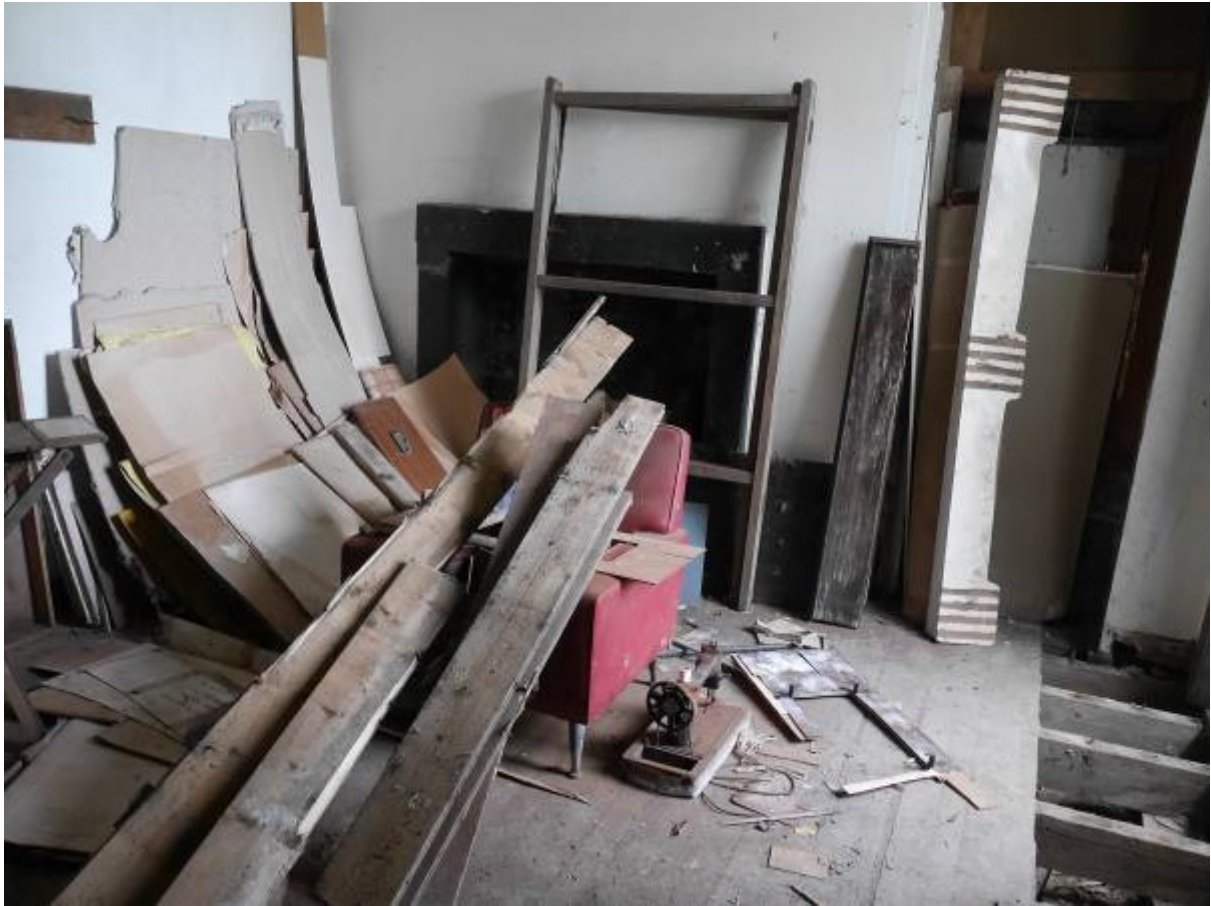
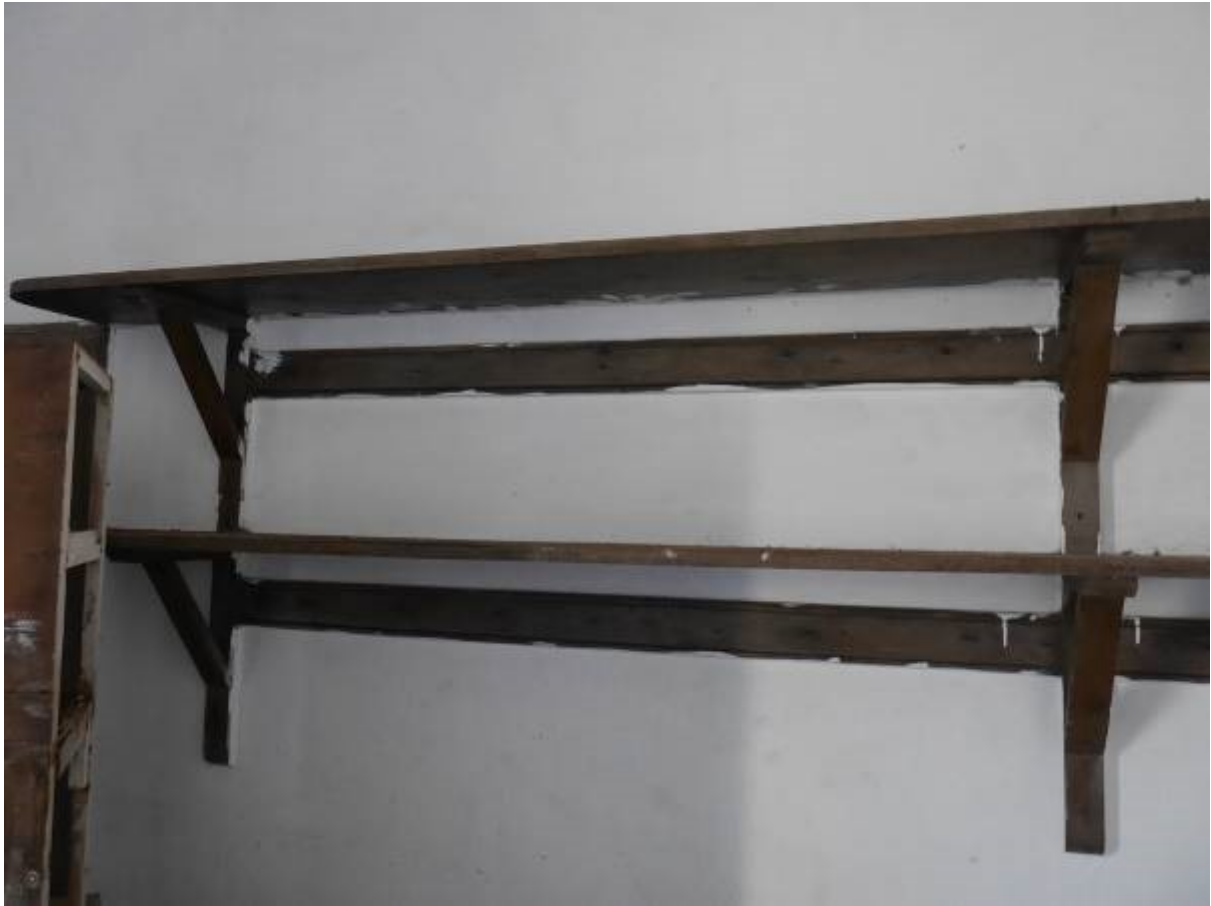
This has a wooden floor, a single doorway in its eastern wall and a fireplace in its Western wall. There is a shuttered wooden framed window in its North wall. It has wooden shelving on its Eastern wall. The room is painted white and its ceiling is not moulded.

Illustration 15 - Building A Room 1 (backroom) shuttered window in North wall

Illustration 16 – Building A Room 1 (backroom) showing fireplace in West wall

Illustration 17 - Building A Room 1 (backroom) wooden shelving on East wall

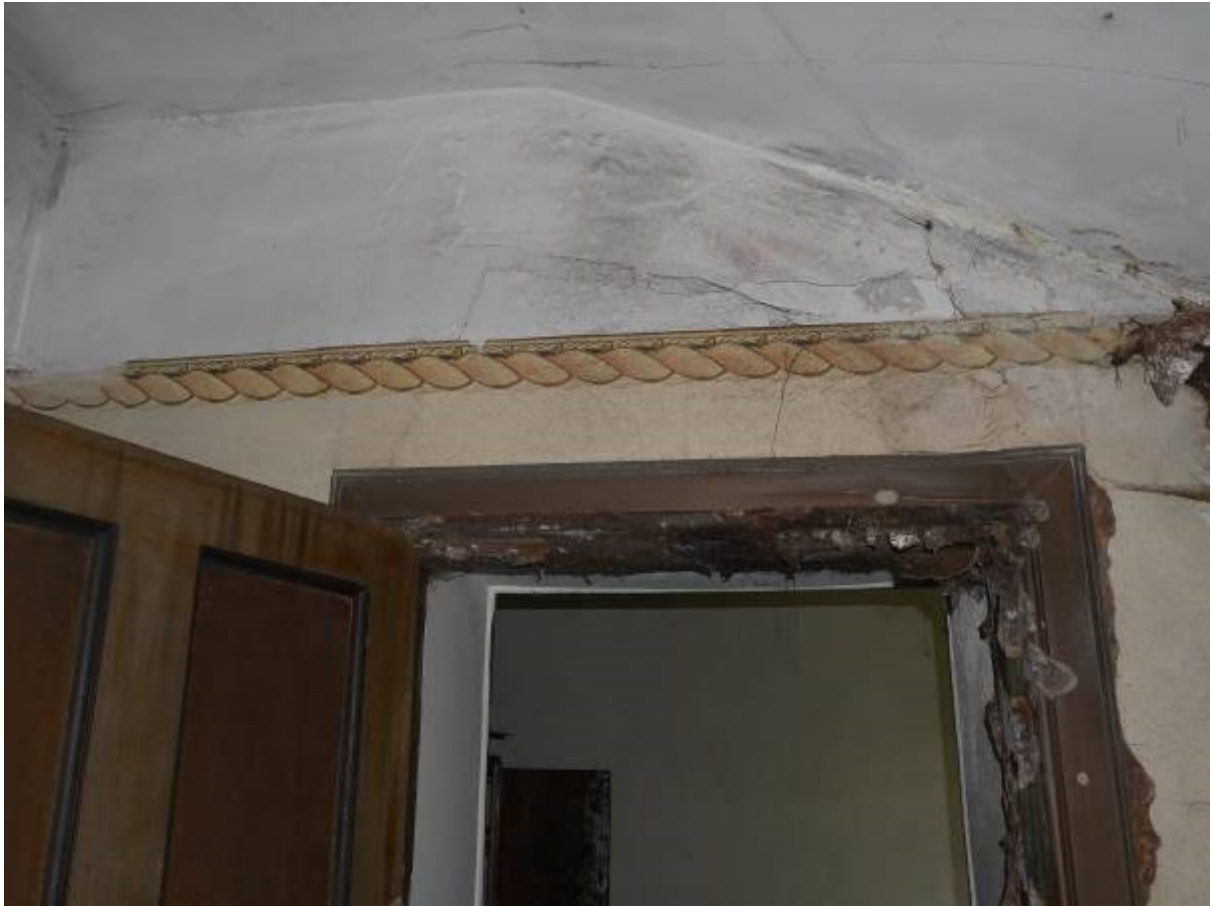
This is accessed through a doorway in the North wall of Room 1 and is at the western end of the boiler house and stores. It has a wooden floor and a single sash window in its Western wall. The walls are painted yellow brown, the ceiling white and there are traces of an ornate wallpaper border with scalloped decoration.

Illustration 18 - Building A Room 1a surviving decorative wall paper on south wall

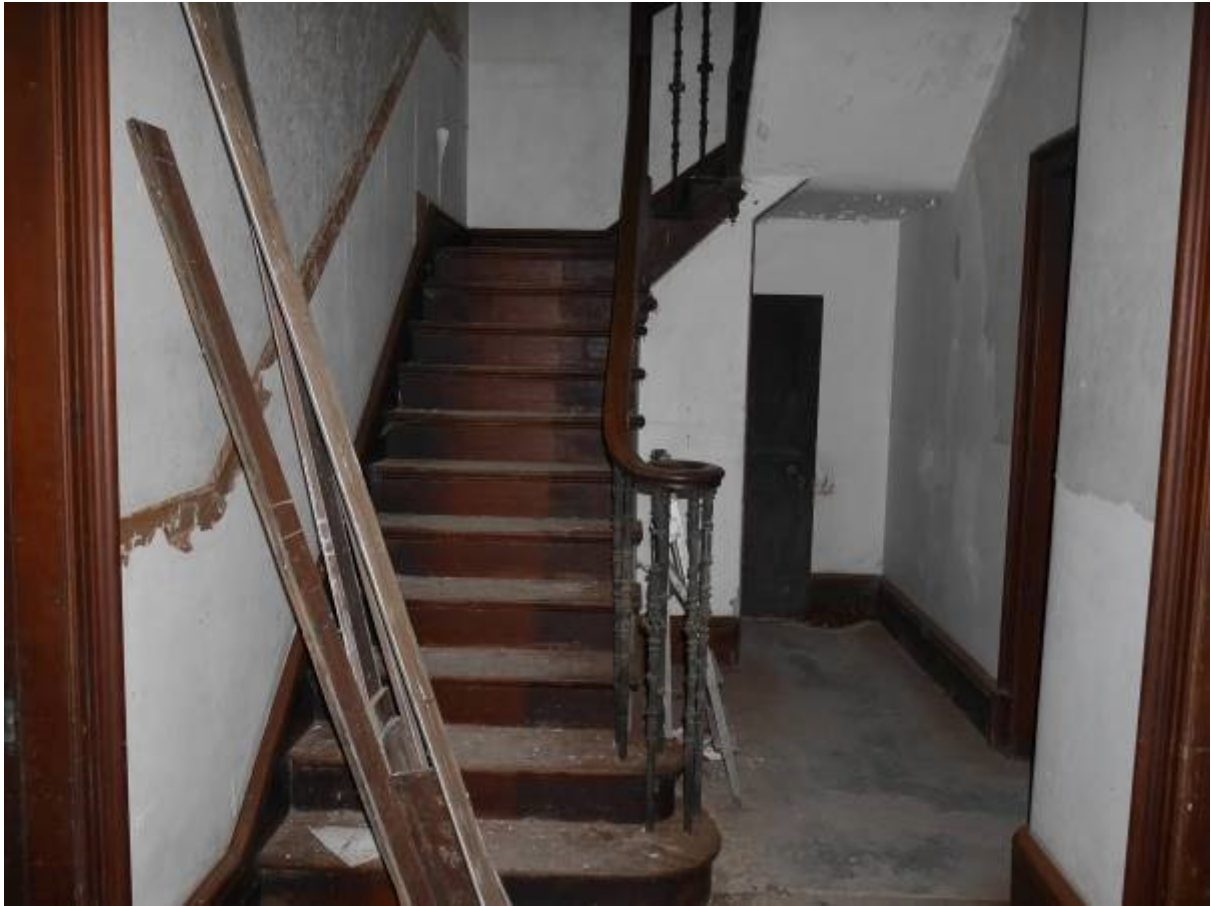
This has a wooden floor and contains the staircase to the first floor. There are doorways into the other rooms at this level and a small lobby for the main entrance into the building. It is painted white and has a plain moulding around the edge of the ceiling.

Illustration 19 - Building A ground floor lobby showing staircase to first floor

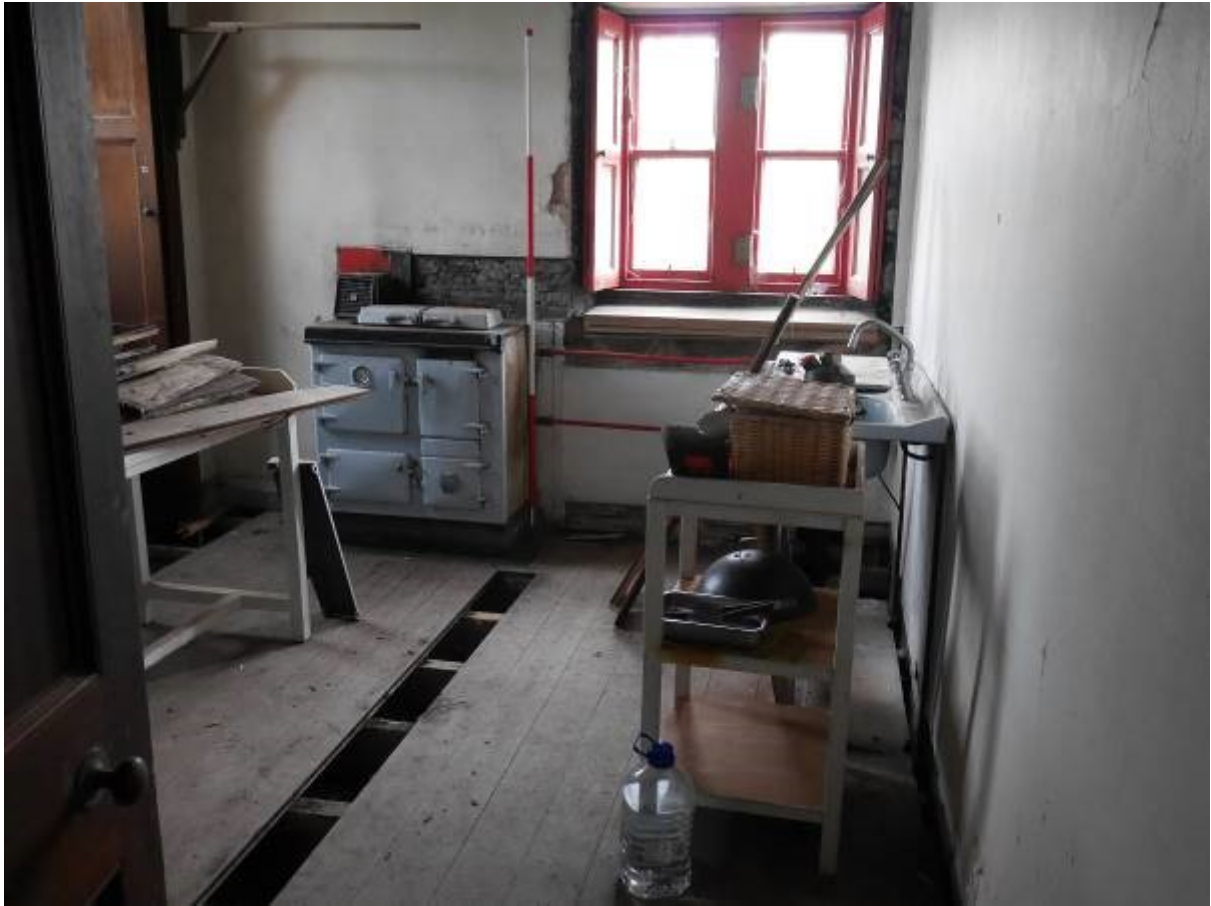
This has a single doorway in its Western wall and has a wooden floor. It contains an Aga stove and a sink. There are shuttered windows in its Northern and Eastern walls. Its walls are painted white and its ceiling is painted red. A plain moulding runs around the edge of the ceiling.

Illustration 20 - Building A Room 3 (Kitchen) looking East

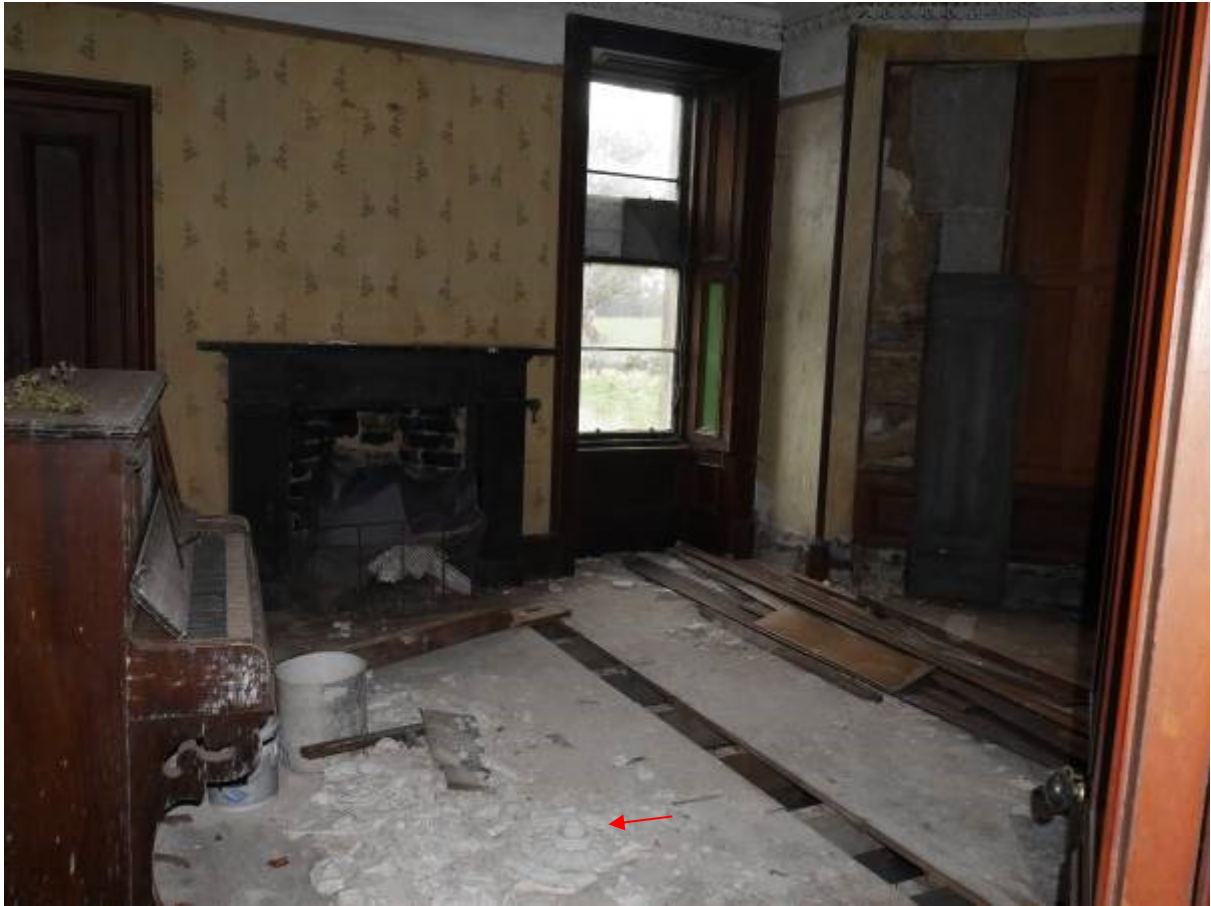
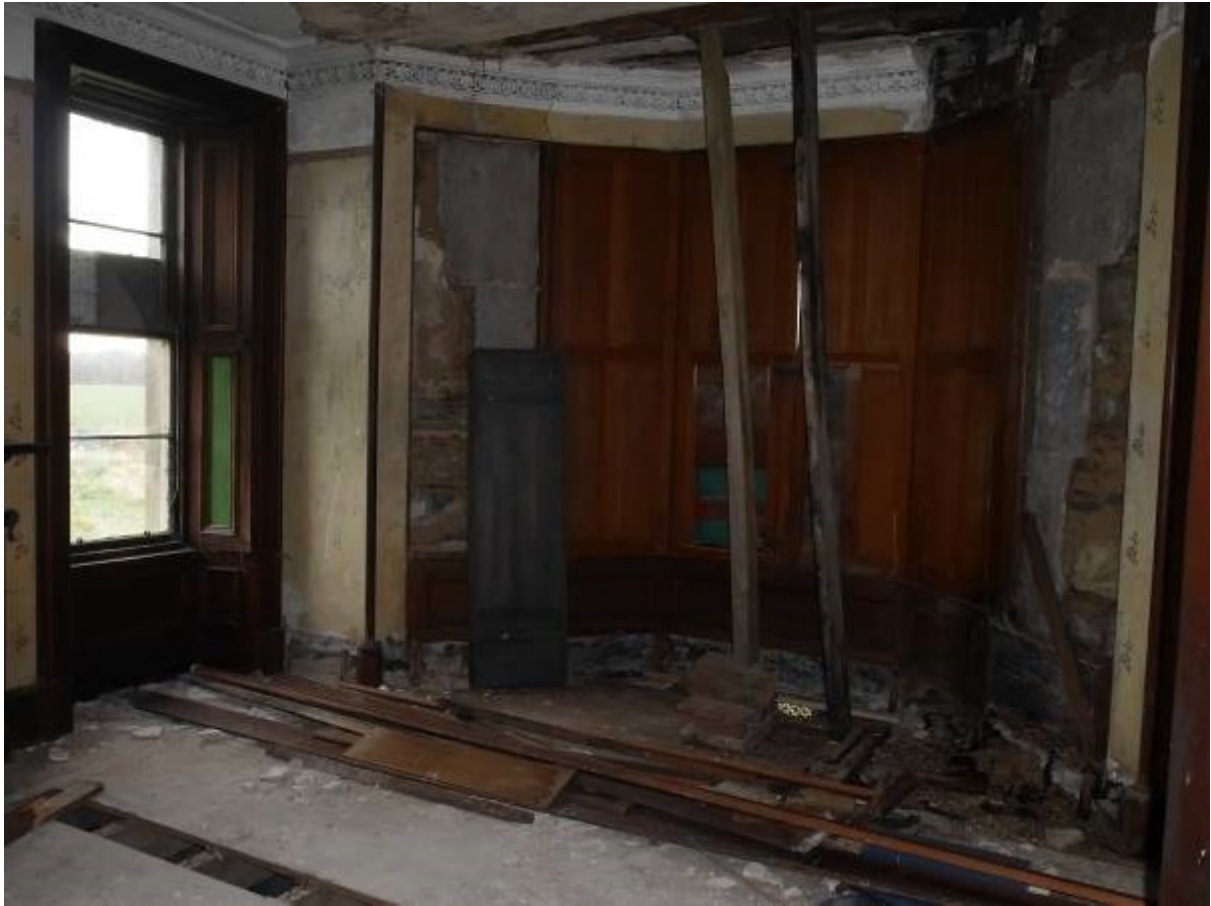
This has a wooden floor and a fireplace in its Eastern wall. The bay window in its Southern wall is shuttered and there is a shuttered window and a cupboard in its Eastern wall. An ornate floral moulding runs around the ceiling and there has been a central ornate moulding which now lies broken on the floor. The moulding runs around the top of the bay window suggesting that it may be a contemporary date. The room is wall papered with a yellow brown coloured pattern and the ceiling is painted white. The section of ceiling above the bay window is collapsing and is currently held up by wooden timbers supported on bricks.

Illustration 21 - Building A Room 4 (Eastern living room) looking East showing collapsed ceiling moulding on floor (red arrow)

Illustration 22 - Building A Room 4 looking South showing interior of bay window and decorative moulding around ceiling
