Standing Building Survey
Kirk O' The Muir manse,
Kinclaven, Perth and Kinross

8th April 2019

| TYPE(S) OF PROJECT: | Standing Building Record |

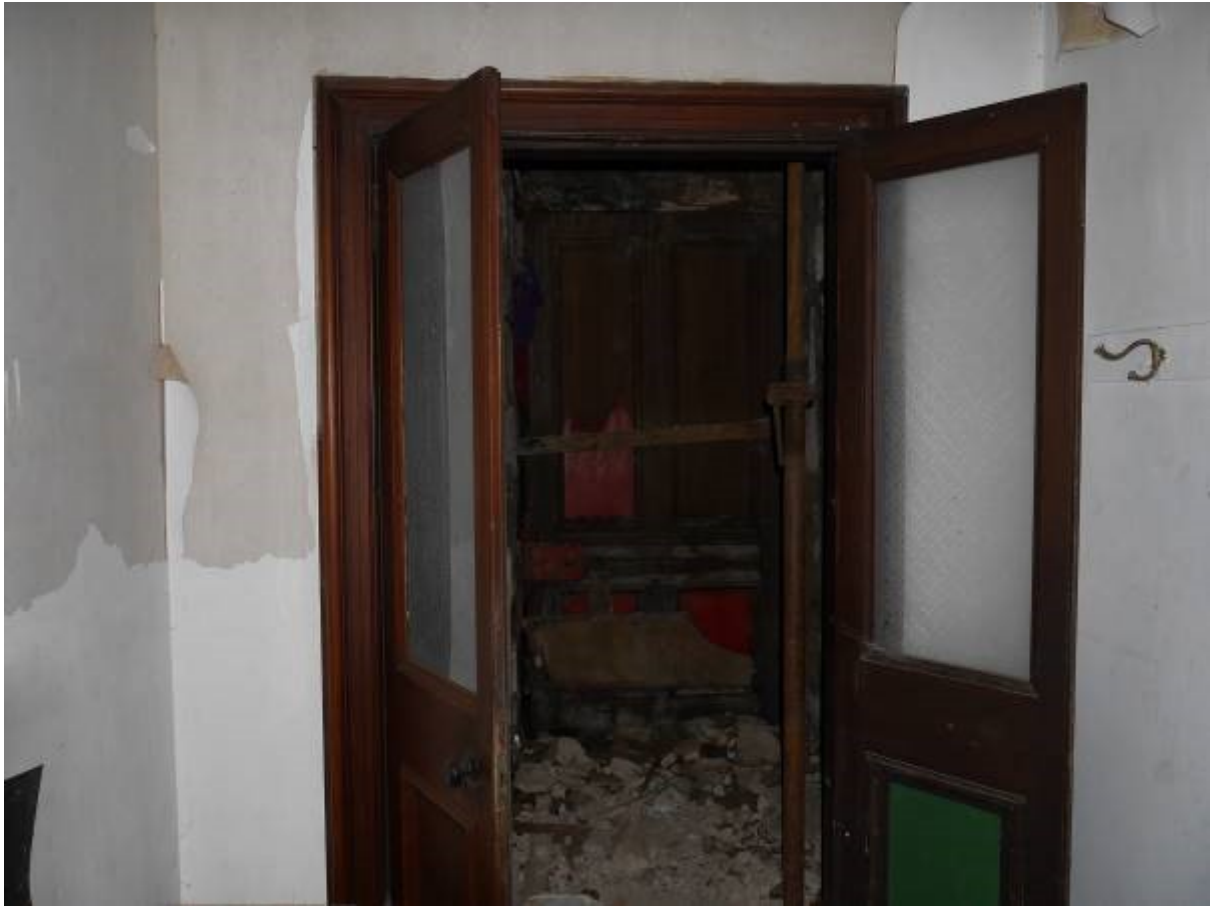
This is accessed from the lobby by double wooden doors with glazed panels. It was inaccessible due to the collapsing ceiling.

Illustration 23 - Building A small entrance lobby for main entrance looking South

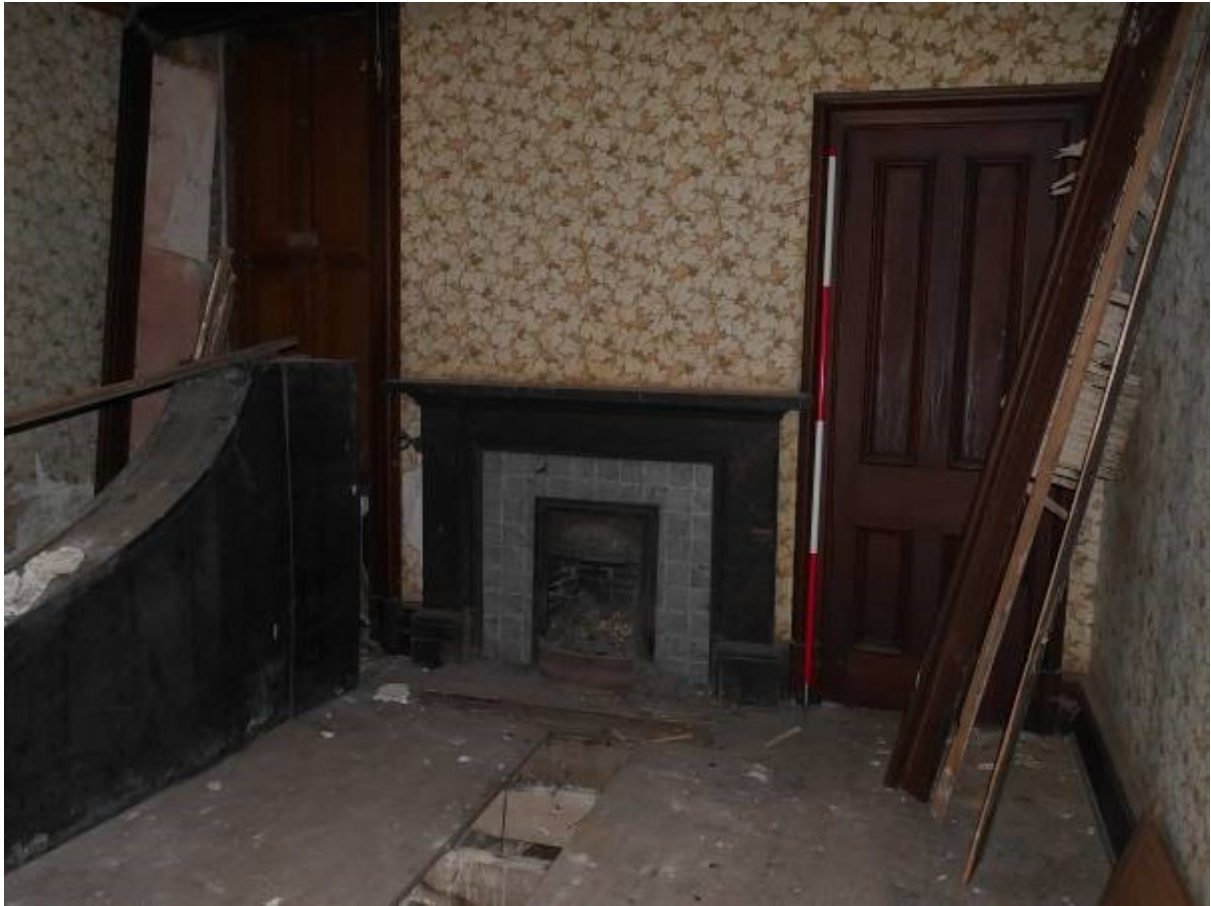
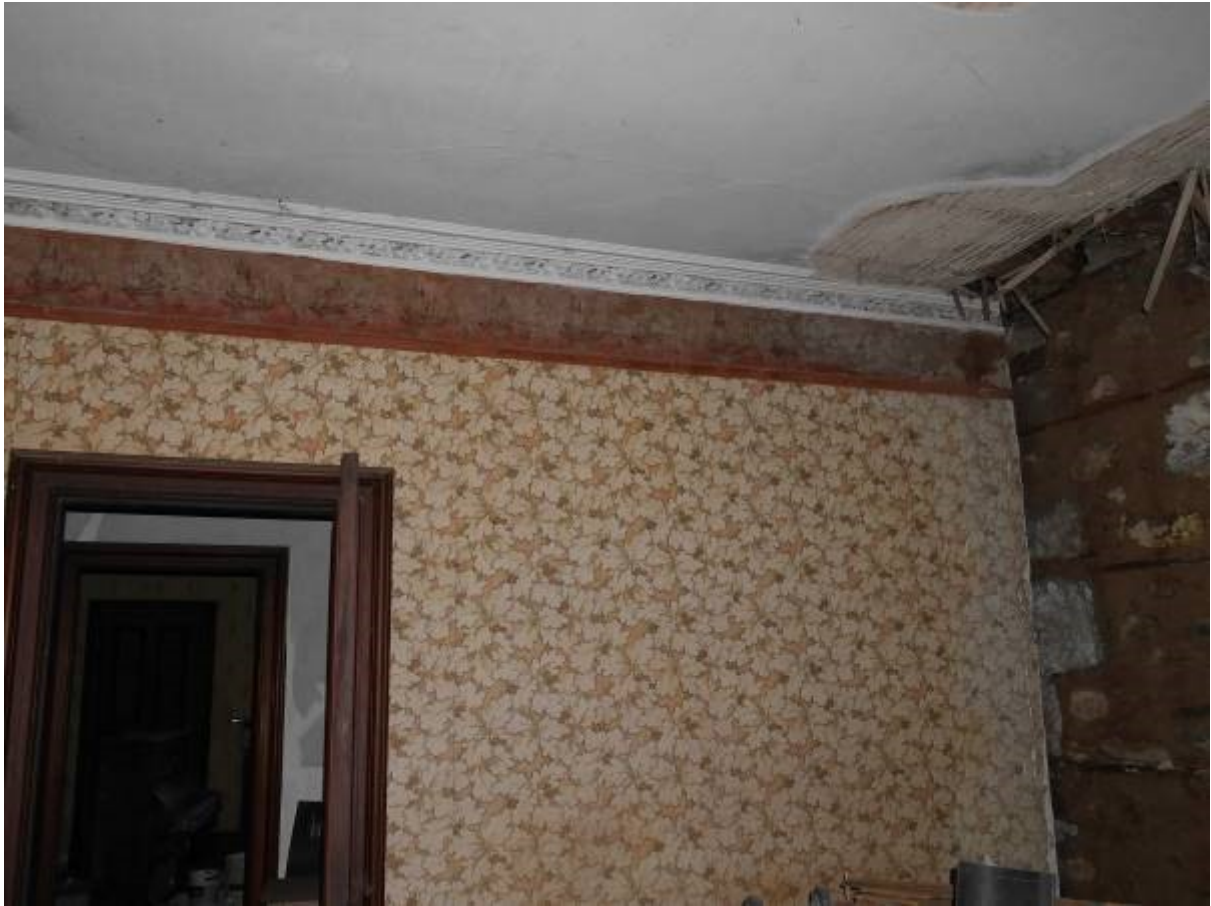
This has a wooden floor and a fireplace with a plain tiled surround and a cupboard in its western wall. There are shuttered windows in its Southern and Western walls. There is an ornate floral moulding running around the ceiling. It is wall papered on wooden panels, where the panelling has gone on the south wall wooden lath supports are visible in the wall. The wall paper comprises a light brown floral pattern with a decorative band running below the moulding around the ceiling that is coloured light red and shows nautical scenes.

Illustration 24 - Building A Room 5 (Western living room) showing fireplace and cupboard in Western wall

Illustration 25 - Building A Room 5 (Western living room) showing decorative moulding around ceiling and wall paper with decorative nautical frieze on Western wall

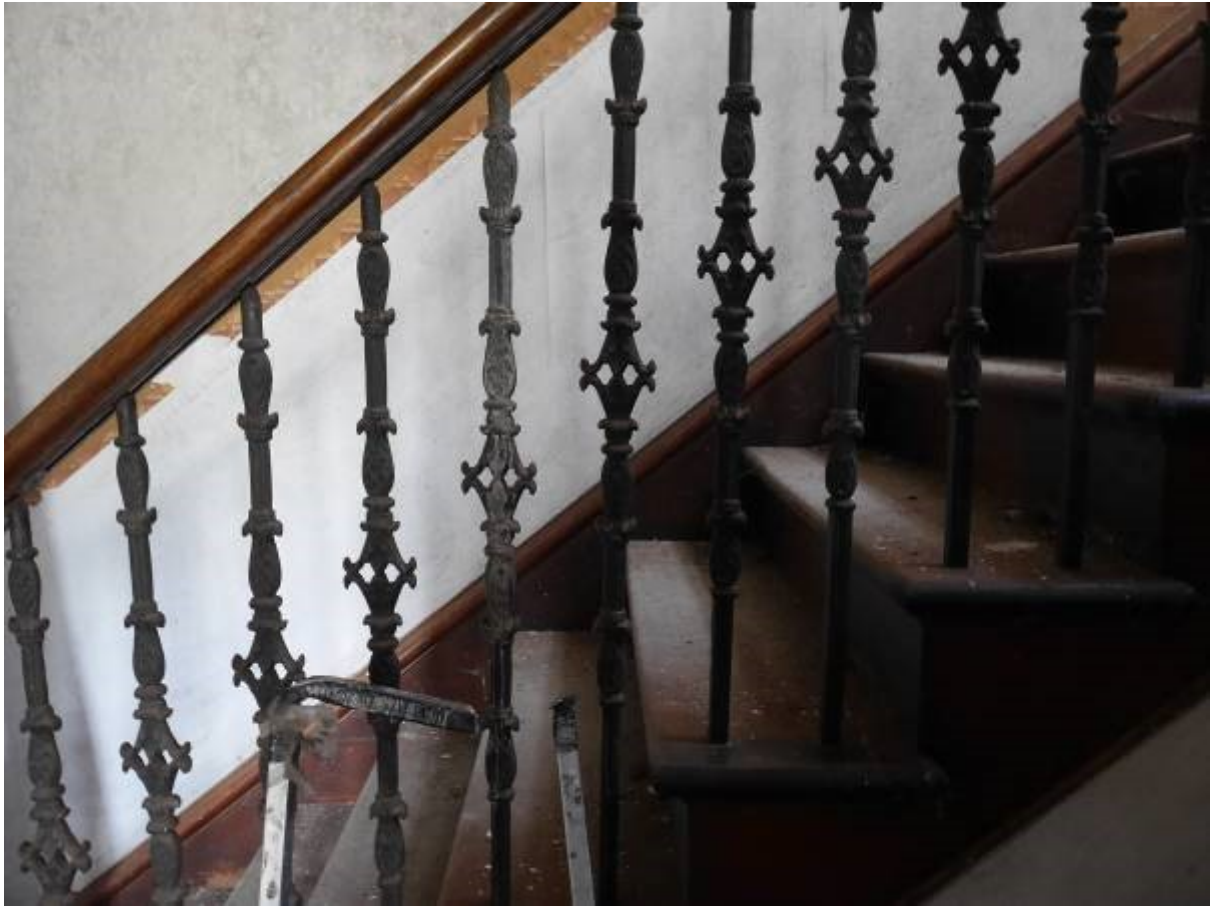
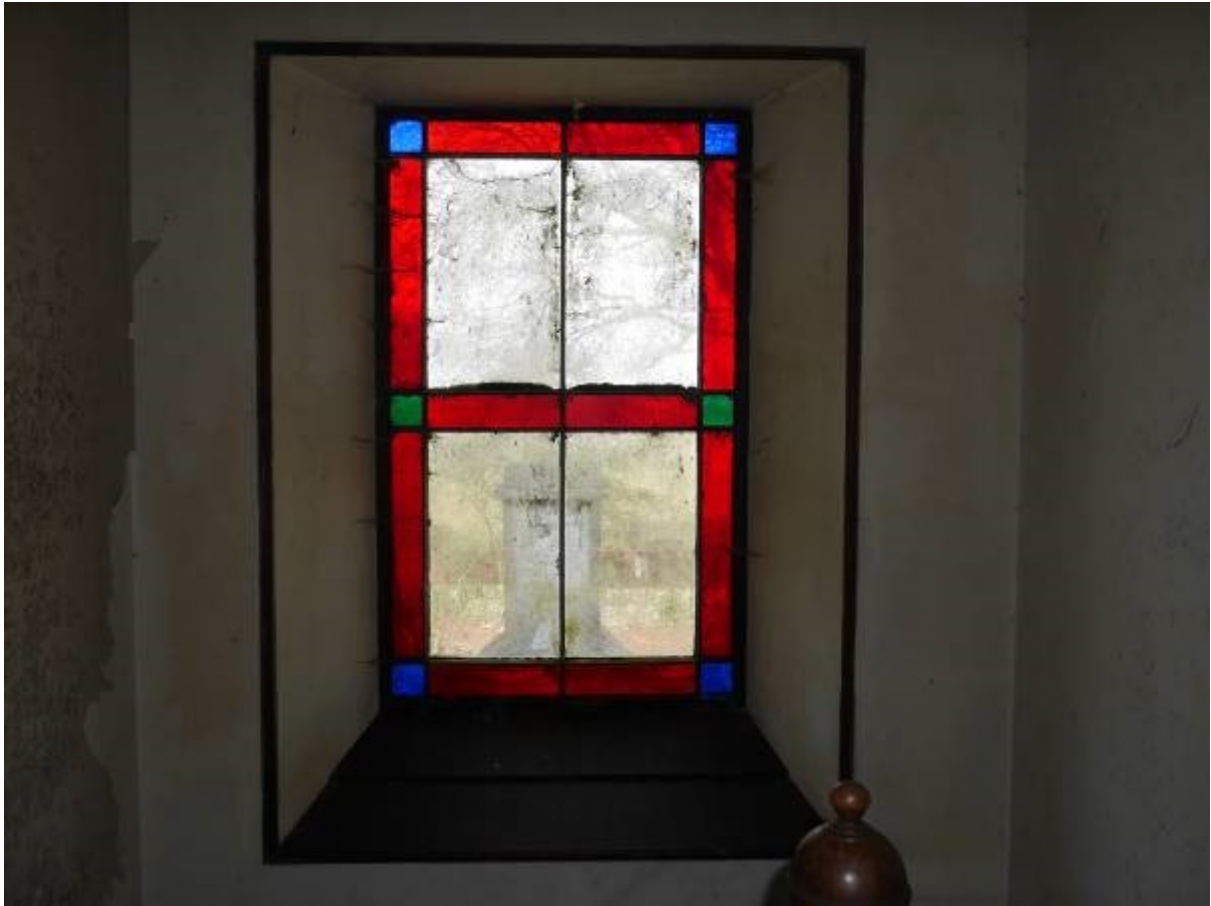
There are flights of wooden stairs to the first floor with cast iron decorated balustrades with wooden banisters. Half way up the stairs there is a large leaded glass window in the North wall which contains narrow panes of red, green and blue glass forming the surround to four plain panes.

Illustration 26 - Building A detail of decorated cast iron balustrade on staircase to first floor

Illustration 27 - Building A coloured leaded glass window half way up staircase to first floor

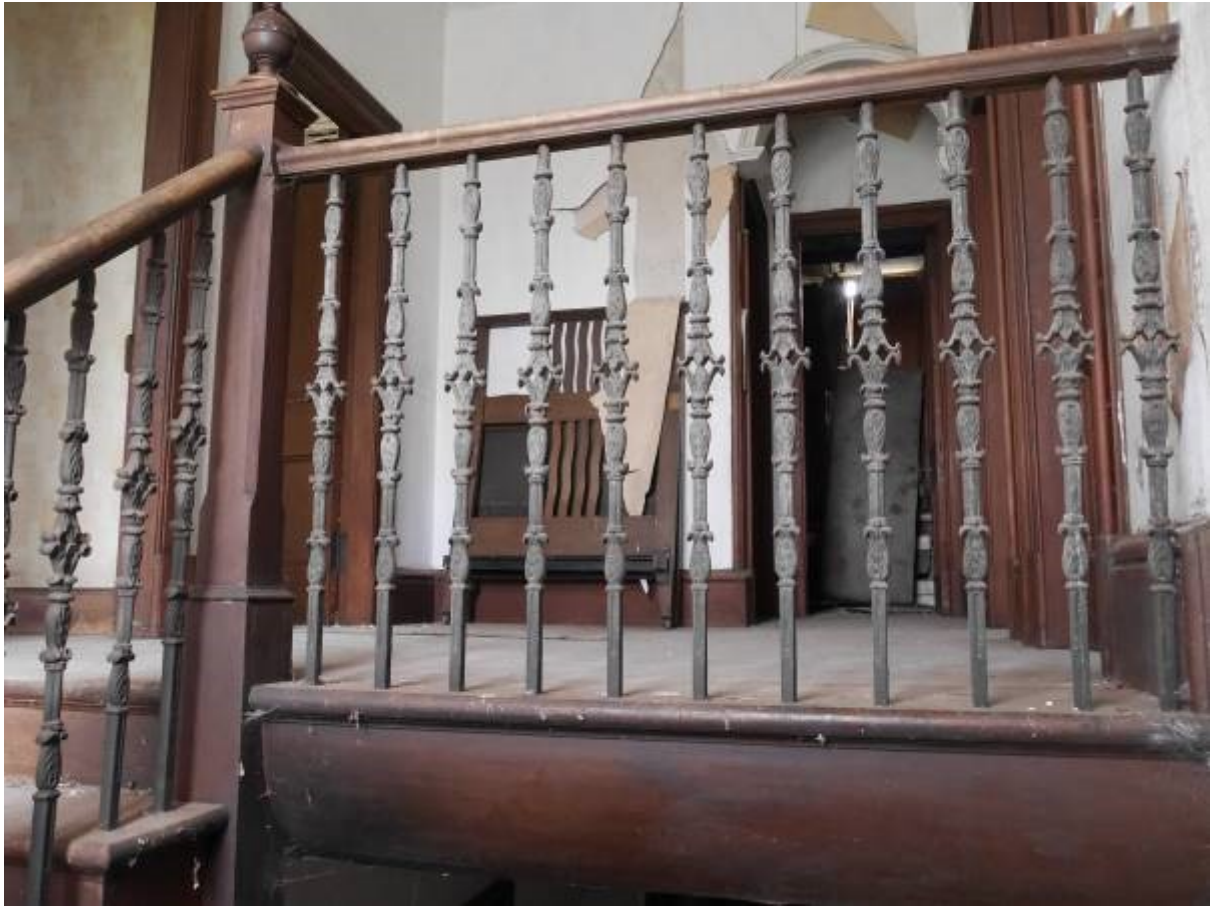
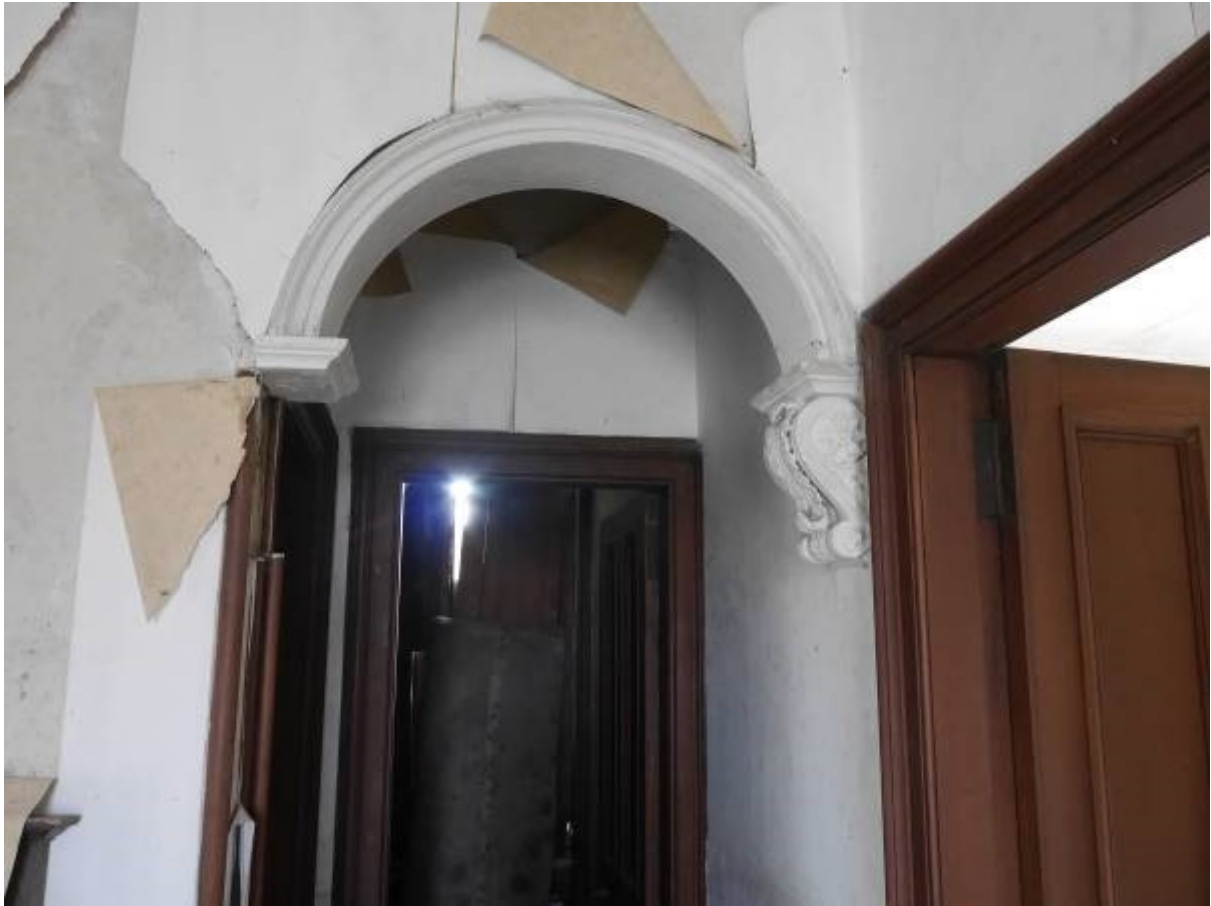
This provides access to the five upstairs rooms in the building. It has a plain moulding running along the ceiling and is painted white. The access to room 9 has an ornate arch at moulding level.

Illustration 28 - Building A Room 6 Upstairs landing

Illustration 29 - Building A upstairs landing showing ornate arch over access to inaccessible room 9

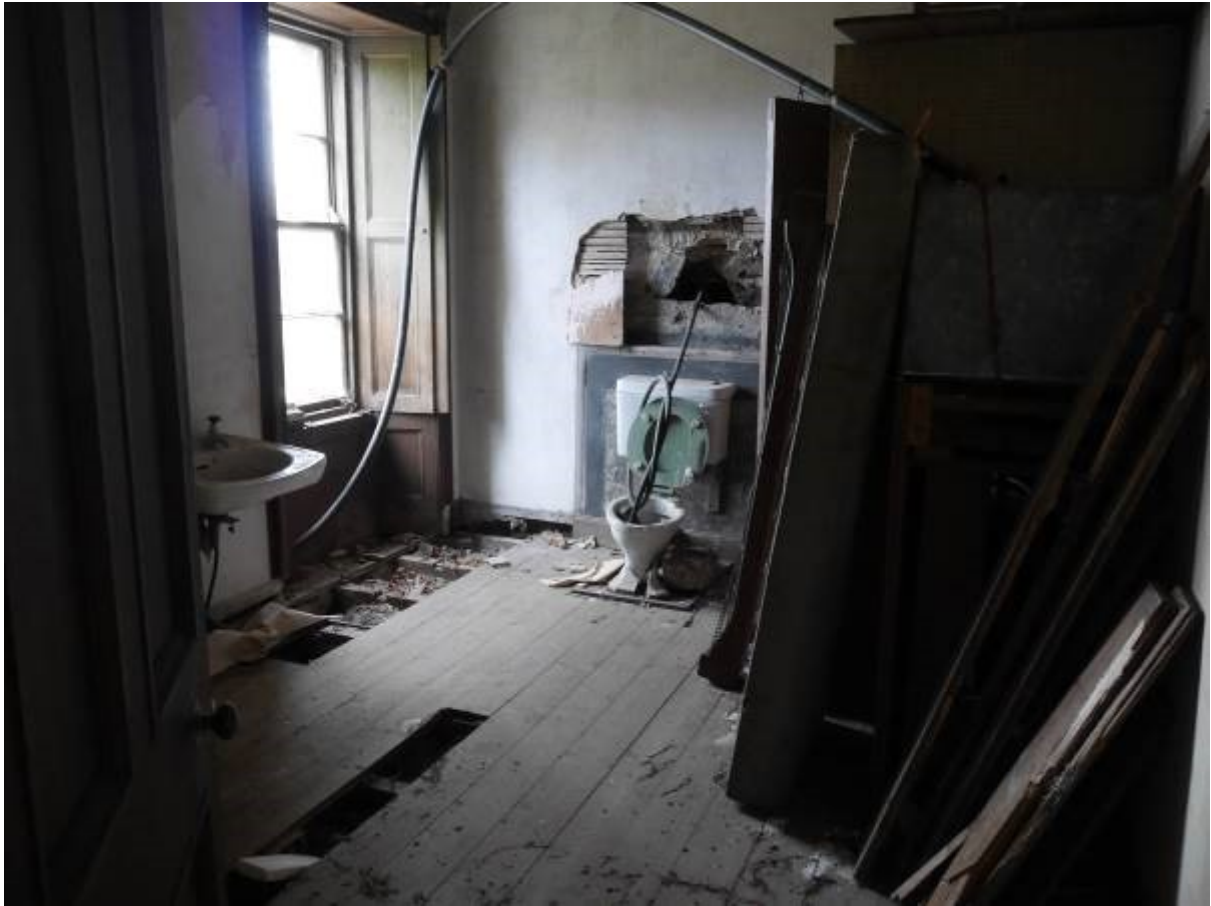
This has a single doorway in its Western wall and has a wooden floor. It contains a bath, a sink and a toilet. It is decorated with light brown wall paper on wooden lath supported panelling and has a plain moulding running around the ceiling.

Illustration 30 – Building A Room 7 (bathroom) showing shuttered window

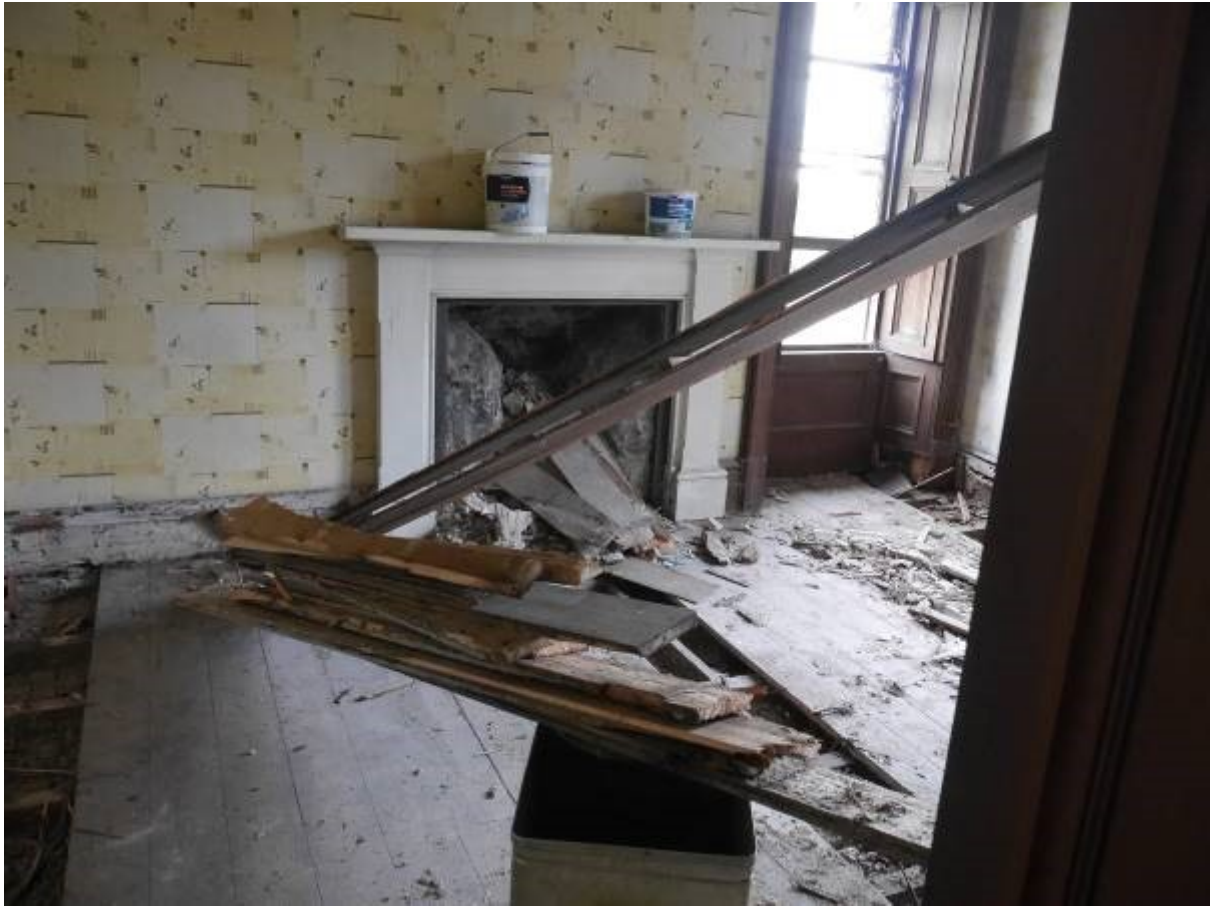
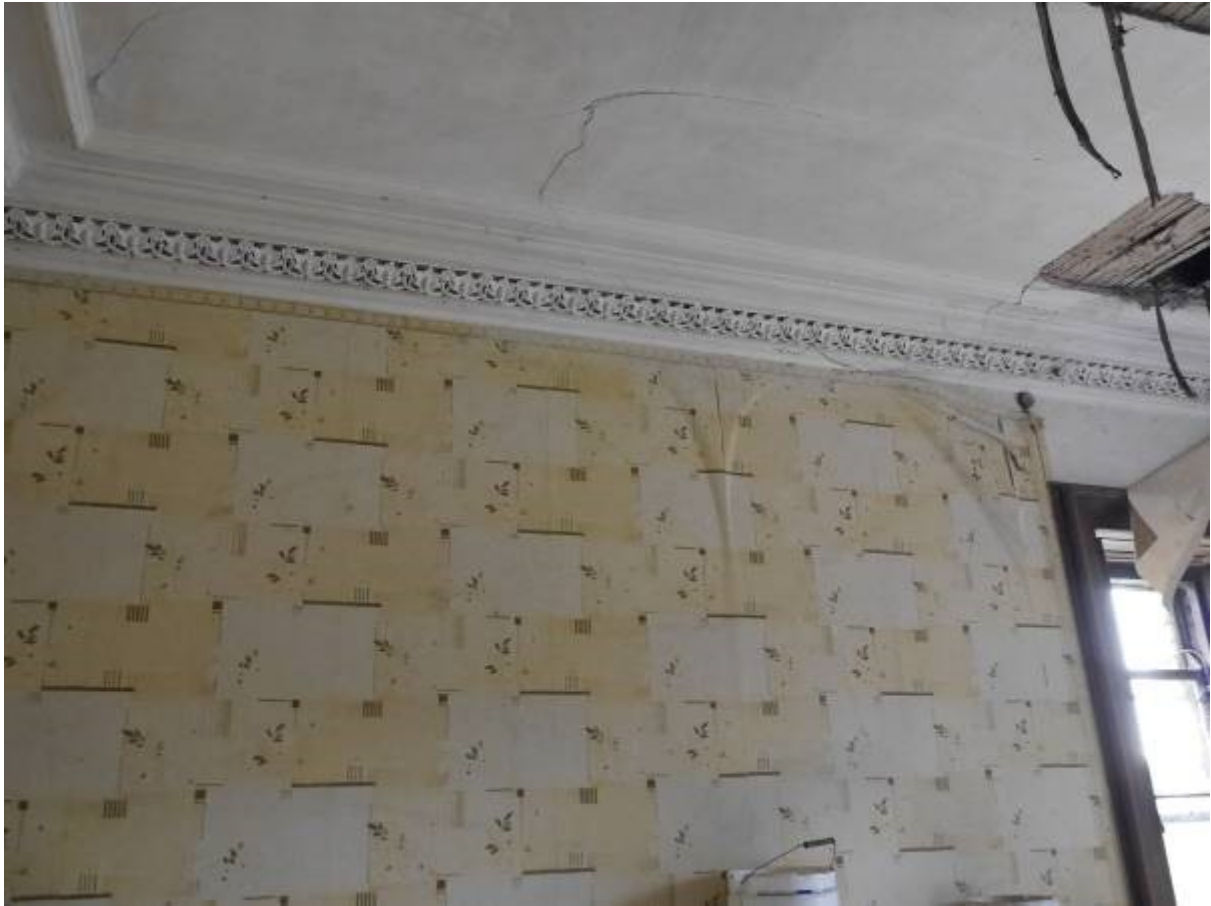
This has a single doorway in its Western wall and a wooden floor. There is a fireplace in its Eastern wall and there are shuttered windows in its Southern and Eastern walls. An ornate floral moulding runs around the ceiling. It is decorated with light yellow brown wall paper and contains uplifted floor boards leaning against the walls.

Illustration 31 - Building A Room 8 (Eastern bedroom) showing fireplace in East wall

Illustration 32 – Building A Room 8 (Eastern bedroom) showing ornate moulding around ceiling

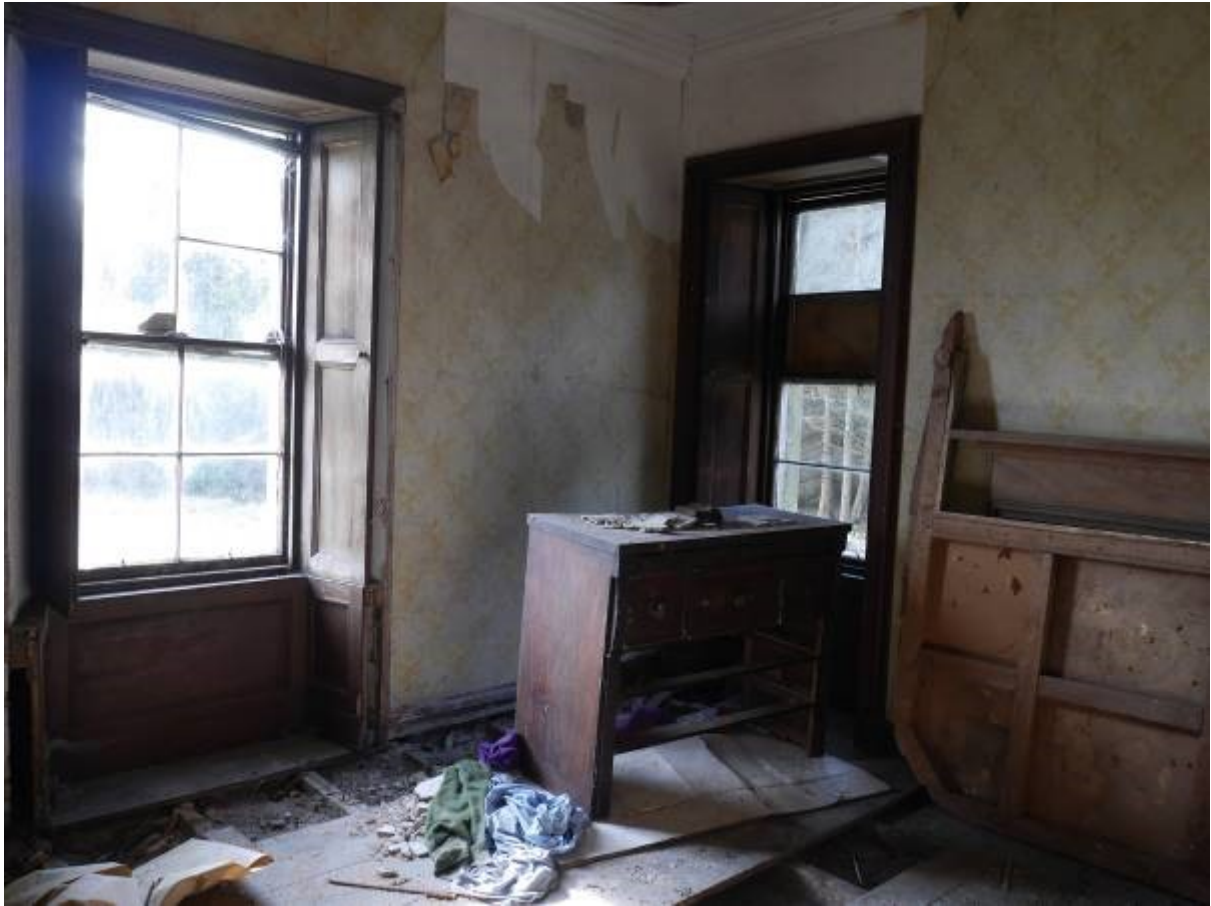
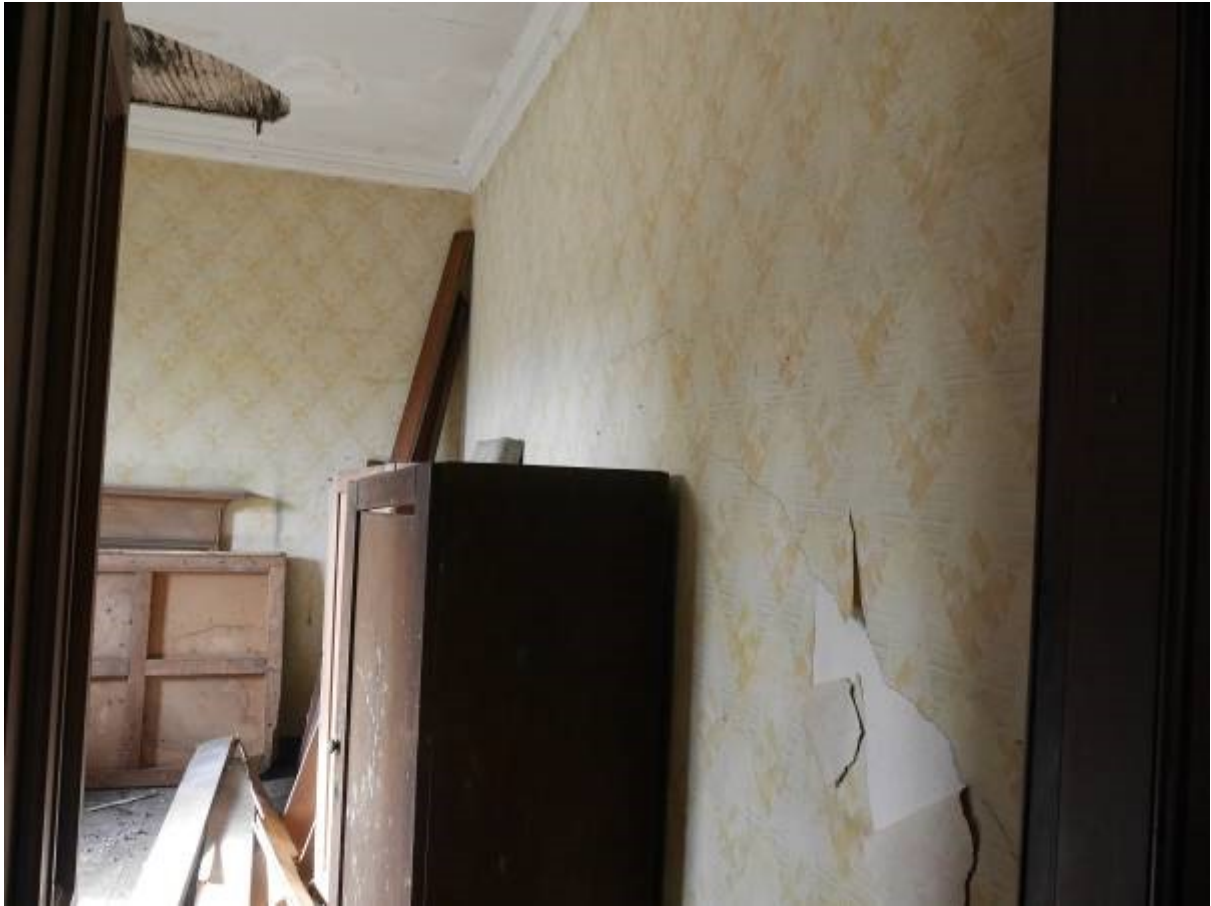
This has a single doorway in its Eastern wall and has a wooden floor. There are shuttered windows in its Southern and Western walls and a fireplace in its Western wall. It is decorated with light brown wall paper and has a plain moulding running around the ceiling.

Illustration 33 - Building A Room 10 (Western bedroom) showing shuttered windows

Illustration 34 - Building A Room 10 (Western bedroom) showing wallpaper and plain moulding, top of fireplace visible behind board against Western wall

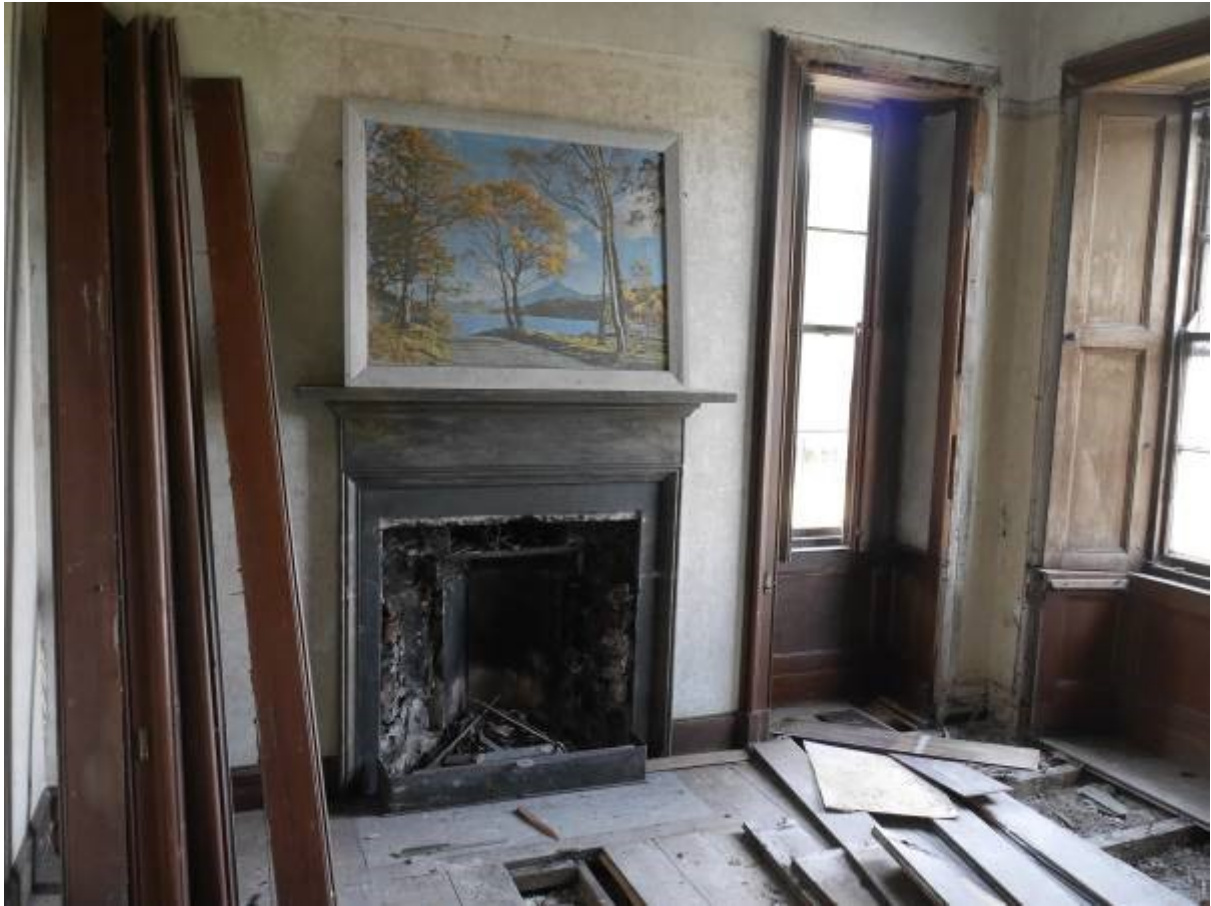
This has a single doorway in its eastern wall and a wooden floor. It has a fireplace in its Western wall with a landscape painting standing on it and shuttered windows in its Northern and Western walls. It is decorated with light brown wall paper and has a plain moulding running around the ceiling.

Illustration 35 - Building A Room 11 (Back bedroom) showing fireplace in Western wall and shuttered windows

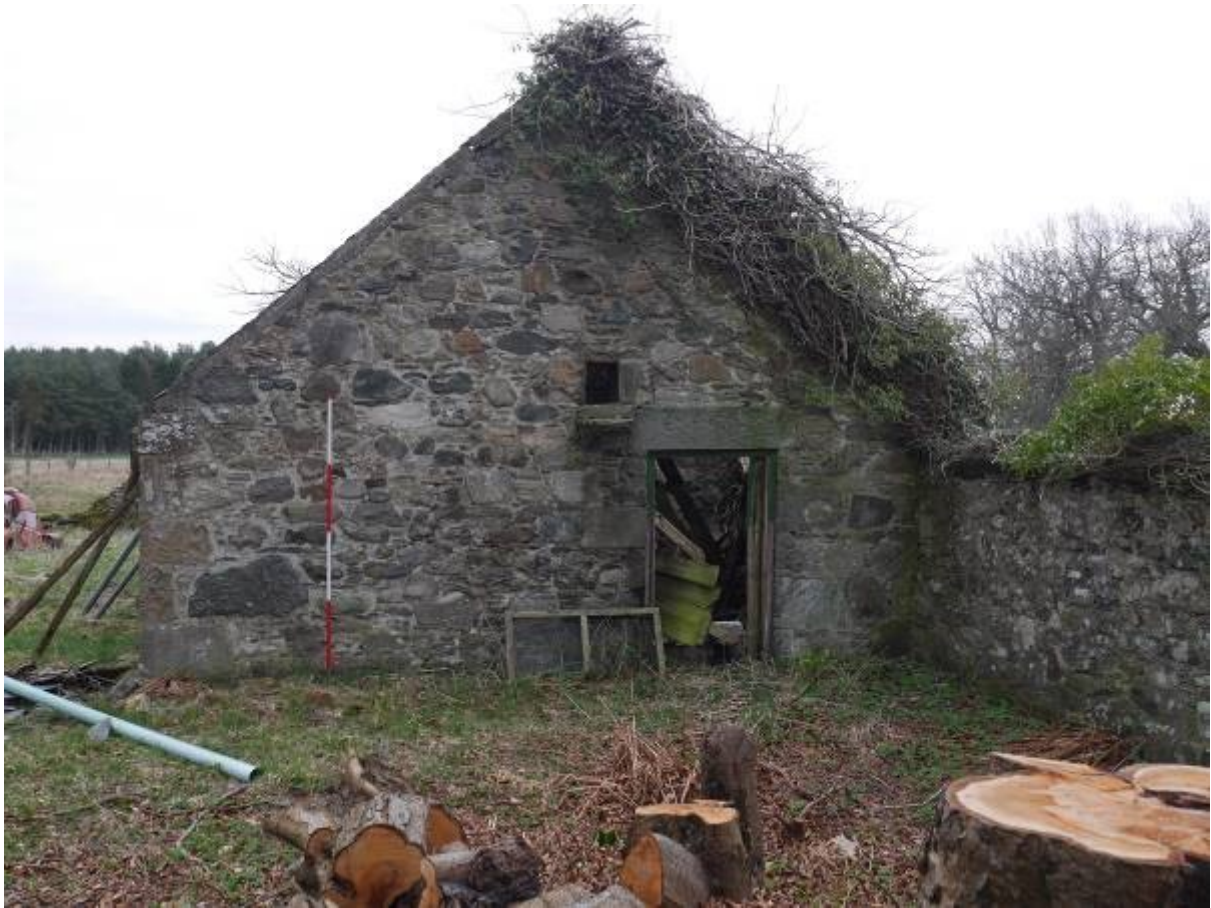
This gable end is built of mortared rough stone with shaped ashlar quoins at its Northern corner. It contains a single doorway with a stone lintel and a small rectangular hole with a projecting stone ledge which sits just above the doorway (bird hole?).

Illustration 36 - Building B Photograph and sketch section of Western elevation of building B showing doorway and bird hole? In wall face

Building B may have originally had a small dovecote at its Western end, the presence of the access hole and associated ledge suggests this. The major room in Building B may have been a small animal byre. Building C would appear to be a small garden shed.

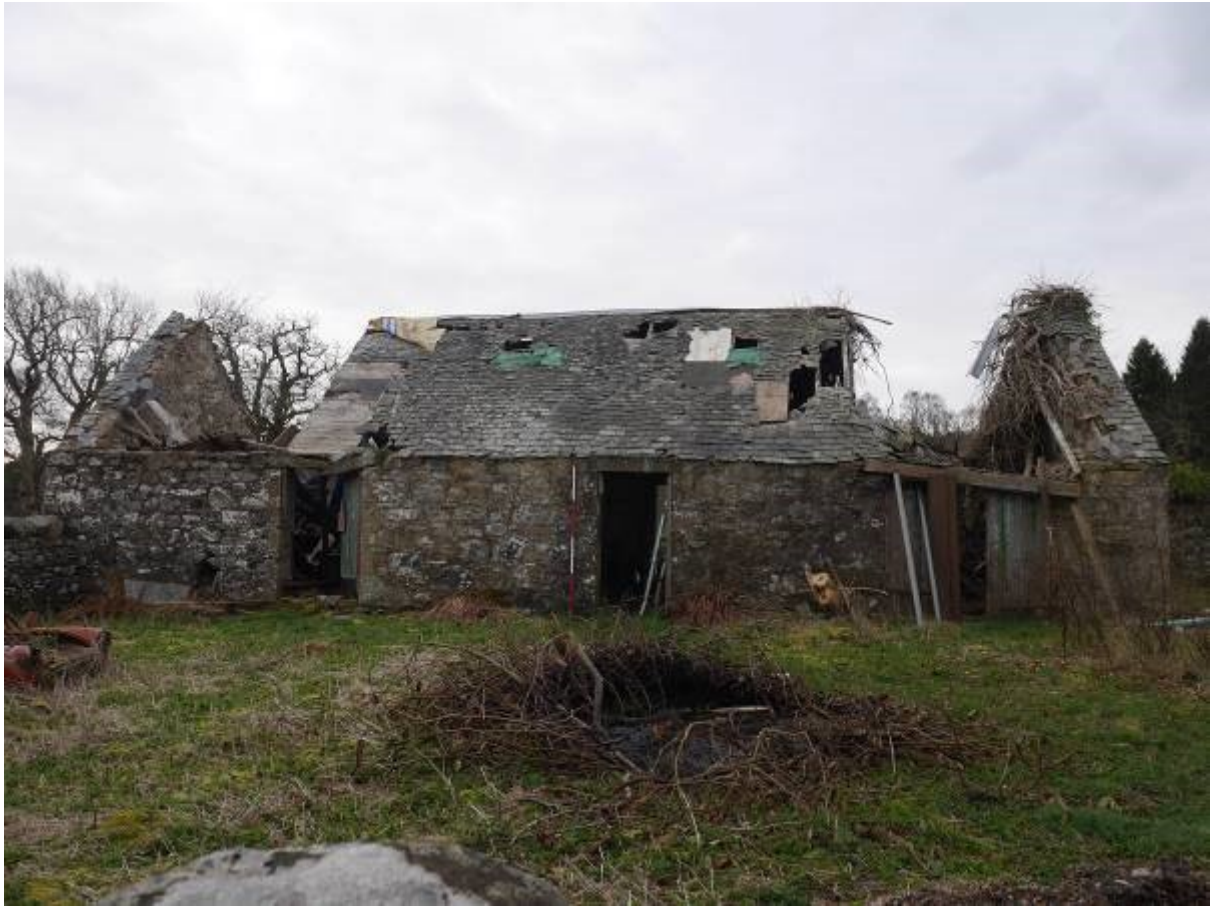
This is built of mortared rough stone with shaped ashlar quoins at its corners. It contains three doorways providing access to the three rooms inside the building, two of these have no surviving doors the third has a collapsing wooden door.

Illustration 37 - Building B Northern elevation

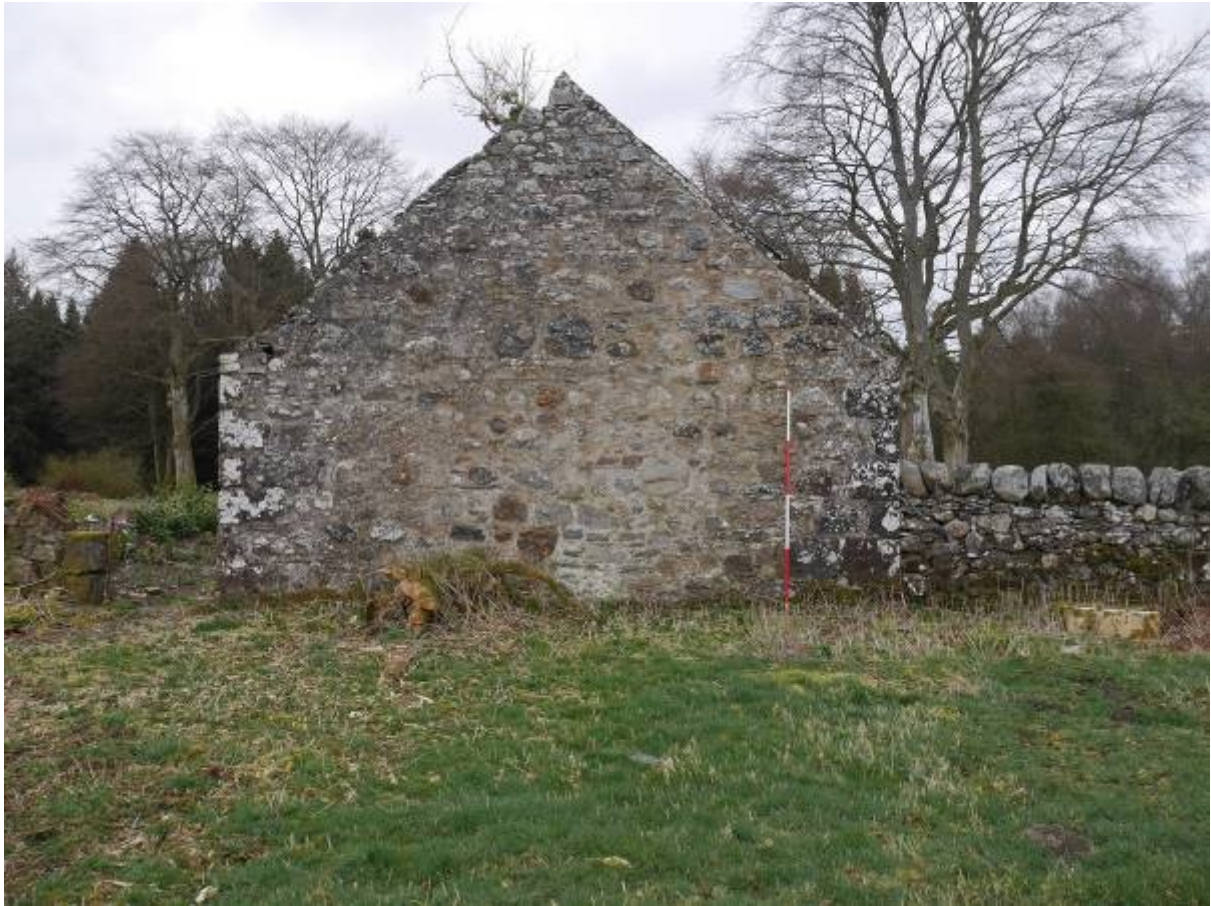
This gable end is built of mortared rough stone and is a blank wall face with shaped ashlar quoins at its corners.

Illustration 38 - Building B Eastern elevation

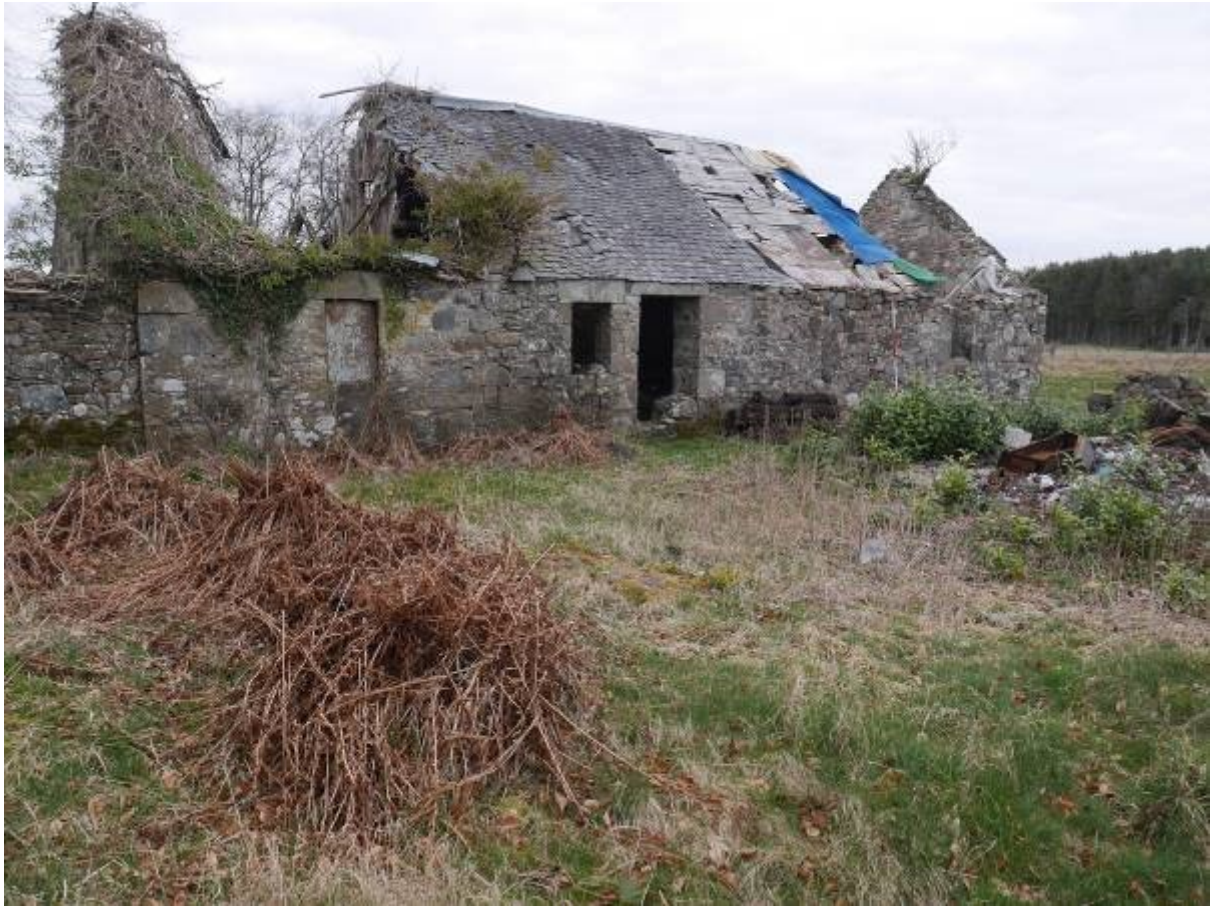
This is built of mortared rough stone with cut ashlar quoins at its corners and contains one doorway and three windows, one of these is blocked with a metal sheet. There is a visible straight joint between the garden wall and Building B at the Western end of this elevation.

Illustration 39 - Building B Southern elevation showing visible straight joint with garden wall

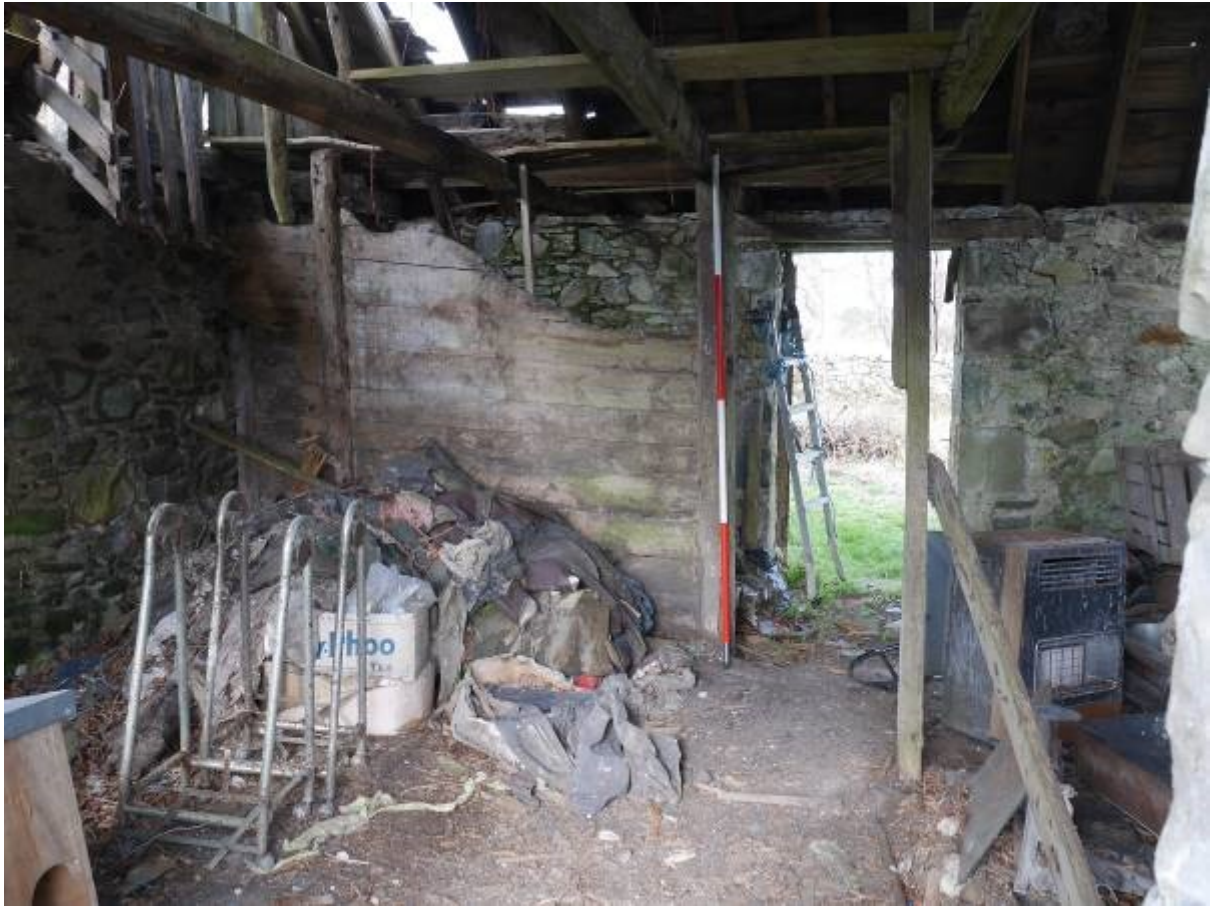
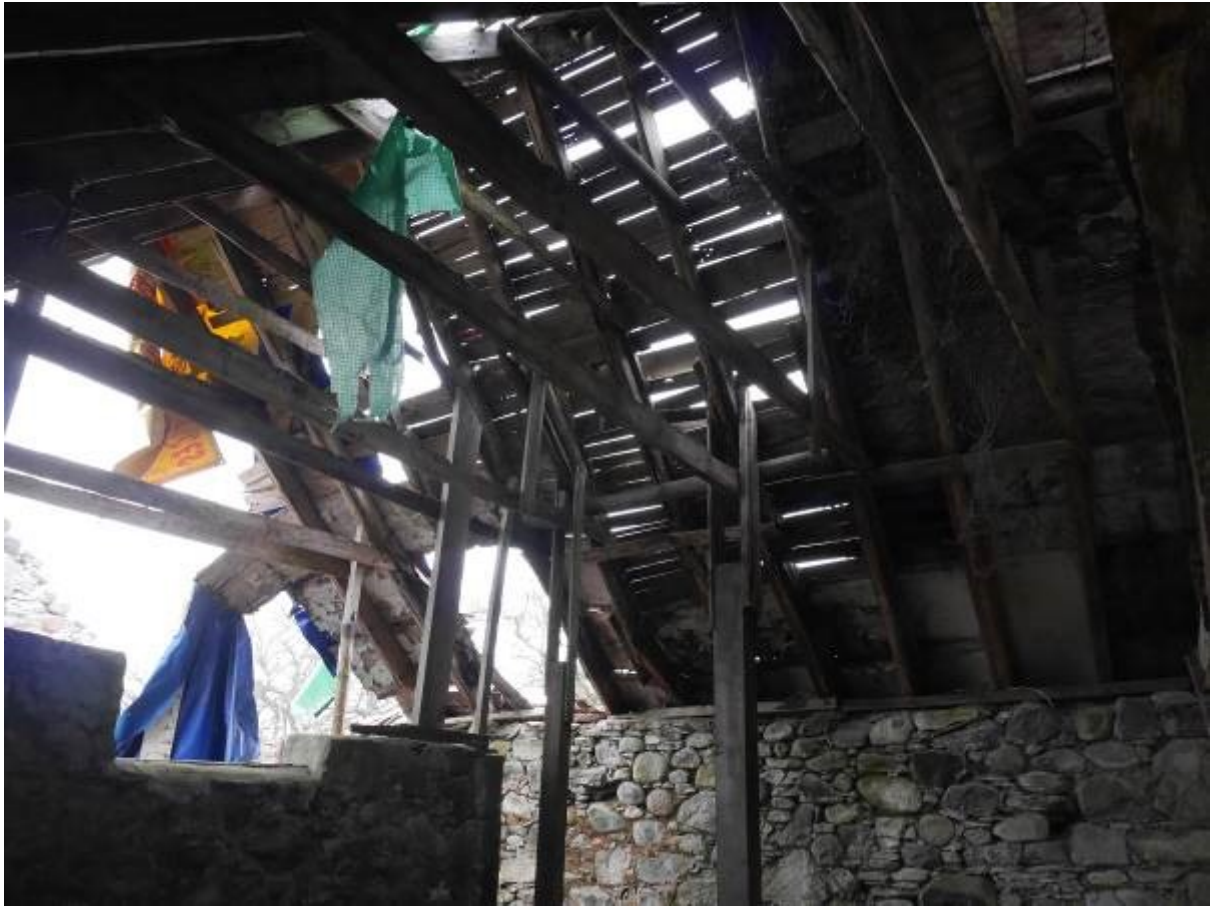
Building B is split into three rooms and has an earthen floor and a surviving central section of a wooden roof to support the slate roof. The room at its western end is now full of collapsed roofing and not accessible, the central room contains a small animal pen and is now used for storage the room at its eastern end is also full of collapsed roofing and not accessible.

Illustration 40 - Building B main room showing possible animal pen

Illustration 41 - Building B internal view of surviving section of wooden roof supports for slate roof
