Standing Building Survey
Kirk O' The Muir manse,
Kinclaven, Perth and Kinross

8th April 2019

| TYPE(S) OF PROJECT: | Standing Building Record |

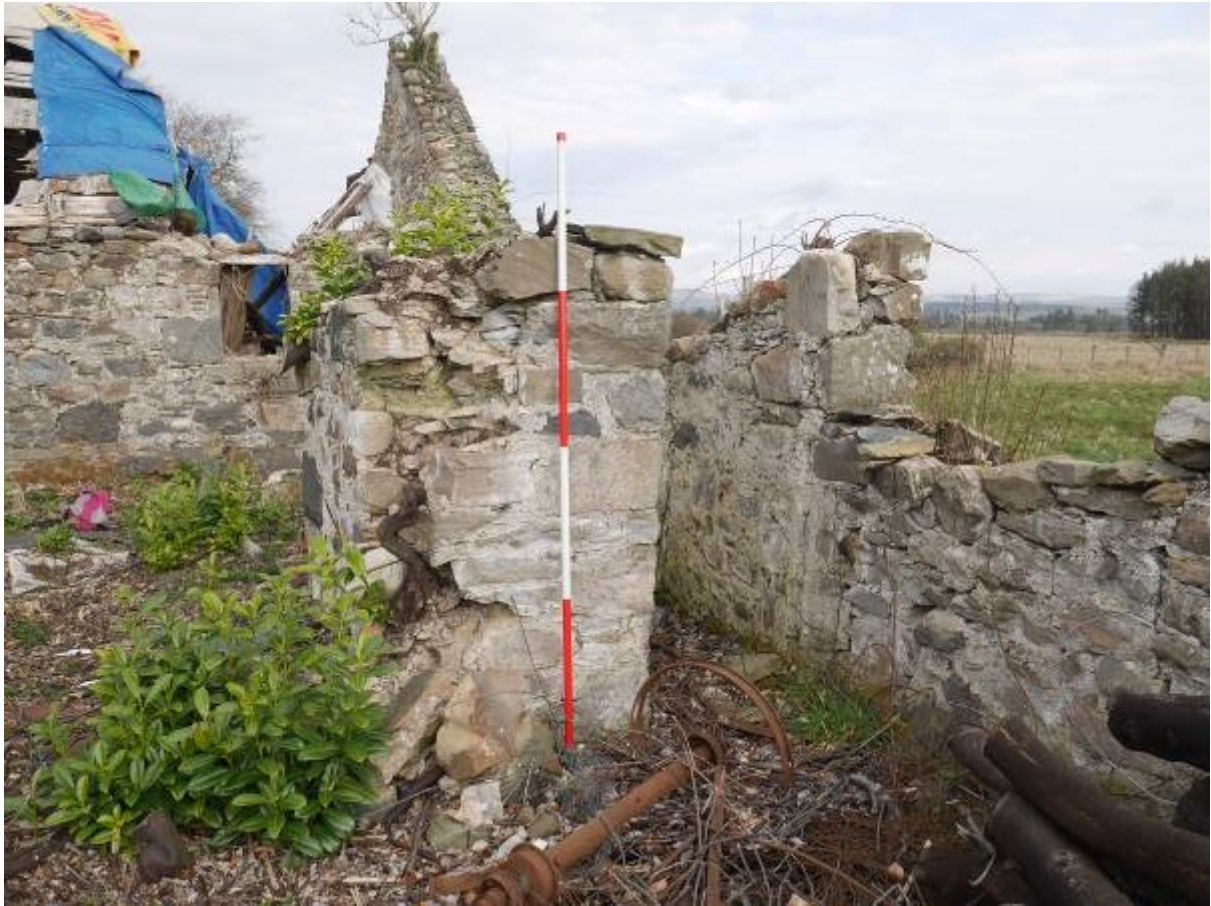
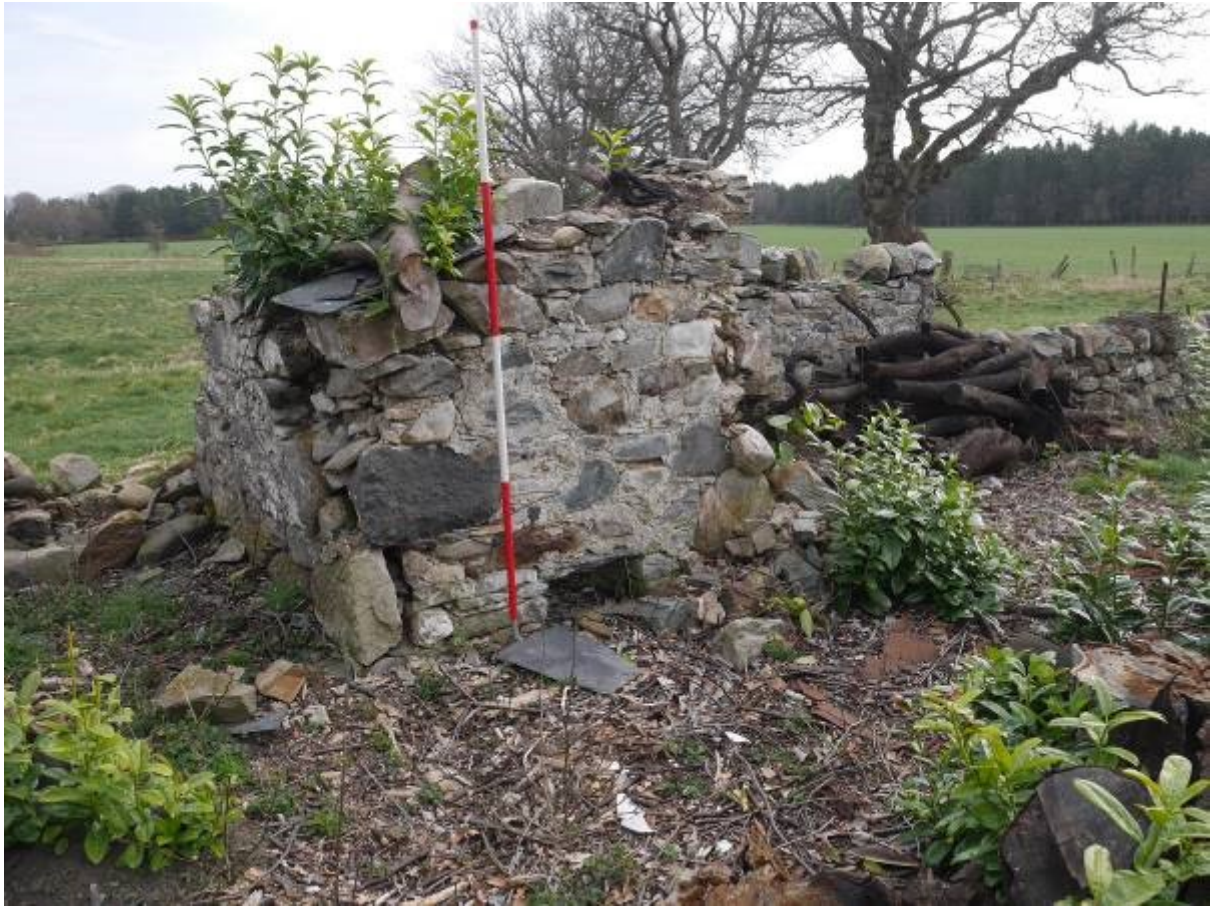
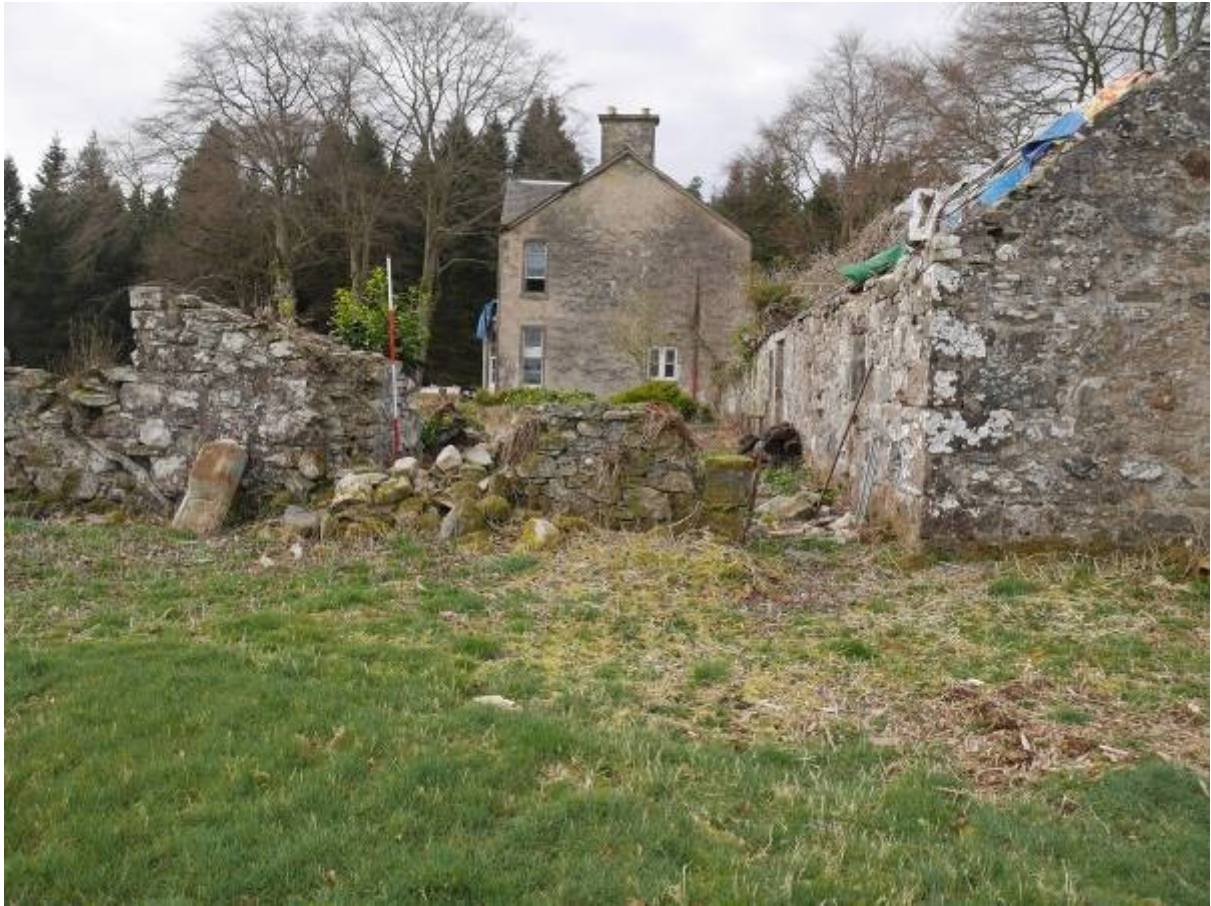
This small building is built of mortar bonded rough stones is now unroofed but has a pitched roof line which slopes to the North. It has a doorway in its Southern wall and hole at a low level in its Western wall.

Illustration 42 - Building C Southern elevation

Illustration 43 - Building C Western elevation showing ventilation hole at base of wall

Illustration 44 - Buildings B and C looking West with Building A in background
