Standing Building Survey
Barnhill Tollhouse,
Perth, Perth and Kinross

17th April 2019

Introduction

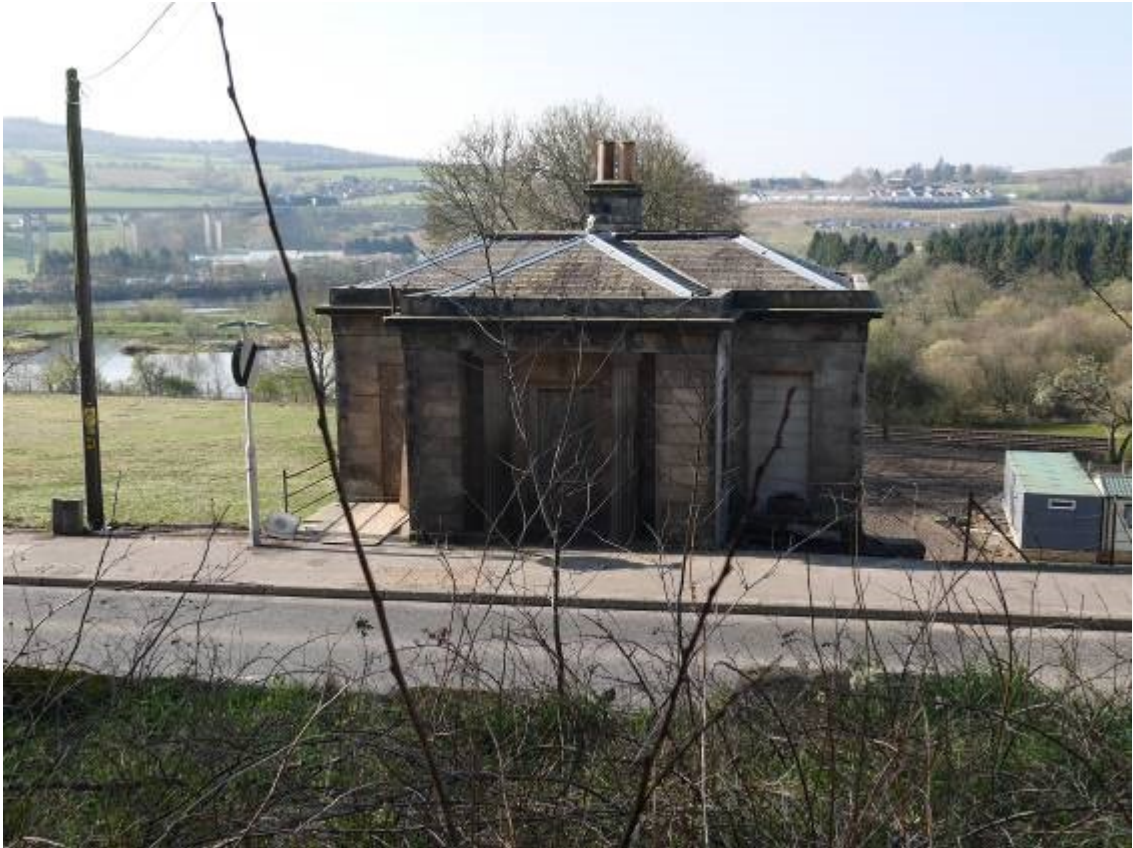
Barnhill Tollhouse looking South East (Friarton bridge visible in background)

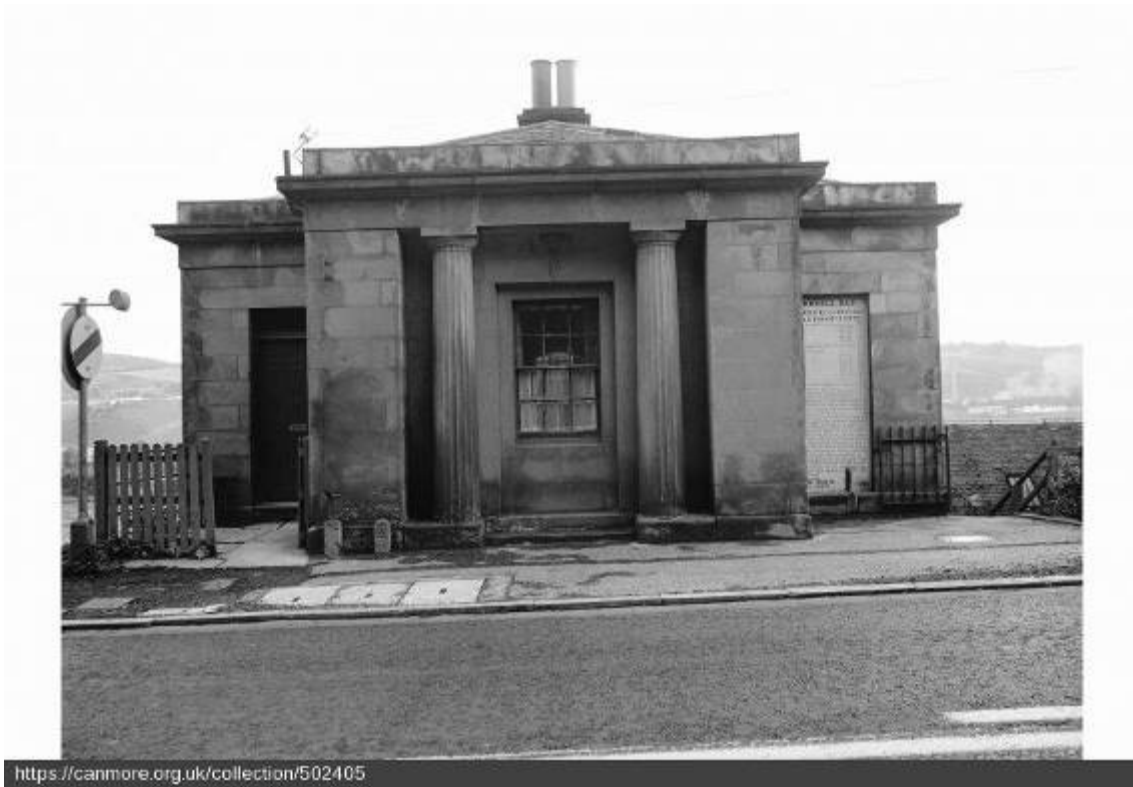
Illustration 4 – Tollhouse in 1976 with table of dues still in place in alcove on right and front window glazed (© HES photograph by J R Hume)

It has been suggested, based on the Greek Doric design of the building, that the tollhouse at Barnhill was probably built early in the 19th century at the behest of Lord Gray of Kinfauns who championed a similar architectural scheme for Perth's Sheriff Court on Tay Street (Haynes 2000, 45). In the Valuation Roll of 1855 'The Carse of Gowrie Road trustees per Tho Duncan Writer Treasurer' are listed as the proprietor and the tenant is 'James McFald Toll Collector' (Valuation Rolls Perth Burgh 1855). Until the removal of the Turnpike road scheme in Scotland in 1878 such tollhouses were common sights in Scottish towns allowing for the charging of tolls on entry to the town boundaries (Roads and Bridges Act (Scotland) 1878). Toll houses also stood on the Edinburgh and Glasgow Roads into Perth and on Smeaton's Bridge at Bridgend. Barnhill tollhouse is mapped on the First Edition Ordnance Survey map of 1859-60 and Easter Cottage (now demolished) once stood on its South Western side, Barnhill tollhouse was still occupied in the mid 1970's (Illustration 4).

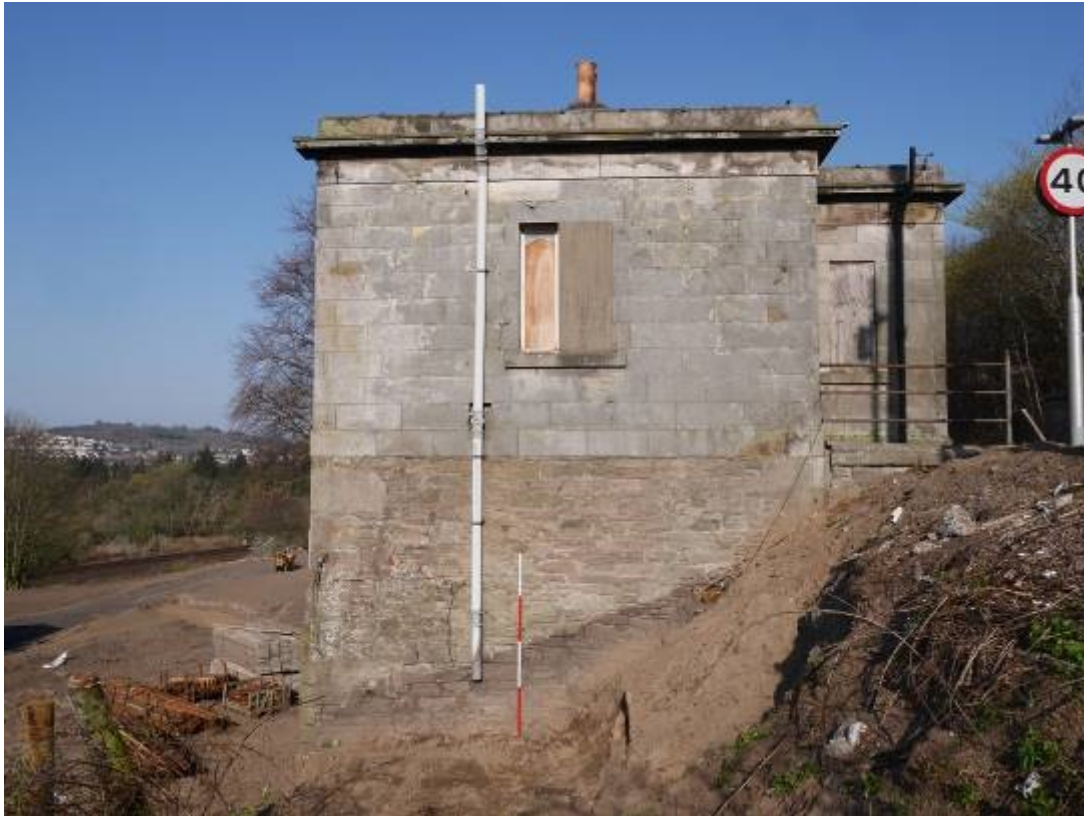
Illustration 5 – South Eastern elevation of tollhouse Scale 1:50 (drawing supplied by architect)

This is built of twelve courses of tightly fitted mortared cut green sandstone blocks with a parapet at roof line with a further single course of cut green sandstone blocks above. The cut green sandstone block coursing sits on shaped mortared sandstone blocks to the base of the foundation and there are shaped quoins at the South Eastern corner. There is a single window half blocked with a stone slab on its Eastern side, the other half contains a broken glazed window filled with a wooden board. The Eastern end of this elevation is set back to form part of the front portico of the building and is built of twelve courses of cut green sandstone blocks to road level. There is a single window blocked with wood.

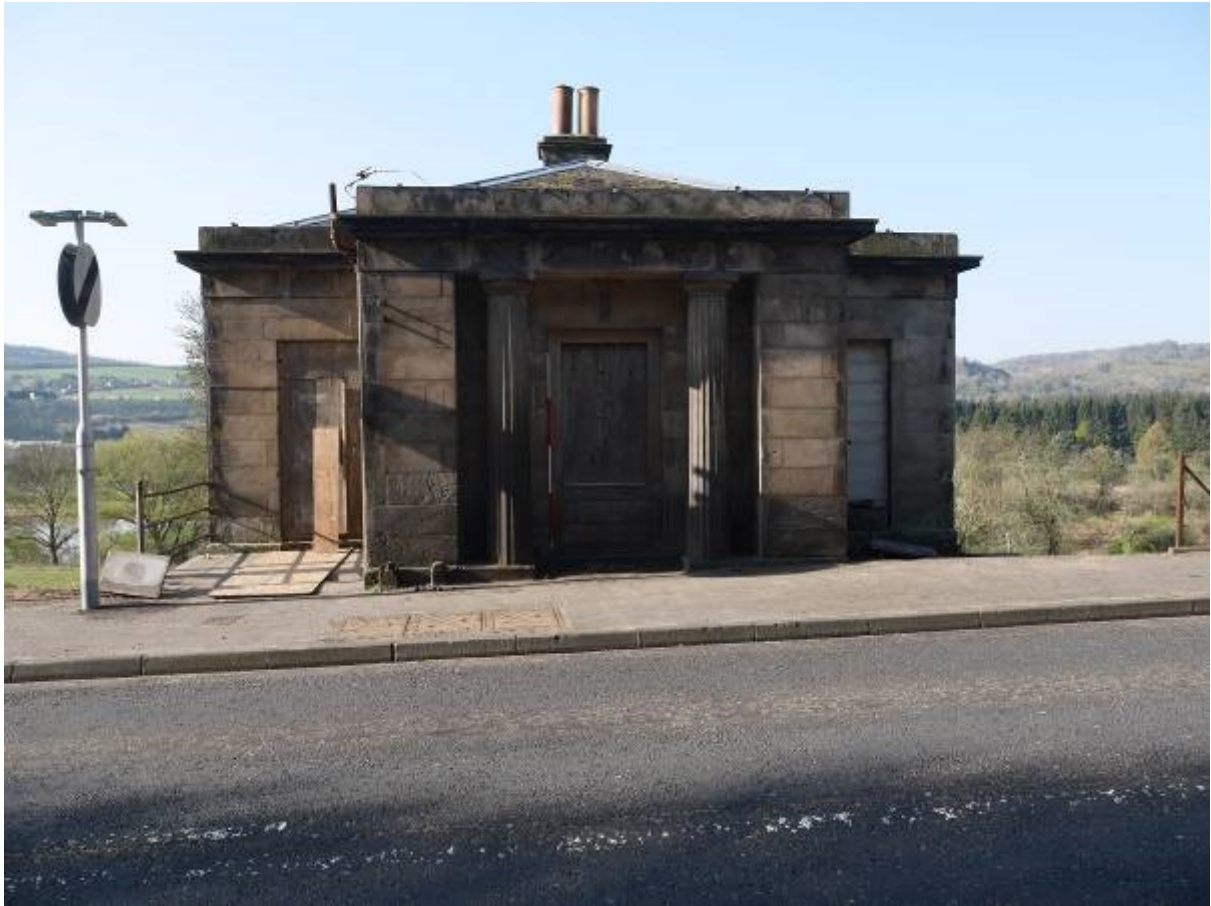
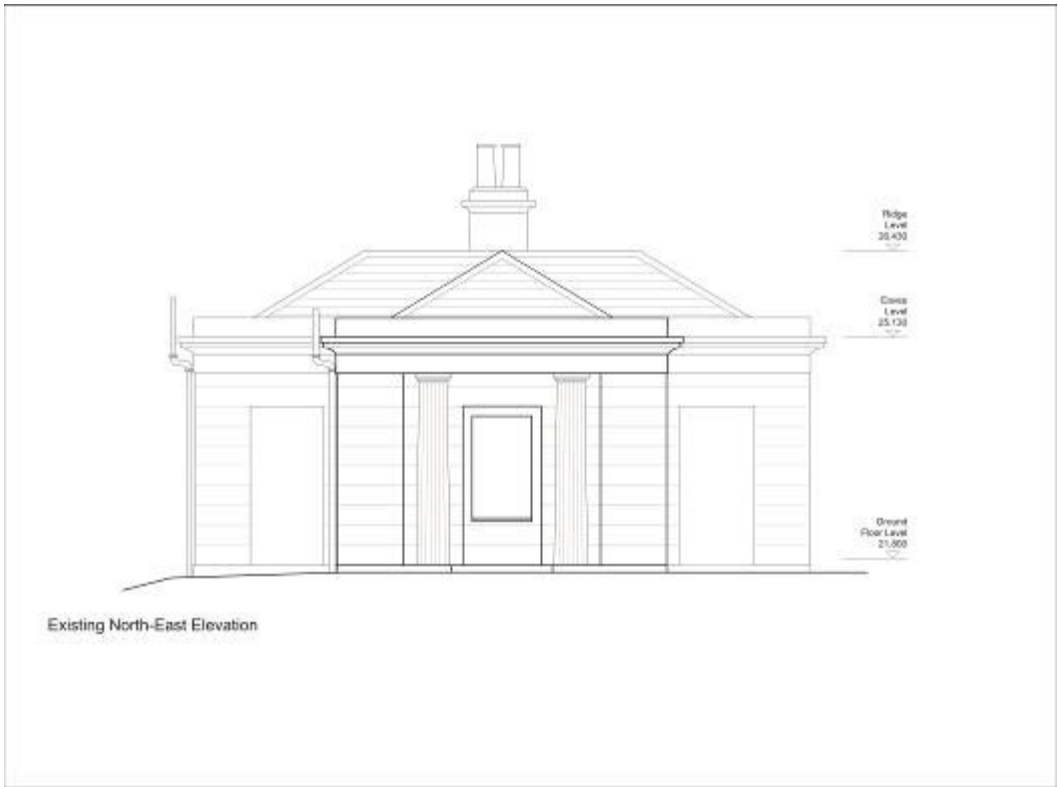
Illustration 6 – North Eastern elevation of tollhouse Scale 1:50 (drawing supplied by architect)

This is built of twelve courses of tightly fitted mortared cut green sandstone blocks and has a doorway at its Southern end. A central portico fronting the road has a blocked window set back between two fluted Grecian pillars that hold up a parapet at roof line, there is a further course of cut green sandstone blocks above the parapet. At the northern end of this elevation there is a rectangular recess in the wall face, from archive photographs this originally held the table of dues for the tollhouse (Illus 4).

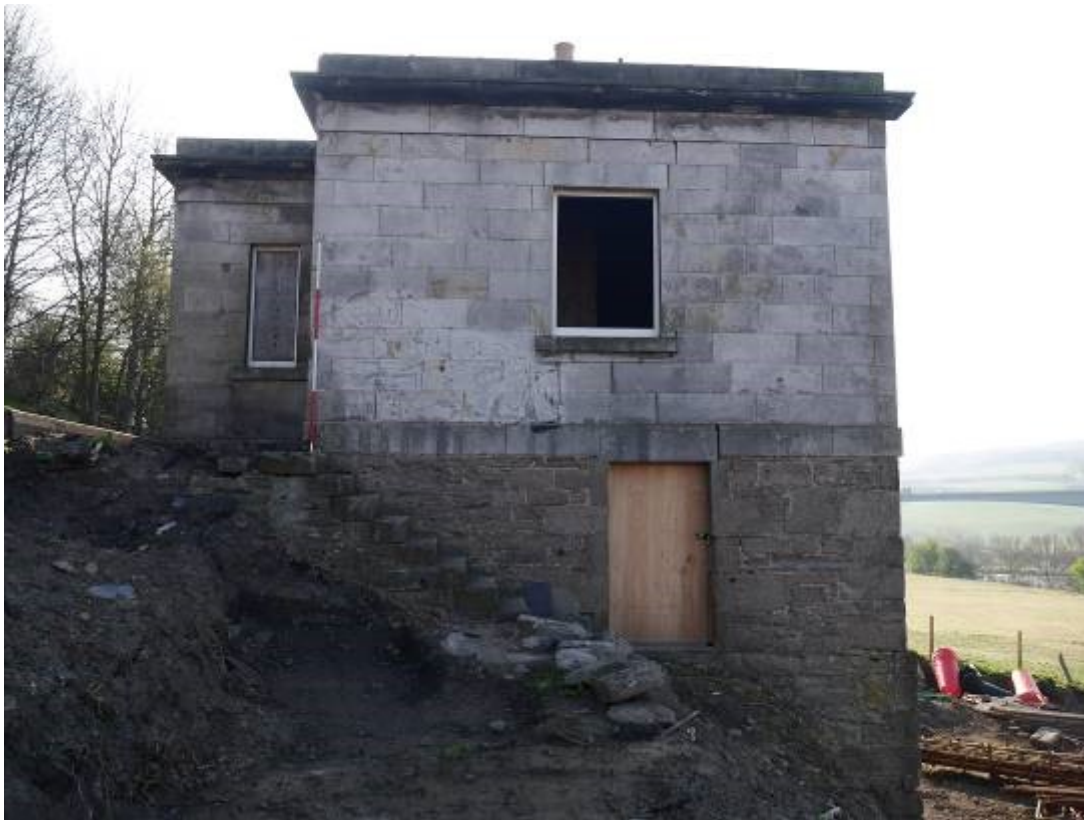
Illustration 7 – North Western elevation of tollhouse Scale 1:50 (drawing supplied by architect)

This is built of twelve courses of tightly fitted mortared cut green sandstone blocks which sit on mortared green sand stone blocks down to foundation level. The Eastern end of this elevation is set back to form part of the front portico of the and is built of twelve courses of cut green sandstone blocks to road level. There is a single window blocked with wood. There is a single window blocked with wood at the upper floor level and a doorway into the 'basement' level of the building. A flight of stairs runs down from the road level to the 'basement' door, this formerly had a metal railing on its Northern side but this has been removed.

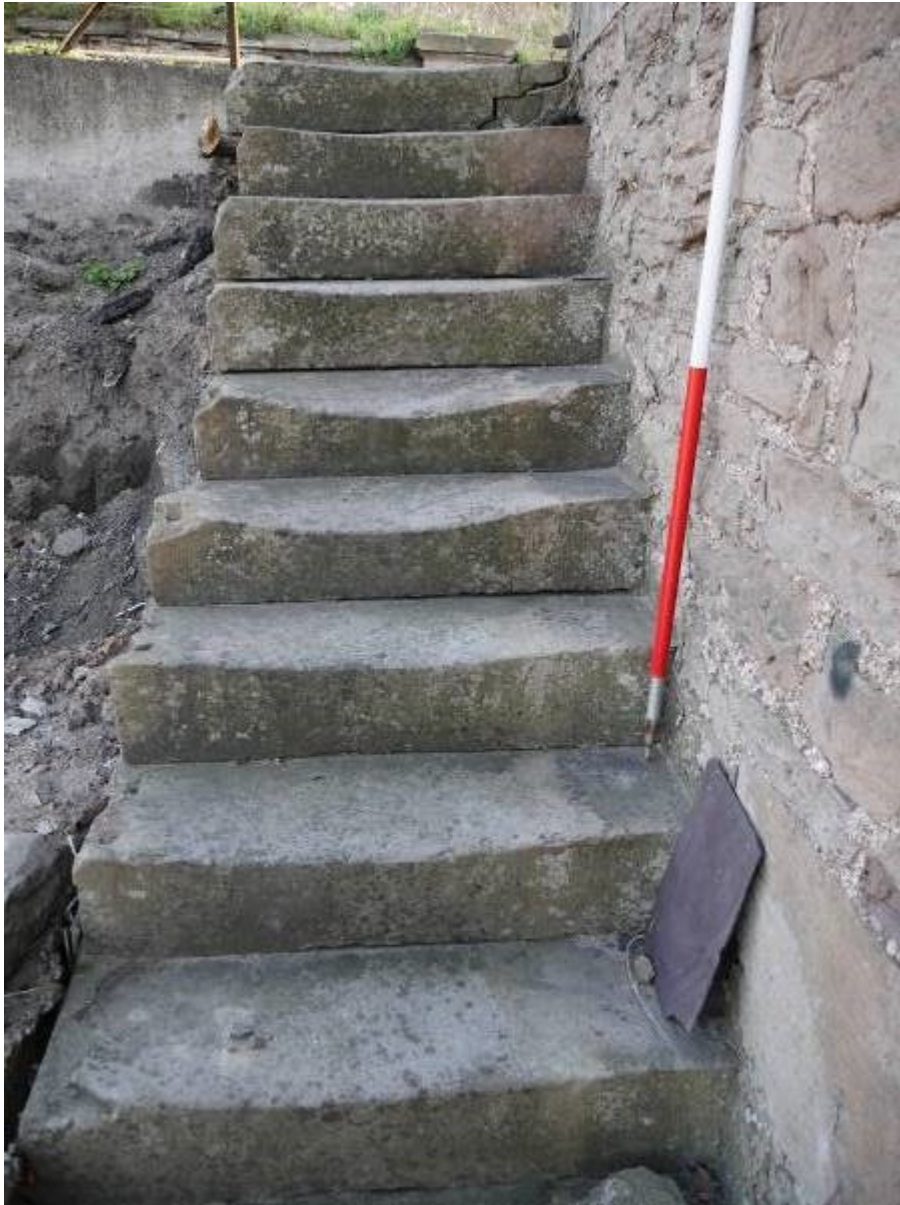
Illustration 8 – Flight of steps down from road level to basement door

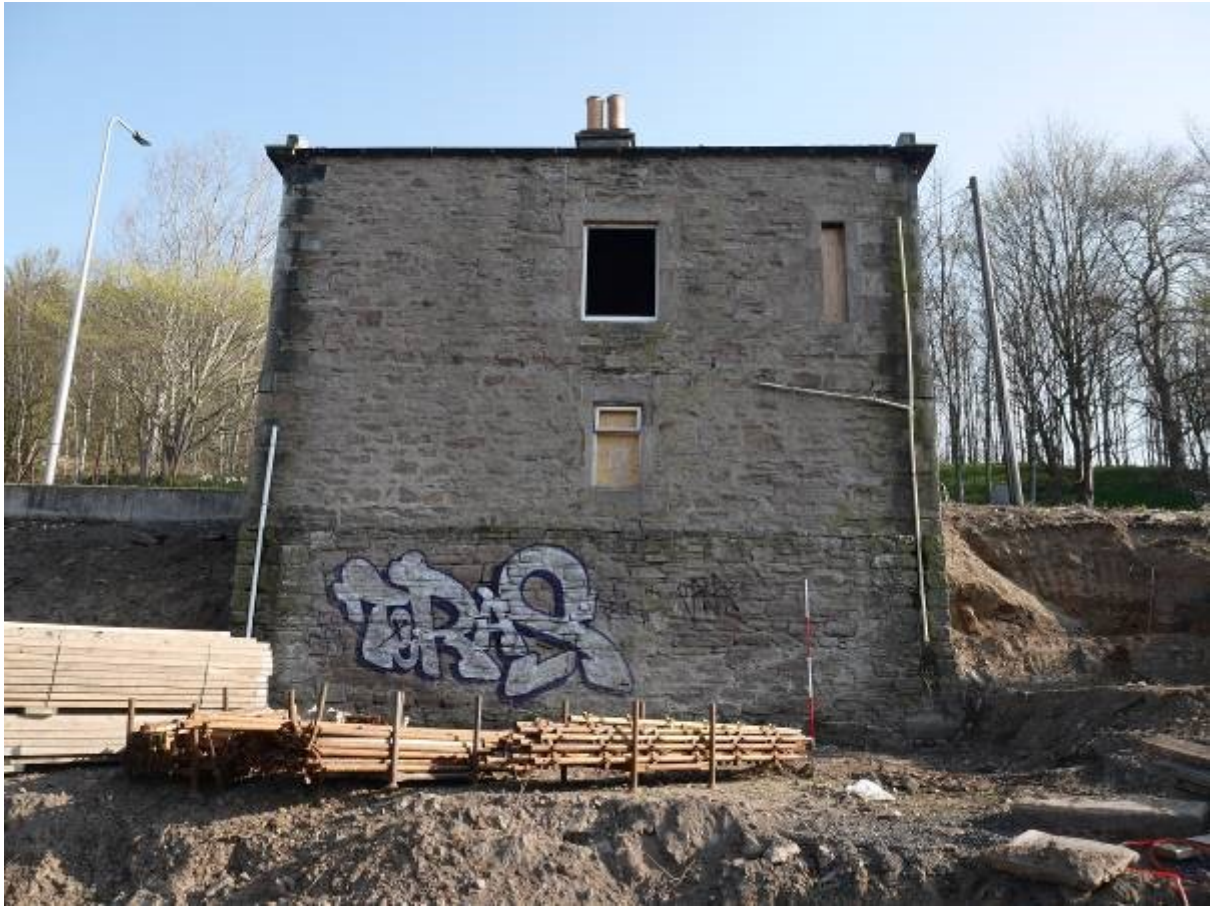
Illustration 9 – South Western elevation of tollhouse Scale 1:50 (drawing supplied by architect)

This is built of twelve courses of rough mortared sandstone blocks with shaped and cut green sandstone blocks at its corners and these sit on a further eleven courses down to foundation level that are slightly stepped out. There are two windows at the upper floor level, one rectangular and one slit these are blocked with wooden panels. At basement level there is a smaller rectangular window. Modern graffiti in black and white has been spray painted on this elevation.

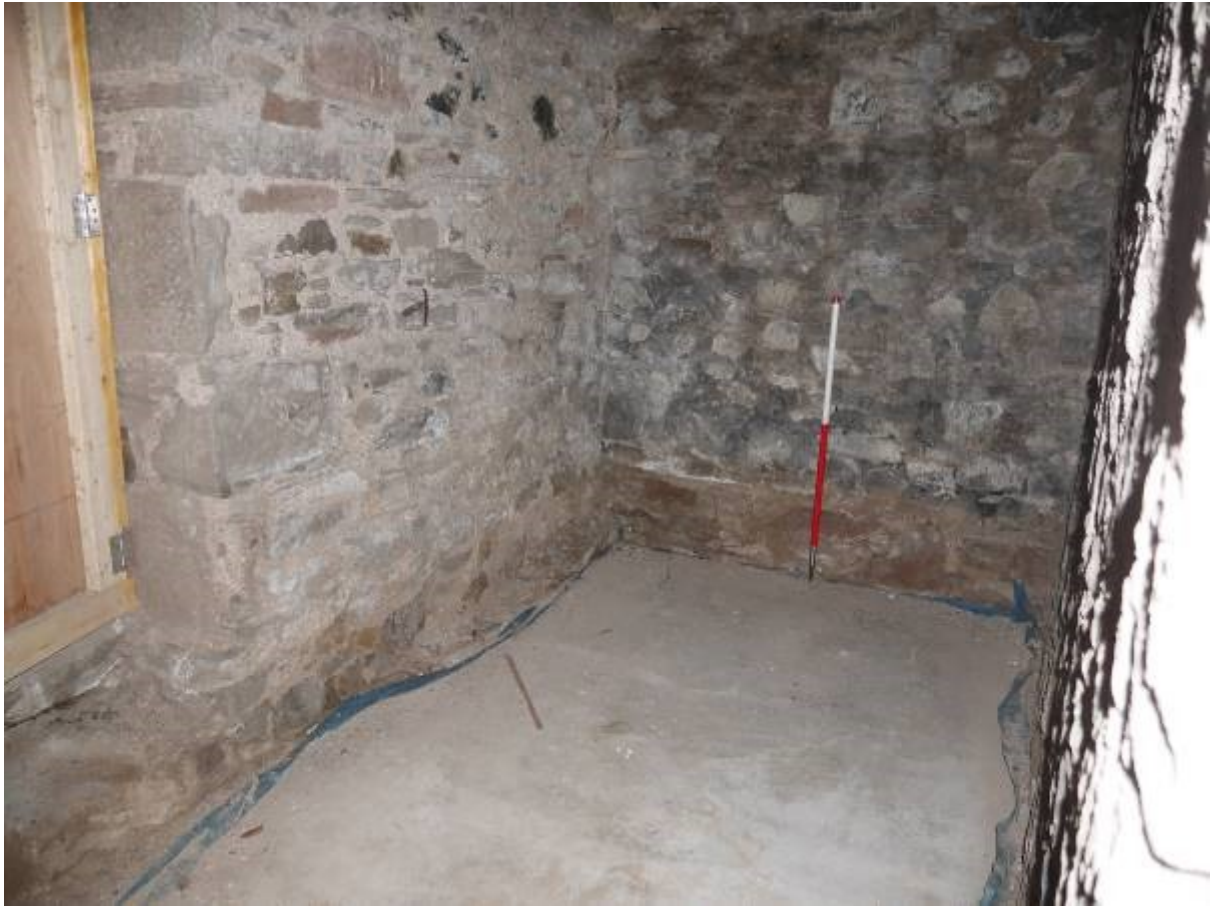
Illustration 11 – Northern section of basement, entrance door visible to left

This is accessed by a doorway in its Northern wall. There are two joining rooms forming an L-shape and all wall elevations are mortared rough sandstone blocks. There is a poured concrete floor in both rooms and the ceiling is formed by the wooden timber supports for the upper floor. There is a slightly flared single window in the Western internal elevation with a sill that is blocked with a wooden board.

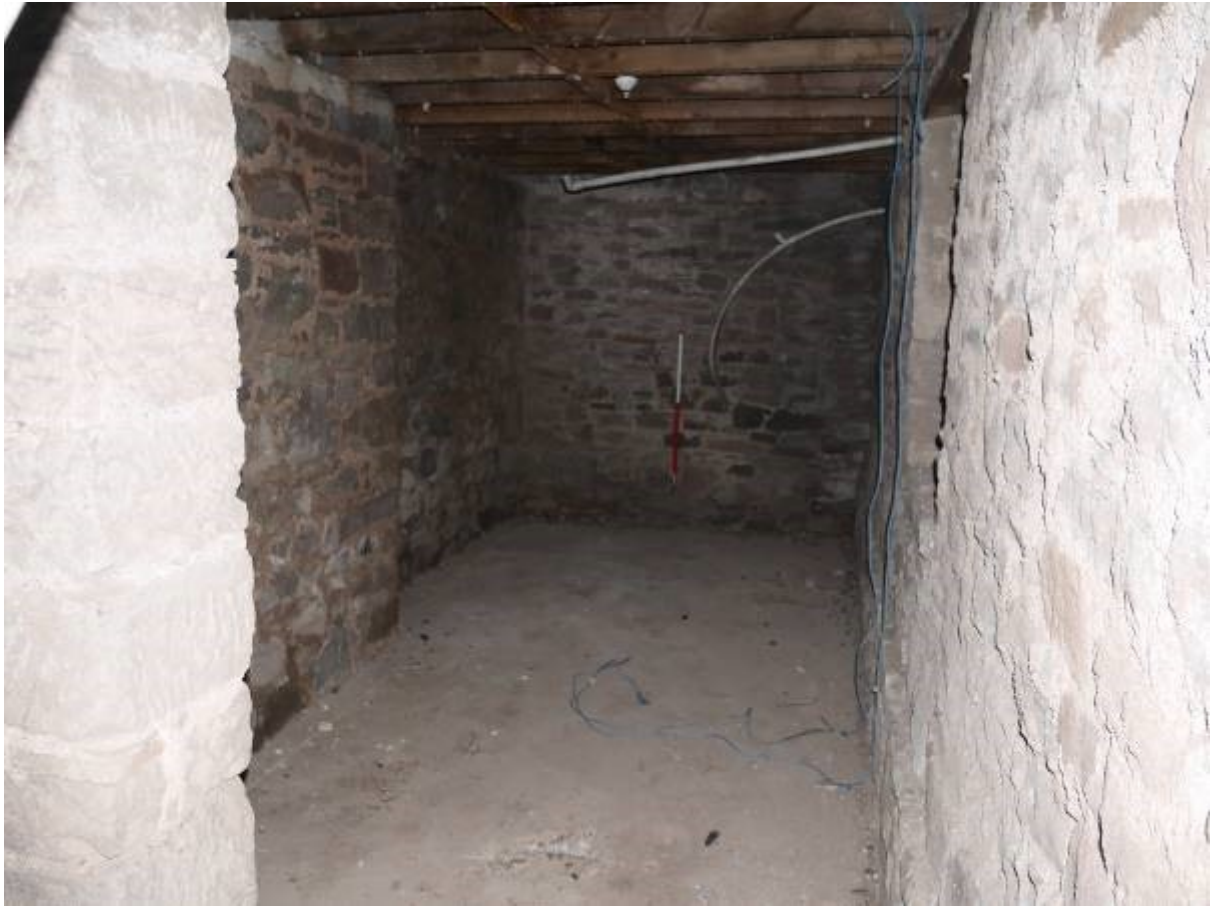
Illustration 12 – South Western section of tollhouse basement

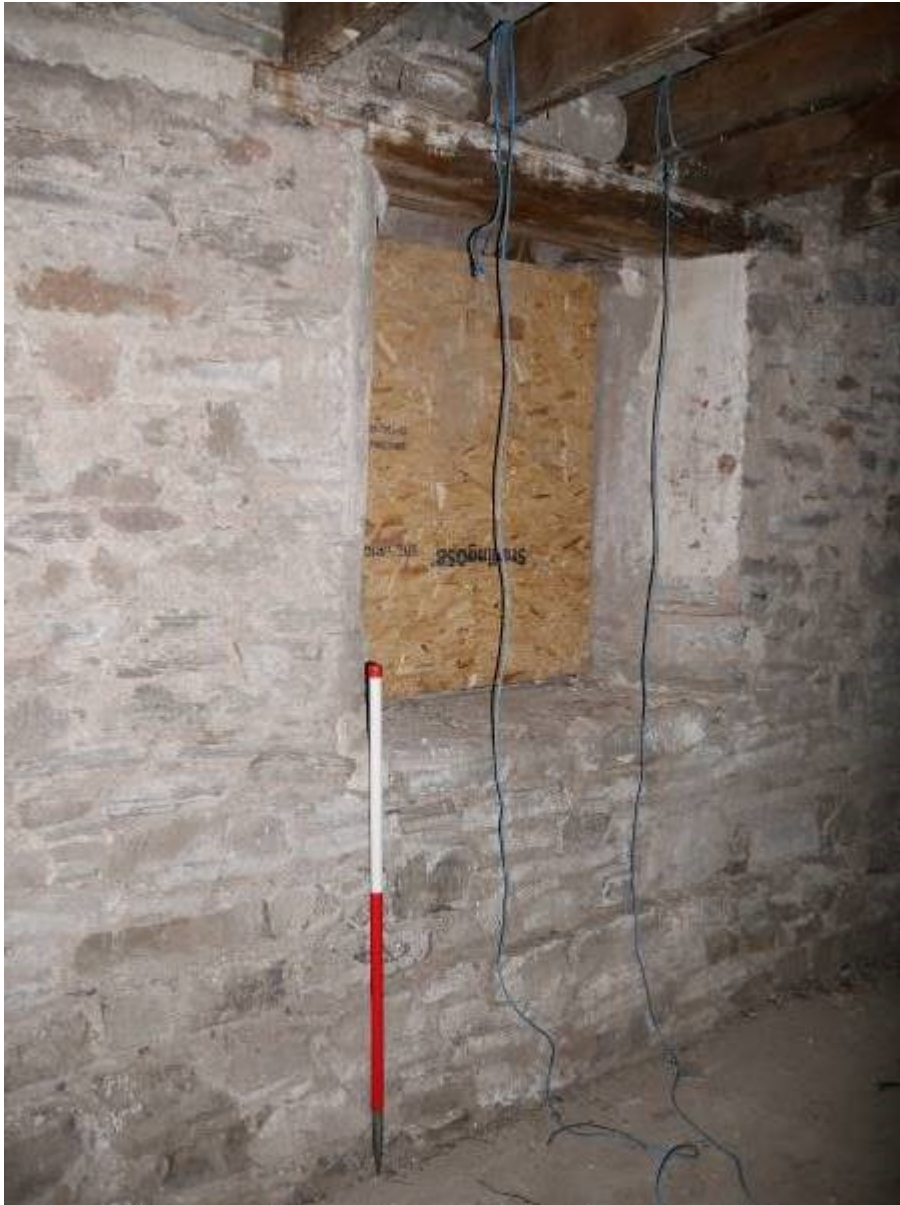
Illustration 13 – Window in North Western internal elevation of basement

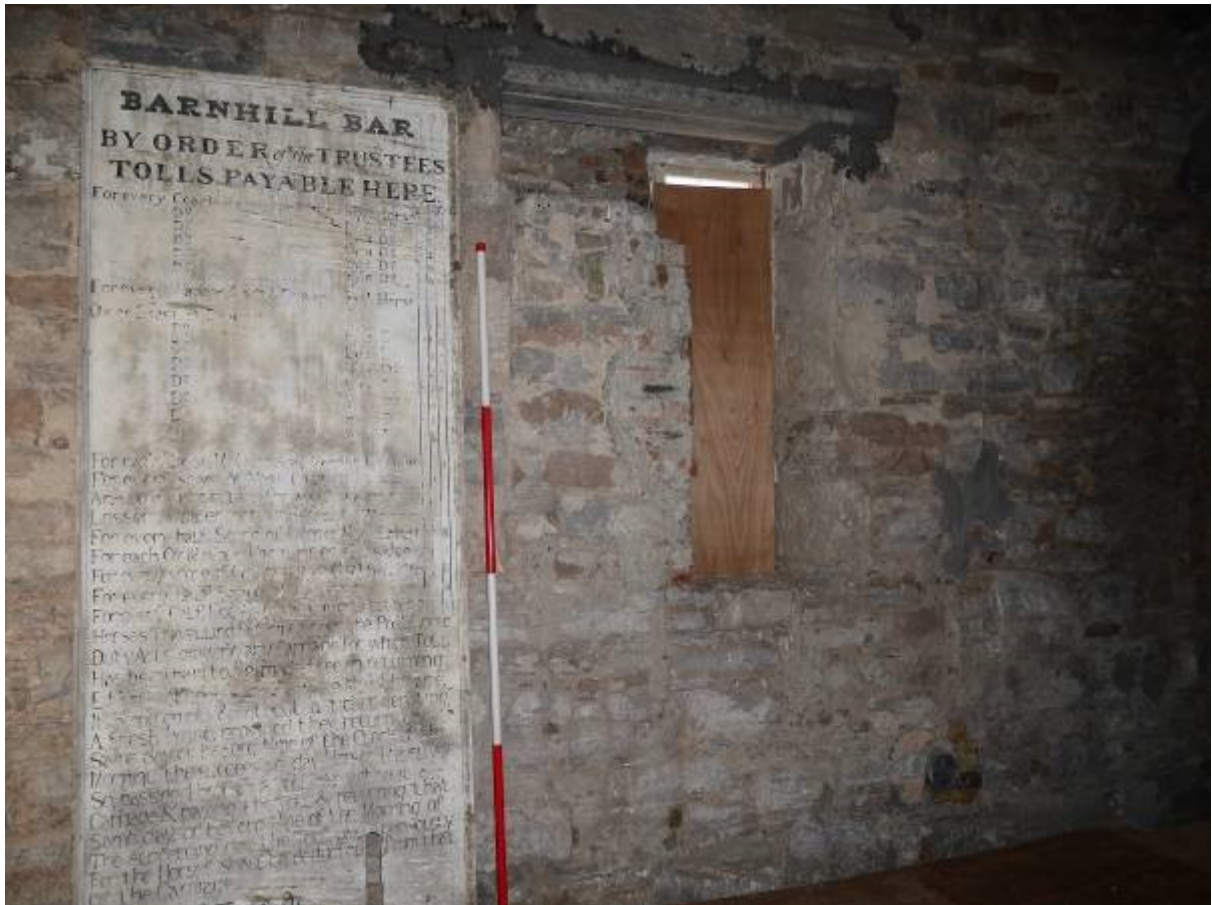
Illustration 15 – North Western internal elevation showing partially blocked window and table of dues propped against wall face

The South Eastern elevation contains a window that is half blocked with mortared bricks, the other half is blocked with a wooden board. The wooden table of dues is currently propped against this elevation, its is slightly dirty but still legible.

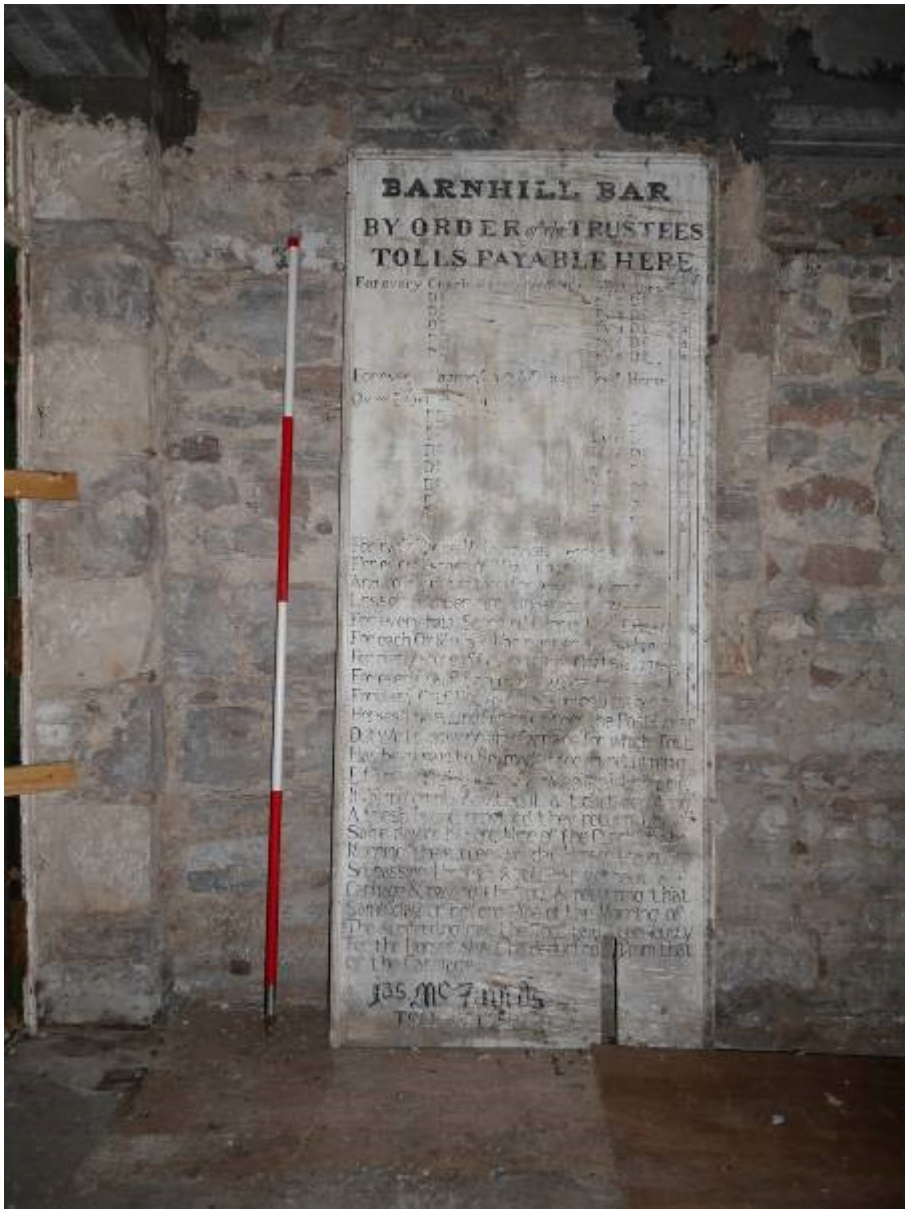
Illustration 16 – Detail view of table of dues now stored inside building. Note use of the name ‘Barnhill Bar’ and ‘Jas McFaulds’ named as toll collector.

Barnhill tollhouse is a good surviving example of a 19th century Scottish tollhouse and is of one construction phase. The table of dues that originally stood in one of the external alcoves is currently safely stored inside the building, if it is not to be resited in the proposed refurbishment some consideration should be given to passing it to Perth museum and art gallery for safekeeping.

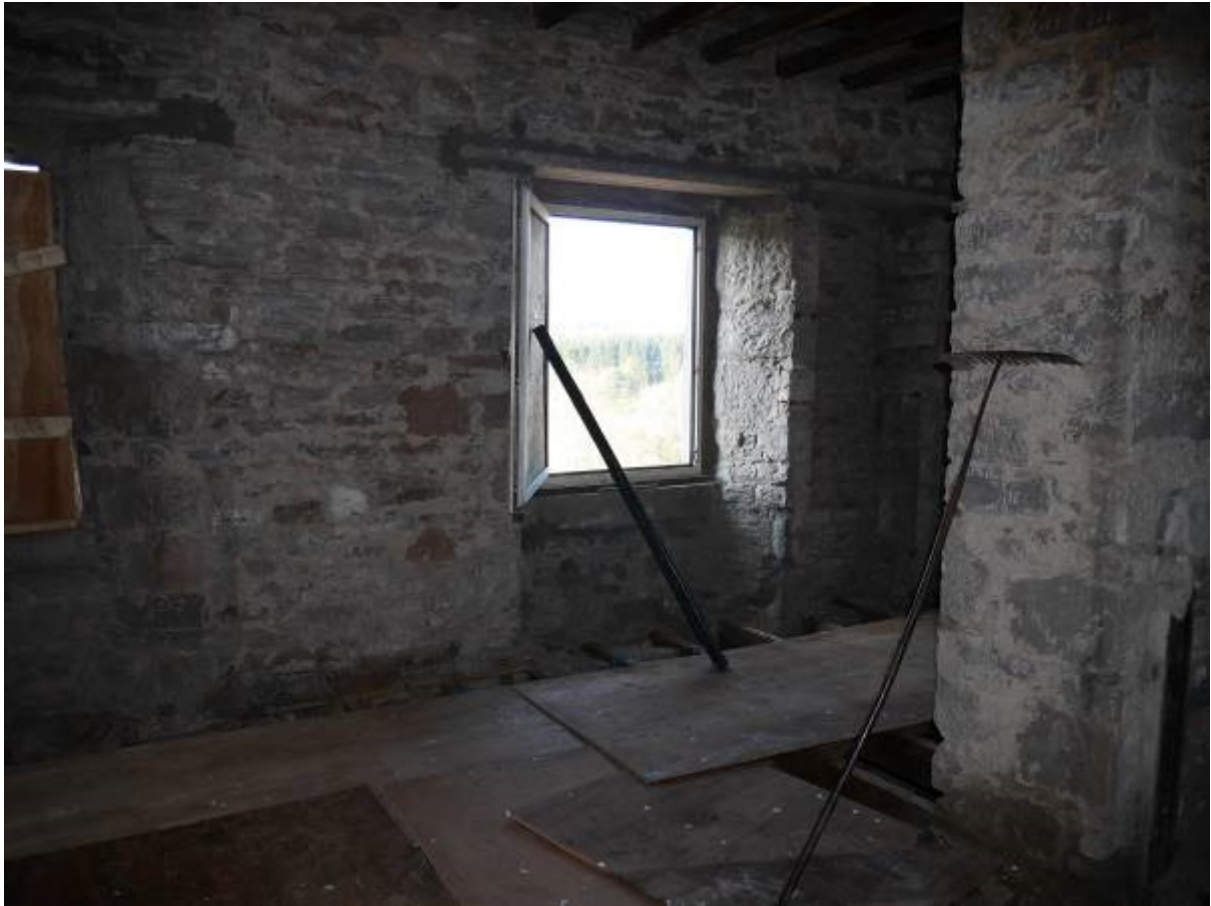
Illustration 17 – North Eastern internal elevation of ground floor of tollhouse

This contains a slit window blocked with a wooden board and a rectangular window with a wooden shutter. There is a rectangular alcove in the wall face on the North side of the window of unknown function.

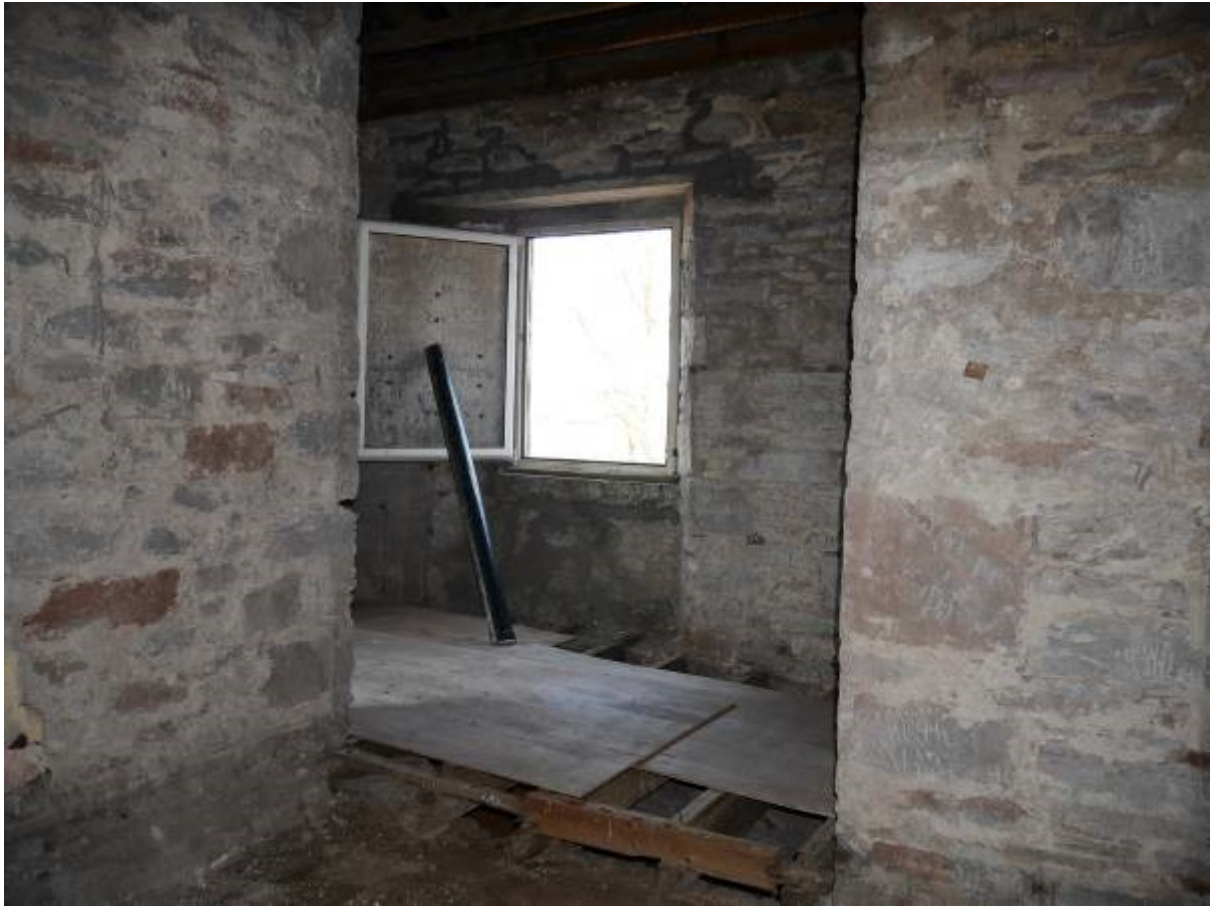
Illustration 18 – South Western internal elevation of ground floor of tollhouse

This contains a single rectangular window with a wooden shutter.

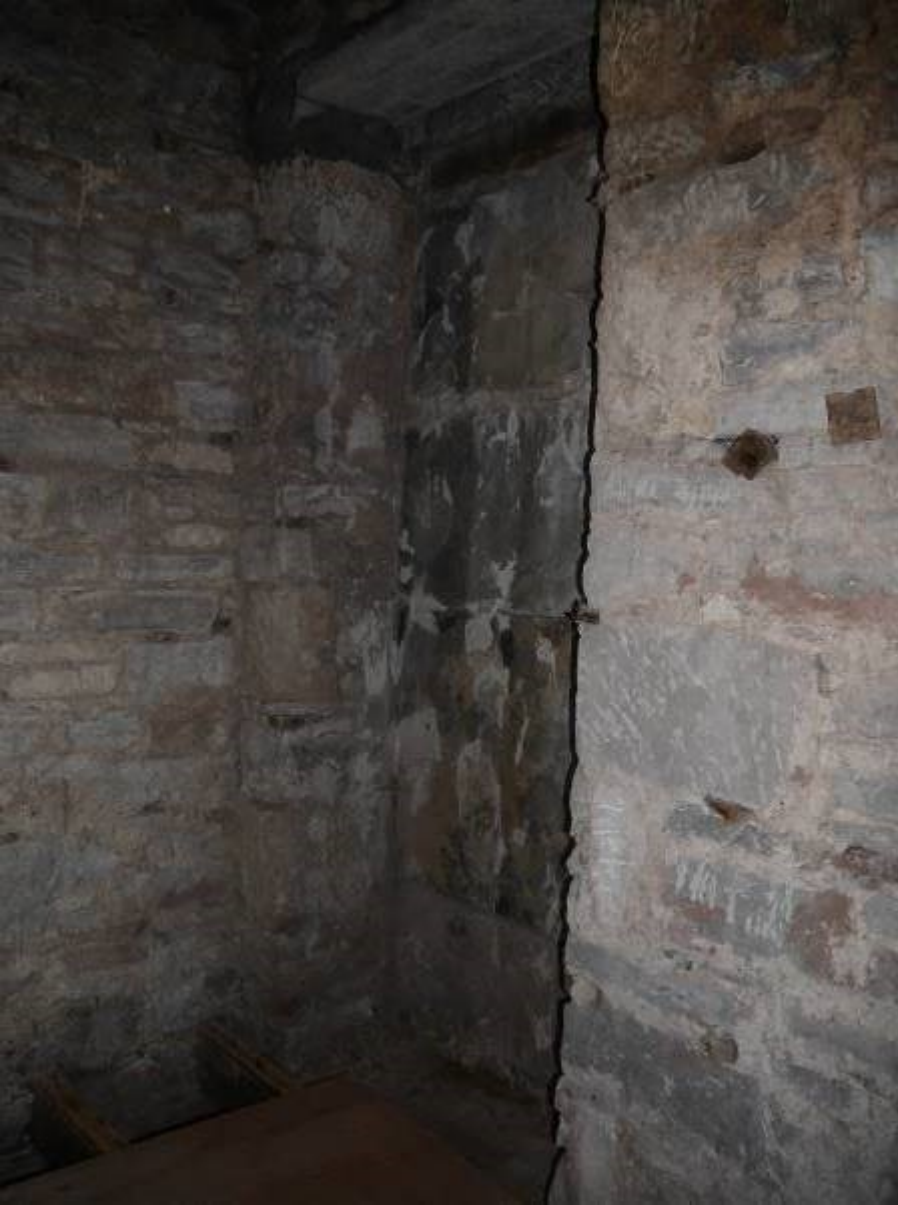
Illustration 19 – Wall recess behind front alcove for table of dues in North Eastern internal elevation of tollhouse

This contains a rectangular alcove filled with mortared stone slates at its Northern end (this is the rear side of the exterior alcove to hold the table of dues). The inside of the front portico has narrow windows in its Northern and Southern elevations and the Eastern elevation contains a rectangular window with a wooden frame. The external doorway in from the road is at the Southern end of this elevation.

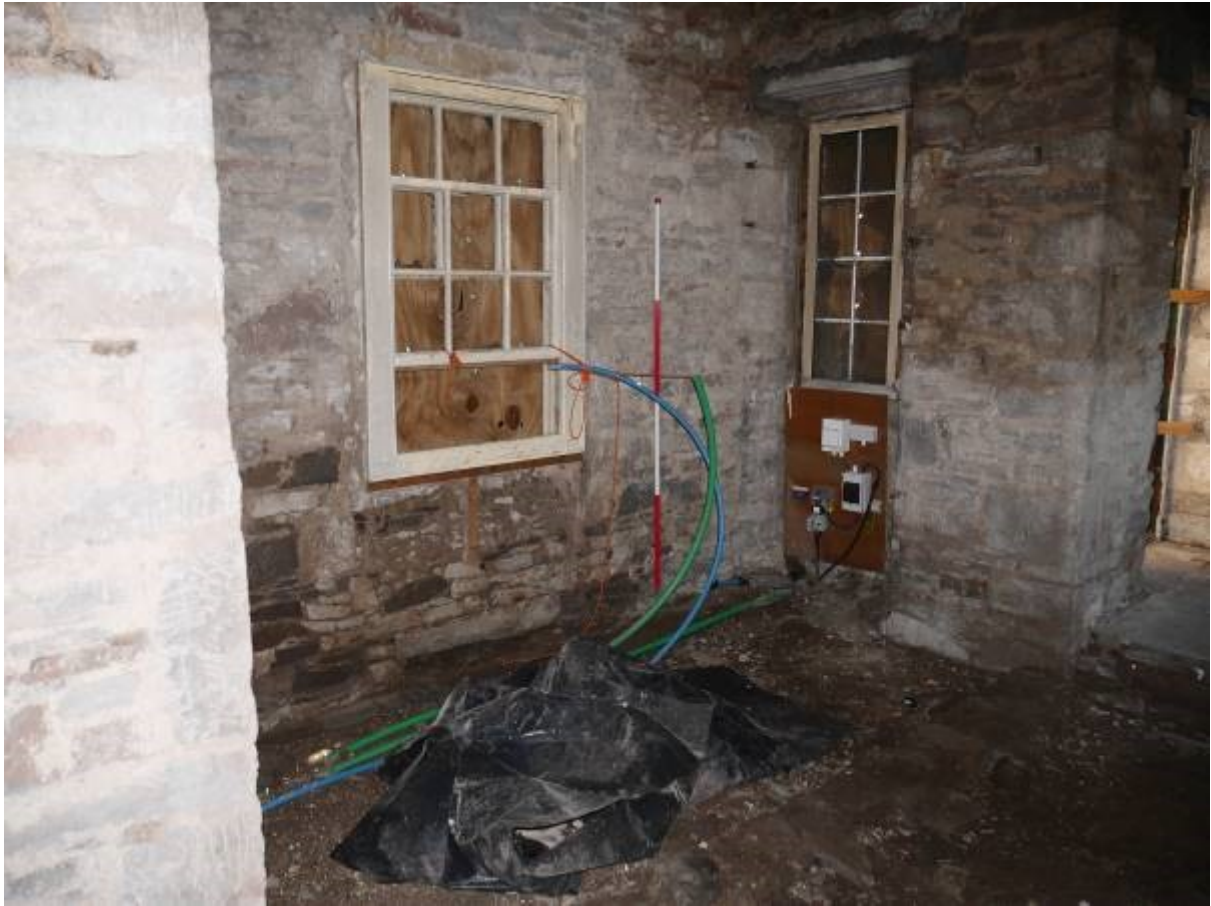
Illustration 20 – General view of internal North Eastern elevation of portico in tollhouse

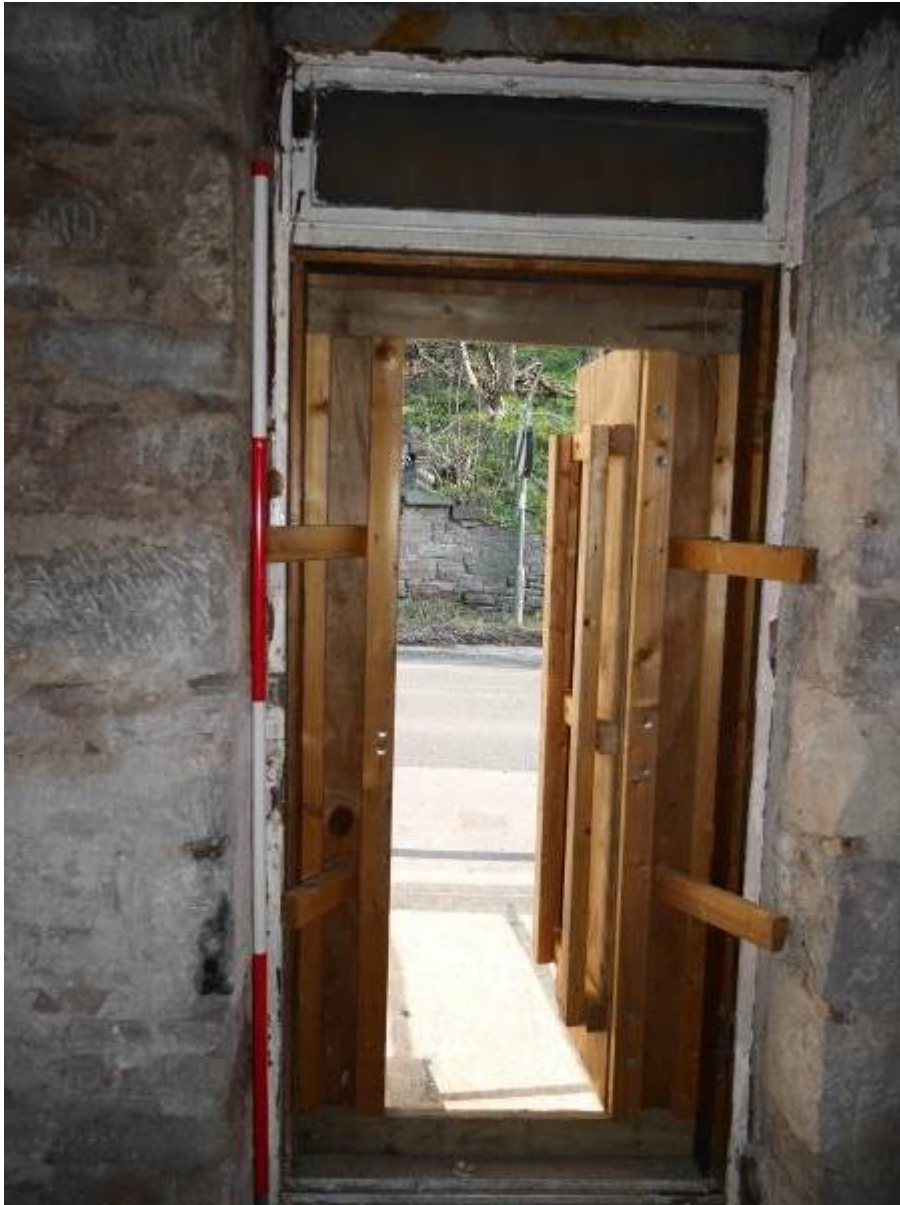
Illustration 21 - Doorway into tollhouse from road level in internal North Eastern elevation

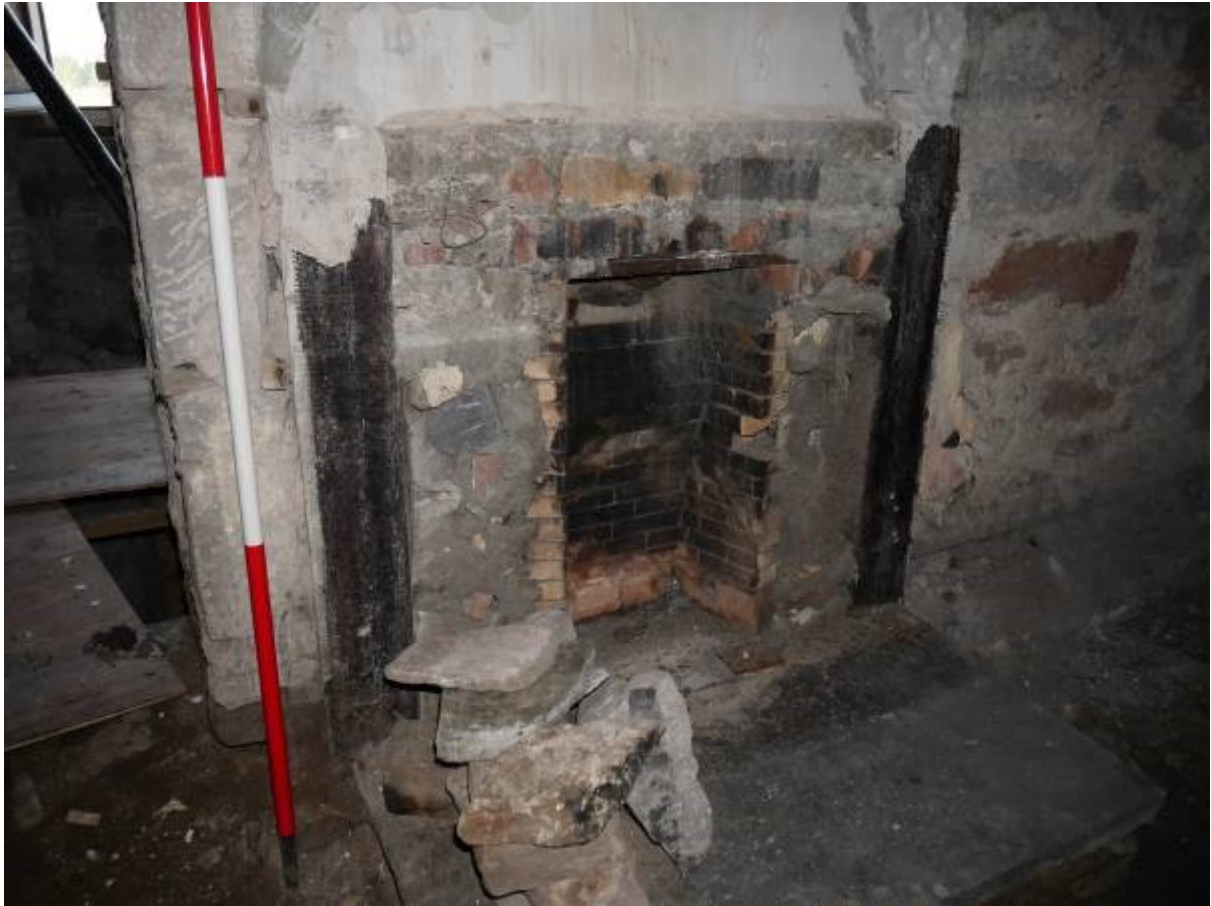
Illustration 22 – Fireplace on North Eastern side of wall in centre of ground floor of tollbooth

There are opposing fireplaces in the middle of the room built into a stone-built chimney stack. The wooden floor supports are still in place above the lower basement level but the floor boards are missing and currently replace with wooden boards. The remainder of the floor is made of beaten earth and there is a visible wall foundation running North to South on the Western side of the portico.
