Standing Building Survey
Barnhill Tollhouse,
Perth, Perth and Kinross

17th April 2019

Introduction

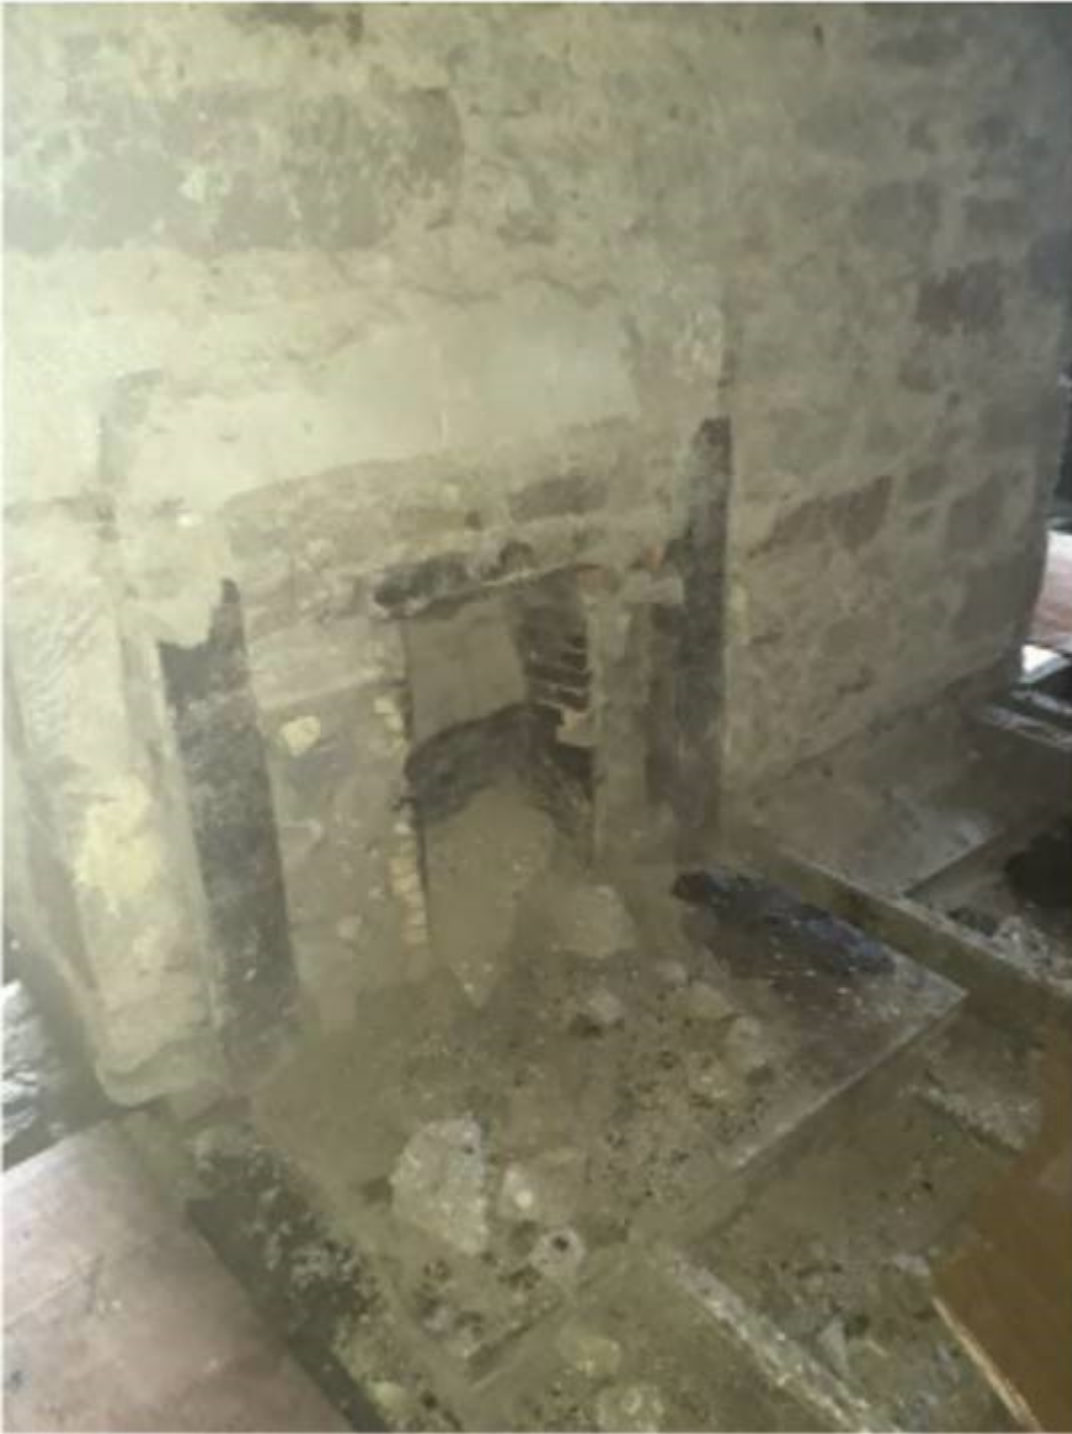
Illustration 23 – Fireplace on South Western side of wall in centre of ground floor of Tollbooth

There are opposing fireplaces in the middle of the room built into a stone-built chimney stack. The wooden floor supports are still in place above the lower basement level but the floor boards are missing and currently replace with wooden boards. The remainder of the floor is made of beaten earth and there is a visible wall foundation running North to South on the Western side of the portico.

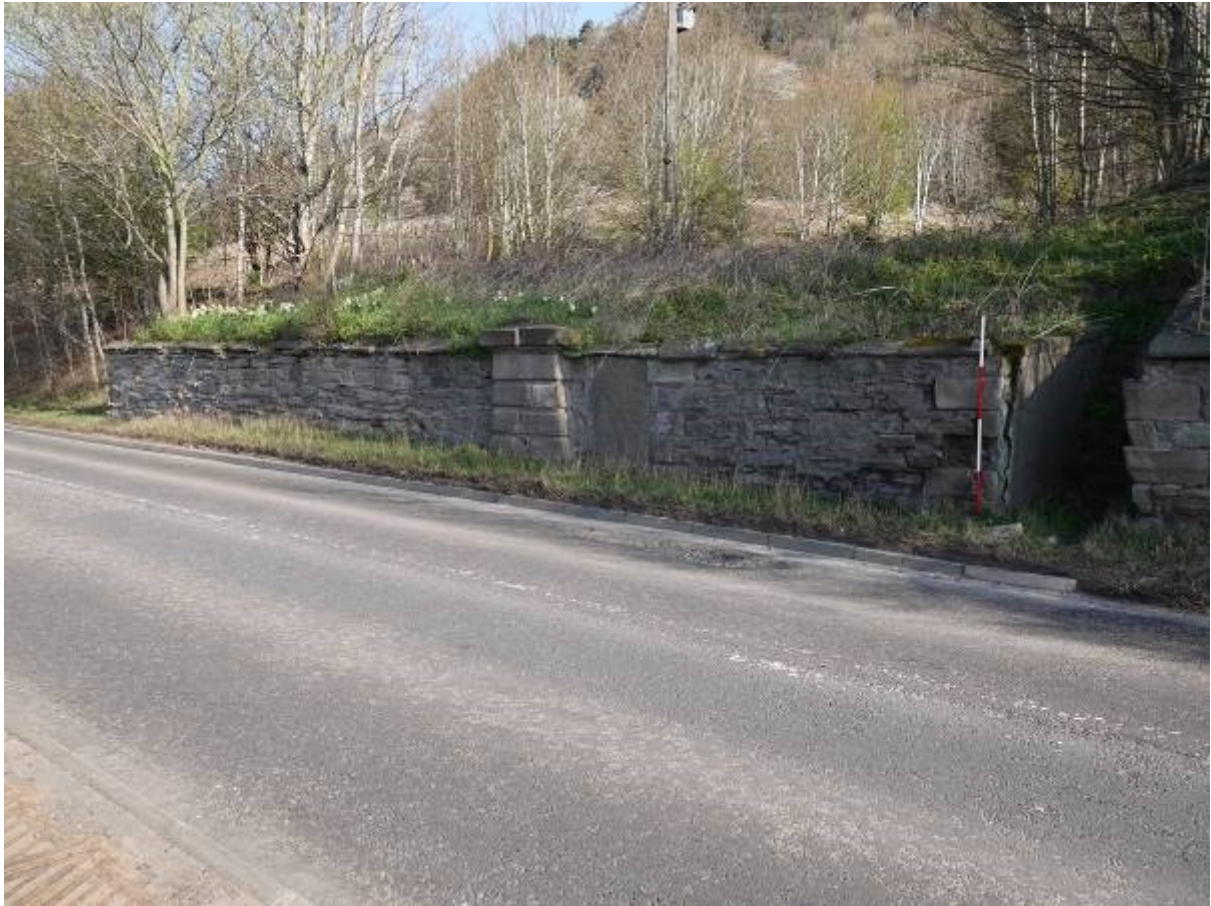
Illustration 24 - General view of raised revetted garden directly across the road from the tollhouse, flight of steps to right of scale, pillar and blocked alcove also visible in wall.

Directly across the road from the tollhouse there is an associated raised garden behind a revetted stone wall. This is accessed by a flight of stone steps from the road level. The revetted front wall contains a pillar and a blocked alcove measuring 0.87m by 1.55m of unknown function.
