Rapid Building Survey

The Old Mill, Kinbuck, Stirling Council

11th March 2021

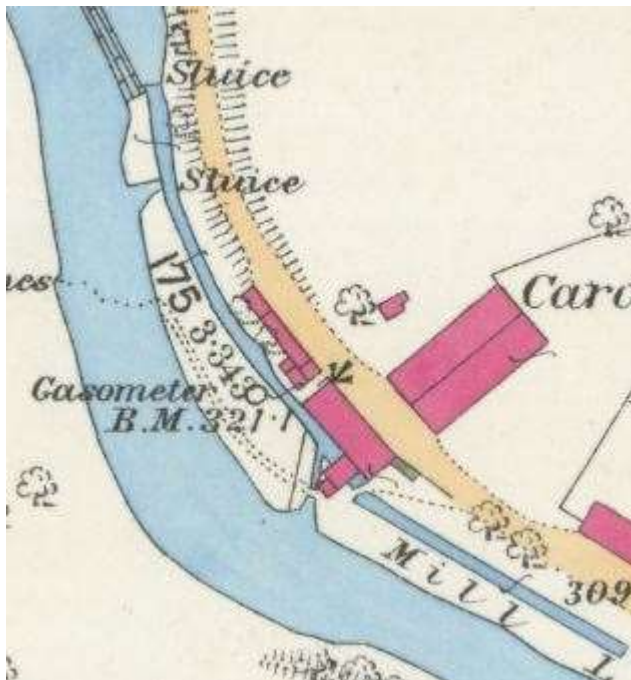
Illustration 4- Detail from Ordnance Survey Map of 1864 showing mill complex including mill lead, gasometer and associated building across the road (site now occupied by Robertson's auctioneers) (© Trustees of the National Library of Scotland)

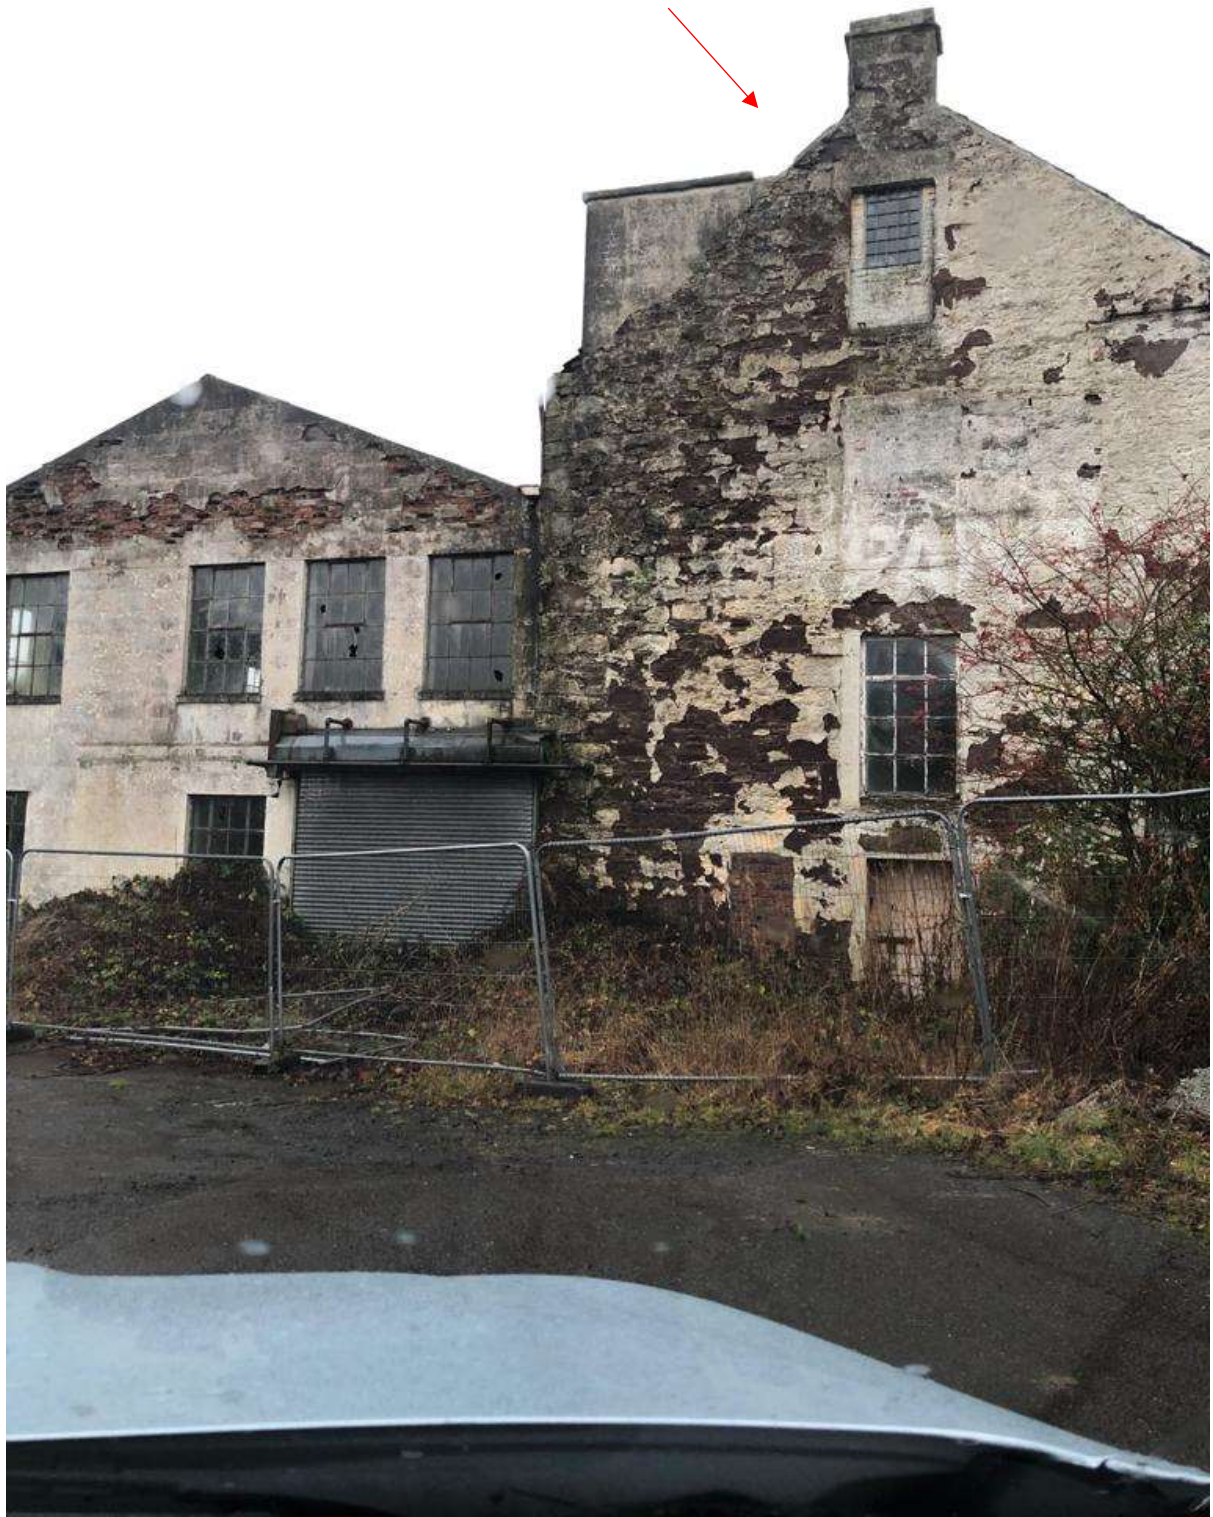
Illustration 11- Mill building complex prior to refurbishment looking North (recorded building marked with red arrow, demolished early modern building on left) (Courtesy of Lee Collins)

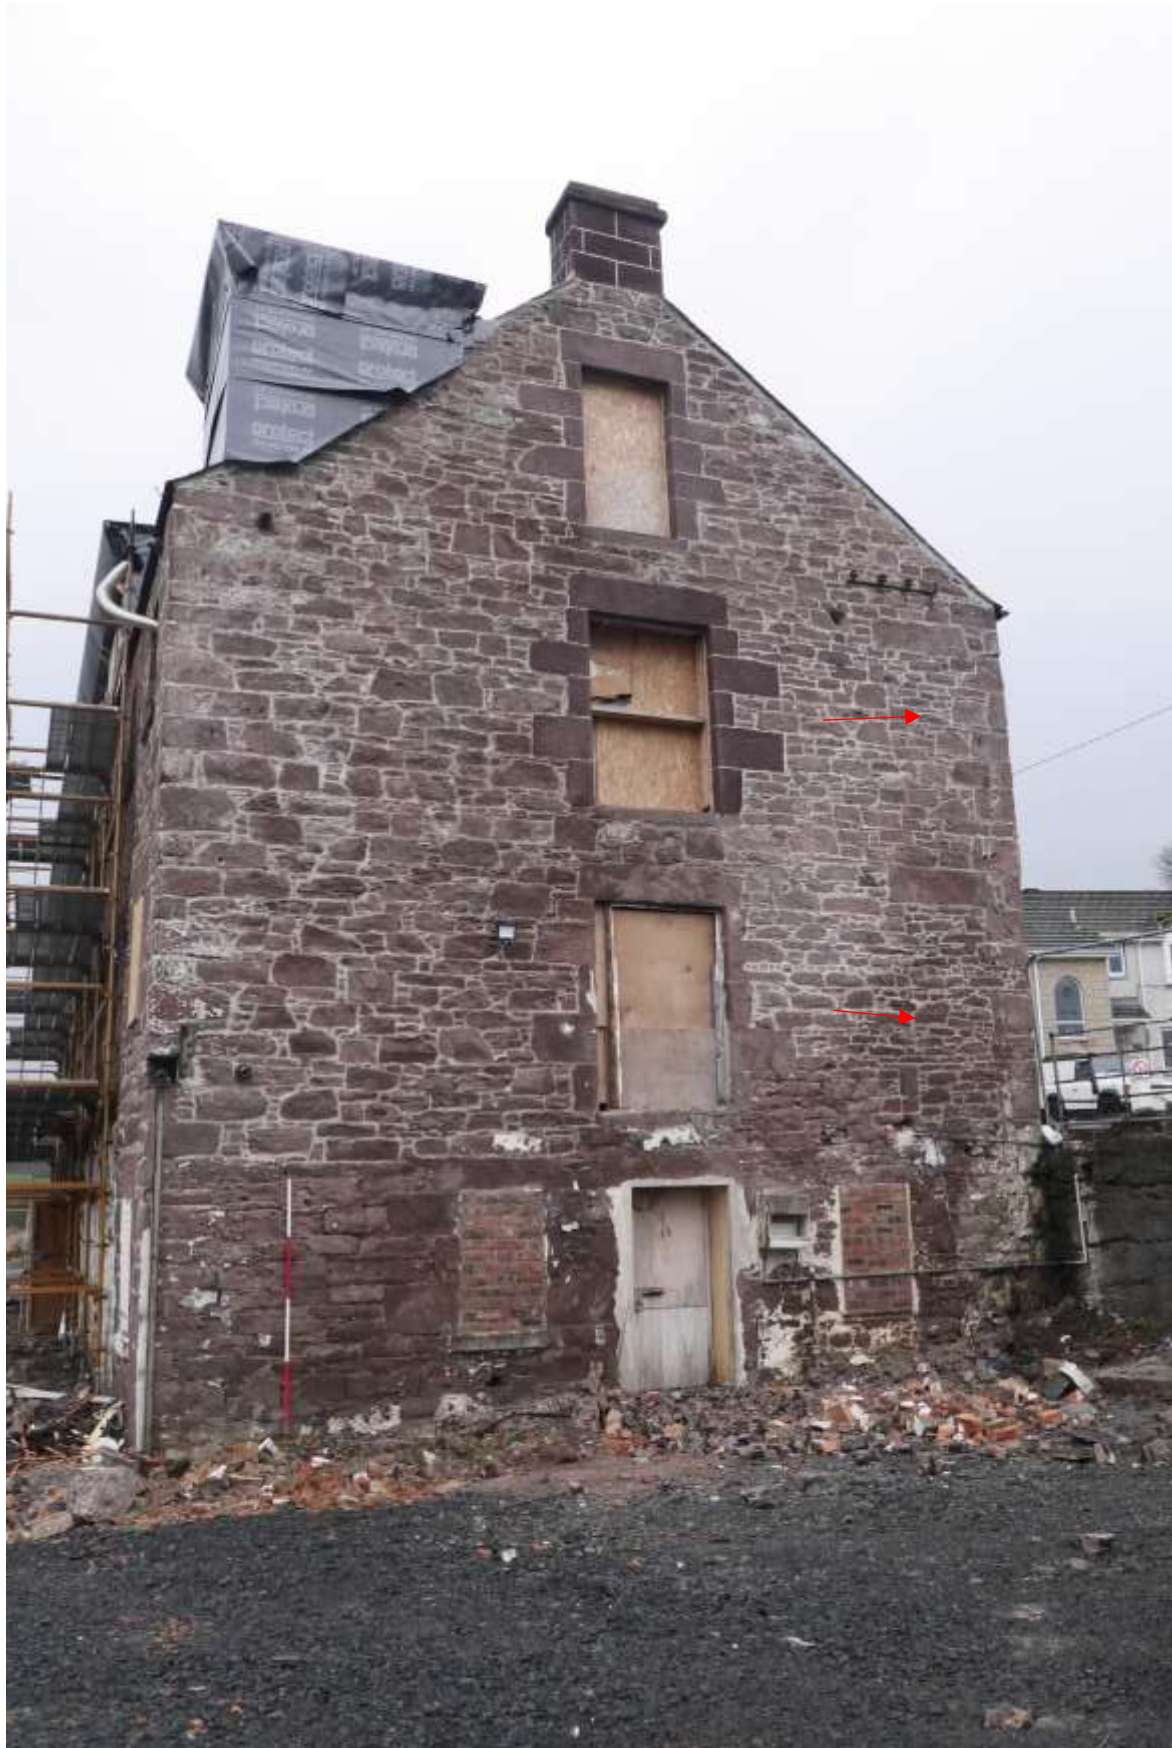
This is a gable end with a chimney at its apex. It is built of mortared red sandstone with shaped quoins at its corners. Looking from its South Western end the basement floor has a window blocked with bricks, a doorway with a wooden door and another window blocked with bricks. The ground floor has a window currently blocked with wood. The first floor contains a window blocked with wood and then a 'dummy' window. The second floor has a window blocked with wood and then another 'dummy' window.

Illustration 12- South Eastern external elevation of building (red arrows show dummy windows)

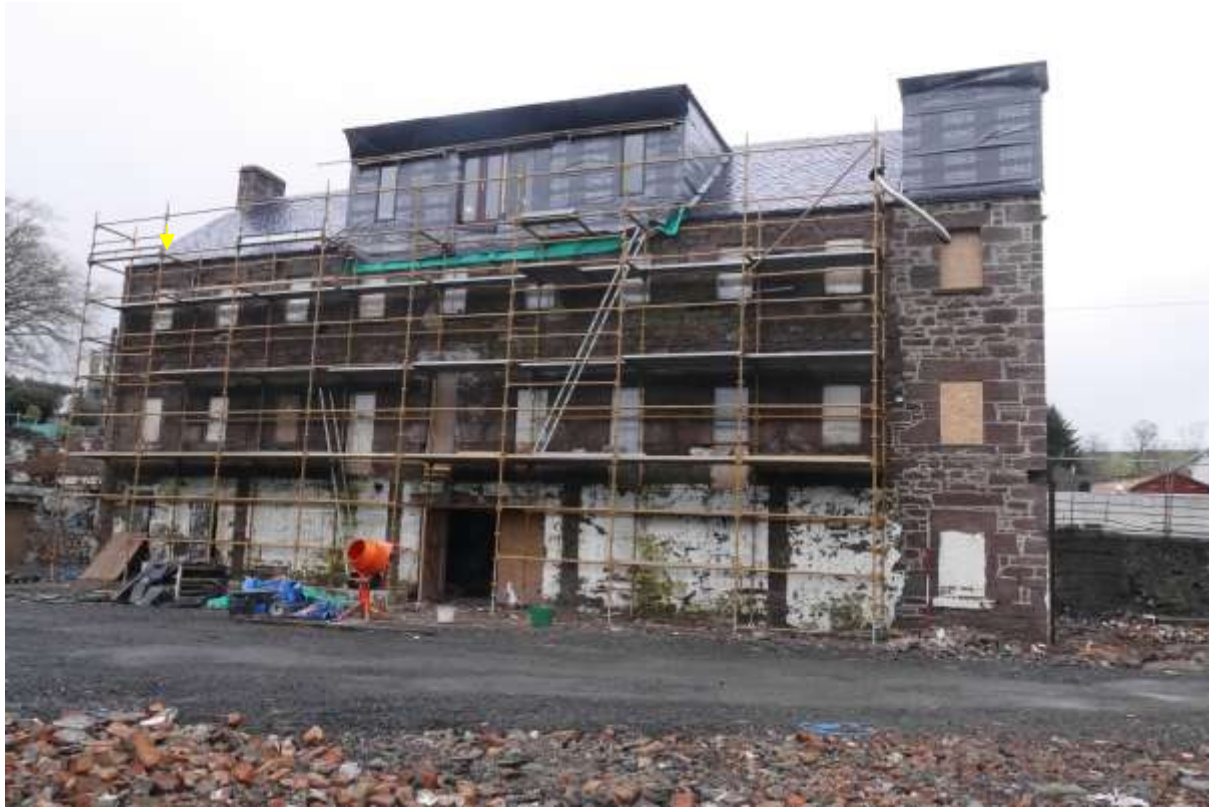
This is built of mortared red sandstone with quoins at its corners. The basement floor level from its North Western end has a doorway (with a wooden door), a window, another window (blocked with bricks), another window (blocked with bricks), a wide doorway with wooden doors, another window (blocked with bricks) and finally a window (blocked with bricks). The ground floor has three small windows, one slightly taller window, a doorway, three slightly taller windows and finally two small windows (all blocked with wooden boards). The first floor has a row of ten small windows all blocked with wooden boards. The new slated roof contains a new central dormer with four windows and a refurbished dormer at its Southern end.

Illustration 13- South Western elevation of Mill building showing new roof and dormers.

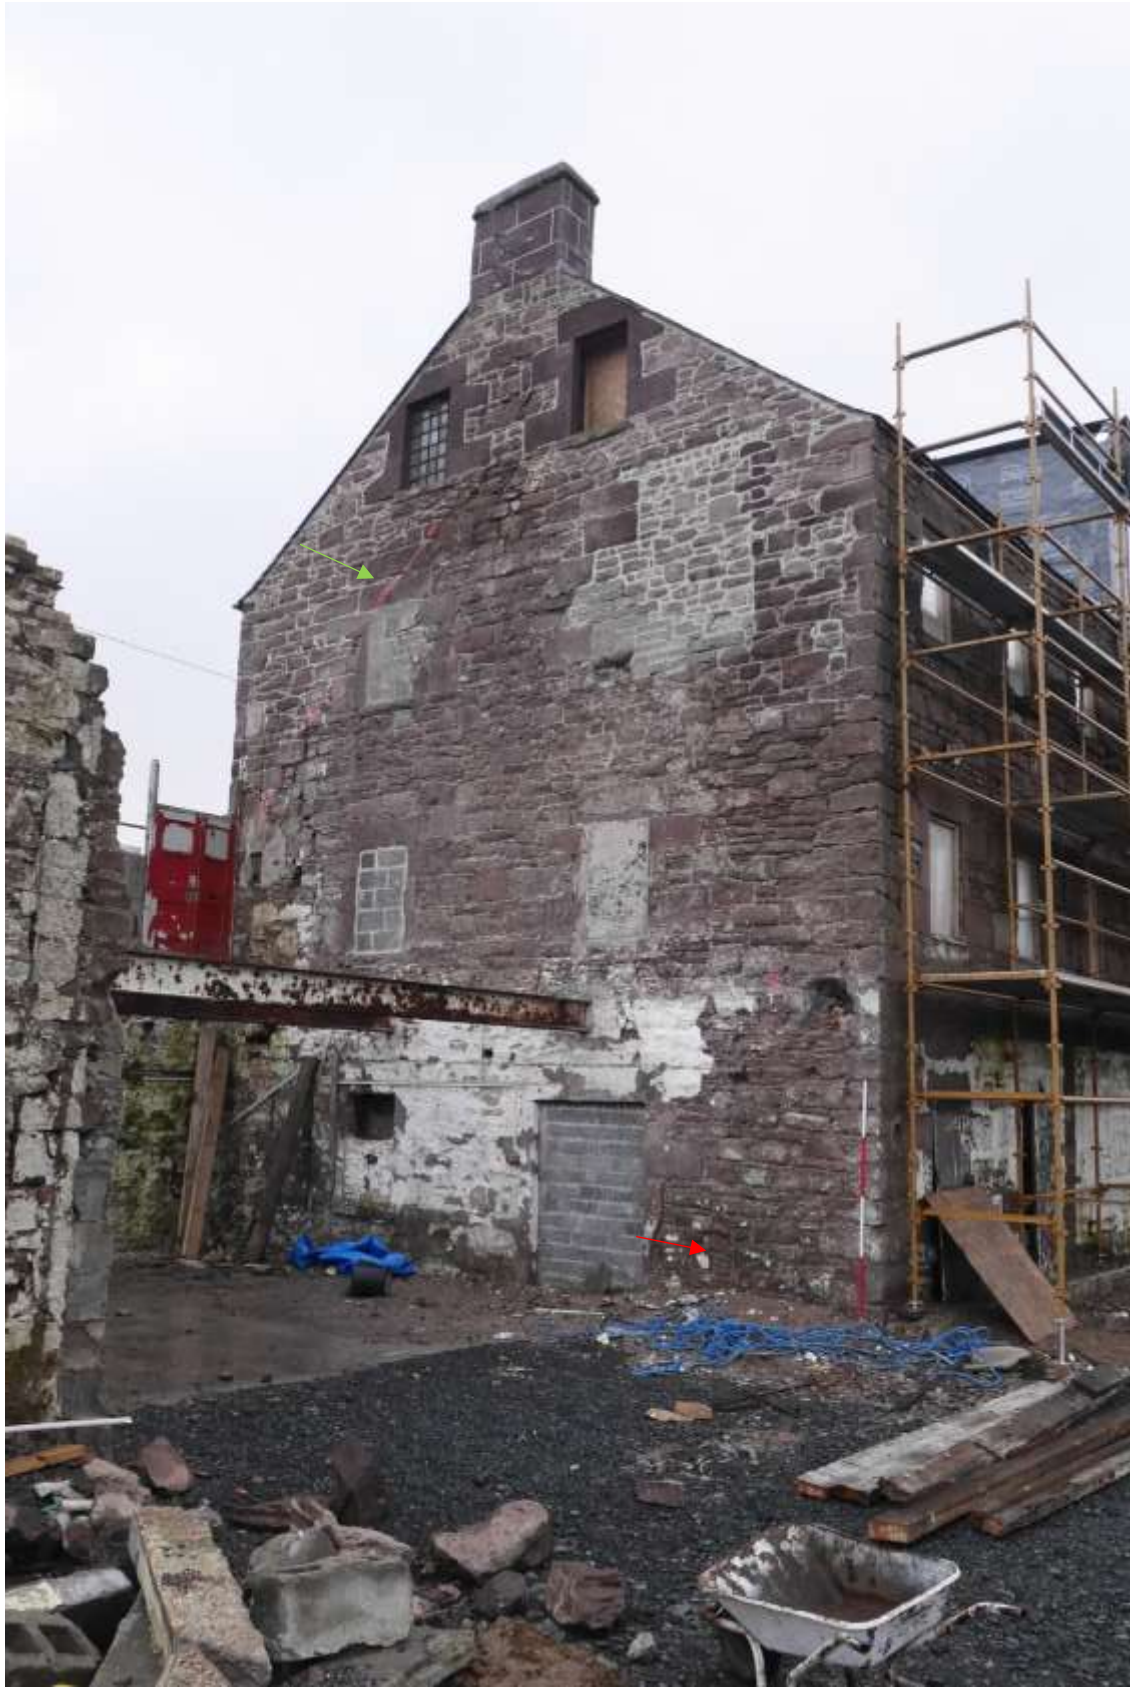
This is a gable end with a chimney at the apex and is built of mortared red sandstone blocks with quoins at its corners, part of a former roof line for a now missing adjoining building is visible. The basement floor contains a window (blocked with bricks), a doorway blocked with concrete breeze blocks and there is a circular hole of 0.70m diameter blocked with mortared stone. The ground floor contains a window blocked with concrete breeze blocks and another blocked window. The first floor contains a blocked window and a blocked doorway. The attic floor contains a small, glazed window and an open window.

Illustration 14- North Eastern elevation of mill building, red arrow shows position of blocked circular hole, green arrow shows former roof line of adjoining building.

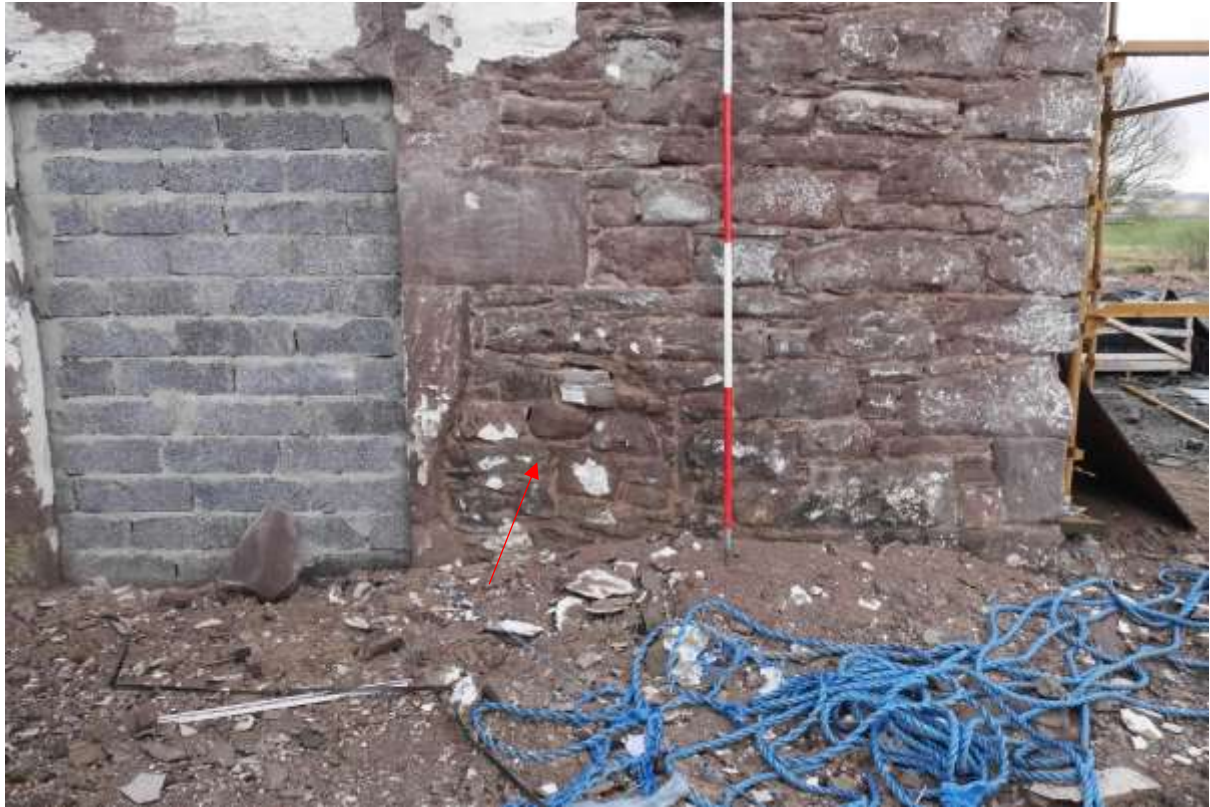
Illustration 15- Detail view of blocked circular hole in North Eastern elevation (red arrow).

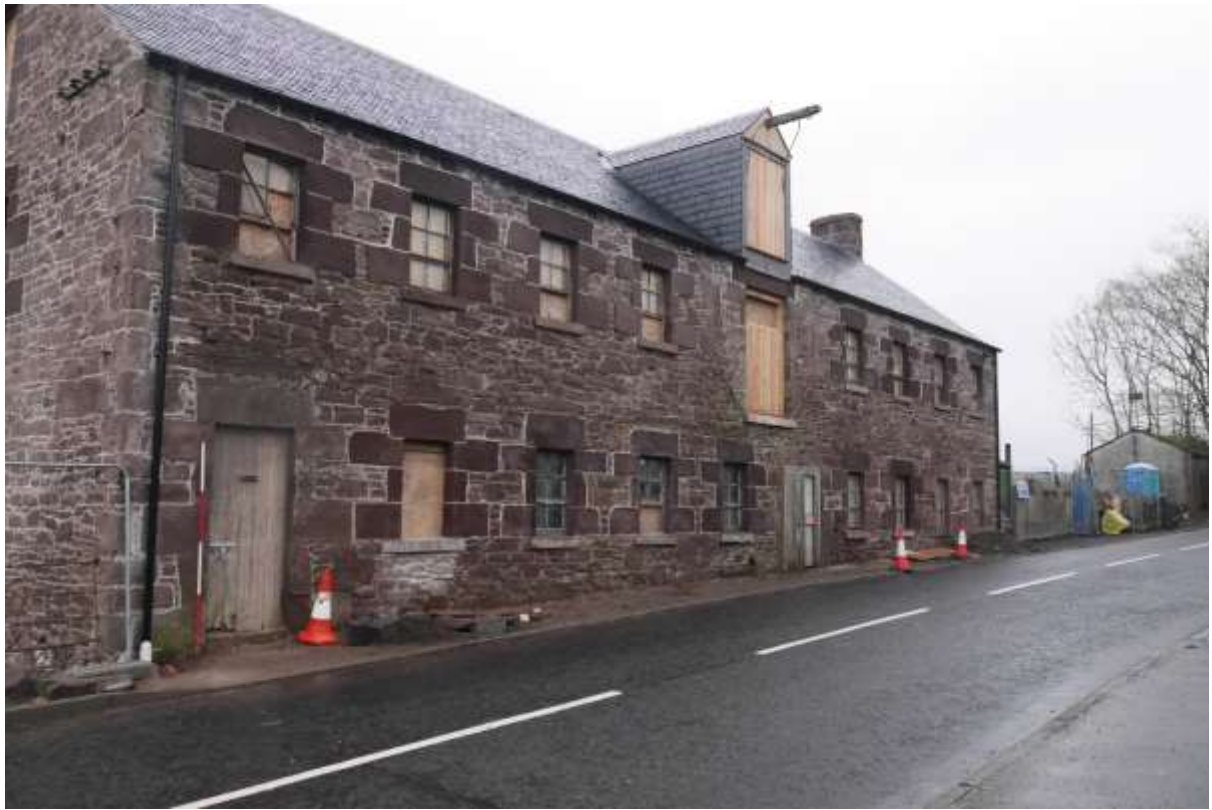
This is built of mortared red sandstone and fronts the road. All of the windows in this elevation are defined by shaped red sandstone blocks. The ground floor contains a doorway (with wooden door), four glazed windows, a doorway with a wooden door and then another four glazed windows. The first floor contains four glazed windows, a door to a loading bay (blocked with wooden panels) and then another four glazed windows. The slated roof contains a dormer with a doorway and a crane hoist (now blocked with wood).

Illustration 16- General view of North Eastern elevation fronting onto road.

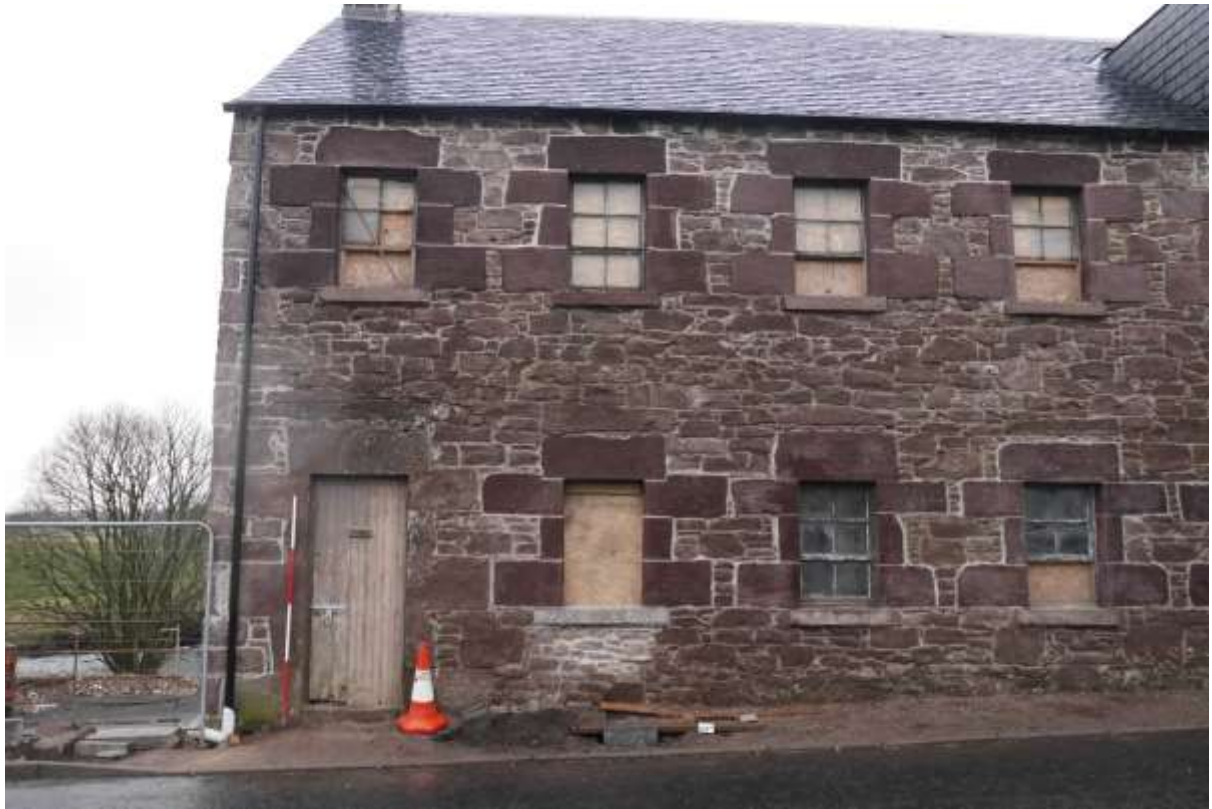
Illustration 17- Southern end of North Eastern elevation showing windows defined by sandstone blocks.

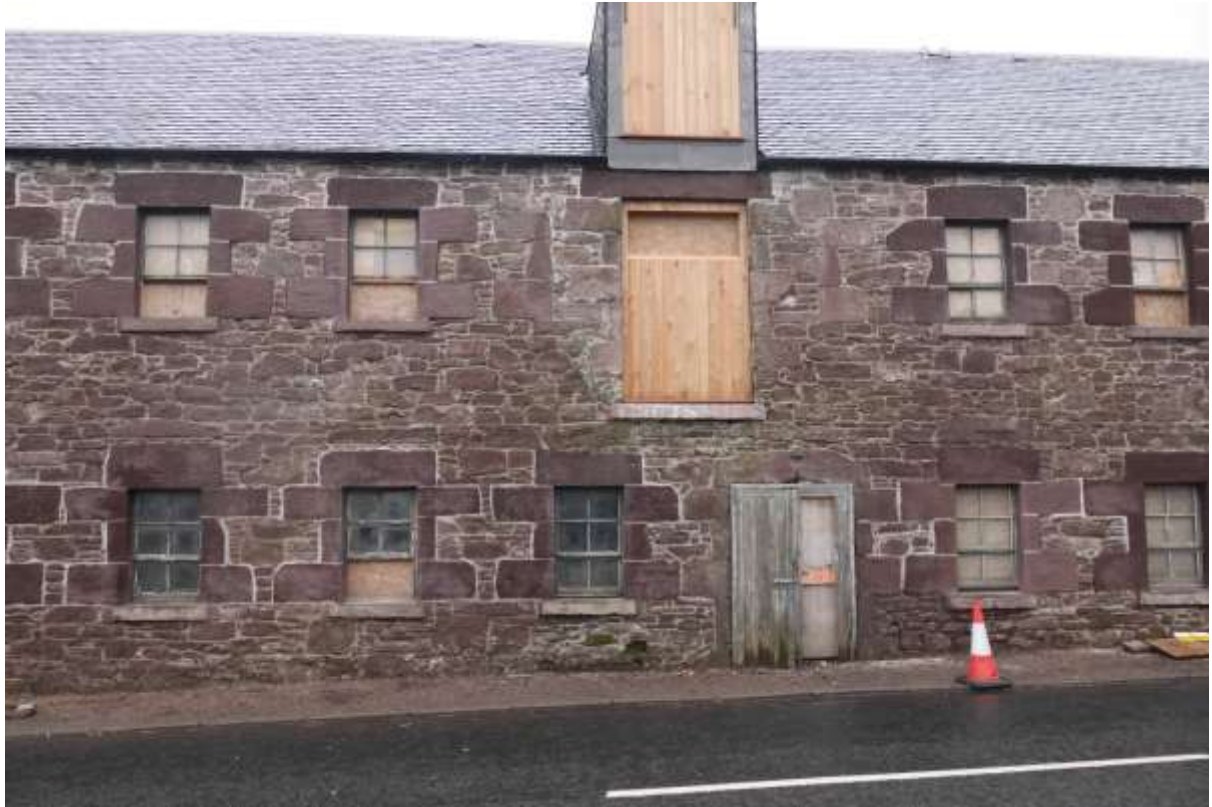
Illustration 18- Centre of North Eastern elevation.

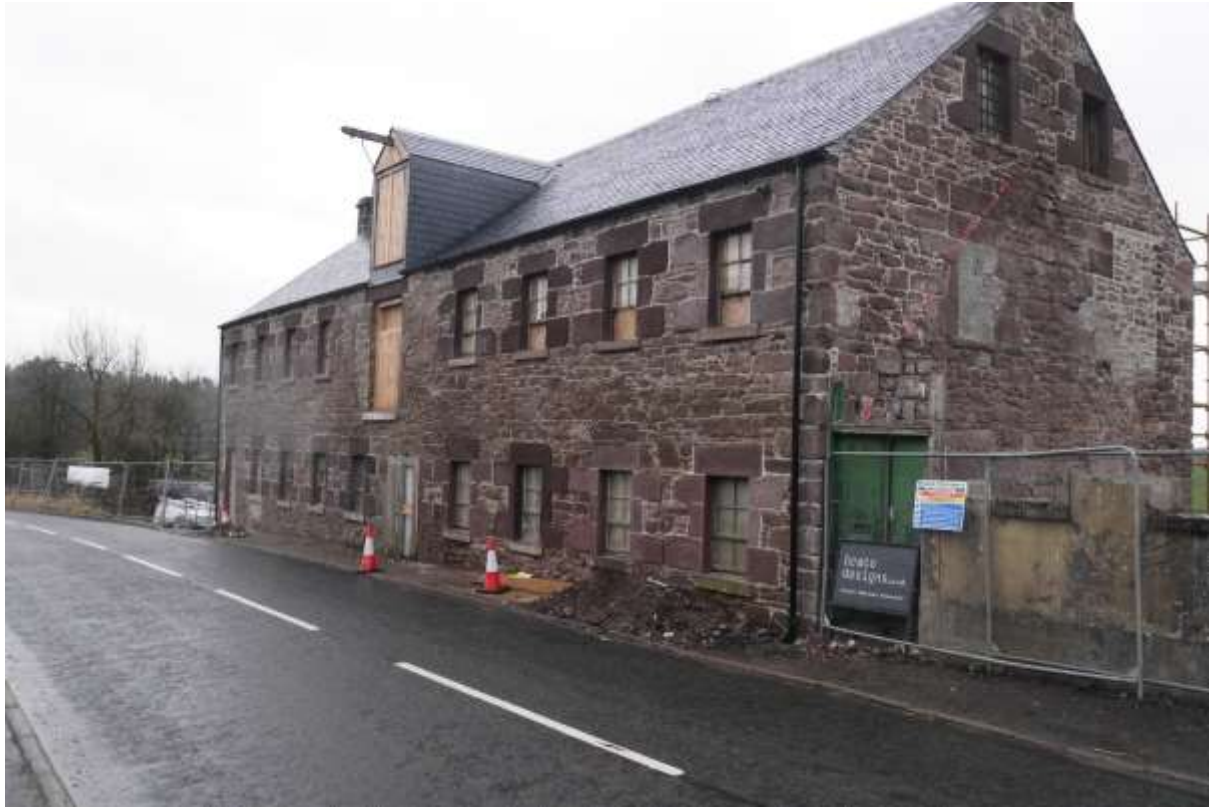
Illustration 19- Northern end of North Eastern elevation

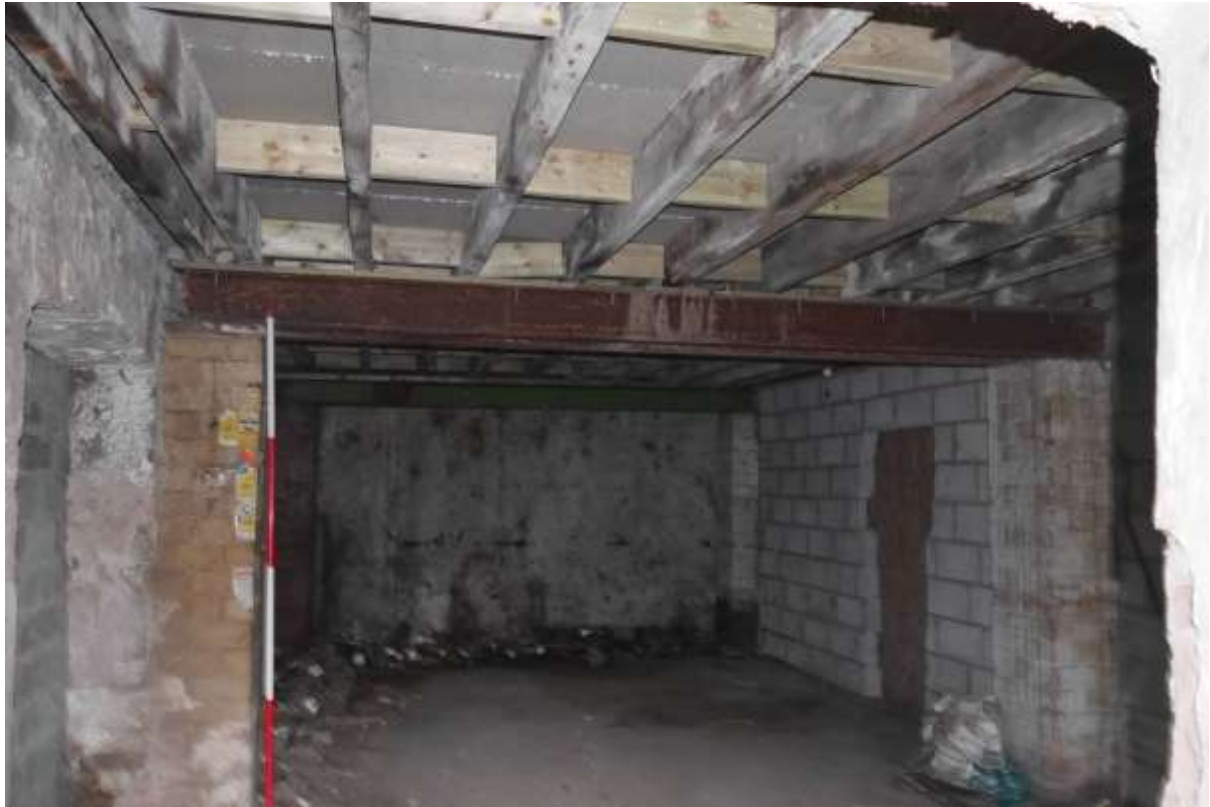
The mill building is in the process of being refurbished for housing and now contains a new attic floor, a new ground floor and a new first floor. The basement floor level contains brick support pillars for the ground floor which relate to a previous use of the building.

Illustration 20- Basement floor at Northern end of mill building looking East.

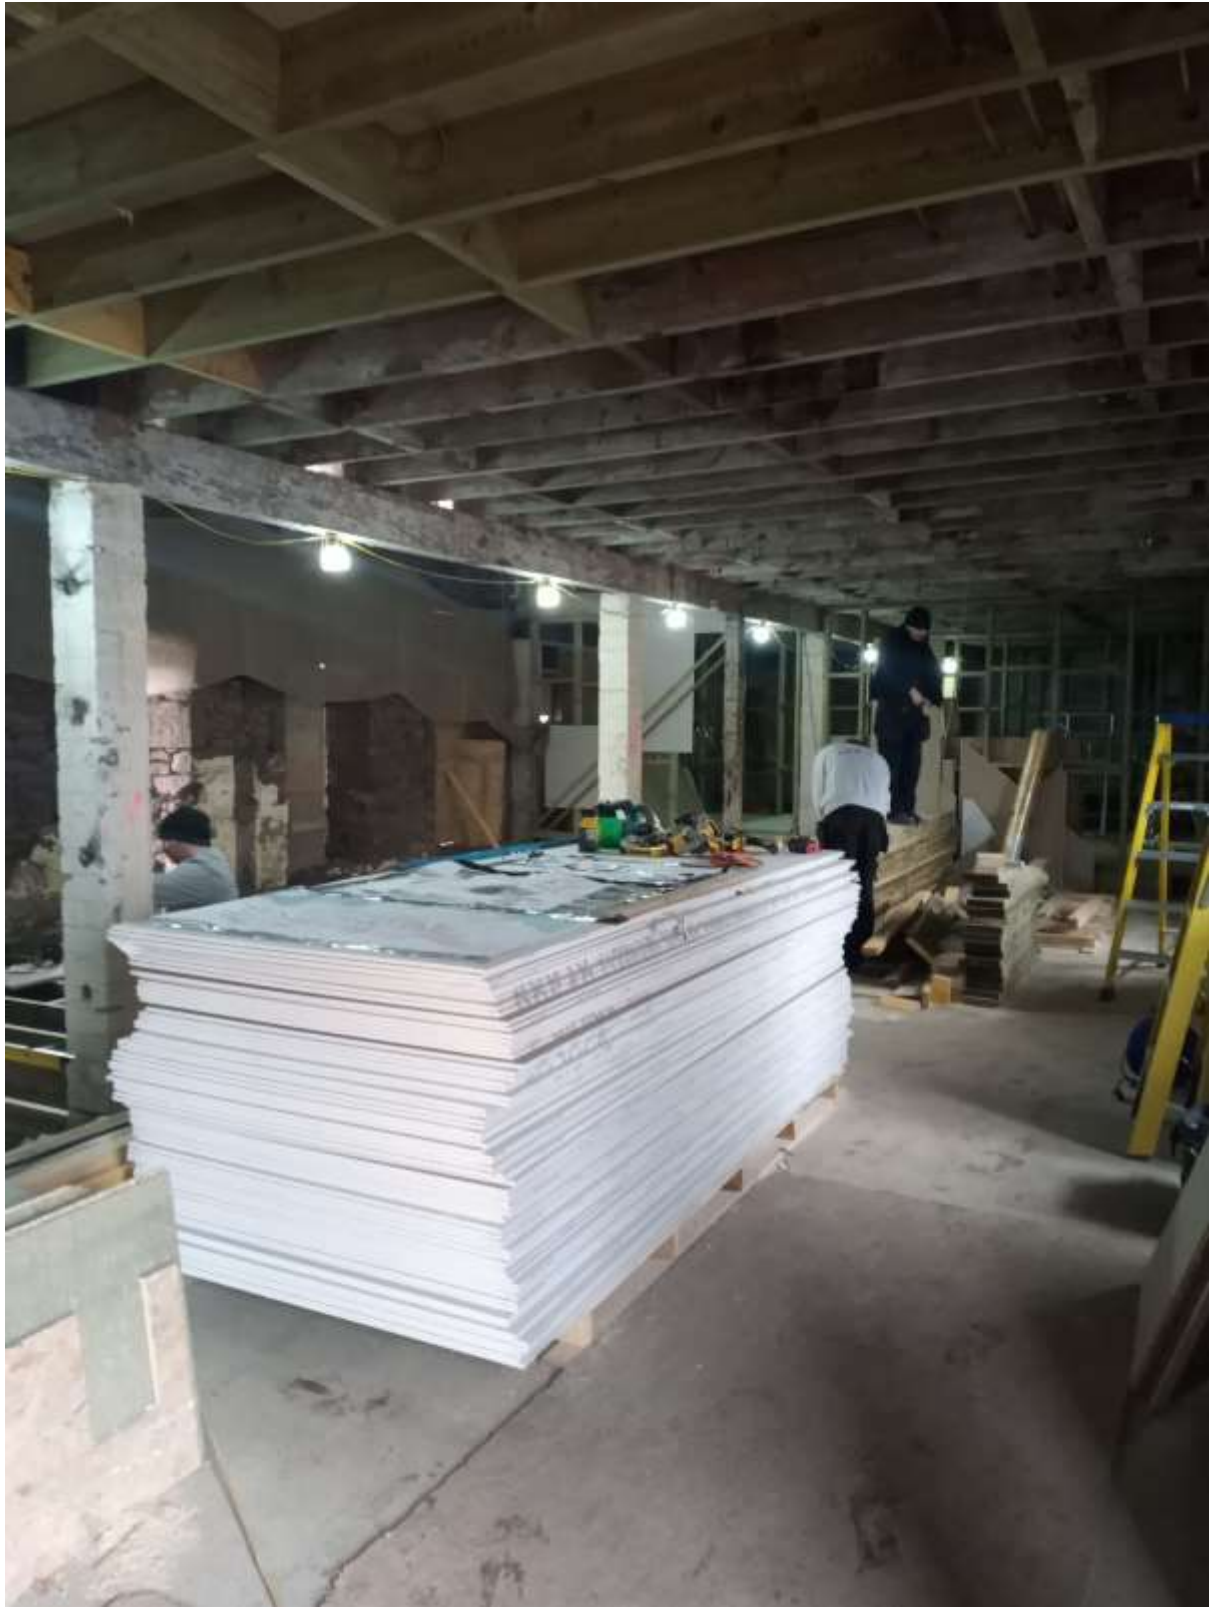
Illustration 21- Ground floor of mill building in process of refurbishment looking North West (2021)

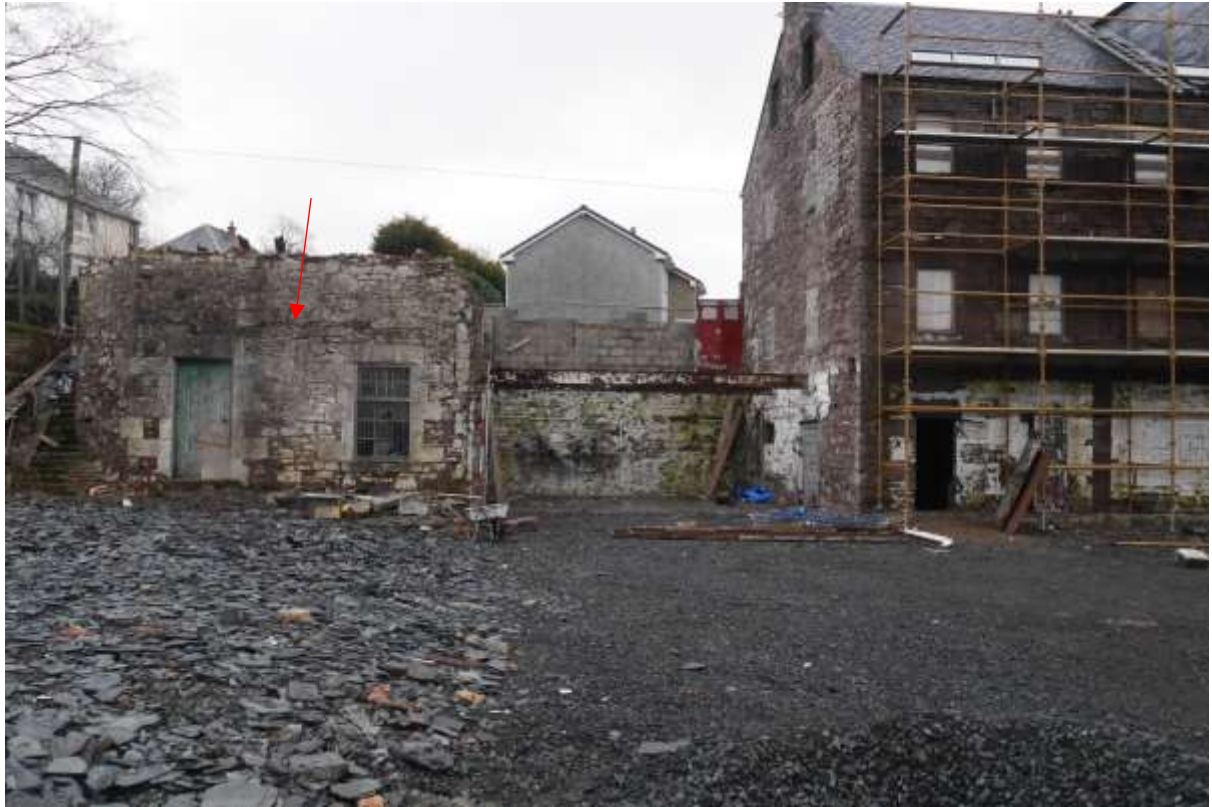
This is built of mortared red sandstone and has a doorway in its South Eastern elevation with a wooden door. Its South Western elevation contains a doorway with a wooden door and a glazed window. Its North Western elevation is slightly angled, and a flight of stairs lead up to the road level in front of it.

Illustration 22- Small building on North West side of mill building (red arrow).

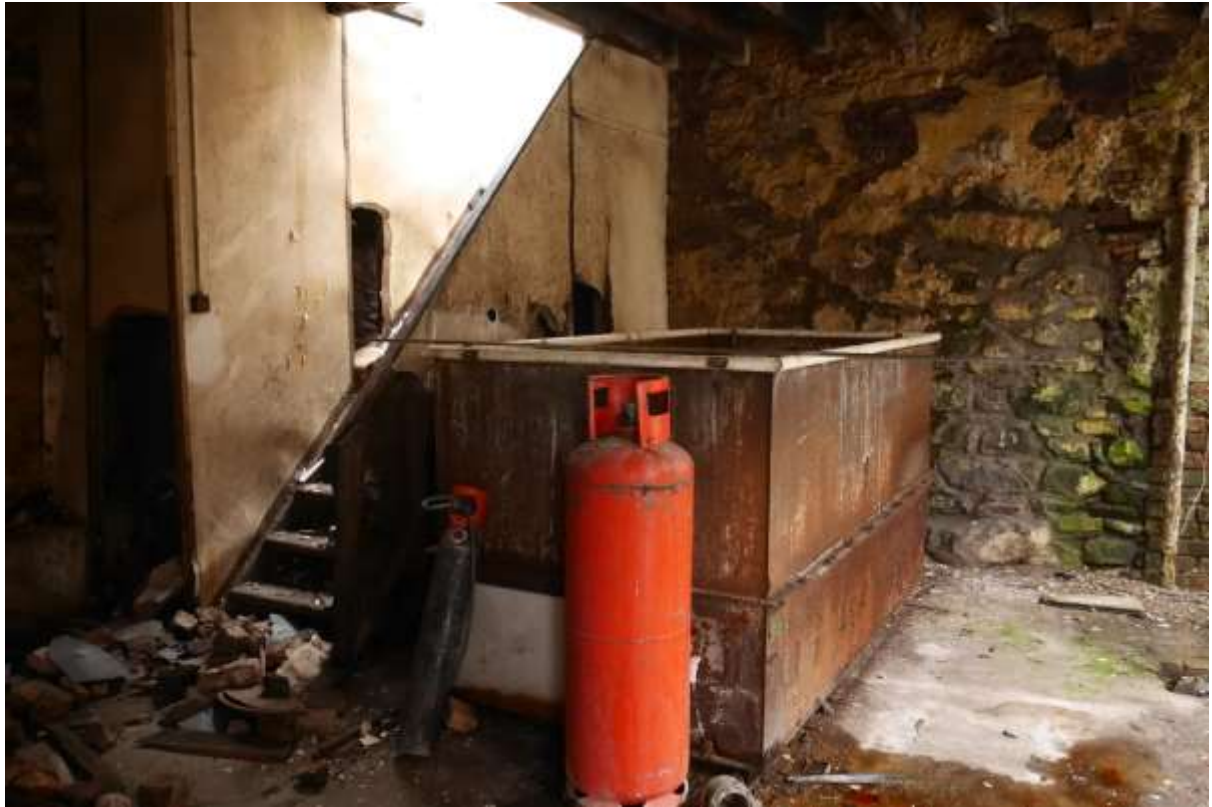
The single room inside is accessed by a staircase that leads up to a doorway in its North Eastern elevation. It contains a cupboard under these stairs and a large cast iron tank of uncertain function.

Illustration 23- Interior of small building showing cast iron tank and flight of stairs to door access from road.
