Standing Building Survey

Dunsinane, Station Road, Murthly

27th May 2021

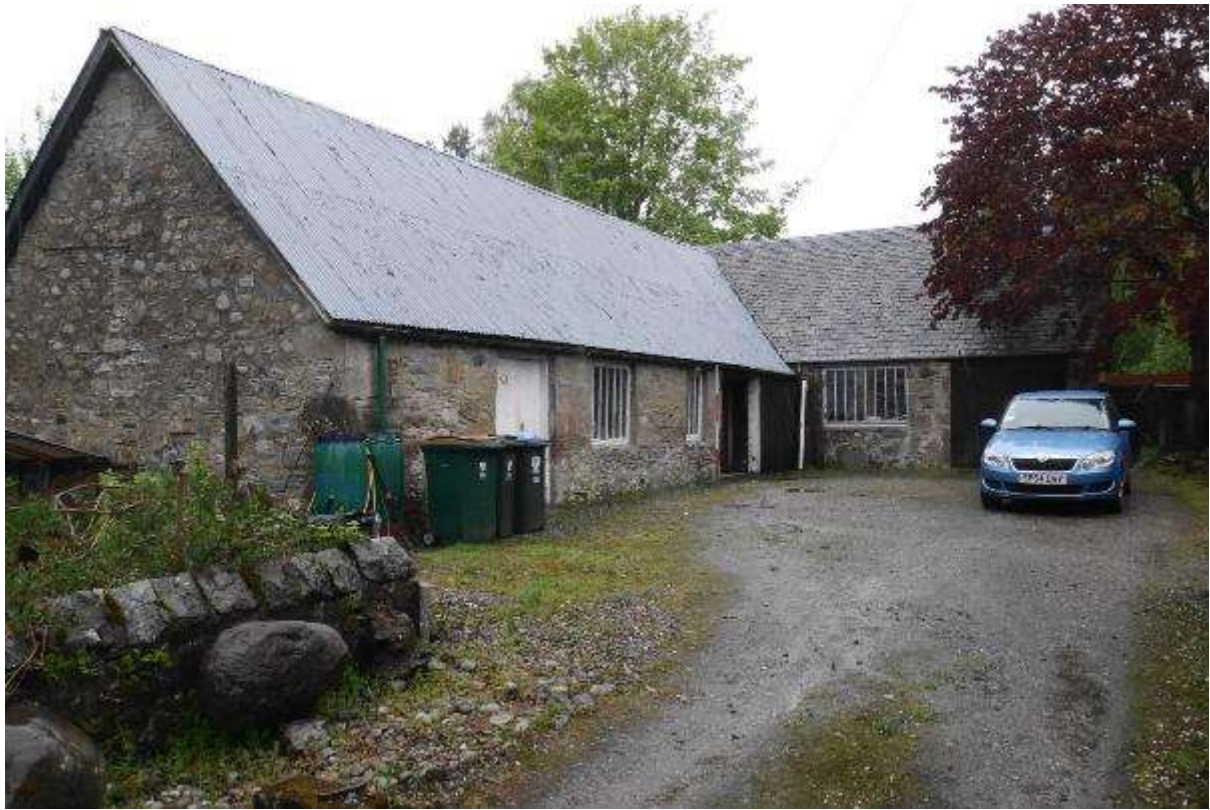
Aligned North to South the building is roofed with corrugated iron sheets painted light blue grey and is built of mortared green sandstone.

Illustration 4- Buildings 1 and 2 at Dunsinane, Station Road, Murthly looking North West.

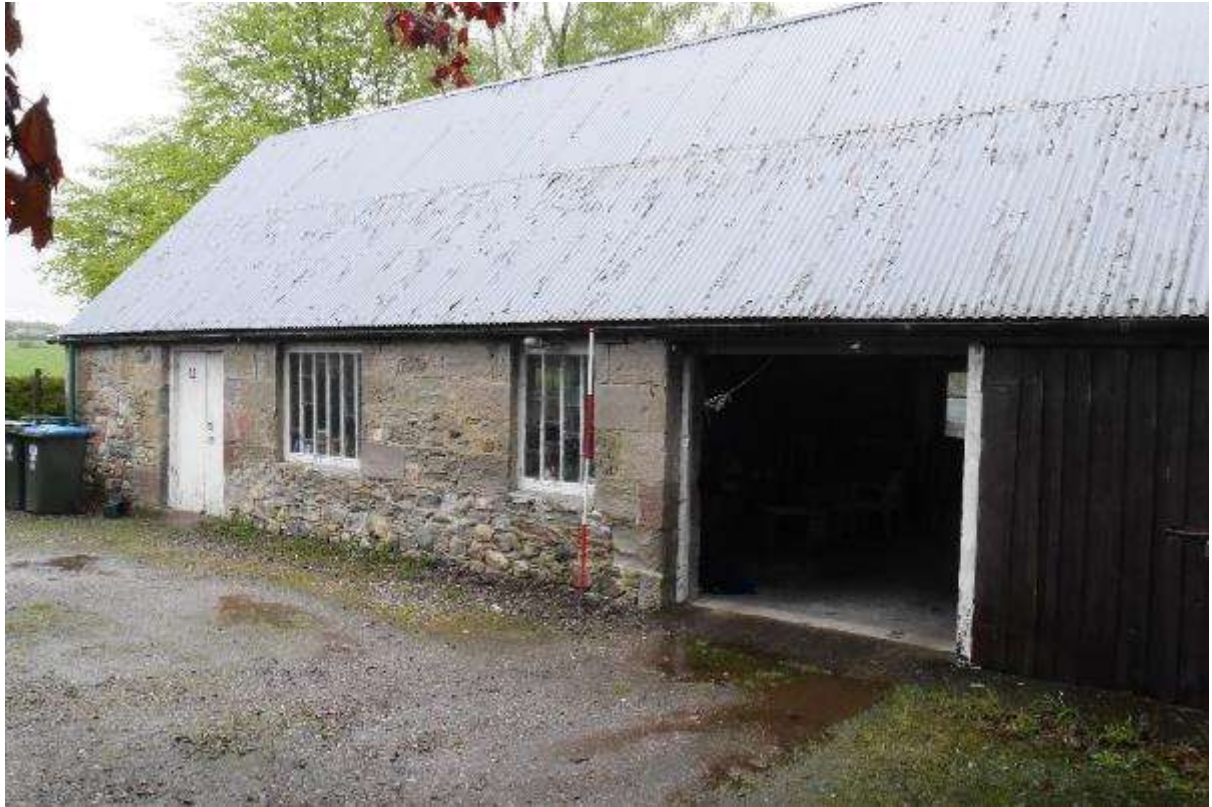
The lower courses of this wall face are built of mortared rough green sandstones, the middle courses and the windows and doorways are defined using cut green sandstone slabs. From the South end there is a doorway with a wooden door, a window with overlapping single panes of glass defined by vertical 'muntins', another window of a similar style, an open doorway and another wide doorway with double wooden doors.

Illustration 5- Eastern elevation of Building 1 looking South West.

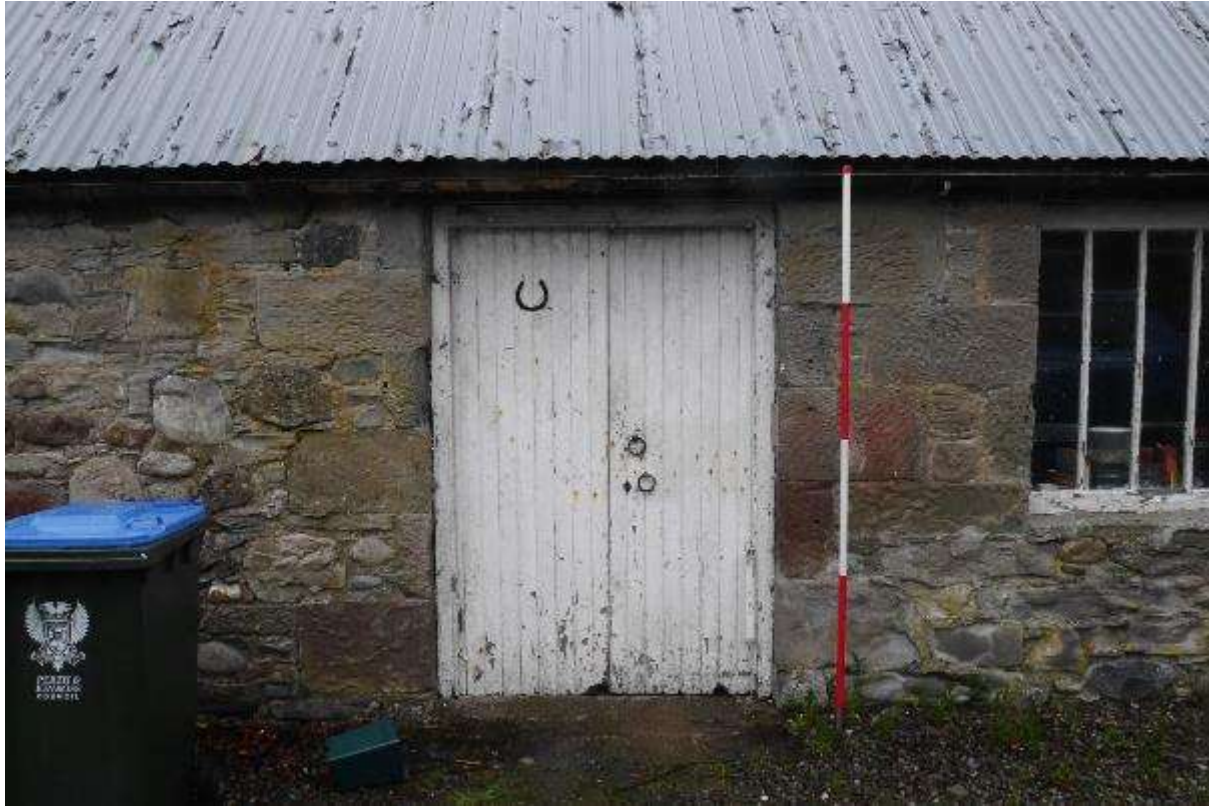
Illustration 6- Doorway at Southern end of Eastern elevation of Building 1.

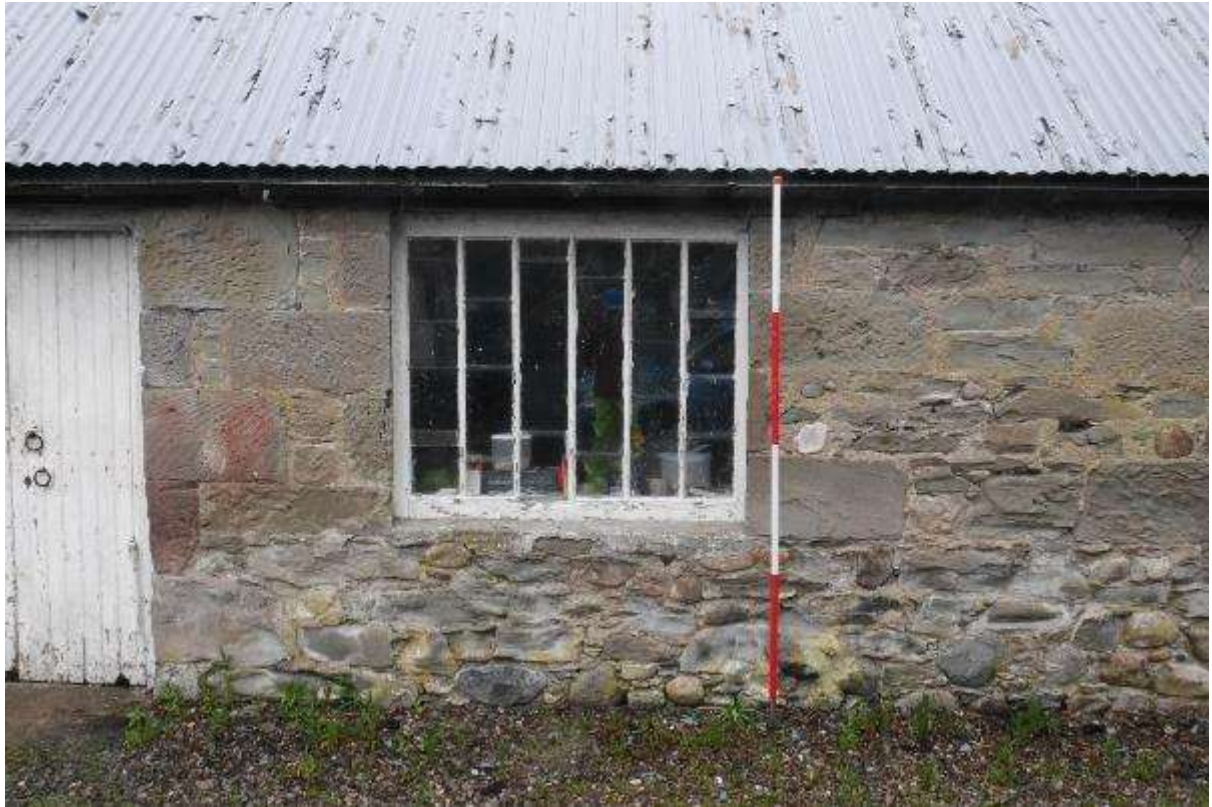
Illustration 7- Window in Eastern elevation of Building 1.

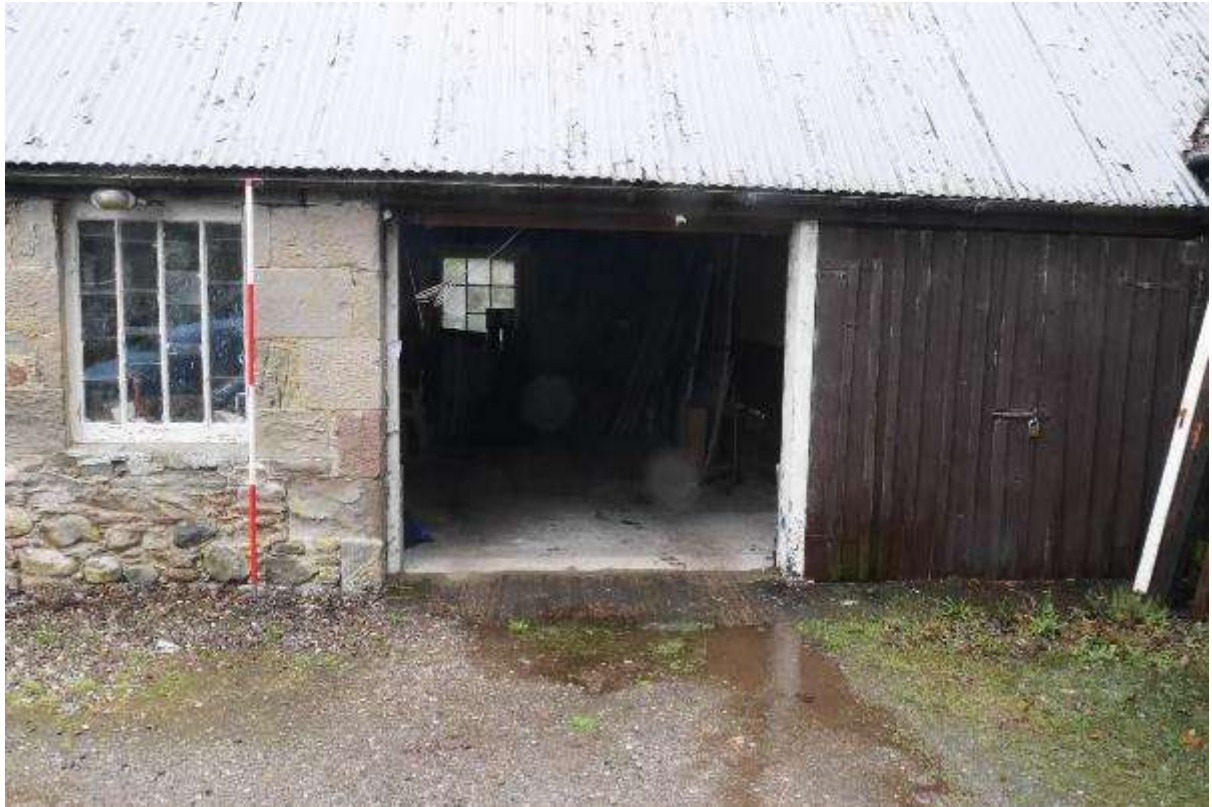
Illustration 8- Window and doorways at Northern end of Eastern elevation of Building 1.

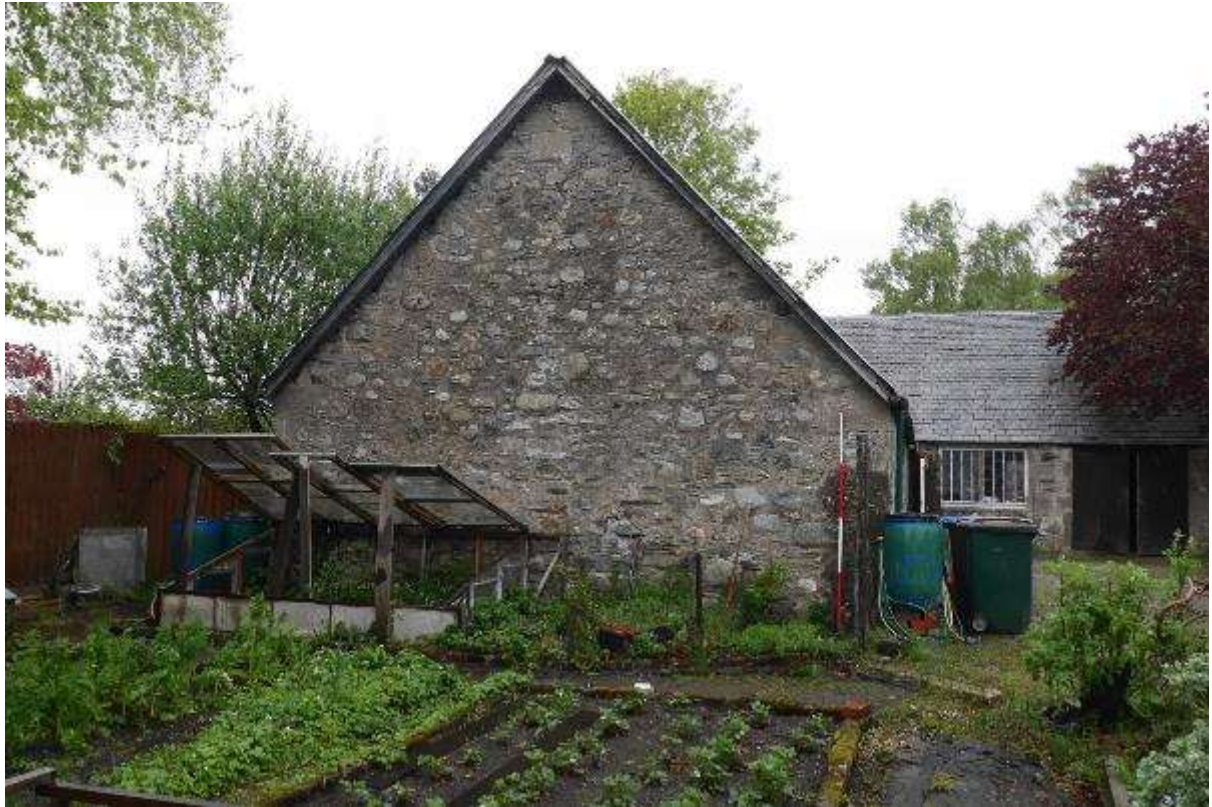
This a gable end and is built of mortared green sandstone it is a blank wall face.

Illustration 9- Southern gable elevation of Building 1 looking North.

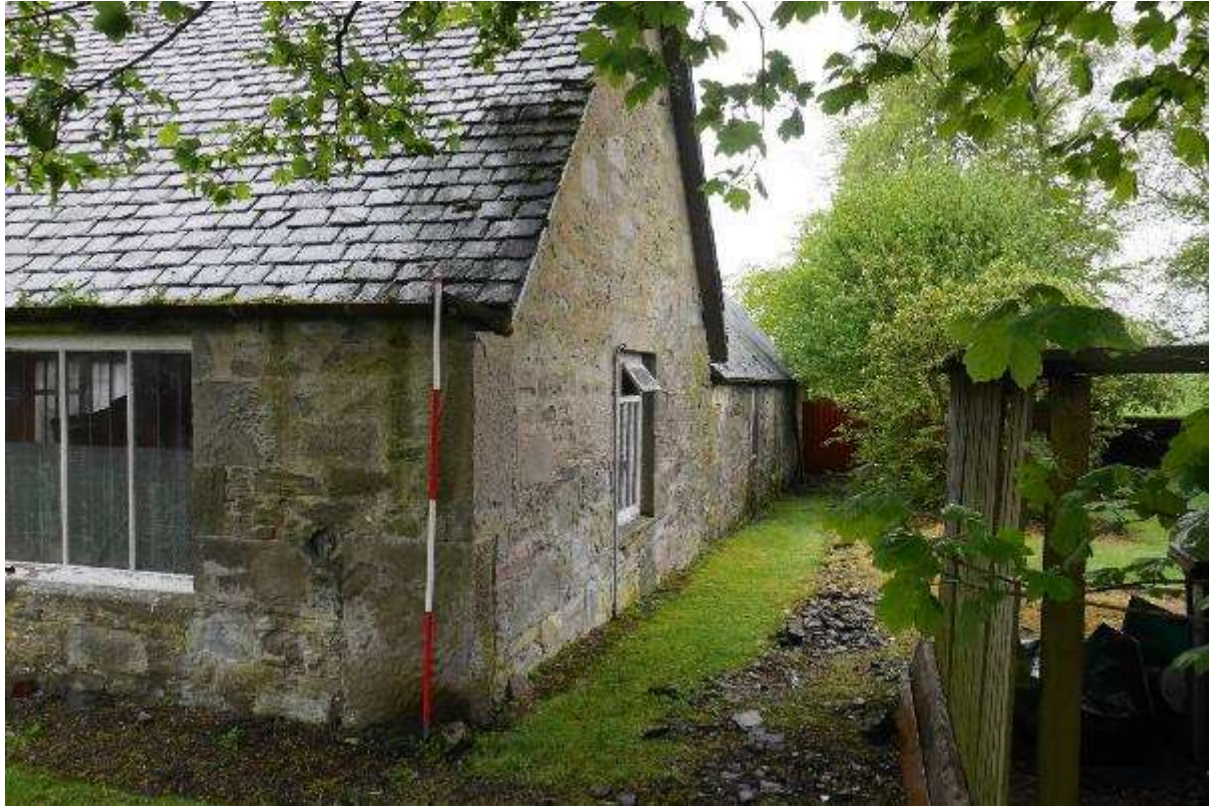
This is built of mortared green sandstone. From the North there is a window with nine separate panes of glass defined by vertical and horizontal wooden bars and then another window with individual overlaid panes of glass between vertical 'muntins'. This elevation joins with the West elevation of Building 2 and both seem integral.

Illustration 10- West facing external elevations of Buildings 1 and 2 looking South.

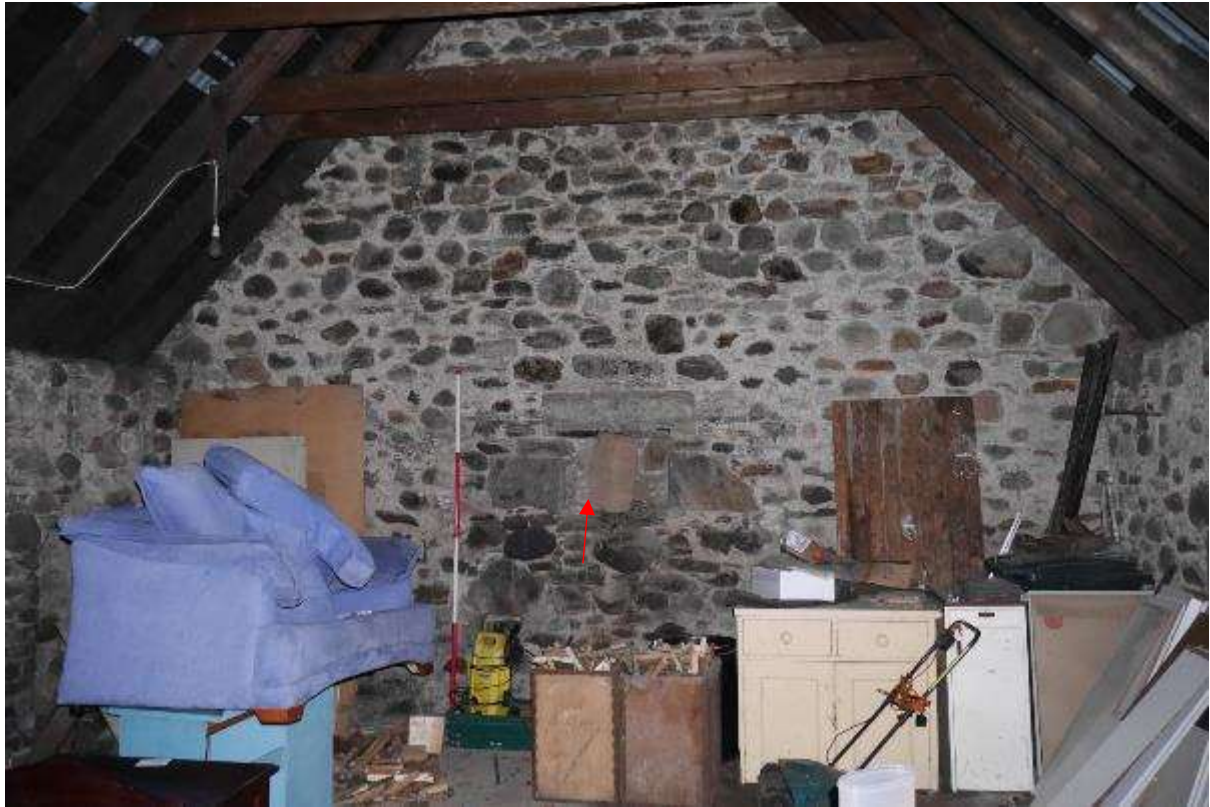
This is built of mortared rough sandstones and contains a small fireplace/hearth that measures 0.45m by 0.62m and is 0.20m deep. The hearth/fireplace sits 1.30m above the floor level.

Illustration 11- North facing internal elevation of Building 1 showing hearth/fireplace in wall (red arrow).

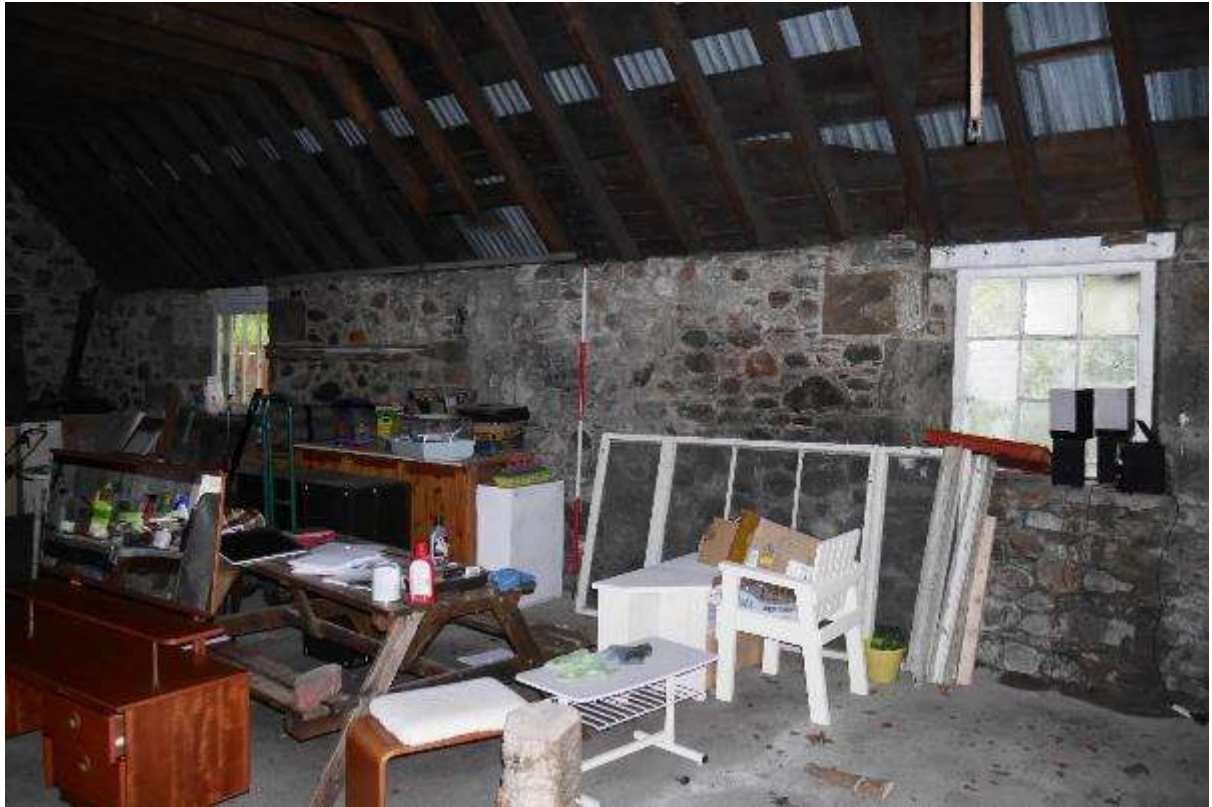
This is built of mortar bonded rough sandstones and contains two windows with glazed wooden frames.

Illustration 12- Internal East facing elevation of Building 1.

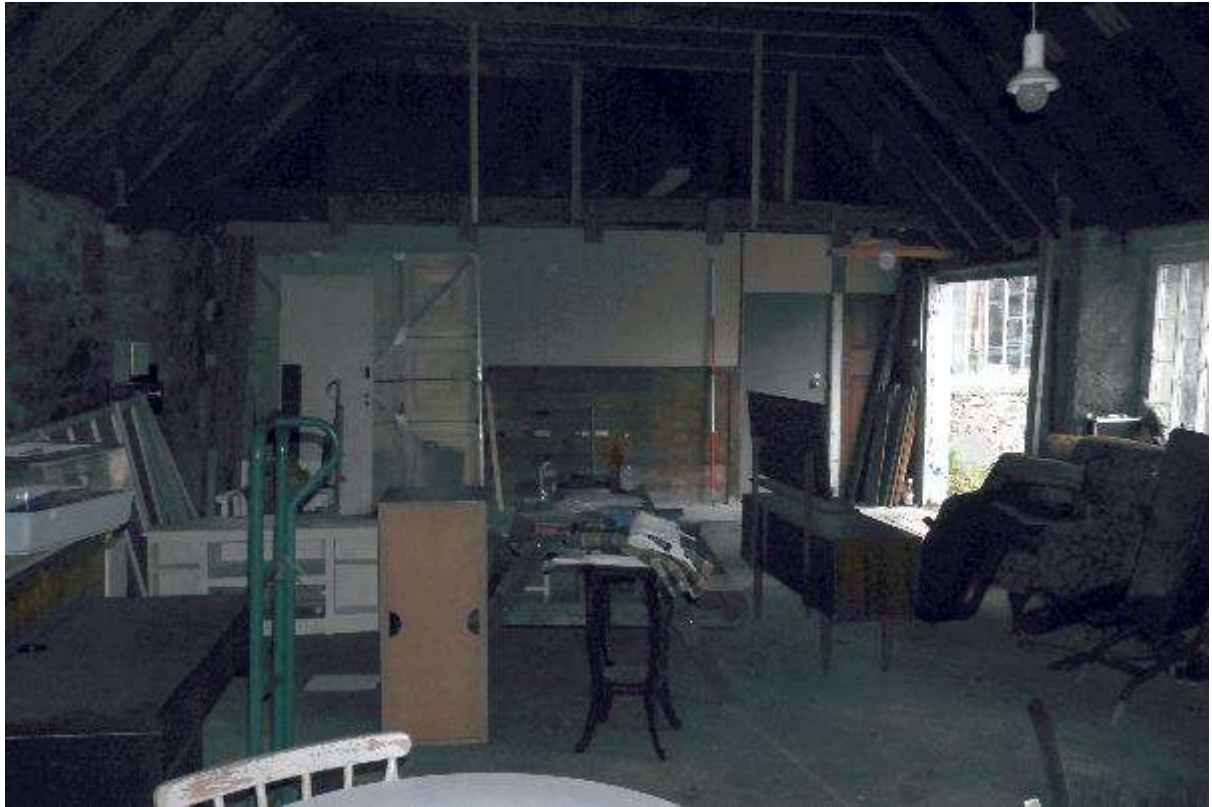
This is built of wooden panelling and contains a wooden door.

Illustration 13- Internal South facing wooden partition wall in Building 1.

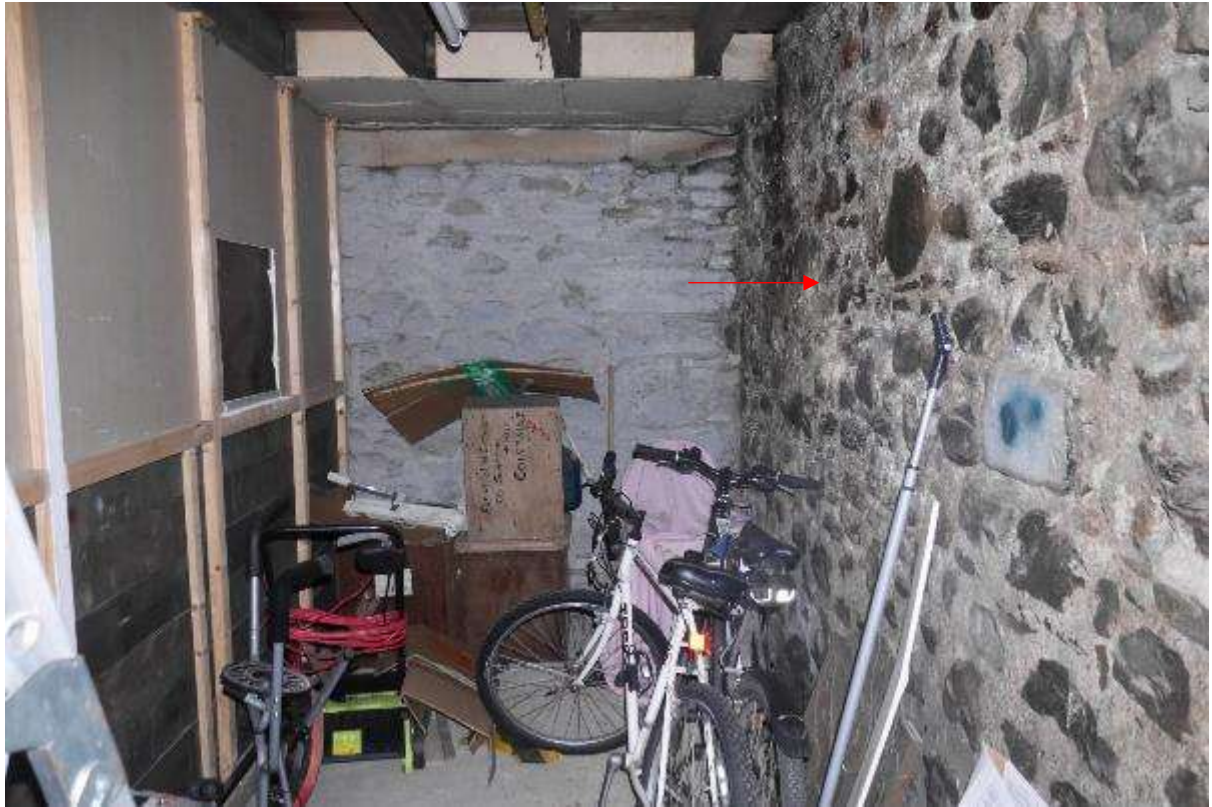
This is built of mortar bonded rough sandstones and has a cupboard built of concrete breeze blocks built into it. The wall face is blank.

Illustration 14- South facing internal elevation of Building 1 (red arrow).

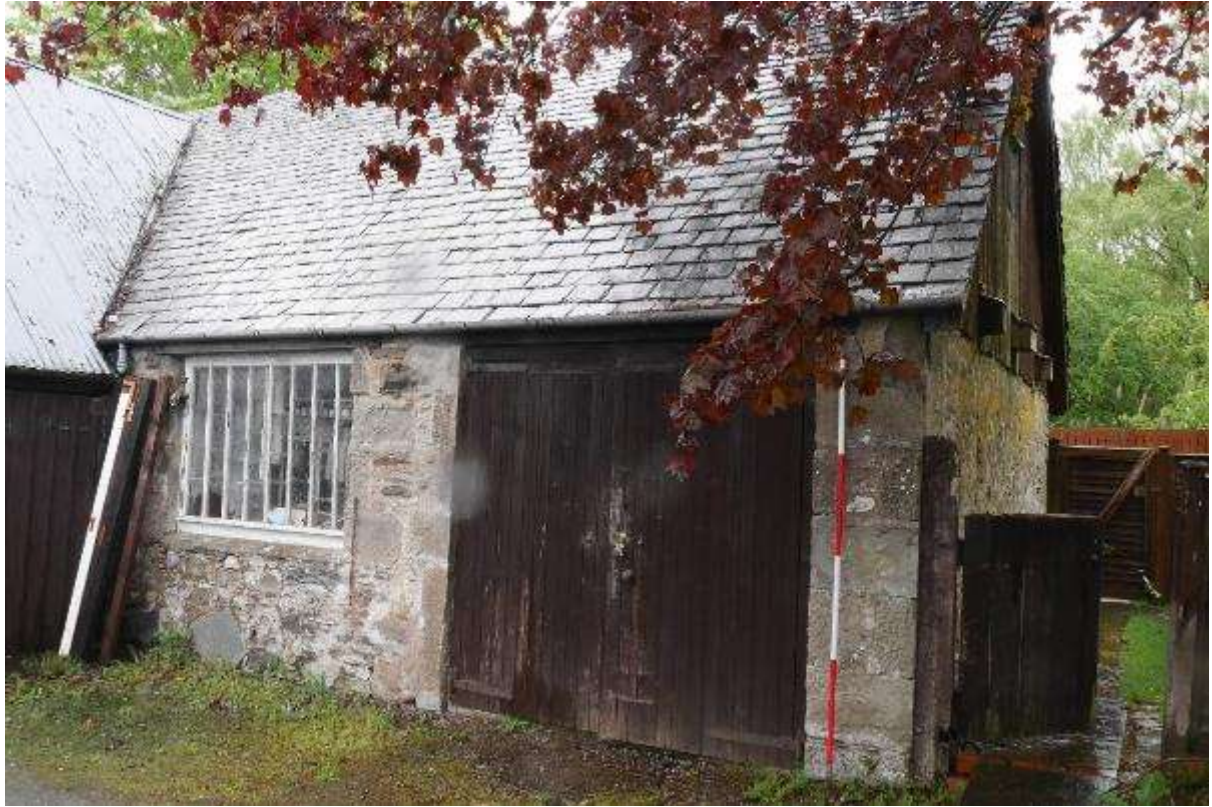
The lower courses of this wall face are built of mortared rough green sandstone, the middle courses and the window are defined using cut green sandstone. The Eastern corner of this wall face is built of cut sandstone blocks. The single window is large and glazed with a concrete sill and there is a doorway with a wooden door.

Illustration 15- South facing external elevation of Building 2 looking North.

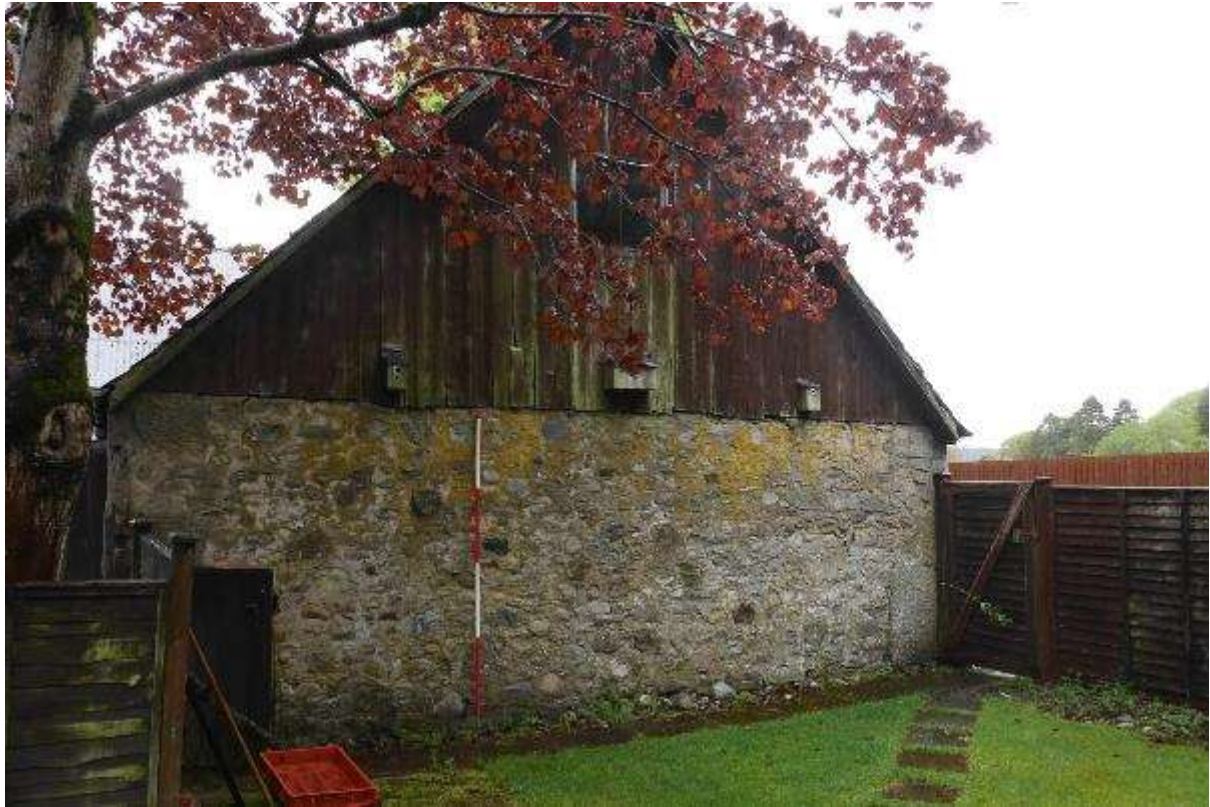
This is a gable end and is half built of mortared green sandstone and wooden planking. There is a single glazed window at attic floor level.

Illustration 16- East facing external elevation of Building 2 looking North West.

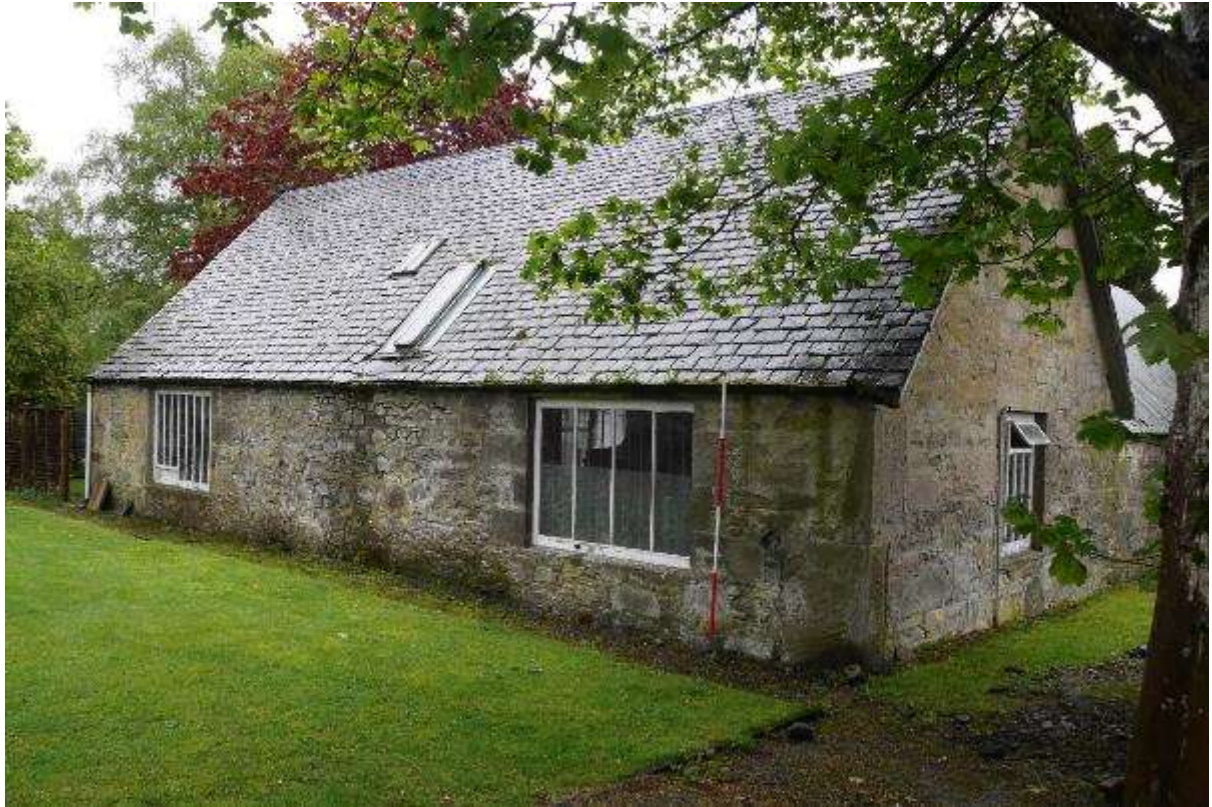
This is built of mortared green sandstone with large cut sandstone quoins at its Eastern and Western ends. It contains a glazed window at its Eastern end and a glazed window at its Western end both of which are defined by green sandstone blocks.

Illustration 17- North facing external elevation of Building 2 looking South East.

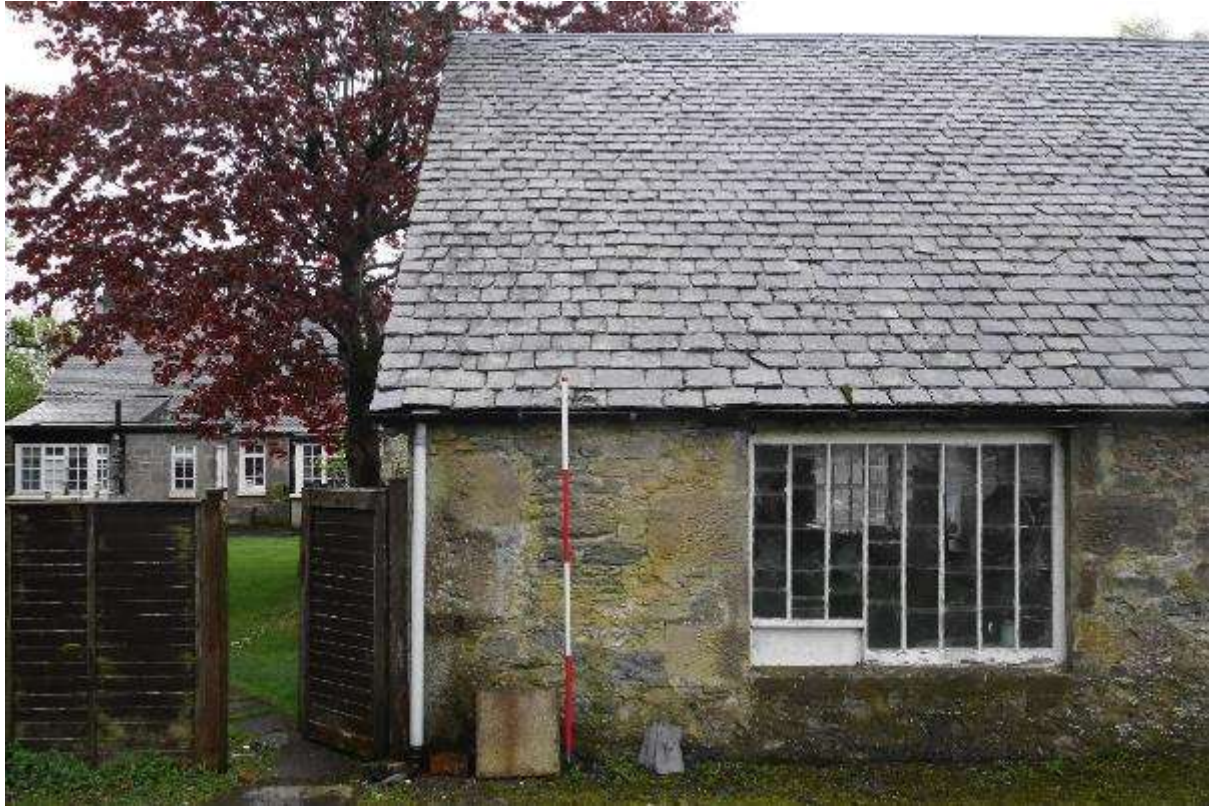
Illustration 18- Eastern end of Northern elevation of Building 2 looking South.

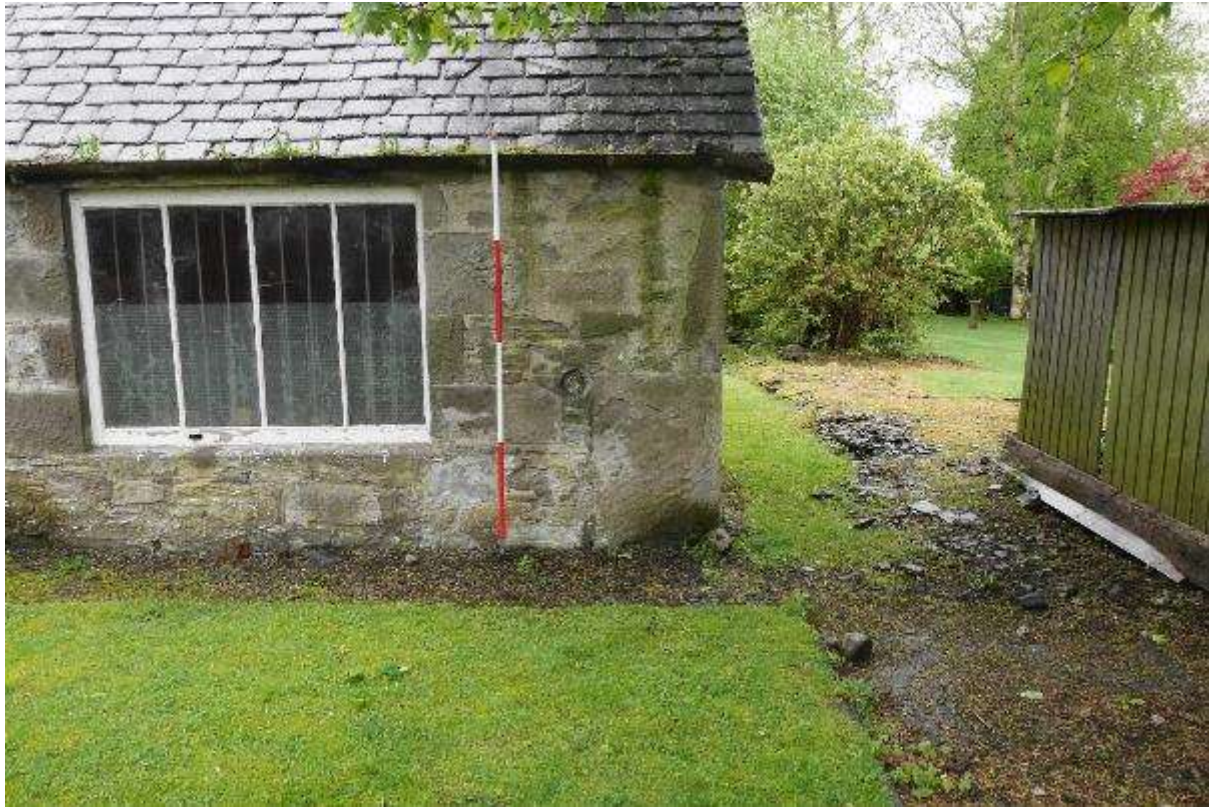
Illustration 19- Western end of North facing elevation of Building 2 looking South.

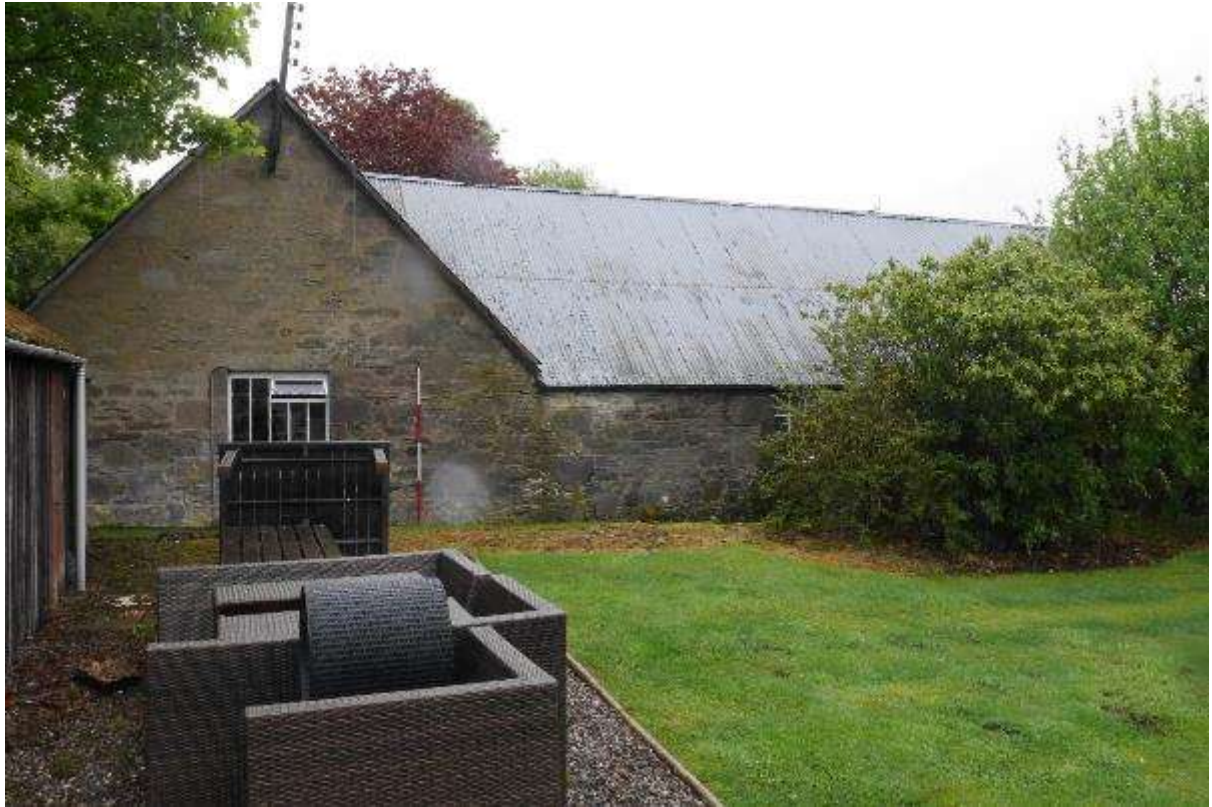
This is built of mortared green sandstone and contains a single window at ground floor level that is defined by cut green sandstone blocks.

Illustration 20- External West facing elevation of Building 2, junction with Building 1 also visible.

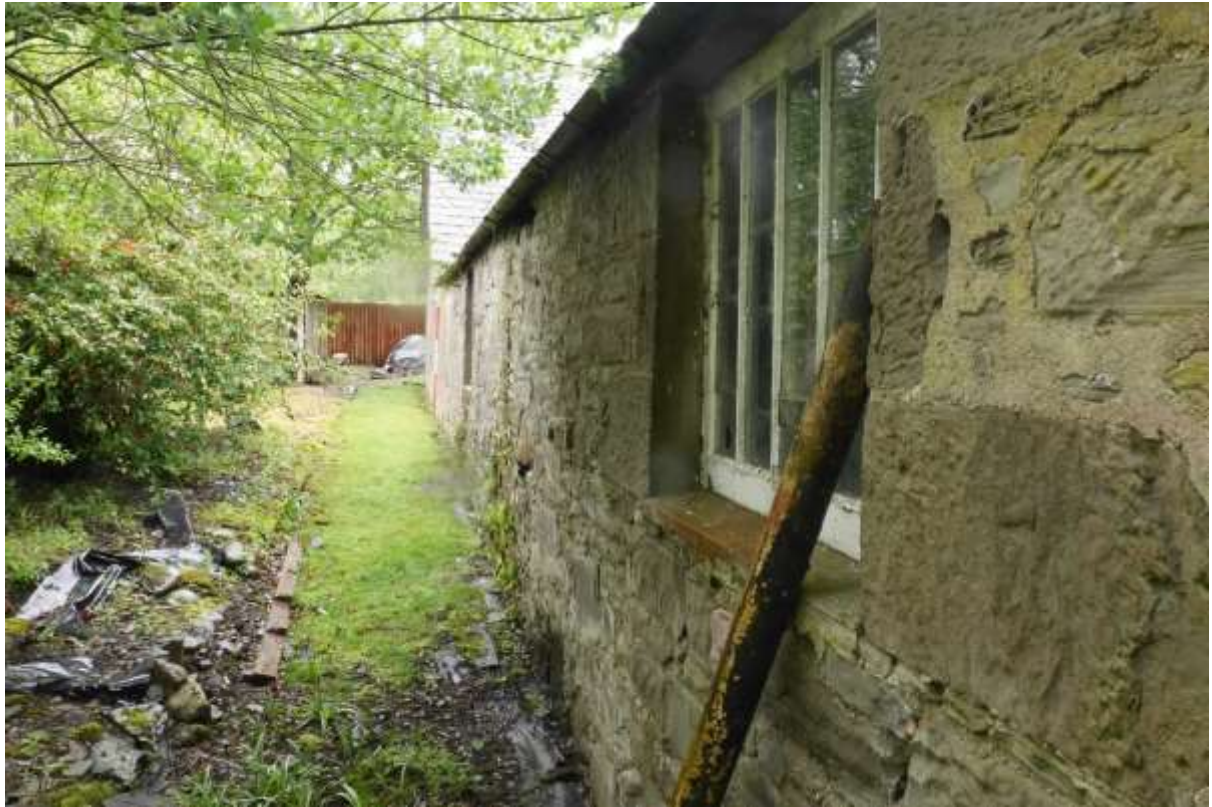
Illustration 21- Southern end of Western external elevation of Building 1 showing window of similar design to those in its external Eastern elevation.

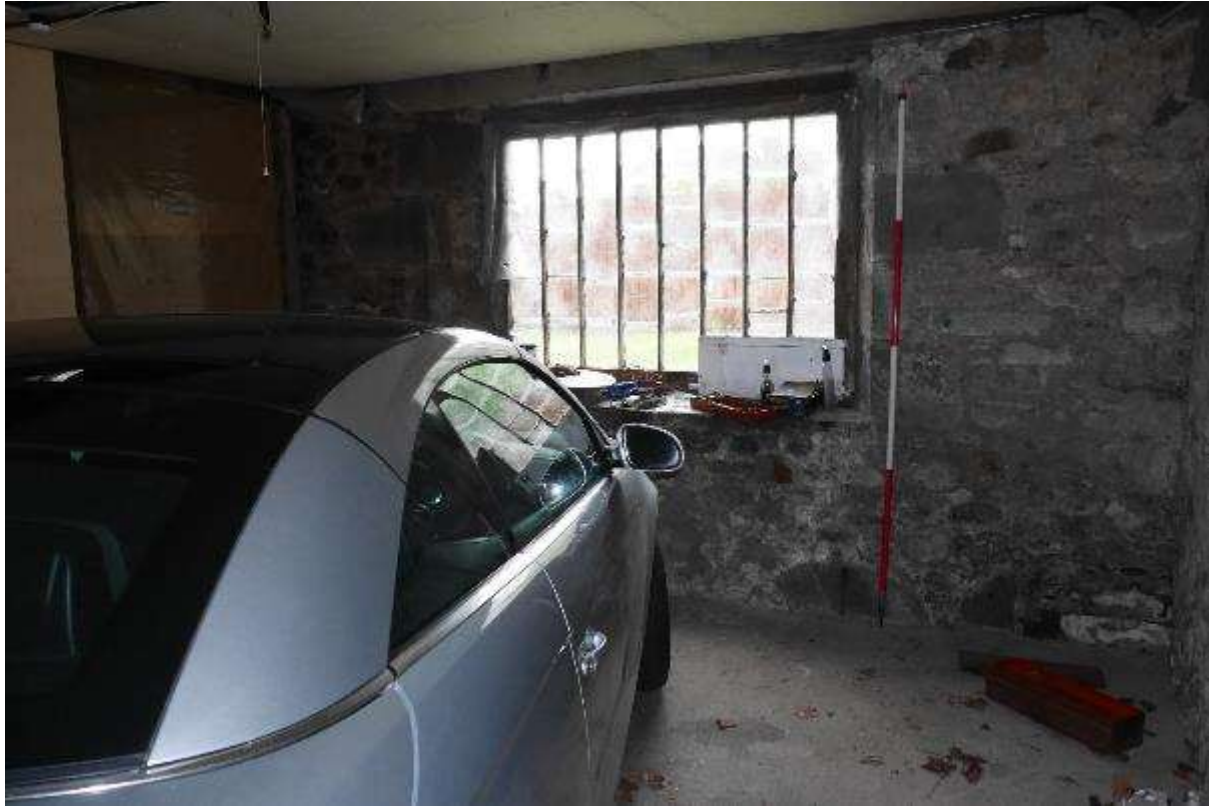
This is a combination of wooden panelling and mortared sandstones at the garage end. There is a glazed window at its Western end and another glazed window at the garage end.

Illustration 22- South facing internal elevation of Building 2 at Eastern end (garage).

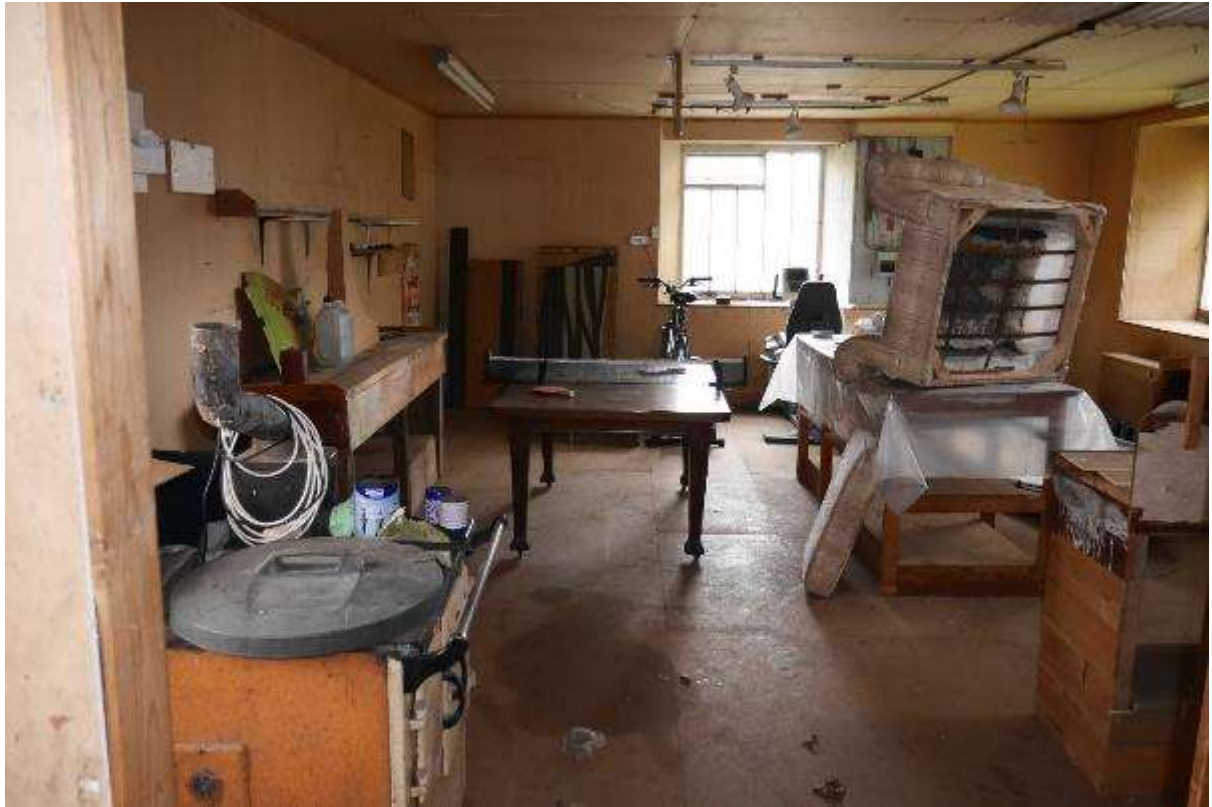
This is wooden panelled and contains a single window with a glazed wooden frame.

Illustration 23- North facing, East facing and South facing internal panelled elevations of Building 2.

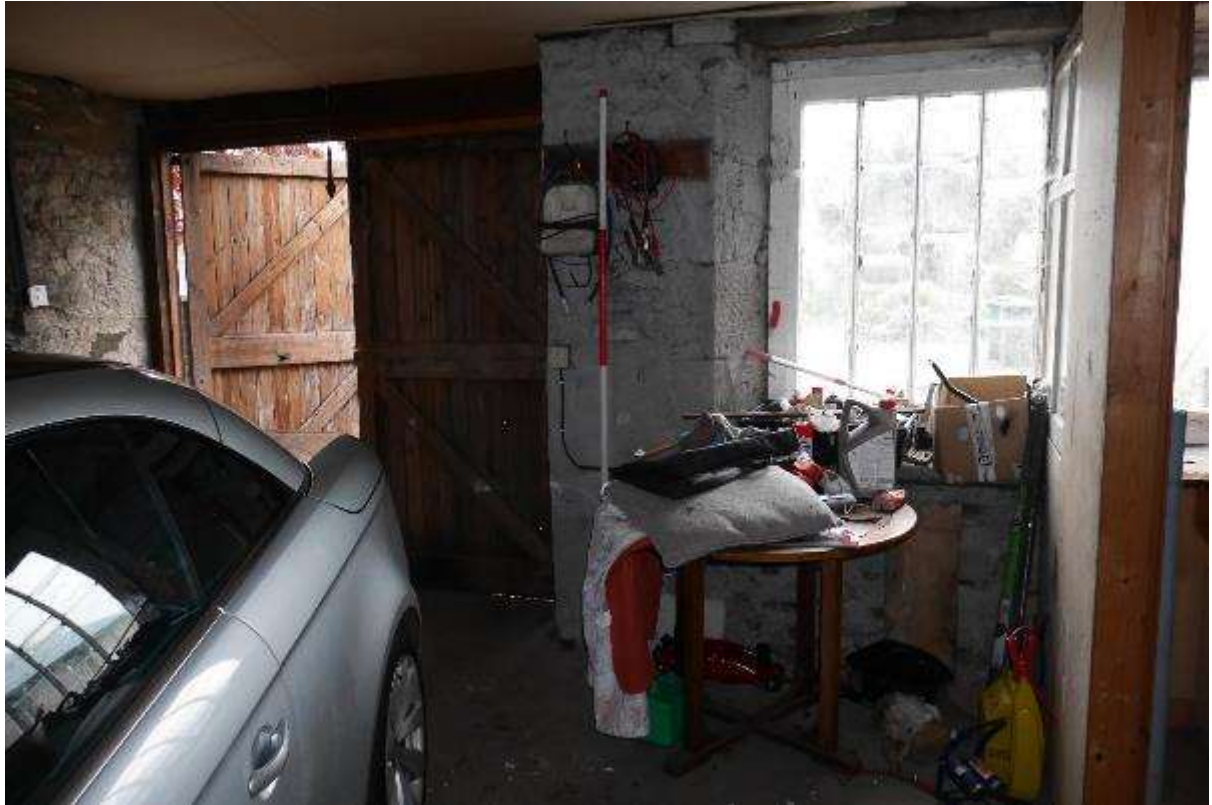
This is a combination of mortared sandstone and wooden panelling. It contains a doorway at its Eastern end and a large glazed window.

Illustration 24- Internal North facing elevation of Building 2 at its Eastern end (garage).

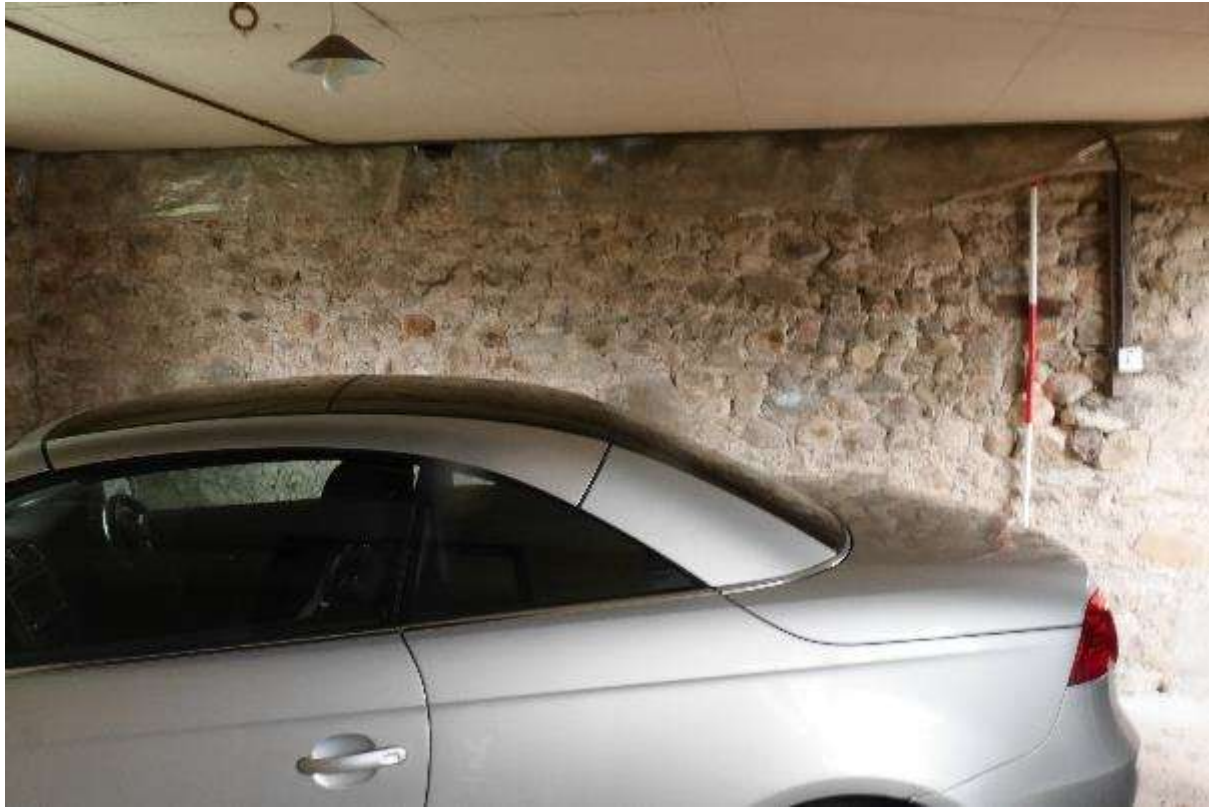
This is built of mortared sandstones and is a blank wall face.

Illustration 25- Internal West facing elevation of Building 2 (garage end).
