Standing Building Survey

Dunsinane, Station Road, Murthly

27th May 2021

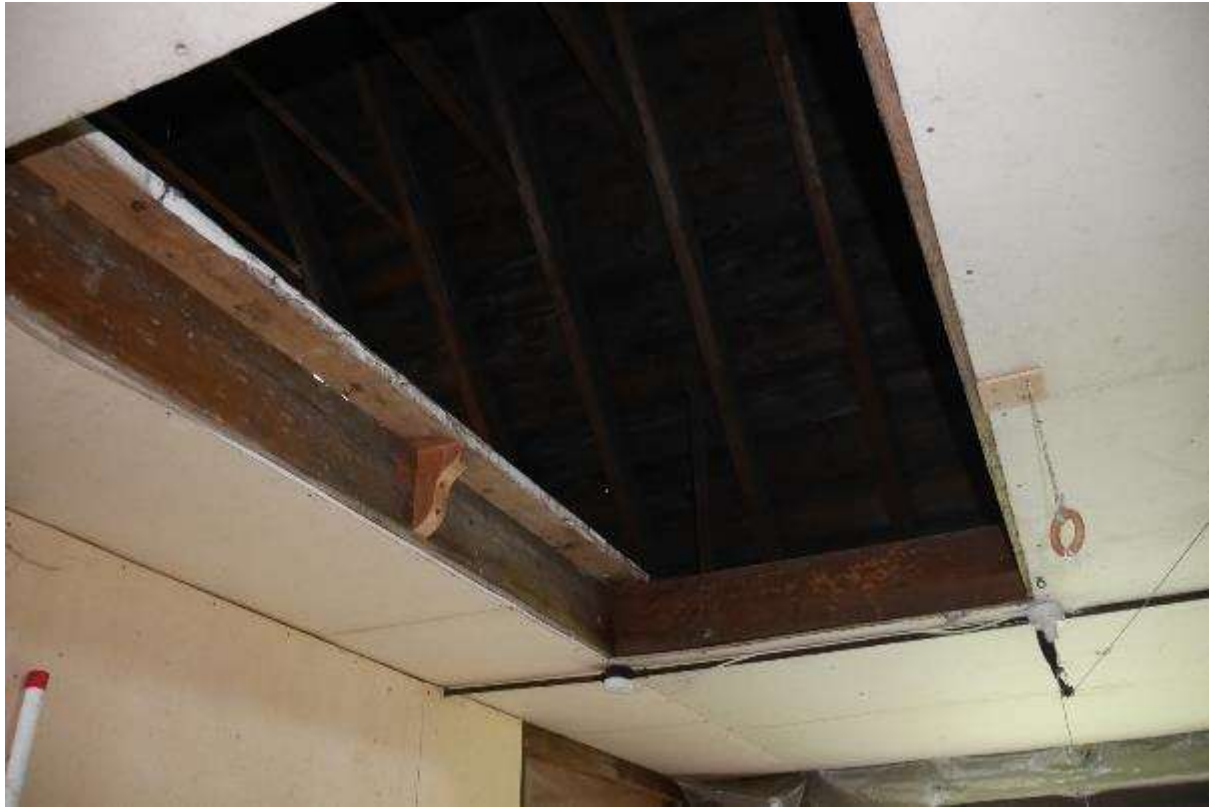
Aligned East to West this has a timber framed roof that is slated. It contains an inaccessible attic space (Illus 26). It is built of mortared green sandstone.

Illustration 26- Access to attic roof space in Building 2.
