Standing Building Survey
Blair Castle (South Wing)
Perth And Kinross Council

Blair Castle (South Wing) looking South East.

16th July 2021

Introduction

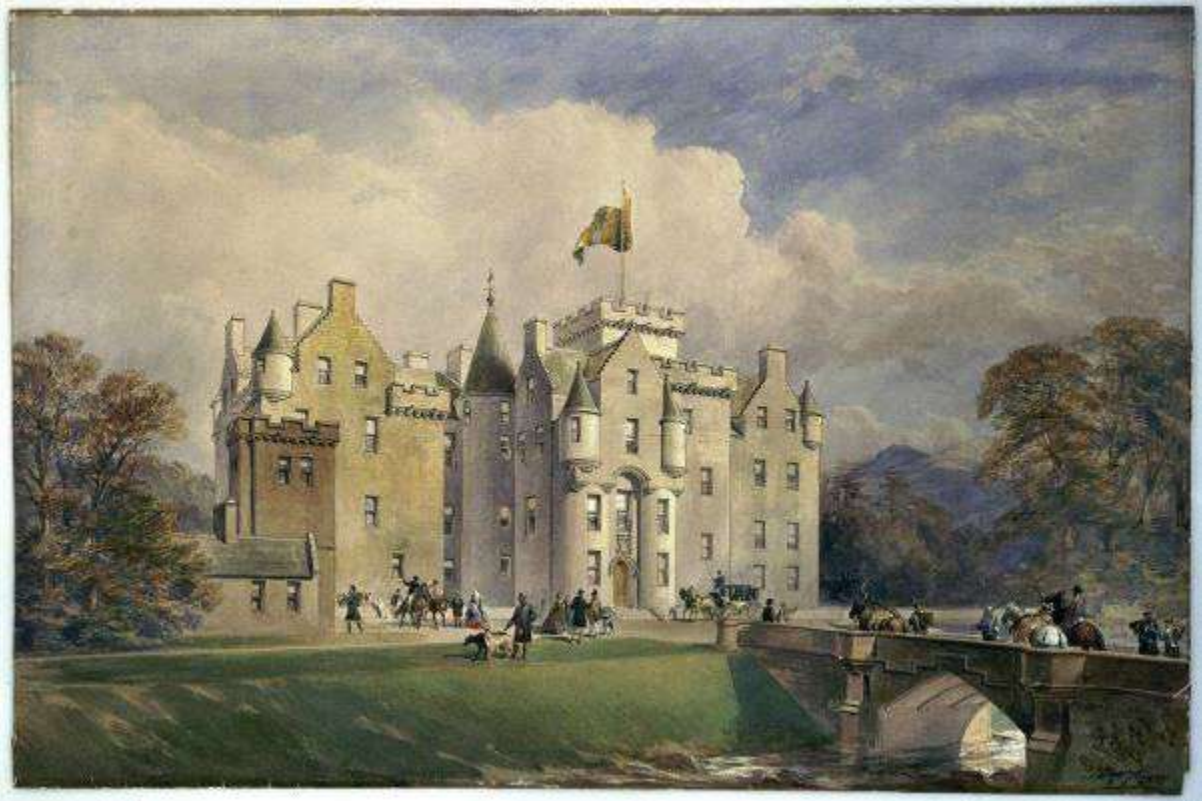
Illustration 4- View of Castle west side looking South East for the first Atholl Gathering in 1846, South Wing visible at red arrow. Note also a small outbuilding of some sort behind the tents, elements of its foundations may remain. Blair Castle Archive (BCA).

Illustration 4- View of Castle west side looking South East for the first Atholl Gathering in 1846, South Wing visible at red arrow. Note also a small outbuilding of some sort behind the tents, elements of its foundations may remain. Blair Castle Archive (BCA).

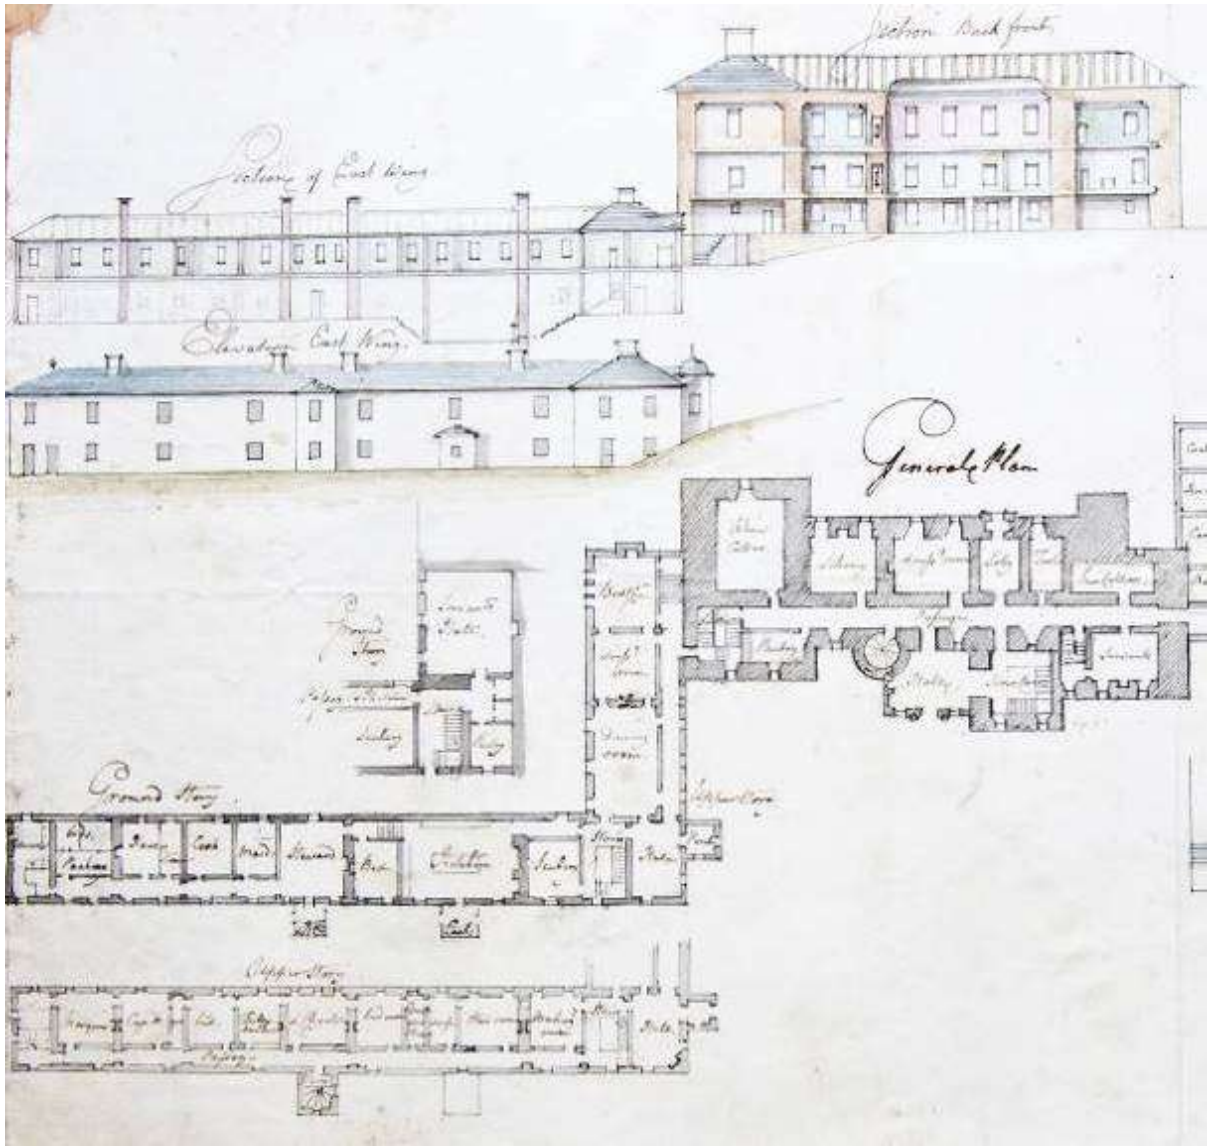
Illustration 7- Atholl House Copy of Ground Floor Plan of new building 1740 BCA.

The plans for the complete rebuilding of a new house by John Douglas (c. 1709-1778) were unable to be found, and we wonder whether in fact they arise from a confusion on the part of those writing "The Buildings of Scotland" as the drawings we found in the Archive are separately named and could be confusing. Therefore, whether this scheme, or another by James Winter or even some other design was started by building this 51-metre-long wing is not certain, but in 1743 the wing's main volume as it now stands was built. It is shown in Illustration 7.

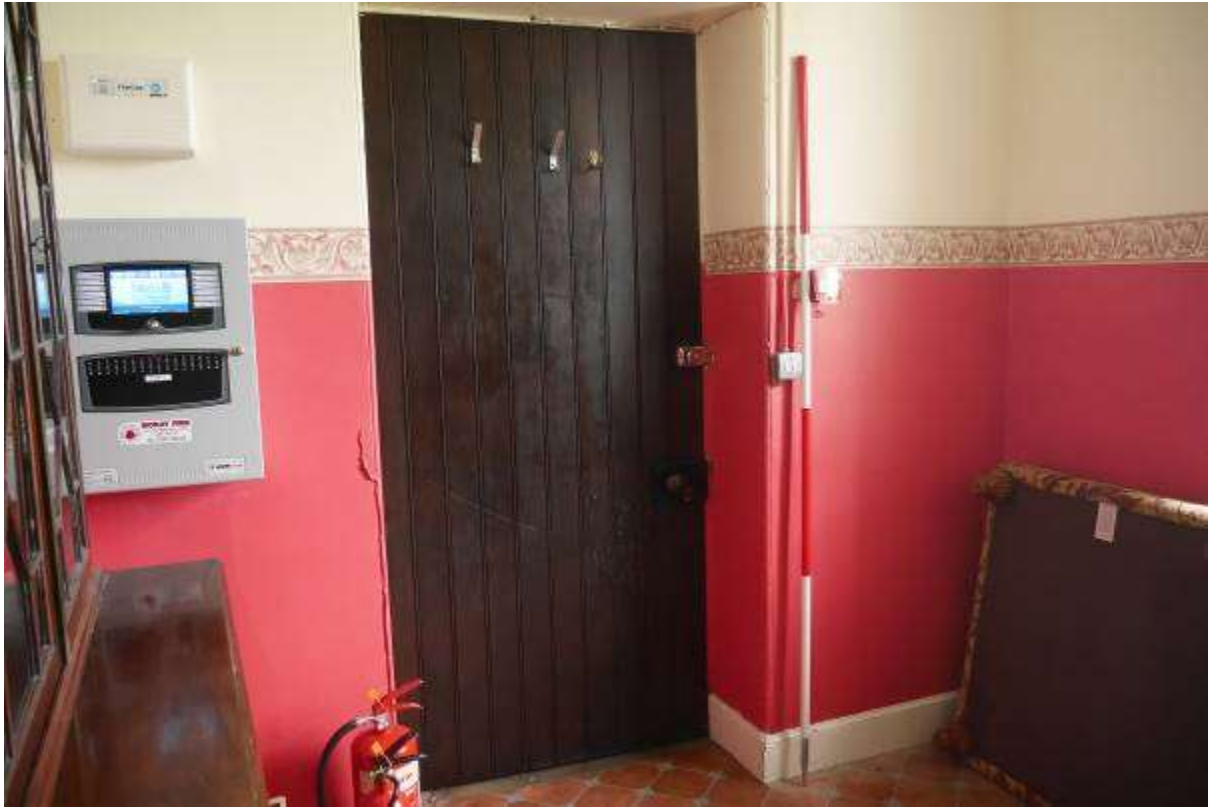
Illustration 34- Entrance Hall (1) North East facing internal elevation. It is proposed to make alterations to this elevation.

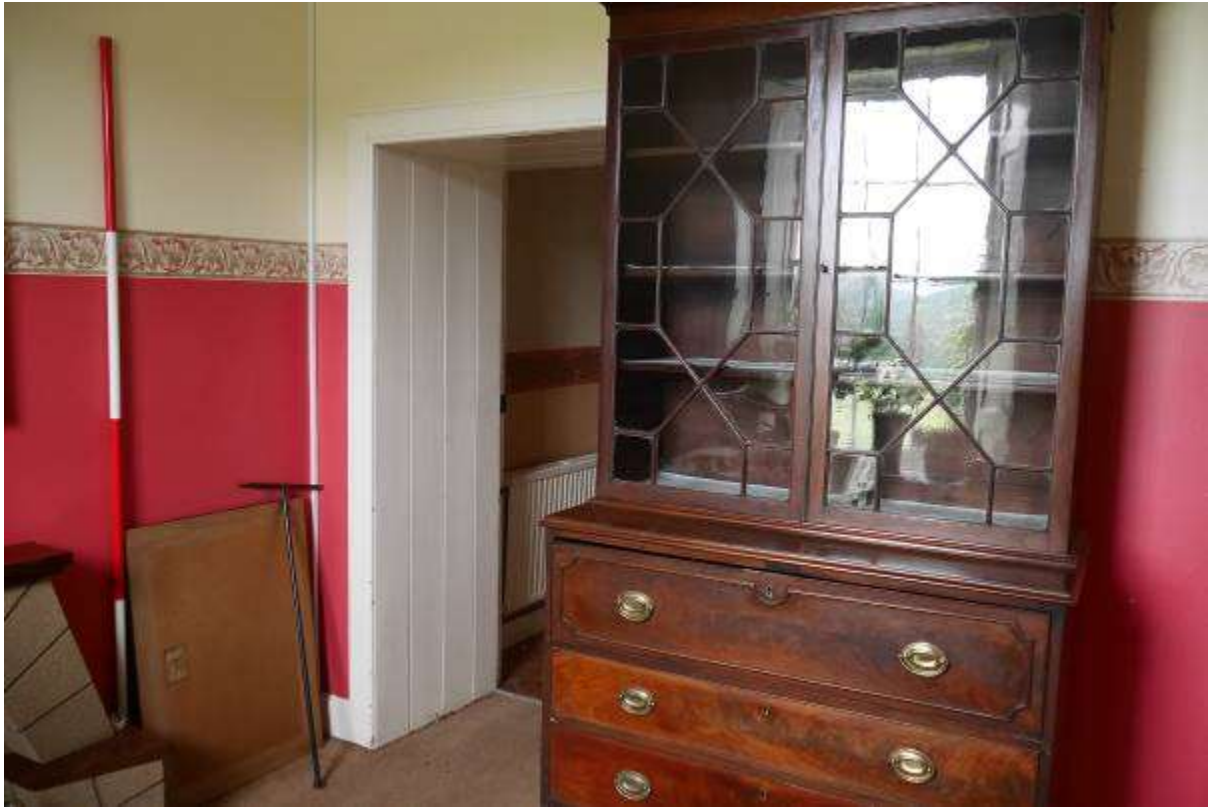
Illustration 35- Entrance Hall (1) North Western facing internal elevation. It is proposed to make alterations to this elevation.

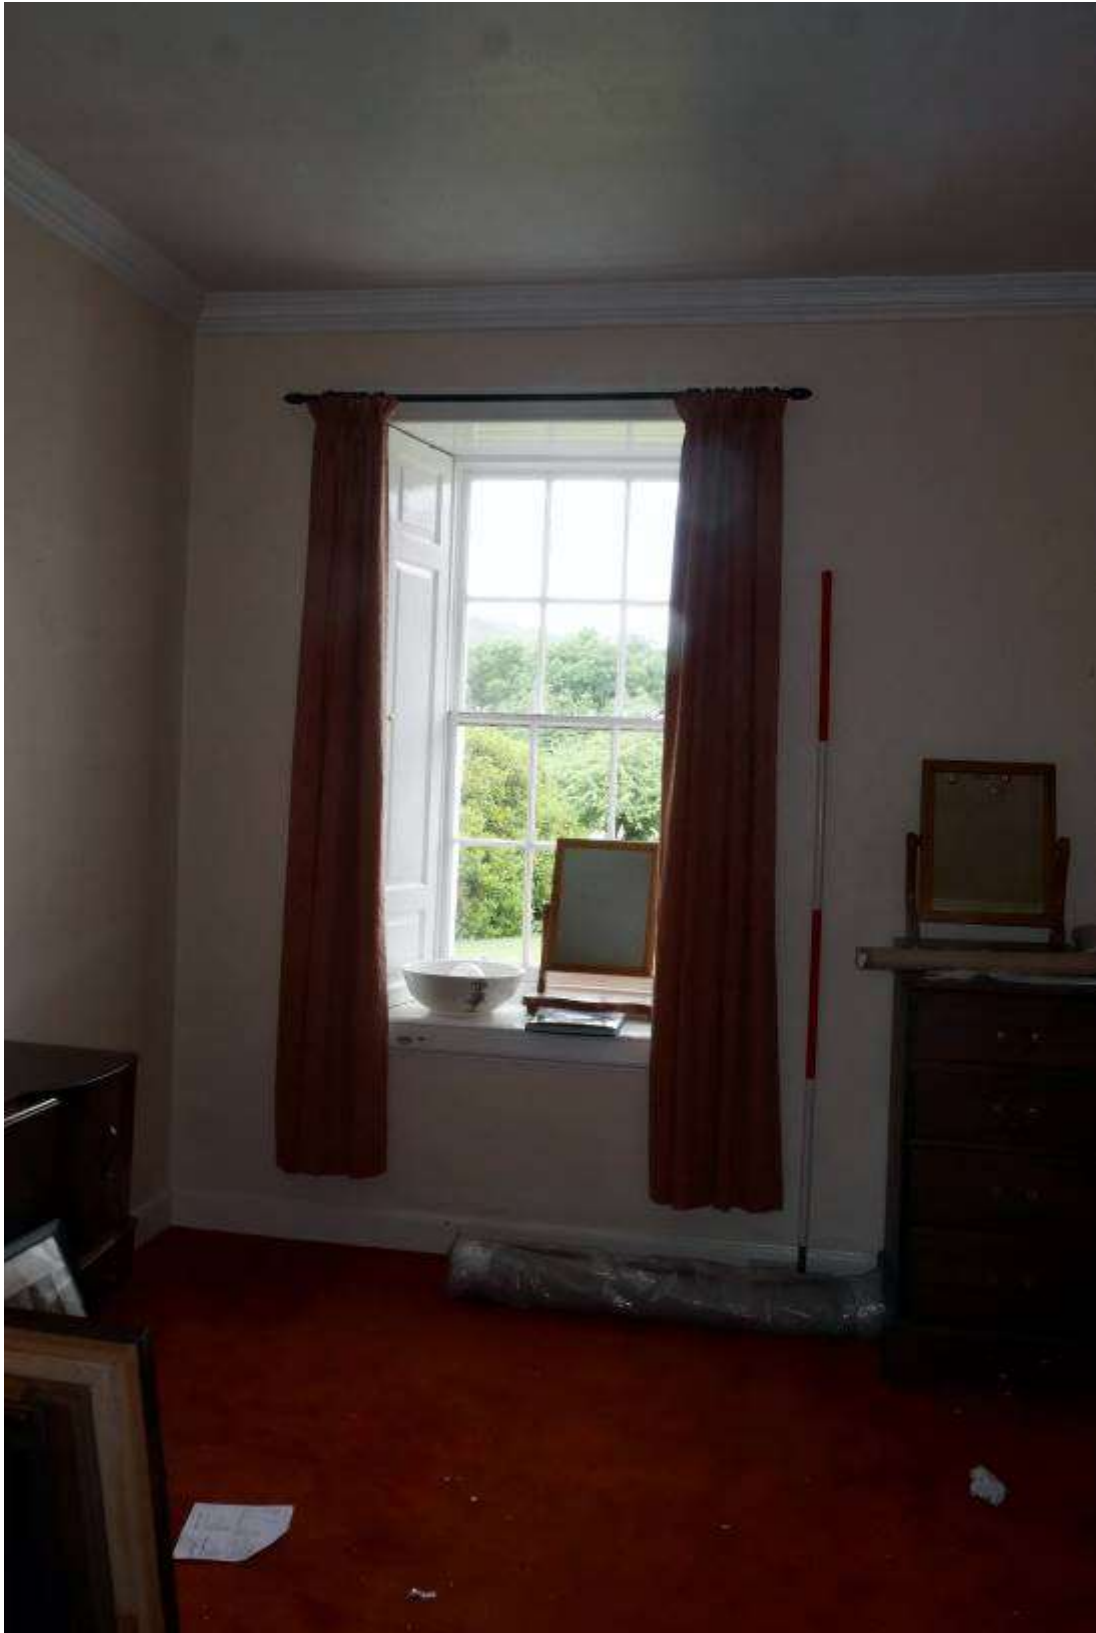
Illustration 47- Glazed, shuttered window in South Western facing internal elevation of South Corridor 3. It is proposed to make alterations to this elevation.

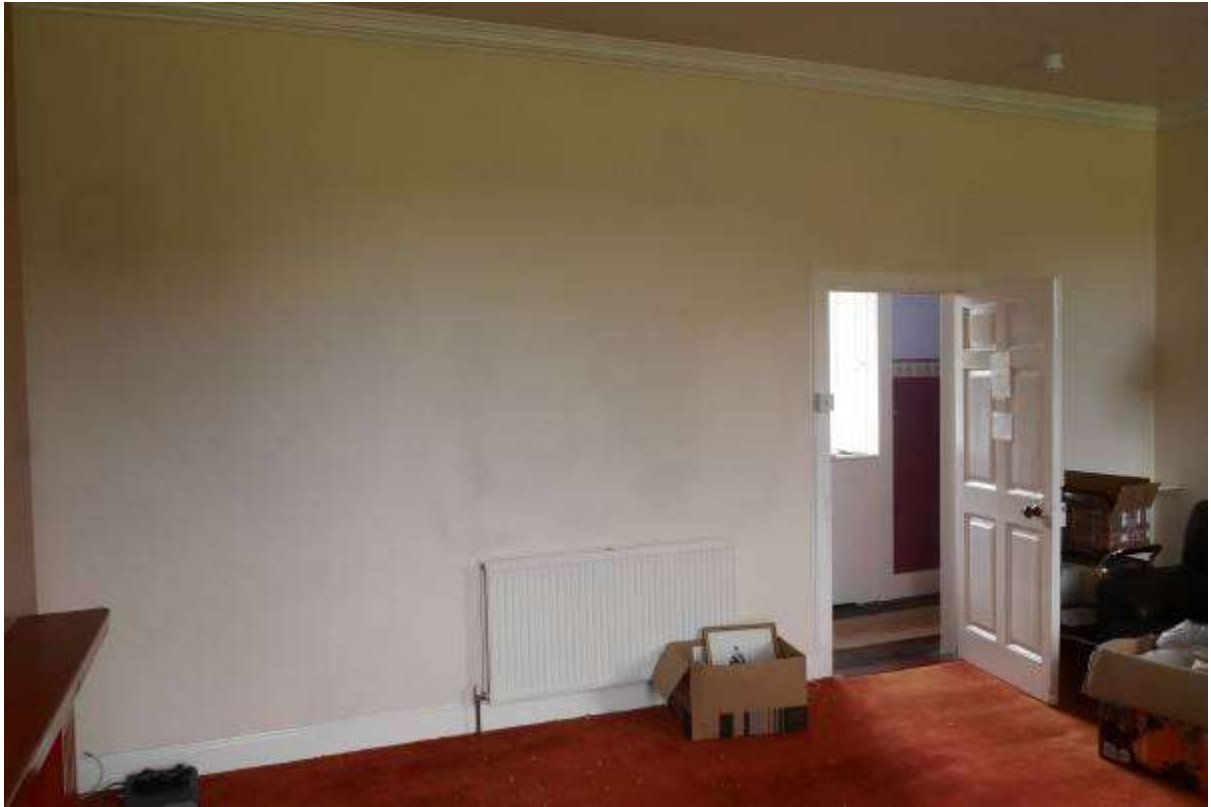
Illustration 50- South Eastern facing internal elevation of Room 4 showing fireplace. It is proposed to make alterations to the fireplace.

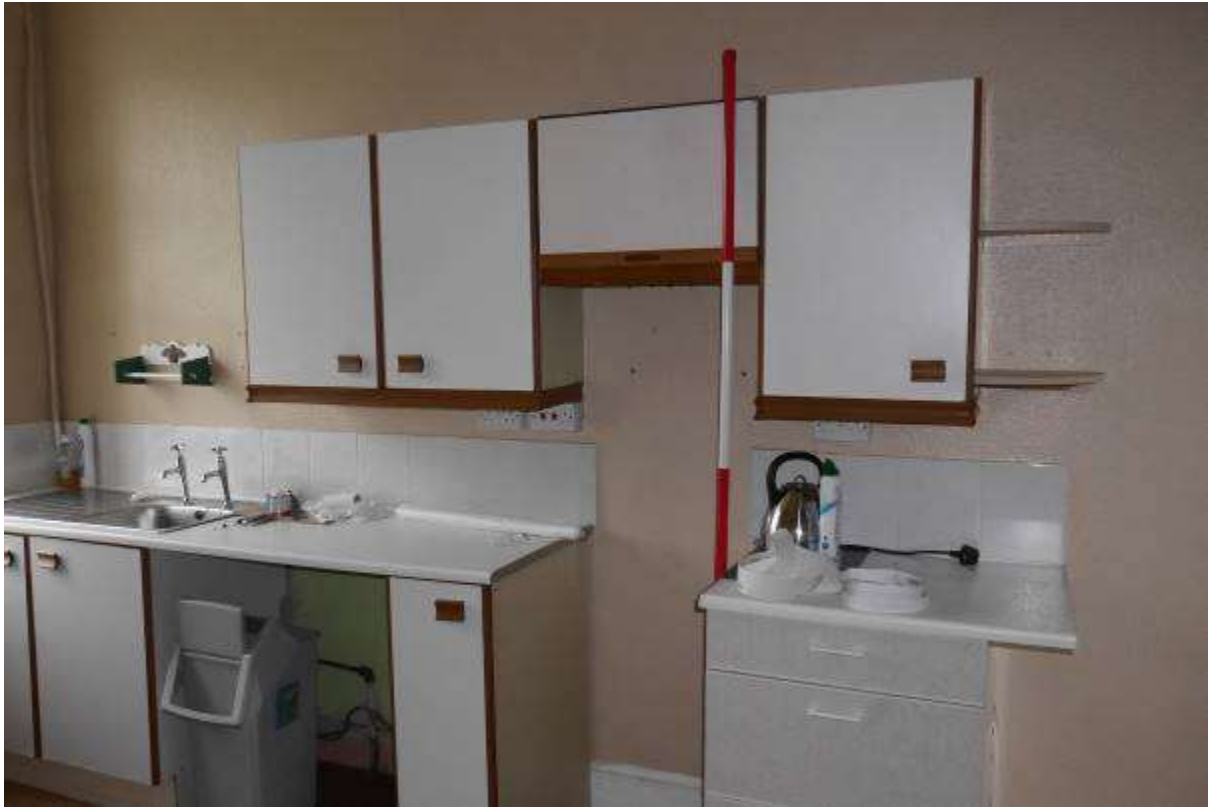
Illustration 53- Internal North Eastern facing elevation of Room 5 (Kitchen). It is proposed to make alterations to this elevation.

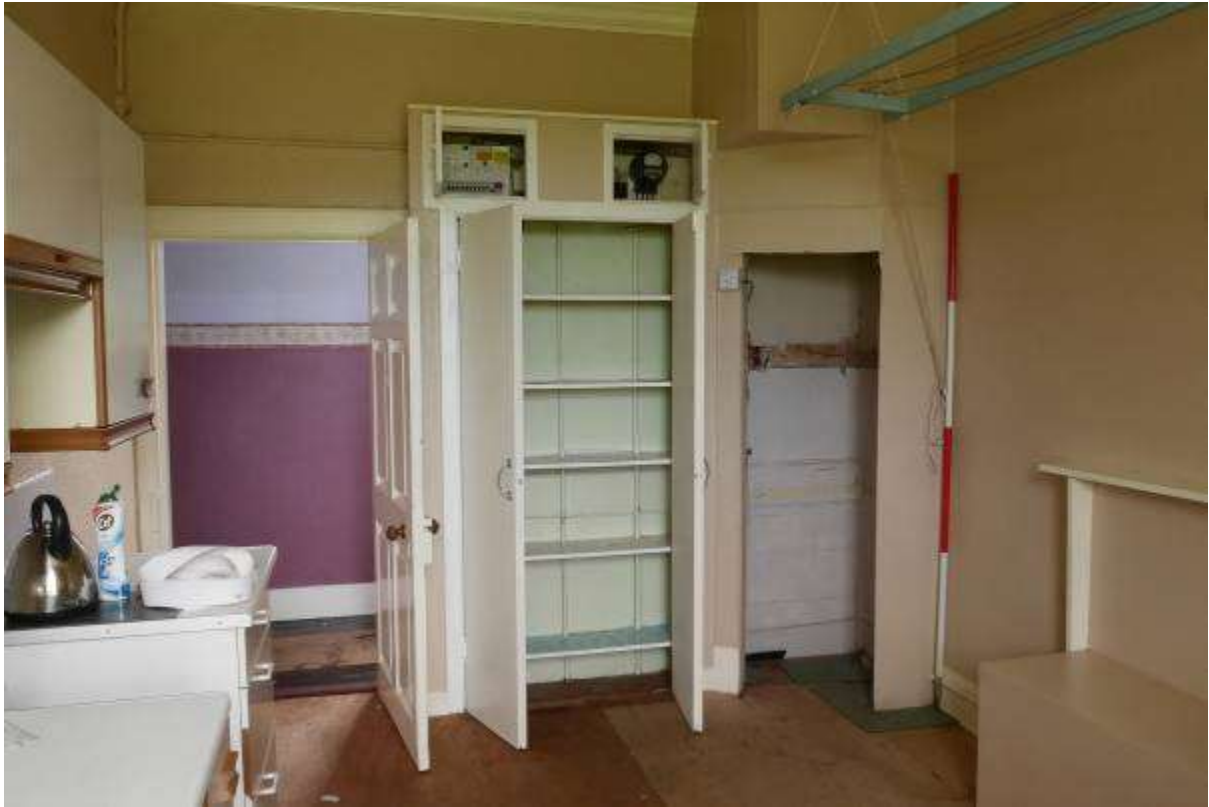
Illustration 54- Internal South Eastern facing elevation of Room 5 (Kitchen). It is proposed to remove the furniture.

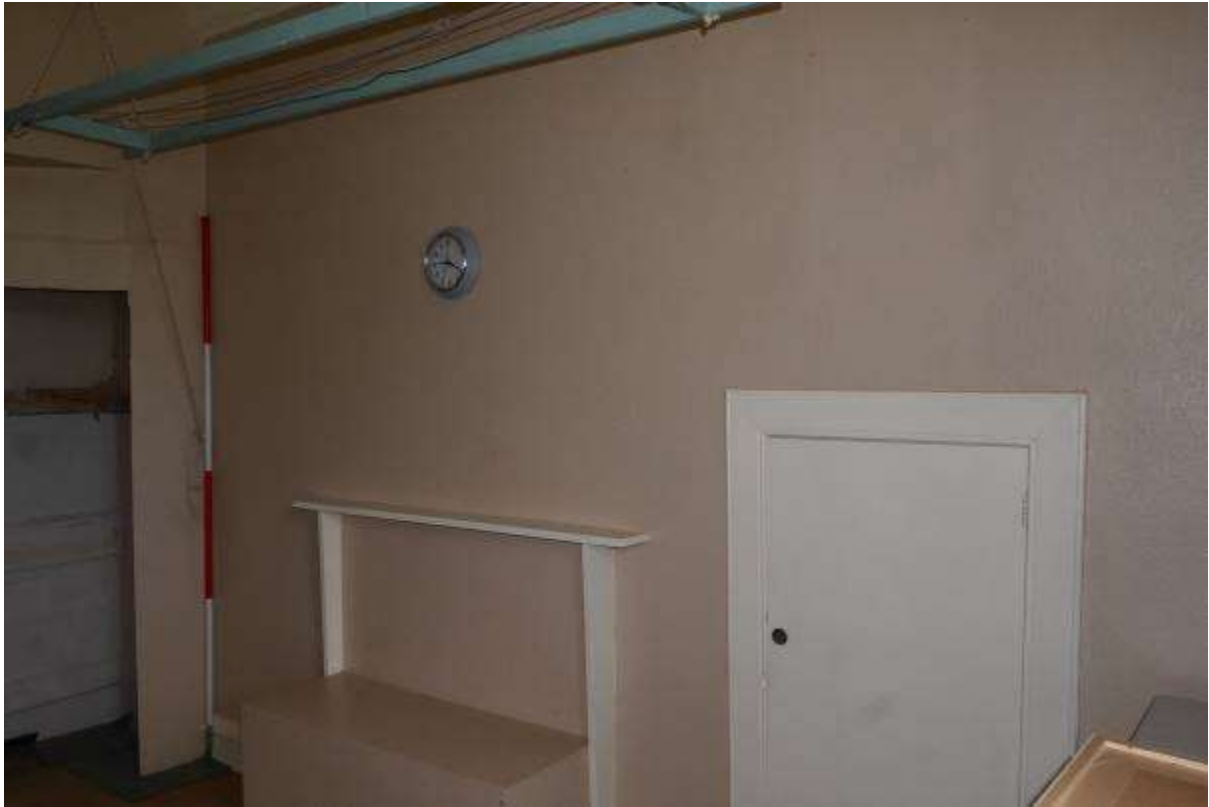
Illustration 55- Internal South Western facing elevation of Room 5 (Kitchen). It is proposed to remove the cupboards.

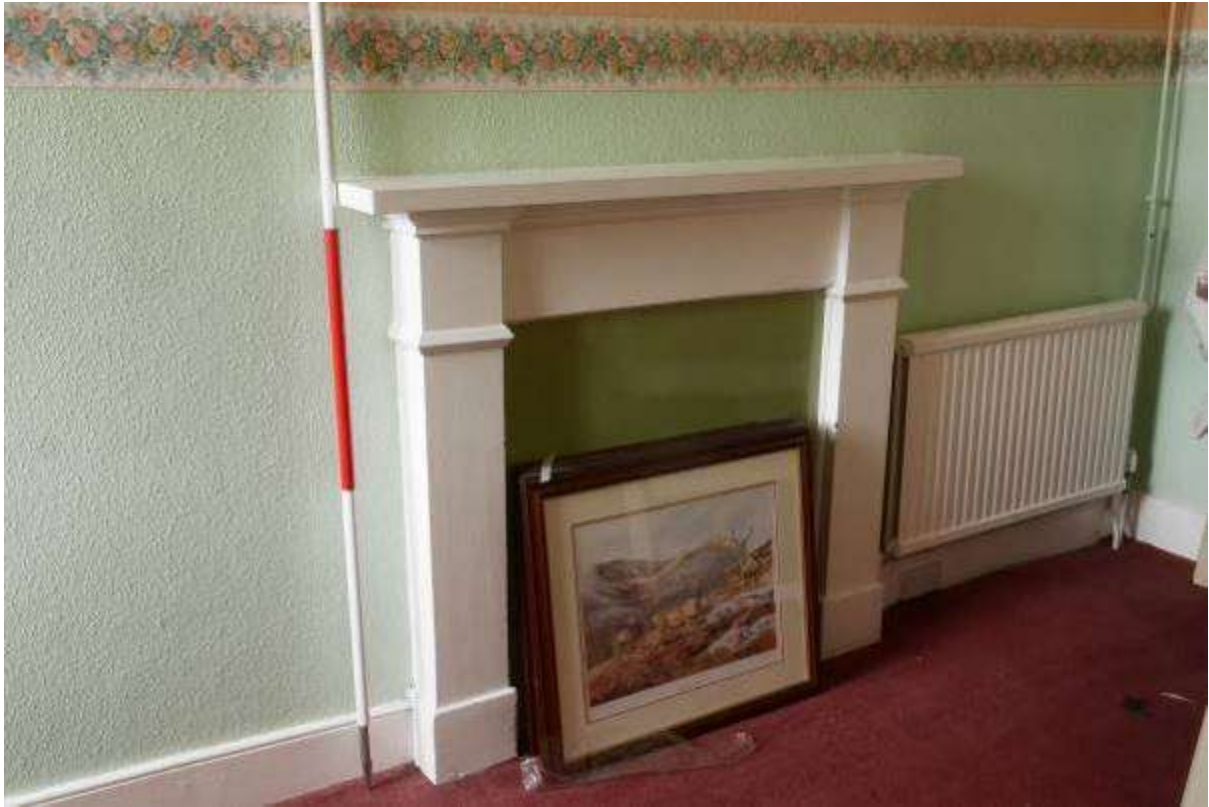
Illustration 57- Internal North Eastern facing elevation of Room 6 (Bedroom). It is proposed to make alterations to this elevation to form access to the new west window extension.

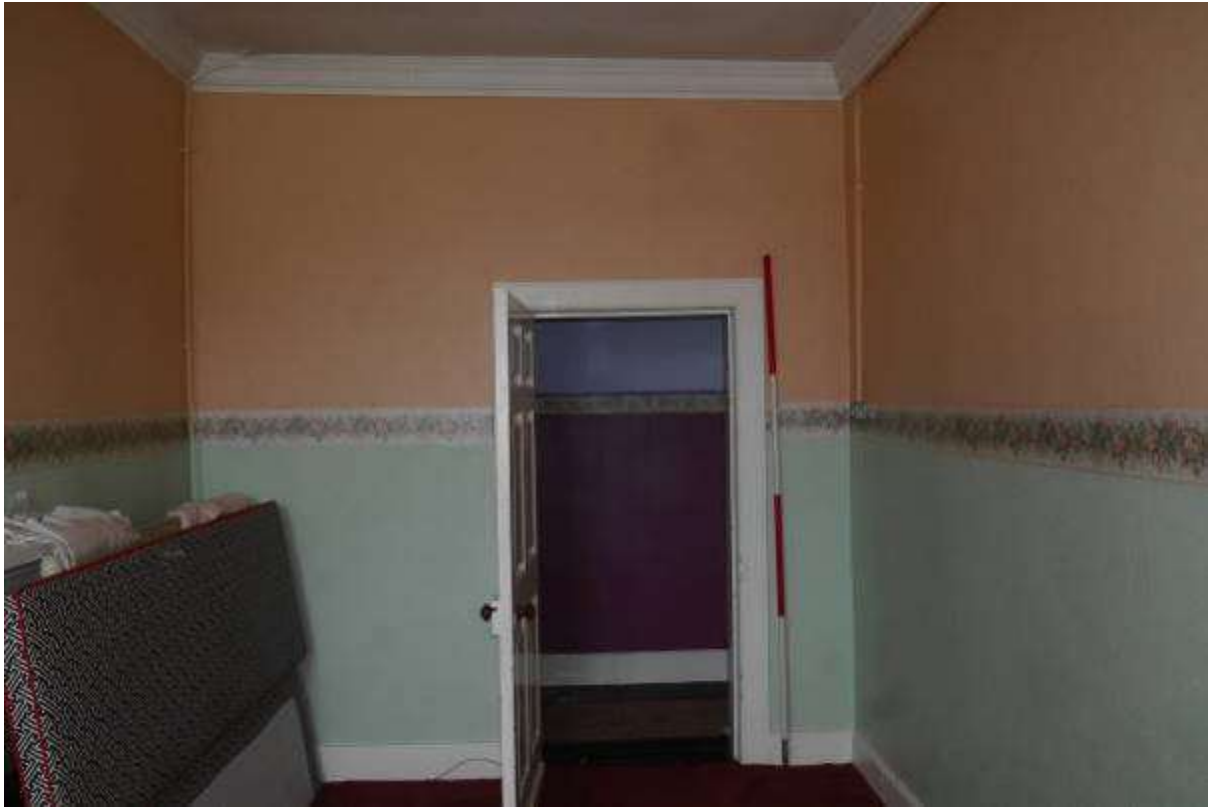
Illustration 58- Internal South eastern facing elevation of Room 6 (Bedroom) showing fireplace. It is proposed to remove part of this wall and the fireplace.

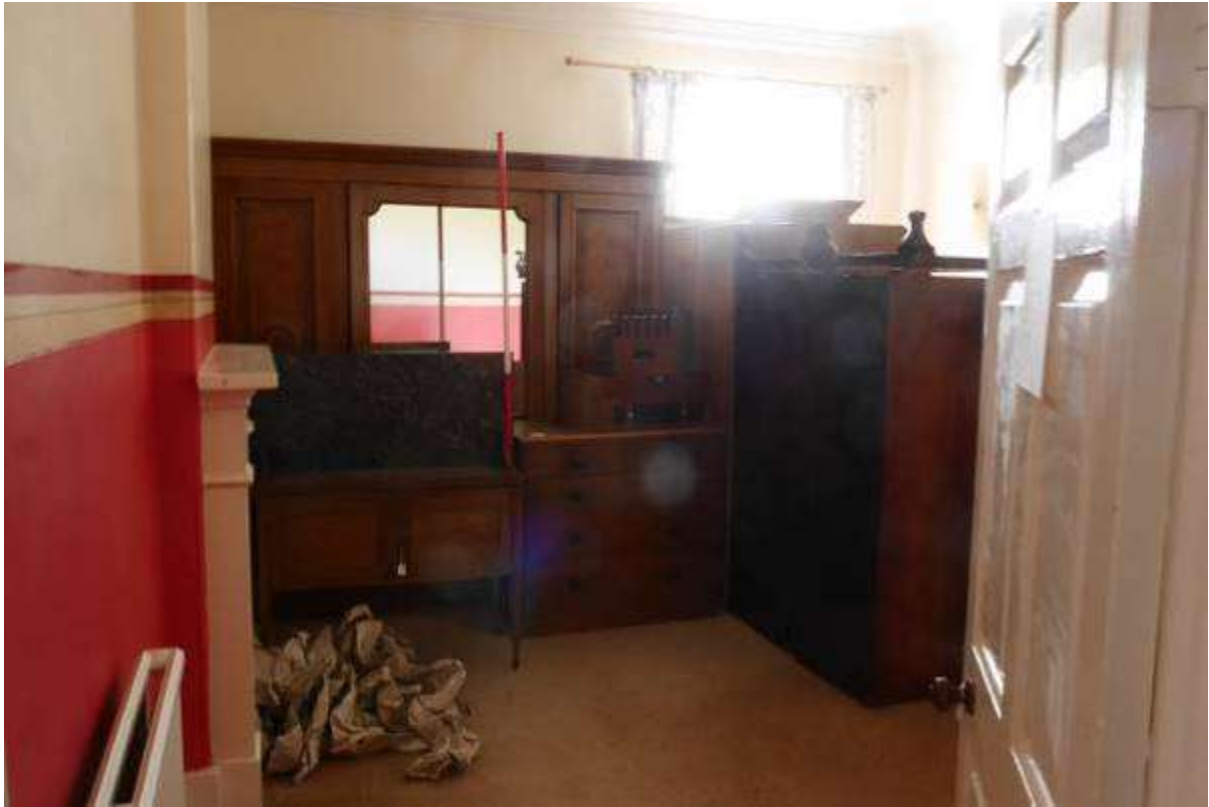
Illustration 60- Internal North Western elevation of Room 6 (Bedroom). It is proposed to make alterations to this elevation.

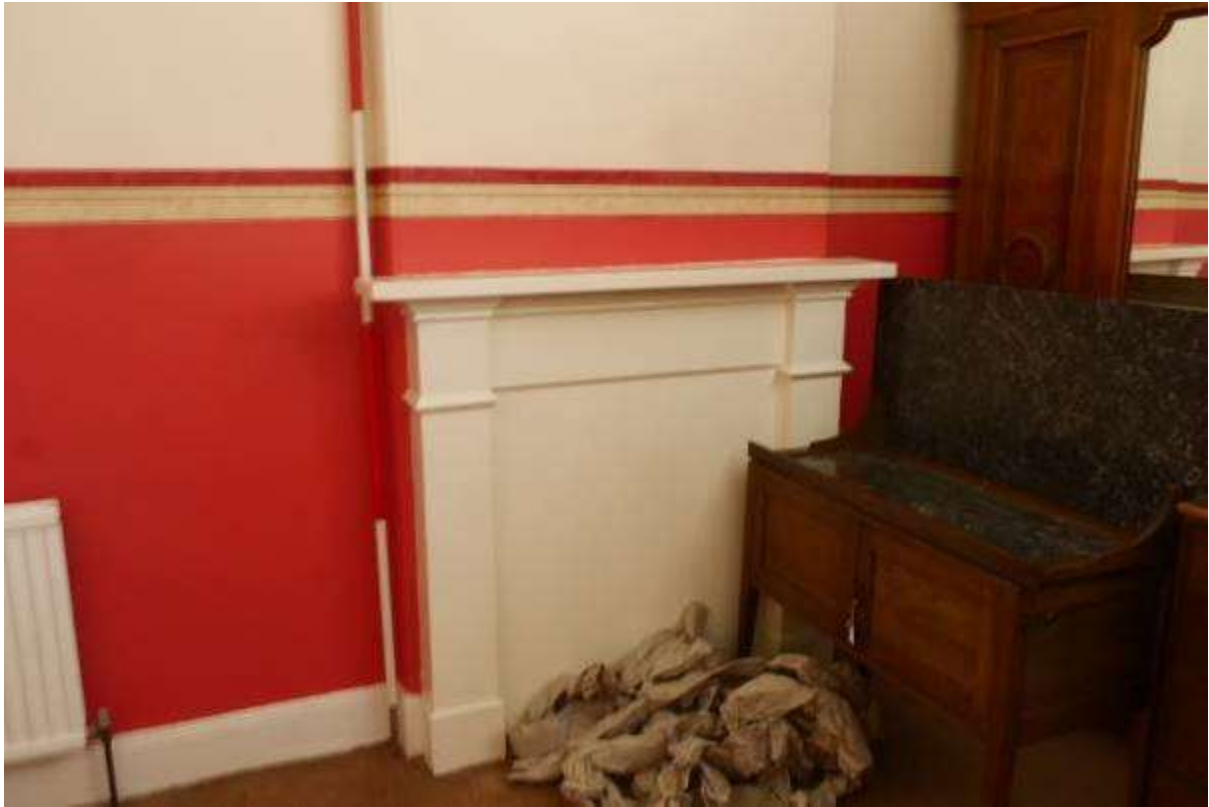
Illustration 63- Internal South Western elevation of Room 7. It is proposed to make alterations to this elevation, it is proposed to remove this wall and doorway below door head level.

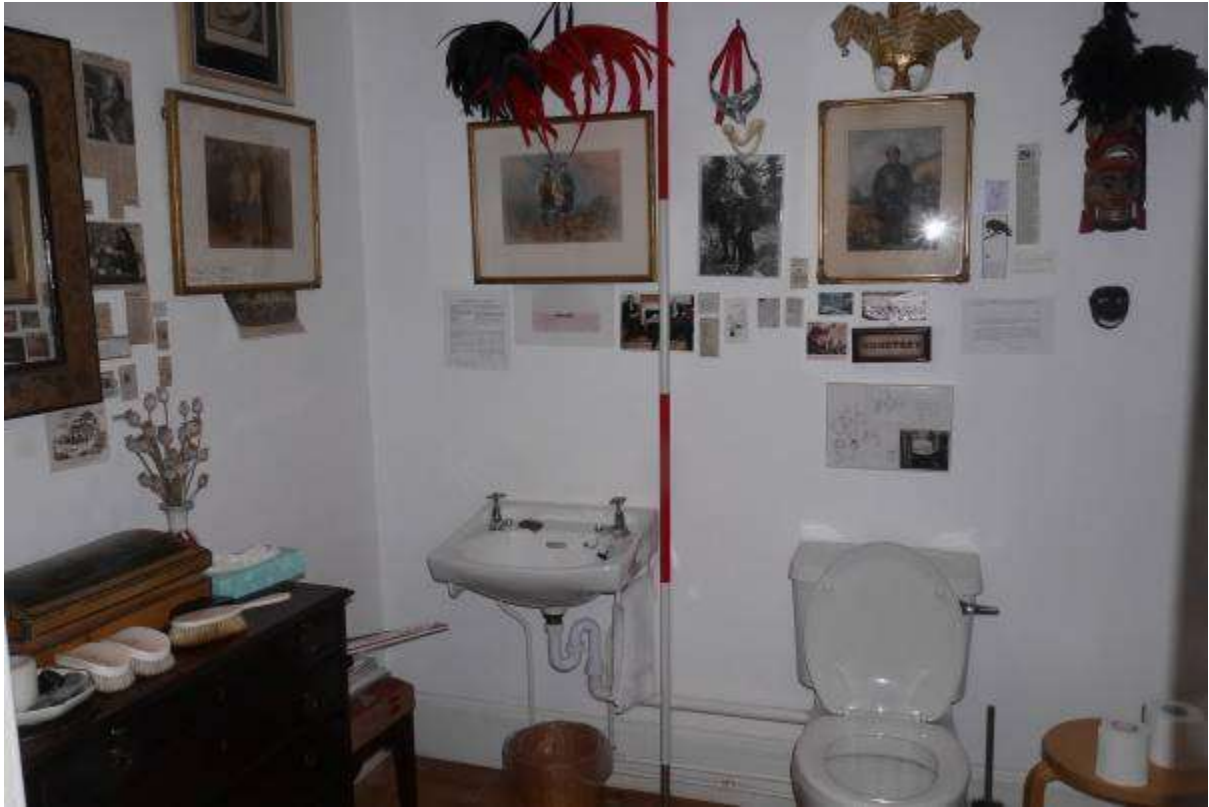
Illustration 77- South Eastern facing internal elevation of Room 11 (Cloak room). It is proposed to remove this wall and the one on the right, shared with the lavatory behind it.

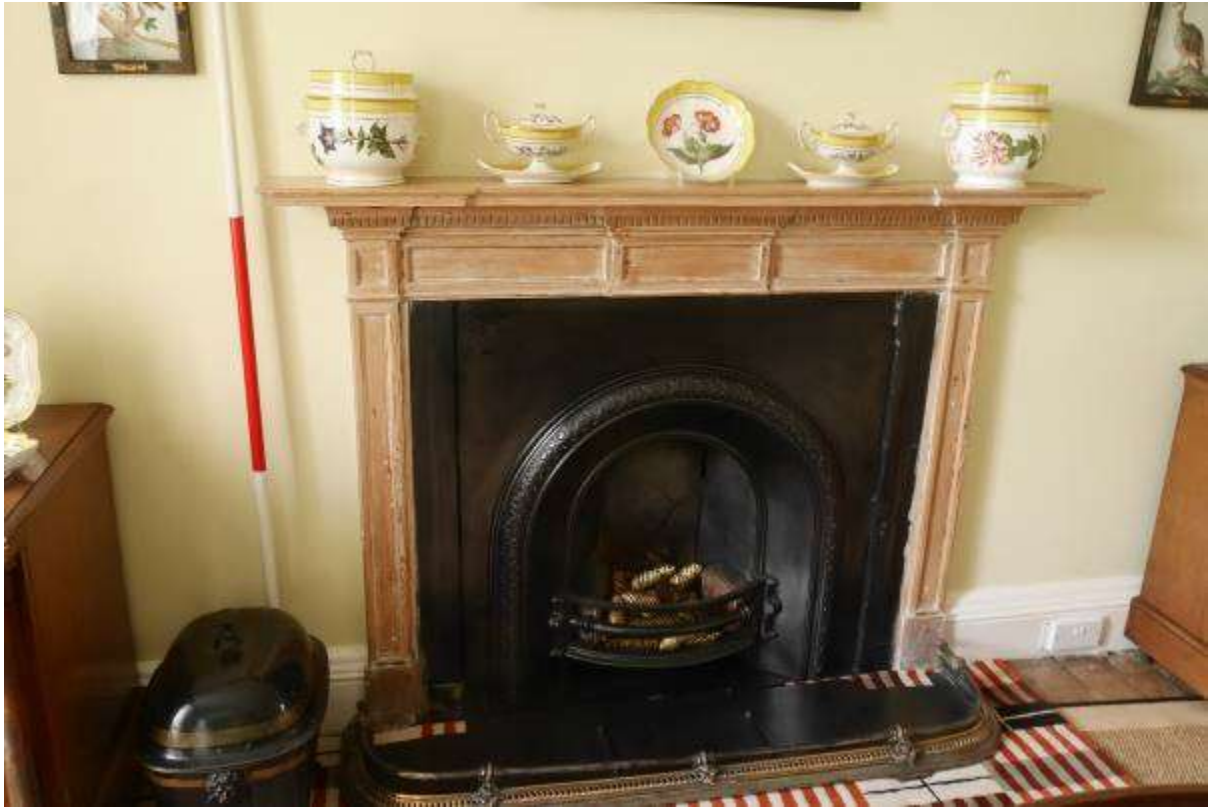
Illustration 80- South Eastern facing internal elevation of Room 13 (Dining Room) showing fireplace. The wall on the right is to go as part of incorporating the corridor back into the room.

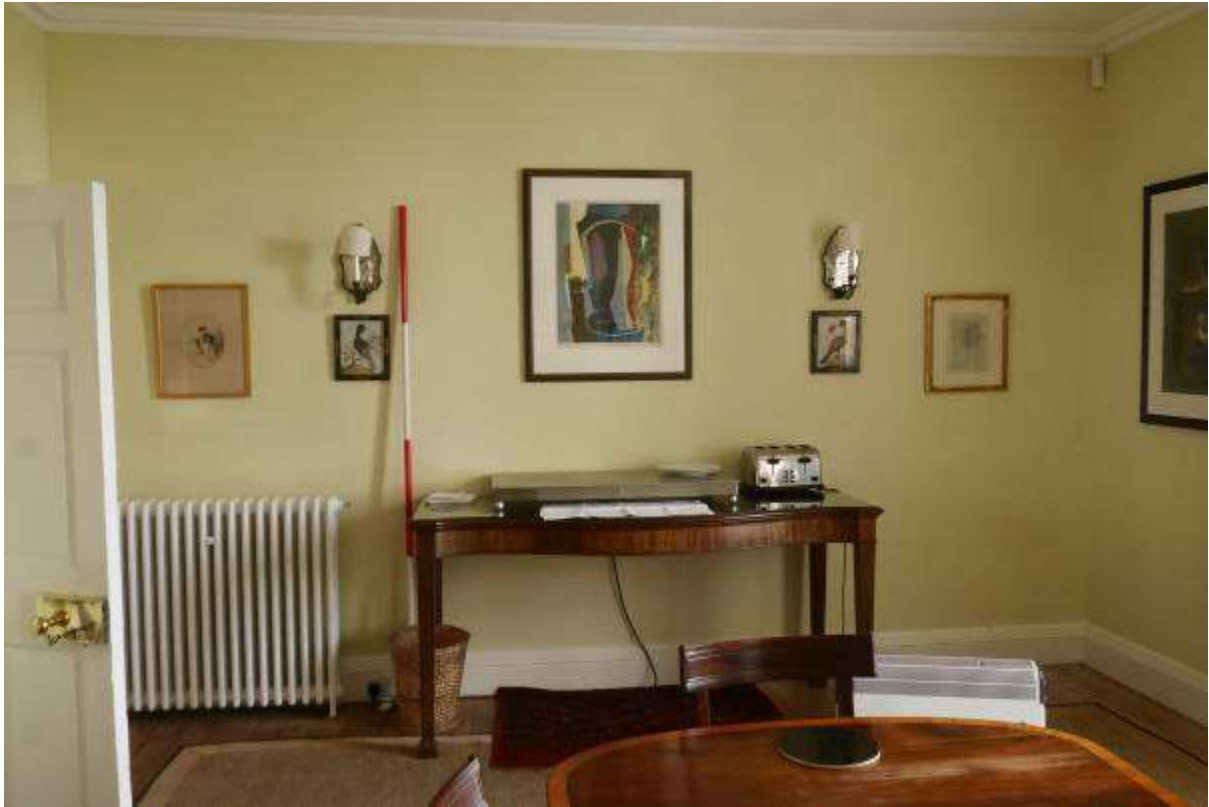
Illustration 82- South Western facing internal elevation of Room 13 (Dining Room) showing doorway into corridor. This entire wall and door are to be removed and the corridor incorporated back into the room (it was originally one larger space with a lower floor, the main Kitchen).

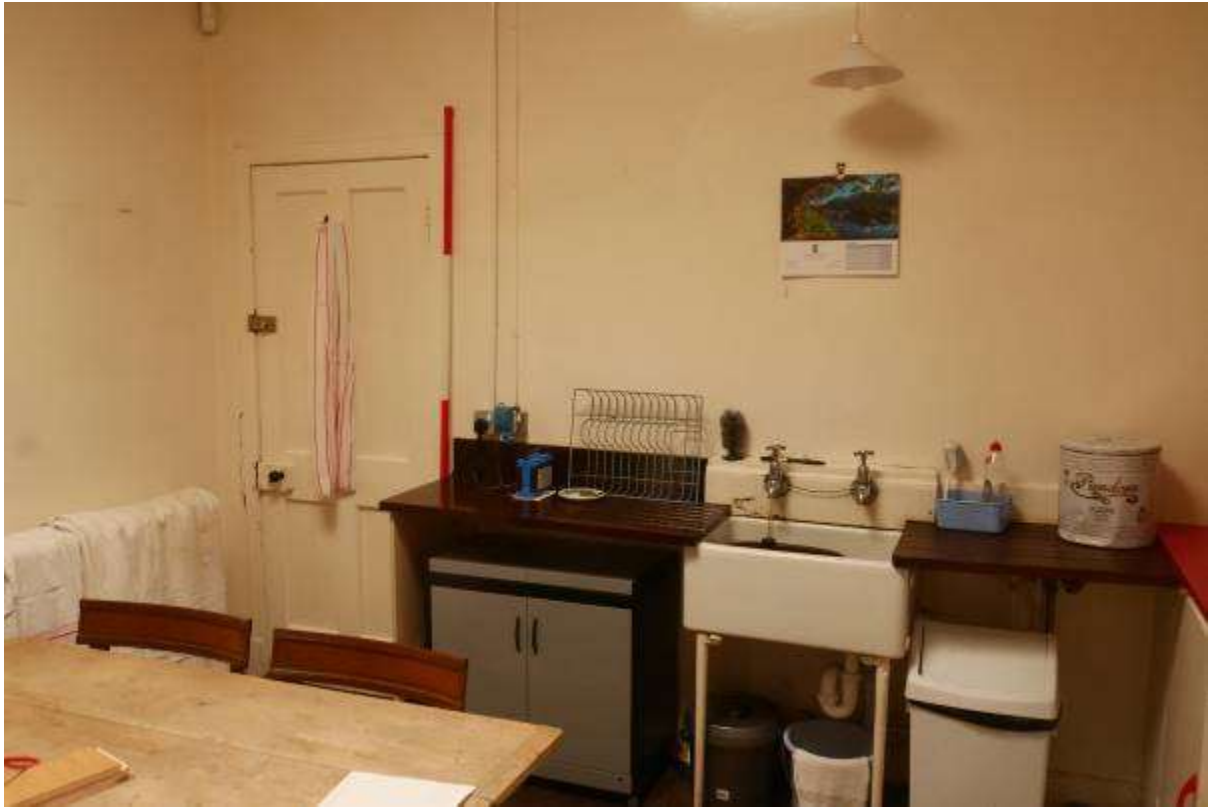
Illustration 85- South Western facing internal elevation of Room 15 (Pantry). It is proposed to remove all the furniture and open a new doorway into Utility Room 16.

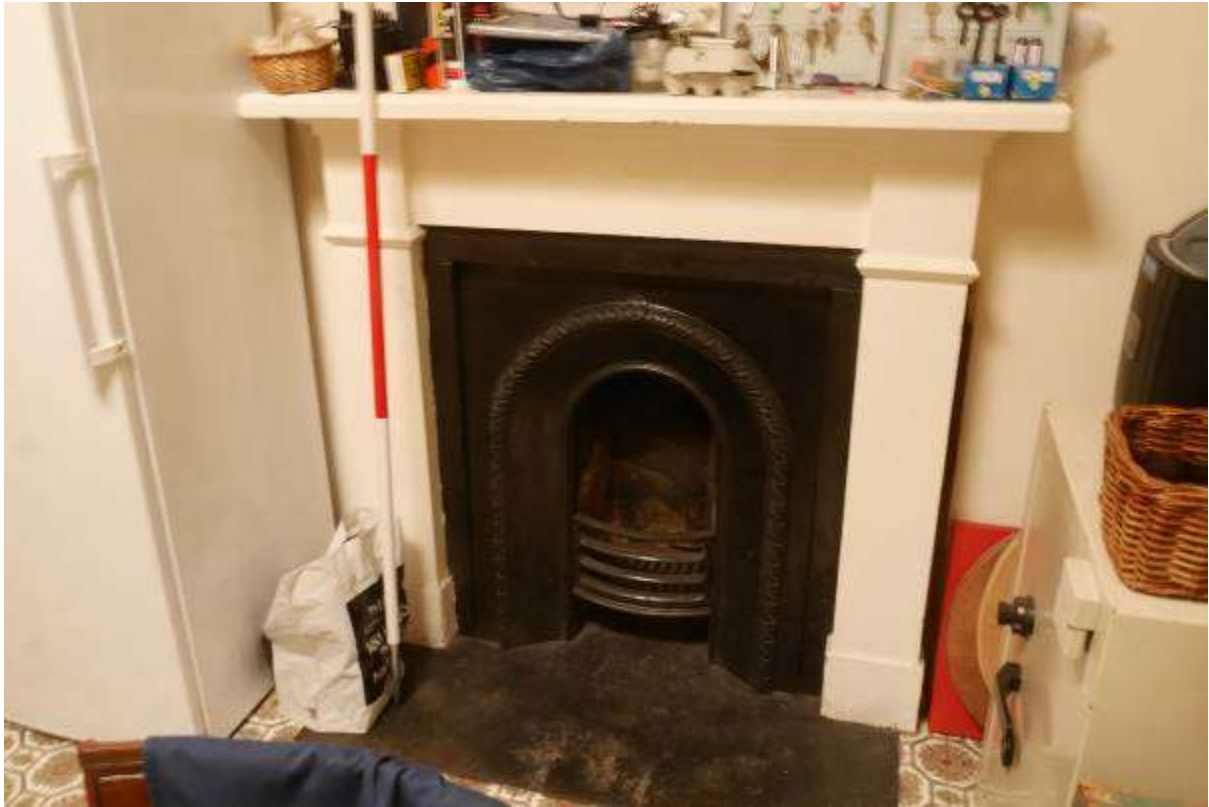
Illustration 87- North Eastern facing internal elevation of Room 15 (Pantry) showing fireplace and door into corridor. It is proposed to block the doorway into the corridor.

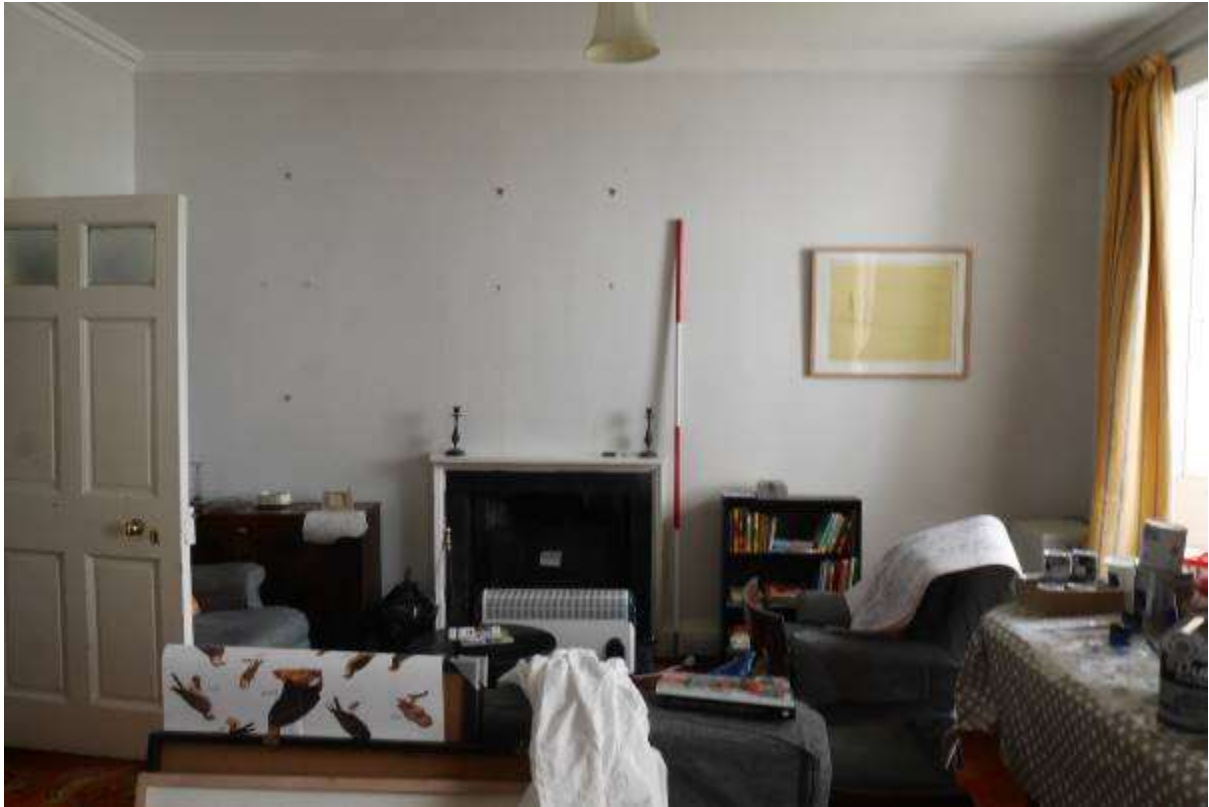
Illustration 94- South Western facing internal elevation of Study/Playroom 18 showing two doorways, it is proposed to block the doorway to the left.

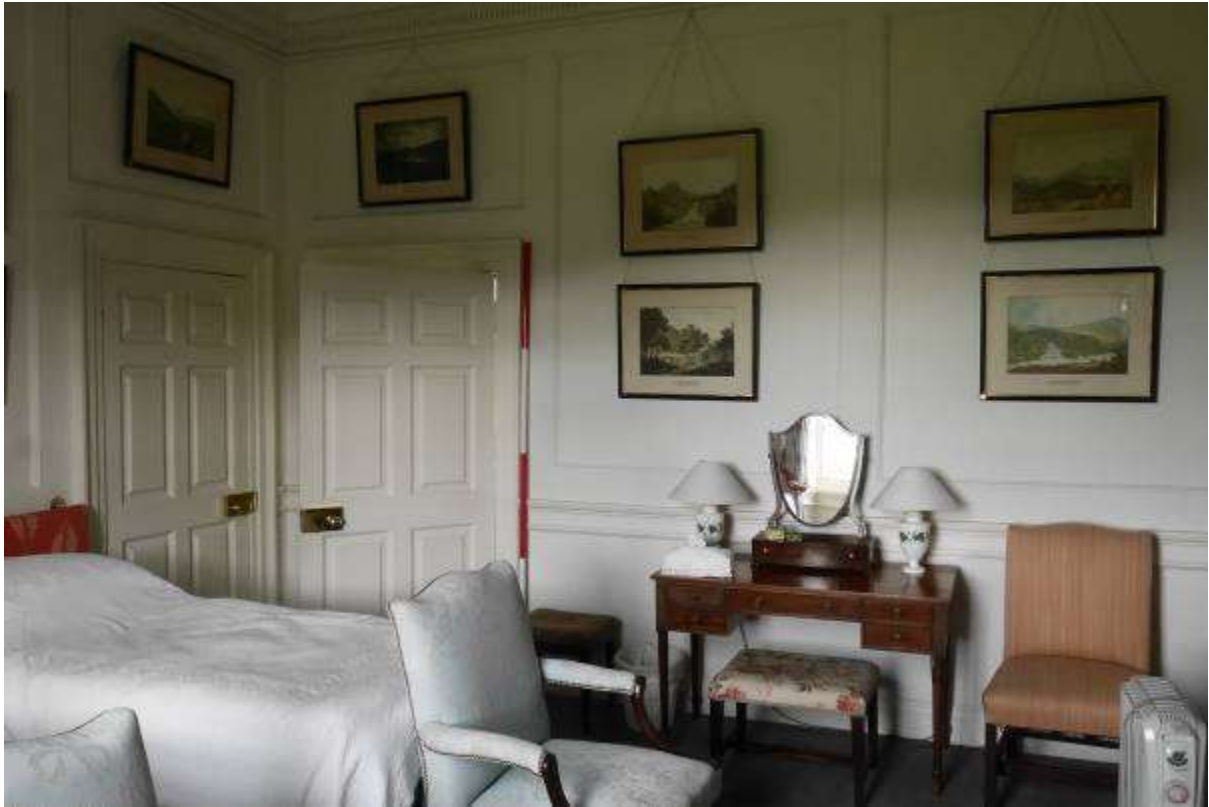
Illustration 101- Bedroom 21 South Eastern facing internal elevation showing wooden panelling and double doors. The door on left is to be blocked, and the one on the right will provide access to a new shower space.

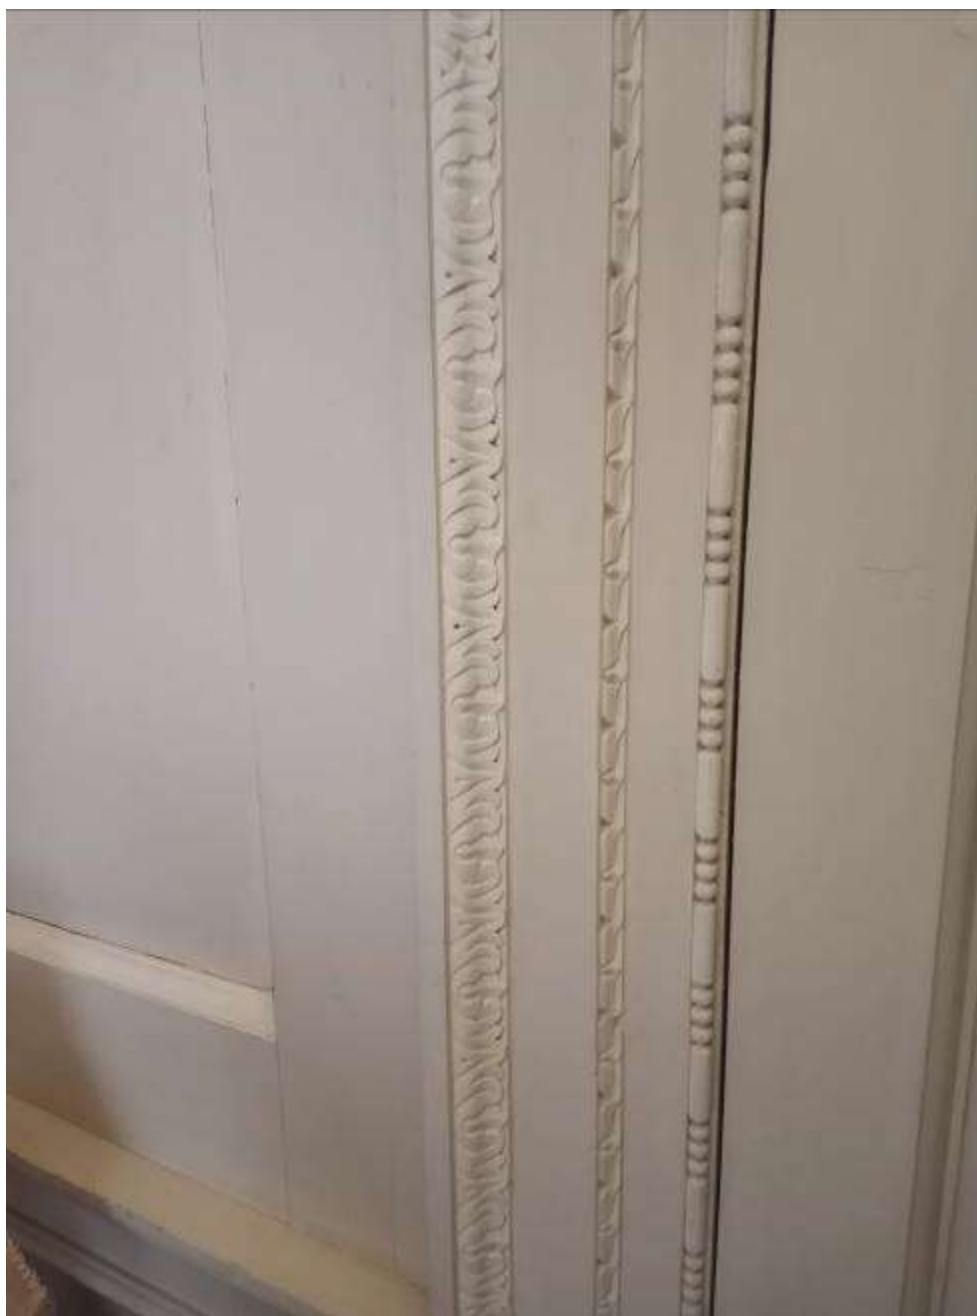
Illustration 107- Doorway 23 in Bedroom F10. This doorway is to be blocked.
