Standing Building Survey
Blair Castle (South Wing)
Perth And Kinross Council

Blair Castle (South Wing) looking South East.

16th July 2021

Introduction

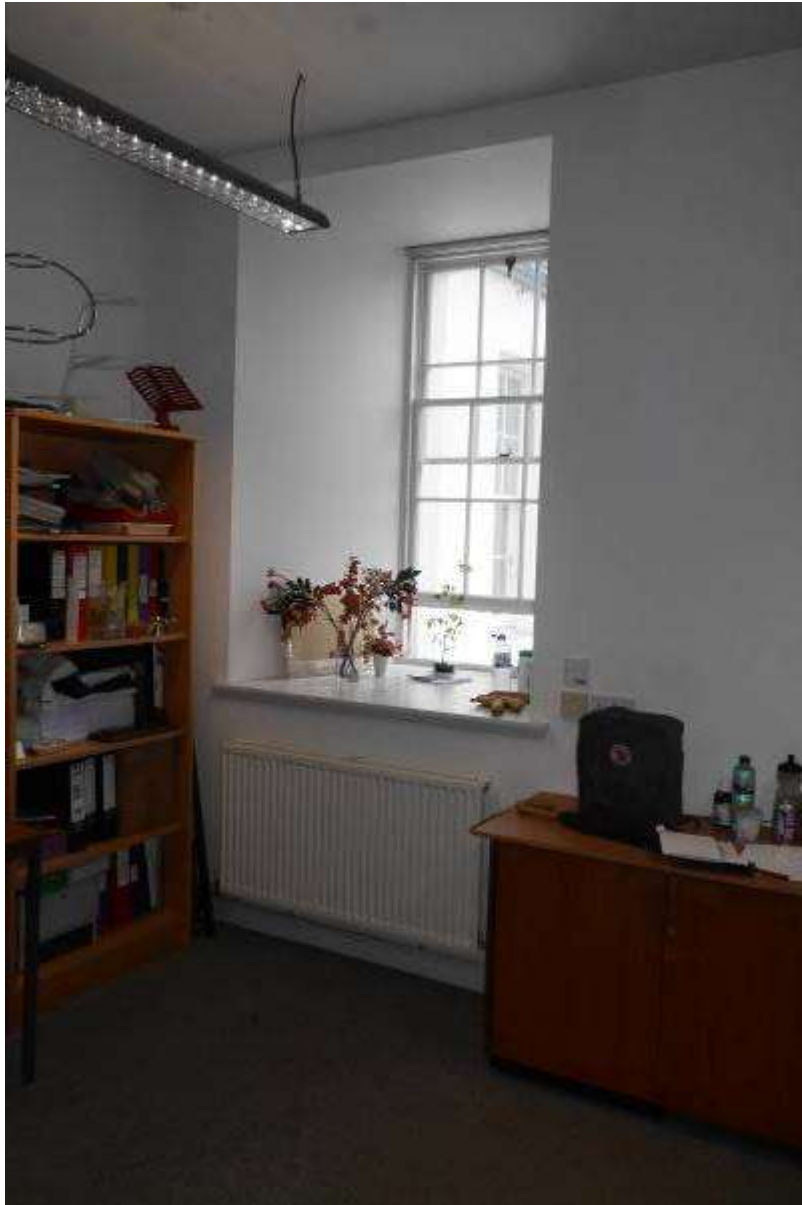
Illustration 119- External view of window 28 in Castle Office looking North East. It is proposed to lower the sill in the window to give access into a new turret and then into the South Wing. The window will be repaired and re-used in the new location.

Illustration 119- External view of window 28 in Castle Office looking North East. It is proposed to lower the sill in the window to give access into a new turret and then into the South Wing. The window will be repaired and re-used in the new location.

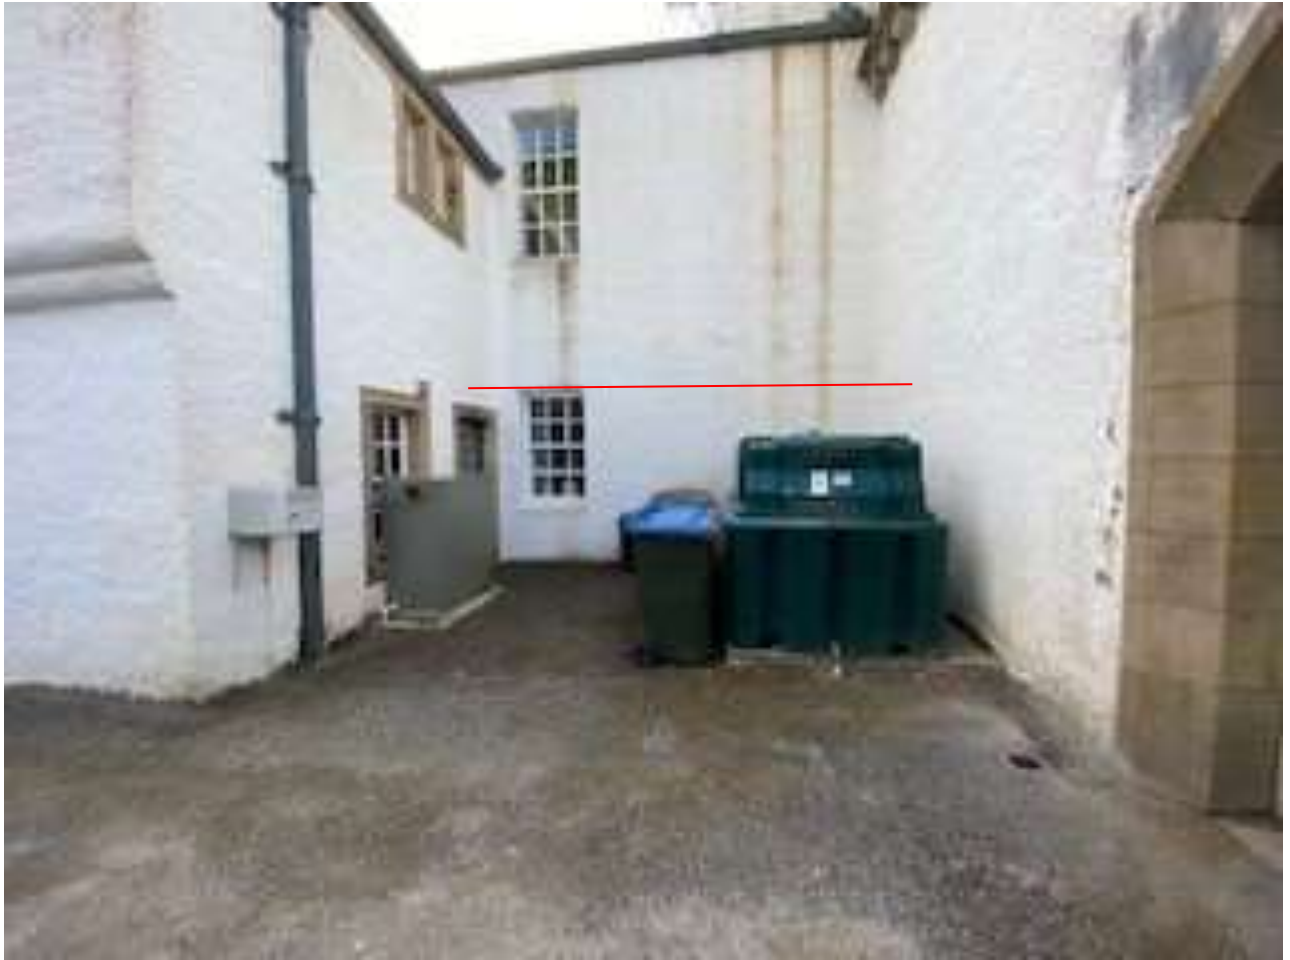
Illustration 121- Location of proposed new door (29) in South East facing internal of Castle Office looking North West.
