# Archaeological Evaluation

## Plot 3, East of Auchsheen, Urlar Road, Aberfeldy

23<sup>rd</sup> September 2021

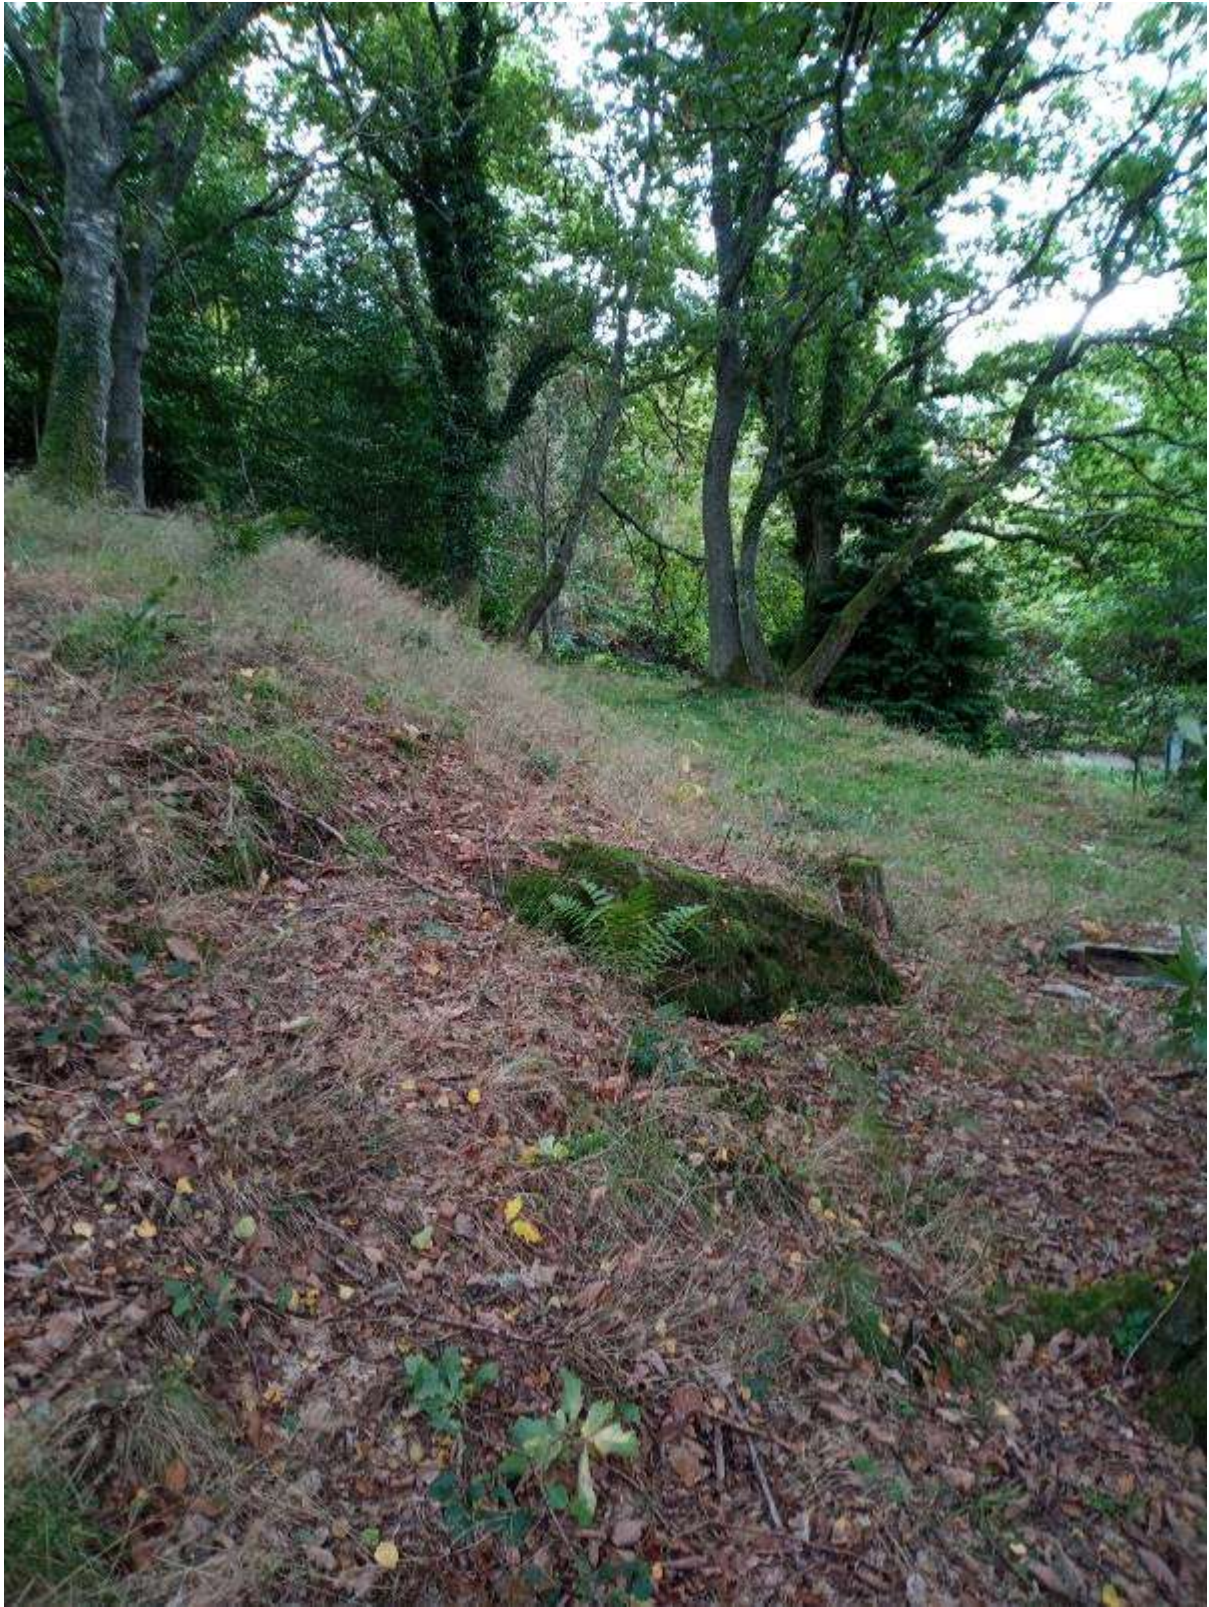
Illustration 4- surviving rampart line on West facing side of fort on Torr Hill above the development site (September 2021).

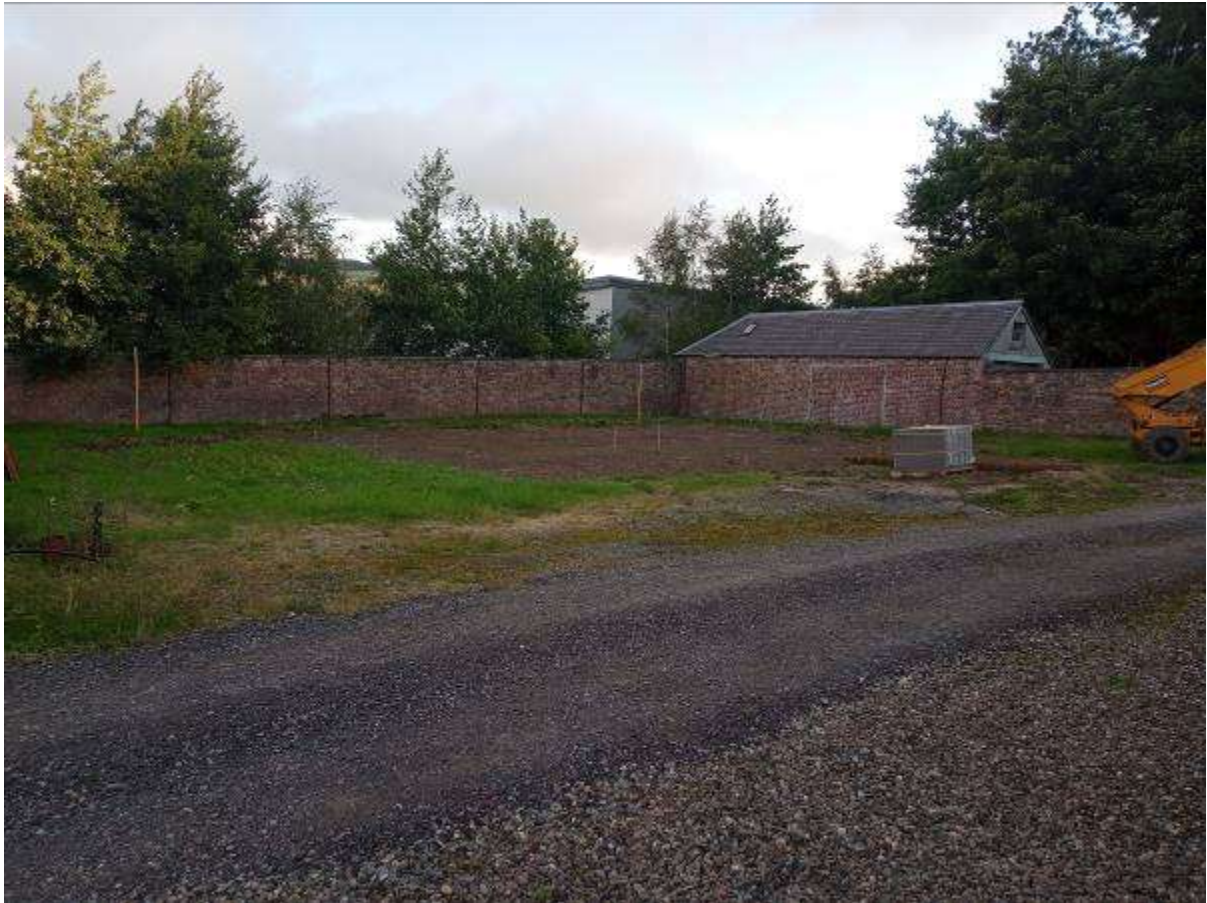
Illustration 6- General view of proposed development area looking North East (marked out house plot visible in deturfed area).

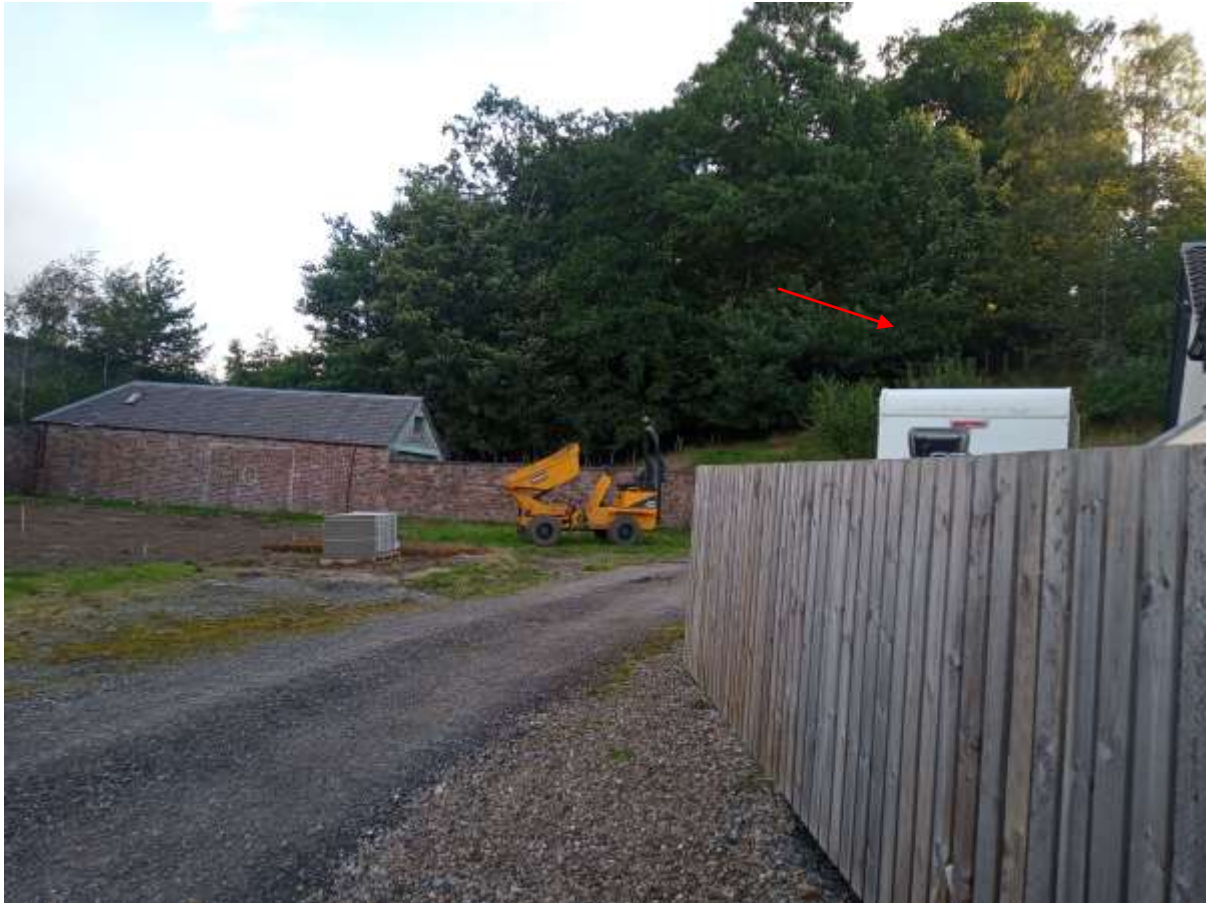
Illustration 7- General view of proposed development area looking North East with Torr Hill visible in the background (red arrow)

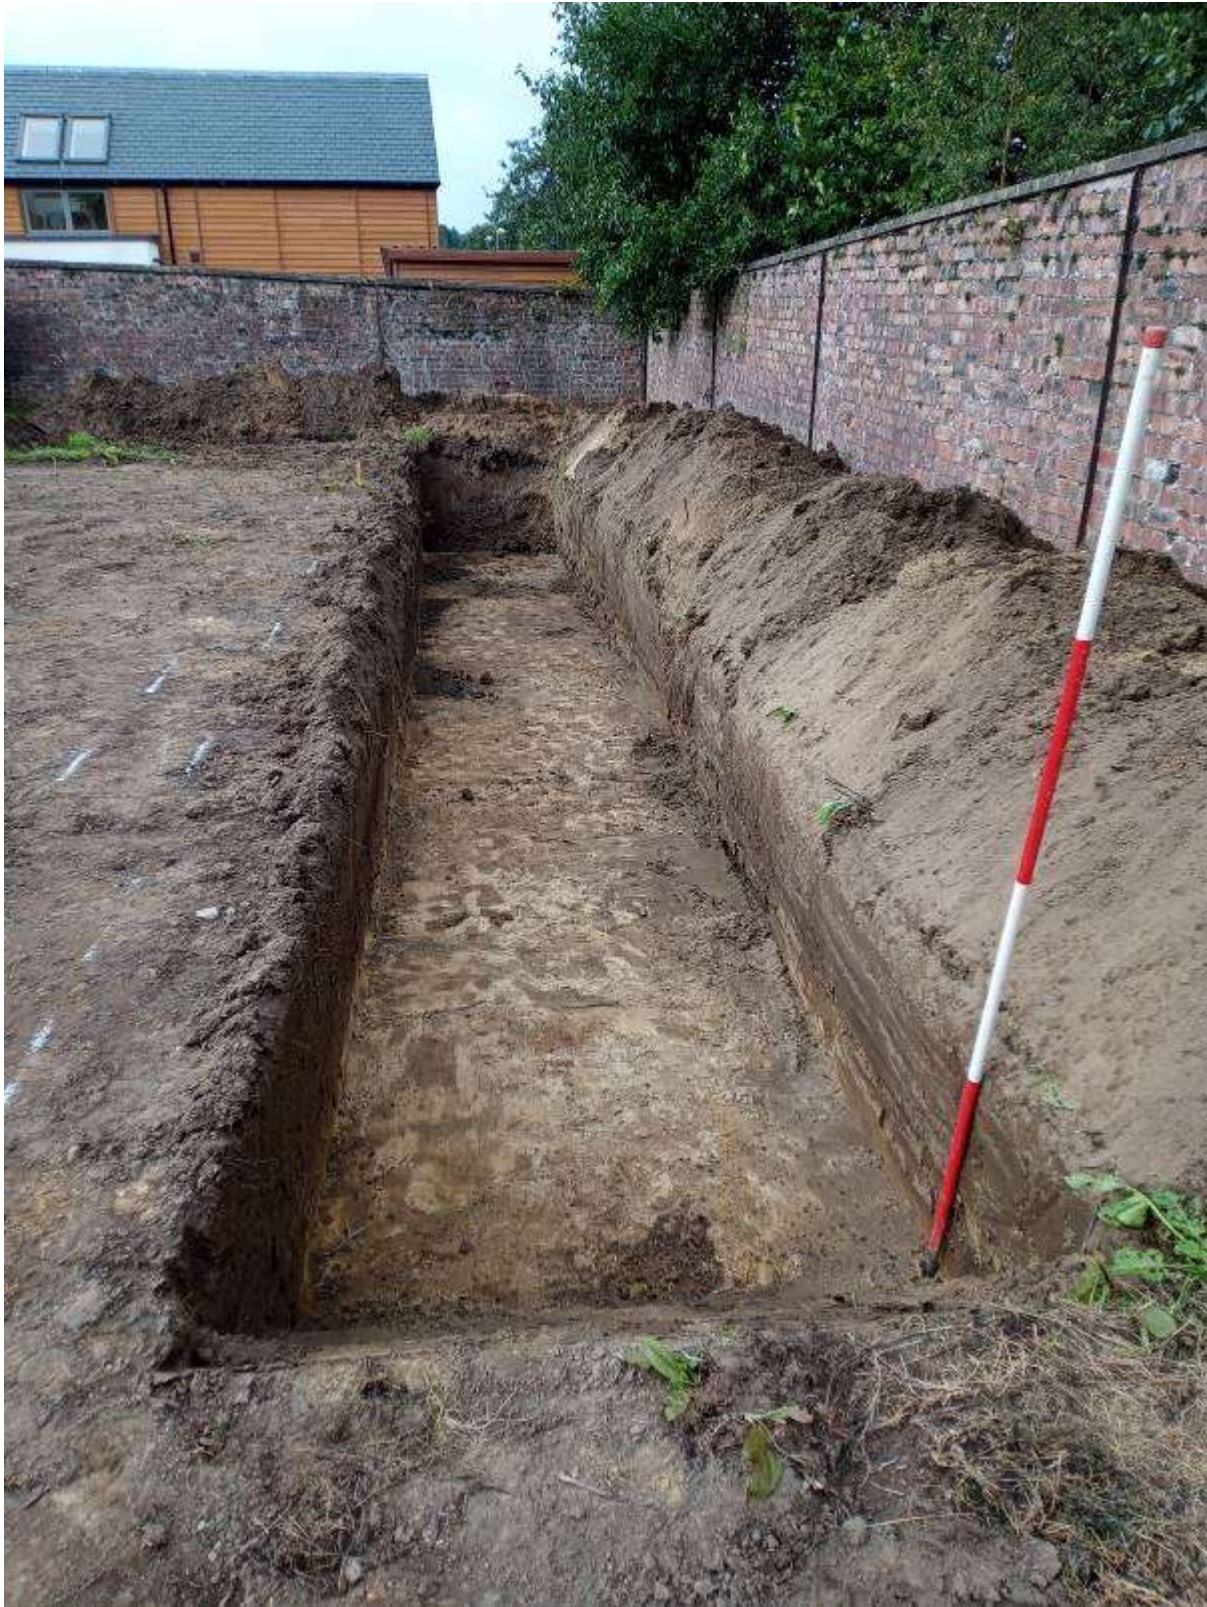
Illustration 8- Trench A looking West showing moderate light-yellow natural sand 101 below overlaying dark brown sandy clay 100.

This trench ran on a South West to North East alignment and measured 14m by 2m. An homogenous dark brown sandy clay (100), 0.70m deep at the Eastern end of the trench and 0.90m deep at the Western end, was removed to reveal a moderate natural light-yellow sand (101). There were no finds and nothing of archaeological interest was located.

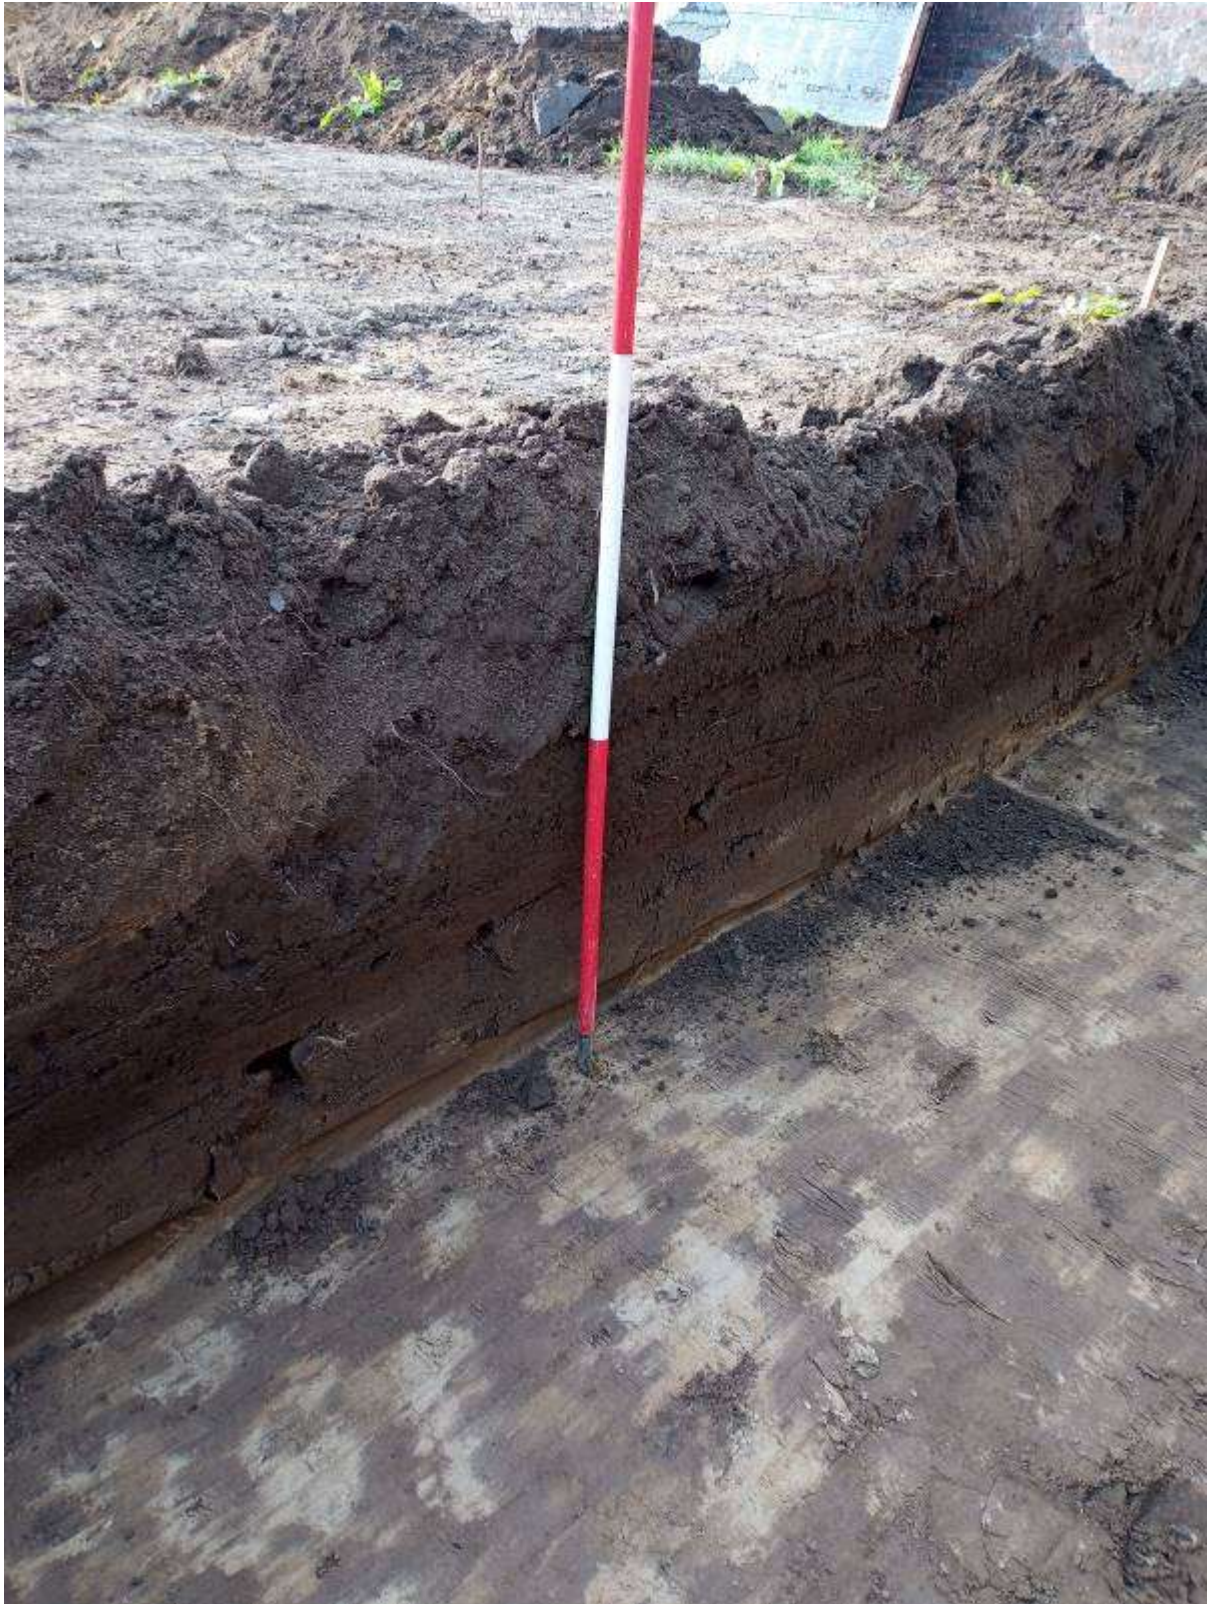
Illustration 9- Detail of North facing section of Trench A showing dark brown sandy clay 100 overlying moderate light-yellow natural sand 101.

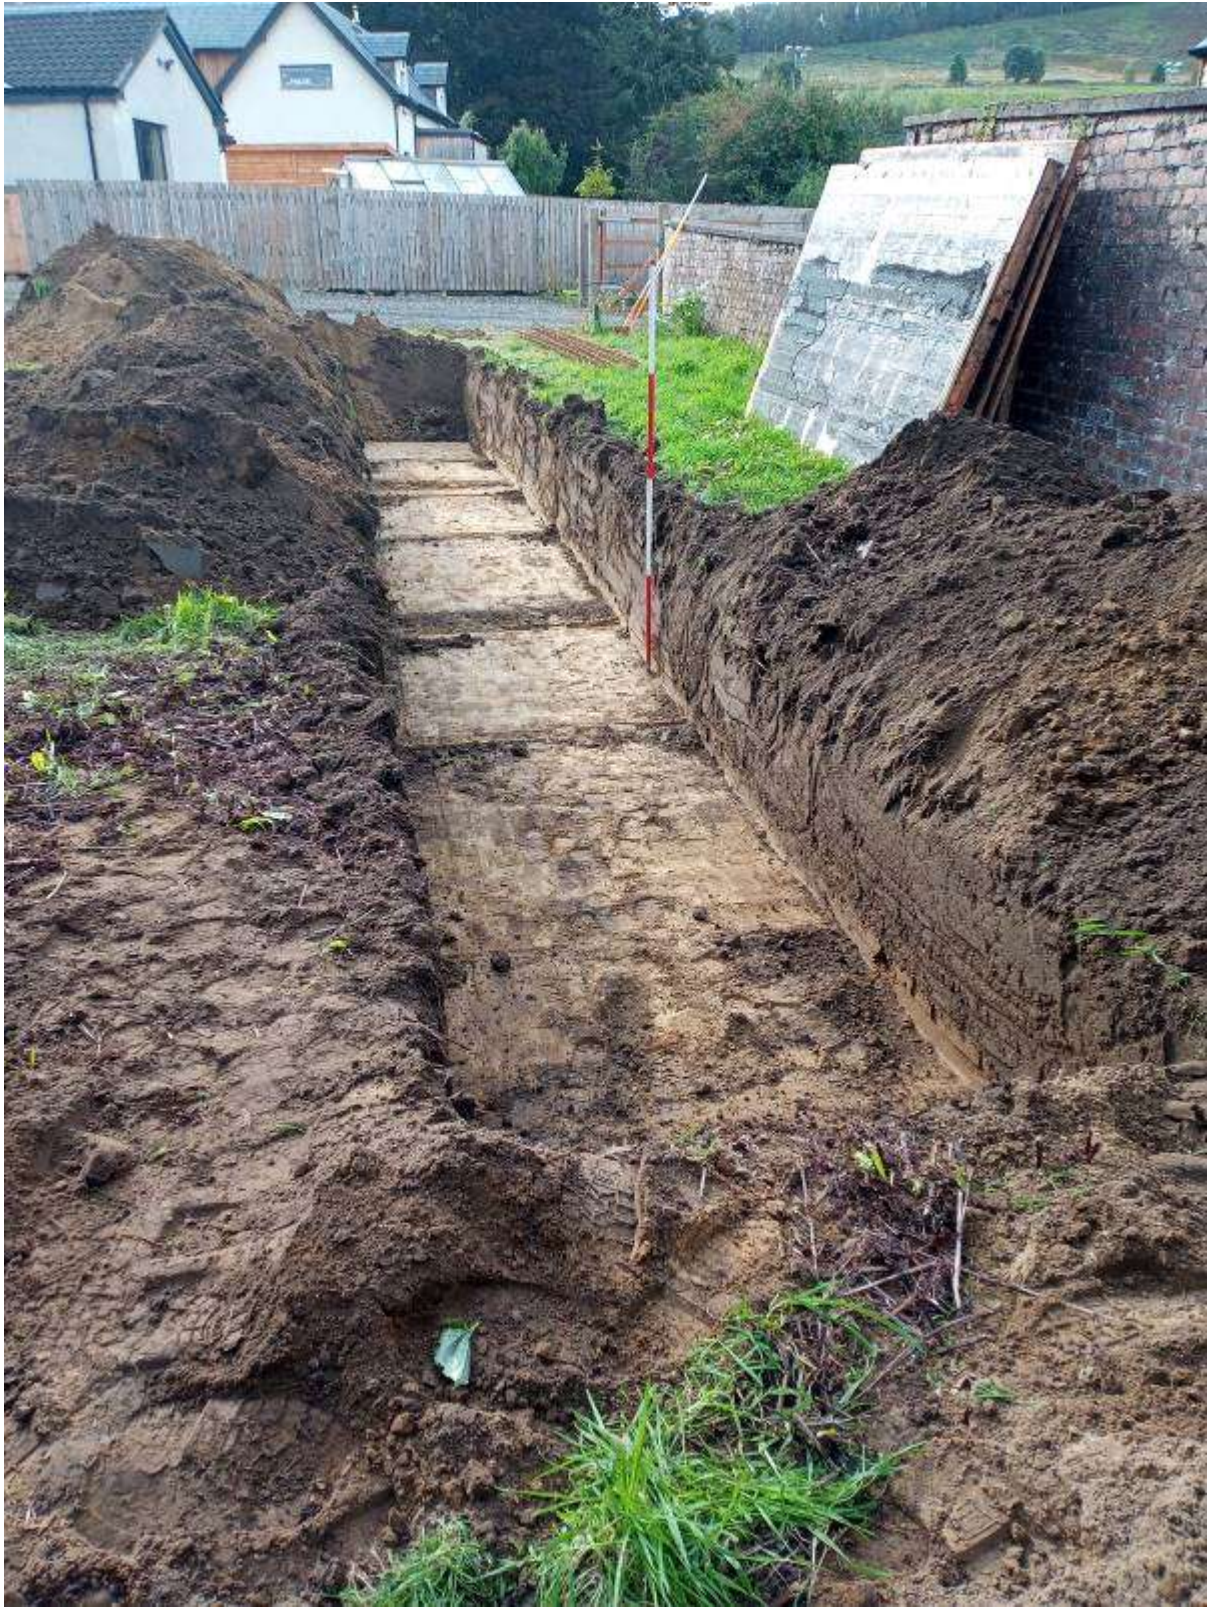
Illustration 10- Trench B completely excavated looking South showing moderate light-yellow sand 201 below dark down sandy clay 200.

This trench ran on a North West to South East alignment and measured 14m by 2m. An homogenous dark brown sandy clay (200) 0.80m deep was removed to reveal a moderate light-yellow sand (201). There were no finds and nothing of archaeological interest was located.

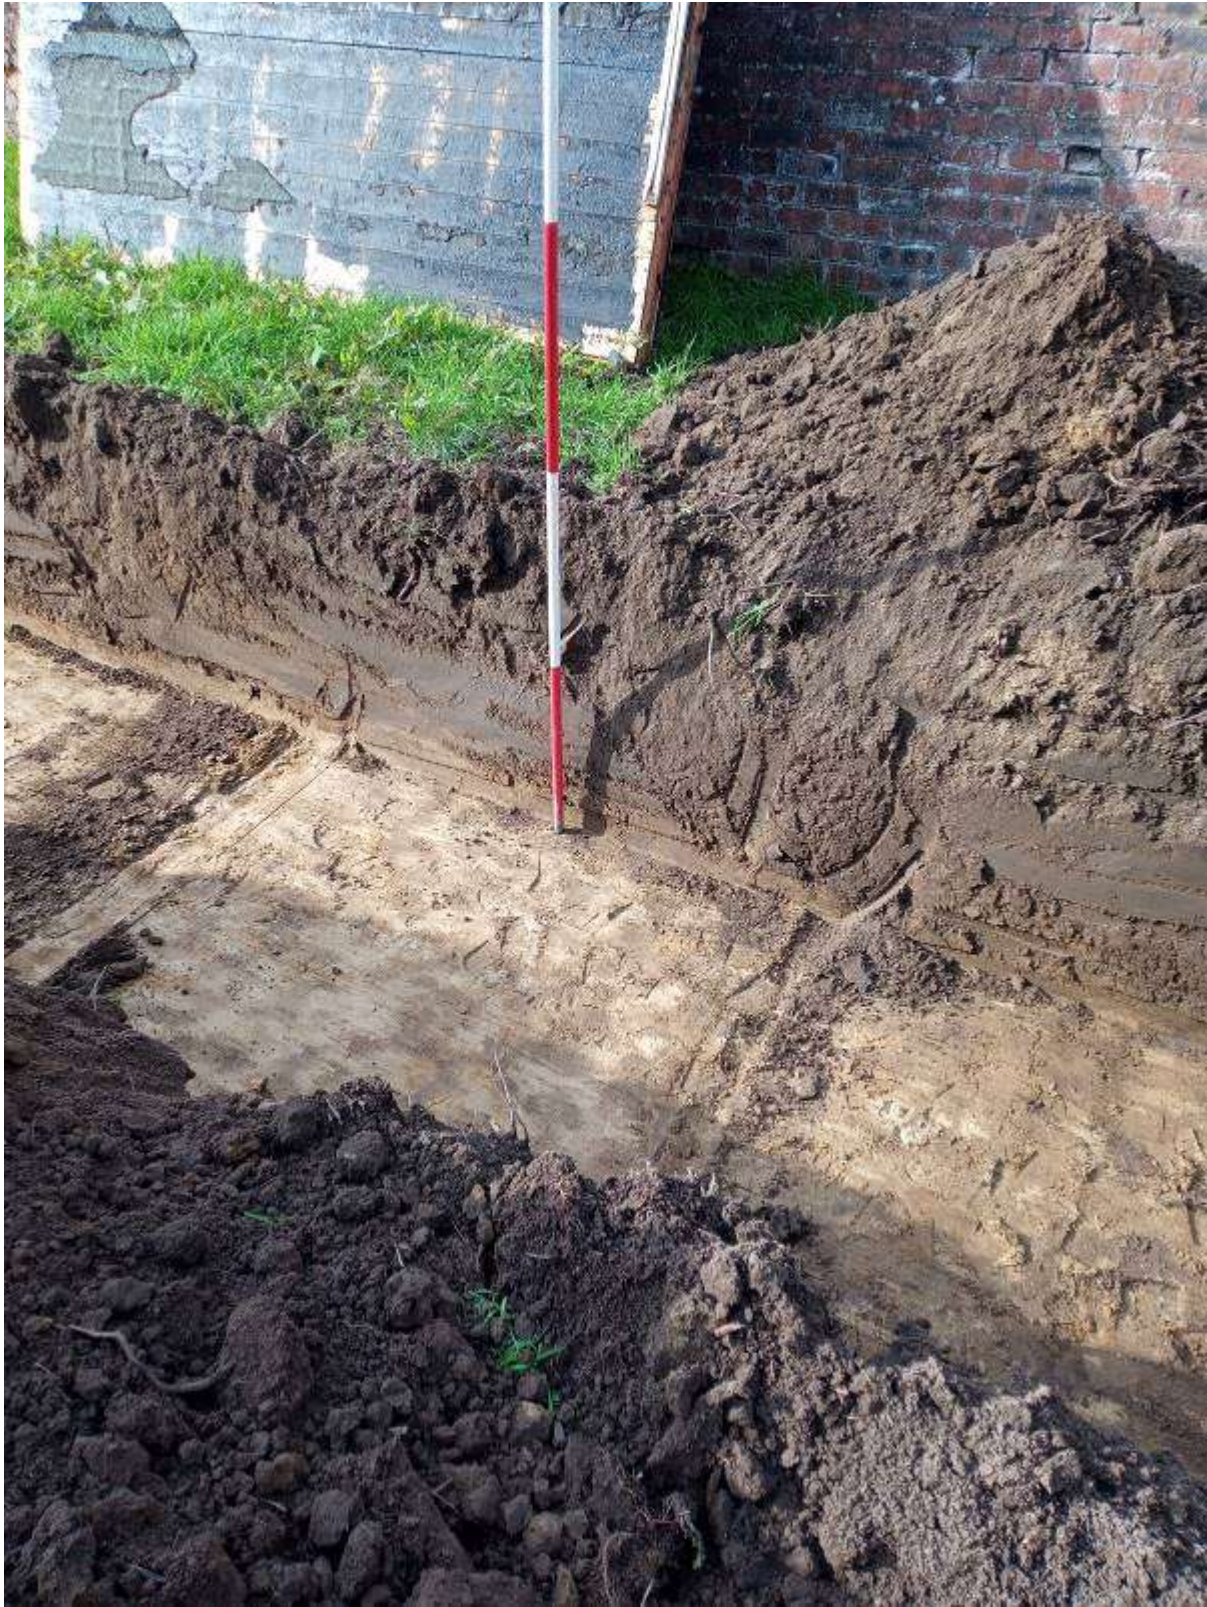
Illustration 11- Detail shot of East facing section of Trench B showing dark brown sandy clay 200 overlying moderate light-yellow natural sand 201.

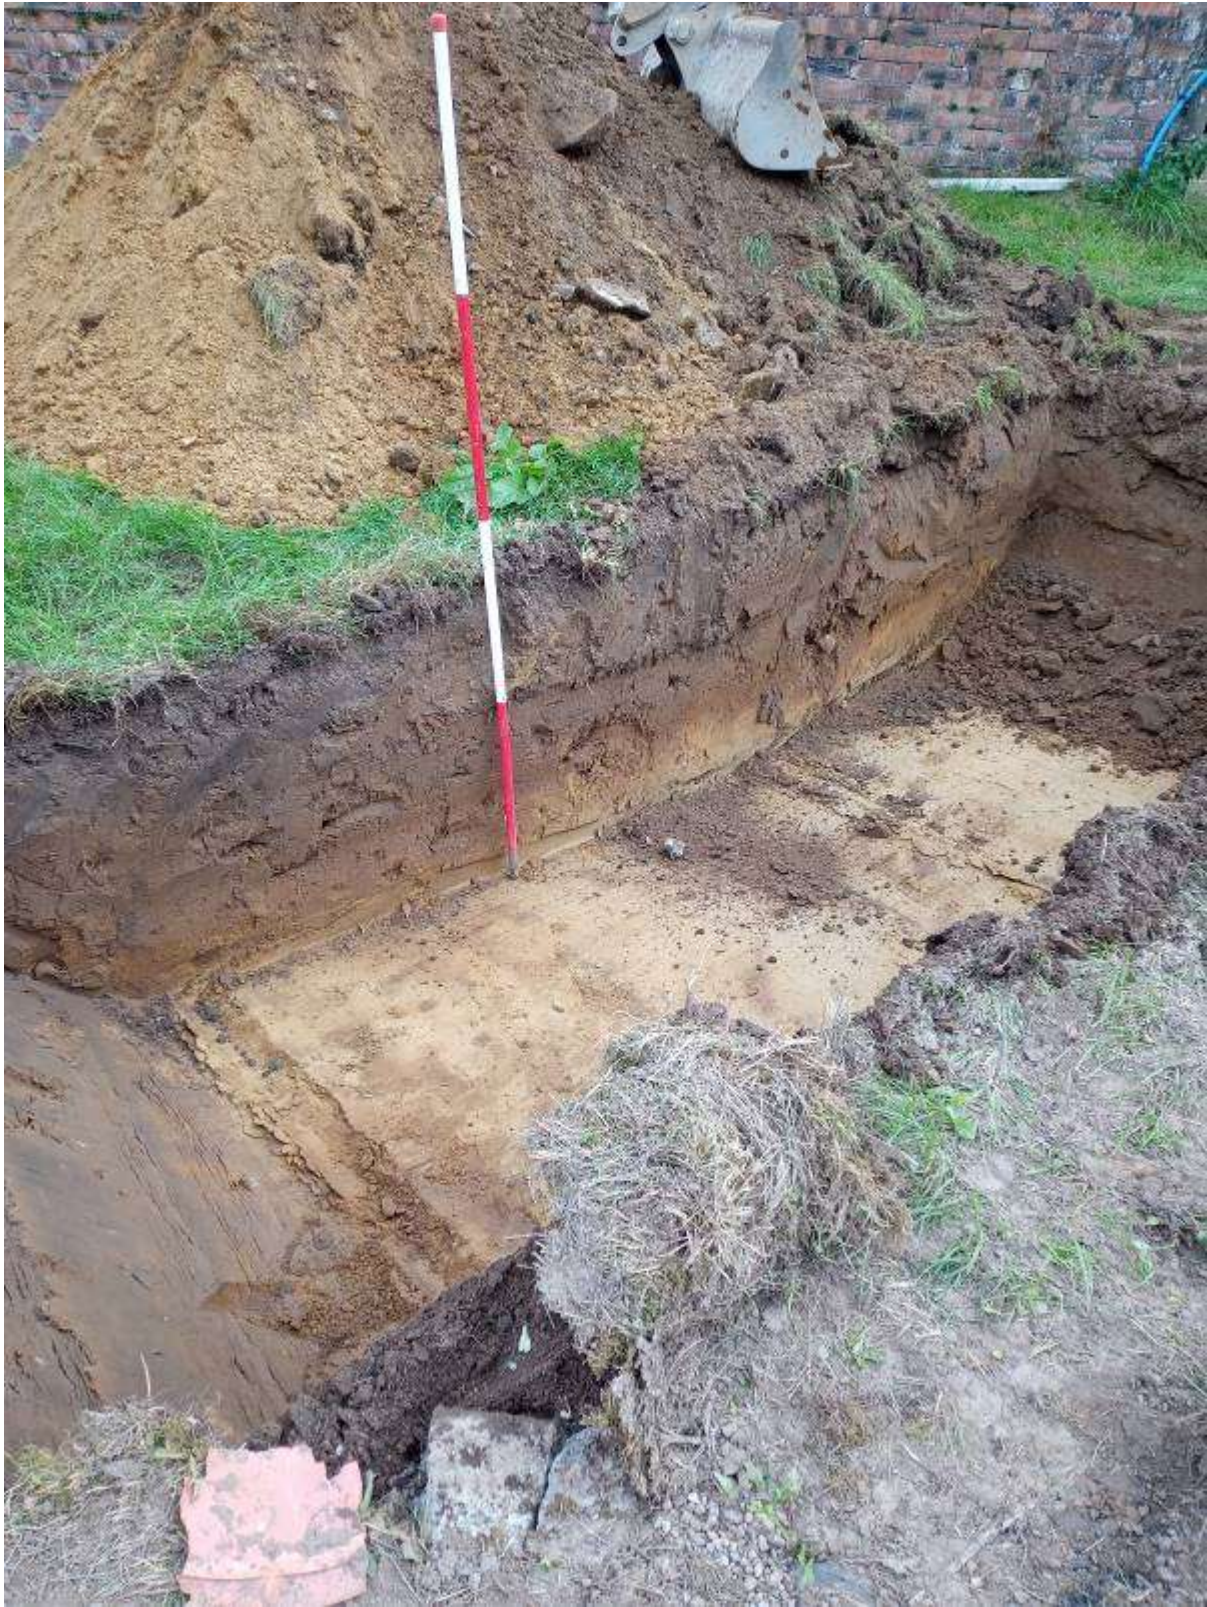
Illustration 12- Trench C completely excavated looking East showing dark brown sandy clay 300 overlying moderate light-yellow natural sand 301.

This trench ran on a North North West to South South East alignment and measured 5m by 2m. An homogenous dark brown sandy clay (300) 0.80m deep was removed to reveal a moderate light-yellow sand (301). Apart from an electrical cable there were no other finds and nothing of archaeological interest was located.

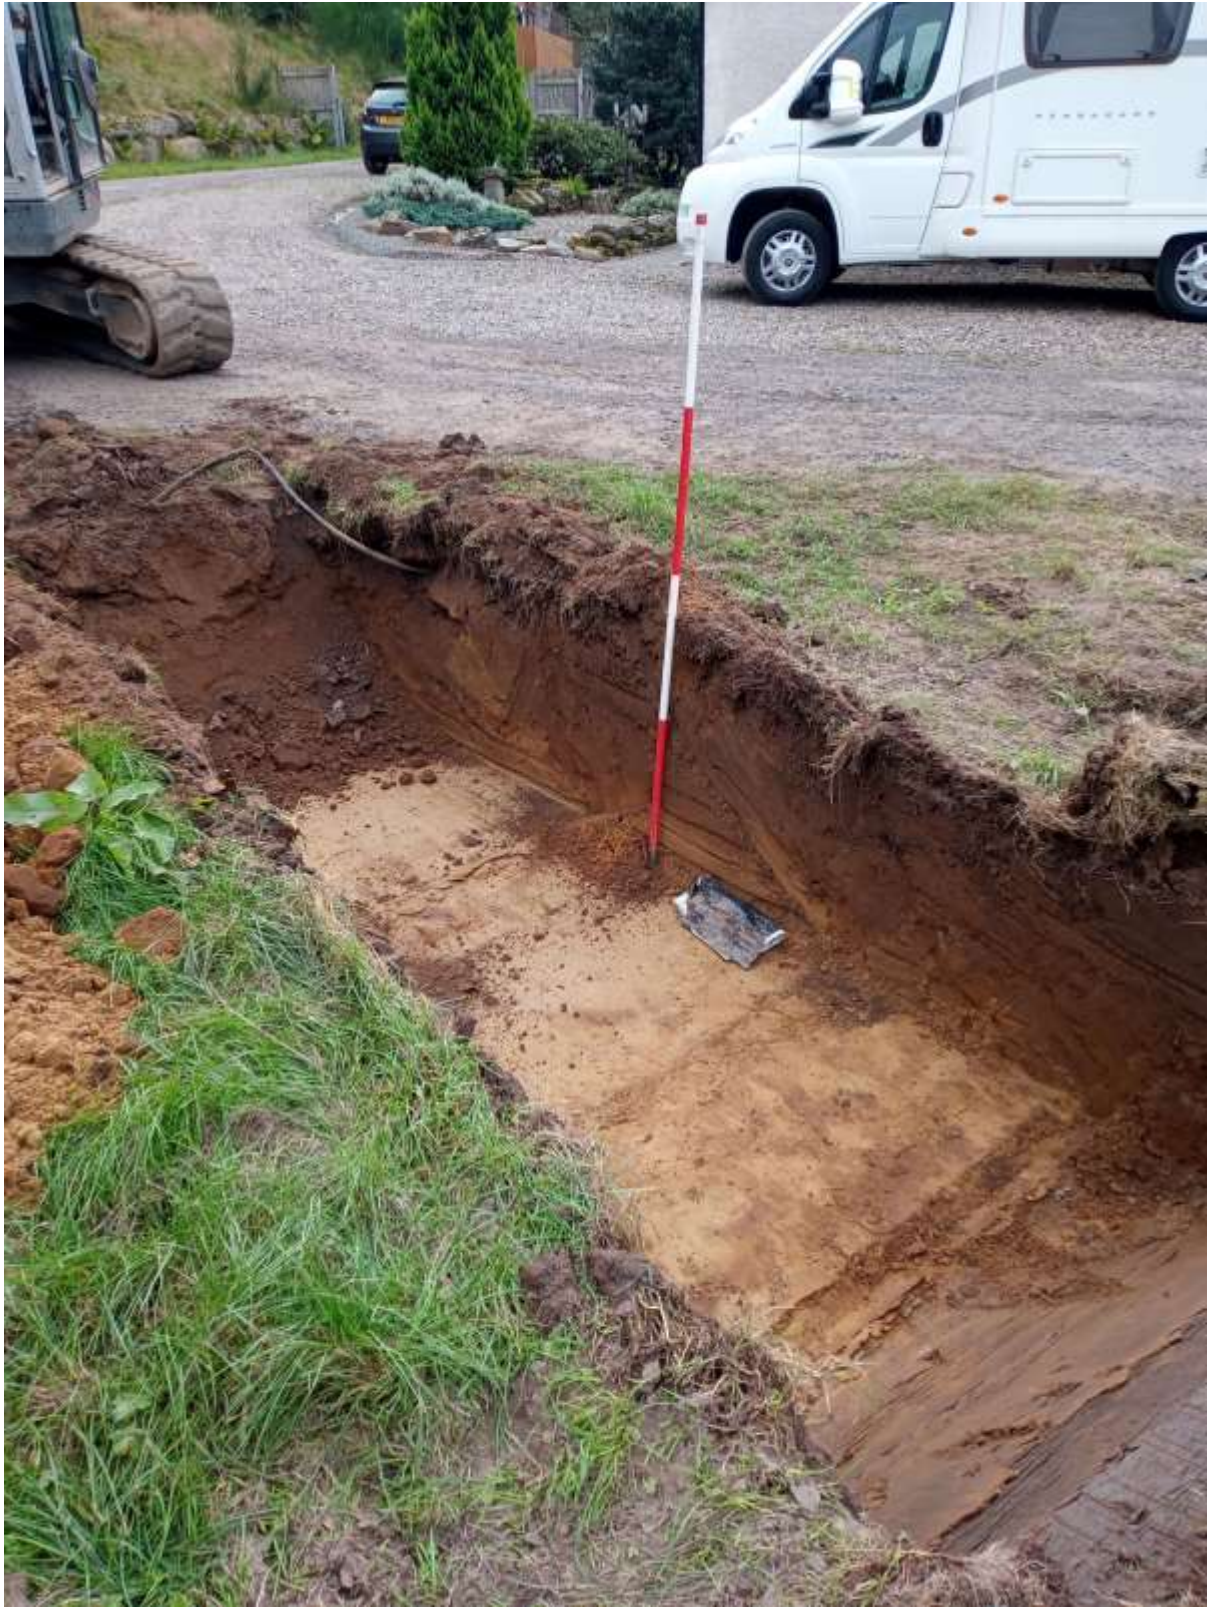
Illustration 13- Trench C completely excavated looking South showing dark brown sandy clay 300 overlying moderate natural light-yellow sand 301.
