## Standing Building Survey

Land 85m N W of Newhall, Kettins, Perth and Kinross

Surviving former steading buildings 'A' and 'B' looking North East, Newhall, Kettins.

24<sup>th</sup> May 2022

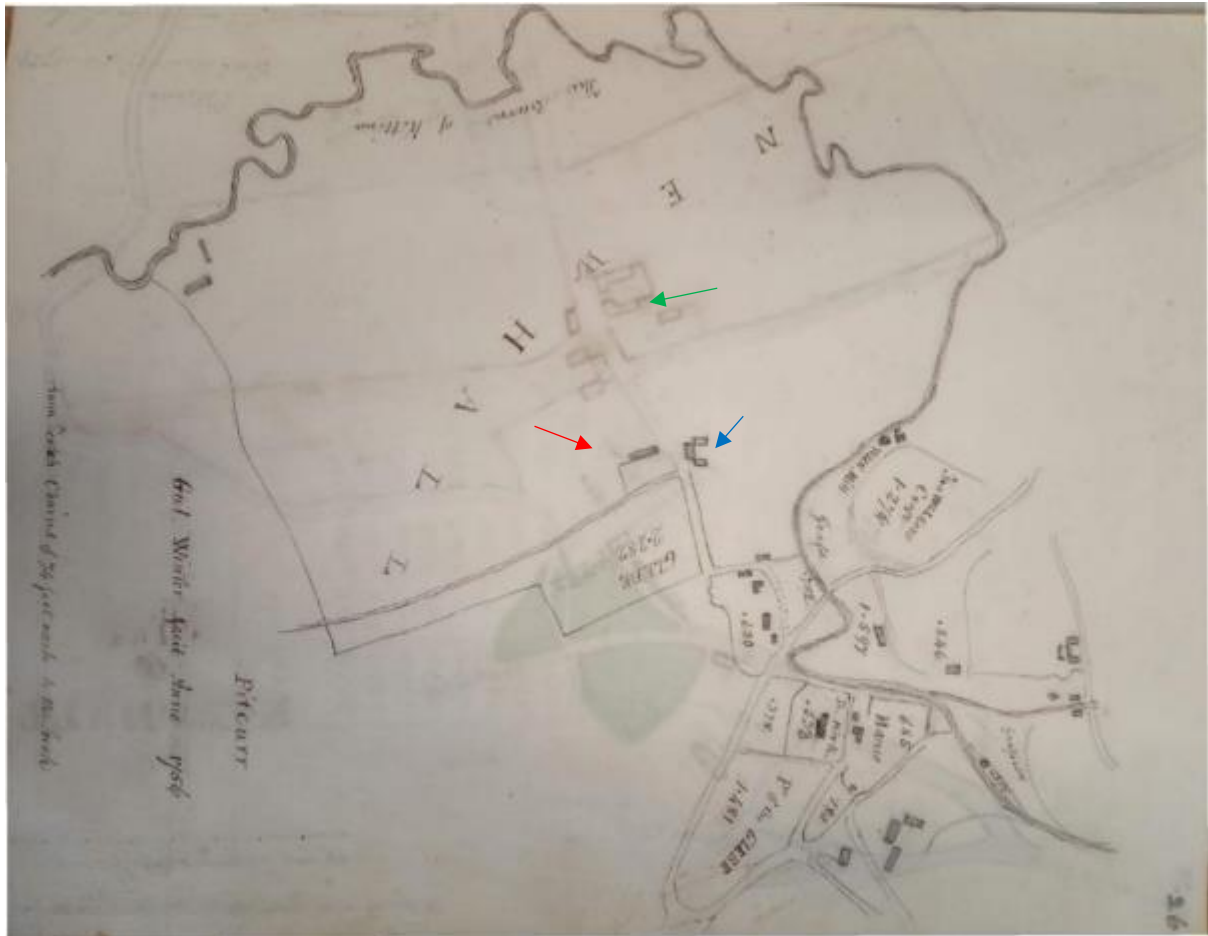
Illustration 3 – Single building (red arrow) and Newhall House (blue arrow) shown on site on Factor's Estate Plan of 1796, apparent buildings at green arrow are bled through from 1819 plan on the back of this sheet (© Perth and Kinross Council Archives acc 18/12).

Building 'B' would appear to be earlier than Building 'A' and may retain elements of the single structure shown on the 1796 Estate map (Illus 3, 42 and 46). In their original forms Building 'B' and Boundary wall 'C' (formerly the North Eastern side wall of a long building) formed part of the farm steading complex first mapped in 1819 and fully depicted on the 1863 Ordnance Survey map, on that map Building 'A' is shown as a stand-alone building. Buildings 'A' and 'B' were retained as single structures following the demolition of most of the farm steading and Boundary wall 'C' was left standing, a former window and entrance in it were blocked. From limited historical research it would appear that the site at Newhall was originally known as 'the church lands of Kettins' and was owned Pre-Reformation by the Trinitarian House of Cross Kirk in Peebles, there is no evidence that it ever belonged to the Cistercian Abbey of Coupar Angus.

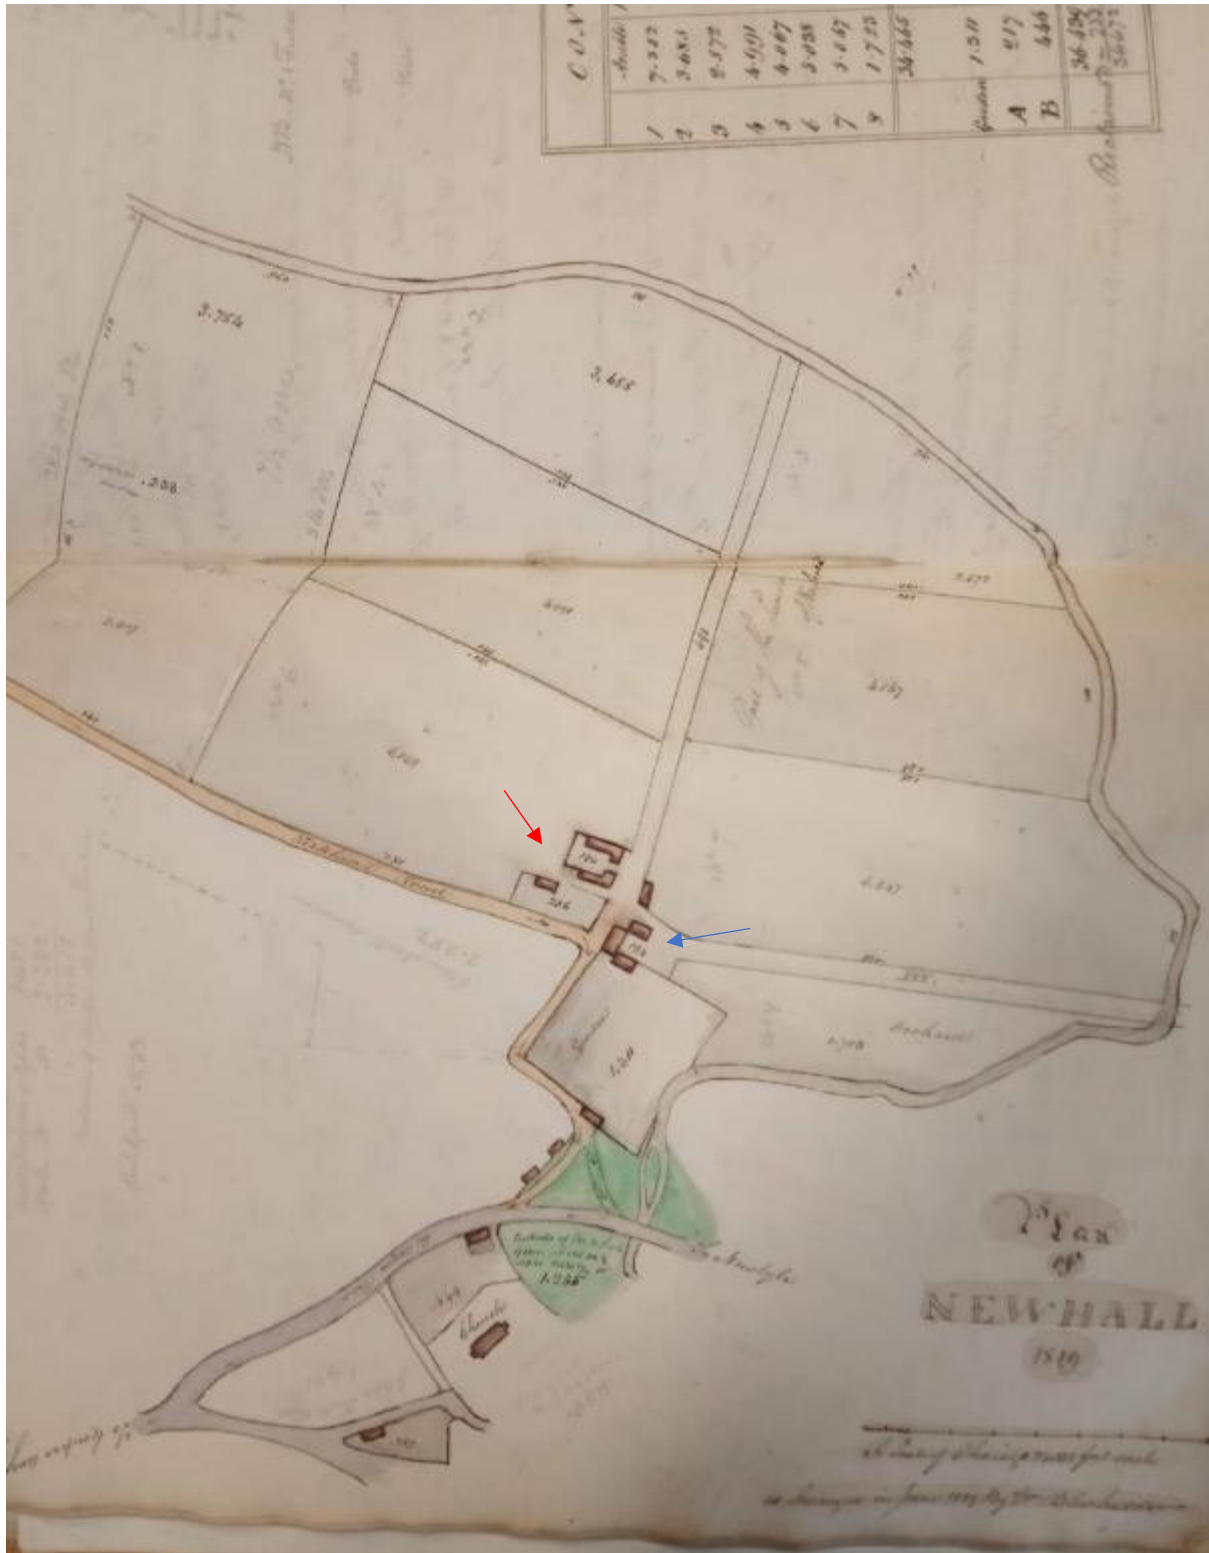
Illustration 4 – Buildings on site (red arrow) and Newhall House (blue arrow) as shown on William Blackadder’s Estate plan of 1819 (© Perth and Kinross Council Archives acc 18/12).

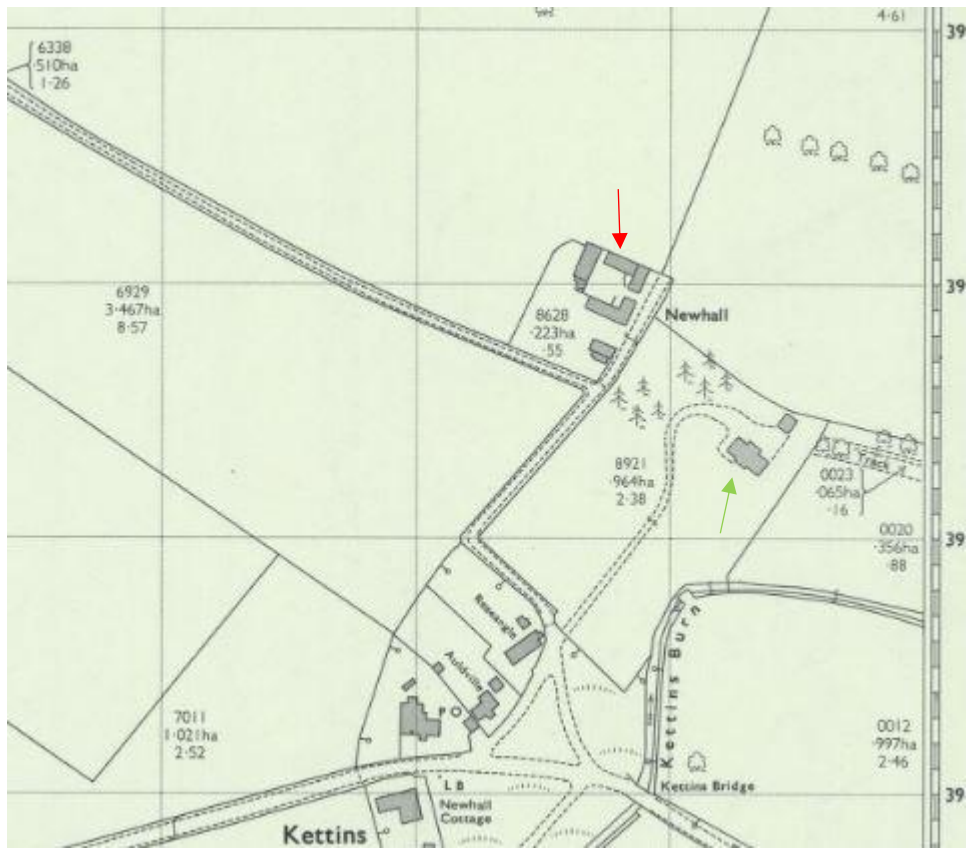
Illustration 6 – Buildings as shown on site (red arrow) on Ordnance Survey map of 1971, Newhall House has been demolished and a new version built (green arrow) (© National Library of Scotland).

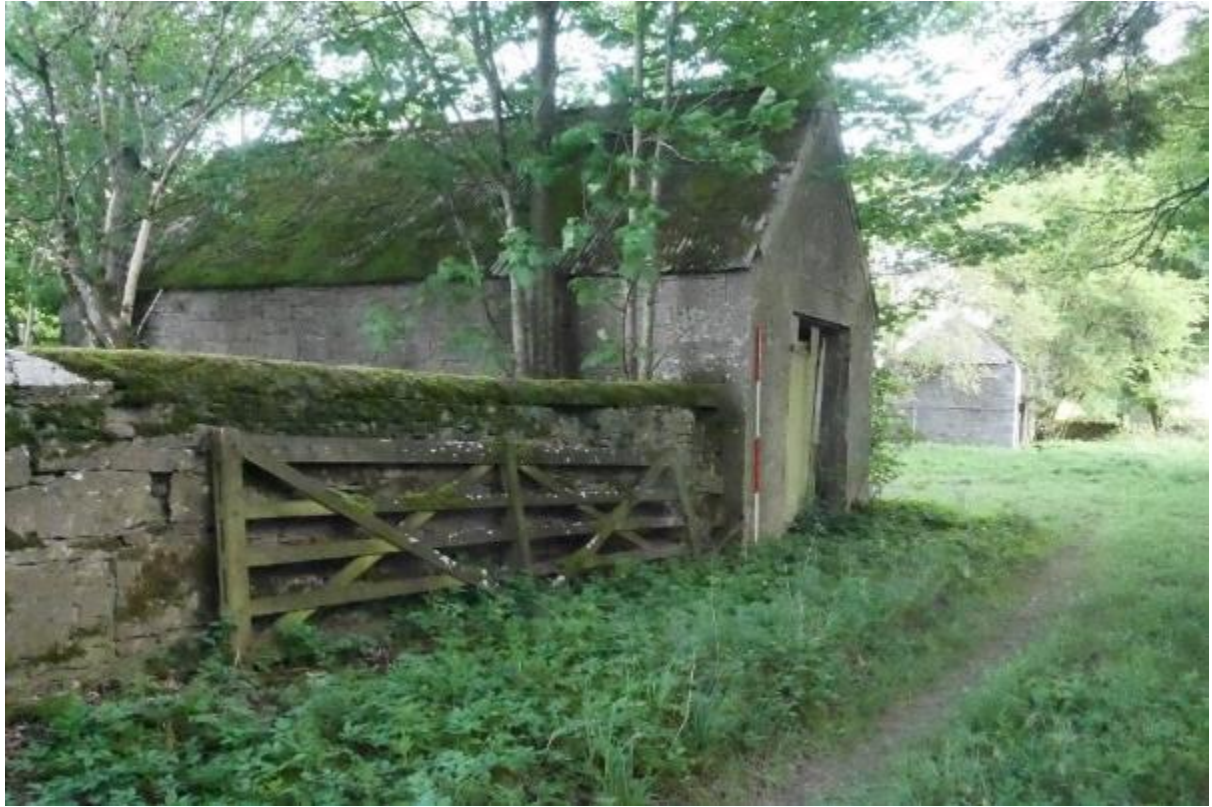
This lies on a North Western to South Eastern alignment and is built of mortared bonded cut and tooled green sandstones and has a corrugated iron roof.

Illustration 8 – Buildings A and B looking NW from site entrance.

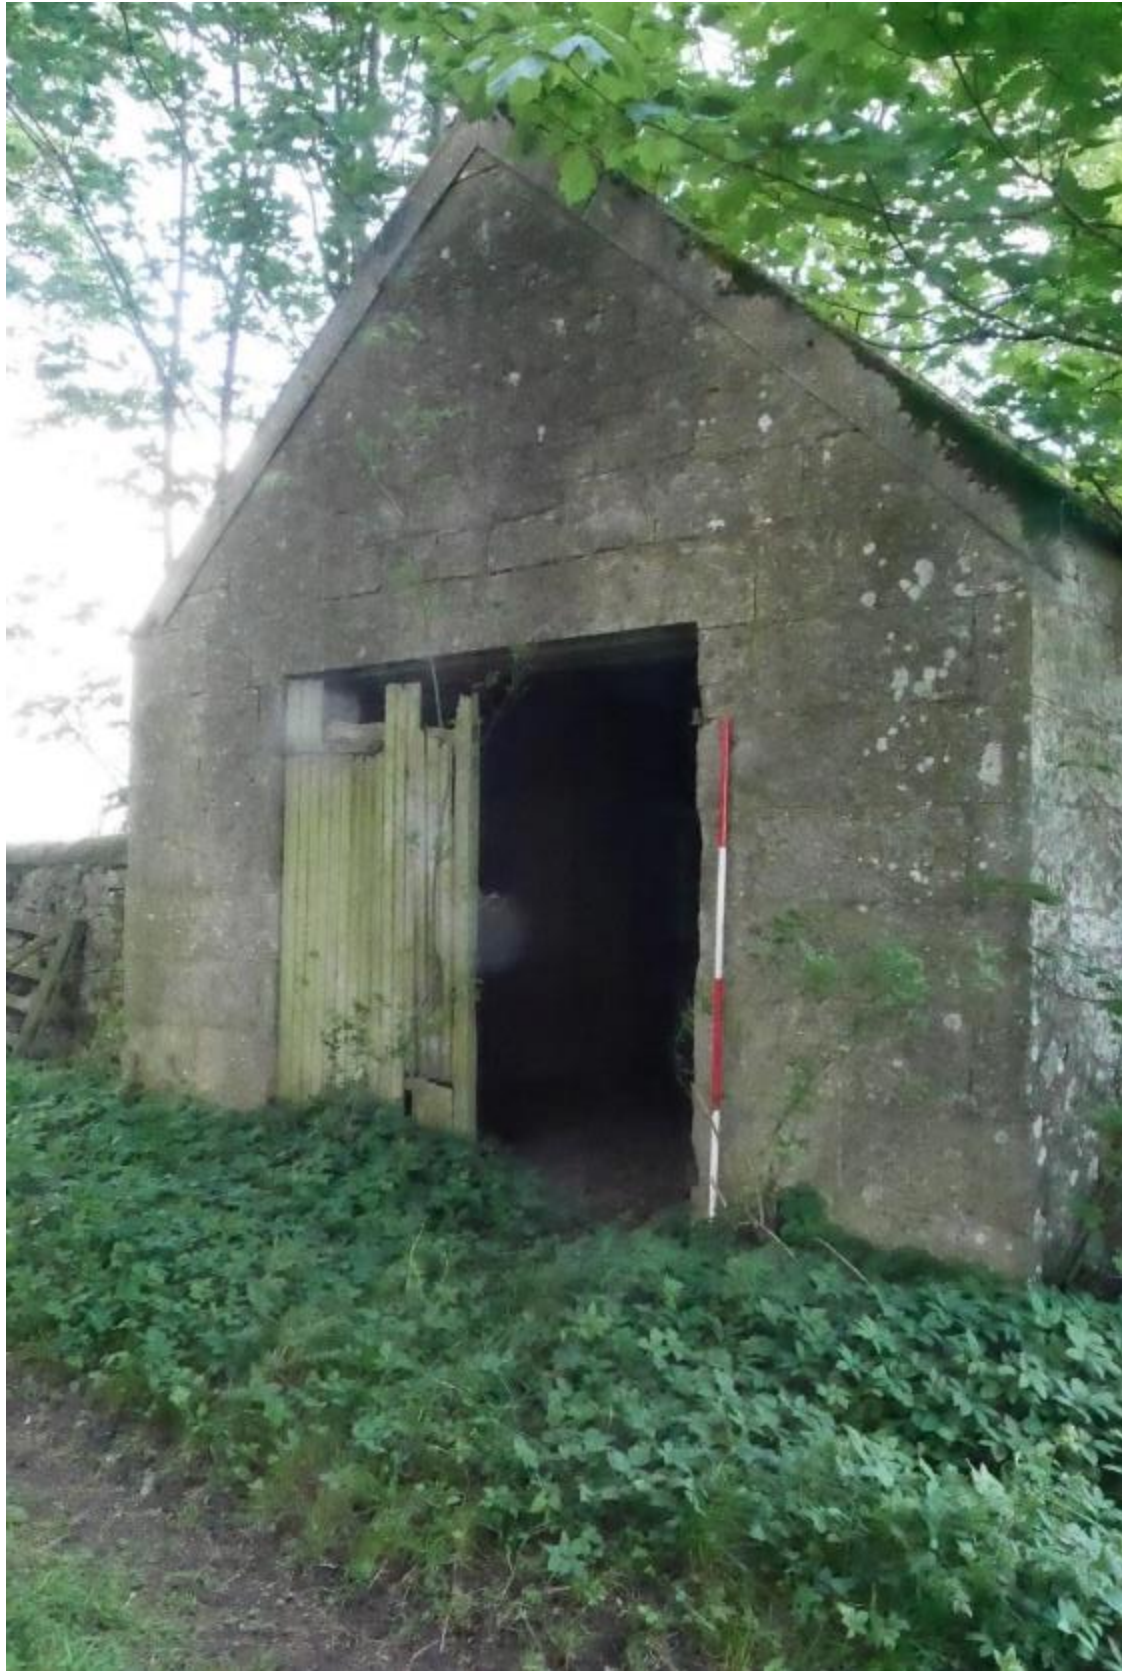
This is built of mortared cut and tooled green sandstones and is a gable end with a wide doorway with one surviving wooden door in place. There are alternate quoins at each end of the wall. There is a stone finial with a symbol (fleur de lys?) at the apex of the gable (Illus 10 and 11).

Illustration 9- South Eastern external elevation of Building A.

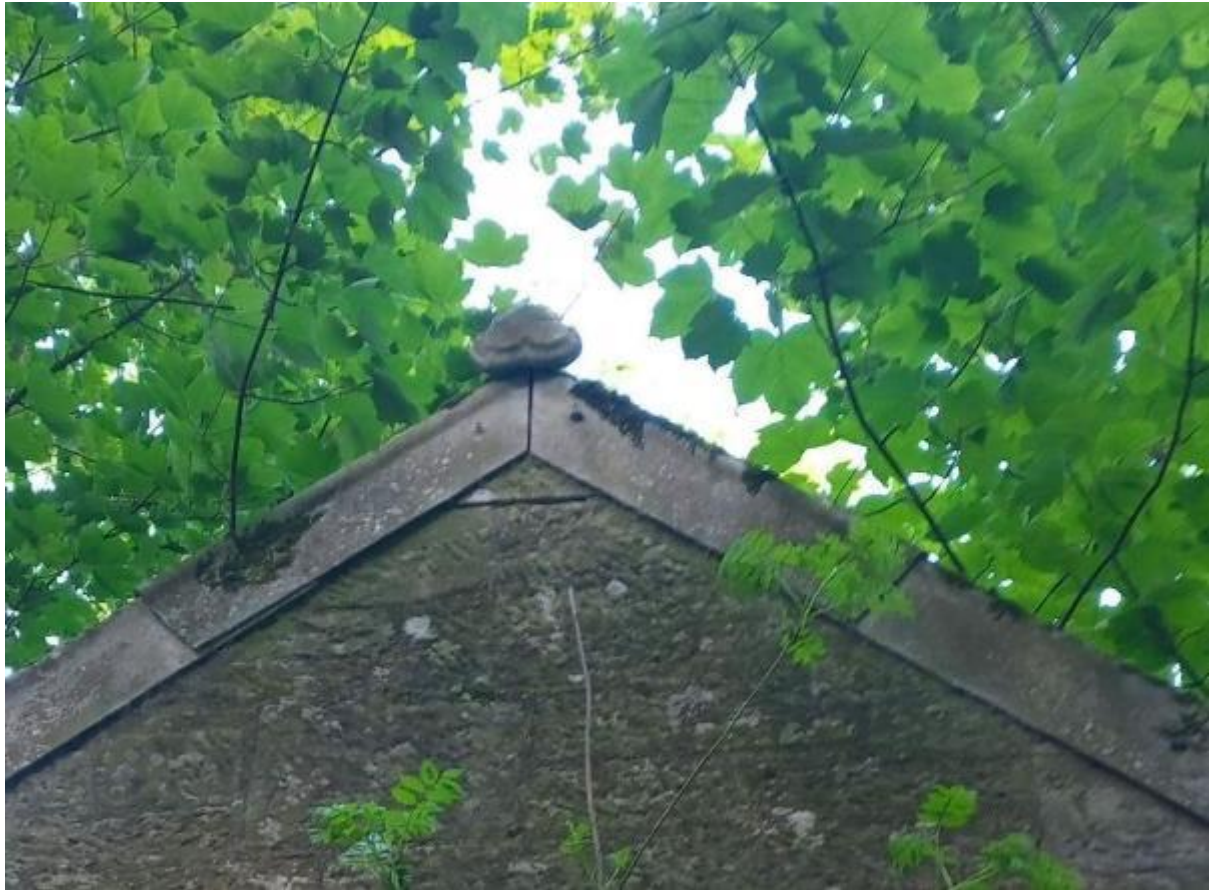
Illustration 10 – Decorative finial at head of gable on South Eastern facing external elevation of Building A.

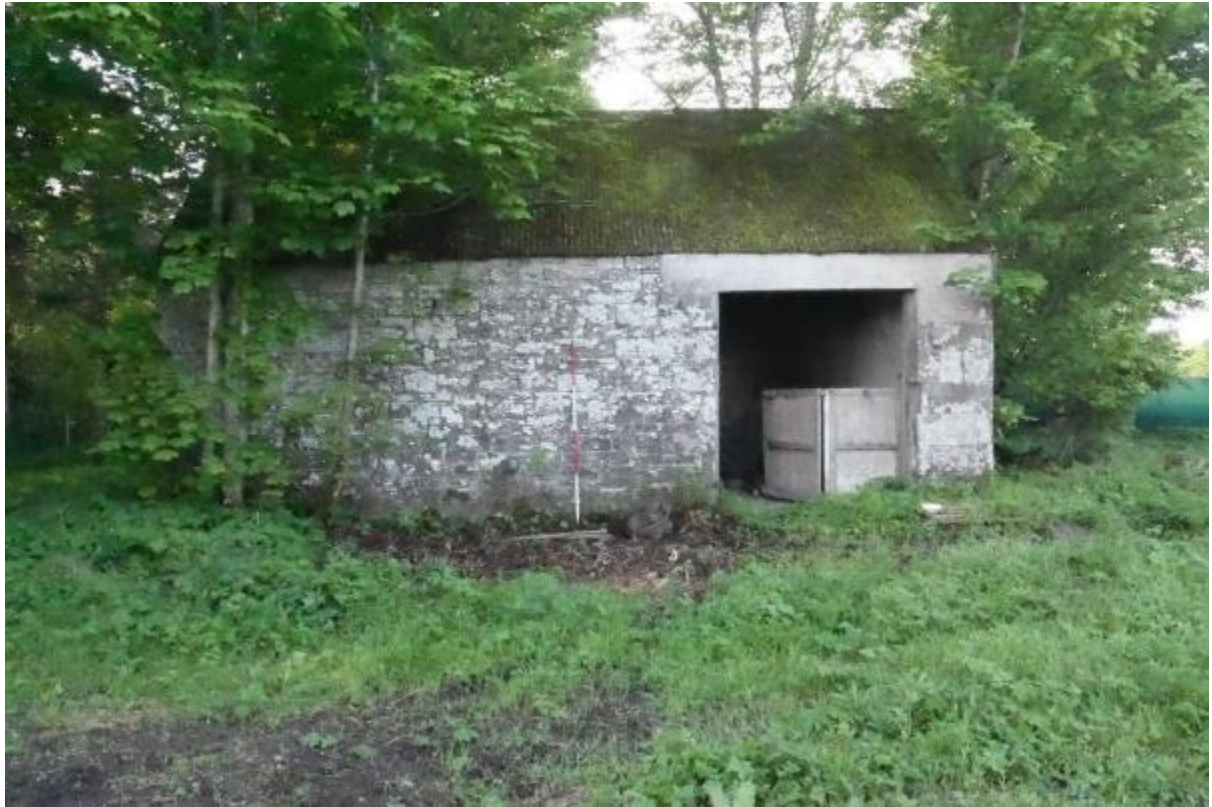
This is built of mortared cut and tooled green sandstones and has some surviving plaster and has a wide doorway at its N end. There is a half-height folding wooden door in situ.

Illustration 12 – North Eastern facing external elevation of Building A.

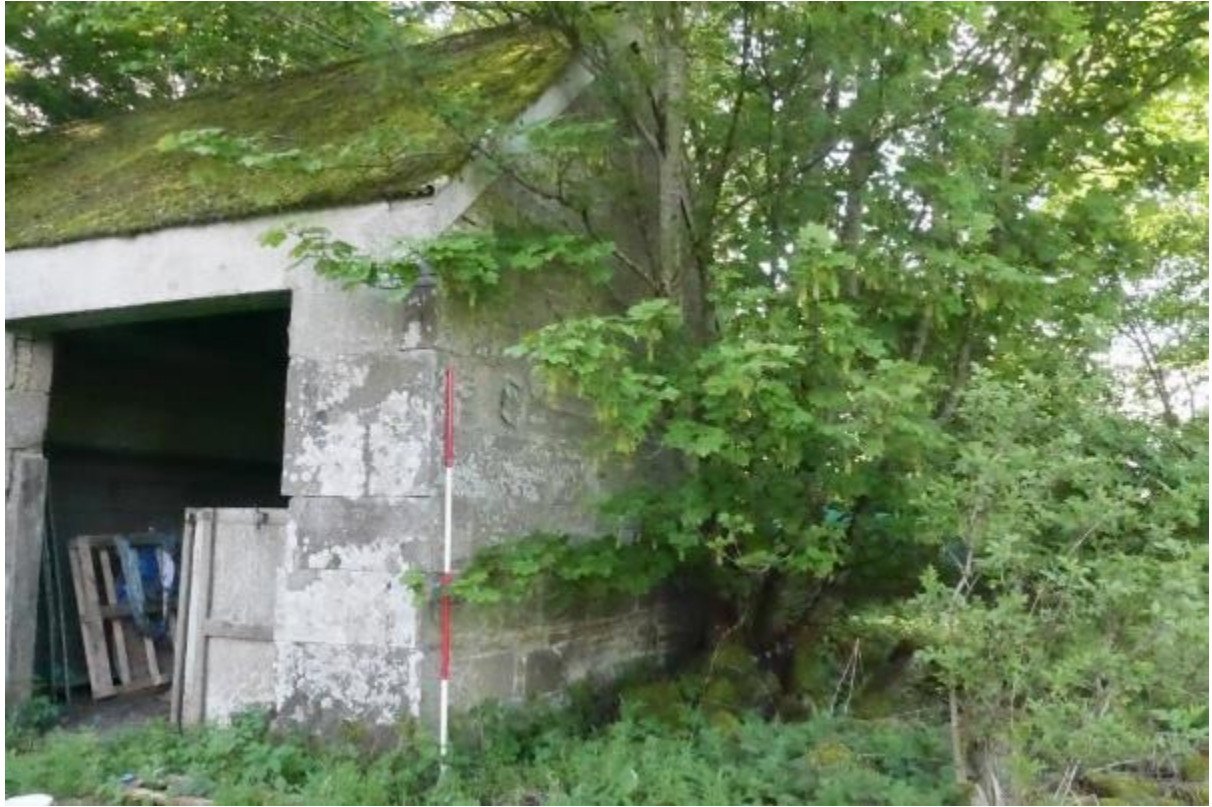
This is built of mortared cut and tooled green sandstones and is a blank wall face and gable end. There are alternate quoins at its ends.

Illustration 14- North Western facing external elevation (gable) of Building A.

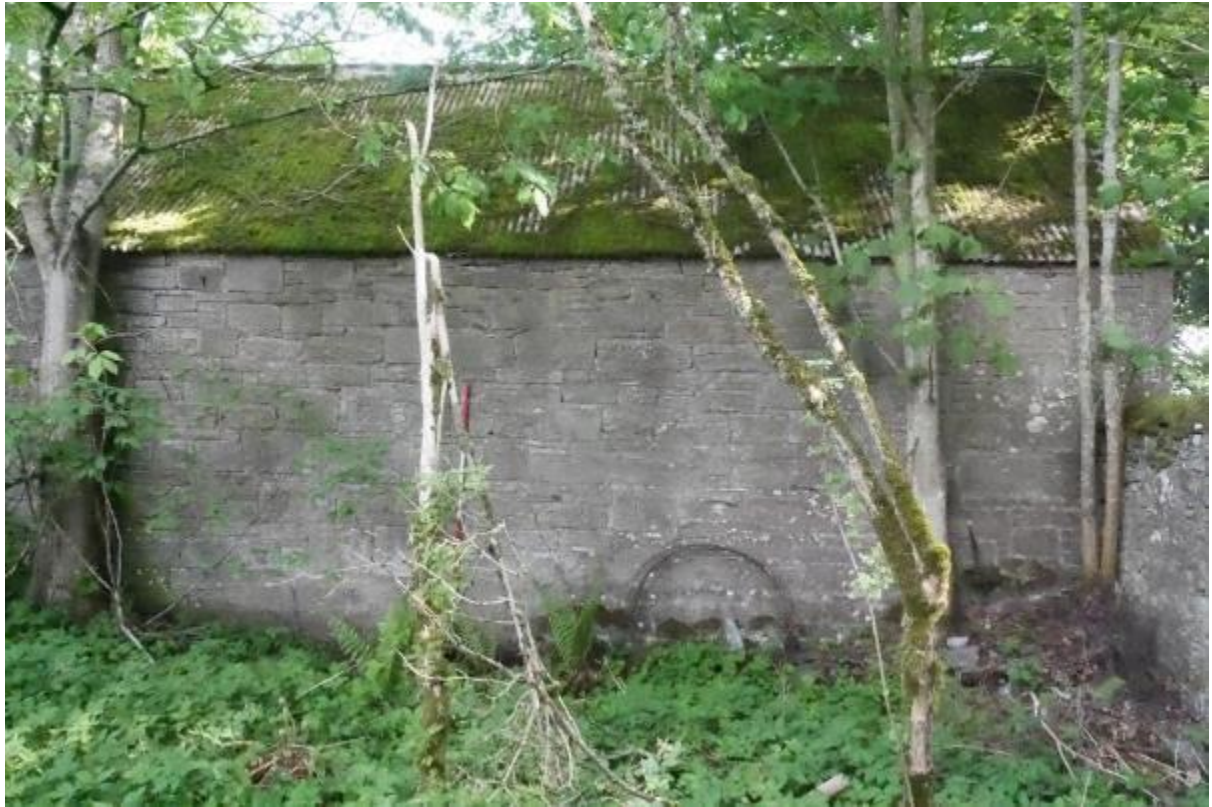
This is built of mortared cut and tooled green sandstones and is a blank wall face. There are alternate quoins at its ends.

Illustration 15- South Western facing external elevation of Building A.

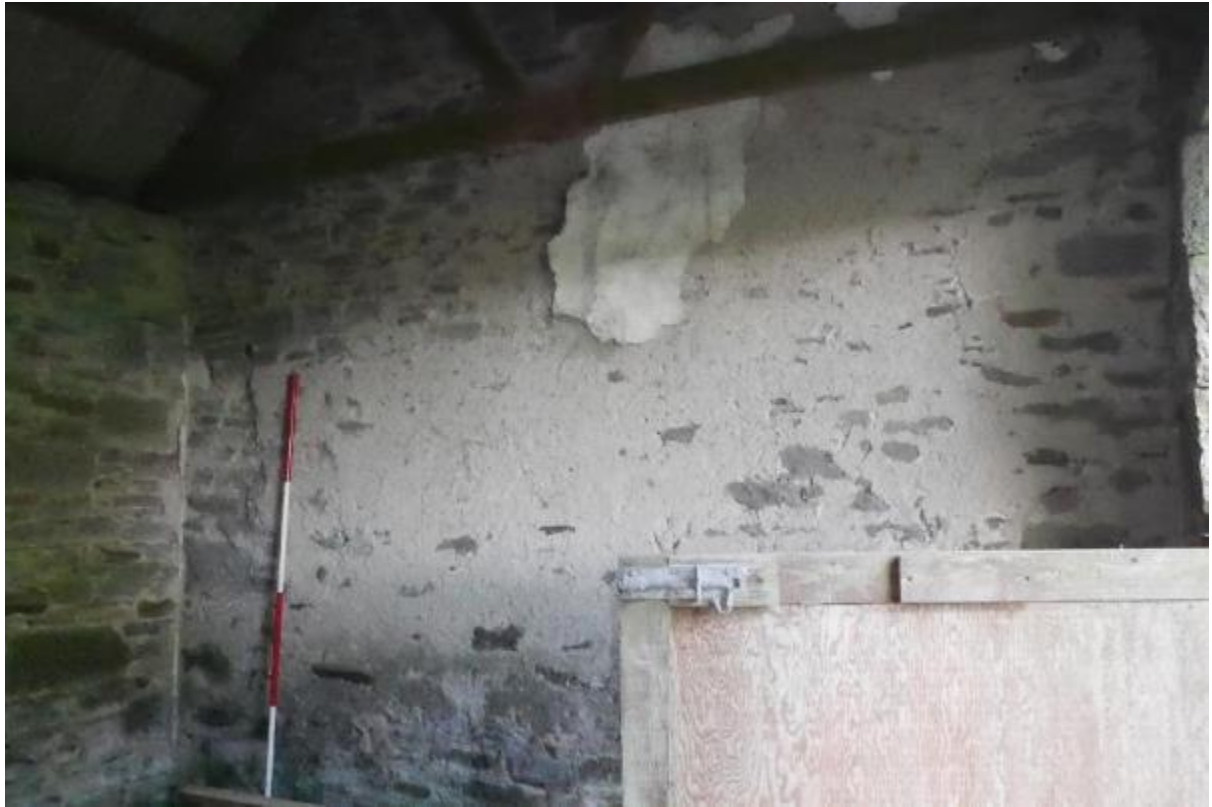
The North Eastern and South Eastern facing internal elevations of this room are blank wall faces built of mortared sandstones. There is surviving plaster on the South Eastern elevation. The South Western facing internal elevation has a wide doorway in it. The North Western facing internal elevation is a wooden wall against a stone wall face. There is an earth floor and there are occasional reused tooled sandstones in the North Eastern and South Western elevations.

Illustration 16- Internal South Eastern facing elevation of North Western room of Building A.

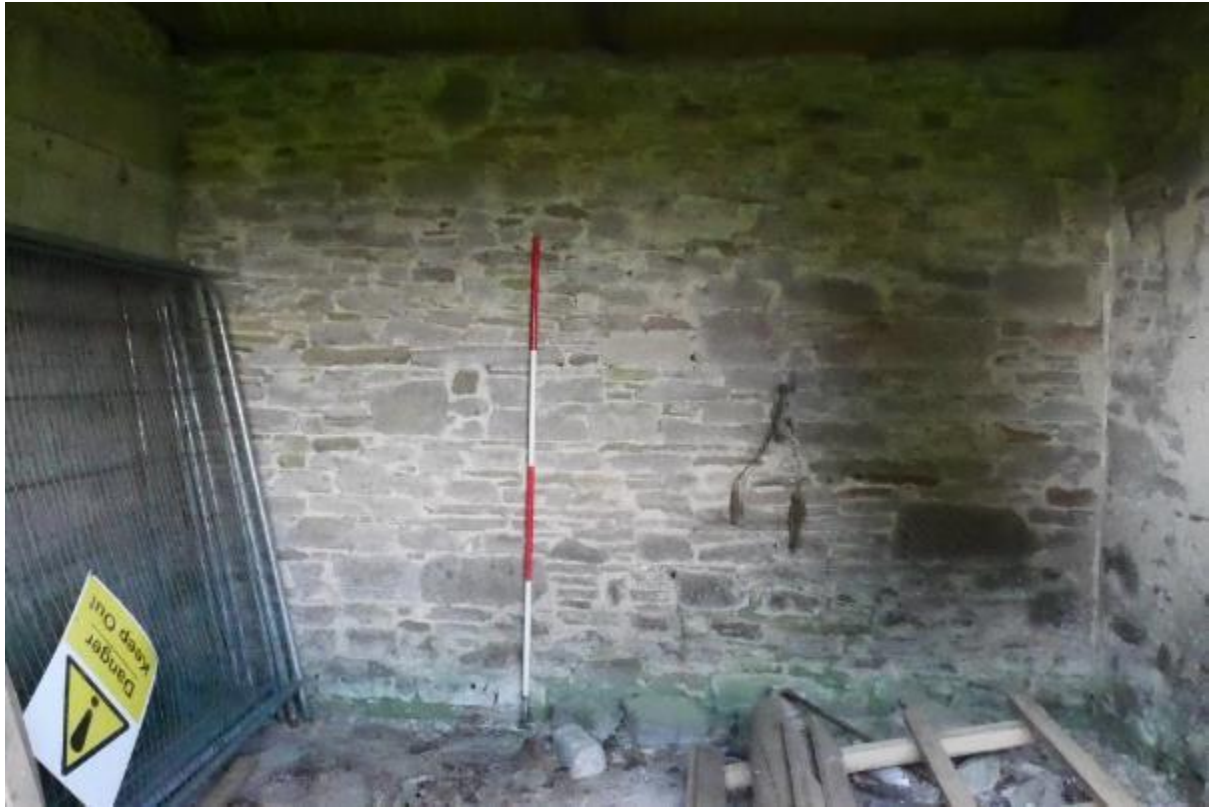
Illustration 17 – Internal North Eastern facing elevation of North Western room of Building A.

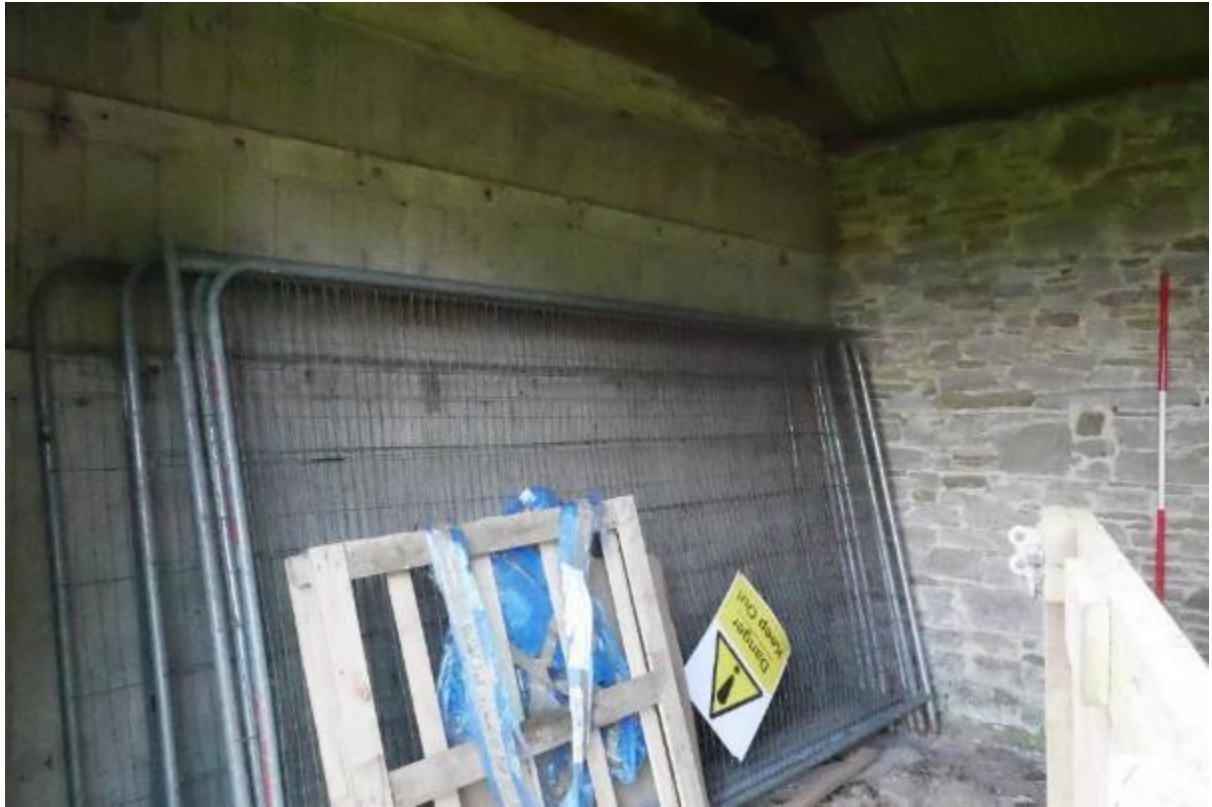
Illustration 18 – Internal North Western facing elevation of North Western room of Building A.

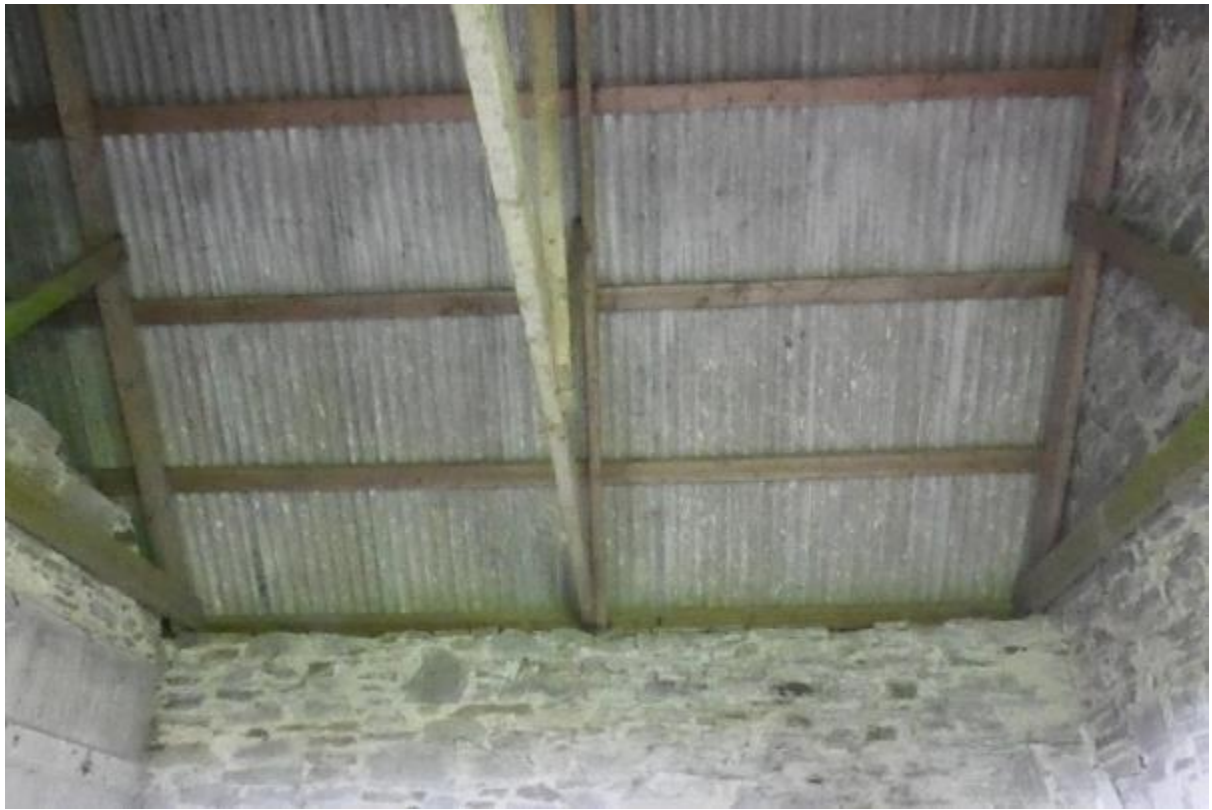
Illustration 19 – Internal view of corrugated iron roof of Building A.

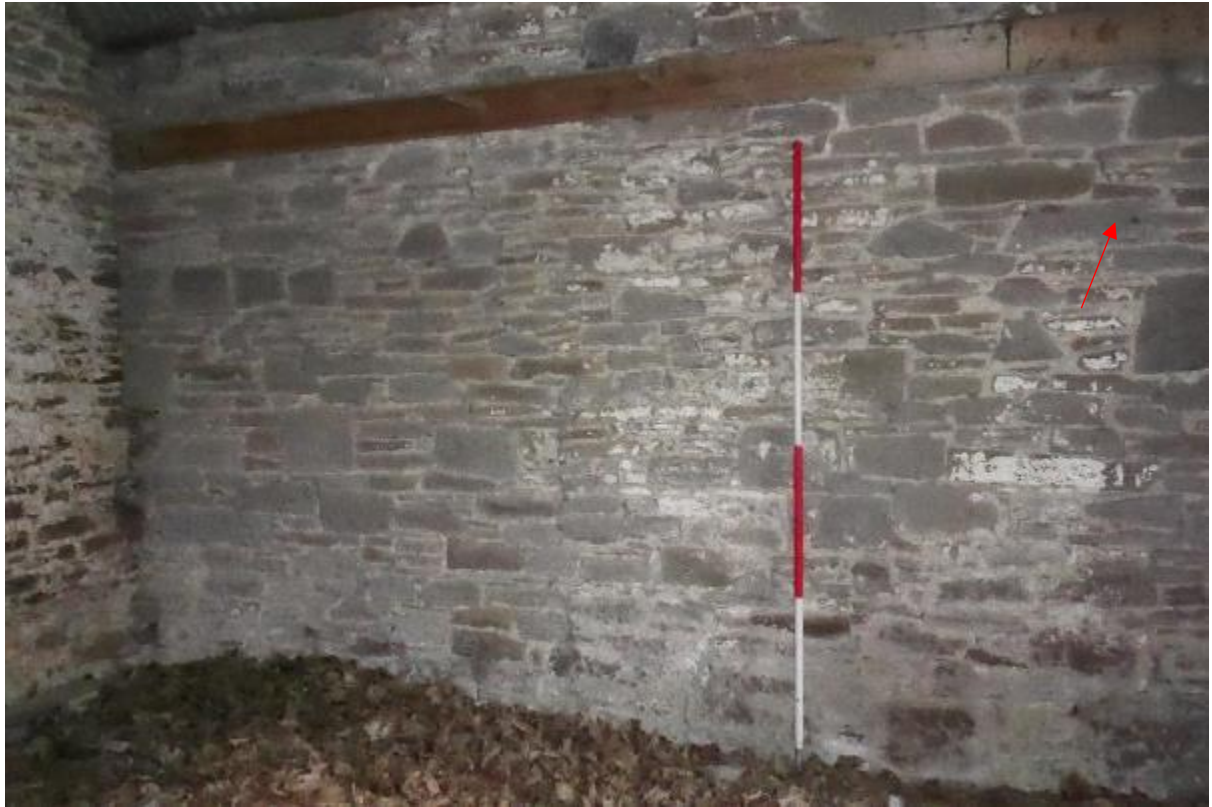
The South Eastern, South Western and North Eastern facing internal elevations are all blank wall faces built of mortared sandstones. There are traces of plaster on the South Eastern and South Western internal elevations. The North Eastern facing internal elevation has a wide doorway in it. There is an earth floor.

Illustration 20 – South Western facing internal elevation of South Western room in Building A.

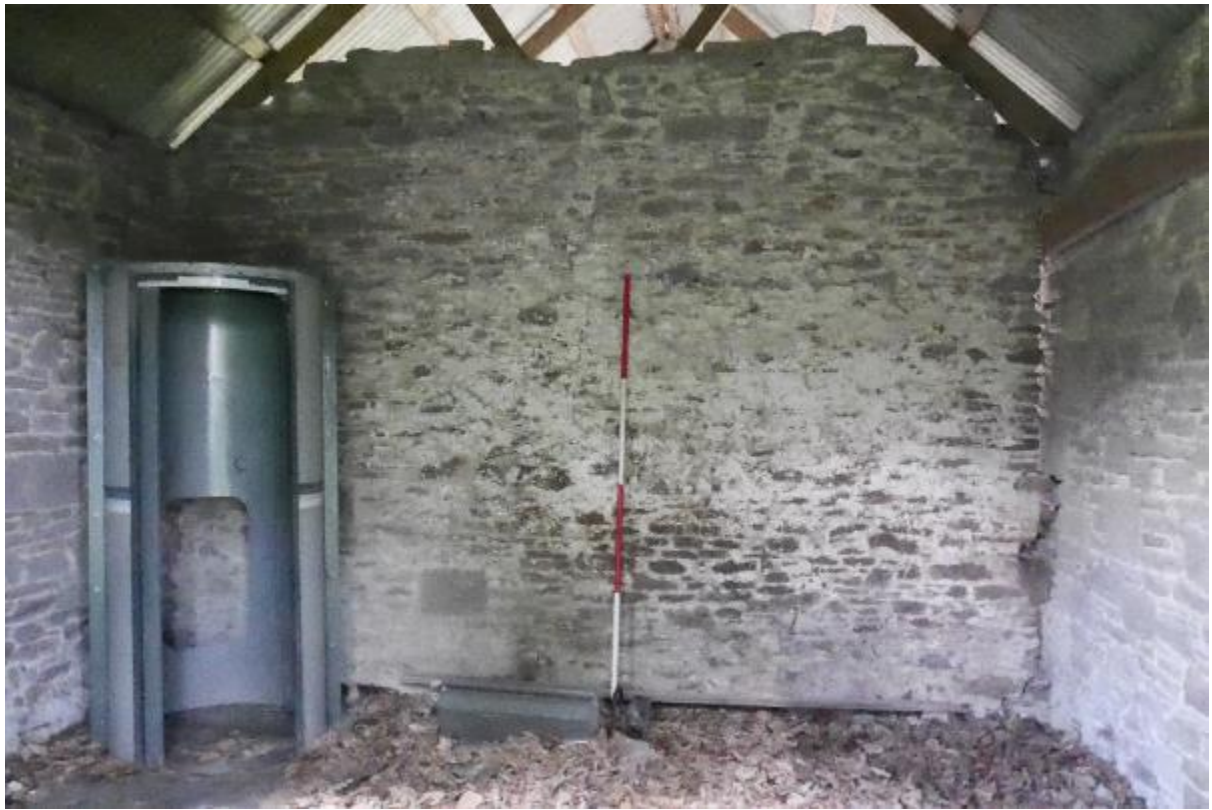
Illustration 21 – Internal South Eastern facing elevation of South Western room of Building A.

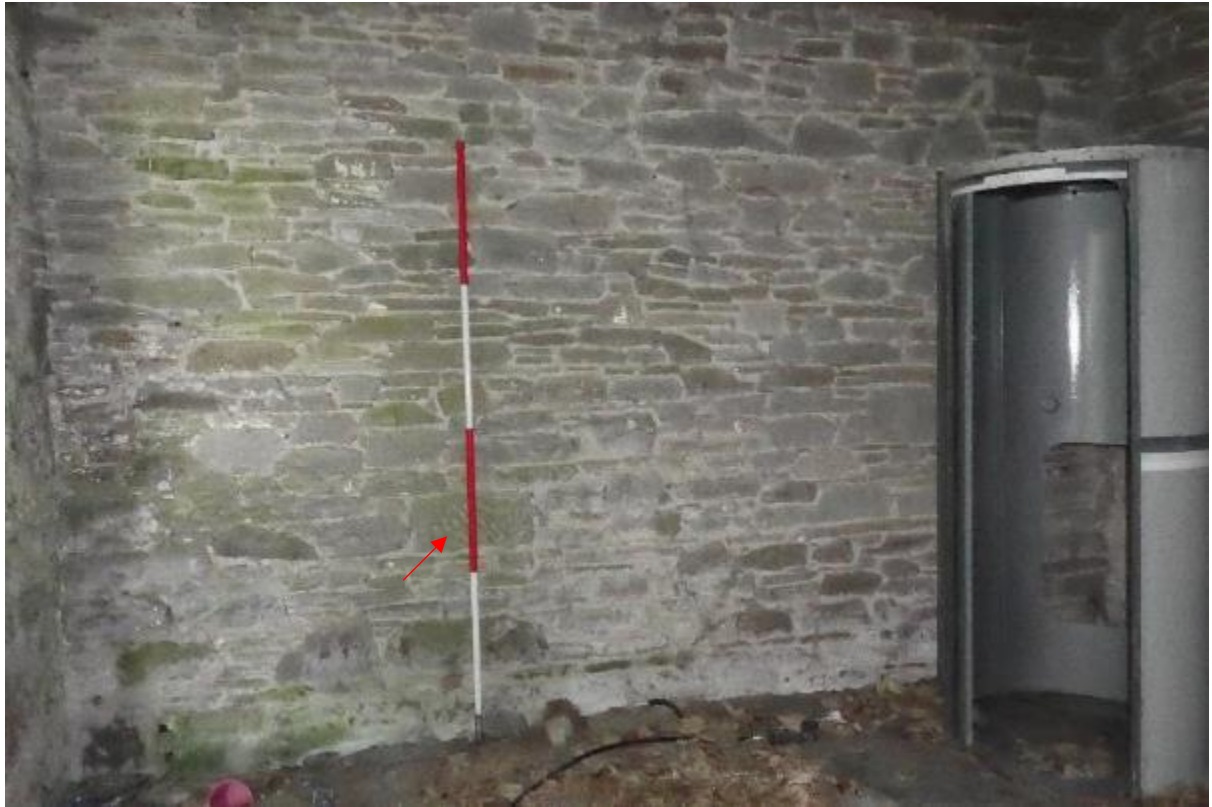
There is only one piece of tooled sandstone visible in the internal North Western facing elevation of the South Eastern room of Building 'A' (Illus 22). Building 'B' contains pieces of reused architectural fragments in its South Western and external South Eastern facing elevations (Illus 24 to 30). Of these pieces the most striking is the upside-down window or door lintel fragment inscribed with the numbers '45' and '77' either side of a 'Jerusalem' cross (Illus 27- 30). From limited study by the author the style of the numbers and tooling on that piece would seem to date to the 18<sup>th</sup> century (pers comm R Oram and J Luxford) however the meaning of the numbers either side of what maybe an ecclesiastical cross is unknown and would require further research. The green sandstones used for the surround of the doorway in the South Eastern elevation of Building 'B' would also appear to be reused and may originate from an earlier building on the site possibly the one depicted on the 1796 Estate plan (Illus 3 and 33).

Illustration 22 – Internal North Eastern facing elevation of South Western room in Building A. Reused tooled sandstone block at red arrow.

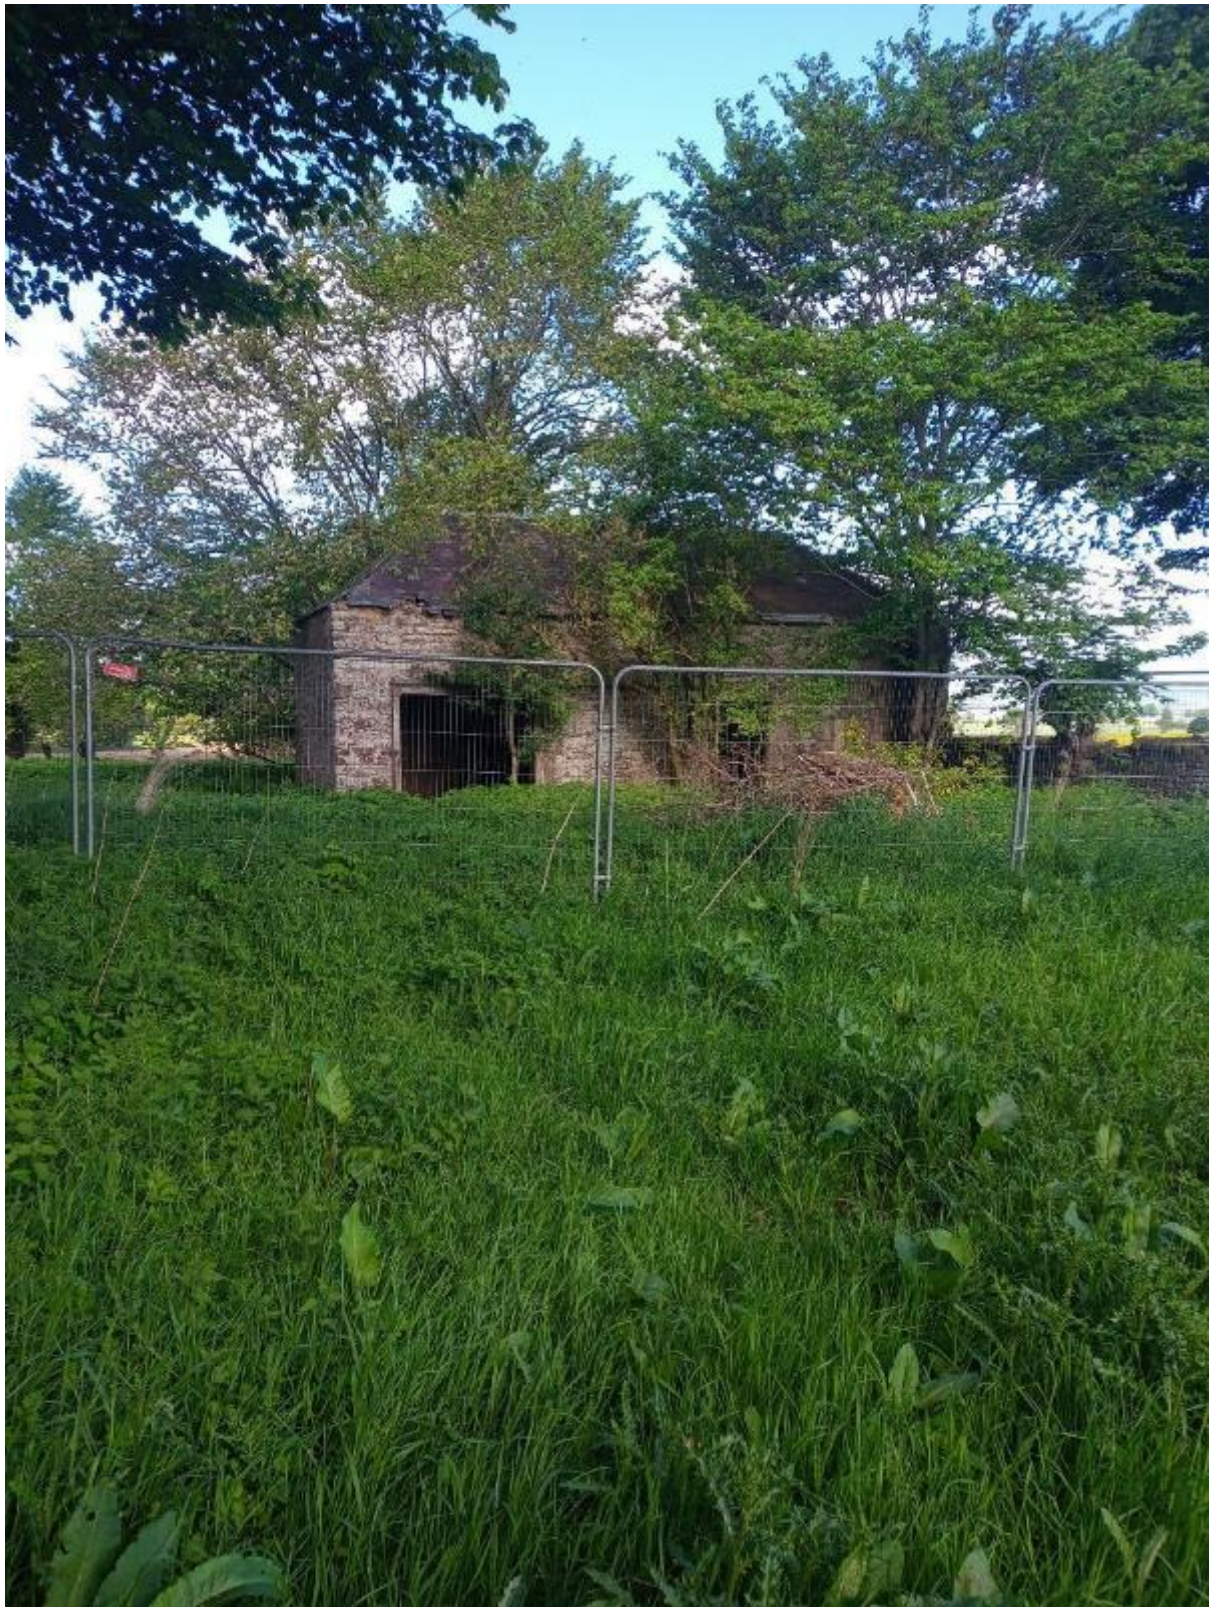
This lies on a North Eastern to South Western alignment and is potentially the earlier of the two buildings, it is built of mortared and tooled red and green sandstones. It has a hipped slated roof.

Illustration 23 – Location of Building B at North Eastern corner of site.

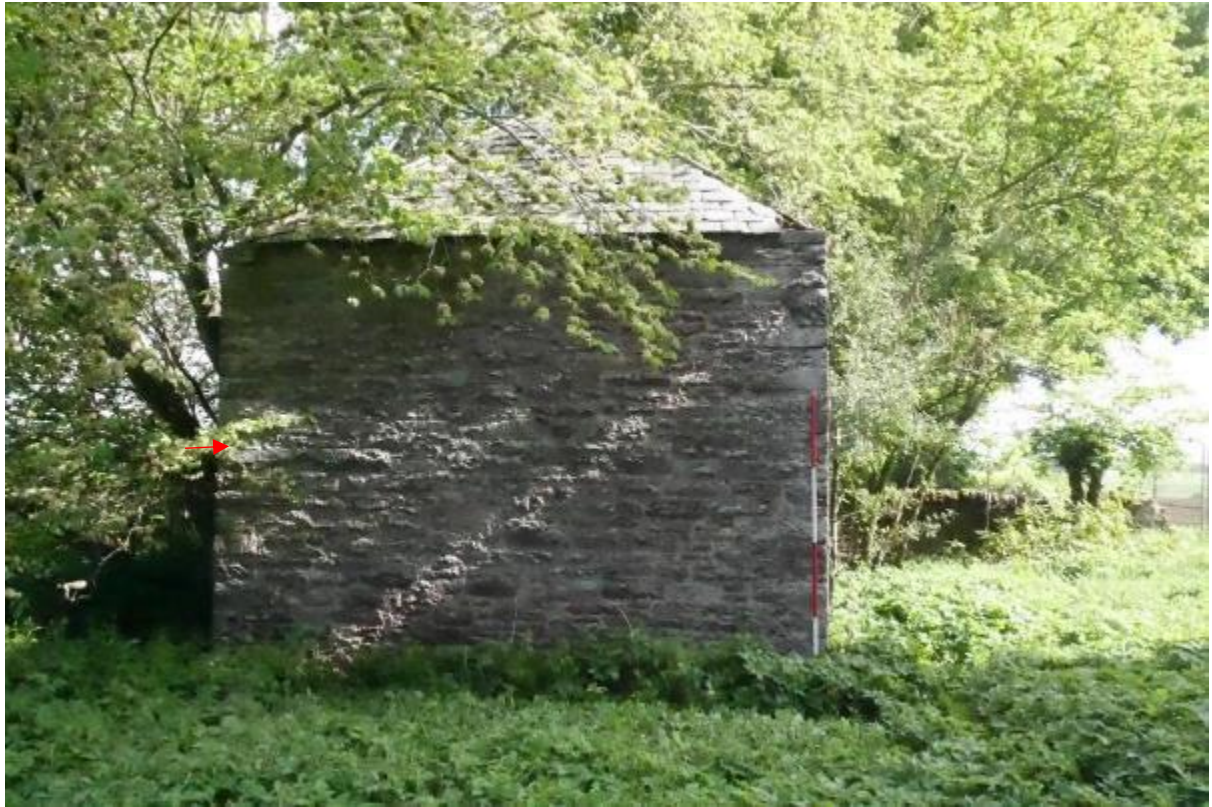
This is built of mortared and tooled red and green sandstones and is a gable end, it is a blank wall face with alternate quoins at its ends. There is a possible reused architectural fragment built into the wall face at its Northern end.

Illustration 24- External South Western facing gable of Building B. Red arrow shows location of reused sculpted stone (see illus 26).
