## Standing Building Survey

Land 85m N W of Newhall, Kettins, Perth and Kinross

Surviving former steading buildings 'A' and 'B' looking North East, Newhall, Kettins.

24<sup>th</sup> May 2022

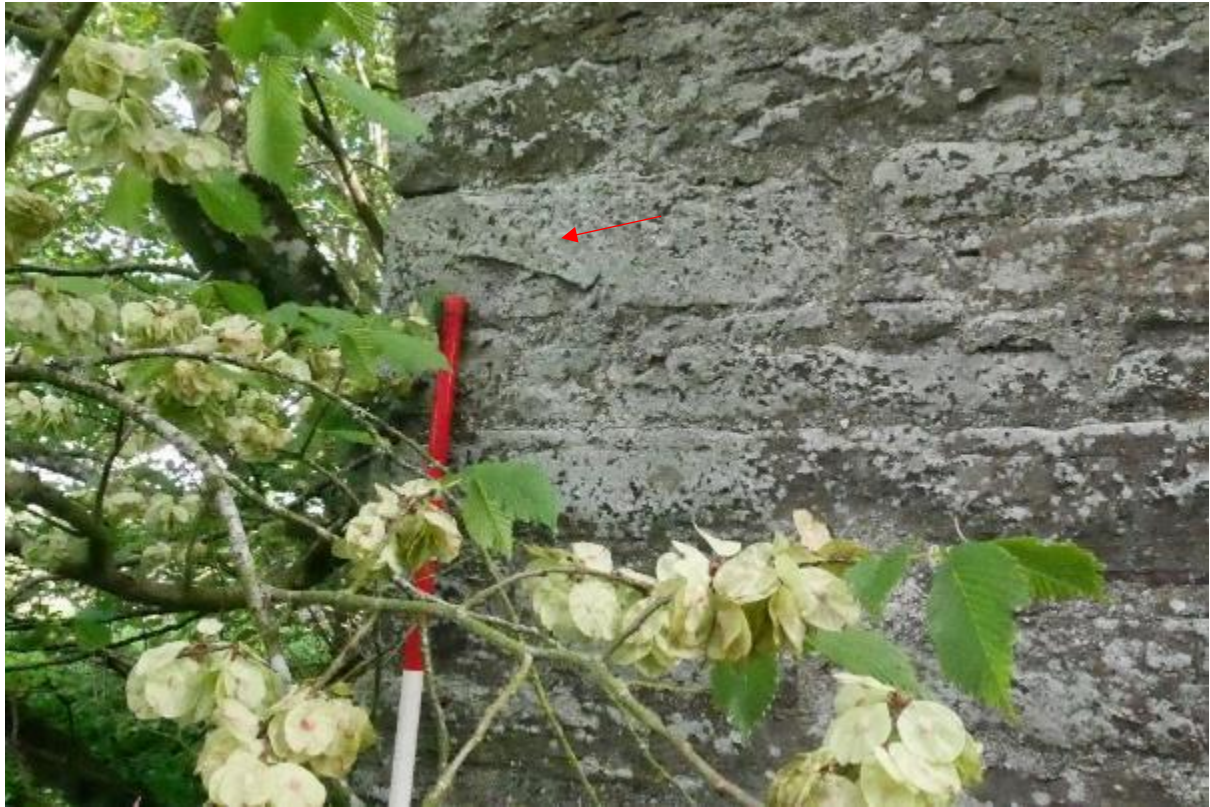
This is built of mortared and tooled red and green sandstones and is a gable end, it is a blank wall face with alternate quoins at its ends. There is a possible reused architectural fragment built into the wall face at its Northern end.

Illustration 26- Detail view of reused sculpted stone (red arrow) in external South Western facing elevation of Building B.

The architectural fragments in Building 'B' are important survivals and based on the style of the numbers and tooling the inscribed lintel stone is probably of 18<sup>th</sup> century date (pers comm Richard Oram and Julian Luxford). The presence of those fragments needs to be taken account of during the proposed refurbishment of that building as part of the proposed development. Potentially they could originate from an earlier building on the site or possibly from the ruins of nearby Coupar Angus Abbey as other architectural fragments from that site have been recorded in Kettins (RCAHMS 1994, 128).

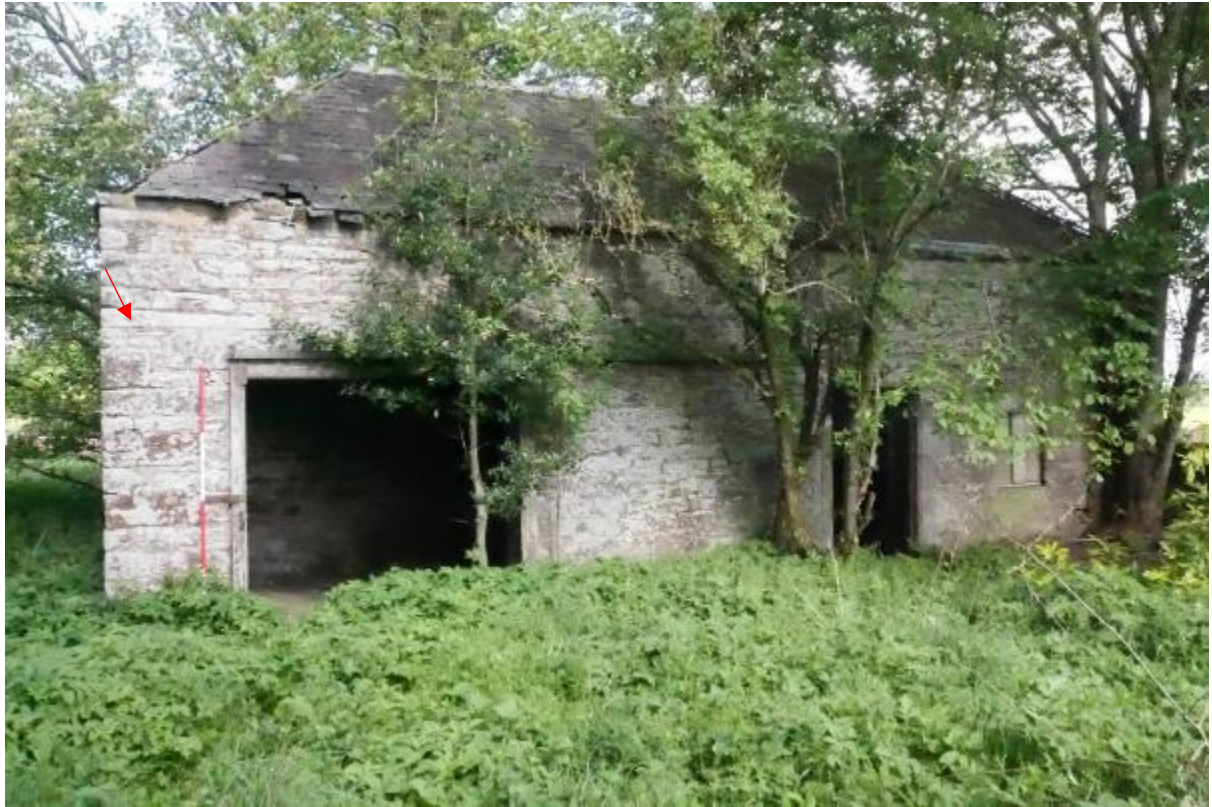
This is built of mortared and tooled red and green sandstones and contains a wide doorway at its South Western end with the remains of a mechanism for a sliding door. There is then a doorway possibly built of reused green sandstones and then a small window. A boundary wall butts against this elevation at its North Eastern end. There is a reused green sandstone lintel built into this face (upside down) at its South Western end with the numbers '45' and '77' either side of a small incised 'Jerusalem' cross.

Illustration 27 – External South Eastern facing elevation of Building B, reused architectural fragment at red arrow.

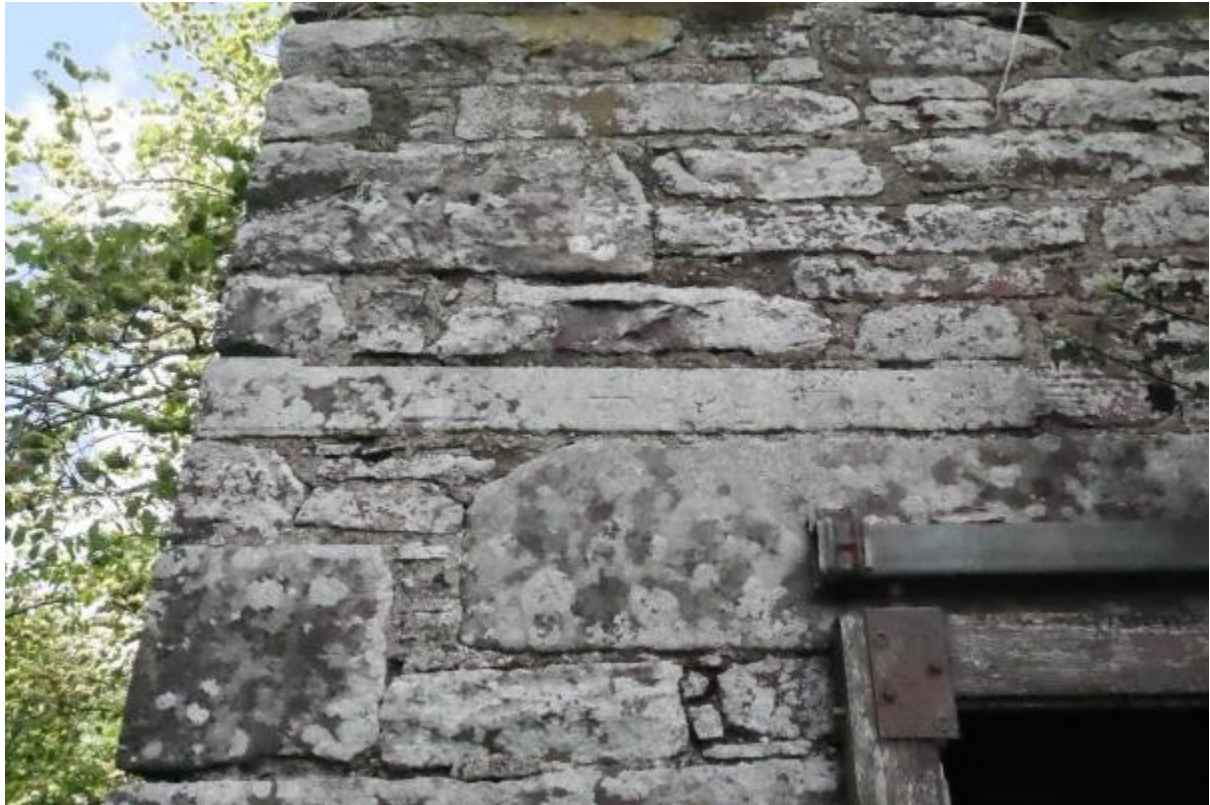
Illustration 29 – Reused architectural fragment (upside down) in South Eastern facing external elevation of Building B incised with numbers '45', '77' that are separated by a 'Jerusalem' cross.

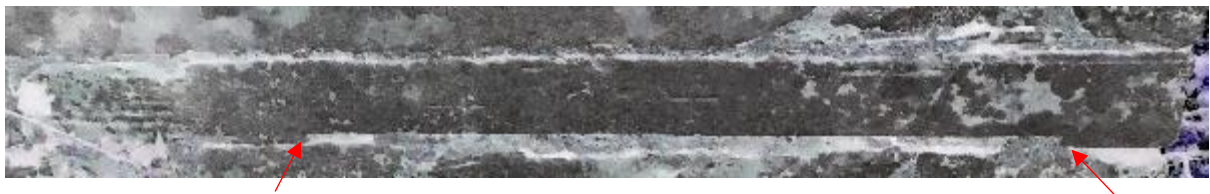
Illustration 30- Cropped negative image of architectural fragment turned the right way up. Red arrows indicate edges of top of former doorway or window.

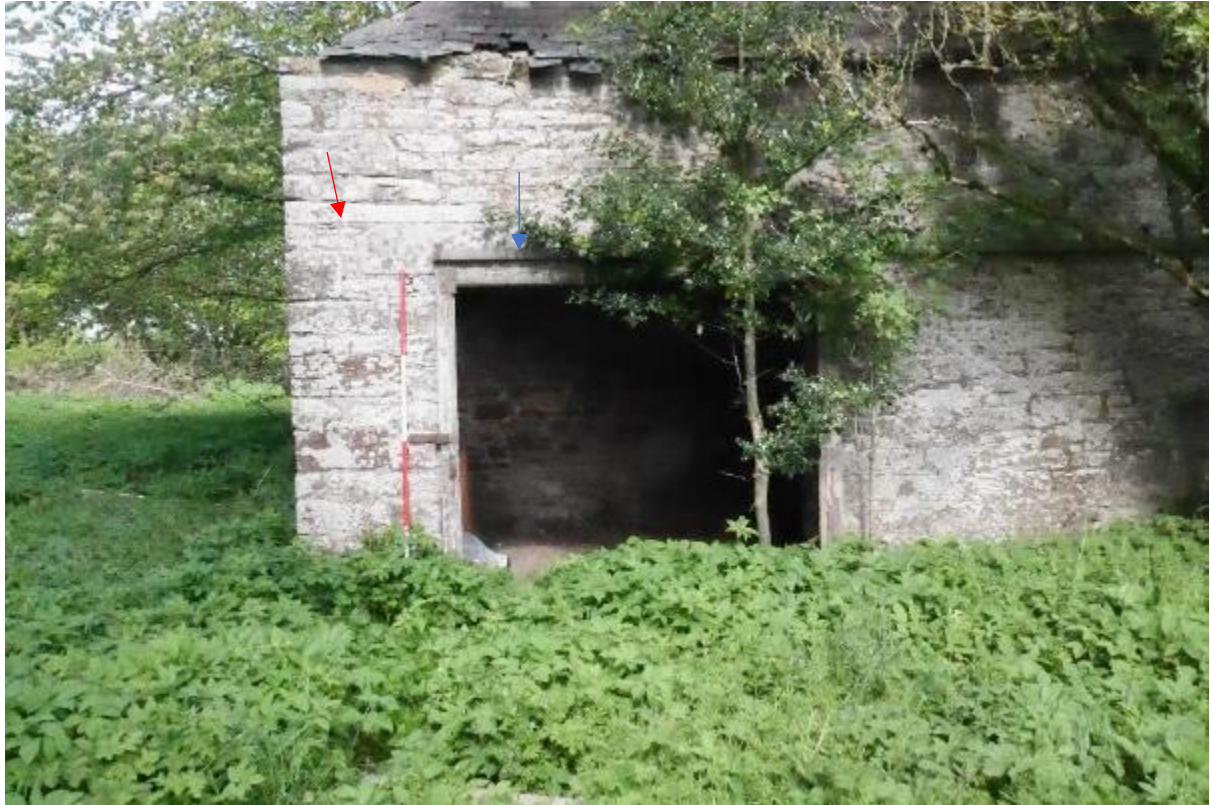
Illustration 31 – Wide doorway at Southern end of South Eastern facing external elevation of Building B, red arrow shows location of reused architectural fragment, blue arrow shows the mechanism for a sliding door.

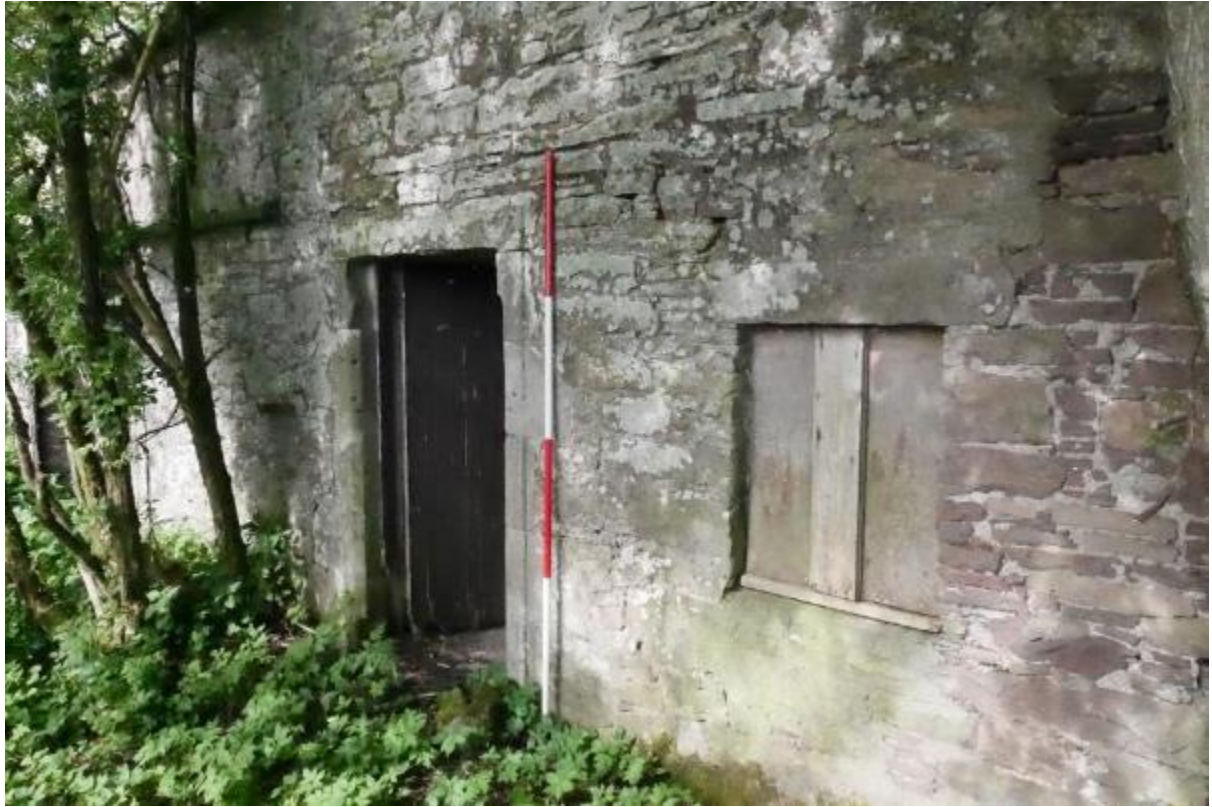
Illustration 32 – Doorway and window in South Eastern facing external elevation of Building B.

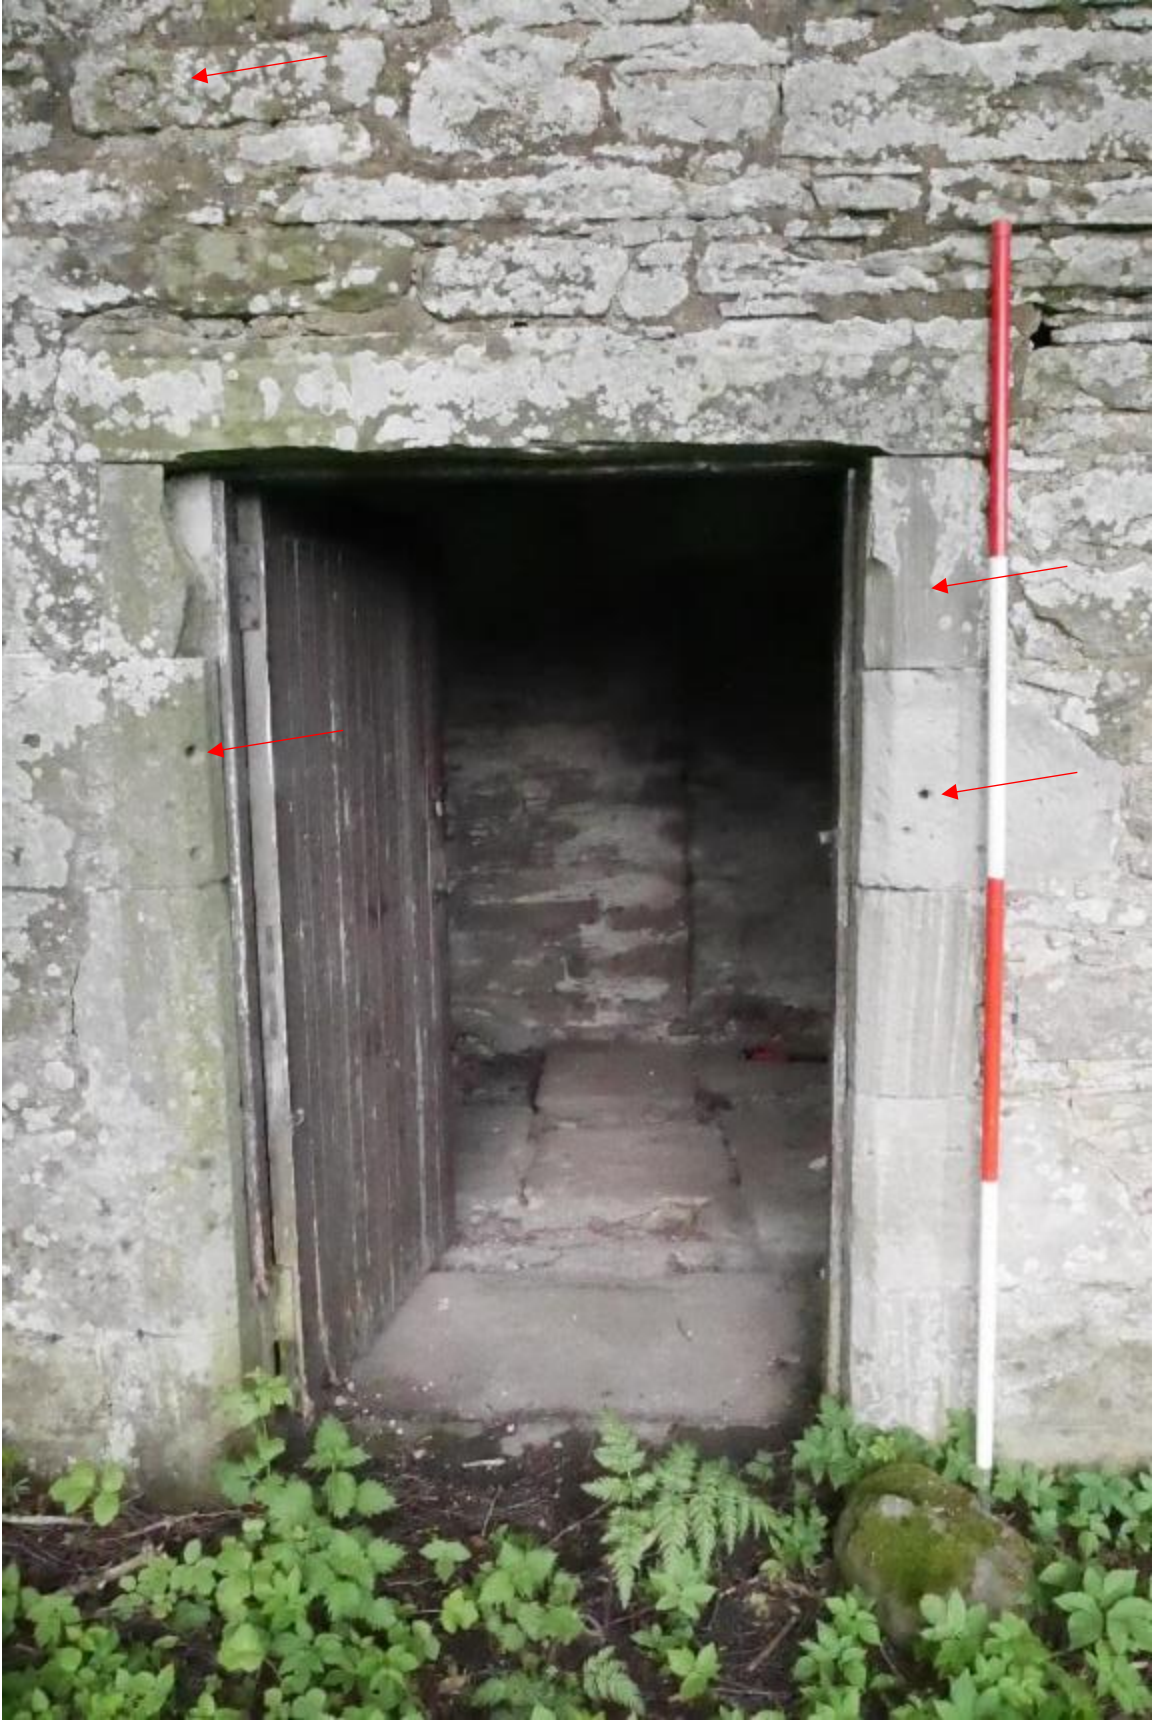
There is only one piece of tooled sandstone visible in the internal North Western facing elevation of the South Eastern room of Building 'A' (Illus 22). Building 'B' contains pieces of reused architectural fragments in its South Western and external South Eastern facing elevations (Illus 24 to 30). Of these pieces the most striking is the upside-down window or door lintel fragment inscribed with the numbers '45' and '77' either side of a 'Jerusalem' cross (Illus 27- 30). From limited study by the author the style of the numbers and tooling on that piece would seem to date to the 18<sup>th</sup> century (pers comm R Oram and J Luxford) however the meaning of the numbers either side of what maybe an ecclesiastical cross is unknown and would require further research. The green sandstones used for the surround of the doorway in the South Eastern elevation of Building 'B' would also appear to be reused and may originate from an earlier building on the site possibly the one depicted on the 1796 Estate plan (Illus 3 and 33).

Illustration 33 – Detailed view of doorway in South Eastern facing external elevation of Building B, possible reused tooled green sandstones at red arrows.

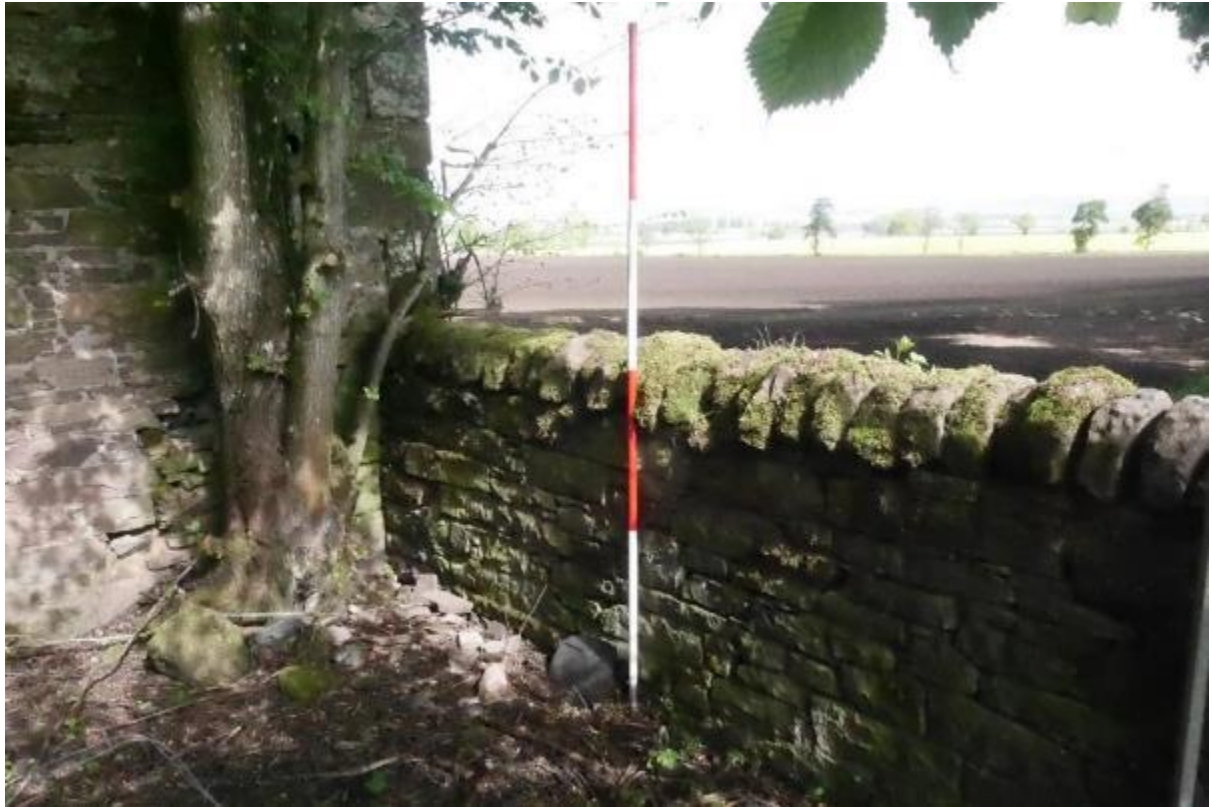
Illustration 34 – Boundary wall built against the face of the external South Eastern elevation of Building B.

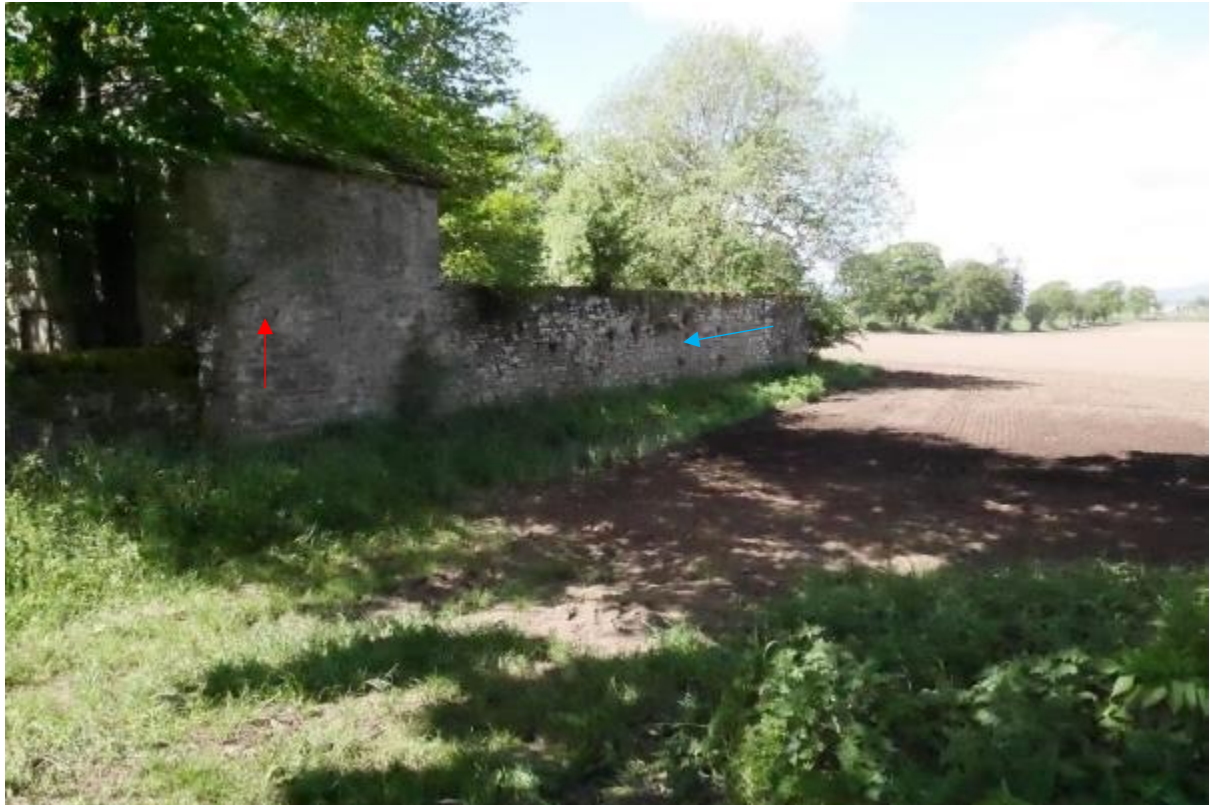
This is built of mortared and tooled red and green sandstones and is a gable end, it is a blank wall face with alternate quoins at its ends.

Illustration 35 – External North Eastern facing elevation of Building B (red arrow) showing Boundary wall C on its North Western side (blue arrow).

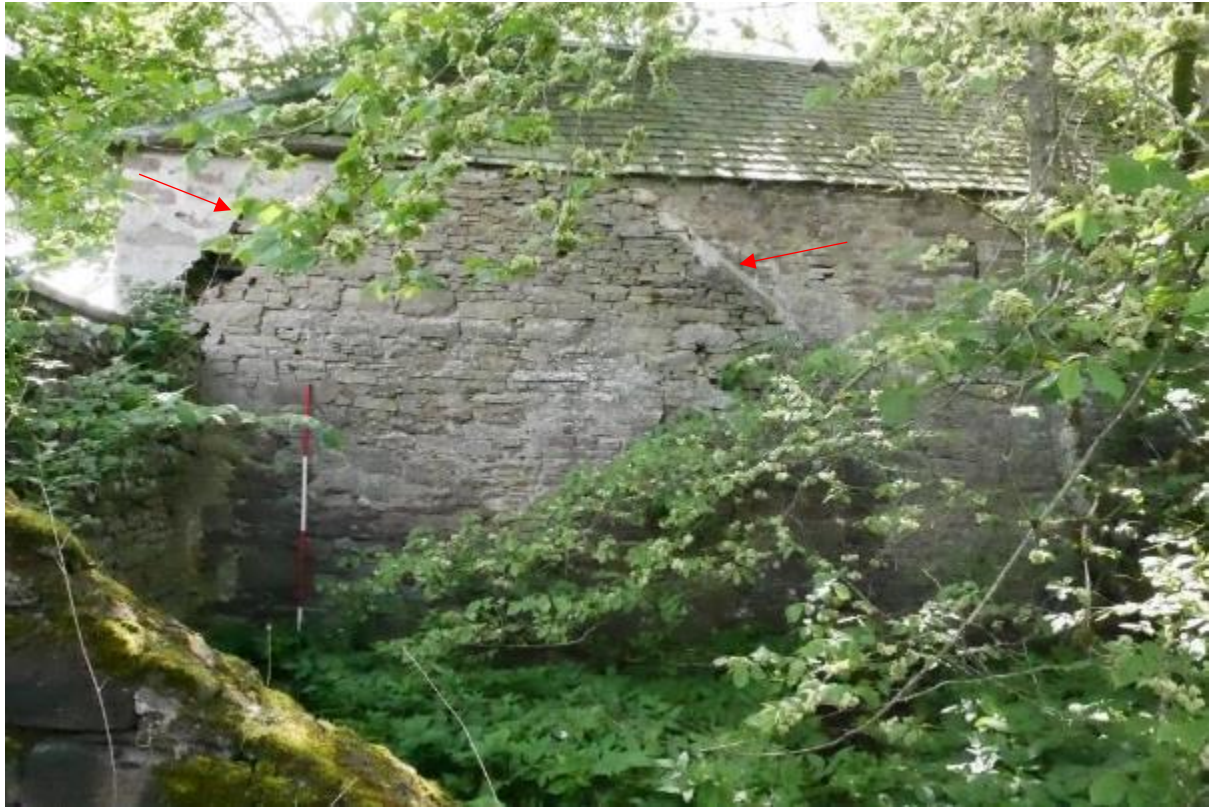
This is built of mortared and tooled red and green sandstones and is a blank wall face with alternate quoins at its North Western end. Its North Eastern end is integrated with Boundary wall 'C' which heads North West and there is a roof raggle in the wall face for a now demolished building.

Illustration 36 – External North Western facing elevation of Building B showing roof raggle from former building (red arrow).

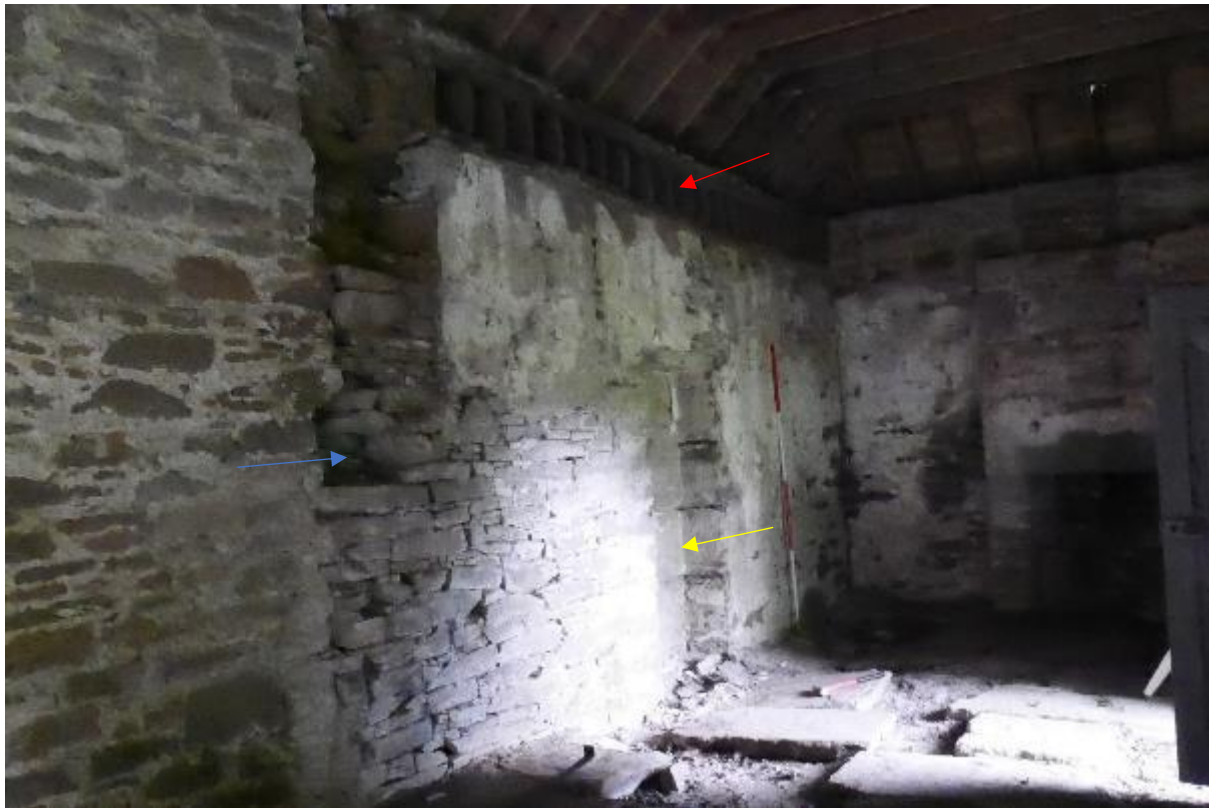
This is built of rough mortar bonded green and red sandstones and there are traces of plaster. There is a line of 21 bird boxes at roof level built of flat stone slabs (0.30m by 0.30m). There is a blocked doorway in the wall face with a wooden lintel and the remains of a broken wall in the wall face which may be from an earlier building.

Illustration 38 – Northern half of internal South Eastern facing elevation of Building B, bird boxes shown at the red arrow, former wall line of earlier building at blue arrow. Blocked doorway at yellow arrow.

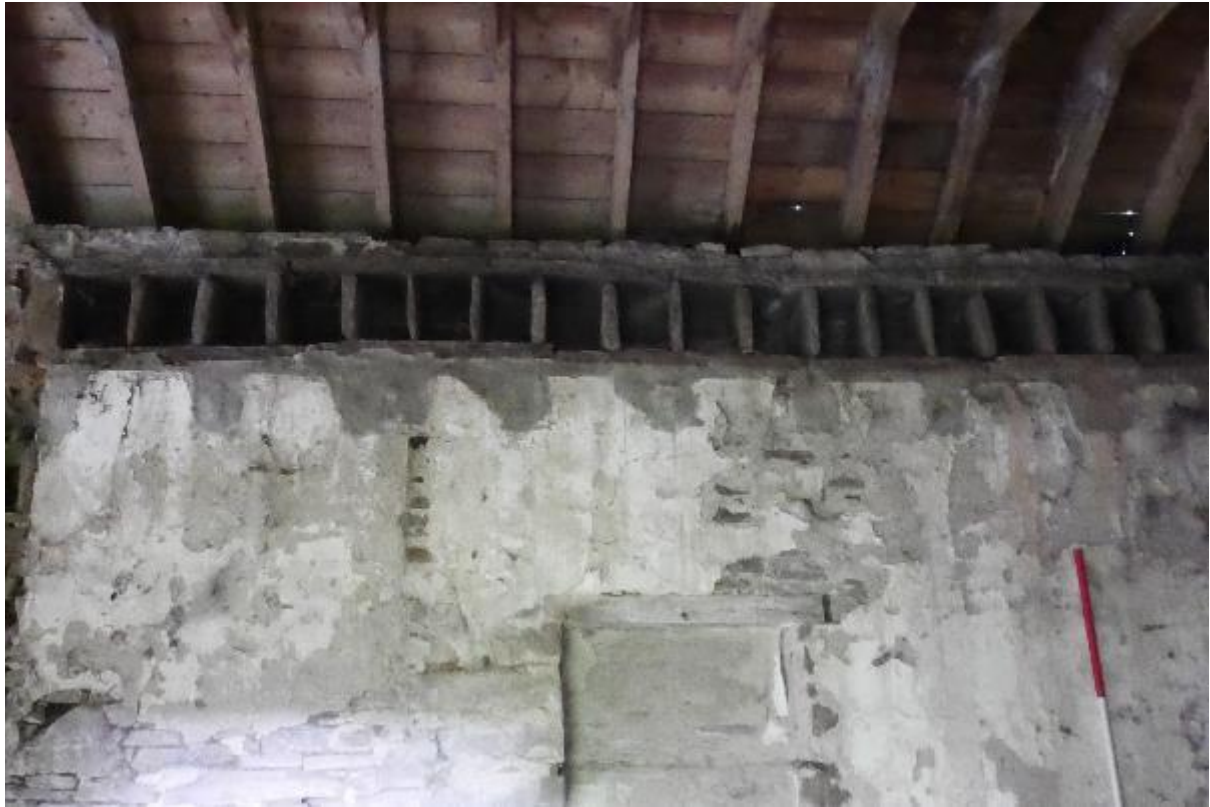
Illustration 40– Detail view of 21 bird boxes at roof line in internal South Eastern facing elevation of Building B. The interior of the wooden roof supporting the slates is also visible.

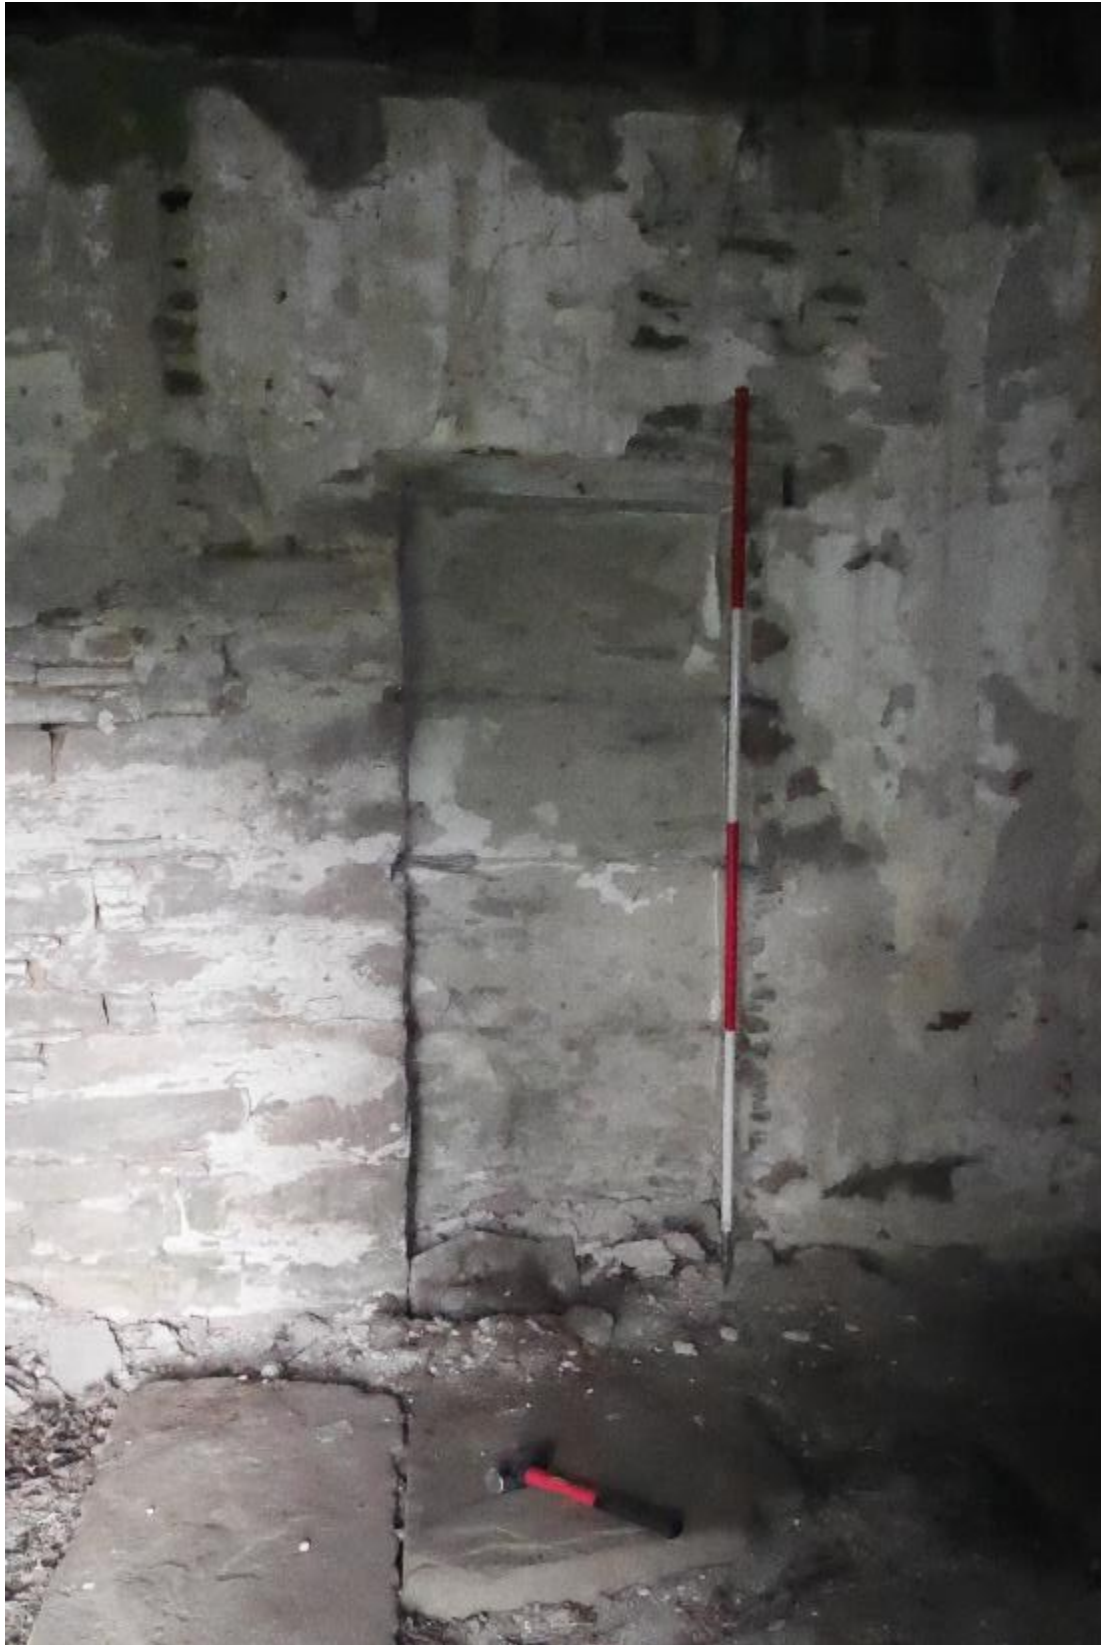
Illustration 41 – Blocked doorway in internal South Eastern facing elevation of Building B.

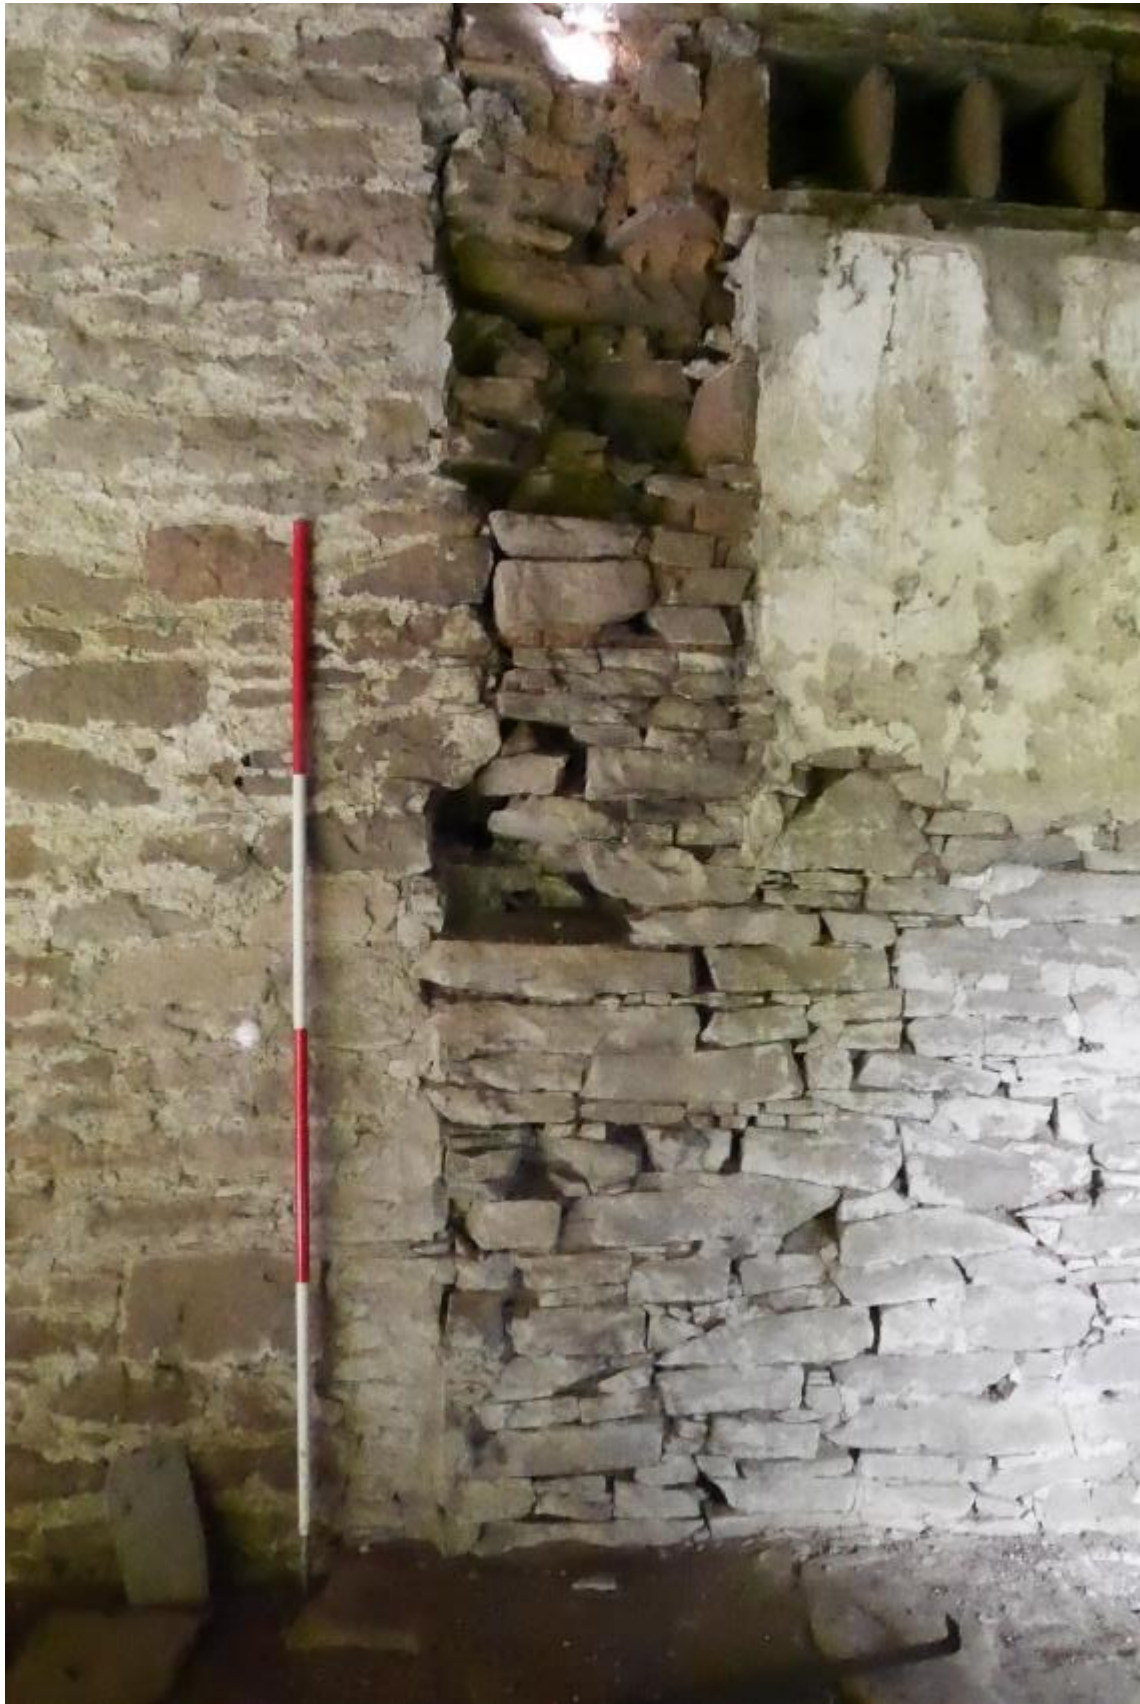
Illustration 42 – Detail of former wall line of earlier building in South Eastern facing internal elevation of Building B.

Building 'B' would appear to be earlier than Building 'A' and may retain elements of the single structure shown on the 1796 Estate map (Illus 3, 42 and 46). In their original forms Building 'B' and Boundary wall 'C' (formerly the North Eastern side wall of a long building) formed part of the farm steading complex first mapped in 1819 and fully depicted on the 1863 Ordnance Survey map, on that map Building 'A' is shown as a stand-alone building. Buildings 'A' and 'B' were retained as single structures following the demolition of most of the farm steading and Boundary wall 'C' was left standing, a former window and entrance in it were blocked. From limited historical research it would appear that the site at Newhall was originally known as 'the church lands of Kettins' and was owned Pre-Reformation by the Trinitarian House of Cross Kirk in Peebles, there is no evidence that it ever belonged to the Cistercian Abbey of Coupar Angus.

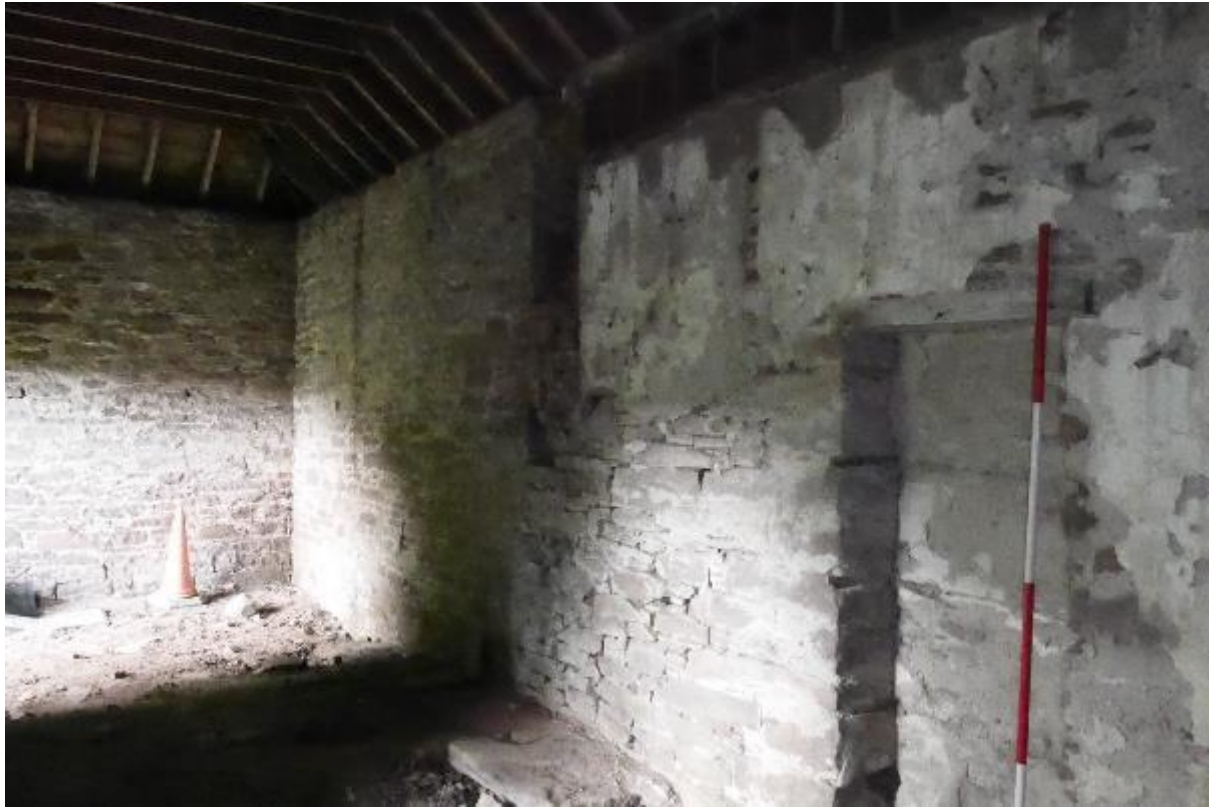
Illustration 43 – Southern half of internal South Eastern facing elevation of Building B.

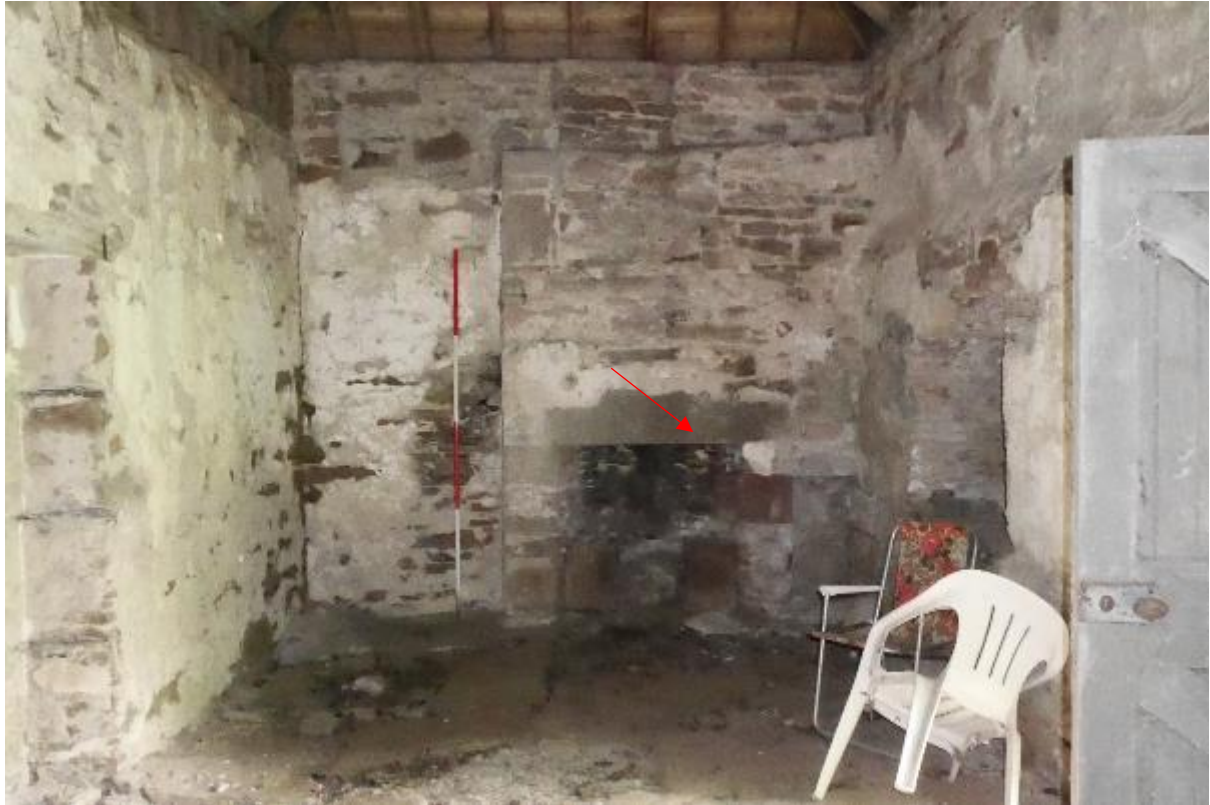
This is built of rough mortar bonded green and red sandstones and there are traces of plaster. There is a fireplace and a cupboard built into a section of wall that steps out from the face of the elevation for 0.22m.

Illustration 44 – General view of internal South Western facing elevation of Building B, fireplace and cupboard at red arrow.

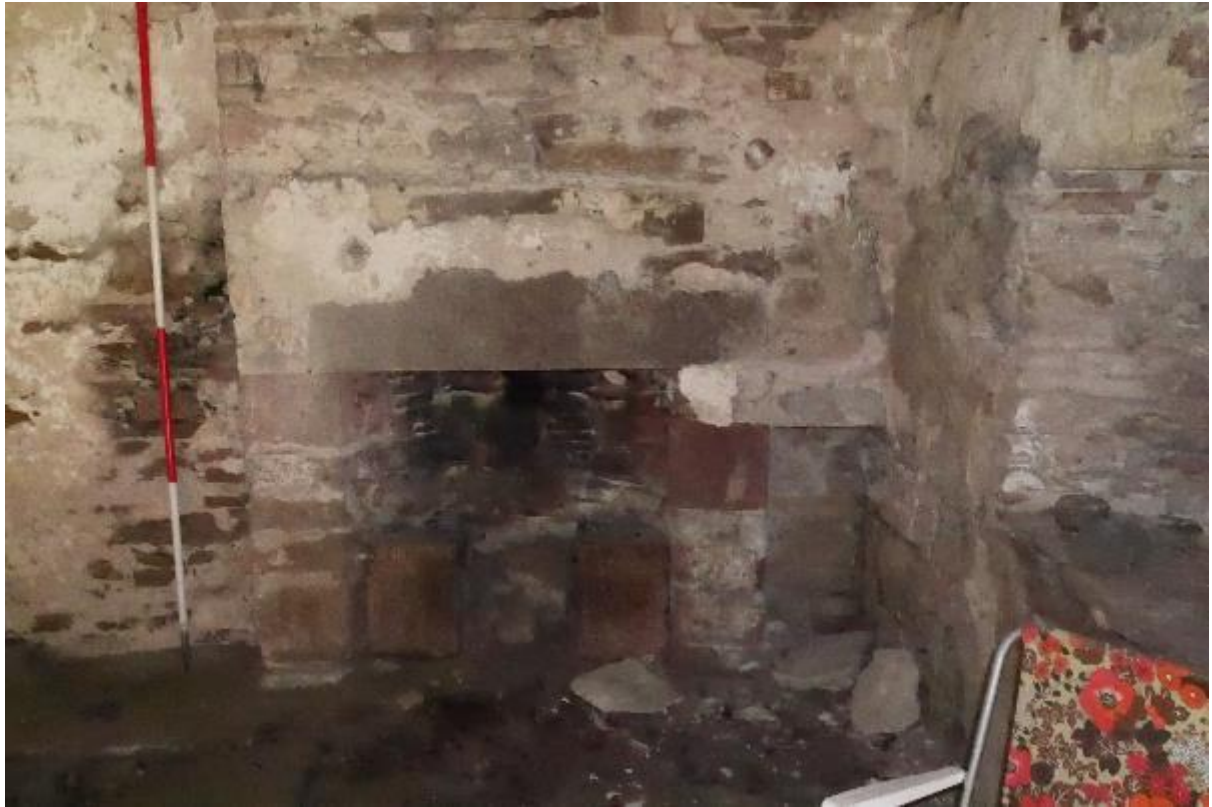
Illustration 45 – Detail view of fireplace and cupboard in internal South Western facing elevation of Building B.

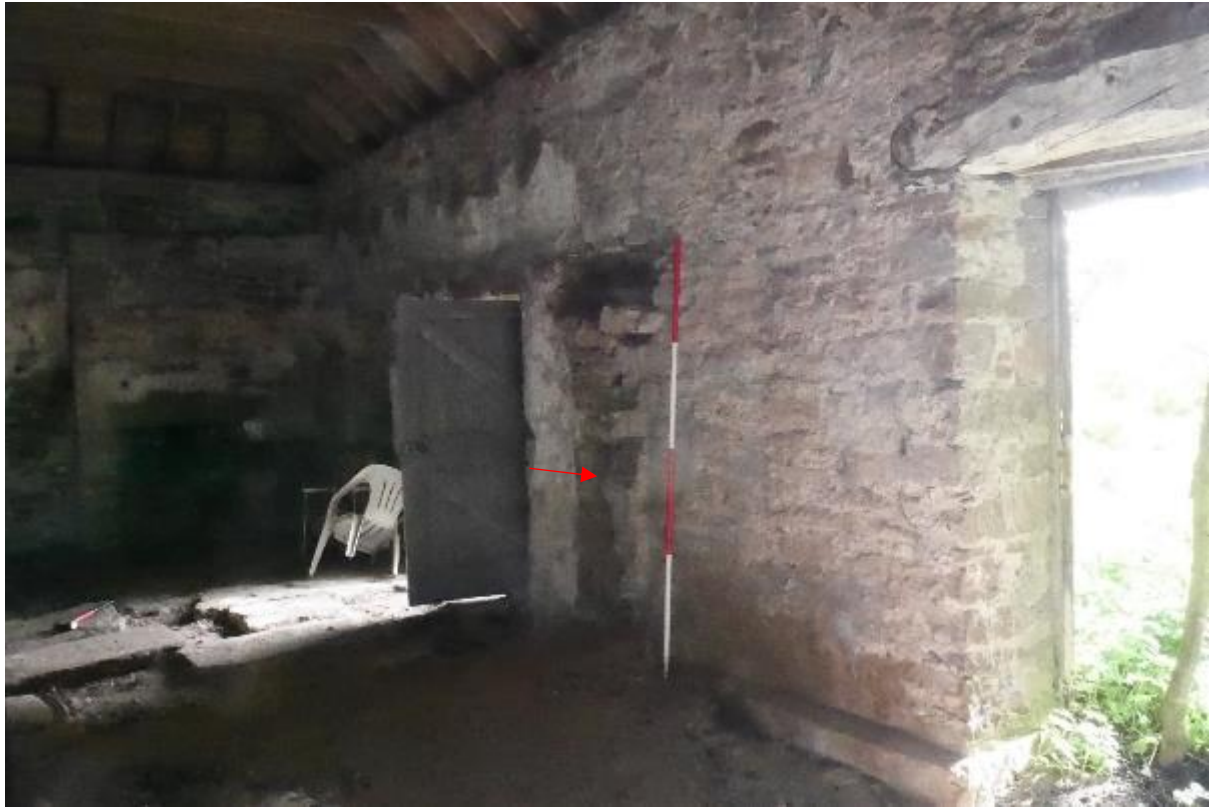
This is built of rough mortar bonded green and red sandstones and there are traces of plaster. It contains a small blocked window with angled edges, a doorway, the remains of a broken wall in the wall face which may be from an earlier building (see description of South Eastern internal elevation) and a wide doorway.

Illustration 46 – General view of internal North Western facing elevation of Building B, red arrow former wall line of earlier building as in opposing elevation (Illus 42).

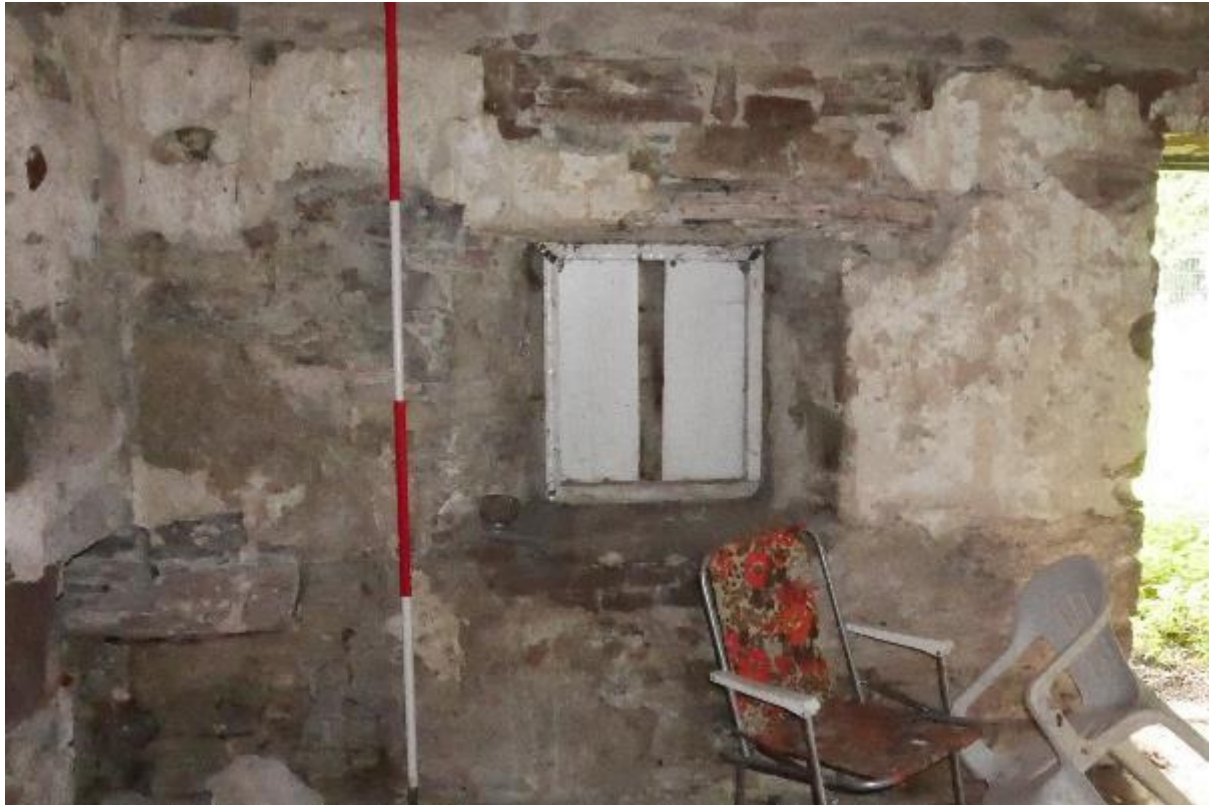
Illustration 47– Blocked window at Northern end of internal North Western elevation of Building B.
