## Standing Building Survey

Land 85m N W of Newhall, Kettins, Perth and Kinross

Surviving former steading buildings 'A' and 'B' looking North East, Newhall, Kettins.

24<sup>th</sup> May 2022

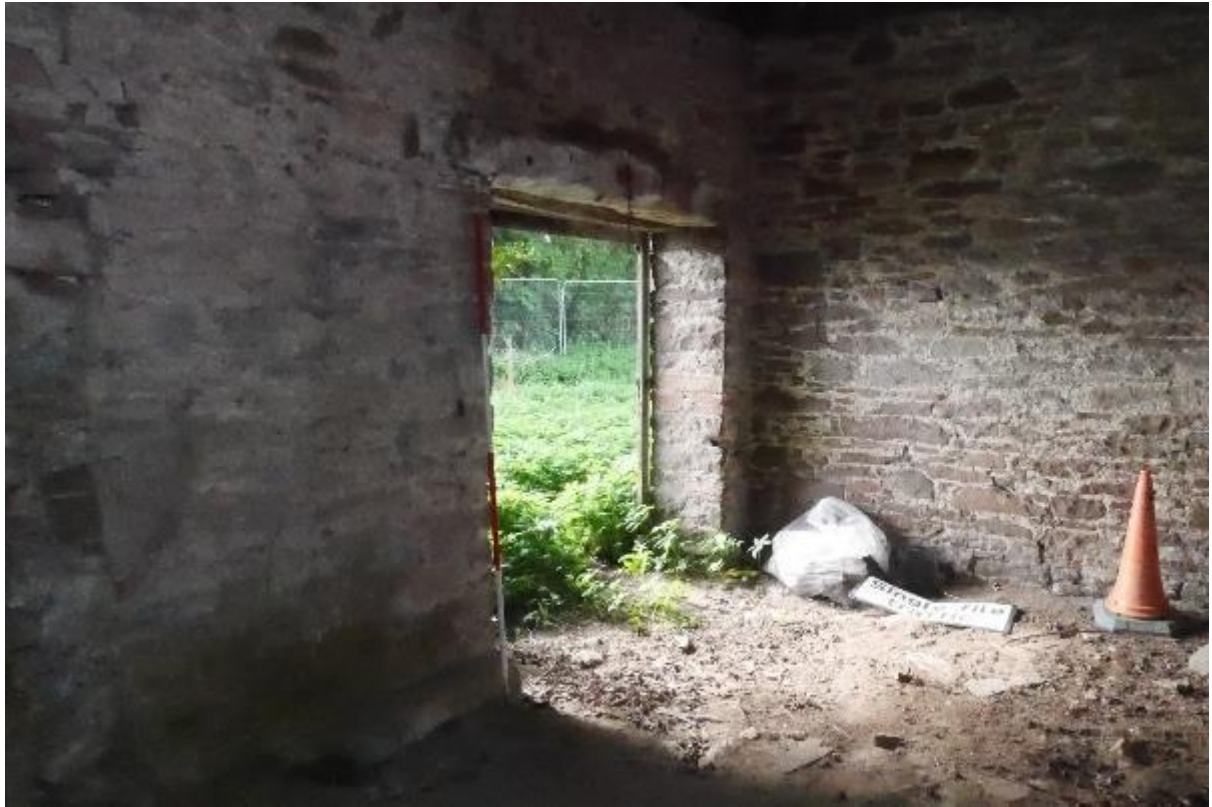
This is built of rough mortar bonded green and red sandstones and there are traces of plaster. It contains a small blocked window with angled edges, a doorway, the remains of a broken wall in the wall face which may be from an earlier building (see description of South Eastern internal elevation) and a wide doorway.

Illustration 48 – Southern half of internal North Western facing elevation of Building B showing wide doorway.

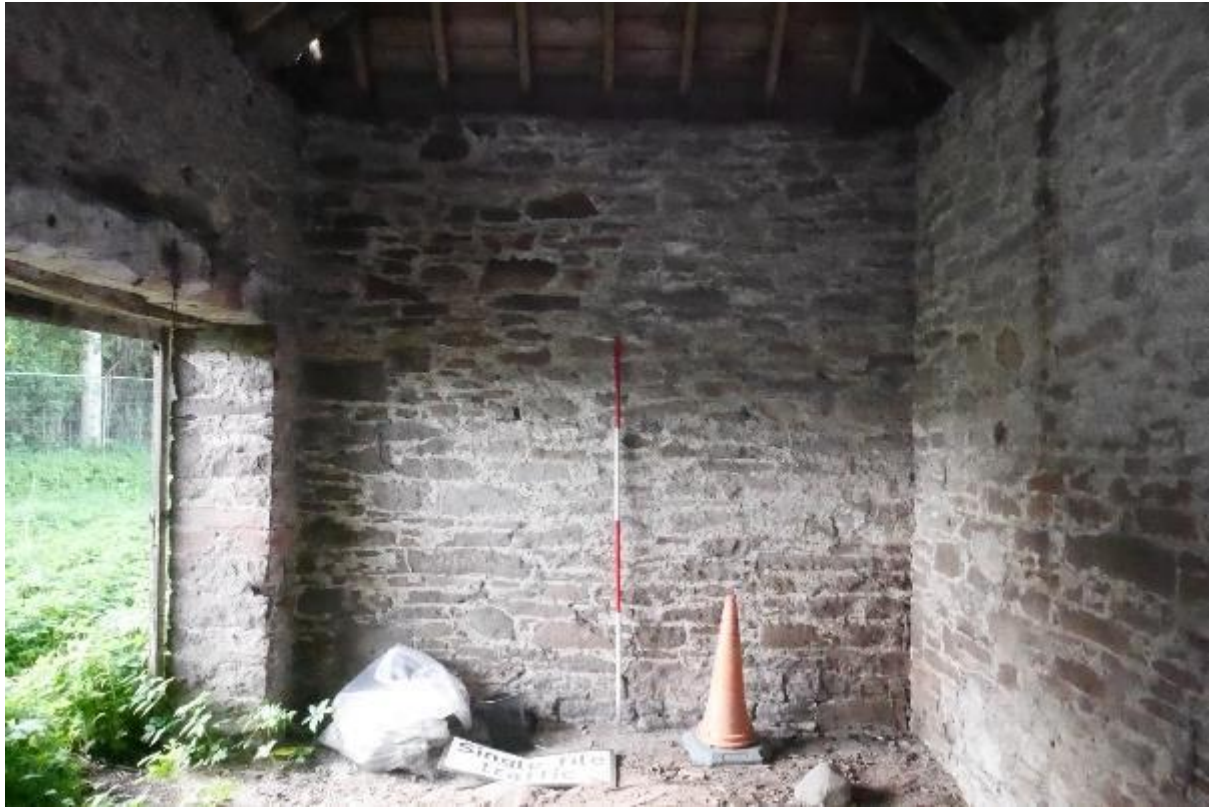
This is built of rough mortar bonded green and red sandstones and is a blank wall face. There are the remains of a slabbed floor in the North Eastern half of the room, the South Western half is an earth floor.

Illustration 49 – General view of internal North Eastern facing elevation of Building B.

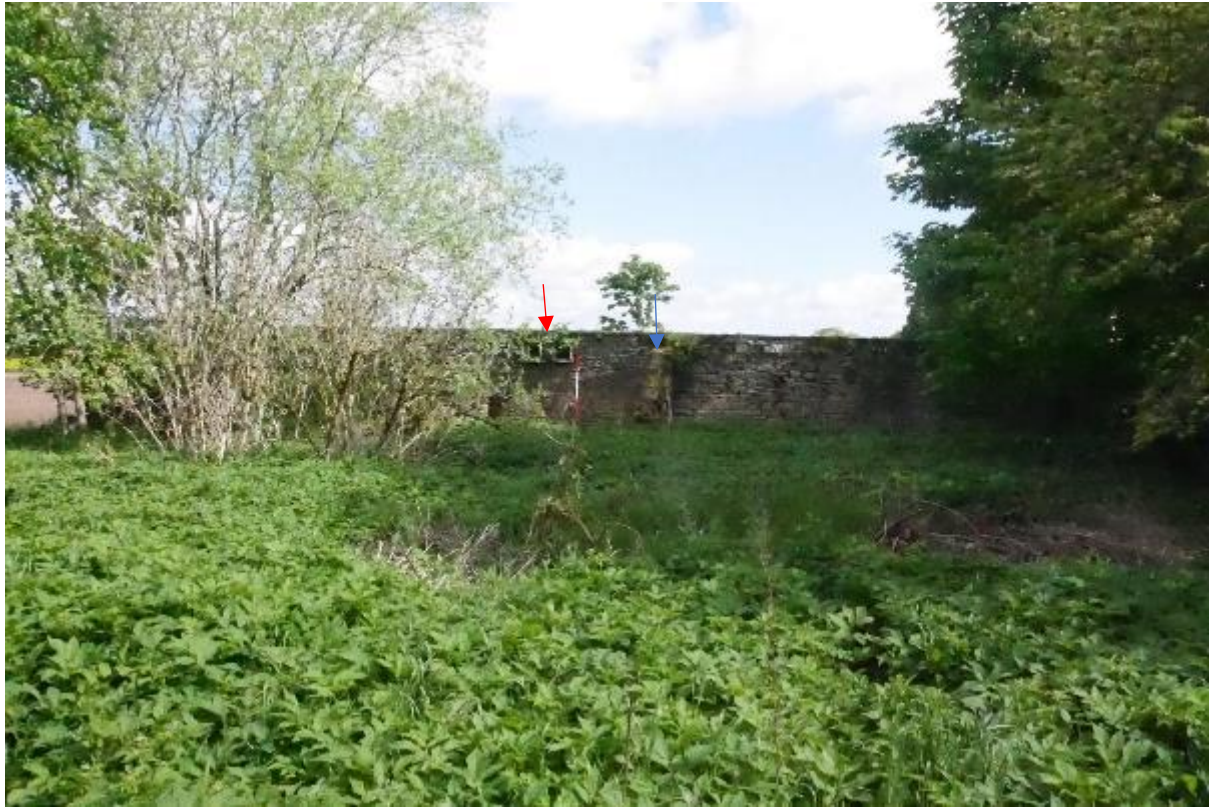
This is built of rough mortar bonded green and red sandstones and is supported by four buttresses on its South Western side that are built against the wall face. The wall is topped with flat coping stones (0.05m thick). There is a single slit window towards its North Western end and a blocked former wide entrance to the South East of that. In its original form this was the North Eastern wall of a long building whose roof raggle is visible in the North Western external elevation of Building 'B' and could potentially be a surviving element of the building shown on the Ordnance Survey map of 1971 (Illus 6). There is now no trace of the horse mill shown on the 1865 Ordnance Survey map.

Illustration 50- General view of Boundary wall C looking North, red arrow shows location of bird boxes (see Illus 51), and blue arrow shows one of four buttresses built against wall face (see Illus 51 and 53).

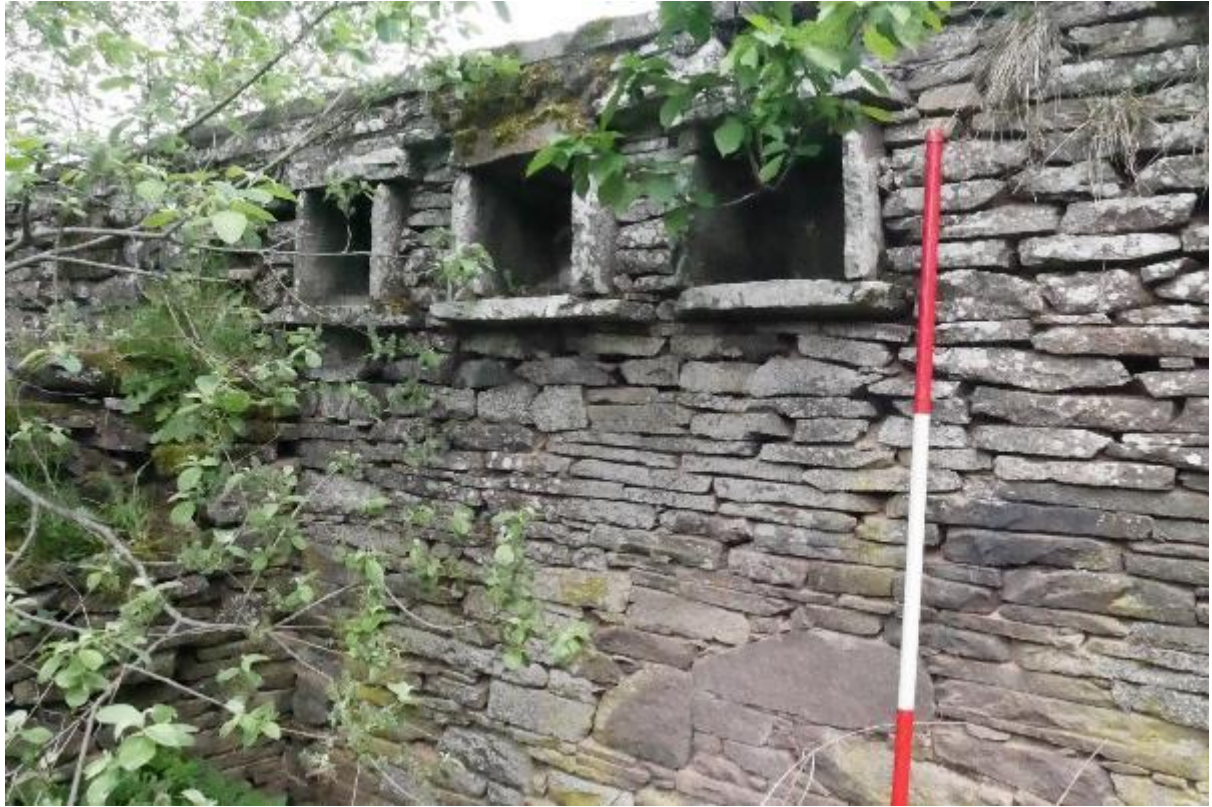
Illustration 52- Detail of three bird boxes built into South Western facing elevation of Boundary wall C.

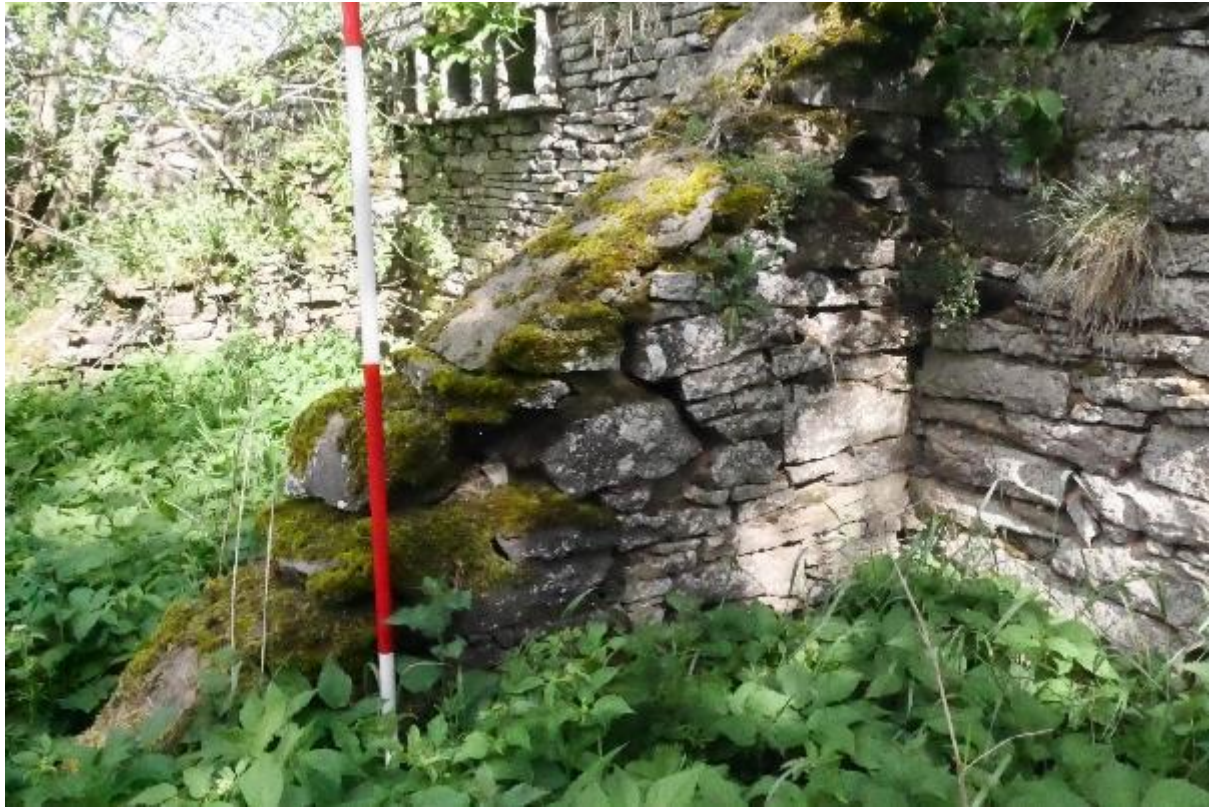
Illustration 53- Detail view of one of the buttresses built against the South Western facing elevation of Boundary wall C.

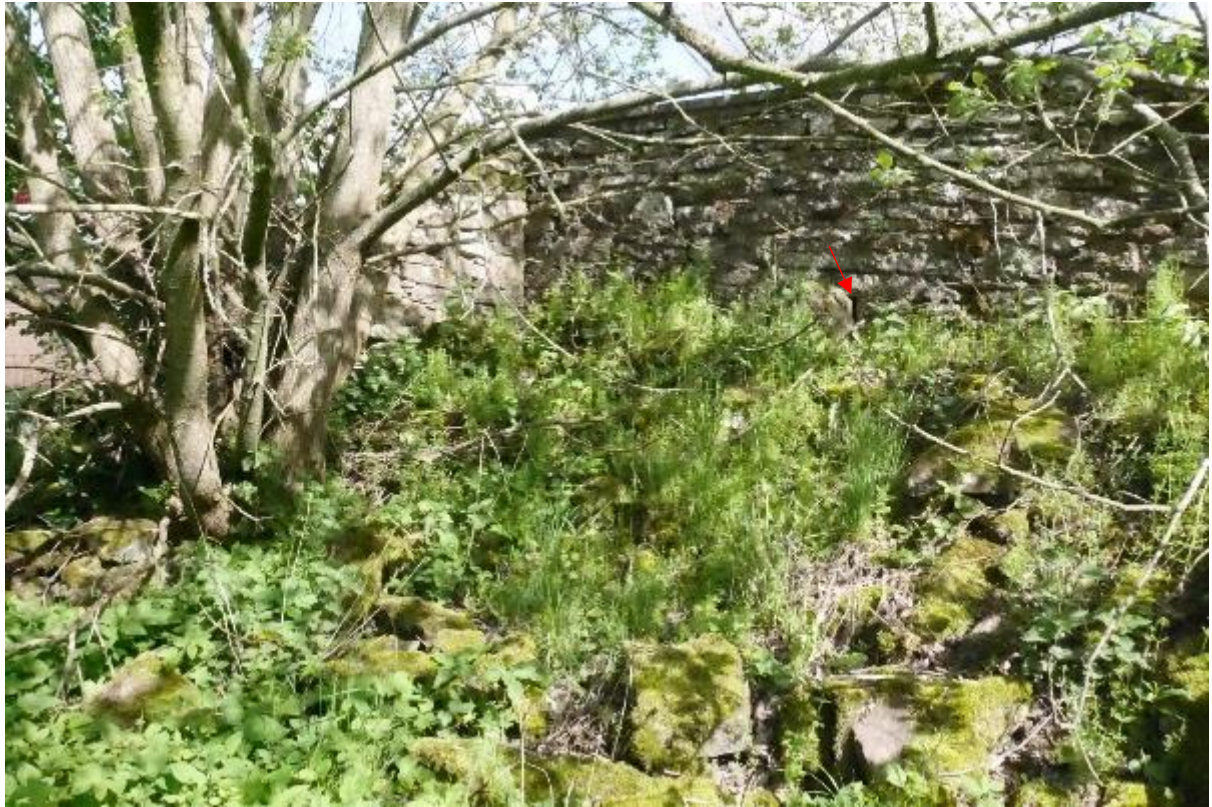
Illustration 54- General view of North Western end of Boundary wall C, red arrow indicates top of slit window visible in outer face (see Illus 56, 57 and 58). Grass is growing over rubble dump against the wall face.

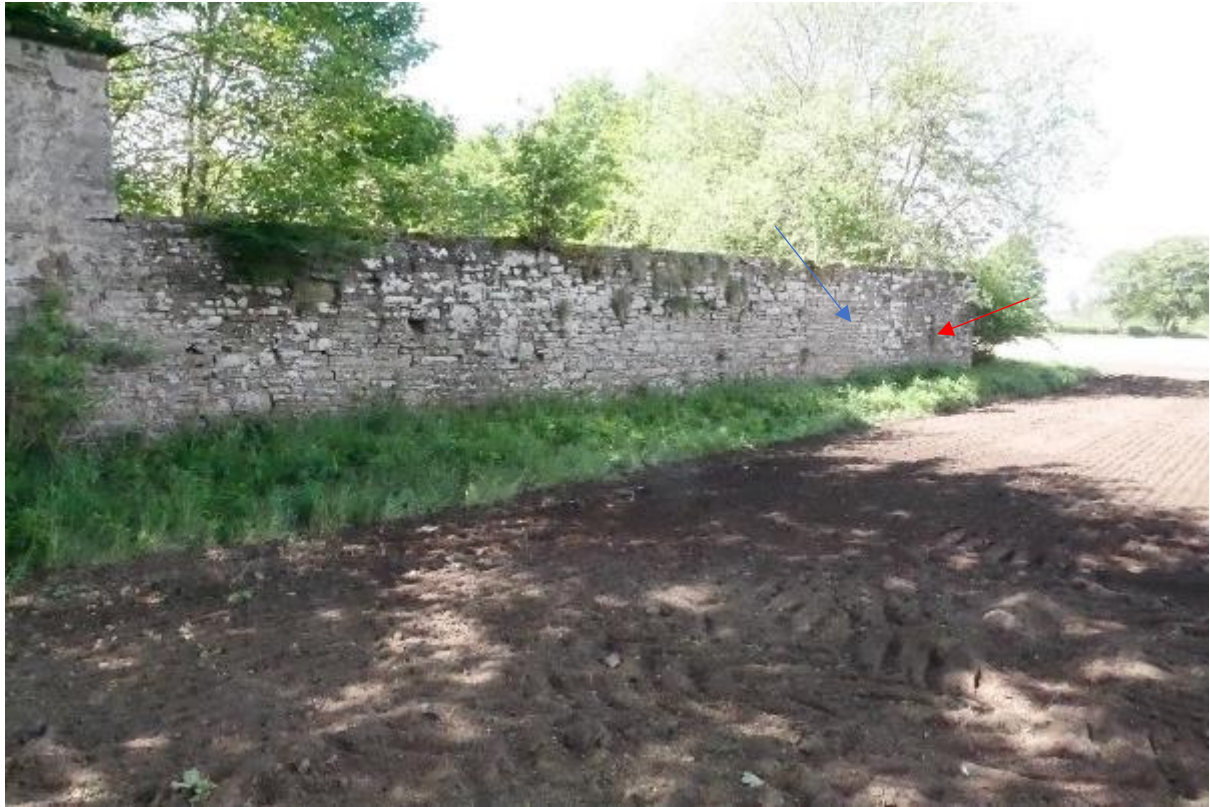
Illustration 55- General view of North Western facing elevation of Boundary wall C, slit window is located at red arrow, blocked entrance at blue arrow.

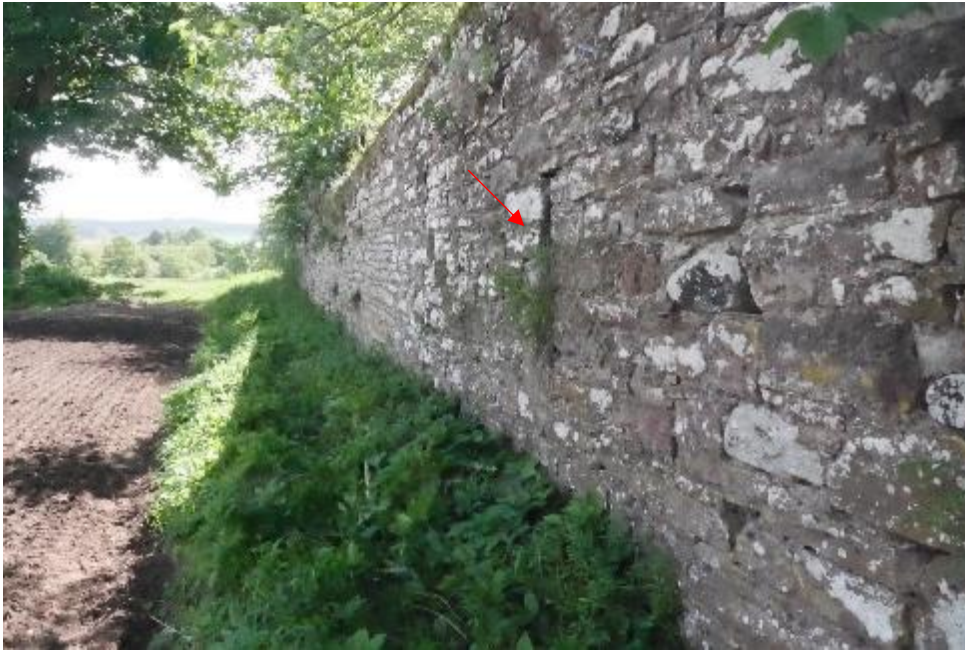
Illustration 56- External North Western facing elevation of Boundary wall C, red arrow shows location of slit window.

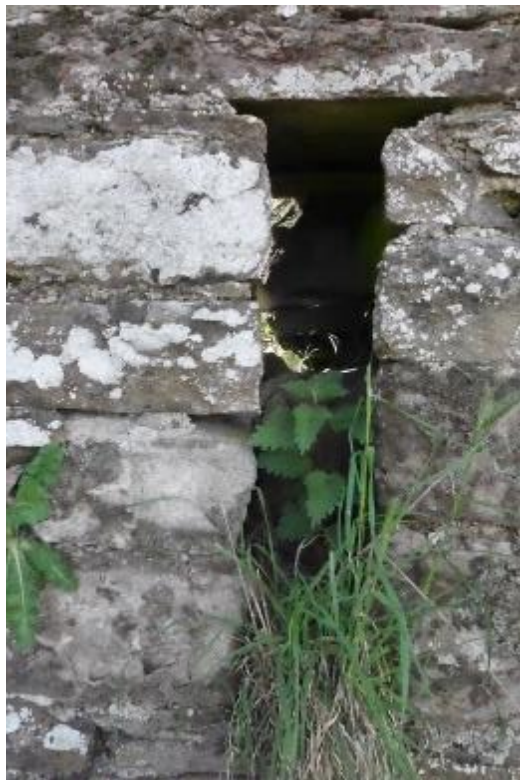
Illustration 57- Detail of slit window in Boundary wall C.

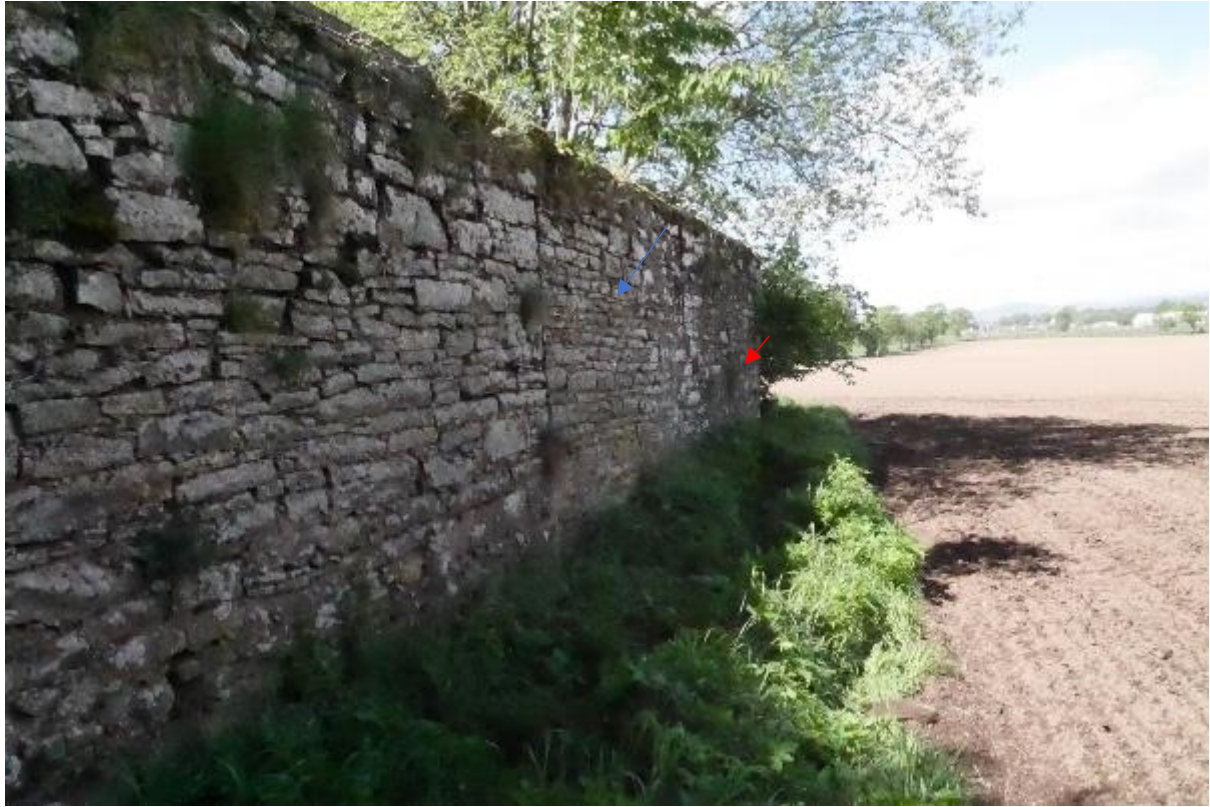
Illustration 58- Detail of Northern end of Boundary wall C, red arrow shows location of slit window, blue arrow blocked entrance.
