Standing Building Survey
Tullymorán Farm, Harrietfield

26th February 2010

Rural Relocation propose to demolish the existing buildings at Tullymoran Farm (NN 9800 2950) and build four new dwellings. The planning consent for this development (Perth and Kinross Planning Application 09/01370/FLL) included an archaeological condition which specified the need for a full photographic record of the farmhouse and steadings prior to their demolition. The photographic survey was carried out by the author on Friday 12th February 2010 (Site Code HAR01); weather conditions were cold with bright sunlight.

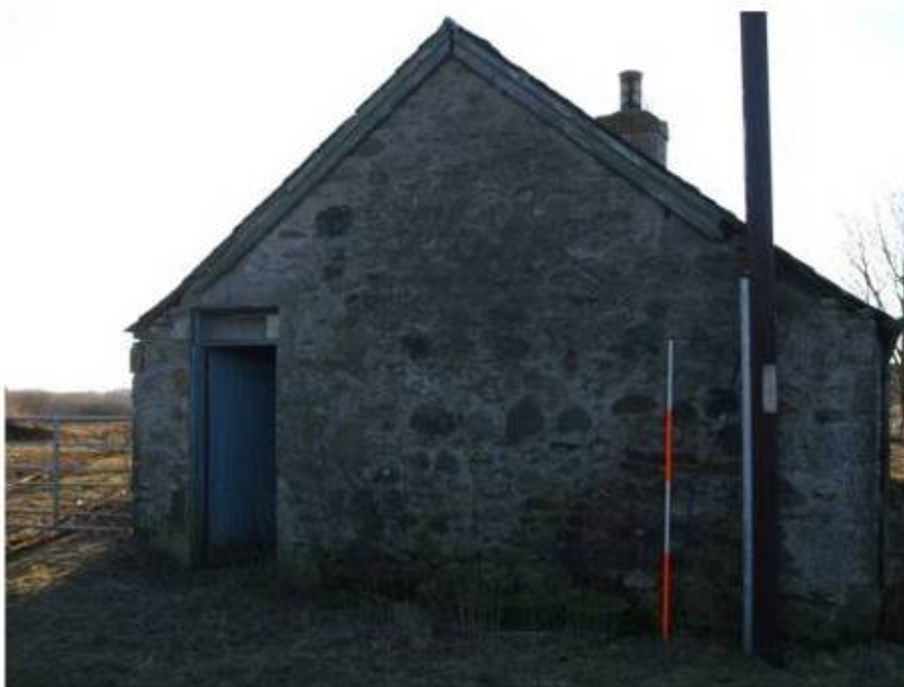
Northern elevation

This gable elevation contains a doorway into the building.

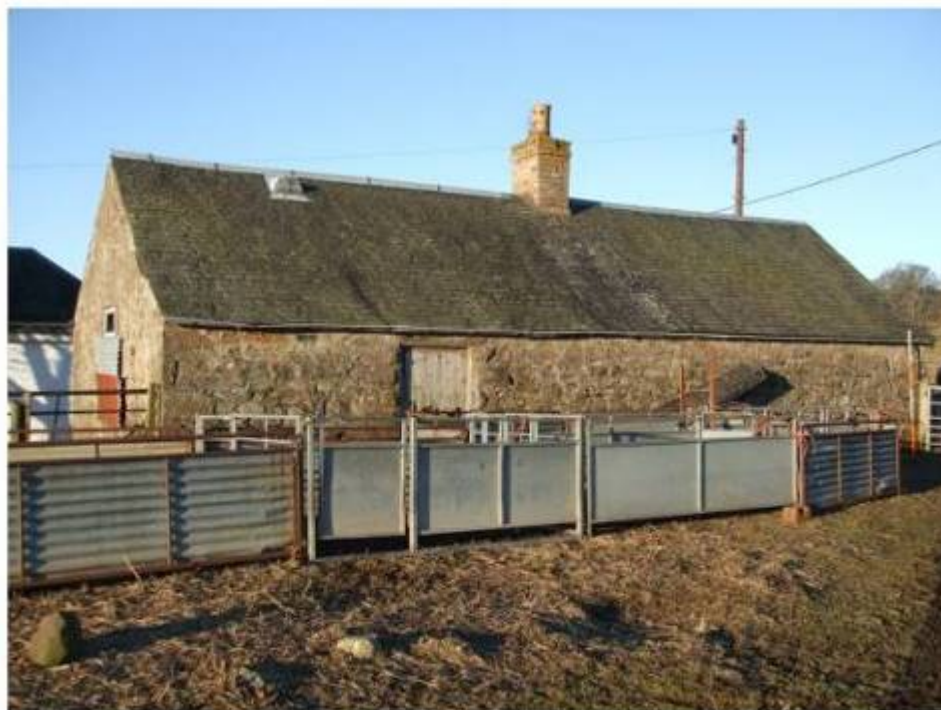
Eastern elevation

This elevation is blank except for a doorway towards its Southern end. Its North Eastern corner contains a reused shaped stone with a small socket in its middle.

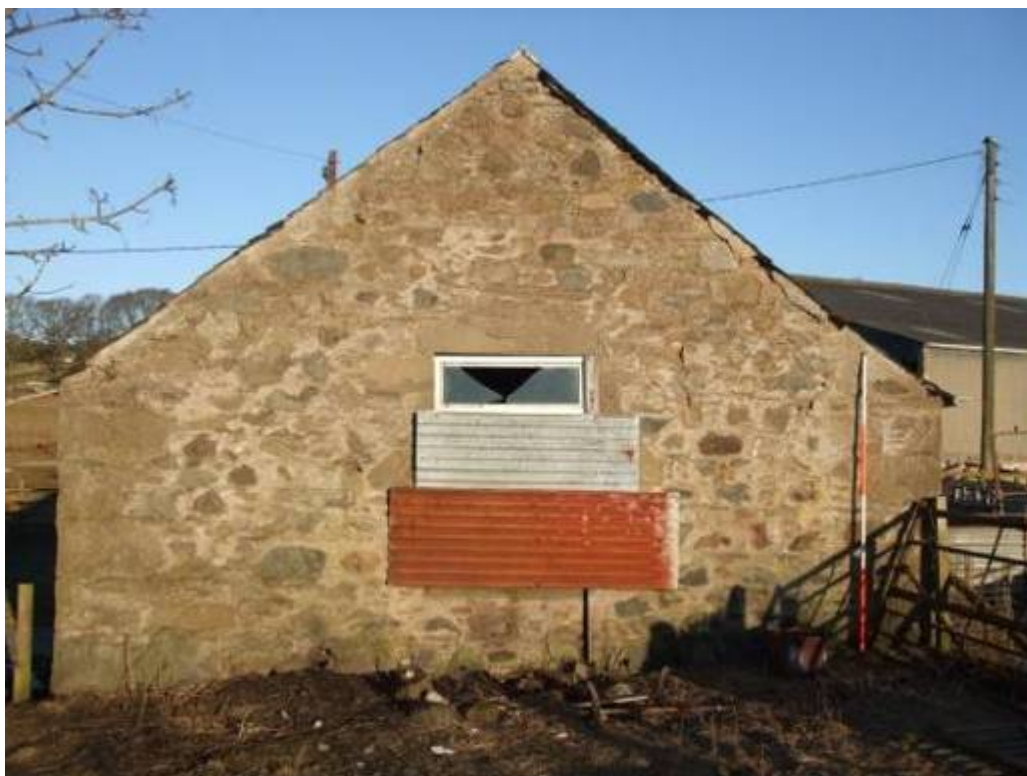
Southern elevation

This gable elevation contains a window.

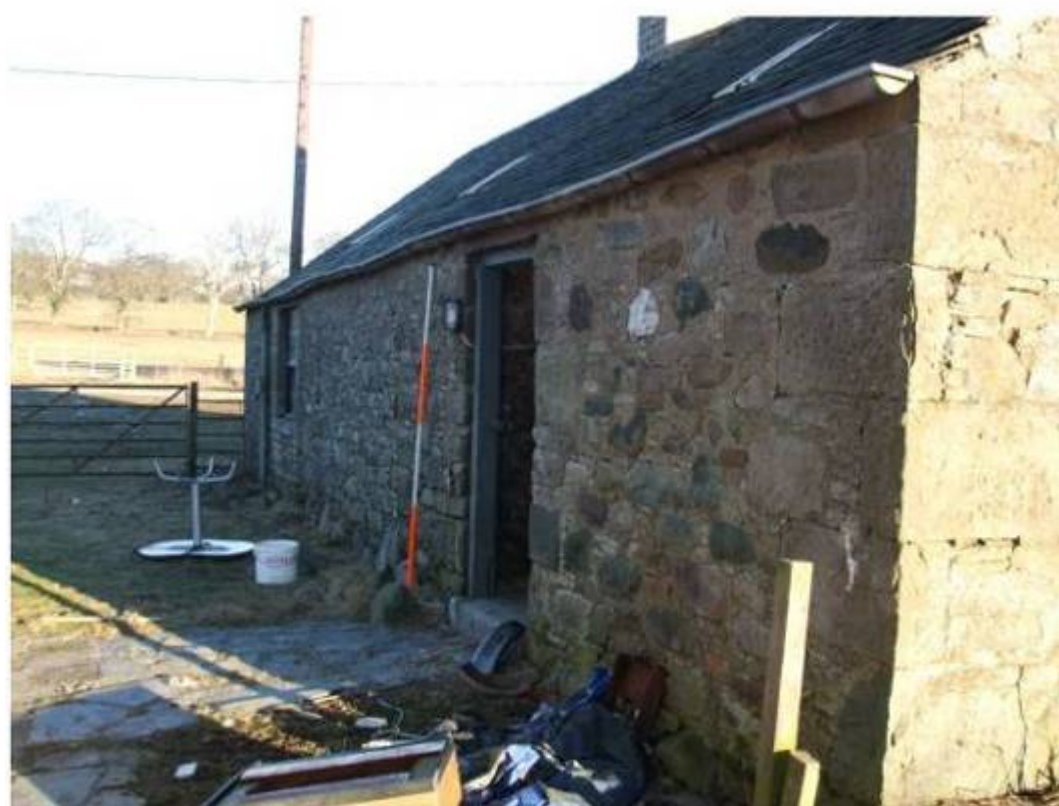
Western elevation (South end)

This elevation contains a doorway towards its Southern end and a single window towards its Northern end. A visible straight joint in the stonework 4.30 m from the northern end of this elevation would seem to suggest that the building may have been extended at some stage.

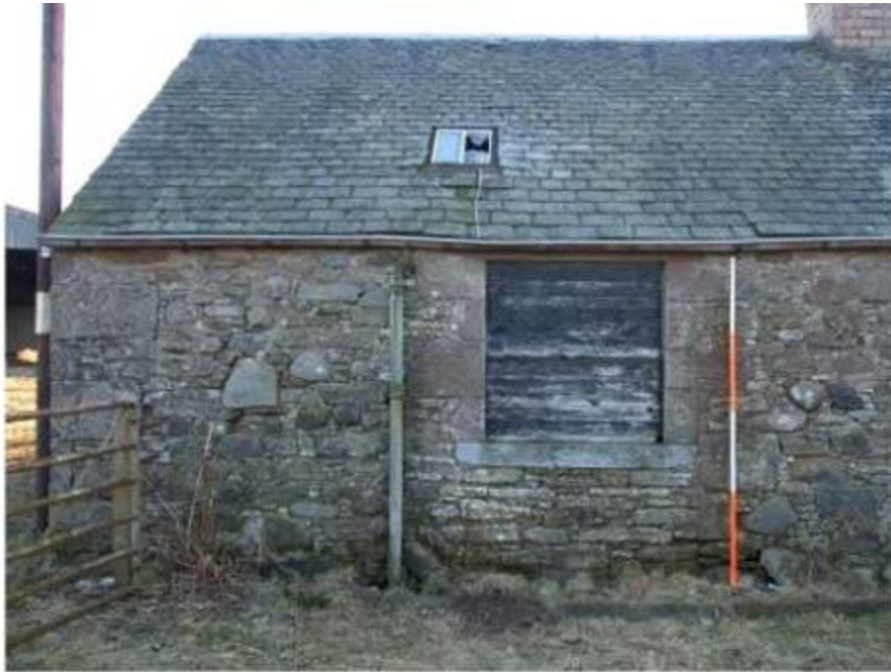
This simple single storey building may retain evidence for an earlier structure in its Western elevation, it contains a reused shaped stone at its North Eastern corner.

West elevation (North end) straight joint to left of scale

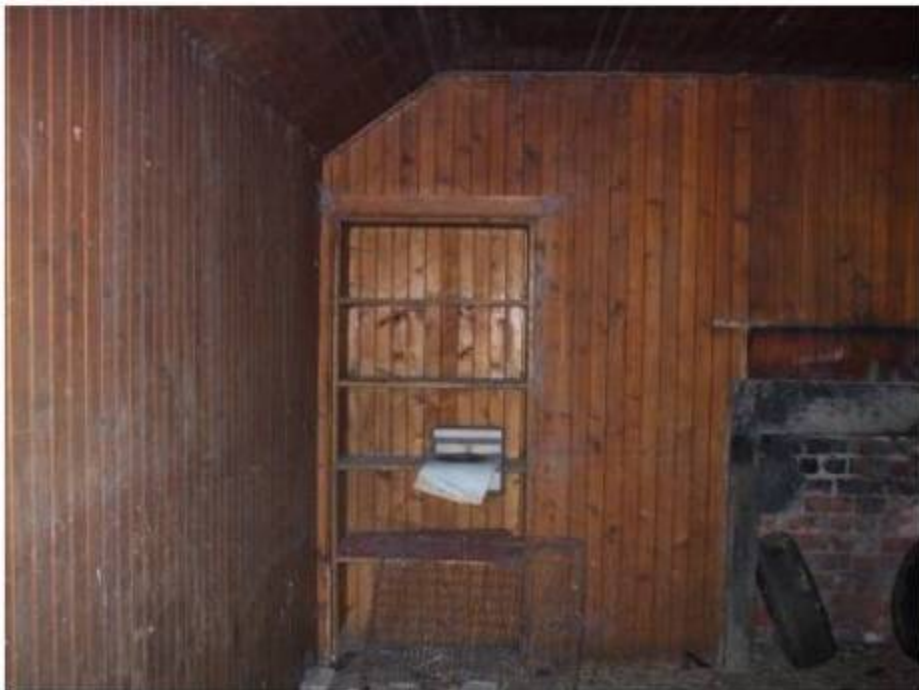
This building comprises two rooms internally, the room at the Northern end is wood panelled and has a fireplace in its Southern wall. The room at the southern end has bare stone walls and has been latterly used for storage.

Wood panelled interior of room at Northern end of building

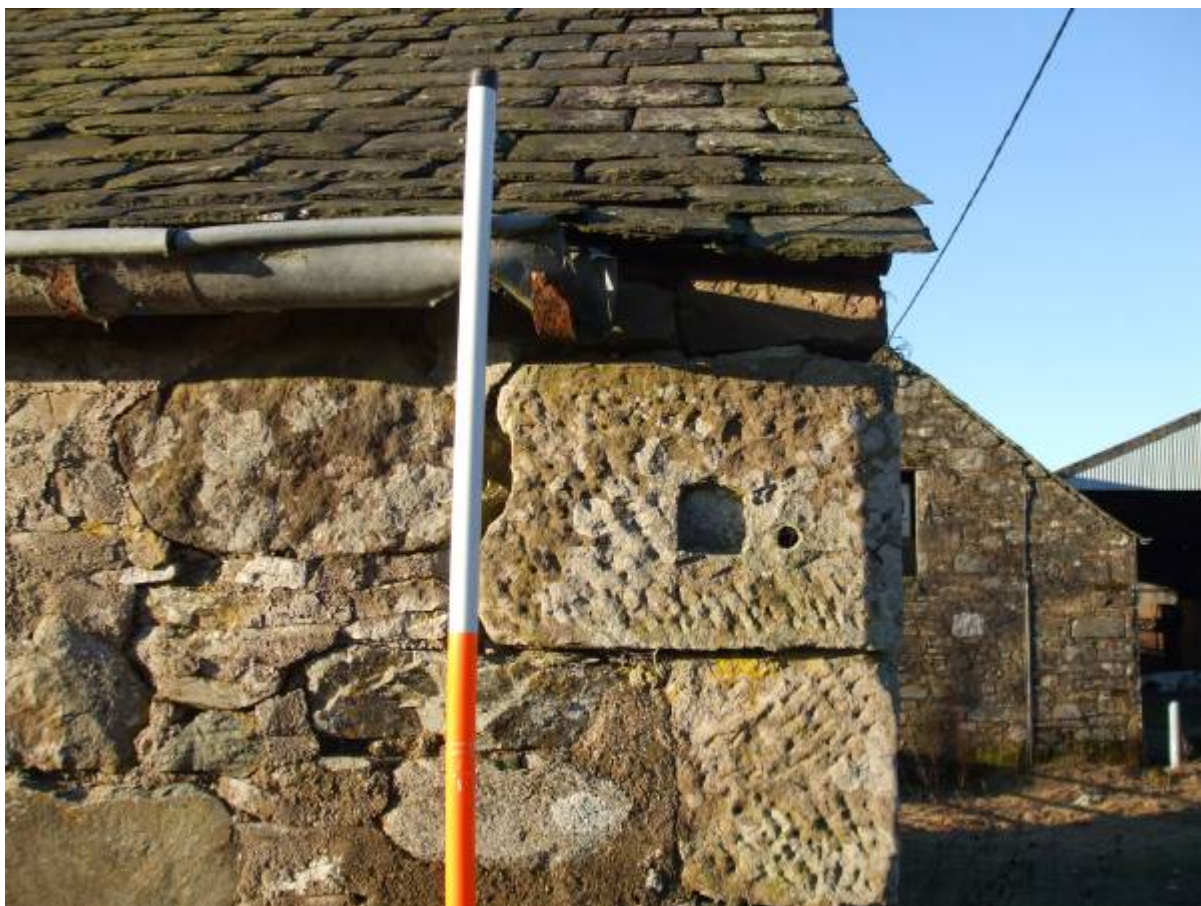
Illustration 9 Building 1 reused worked stone in North Eastern corner of Eastern elevation

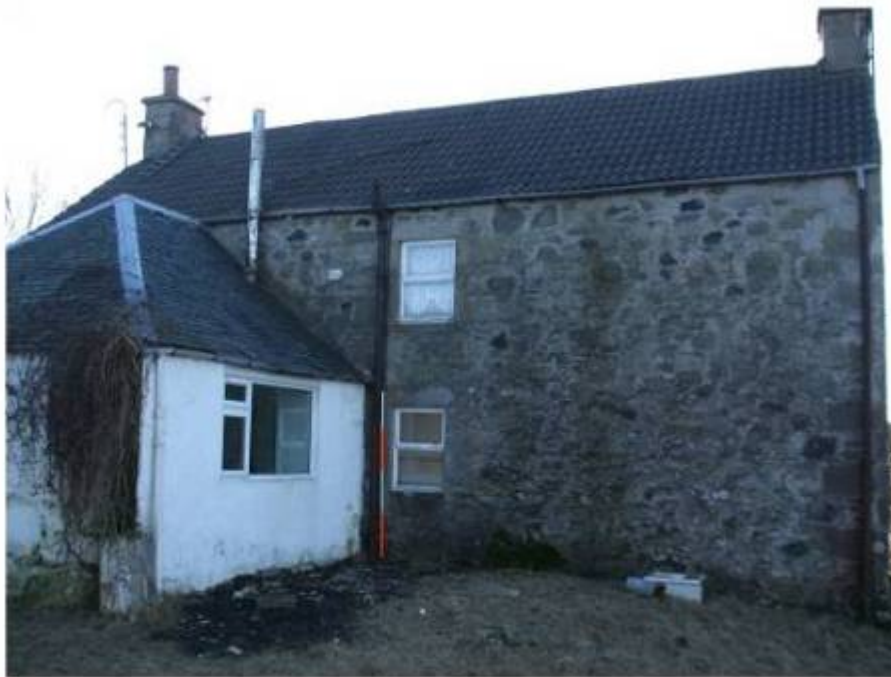
Northern elevation

This elevation has small windows at ground and first floor level and the attached kitchen extension at its eastern end.

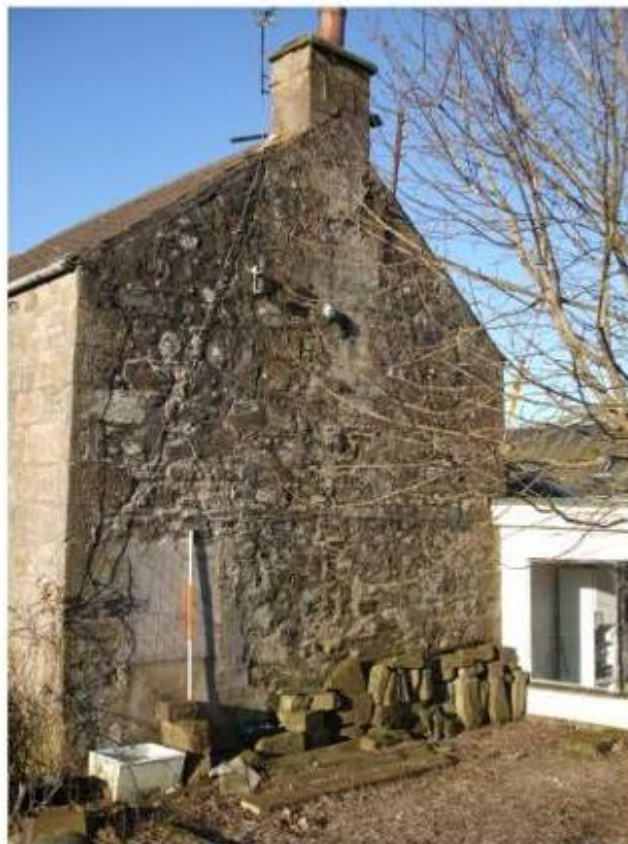
Eastern elevation

This elevation has a chimney at its gable and a blank wall face, a blocked doorway is visible at its southern end. There is a pile of shaped building stone sitting against this elevation, nothing decorative could be discerned.

Illustration 10 Building 2 Northern and Eastern elevations (note pile of worked stone)

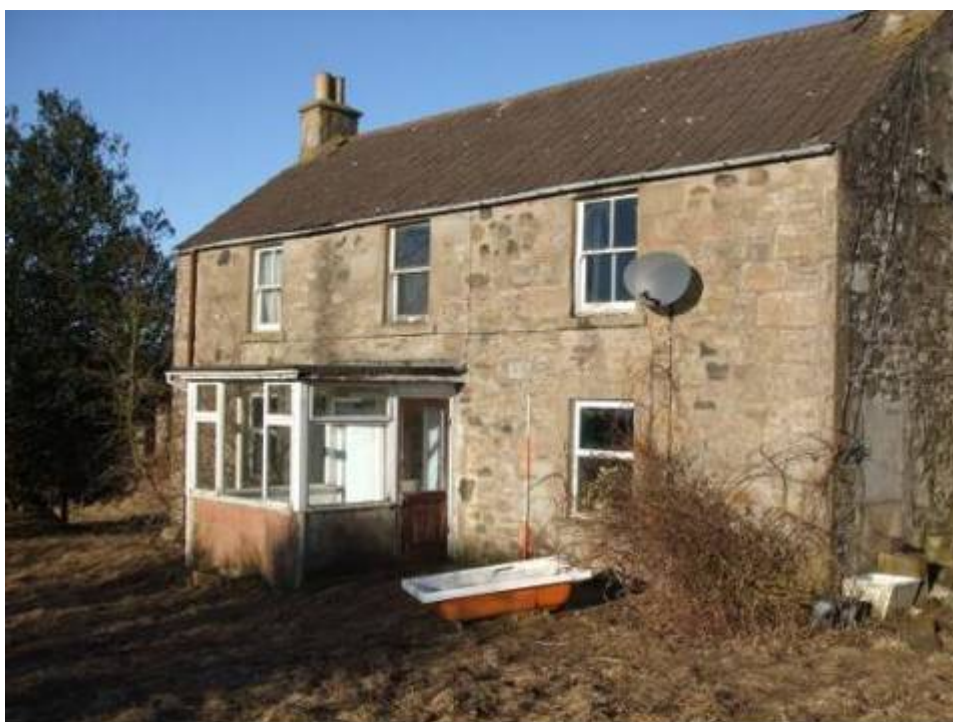
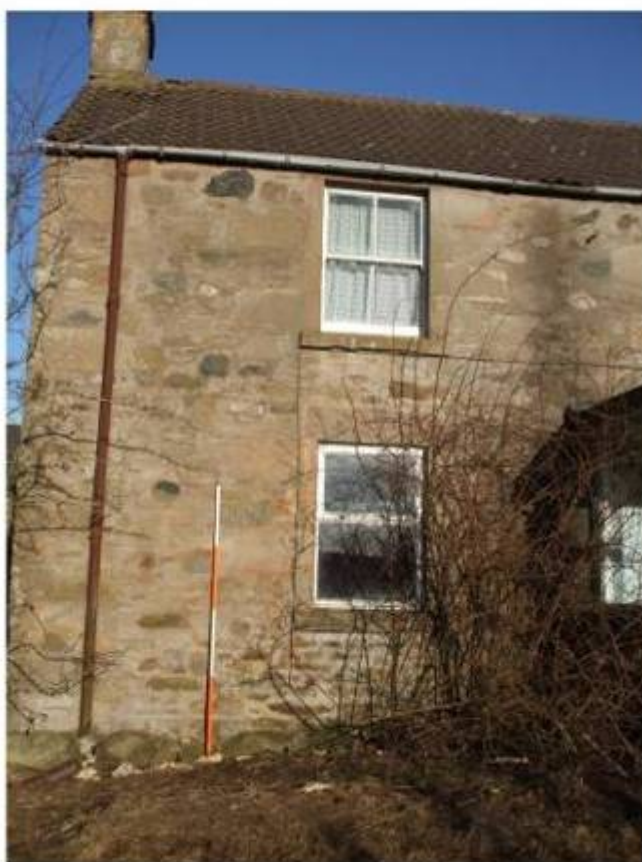
Illustration 11 Southern elevation eastern and western ends

This elevation has three windows at first floor level and a porch with windows either side at ground floor level.

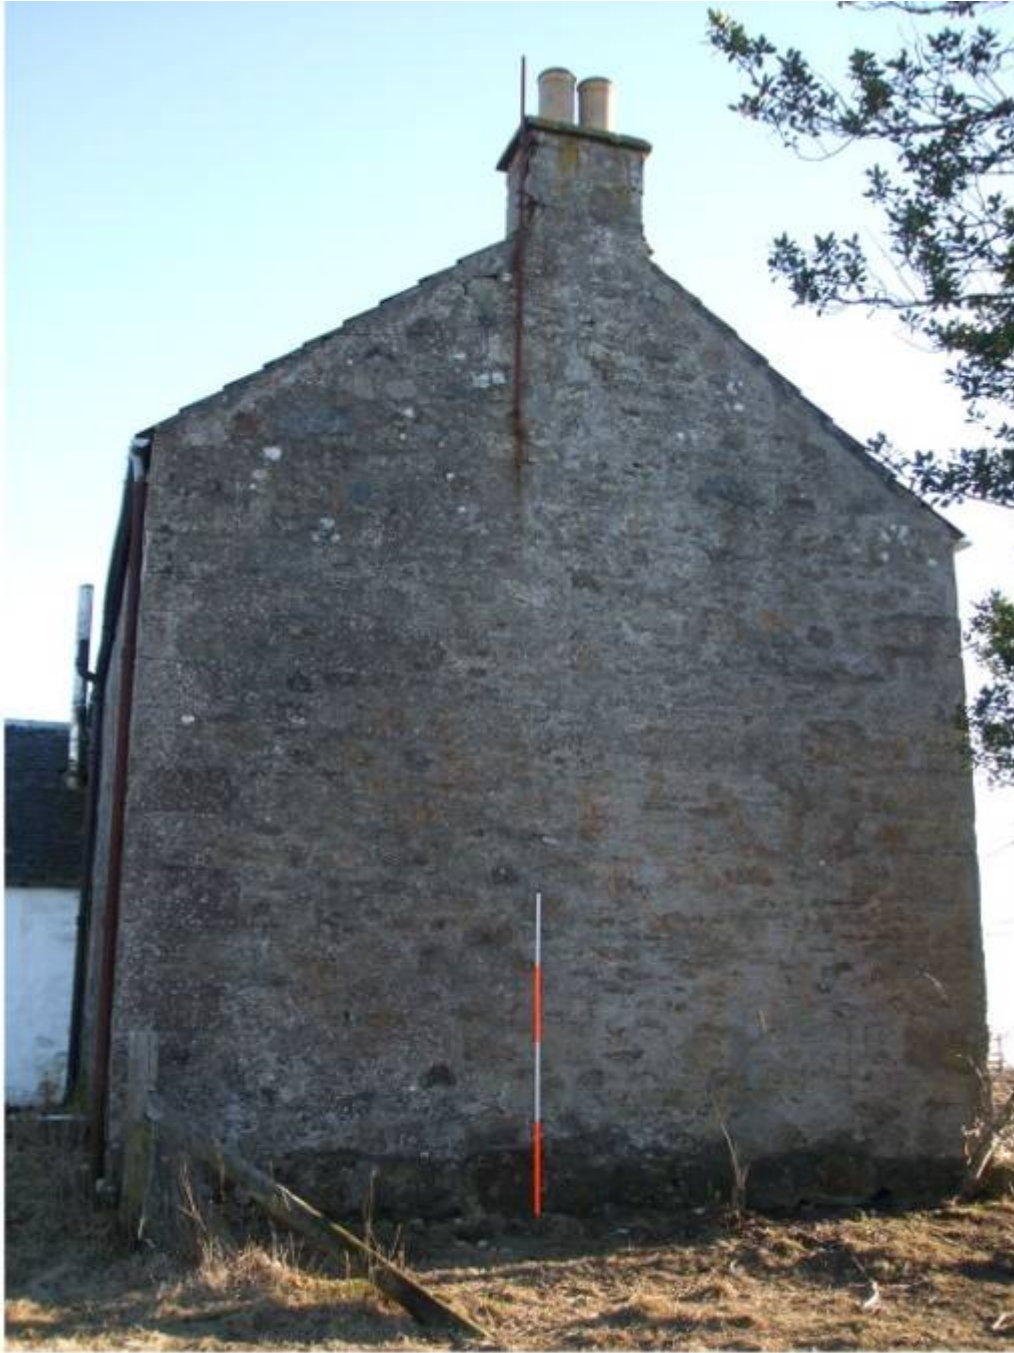
Illustration 12 Building 2 Western elevation

This elevation has a chimney at its gable and a blank wall face.

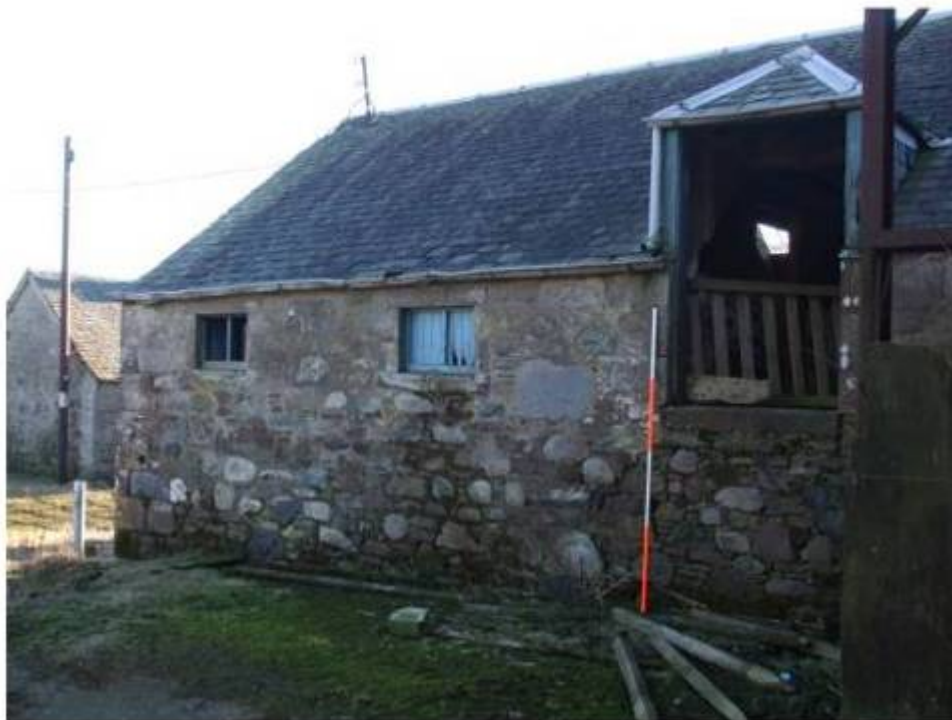
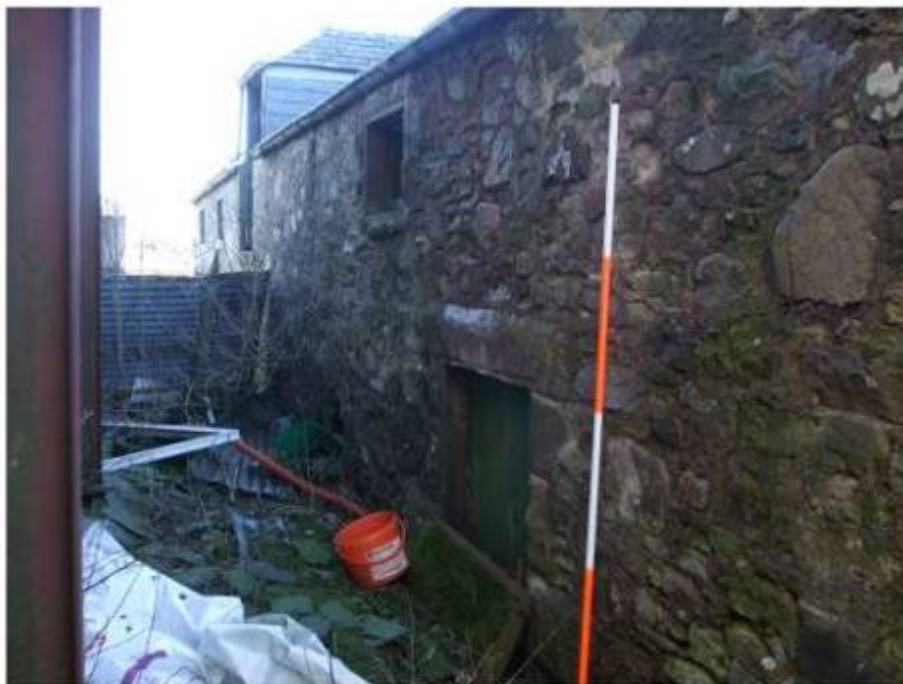
Illustration 13 Building 3 Northern elevation eastern and western ends

This elevation has a doorway/loading bay at first floor level with three small windows on its eastern side, there are two doorways at its western end.

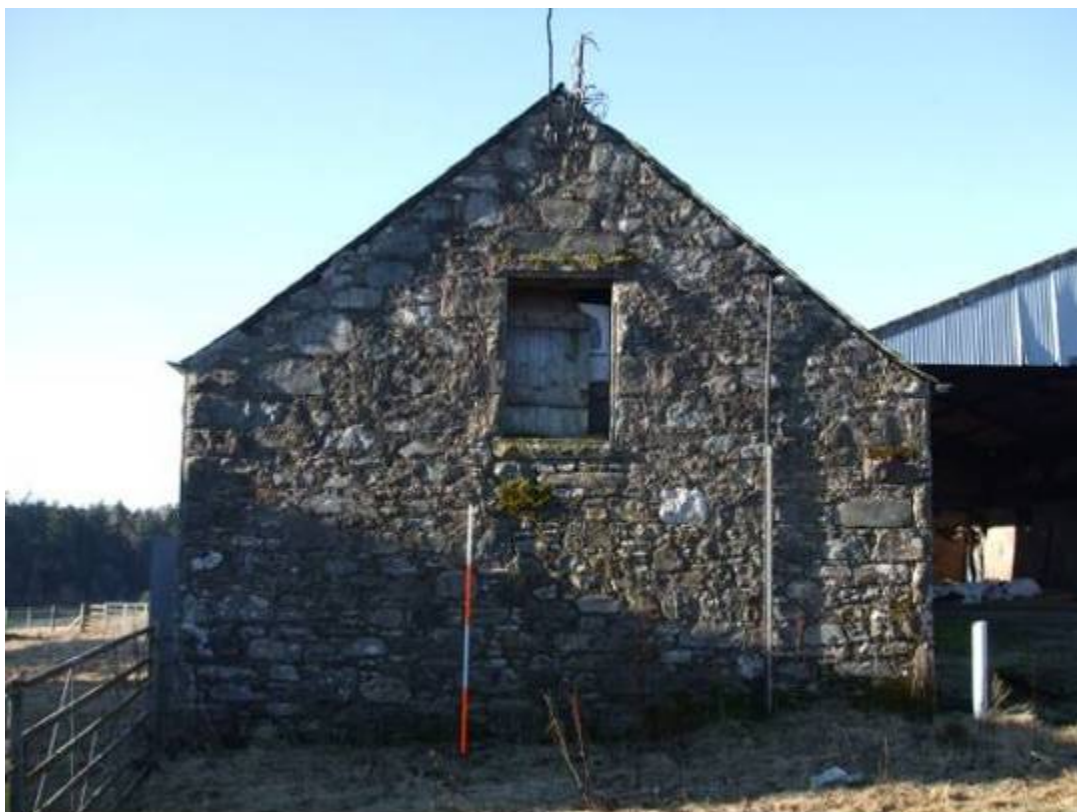
Eastern elevation

This gable elevation has a single window at first floor level.

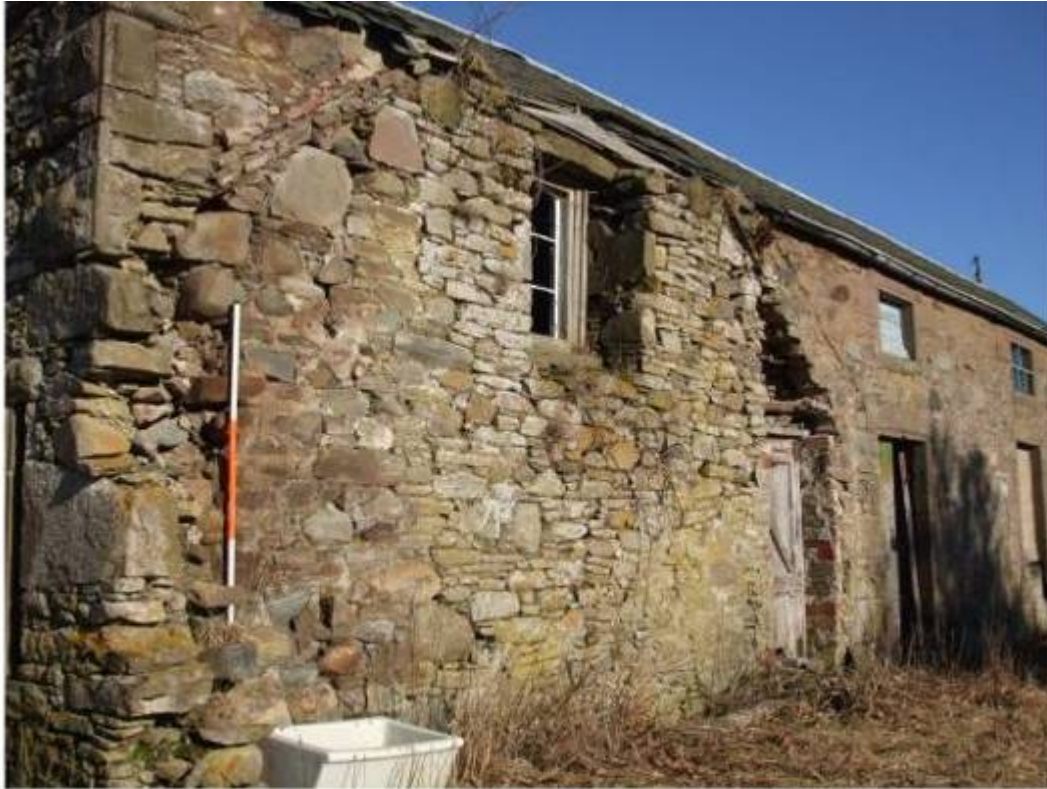
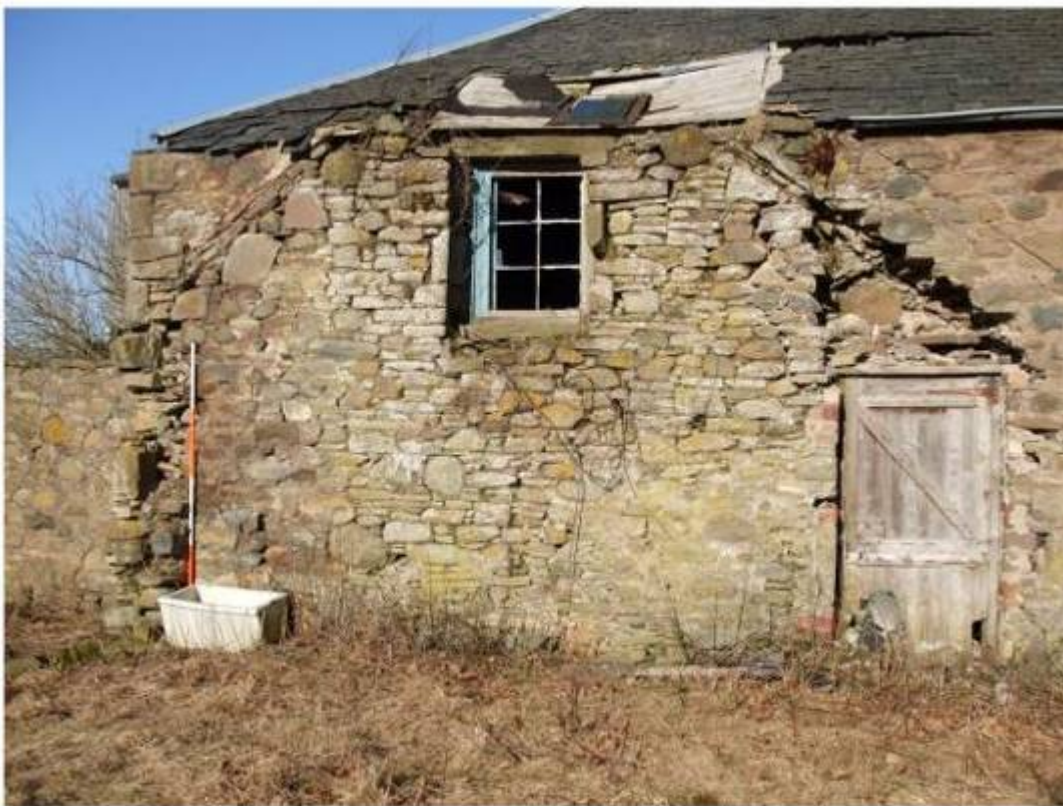
This elevation contains the remains of the blocked gable end of a building which formerly ran South off its western end. The roof raggles of this structure are still visible in the stonework and the gap has been filled in with mortar bonded rubble and occasional brick (Pitfour Brick Company). A window at first floor level and a ground floor doorway have been inserted into this blocking. The remainder of this elevation contains four small windows at first floor level, one of which contains dove/pigeon holes (see Illus 23). At ground floor level there are two large doorways/entrances at its Eastern end which have a long iron lintel, and a window and doorway lie to the West of these entrances. There is a building platform visible running for 11m south of the blocking in this elevation which represents the former footprint of the demolished range.

This building contains the remains of the blocked gable end of a former southern range. There are visible raggles of at least two roof lines in the face of the southern elevation of the standing building and the core of the demolished structures West wall. A building platform is still visible running 11m south of the Western end of the steading (Illus 1 and 17).

Illustration 15 Southern elevation (Western end) and detail of blocked gable end of earlier structure

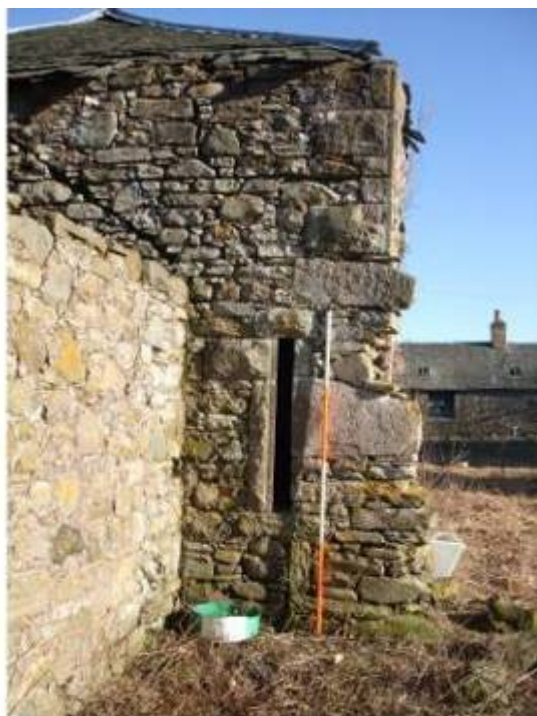
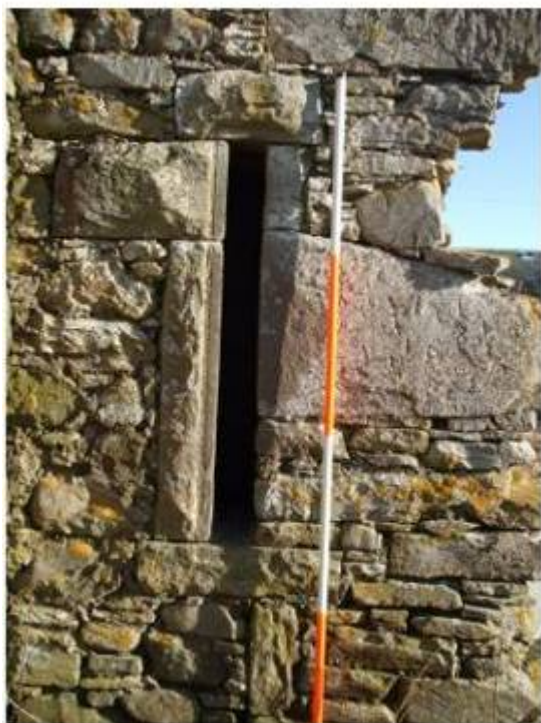
Illustration 16 Building 3 narrow window opening in Western elevation

This elevation has building 4 butted against it and there is a single doorway leading from building 3 into building 4. The external part of this elevation contains a single narrow window which may have originally been part of the demolished southern range (see above).

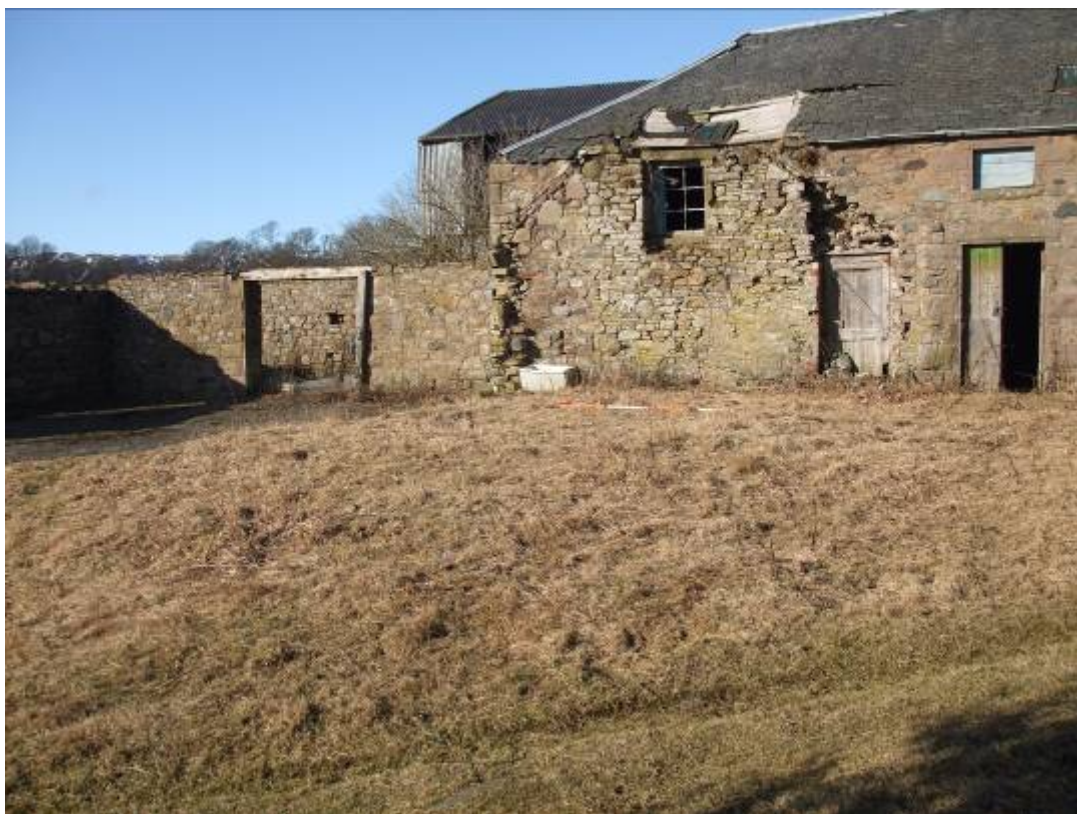
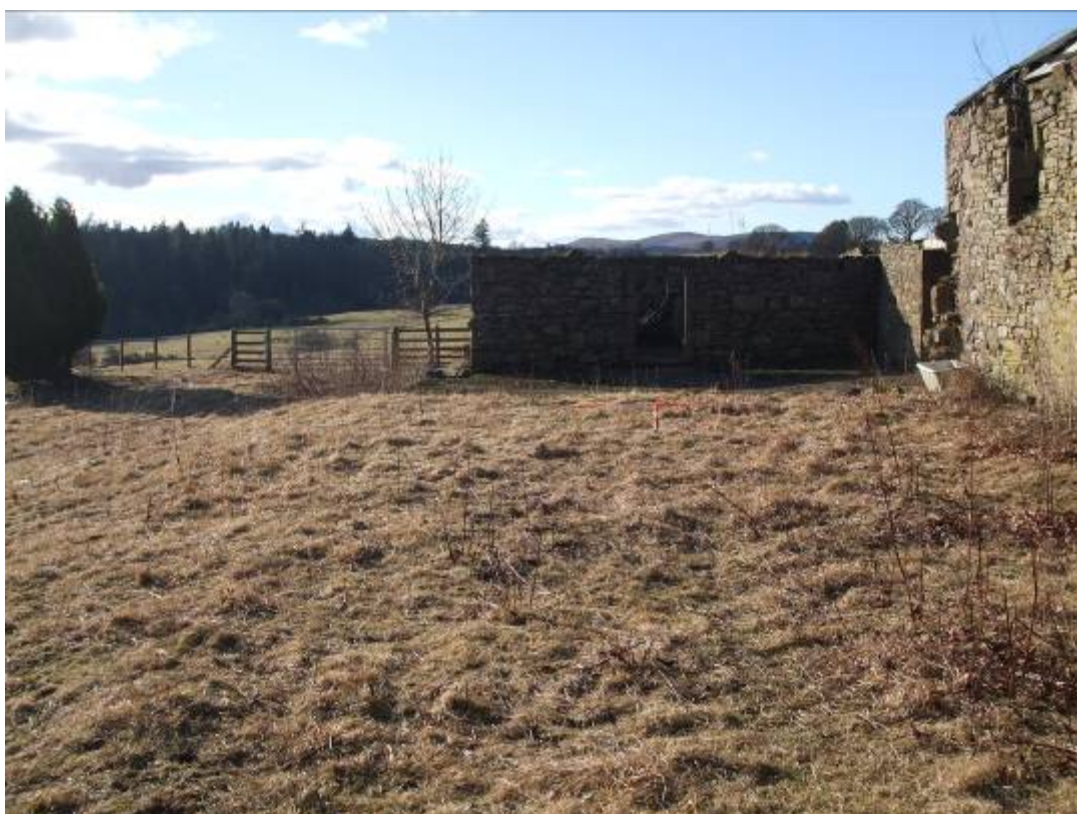
Illustration 17 Building platform running South from West end of Building 3 looking North (top) and West (bottom)

The author feels that the photographic survey, written notes and drawn elevations of the buildings are an adequate record of them prior to their demolition. The survival of a visible building platform for one of the earlier structures means that consideration may need to be given to recommending the need for a watching brief on all ground breaking works in that area that are part of the redevelopment. However the final decision on the need for any further work rests with Perth and Kinross Heritage Trust.

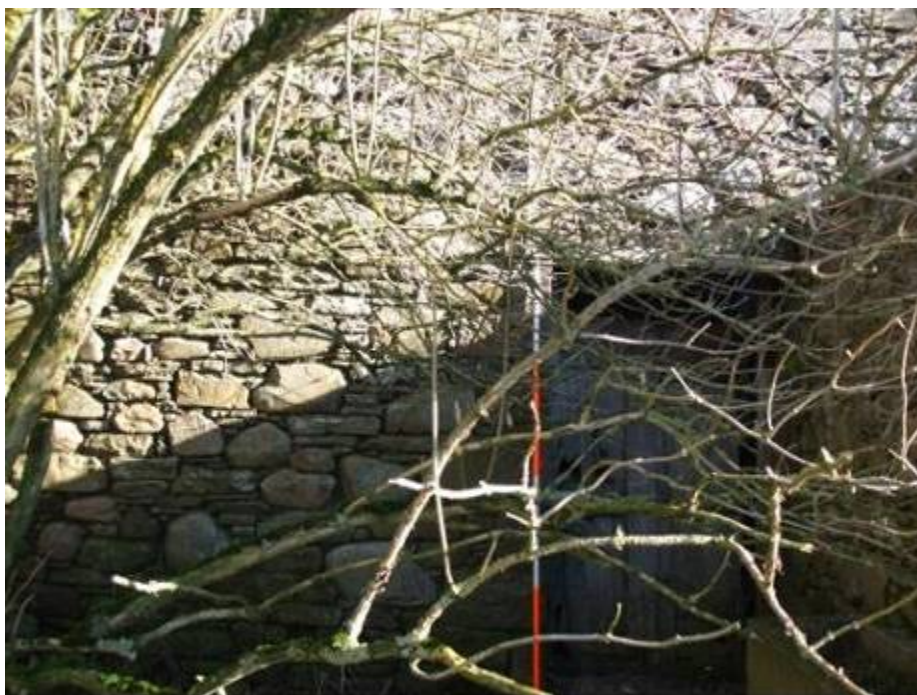
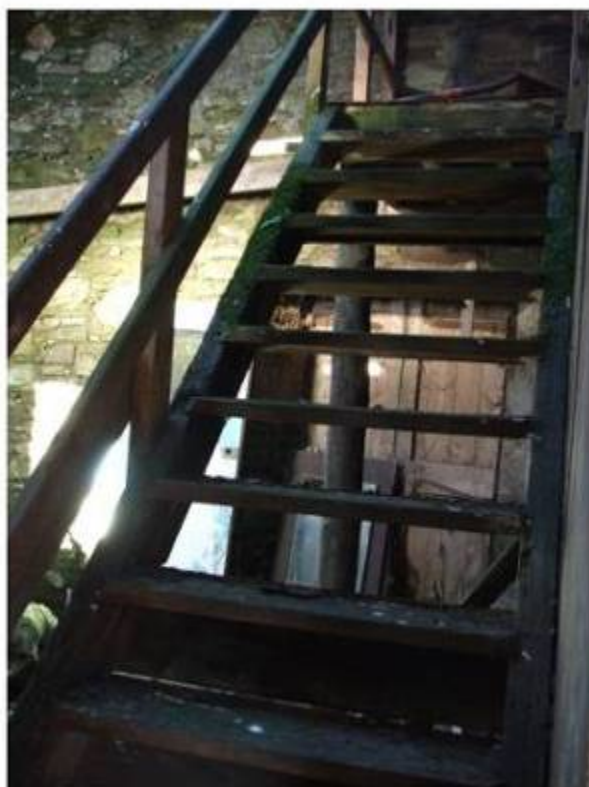
It was only possible to gain entry to the western end of this building which was being used for storage, wall thickness was seen to be c 0.50m. A wooden staircase affords access to the first floor level which can also be accessed from the loading bay in the north elevation, the wooden floor at this level is rotten and unsafe.

Illustration 18 Building 3 Western elevation (at junction of bldgs 3 and 4) and internal staircase to first floor

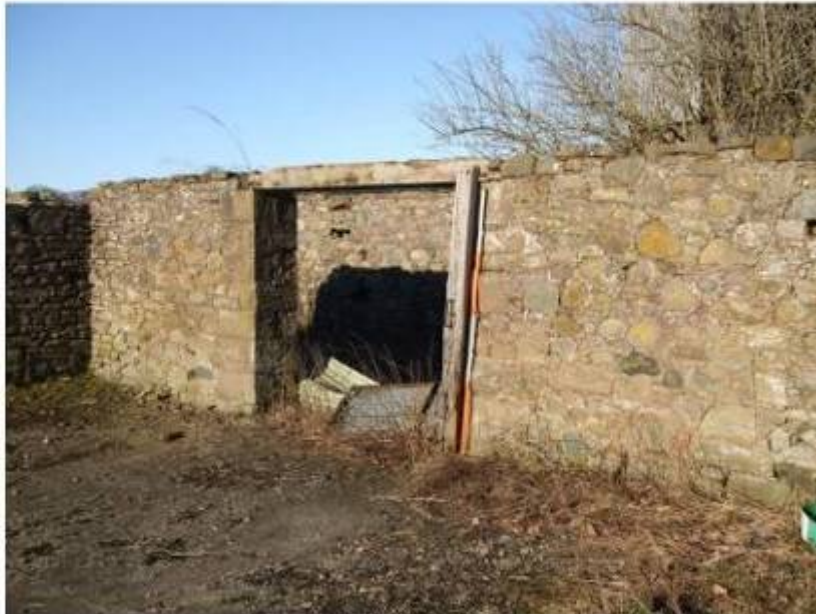
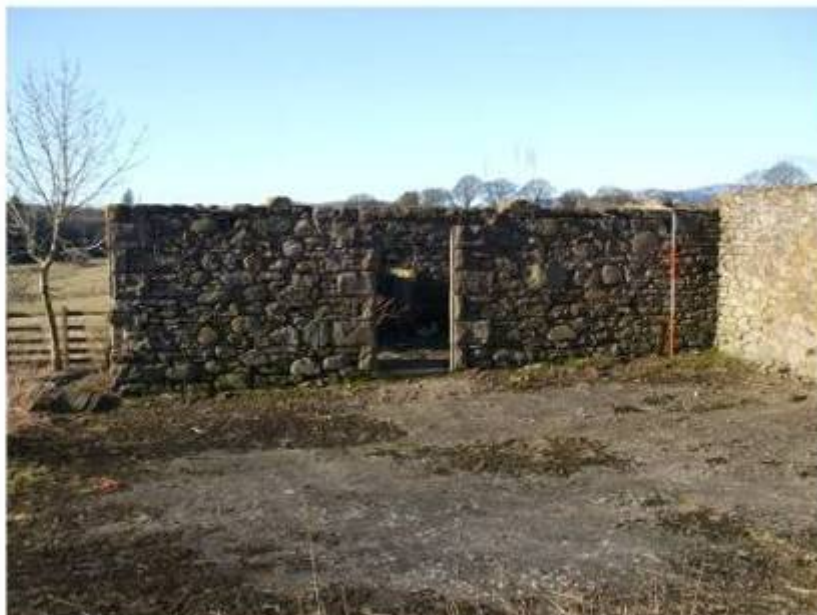
There is a single wide entrance into this structure (2.25m high by 2.65m wide) which has a wooden lintel.

There is a single doorway (1.06m wide by 2m high) into the building.

Illustration 19 Building 4 Southern elevation of north range and Eastern elevation of South range

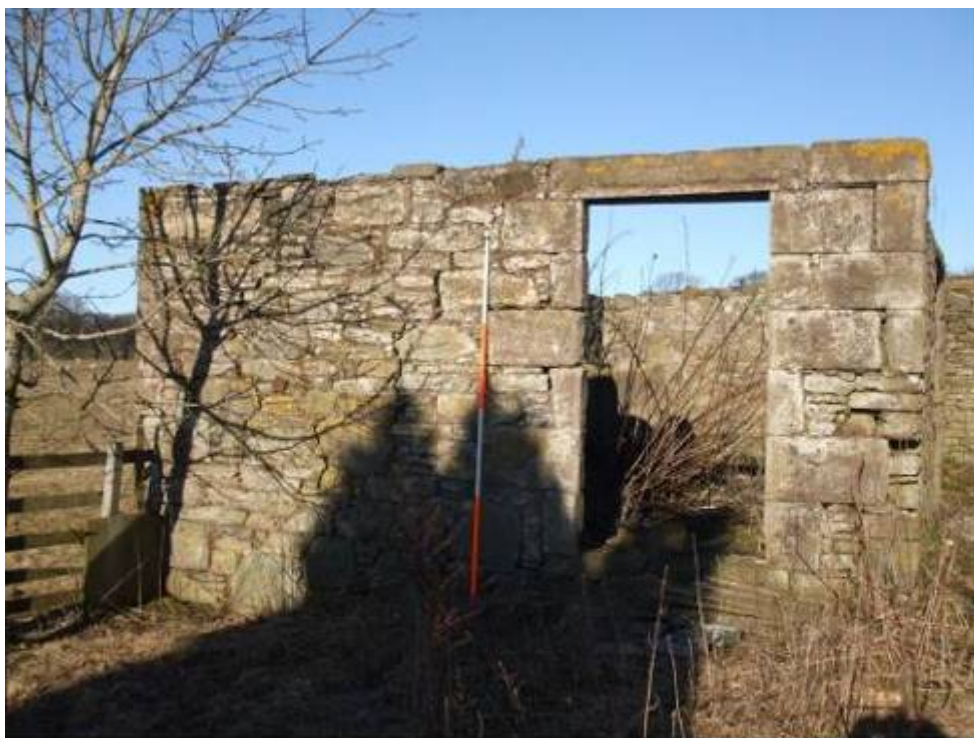
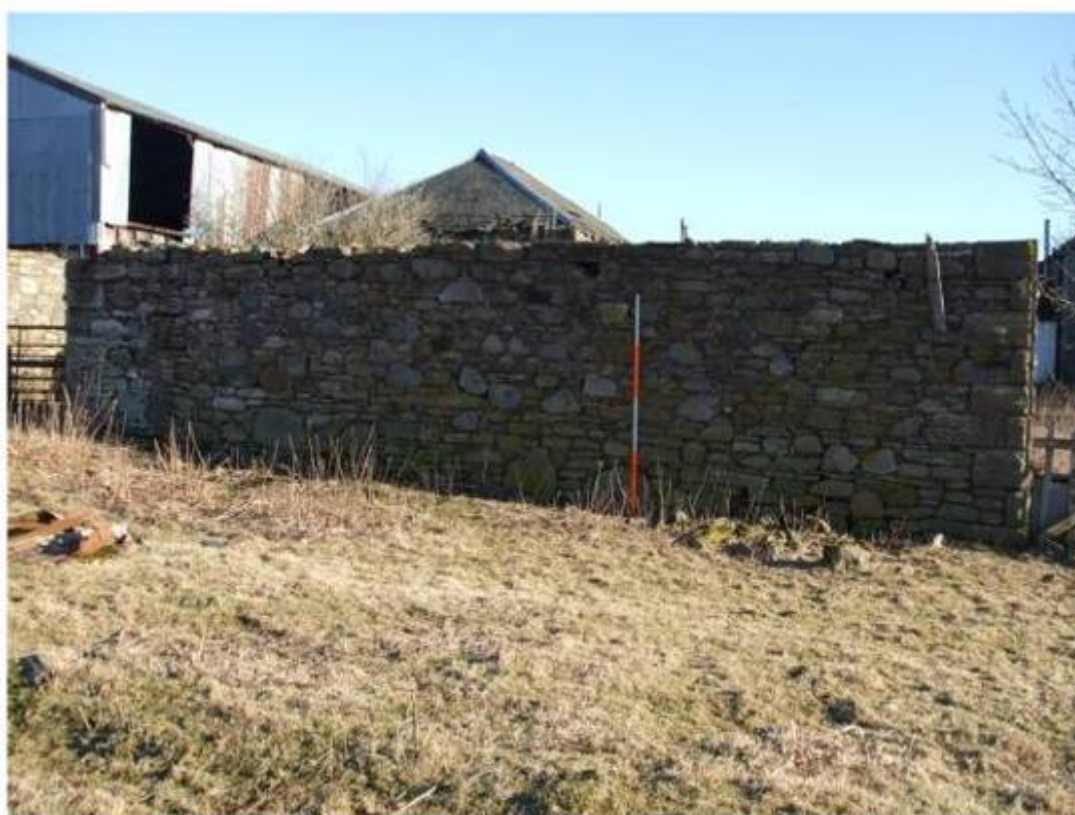
There is a single doorway into the building (1.05m wide by 2.05m high).

This is a completely blank wall face.

Illustration 20 Southern and Western elevations of south range

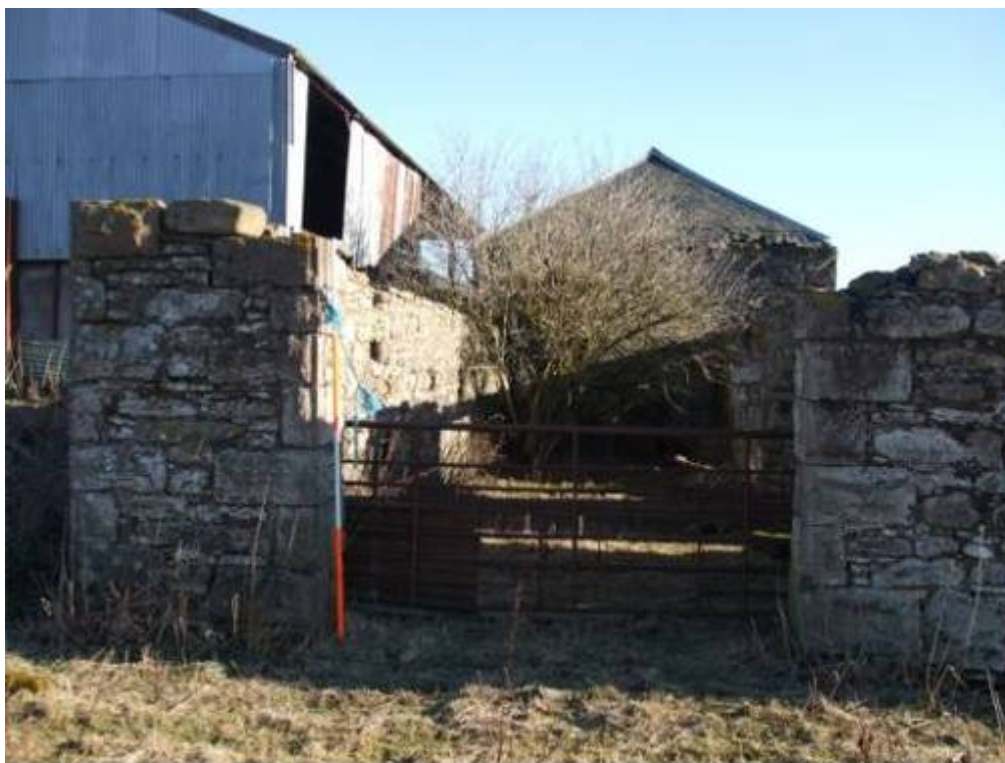
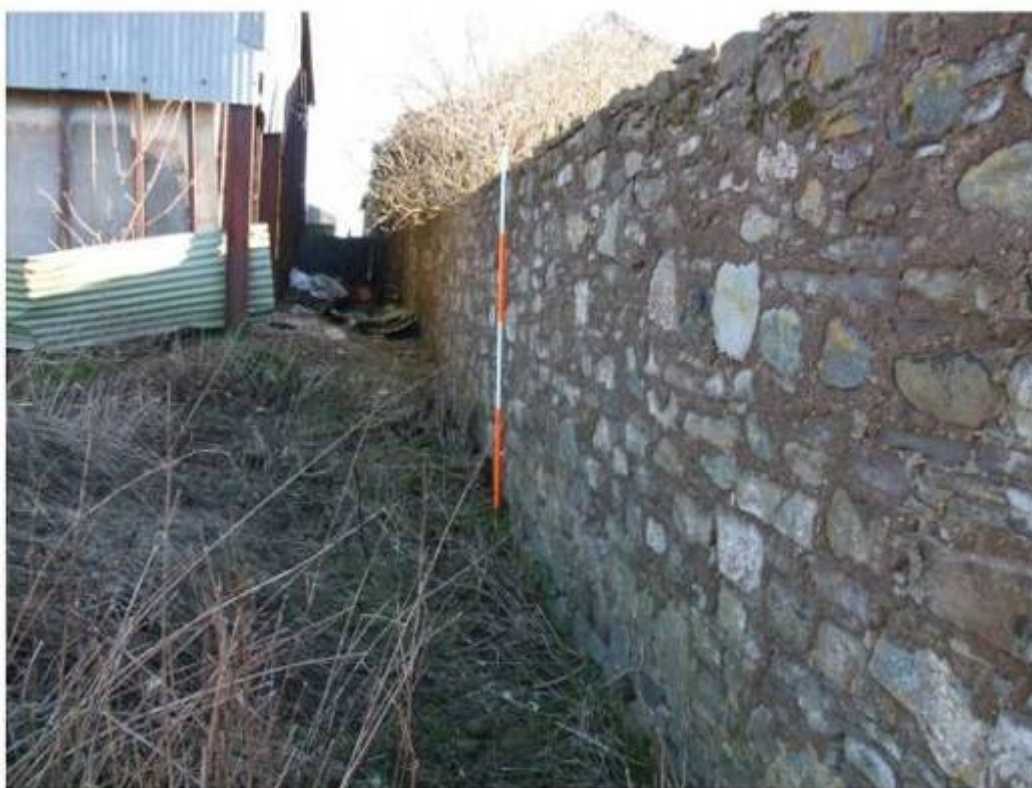
This is a completely blank wall face.

There is a single wide entrance (2.35m high by 2.65m wide) leading into the neighbouring field.

Illustration 21 Western and Northern elevations of North range
