Standing Building Survey
Tullymorán Farm, Harrietfield

26th February 2010

Rural Relocation propose to demolish the existing buildings at Tullymoran Farm (NN 9800 2950) and build four new dwellings. The planning consent for this development (Perth and Kinross Planning Application 09/01370/FLL) included an archaeological condition which specified the need for a full photographic record of the farmhouse and steadings prior to their demolition. The photographic survey was carried out by the author on Friday 12th February 2010 (Site Code HAR01); weather conditions were cold with bright sunlight.

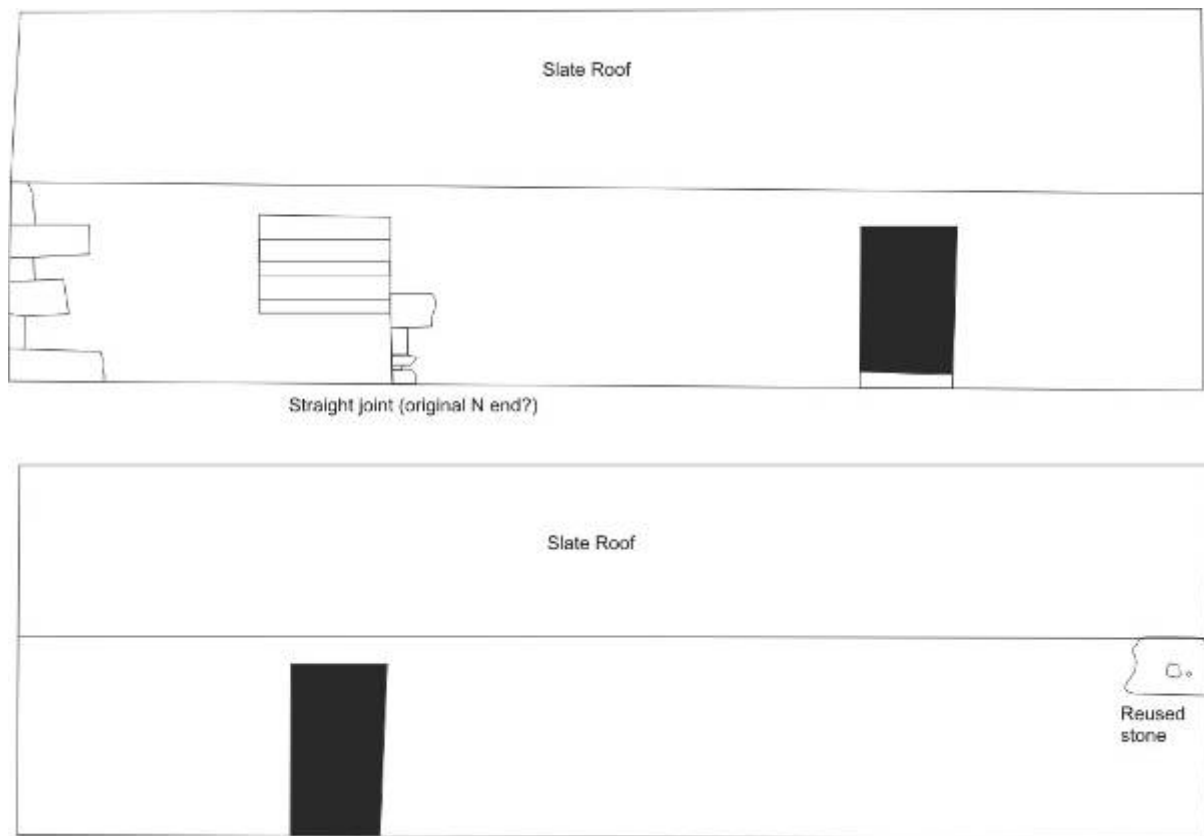
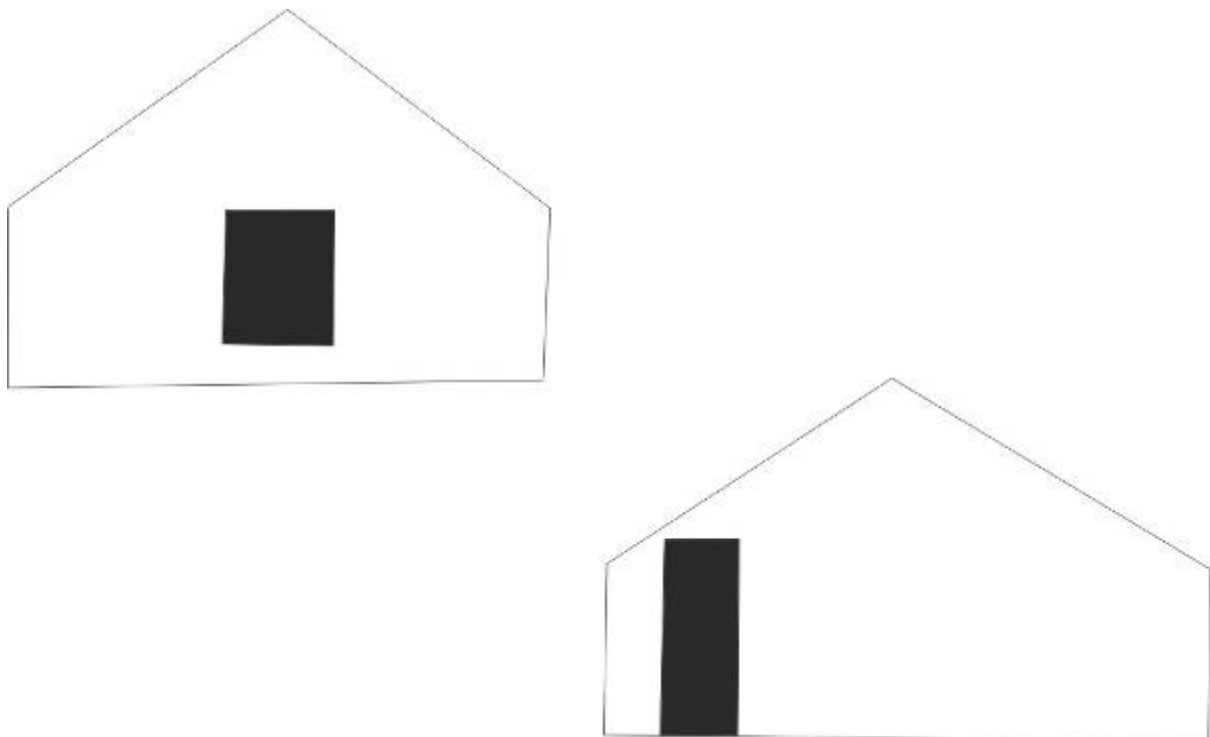
Illustration 22 Elevations of Building 1 at 1:50

Two of the four buildings at Tullymoran appear to preserve evidence for earlier structures on the site (Buildings 1 and 3). For this reason full elevations of these two buildings (apart from the western elevation of building 3) were drawn to complement the photographic survey (Illus 22 and 23).

Building 1 Western elevation (top) and Eastern elevation (bottom) scale 1:50

Building 1 Southern elevation (top) and Northern elevation (bottom) scale 1:50

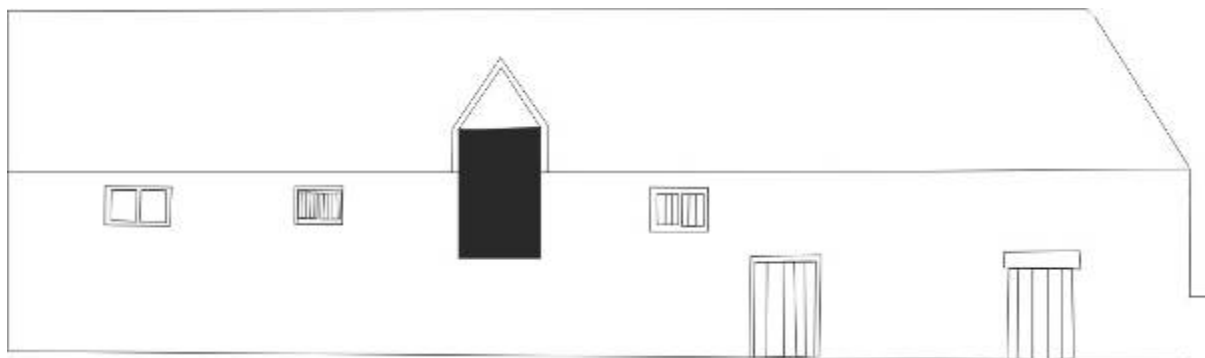
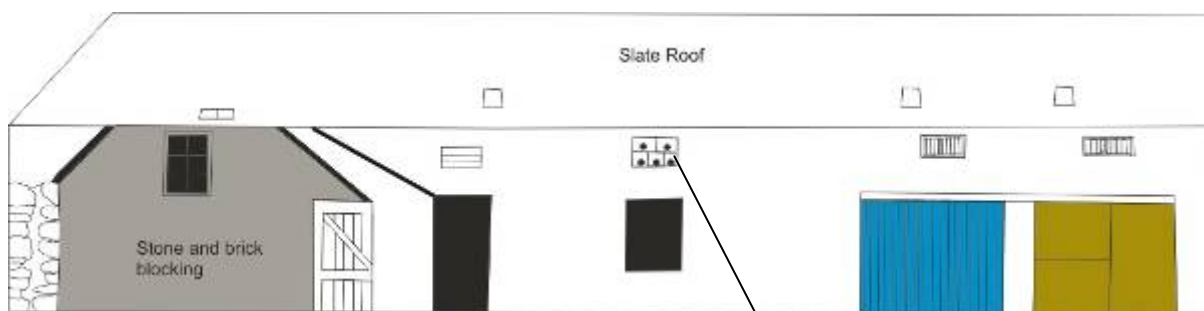
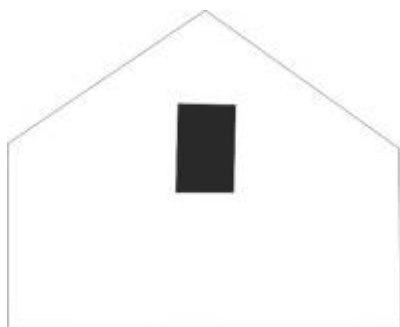
Illustration 23 Elevations of Building 3 at 1:50 (inset photo of bird holes)

Northern elevation Building 3 scale 1:50

Southern elevation Building 3 scale 1:50

(thick black lines indicate roof raggles)

Eastern elevation Building 3 scale 1:50
