# Standing Building Survey

## Orchilmore Farm and Cottage, Killiecrankie

Orchilmore Farm looking South

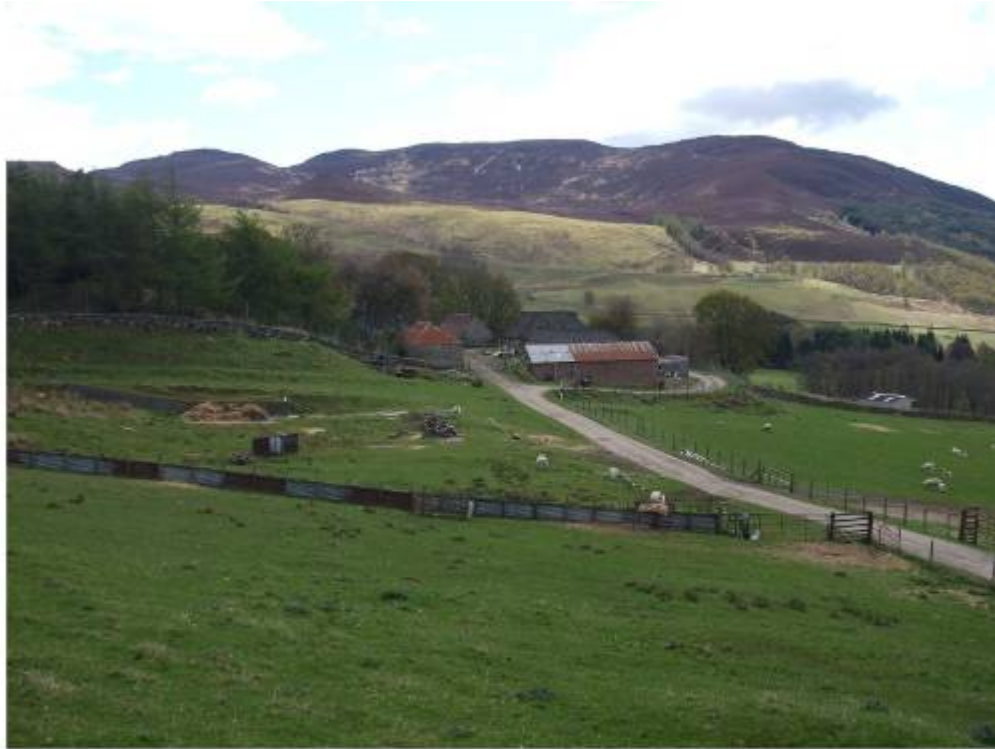
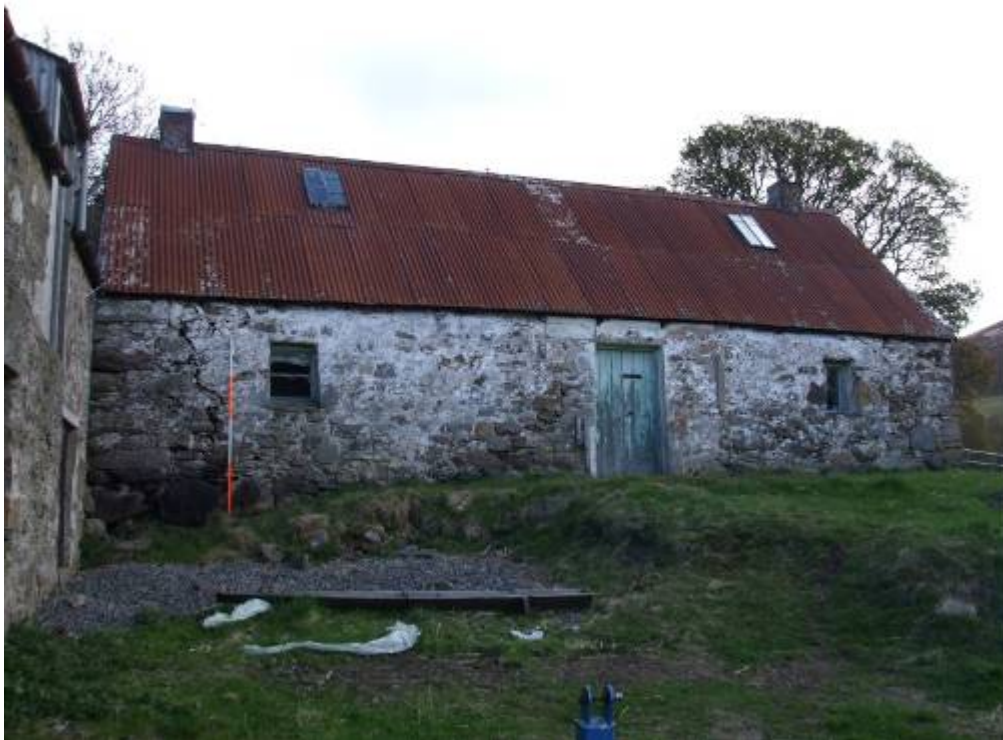
This elevation contains two small windows and a doorway that is located slightly off centre. A visible straight joint in the wall face indicates a blocked much wider entranceway.

Illustration 5 General view of Orchilmore Farm looking South South West and South Western  
Elevation of Orchilmore Cottage (Building 1) (B listed)

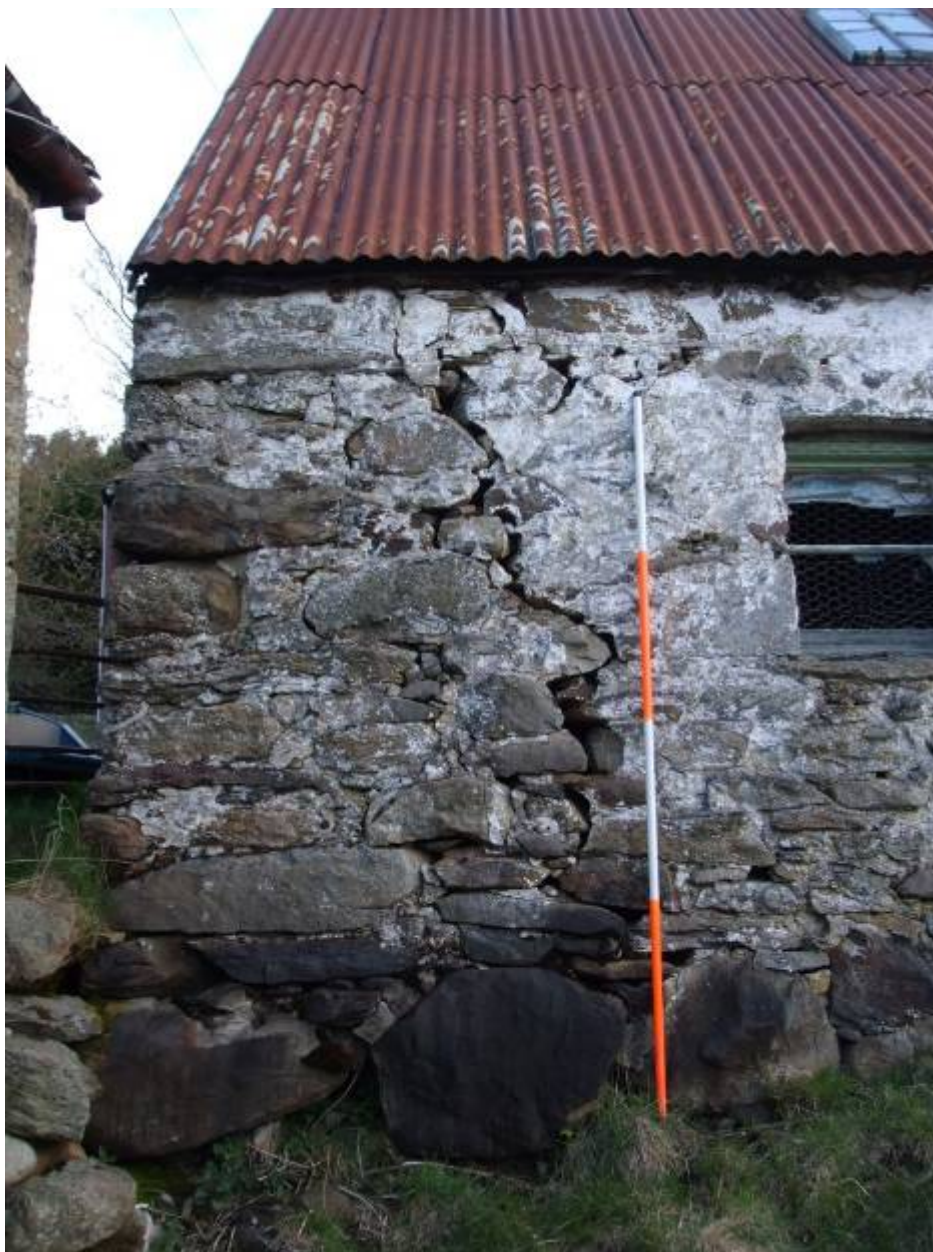
Illustration 6 Northern end of South Western elevation of Building 1

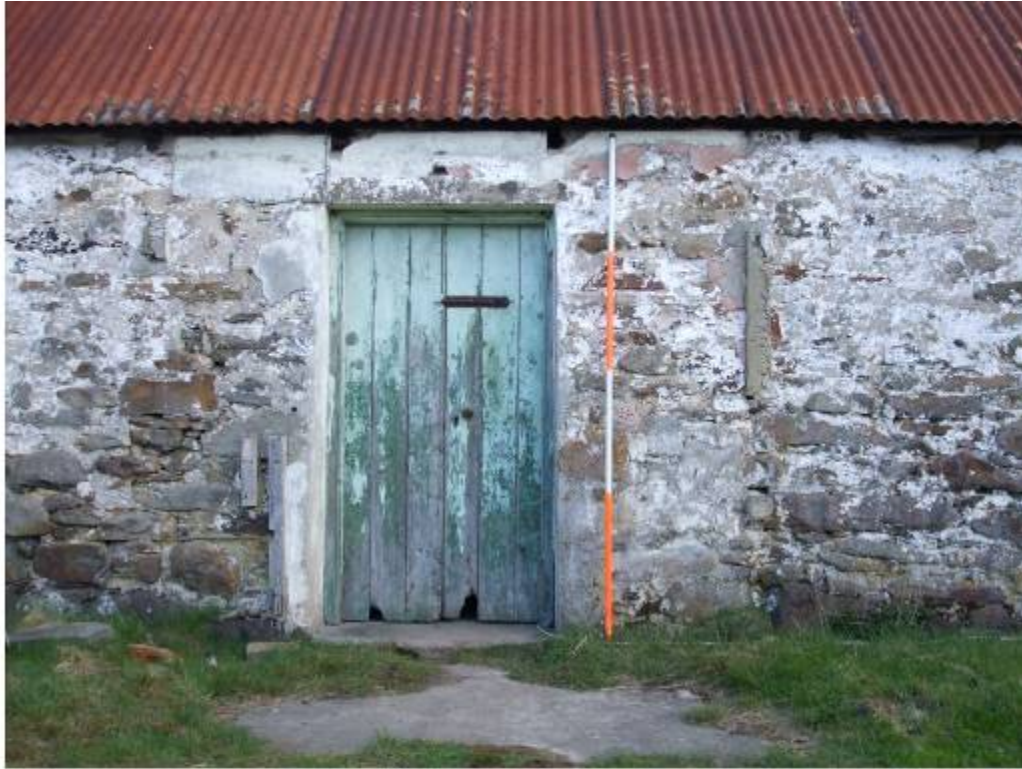
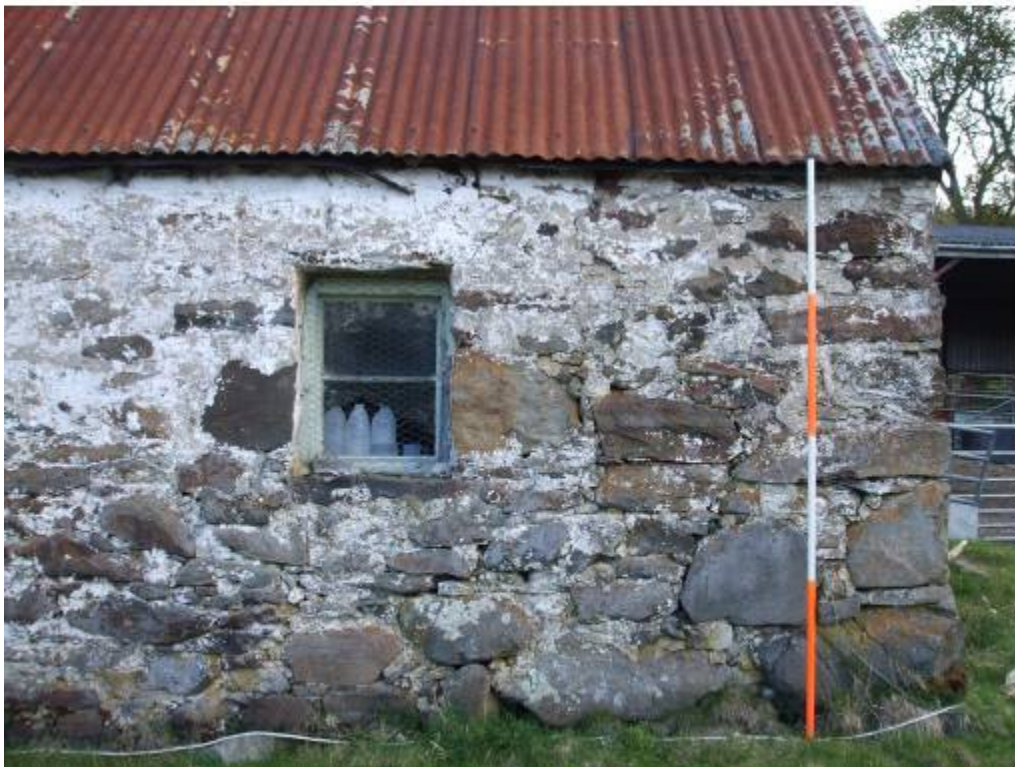
This simple single storey building seems to have originally had much wider entrance through its South Western wall, at its gable ends its wall corner elevations slope inwards from base to roof line. The fireplace, hearth and 'hanging lum' are unique survivals and appear to be largely unaltered. A function for the earthwork platform in front of the cottage is difficult to define, there are traces of a former kerbed pathway leading up to the front door.

Illustration 7 Existing doorway in South Western elevation to Building 1 with straight joint indicating blocked wider entrance and Southern end of South Western elevation

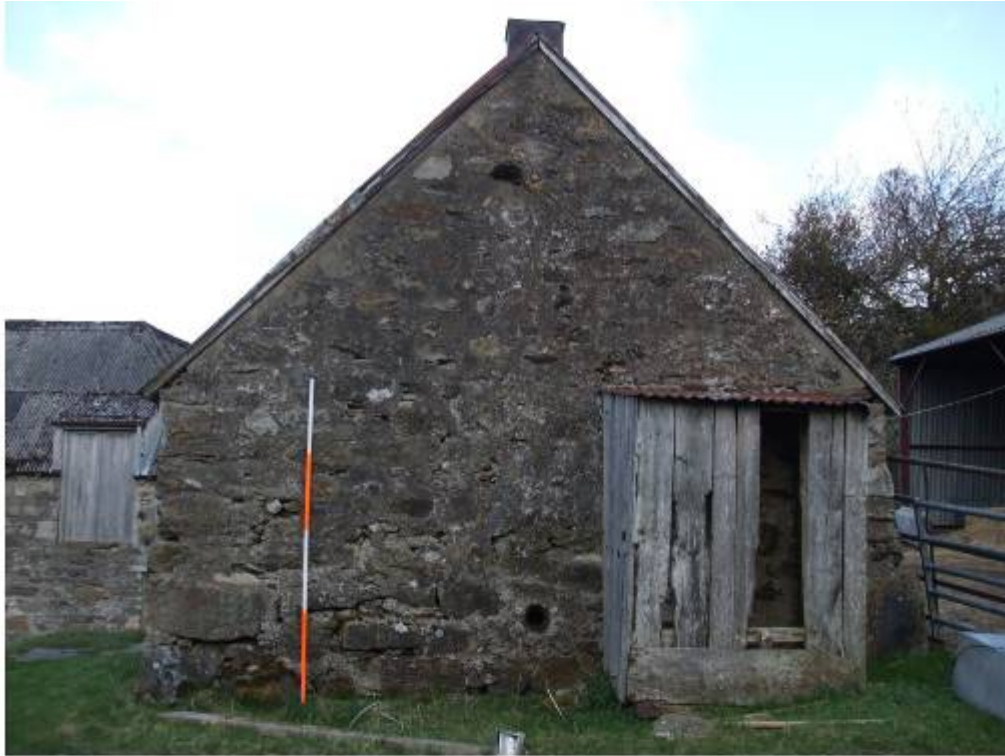
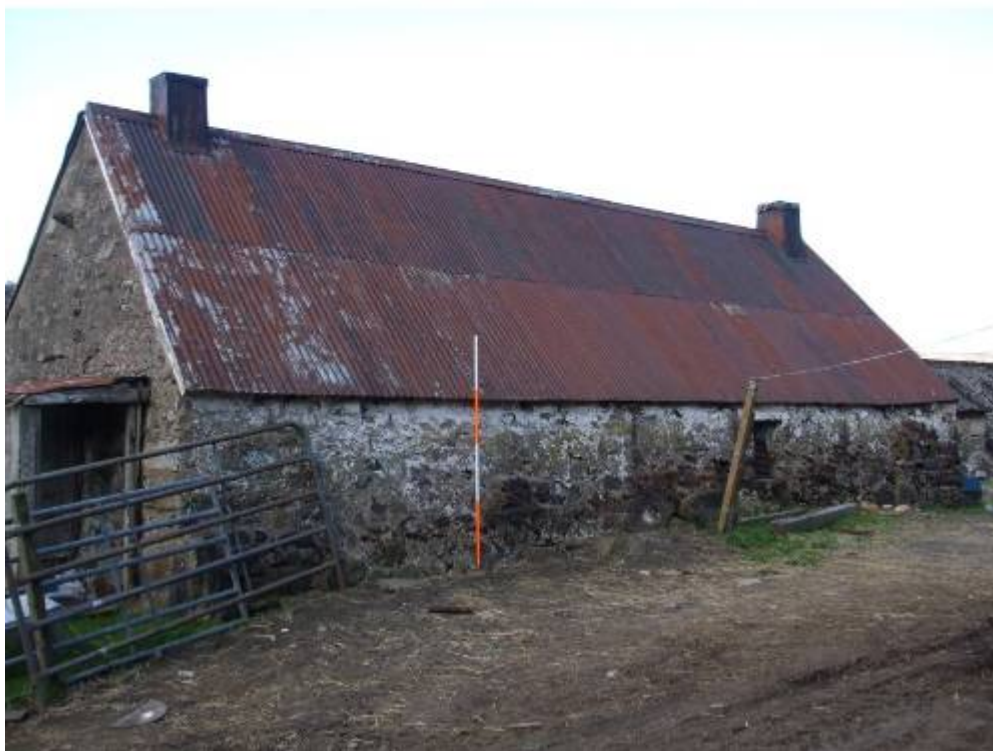
This gable elevation is blank with a small wooden outhouse/toilet built against it. There is a projecting stone at a height of 3.25m from ground level 0.50m from the roof line.

Illustration 8 Southern and South Eastern elevation of Building 1

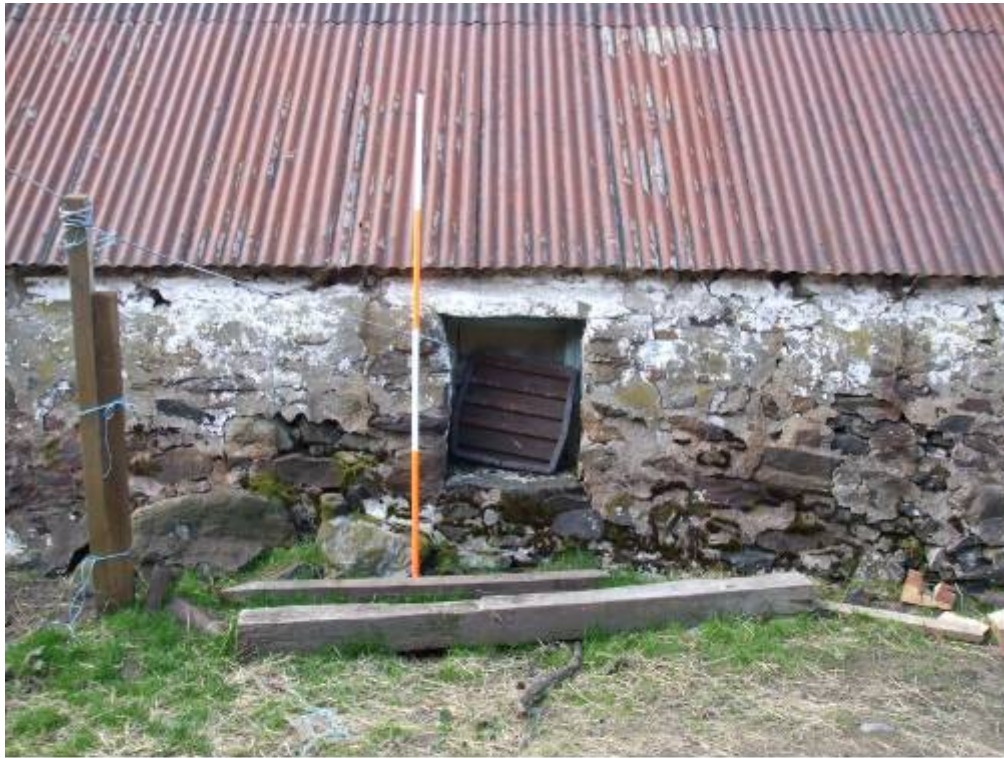
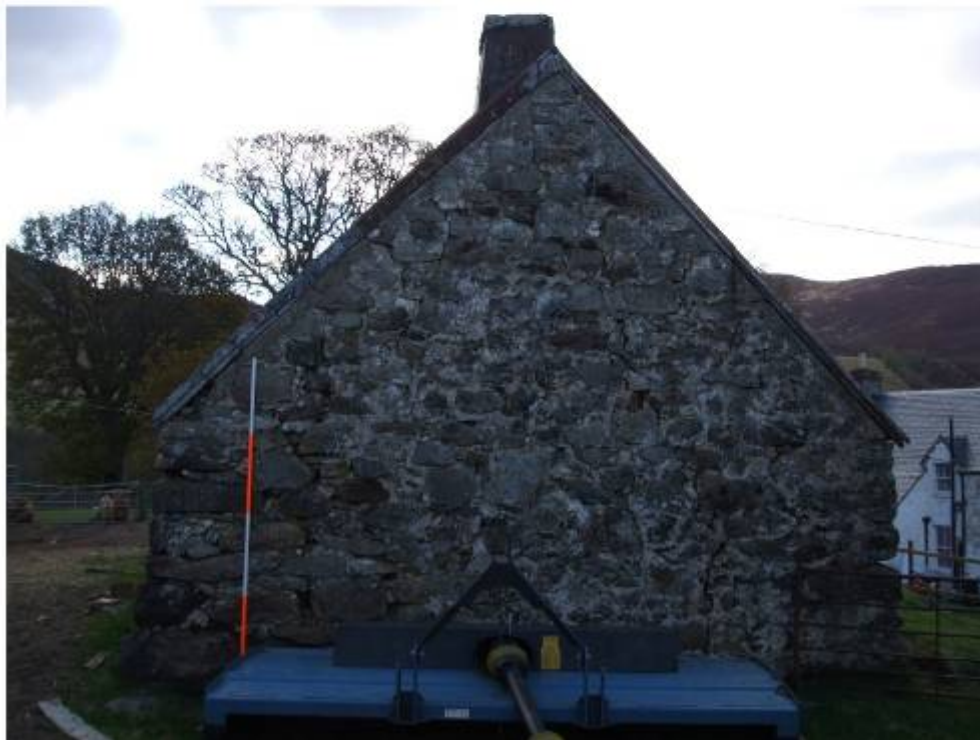
This elevation has a small window half way along its length.

This gable elevation is blank.

Illustration 9 Window in South Eastern elevation of Building 1 and Northern elevation

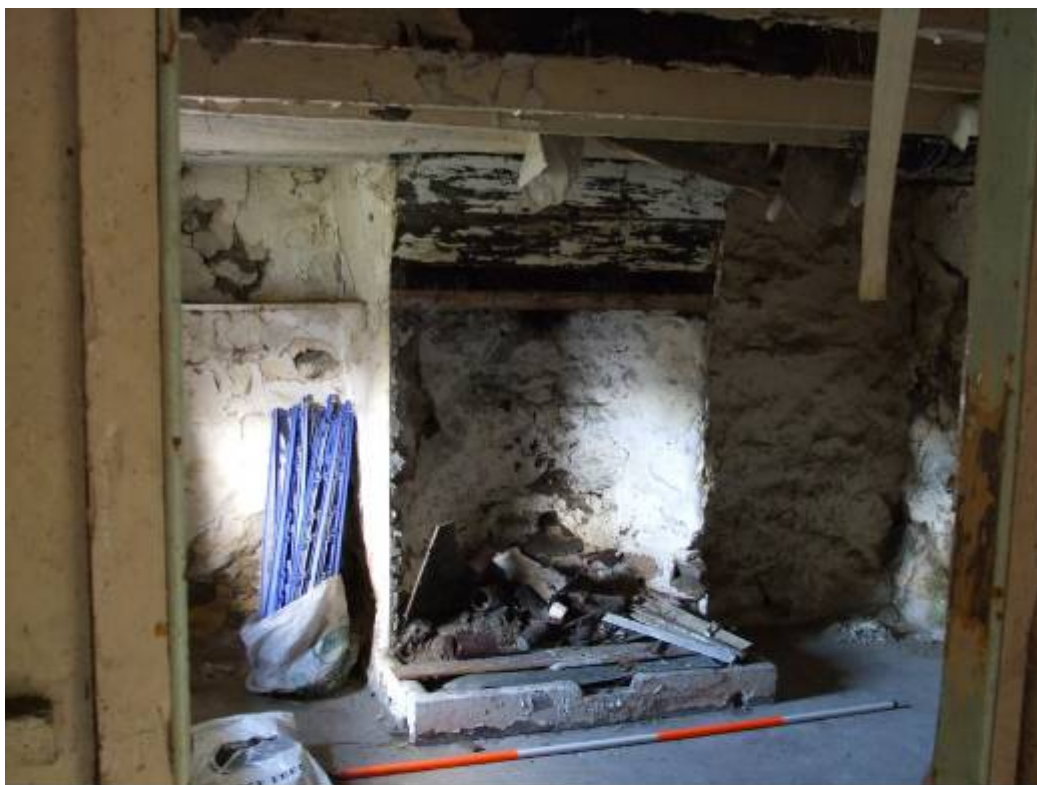
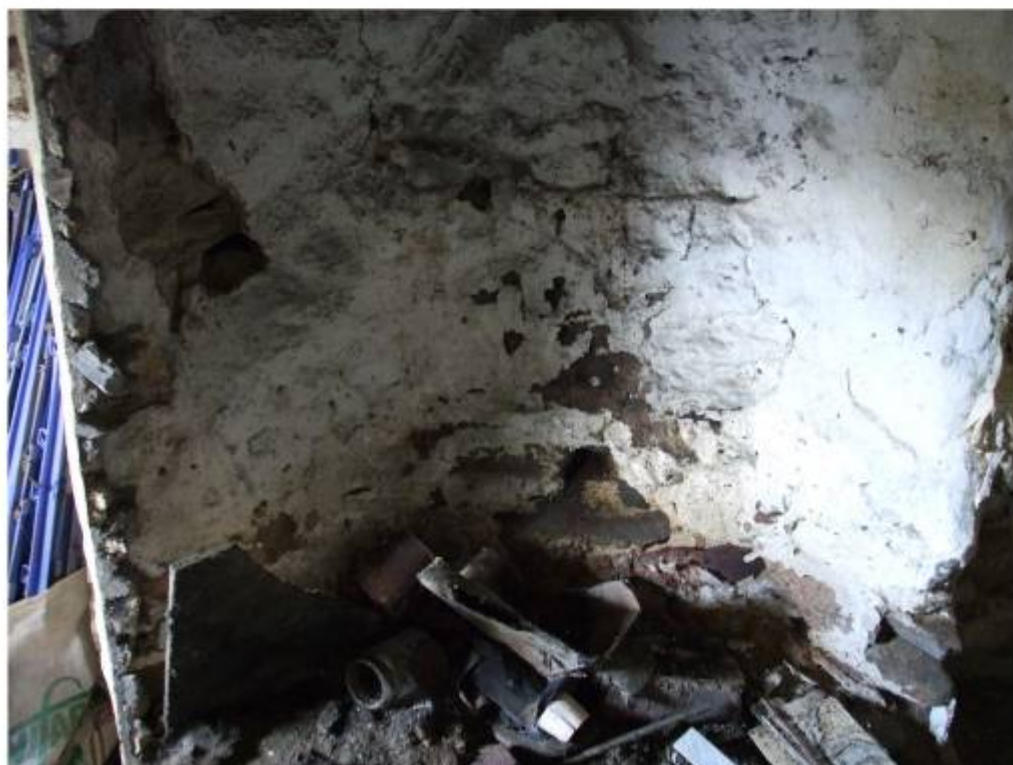
This building comprises two rooms internally, the room at its north western end contains a fire place and hearth of 'cat and clay' construction projecting out from the gable wall (Walker 1979, 52). This room has a low ceiling and attic space above which contains the 'hanging lum' (Illus 11). The other room contains the remains of two wooden crucks built into its North Eastern wall face, the southernmost cruck (2) survives to a height of 1.37m and stands on a cruck stone 0.60m above the floor and has been sawn off where it meets the roof line (Illus 13). The northernmost cruck (1) survives to a height of 1.3m and runs up into the attic space. This room has a curved panel board ceiling which extends up to ridge height. Both rooms have concrete floors.

Illustration 10 General view of 'cat and clay' fireplace in Building 1 and detail view of fireplace

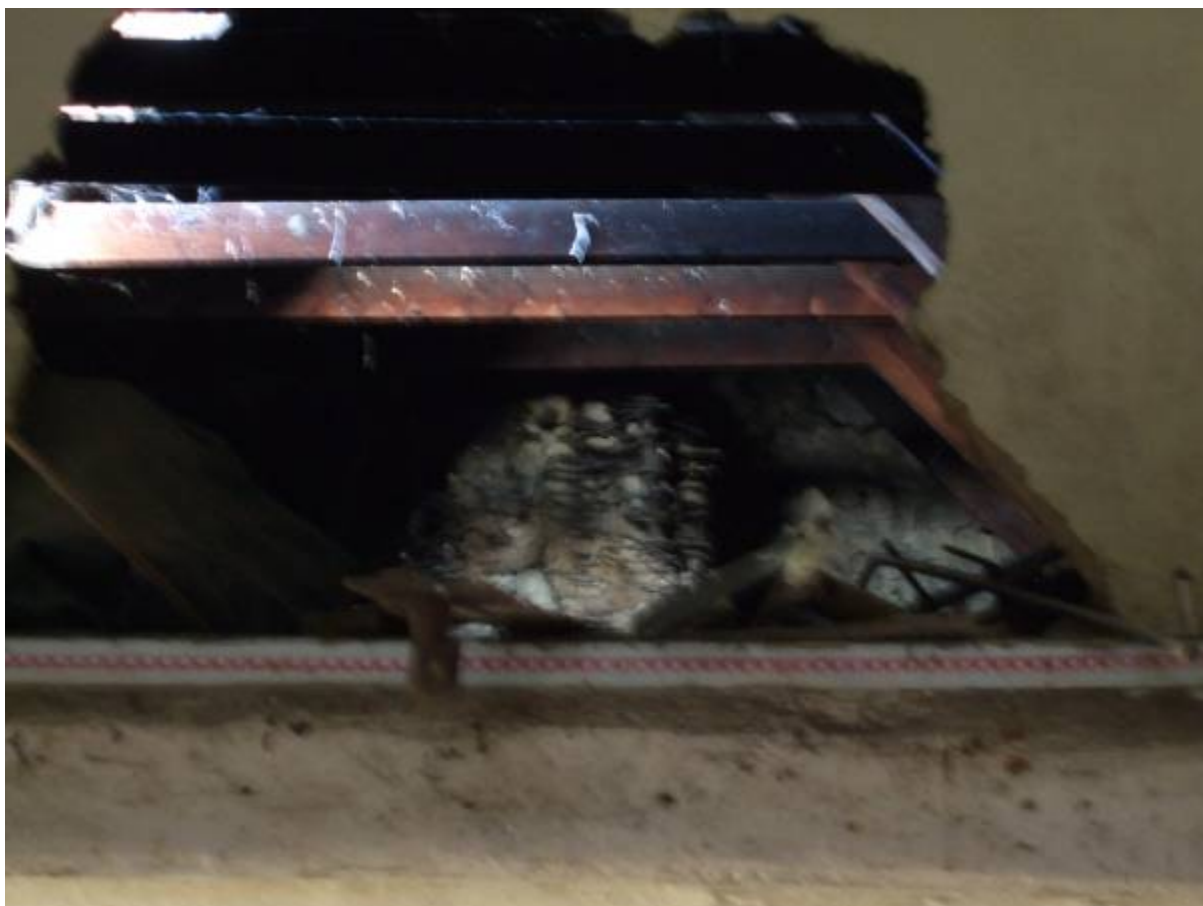
Illustration 11 'Hanging Lum' visible in attic of Building 1

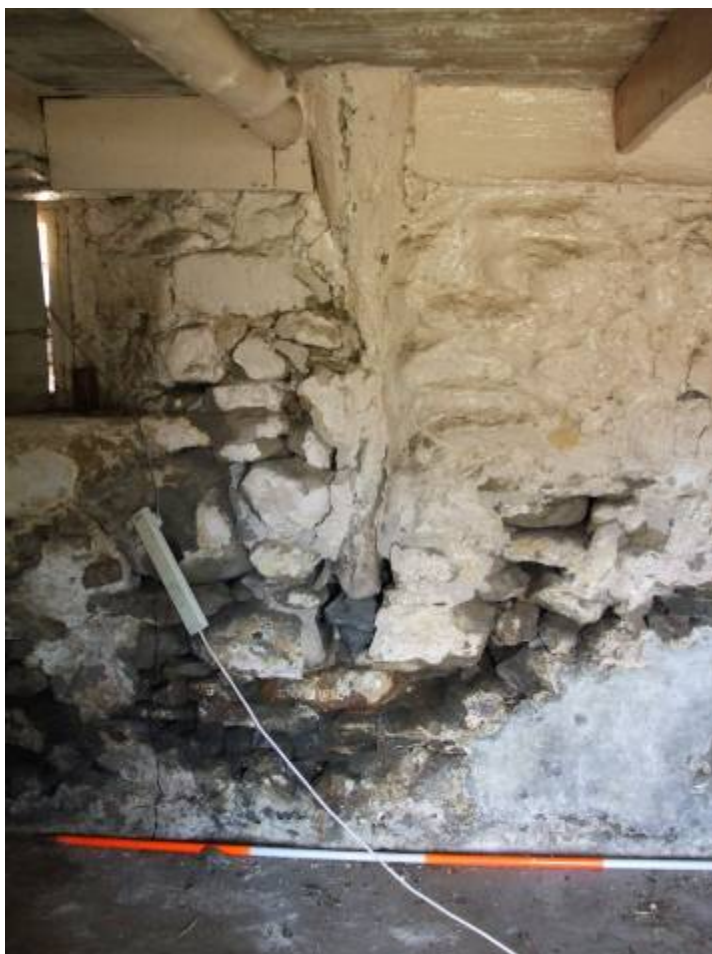
Illustration 12 Cruck 1 in Eastern wall of Building 1

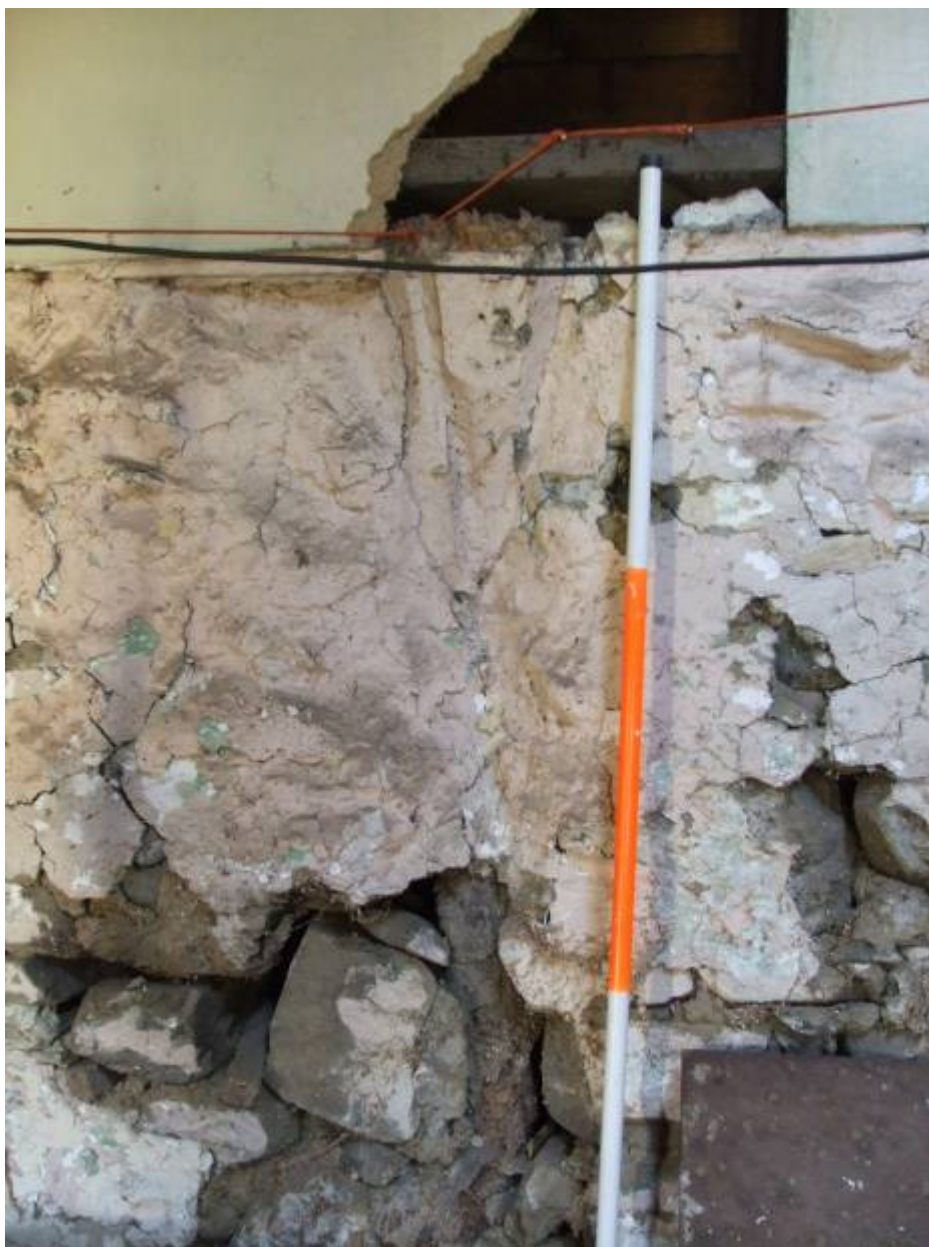
Illustration 13 Cruck 2 visible in Eastern wall of Building 1

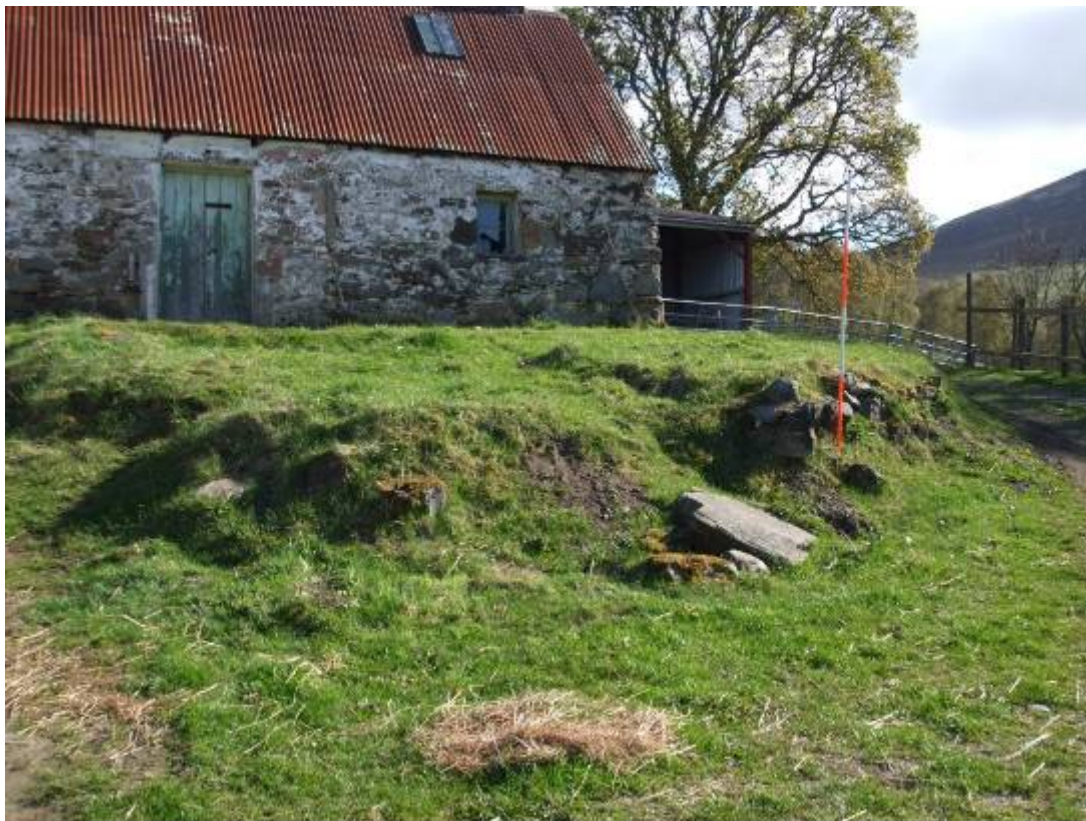
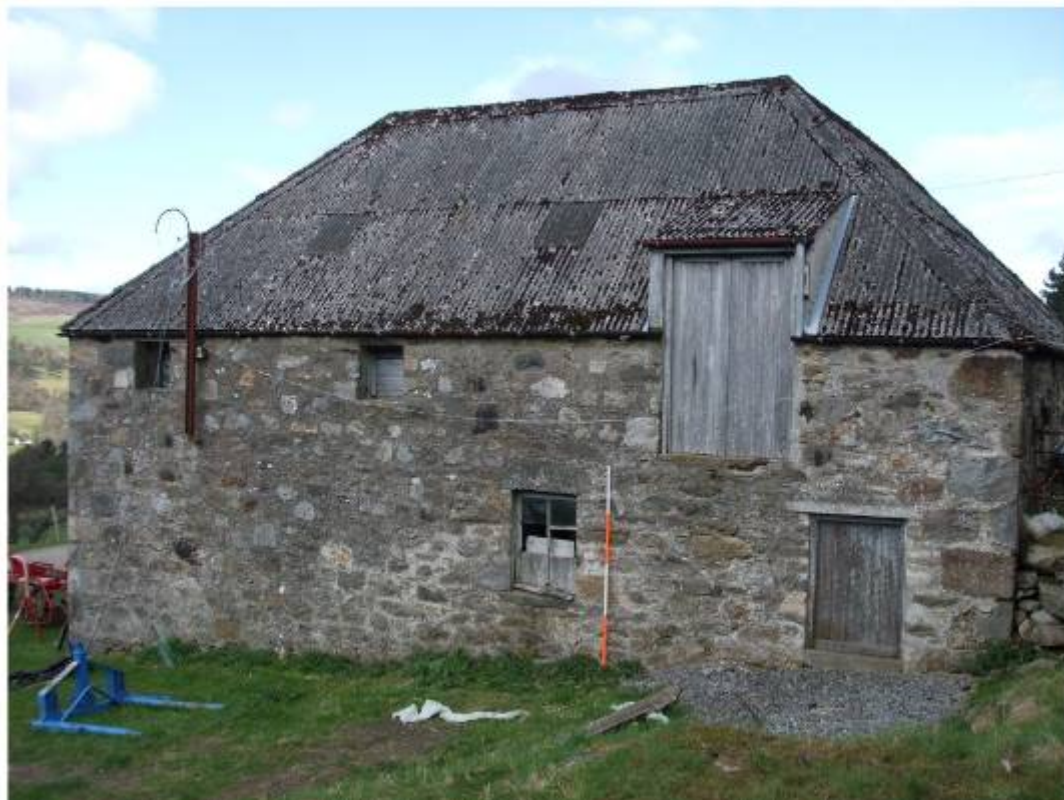
A semicircular earthwork platform is visible in front of the South Western Elevation of this building. It has the remnants of a revetted stone face on its Western side.

This elevation has two small windows and a loading bay at first floor level and a window and small doorway at ground level.

Illustration 16 Revetted platform in front of Building 1 and Southern elevation of Building 2a

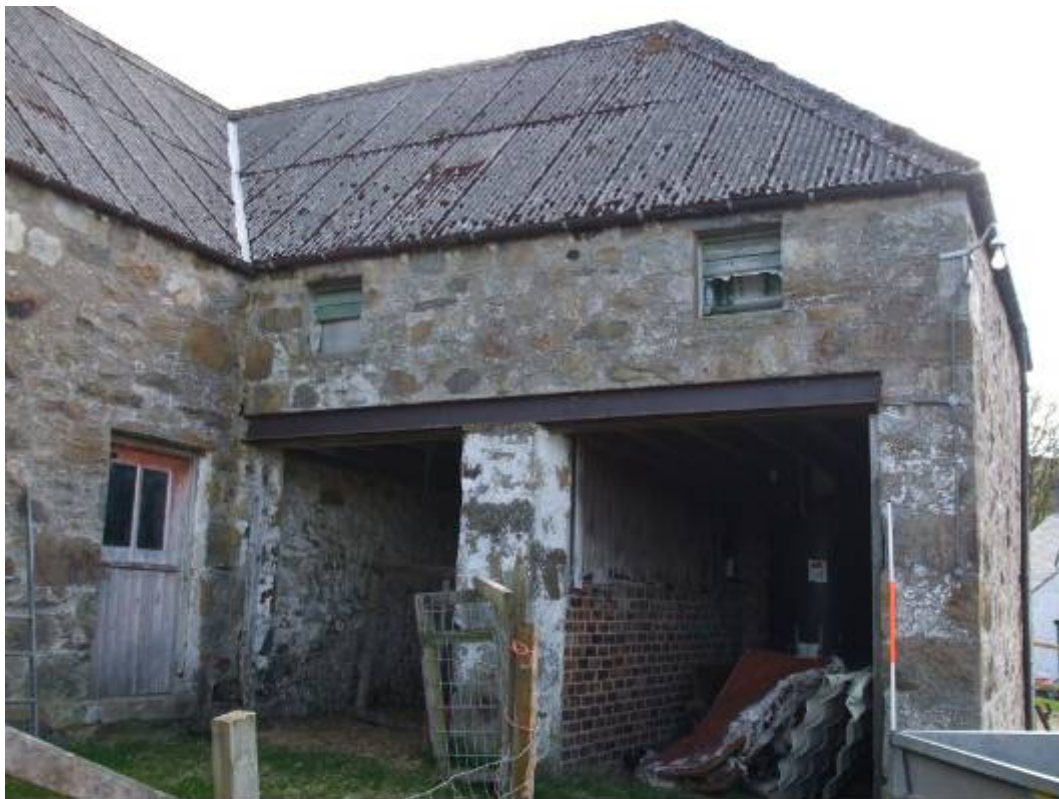
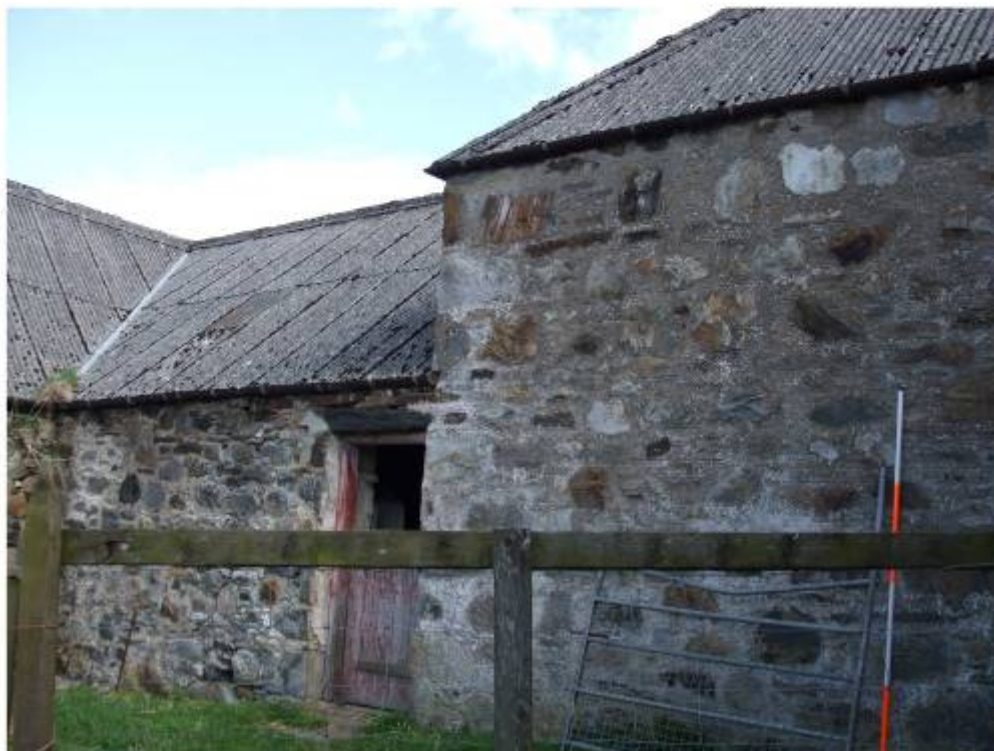
This gable end has a blank wall face.

This elevation has two shed/loading bays at ground level and two small windows at first floor level. The lintel for the entrances into the shed/bays is a long cast iron girder.

This elevation contains a single doorway.

Illustration 17 Northern elevation of Building 2a and South Western elevations of Buildings 2a and 2b

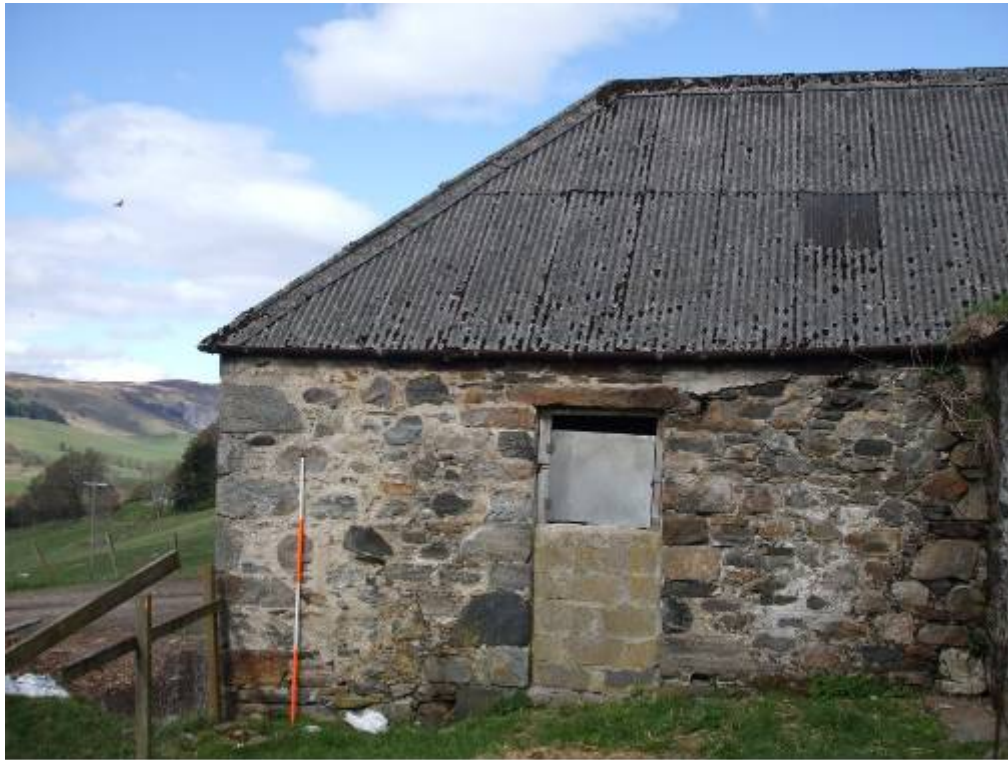
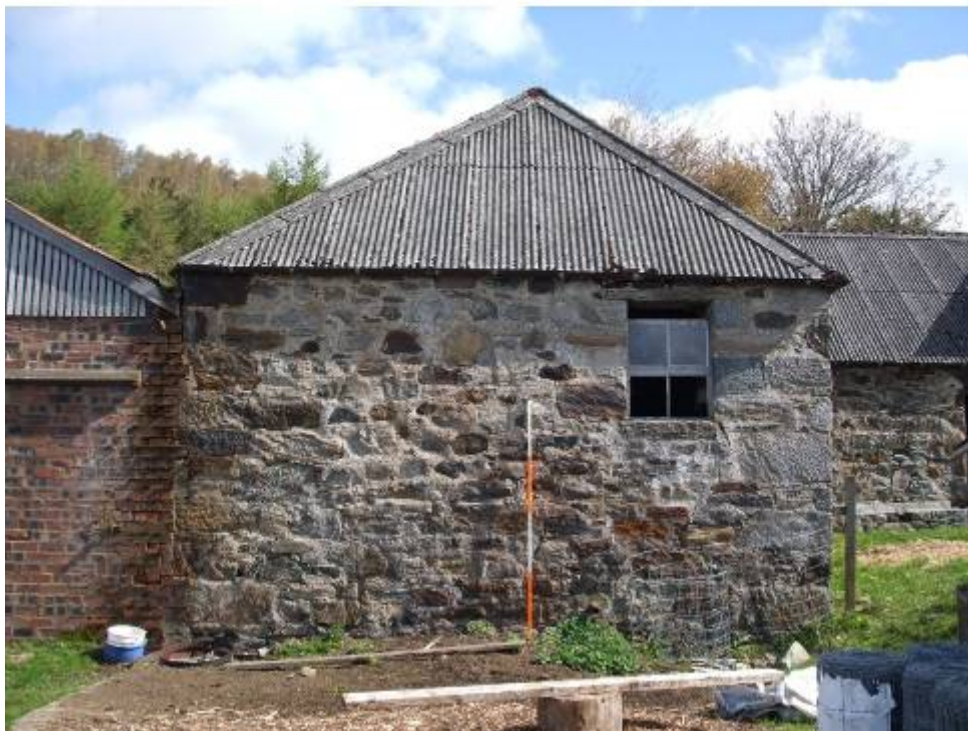
This elevation contains a single doorway.

This elevation contains a single doorway that is blocked with concrete breeze blocks.

Illustration 18 Southern elevation and South Western elevation of Building 2b

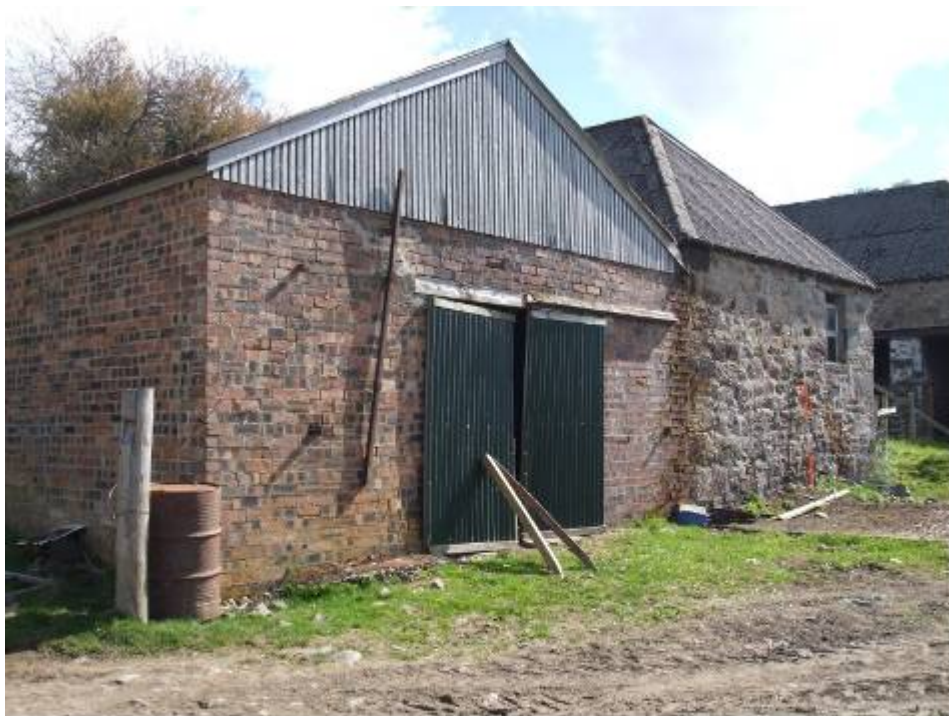
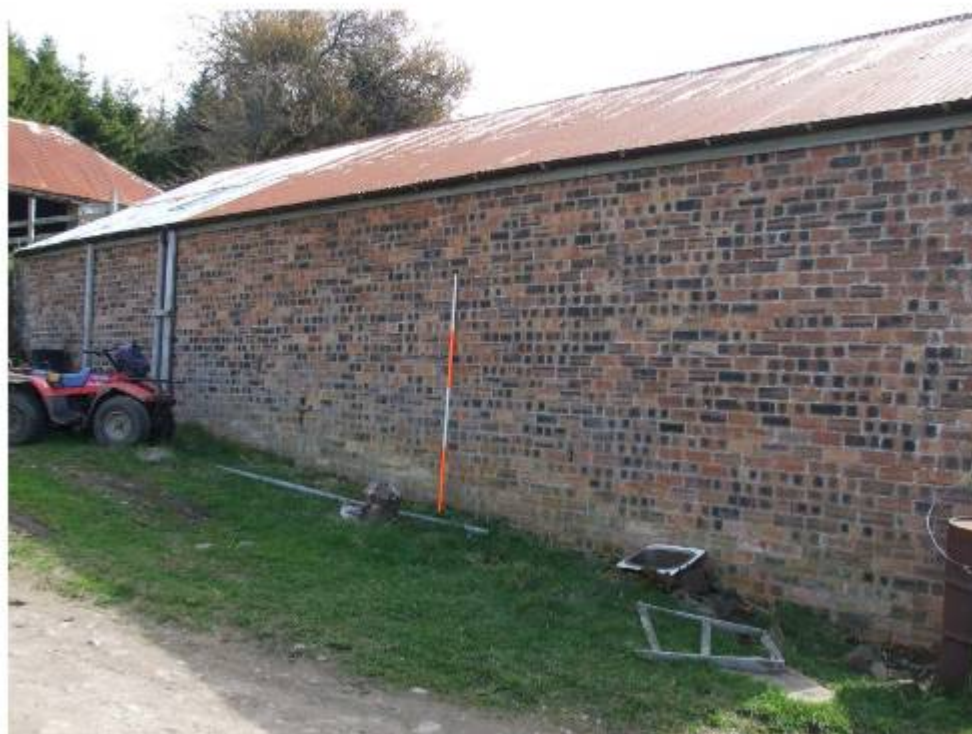
This elevation has a wide entranceway with two wooden doors.

This is a blank wall face.

Illustration 19 South Western and Northern elevations of Building 3

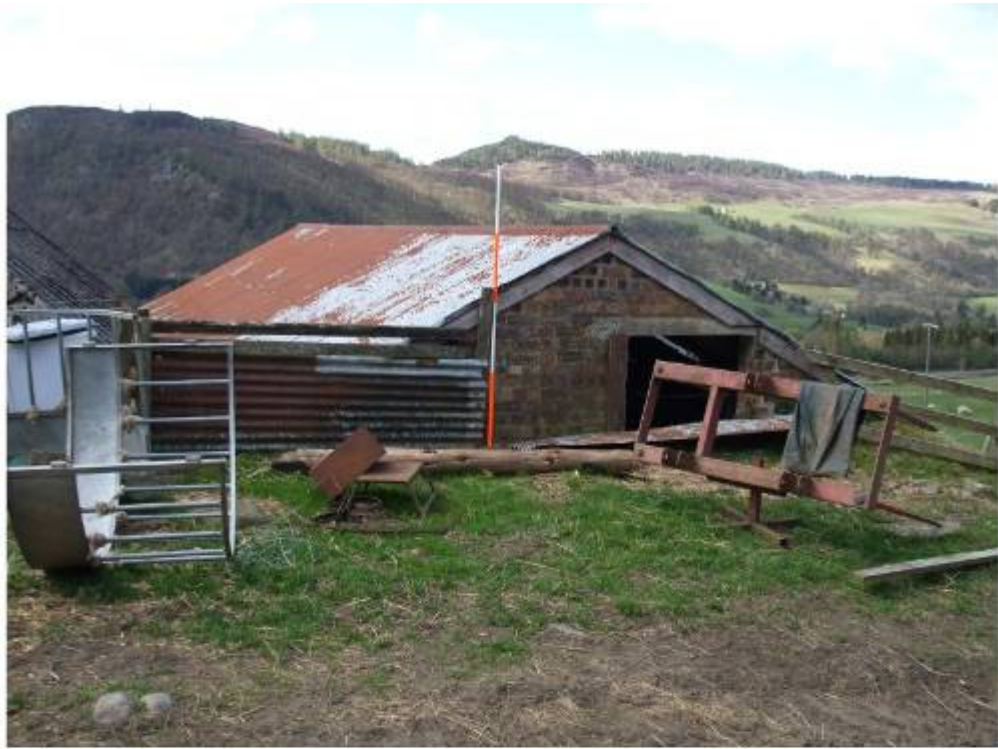
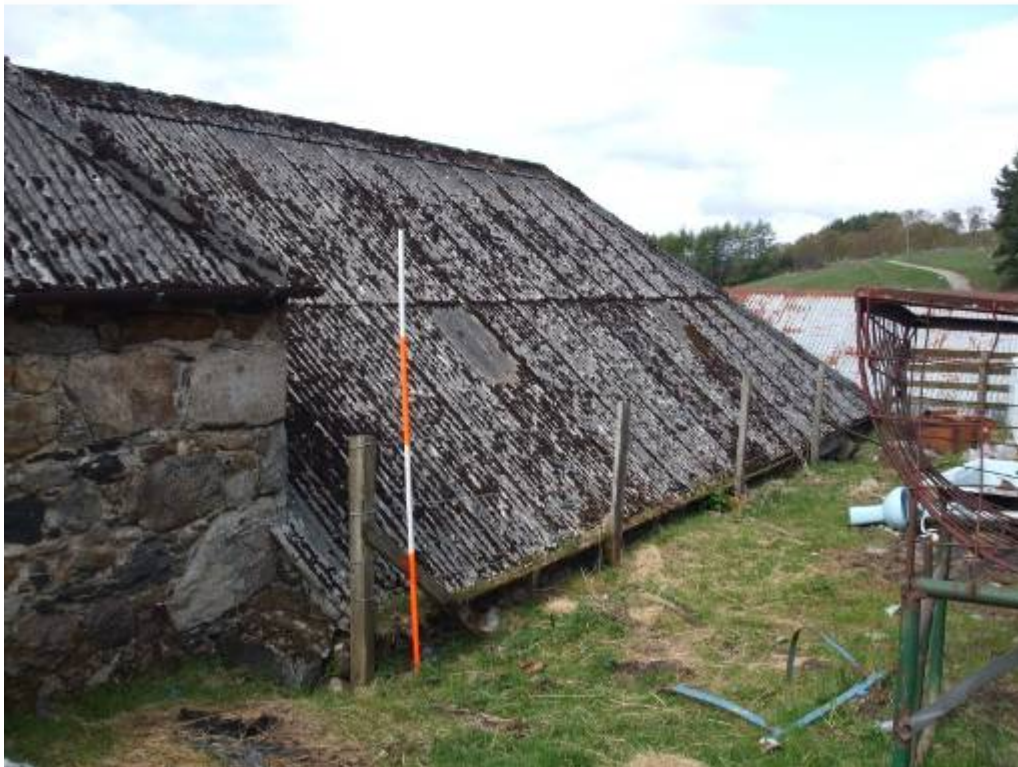
This structure has Building 3 butted against its North Western elevation.

This structure is butted against the North Eastern face of Building 2b and its Northern Eastern and North Western walls are built of brick it has a corrugated iron roof.

Illustration 20 Eastern elevations of Buildings 3 and 2b

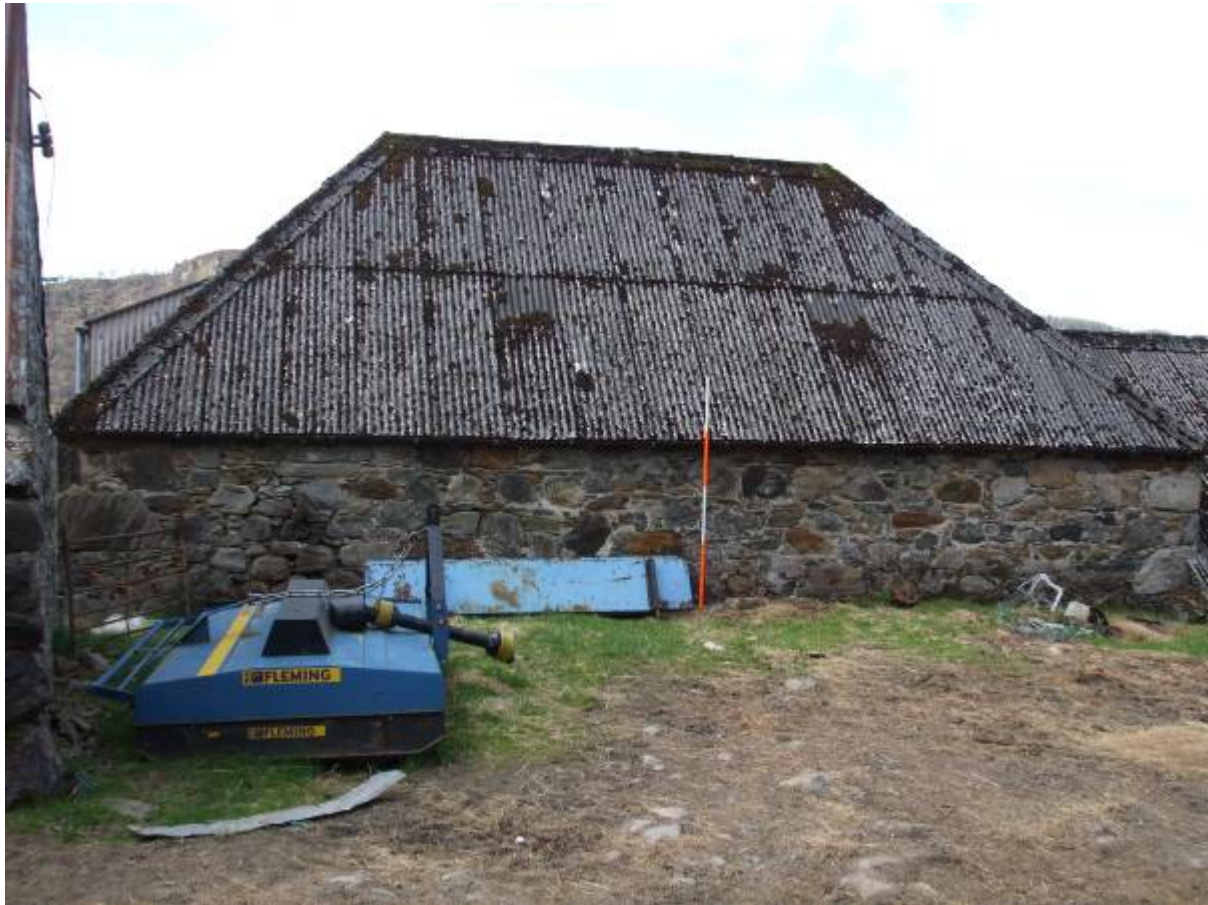
This southern half of this building has two storeys (2a), the northern half only one (2b). It is built of mortar bonded dressed cut stone and has a concrete tile roof.

Illustration 21 Eastern elevation of Building 2a

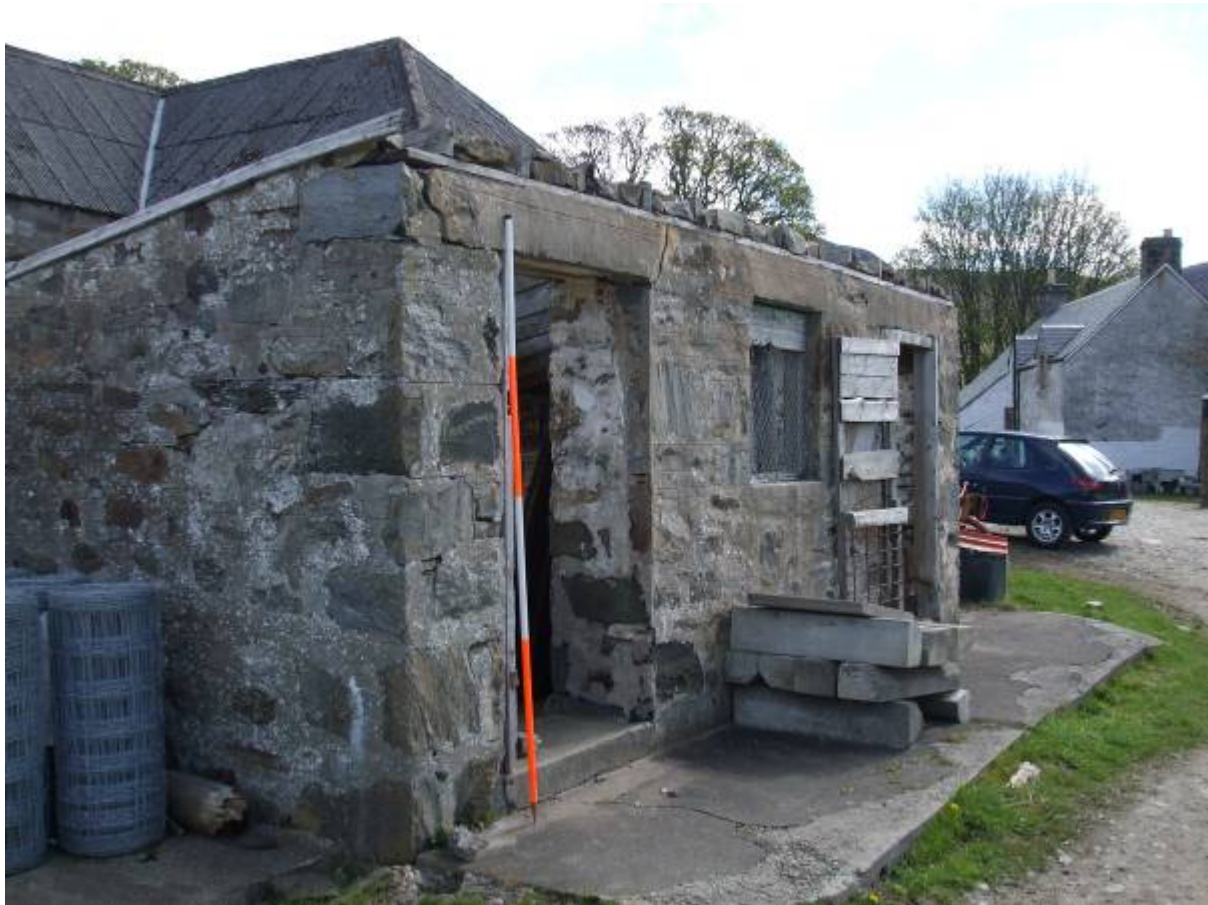
This elevation contains two doorways and a central window.

There are the remains of small wooden cages suggesting this may have been a chicken shed.

Illustration 22 South Western elevation of small shed
