# Standing Building Survey

## Orchilmore Farm and Cottage, Killiecrankie

Orchilmore Farm looking South

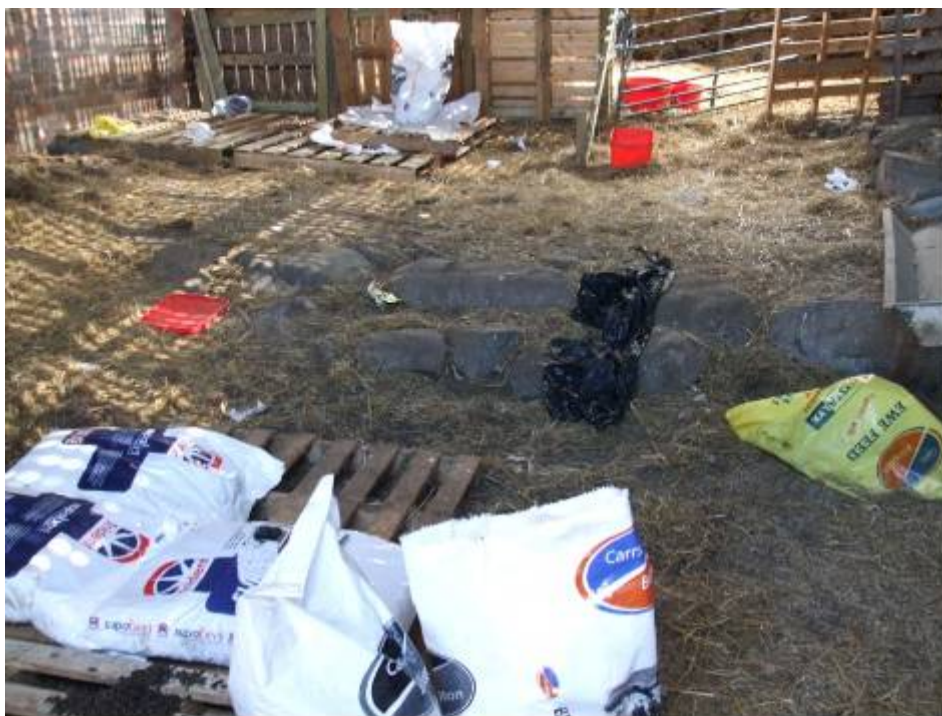
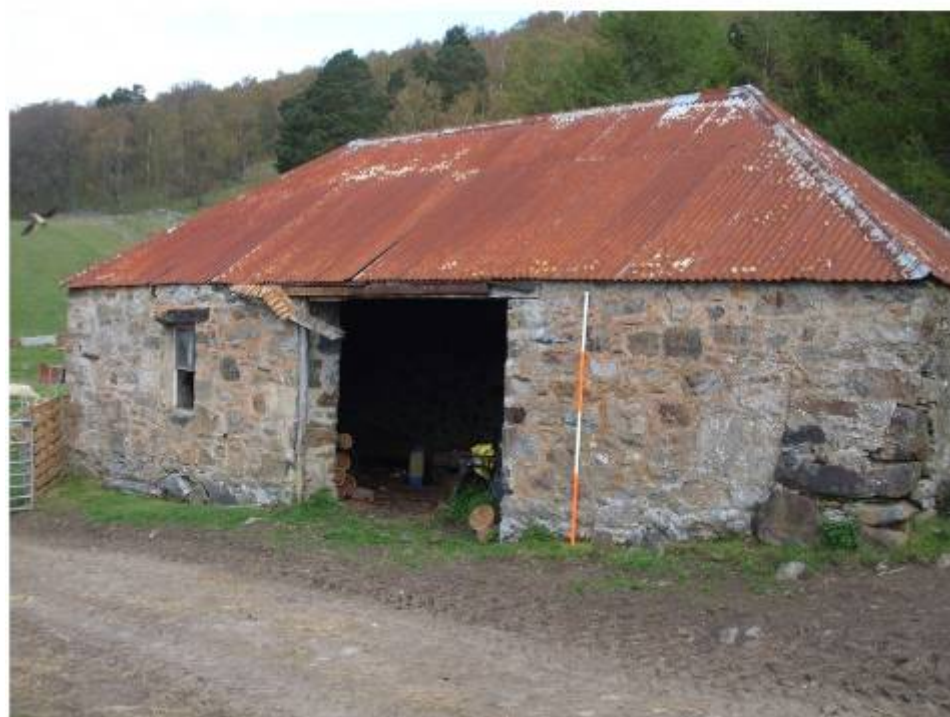
This building contains straw and was probably an animal shed. There are traces of large paving stones on the floor of this building (Illus 23) and a stepped area into the North end of 2b.

This brick built structure is butted against the North Eastern face of Building 2b, the paving and step suggest that prior to its erection this area was an open courtyard in front of the Northern end of Building 2b.

There is a central wide entrance into this building and one window at the Northern end of this elevation. There is a visible change in build at the Southern end of this elevation, it is of similar construction to Building 1 (the listed cottage).

Illustration 23 Large paving stones visible in floor of building 3 and South Western elevation of Building 4

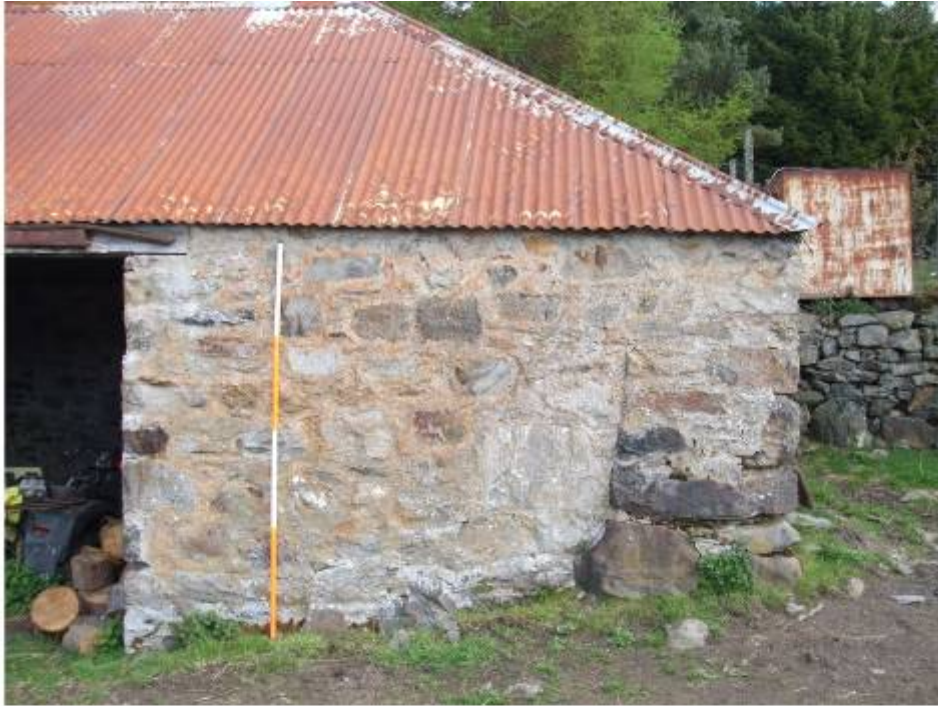
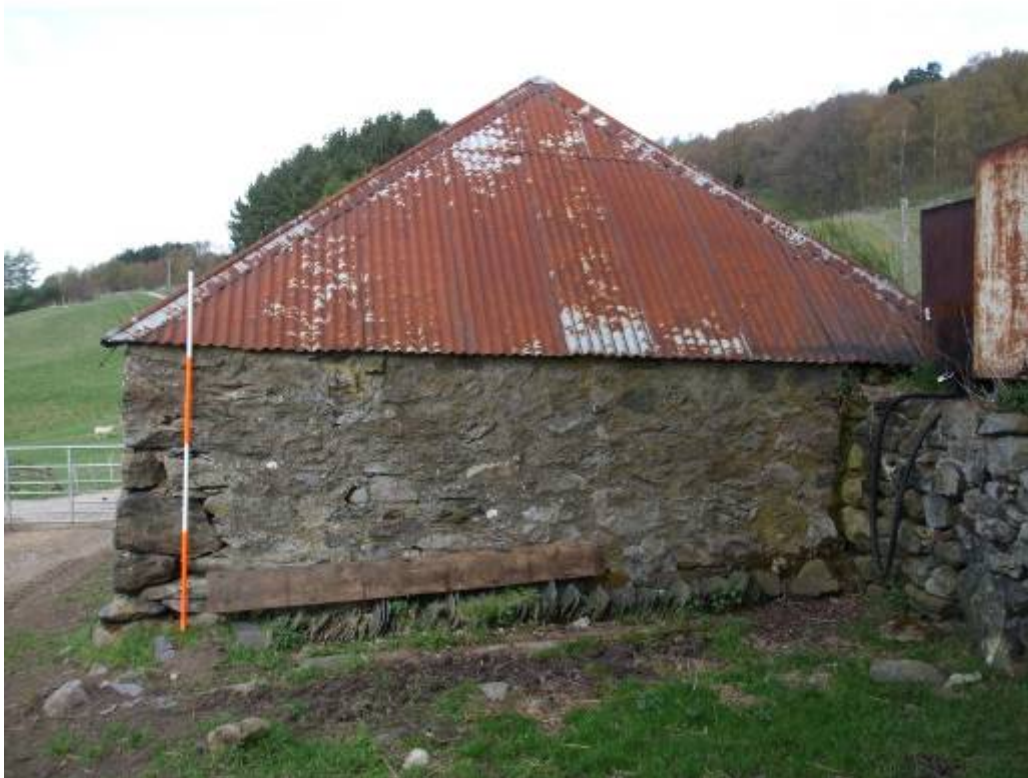
This is blank wall face, there is a slight slope to the wall corner from roof to ground level.

This building would appear to have originally been of a similar date to the listed cottage but has been rebuilt at a later stage. The only surviving element that may be of an early date is visible at its South Eastern corner where the stonework resembles that visible in Building 1 (Illus 24). The projecting stones on the South Eastern elevation may have been designed to aid the support of a thatched roof?

Illustration 24 Change in build visible in South Western elevation of Building 4 and its Southern elevation

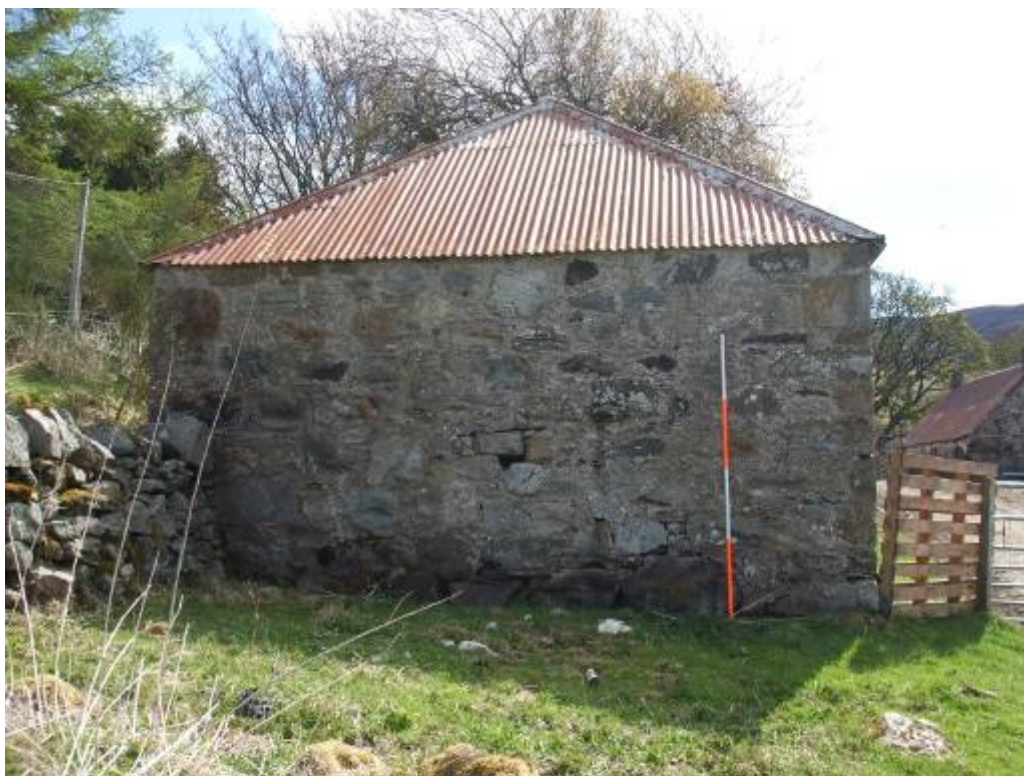
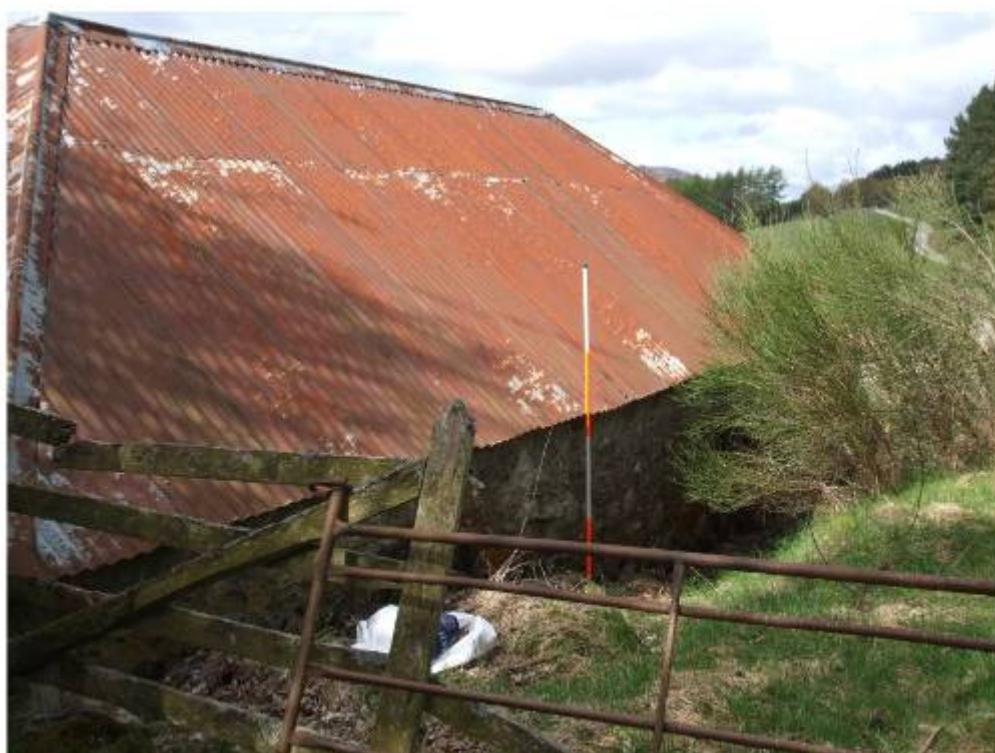
This is a blank wall face.

This is a blank wall face. At two places on this elevation there are pairs of large stones projecting from the wall face.

Illustration 25 Northern and North Eastern elevations of Building 4

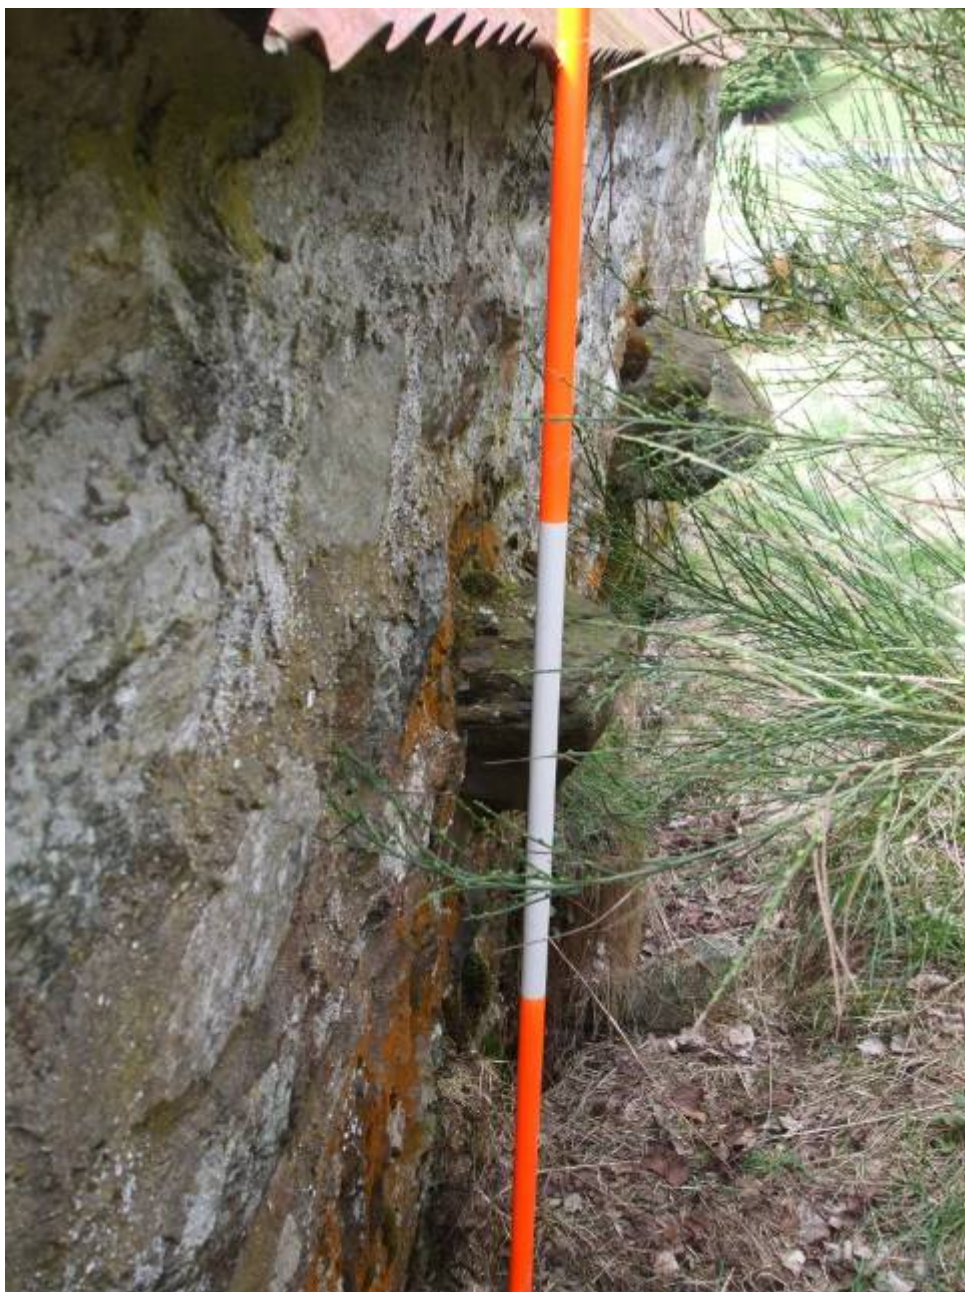
Illustration 26 Protruding thatch supports in North Eastern elevation of Building 4

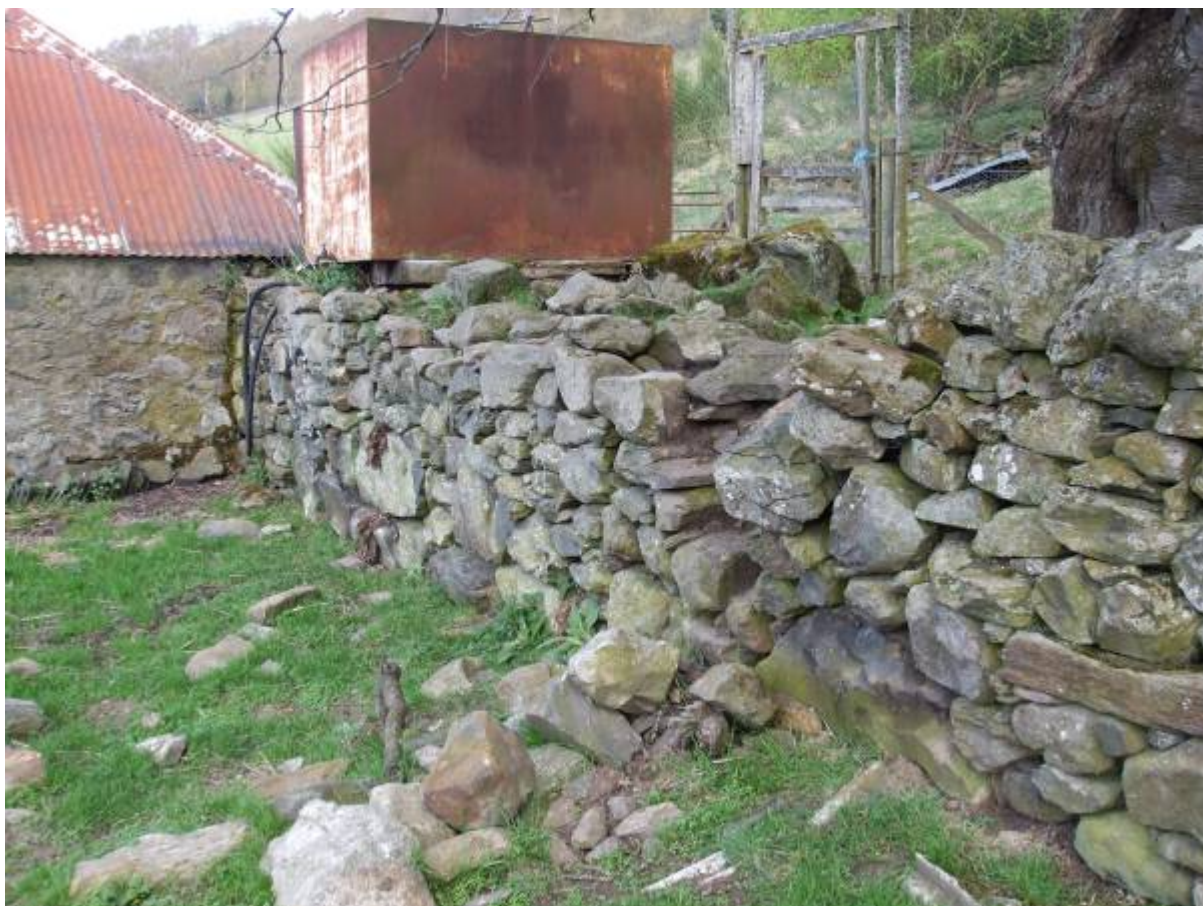
This drystone built wall is 1.4m high and runs for 9.32m South from the back SE corner of building 4. It may represent the back wall of the line of buildings that are marked on the 1<sup>st</sup> Edition Ordnance Survey map.

Illustration 27 Stone wall running South East from Building 4

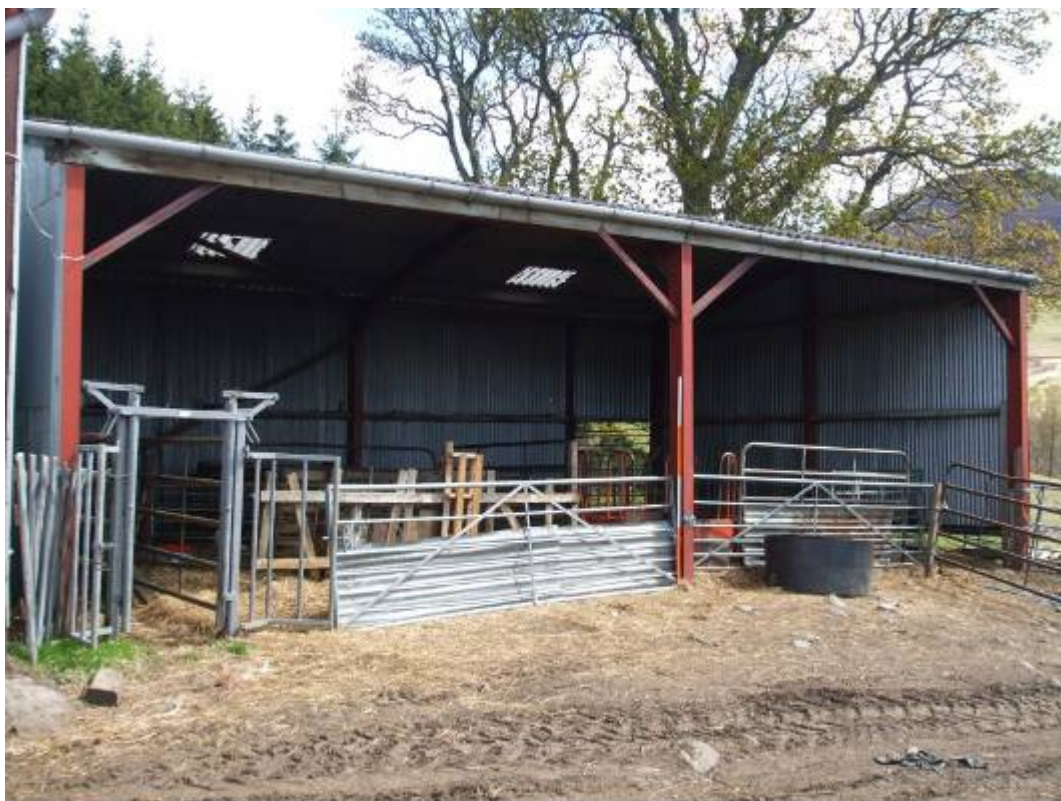
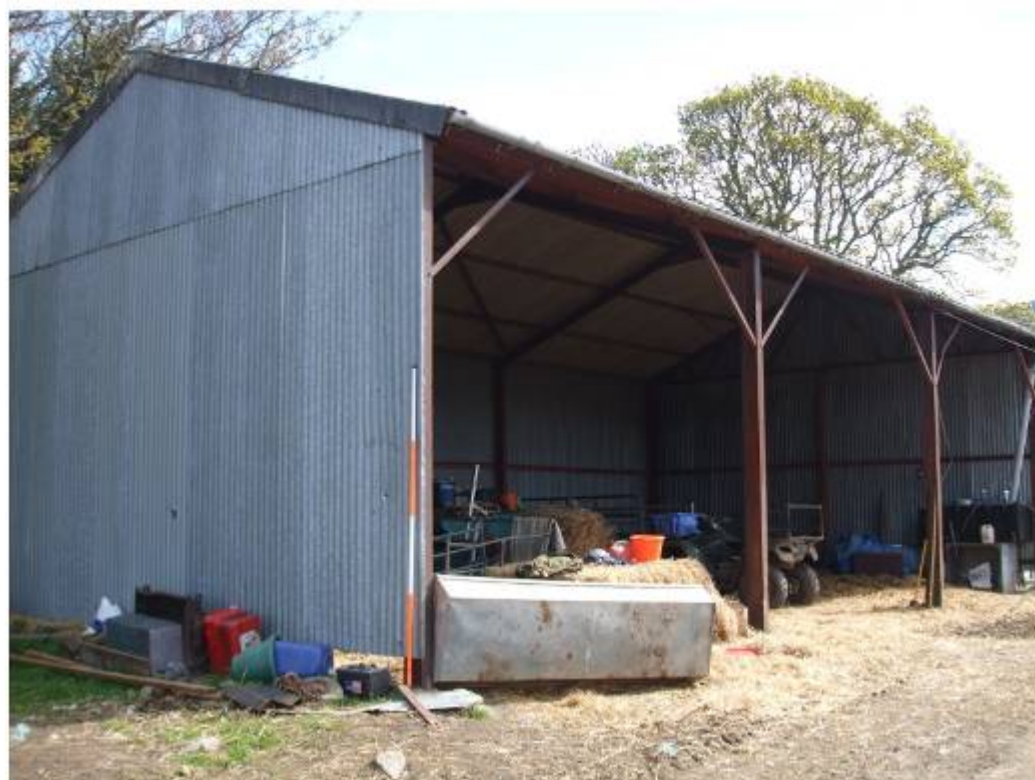
These two structures are modern steel frame animal sheds. There are large piles of stone rubble visible both behind and on the Northern side of these buildings (Illus 2 and 29), this may well represent the remains of earlier buildings that have been cleared during their construction.

Illustration 28 Buildings 5 and 6

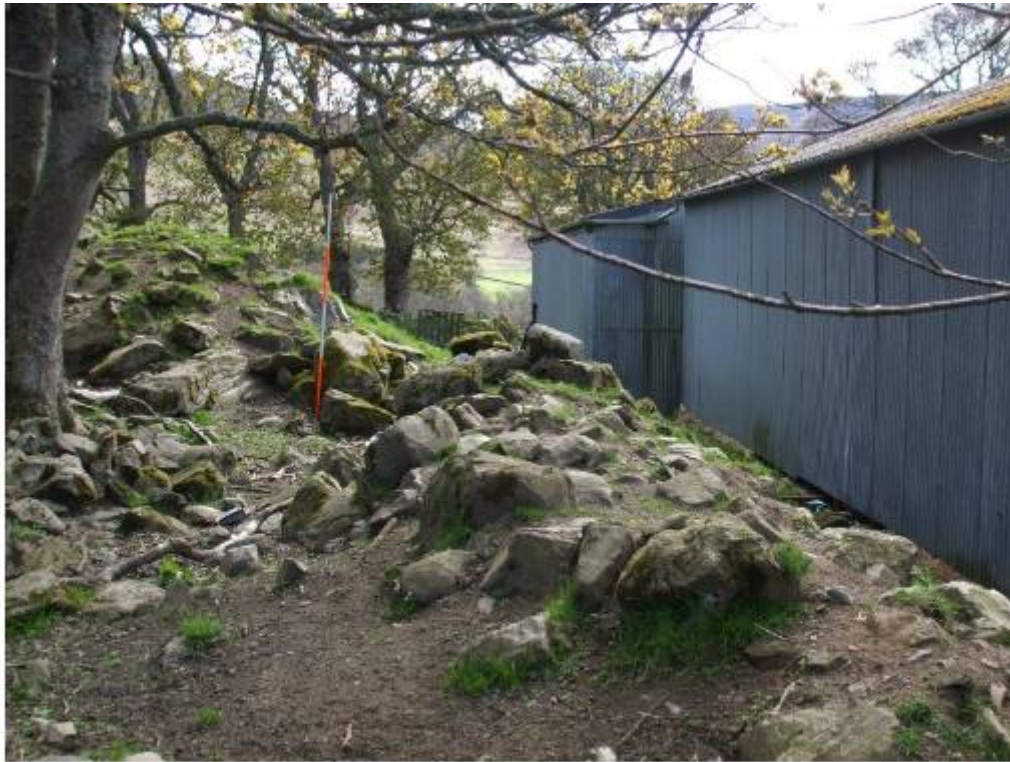
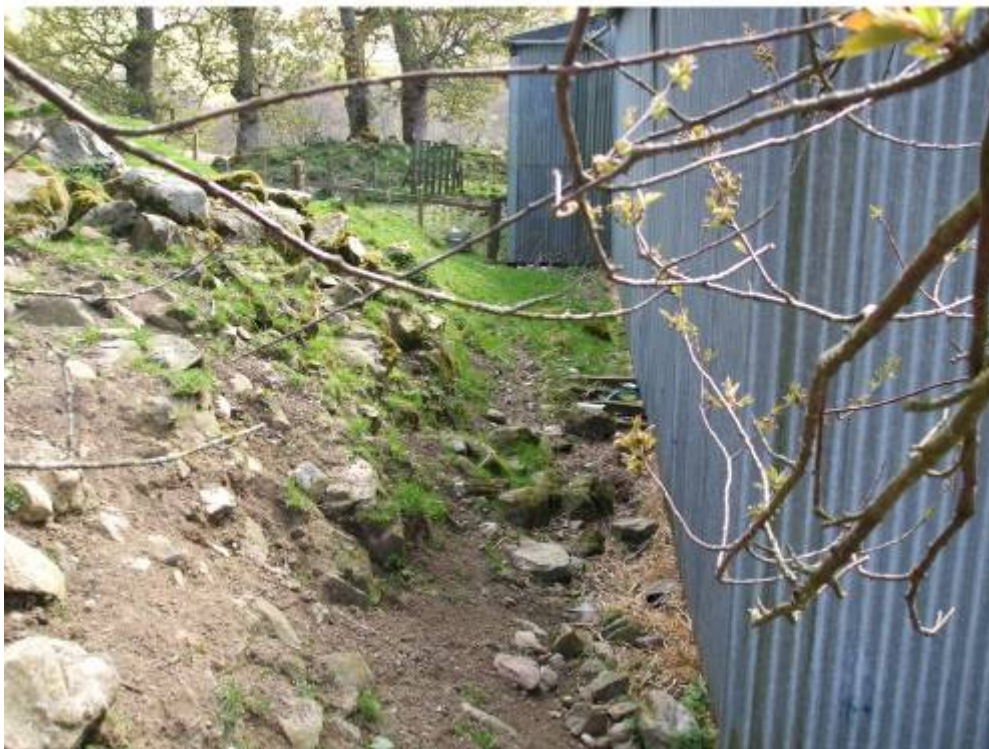
Illustration 29 Rubble visible behind Buildings 5 and 6
