DB 26/2/8

Cow Tag	Function Code
328	S28.5

complete, shorter plank, edge = 327

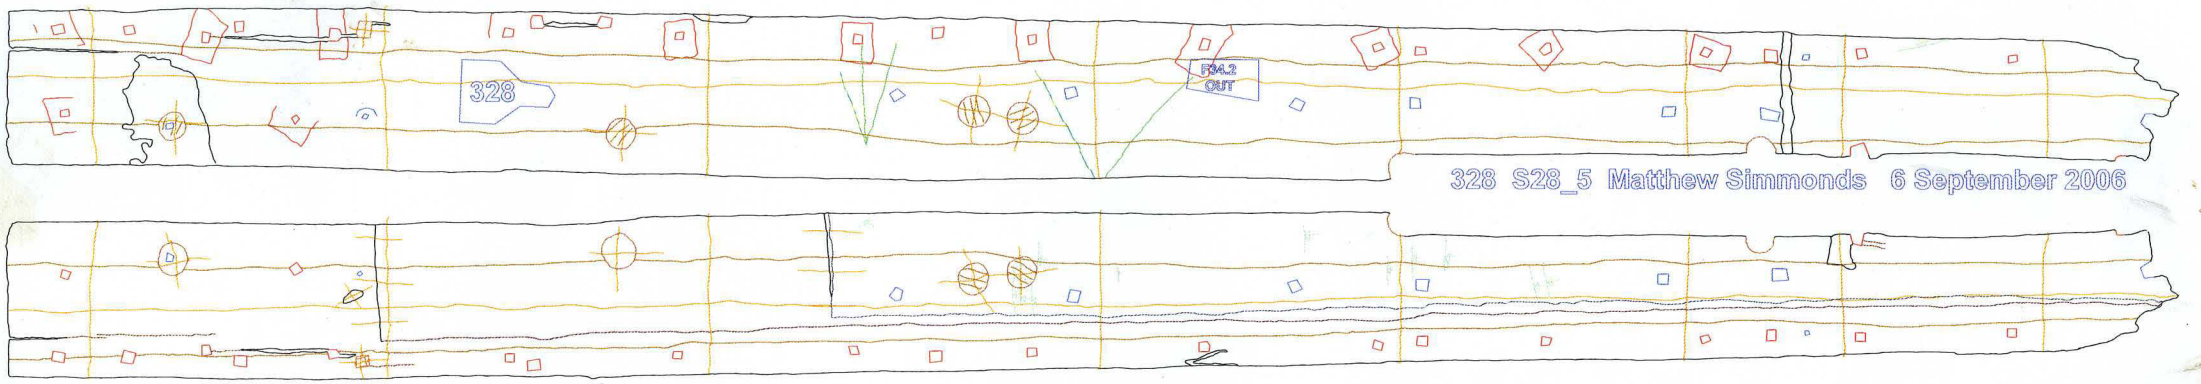
good tool marks with good tool signatures - good cand. date for casting - all add. nails for tingle are longer than ord. nails and on the fore + AFt side of each nail hole the wood has been pushed up - not on other edges nor on any other nail

missing nail

Add missing nail ?
