| Cow Tag	362	Function Code	S30.3B	**OB 11/3/8**

826 S30_3B Matt Simmonds 21 September 2006

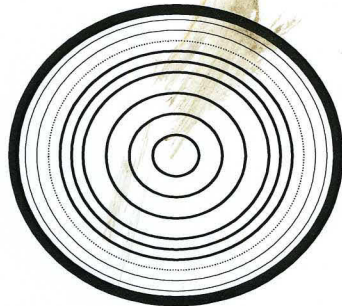
Plank in good cond. although somewhat damaged. edges

OB: Type 4, double X

IB: poss type 1 next to scarf

Radial. 105 H. Pith beyond lower edge? ARW = 200/105.
