Cow Tag	422	Function Code	T/NG/E L ≤28.51

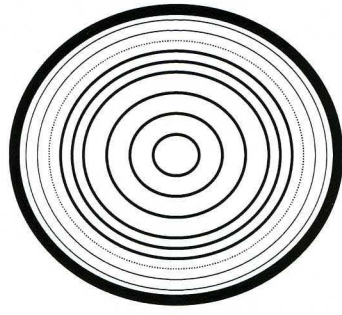
I.B. N.N.F axe marks

O.B. - Lots of lines along length of plank

double 'o' c. middle of plank -
clamp work?

NB No rebates = later repair?
