DB 12/3/8

Cow Tag: S21	Function Code: S 6.5

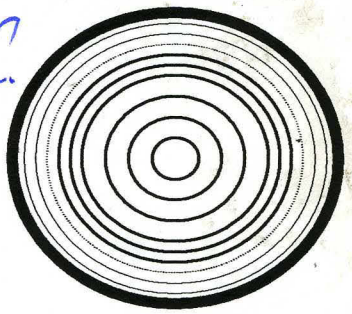
Brief Description: [timber element, p/s, condition, fragments]
GOOD CONDITION

INBOARD:- STEP IN LAND, c. 1 m FROM AFT END
" " " " 0.6 m " FORE END
clamp impression horn upper edge

OUTBOARD:- POSSIBLE STAIR ON AFT EDGE OF 4th
NAIL HEAD IMPRESSION ON UPPER EDGE OF
PLANK FROM AFT END OF PLANK

c110 radial pith beyond upper edge?
ARW = 235/110.

Recommended action: [samples, additional photos, moulding, queries and problems]
photo: inboard face (middle section) ꝏ-shaped impression
