# Plot G, Walled Garden House, Wardhouse Estate, Kennethmont, Huntly, AB52 6YL
# Report on Level 1 Standing Building Survey

**Alison Cameron**
**Cameron Archaeology**
**30 June 2015**

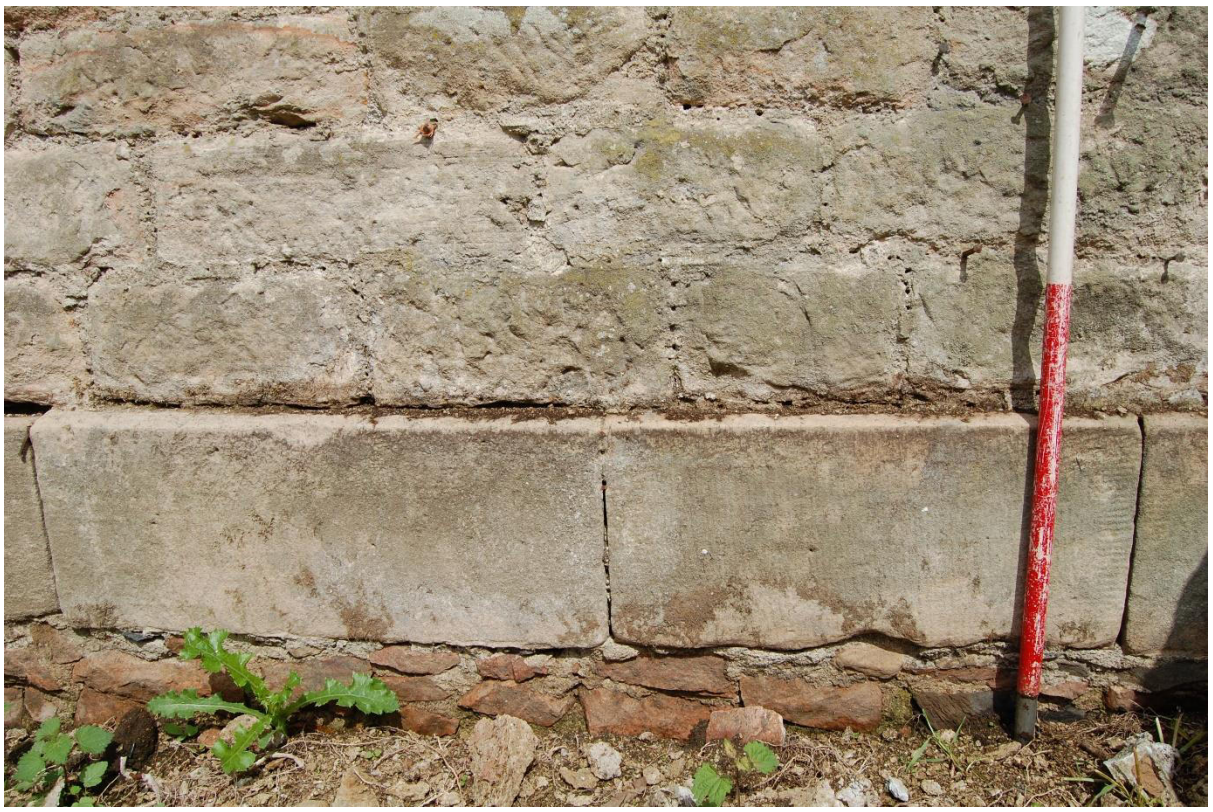
Illus 4 Foundation for the wall F7; facing NNW
