DB 19/2/8

Cow Tag	Function Code
248	TINGLE (OB)

TINGLE - S 24.4 - S24.5

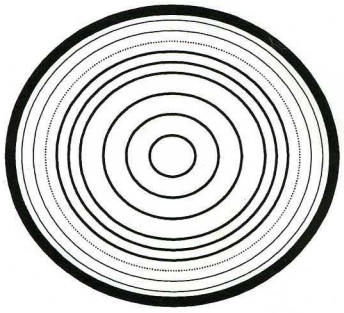
INBOARD:- ~~Cutting~~ LUTING - upto 3 - 4 mm for end
" - " 5 mm aft end (upto 10 mm in ace niche)

outboard:- possible toolmarks & for end

AFT EDGE POSSIBLY SAWN?
Series of Type 3 drawnnds along crack outboard from foremast, upper rail.

Pith beyond upper edge.
Marked growth band.
c 60 A ARW = 165/60.
Radial

Need to check possible saw cut on end (aft).
Photo type 3 lines at crack forward OB.
