| Cow Tag 301	Function Code filler between F10.2 and coco 2035

Cow Tag	301	Function Code Not AVAIL. ceiling Plank?

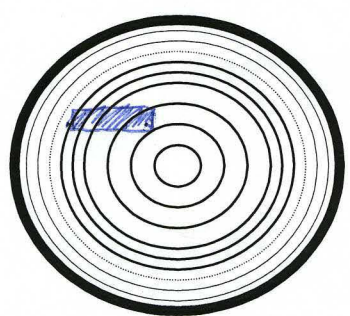
Filler.

Rec as starboard.
Nail on edge JB → at an angle so that it is not visible on the OB.

$$ARW = \frac{125}{33}$$

Tangential Sawn

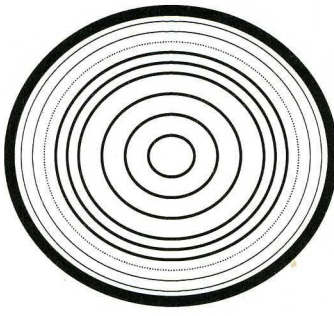
fragment

Lots of tool marks, both Sides
