Cow Tag 564	Function Code P2.4

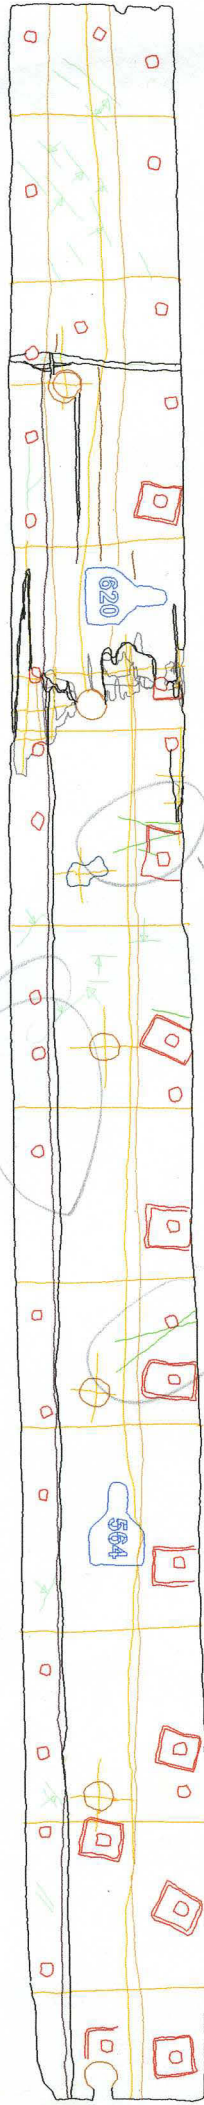
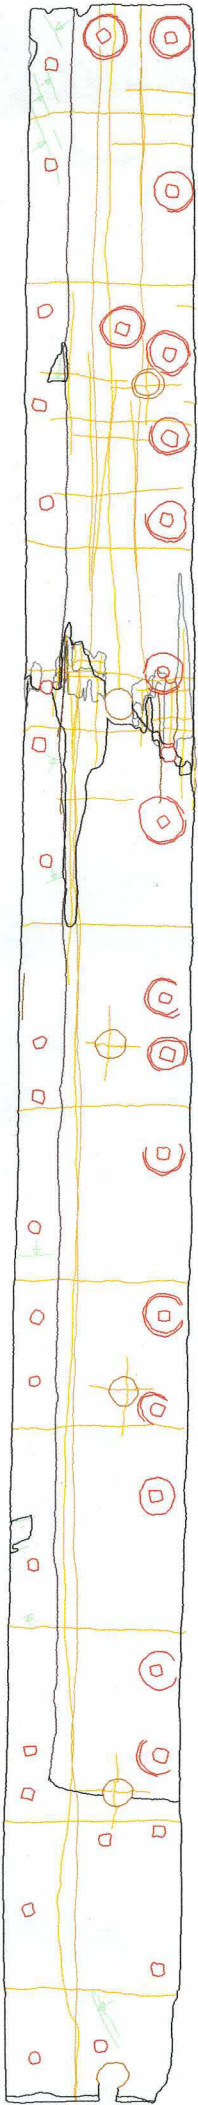
Radial with bevel on inboard last
cutting across grain — see drawing
Age tree? If so path beyond upper

ledge. c.110↓ ARW = 195/110.

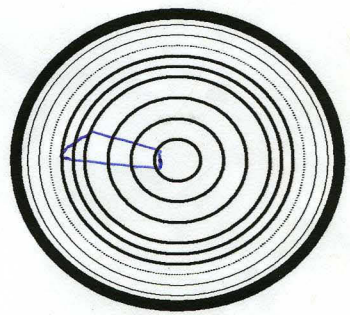
Notable Features: [tool marks, scribed lines, decoration, repairs] POINTS TO LOOK OUT FOR WHEN RECORDING ufos
ON THE INBOARD FACE TWO INTENTIONAL MARKS, ON THE
LAND ~~WE~~ VERY WELL VISIBLE TOOL MARKS. ~~SOME~~
~~PART OF THOUSE MAI TO MARKS HALE~~
