DB 13/3/8

Cow Tag	Function Code
~~581~~ 581	P2.6

Brief Description: [timber element, p/s, condition, fragments]

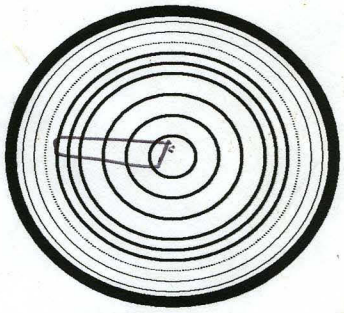
Near complete plank with marked bend.

2 small Fe nails at aft end with head impressions on outboard.
Well defined tool signatures on forward scarf.
Heavily eroded outboard upper land.

c 67H ARW = 170/67. Radial unclear which edge nearest centre
A number of small knots.

Mould tool signatures forward scarf.

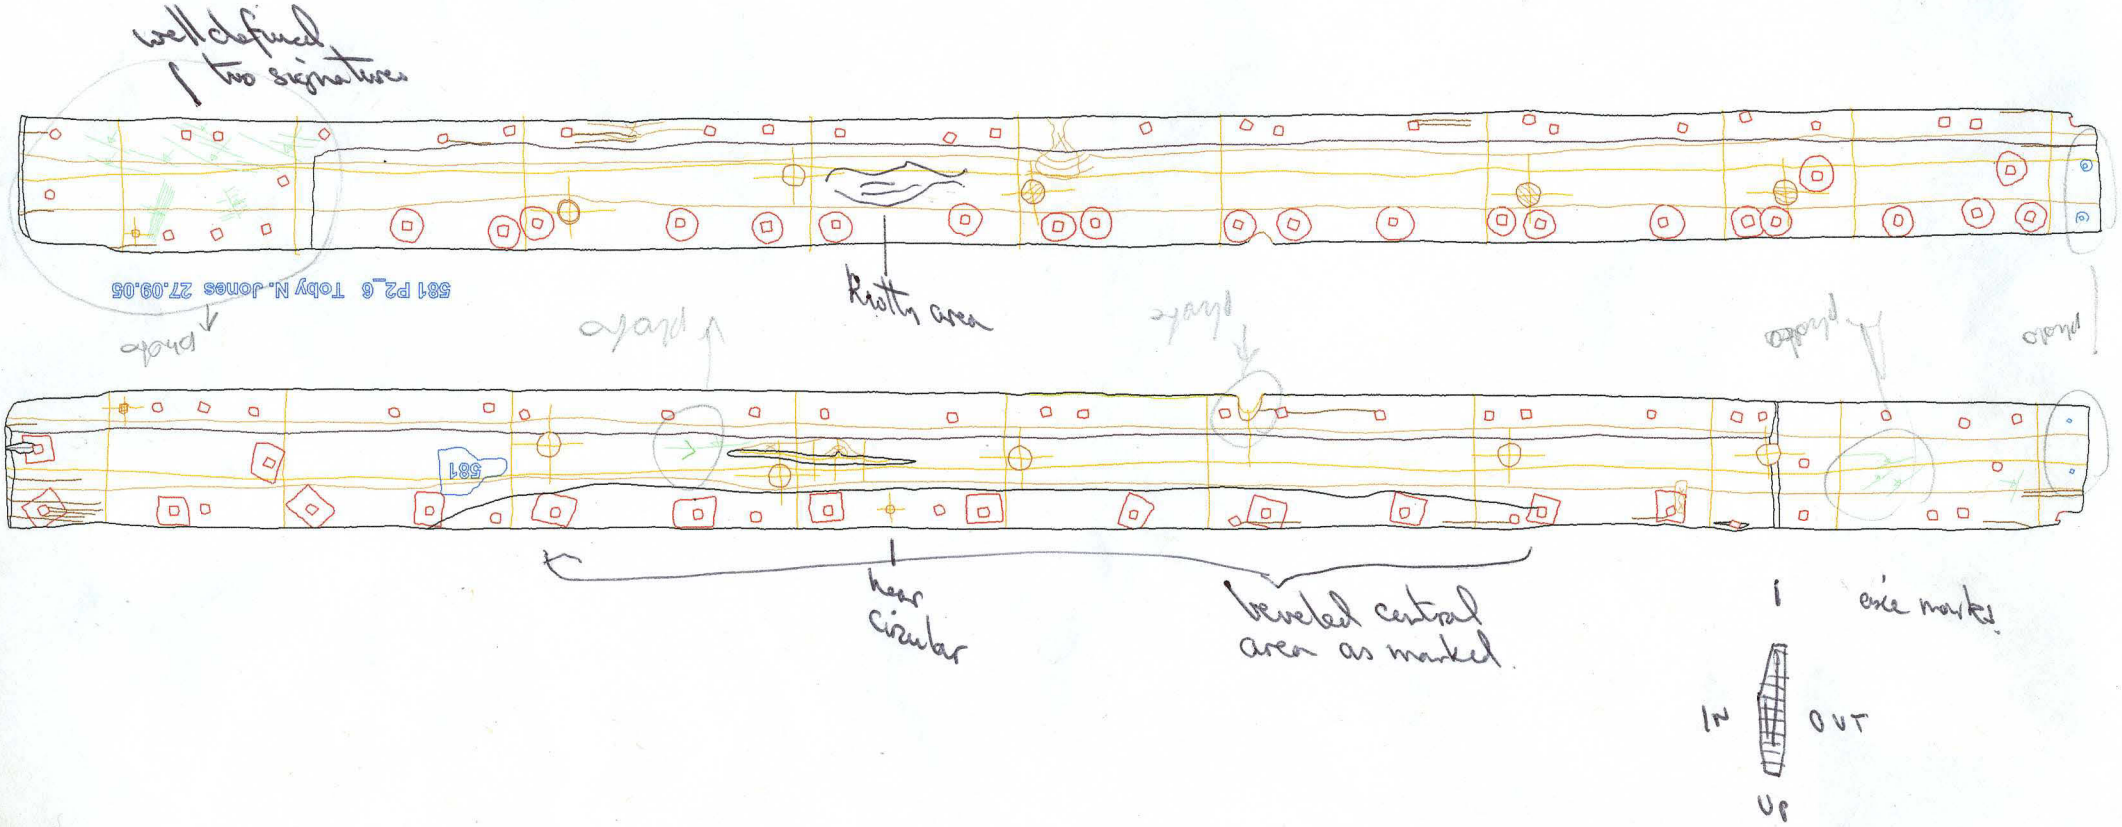
3/D

well defined
/ two signatures
581 P2_6 Toby N. Jones 27.09.05
Rivet area
bevel
bevel
bevel
bevel
581
bevel
bevel
bevel
bevel
rear
circular
beveled central
area as marked
1
exit marks
IN
OUT
UP
