DB 13/3/8

Cow Tag 583	Function Code 52.8

Brief Description: [timber element, p/s, condition, fragments]

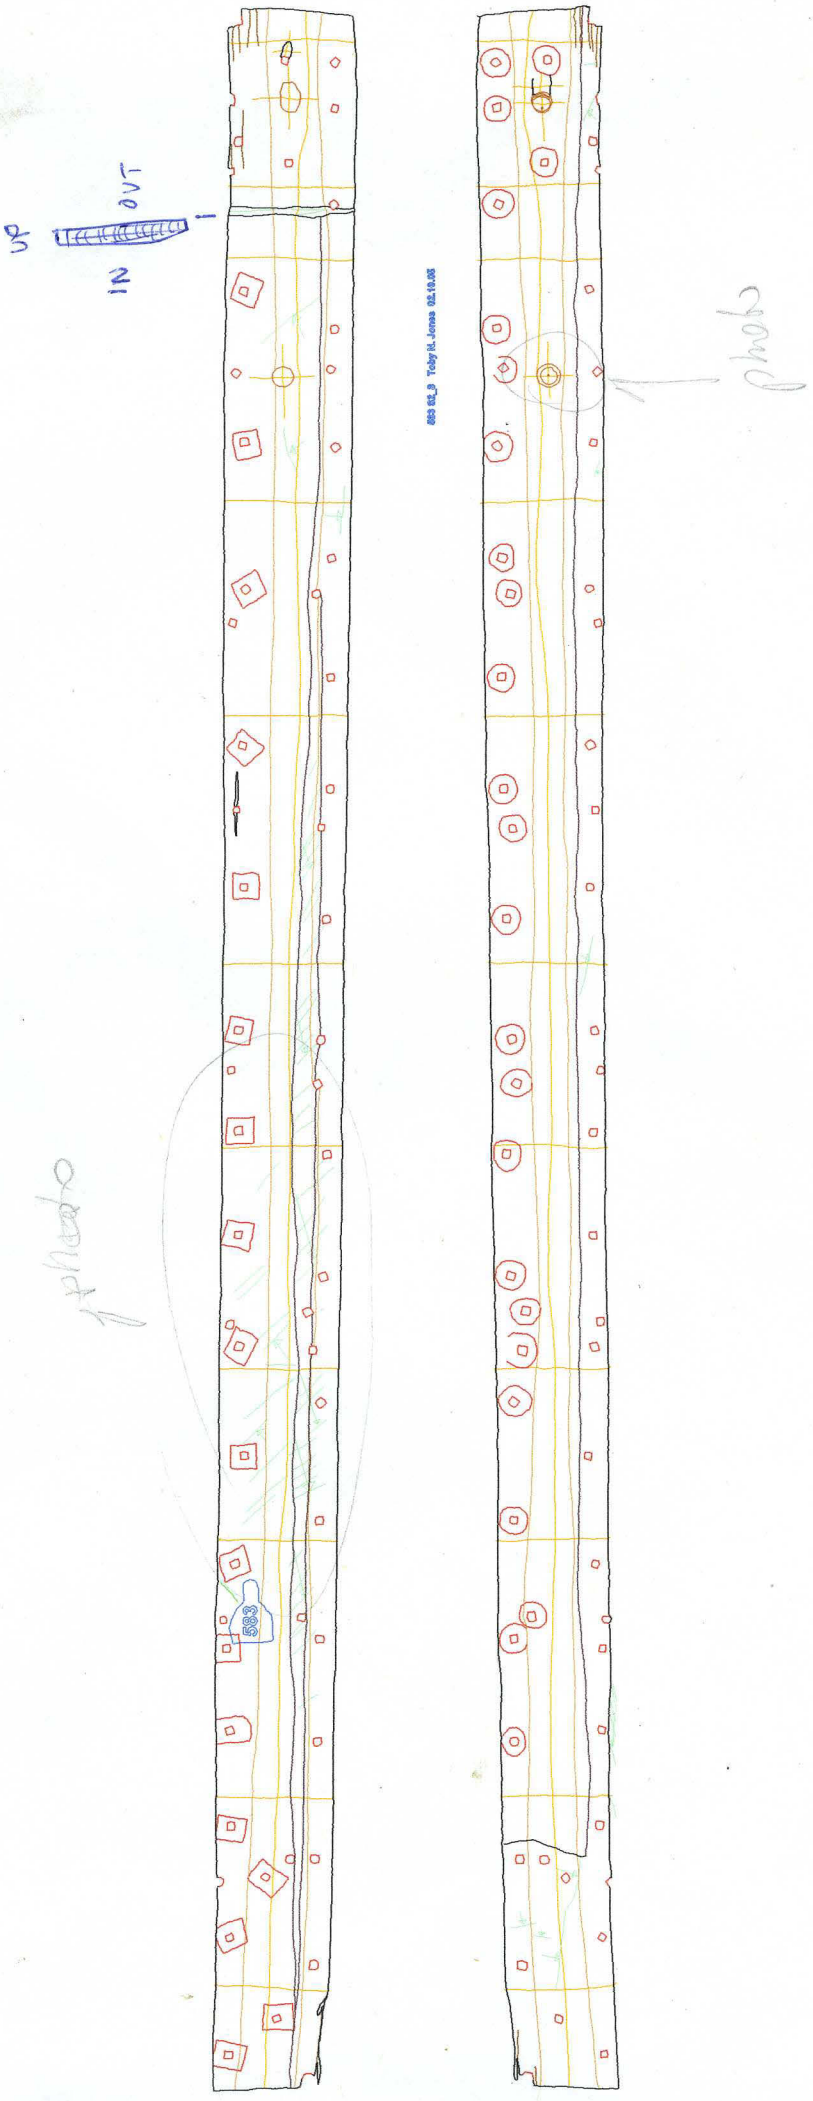
UP
OUT
IN
583
photo
photo

Near complete plank

Heavily worked inboard face.

Radial, Centre beyond lower edge

c 80H ARW = 18 1/60

Cleaned:	Recorded: TNJ 02.10.05	Photos: 09/03/06 MMR IN: TOOL SIGNATURES INS. LINES OUT: TREENAIL WITH DIMPLE B/D
Checked: [corrections needed] NN.		Initials & Date: 11/10/5
Corrections Done [desktop, Faro Arm?]:		Initials & Date:
